Research Report
KTC-94-8

FOLLOW-UP INSPECTION OF PREMATURE
CRACKING ON THE
NATIONAL TURNPIKE, JEFFERSON COUNTY

March 1994

Appendix A
Concrete Slab Distresses 1993

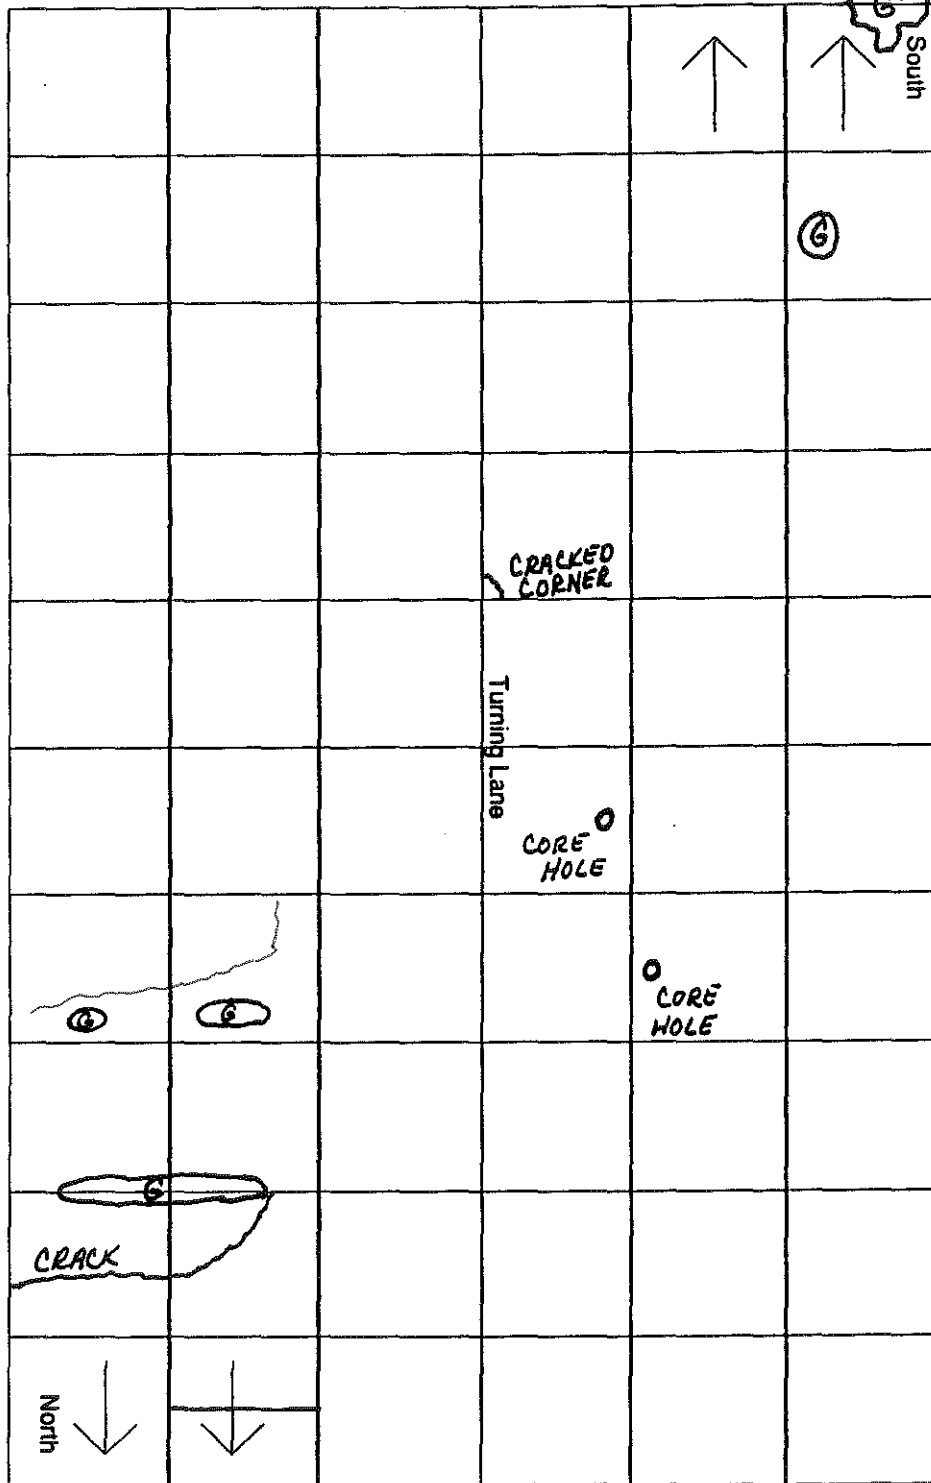
Significant faulting and cracking were observed at Station 82+12 and Station 75+04. Both of these stations are located adjacent to manholes (storm drains). It appears that substantial settlement is still occurring around the some of the storm drains.

4. Significant faulting and cracking was observed at Station 82+12 and Station 75+04. Both of these stations are located adjacent to manholes (storm drains). These slabs need to be replaced. Table 3 also indicates several other slabs that need to be replaced.
