Research Report
KTC-94-20

EVALUATION OF PAVEMENT EDGE DRAINS
AND THE EFFECT ON
PAVEMENT PERFORMANCE

September 1994

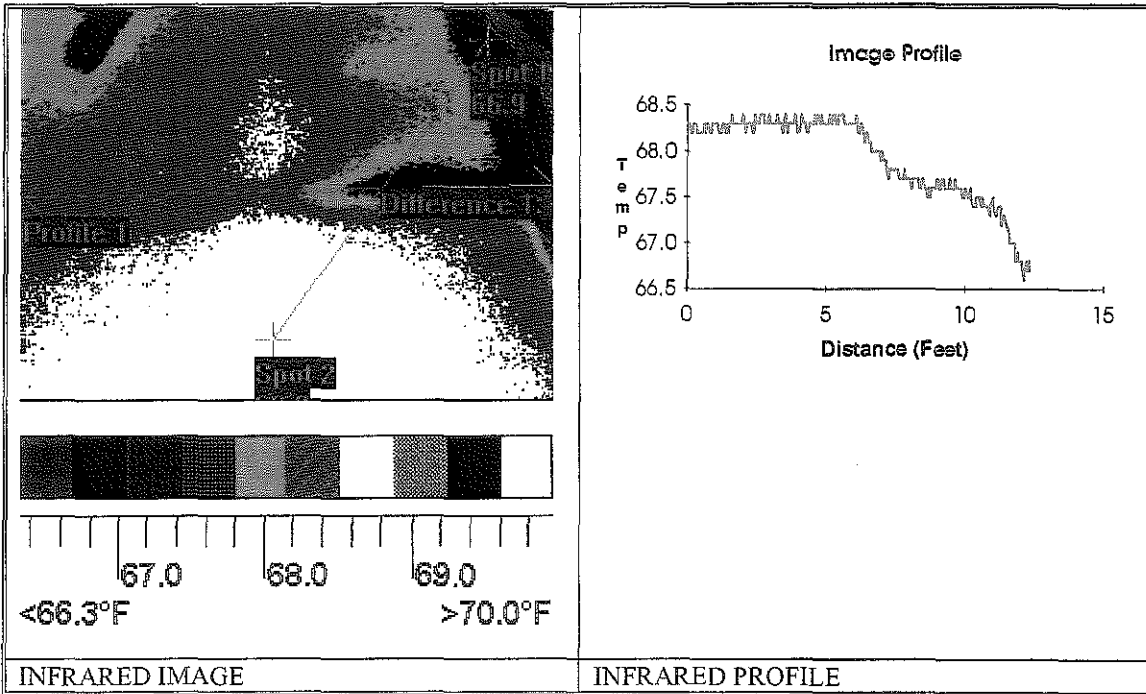
ROUTE	BLUEGRASS PARKWAY
MILEPOST	36.0
DIRECTION	WEST BOUND
LANE	OUTSIDE
DRAINAGE TYPE	NON
DATE	09/24/1993
TIME	10:22:05 AM

IMAGE NAME	A:\16.TIF
MINIMUM TEMPERATURE	66.9
MAXIMUM TEMPERATURE	68.8
TEMPERATURE DIFFERENCE	-1.9
TEMPERATURE UNITS	F

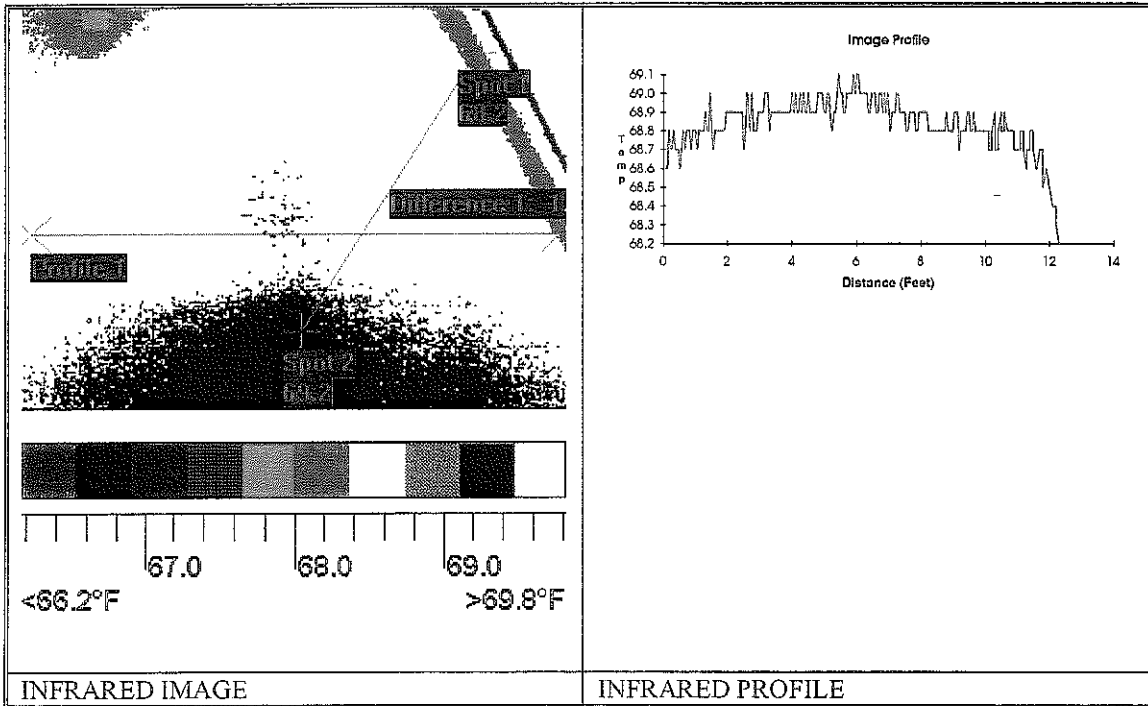
FIGURE 23. THERMOGRAPHIC INSPECTION OF BLUEGRASS PARKWAY
(M.P. 34.4).

ROUTE	BLUEGRASS PARKWAY
MILEPOST	34.4
DIRECTION	WEST
LANE	OUTSIDE
DRAINAGE TYPE	ADVANEDGE PANEL DRAIN
DATE	09/24/1993
TIME	10:38:07 AM

IMAGE NAME	a:\01.tif
MINIMUM TEMPERATURE	68.2
MAXIMUM TEMPERATURE	69.2
TEMPERATURE DIFFERENCE	-1
TEMPERATURE UNITS	F
