**Research Report
KTC-93-30**

**VISUAL OBSERVATIONS OF PARKING AND DRIVING AREAS AND
DRAINAGE CONDITIONS ON COLVERFIELD LANE
FORT WRIGHT TRACE, FORT WRIGHT, KY.**

David L. Allen
Chief Research Engineer

November 1993

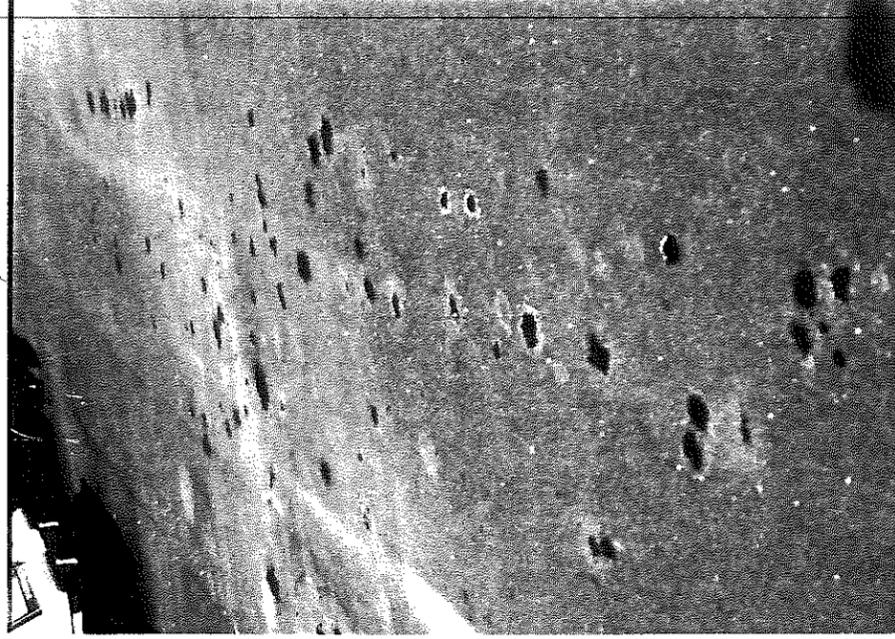
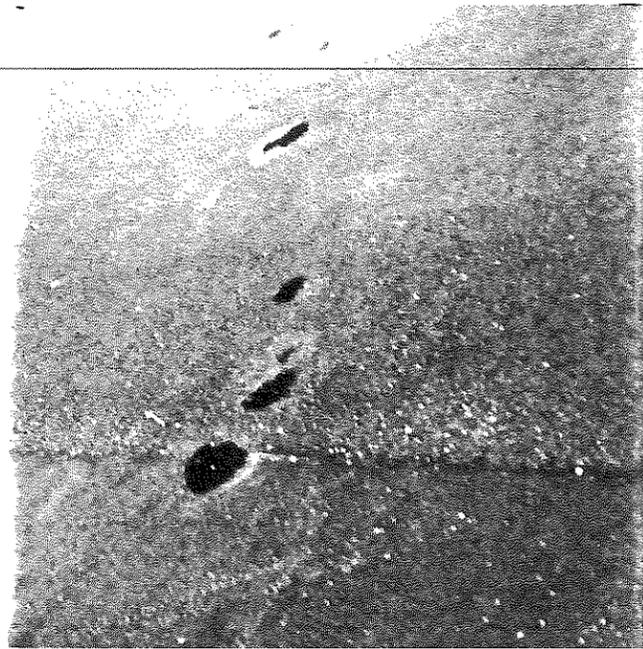
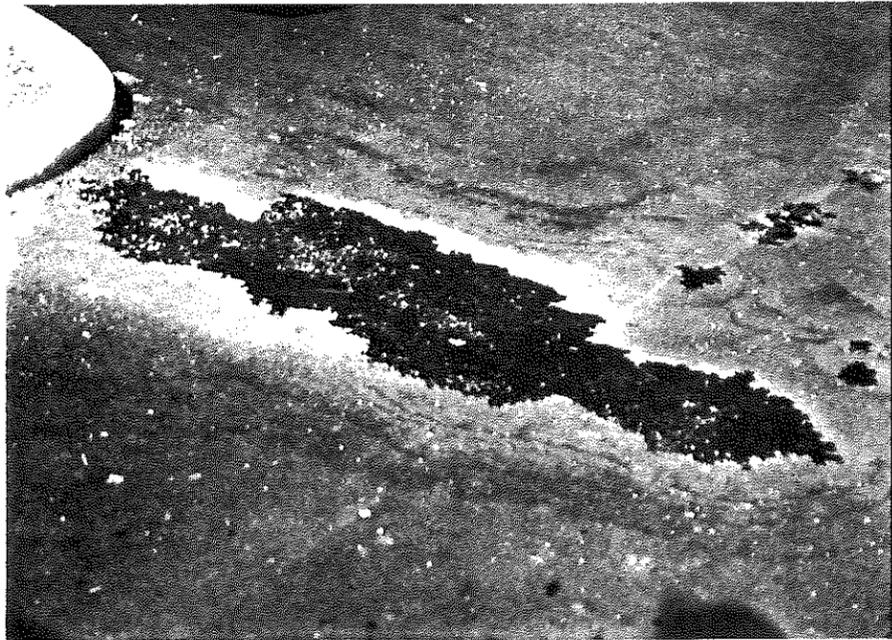
Figure 12

Figures 12 through 16 show where water is seeping through the asphalt layers in locations that are not associated with the construction joint between the curb and the asphalt pavement. The light-colored stains associated with the seepage in Figures 12 through 14 appear to be fine-grained material flushing or pumping up through the asphalt layers from the subgrade. Figure 15 shows some darker brown staining. This may indicate that the water that is seeping through the asphalt is emulsifying (dissolving into the water) the asphalt binder or cement used in the asphalt mixture.

From the amount of subsurface seepage evident, it is indicated that much of the subgrade soil may be saturated or nearly saturated. It is assumed the subgrade soil is probably a fine-grained clay. Fine-grained clays usually lose much of their shear strength and/or bearing capacity when they become saturated. This will drastically reduce the service life of the pavement, probably causing premature failure of the pavement.

Additionally, if the bottom of the asphalt layers is saturated for extended periods of time (as suspected in this case) or if there are extended periods of seepage through the asphalt layers, this may dissolve or strip the asphalt cement from the aggregate, and cause rapid deterioration in the asphalt layers.

4. All storm drain sizes should be checked to determine if proper sizes were installed.
5. Core samples should be obtained of the asphalt layers in areas of alligator cracking, in areas where there are water seeps in dry weather, and in areas where depressions the asphalt have occurred. The following items should be checked:

- C. ~~Visually check all cores for signs of asphalt stripping or emulsion due to water seepage or saturation,~~
- D. Determine grain-size distribution on at least two cores from the portion of the pavement that was paved in July 1993 and determine if the gradation meets a surface gradation as specified by the Kentucky Department of Highways or Kenton County,
- E. Repeat Item D for the portion of pavement that was paved approximately two years ago,
- F. Sample the subgrade soils at the bottom of each core hole,
- G. Determine in-situ moisture content of each soil sample and determine grain-size distribution of one or two of the soil samples, and
- H. Monitor the core holes for one to three hours after the sample was obtained to determine if the hole fills with water (this will help to determine if the water under the pavement is under a pressure head),

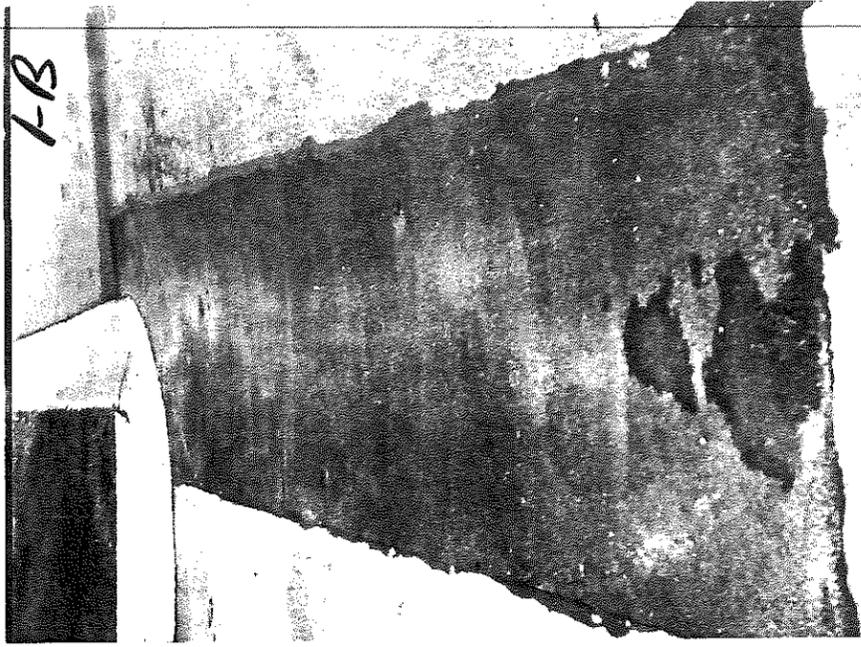
Figure 16 shows a patch located right of Station 2+25 on Cloverfield Lane. Water is also seeping under this patch, and the surface of the patch has sunk.

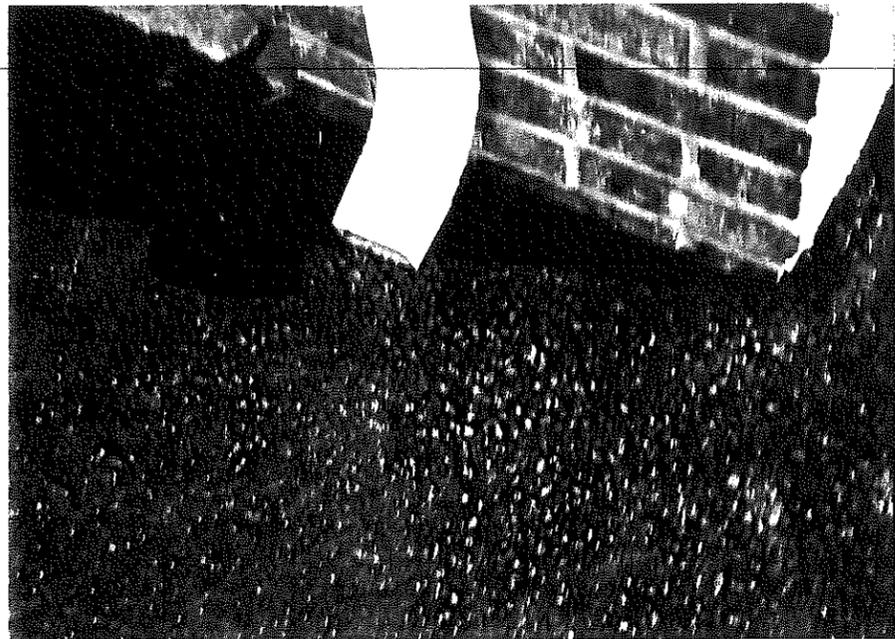
Figure 19

The typical pavement section for Cloverfield Lane indicated there should be a final two-inch surface course for the driving lanes and parking areas. It is presumed by the author that this implies the top two inches of asphaltic material would consist of an asphaltic mixture that would meet the gradation and asphalt cement content specifications of a typical asphaltic surface mixture (the Kentucky Department of Highways publication entitled "Standard Specifications for Road and Bridge Construction" contains a typical specification). However, the surface mixture on the portion of Cloverfield Lane and adjacent parking areas from approximate Station 6+50 to Station 11+85 appears to be a very "atypical" mixture. From the visual inspection, the author would question the possibility of this mixture being a surface mixture. The visual appearance would indicate the mixture to be somewhat open or gap-graded with the top size aggregate appearing to be somewhat larger than what might be expected of a surface mixture. Additionally, the appearance of the material

in front of the garage entrances located to the right of centerline would indicate the possibility that the material may not have been properly compacted. The owners' representatives indicated that the surface was very porous, and that water which came from the downspouts on the garages quickly disappeared into the asphalt surface. This also would indicate poor compaction. Figures 19 through 21 are typical examples of the appearance of the surface mixture.

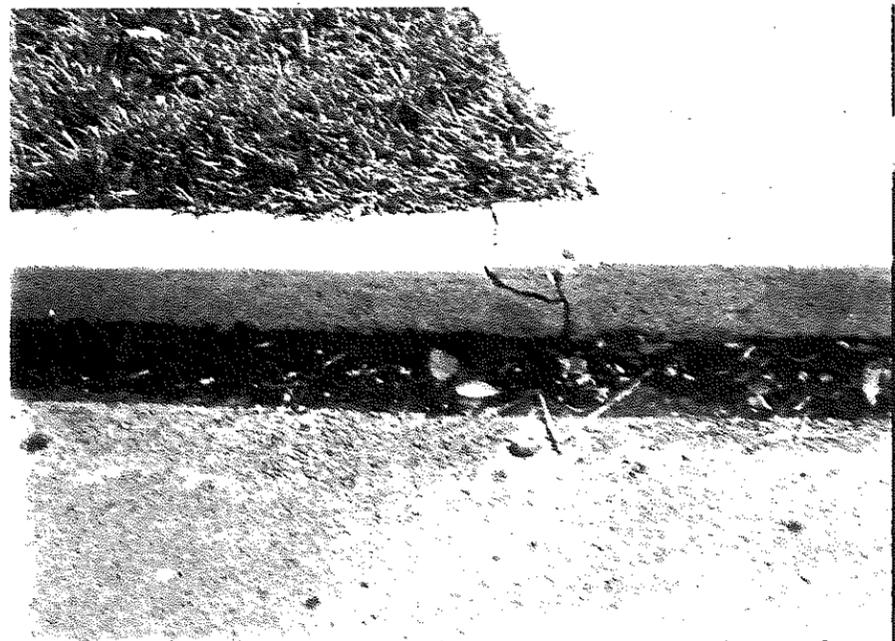
Figure 22

The typical section for Cloverfield Lane indicated the concrete box curb was to be constructed on top of the final asphalt base course. The owners' representatives said the curb had been constructed on the soil. Although the author did not attempt to definitely confirm this, in one location, soil did appear to be in contact with the base of the curb. From Station 2+25 to approximate Station 5+00, joints had not been sawn into the concrete curb. The results of this failure to do so are shown in Figure 22.

6. The concrete curb should be scored to control cracking.
