Research Report
KTC-89-45

CONSTRUCTION AND INSPECTION
REPORT ON CORRUGATED
POLYETHYLENE PIPE, N-12

October 1989

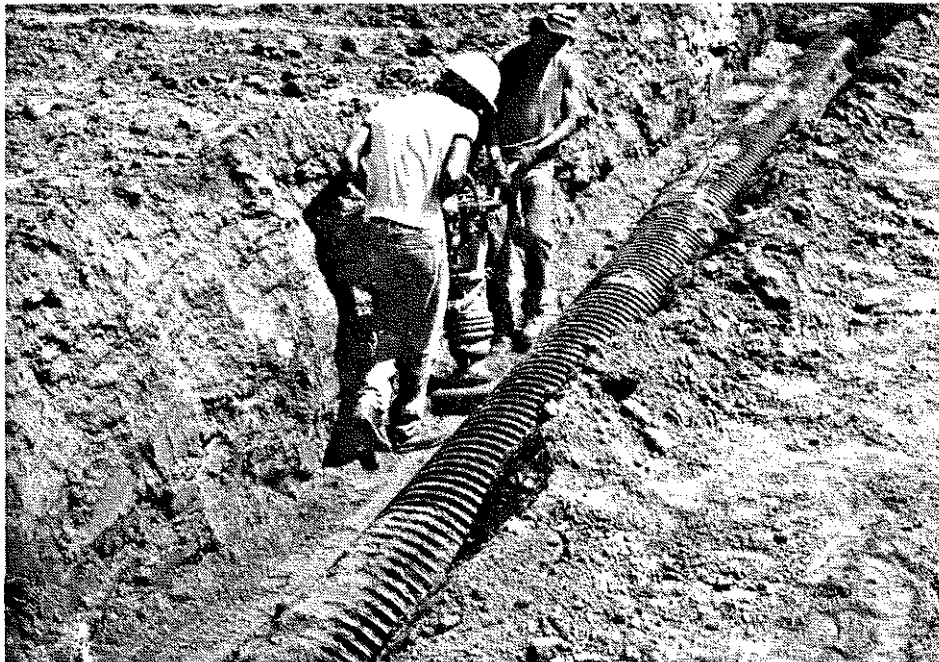
The project begins at Station 93+81.17 and ends at Station 152+00. The first section of N-12 pipe was placed May 18, 1988, at Station 137+88. Approximately 104 feet of 18-inch N-12 were placed at that location. The trench was backfilled with a coarse, clean sand approximately midway up the pipe, and compacted with a vibratory tamper. The remainder of the trench was backfilled with excavated material (Photo 1).

Photo 1. Compacting sand backfill around 18-inch N-12 pipe in Daviess County.

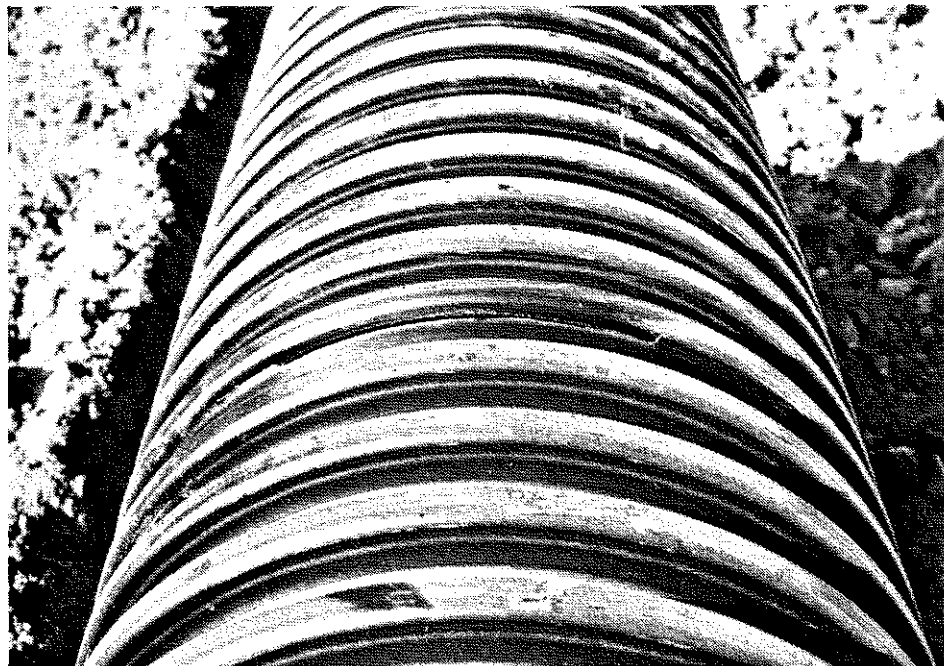
Prior to installation, it was observed that a number of the pipe sections had been cut during construction. It appeared that the sections had been damaged during transport with a backhoe. The damaged sections were returned to the manufacturer for inspection (Photo 2).

Photo 2. Damaged 18 inch N-12 pipe.

From visual observations at all three sites, it is apparent the ends of the pipes at the couplings are rarely butted completely together. This permits material to be deposited in this area. Care should be taken during construction not to damage the plastic pipe during transportation.

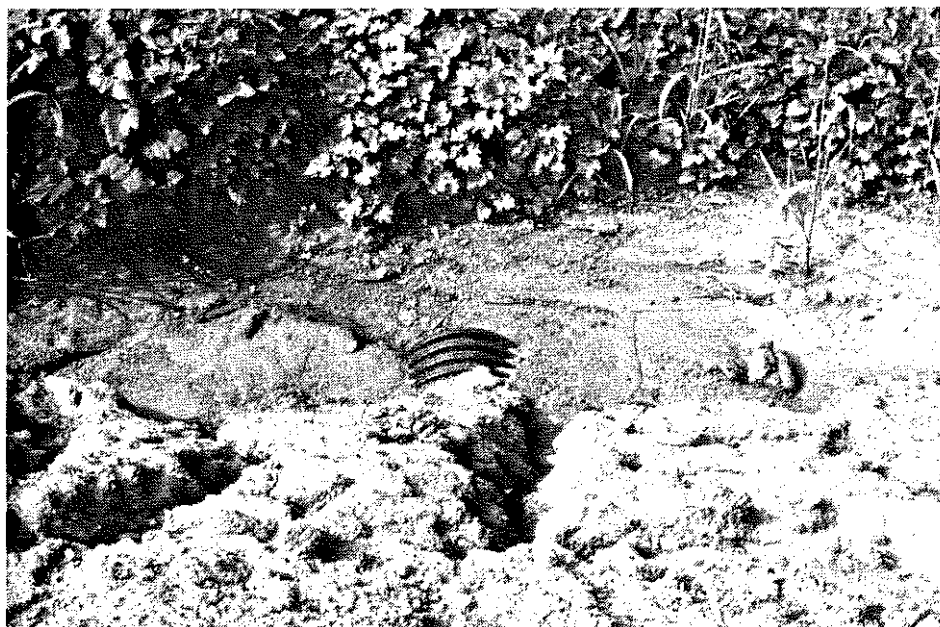
During construction inspection, it was apparent the pipes were becoming clogged due to the time interval between placement of the pipe and the headwall (Photo 3).

Photo 3. Silted pipe in Owensboro.

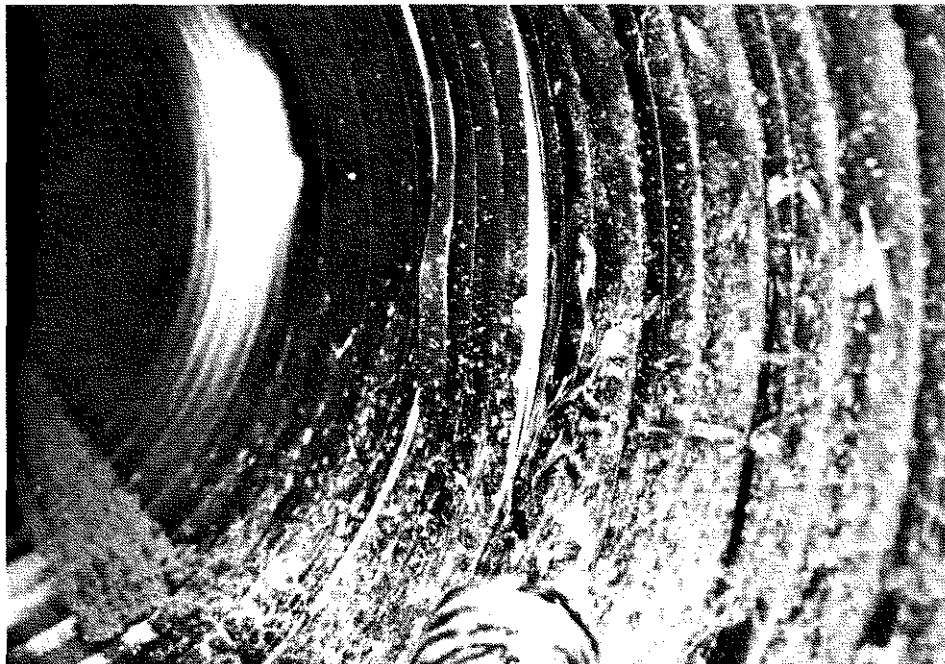
All pipes, including the 18-inch and 15-inch were inspected and photographed. All appeared to be symmetrical. On June 18, 1988 during the inspection of the 104-foot, 18-inch pipe at Station 137+88, a rip or cut was noted in the smooth interior lining of the pipe. The rip follows one of the corrugations and is approximately seven inches in length (Photo 4). The rip was closely inspected again on September 18, 1989. The rip appeared to be approximately the same length and had bulged approximately a one half-inch.

Photo 4. Rip or cut inside an 18 inch pipe.

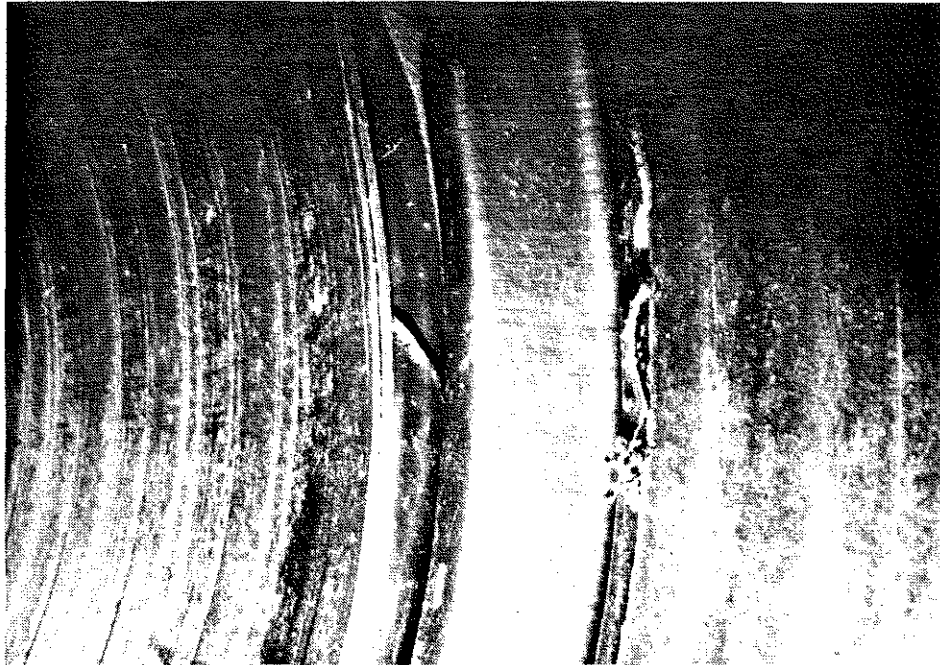
The interior of a 216-foot 18-inch pipe was inspected in detail on September 19, 1989, from Station 126+00 to 128+20. Each 20-foot section was photographed and visually inspected. The pipe appeared to be clean and symmetrical. A four-inch gap was discovered between the first and second joint south of Station 128+20 (Photo No. 5). It was apparent that the sections were not completely butted together at the time of installation. All other joints were inspected and their conditions were recorded. The next largest separation was one inch. A one half-inch separation was fairly common throughout the pipe section.

Photo 5. Four-inch separation between the two connecting pipe ends at the coupling.

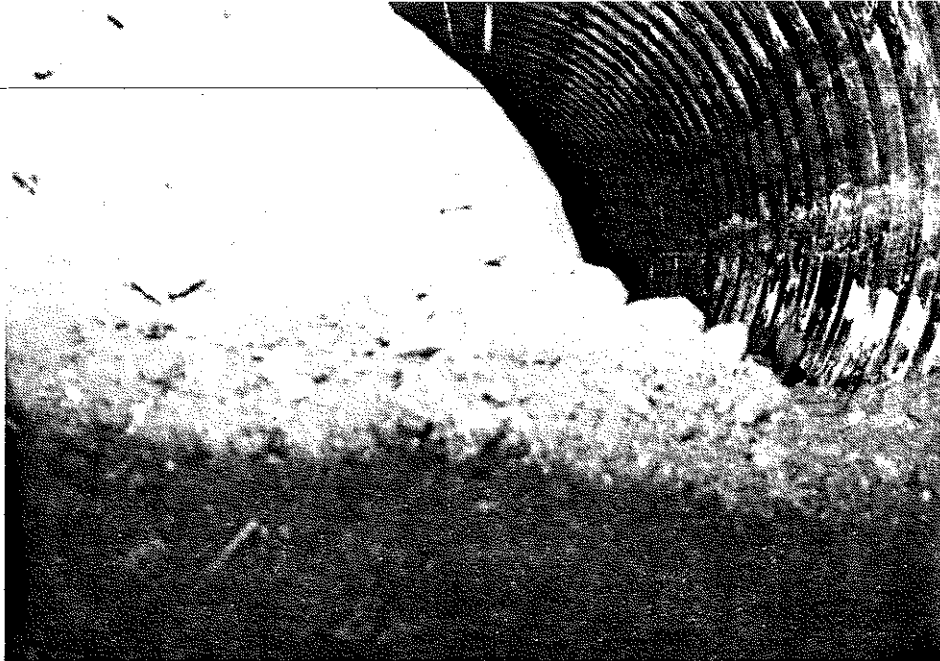
Large amounts of soil and rock had been deposited in two of the pipes leading to the manhole at Station 137+95. It is apparent the material had entered during construction through the grated inlet adjacent to the manhole . Photo No. 6 and Photo No. 7 shows the two partially clogged pipes.

Photo 6. Partially clogged 18-inch pipe.

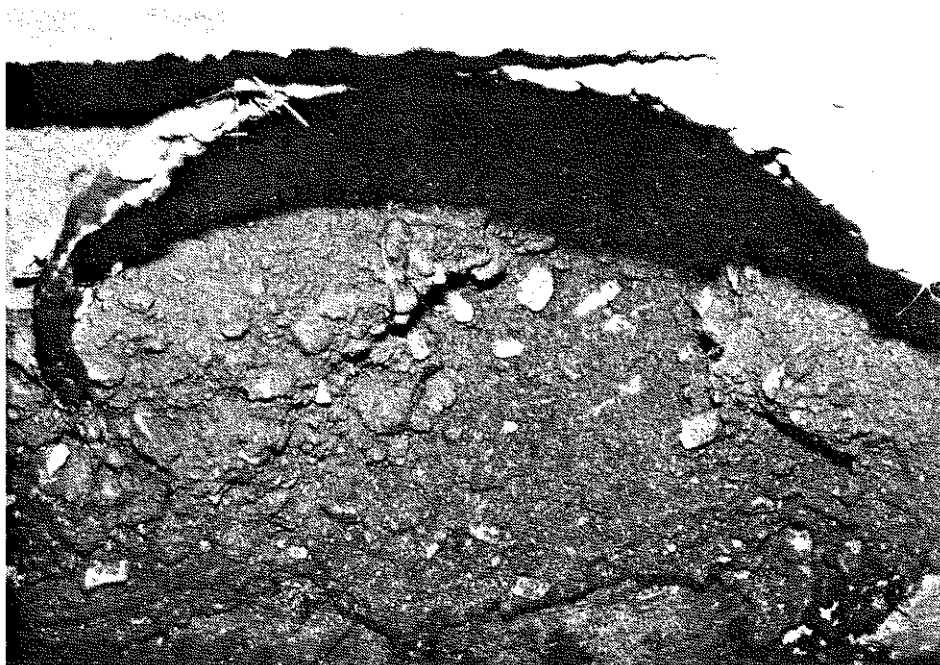
Photo 7. Partially clogged 15-inch pipe.

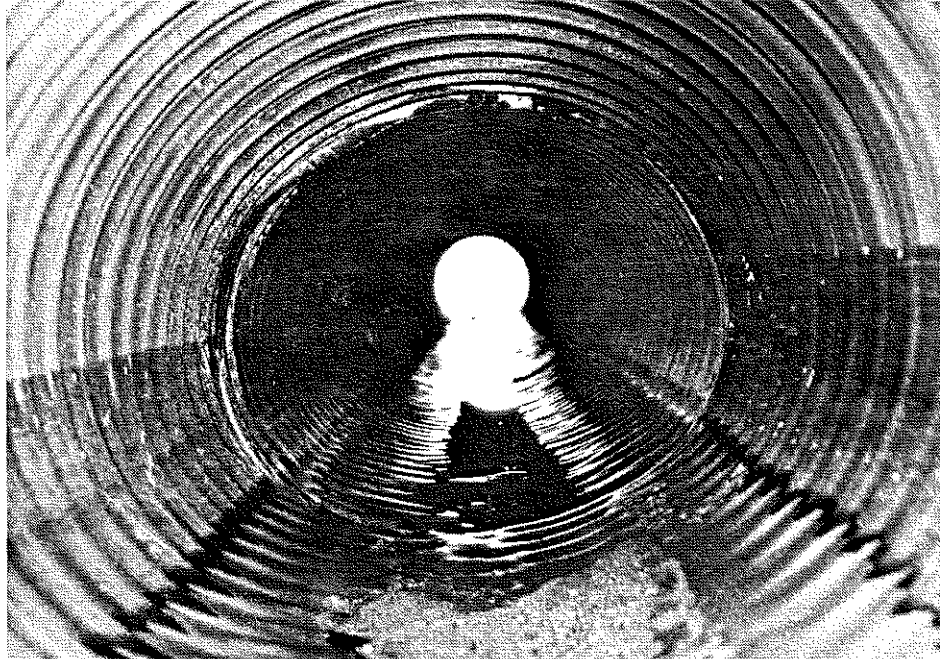
Photo 8. Compression in a 24-inch entrance pipe at Station 174+00.

SITE	DESCRIPTION
No. 1	18-inch entrance pipe slightly irregular
No. 2	24-inch entrance pipe (Station 174+00). Approximately 2.3 inches of deflection at the pipe connection. Some settlement is observed in the gravel drive above the pipe. Approximately 1.5 feet of cover at the south end of the pipe, south side of the gravel drive. The pipe sections are not completely connected.
No. 3	18-inch entrance pipe (Station 167+50). The pipe has approximately 3 inches of cover at 6 feet north of the south end. Approximately 2 inches of compression is noticeable at this point. Inloader tracks are also present on the surface at this point.
No. 4	18-inch entrance pipe (Station 161+50). Slight bow is present at the joint in the pipe. Overall installation looks good. Asphalt surface has been placed within 1 to 2 inches of the top of the pipe.
No. 5	18-inch entrance pipe (Station 151+00-Highland Road). The installation is in good condition.

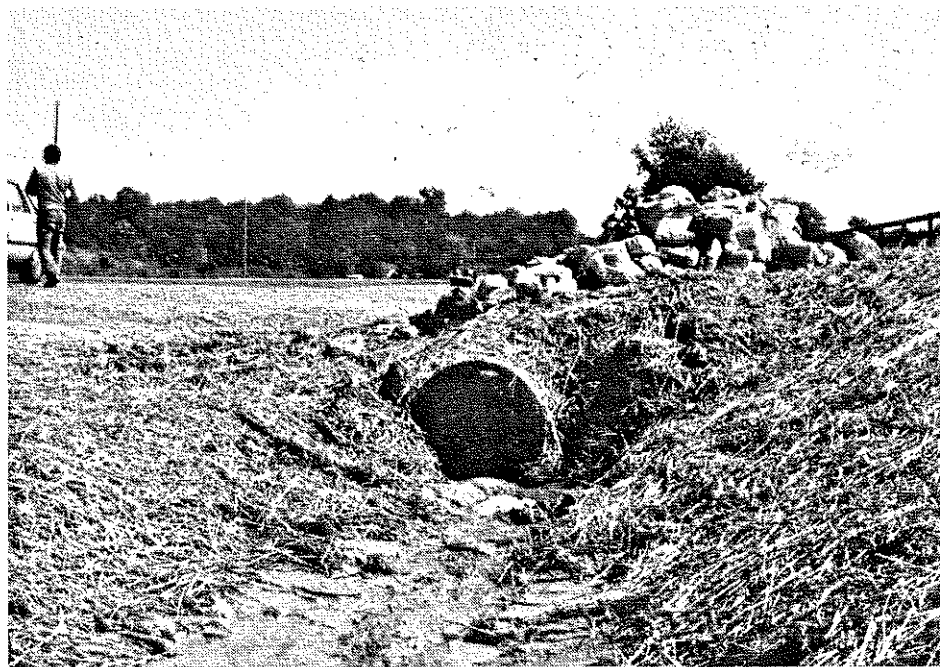
Photo 9. Inloader tracks are present in the thin soil cover above the compressed pipe (Station 167+50).

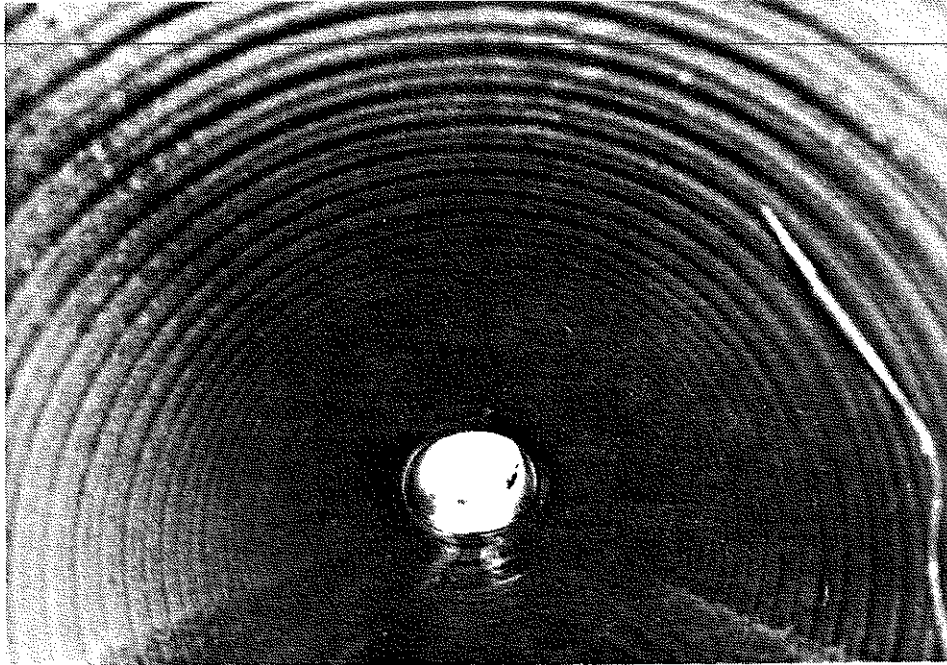
Photo 10. Pipe deflection at Station 167+50
(18-inch pipe).

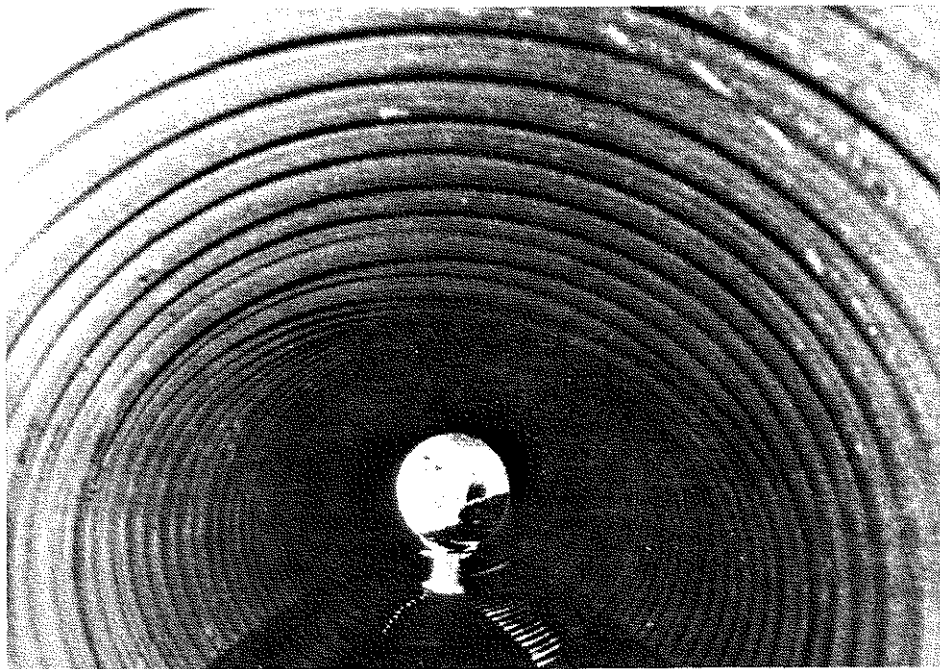
Photo 11. Compression in a 24-inch entrance
pipe at Station 138+50.

No. 6	24-inch entrance pipe (Station 138+50). Approximately 2 inches of compression on the south end. Approximately 4 to 4.5 feet of fill. Pipe does not appear to be bedded on sand or crushed stone.
No. 7	24-inch culvert pipe (Station 134+50). Good installation.
No. 8	30-inch culvert pipe (Station 124+50). Slight vertical deflection approximately 25 inches from the east end. Fairly good shape.
No. 9	15-inch entrance pipe (Station 121+00). Truck entrance for Turner Dairy. Half full of soil. Not much deflection.
No. 10	15-inch entrance pipe (Station 111+00). Half full of soil. Little to no deflection.

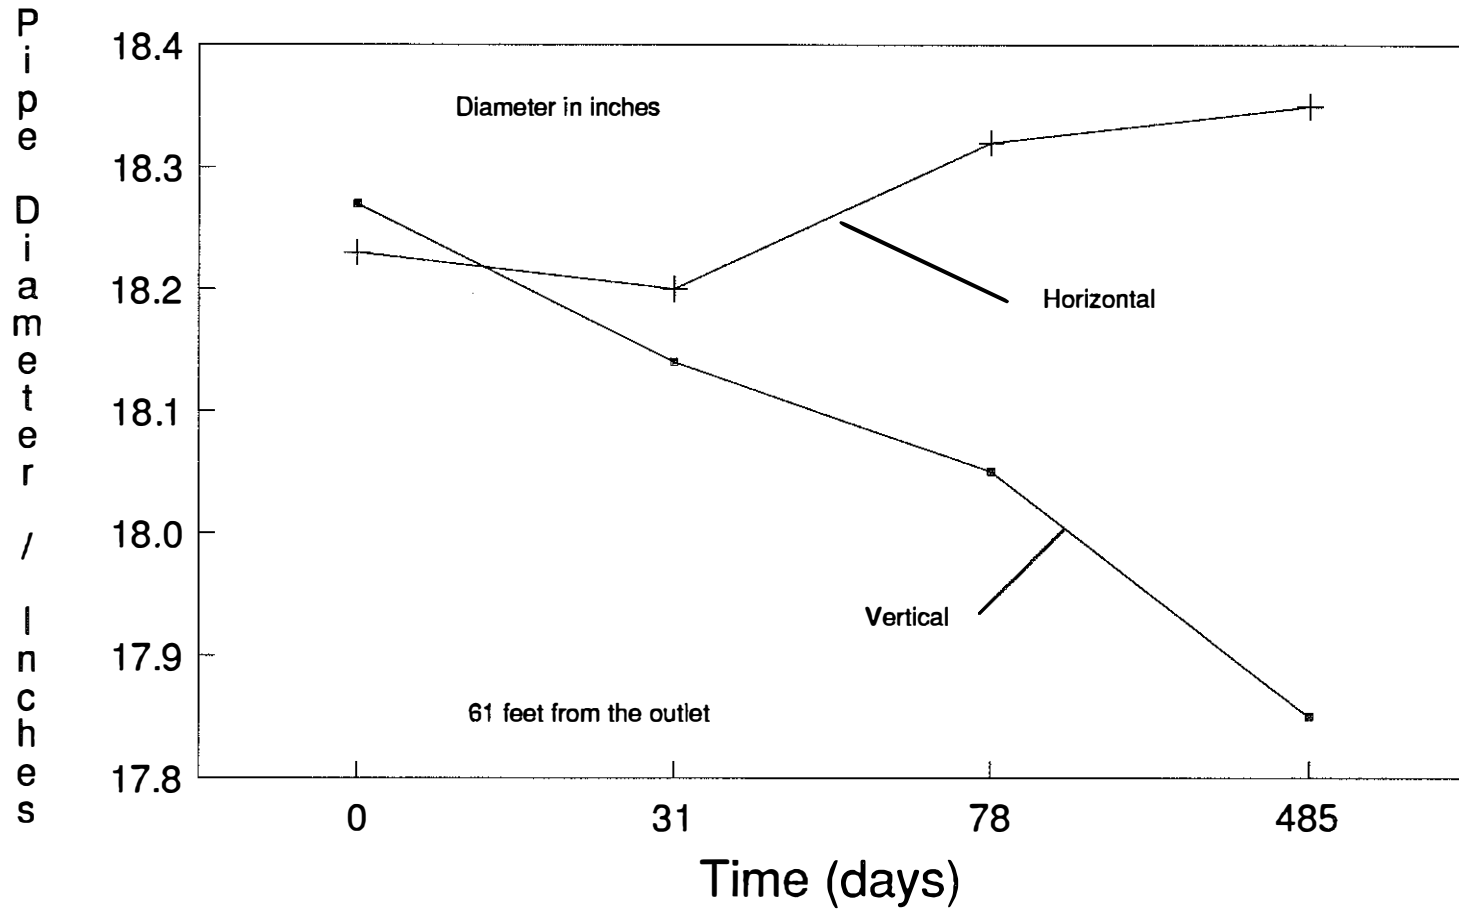
Figure No. 1: 18-Inch N-12 Ky 54, Daviess County, Station 137+88

Two sets of monoritoring points were placed in the pipe at Station 137+88 prior to installation. The monoritoring points were placed at 41 feet and 61 feet from the outlet. The points were monoritored three times in 1988 and on September 18, 1989. Since installation, the interior of the pipe at 61 feet had deflected approximately 0.42 inch, and approximately 0.25 inch at 41 feet (Figures 1 and 2). The fill height above the 61-foot monoritoring point was 6 feet, and the fill height at the 41-foot monoritoring point was 8 feet.

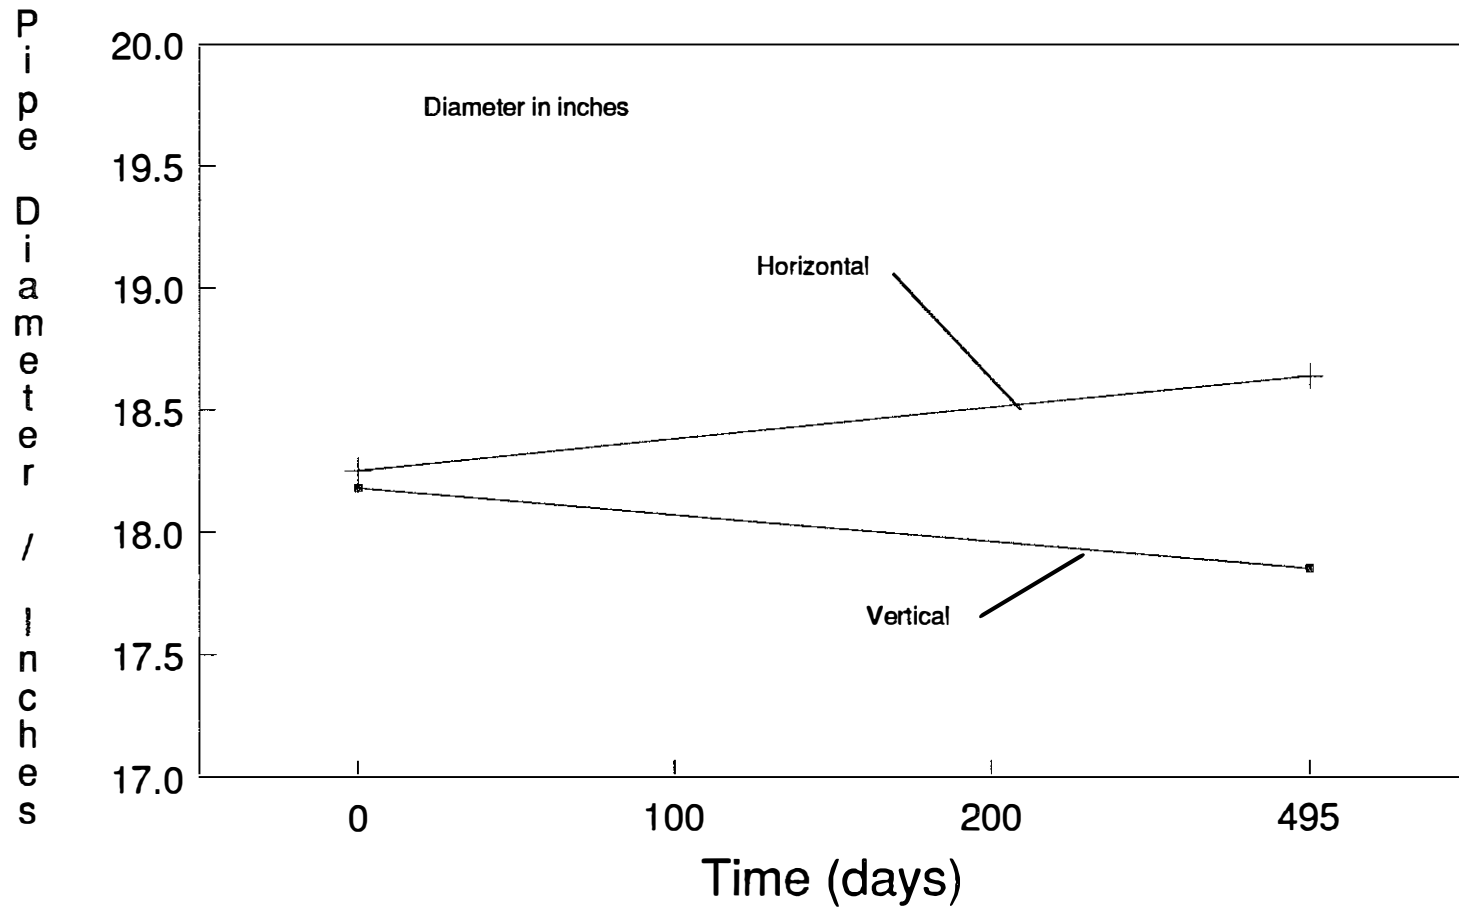
Figure No. 3: 18-Inch N-12 Ky 54, Daviess County, Station 126+00

Monoritoring points were also placed at Station 122+50. Since installation, the interior of the 18-inch pipe has deflected 0.34 inch (Figure 3). Eight additional monoritoring points were placed in the pipes prior to installation. Due to water and mud, the monoritoring points could not be accessed during the last inspection.
