Research Report
KTC-89-50

MOUNTAIN PARKWAY EDGE
DRAIN INSPECTION
(SEPTEMBER 29-OCTOBER 5, 1989)

APPENDIX A
INSPECTION OF STAINING ON THE ASPHALT SURFACE
October 5, 1989

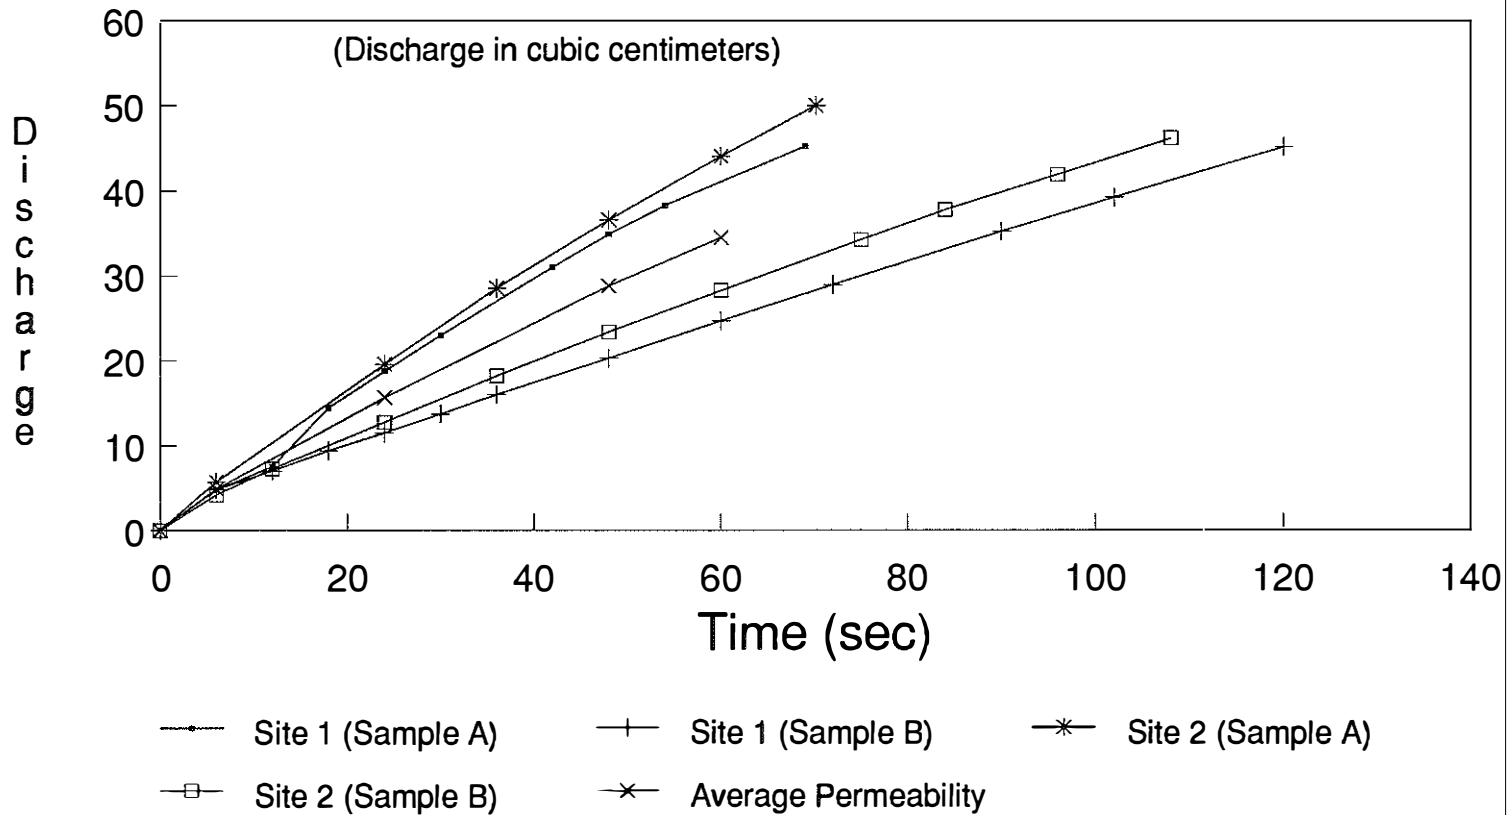
Figure 6. Permeability Asphaltic Surface Course

Samples of the newly placed asphaltic concrete surface course were collected in two locations. Constant-head permeability tests were performed on those samples in the laboratory. Three tests were conducted on each sample. Figure 6 shows the results of the average flow-versus-time curve for each sample (two samples were obtained at each site).

The average coefficient of permeability for the four samples was .000662 centimeters per second.

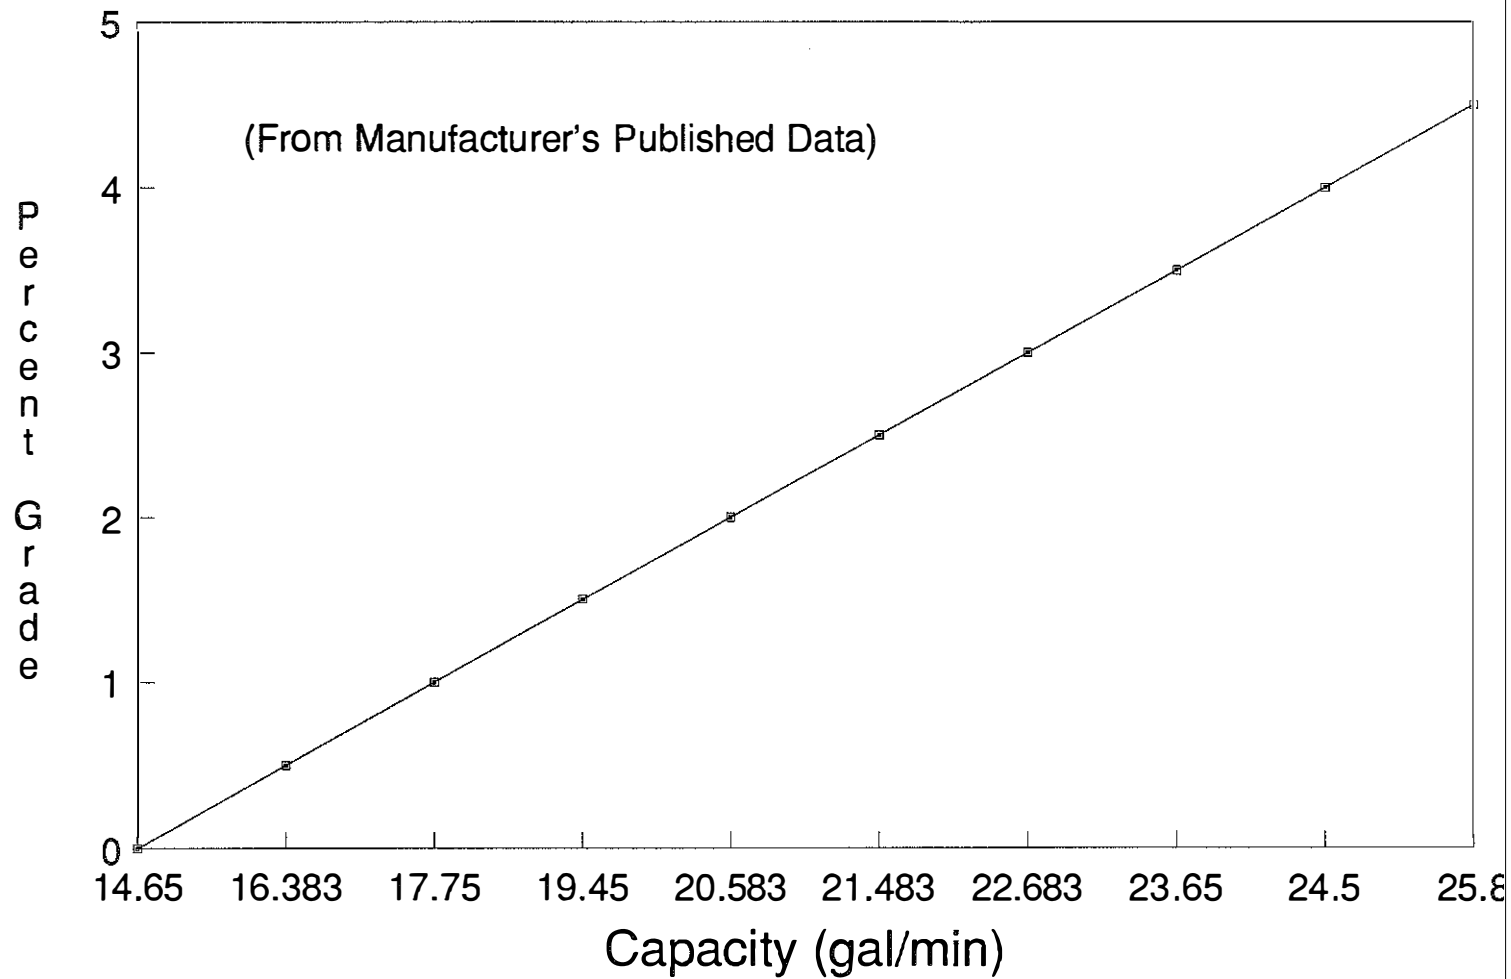
Figure 7. ADS Flow Capacity

The grade of the roadway at Site 2 was 3.7 percent. The manufacturer's published data indicate the capacity of the panel edge drain is approximately 24 gallons per minute at a 3.7 percent grade (Figure 7). At 820 feet between headwalls, the capacity of the drain was exceeded by more than eight times.

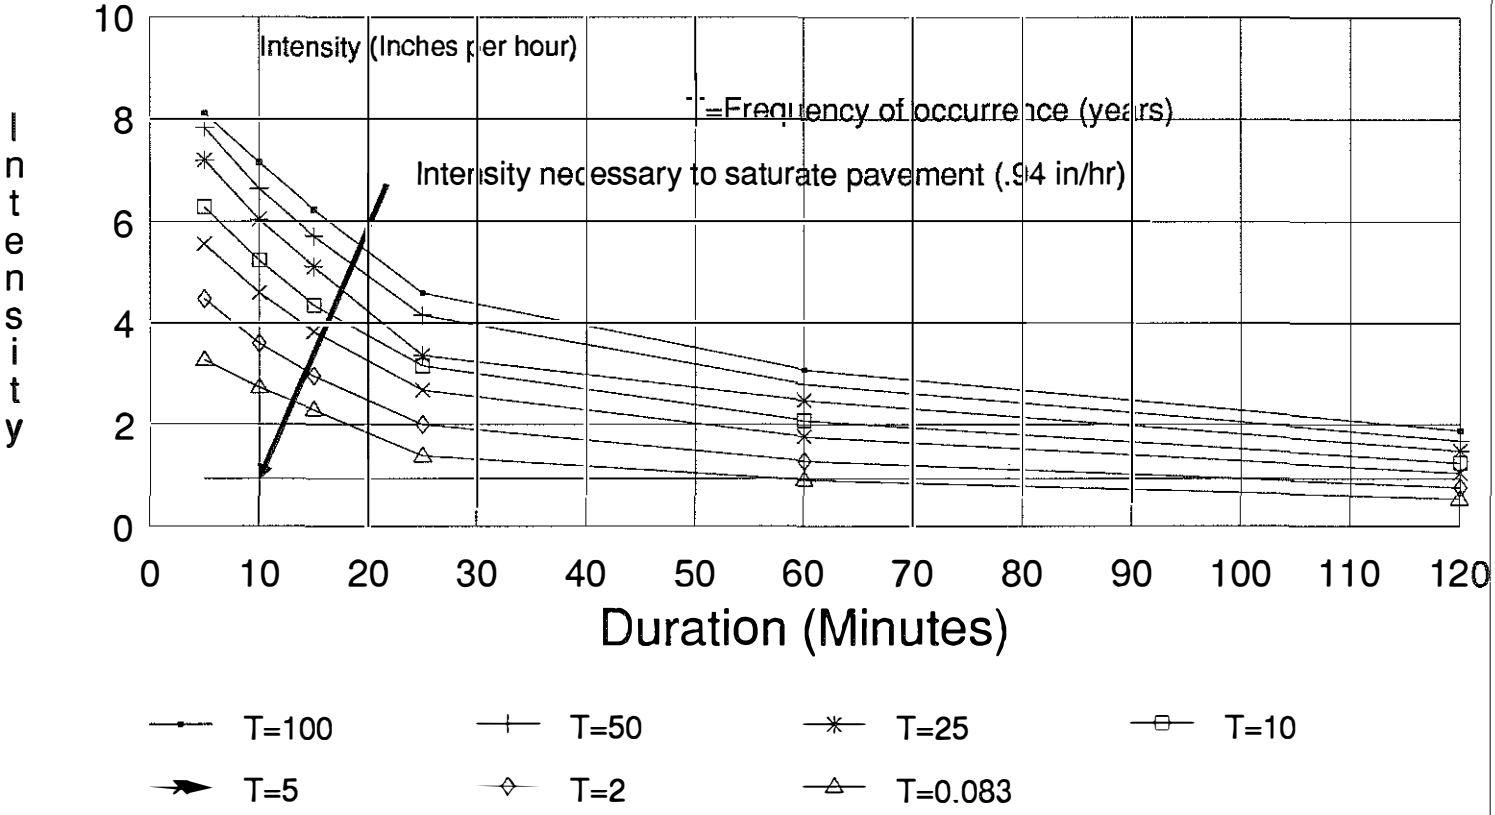
Figure 8. Intensity Duration Curves Lexington, Kentucky

This is approximately equal to 0.016 inch per minute or 0.94 inch per hour of rainfall intensity. Figure 8 shows the frequency of occurrence of this rainfall intensity for Lexington, Kentucky (the closest city for which data are available). A rainfall intensity of 0.96 inch per hour, and a duration of 60 minutes may occur one time each month. However, a rainfall of equal intensity but having a shorter duration could occur several times each month. It appears the capacity of the drains could be exceeded several times each month. Figure 9 is a design chart that may be helpful in determining headwall spacing, if the permeability and the percent grade are known.

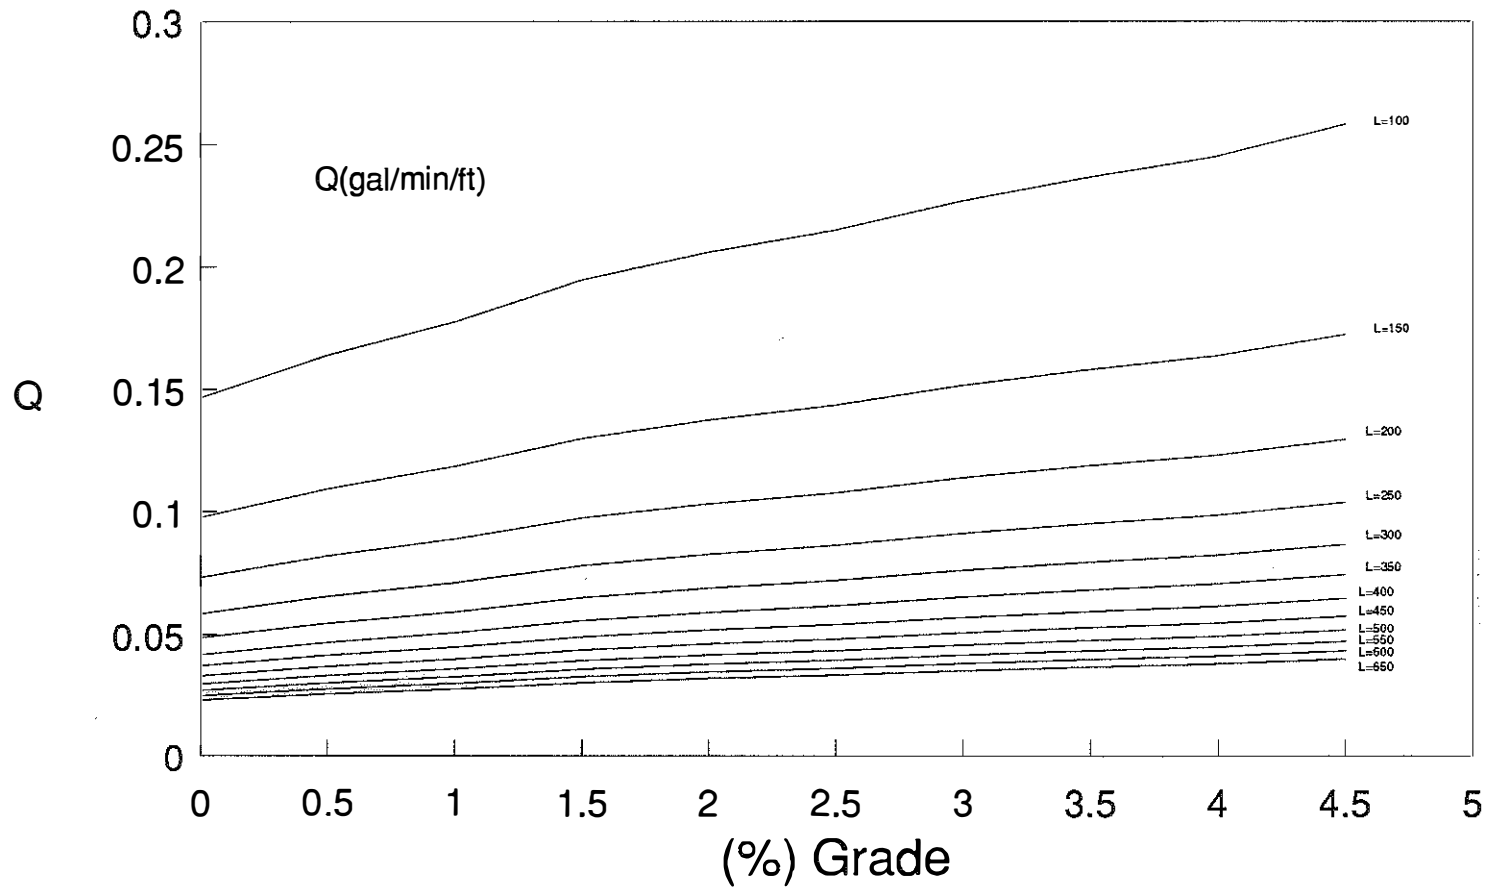
Figure 9. Headwall Spacing Chart

Chart only applies to 12-inch ADS Panel
