Research Report  
KTC-89-48

PAVEMENT BASE EVALUATION  
KY 55 TAYLOR COUNTY

October 1989

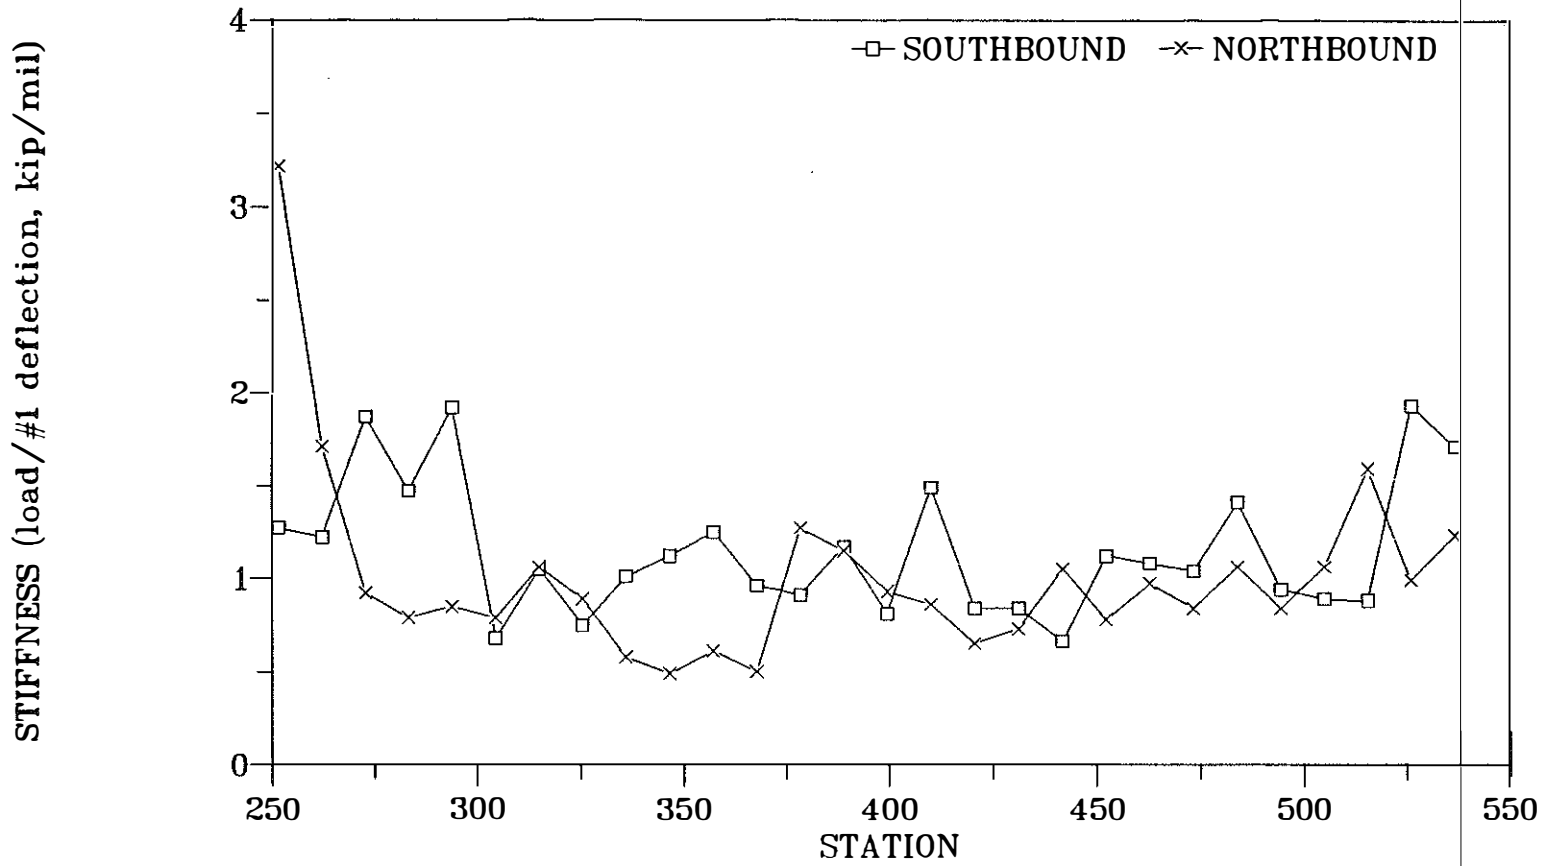
Figure 1. Stiffness vs. Station, 600-lb Load

Model 400 B Road Rater deflection measurements were obtained on August 14, 1989. Deflection measurements were taken at 0.2 - mile increments in the right wheel path of both the northbound and southbound lanes. The stiffness (applied load/sensor number 1 deflection) at each location is plotted versus station for a 600-pound and 1,200-pound dynamic load. Results are tabulated in Figures 1 and 2.

As shown in Figures 1 and 2, there appears to be higher stiffness between Stations 250+00 and 300+00. Section 1 was constructed with an 11.5-inch DGA base and is located in this area (Station 276+18 to 302+76). Section 6 (Station 409+07 to 435+65) was also constructed with an 11.5-inch DGA base. This section does not show as large an increase in stiffness as Section 1. However, it does indicate a higher stiffness in the southbound lane. The remainder of this section (Station 250+00 to 276+18) is located outside the experimental section.

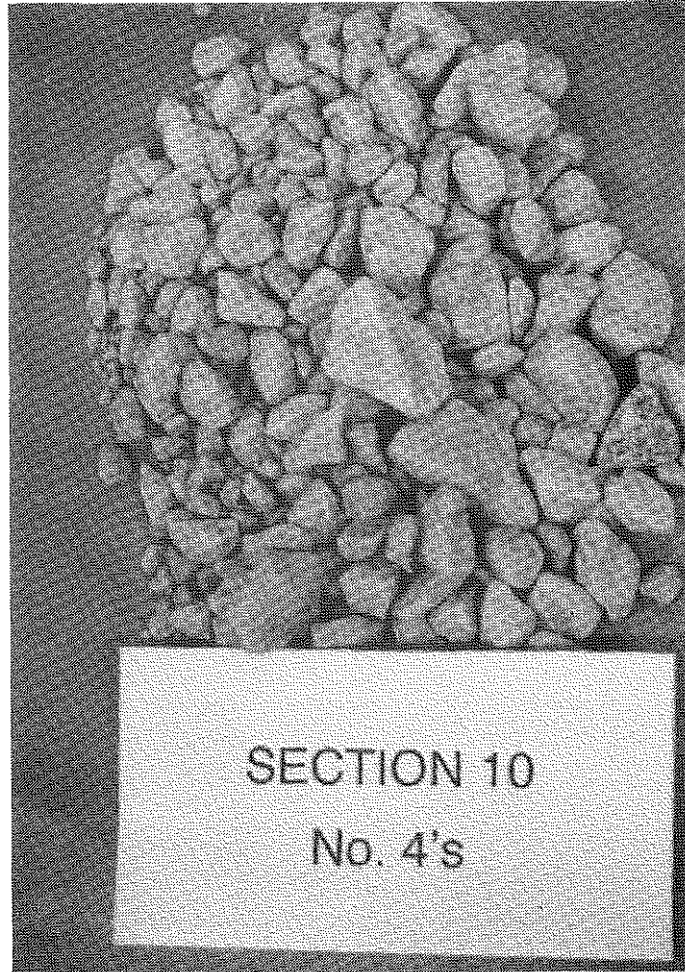
Figure 3. Section 10, No. 4's

Asphalt cores were obtained at each location, along with bag samples of the drainage blanket and DGA. Figures 3 through 5 show the condition of the drainage layer at each location.

At each location, the drill water drained freely through the base. The drainage

base appeared to be in good condition. At the locations tested, the base was open and no evidence of clogging or silting was observed. Most of the headwalls observed were partially clogged with vegetation, causing water to stand in the outlet pipe.

In the sections which were inspected, the drainage blanket appeared to be in good condition and is performing well. The clogged headwalls, which were observed, should be cleaned to allow water to completely drain from the base.

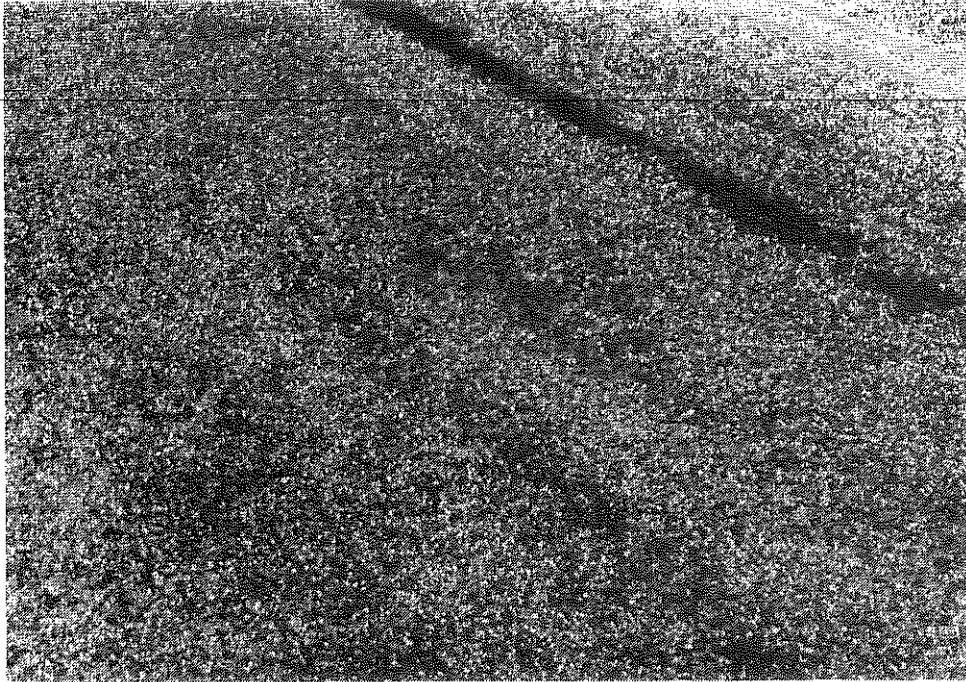
Figure 6. Surface Condition, Section 1

The open graded riding surface is beginning to show signs of wear. The aggregate has begun to ravel from the wheel paths and collect along the shoulder. This has not greatly diminished the ride quality of the roadway, but may begin to affect the skid resistance of the pavement. Figures 6 and 7 depict the condition of the riding surface of Sections 1 and 2. At the time of inspection, these areas contained the most severe raveling.

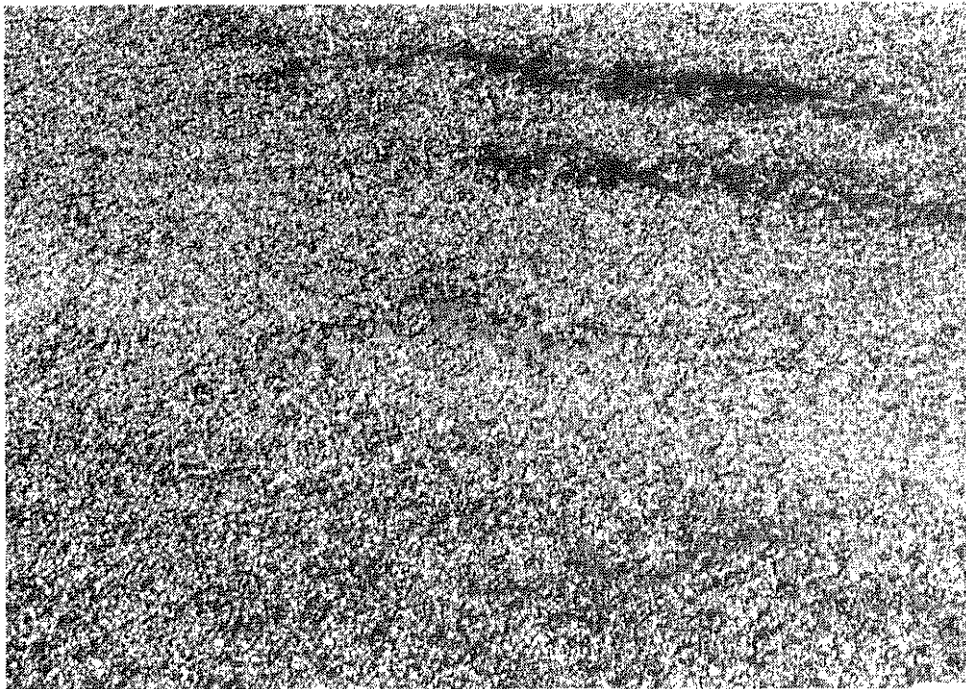
Figure 7. Surface Condition, Section 2

Section 2 northbound has begun to show signs of distress. Distress is indicated by the presence of alligator cracking and rut depths of 0.875 to 1.25 inches at Station 320+00. Table 2 contains the average rut depths for each section along with the structural cross section.
