Research Report
KTC-89-2
MODULAR EXPANSION JOINTS
AND DECK DRAINS

March 1989

16. Abstract Inspections were conducted on bridge modular expansion joints and deck drains to assess their performance. Forty-four modular expansion joints were inspected including 38 Wabo-Maurer and 16 Acme joints. Twenty-three elastomeric dams were also inspected for comparative purposes including 21 Transflex dams and 2 Fel-Span units. The joints were rated using a quantitative subjective rating system developed by Penn DOT. Both the modular expansion joints and the newer expansion dams were performing satisfactorily. Both types of joints leaked and experienced a number of minor hardware problems. some of the joints may warrant repairs to restore their complete function. Deck drains and drain outlet piping systems were inspected. The deck drains inspected included those having square and rectangular inlets, pipe drains, and scuppers (edge drains). All types of deck drains appear susceptible to clogging. Large scuppers performed well. Also, simple straight drop pipes were less clog prone than complex piping systems. Recommendations are provided to minimize clogging problems.

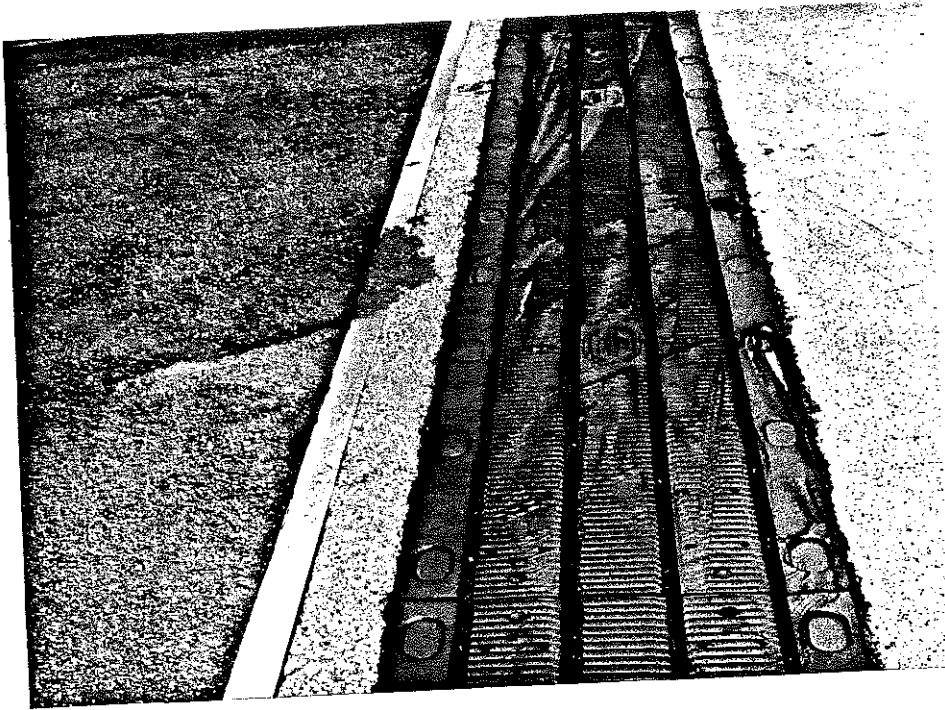
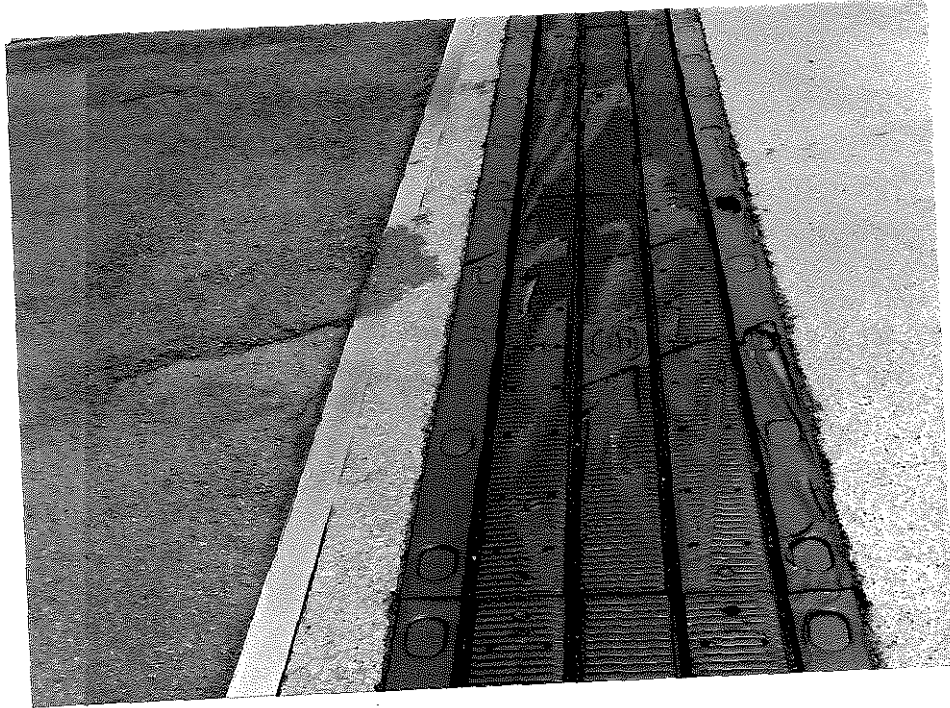
The 1981 report noted the susceptibility of expansion dams to surface damage (Figure 3). In 1987, 61 percent of those joints had surface abrasions or gouges in the rubber wearing surface. Probably, snowplowing caused most of those flaws.

Figure 3. A Transflex 650 Joint Exhibiting Surface Abrasions and Gouges.

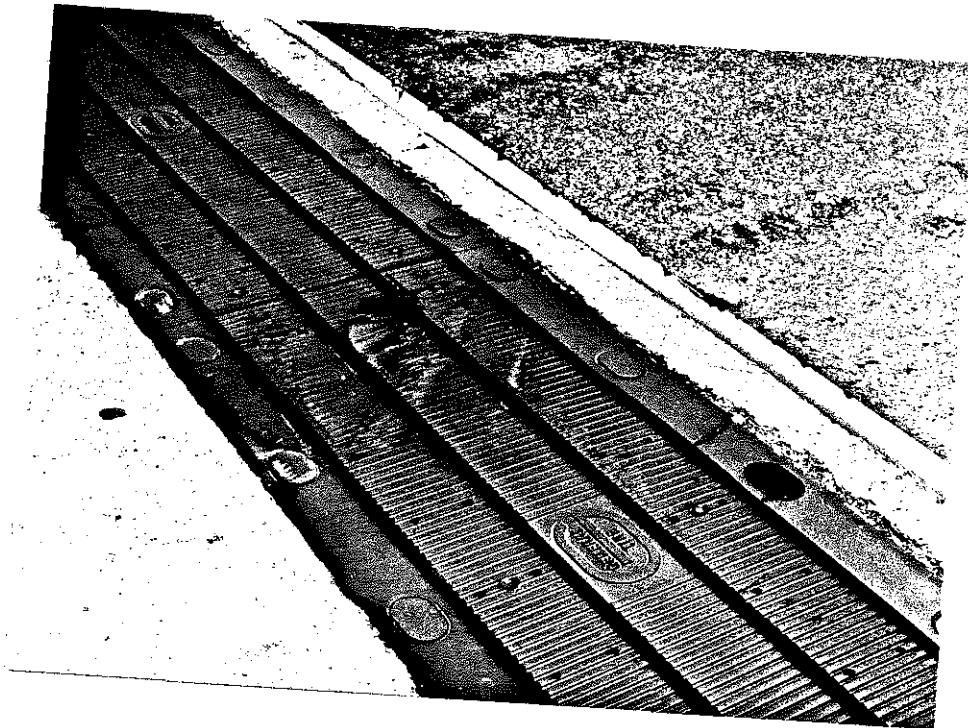
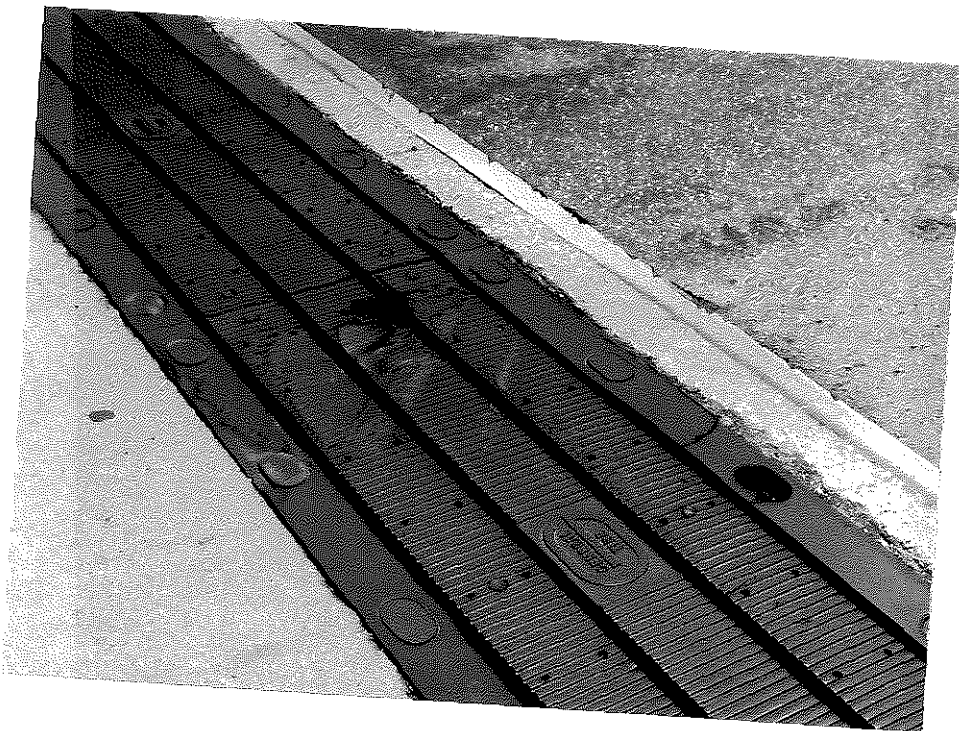
The 1981 report mentioned the loss of stud covers only on the US 31 (Clark Memorial) bridge. In 1987, stud covers were missing from joints on all the bridges inspected (Figure 4). The 1987 inspections revealed that several joints having missing stud covers also had missing or loose joint retention nuts.

Figure 4. Missing Stud Cover on Transflex 650 Joint on the US 421 Bridge over the Cumberland River.

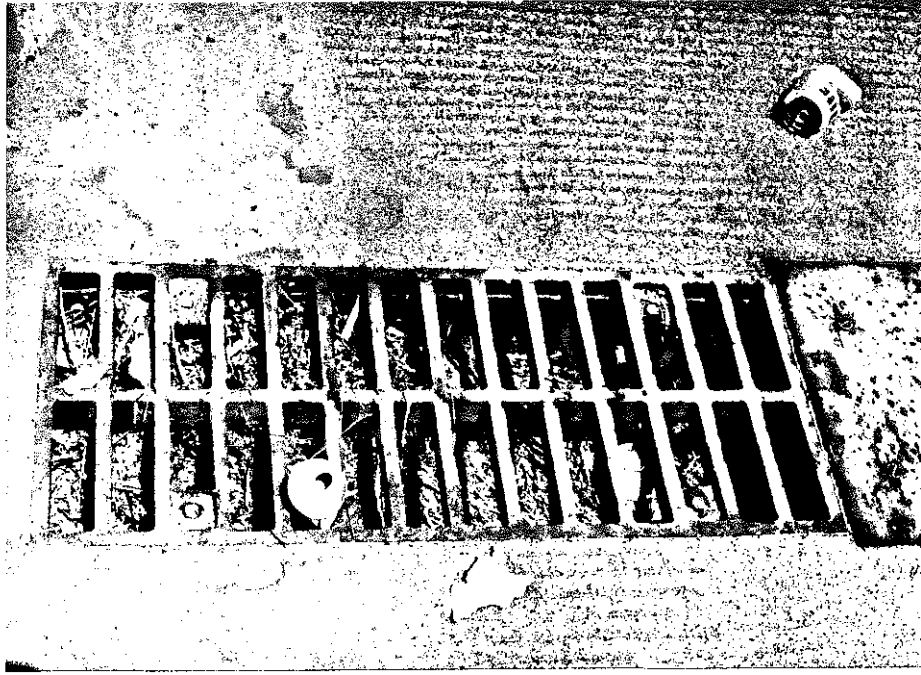
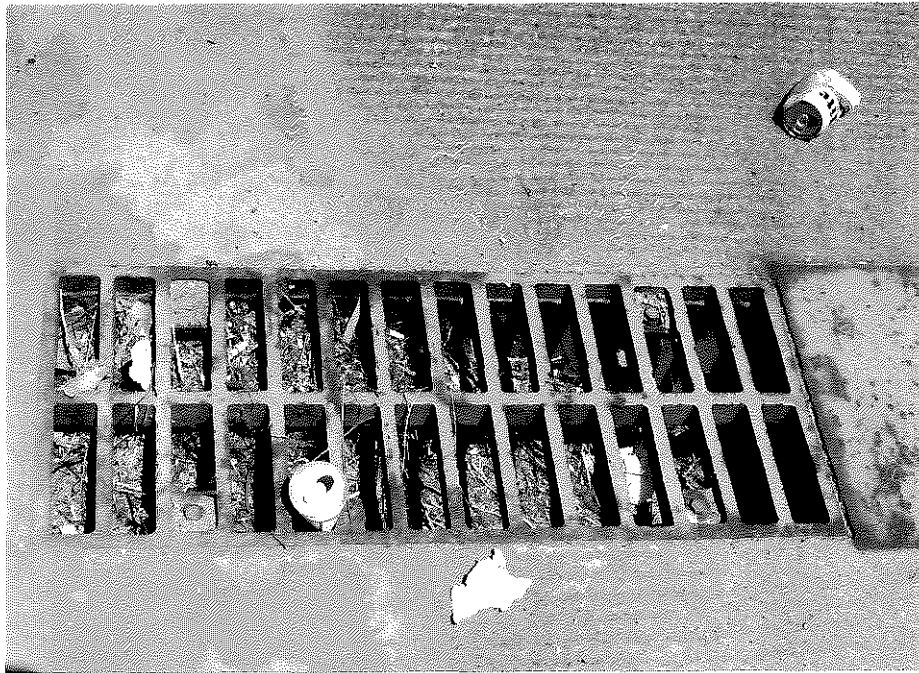
Inspections revealed that regardless of size (9" x 9" to 1'-9" x 2'-2" grates), all square inlet drains were susceptible to clogging. The clogging was caused by a mixture of large and fine debris. Smaller drains could gradually become clogged by fine debris. Some square inlet boxes had the gutter recessed into the barrier to provide an opening to accept larger debris. Those were also susceptible to clogging.

Figure 5. Rectangular Drain Inlet Box Filled with Loose Debris on the US 27 Bridge over the Kentucky River at Camp Nelson.

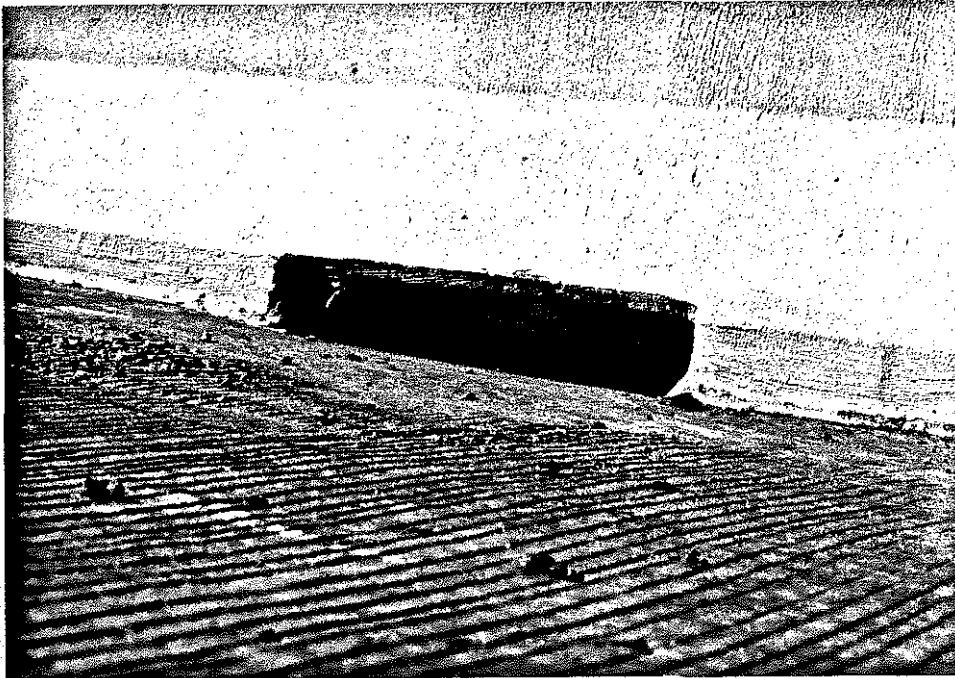
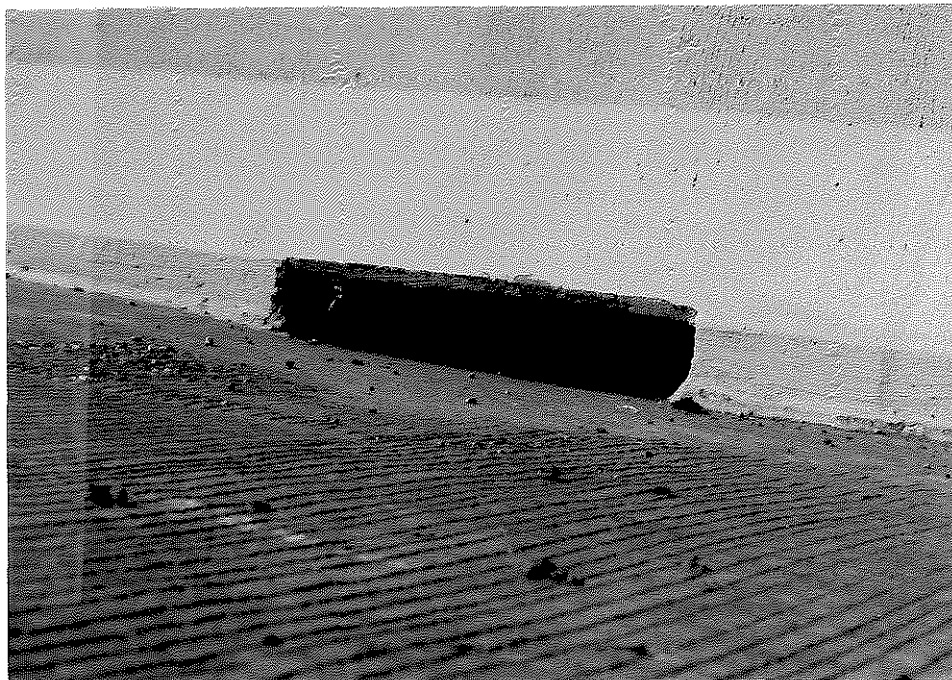
KTC personnel inspected several prestressed concrete bridges that employed larger scuppers (2'-0" x 3"). Inspections revealed that those scuppers were performing well (Figure 6). Partial blockages of scupper holes did not hinder their function. The scupper outlets lacked spouts and the draining water stained the exterior barrier walls. However, that was a minor problem.

Figure 6. Scupper (Edge Drain) in Good Condition.

For smaller bridges, scuppers work well when sized sufficiently large. A slight increase in the slope of scupper outlets would promote better drainage. Also, adding a spout to scupper outlets would prevent staining of the exterior barrier wall. Treating the concrete in the outlet area with a sealant might extend its durability. Otherwise, the scuppers do not need improvement.

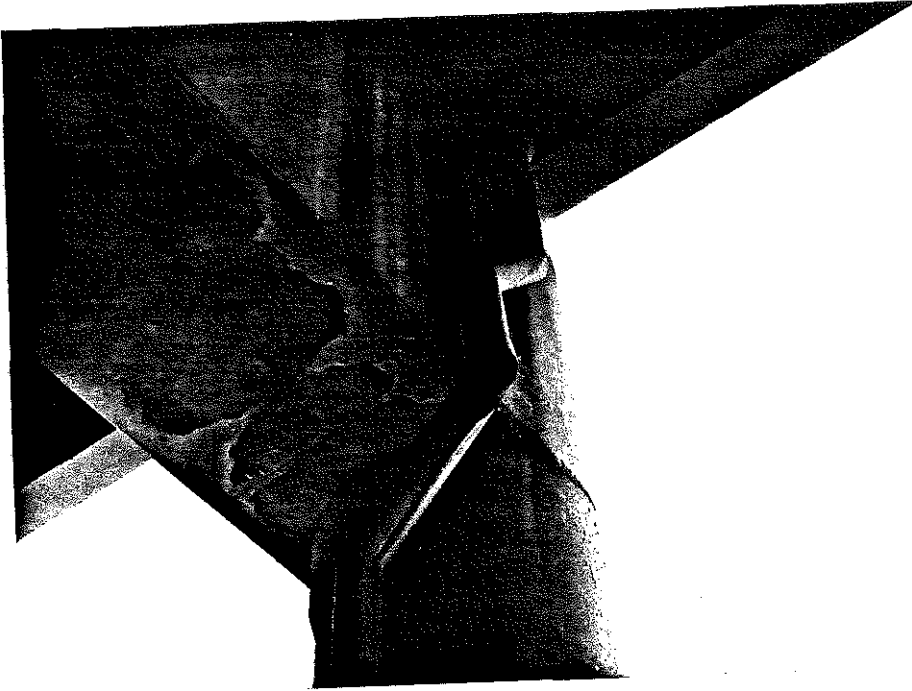
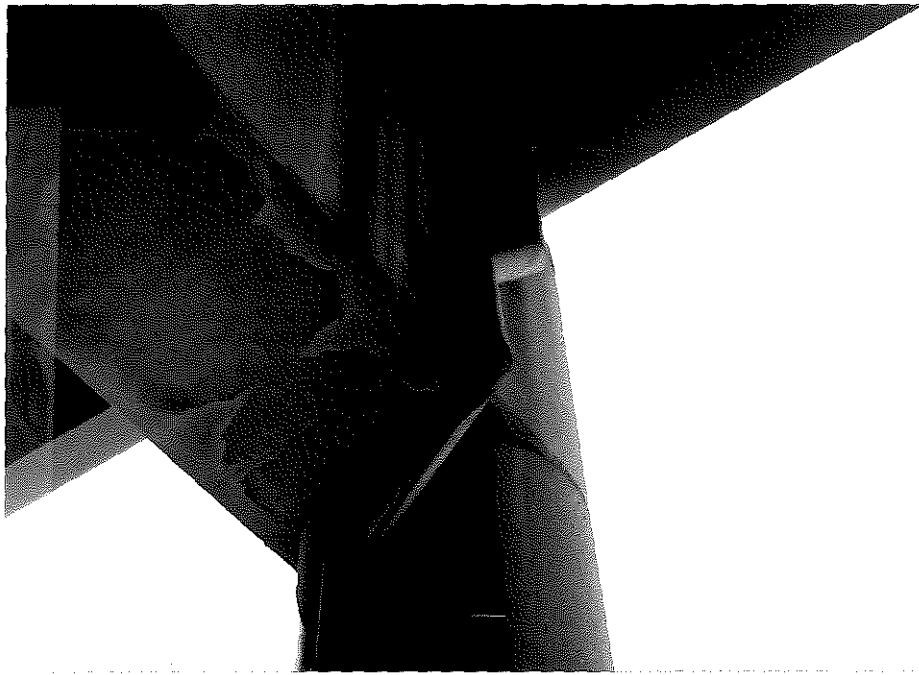
During several inspections, KTC investigators detected rust stains on drain pipes revealing loose joints or fractures (Figure 7). Probably, most of those problems relate to water trapped in the drain pipes that froze and caused loose joints or fractures. KTC inspectors found abrupt pipe transitions (angles and connections that may promote clogging). It is desirable to use 18-inch minimum radii for all pipe bends (6).

Figure 7. Broken Drain Pipe.

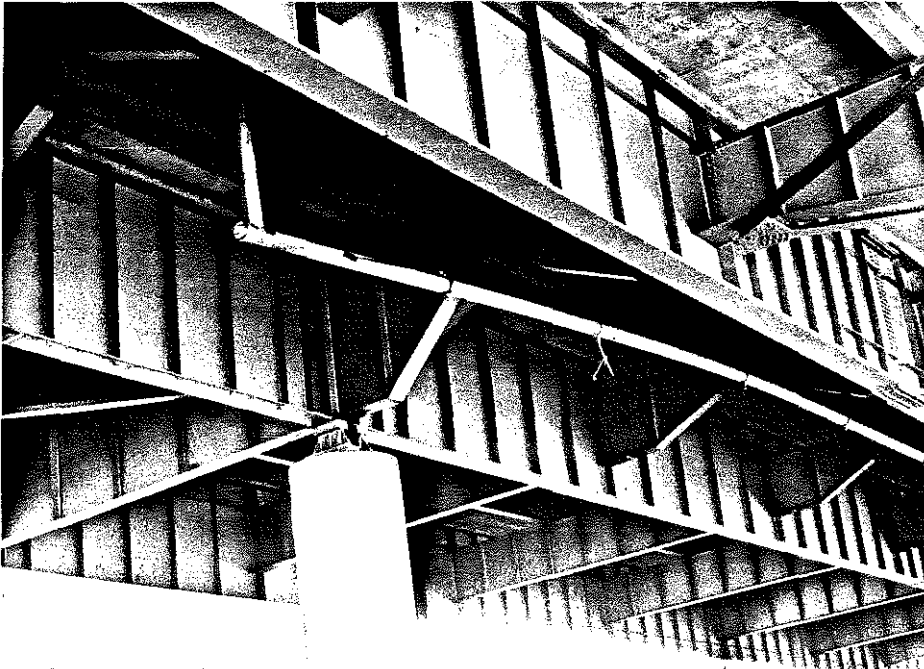
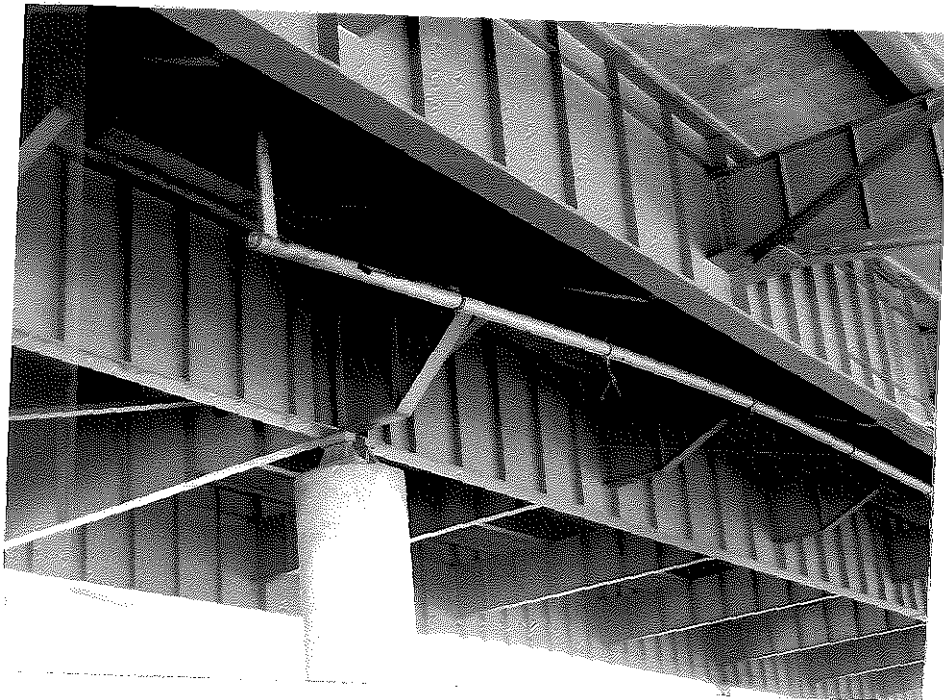
The inspections revealed several problems related to clogging. At one location, inspectors noted a vertical drain pipe detached from an inlet box. The vertical pipe fed into a horizontal pipe run at a tee. KTC personnel observed a broken pipe hanger on the horizontal pipe next to the tee. The broken hanger allowed the pipe system to detach from the drain inlet box (Figure 8). Clogging may have promoted that failure.

Figure 8. Sagging Drain Pipe Caused by Broken Hanger.

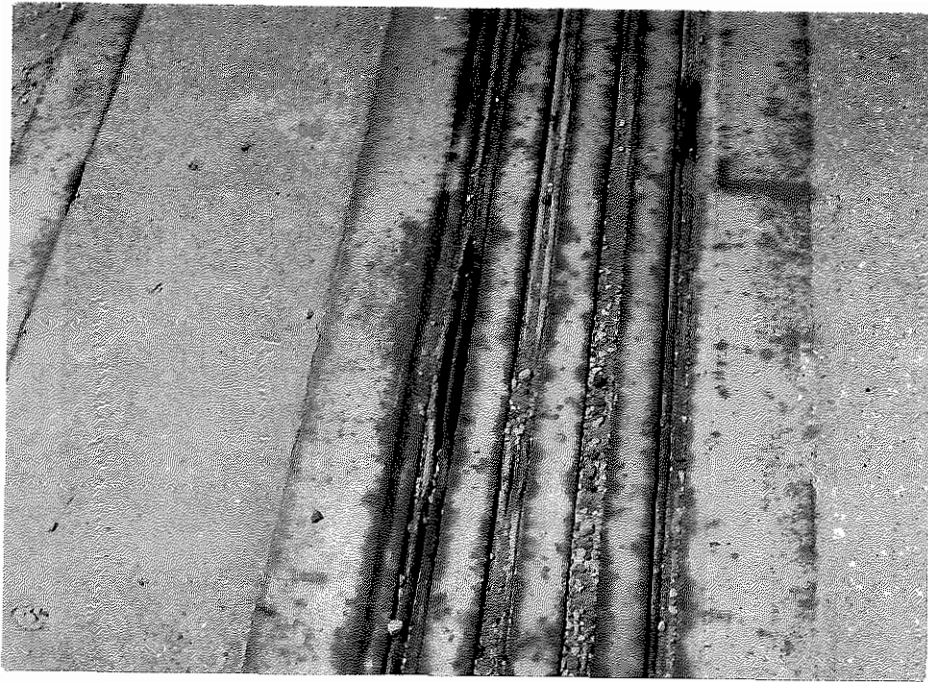
Thirty-seven percent of the joints inspected in 1987 had torn or loose module seals (Figure 1). All of those joints leaked. In several instances, module seals separated from joints and protruded above the top of the separation and edge beams. Normal traffic or snowplows tore many of those protruding module seals. The separation of the module seals from the joint may be due to faulty hardware that imparts excessive vibrations to the seal-to-joint bond.

Figure 1. Loose Module Seal on Wabo-Maurer D1040 Joint on the US 27 Bridge over the Kentucky River at Camp Nelson.

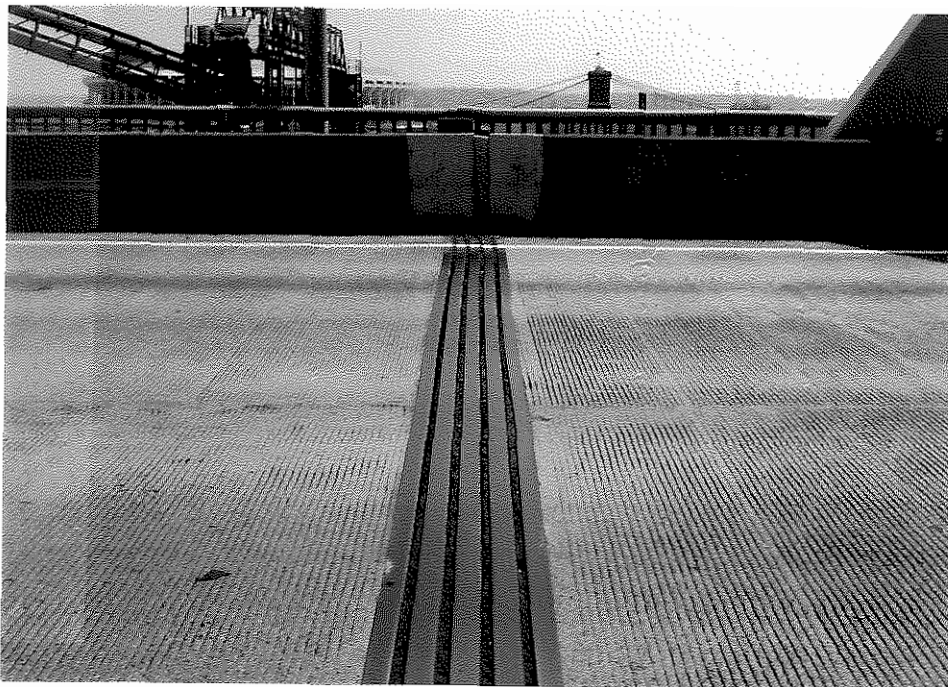
The 1981 KTC report noted horizontal and vertical misalignment problems. The 1987 inspections revealed those problems on 13 percent of the joints. Vertical misalignment caused joint noise under traffic. The 1987 inspections revealed horizontal misalignments (variable module seal spacings along a joint) up to 1/2-inch difference for the larger joints. In several instances, steel separation beams had an irregular sweep along the length of the joint. That resulted in a varying module spacing along a joint (Figure 2). Horizontal misalignment may inhibit the watertight seal between the separation beams and modules resulting in joint leakage.

Figure 2. Irregular Horizontal Misalignment on Wabo-Maurer D1040 Joint on US 25 Bridge over the Ohio River at Covington.
