**Research Report
KTC-89-54**

**PERFORMANCE OF CORRUGATED
POLYETHYLENE ENTRANCE PIPE**

**Kentucky Transportation Center
College of Engineering
University of Kentucky
Lexington, Kentucky**

October 1989

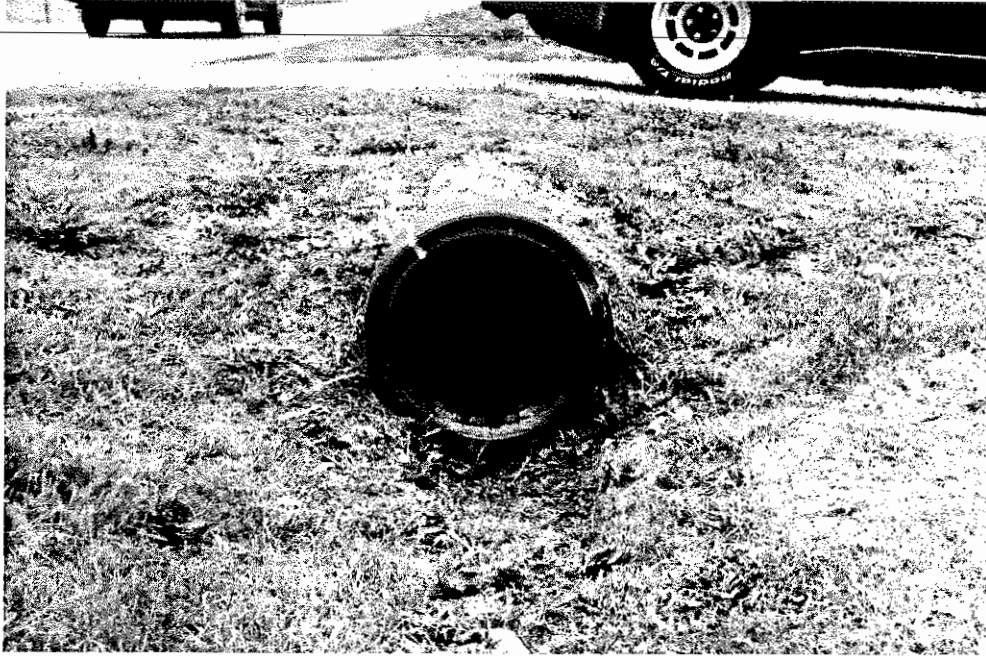
Figure 1. Grass Lined Channel Prevents Erosion;
KY 130, Union County.

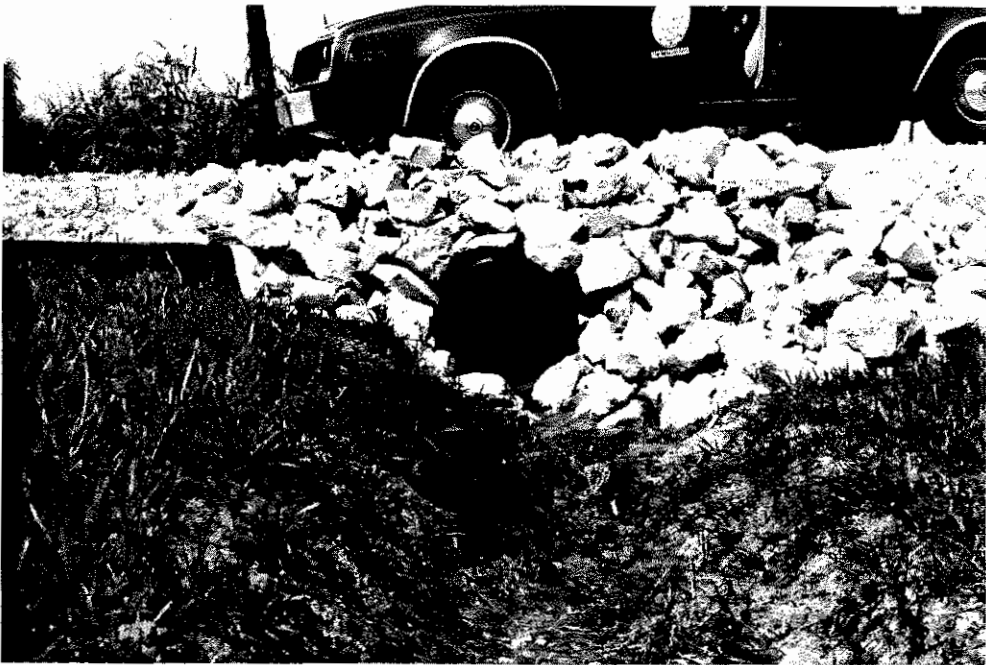
Figure 2. Large Stone Protects Outlet; US 41 A,
Henderson County.

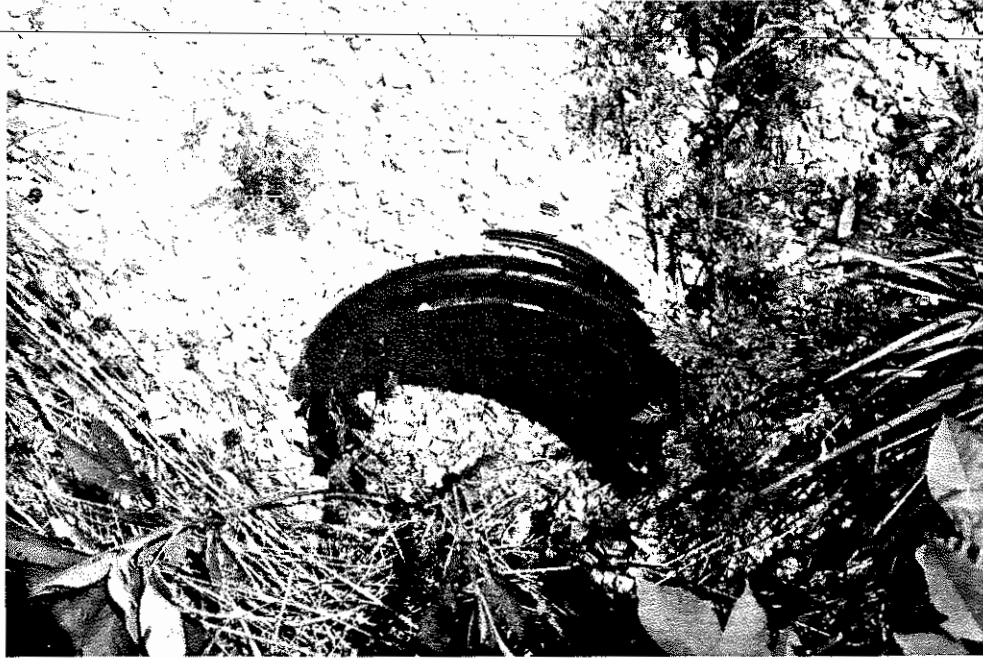
Figure 3. Aggregate on Embankment Erodes and Obstructs Outlet.

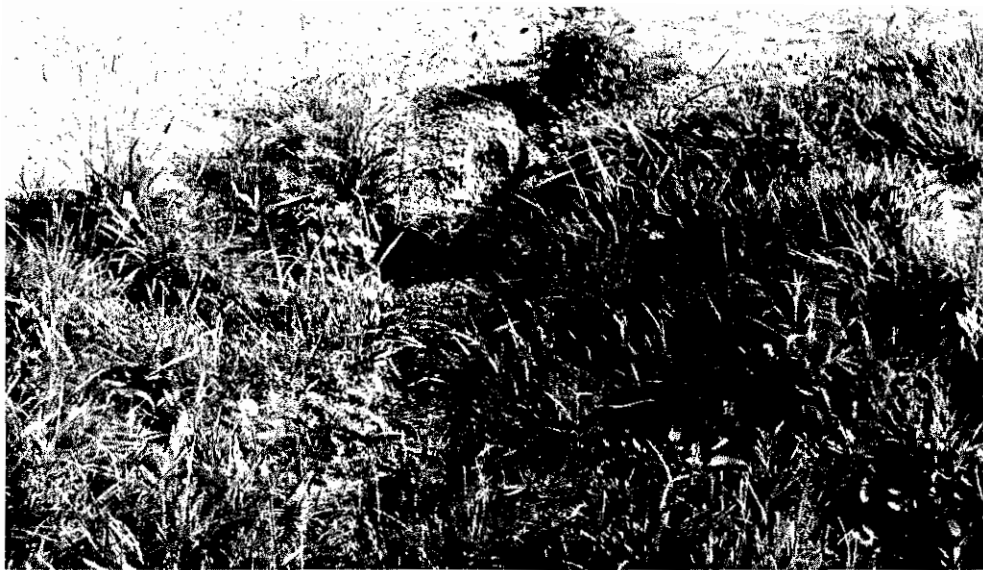
Figure 4. Aggregate Washed from Shoulder and Blocked Outlet.

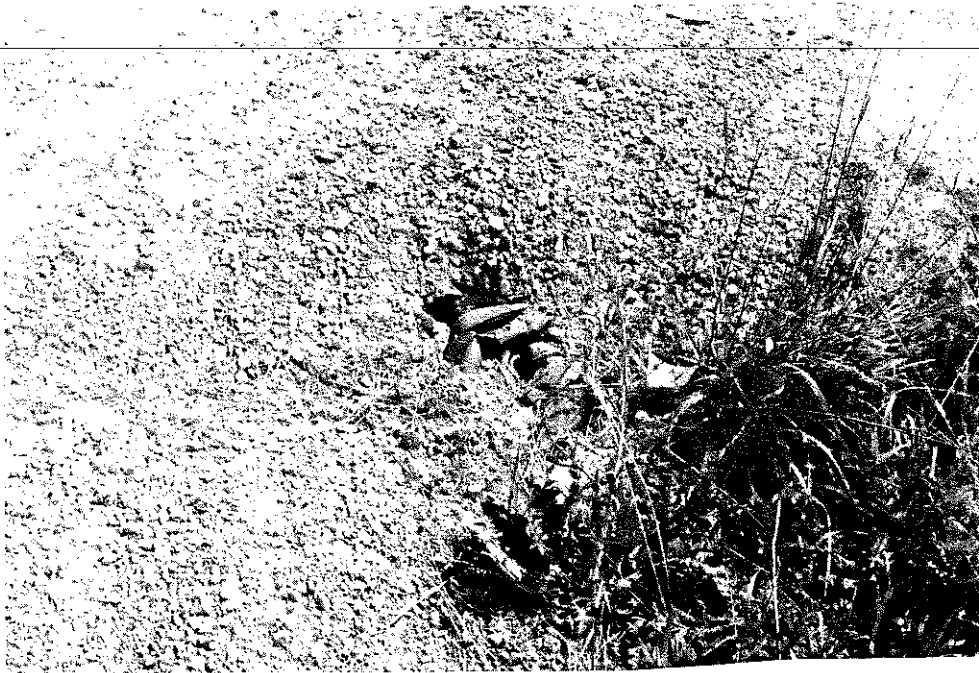
Figure 5. Heavy Vehicle Damaged Unprotected Outlet.

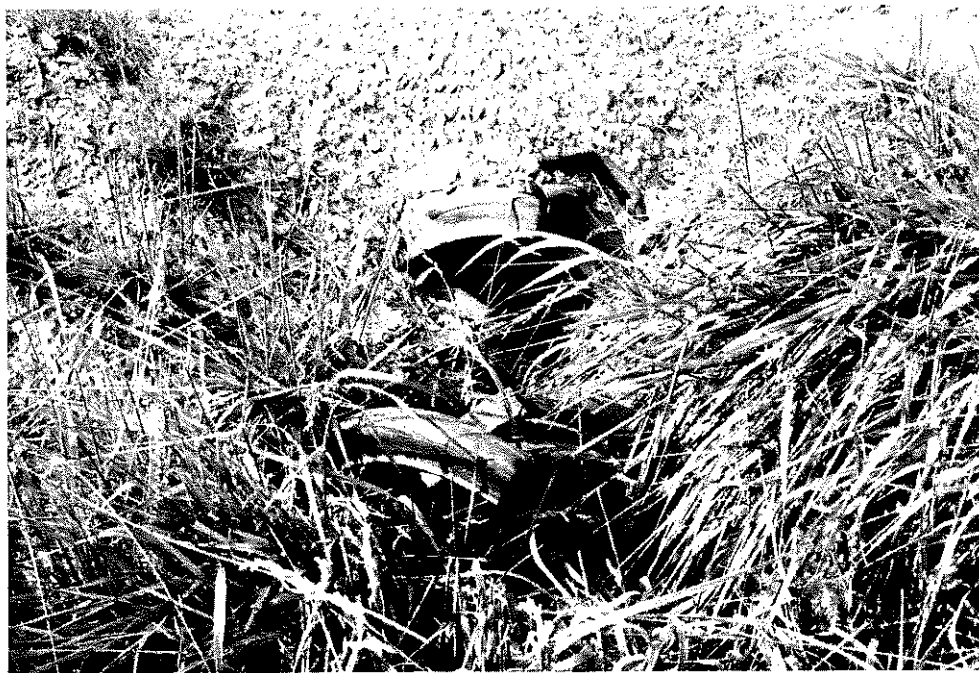
Figure 6. Truck Damage to Inlet.

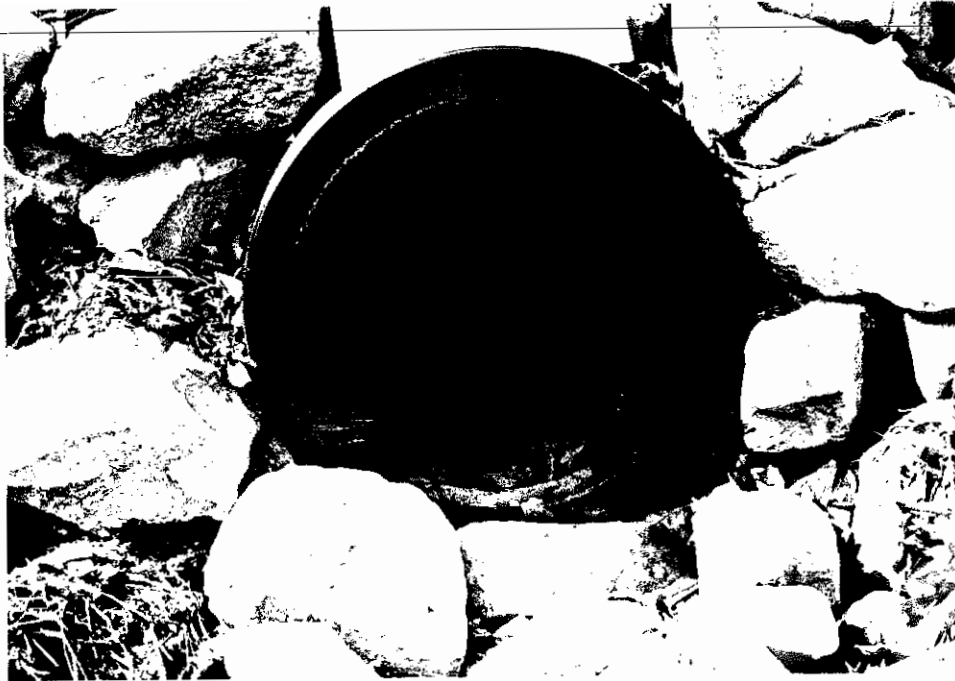
Figure 7. Large Stone Protect Outlet.

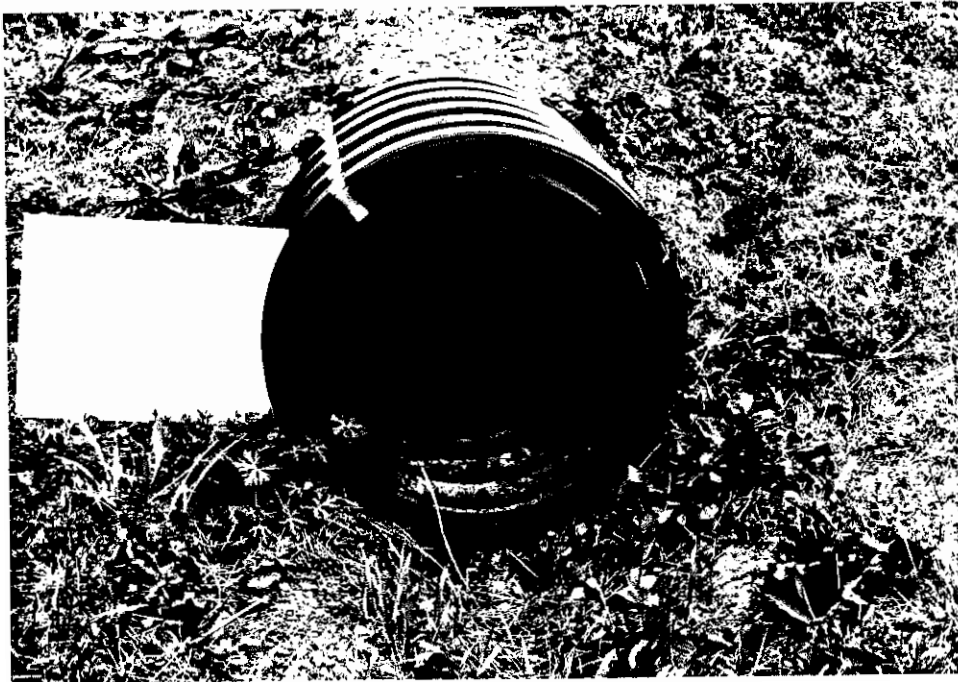
Figure 8. Vegetation Prevents Silting.

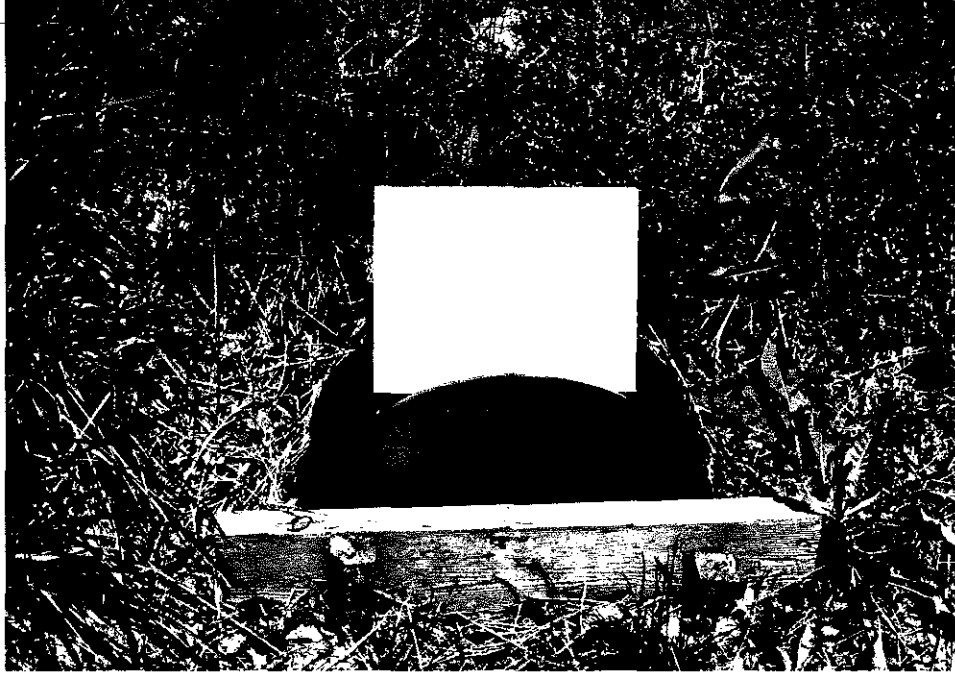
Figure 9. Timber Sill Protects Inlet.

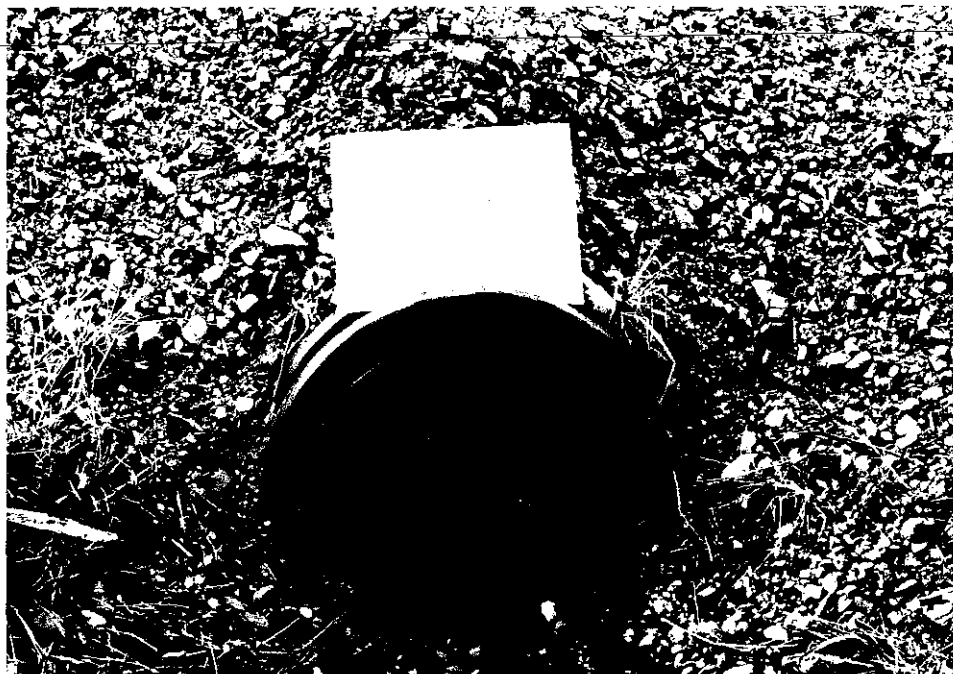
Figure 11. Aggregate from Embankment Obstructs Flow.
