Research Report  
UKTRP-87-1

BRIDGE DECKS AND OVERLAYS

Kentucky Transportation Research Program  
College of Engineering  
University of Kentucky

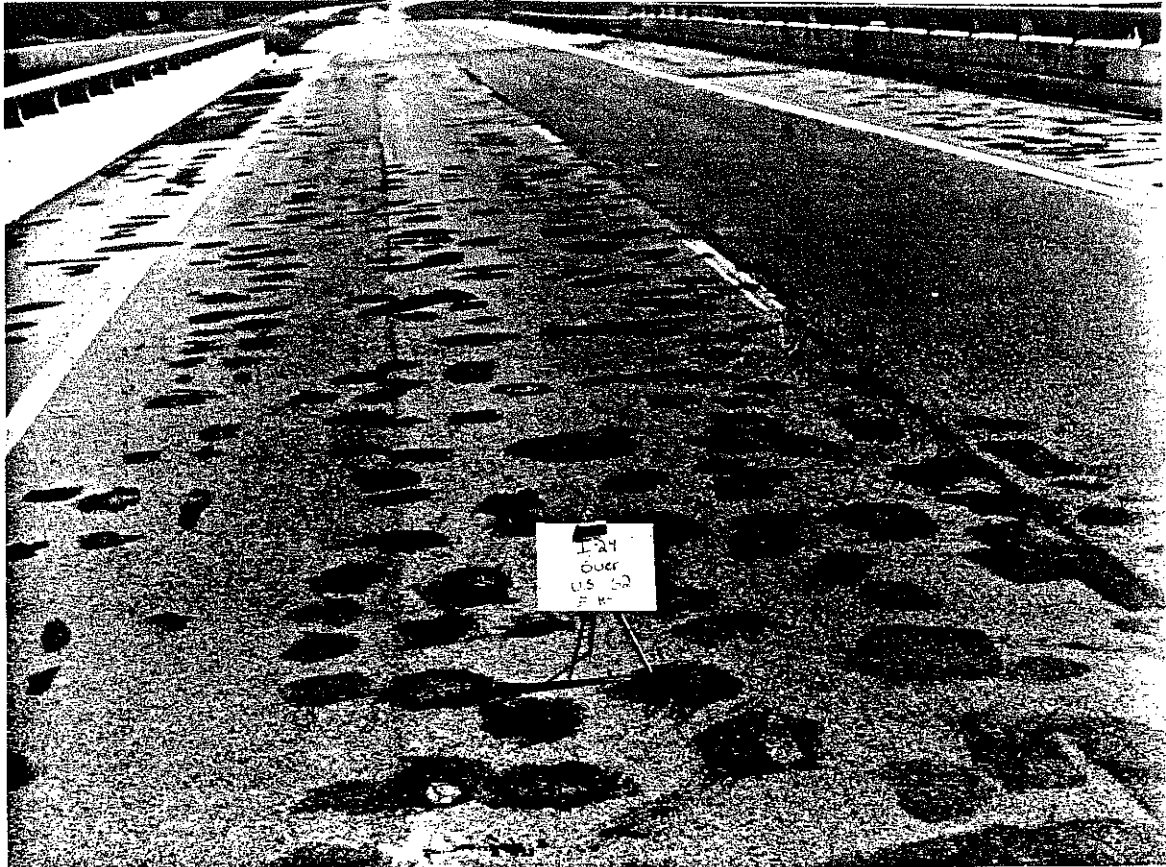
Several membranes experienced blistering problems (most notably the I-24 bridge over US 62 in Marshall County). As with the I-24 bridge over the Ohio River, those were repaired by puncturing the blisters and resealing them (Figure 7). The Division of Maintenance also experienced problems in acquiring the small quantities of Class I asphaltic concrete required for most bridges. Those problems coupled with the success of rigid concrete overlays led to disuse of membranes by the Transportation Cabinet (except for the KY-676 bridges).

Figure 7. Resealed Blisters on the Membrane of the I-24 Eastbound Bridge over US 62 (1980).

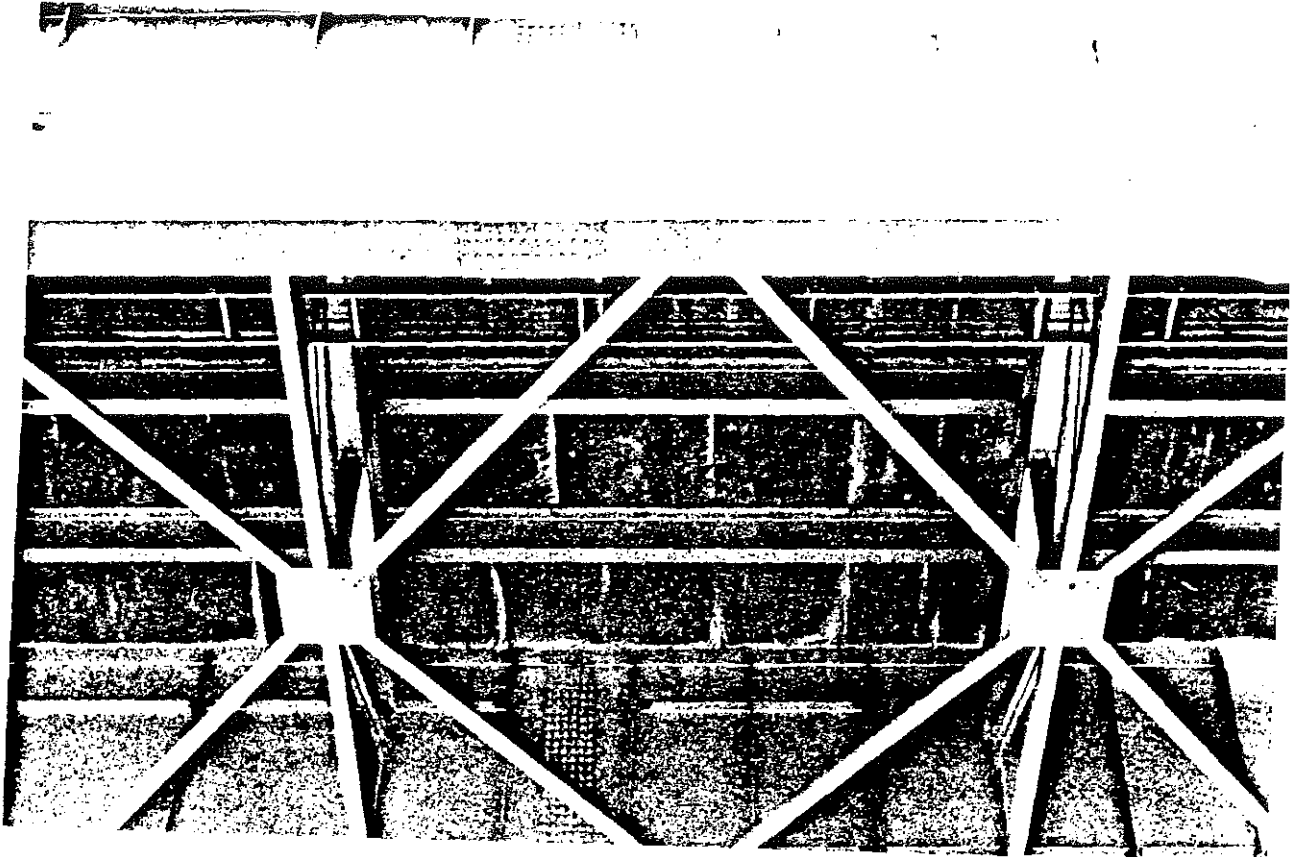
Reinforced concrete containing at least 0.6 percent steel cracks on an interval of about 30 inches (5-10). Those cracks may not be readily visible. In bridge decks, some may become working cracks and appear prominently. Temperature cracks in bridge decks are often observed to merge with regularly occurring temperature cracks located in the plinth. Usually, those cracks completely penetrate the bridge deck. If left uncovered, efflorescence eventually appears on the bottom of the deck. That is due to seepage of water through the cracks and deposition of lime along the underlying crack face after drying (Figure 8).

Figure 8. Example of Cracking in Deck on Steel Girders; Note Efflorescence Stain (I 24, Cumberland River) (June 1981).

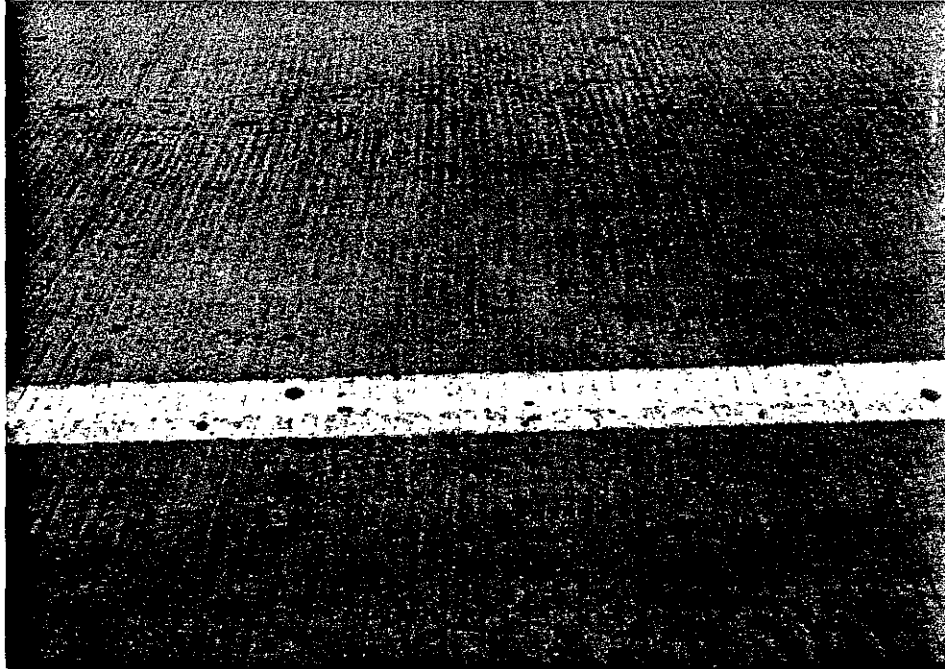
The earliest research inspections and reports prior to or at the onset of service indicated no serious problems with the decks. In a recent inspection, many deck cracks were visible (11). It was possible to associate upper deck surface cracking with underside cracking in a manner developed during the study of mainline bridges on I 64 between Morehead and the West Virginia line (Op. Cit. 1). Cracks (patterns of cracks) were then associated with styles of bridges and termed natural cracks (due to flexure and to temperature expansion). When natural (structural) cracks and those obviously attributable to workmanship were sorted and excluded from overlay performance, the defects remaining and attributable directly to overlay failures on the US-119 bridges became minimal.

Figure 10. US-119 Bridge at MP 31.122 Showing Transverse Flexure Cracking.

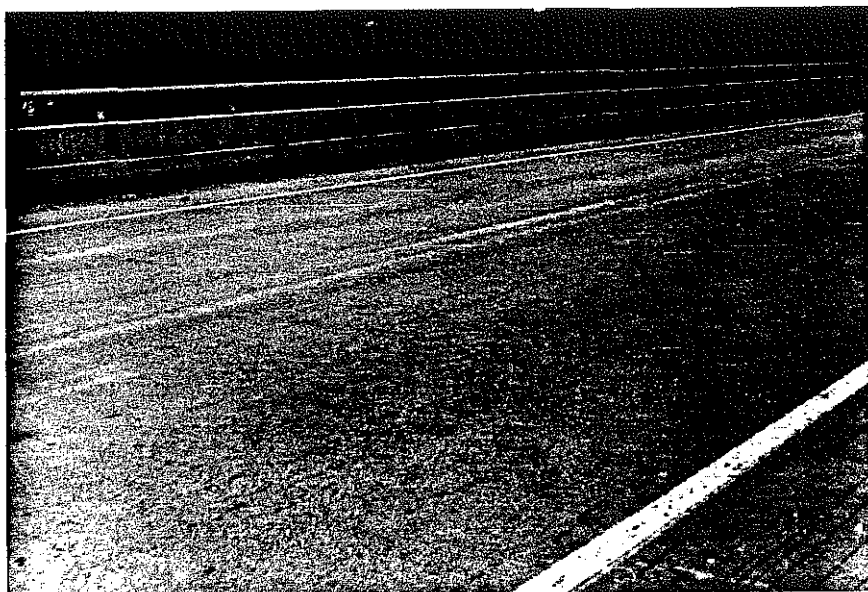
Figure 13. Latex Concrete Overlay, US 119 over Poor Fork  
(MP 27.626)(11/17/83).

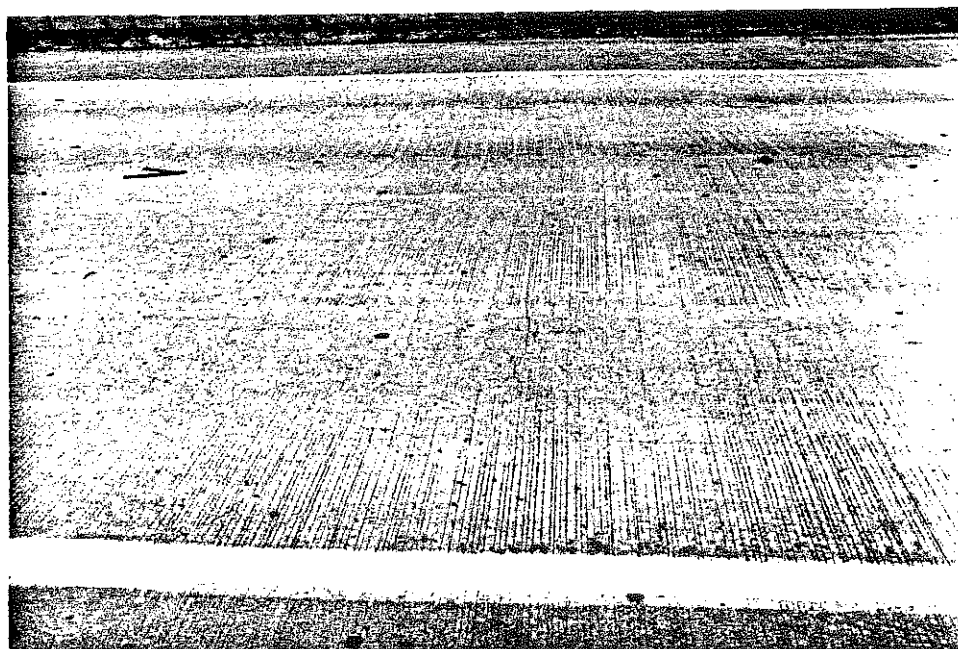
Figure 14. Low-Slump Concrete Overlay, US 119  
(MP 18.214)(9/11/85).

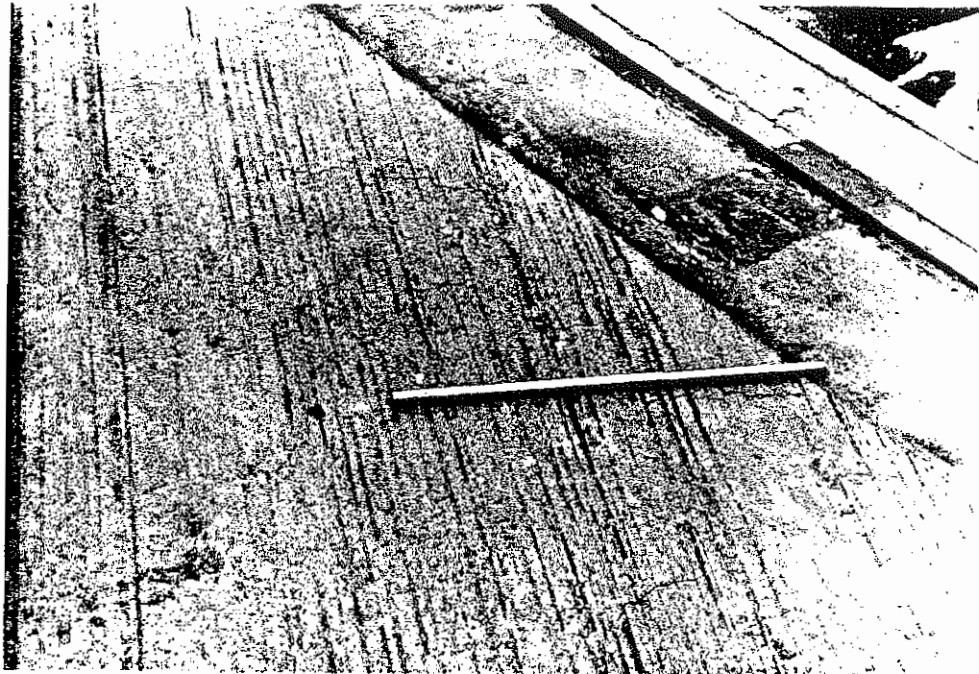
Many overlay cracks detected during the recent study of the I-64 bridges were attributable to deep tining. Those cracks were probably due to tining when the overlay was in a plastic state, but beginning to set (Figure 15). Recommendations for the prevention of that type cracking have been provided (Op. Cit 1). However, tined grooves

Figure 15. Pull-in Cracks Created by Overlay Tining (US-25 Bridge over the Ohio River at Covington).

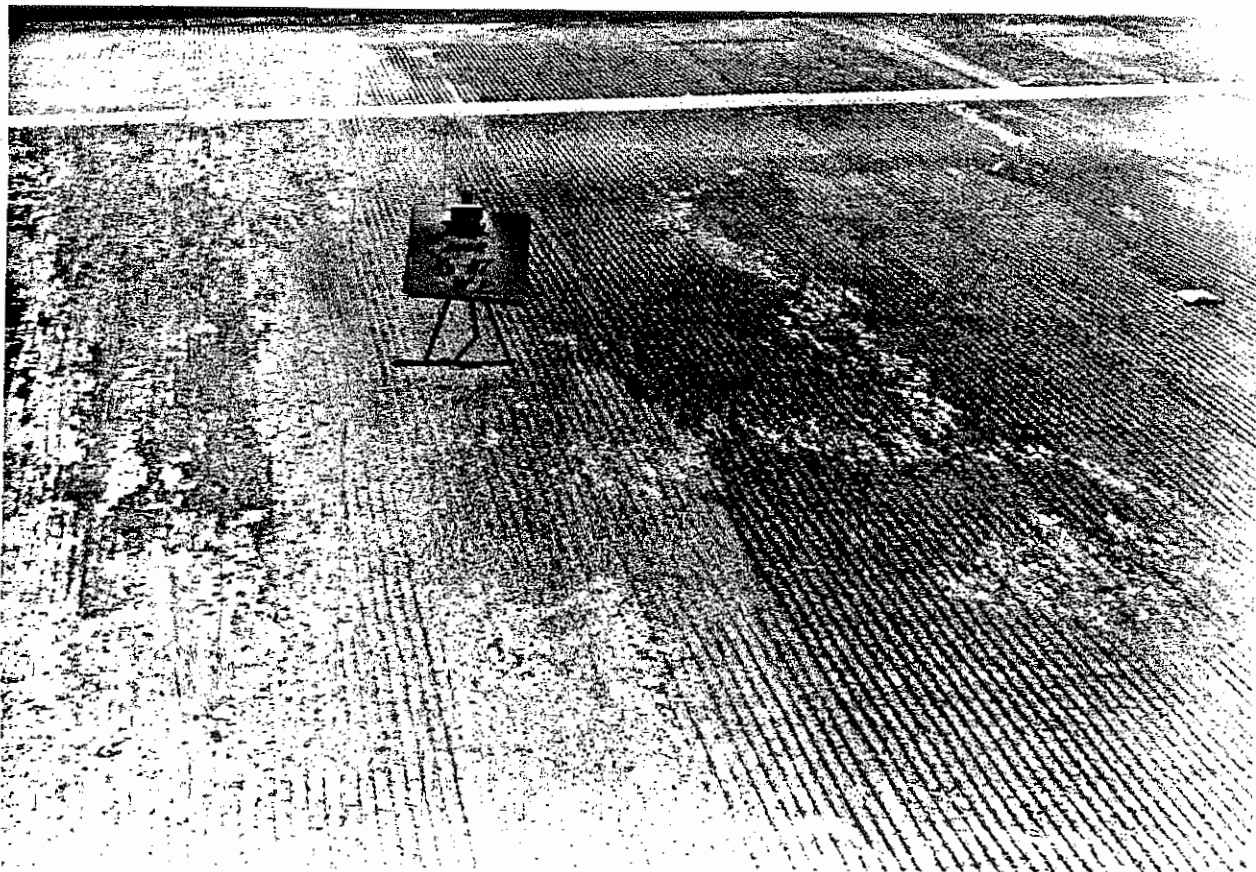
Figure 16. Irregular Pavement Grooves in a Tined Bridge Deck (I 24 over KY 117)(1980).

generally tend to be irregular (Figure 16). Even when properly performed, tining may pull aggregates and roughen deck surfaces (Figure 17). A recent report by the New Jersey Department of Transportation noted tining to be unsatisfactory and recommended that it be replaced with sawed grooves (13). Grooves were sawed on the Manchester Avenue approach to the Jefferson Street Viaduct in Lexington (Figure 18).

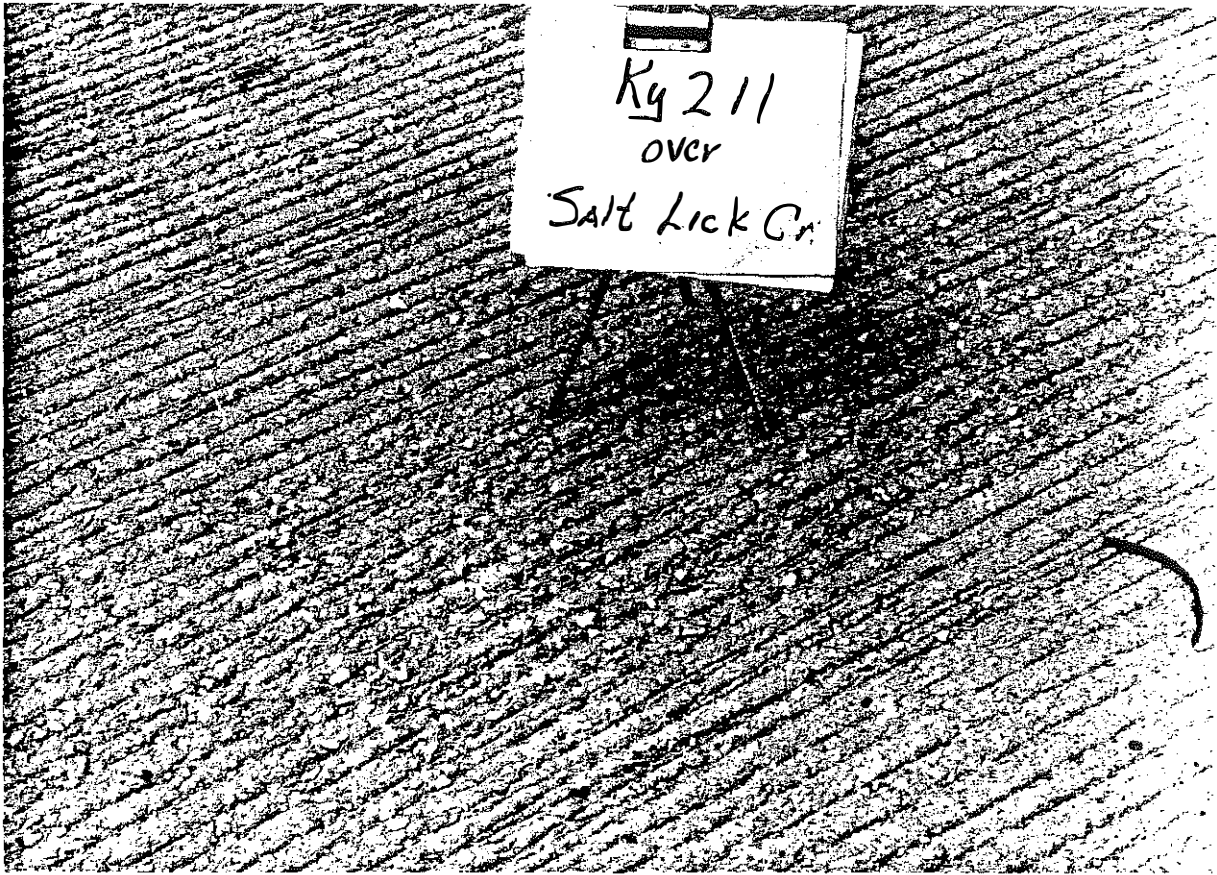
Figure 17. Rough Deck Surface Texturing Caused by Tining (KY 211 over KY 117)(1980).

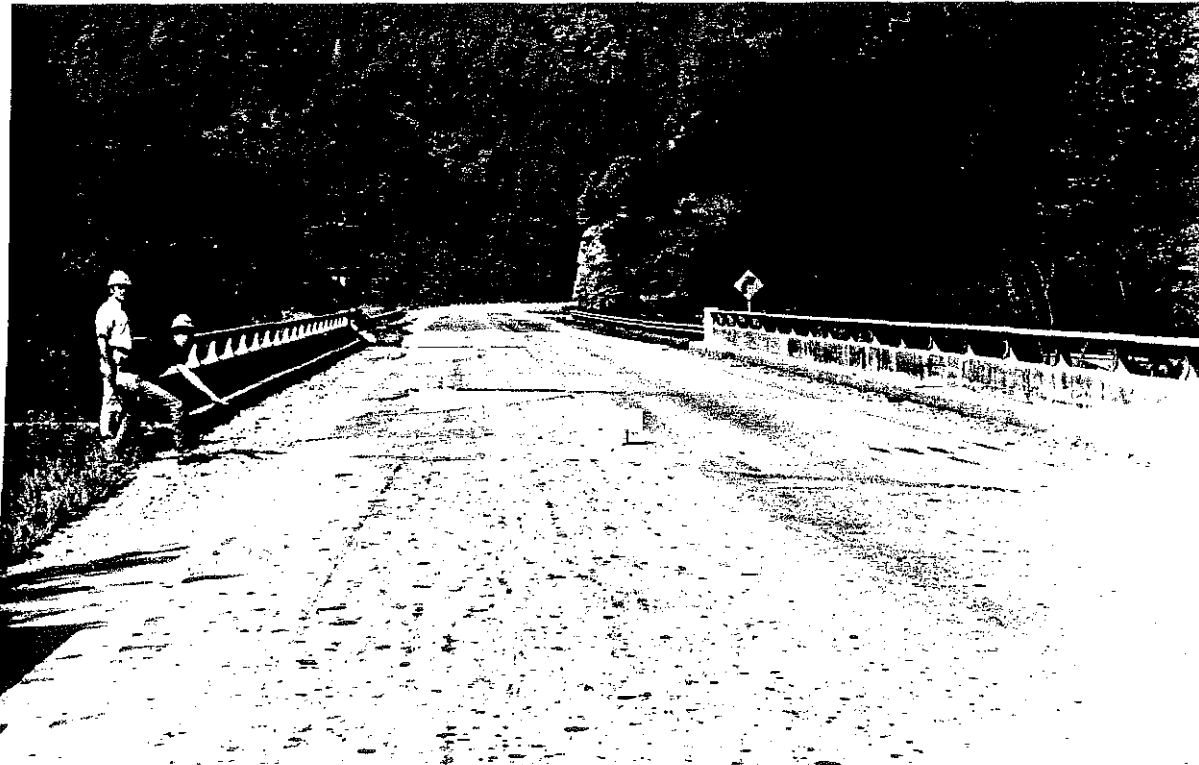
Figure 19. Partially Debonded Dow Latex Overlay (KY 114 over Middle Creek)(1980).

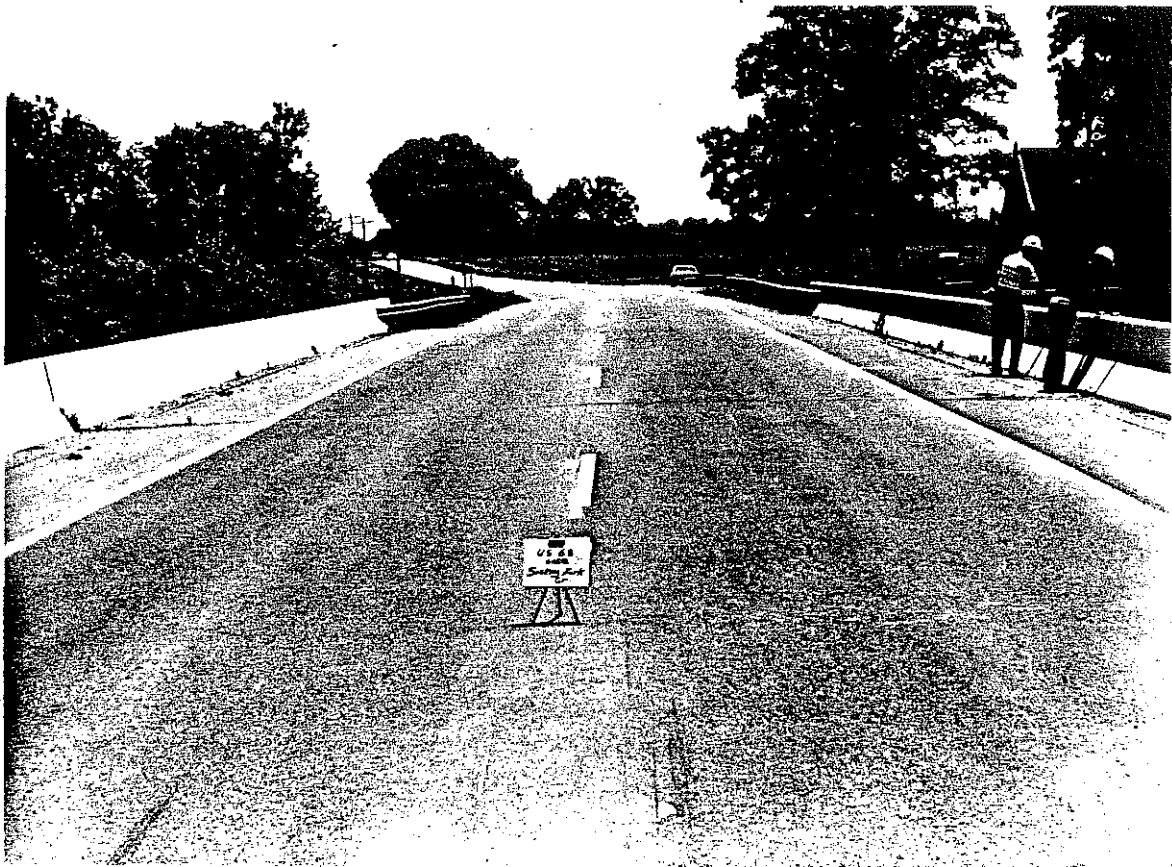
Figure 20. Liquid-Applied Membrane Overlay (US 68 over Sinking Fork Creek)(1980).

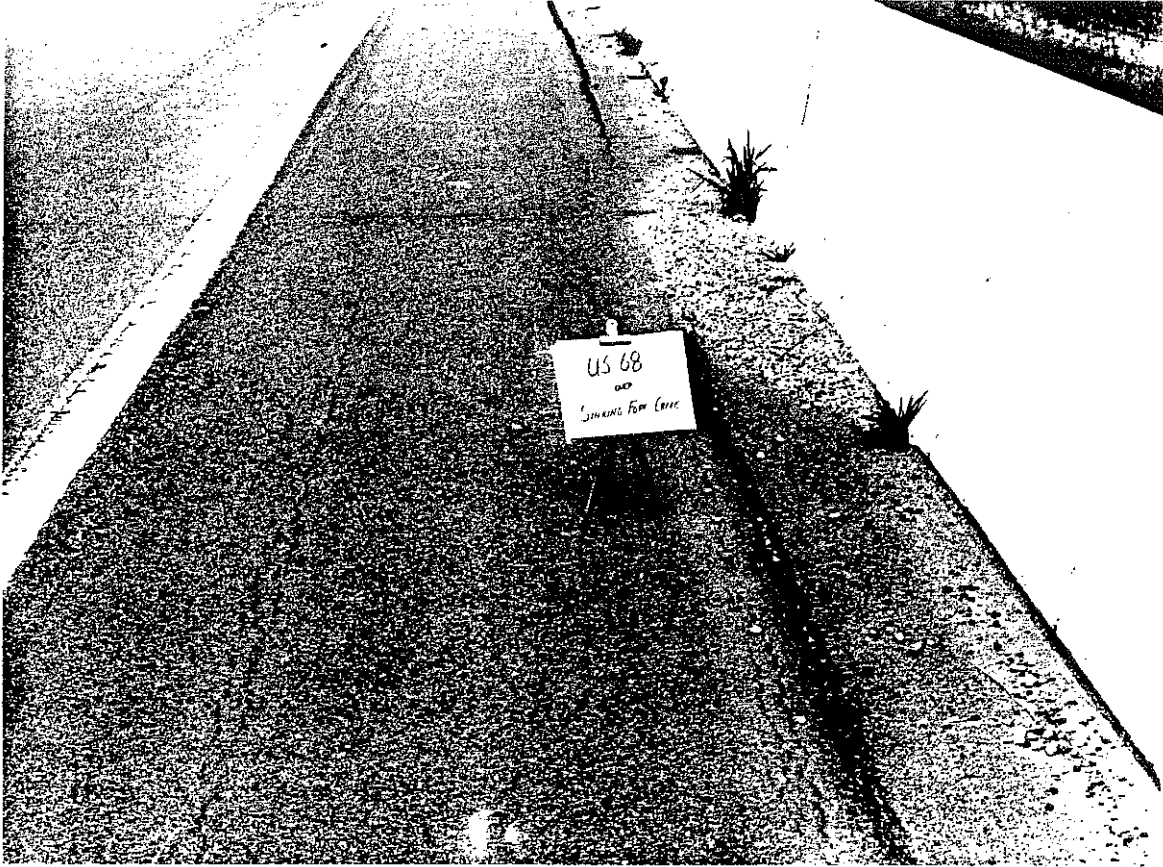
The main problems detected on membranes were blistering and cracks along laps or seams in the membranes or roofing paper that had reflected through the thin asphalt wearing surfaces (Figures 7 and 21). Many of those problems appeared early in the bridges' service lives. A year after placing the membranes on the I-24 twin bridges over US 62, District 1 personnel recommended that badly blistered membranes (Royston) be removed and replaced with concrete overlays. Research personnel suggested that the membrane blisters should be punctured and sealed. That recommendation was followed and the subsequent performance of those membranes appears to have justified that course of action. As with the other membrane bridges, no visible efflorescence can be detected on the undersides of the I-24 twin bridges, indicating that large amounts of water have not penetrated through the membranes into the concrete decks. To date, surface blemishes have not severely affected performance of the membranes.

Figure 21. Cracking in Asphalt Wearing Surface Created by Laps in Underlying Roofing Paper (US 68 over Sinking Fork Creek) (1981).

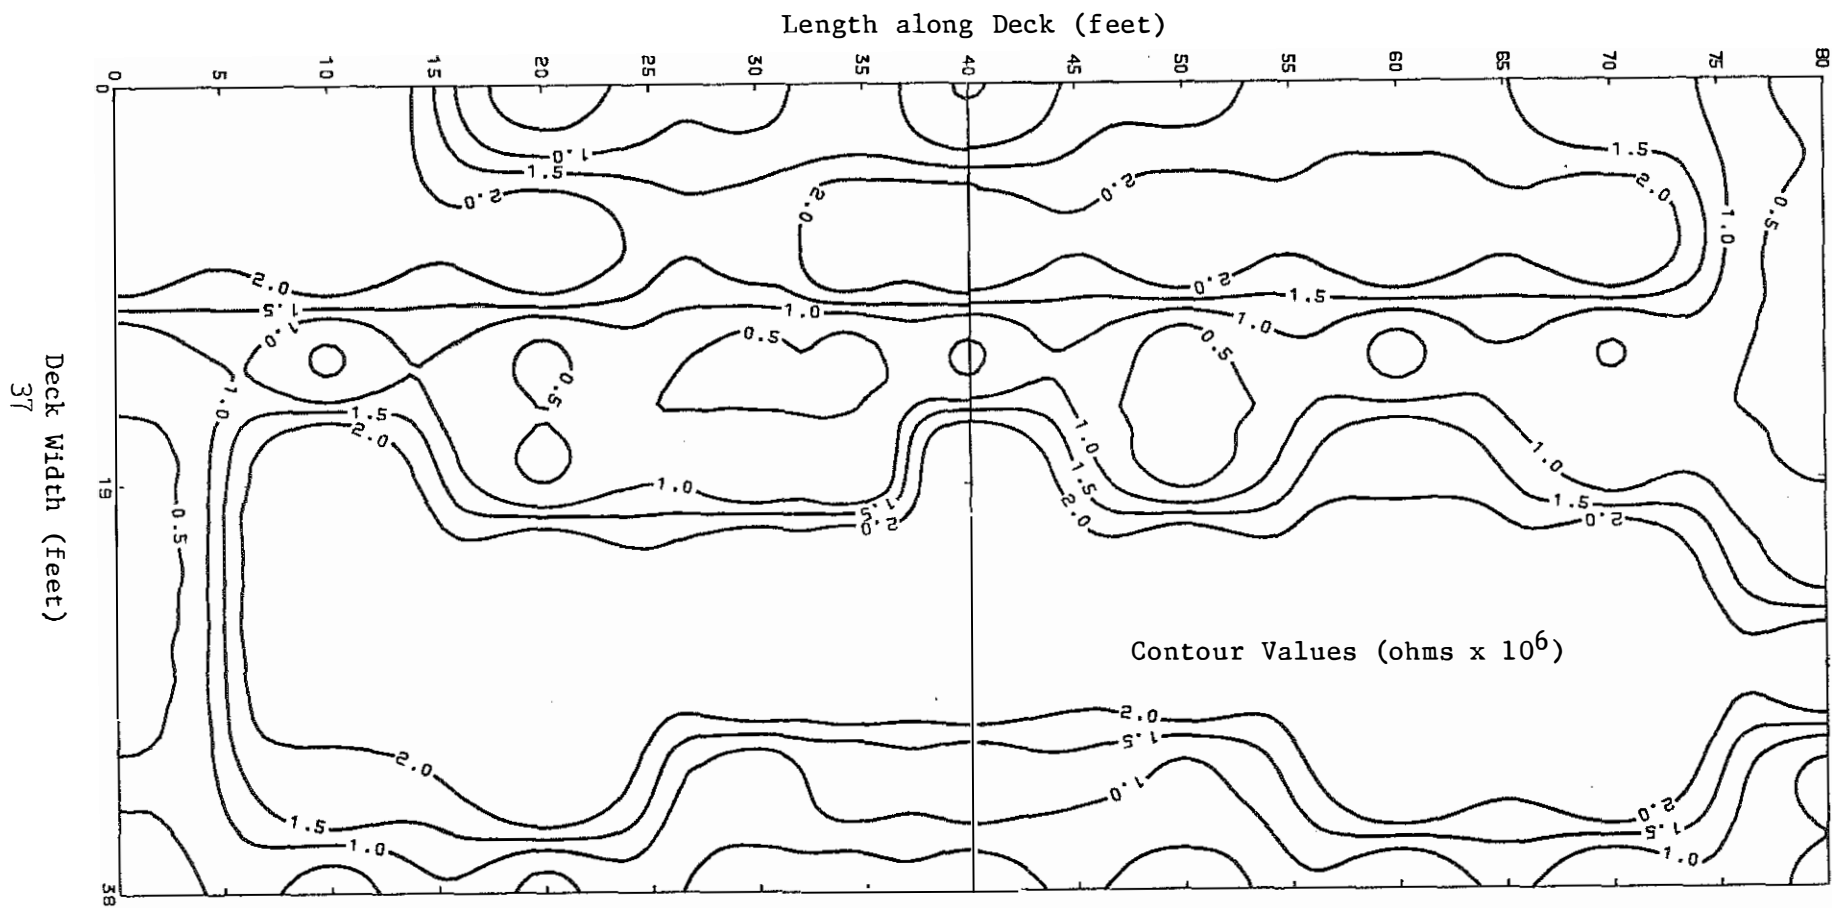
Creek). Both bridges had finite resistance readings, indicating some deterioration of those membranes (Figures 22 and 23). Since the membranes possessed significant resistance (in the range of approximately one million ohms), they are still probably satisfactory. However, they probably will not be effective more than 5 to 10 years longer. That would result in membrane service lives of approximately 15 to 20 years. If those bridges could be overlaid again, they may provide 30 to 40 years of service without requiring re-decking. The US-460 bridge deck over the Forks of Elhorn should provide 5 to 10 years additional service.

Figure 22. Resistivity Plot for Membrane Overlay (US 68 over Muddy Fork Creek)(1985).

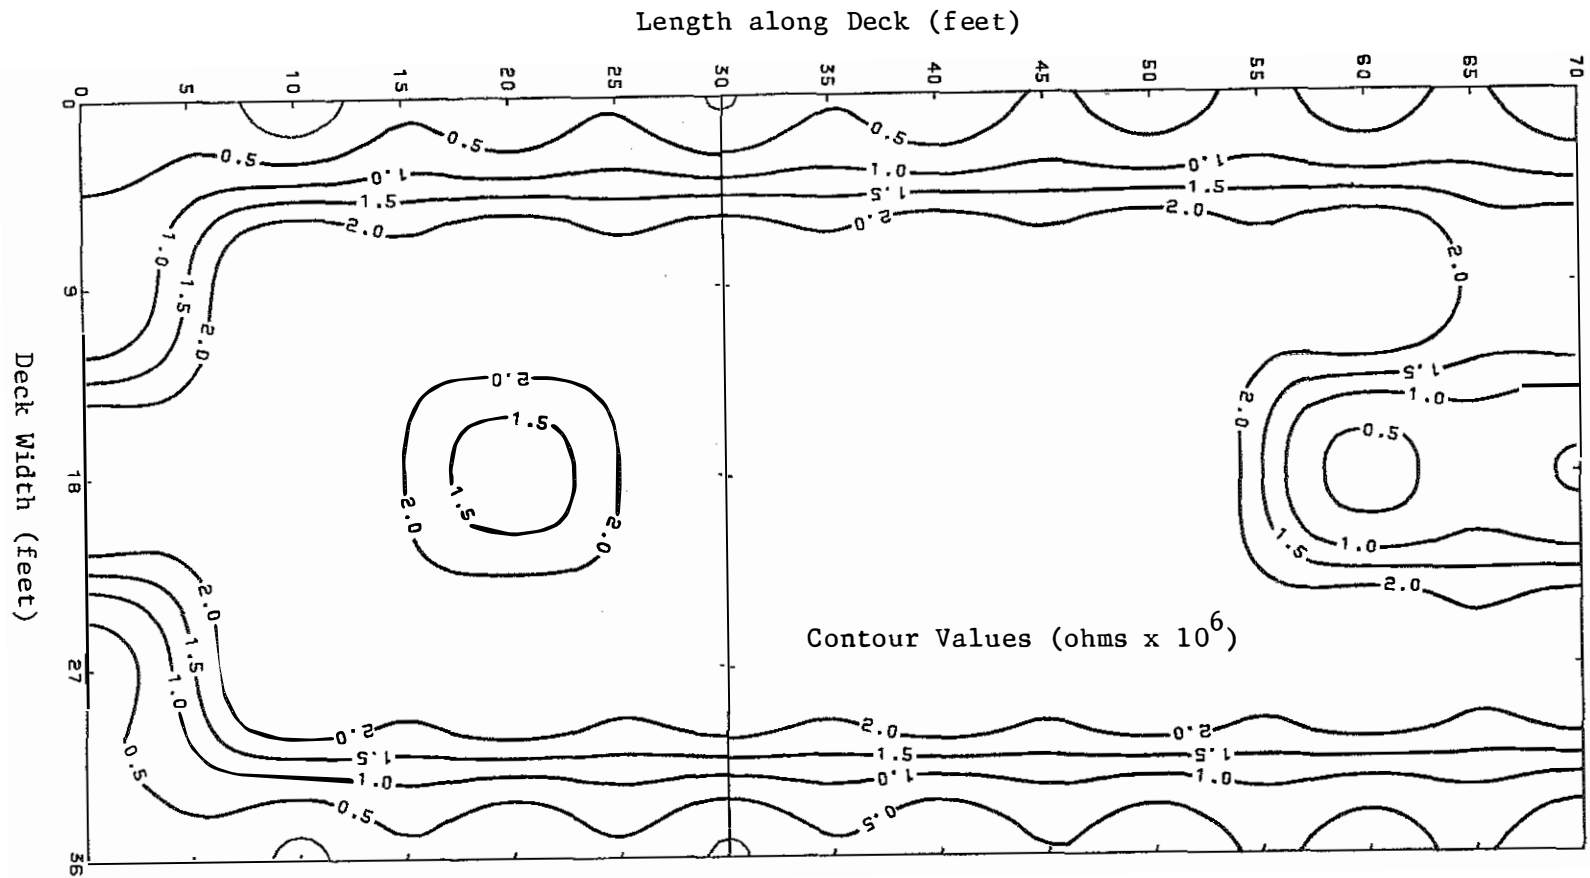
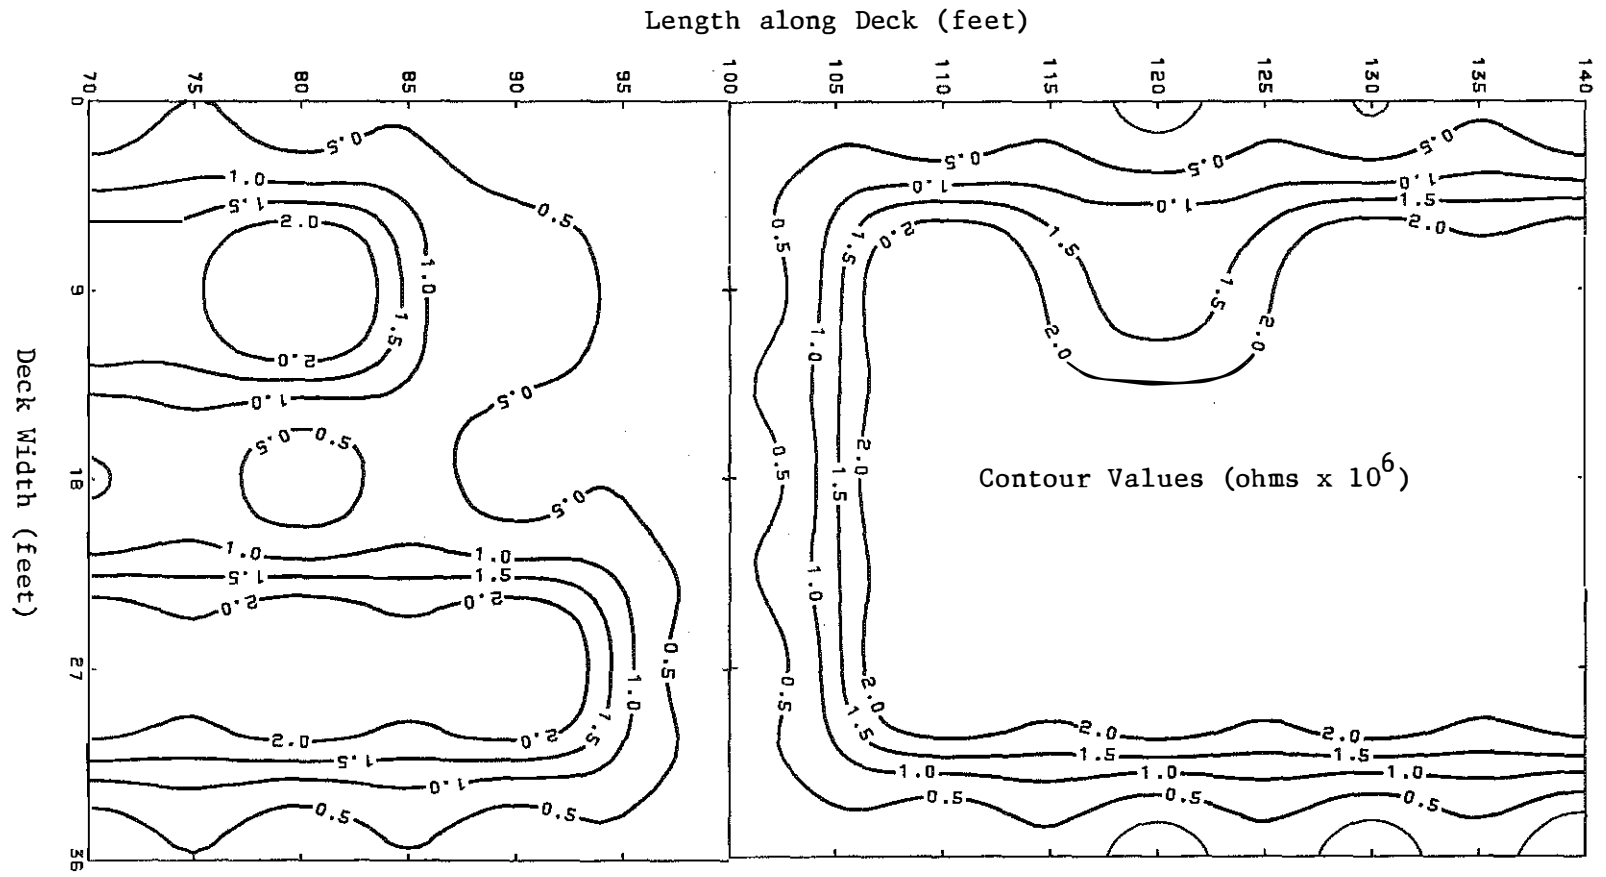
Figure 23. Resistivity Plot for Membrane Overlay (US 68 over Sinking Fork Creek)(1985).

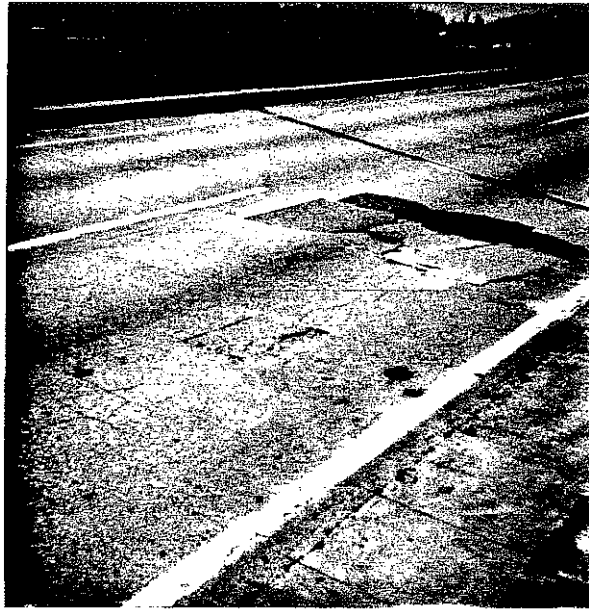
Figure 24. Patches on Areas of Overlay Debonding Thermoflex Latex (I 75 over Rhodes Creek in Scott County)(1987).

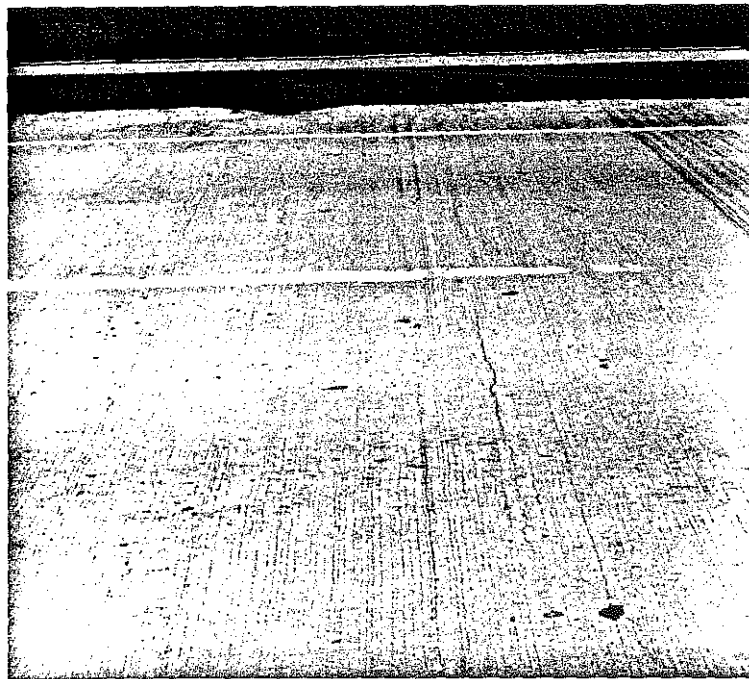
Figure 30. Cracking in the Deck of the US-60 Bridge over Clear  
Creek in Shelby County due to Differential  
Settlement (1984).

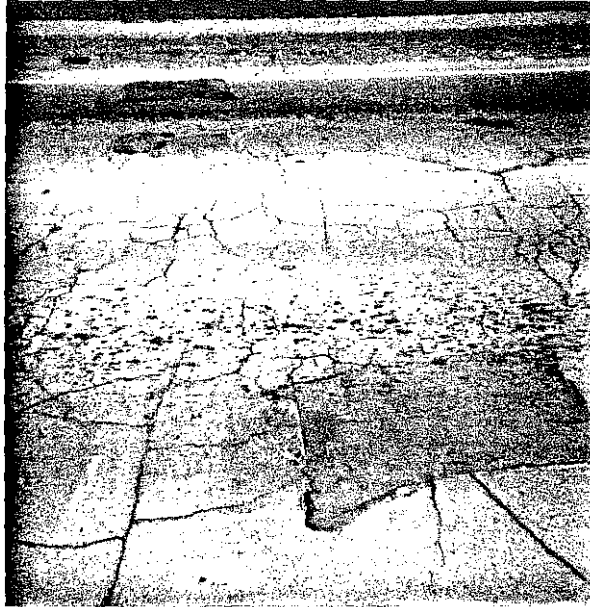
On some heavy-haul and interstate routes, decks of continuous steel-girder bridges contain extensive block cracking. Apparently, those bridges are not sufficiently stiff. Conversely, bridges employing precast, prestressed concrete I-beams, especially the integral abutment bridges, contain very few cracks. Most of those cracks are longitudinal and may indicate the need for more transverse reinforcement. Deck cracking may probably be eliminated by prestressing the slab. Previous efforts to seal cracks have not proven satisfactory. Further investigations are needed relative to that issue.

Figure 31. Patch in Concrete Deck Adjacent to Area Showing Block Cracking (US 460 over I 75 in Scott County)(1987).
