Research Report
UKTRP-87-5

SUMMARY OF EXPERIMENTAL BRIDGE FEATURES

March 1987

Kentucky Transportation Research Program

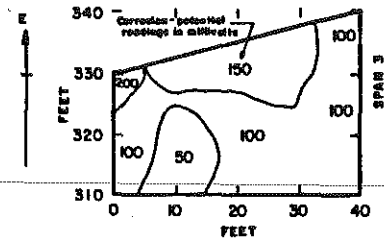
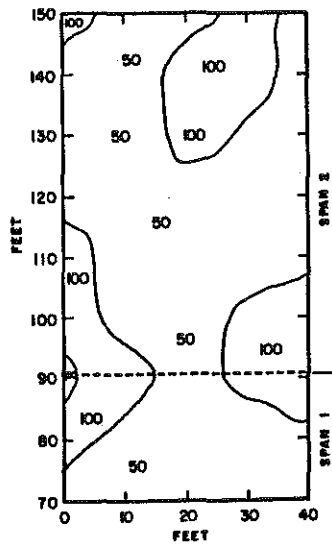
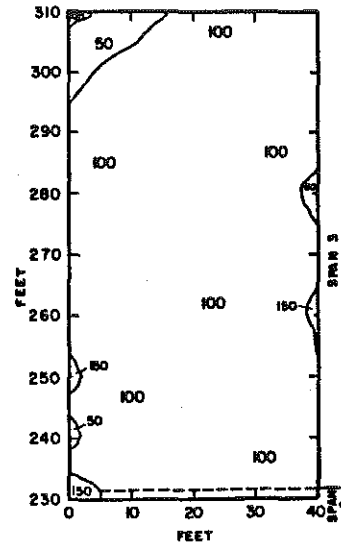
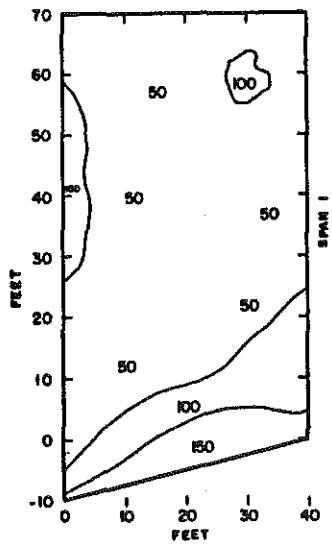
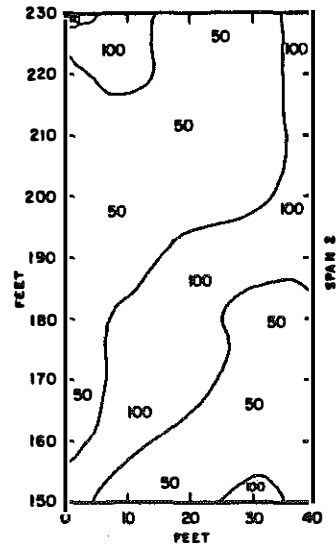
Follow-up corrosion-potential tests performed in late 1982 and early 1983 revealed no signs of corrosion on any of the bridges (Figures 1 through 4). At that time, the KY-80 bridge was 5 years old and the CR-1381 bridge was 6 years old. The I-64 (Elkhorn Creek) and the Yarnallton Road bridges were 12 and 11 years old, respectively, when inspected. However, corrosion-potential measurements for all of the bridges had increased over the values originally measured.

Figure 1. Corrosion-Potential Test of the KY-80 Bridge over Buck Creek, February 21, 1983 (1).

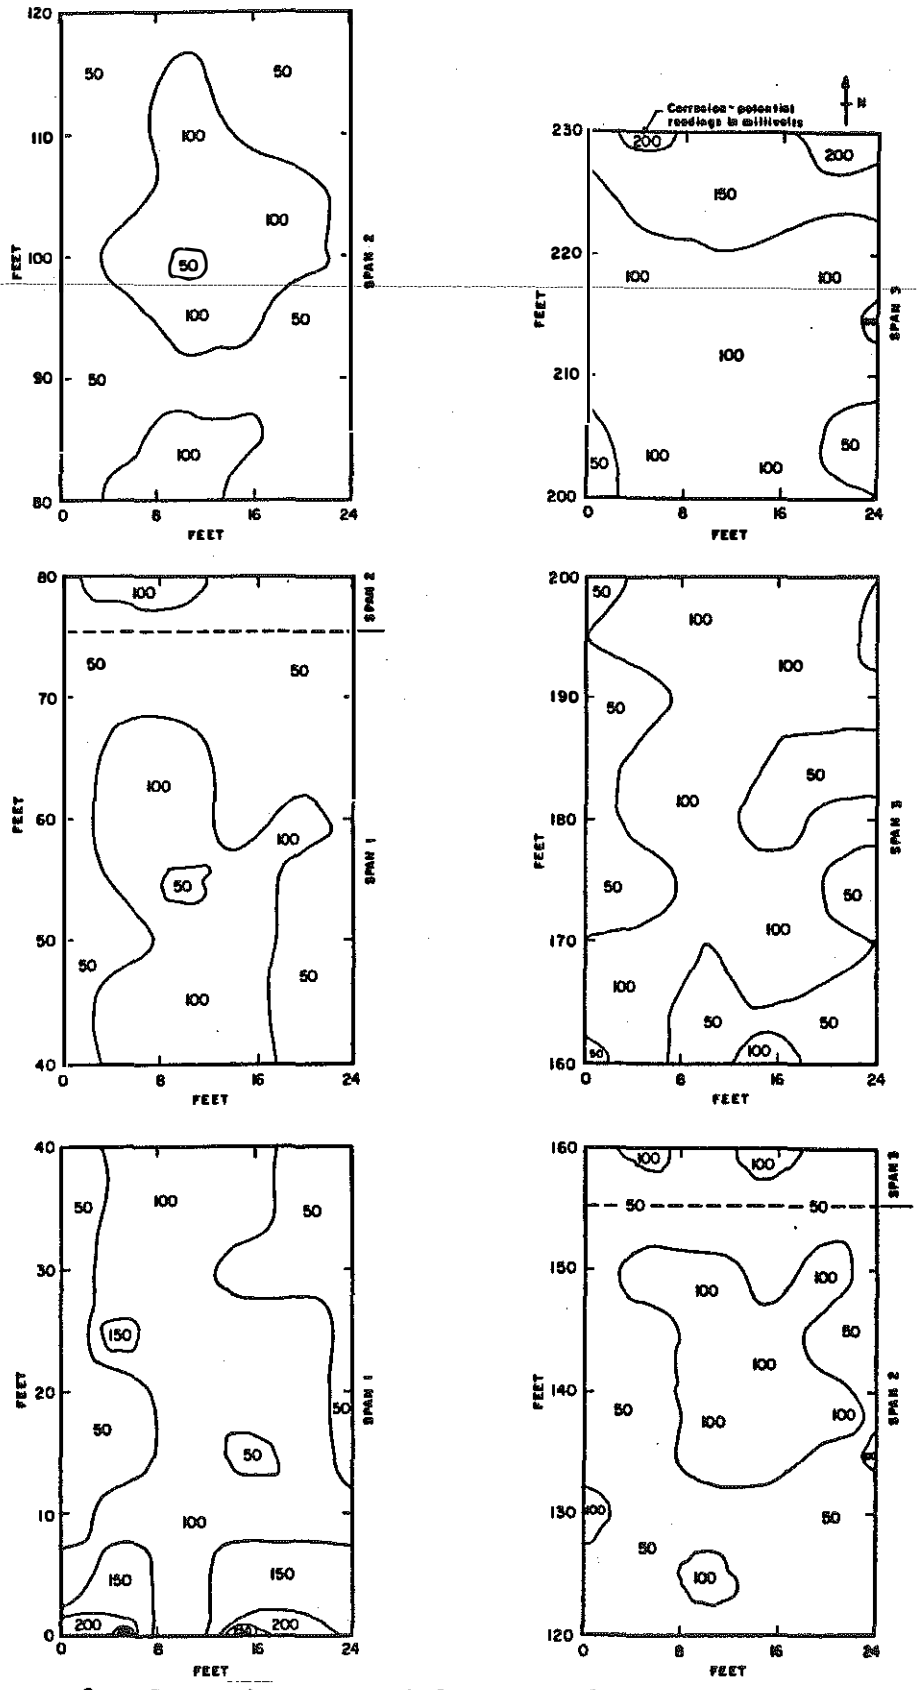
Figure 2. Corrosion-Potential Test of the CR-1381 Bridge over Panther Creek, October 13, 1982 (1).

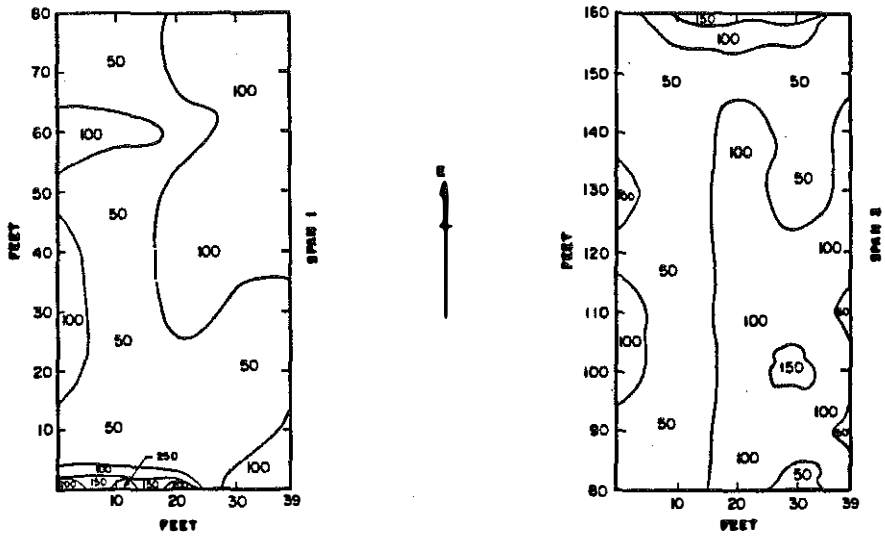
Figure 3. Corrosion-Potential Test of the I-64 Bridge over Elkhorn Creek, February 20, 1983 (1).

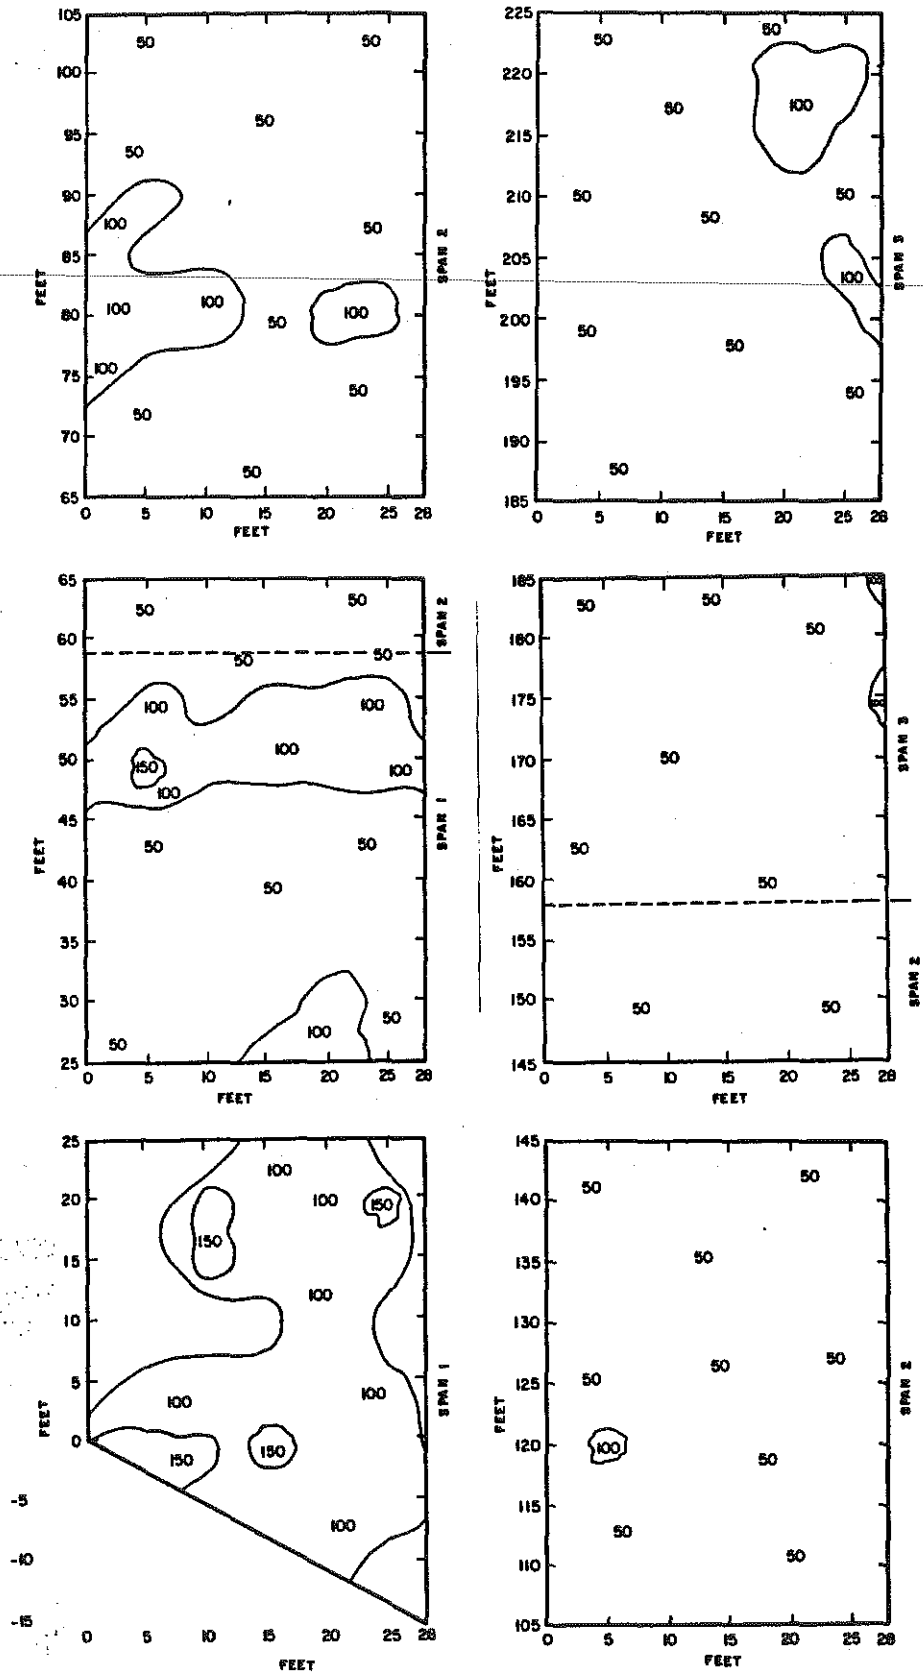
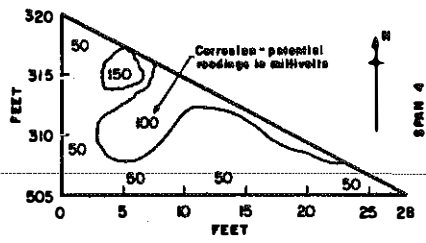
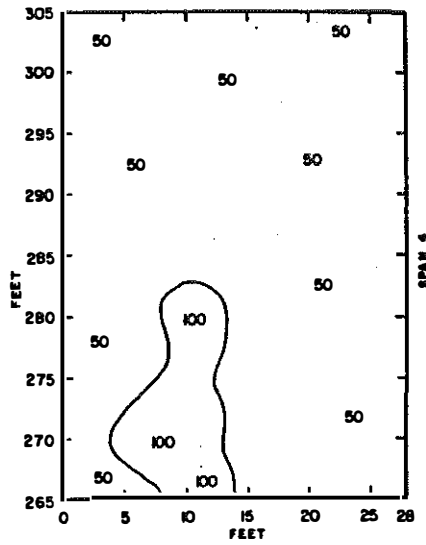
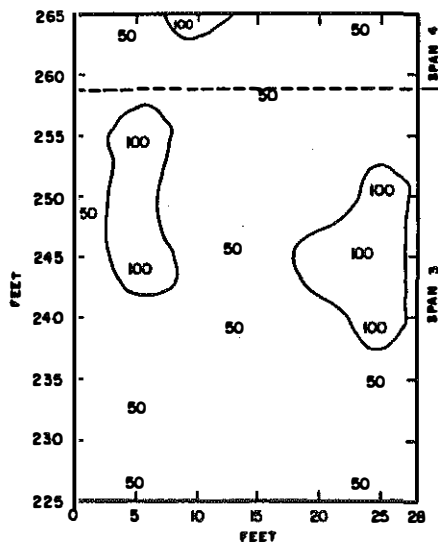
Figure 4. Corrosion-Potential Test of the Yarnallton Bridge over I 64, February 20, 1983 (1).

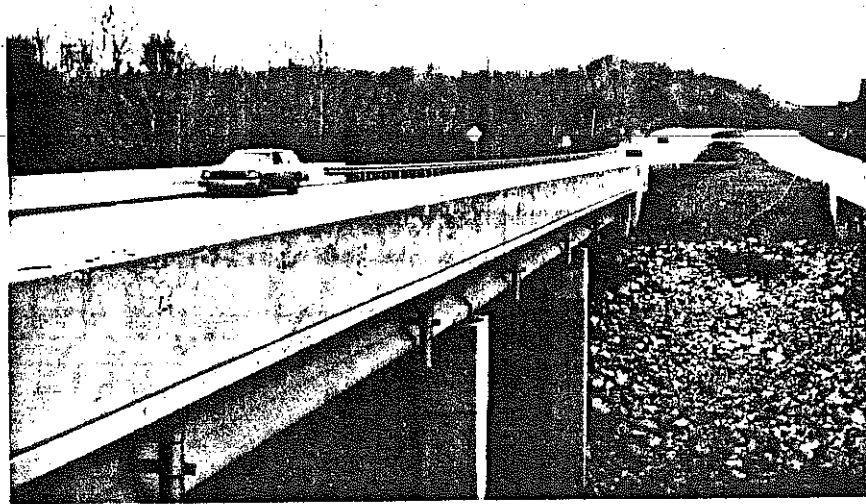
Figure 5. Failure of Masonry Coating on US-25E Bridge over Big Richland Creek (Westbound) (1984).

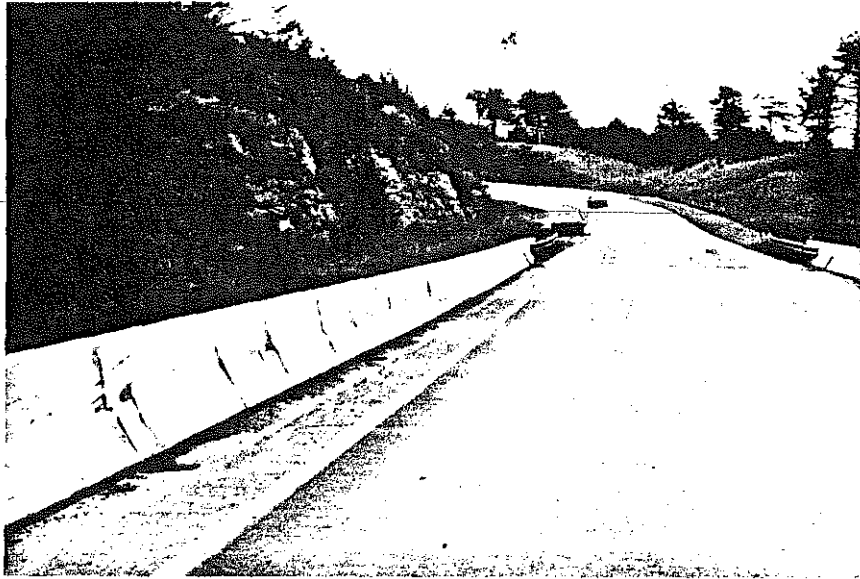
The KY-770 bridge is a continuous steel-girder bridge having a number of flexure cracks that extended up the plinth walls (Figure 7). Those cracks acted as nucleation sites for failures of the masonry coating (Figure 8). District 11 personnel were of the opinion that some steel bridges were prone to deck and plinth cracking. Similar observations have been made by research personnel in the last two years.

Figure 7. Failure of Masonry Coating on a Plinth Wall of the KY-770 Bridge over the Laurel River Reservoir (1984).

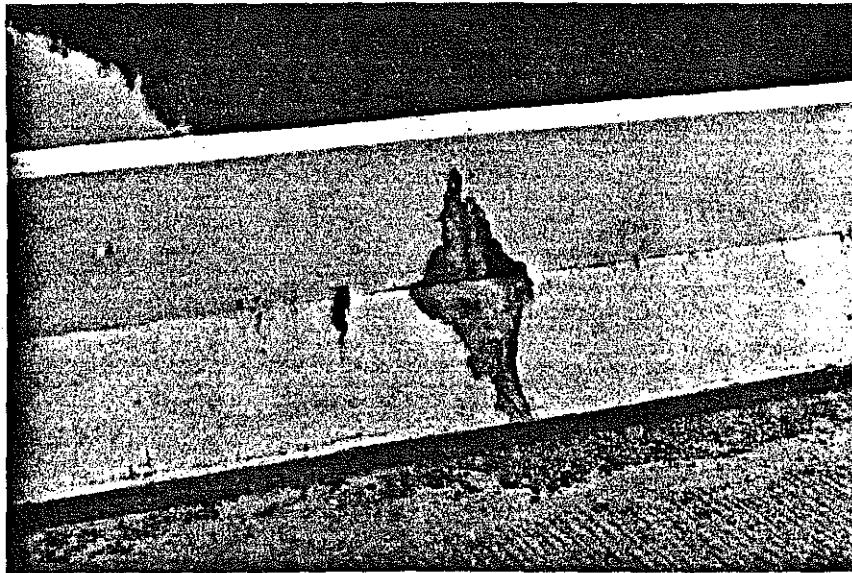
Figure 8. Failure of Masonry Coating Spreading from Vertical Crack in the KY-770 Bridge (1984).

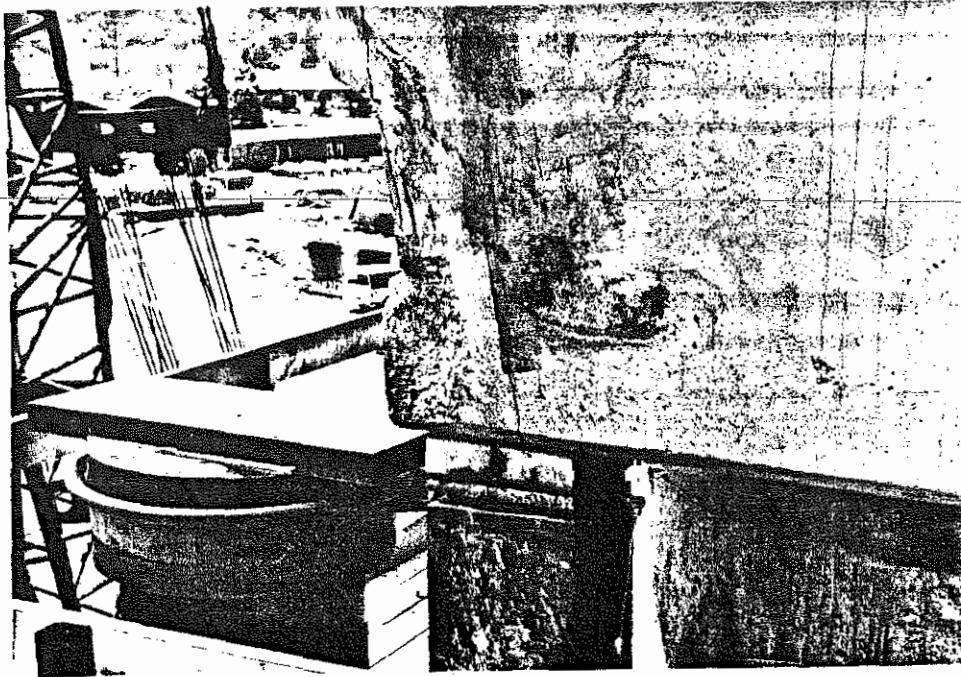
A few problems were encountered. Initially, erection was slow due to the contractor's unfamiliarity with segmental construction. Also, a few segments had problems with oversized shear keys that spalled during placement. The cantilevered superstructure had to be rotated about the piers to achieve proper alignment prior to casting the connecting key. However, most of those problems were minor and were easily rectified.

Figure 30. Damaged Shear Key.

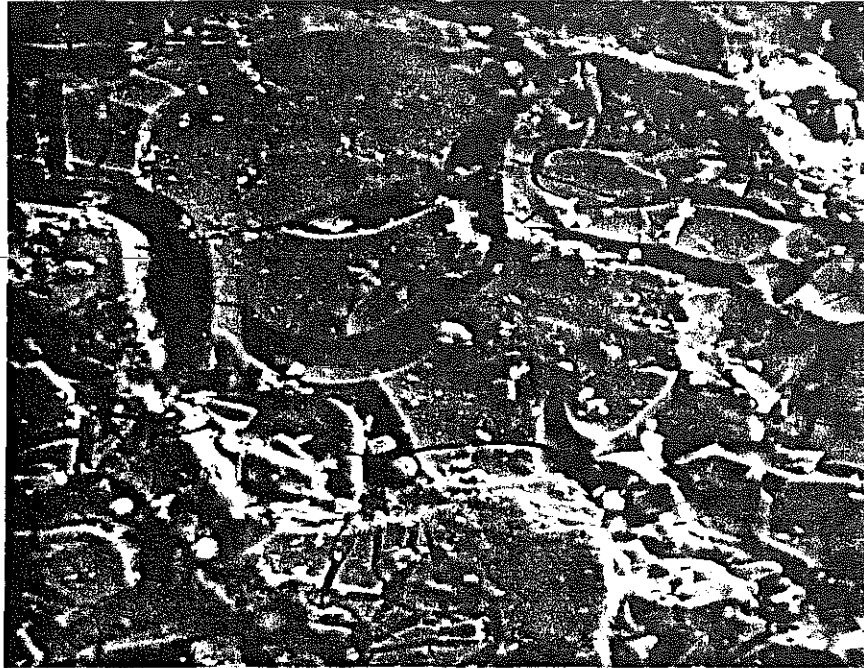
In 1985, failures of aluminum nuts used to retain a plinth aluminum guardrail were investigated. Initial laboratory tests revealed that the nuts failed by several types of corrosion (exfoliation and stress corrosion). Field inspections of three KY-4 bridges in Lexington indicated nut-failure rates from 0 to 40 percent. Kaiser Aluminum and Chemical Corporation analyzed the nuts and reported that those which failed were of the wrong alloy type (2024 series rather than 6061 series). Apparently the 2024 series alloy nuts were substituted accidentally for the proper type.

Figure 40. Scanning Electron Microscope Picture of Nut Fracture Surface (X300).

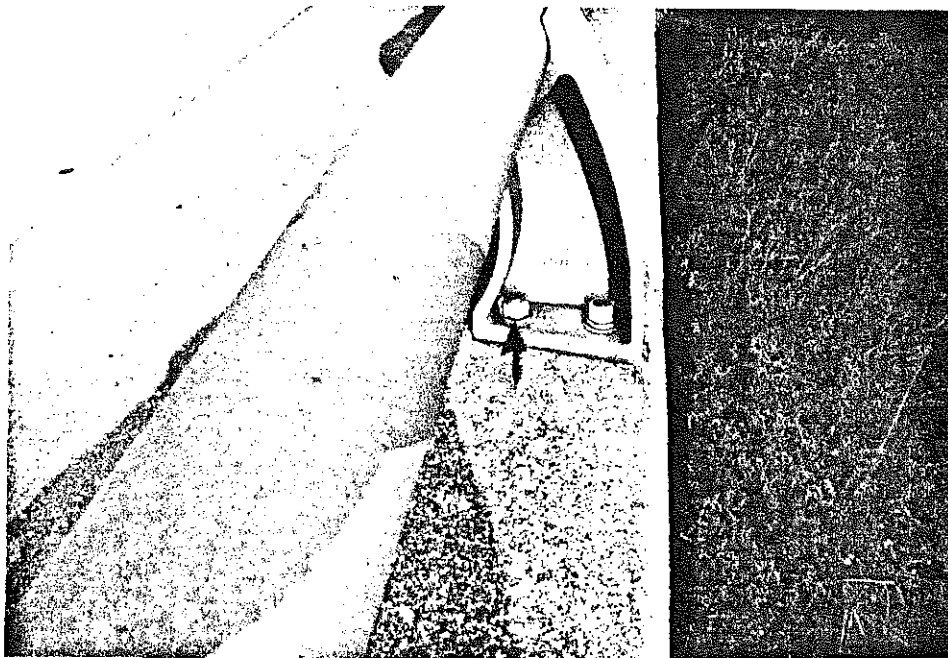
Figure 41. Nut on Guardrail Exhibiting Exfoliation Corrosion -- New Circle Road (KY 4) over Clays Mill Road In Lexington, Kentucky.

Retaining nuts on several aluminum handrail installations were observed as being badly corroded. A detailed investigation revealed that all corroded aluminum nuts were manufactured from alloys that did not meet specification requirements. Corroded retaining nuts are being replaced with nuts manufactured of the specified alloy.

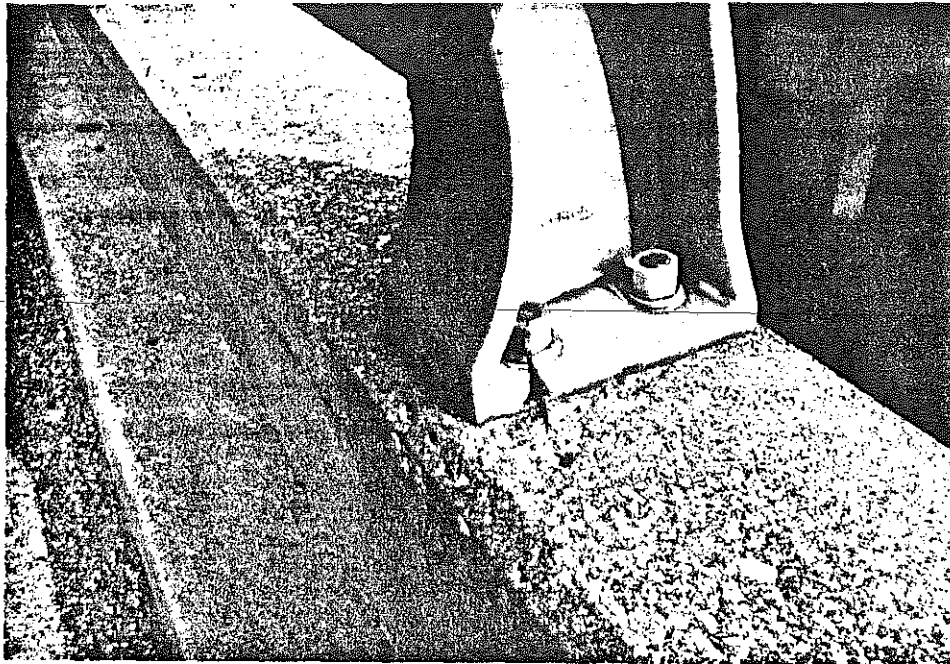
Figure 42. Nut on Guardrail Exhibiting Stress Corrosion Cracking -- New Circle Road (KY 4) over Clays Mill Road in Lexington.

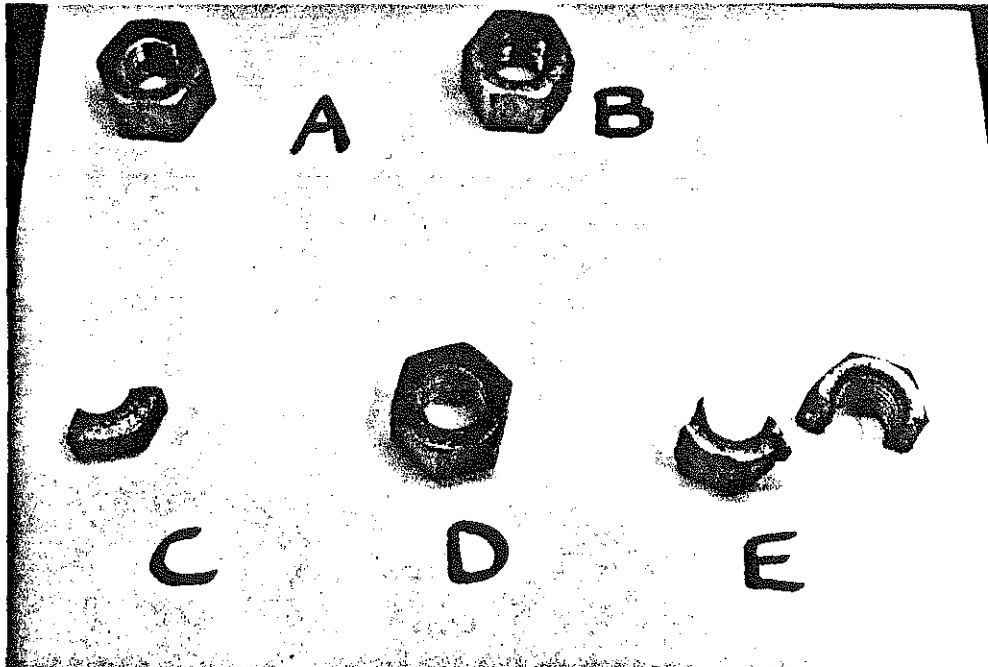
Apparently, some party unaware of the consequences mixed wrong nuts with batches of correct 6061 alloy nuts. That would account for random nut failures experienced on Kentucky bridges having the currently obsolete aluminum guardrails.

Figure 43. Nuts Sent to Kaiser Aluminum and Chemical Corporation for Element Analysis and Alloy Identification. Note that Nuts A and B Are in Good Condition. Nuts C, D, and E Have Cracked.
