Research Report  
UKTRP-84-14

CORROSION OF CABLE SUSPENSION BRIDGES

May 1984

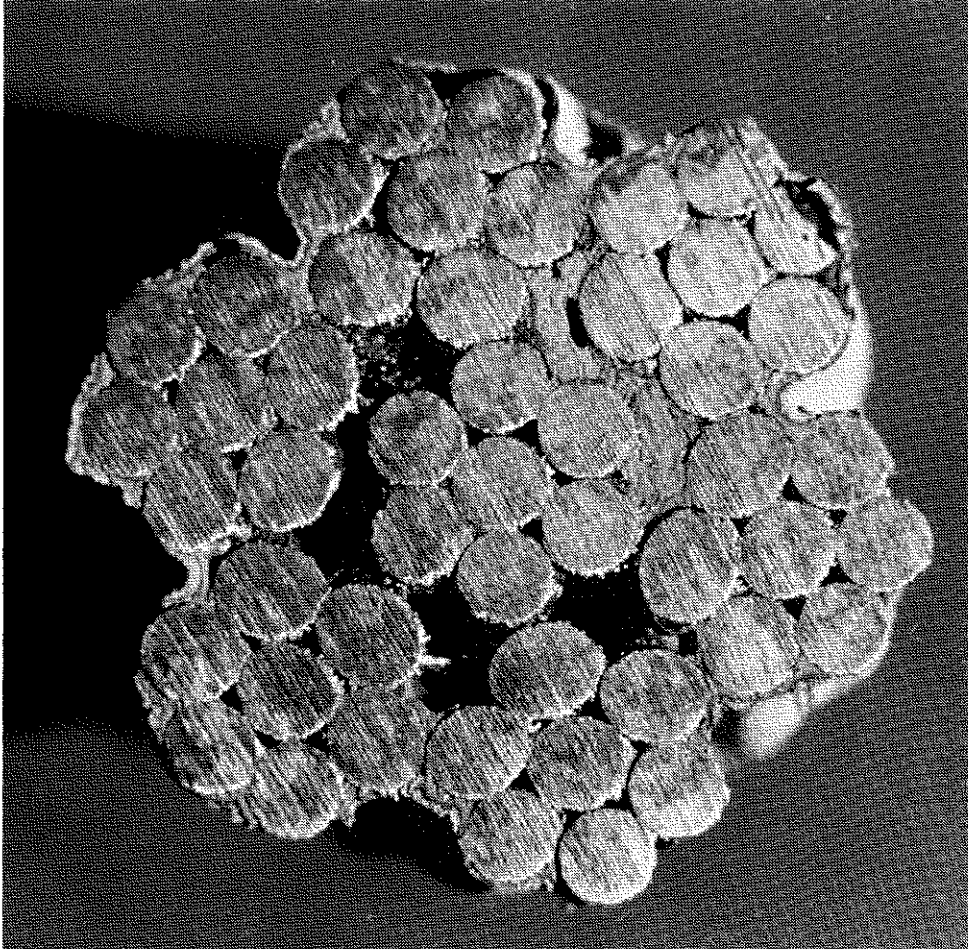
Figure 3. Swollen Section of Ohio Bridge Suspender Rope (1974).

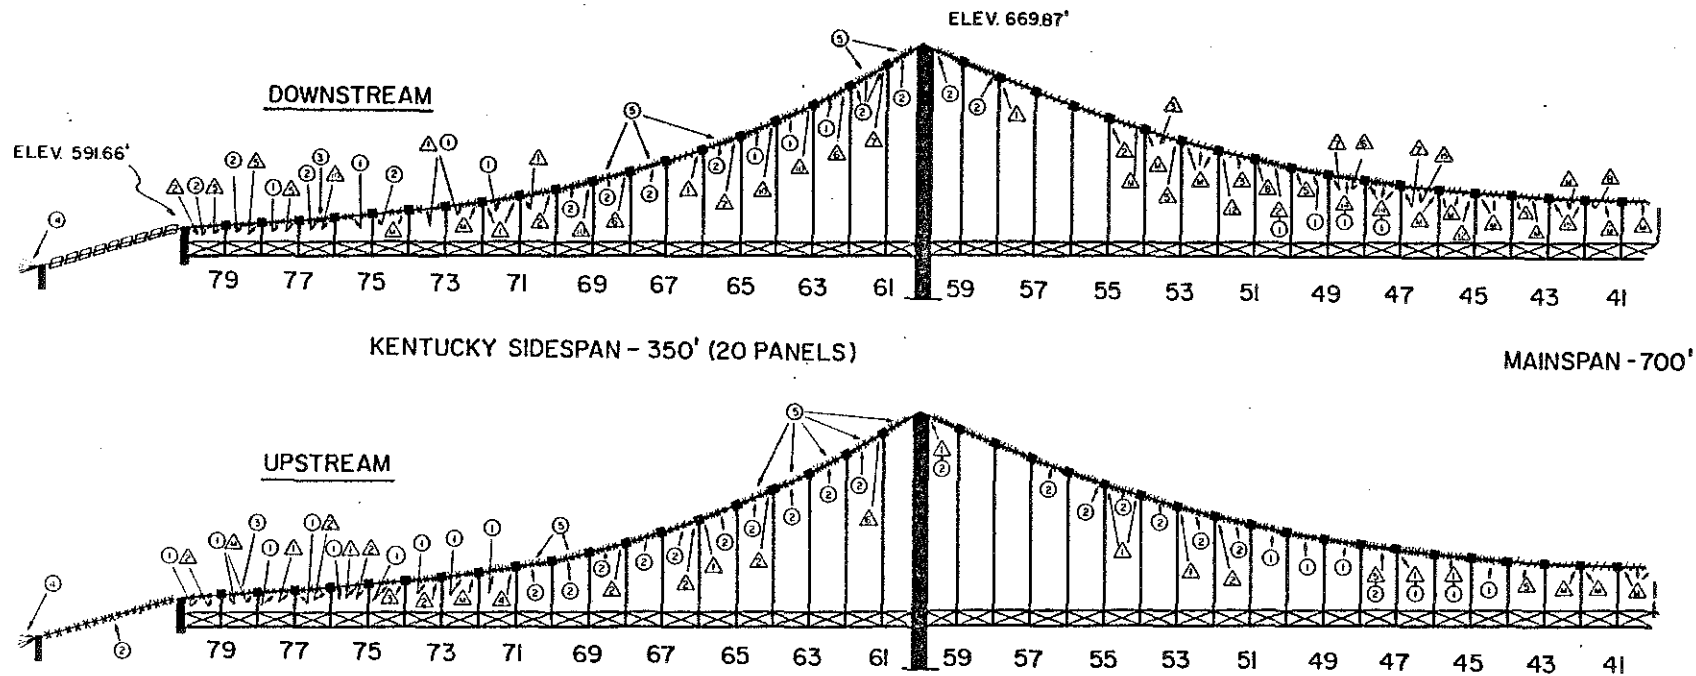
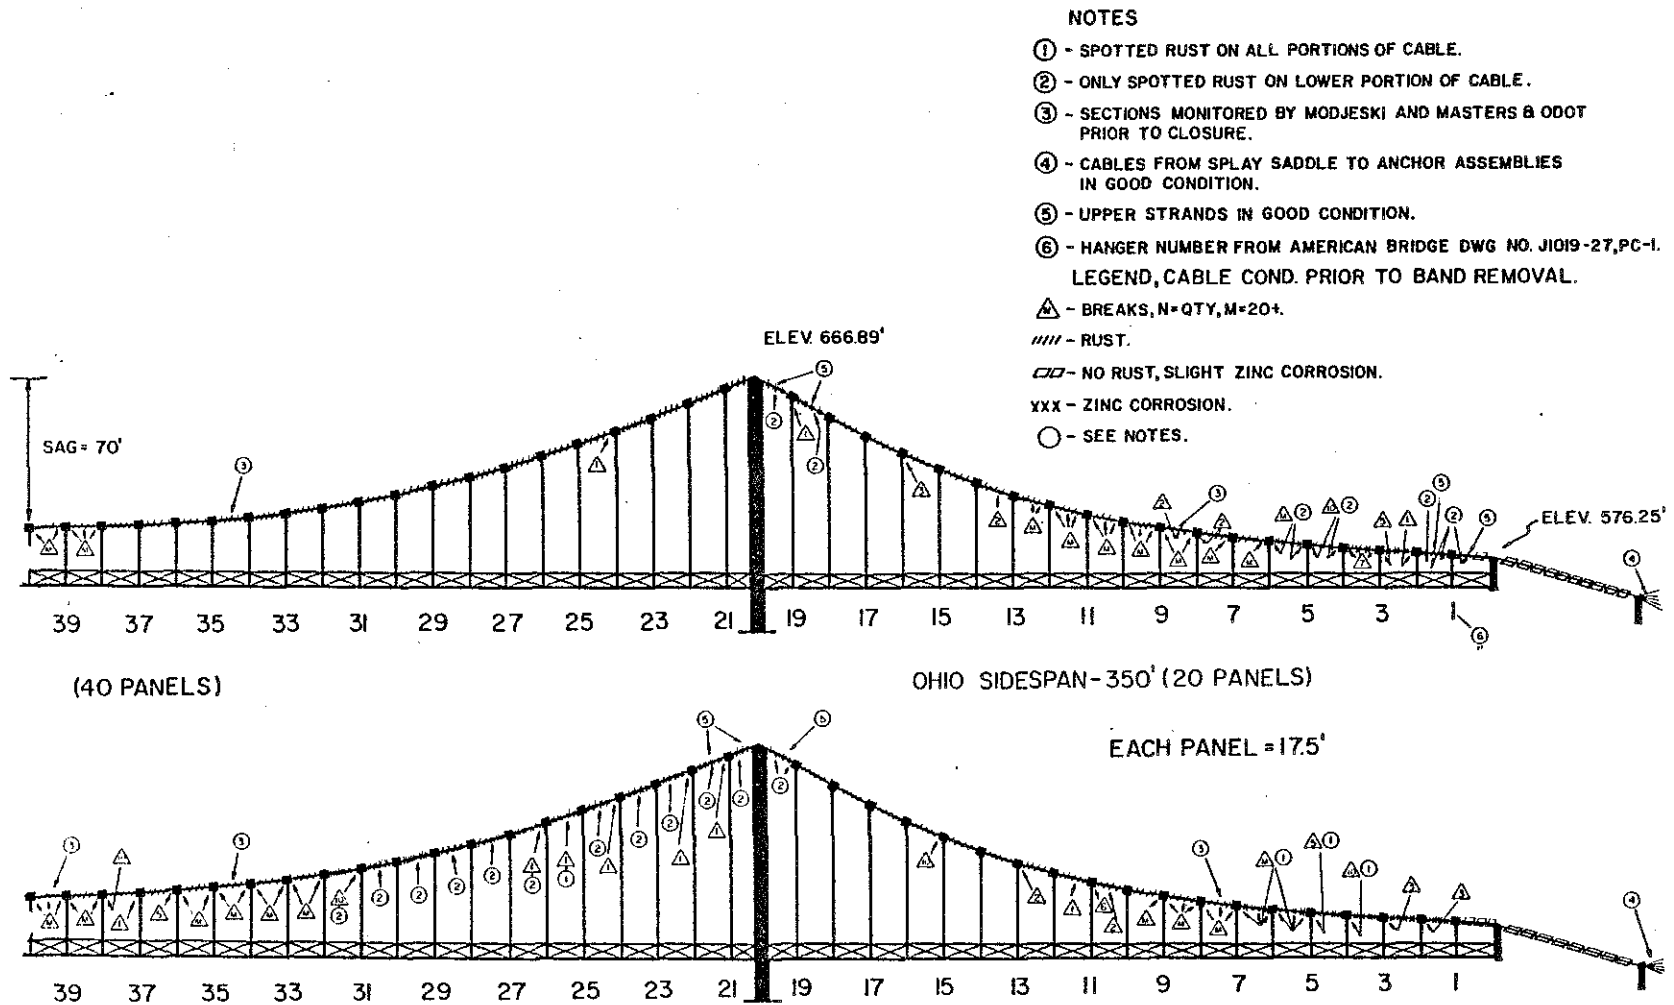
Only one panel (66-67, downstream) had severe rust on the Kentucky side span. Thirty-three of the forty main-span panels on the downstream cable were severely rusted. Twelve of the main-span panels of the upstream cables showed extensive rusting. Those were located on the lowest (shallowest) portion of the cable. Twelve panels of each cable on the Ohio side span showed severe rust.

Figure 4. Corrosion Survey on the Portsmouth Bridge Prior to Recabbling in 1979.

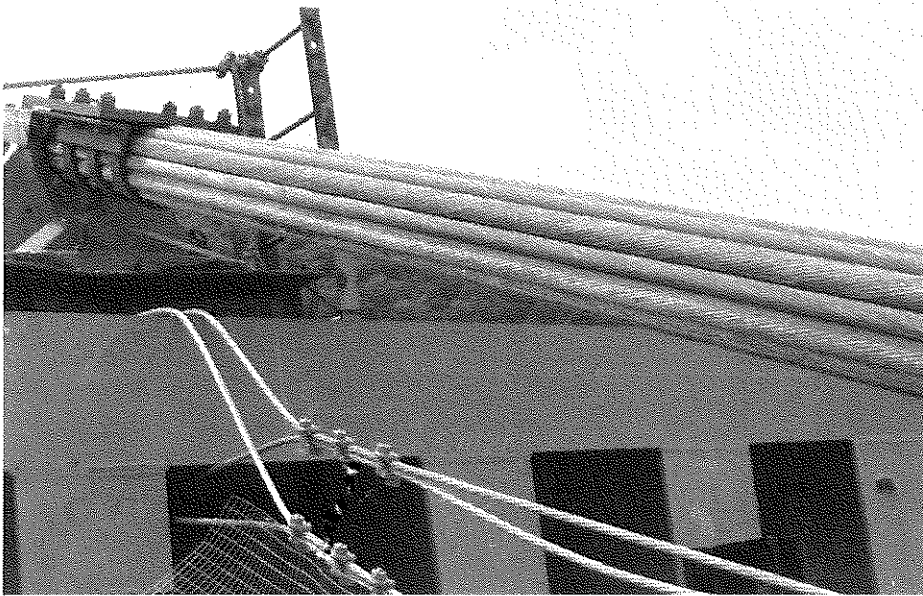
Figure 5. The Portsmouth Bridge, Downstream Cable, at the Kentucky Tower (Mainly Stage 2, Except Some Stage 3 on Lower, Outer Strands) (1979).

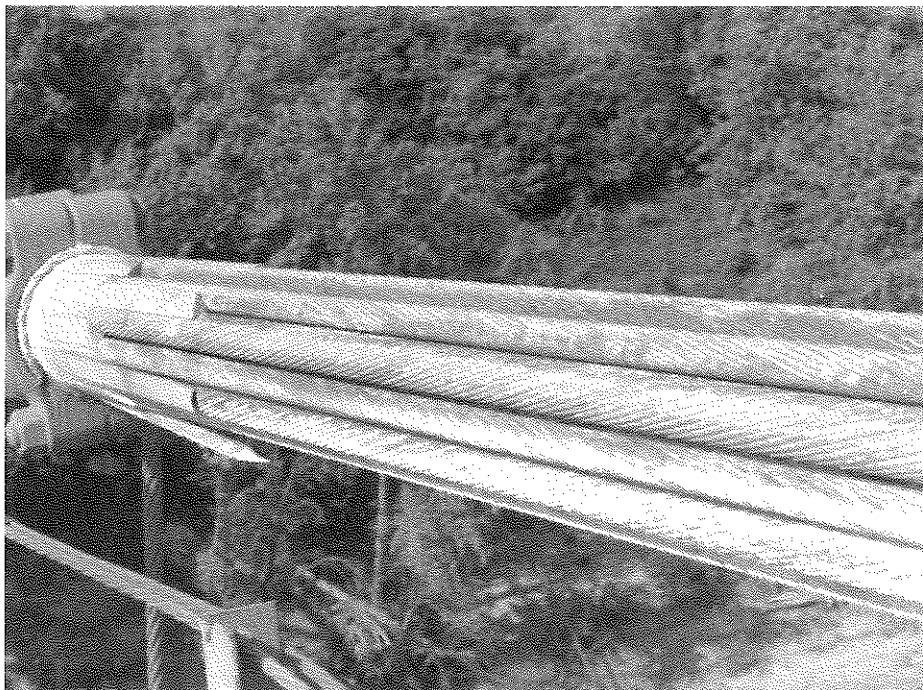
Figure 6. The Portsmouth Bridge, Downstream Cable, on the Kentucky Sidespan (Mainly Stage 2 Corrosion Damage)(1979).

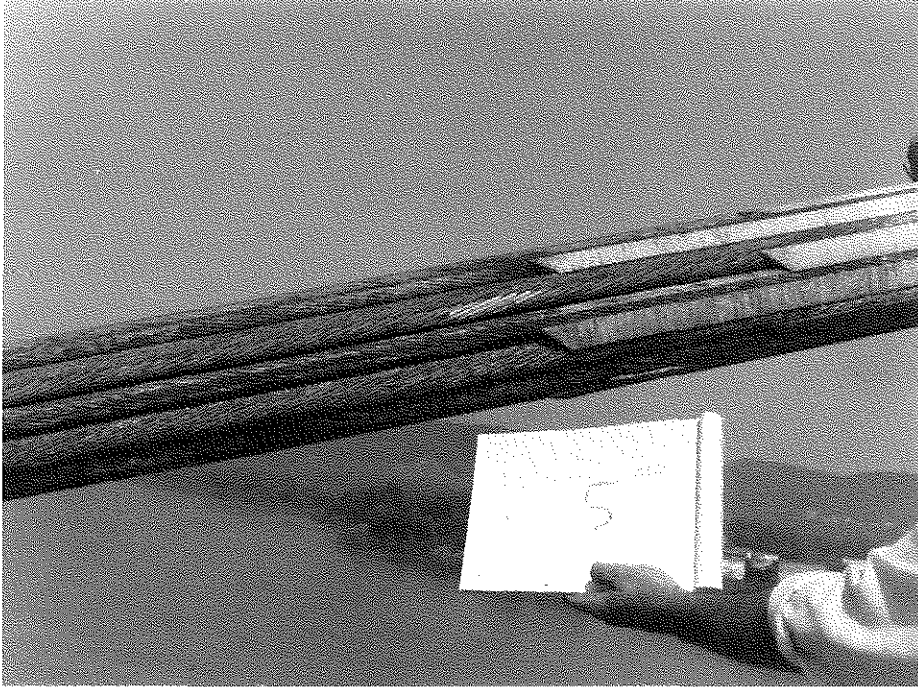
Figure 7. Stage-4 Deterioration on the Main Span, Downstream Cable, also Exhibiting Signs of Washing (1979).

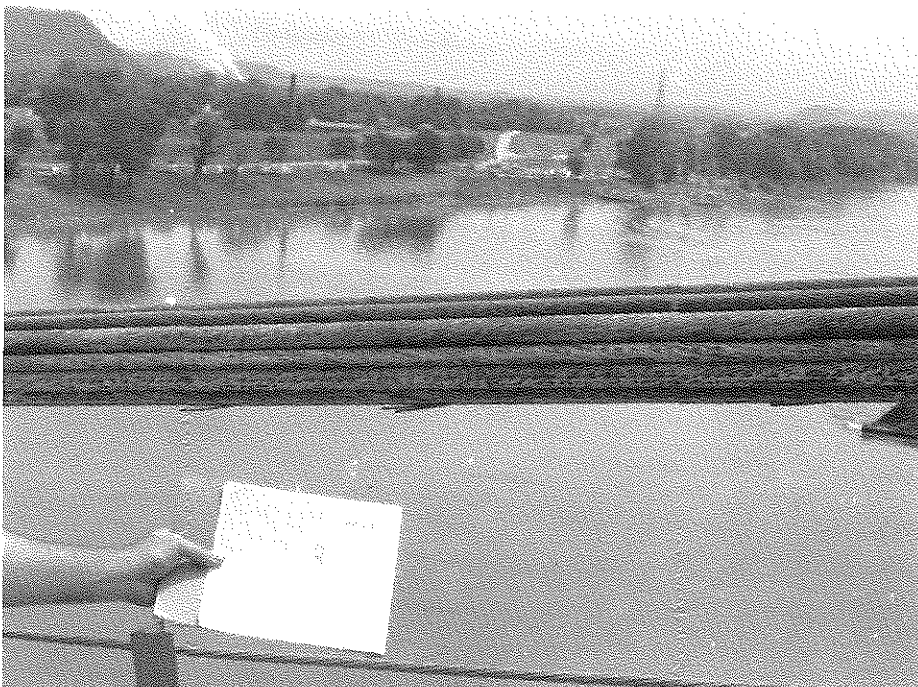
Figure 8. Breaks Clustered on Longer, Outer strands on Main Span, Upstream Cable, at Stage 4 Deterioration Site that Does Not Show Signs of Washing (1979).

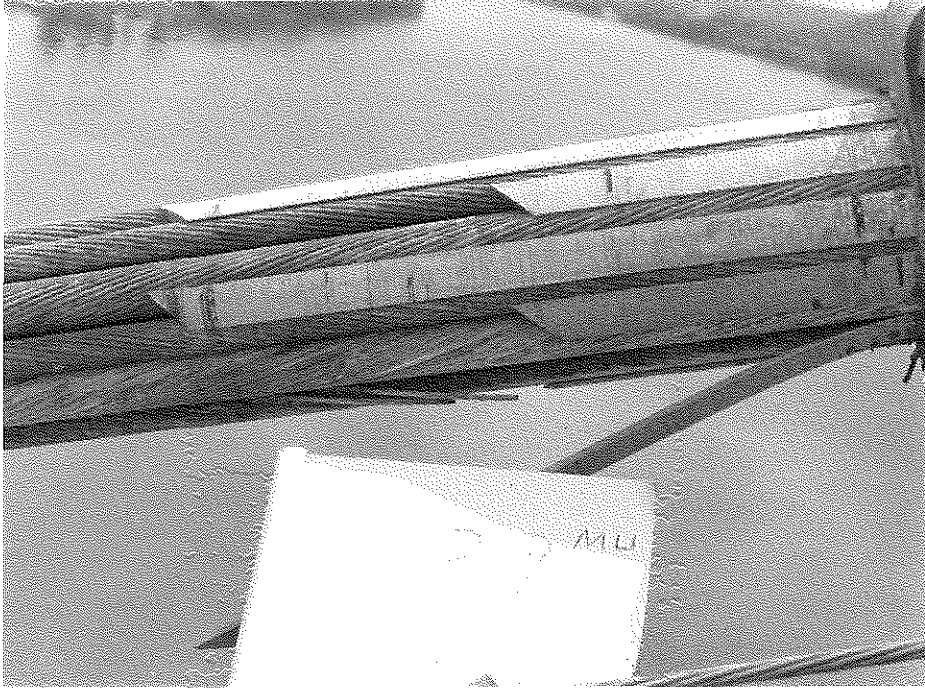
Figure 9. Wire Fractures Adjacent to a Cable Band (Strands Show Signs of Early Stage 3 Deterioration)(1979).

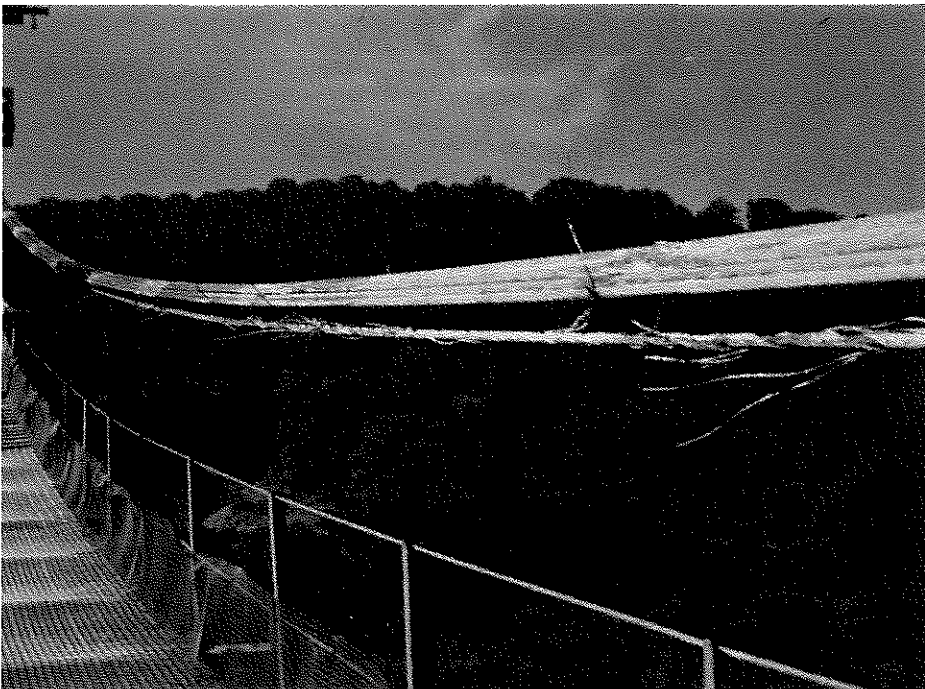
Figure 10. Portsmouth Bridge after Band Removal (Note Corrosion Marks at Band Locations)(1979).

points previously covered by bands. Many breaks were discovered on the upper strands at those locations. Prior to removal of the bands, no breaks had been observed in the upper strands. Under one band, breaks were noted on every exterior strand. Inspection of the interior strands at those points revealed extensive corrosion and new breaks (Figure 11). Unfortunately, the construction schedule precluded a detailed inspection of interior strands.

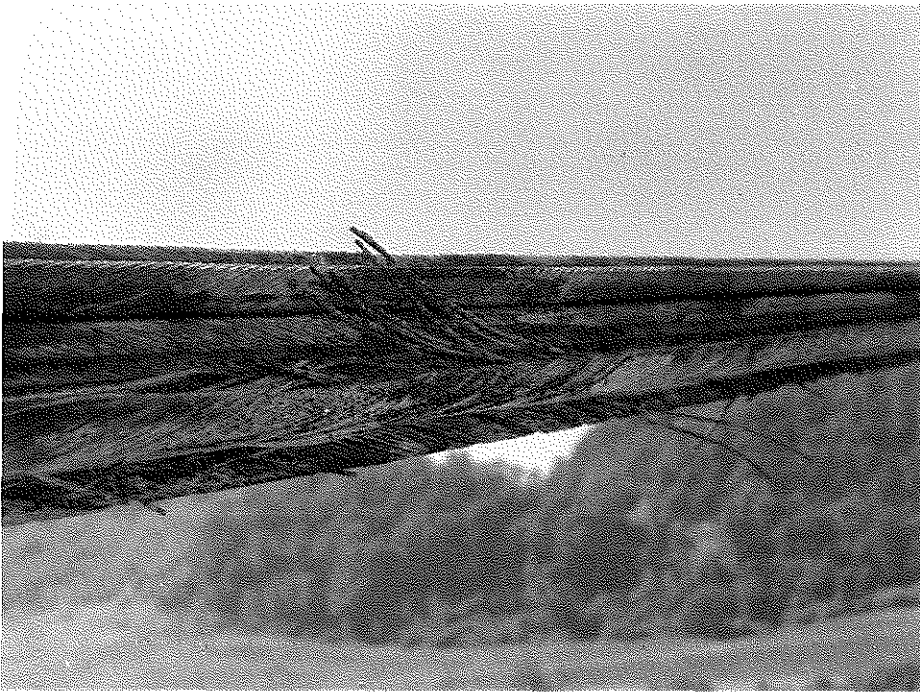
Figure 11. Portion of a Cable previously Covered by a Cable Band (Stage 4 Corrosion Damage) (1979).

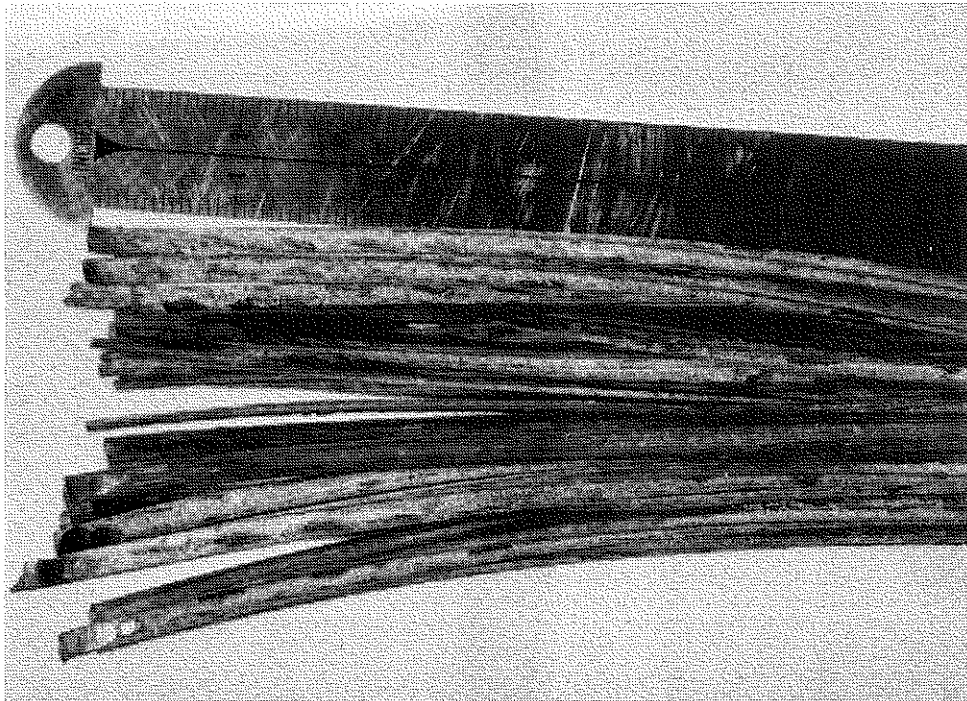
Specimens of the Portsmouth strand also indicated occurrence of crevice corrosion. Some specimens appeared to be in good condition, having only slight zinc corrosion near wire interfaces. When splayed, those specimens revealed zinc corrosion and spotted rust on the backside of exterior wires. The second layer of wires was covered with corrosion products. The third layer was in good condition, as were the other interior layers (Figure 12).

Figure 12. Separated Portsmouth Bridge Strand Showing Fretting Marks and Stage 2 Corrosion.

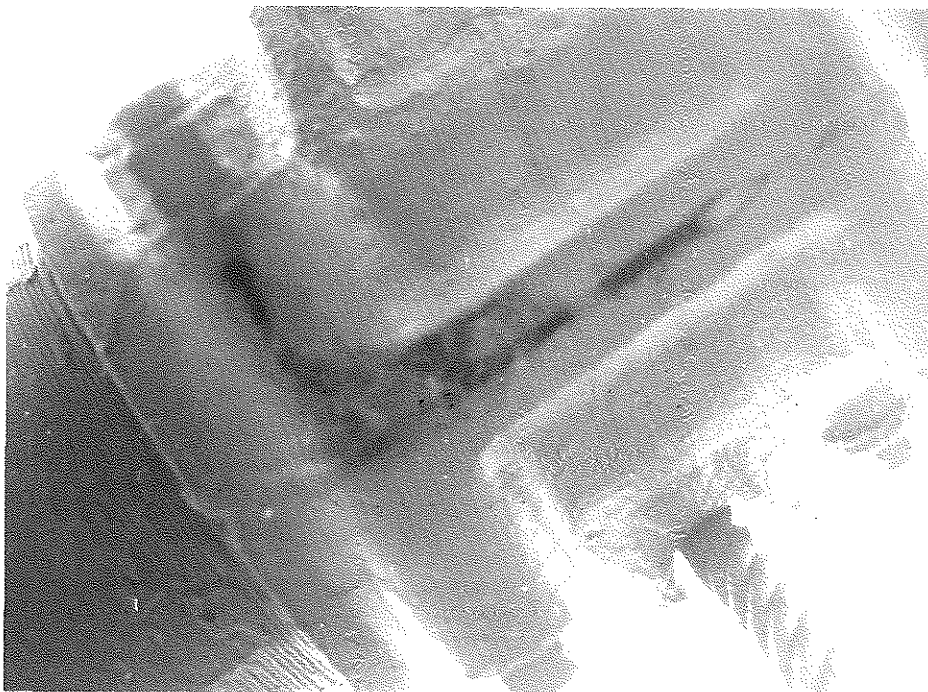
On December 5, 1979, a follow-up examination of inspection ports was performed. Several days before the inspection, the Maysville area was subjected to a heavy rain. Water was dripping from popped-out packing

Figure 15. Pop-out and Rust Stain on Cable Band of Maysville Bridge (1980).

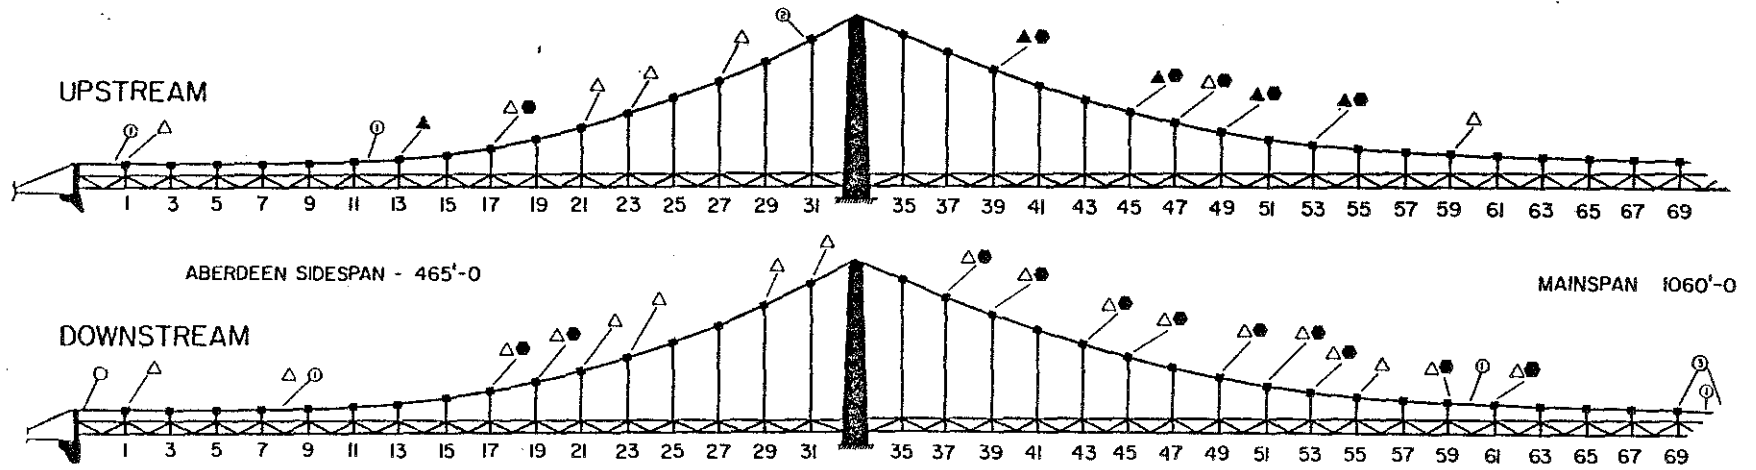
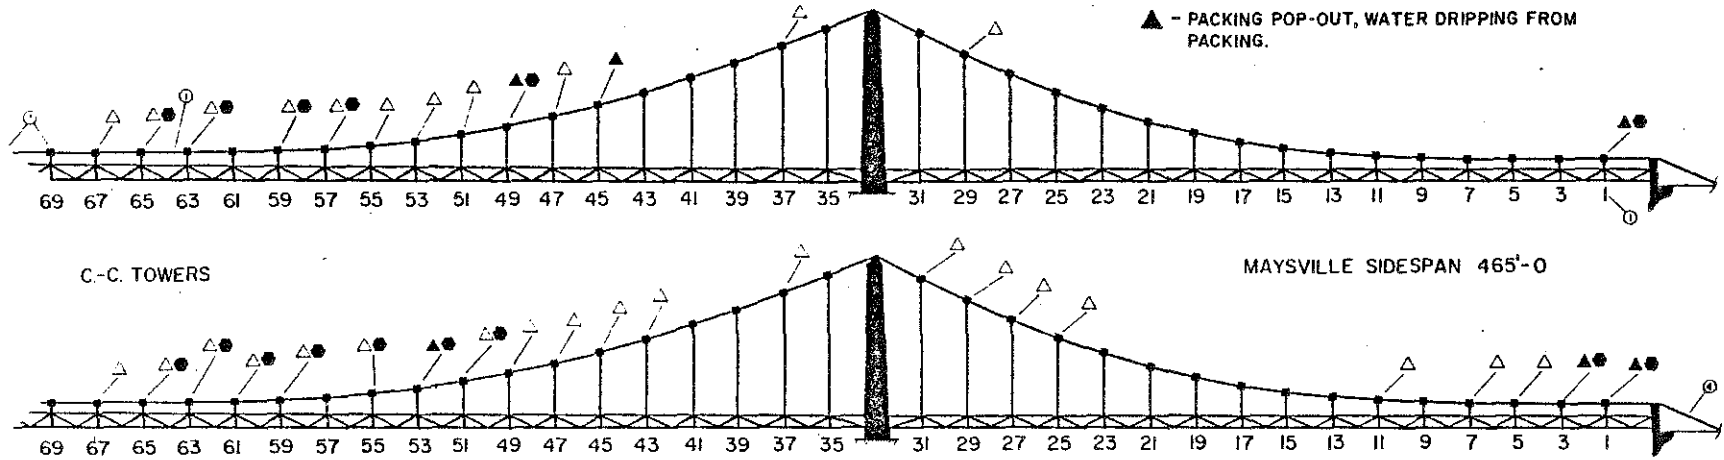
Figure 17. Exterior Survey of the Maysville Bridge (1980).

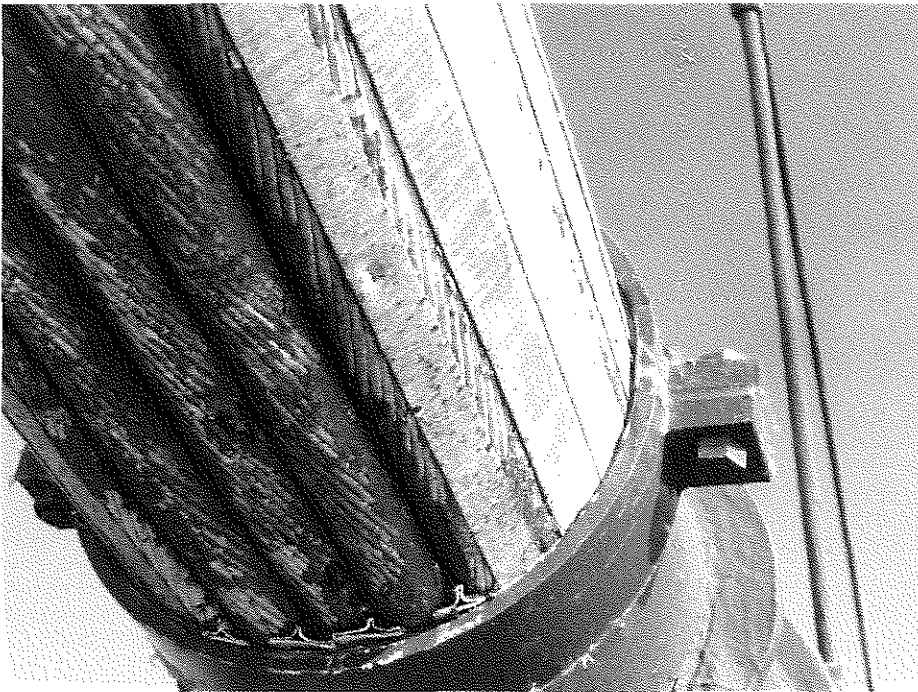
Figure 18. Rust Spots on Strands of the Maysville Bridge Cables (Early Stage 3 Deterioration)(1980).

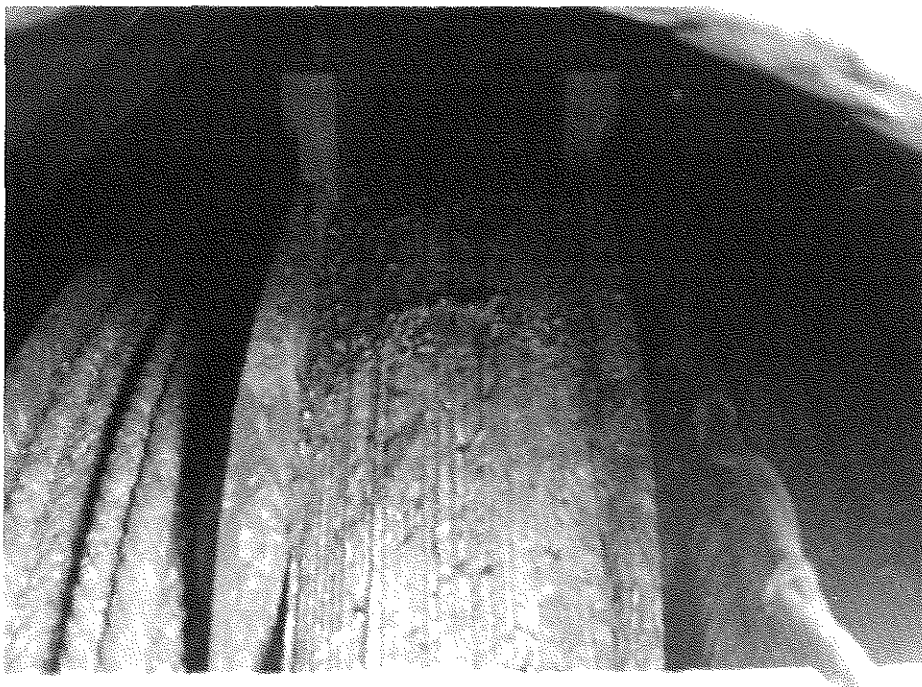
An inspection also was made on the secondary cables at the Kentucky tower roller supports. The upper cables, located in the tower turrets, were covered with a thick layer of pigeon droppings. Stay cables also were covered with pigeon droppings (Figure 19). A bird screen was in place on the turret apertures, but the pigeons had obviously penetrated

Figure 19. Pigeon Droppings on the Secondary Cables of the Ohio Bridge (1980).

the defense. One broken wire was found on the downstream cable at the roller support.

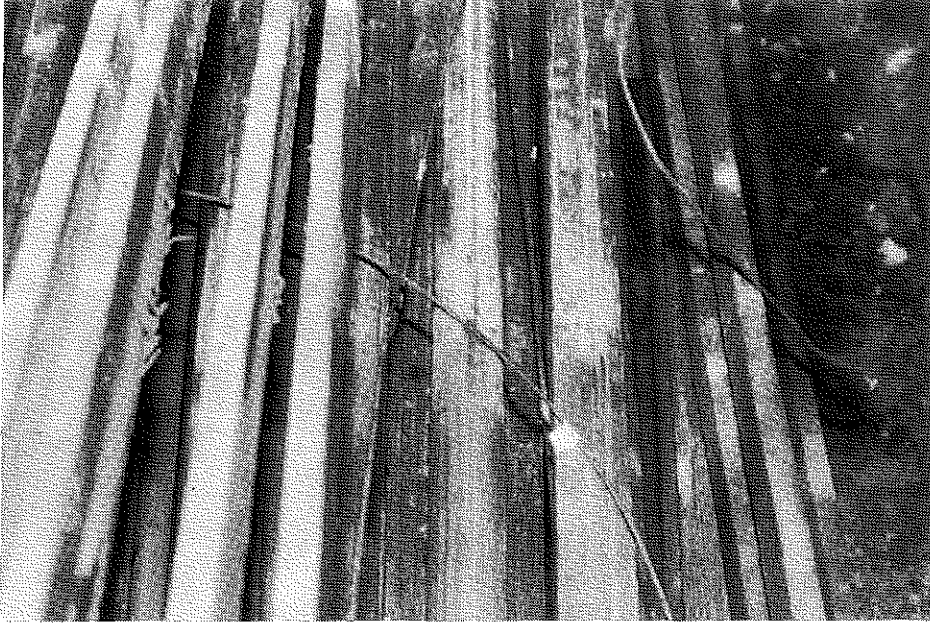
Figure 20. Broken Wires and Water Leakage Stains in the Upstream Kentucky Anchorage of the Ohio Bridge (1980).

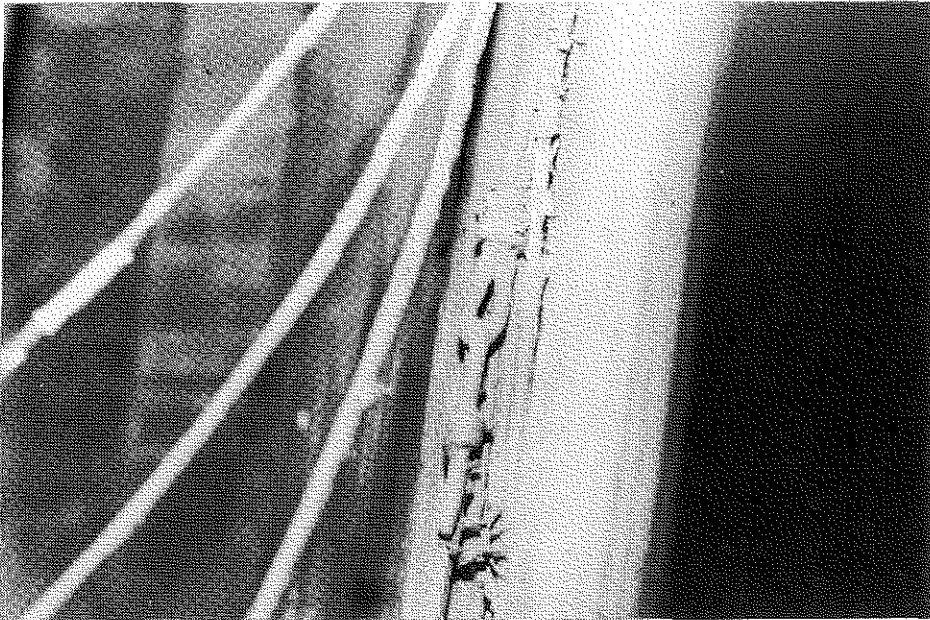
Figure 21. Repair Splice on Wires in Upstream Kentucky Anchorage of the Ohio Bridge (1980).

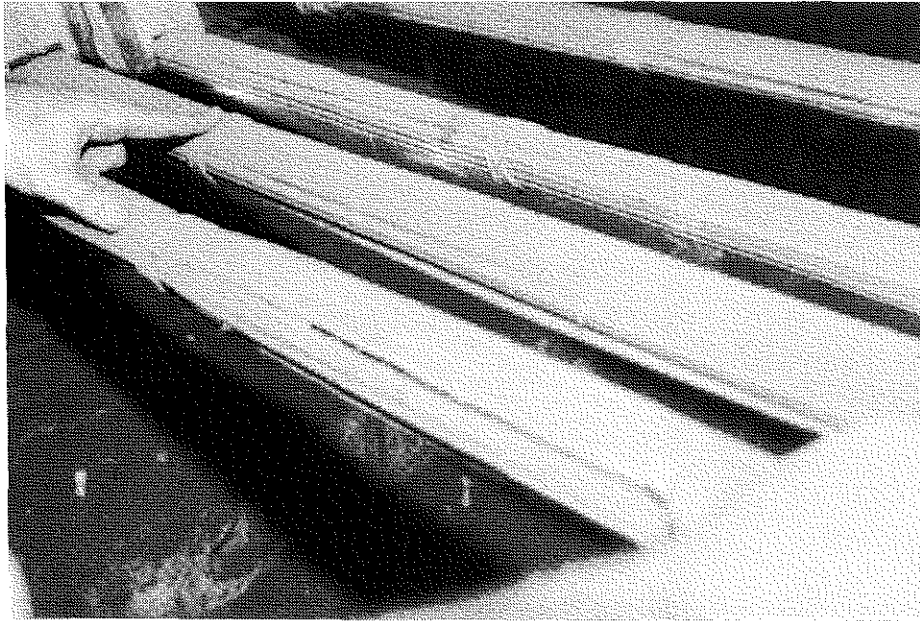
Figure 22. Swollen Strands in the Ohio Bridge, Secondary Anchor House (1980).

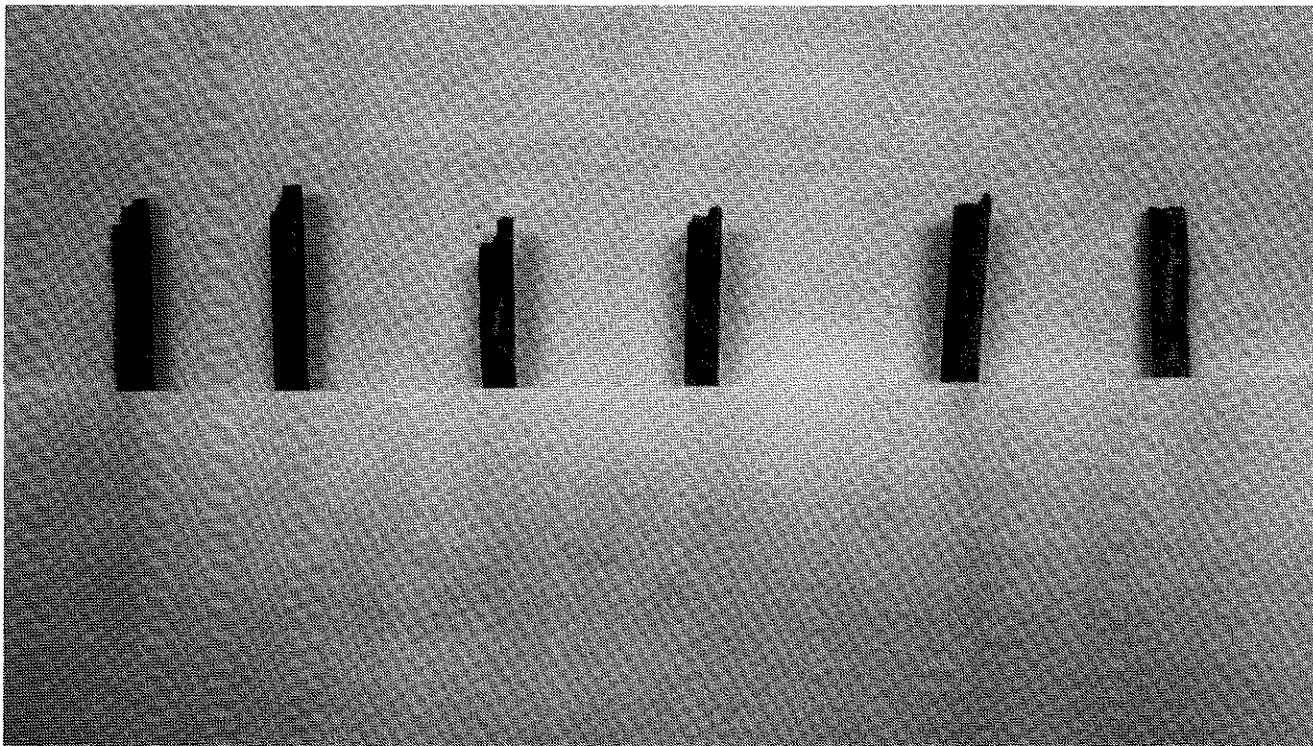
The family of fractures evident on the Portsmouth Bridge wires represented a progression of failure of the strands and, eventually, the cables (Figure 27). Early failures were probably of the flat type and occurred at low dead-load stresses (where corrosion fatigue was the sole

Figure 27. Progression-of-Fracture Using Wire Fractures from the Portsmouth Bridge Second Cables.
