Research Report
UKTRP-84-7

SPECIALLY CONSTRUCTED BRIDGES: ACTIVITIES FOR
FISCAL YEAR 1983

April 1984

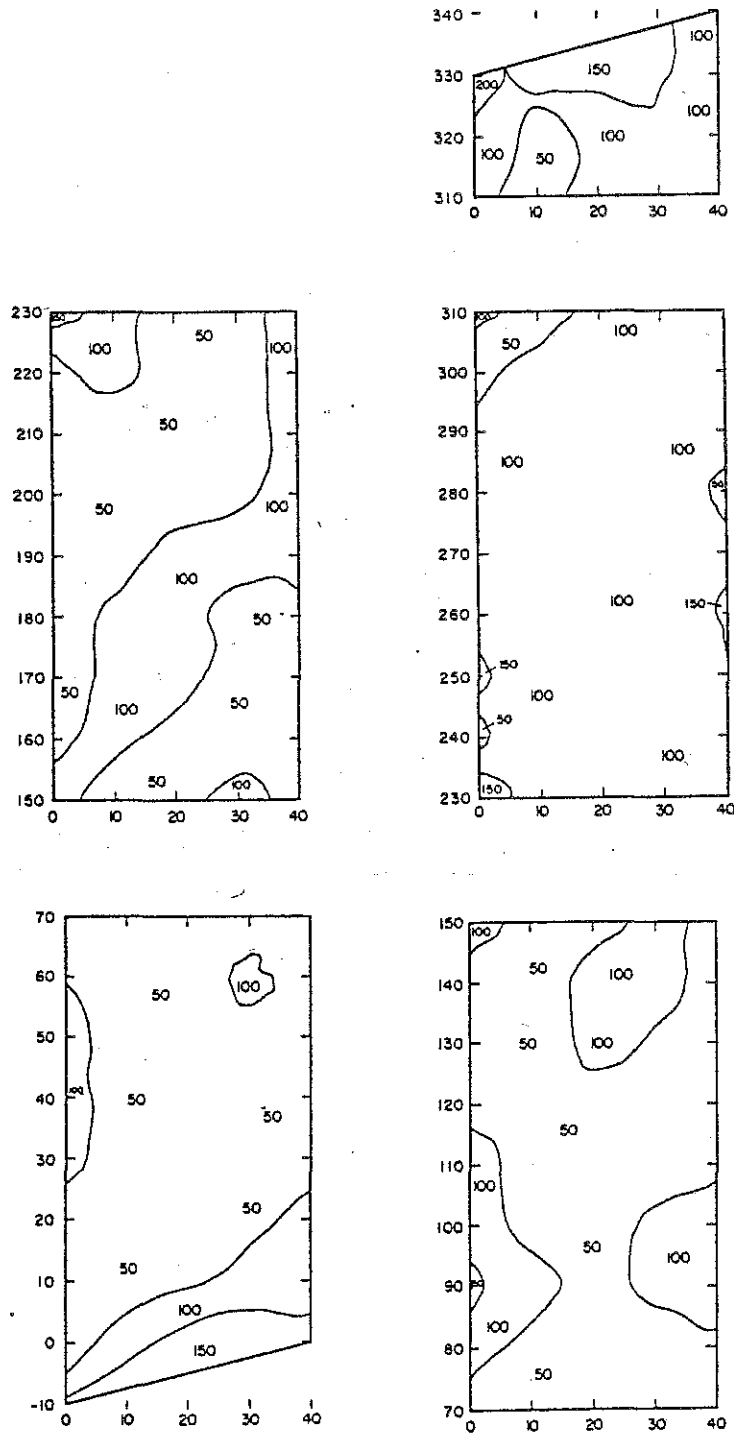
Follow-up corrosion potential tests performed in fiscal year 1983 revealed no signs of active ferrous corrosion on the reinforcing steel of any of the bridges (Figures 1-4). However, corrosion potential measurements for all of the bridges had increased over values originally measured.

Figure 1. Corrosion Potential Test of the KY-80 Bridge over Buck Creek, February 21, 1983.

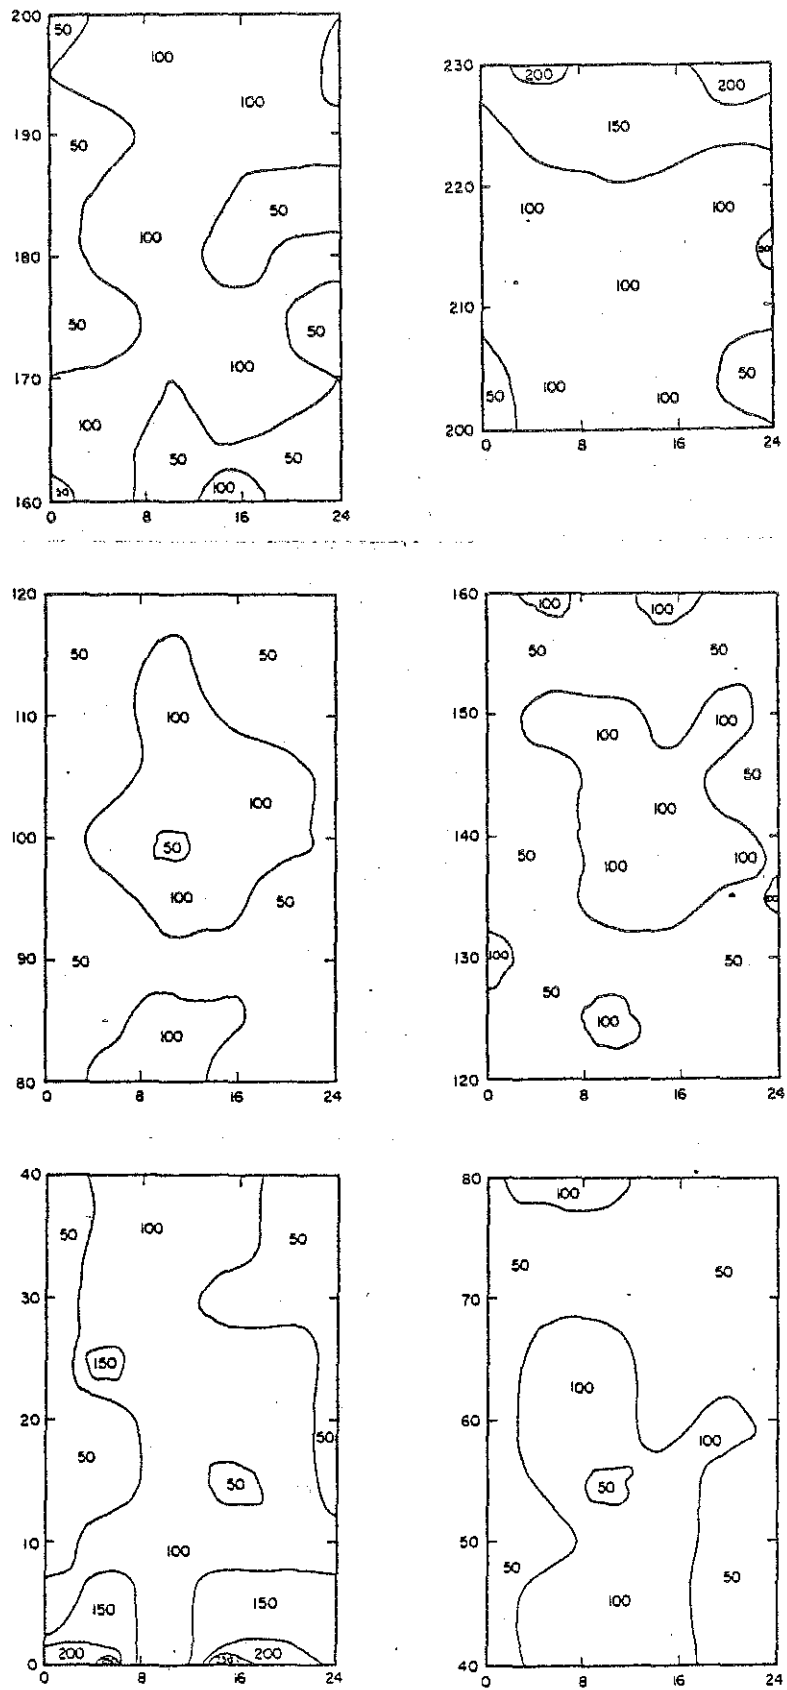
Figure 2. Corrosion Potential Test of the KY-56 Bridge over Panther Creek, October 13, 1982.

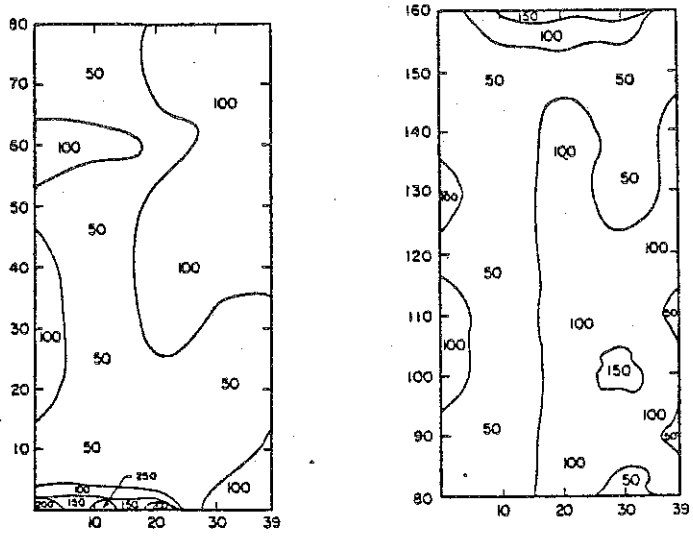
Figure 3. Corrosion Potential Test of the US-460 Bridge over Elkhorn Creek, February 20, 1983.

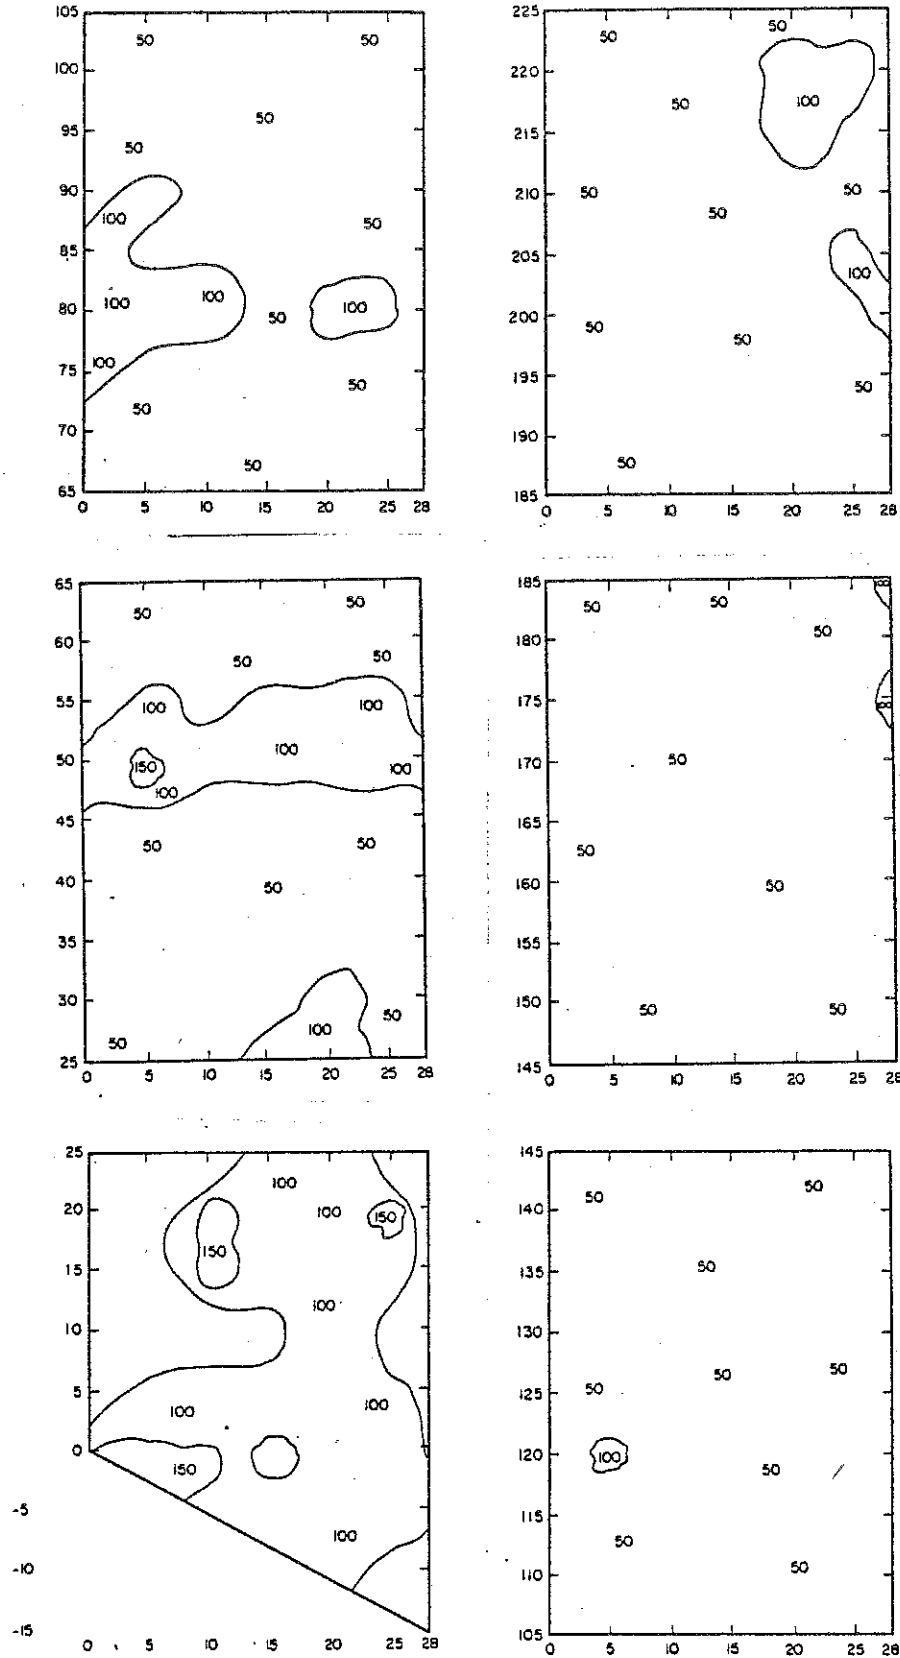
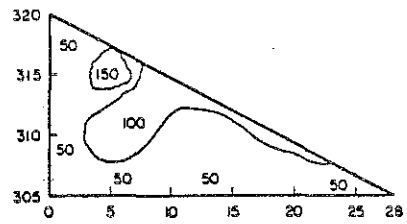
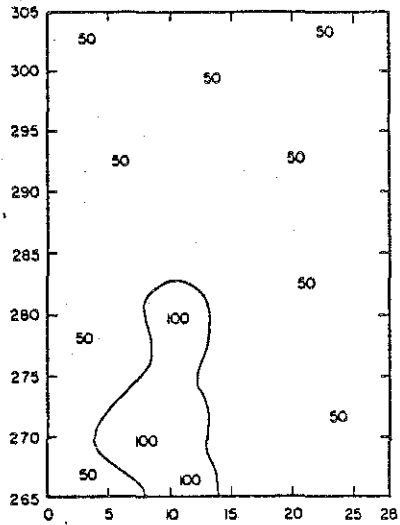
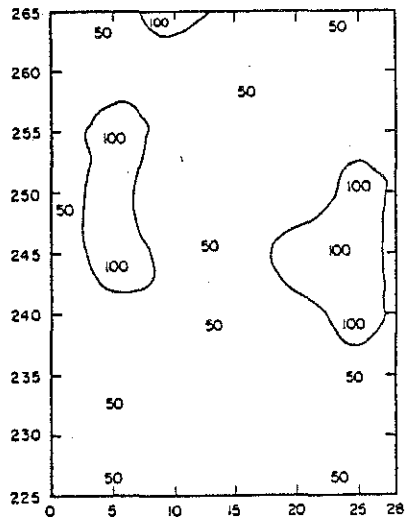
Figure 4. Corrosion Potential Test of the Yarnalton Bridge over I 64, February 20, 1983.

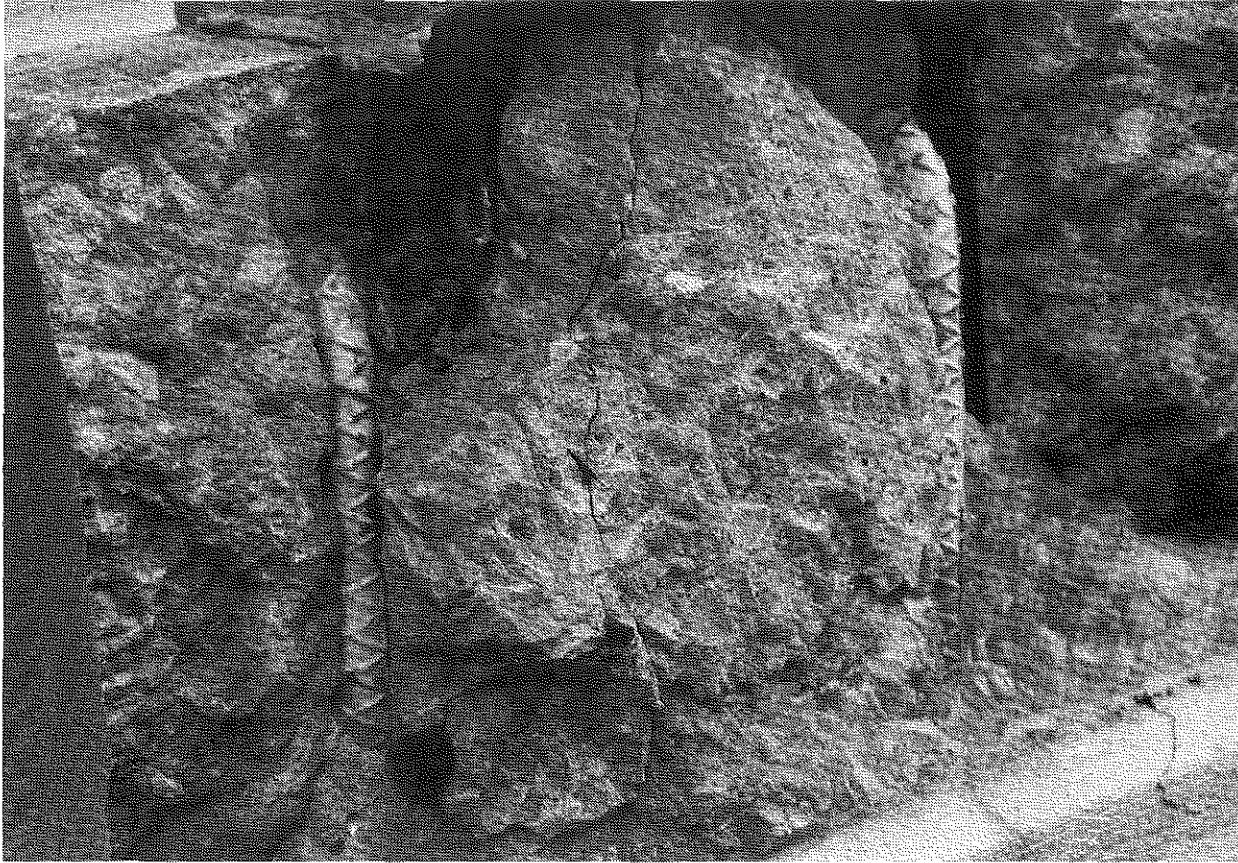
Figure 5. Broken Epoxy and Rust on Exposed Reinforcing Steel, US-45 Bridge at Brookport, IL (1982).

While circumstances of exposure indicated that mechanical action might be involved in stripping the epoxy, it also was possible that the bond between the epoxy and steel may not be very strong in some instances. The relative newness of this type of corrosion-prevention treatment and lack of long-term service testing prior to its widespread application allow for the possibility of some eventual corrosion problems.

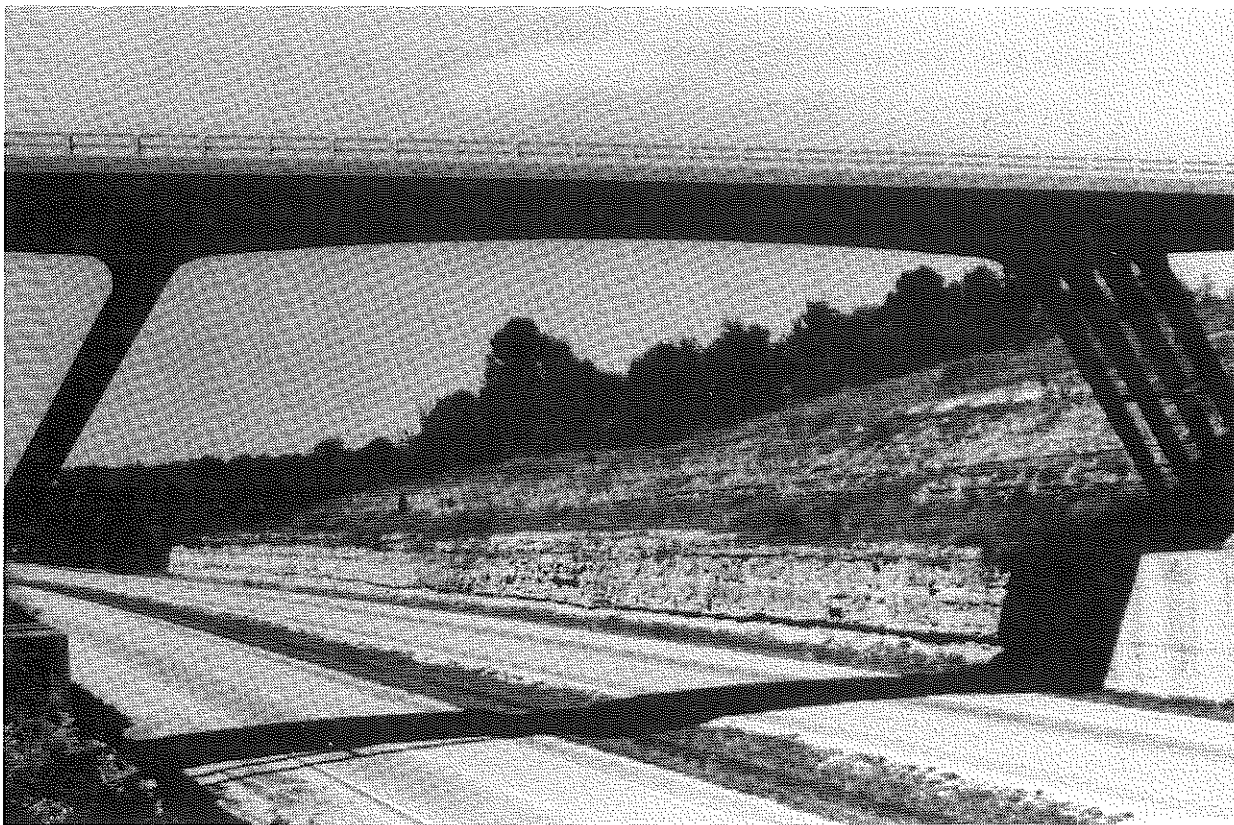
On October 14, 1982, the Scenic Bridge was inspected (Figure 6). That bridge was a conventional deck-girder bridge (as were the other unpainted weathering-steel bridges owned by the Department). The surface corrosion product (rust) showed some slight pitting. However, the rust was tight. It was performing satisfactorily (Figure 7). The concrete deck had effloresced slightly and some faint streaks were visible on girders. Rust washed from the steel had stained the abutment pedestals. A loud knocking sound could be heard when traffic passed over the bridge; however, the source of the noise could not be located.

Figure 6. The Scenic Bridge over the Green River Parkway in Warren County.

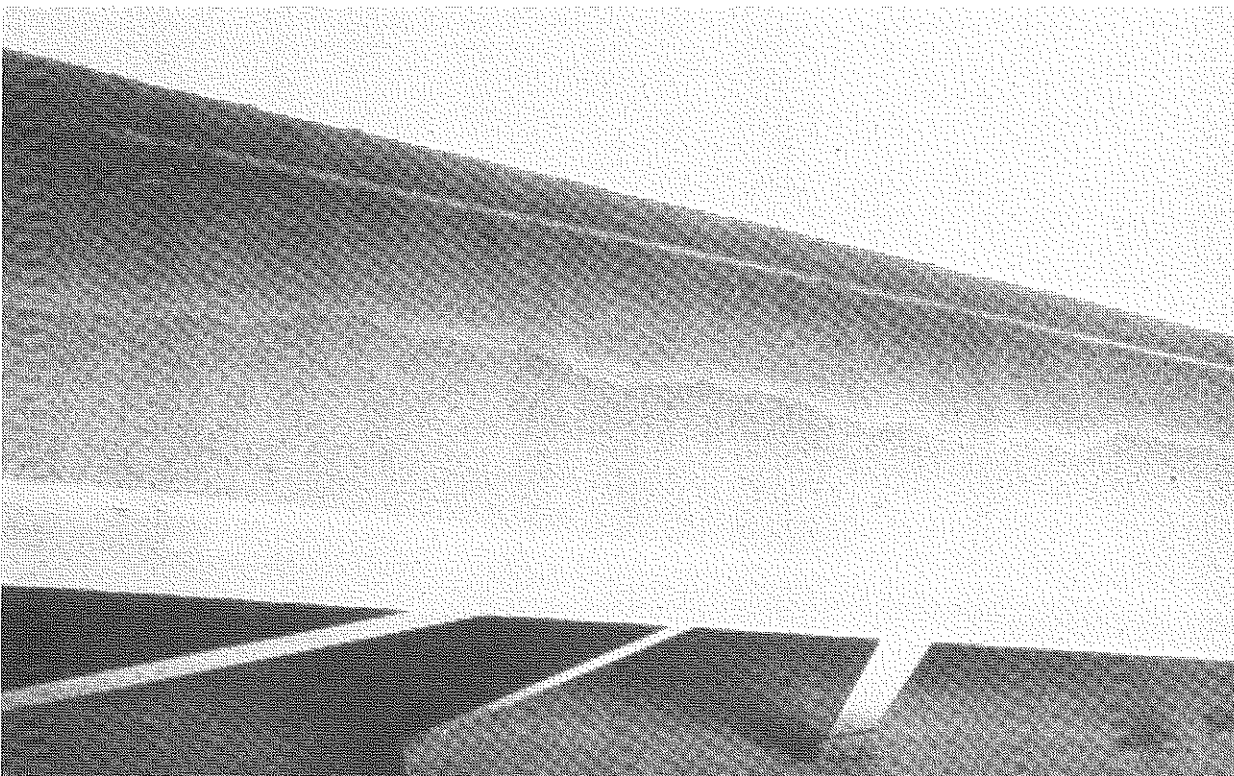
Figure 7. Weathering Steel on the Scenic Bridge, which Is Performing Satisfactorily.

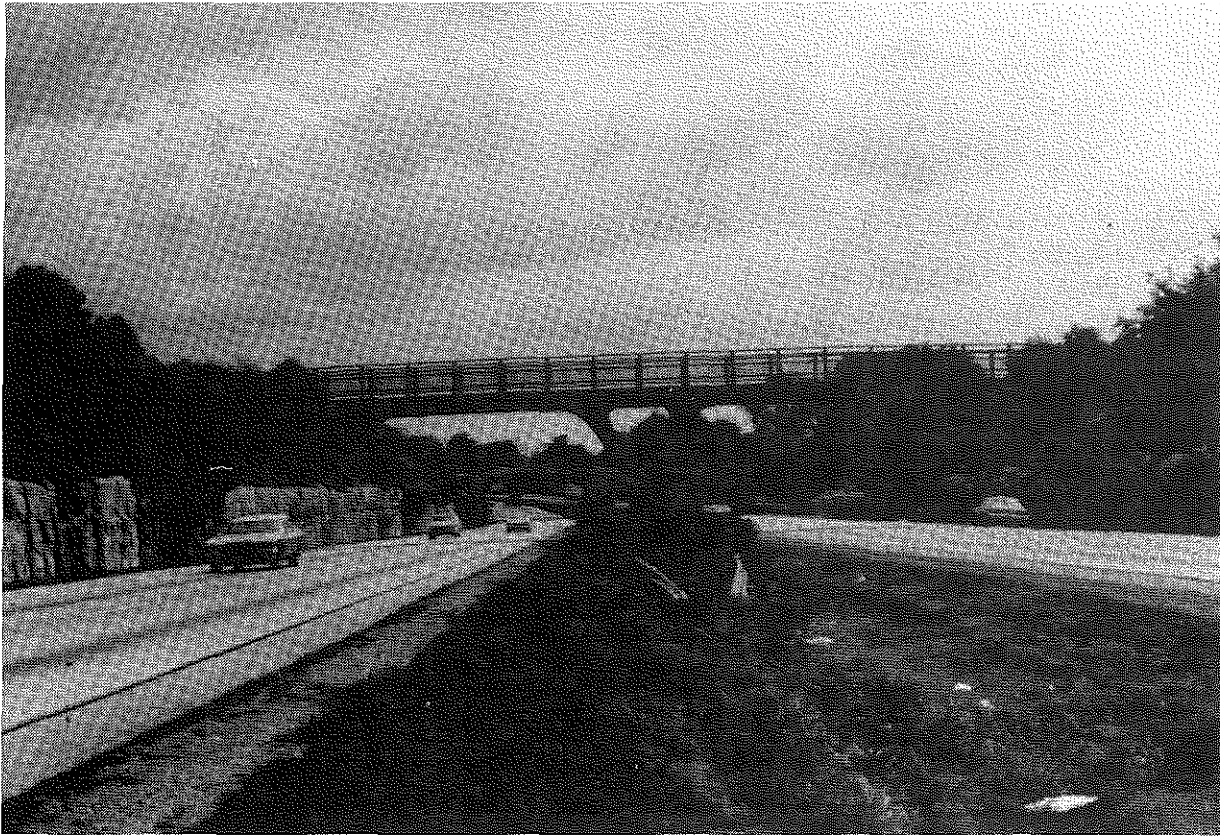
The equestrian bridge at Louisville was inspected on October 15, 1982 (Figure 8). As with the Scenic Bridge, the weathering steel was performing satisfactorily. A rolling seam was detected on the center column near the base of the column. One small spot was found inside the center column, near the base, where the weathering steel had performed like stainless steel and had not rusted (Figure 9). At another location, a small patch of corrosion product had a bright orange appearance similar to common ferrous rust (Figure 10). However, that rust spot was as tight as the normal dark rust on the remainder of the bridge. Some faint efflorescence stains and graffiti were present on exterior surfaces of the fascia girders. Also, rust stains were visible on faces of the abutment pedestals.

Figure 8. The Equestrian Bridge over I 65 in Louisville.

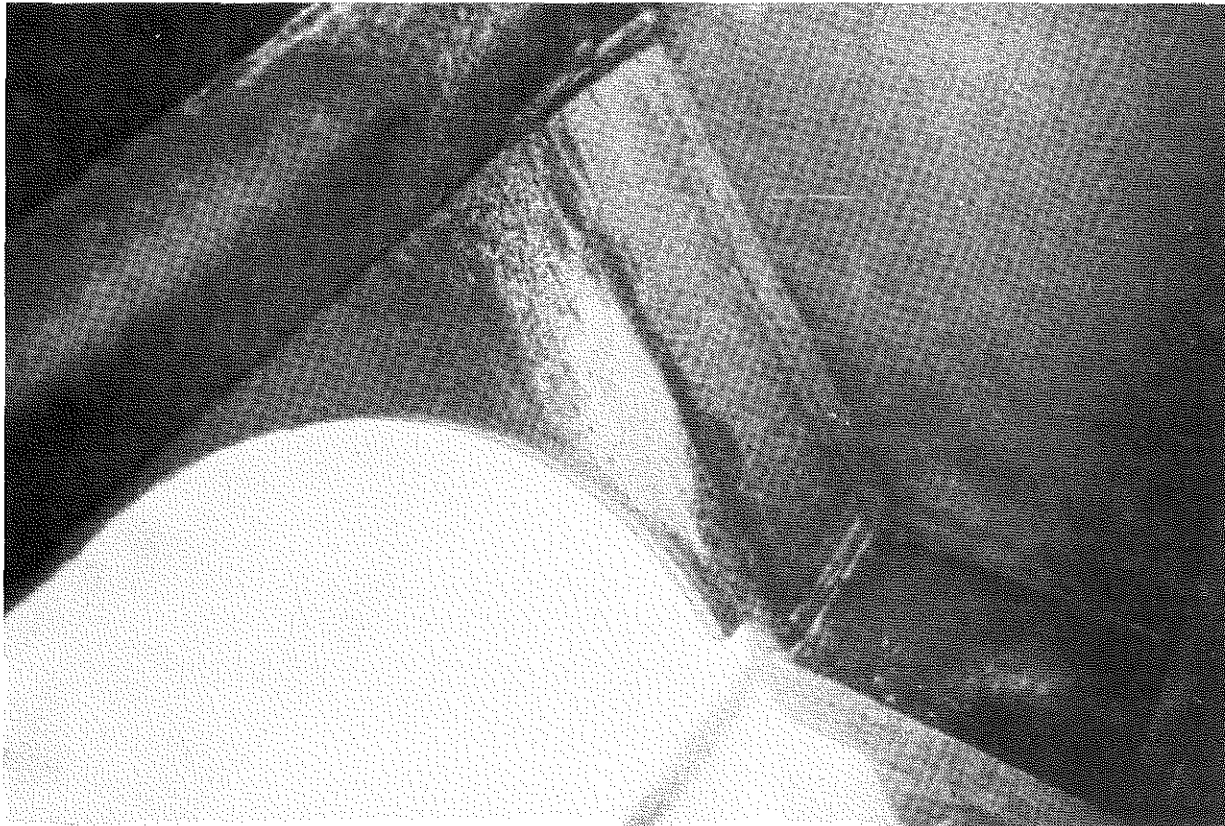
Figure 9. Alloy Segregation Spot on the Equestrian Bridge Showing No Visible Corrosion.

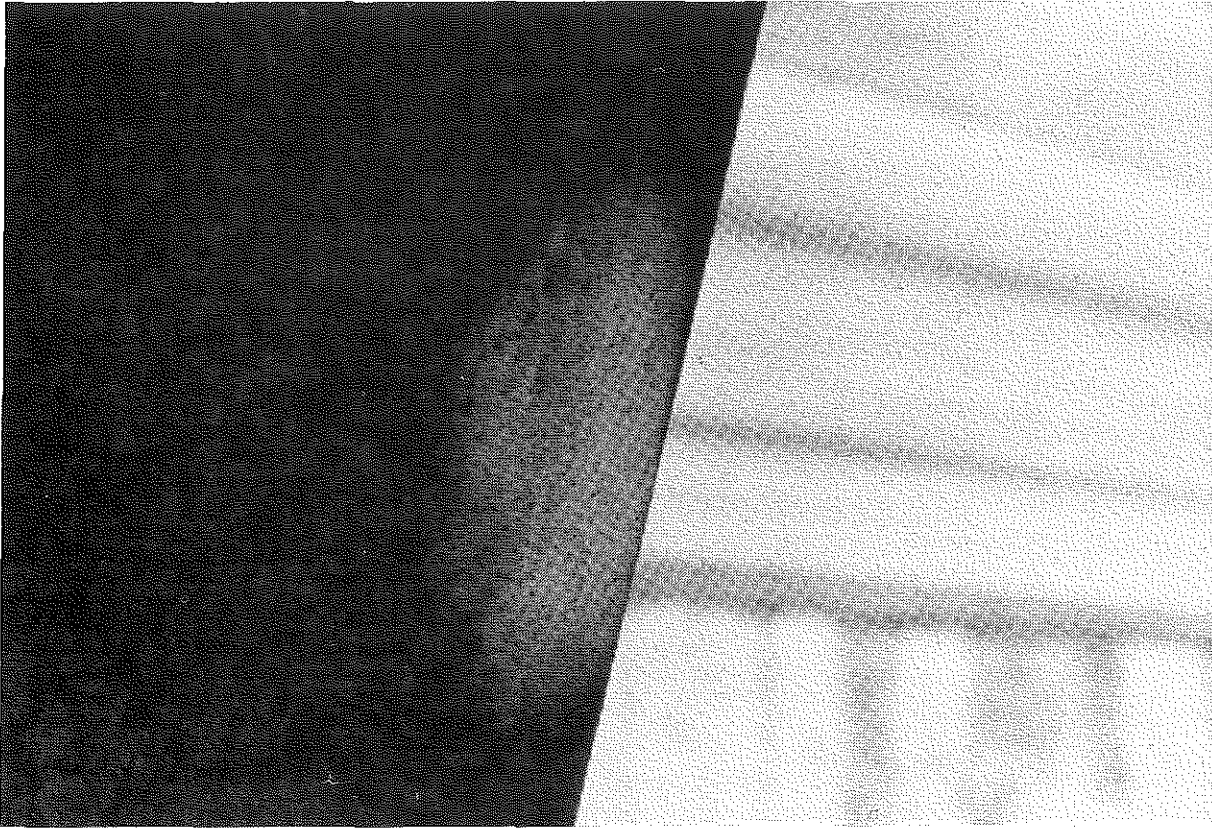
Figure 10. Alloy Segregation Spot on the Equestrian Bridge Showing Apparent Ferrous Corrosion (Rust).

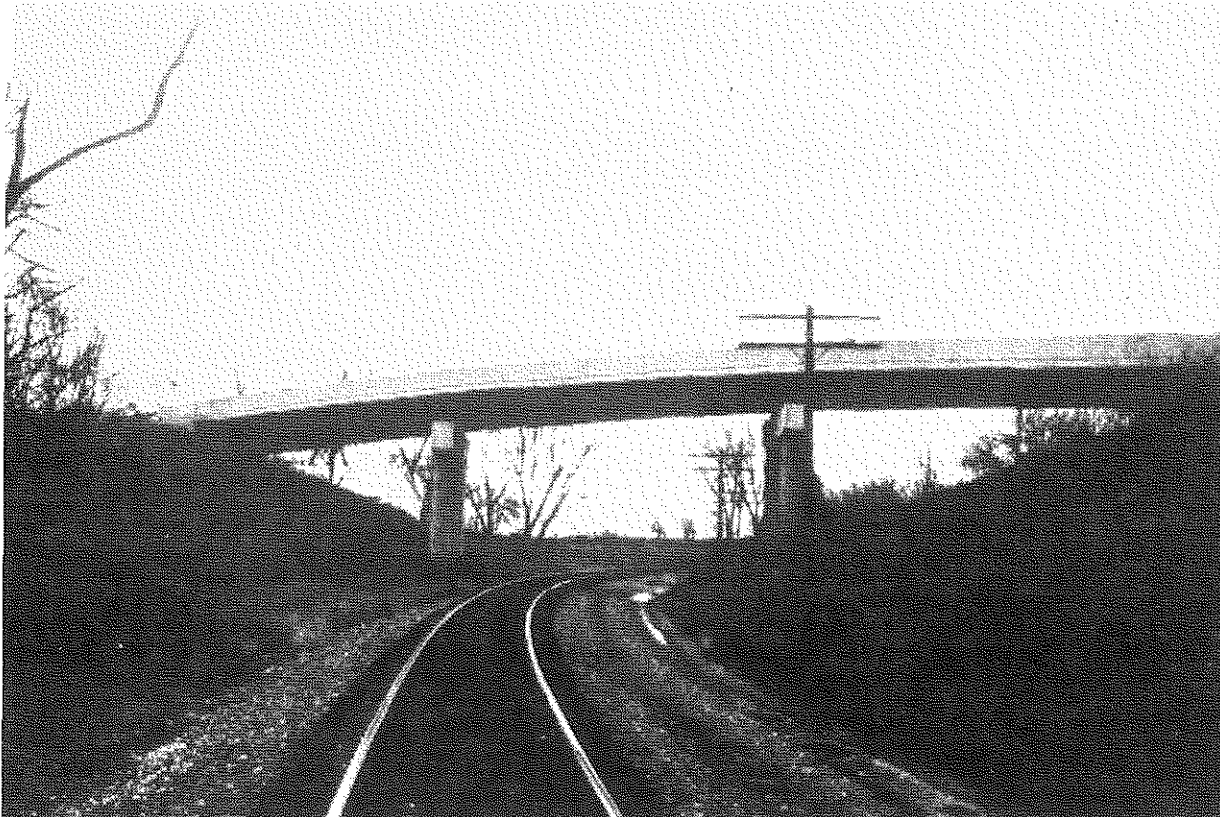
The weathering-steel bridge (KY 1893) at Shawhan was inspected on November 12, 1982 (Figure 11). The weathering steel was in good condition away from the bridge abutments (Figure 12). However, at both ends of the bridge, the girders, rockers, and bearing plates showed signs of abnormal corrosive damage in the form of scaly, loose rust. That corrosive activity was worse on interior girders and interior faces of fascia girders. On the beams, corrosive damage was worse on the lower portion of the webs and the upper horizontal faces on the lower flanges. That damage appeared to be limited to 5-foot portions on the ends of the beams (Figures 13 and 14). Stains on the webs of girders indicated water was leaking through the bridge deck and settling on the lower portions of the beams.

Figure 11. KY-1893 Bridge at Shawhan.

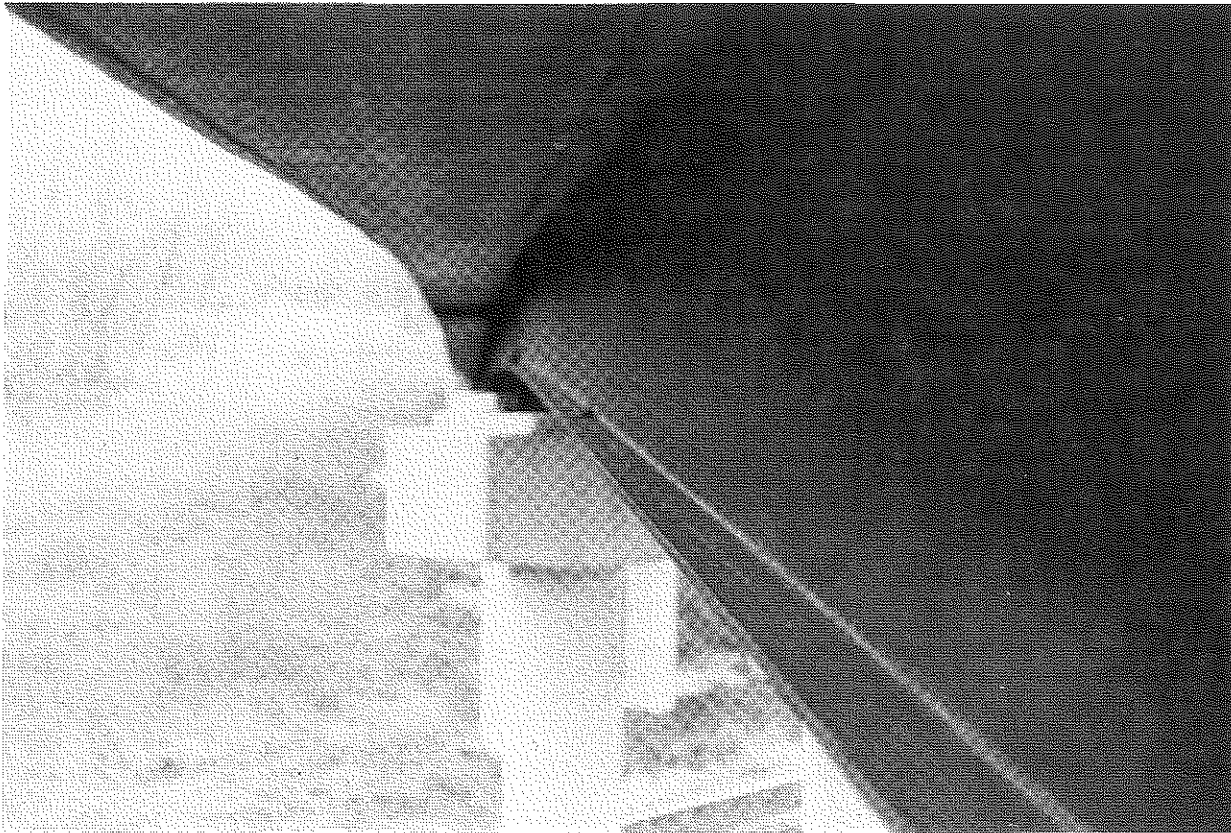
Figure 12. Fascia Girder of KY-1893 Bridge, which Is Weathering Satisfactorily.

The bridge steel at Shawhan shows "bold exposure" weathering on exterior portions of fascia girders. However, at the abutments, especially on interior girders, conditions for "bold exposure" were not present. Wind flow around interior girders and girder ends, rockers, and bearing plates was insufficient to flush or rapidly dry those components.

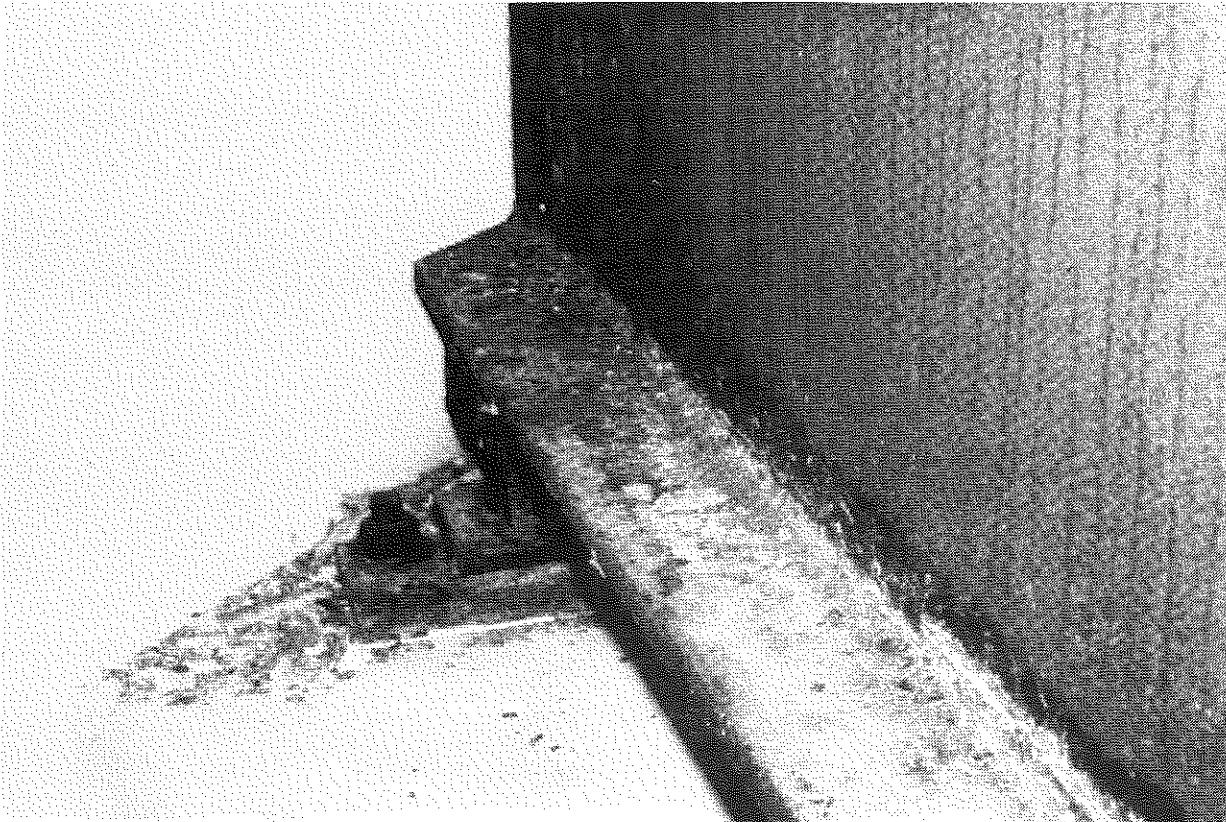
Figure 13. Abnormal Corrosion on Interior Girder at East End of KY-1893 Bridge.

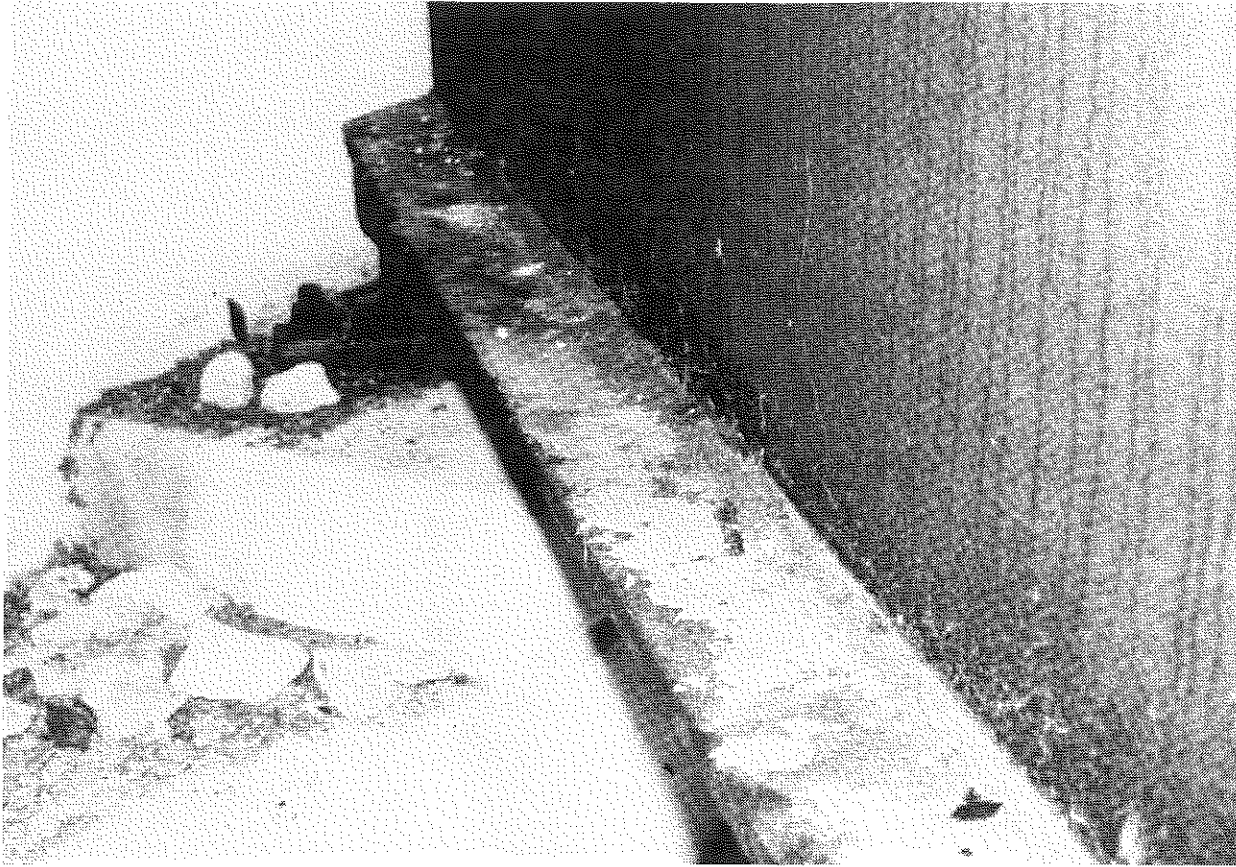
Figure 14. Abnormal Corrosion on Interior Girder at West End of KY-1893 Bridge.

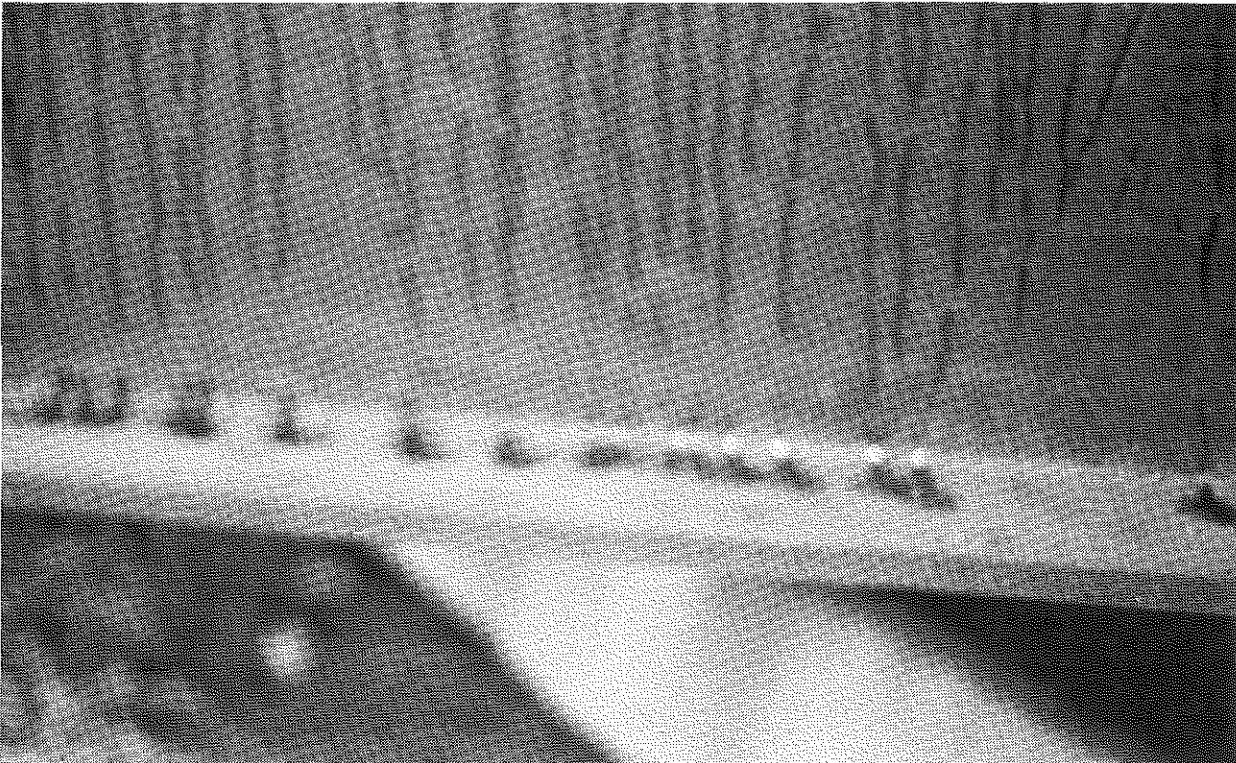
the deck and ponding on upper faces of the lower flanges (Figure 15). Also, water was seeping through expansion joints on both ends of the bridge and was being deposited on the extreme ends of the beams and rockers. Those expansion joints were simple units consisting of neoprene and cork.

This inspection confirmed the early suspicions about the entry of water through the bridge deck. The other two weathering steel bridges have similar vertical stains, which ran from the deck-to-beam interface down the web to the bottom flange. However, on those bridges, there were no signs of the unstable corrosion activity detected at Shawhan. One obvious reason is that the other two bridges were more subject to "bold exposure." This term describes the premise to which the weathering steel bridges were constructed. Originators of the steel assumed that wetting and drying cycles would occur in short intervals. Also, they assumed that wind and rain would wash harmful corrodants (usually salts) from the surfaces of the weathering steel. In locations like the Scenic Bridge, that could be anticipated. The good condition of that bridge indicated "bold exposure" conditions were prevalent.

Figure 15. Water Ponding on Interior Girder of KY-1893 Bridge.

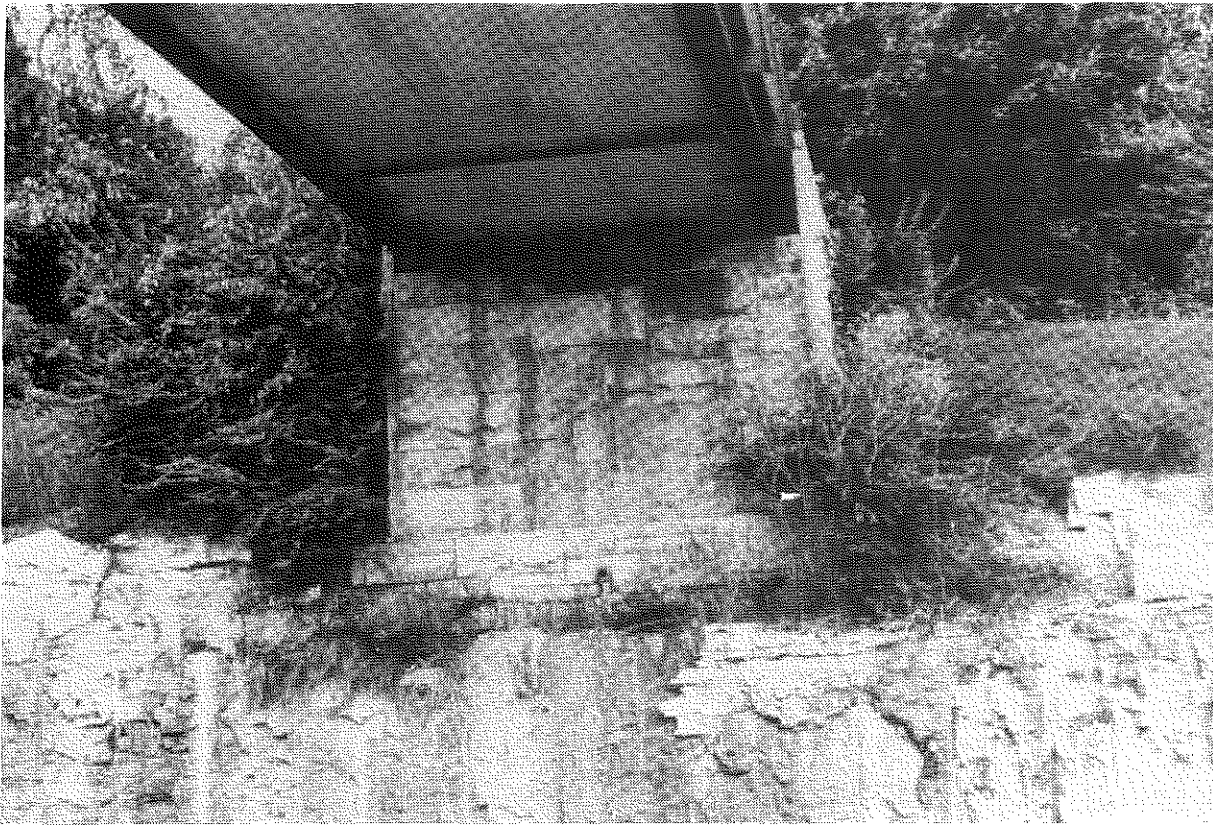
Several minor problems were discovered during inspections of the weathering-steel bridges. Washing of the steel surface deposits unsightly stains on piers and abutments (Figure 16) was noted. On bridges over waterways, that is not important. However, on bridges over roadways, that gives the impression the structure is not well tended. The central pier of the equestrian bridge has a catch basin filled with sand or soil that retains rust and maintains the proper appearance of the pier (Figure 17). That detail should be considered for construction of future weathering-steel bridges that

Figure 16. Rust Stain on Abutment of Equestrian Bridge at Louisville

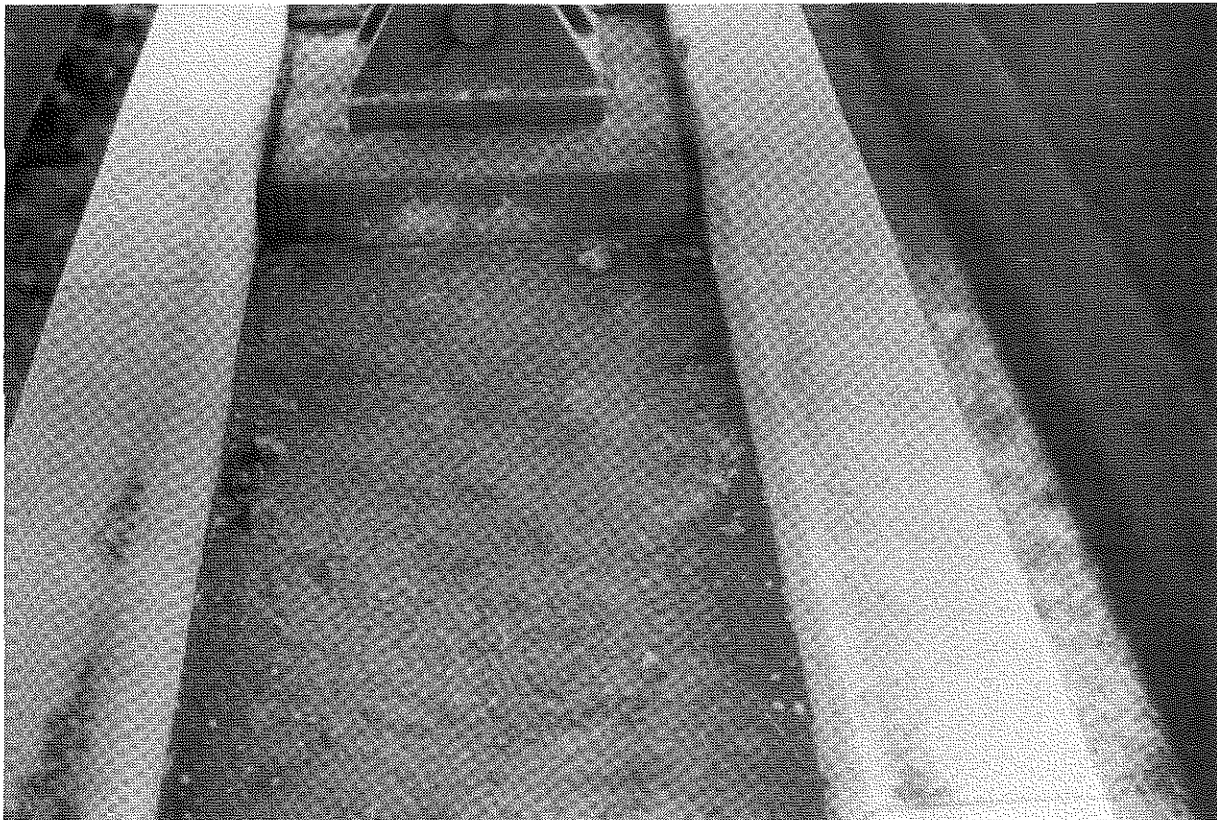
Figure 17. Central Pier on Equestrian Bridge at Louisville.

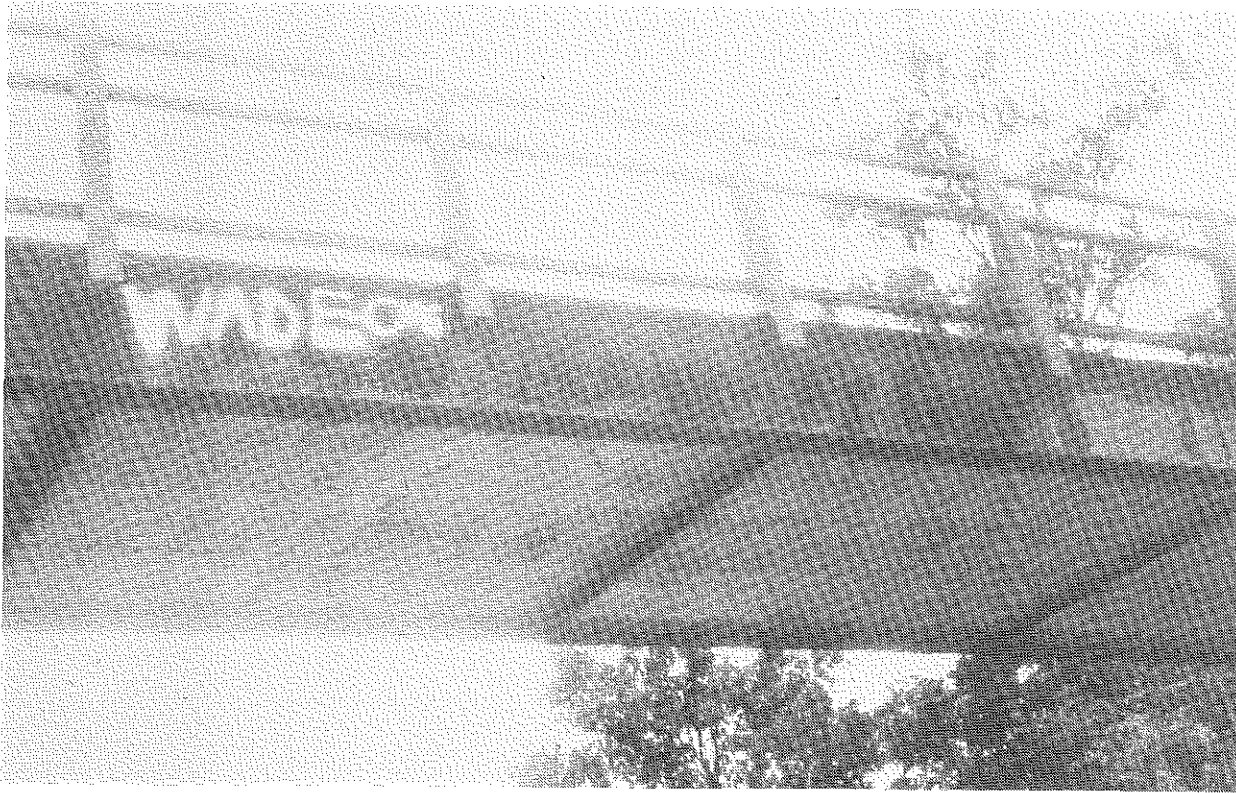
Figure 18. Graffiti (Spray Paint) on Girder of the Equestrian Bridge at Louisville.

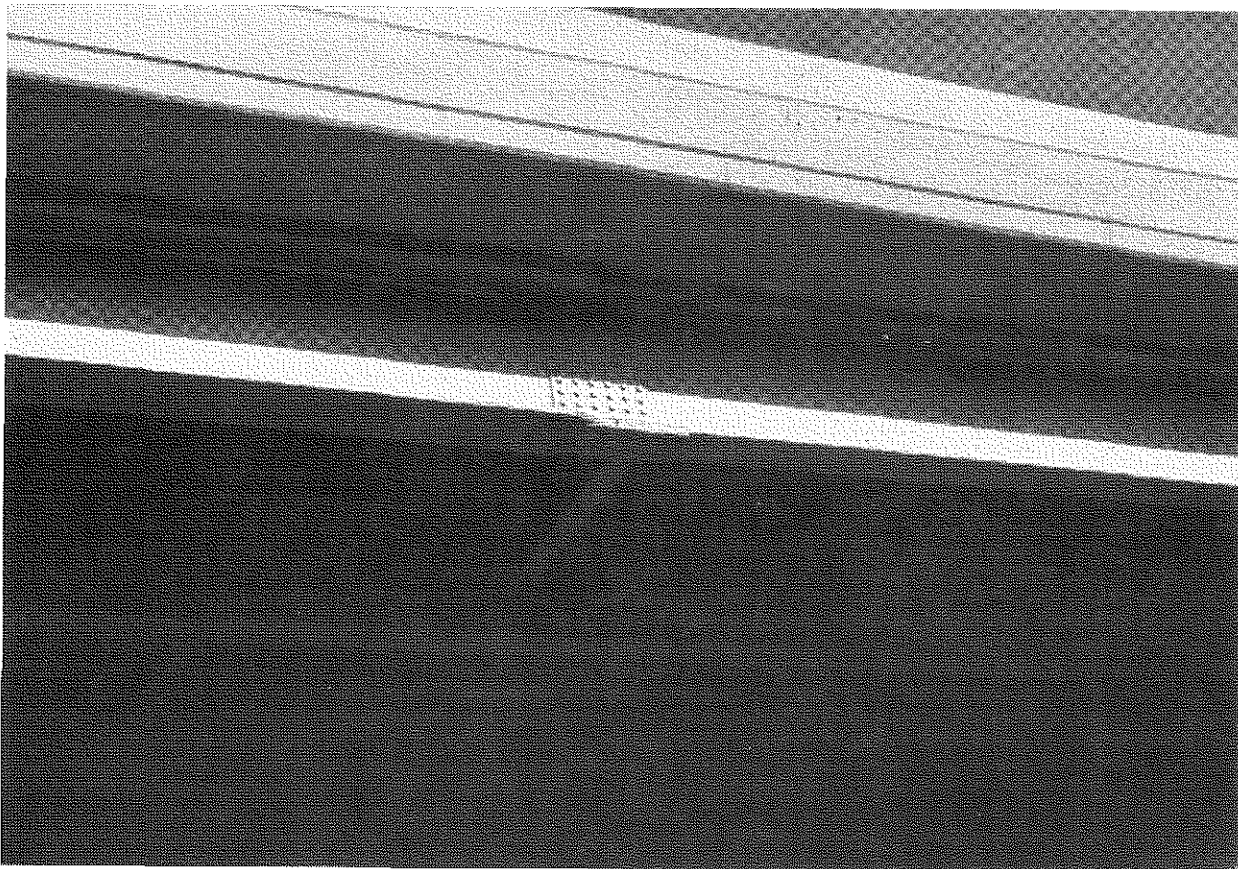
The paint on the eastbound bridge was in very good condition (Figure 19). The only coating defects were some slight rust stains on splice plates on the bottom flanges of the girders.

Figure 19. I-24 Eastbound Bridge over KY 93 (Painted Girders).

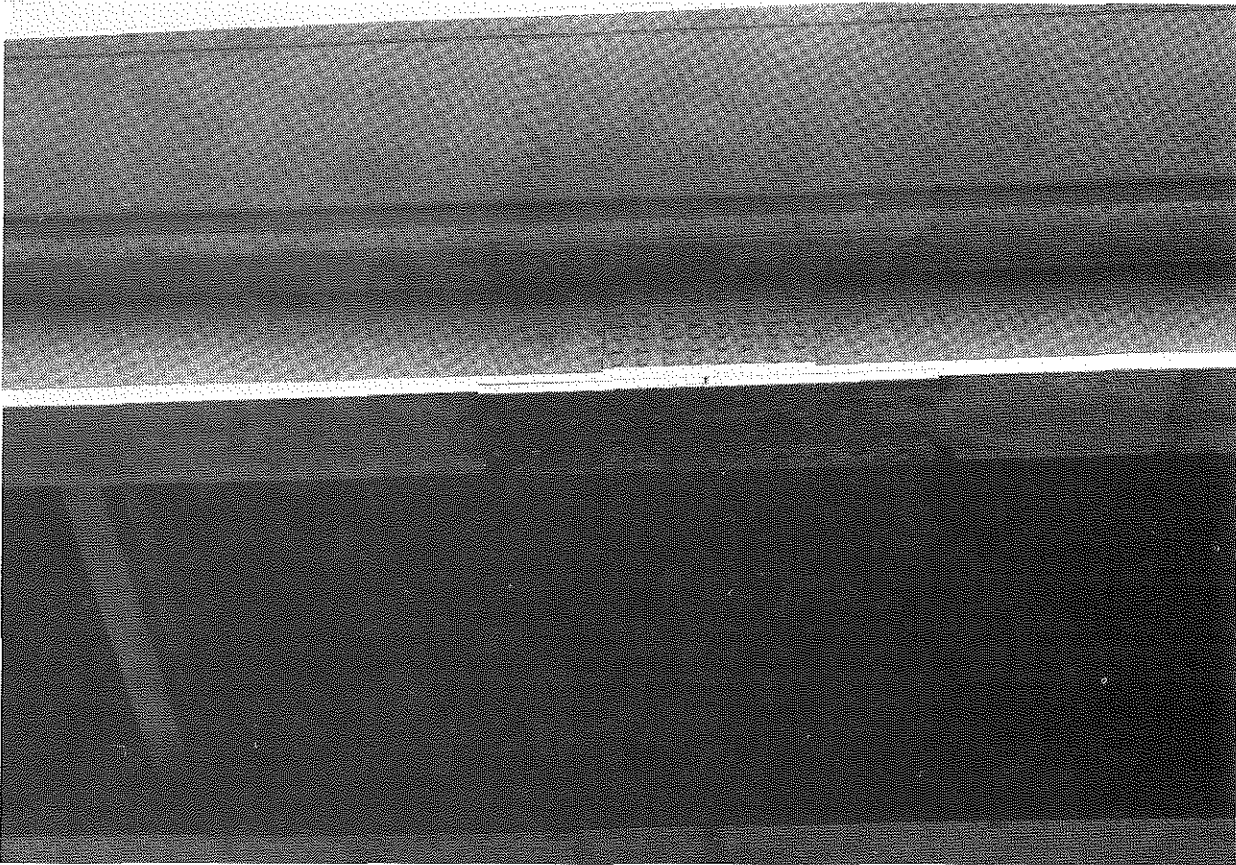
The galvanized coating on the westbound bridge was generally in good condition (Figure 20). A white zinc corrosion product was observed infrequently at random sites on the bridge. However, at flange-deck interfaces, it was difficult to determine if the white stains were efflorescent stains from the concrete deck or a white zinc corrosion product (Figure 21). One diaphragm showed what appeared to be initial ferrous corrosion (Figure 22). Apparent rust stains were visible on splice plates on the lower flange, similar to the eastbound bridge (Figure 23).

Figure 20. Typical Galvanized Girder on the Westbound, I-24 Bridge.
