Research Report
UKTRP-84-7

SPECIALLY CONSTRUCTED BRIDGES: ACTIVITIES FOR
FISCAL YEAR 1983

April 1984

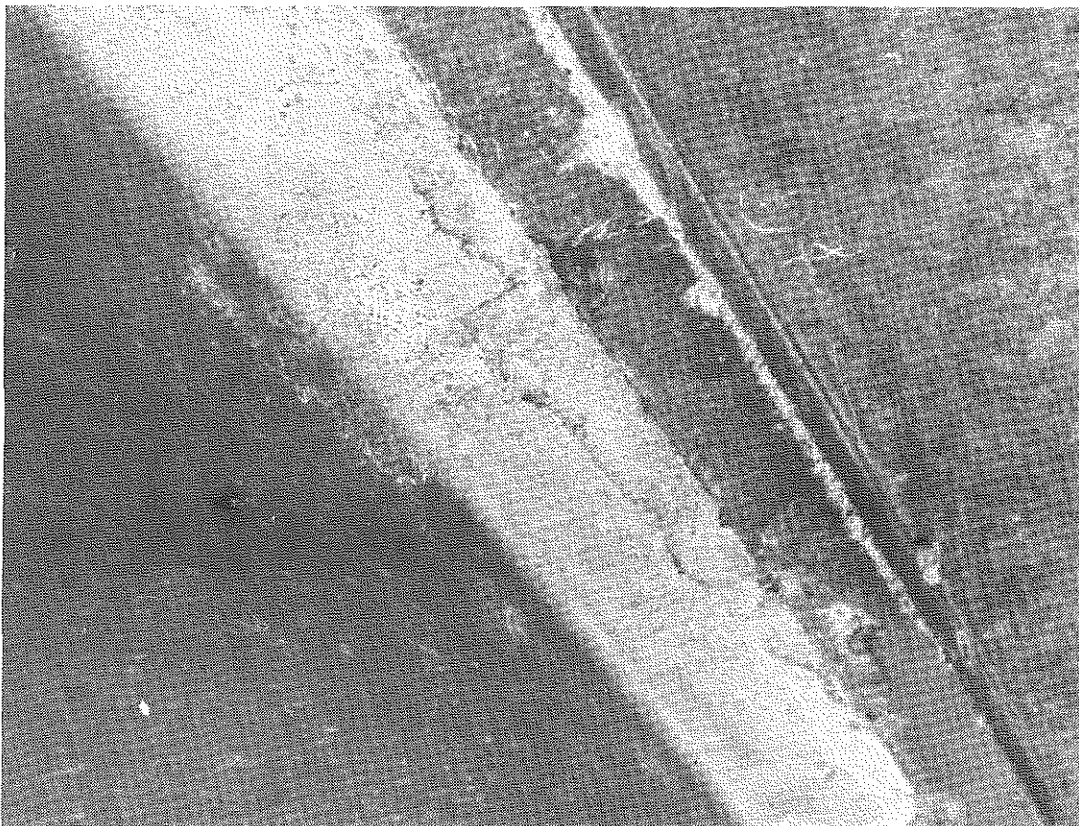
Figure 21. Possible Zinc Corrosion Product or Efflorescent Stain on Galvanized Girder.

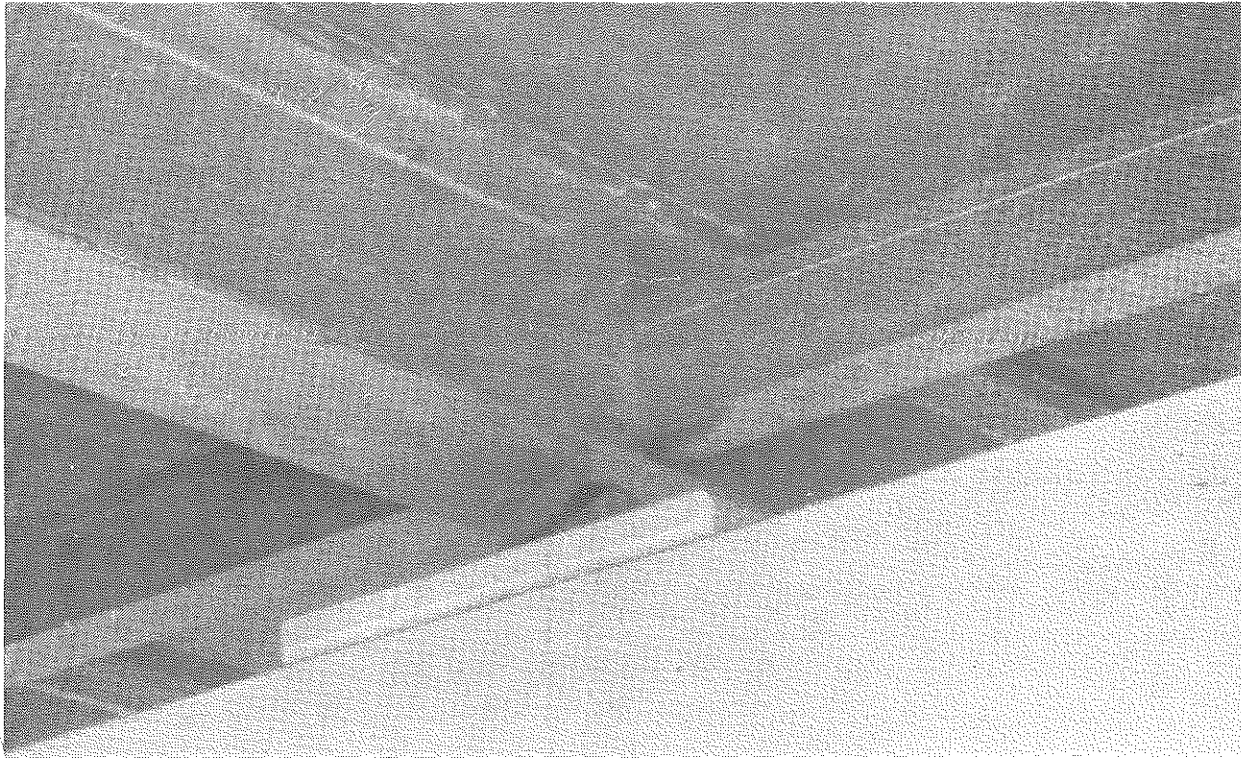
Figure 22. Possible Steel Corrosion Product on Diaphragm of I-24 Westbound Bridge.

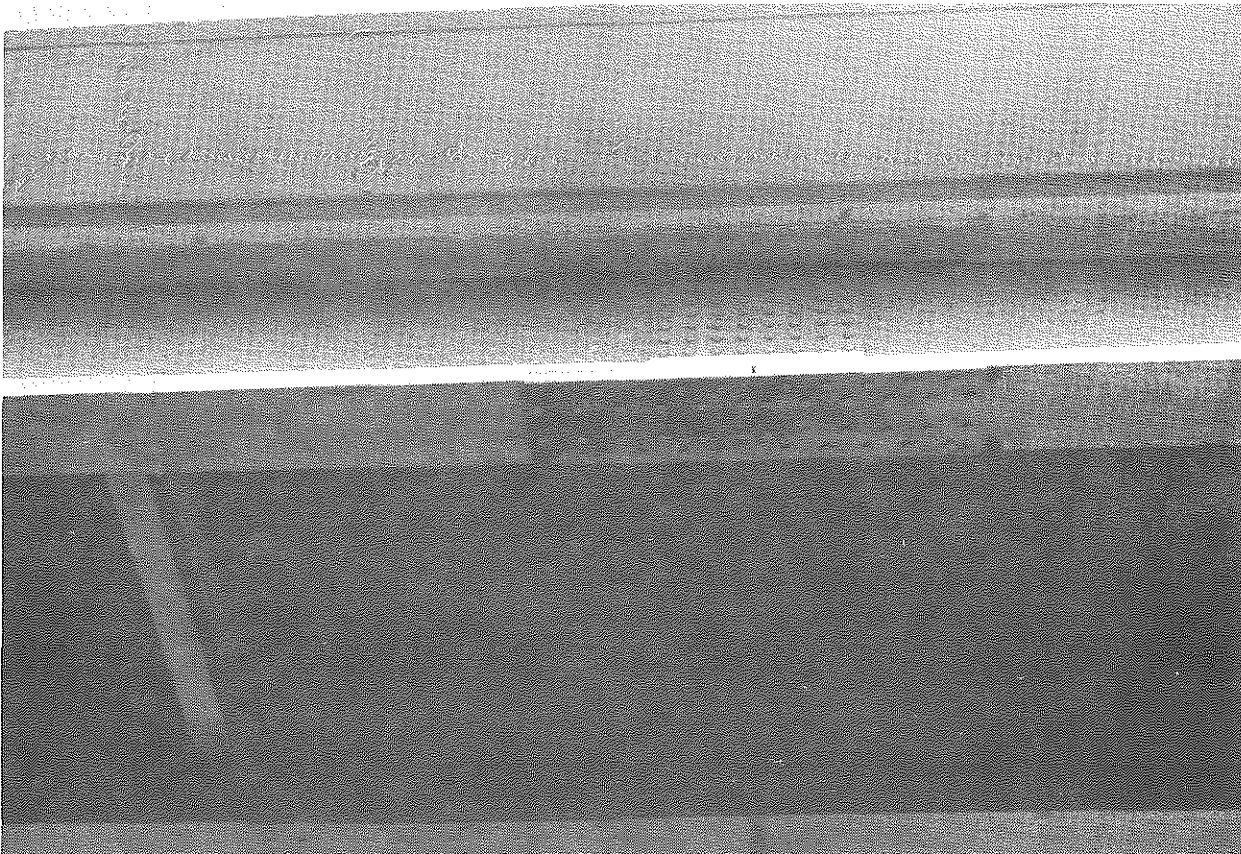
Figure 23. Apparent Rust Stain on Splice Plate and Girder of I-24 Westbound Bridge.

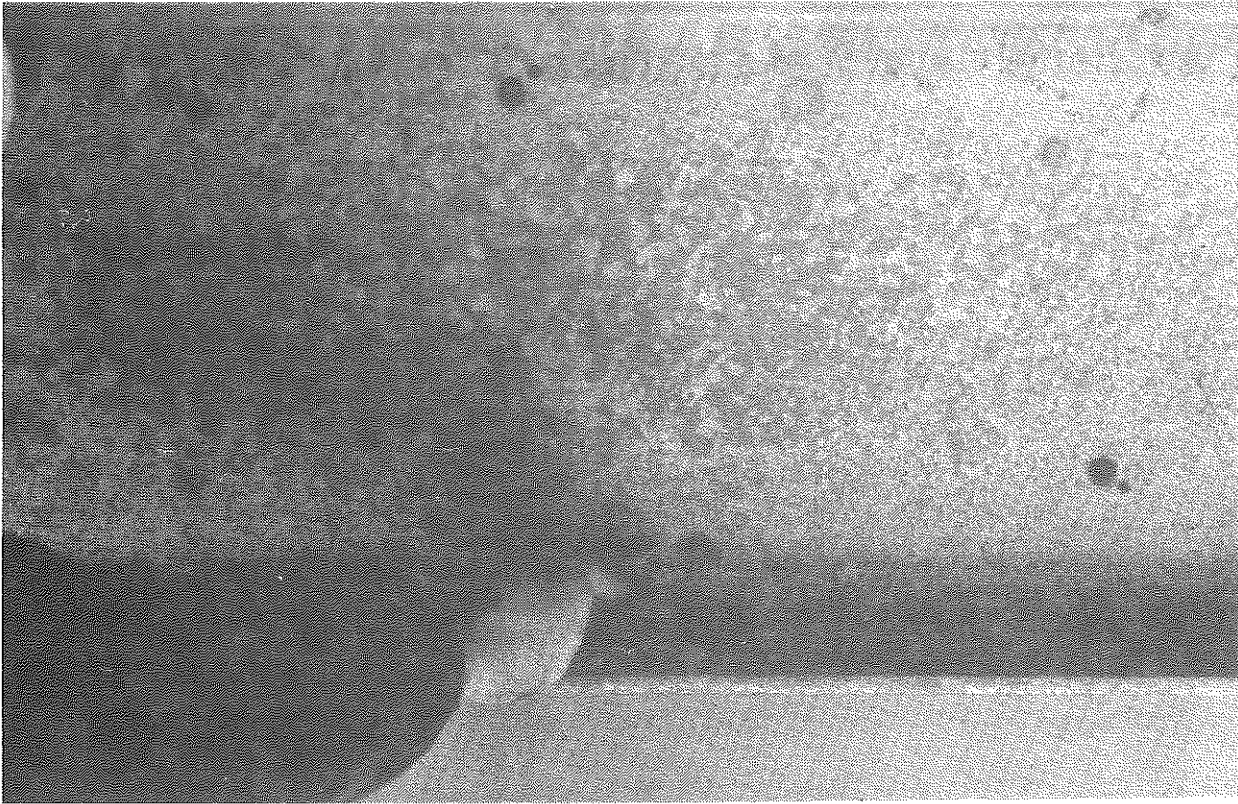
The galvanized coating had several construction nicks that were not overcoated with sprayed-on zinc-rich paint. Also, numerous repair marks indicated some difficulties were encountered in erecting the zinc-coated members (Figure 24). Some apparent dirt was visible on the lower portions of girders. If the dirt was construction-related, it should have been removed prior to erection.

Figure 24. Galvanizing Repair Marks on I-24 Westbound Bridge.

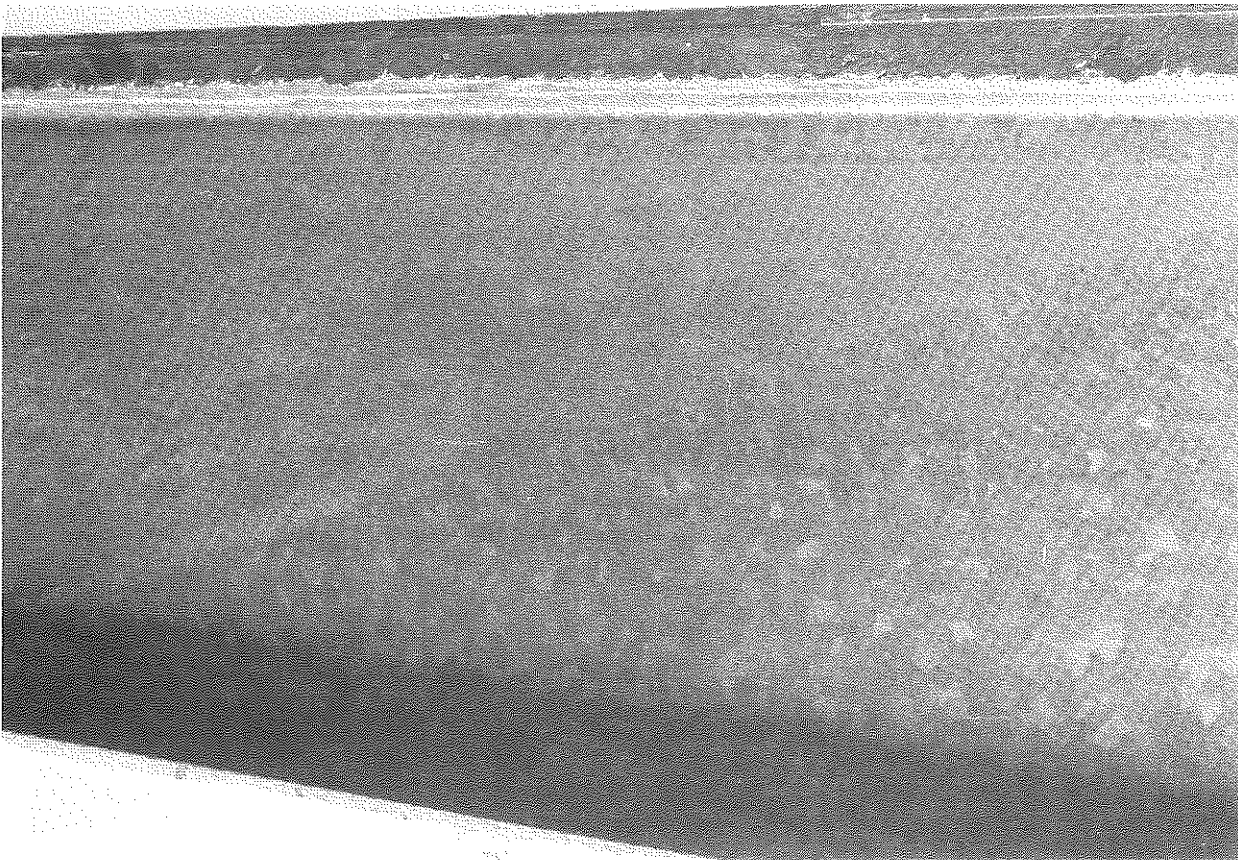
Figure 25. Galvanized Coating on a Girder of I-24 Westbound Bridge Showing a Variance in the Size of Zinc Spangles.

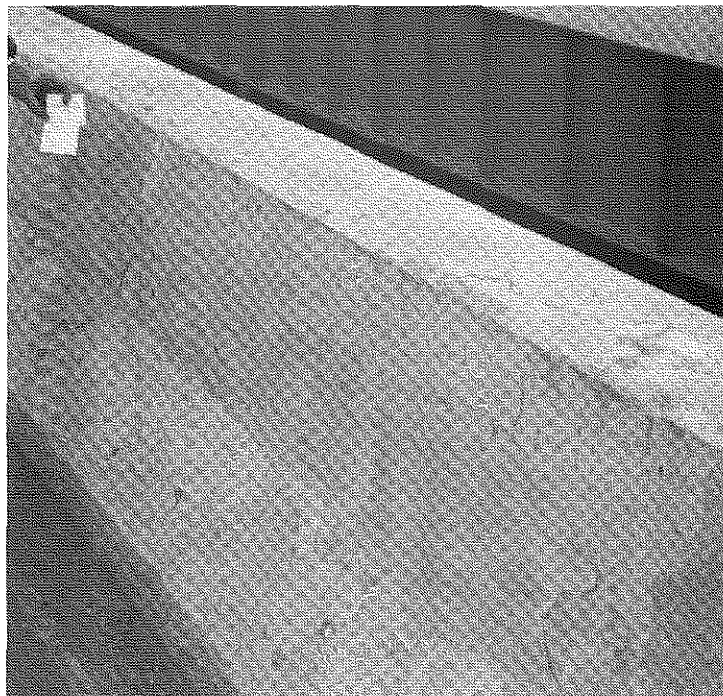
A. KENTUCKY APPROACH -- Many failures (delaminations) occurred on both the horizontal (top) face and vertical (inner) face (Figure 27). Failures on the outer faces of both upstream and downstream sidewalls were limited to small spots, approximately 1.0 inch in diameter, apparently aggregate pop-outs (Figures 28 and 29). The upstream inner face showed signs of frequent vehicle impacts. In some instances, the coating suffered only slight mechanical damage. In other cases, the impacts removed large pieces of the finish coating (Figure 30). At some delamination locations on the inner face and curb, rust stains and exposed rusted reinforcing steel were visible. That also occurred infrequently at other locations on the bridge, but was more pronounced on the northbound upstream approach sidewall.

Figure 27. Northbound Kentucky Approach of the I-471 Bridge Showing Delamination of the Masonry Coating.

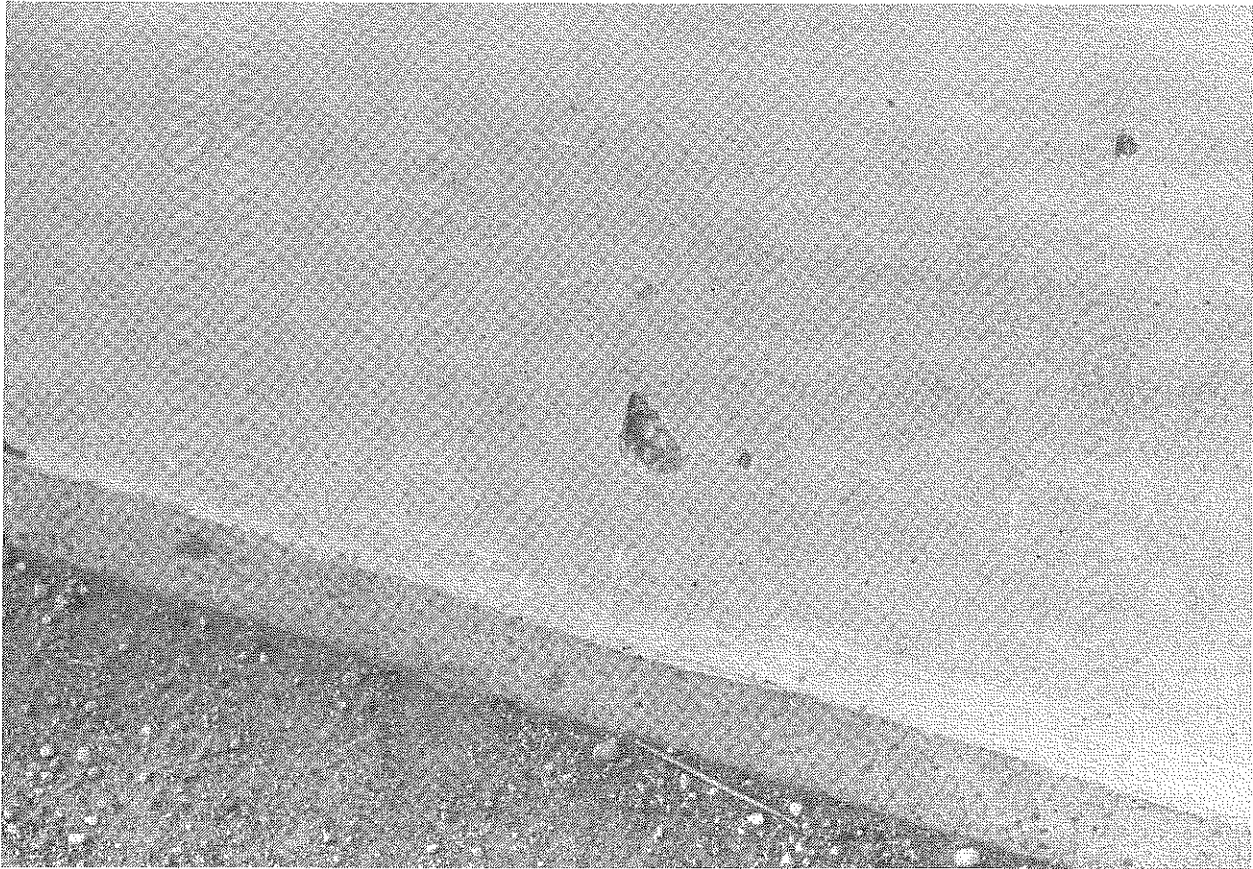
Figure 28. Pop-out Caused by Porous Aggregate.

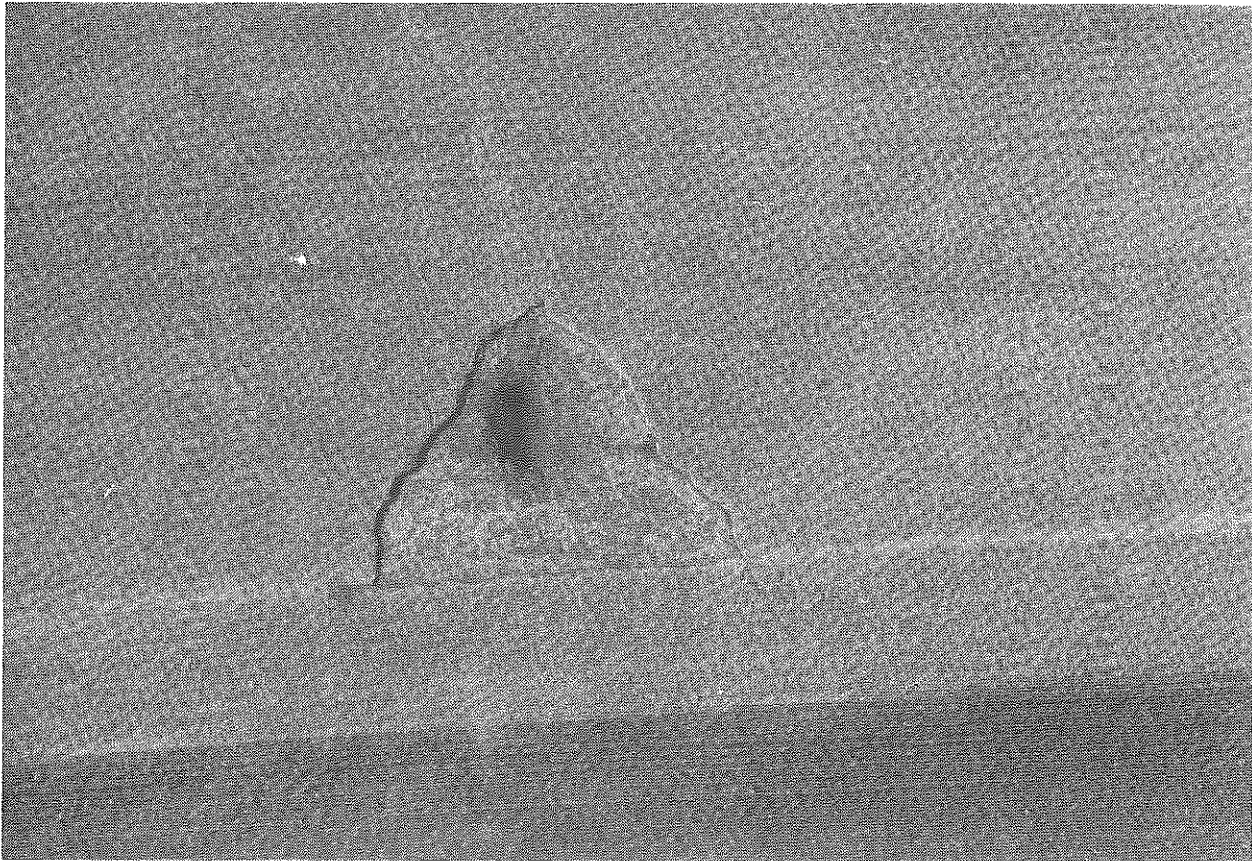
Figure 29. Pop-out Caused by Shale.

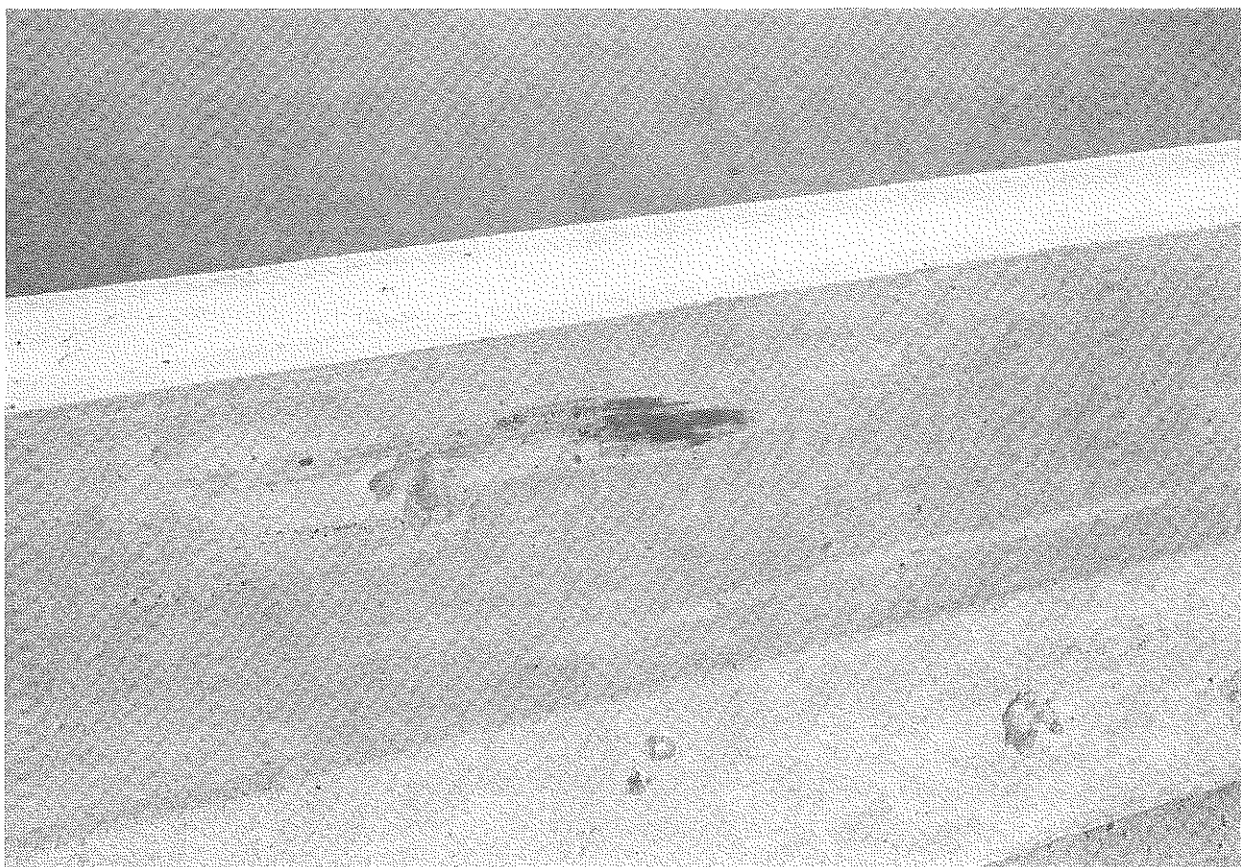
Figure 30. Delamination Caused by Vehicle Impact.

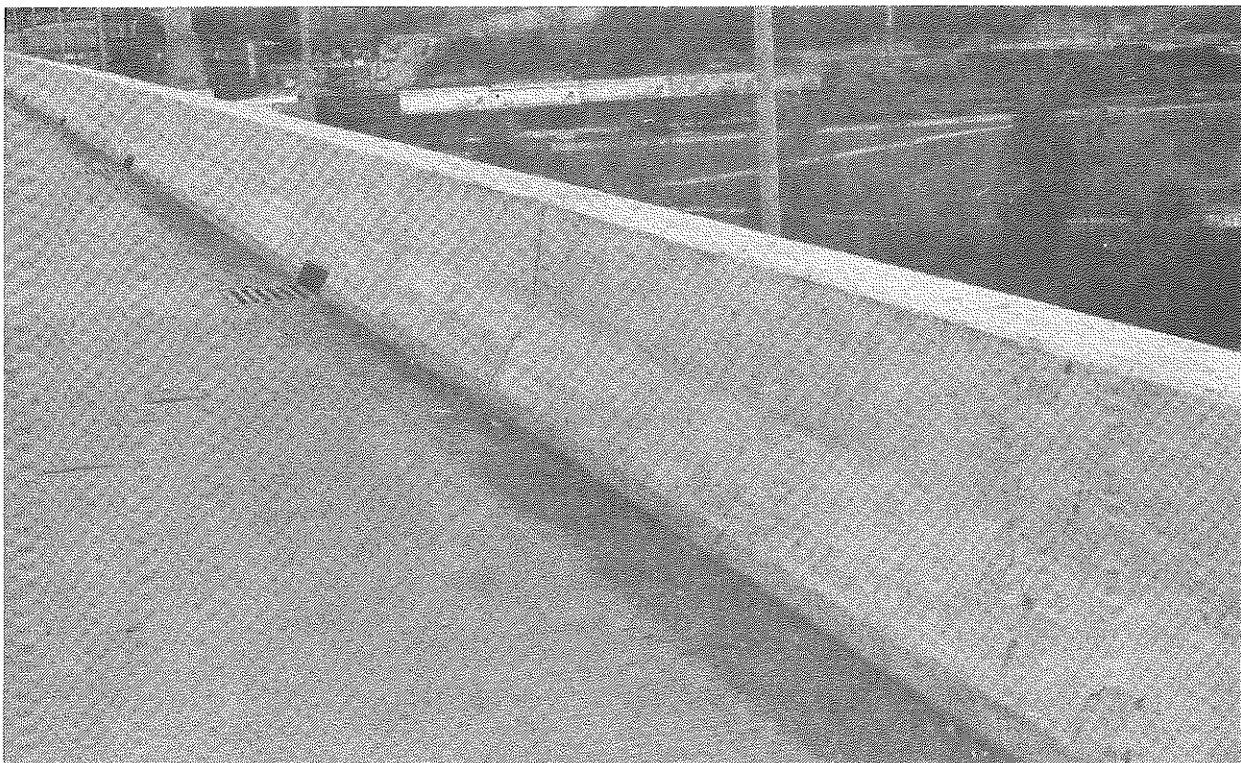
Figure 31. Patch on Northbound Main Span of the I-471 Bridge.

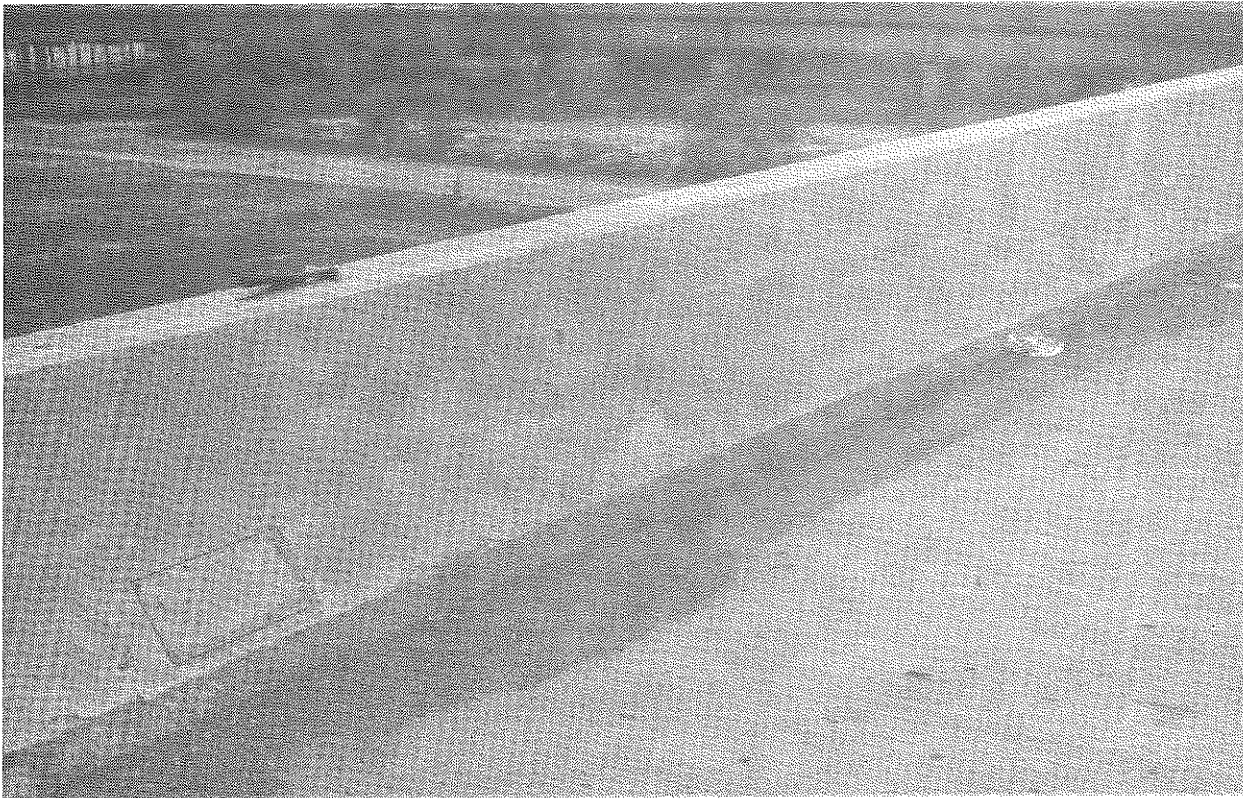
Figure 32. Delaminations on Sidewalls of Ohio Southbound Approach of the I-471 Bridge.

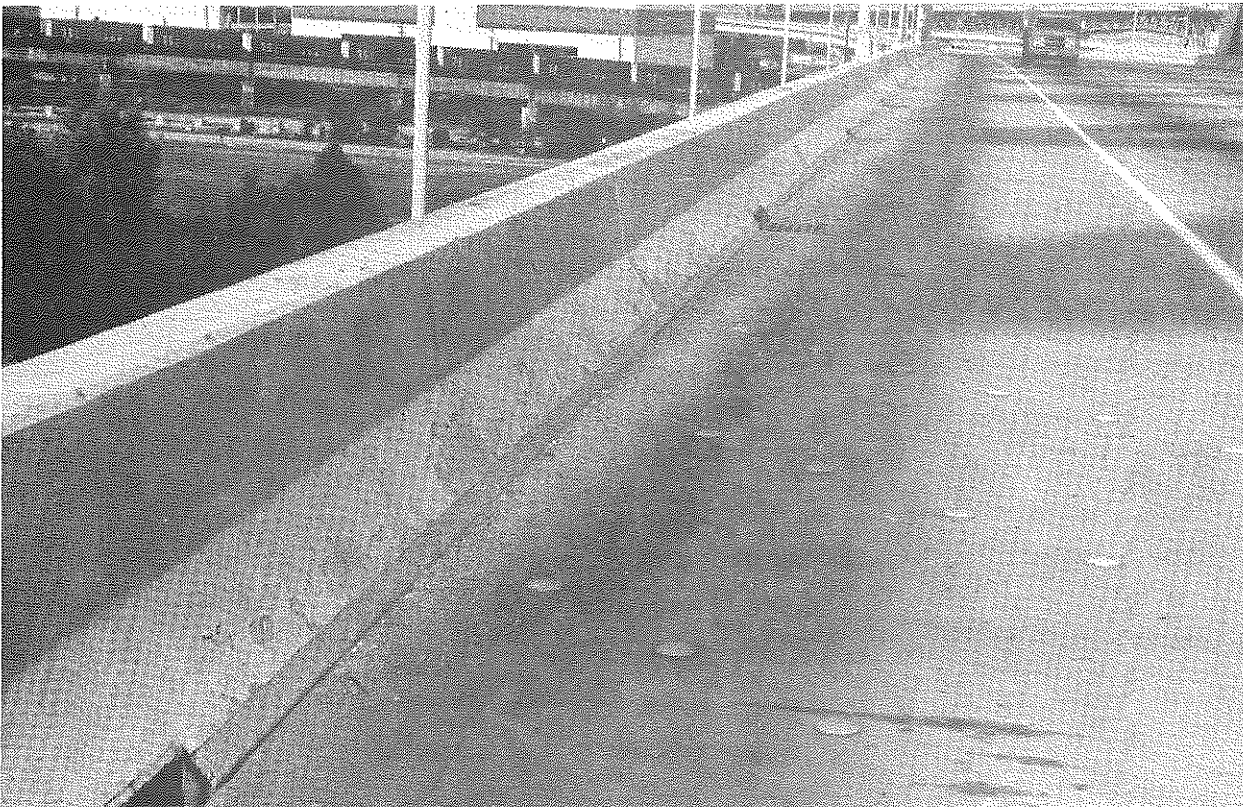
B. MAINSPAN - The downstream (traffic) sidewall showed more deterioration (spalls) than any other location (Figure 33). Along many panels, the top face had lost most of the masonry coating. Along the inner and curb faces, the coating was debonded but had yet to be mechanically broken from the sidewall. More severe failures were concentrated on the lower portions of the inner and curb faces. Some panels evidenced few failures, except for random pop-outs of underlying aggregates. Others exhibited massive spalls, most of which ran to the coating parting line. Some failures were associated with vertical cracks that ran the height of the sidewall. There were fewer spalls on the upstream (passing) lane. Most were either on the top face or were small failures along the parting line of the curb face. Some failures were near poured joints between panels. While visible spalls were less frequent on upstream panels, delaminations were probably as severe. The coating bulged in many locations. In some places, even where bond was good, the coating showed signs of fine crazing. The outer faces of both sidewalls exhibited a condition similar to the other locations.

Figure 33. Traffic Lane Sidewall on the Southbound Main Span of the I-471 Bridge.

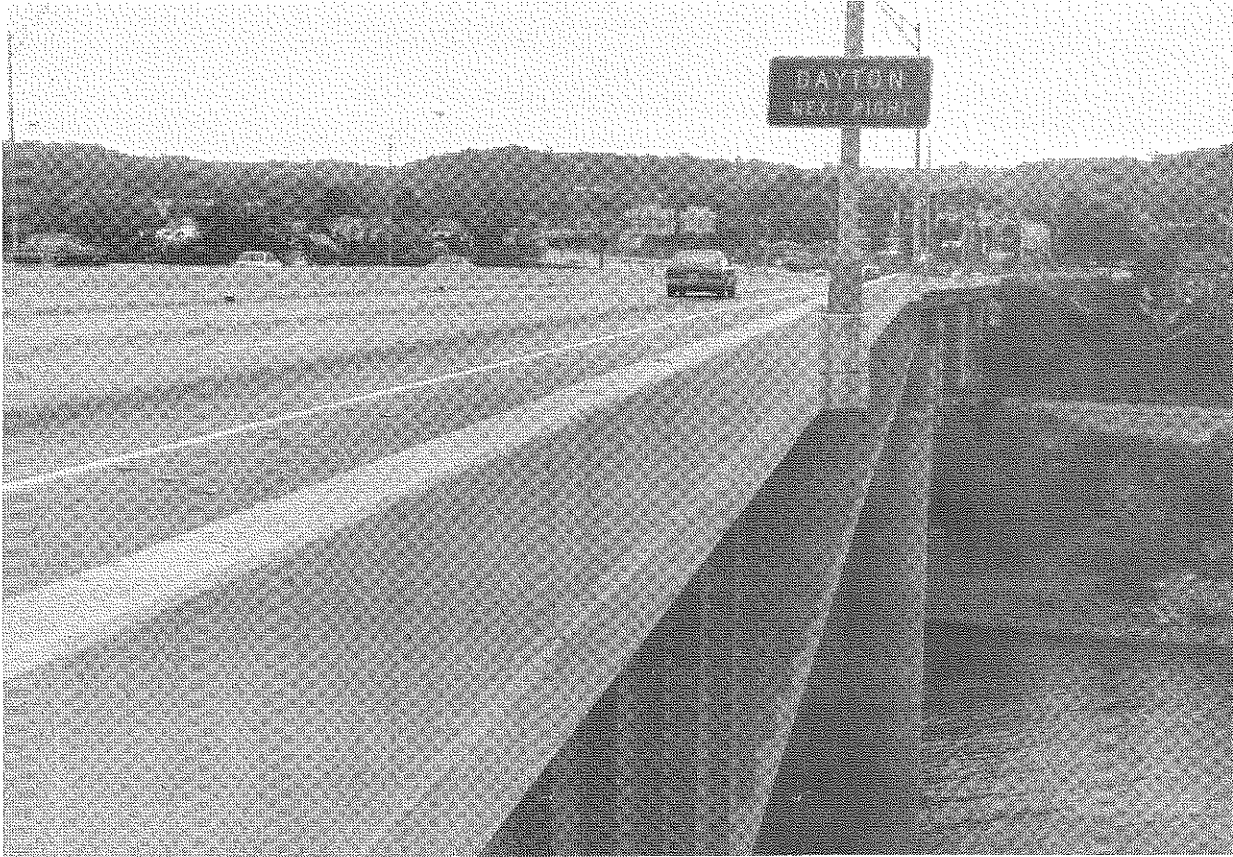
C. KENTUCKY APPROACH -- The Kentucky southbound approach sidewalls showed fewer spalls than the southbound Ohio and mainspans. Most of the visible spalls on both sidewalls were detected on the top faces rather than the inner faces. The condition of the outer faces of both sidewalls were similar to the other locations (Figure 34).

Figure 34. Southbound Kentucky Approach Showing the Condition of the Outer Walls.

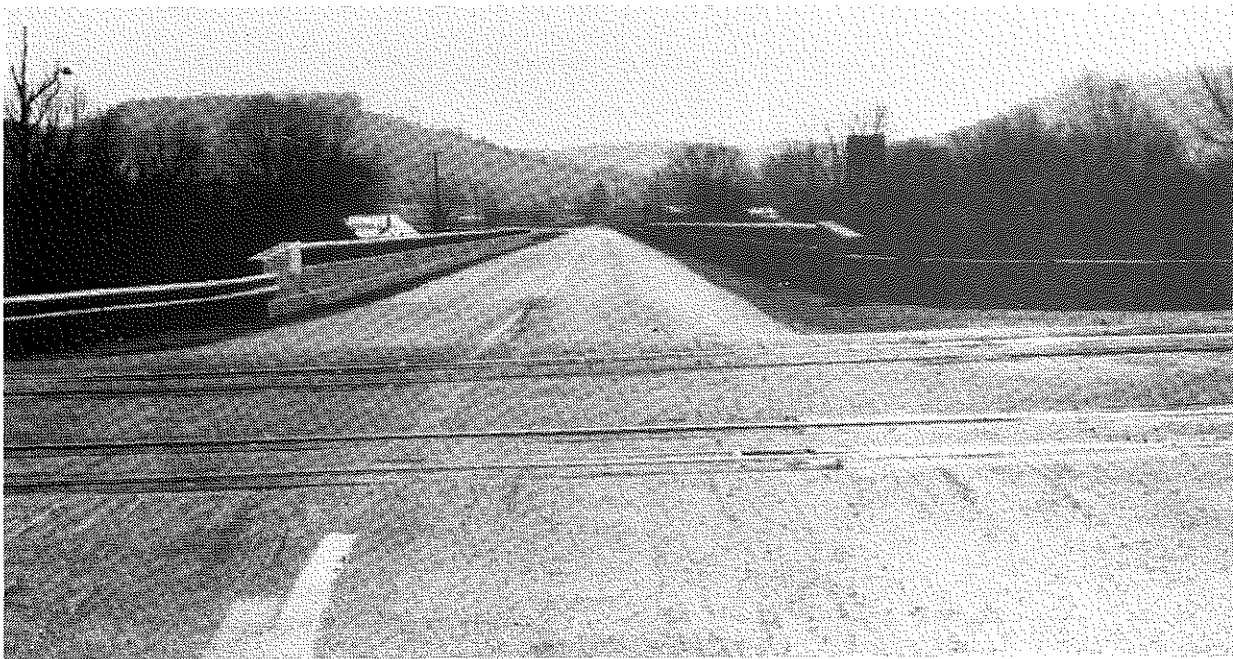
On March 3, 1983, the masonry coating on the KY-35 bridge at Sparta, Kentucky (Figure 35), was inspected. That was the second Kentucky bridge treated with a masonry coating (1970). The bridge was sprayed with TEX-COTE.

Figure 35. KY-35 Bridge at Sparta.

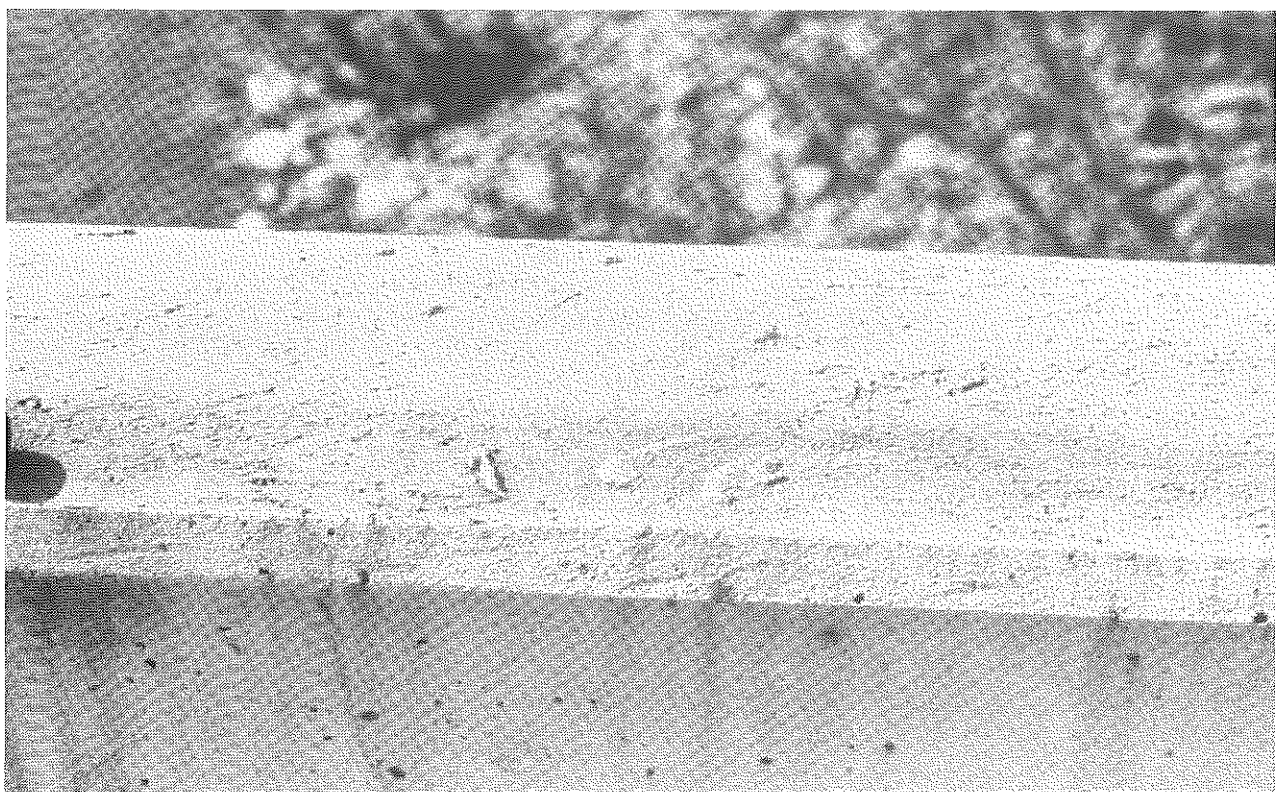
The masonry coating was applied much heavier to the top face of the sidewall than to the vertical faces or the horizontal face of the curb (Figure 36). At the guardrail bases on the top face, the TEX-COTE was debonding from the concrete. When the coating was applied, a small box was placed over guardrail studs to mask them during the spraying operation. That created an interface that moisture could penetrate and subsequently freeze, debonding the TEX-COTE. Also, the masonry coating did not completely fill many small voids in the surface of the concrete. Unexpectedly, the TEX-COTE performed very well in those locations.

Figure 36. Uneven Masonry Coating on KY-35 Bridge.

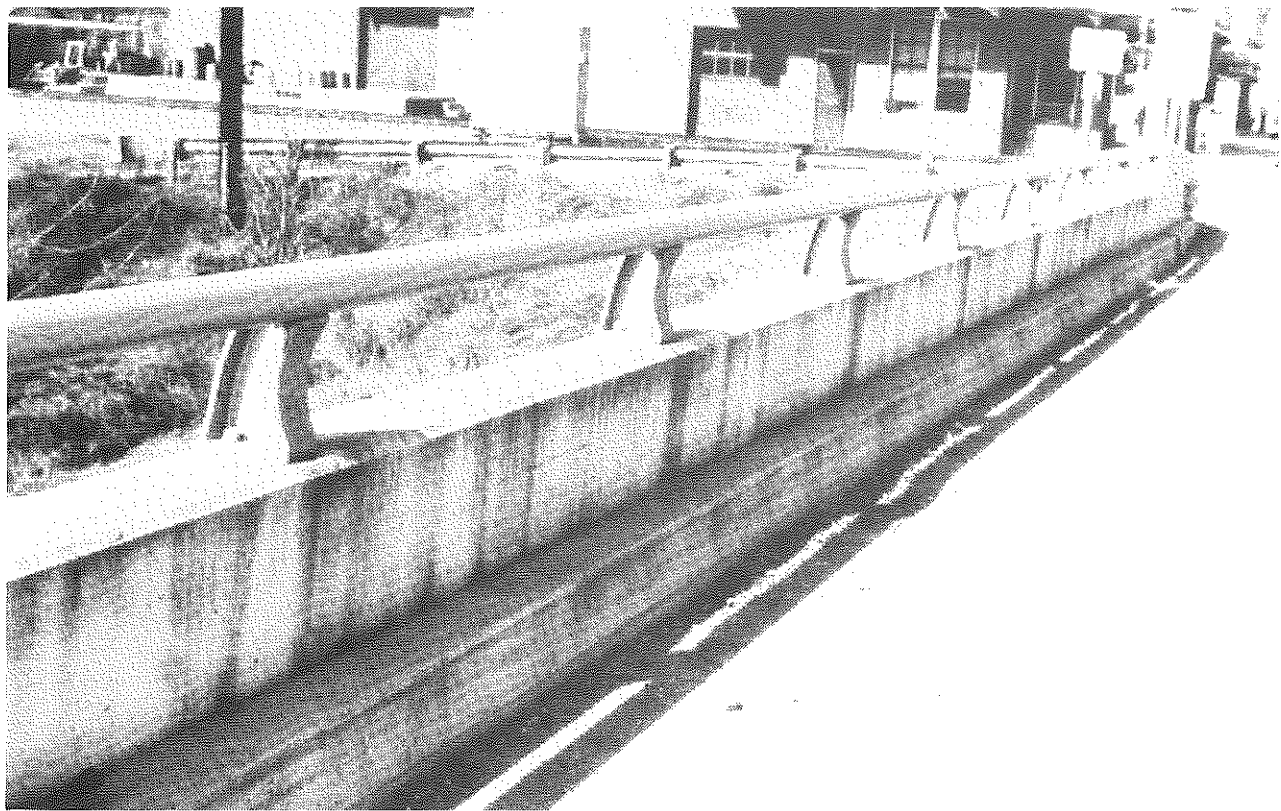
Stains were detected on the innerface of the downstream sidewall and the outer face of the upstream sidewall (Figure 37). That could be expected, since the prevailing wind direction is west to east. Therefore, the outer face of the downstream sidewall and the inner face of the upstream sidewall would experience more washing. Parting failures at guardrail bases were less numerous on the upstream sidewall. That was probably due to decreased time-of-wetness on the windblown upstream sidewall.

Due to the light off-white color of TEX-COTE, stains were very prominent. That detracted from the effect of the masonry coating and made an otherwise good bridge appear shabby.

Figure 37. Stains on KY-35 Bridge Masonry Coating.
