1. Report No.		2. Government Accession No.		3. Recipient's Catalog No.	
4. Title and Subtitle Analysis of Accidents Involving Crash Cushions				5. Report Date June 1984

Research Report
UKTRP-84-17

ANALYSIS OF ACCIDENTS INVOLVING CRASH CUSHIONS

Kentucky Transportation Research Program
College of Engineering
University of Kentucky
Lexington, Kentucky

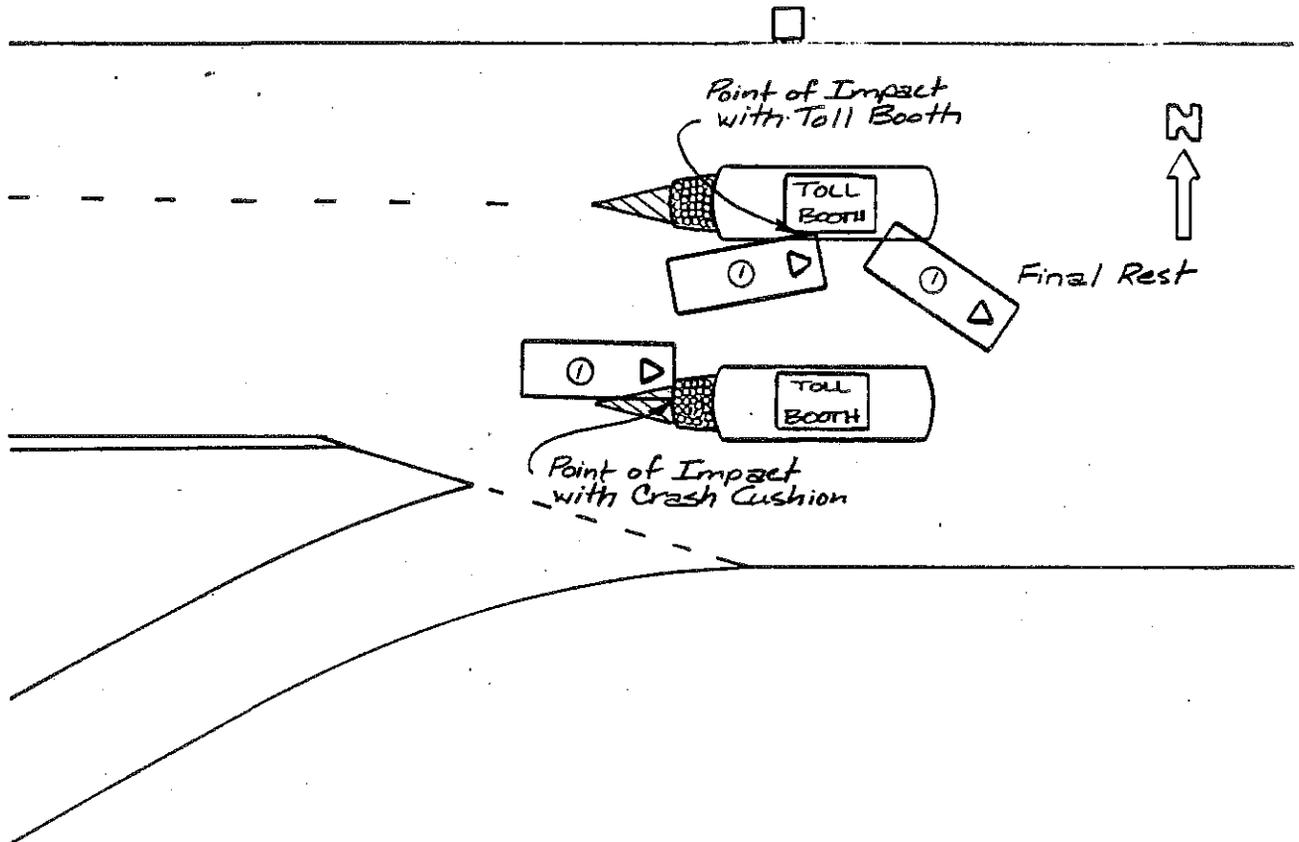
COMMENTS: A 1981 Ford pickup impacted a crash cushion with its right front corner, glanced to the left and passed between two toll booths before coming to rest. The impact was sufficient enough to disable the truck. The driver was uninjured; he was not wearing a safety belt at the time of the accident.

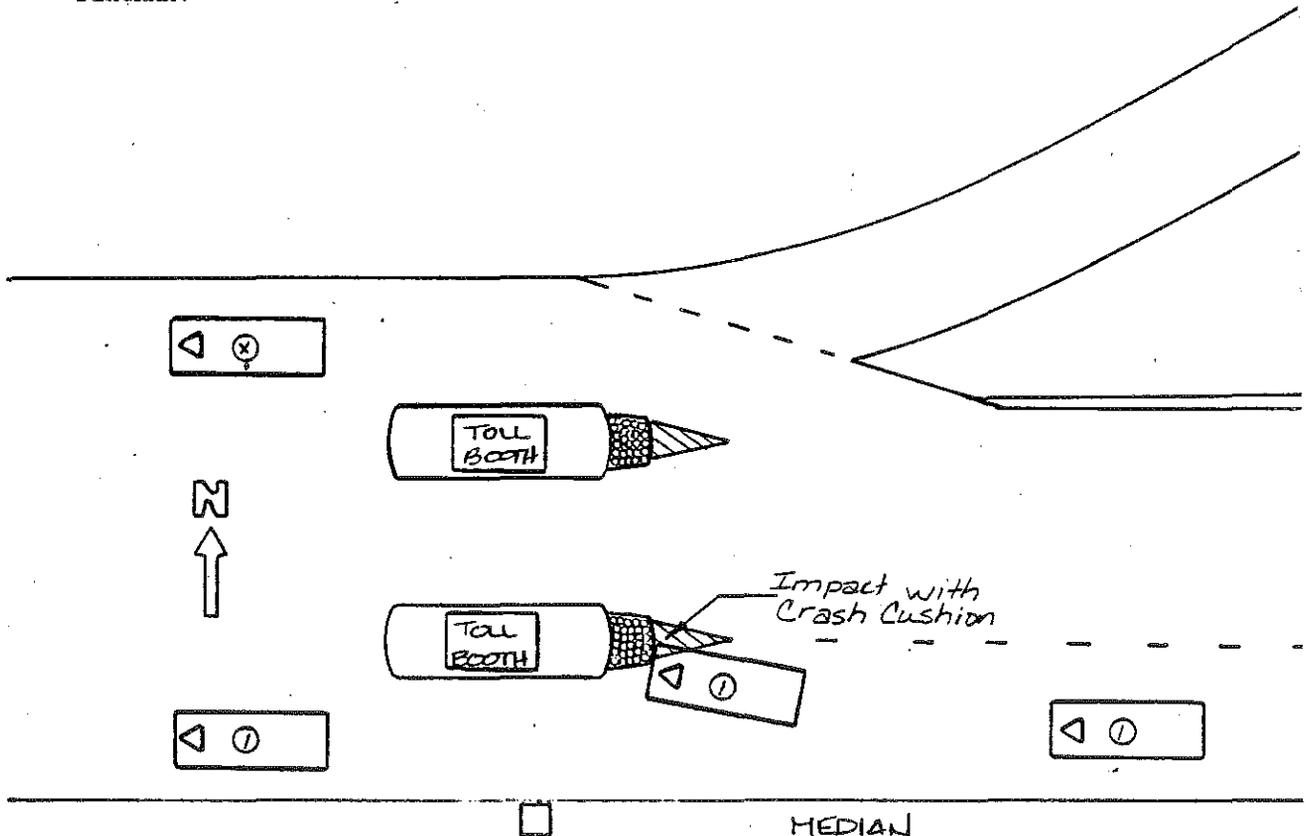
COMMENTS: A 1978 Ford pickup truck westbound on the Western Kentucky Parkway ran into the crash cushion with the right front of the vehicle. The vehicle continued on through the toll lane approximately 0.1 mile before stopping. The vehicle was disabled. The driver was not injured. He was not wearing a safety belt.

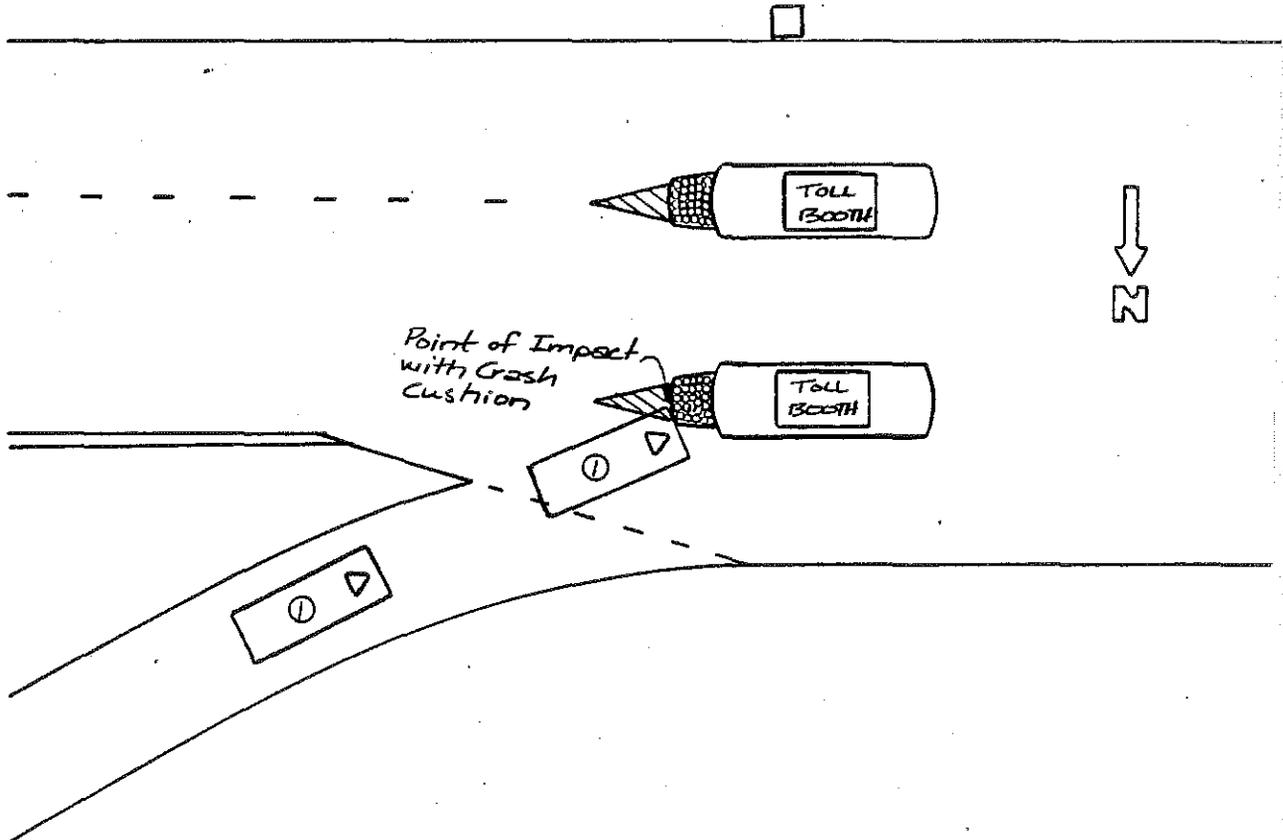
COMMENTS: A 1973 Oldsmobile 2-door sedan struck the crash cushion as the vehicle was entering the parkway. The driver stated he dropped his change; as he was looking down to pick it up he hit the crash cushion. The vehicle received non-functional damage. The driver was uninjured. He was not wearing a safety belt.

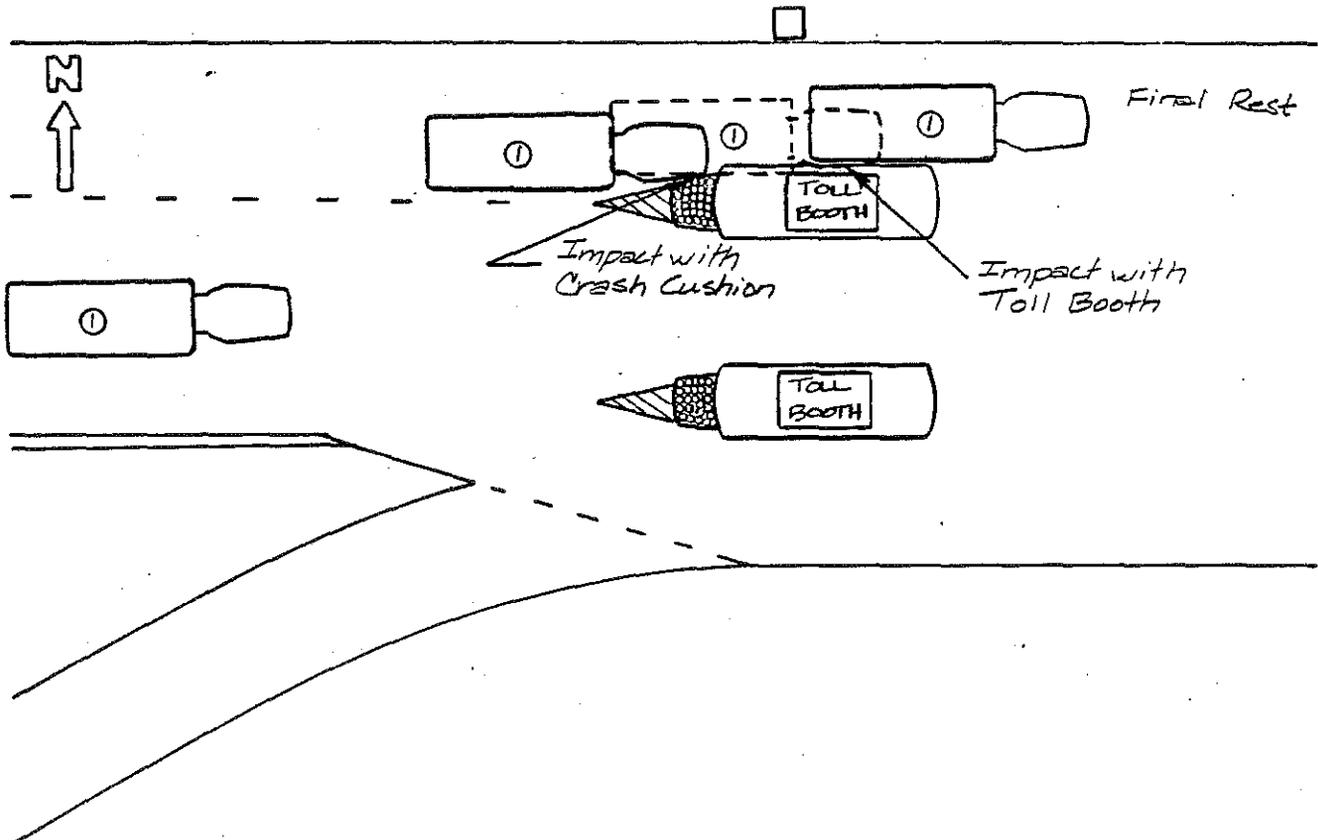
COMMENTS: A 1983 Peterbilt tractor and semi-trailer was approaching the toll booth when the left front tire blew out, causing the vehicle to swerve left and impact the crash cushion. The vehicle hit the toll booth after impacting the crash cushion. The right front of the truck hit the crash cushion with unknown damage. The driver was not injured and he was not wearing a safety belt.

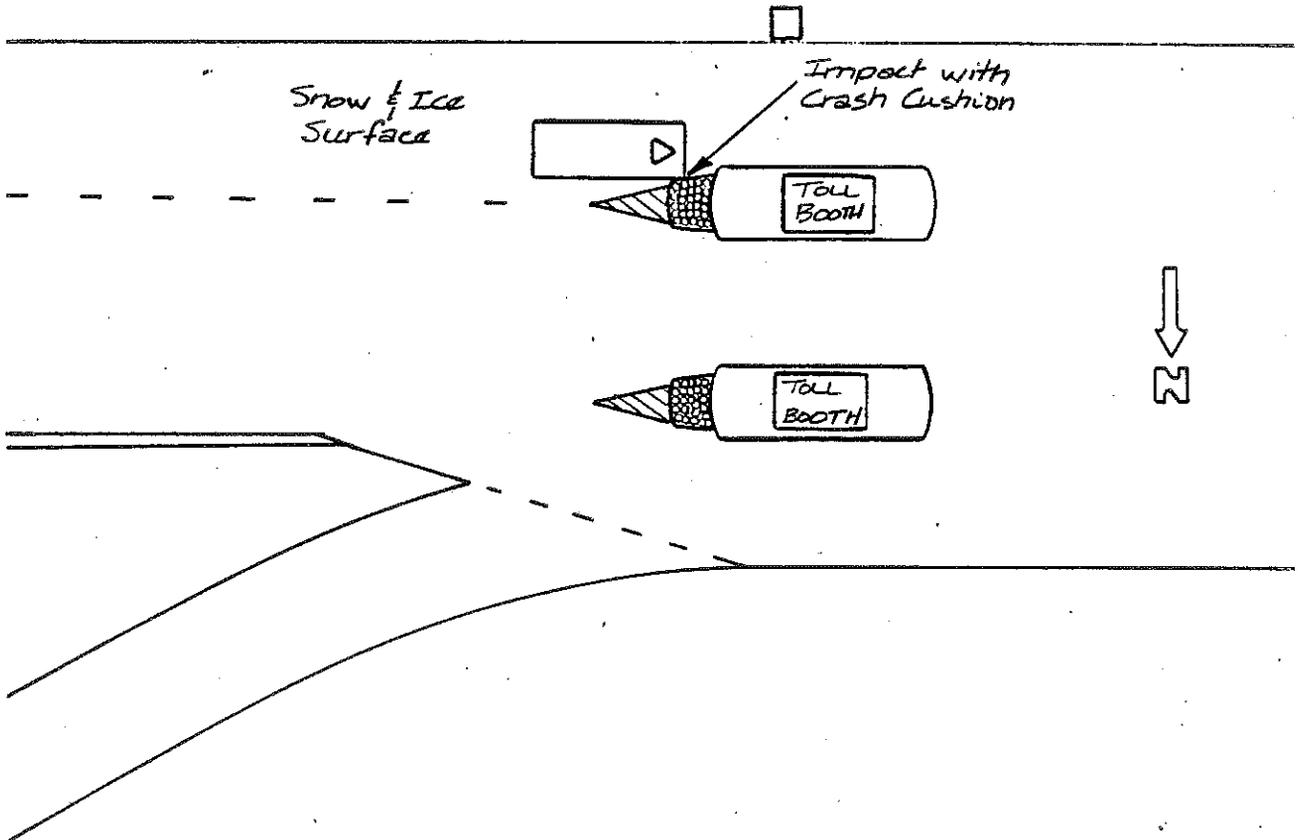
COMMENTS: A 1967 Plymouth 4-door sedan impacted a crash cushion with its right front corner and then came to rest in the traffic lane. The vehicle received functional damage to the front end. The driver of the vehicle, who was not wearing a safety belt, was not injured. Snow on the roadway was listed as a contributing factor.

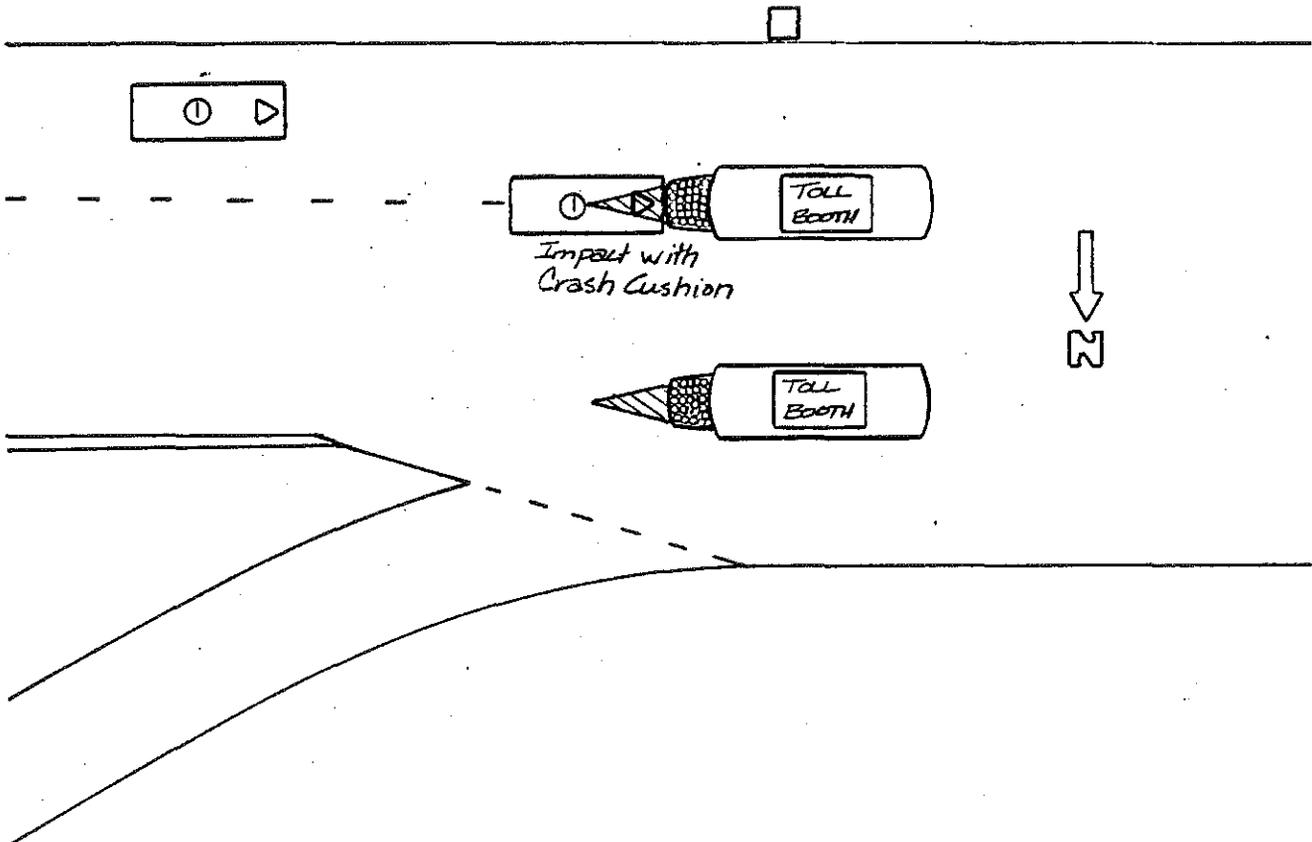
COMMENTS: A 1977 Buick 2-door sedan, travelling in the inside lane (adjacent to the median), veered to the right as it approached the toll plaza and bumped the crash cushion head-on, where it came to a stop. The driver, who was uninjured, claimed that he lost control as he looked down to get a coin. The vehicle was not damaged. He was not wearing a safety belt.

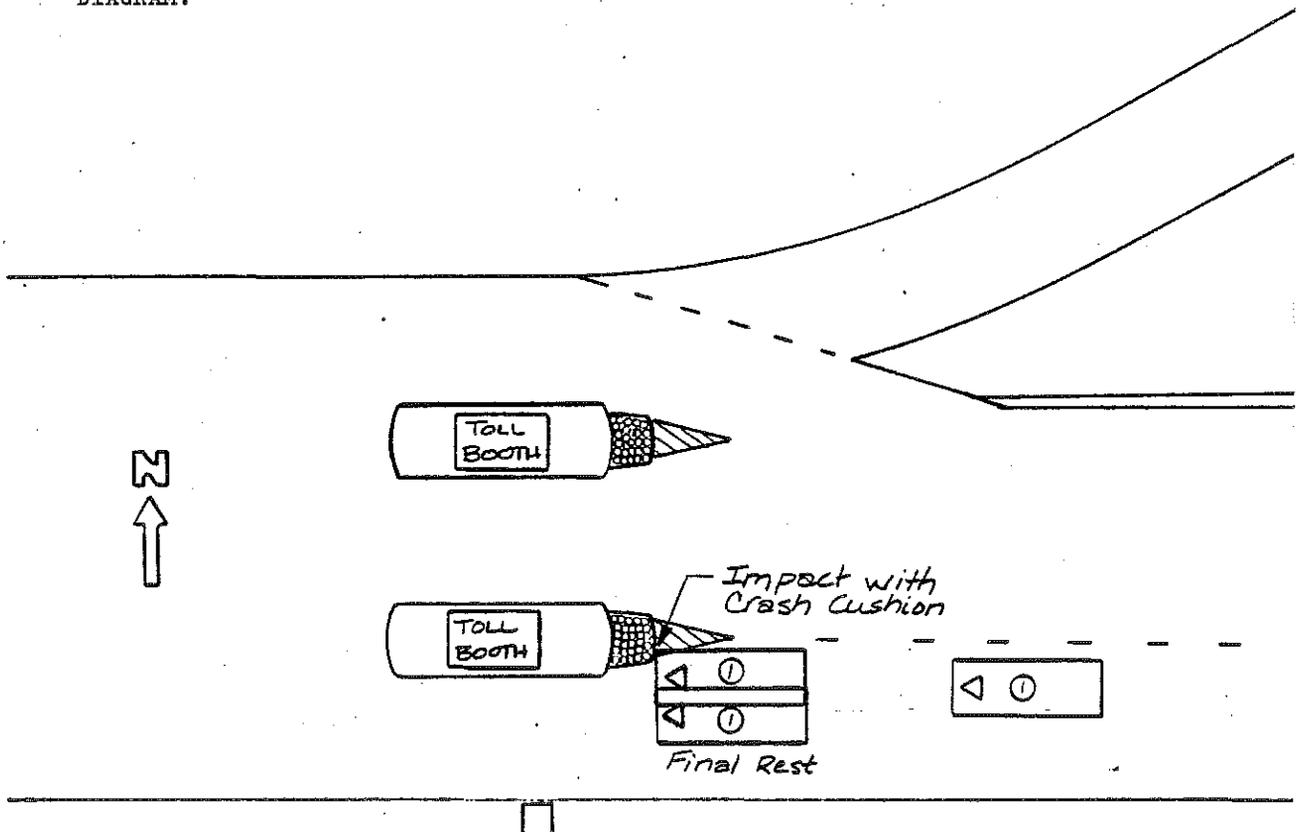
COMMENTS: The vehicle, a 1979 Pontiac 2-door sedan, struck the crash cushion with the right front corner and then bounced sideways to the left into the middle of the traffic lane. The driver claimed that she looked down to get change and the vehicle then veered to the right. The car received functional damage. The driver received a possible head injury; she was not wearing a safety belt when the accident occurred.

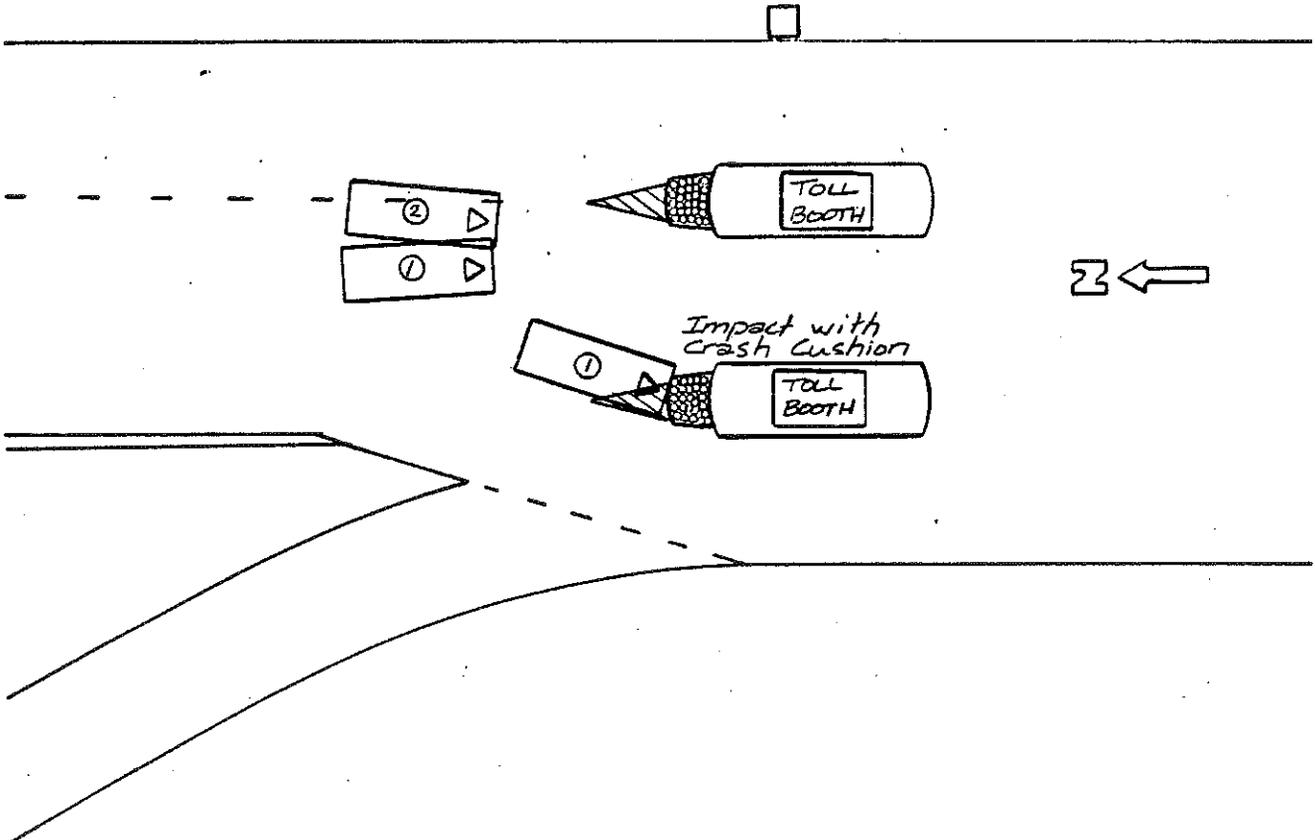
COMMENTS: Unit 1, a 1972 Chevrolet Vega, struck another vehicle as both attempted to go through the toll plaza in the same lane (right "through" lane). Unit 1 glanced off Unit 2, veered to the right and struck the crash cushion head-on. Both impacts were minor and Unit 1 suffered only slight damage. No one was injured. The driver of Unit 1 was not wearing a safety belt.

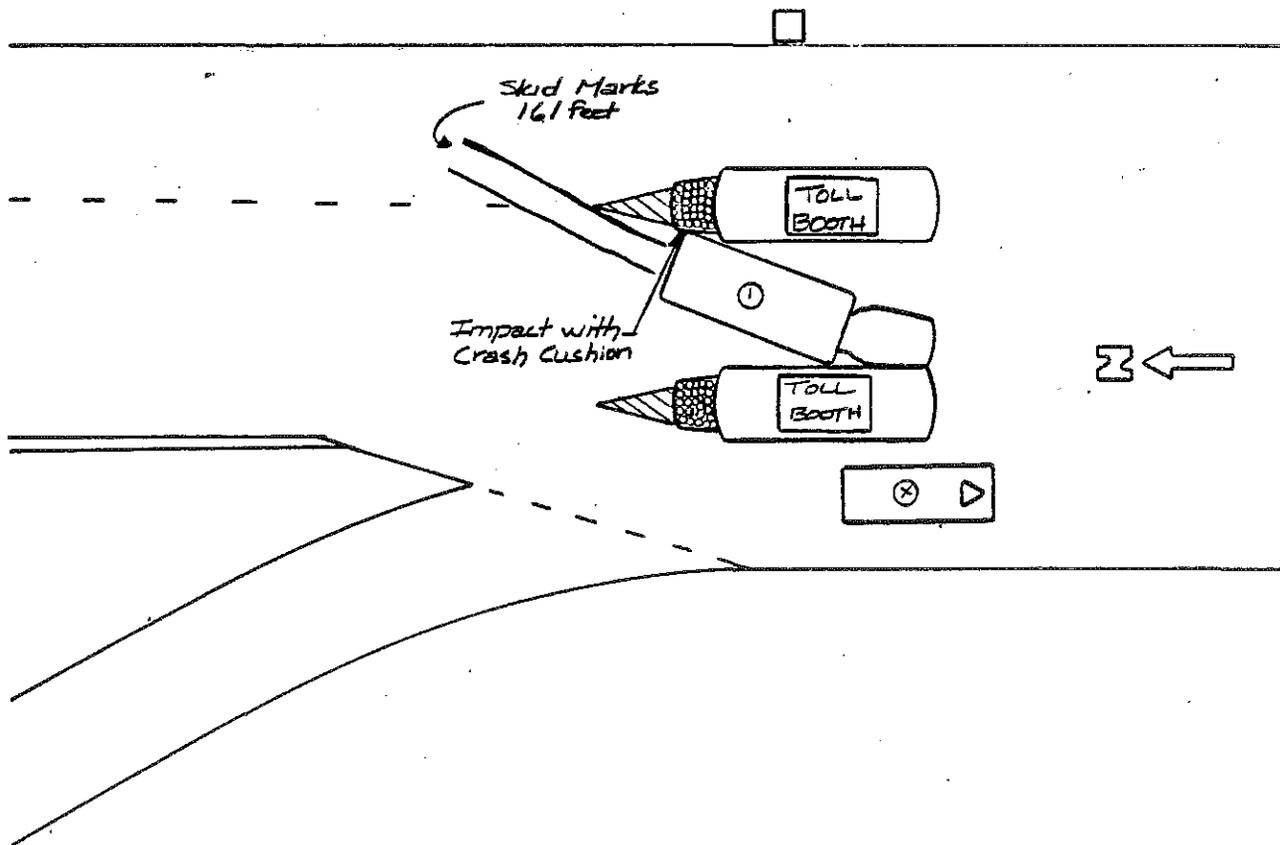
COMMENTS: A 1979 Kenworth tractor trailer was approaching the Hartford Toll Plaza when his trailer brakes failed and later locked up, causing the trailer to slide sideways into the toll booth crash cushion. The trailer wheels fell off and it continued and fell to the right into the toll booth occupied by an attendant. The vehicle was disabled. The driver was not injured; however, the attendant received non-incapacitating injuries. The driver was not wearing a safety belt.

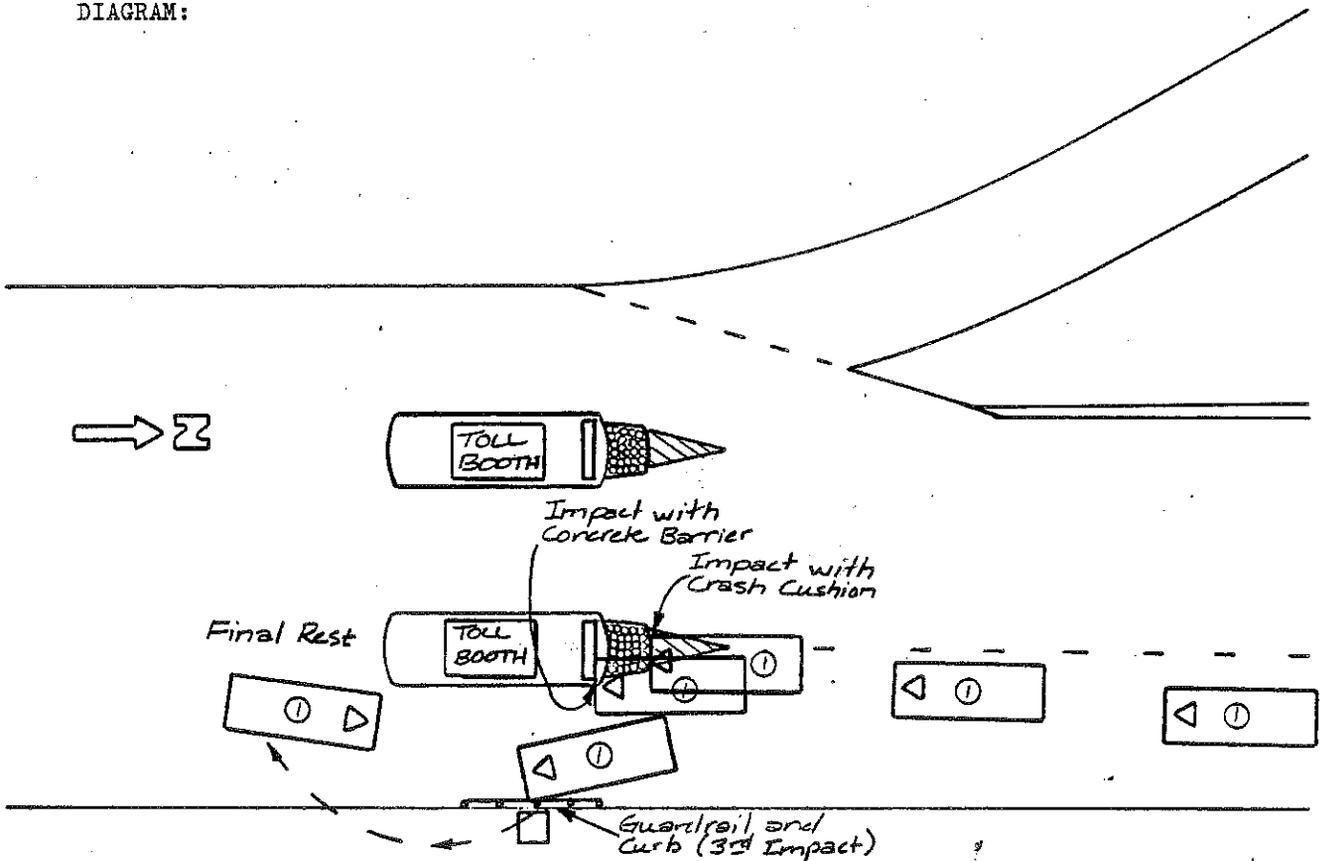
Figure C1. Accident Number 015, Webster County, Pennyrite Parkway, MP 62.6, at Sebree Toll Plaza.

COMMENTS: A 1979 Ford pickup attempted to pass through the toll plaza at a high rate of speed and struck the crash cushion head-on. It was thrown to the left, where it struck a guardrail and then spun around 180 degrees. The driver was killed and the vehicle was disabled. The driver was not wearing a safety belt.

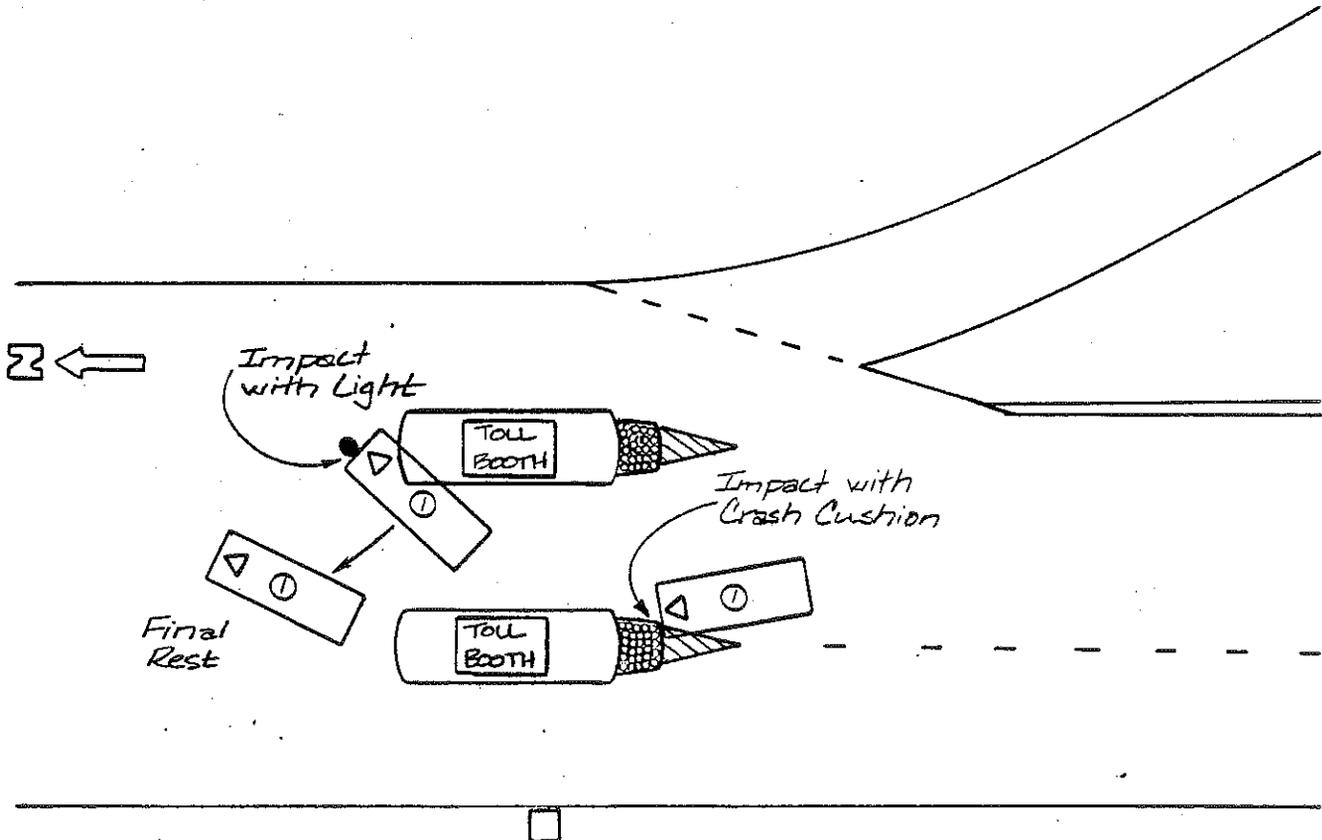
COMMENTS: The vehicle, a 1981 Chevrolet Chevette, was approaching the toll plaza at an unsafe speed due to driver intoxication. The vehicle struck the crash cushion on the left with its left front end, slid between the two toll booths, struck the light behind the toll booth to the right and bounced sideways back to the left, where it came to rest in the traffic lane. The driver received a non-incapacitating injury to the legs, while the passenger received a non-incapacitating head injury; neither occupant was wearing a safety belt. The vehicle was disabled.

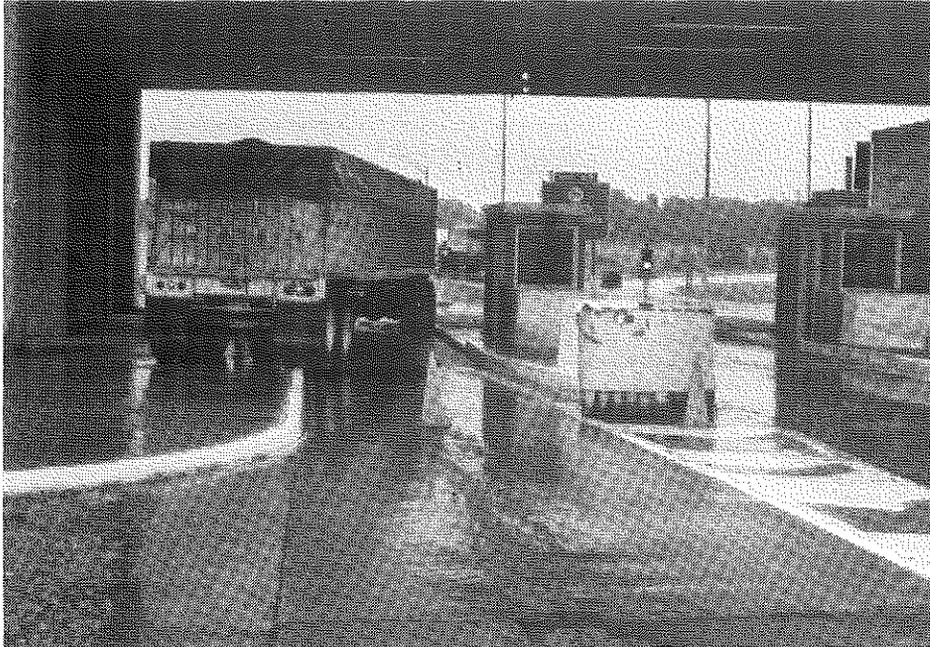
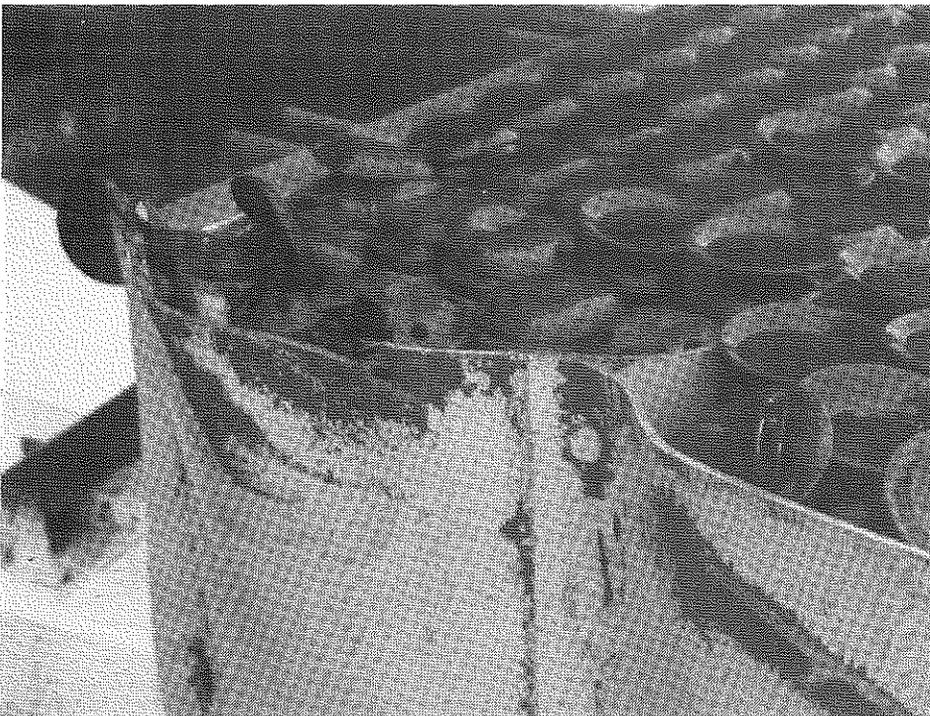
Figure C2. Accident Number 017, Webster County, Pennyrite Parkway, MP 62.6, at Sebree Toll Plaza.

COMMENTS: A 1978 International tractor and semi-trailer was unable to stop due to excessive speed on the wet pavement as it approached the toll plaza. The tractor made it into the left lane, but the trailer struck the crash cushion in the center with its right side and bounced off into the guardrail and coin machine on the other side of the lane. The trailer was damaged slightly on its right side from impact with the crash cushion. The driver, who was uninjured, was not wearing a safety belt.

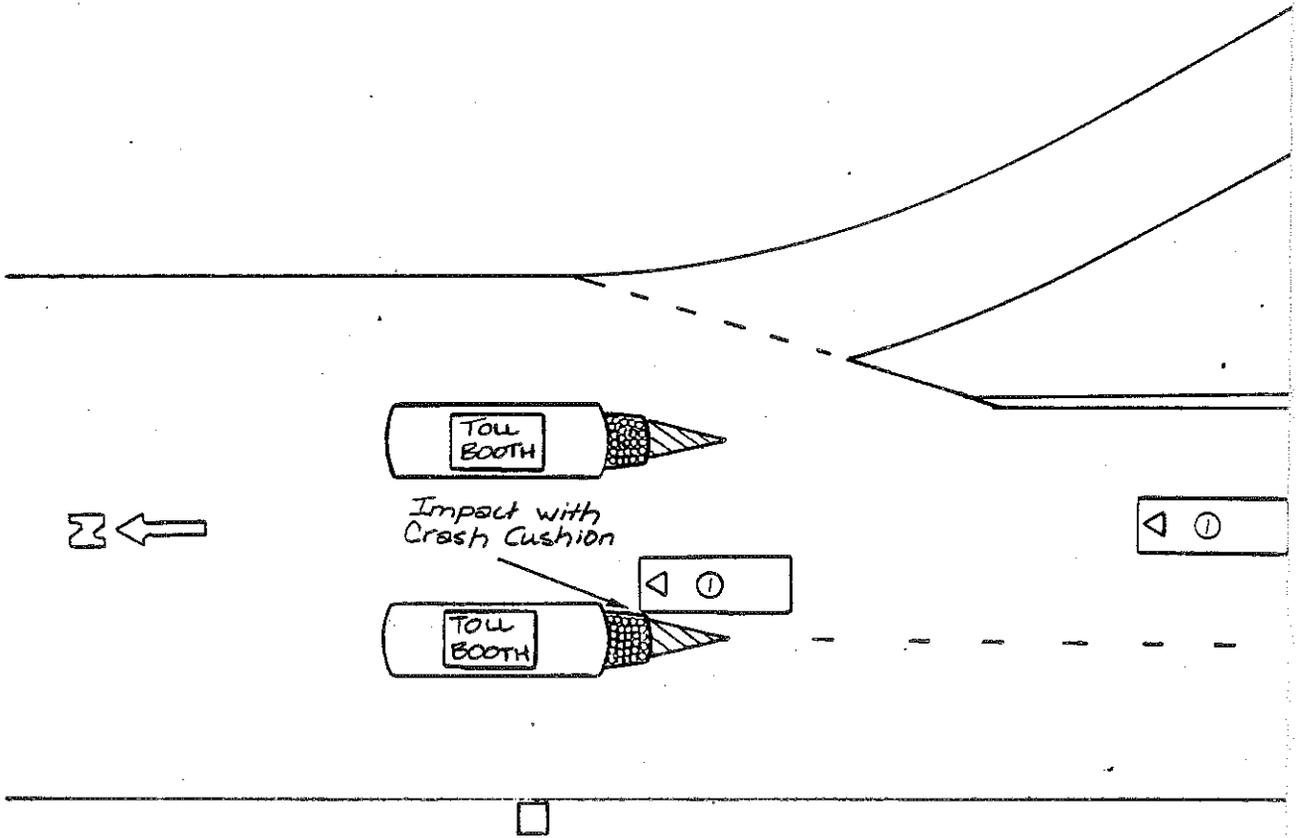
COMMENTS: The vehicle, a 1977 Lincoln 2-door sedan, went out of control on the ice-covered roadway and sideswiped the crash cushion at the toll booth. Non-functional damage was done to the left front corner of the car, which remained in service. None of the five occupants of the car were wearing safety belts. No one was injured.
