Research Report
UKTRP-83-14

GEOTECHNICAL, HYDROLOGIC, AND HYDRAULIC
INVESTIGATION OF MILL CREEK DAM -- PHASE II

July 1983

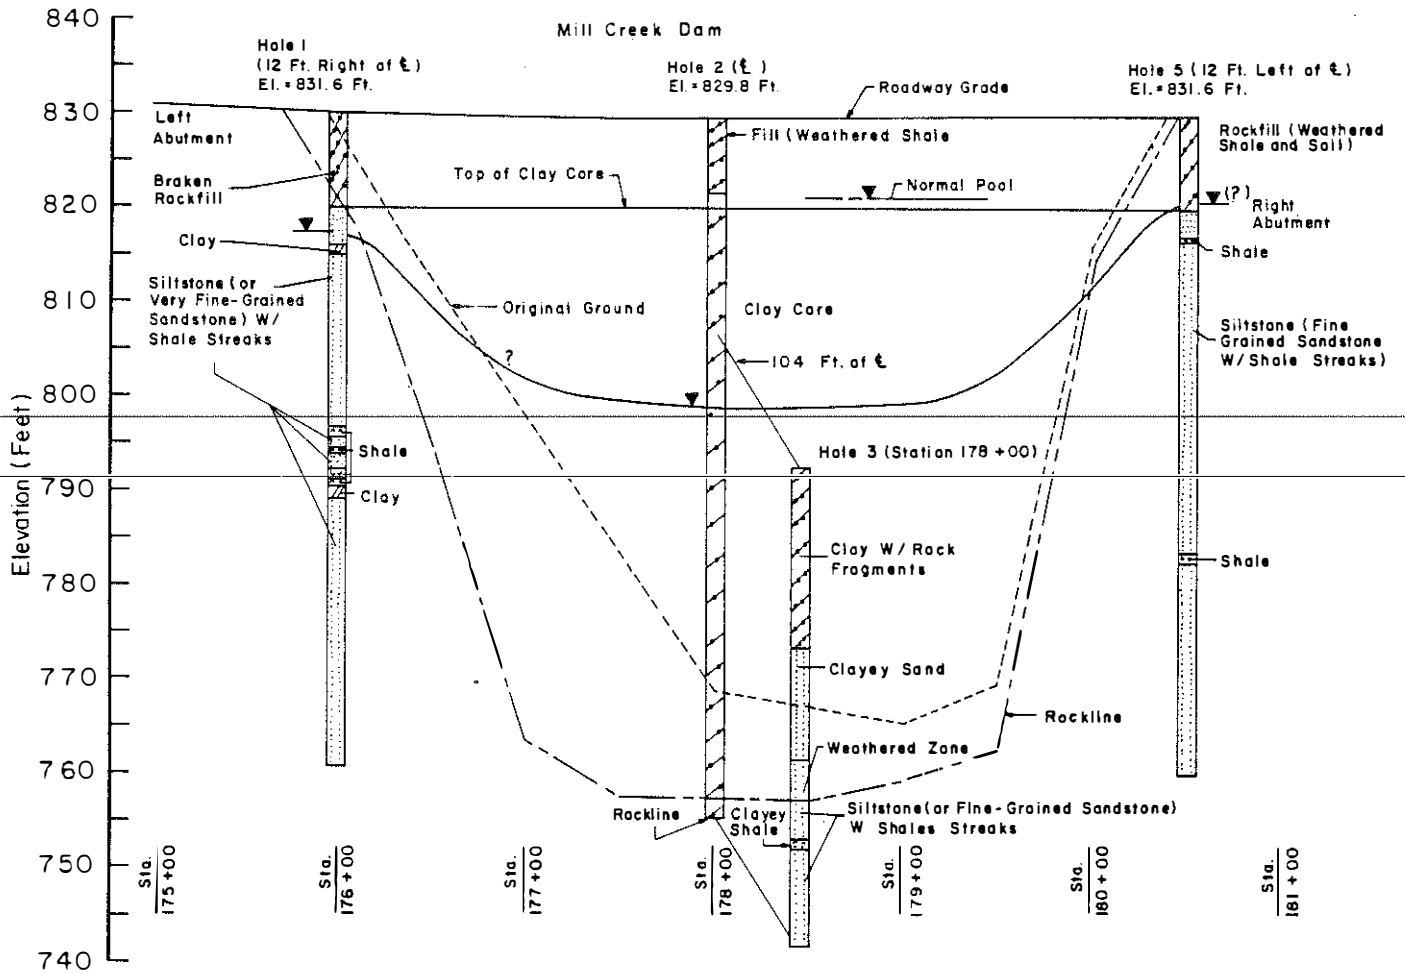
Figure 6. Typical Cross Section of the Mill Creek Dam at Station 178+00.

respectively. The location of the phreatic line, based on groundwater elevations in Holes 2, 3, and 4, is shown in Figure 6, a typical cross section of the dam at Station 178+00. A sketch of the phreatic surface along centerline axis of the dam is shown in Figure 7. Groundwater elevations at Station 181+00 (sidehill portion of the embankment) are shown in Figure 8.

Essentially, the dam consists of five zones of materials as shown in Figure 6. Those zones include the earth core, foundation soils, shell materials situated to each side of the earth core, waste disposal berm materials, and the rock abutments and foundation. Transitional filter zones are not shown on the as-built construction cross sections, although they are shown on original record plans.

The shell zones were to be constructed of rock, presumably durable rock. Also, the portion of the shell zone above the clay core was designated as rock. However, as shown in APPENDIX A, Borings 1, 3, 2, and 2A, and in Figure 6, the shell zones contained a matrix of highly weathered shale, siltstone, and soil. Sound durable rock was not found during exploration. Rather, the shell materials classified as CL; the materials contained fairly high percentages of soil particles passing the No.-200 sieve and do not qualify as rock for shell zones of an earth dam of the type constructed at the Mill Creek site. According to Wagner's engineering use chart (10), the

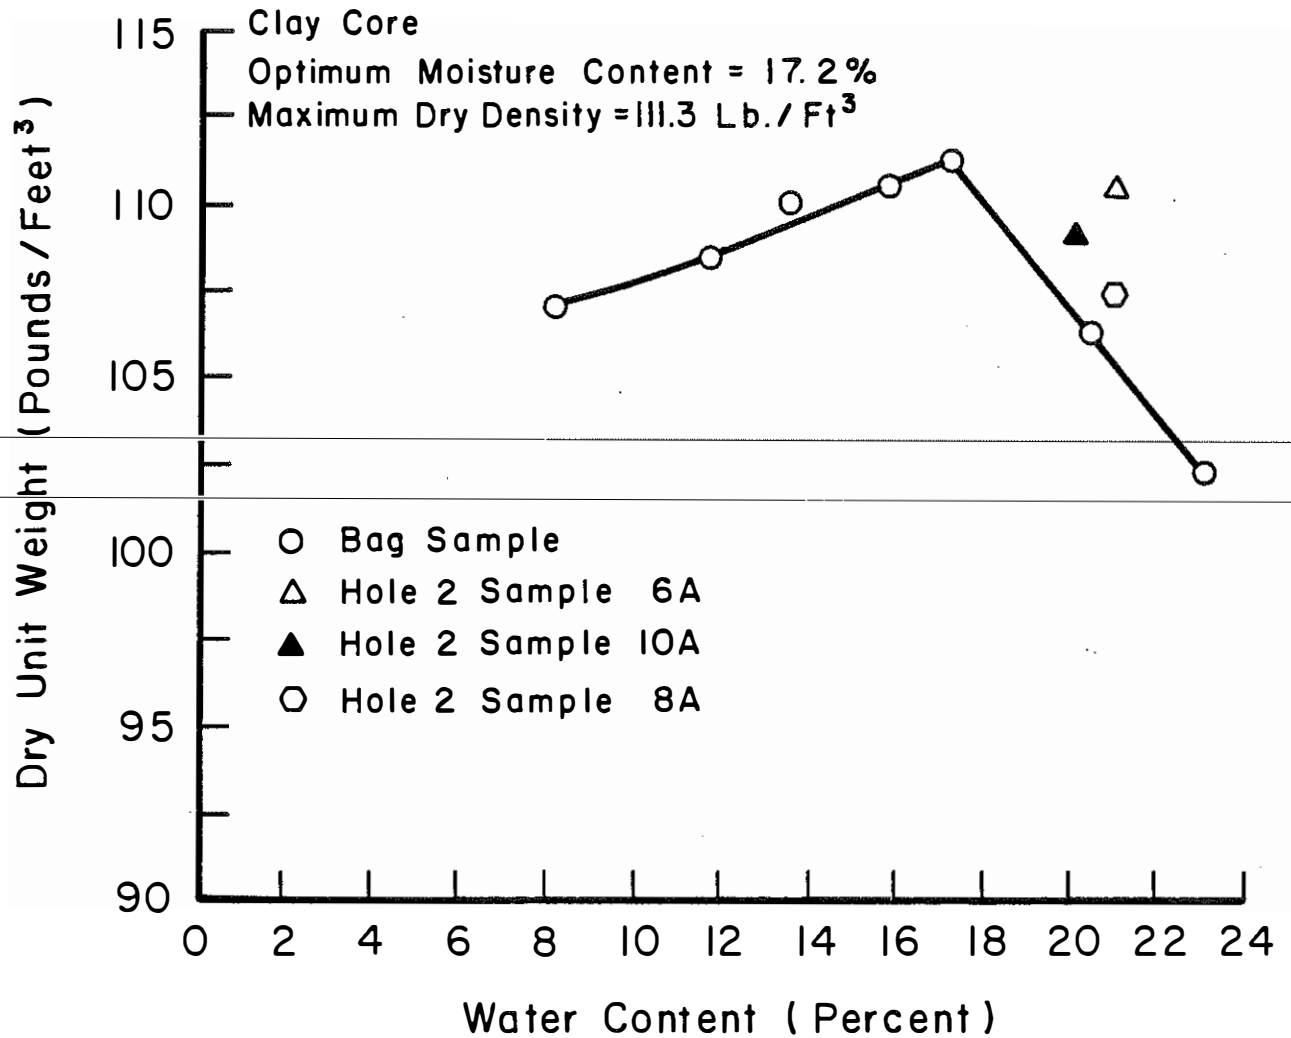
Figure 13. Comparison of Dry Unit Weight-Water Content Relationship of the Earth Core Obtained from Standard Compaction (ASTM D-698, Method A) and In Situ Dry Densities and Water Contents Obtained from Shelby-Tube Samples.

Results obtained from moisture-density compaction tests (ASTM 698-78) on bag samples of the clay core are shown in Figure 13. To determine values of relative compaction of the clay core, dry unit weights and water contents obtained from three Shelby-tube specimens were compared to the maximum dry density and optimum water content of the clay core in Figure 13.

overconsolidated. The material appeared to have been compacted near or slightly wet of optimum moisture content. Clays compacted near or slightly wet of optimum moisture retain a plastic character and will deform without cracking more readily than soils compacted dry of optimum. Based on a visual inspection, no cracking of the dam was observed.

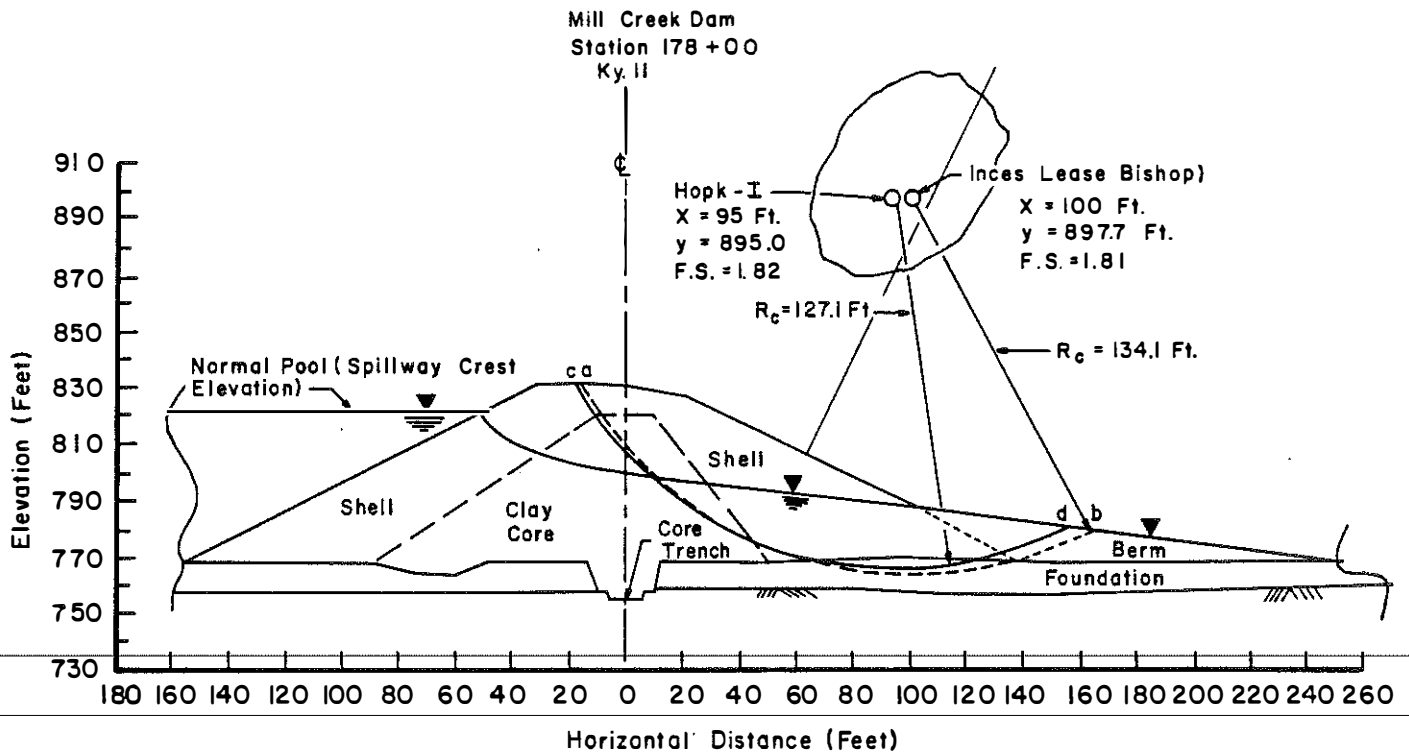
Figure 16. Results of Circular Stability Analyses of the Downstream Slope of Mill Creek Dam, Station 178+00.

Stability analyses of the downstream slope assuming a circular failure mode are shown in Table 3. Those analyses were based on the effective stress shear strength parameters in Table 2. The minimum factor of safety obtained from the ICES-LEASE program for the downstream slope of Mill Creek Dam using the observed seepage line was 1.81. A factor of safety of 1.82 was obtained from the HOPK-I program. Critical circular shear

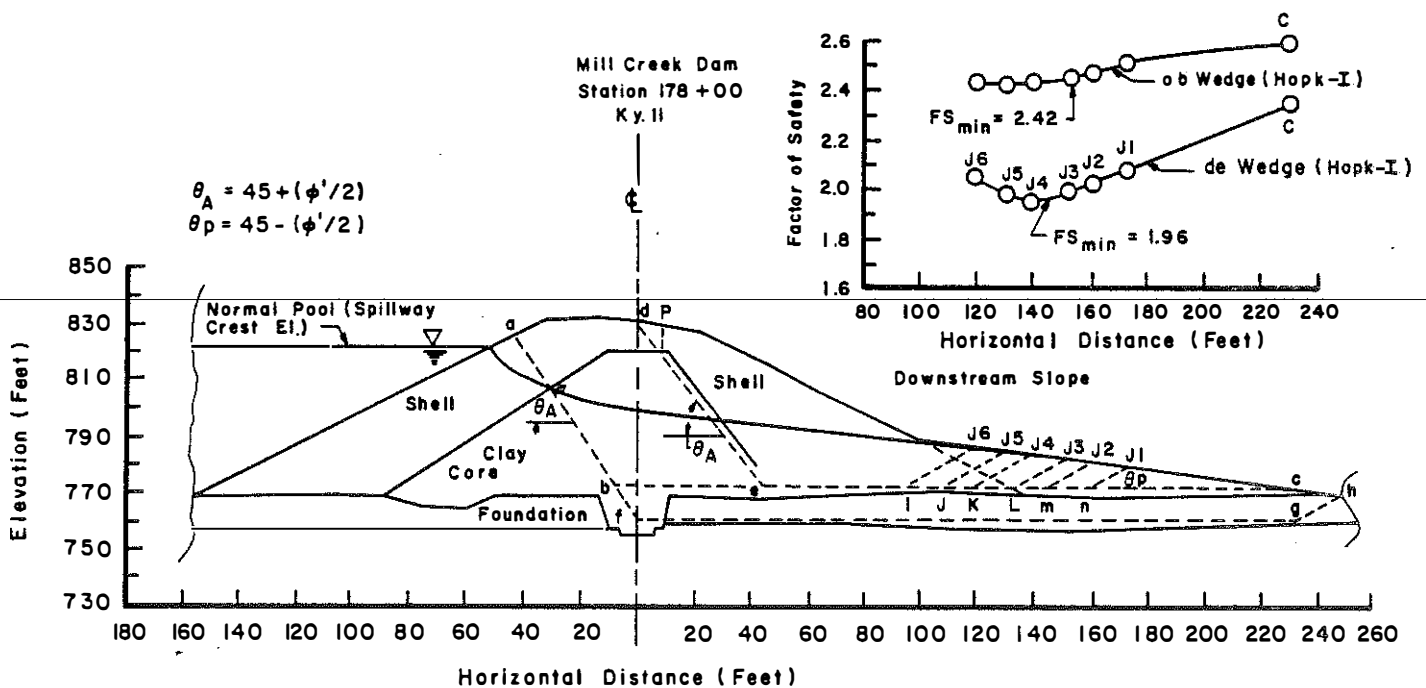
Figure 17. Results of Stability Analyses of the Downstream Slope of Mill Creek Dam, Station 178+00, Assuming Various Wedge-Shaped Configurations.

Various wedge-shaped failure configurations of the downstream slope were examined using the HOPK-I computer program. Those analyses are summarized in Table 4. Various two-block and three-block failures were examined, as shown in Figure 17. Factors of safety are shown as a function of horizontal distance in Figure 17. The upper curve in Figure 17 is for shear surfaces abc, abnJ1, abmJ2, etc. while the lower plot is for shear surfaces dec, denJ1, demJ2, etc. The lowest factor of safety obtained from the wedge analysis (shear surface dekJ4 in Figure 17) of the downstream slope was 1.96.

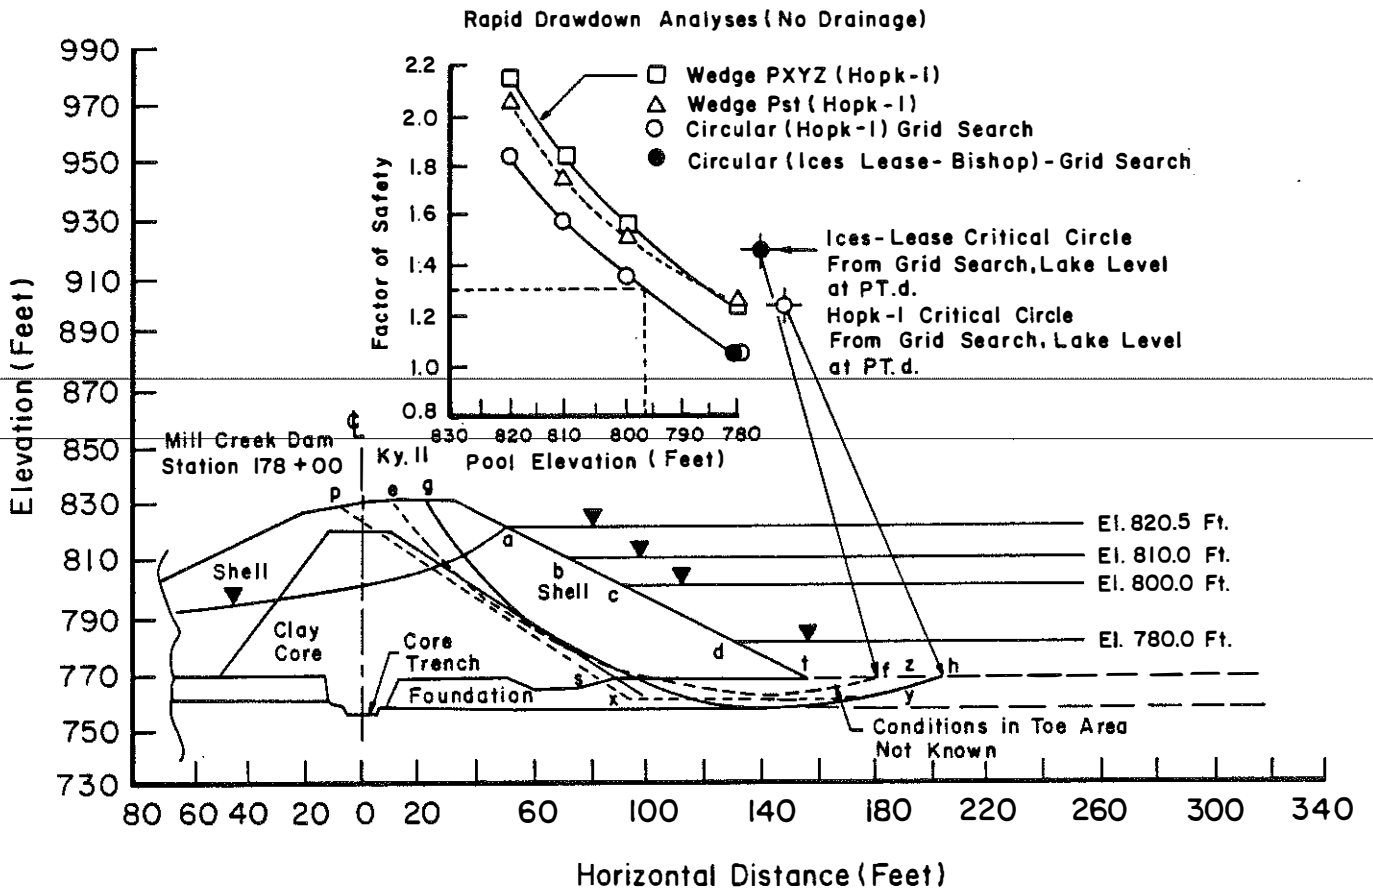
Figure 18. Results of a Rapid Drawdown Stability Analysis of the Upstream Slope of Mill Creek Dam, Station 178+00, Assuming Various Wedge-Shaped Failure Configurations, Circular Failure Configurations, and Various Pool Elevations.

2. For the case of rapid draw-down and in the event the lake must be lowered, the pool elevation may be drawn down to about elevation 796 feet; that elevation corresponds to a recommended safety factor of 1.3. Drawdown below that level should be conducted at a rate that does not exceed a difference in elevation between the upstream seepage line and pool elevation of about 20 to 24 feet. A value smaller than 24 feet is preferred. That difference should be measured in the vicinity of the intersection of normal pool and the upstream slope. Two observation wells should be installed in the upstream slope to observe the seepage line during drawdown; actual seepage lines should be used in a stability analysis to ascertain the safety of the upstream slope.

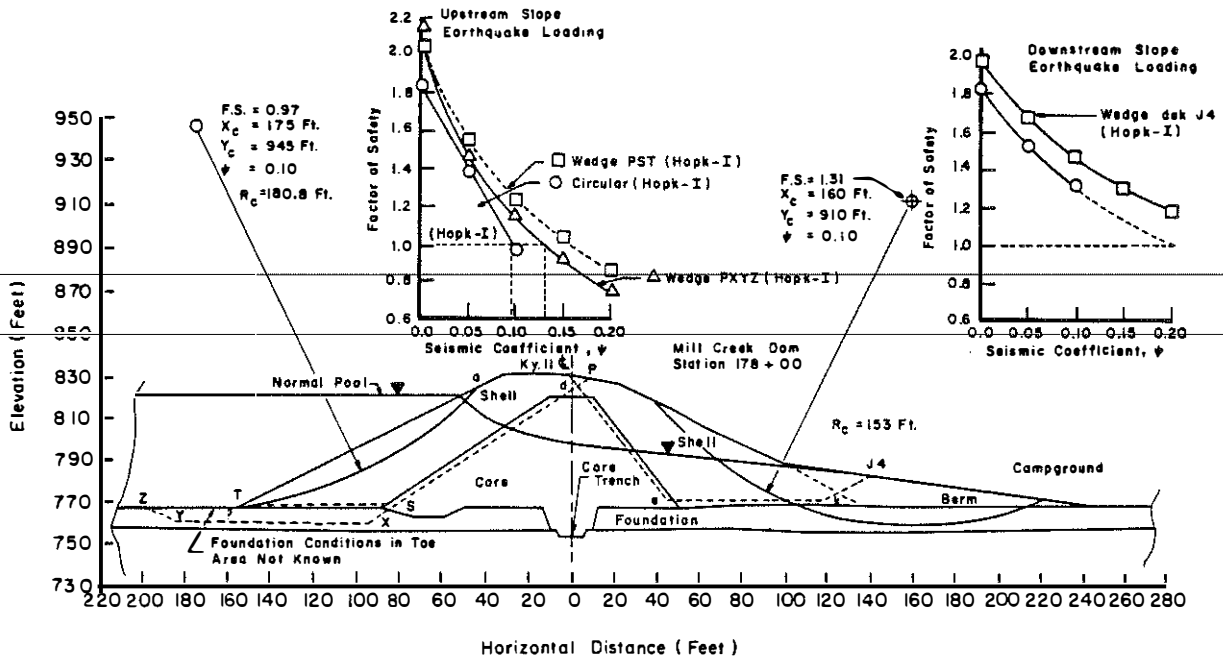
Figure 19. Stability Analyses of Upstream and Downstream Slopes of Mill Creek Dam, Assuming Various Earthquake Loadings.

Factors of safety obtained from earthquake analyses, assuming a shear-type failure occurs, for the upstream and downstream slopes are summarized in Tables 6 and 7. Factors of safety obtained from those analyses are plotted as a function of seismic coefficient in Figure 19. Both wedge and circular failure configurations were investigated. Critical arcs corresponding to a seismic coefficient of 0.10 are shown in Figure 19. Various seismic coefficients were assumed. As shown in the upper left-hand plot in Figure 19, a factor of safety of 1.0 corresponds to a seismic coefficient of about 0.095. At a safety factor of 1.0, the seismic coefficient for the

downstream slope is greater than 0.15 and close (based on a projection of the curve) to about 0.20. Hence, for both slopes, the seismic coefficient is greater than 0.05 -- the seismic coefficient for Zone 1. Consequently, the dam could withstand fairly large earthquake forces with regard to a shear-type failure.

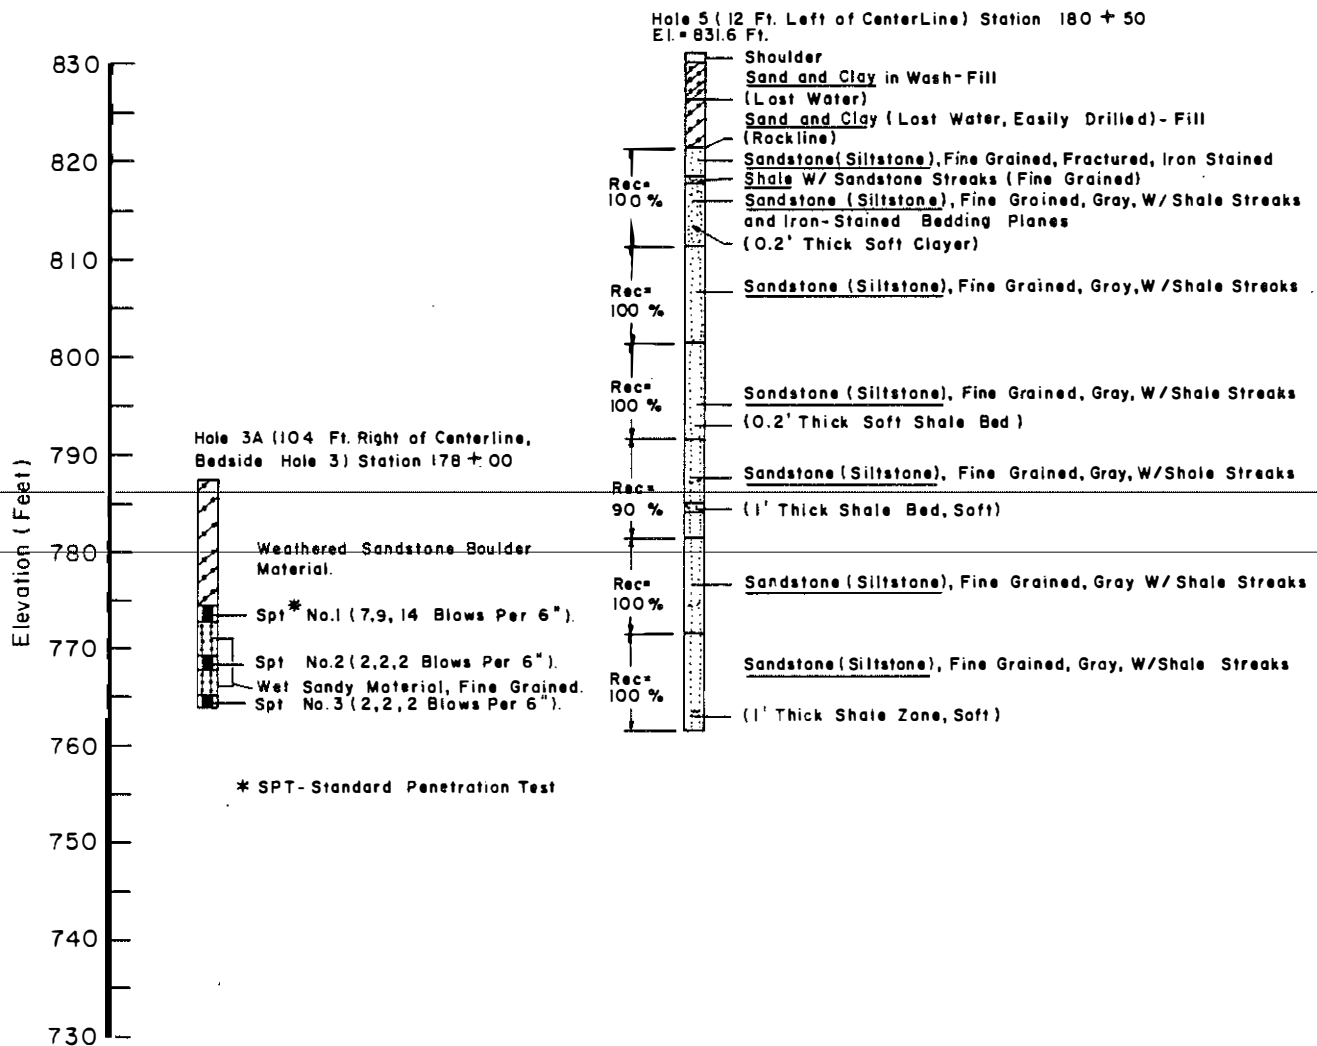
The material was composed mainly of sand- and silt-size particles. The material is apparently alluvium. Values obtained from the standard penetration tests were very low, on the order of 4, as shown in Figure A.3 of APPENDIX A. Based on those low values, the sandy material was in a loose state.
