Research Report UKTRP-83-1

SANDSTONE AS A CONSTRUCTION MATERIAL KY 80, Hazard to Watergap

Kentucky Transportation Research Program University of Kentucky

January 1983

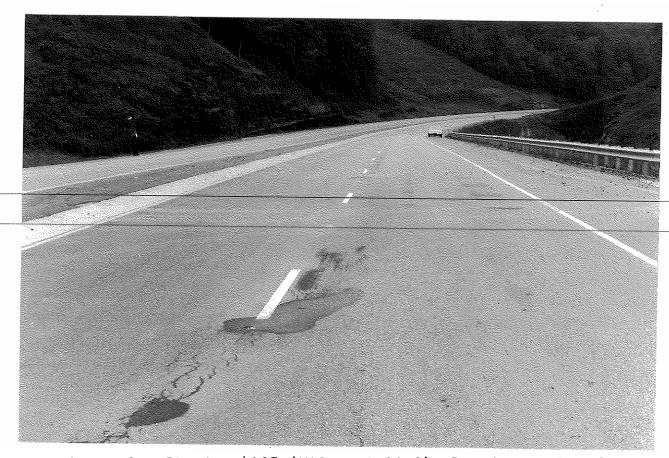
Figures 2 through 4 illustrate typical areas of distress that have been observed. There are a number of sites where water persistently emerges. For the most part, those sites occur slightly downgrade from cuts. It appears, therefore, that groundwater from cuts develop piping to the surface. The design of the raised median surrounded by concrete lip curbs provides opportunities for infiltration of surface water and a capacity for storage and facilitates the movement of water into embankments.

Figure 2. Station 4195 (Milepost 10.2), Looking Eastward; September 22, 1982.

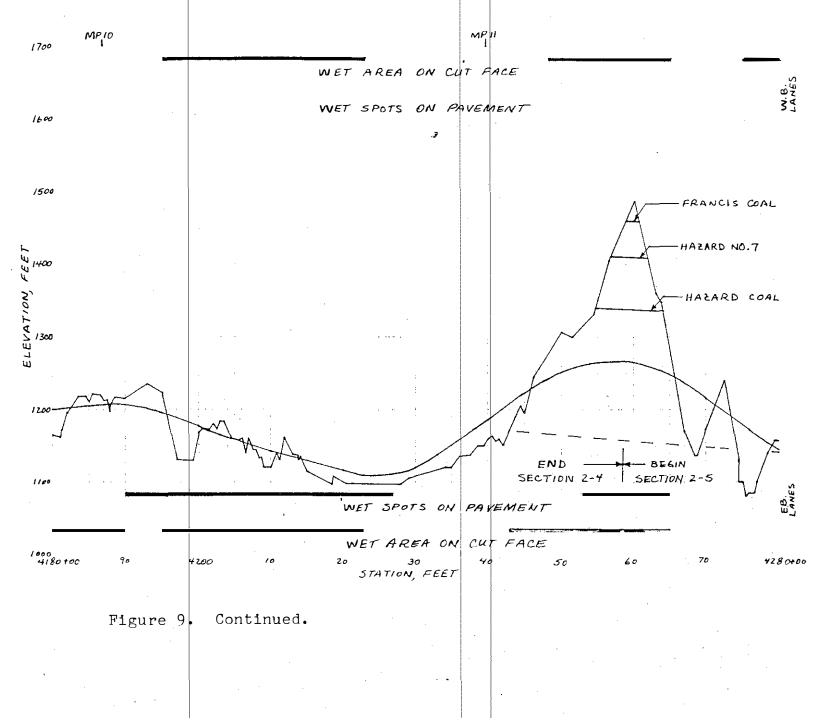
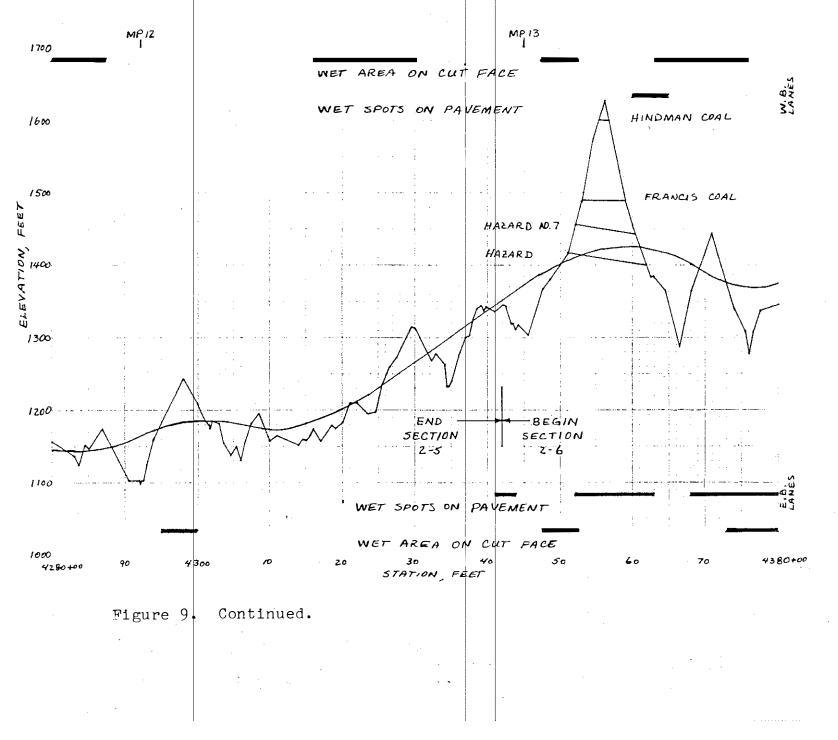
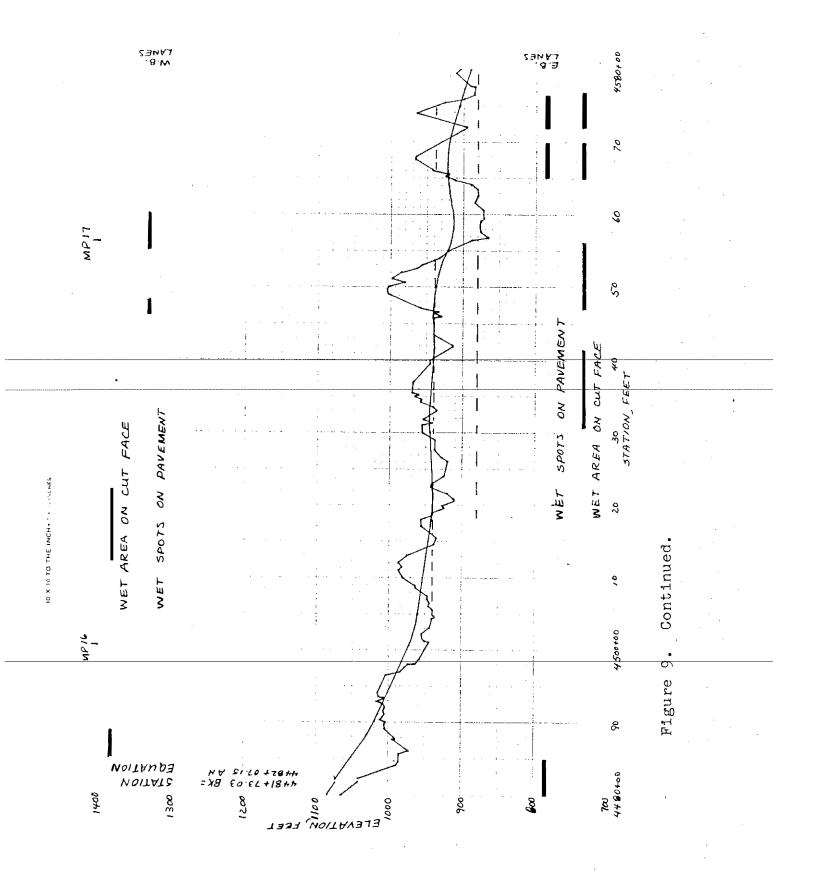
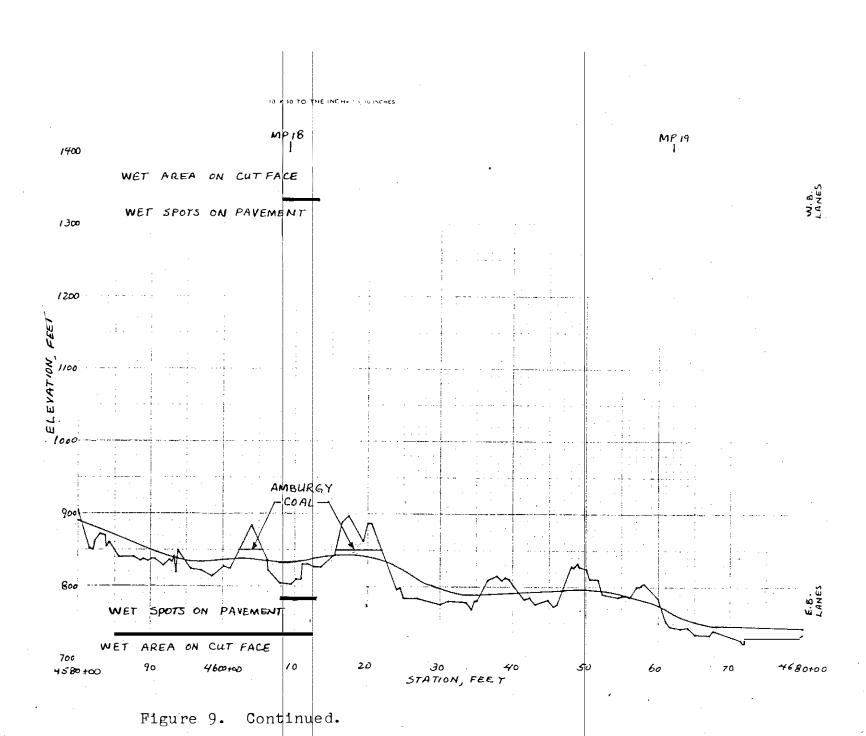
Figure 9. Association of Seepages with Geological Stratification and Outcroppings.

A strip chart (Figure 9) was prepared to show the profile of the pavement in relation to the geologic profile along the centerline. At the top of the strip chart are the approximate mileposts. The next lower line locates the seepage zones on the north cut faces. The next line down locates areas of wet pavement in the westbound lanes. The center of the chart is the profile. The line below the profile shows areas of wet pavement in the eastbound lanes, and the next lower line locates water seepage areas on the south face. The bottom line locates the data by station.

During an inspection of KY 80 after a rainy period, locations of water seepage were recorded and located by milepost. Every wet area observed could be associated with those coal seams.

Because plastic underclays will not permit groundwater to drain vertically, the water must move laterally through the interbedded coals and shales. When a highway cuts through the bedding, the water outcrops and moves down the face of the cut and eventually into the ditches.
