RESEARCH REPORT
UKTRP-81-12

Evaluation of Watertight Bridge Expansion Joints

July 1981

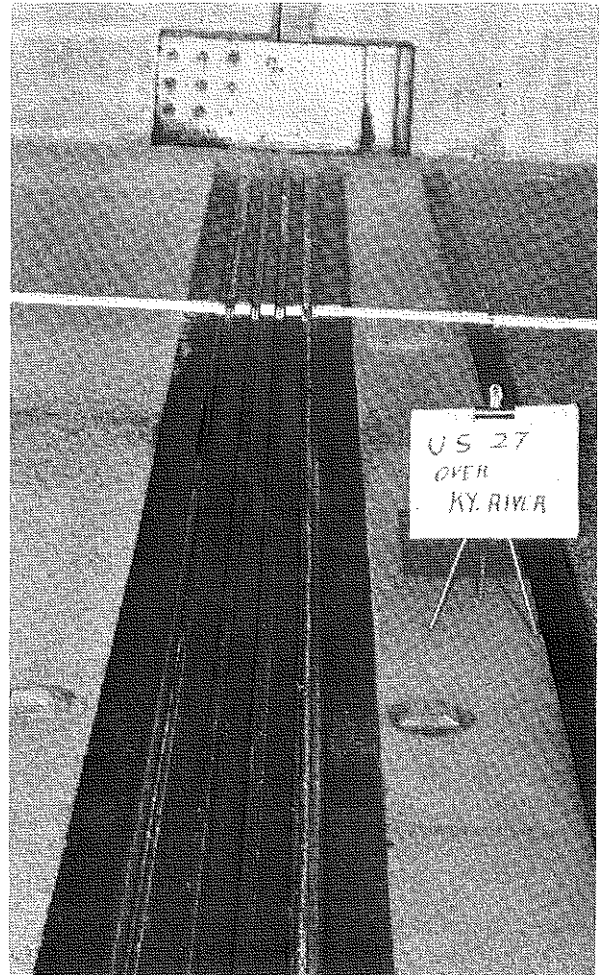
Comments: Joints are in excellent condition
Compression of modules is very even
No apparent vertical or horizontal misalignment of joint

Figure A1. Wabo-Maurer D1040; joint in excellent condition.

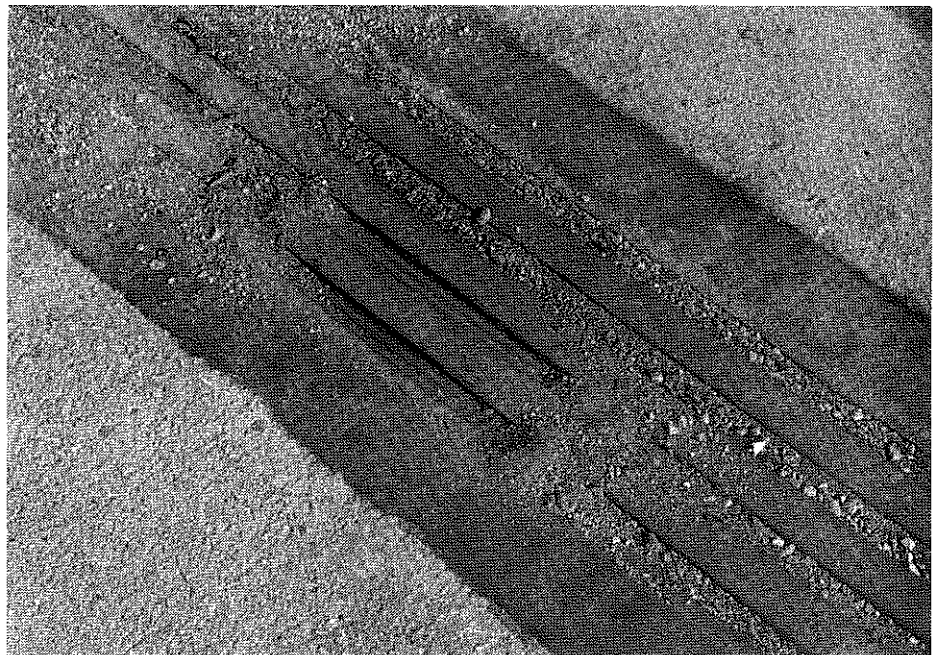
Figure A2. Wabo-Maurer D1040; debris in gutter area.

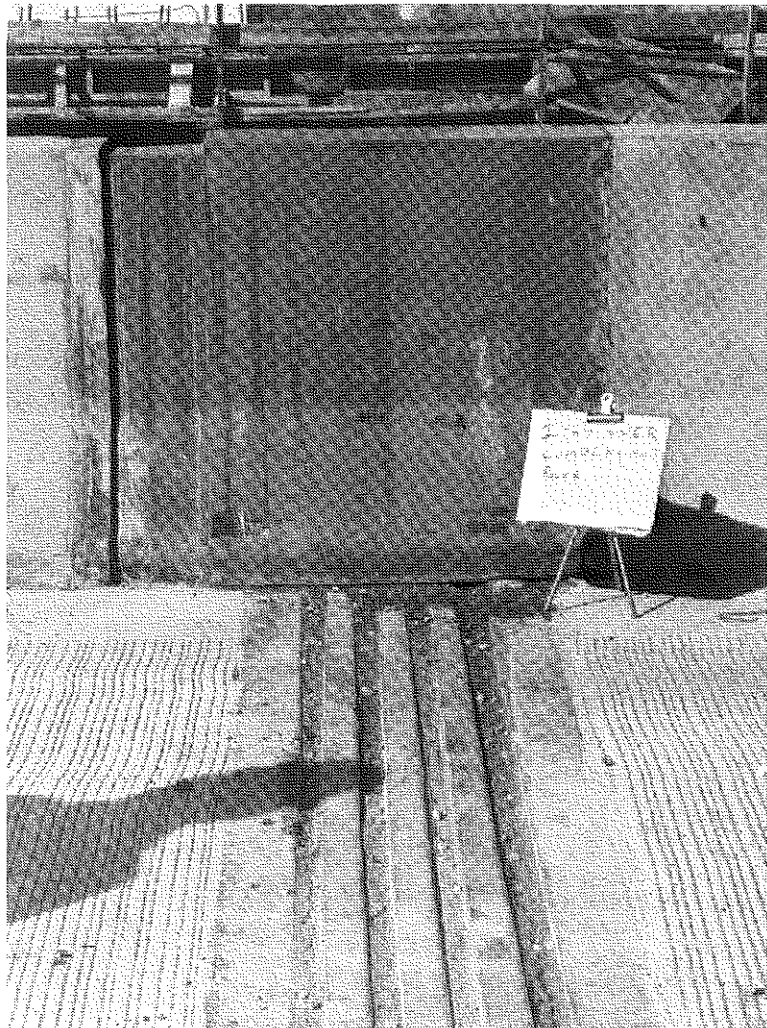
Joints in excellent condition

Figure A3. Acme Beta B1300; joint in excellent condition; note debris above neoprene seals.

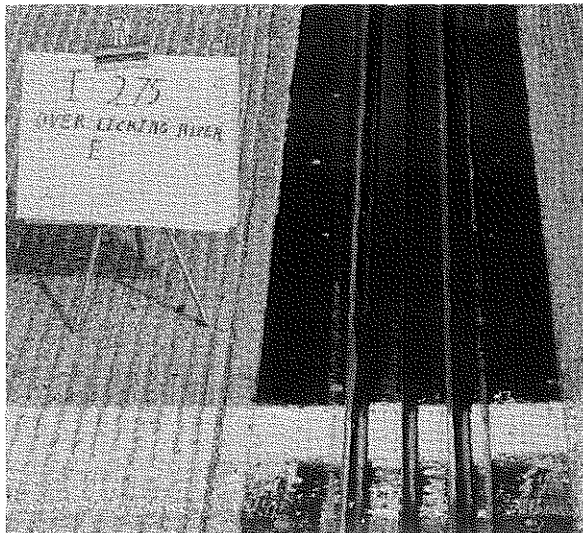
Figure A4. Acme, Acma Modular II 3M600; joint in excellent condition; note irregularity in neoprene seal.

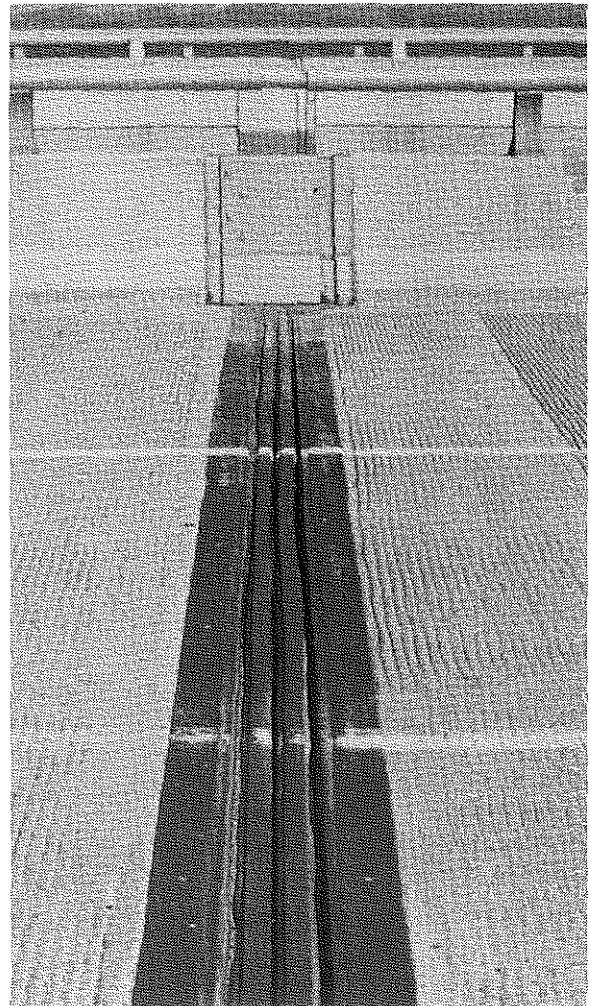
Joint Leaking: Piers beneath joints stained -- evidence of leaking
Distress around Joint: None

Comments: Uneven compression of modules evident
Some horizontal misalignment of channels

Figure A5. Acme, Acma Modular II 3M600; note uneven compression of neoprene seals and horizontal misalignment of seals and support bars.

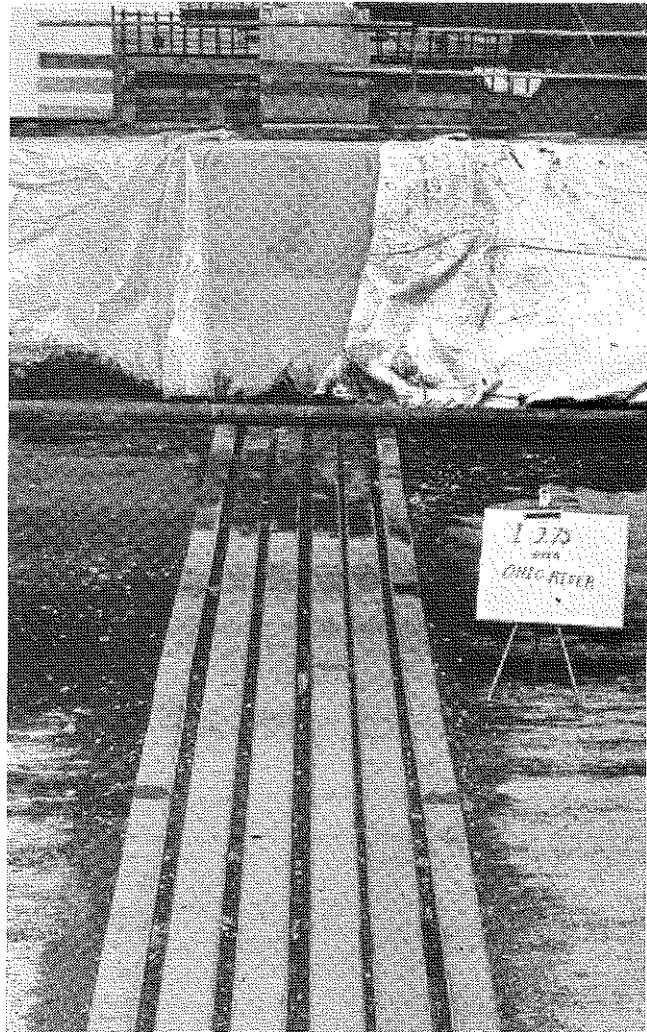
Figure A6. Wabo-Maurer D1300; note uneven compression of seals.

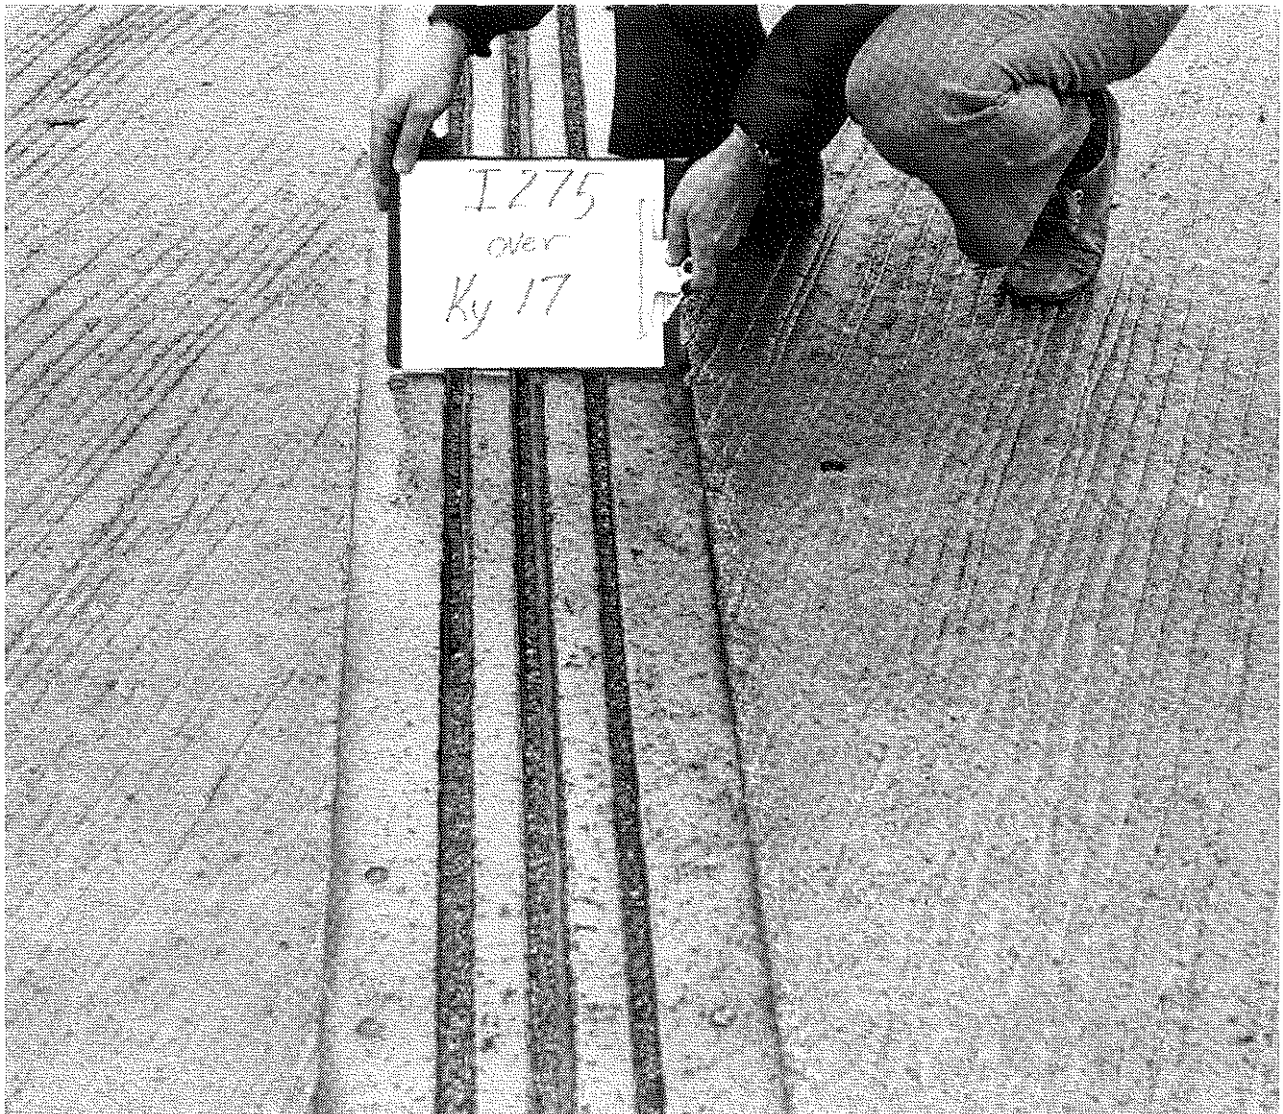
Figure A7. Acme, Acma Modular II 3M600; note debris above seals.

Joint Leaking: Stains on piers indicate leaking

Modules twisting in place, steel channels possibly rotating under traffic

Modules cut where turned up into barrier walls

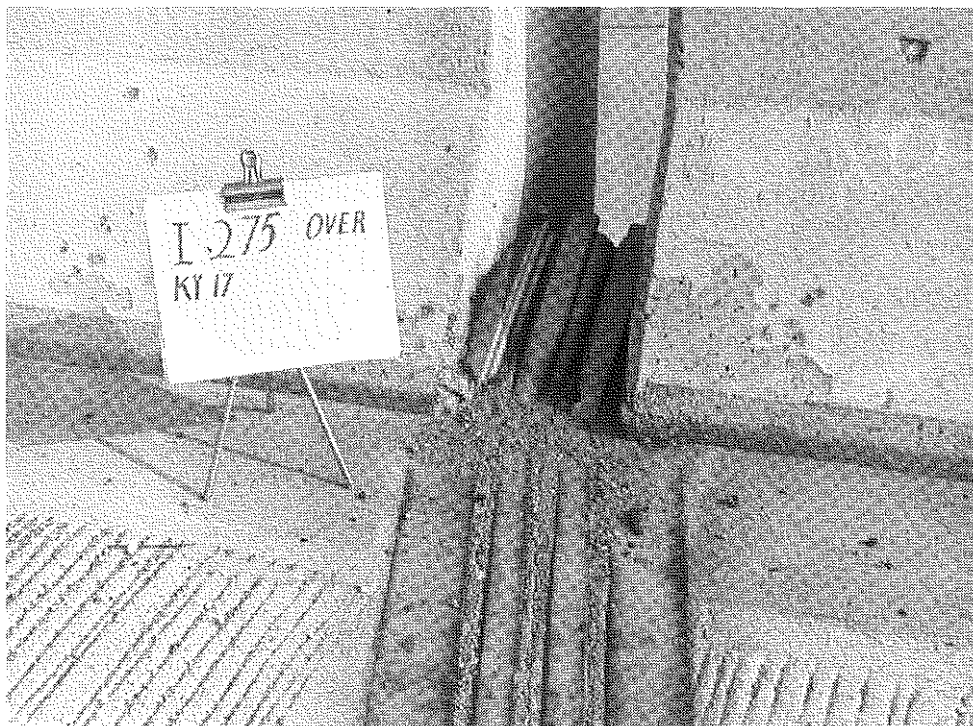
Figure A8. Acme, Acma Modular II 3M600; note debris in gutter area.

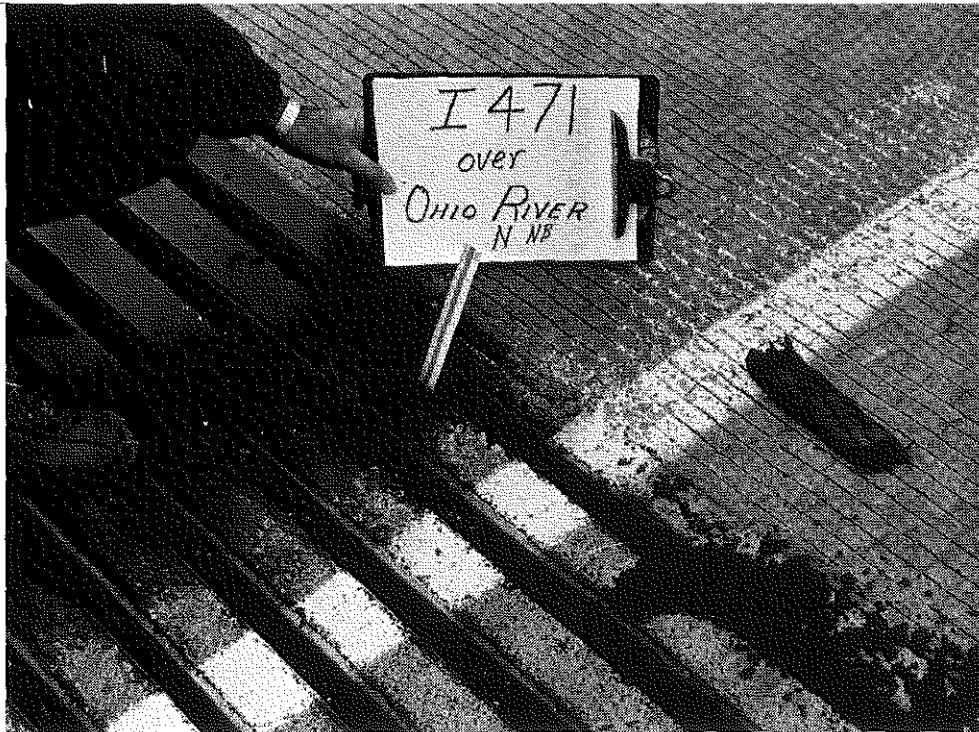
Figure A9. Wabo-Maurer D1560; note cavity above seal and pavement surface and accumulation of debris.

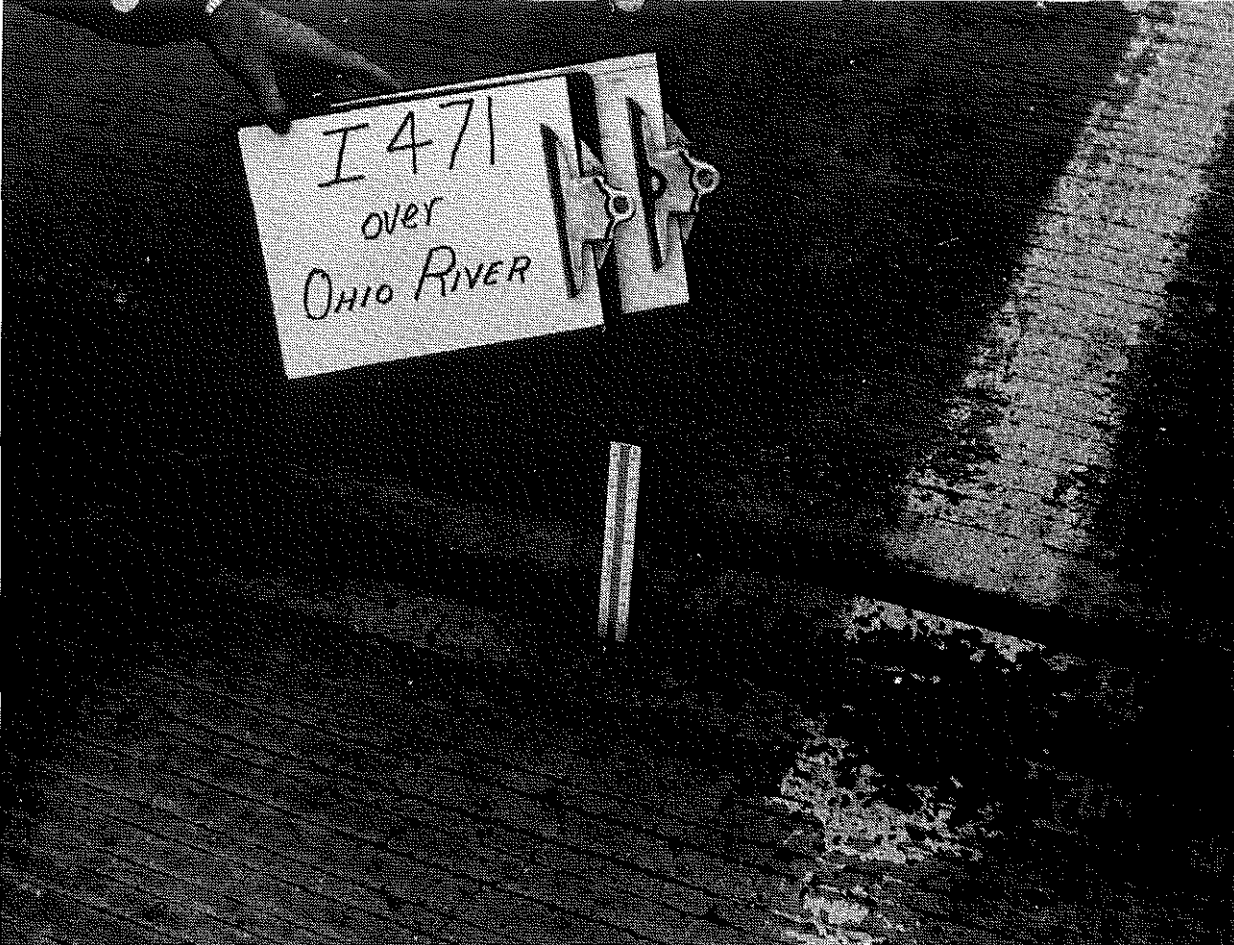
Comments: Compression of modules uneven

Water present in the interior of compression module evidence that the module has been punctured or water is infiltrating from the end of the module

Figure A10. Wabo-Maurer D520; note debris above seal which is depressed below pavement surface.

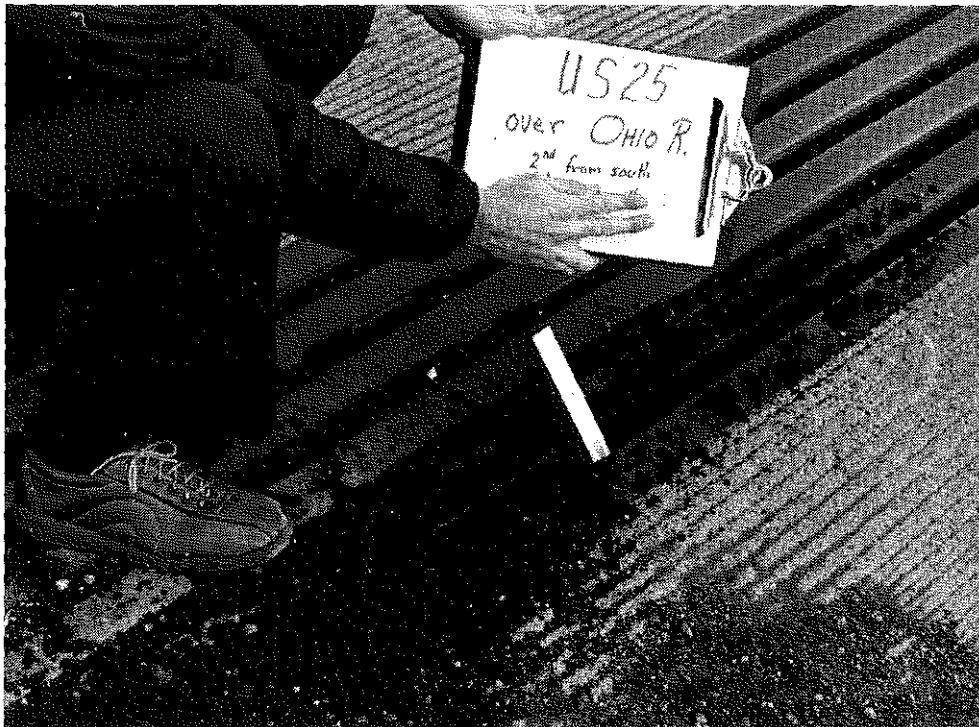
Figure A11. Wabo-Maurer D1300; note debris above seal which is depressed below the pavement surface.

Joint Leaking: No apparent leaking -- end of joint showing signs of weathering (i.e, rust)

Comments: Neoprene approximately 2 in. (51 mm) below surface
Compression of modules uneven

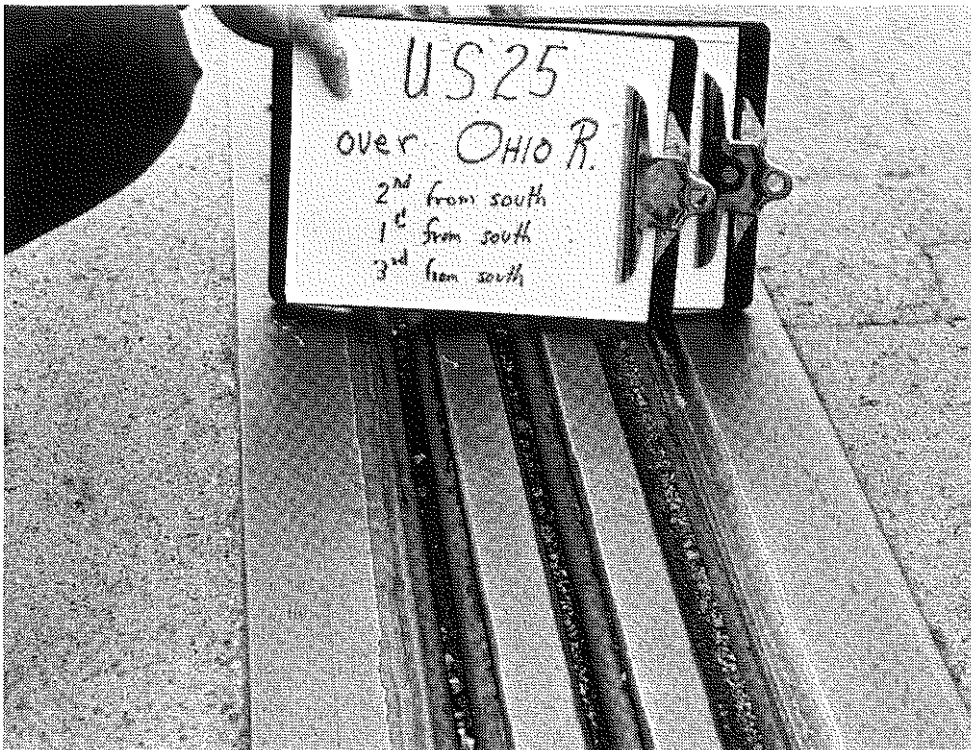
produce some noise and ride discomfort. Uneven compression of the neoprene modules is also evident. No distress in the concrete attributable to joint performance, and no leakage has been detected with this joint type. The D780 is providing satisfactory performance.

Figure A12. Wabo-Maurer D780; accumulation of debris above the seals.

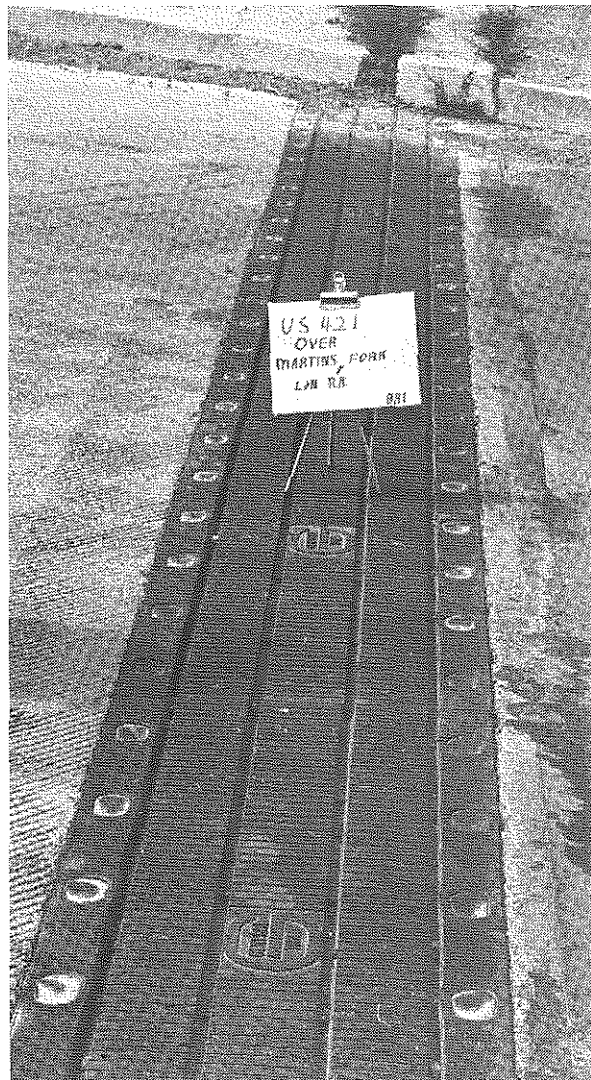
Comments: Joints in very good condition
Some blemishes or tears in rubber

Figure A13. Transflex 650; joint in excellent condition.

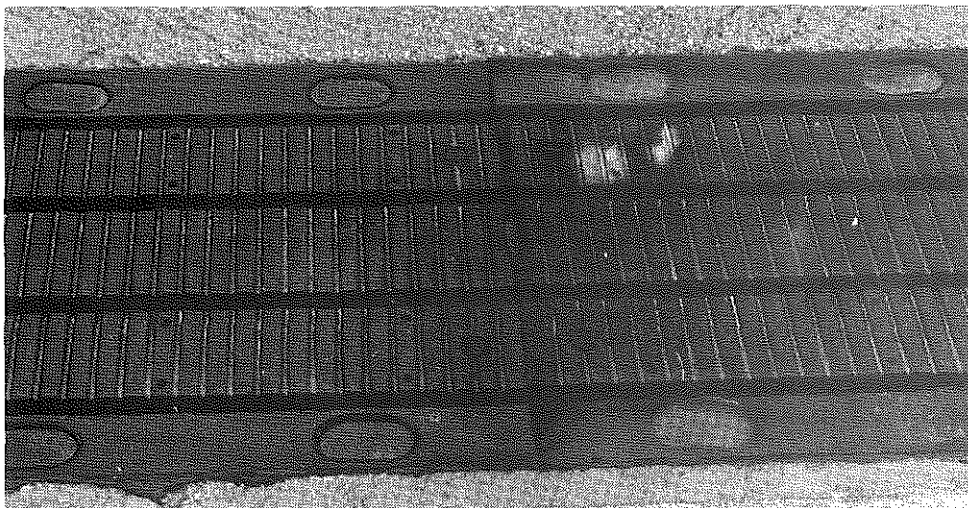
Figure A14. Transflex 650; abutted sections, US 421 over Martins Fork.

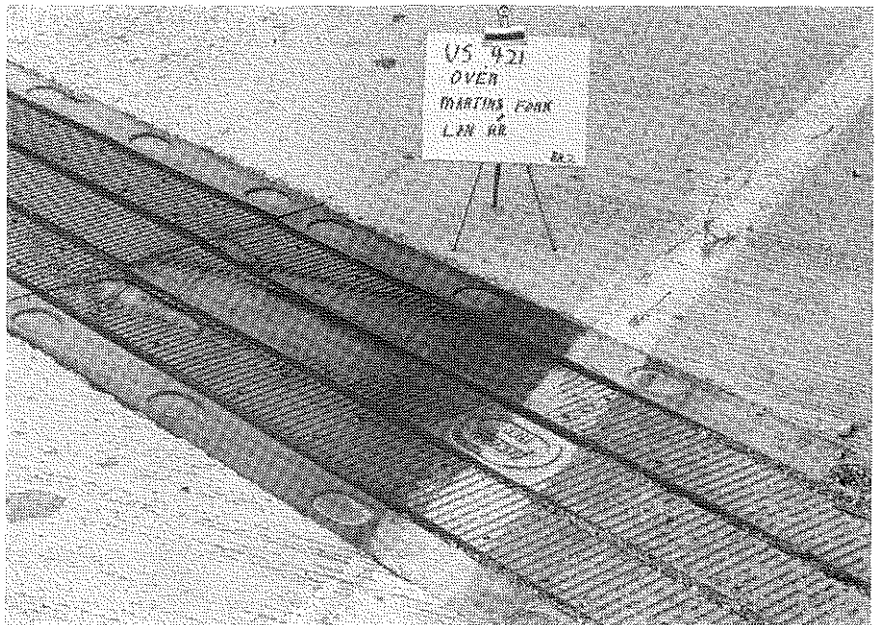
Comments: Joints in very good condition
Some blemishes in rubber

Figure A15. Transflex 650; note blemishes in the surface of the joint.

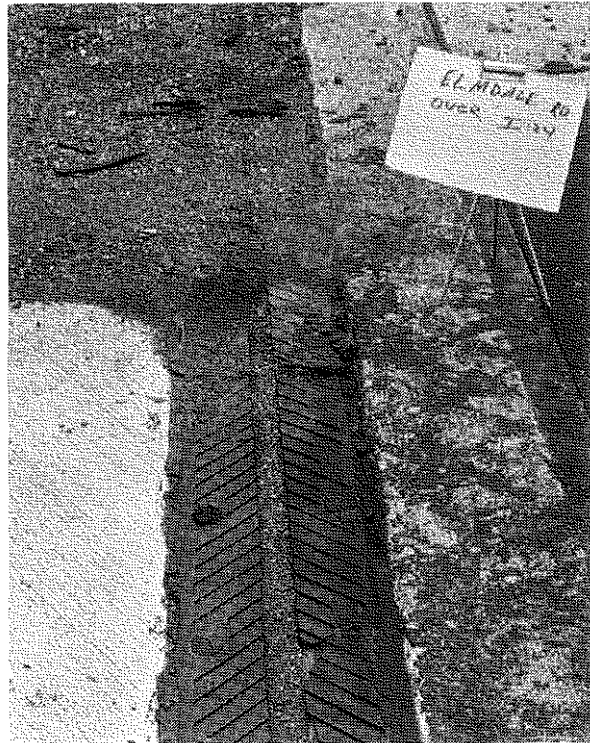
Sealant between joint and concrete wearing, i.e., not functioning properly -- sealant is brittle and is pulling from surface

Figure A16. Fel Span T20; note edge sealant and deterioration of the hole plugs.

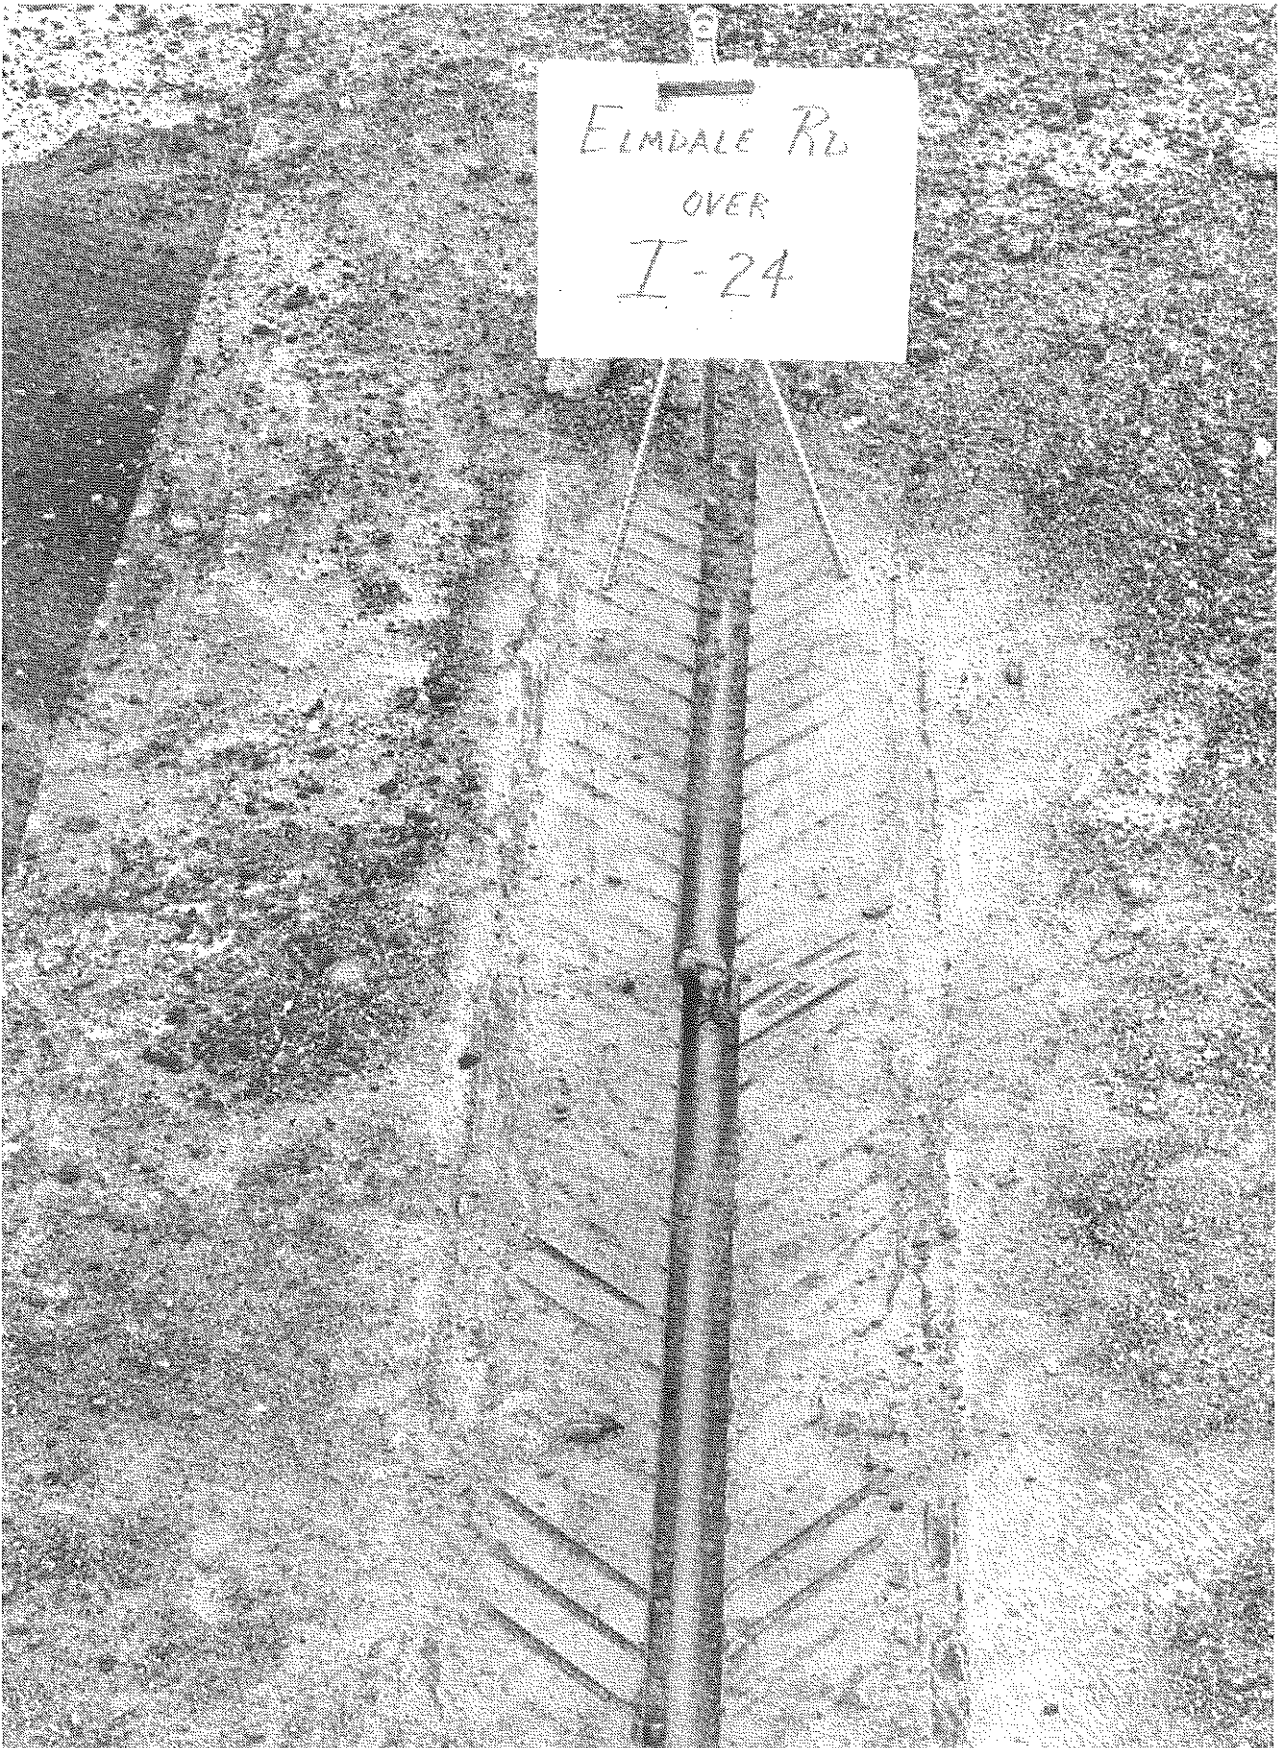
Figure A17. Fel Span T20; abutted sections.

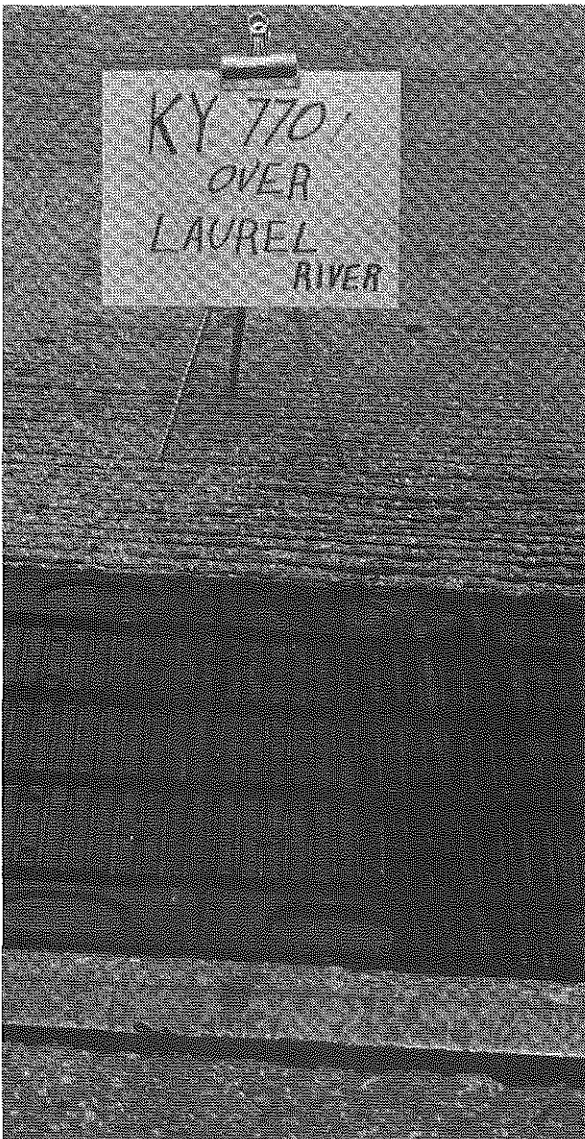
Figure A18. Transflex 650; abutted section.

Joint Leaking: Stains on abutments indicate leakage --
possibly leaking is joint sealant

Leaks could possibly occur where sections
are put together

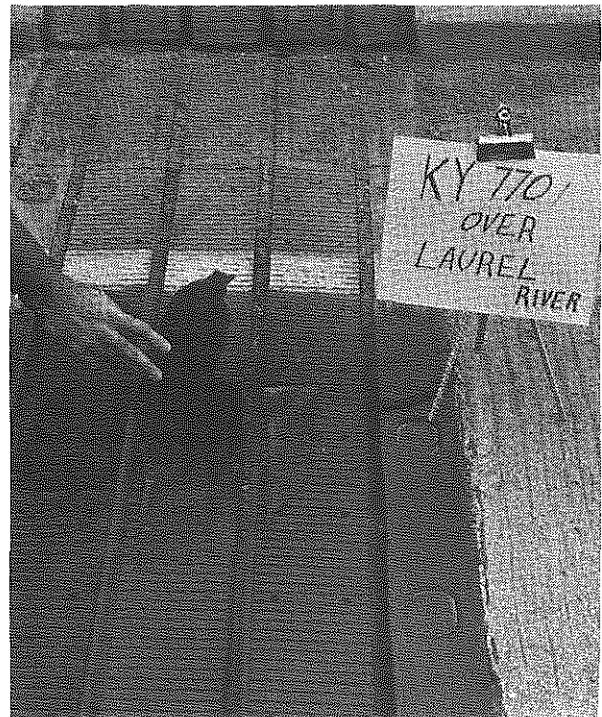
Comments: Some tears noted in rubber

Joints appear in good condition except for
tears noted in rubber

Figure A19. Transflex 650; note tears in the surface of the joint.

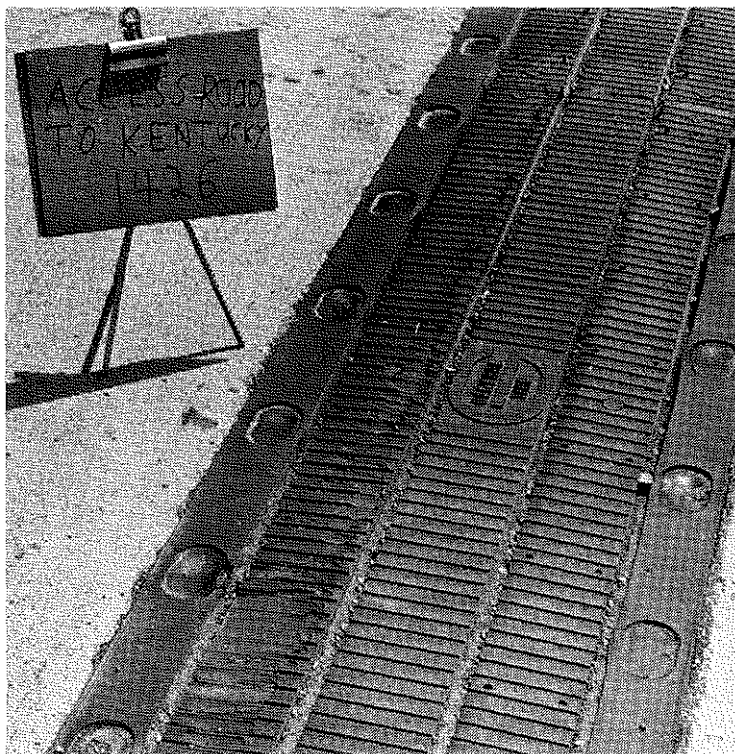
Comments: Sections show signs of wear
Some tears noted
Plug covers becoming loose,
coming out, and tearing

Figure A20. Transflex 400A; note blemishes in the surface of the joint.

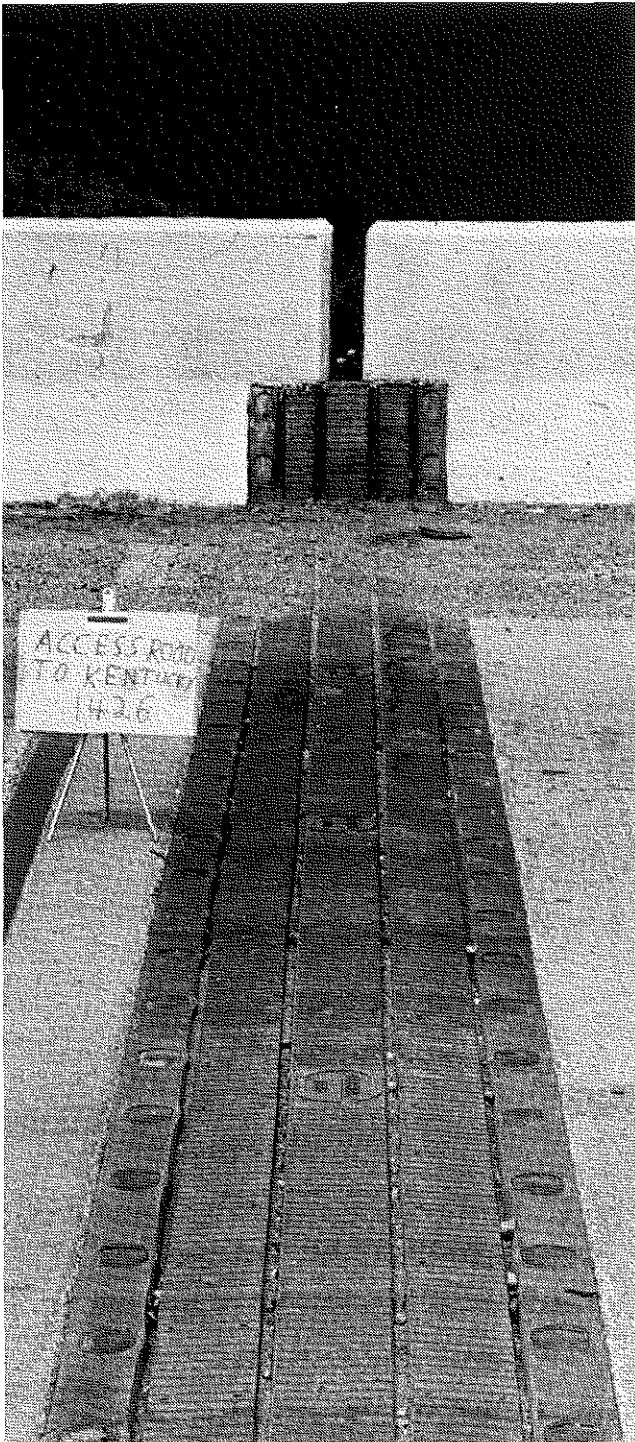
Figure A21. Transflex 400A; note accumulation of debris and initial deterioration of the hole plugs.

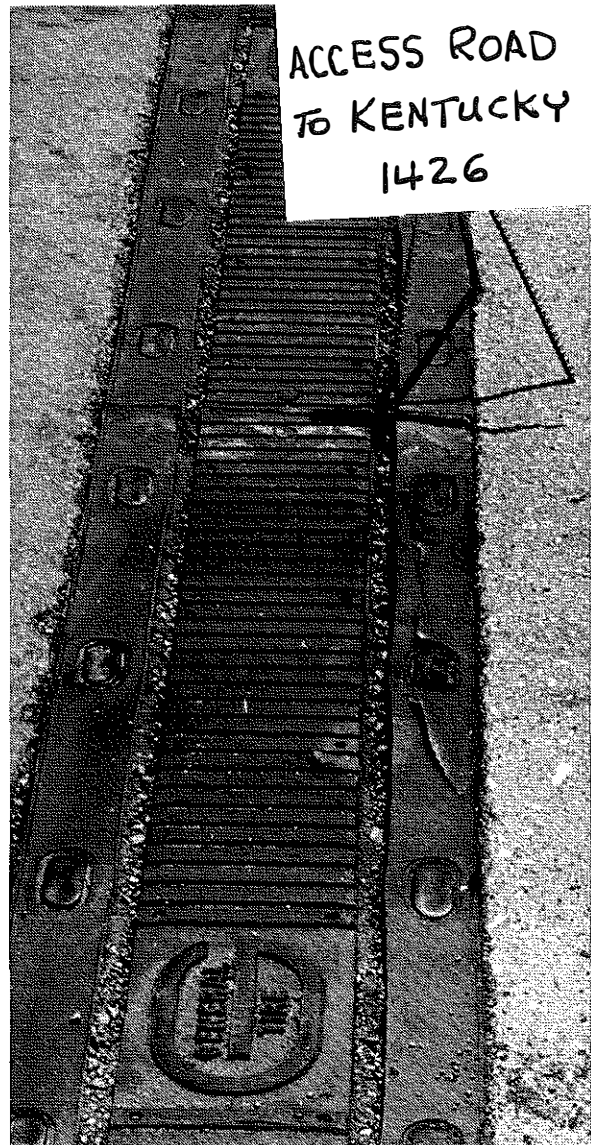
Figure A22. Transflex 250; note tears in the surface of the joint.

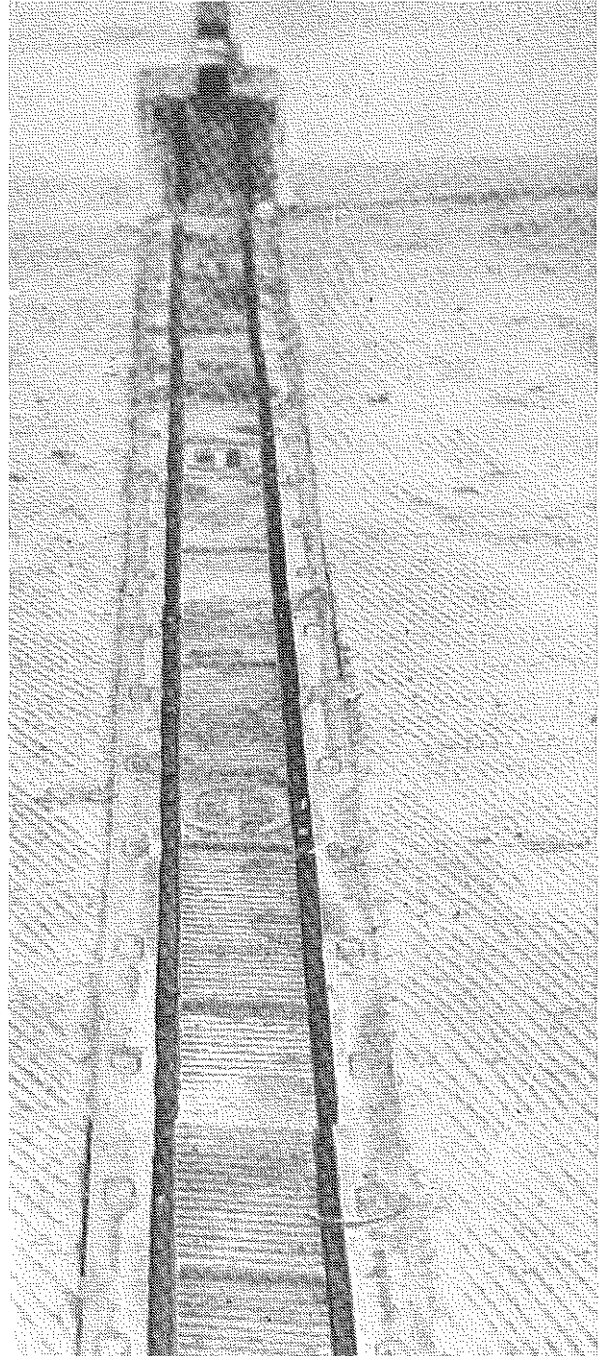
Figure A23. Transflex 200A; note loss of edge sealant and horizontal misalignment.

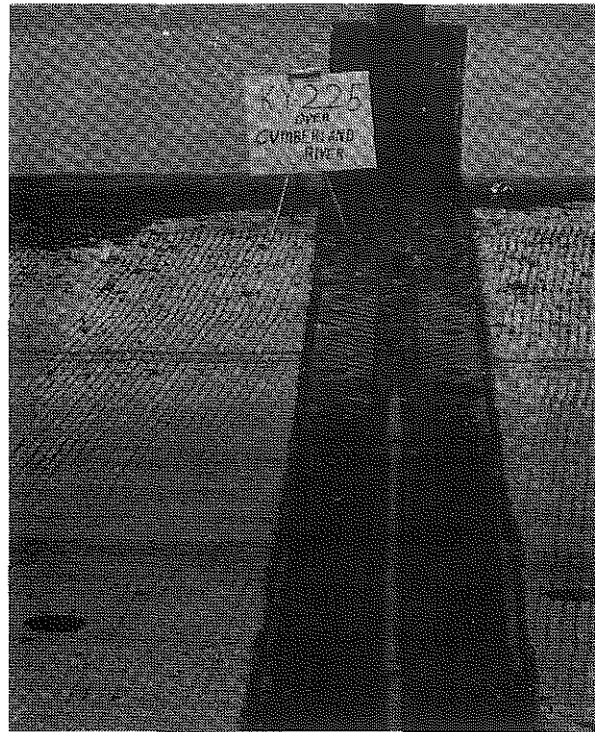
Comments: Plugs covering bolts are loose or missing
Joint approximately 3/8 in. (10 mm) lower
than deck

Figure A24. Fel Span T40; note deterioration of the hole plugs and accumulation of debris in the gutter area.

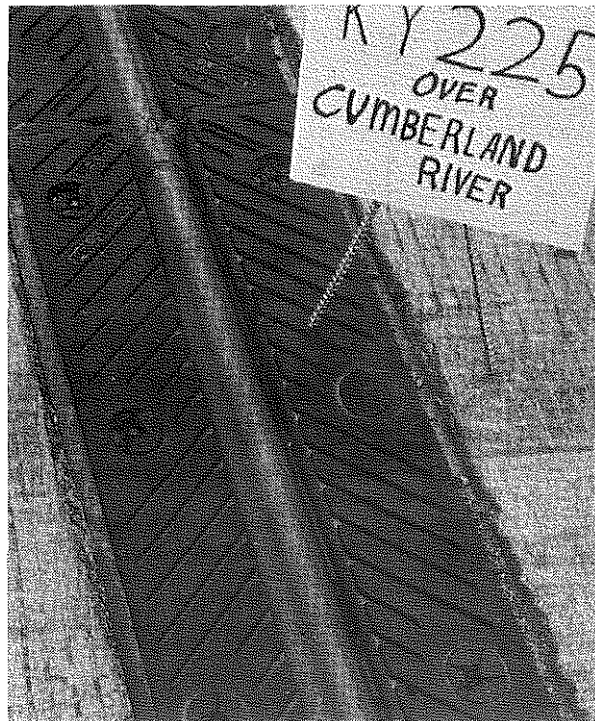
Figure A25. Fel Span T40; note deterioration of the hole plugs.

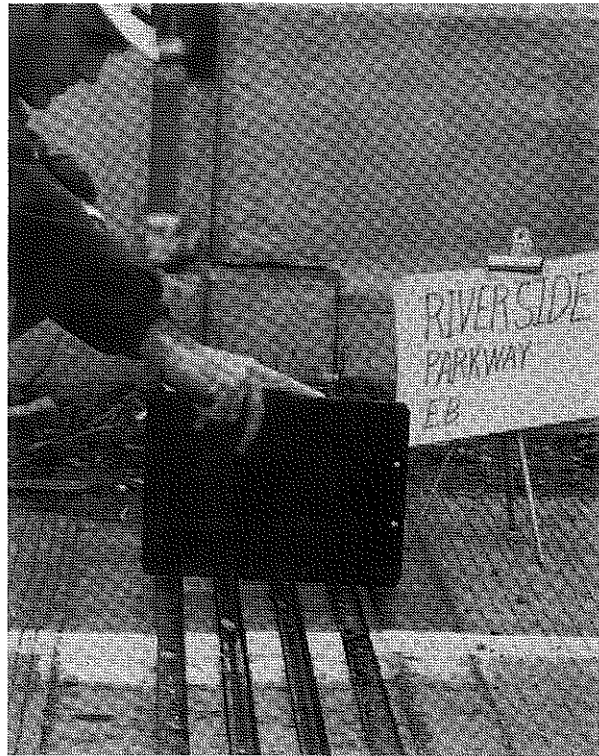
Several joints loud under traffic as a result of
steel channels moving under traffic and plates
becoming loose.

Vertical misalignment between channels
noted on several joints.

Figure A26. Wabo-Maurer D1040; note vertical misalign-
ment across the joint.

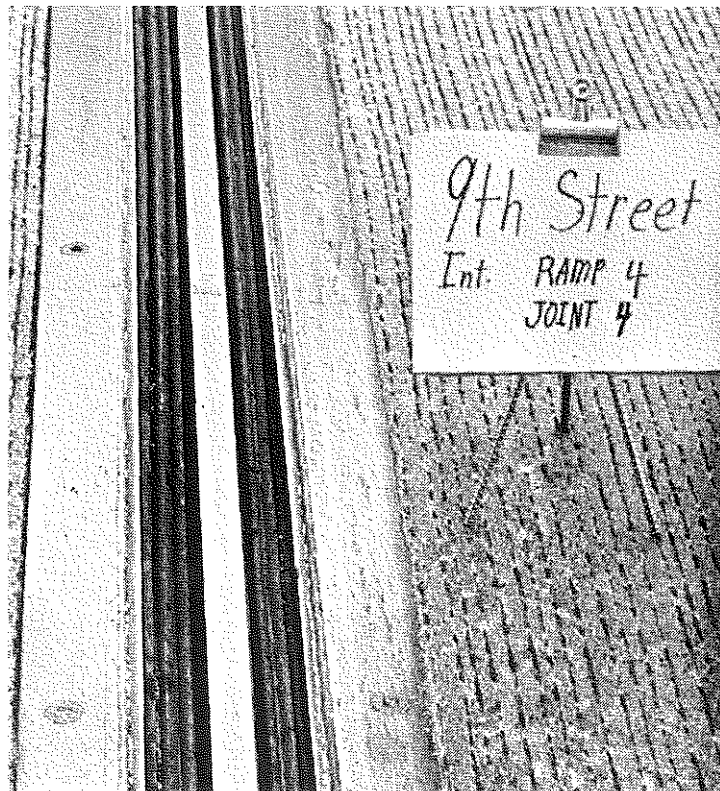
Figure A27. Wabo-Maurer D520; joint in excellent condition.

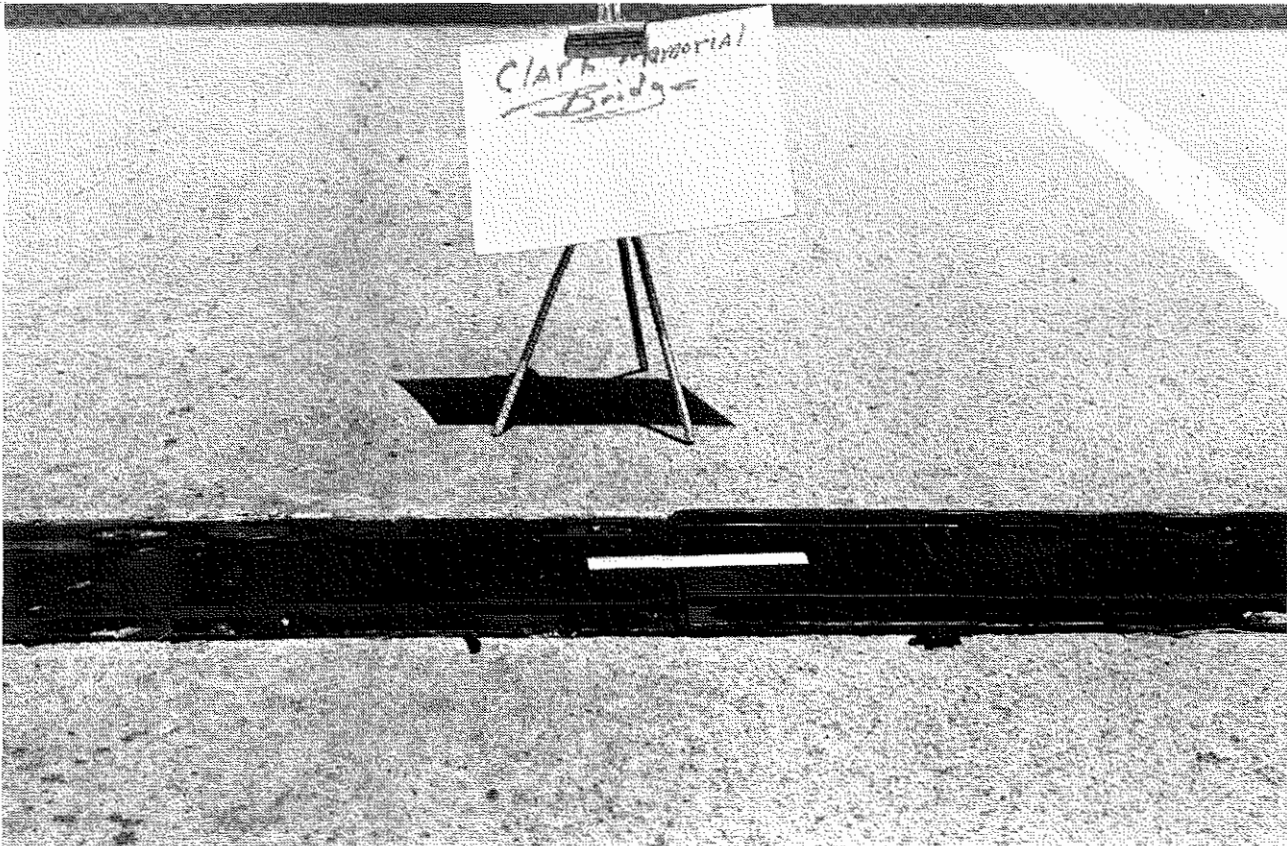
Figure A28. Transflex 200A; note vertical misalignment of the abutted sections, loss of edge sealant, and loss of the hole plugs.

Transflex 200A -- loss of plug covers, sections of joint not properly installed, edges have little or no sealant, intrusion of debris and water, leakage severe due to poor joint and pavement performance, sections misaligned both vertically and horizontally, partial sections missing

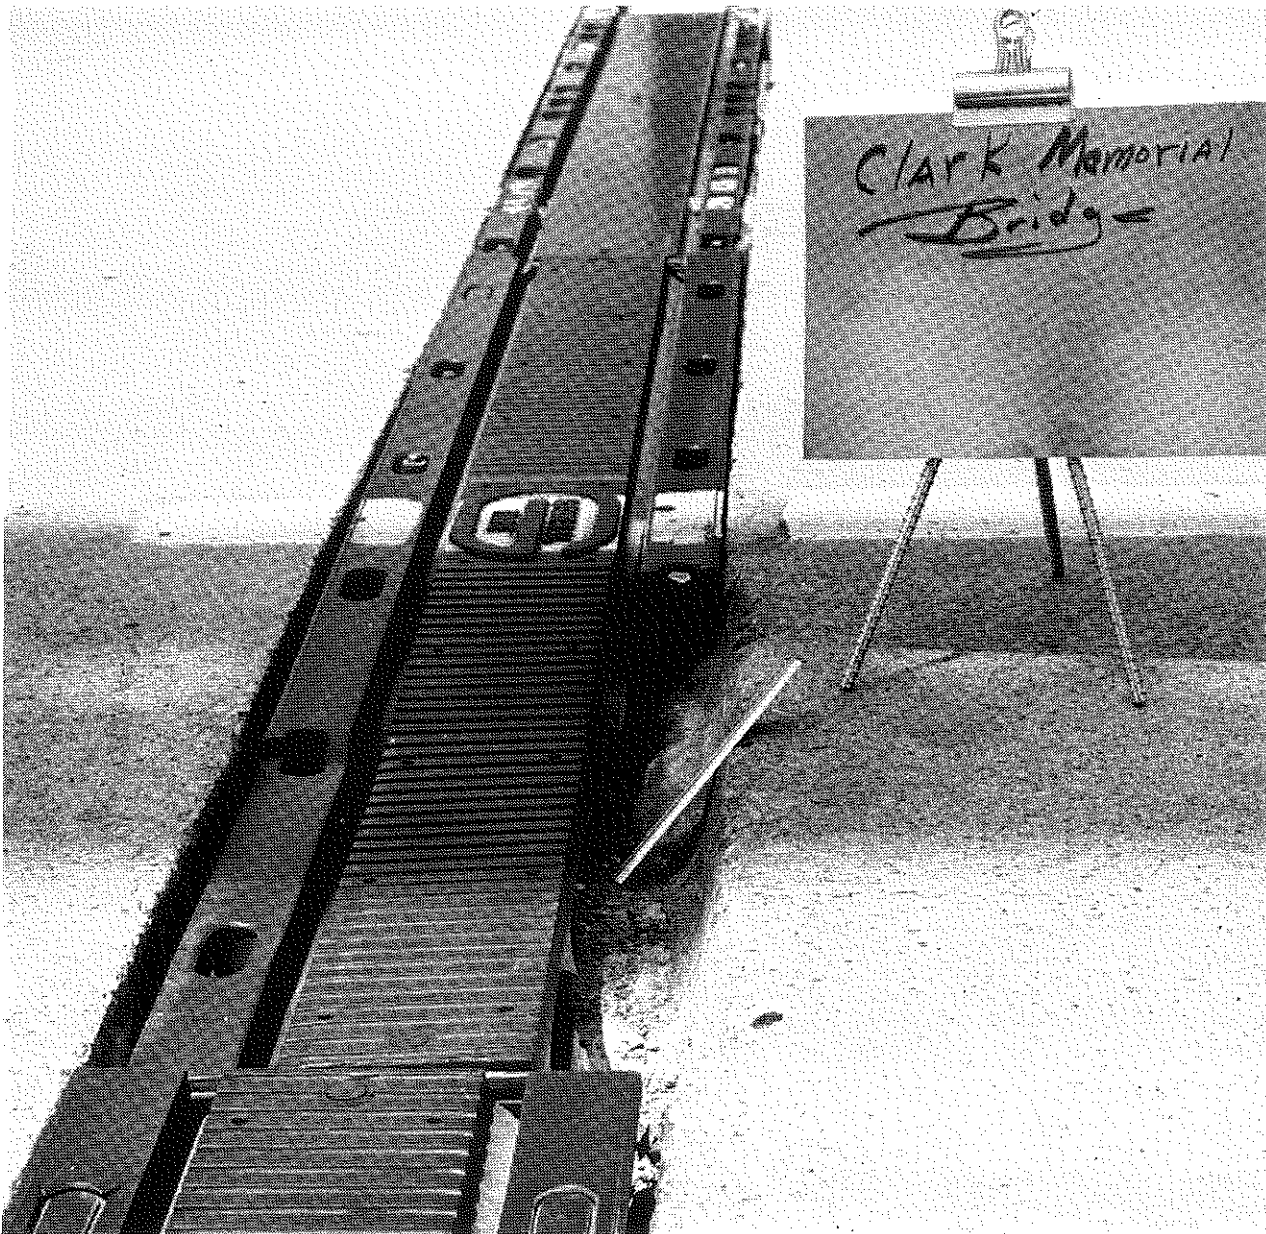
Joint Leaking: All joints -- due to distress and lack of sealant

Distress around Joint: Severe

Figure A29. Transflex 200A; total deterioration of the joint.
