RESEARCH REPORT
UKTRP-81-12

Evaluation of Watertight Bridge Expansion Joints

July 1981

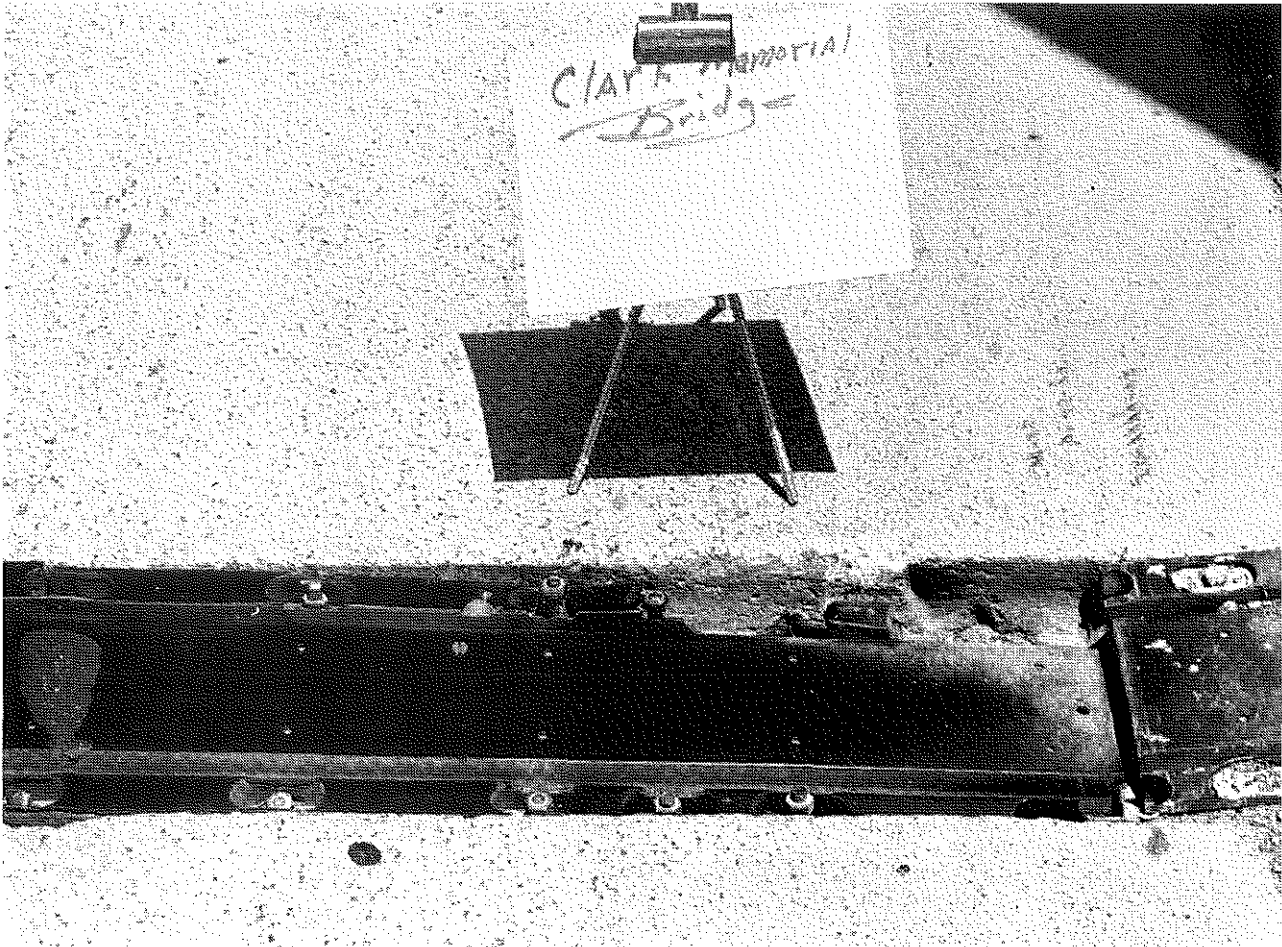
Figure A30. Transflex 200A; total deterioration of the joint.

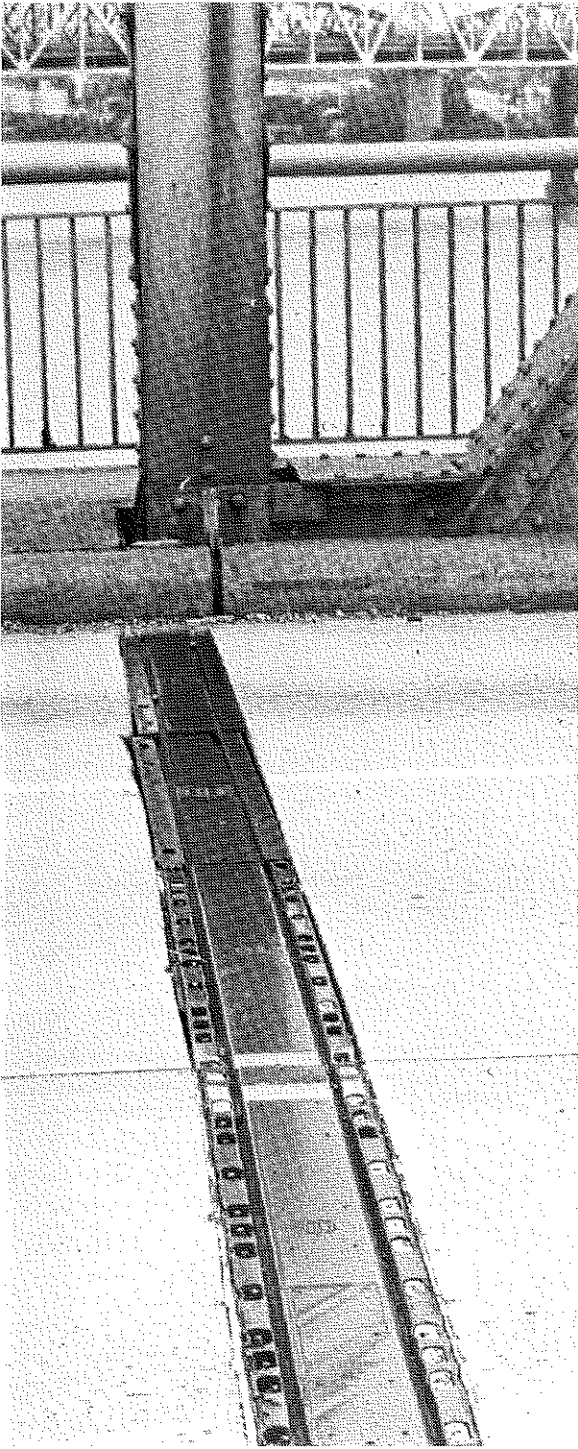
Figure A31. Transflex 200A; misalignment of the abutted sections, loss of edge sealant, loss of the hole plugs, and poor construction of concrete blockout.

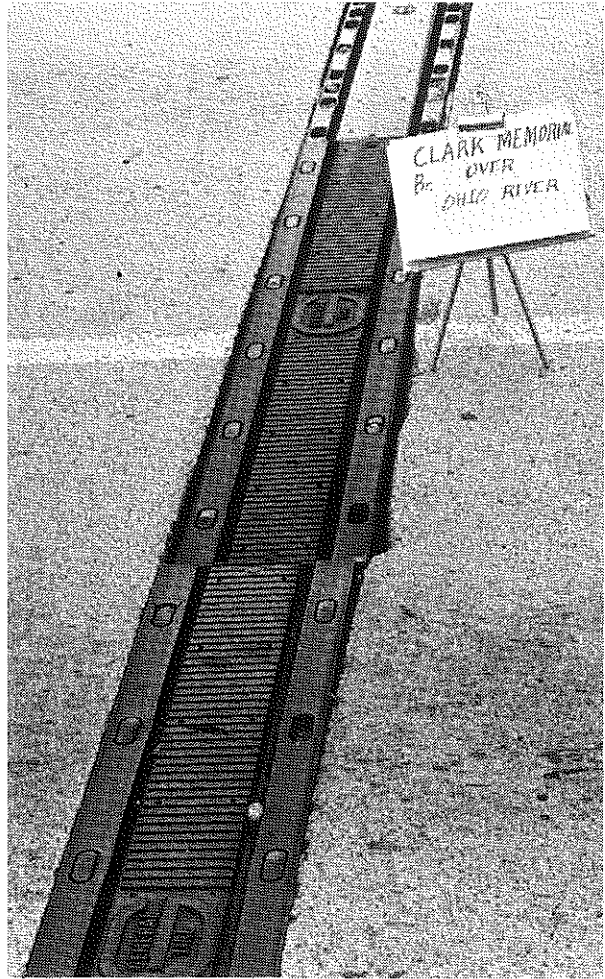
Figure A32. Transflex 200A; no edge sealant, loss of the hole plugs, and total deterioration of the joint.

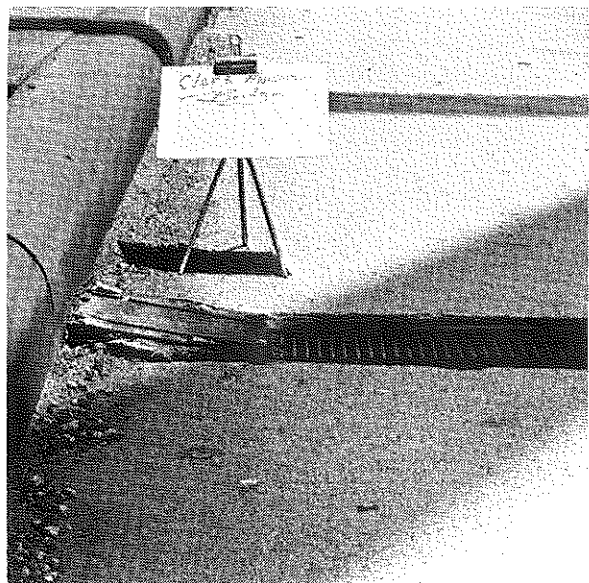
Figure A33. Transflex 200A; total deterioration of the joint.

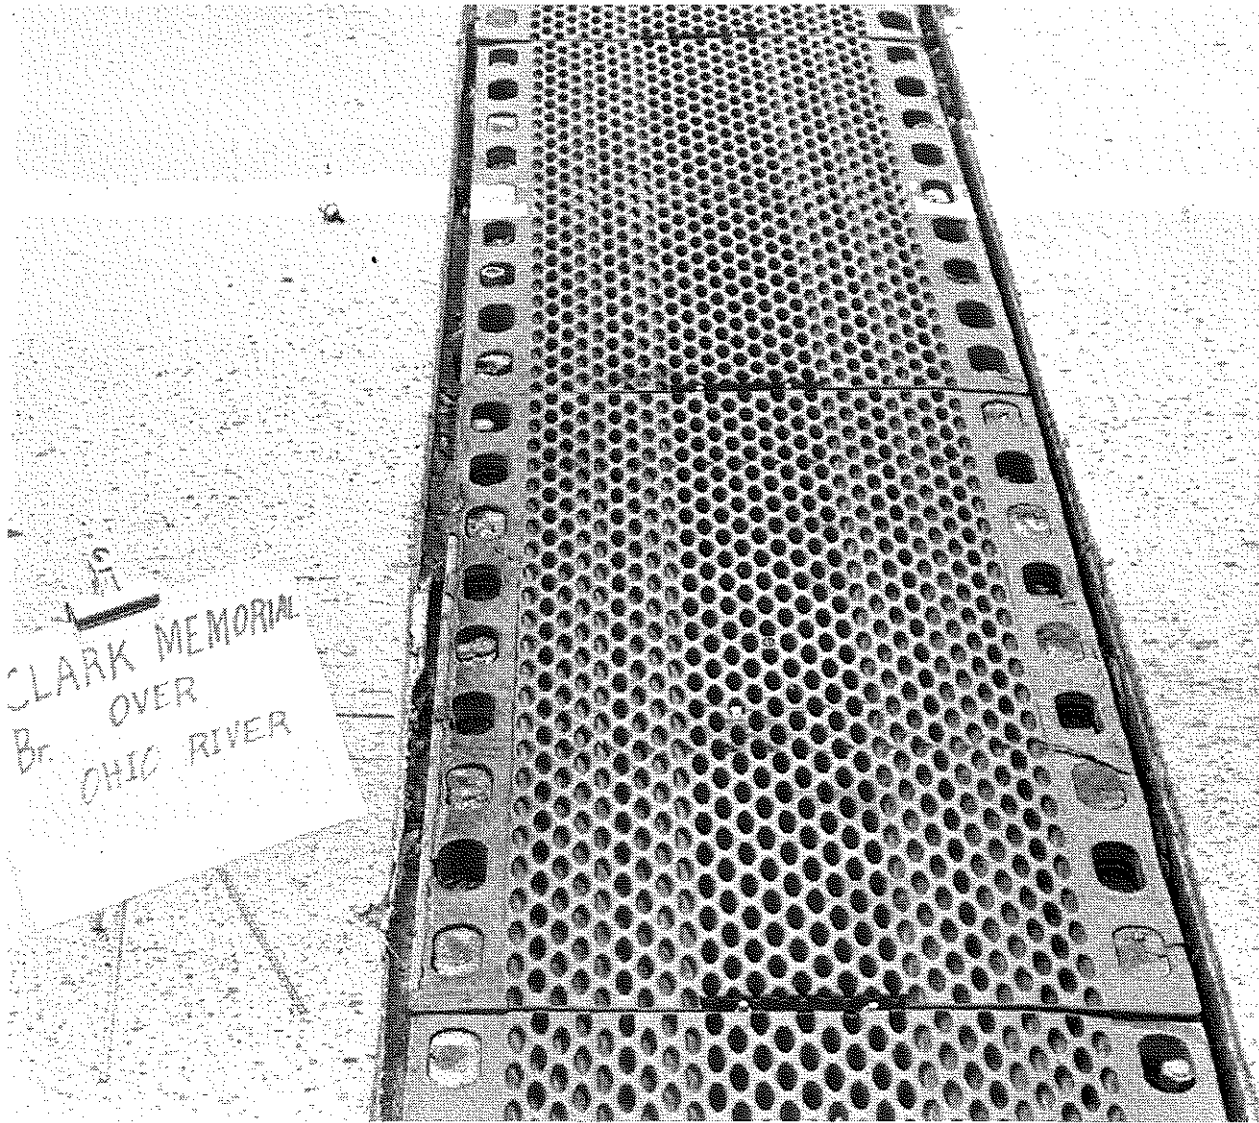
The two joints of this type have been in service 12 years on a heavily traveled urban facility. The open grid configuration becomes filled with all types of debris inhibiting the function of the joint. As with other Transflex models, the loss of hole plugs and edge sealant makes leaking inevitable.

Transflex 400 -- waffle design fills with debris, loss of plug covers, loss of joint sealant, deterioration around joints, leaking inevitable

Figure A34. Transflex 400; no edge sealant, no hole plugs, misalignment of the abutted sections, open grid system collects debris.
