Research Report
UKTRP-81-6

Ohio River Suspension Bridges: An Inspection Report

Theodore Hopwood II
Research Engineer Principal

June 1981

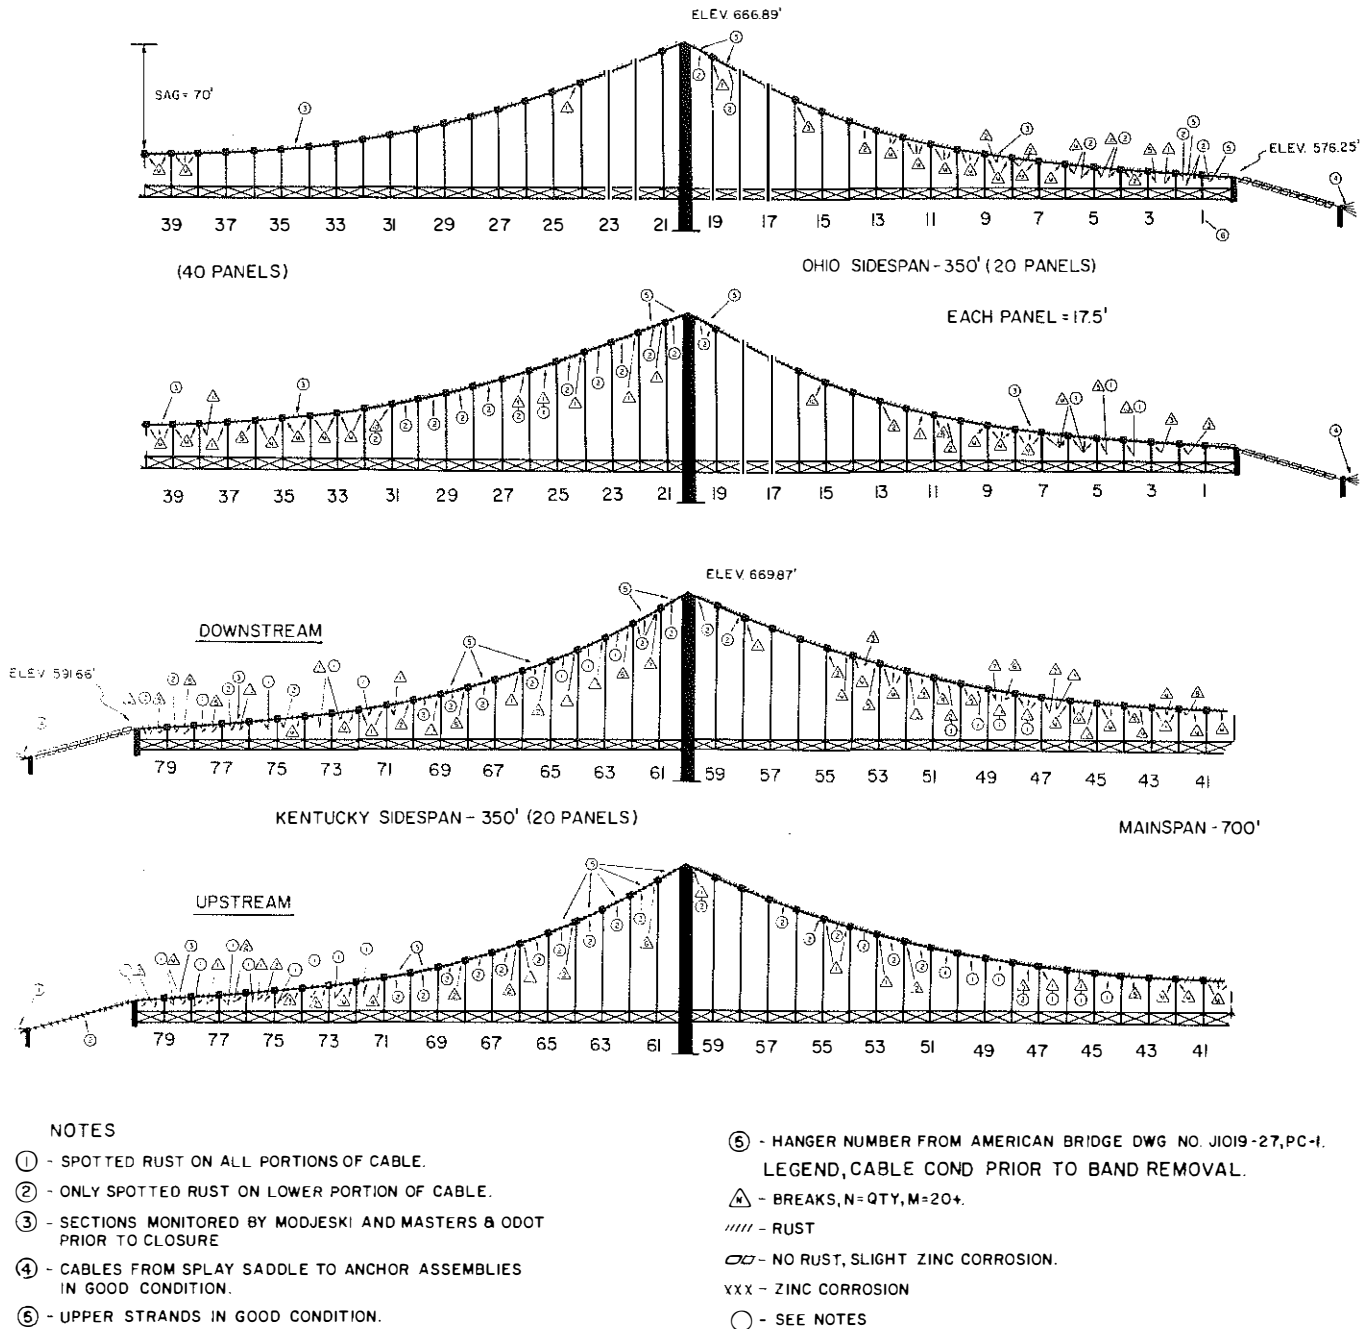
Exterior strands were severely corroded in many locations. At points, all exterior strands showed ferrous corrosion or rust (Figure 2). That type of corrosion was either evident on all exterior strands for an entire panel (band-to-band) or concentrated in the lower strands for the entire panel length. Severe rust was present for more than one consecutive panel, with the exception of panel 66-67, downstream, on the Kentucky side. Contrary to expectations, severe rusting was observed on both horizontal and inclined portions of the cables. Panels where cables were steeply inclined generally contained more severe rusting than adjacent panels of less inclination.

Only one panel (66-67), downstream, had severe rusting on the Kentucky side span. Thirty-three of the 40 main-span panels on the downstream cable were severely rusted, while eleven panels on the upstream cable were seriously rusted. These were located on the lowest (shallowest) portion of the cable. Twelve panels of each cable on the Ohio side contained severe rust.

Figure 2. U. S. Grant Bridge corrosion survey (May - June, 1979).

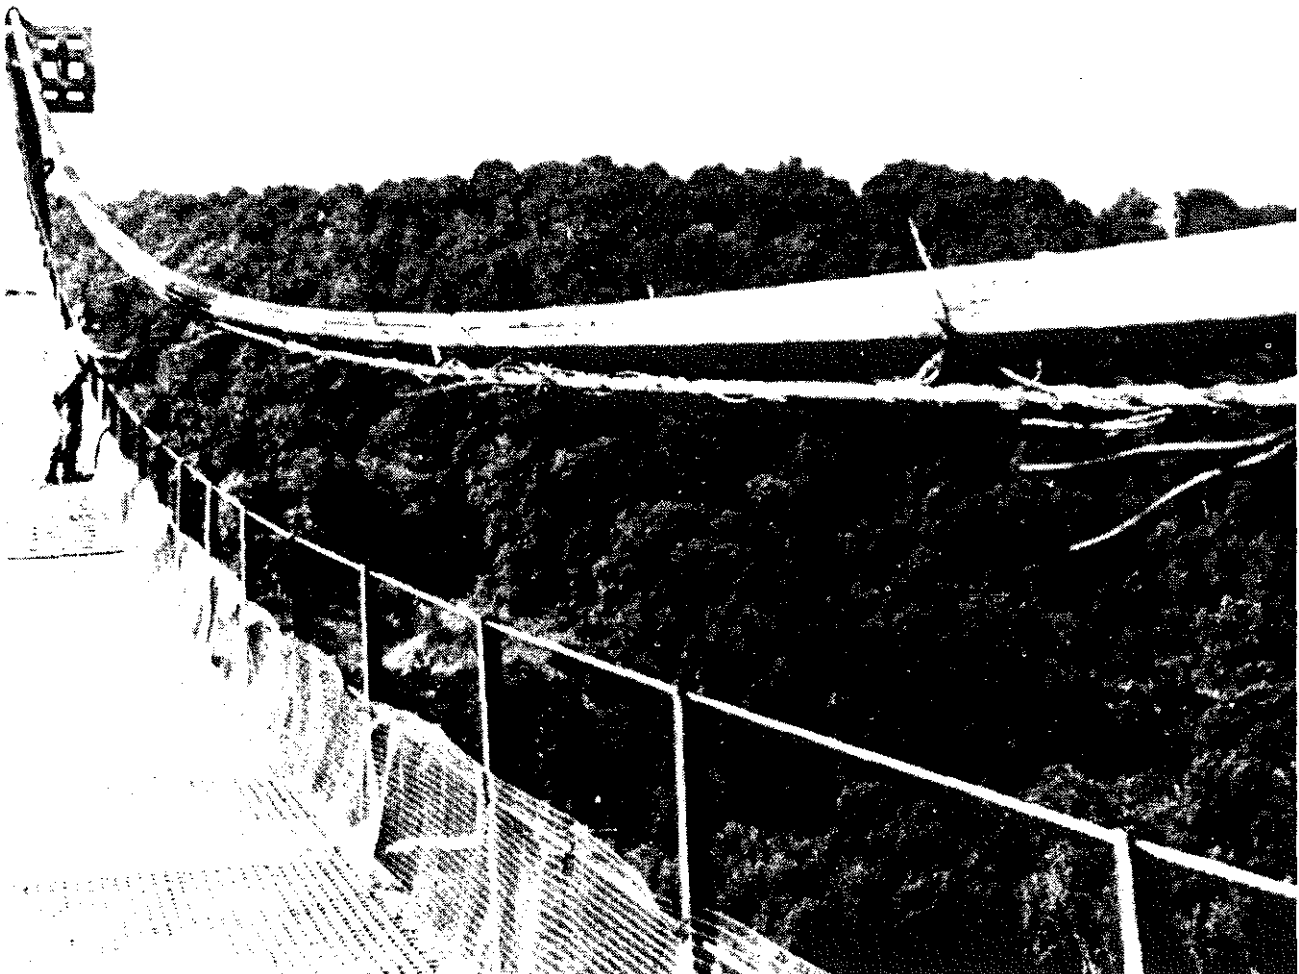
Figure 3. Portsmouth Bridge, Ohio span, downstream after band removal.

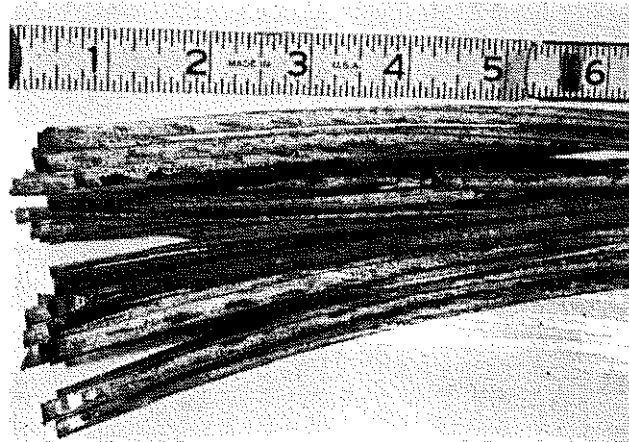
Specimens of the Portsmouth structural strand also indicated capillary action allowed moisture to be retained in the cables. Some strand specimens appeared to be in good condition with only slight zinc corrosion near the wire interfaces. Splayed specimens revealed zinc corrosion and spotted rust on the backside of the exterior wires. The second layer of wires was covered with corrosion products. The third layer of wires was in good condition, as were the other interior layers (Figure 5).

Figure 5. Splayed wire specimen from the Portsmouth Bridge. Note uncorroded interior wires.

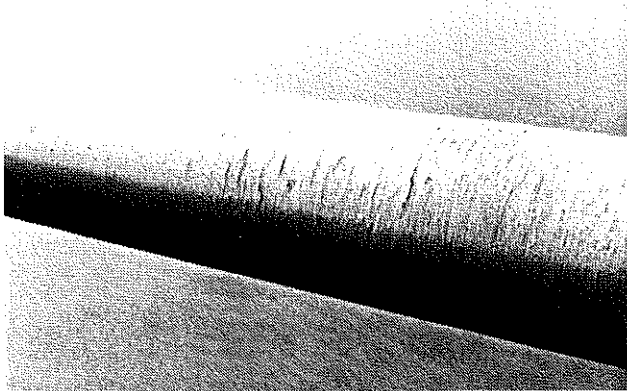
Figure 7. Transverse cracks in paint on the main cables of the Maysville Bridge.

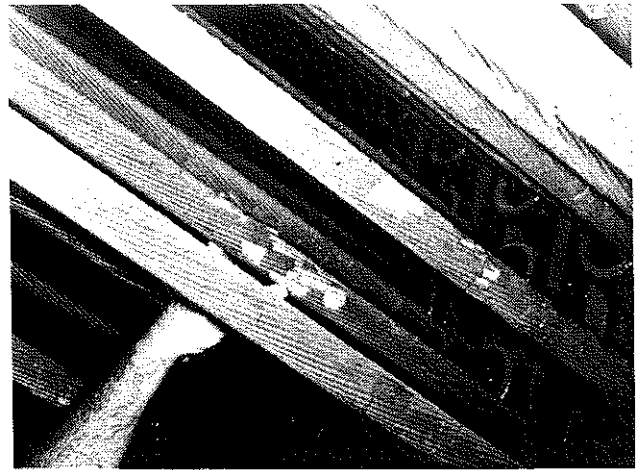
Figure 9. Maysville Bridge anchor assembly. Note the strands enter the anchor assembly through sleeve bushings.

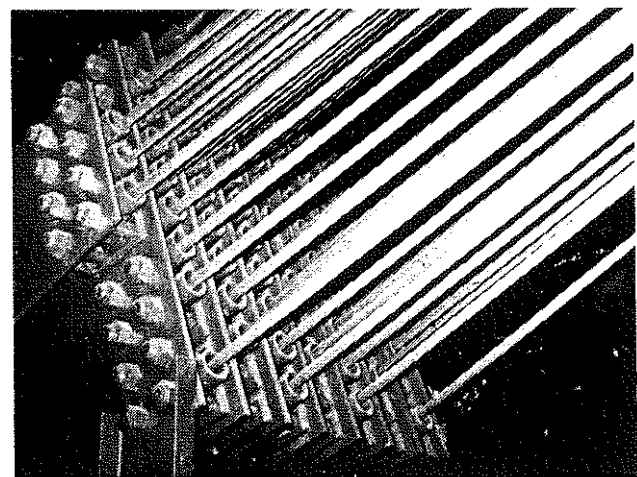
Figure 10. Strands in the Ohio downstream anchor house. Note white zinc corrosion deposits on the strands.

sleeve bushings appeared to be in worse condition. There was considerable loose rust and chipped paint in the recesses of the sleeves. Due to poor lighting, the exact condition of the strands inside the sleeves could not be determined. At the splay saddle in the Ohio upstream chamber, some washing of red lead or rust from the exterior cable was visible on the lower strands.

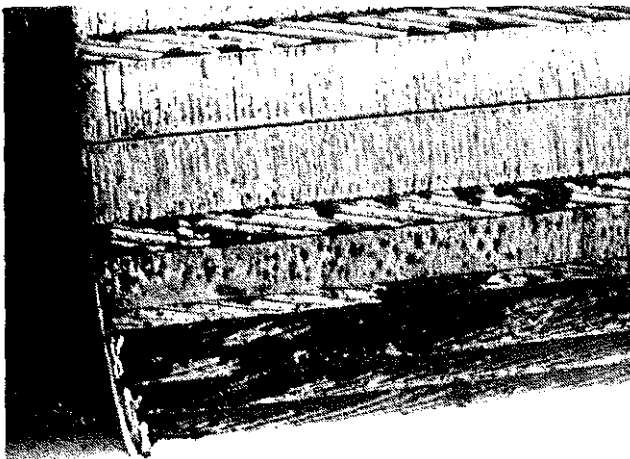
The exposed cables revealed that, unlike the Portsmouth Bridge, the Maysville Bridge strands were individually covered with a generous coating of red lead. Unfortunately, that coating was deteriorating, and in many locations, the galvanizing was depleted.

Figure 13. Inspection port on Panel 65-63 on the upstream main span cable. Note the rust spots and red lead coating.

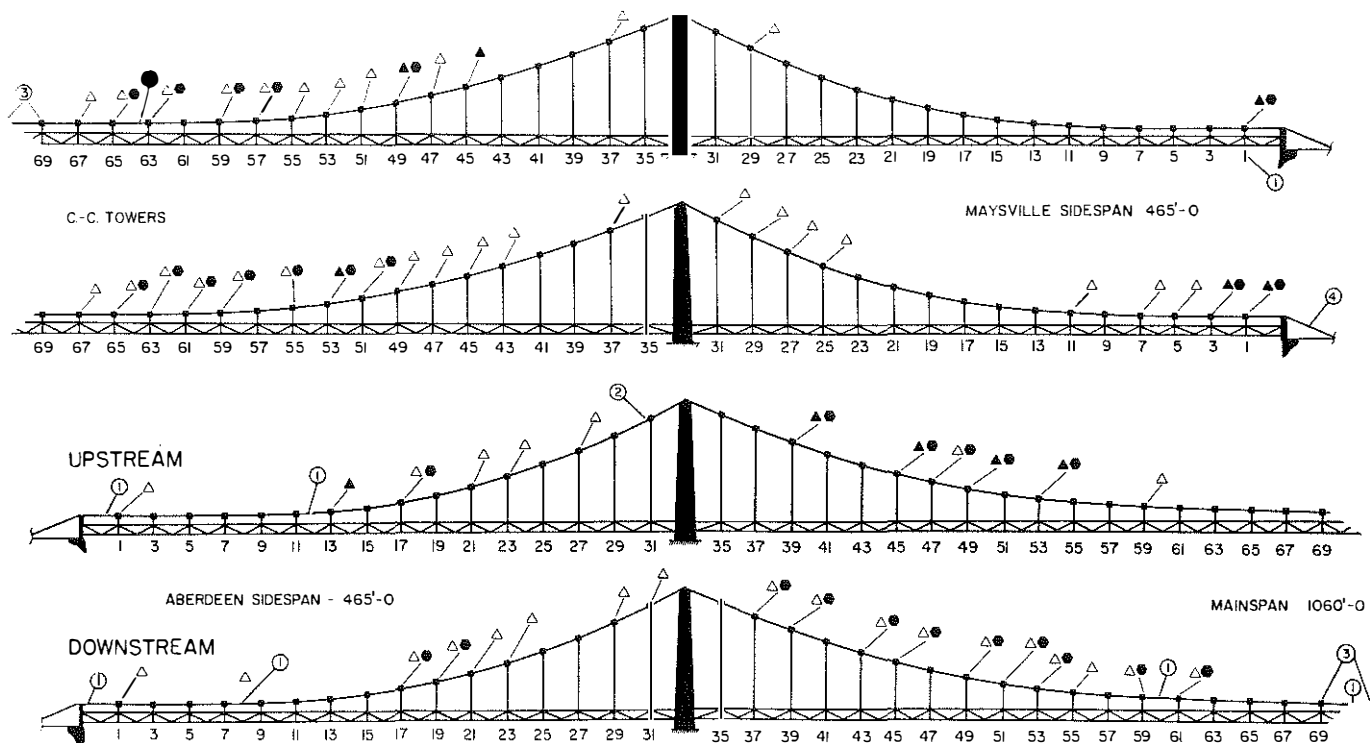
Inspection of the packing pop-outs was conducted from the sidewalk using binoculars. While all the packing pop-outs were detected, it is possible that some seepage was overlooked. This would be especially true of the upstream cable, which was across the roadway from the sidewalk. The frequency of band pop-outs indicates that, despite the wire wrapping, the cables are virtually porous. The presence of pop-outs near the towers shows that a significant amount of water can be entrained, either at wrapping discontinuities along a single panel or at a sealing failure on a band. Seepage of water from a band that is one panel lower than another band with a pop-out

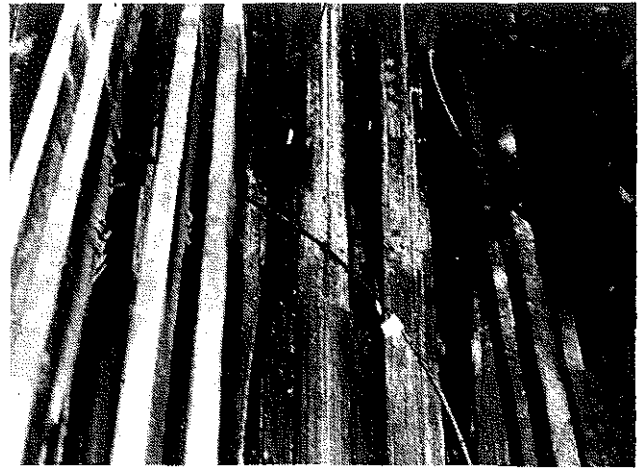
Three original anchor houses showed evidence of water leaking from the roofs of both upstream anchorages and the Kentucky downstream anchorage. Water seepage into the Ohio downstream anchorage was slight and the anchor assemblies and strands were not damaged. In other original anchorages, water had dripped onto the strands, eyebars, and anchor assemblies, causing a deterioration of a whitewash wall-and-ceiling coating. Wrought-iron roof beams were also rusted. The dissolved whitewash was deposited as a white residue at spots where leaks impinged on wires and anchor assemblies.

Figure 18. Deterioration to the strands due to roof leakage in the original anchor house.

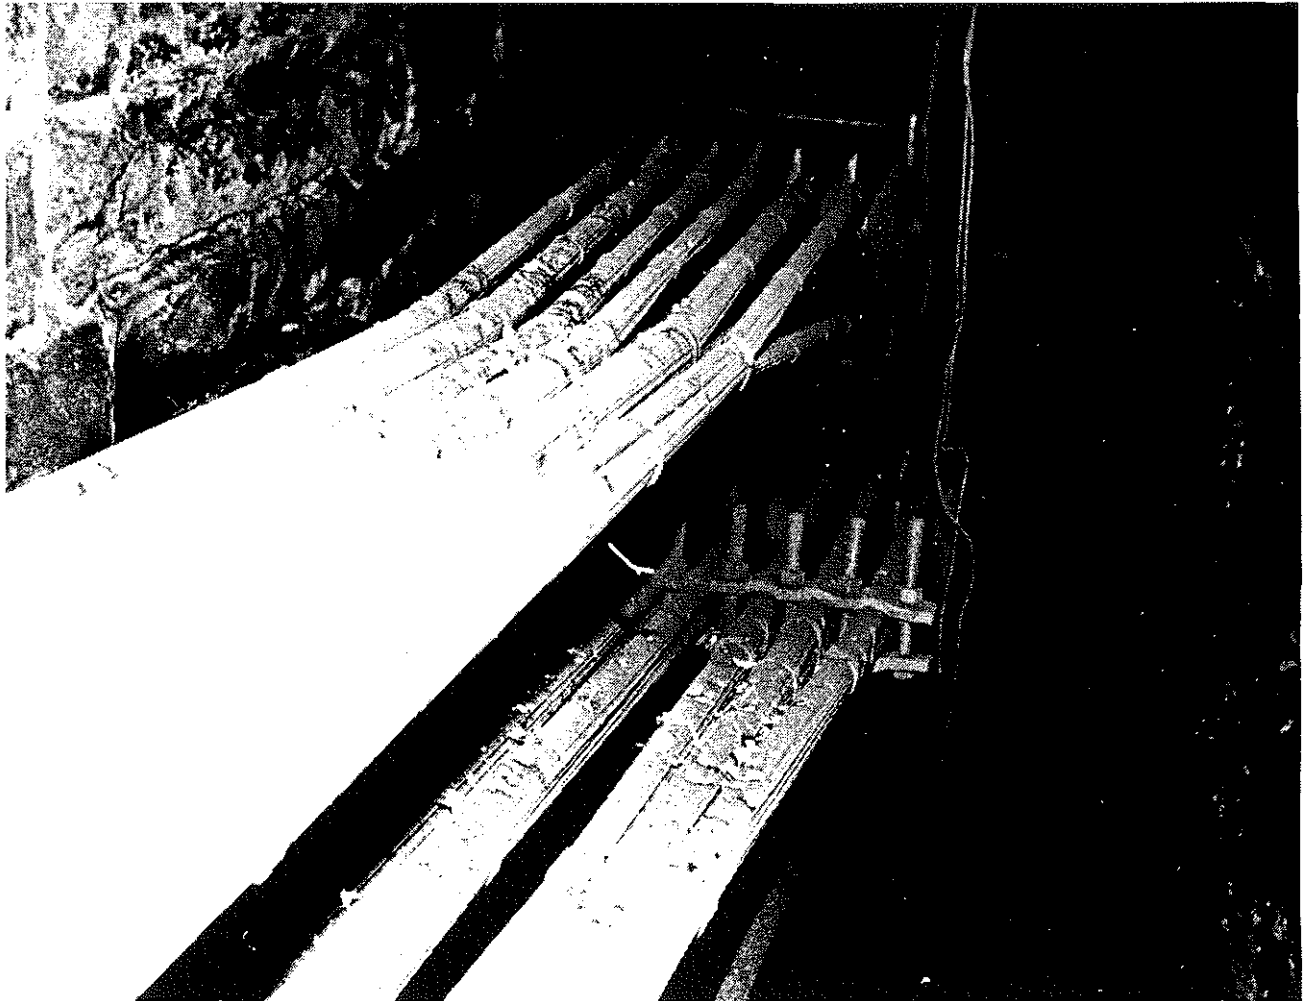
Figure 20. Cable strands in the upstream Ohio secondary anchor house. Note the pigeon pollution and sandblast refuse on the strands.

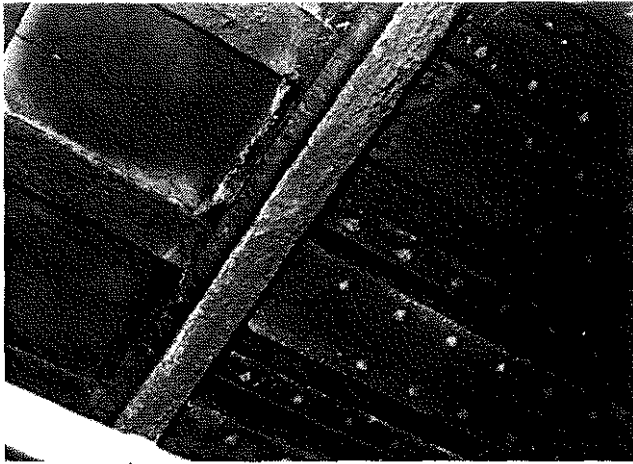
Figure 21. Stains on the ceiling of the upstream Ohio secondary anchor house.

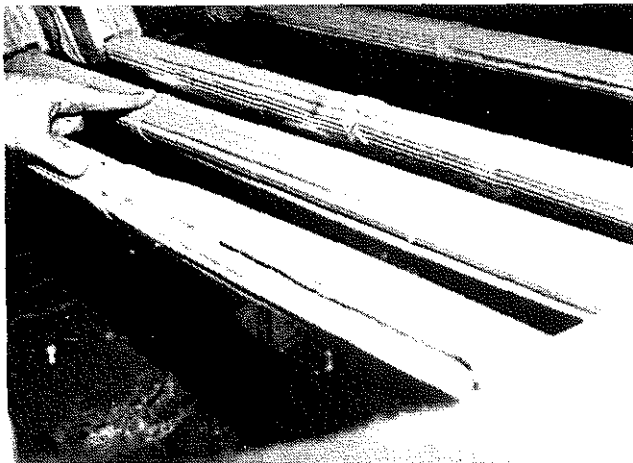
Figure 22. Swollen strands in the downstream Ohio secondary anchor house.
