Research Report UKTRP-84-16

ANALYSIS OF ACCIDENTS INVOLVING
BREAKAWAY-CABLE-TERMINAL END TREATMENTS

Kentucky Transportation Research Program
College of Engineering
University of Kentucky
Lexington, Kentucky

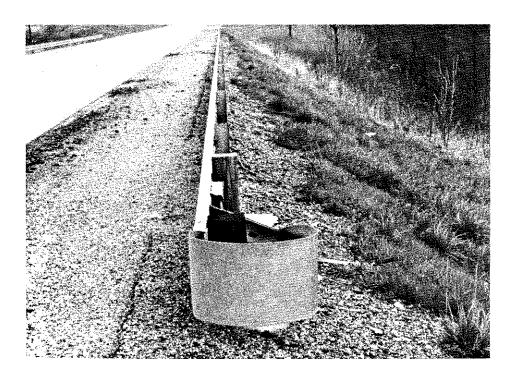
Figure 2. BCT End Treatment Without Proper Flare.

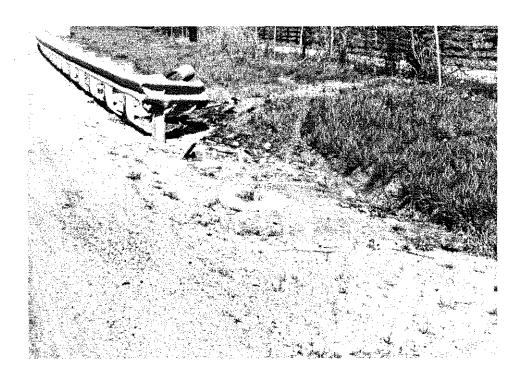
End-treatment performance, when it could be determined, was defined as either proper or improper. Proper performance resulted when the end treatment performed as designed, with the wooden posts breaking away or the guardrail redirecting the vehicle. Performance was rated for 46 of the 50 BCT accidents. Of those 46 accidents, the BCT end treatment was judged to have performed properly in 33 accidents (72 percent). A photograph showing the end treatment after proper performance in an accident is shown in Figure 3.

Figure 3. Proper Performance of a BCT End Treatment.

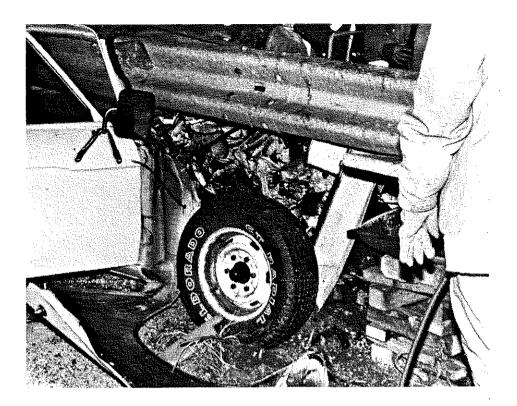
Only two of eight severe impacts (25 percent) resulted in proper performance while all four non-severe impacts were termed proper. Impact angles were classified as either shallow or moderate. For both impact angles, only two of five accidents (40 percent) resulted in proper performance. All accidents (three) in which heavy or extensive guardrail damage resulted and in which performance was also rated resulted in improper performance. Only two accidents of known vehicle size involved a small vehicle. Both vehicles involved collision with an MBCT placed in a gore and resulted in improper performance with the end spearing the vehicle (Figure 5).

Figure 5. Spearing of Vehicle by a MBCT End Treatment.

The old MBCT design should be removed from gore locations. The recommended replacement at gore locations would be a crash cushion. Because of the stiffness of the MBCT and the problems associated with impacts at shallow angles, consideration should be given to use of a turned-down end-treatment design for median applications. A turned-down design should be used in medians for new installations or when old end treatments must be replaced. However, data do not justify removal of existing installations.

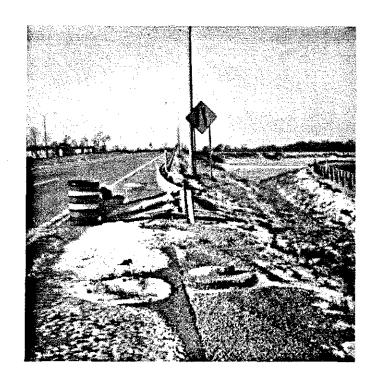
Figure B1. Accident Number 009, Henderson County, Audubon Parkway, MP 0.1, at SB Off-Ramp.

No accident report could be found for this accident. From the photographs, it appears that the vehicle involved was initially bound for an exit ramp and swerved across the gore area back toward the mainline, striking the guardrail end from the backside in the process. Both wooden posts were broken and the guardrail was bent outward toward the roadway. Injury to vehicle occupant(s) and extent of damage to the vehicle is unknown.

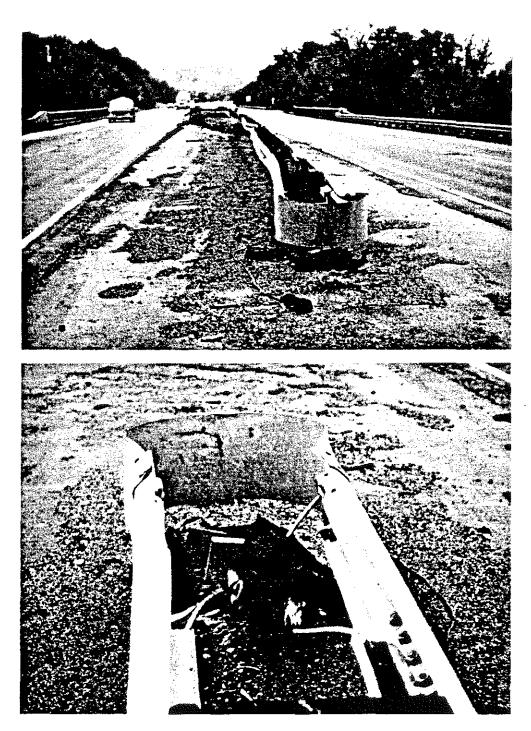
Figure B4. Accident Number 015, Bullitt County, I 65, MP 116.

or damage to the vehicle remains unknown.

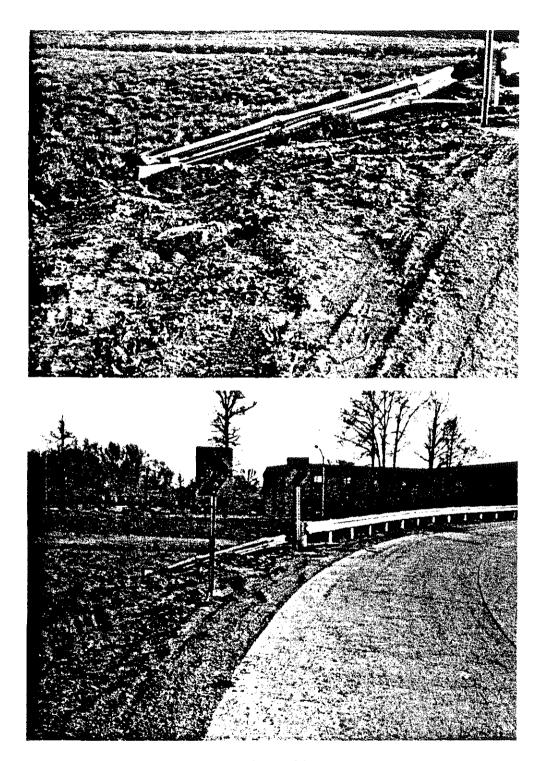
Figure B5. Accident Number 019, Jefferson County, I 65, MP 128.3

treatment was unknown.

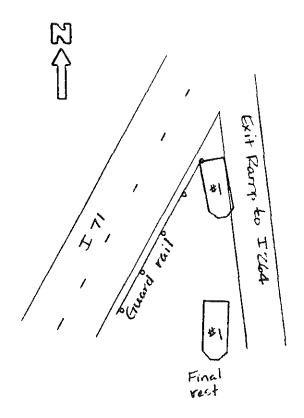
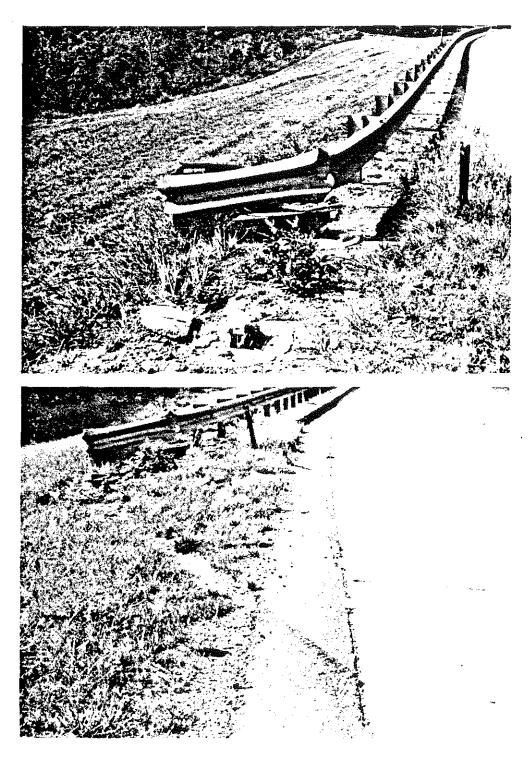
Figure B6. Accident Number 022, Jefferson County, I 71, MP 4.000, Exit Ramp to I 264 WB.

A 1978 Chevrolet station wagon ran into a guardrail end at a gore area, broke through the end treatment (breaking both wooden posts) and came to rest at the bottom of the embankment behind the guardrail. The vehicle impacted the end of the guardrail at an angle with the passenger-side door and a passenger in the right rear seat received a possible leg injury. It is probable that her injury resulted from collision of the door with the guardrail end. The driver and two other passengers were uninjured. None of the occupants wore a safety belt. The vehicle was damaged on the right side but remained functional.

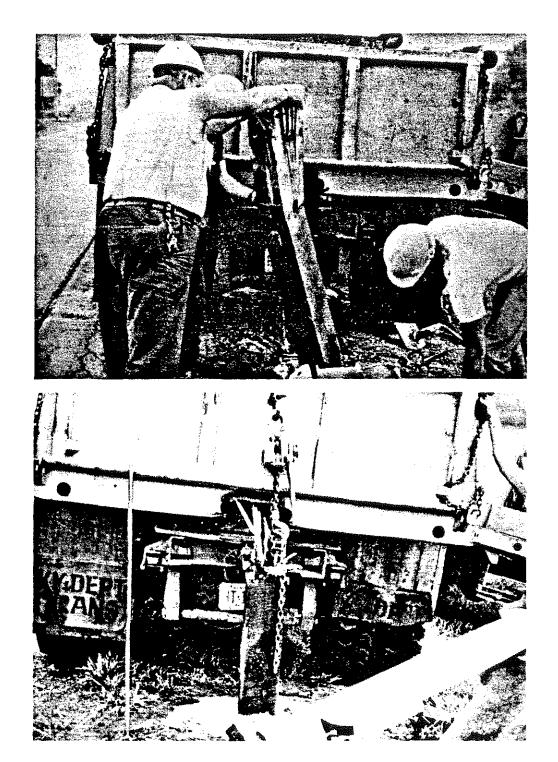
Figure B13. Accident Number 029, Boone County, I 75, MP 181.257, KY 18 Exit Ramp.

The driver of the car received incapacitating leg injuries. He was not wearing a safety belt. The car suffered disabling damage to the front end.

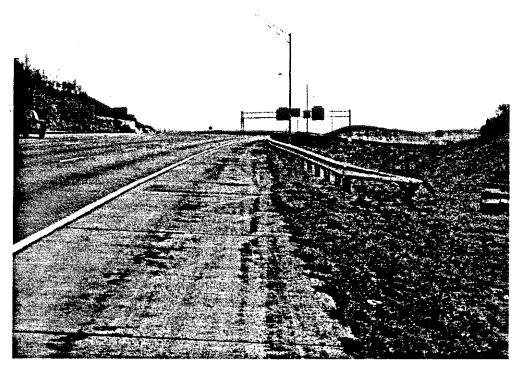
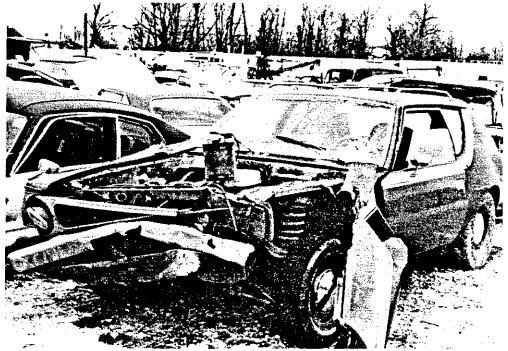
Figure B16. Accident Number 037, Campbell County, I 275, MP 74.813, I 471 SB Exit Ramp.

The driver of the vehicle received possible injuries to the legs and back. He was not wearing a safety belt. The vehicle received significant damage.

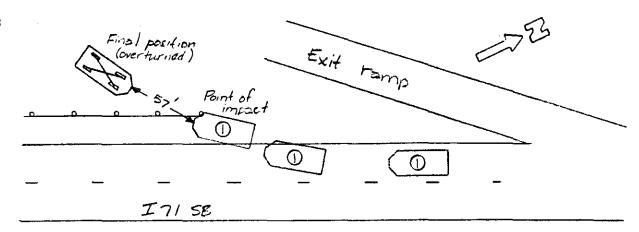
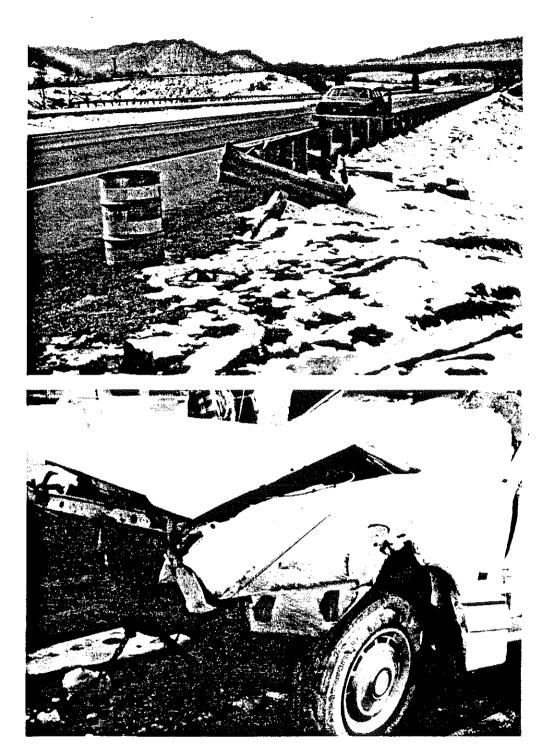
Figure B17. Accident Number 038, Carroll County, I 71, MP 42.986, KY 389 Exit Ramp.

The driver of a 1981 Ford Fairmont stated that he fell asleep at the wheel. The vehicle ran off the right-hand side of the road, struck the end treatment head-on, broke through the end treatment and travelled down the slight embankment where it overturned. The car sustained disabling damage. Extensive damage was done to the guardrail as the two wooden posts were broken and a steel post was bent over. The driver suffered non-disabling multiple injuries, while his wife suffered a non-disabling head injury. Neither occupant was wearing a safety belt. The deep wheel ruts in the photographs are not from the car, but were probably caused by the wrecker that towed the car from the scene.

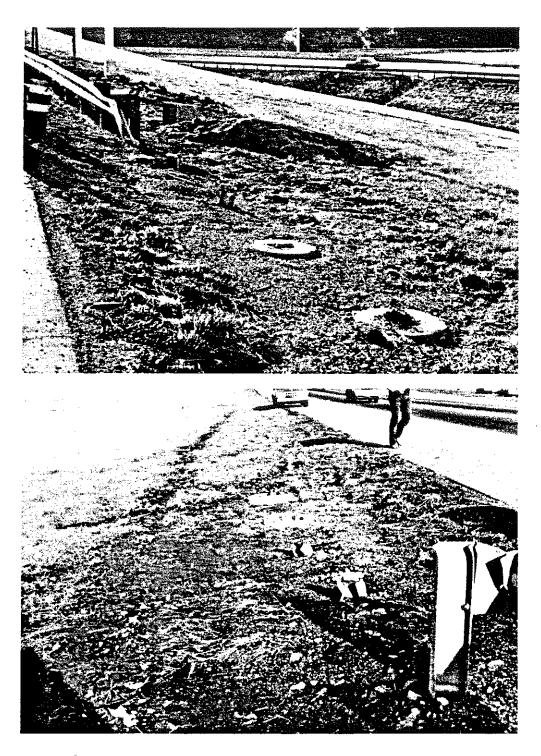
Figure B18. Accident Number 039, Kenton County, I 75, MP 184.716.

truck struck the guardrail end, breaking both wooden posts and damaging two metal posts. The truck then overturned.

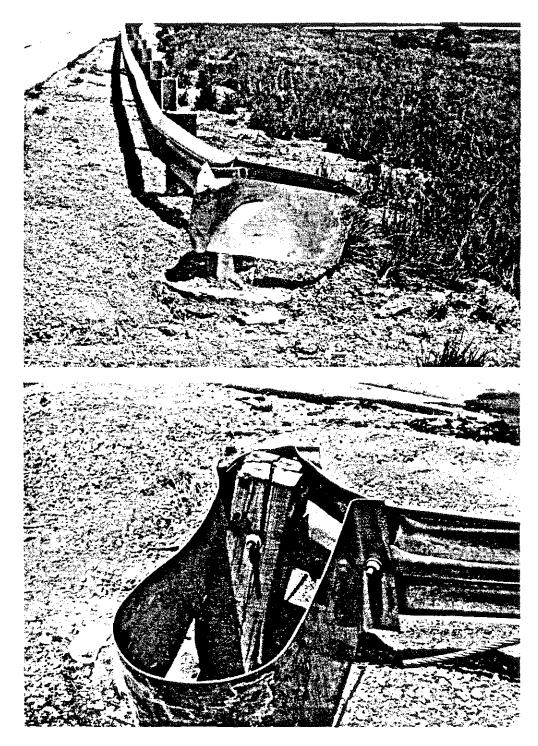
Figure B21. Accident Number 045, Kenton County, I 275, MP 82.475, US 42 Exit Ramp.

No accident report could be located. Photographs show that the guardrail was struck directly on the end, deforming the buffered end section and cracking the first wooden post. The guardrail was slightly bent at the second wooden post, but the post did not break. No other damage to the guardrail was evident. The extent of vehicle damage and occupant injury is unknown. It appears that the guardrail end received only a light hit. The vehicle probably proceeded on and no accident report was filed.

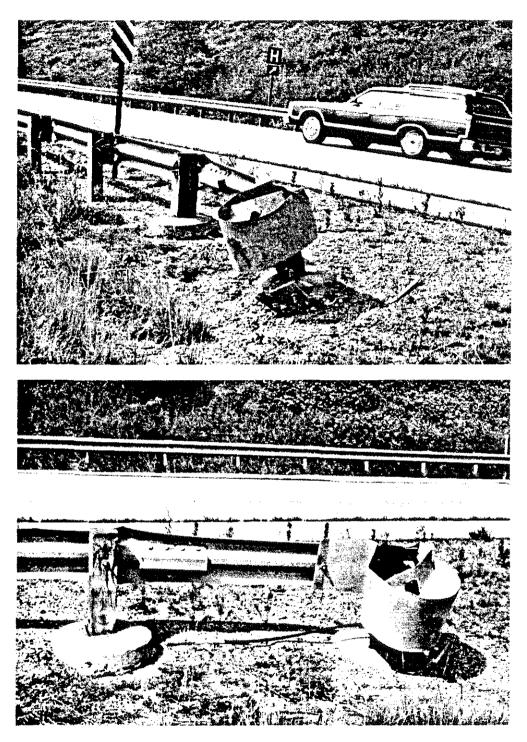
Figure B22. Accident Number 046, Kenton County, I 275, MP 0.000, I 75 Exit Ramp.

No accident report was filed. Accident was said to have been caused by slick roads during the winter as the trailer on a combination tractor and semi-trailer skidded sideways off the left-hand side of the road and bumped broadside against the guardrail end. Photographs show that only the rounded end of the guardrail was damaged. The concrete footing under the first post was pushed over slightly, but neither wooden post was broken. Apparently the trailer was not damaged.

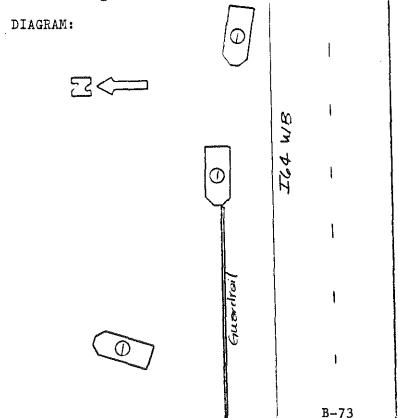
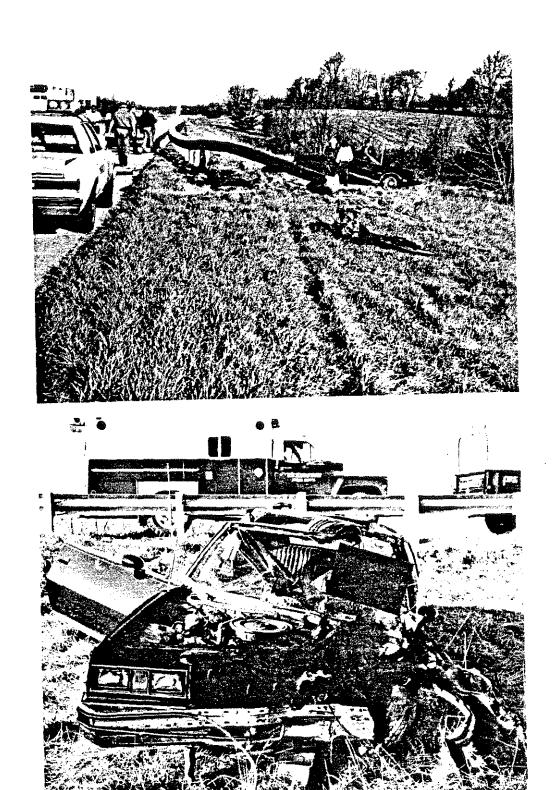
Figure B24. Accident Number 049, Fayette County, I 64, MP 85.037.

Both wooden posts broke away, but the guardrail did not wrap back around the steel posts after impact. Instead, the guardrail appears to have vaulted the car after initial impact. The photos show oil splattered over the entire guardrail end treatment.

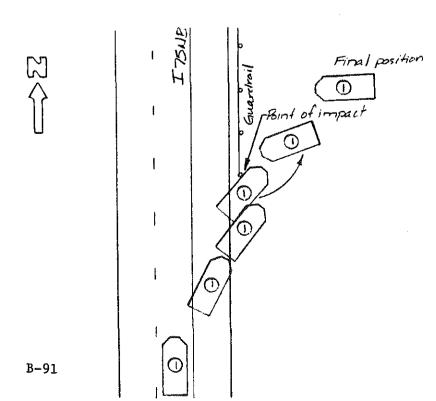
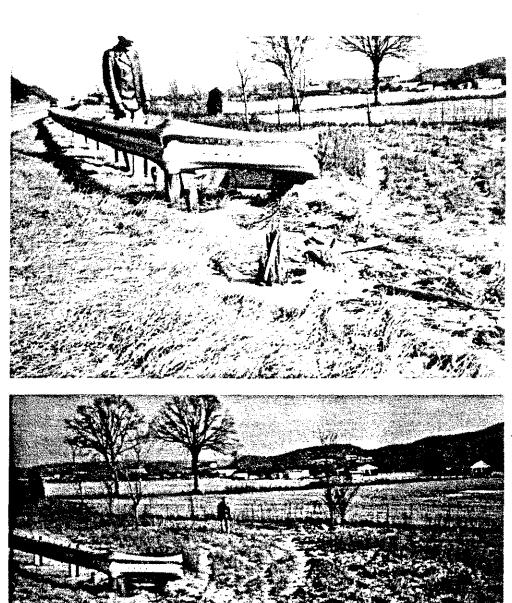
Figure B30. Accident Number 061, Rockcastle County, I 75, MP 69.2.

The vehicle ran off the road, slid sideways, and struck the guardrail end at the driver's door. The driver either went to sleep or was blown out of control by strong, gusty winds. The guardrail was then struck again by the left rear passenger door. The vehicle spun around and travelled backward 55 feet before coming to rest. Photos show that the first wooden post broke completely at ground level. The guardrail end wrapped around the second wooden post, which was cracked, but remained intact and upright. The vehicle was a 1978 Chevrolet 4-door (mid-size) sedan. It sustained disabling damage to the driver's side. The driver received a fatal neck injury. She was not wearing a safety belt. It appears that the guardrail end punched into the driver's door, causing the car to spin 180 degrees counterclockwise. The first wooden post broke off completely. The guardrail was bent more than 90 degrees around the second post, which was split longitudinally but was still intact with the concrete footing. The fatality was probably caused by the vehicle striking the guardrail end against the driver's door, which offers little protection compared to the front end.

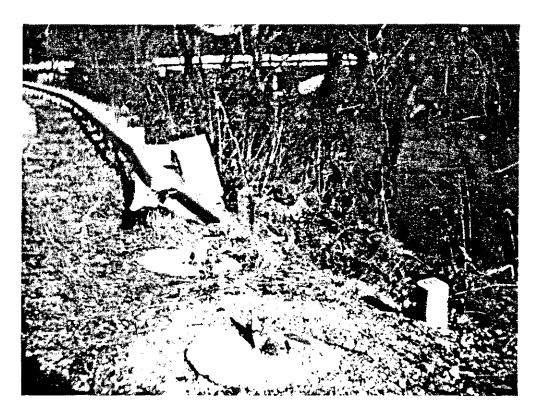
Figure B31. Accident Number 063, Harlan County, KY 413, MP 0.963.

Both wooden posts were broken off at ground level and 15 feet of rail were damaged. The rail was bent around behind the first metal post.

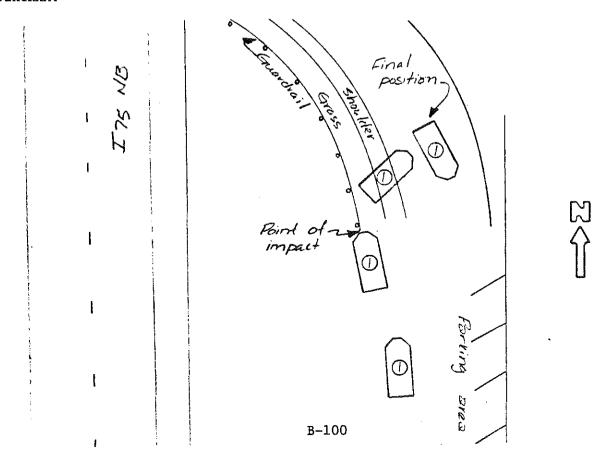
Figure B33. Accident Number 067, Whitley County, I 75, MP 2, Rest Area Parking Lot.

The driver received incapacitating injuries to the arms and legs, while the passenger received an incapacitating back injury. Neither occupant was wearing a safety belt. The first wooden post was broken while the second post was not damaged. The broken post and end terminal was pushed toward the roadway by the impact indicating the direction of the vehicle at impact.
