CORRECTIVE MEASURES FOR UNSTABLE BRIDGE-APPROACH EMBANKMENT

US 68, LICKING RIVER, BLUE LICKS

KYP-72-38, HPR-PL-1(15), Part III B

November 1979

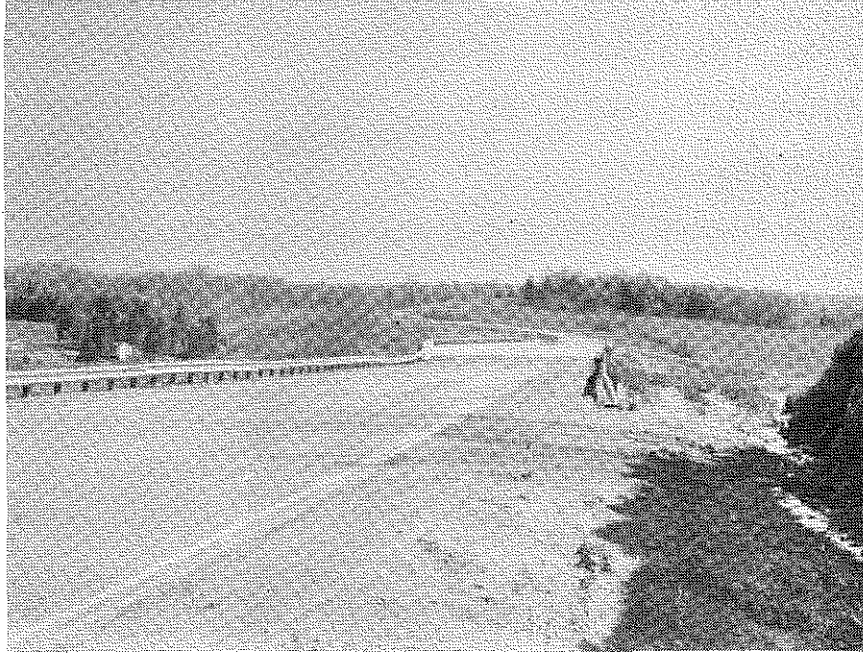
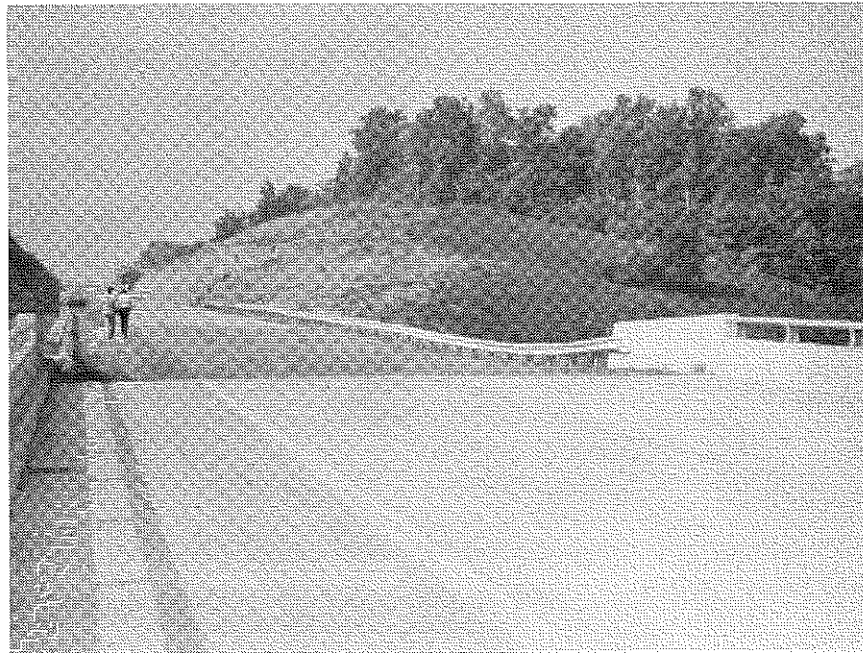
ceased. The bridge was completed in 1969. In December 1975, movement of the west abutment and approach embankment required extensive patching of the pavement and repair of the guardrail near the abutment (Figures 2 and 3). On the basis of displaced guardrail, the unstable embankment extended from approximately Station 220 + 00 to the bridge. This information was useful in establishing the configuration of a possible deep failure surface. Movement of the bridge abutment has also been evidenced by an extreme tilt of rocker arms and jamming of the bridge girders against the concrete abutment; this is shown in Figure 3. Figure 4 shows break up of one of the expansion dams on the west abutment. This was additional evidence that the abutment was moving toward the river because rocker arms on top of both piers were still vertical. Voids and cracks are shown in Figure 5 along the front of the soil-abutment interface. These openings were as large as 2 to 3 feet (0.6 to 0.9 m) deep and 3 feet (0.9 m) wide. This suggested the presence of a shallow slide developing directly in front of abutment.

Figure 2. View of Displaced Guardrail, West End of Bridge over the Licking River on US 68 (a) Looking East and (b) Looking West.

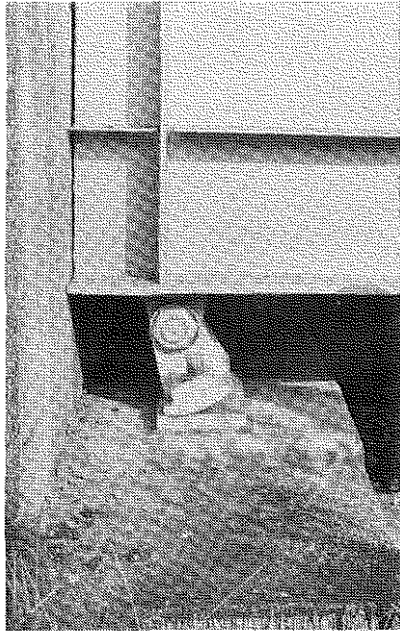
Figure 3. Extreme Tilt of Rocker Arms and Jamming of Bridge Girders against Concrete Abutment.

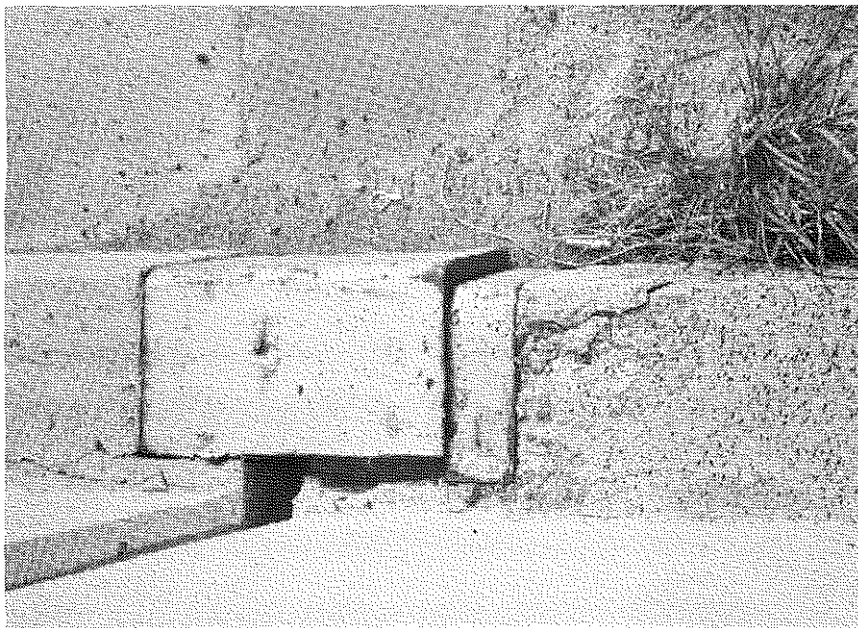
Figure 4. Breakup of Concrete Expansion Dams on West Abutment of US-68 Bridge over the Licking River.

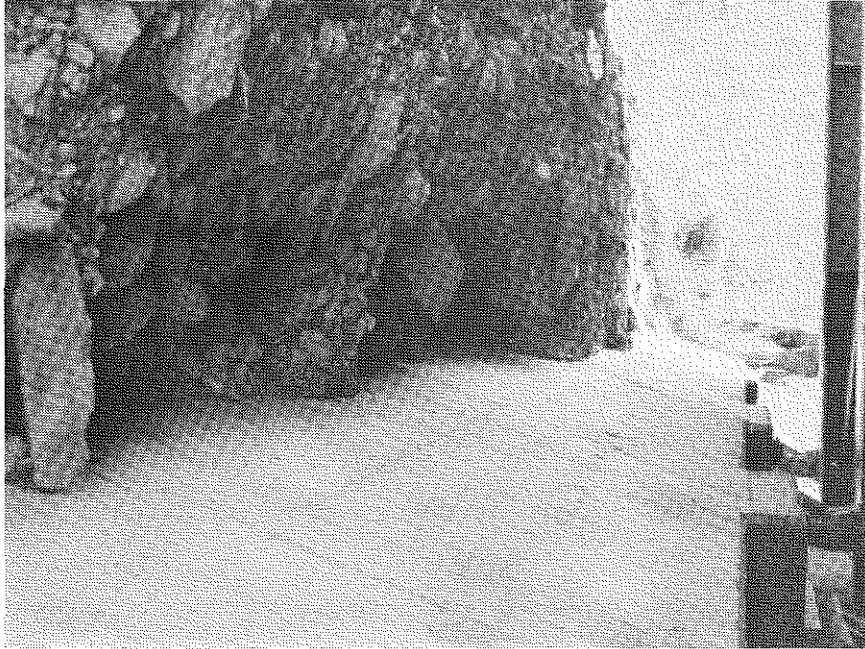
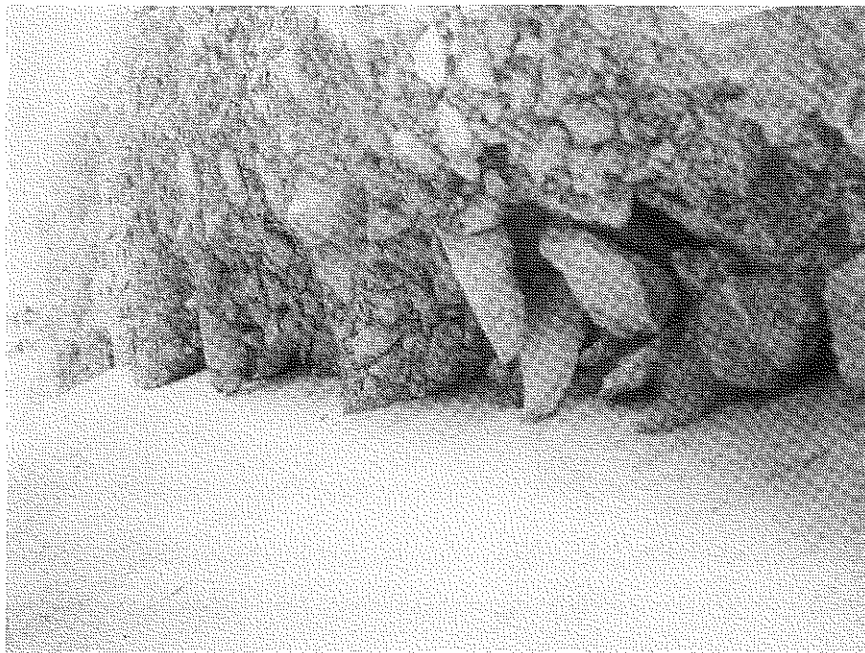
Figure 5. Voids and Cracks in Soil along Face of West Abutment of US-68 Bridge over the Licking River.

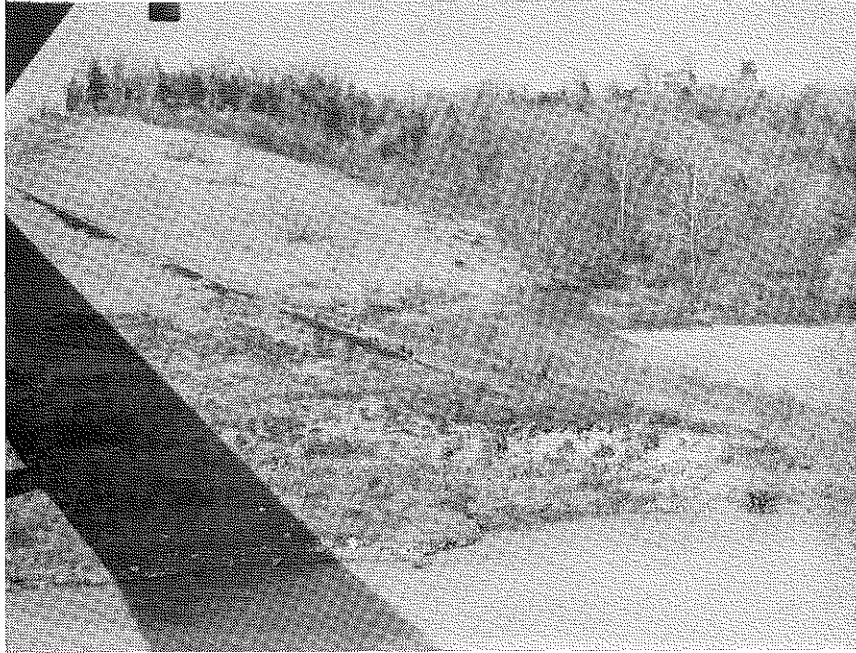
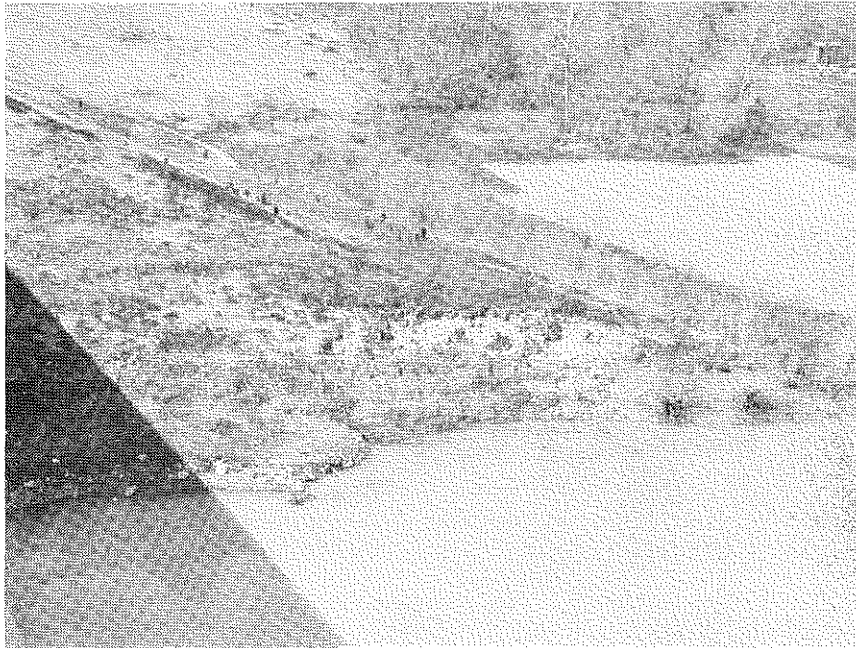
Because the embankment partially rests against a hillside, seepage along the original foundation may have raised the water table into the fill, lowered the factor of safety, and caused the movements. Erosion of the toe of the embankment may have contributed to present movements. Upstream from the bridge, the lower end of a concrete-lined ditch collapsed because supporting soil eroded. Downstream from the bridge, eddy currents apparently caused the deep

groundline near the toe was confirmed in a recent field inspection (April 1979). The scarp at the toe of this section (Figure 6) actually may be due to failure of several small sluff circles similar to Circle 1 instead of erosion, as previously suggested. Table 8 shows that small increases in stability will result with the addition of Berms 1 or 2. However, this escarpment area should be filled with rock as soon as possible to prevent further erosion.

Figure 6. Erosion of Toe along Downstream Side of West Embankment, US-68 Bridge over the Licking River.

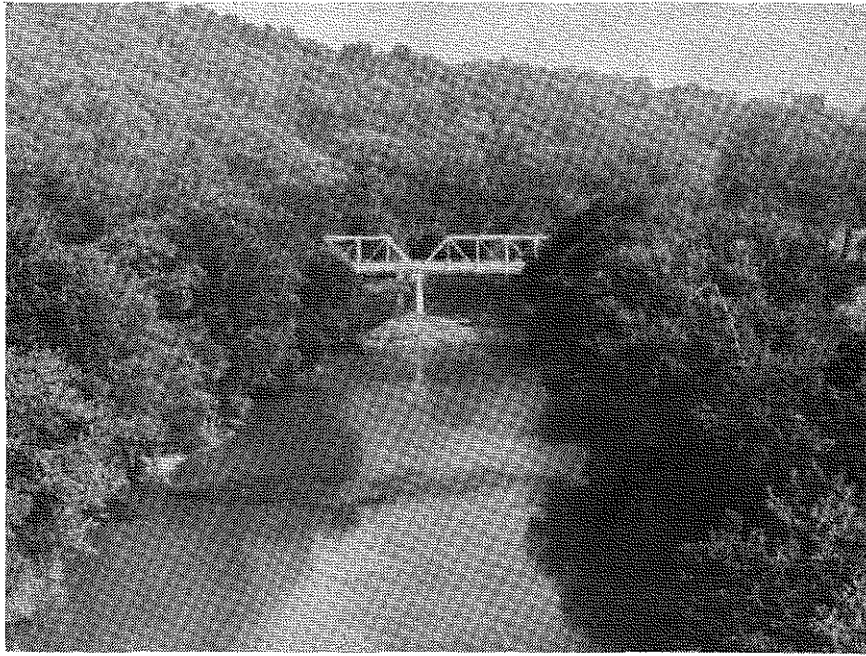
cuts shown in Figure 6. The effects of erosion and a high water table may have been aggravated by a rise in the normal backwater curve due to debris piled up in front of the old US-68 bridge downstream from the present bridge (Figure 7.)

Figure 7. Debris in Front of the Piers of the Old US-68
Bridge Downstream from Present Bridge.

The need for a partial channel change to accommodate the proposed berm configuration along the west side of the Licking River during periods of high flow should be investigated. Debris piled in front of the old US-68 bridge should be cleared. This should increase the hydraulic efficiency of the river channel and reduce the elevation of the backwater curve.

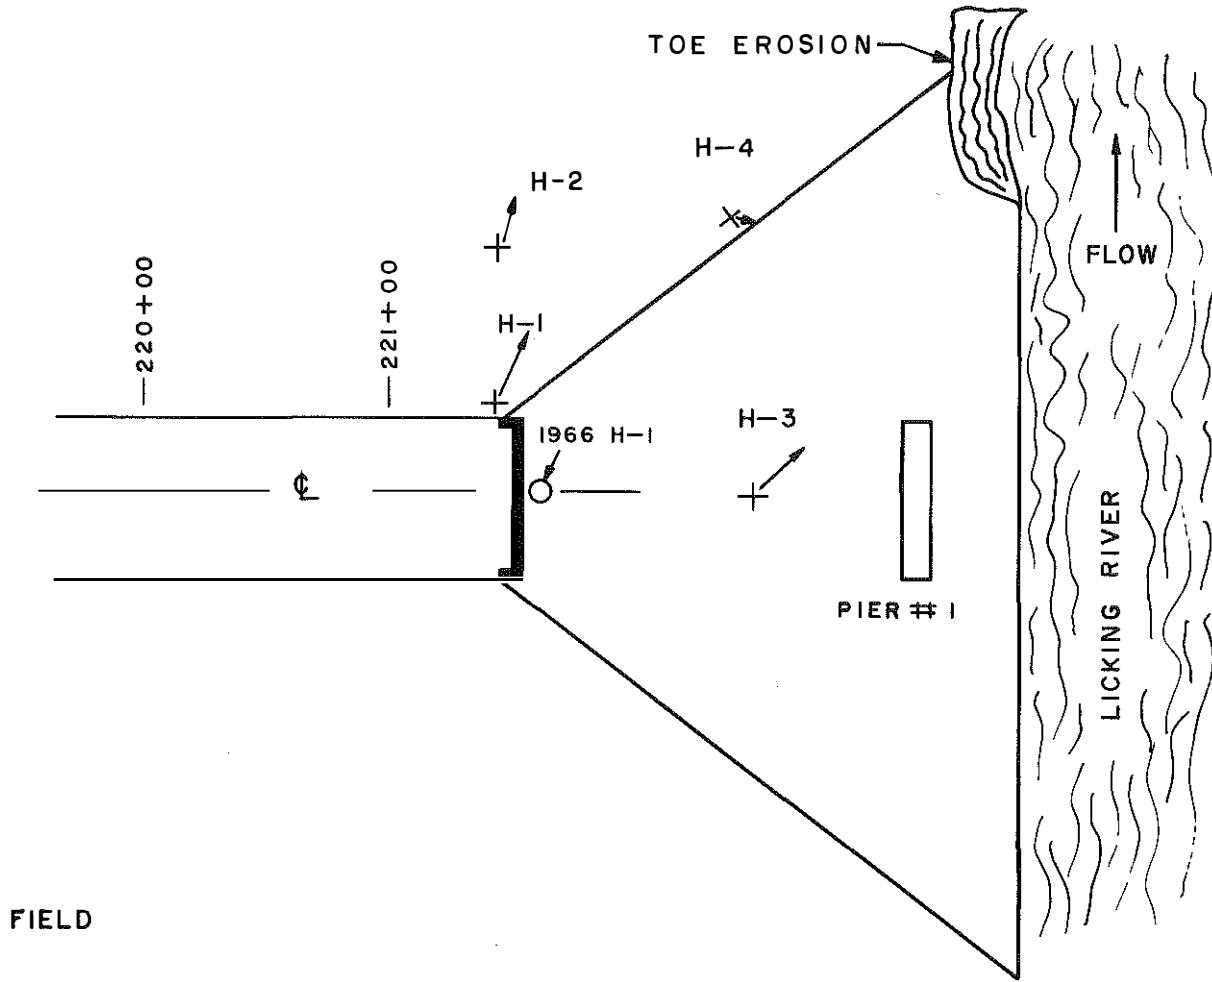
through 16. Relative magnitudes of these movements are shown in Figure 10. Hole 4 indicates less movement because it was installed 16 months later. Table 2 is a summary. A maximum rate of movement of 0.056 inches (1.4 mm) per month was found for the period between August 1977 and August 1978. This rate of movement has remained constant through August 1979 and is less than the 0.125 inches (3.2 mm) per month recorded in April 1976.

Additional failure circles may be present as shown in Figure 24. Circle 2 may exist because Hole 4 is moving directly toward the river, as shown in Figure 10. Therefore, the increase in the factor of safety from 1.056 to 1.286 due to the addition of Berms 1 or 2 is very desirable.

Figure 10. Direction and Relative Magnitudes of Slope Inclinometer Movements, Holes 1, 2, 3, and 4.

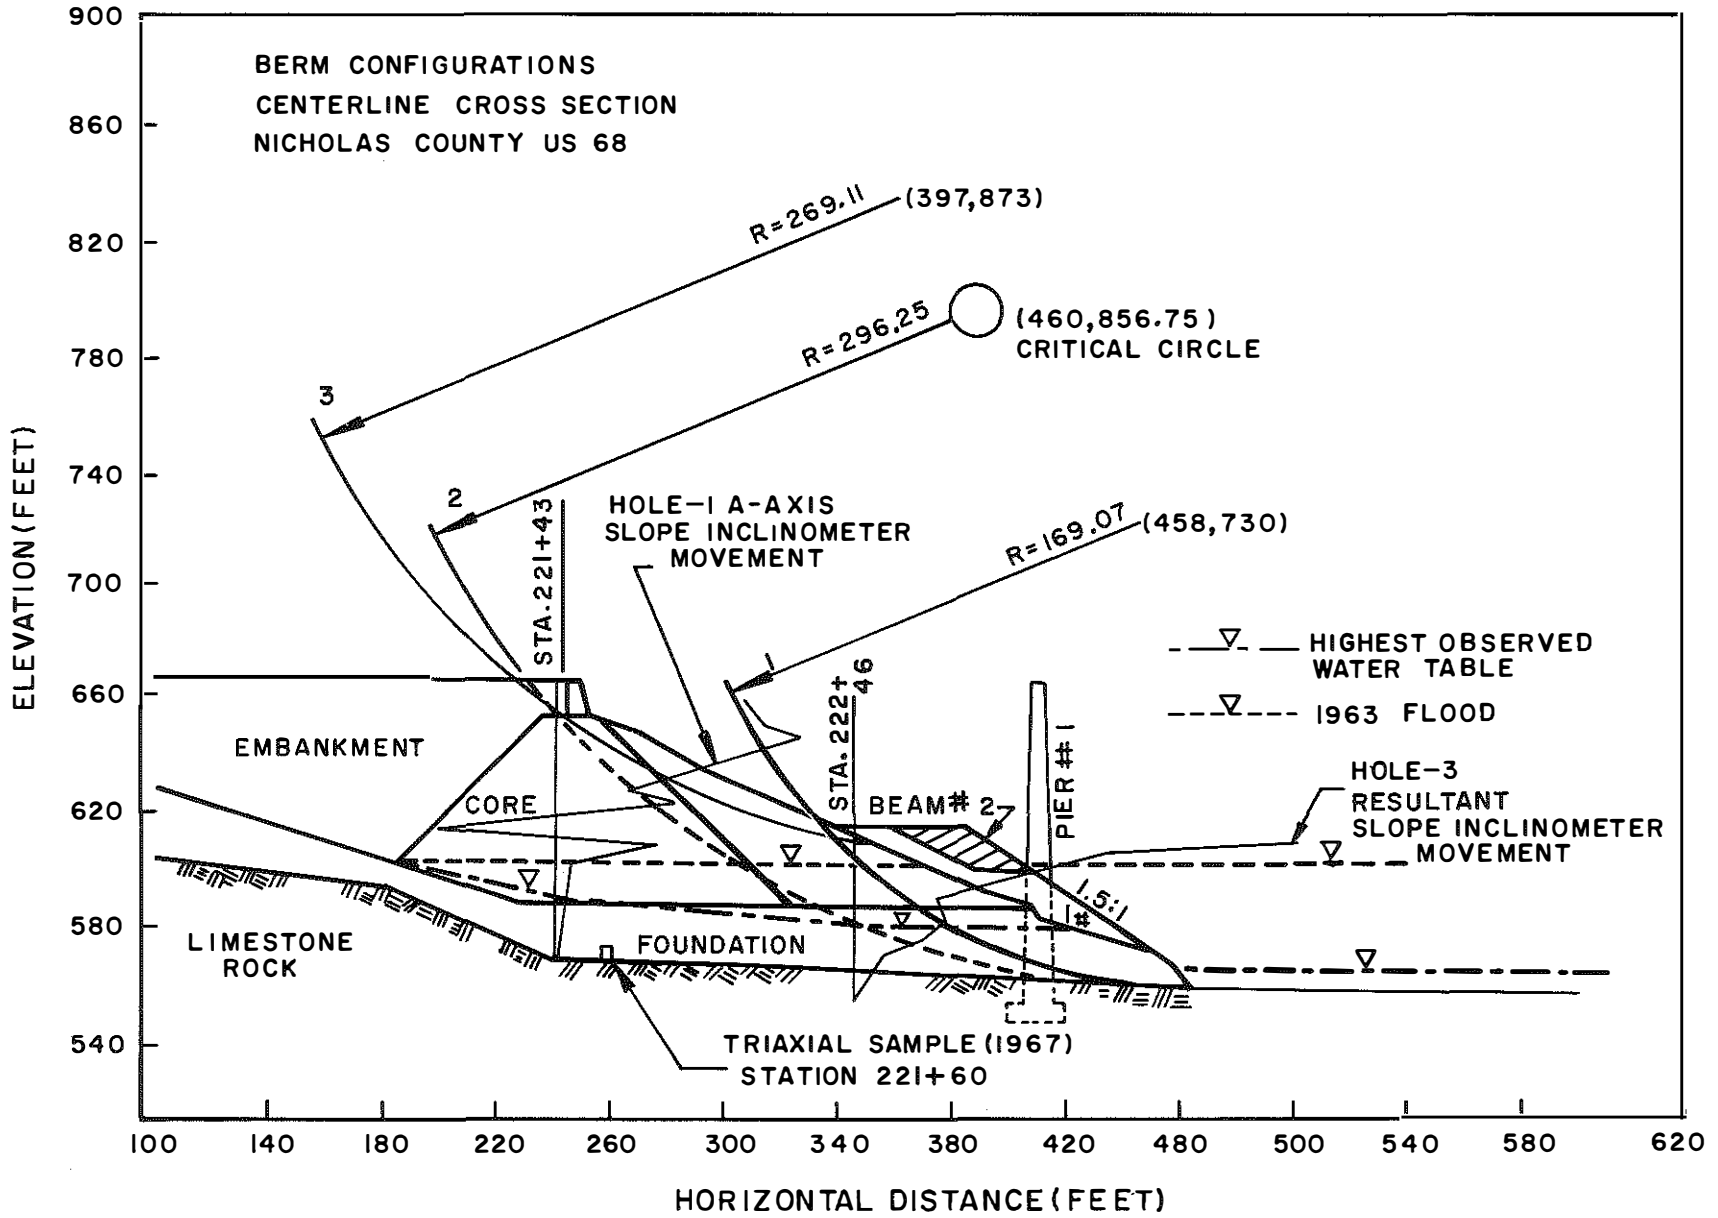
The critical circles for the cross section parallel to the centerline are shown in Figure 23 along with possible berm configurations. These circles seem to explain the slope inclinometer movements at Holes 1 and 3. However, Figure 10 shows that Holes 1 and 3 are not moving parallel to the centerline, but movement is skewed in a northerly direction. The retaining-wall effect of Pier 1 probably prevents or forestalls a major slide along the easterly direction. However, this effect could not be accounted for in the ICES Lease program. Therefore, the results given in Table 7 are on the low side of a range of possible safety factors. The toe circle in Figure 23 (Circle 1) has the lowest factor of safety, 0.861, because a substantial portion of the circle is below the water table. However, field inspections have revealed no evidence of tension cracks or any other signs of movement at the toe. Pier 1 apparently has prevented this circle from developing.

Circle 2 seems to explain the guardrail and slope inclinometer movement fairly well. Figure 23 shows only the A-axis movement (parallel to centerline) for Hole 1. In Figure 23, the shear zone found below Hole 3, near the water table, is probably associated with a wedge rather than a circular slide because this slope inclinometer data correlate better with the movements slightly above the water table at Hole 1. In addition, because Hole 1 is located 33 feet (10 m) to the left of centerline while facing east, movements near the top of Hole 1 may not be related to those

at Hole 3. Field inspections of the toe of the slope did not confirm existence of Circle 2. Expansion shoes on Pier 1 were not tilted, and evidence of soil "flow" around the base of the pier was not found.

A shallow failure surface similar to Circle 3 may exist along the centerline slope as shown in Figure 23. This circle would explain the displaced guardrail immediately behind both sides of the abutment and the depressions between the abutment and soil directly in front of the bridge. This circle may also explain some of the movement near the top of Hole 1.

Table 7 shows that Berms 1 and 2 improve the stability of Circle 3 from a factor of safety of 0.897 to 1.419. In contrast, the stability of Circles 1 and 2 improves only slightly. The Licking River limits the amount of berm material which can be placed to resist movements of Circles 1 and 2. However, these circles appear to be stable because of the retaining-wall effect of Pier 1.

Figure 23. Centerline Cross Section, Critical Circles.

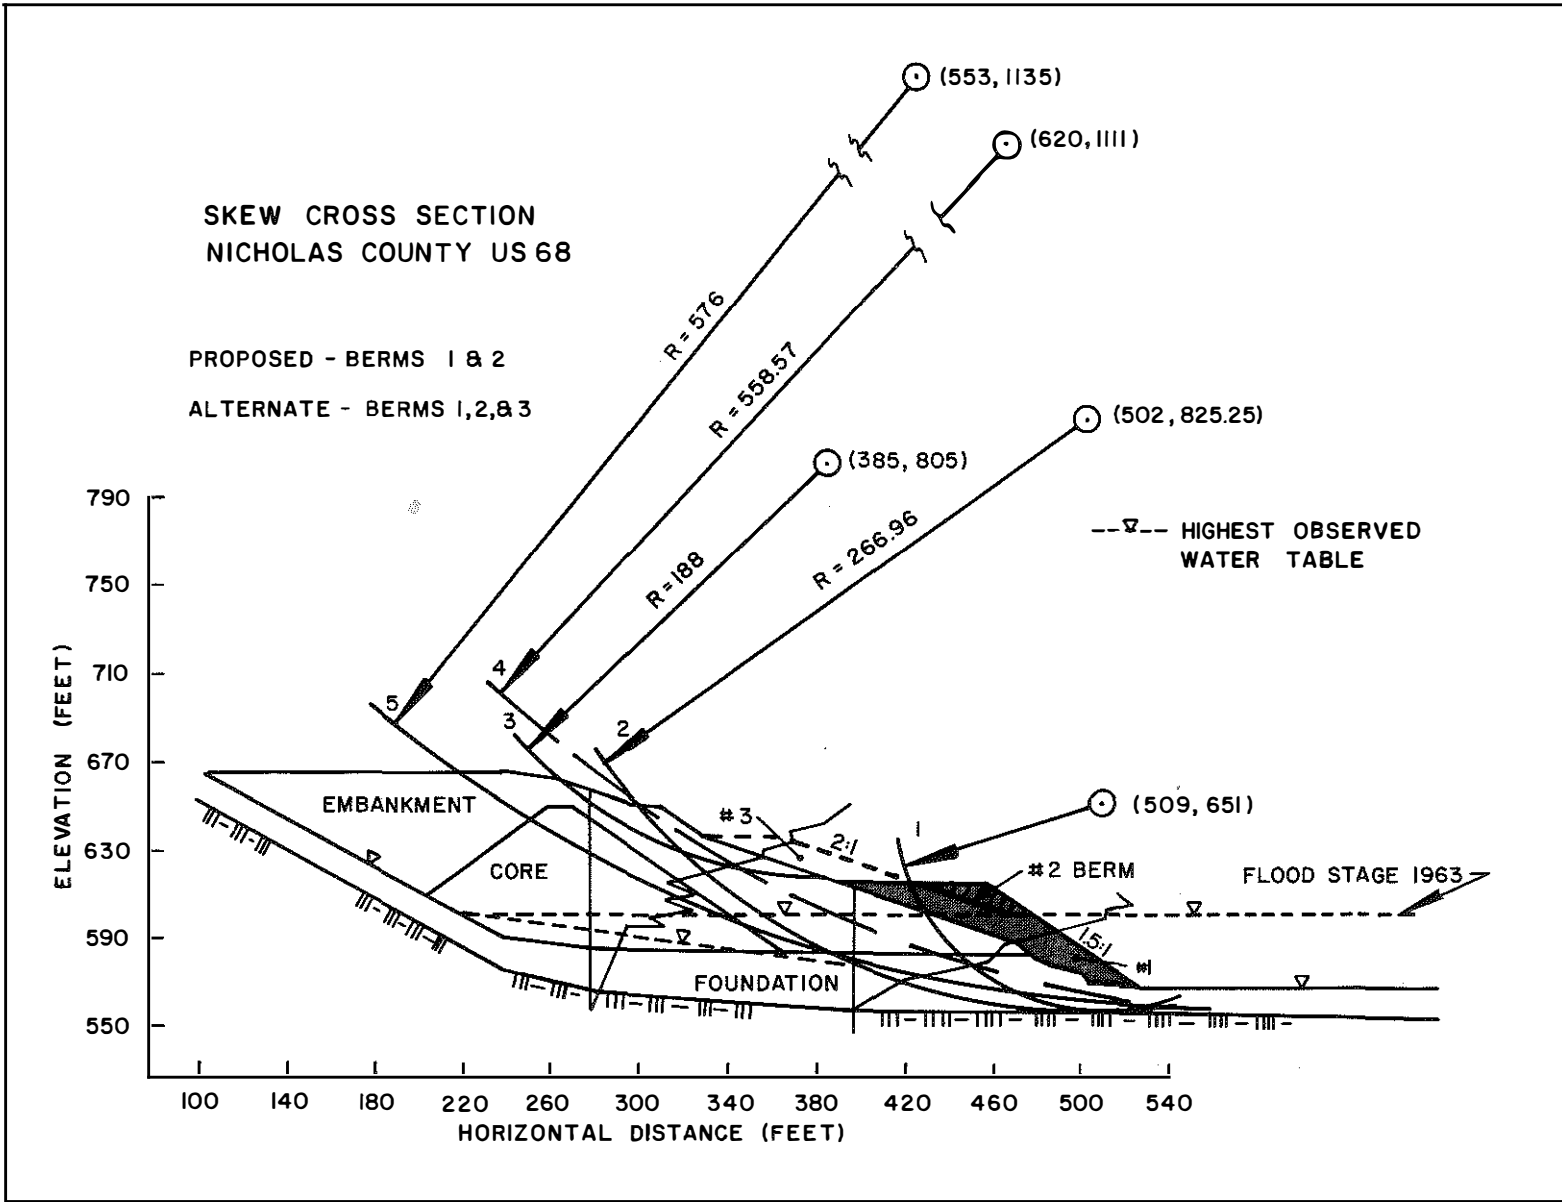
The critical circles for the cross section taken skew to the centerline are shown in Figure 24 along with suggested berm configurations. This cross section approximately parallels the directions of slope inclinometer movement given in Figure 10. Of the critical circles found on this cross section, only the toe circle (Circle 1) had a factor of safety less than 1.0. This is because a substantial portion of Circle 1 lies below the water table. The location of the water table as it intersects the original

Circles 3 and 4 are relatively shallow and have factors of safety greater than one. Table 8 shows that only the stability at Circle 4 would be improved with the addition of Berms 1 or 2. In contrast, the stability of Circle 3 is not affected. In any case, field inspections have revealed no evidence that these circles exist. However, while the addition of Berm 3 greatly improves the stability of Circle 3, Table 8 shows a reduction in the stability of all other critical circles, in particular, Circle 1. Unless definite field evidence is found for the existence of Circle 3, only Berms 1 or 2 should be used.

Figure 24. Skewed Cross Section, Critical Circles.

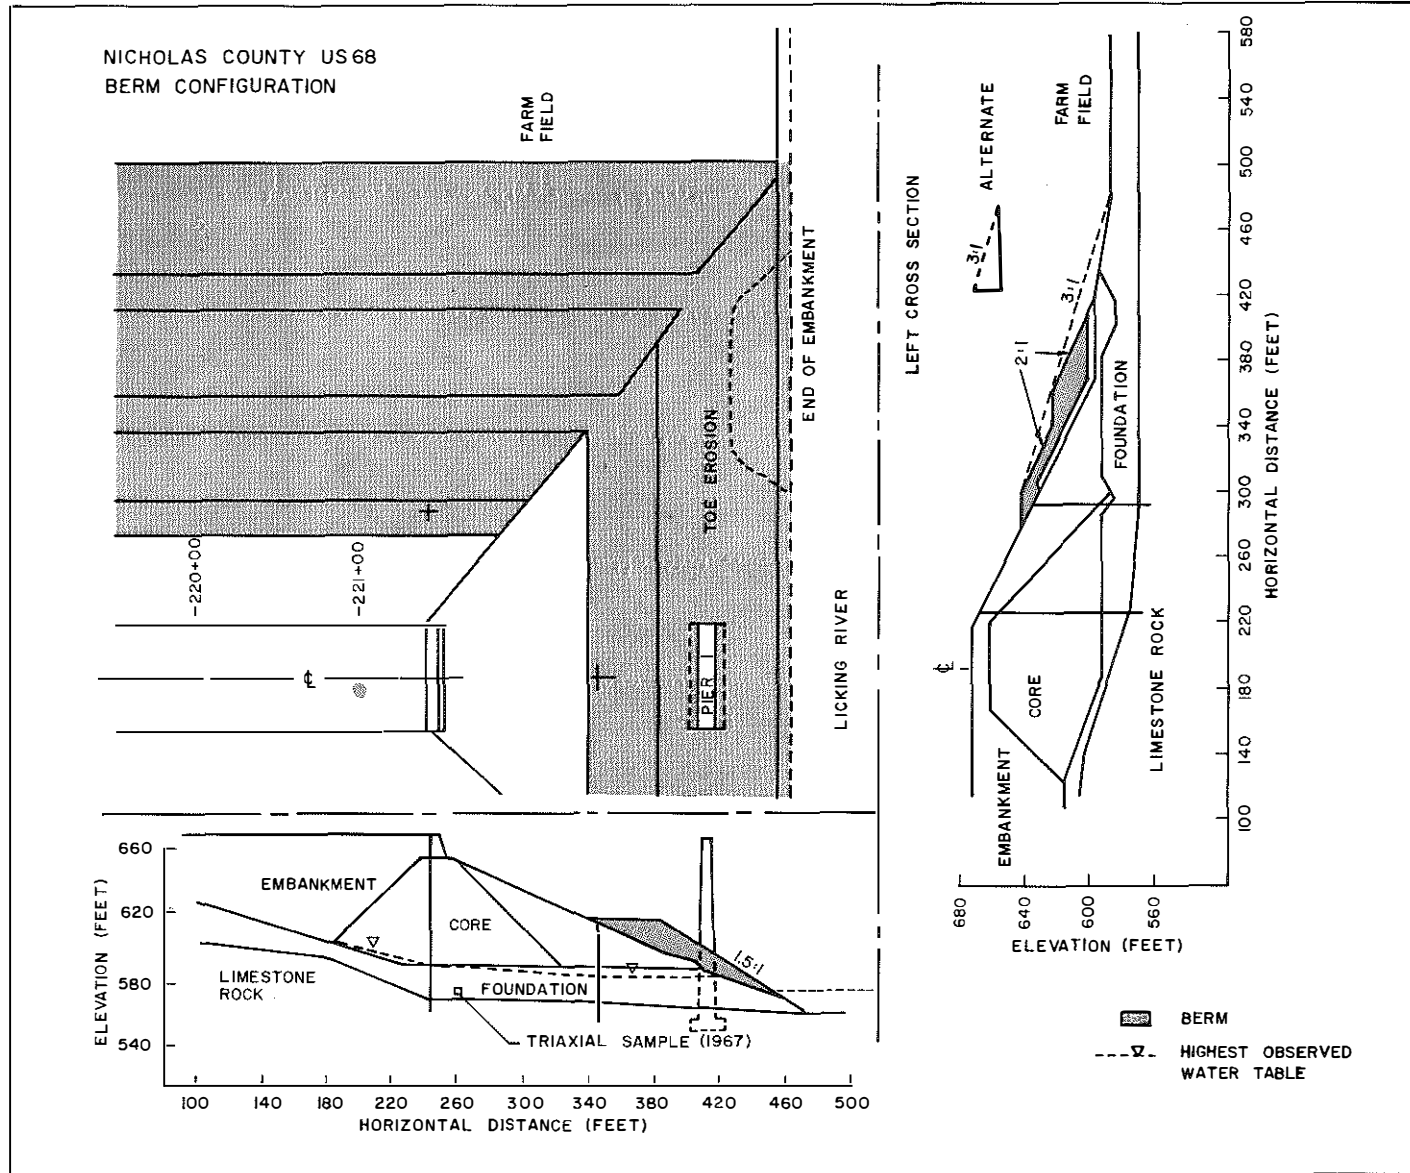
Figure 25. Proposed Berm Configuration for West Embankment of US 68 over the Licking River.

Figure 25 summarizes the measures proposed for correcting the possible circular modes of failure. The cross section left of centerline is the most critical. If right-of-way limitations permit, a berm with a 20-foot (6-m) bench and a 3:1 slope should be built from the original 635-foot (194-m) groundline elevation of the left cross section. In addition, a berm with a bench of approximately 40 feet (12 m) and having a 1.5:1 slope should be built from the 615-foot (187 m) elevation along the embankment of the Licking River. Efforts should be made to extend this berm as far past the river bank as possible.

To stabilize the approach embankment and increase the safety factor to an acceptable limit, it is proposed that the berm and lightweight fill configurations shown in Figures 25 and 32, respectively, be constructed. The berms should be constructed first to stabilize against the circular modes of failure shown in Figures 22, 23, and 24. Berms should be constructed of free-draining materials (sound limestone or a comparable material) having a minimum ϕ' of 30 degrees. If right-of-way limitations permit, the berm left of centerline should be constructed with a 3:1 slope from a 20-foot (6-m) bench at 635-foot (194-m) elevation. If a free-draining material is used, the use of the drainage blanket is optional. If a drainage blanket is constructed, a 36-inch (0.9-m) blanket of No. 9 stone should be placed against existing slope below the 625-foot (190-m) elevation as shown in Figures 22 and 25. Provisions should be made for drainage of the upper flat reaches of each berm. A collector system should be used to funnel all excess water to drainage pipes. Water should be channeled into existing paved ditches. A perforated pipe should be placed in the trenches shown in Figures 22 and 25 at the toe of the left-of-centerline cross section and backfilled with rock or any other free-draining material. The face of the berm along the river should be protected with rip rap at least 2 feet (0.6 m) in thickness. This blanket should extend several feet upstream and downstream from the embankment area to minimize erosion.

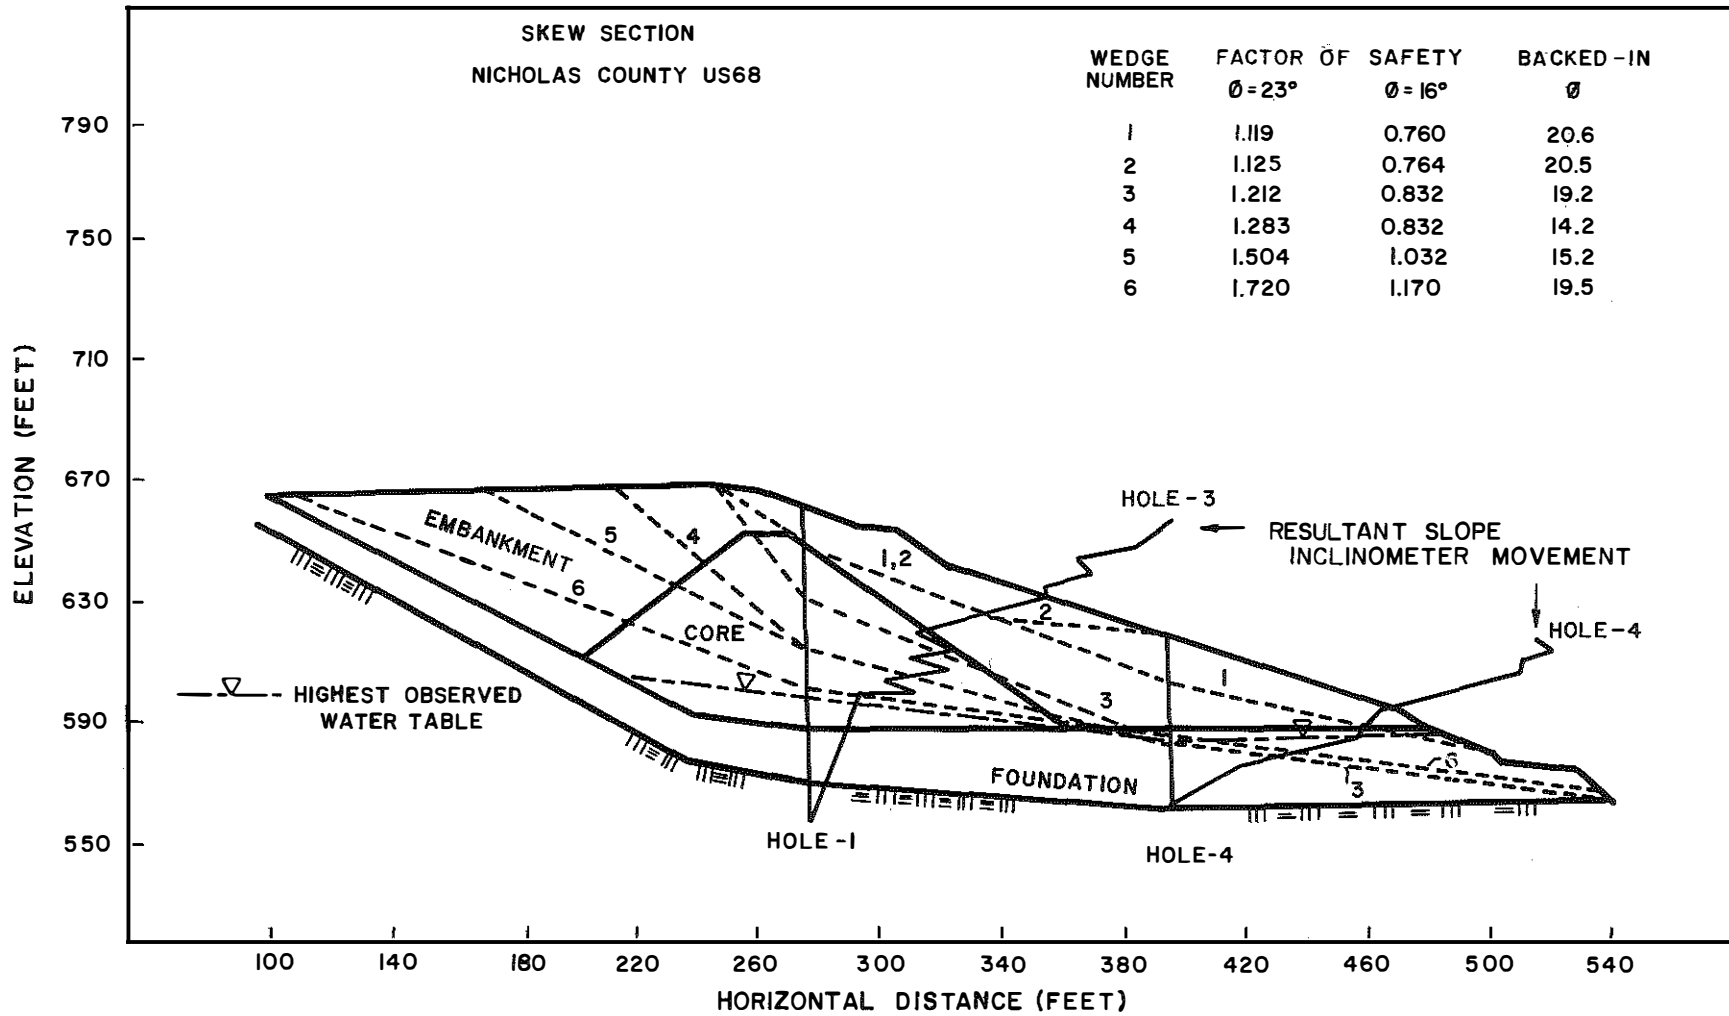
best correlated with slope inclinometer movements and observed guardrail displacement. This was best explained by Wedge 6 of Figure 28. Angles of 21.5 and 8.5 degrees with the horizontal for the two planes of sliding of Wedge 6 were used. A length of 184.7 feet (56.3 m) was used for the top sliding surface. The slope of the groundline was approximately 20.5 degrees. The pore pressure parameter, ru , was set equal to 0.05 to approximate the effect of the water table at the highest observed well elevations. A friction angle of 16 degrees was assumed; zero pounds per square foot (0 kg/m³) was assumed for cohesion. The internal friction was obtained from consolidated-undrained direct shear tests and used as the residual value of ϕ^r . When plane-strain conditions are assumed, Wedge 6 has a factor of safety of 1.170. When ICES Lease⁴ approximated Wedge 6 as a circle, a factor of safety of 1.15 was obtained.

The skewed cross section in Figure 28 lies on the intersecting edge of the cross sections in Figures 26 and 27. The section properties change significantly in the direction perpendicular to the plane of Figure 28. consequently, too much error results in the assumption of a plane-strain situation. Instead of assuming plane-strain, weights of the sliding block above each failure plane were used. In addition, because the use of berms to increase stability was limited by the proximity of the Licking River, a design using a lightweight fill was investigated.

Figure 28. Skewed Cross Section, Critical Wedges.

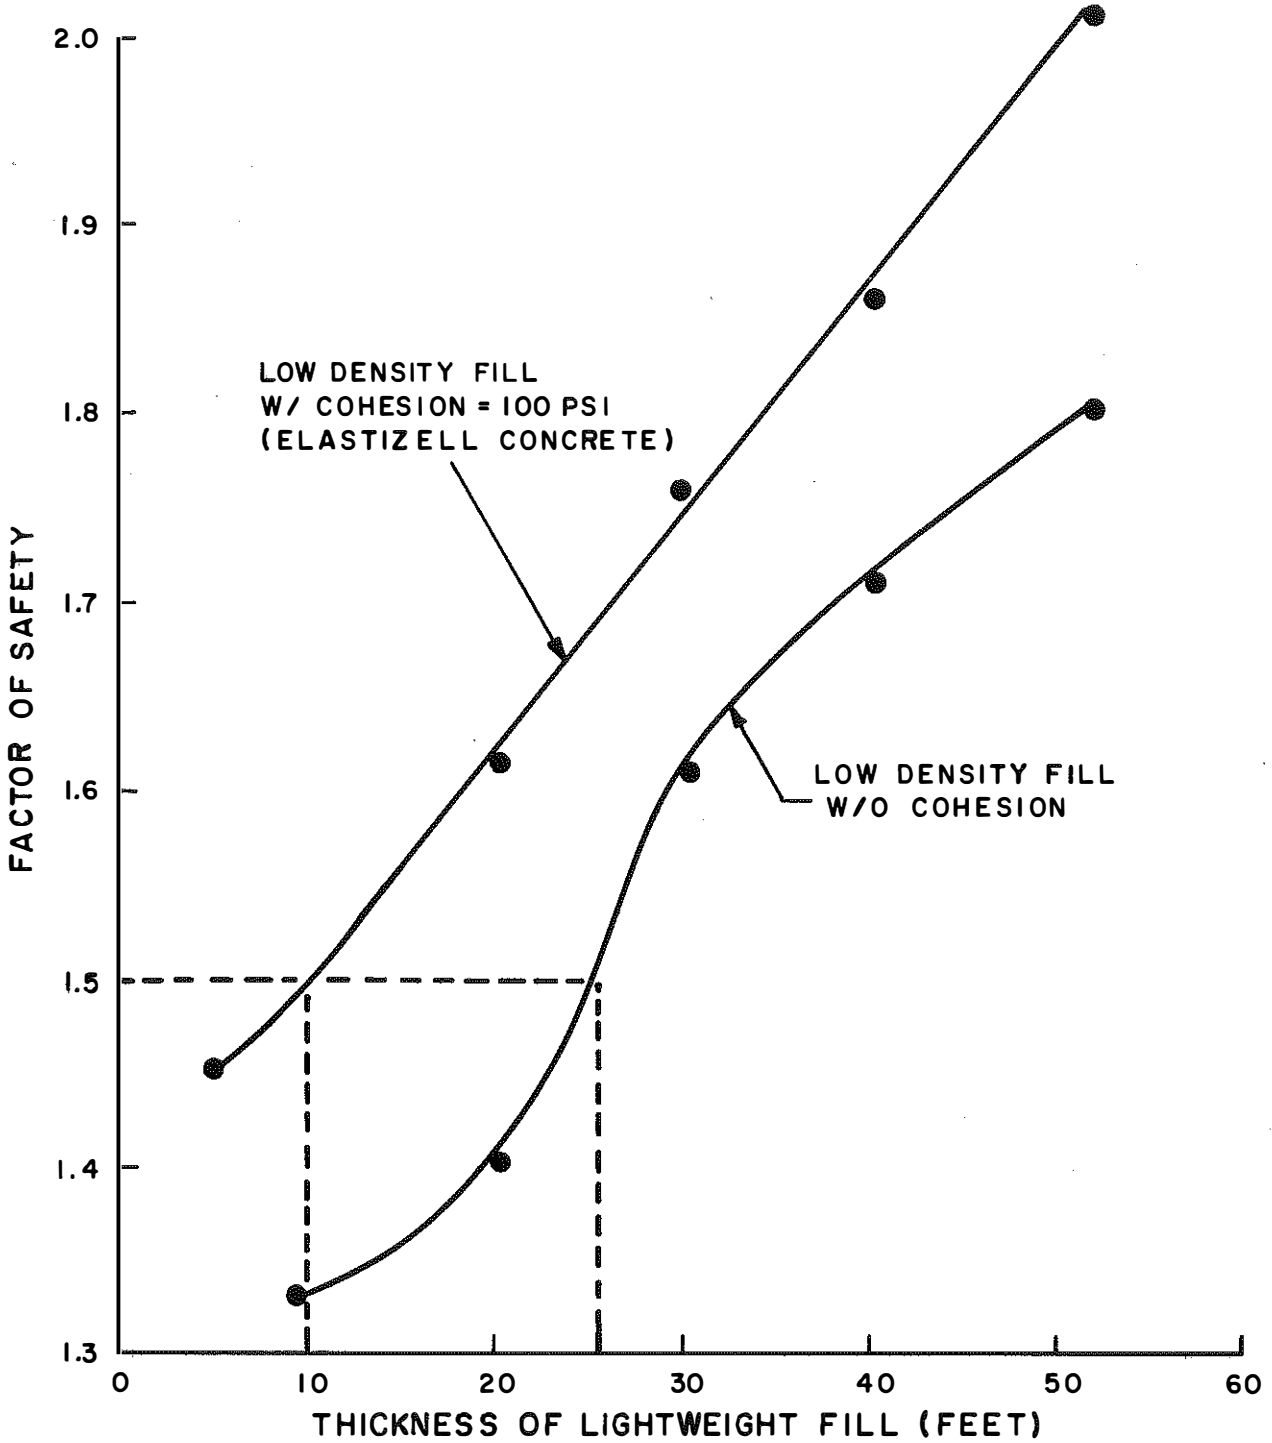
Figure 31 summarizes the factors of safety obtained for different thicknesses of lightweight fill. Figure 31 shows that a cohesionless, lightweight fill configuration requires a thickness of at least 27 feet (8 m) to yield a factor of safety of 1.5. A lift of at least 30 feet (9 m) should be used in design. In contrast, a cohesive, lightweight (Elastizell concrete) fill configuration requires a thickness of only 10 feet (3 m) to give the same factor of safety. Figure 32 details the proposed lightweight fill configurations. The cross sections for the left and centerline wedges were estimated from observed guardrail and slope indicator movement.

Figure 31. Summary of Factors of Safety as a Function of Thickness of Lightweight Fill Material (Density of 55 Pounds per Cubic Foot (880 kg/m³)).

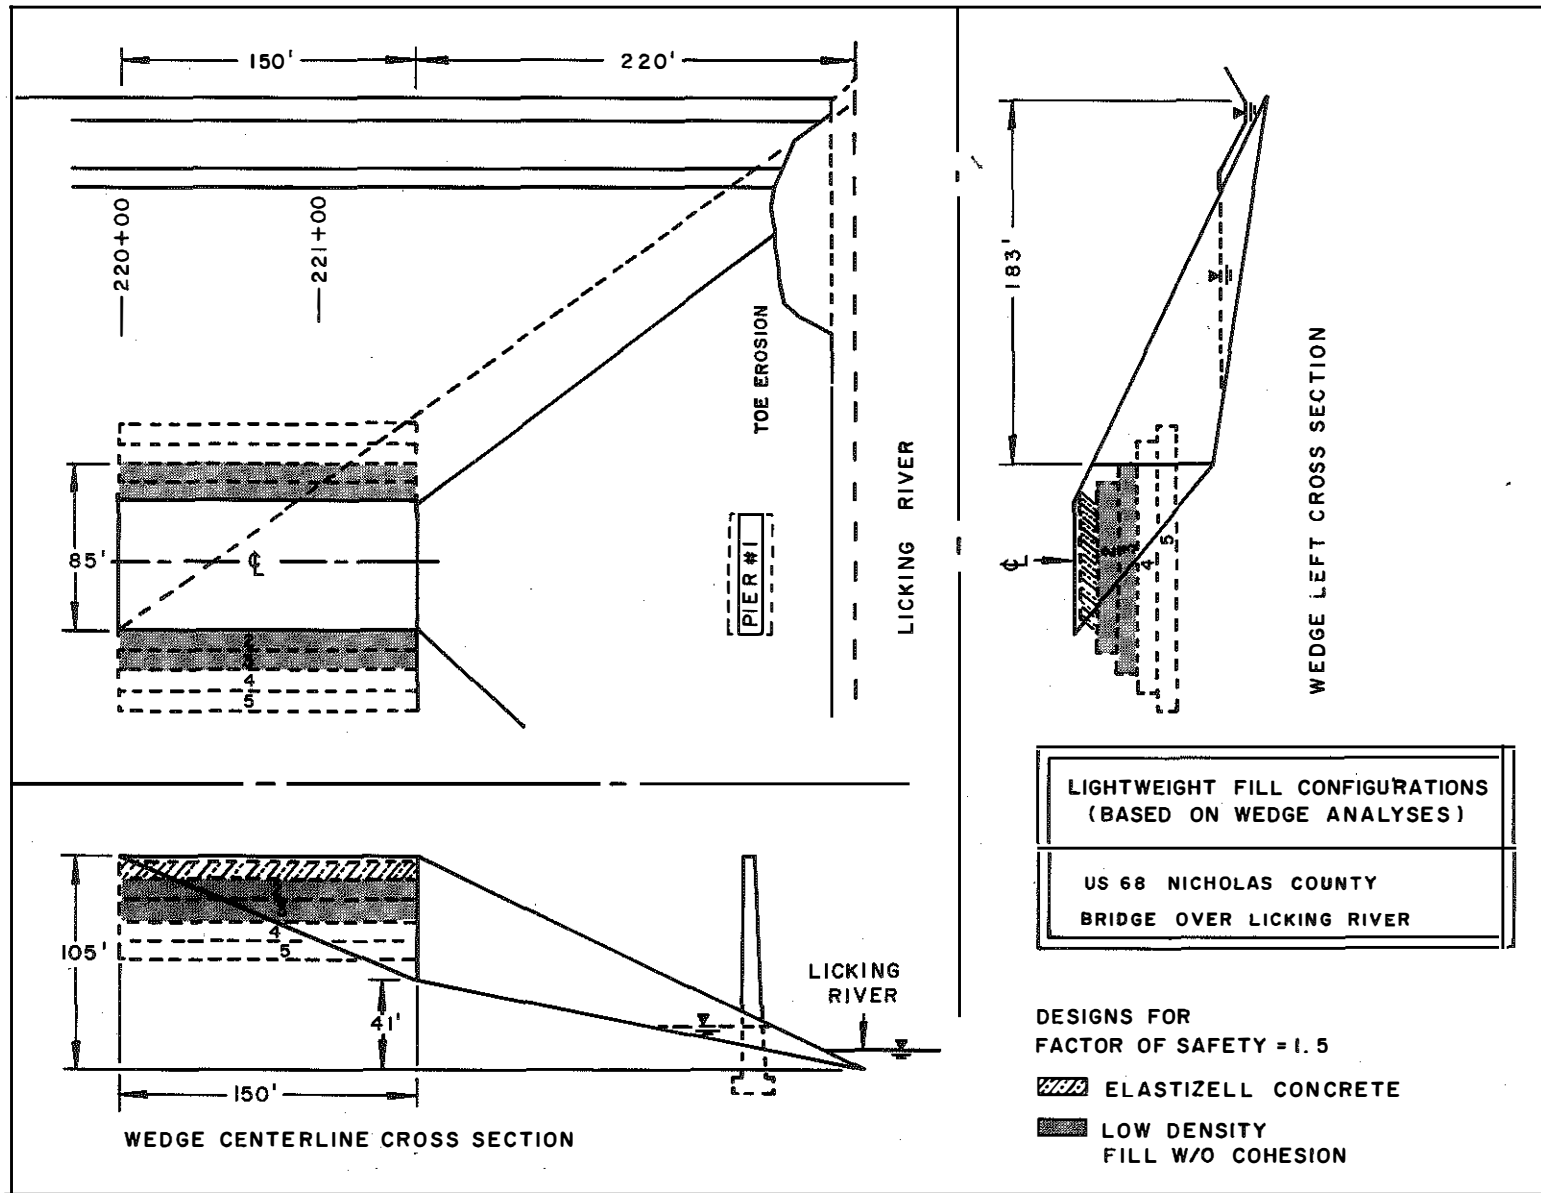
Figure 32. Proposed Lightweight Fill Configurations.

Upon completion of the proposed berms, slope inclinometer data should be obtained to evaluate effectiveness of newly constructed berms. A decision should be made then on whether to proceed with one of the lightweight fill configurations proposed in Figure 32 to increase the stability of the embankment against the deep-seated wedge failure shown in Figure 30. Replacement of a portion of the upper reaches of the approach embankment with lightweight material will require closing the bridge and rerouting traffic over the old US-68 bridge. In addition, about 200 feet (60 m) of the present roadbed would have to be removed and rebuilt after placement of the lightweight fill. The lightweight fill configurations (cohesionless or cohesive) should have dimensions shown in Figure 32 to insure a safety factor of 1.5. In both cases, the fill material should not have a density greater than 55 pounds

per cubic foot (880 kg/m³). Provisions should be made to include temperature reinforcement to prevent excessive cracking in lightweight concrete fill (e.g. Elastizell). Finally, measures should be taken to insure that the lightweight fill is properly drained.
