SUBJECT: Report on Stability Analysis of Slide at Milepost 152.7, I 64, Carter County

Research Report
372

**STABILITY ANALYSIS OF SLIDE
AT MILEPOST 152.7, I 64, CARTER COUNTY**

KYP-72-38; HPR-1(9), Part III

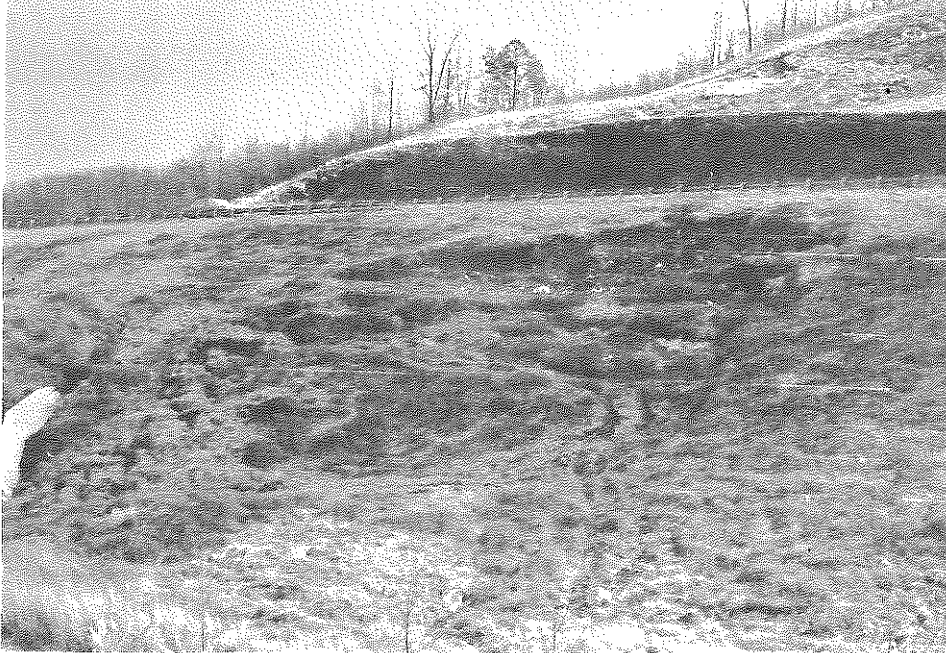
Cross sections of the slide were taken near Station 3483+00 to establish an existing ground line and to define the major cracks. The sliding section begins (see Figures 1, 2 and 3) approximately 78 feet from centerline at Station 3483+00 and extends to the right and left about 50 feet. At mid-slope on the east end of the slide area, slope movement has partially covered

a small outlet headwall and filled the paved ditch (Figure 1). Water is running from the pipe into the slip area at this point.

Figure 1. General View of the I-64 Embankment Failure Located Near Milepost 153, Station 3483+00.

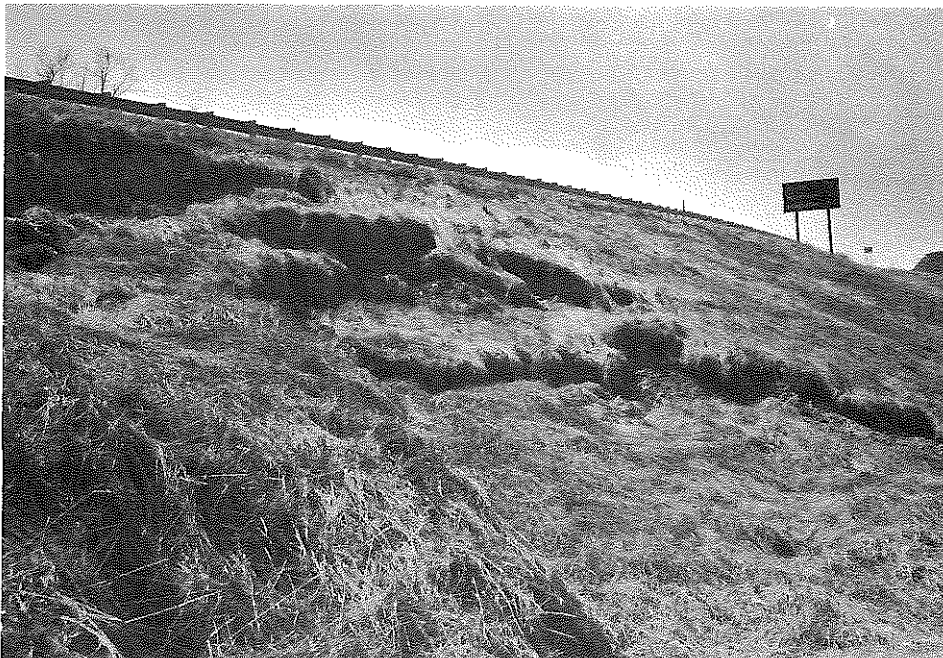
Figure 2. View of Surface Breaks Located at the Western Flank of the Embankment Failure.

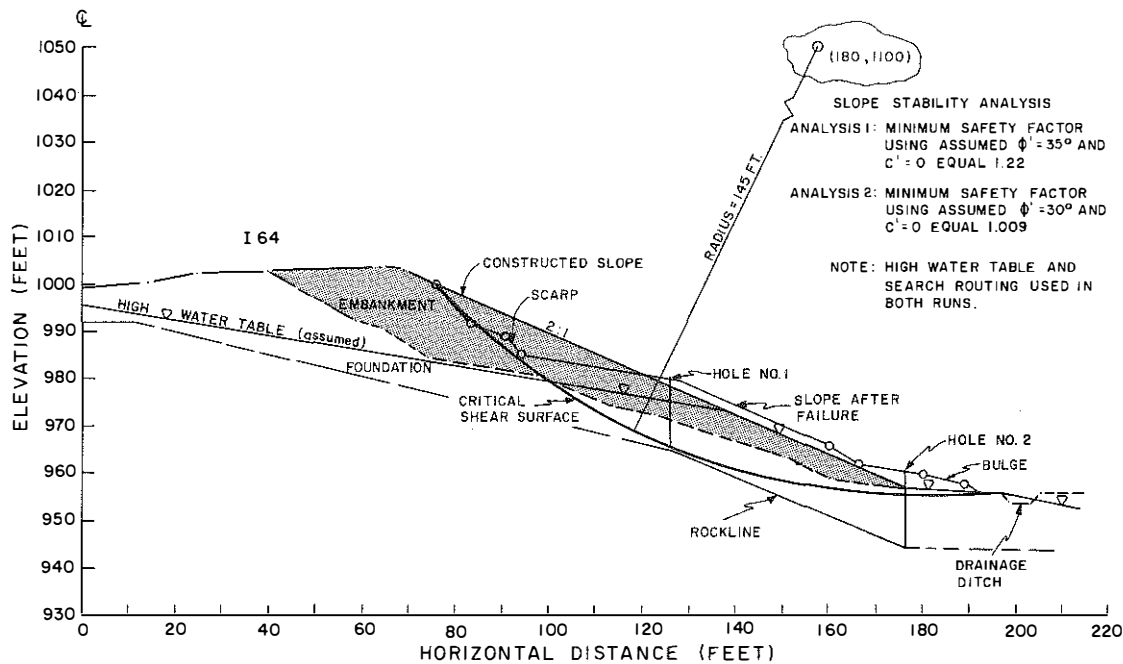
Borings (Figure 4) were obtained at Station 3483+00 on the slope and in the toe area of the slide using a drill mounted on a dozer. Hole 1 was located 126 feet from centerline in the upper portion of the unstable mass (Figure 3). The embankment consists of a brown clay with weathered shale. The foundation is soft sandstone overlaying a green weathered shale formation common to the area. Hole 2 is located 176 feet from centerline at the toe of the slide. The material in this area is some 18 feet thick and consists of brown clay, red weathered shale, and sandstone. Three Shelby tubes obtained from this hole produced four undisturbed triaxial specimens. One tube from Hole 1 produced two undisturbed samples suitable for triaxial testing. Water table elevations were not available and could not be accurately obtained from the boreholes drilled at the site.

1. Assuming a ϕ' -value of 35° (arbitrarily chosen) and a c' -value of zero, the circular failure surface having a minimum safety factor was determined using the search routine of the slope stability computer program (see Analysis 1, Figure 3). The critical failure circle determined in this matter agreed well with actual ground breaks observed at the site. In performing these computations, a reasonably high water table was assumed. Position of the critical surface did not change when the water table was lowered.

2. Using the critical circle determined in Step 1 and a high water table, the ϕ' -value was adjusted until the safety factor was equal to 1.00 (see Analysis 2, Figure 3). In these computations, the cohesion, c' , along the failure surface was assumed to be zero since the unstable mass had moved a considerable distance. It was assumed that, since the slope was failing, the safety factor was by definition equal to one. The ϕ' -value determined in this manner was 30° .

3. Using the adjusted ϕ' -value of 30° , corresponding to a safety factor of 1.00, and the assumed high water table, a grid-type search operation was used to determine the critical shear surface (see Analysis 2, Figure 3). The critical shear surface determined in this manner and the one from Step 1 coincided.

Figure 3. Cross-Sectional View of Embankment Failure at Station 3483+00 Showing Boring Locations and a Comparison of the Failed Slope and the Critical Shear Surface Obtained from the Slope Stability Analysis.

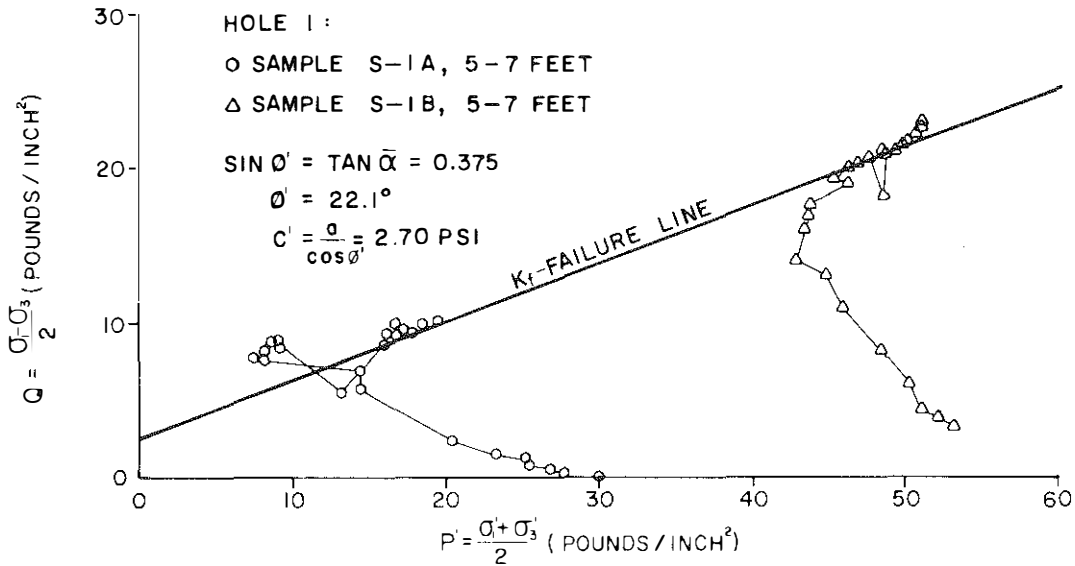
Shear strength parameters of the embankment and foundation soils were established from consolidated, isotropic, undrained triaxial tests (CIU') with pore pressure measurements. Triaxial test results for the embankment and foundation materials are shown in Figures 5 and 6, respectively. The unstable embankment material from Hole 1 had an angle of shearing resistance, ϕ' , of 22.1° and a cohesion, c' , of 2.70 pounds per square inch. Foundation soils from Hole 2 located near the toe of the slip had a ϕ' -value of 28.5° and a high cohesion, c' , of 4.55 pounds per square inch. The limited number of samples successfully recovered prevented further testing and confirmation of these values. Classification results of the soils are recorded in Table 1. Generally, the soils in the slide area are heterogeneous. Liquid limits of materials from Hole 2 ranged from 30 to 43 percent; plasticity indices ranged from 10 to 21 percent.

$$\sin \phi' = \tan \bar{\alpha} = 0.375$$

$$\phi' = 22.1^\circ$$

$$c' = \frac{q}{\cos \phi'} = 2.70 \text{ PSI}$$

Figure 5. Consolidated, Isotropic, Undrained Triaxial Test Results, Embankment Soils, Hole 1.

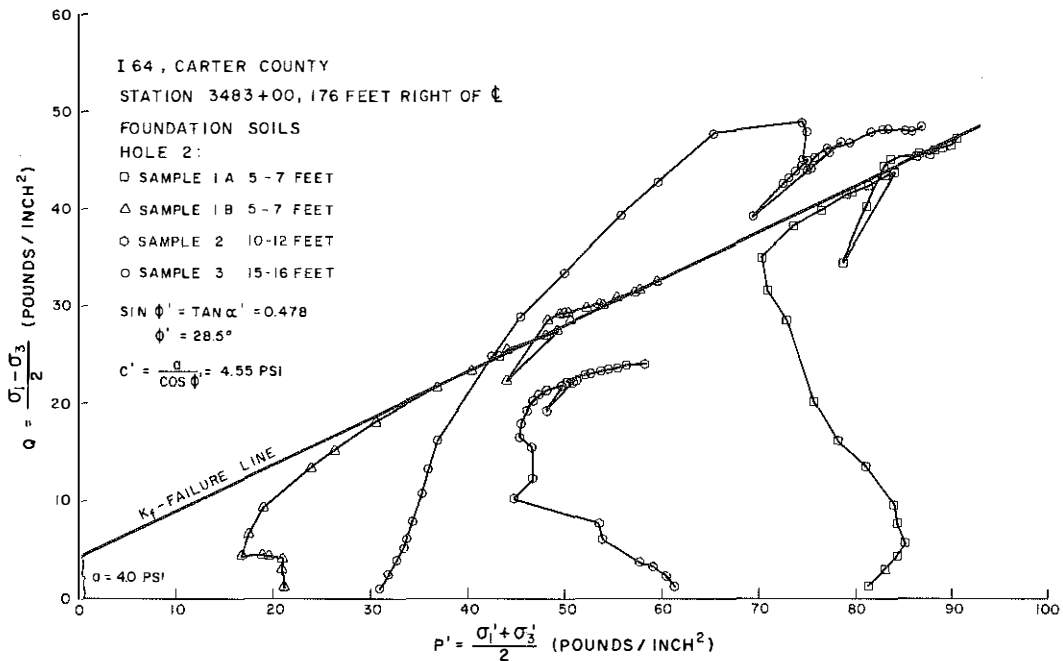
Figure 6. Consolidated, Isotropic, Undrained Triaxial Test Results, Foundation Soils, Hole 2.

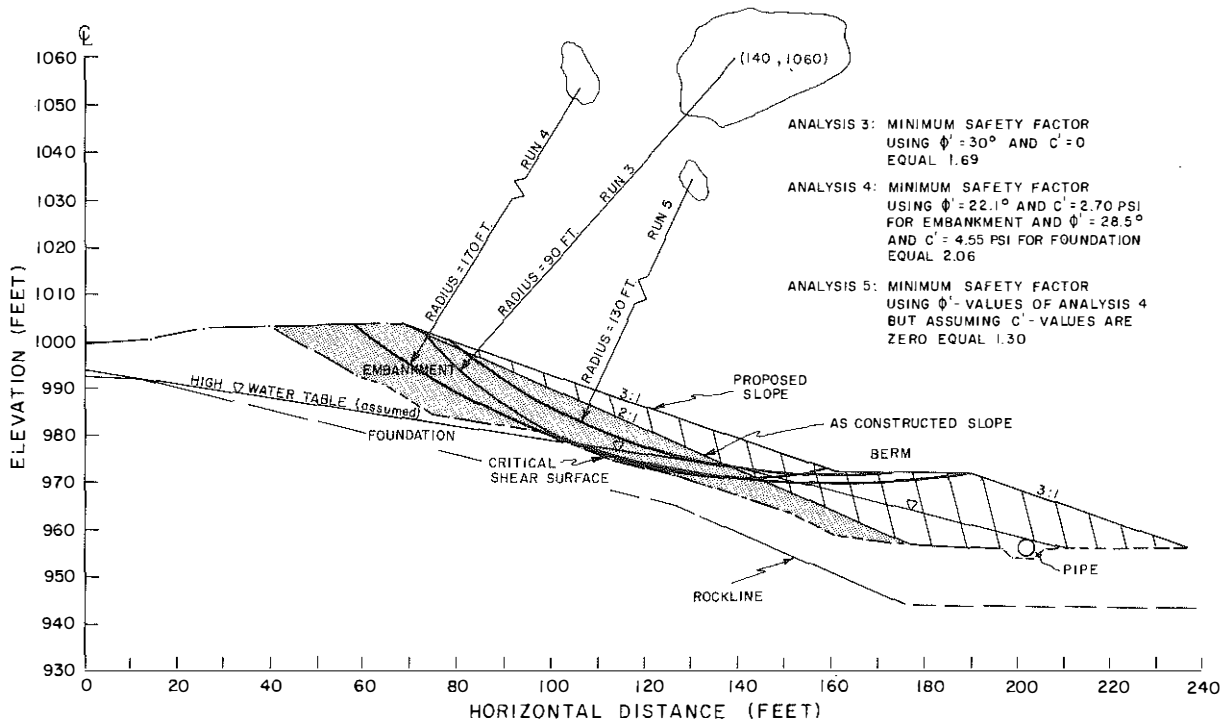
4. Finally, using the adjusted ϕ' -value (30°) corresponding to a safety factor of 1.00, the assumed high water table, and a c' of zero, stability of the proposed embankment-berm configuration was checked as shown by Analysis 3, Figure 7. A ϕ' -value of 30° was assumed for the proposed berm materials. The minimum safety factor obtained from the computer program's search routine was 1.69. The second method of checking the stability of the

proposed berm involved using the shear strengths of the slide materials determined from the CIU' triaxial tests (Figures 5 and 6). For this case, the minimum, long-term safety factor obtained from the computer program's search routine was 2.06 (see Analysis 4, Figure 7). Finally, stability of the embankment-berm configuration was checked based on the assumption that the cohesion, c' , obtained from the CIU' tests might decrease to zero at some future time. For this case (Analysis 5, Figure 7) the safety factor was 1.30.

Figure 7. Stability Analysis of the Embankment-Berm Configuration Based on Computed Shear Strengths and Shear Strengths from CIU' Triaxial Tests.

Using a 3:1 slope on the existing embankment and by adding a berm 15 feet high and approximately 30 feet wide at the toe, the critical safety factor can be increased to 2.06 (Analysis 4, Figure 7) at the assumed high water level. The berm should extend from Station 3481+00 to 3484+00, as previously recommended. Since embankment stability in this area is extremely sensitive to moisture, provisions should be made to properly drain the berm and embankment. A drainage blanket of No. 9 stone 24 inches thick placed against the existing embankment below the 980-foot elevation should permit ground water drainage without berm saturation. A surface collector system draining into a pipe placed at the embankment toe in the existing paved ditch should further reduce soil moisture content at the site.

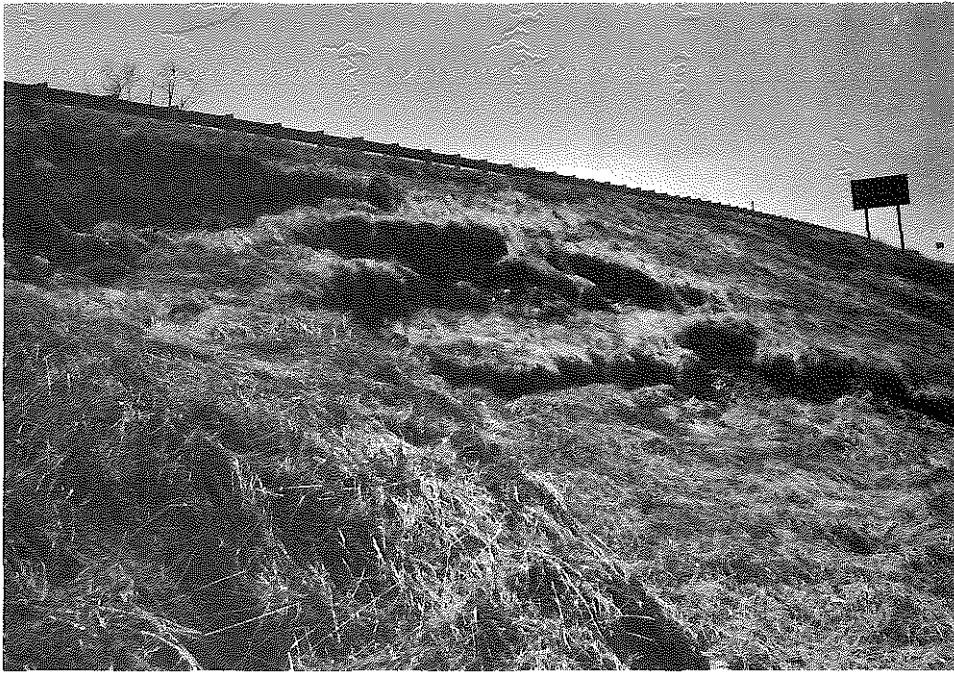
Figure 1.

An inspection of the area was made April 11, 1972, and documented in a memo prepared by B. H. Banks on April 12. Since that time, cross sections have been taken and a slope stability analysis run at Station 3483+00 (Figure 1). The analysis shows a design fashioned after the recommendations of the inspection team to be in order. A berm approximately 27 feet wide and 15 feet high and having a slope of 3:1 merging into natural ground and the top of the present scarp should provide sufficient stability (Figure 2). The berm should start near Station 3481+00 and continue to Station 3484+00. The upstream and downstream ends may vary in size, but the full section should extend a sufficient distance to cover the existing slide.

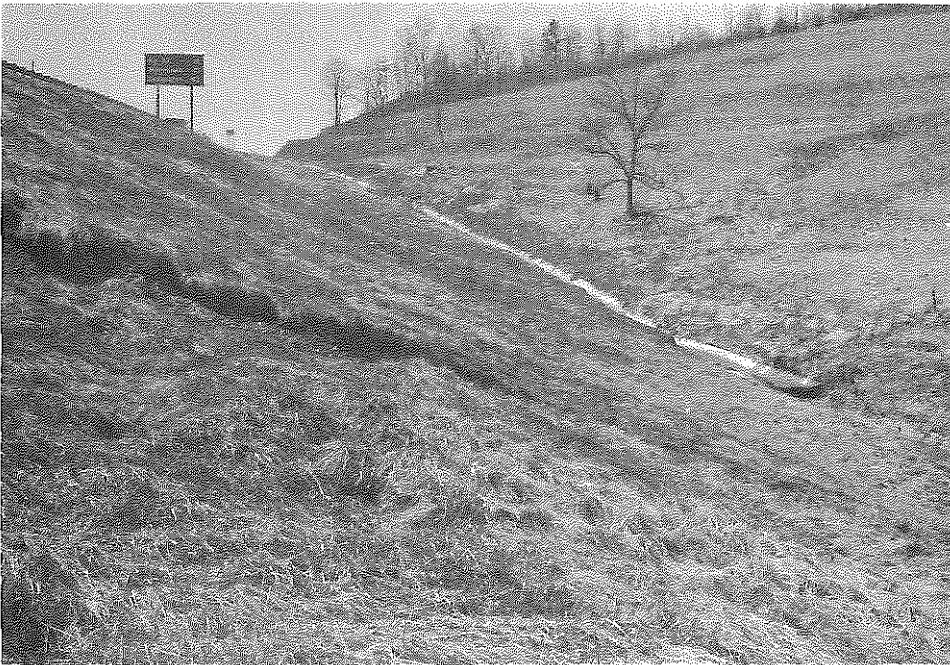
Figure 4.

Attention should also be given to the area approved for borrow. The hill opposite the slide appears to be marked with ancient slides (Figure 4), and it does not seem likely that removal of any support there would be in the best interest of the Department.
