SUBJECT: I 64, Boyd County; MP 188; SP-10-115-29-L; Repair of Unstable Embankment

Research Report
363

STABILITY OF A SIDE-HILL EMBANKMENT

I 64, LEXINGTON-CATLETTSBURG ROAD
Milepost 188, Stations 282+38 to 284+20
Project SP-10-115-29L

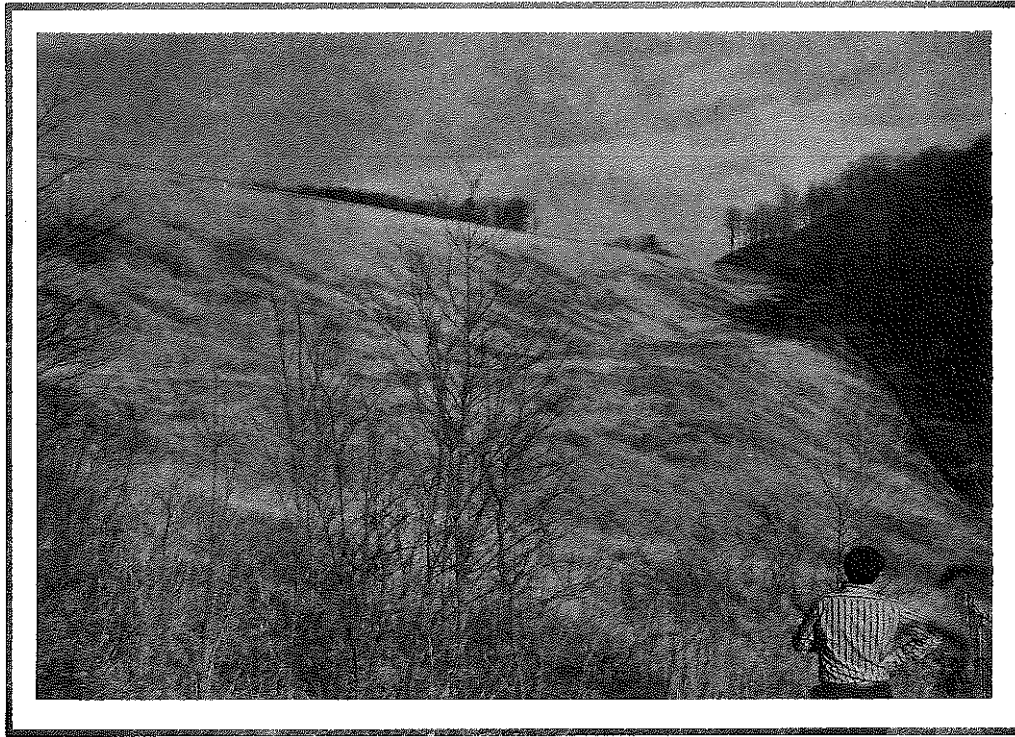
Figure 1. General View of the I-64 Embankment Slip Located Near Station 284+00.

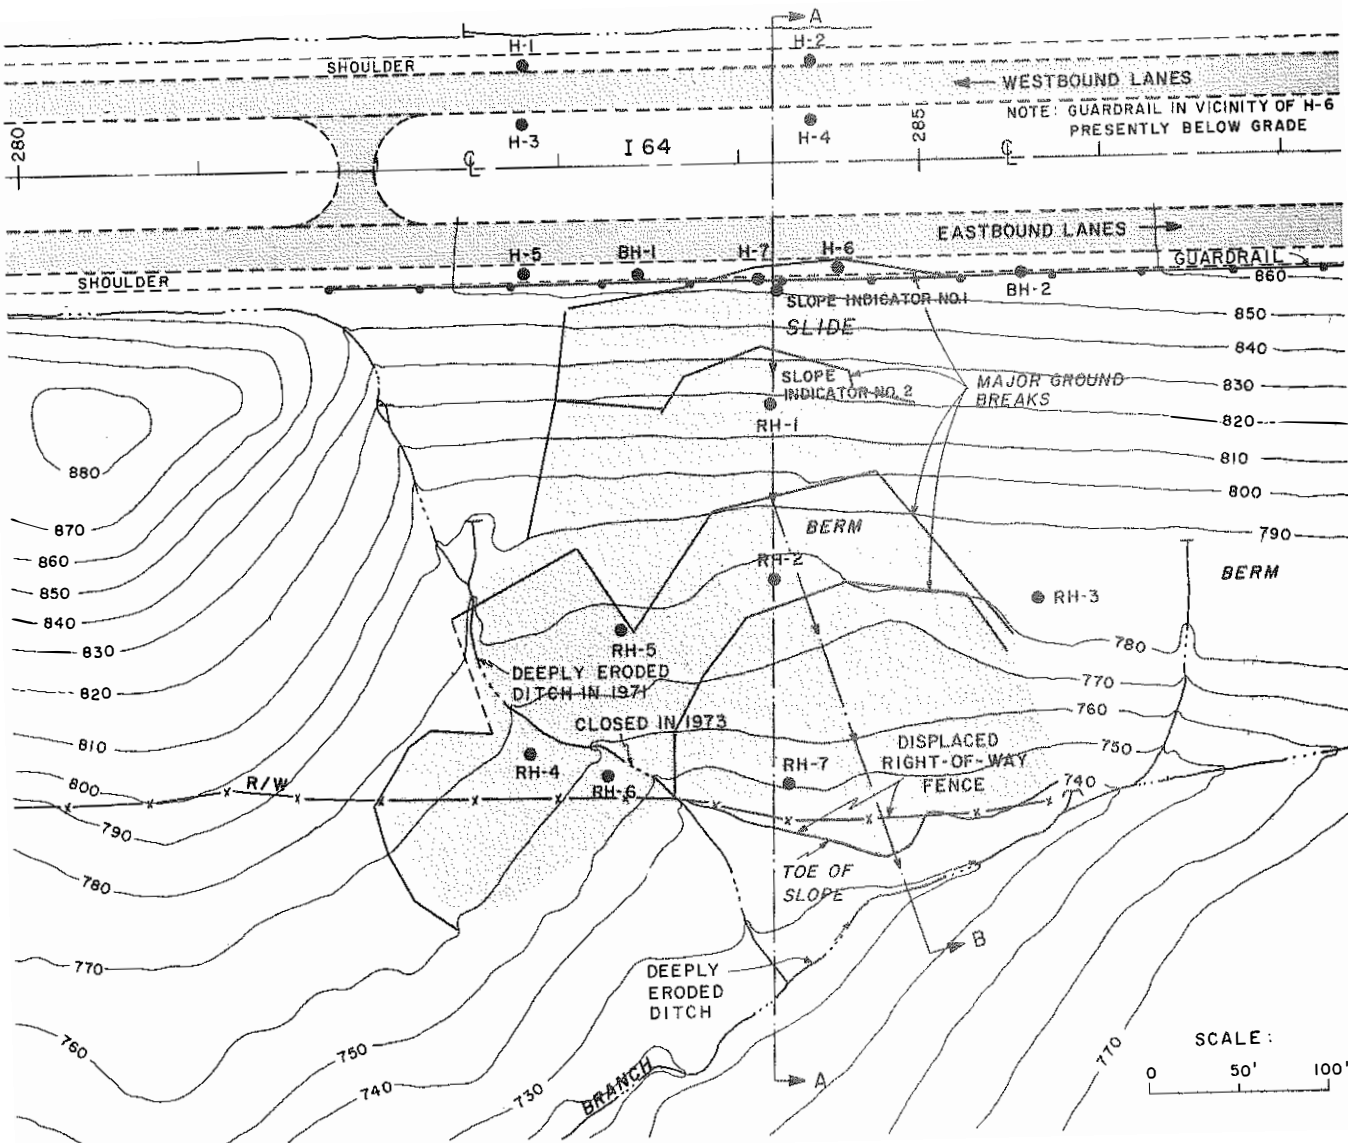
Figure 2. Areal Plan of the I-64 Embankment Slip.

Slide Surface Conditions. Surface conditions observed at the site in early 1973 are depicted in Figure 2. A portion of the surface study was devoted to mapping the limits of the slip. Stadia was used to determine the locations of the major ground breaks and all borings and slope indicator casings. These data were reduced using a computer program and transferred to an aerial topographic map obtained from the Division of Photogrammetry, Bureau of Highways. The mapped data show that there are four major surface breaks in the embankment slip area; a fifth break occurs at the western flank of the slide area.

Nature of Embankment Failure. As shown in Figure 2, the upper portion of the embankment is moving southward and in a direction approximately perpendicular to roadway centerline. The lower half of the unstable mass is moving in a southeasterly direction and about perpendicular to the flowline of the branch located at the toe of the failure mass. The direction of movement is indicated by Section A-B in Figure 2. Surface cracking indicates there are four major failure blocks (numbered 1 through 4 in Figure 3). Three factors contributed to the embankment slip: 1) erosion at the toe of the failure and in a ditch running along the western flank of the slip, 2) intrusion of ground water into the embankment lowering the shear strength of the soils in the slip area, and 3) marginal stability of the original embankment and berm configuration, that is, oversteepened slopes.

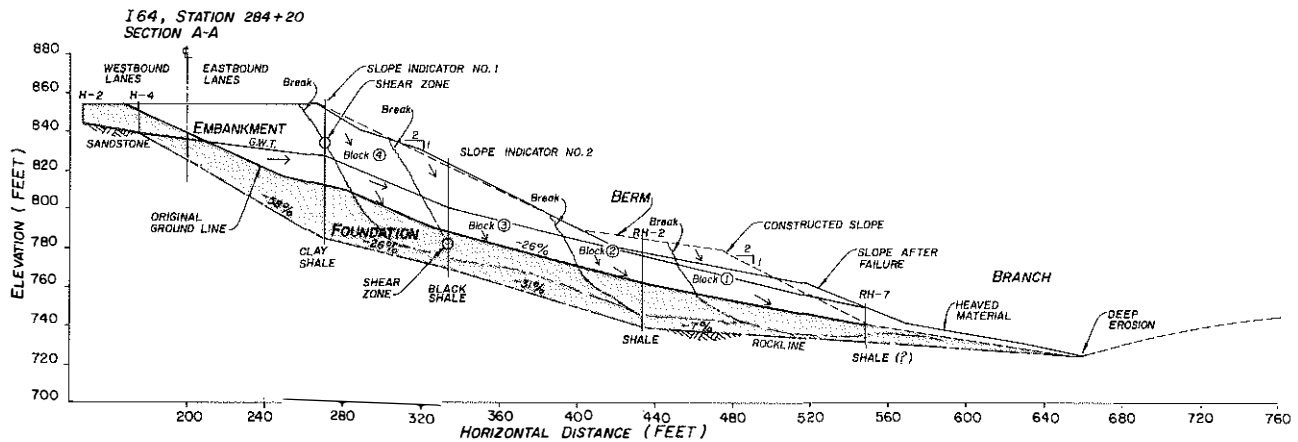
Figure 3. Typical Cross-Sectional View of the I-64 Slip, Station 284+20, Boyd County.

drain at Station 282+00 and a 24-inch pipe at Station 282+50. As shown in Figure 3, the toe of the berm has moved outward (southward) some 20 feet; a deeply eroded ditch is located at the toe of the embankment failure. Other signs of incipient failure were observed in early 1973. The guardrail located on the shoulder of the eastbound lanes has moved outward and downward 1 or 2 feet. The right-of-way fence located at the toe of the berm has moved outward approximately 15 feet. The slide in the berm was observed in 1967 (1).

The slow, progressive failure of the I-64 embankment developed when a slump (Block 1 in Figure 3) occurred in the berm located in the bottom portion of the embankment. This slip occurred in or prior to 1967 (5) and was triggered by erosion in the stream. With downward and outward movement of Block 1, the shear strength of soils in Block 2 were mobilized. Gradually, the failure continued to spread up the embankment slope until the eastbound lanes were affected. Large pavement settlements observed in 1972 were probably due to movement of Blocks 3 and 4 toward the deeply eroded ditch located at the western flank of the slide.

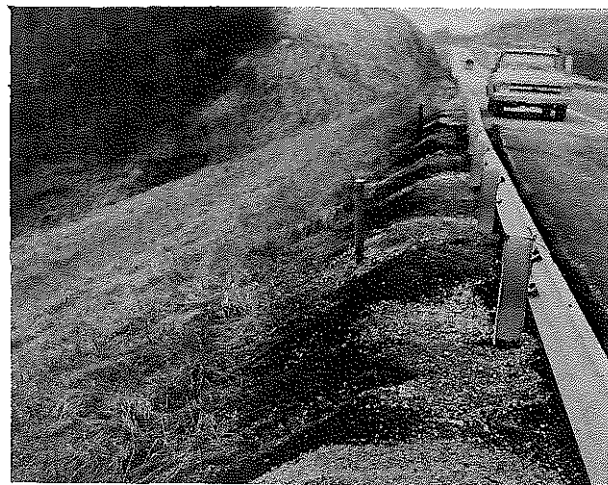
The emergency lane of the eastbound lanes has been patched on numerous occasions (see Figure 4). The deeply eroded ditch running along the western flank of the slip and observed in March 1971 (1) has completely closed. This ditch, which ranged from 3 to 5 feet in depth and measured about 5 feet in width, was formed by large quantities of water draining from a median

Figure 4. View of Patched Pavement.

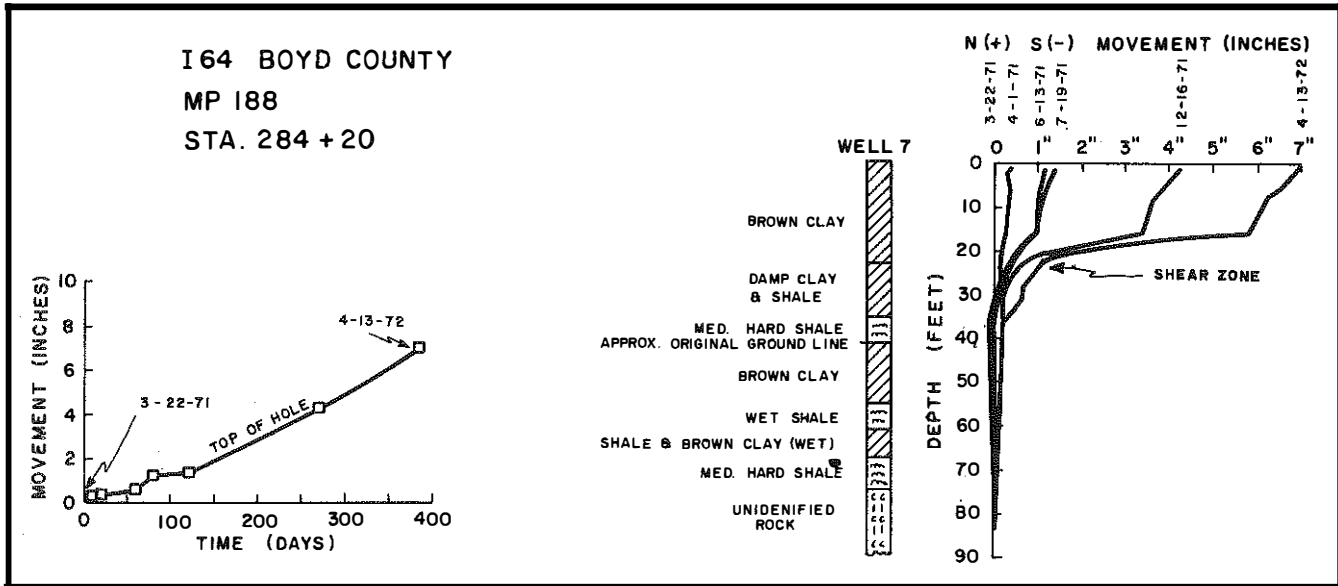
Field Instrumentation. In 1971, slope indicator casing (No. 1 in Figure 3) was installed at Station 284+20, about 70 feet right of centerline (5). During the investigation conducted in February and March 1973, a second slope indicator was installed in Boring RH-1 (see Figure 2). These indicators were installed in an effort to determine the slip zones, rate and direction of movement, and mode of failure of the fill slip. Horizontal resultant movement as a function of depth and resultant movement-time curves for selected depths are shown in Figures 9 and 10. Data obtained from Slope Indicator 2 indicate a shear zone is located approximately 45 feet below ground surface. Slope indicator data obtained from Well No. 1 during the period March 1971 to April 1972 shows a distinct shear plane is located about 20 feet below ground surface. No slope indicator data was obtained from that well after the later date because the casing grooves closed at a depth of about 20 feet below ground surface.

Figure 9. Slope Indicator Results, No. 1.

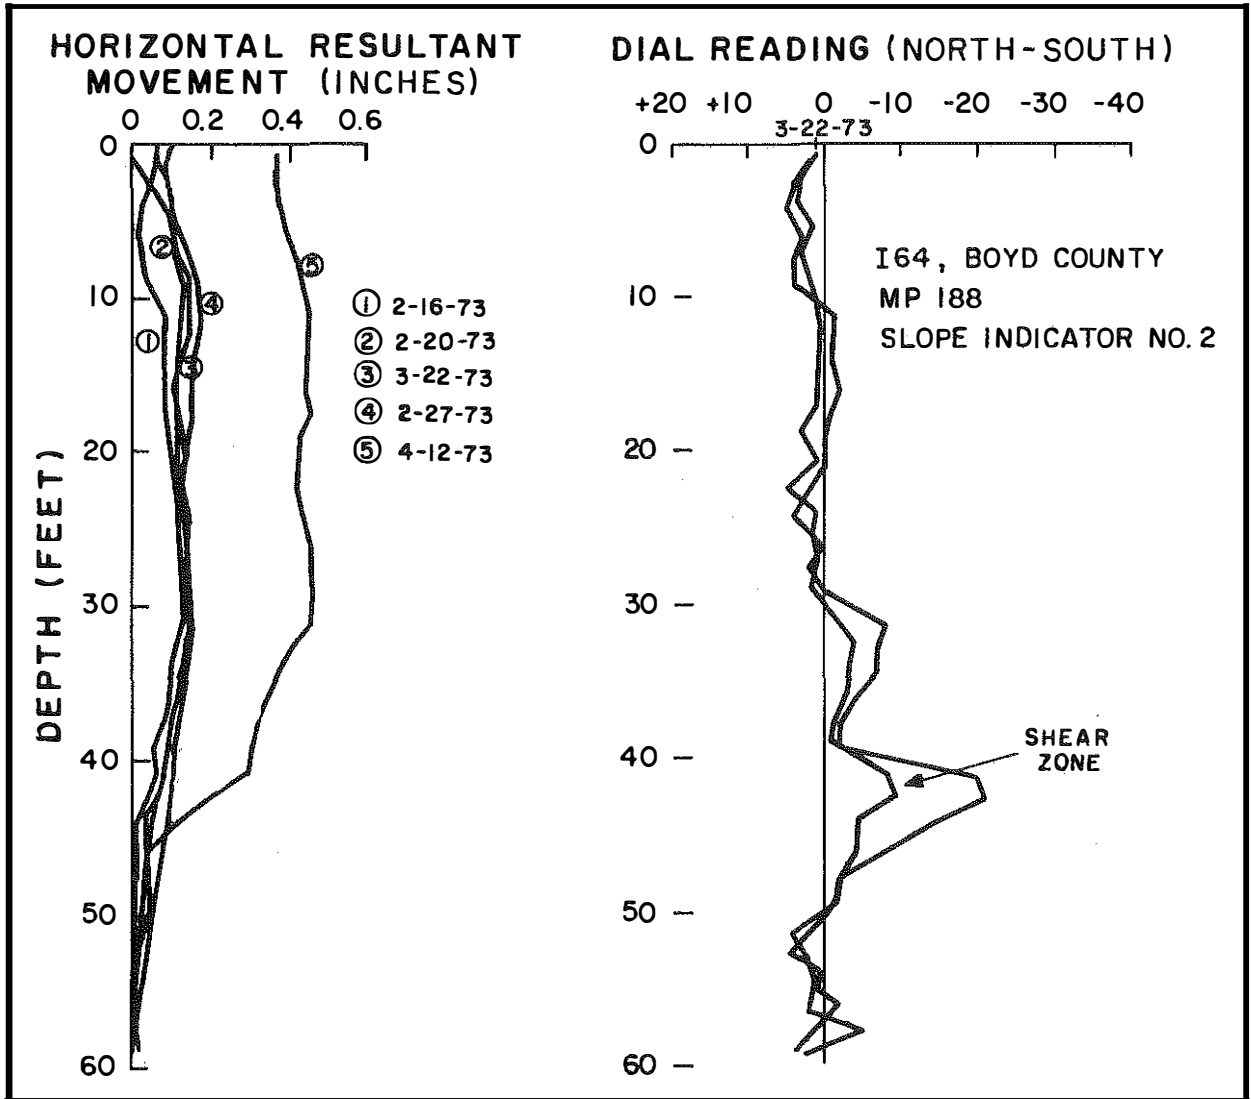
Figure 10. Slope Indicator Results, No. 2.

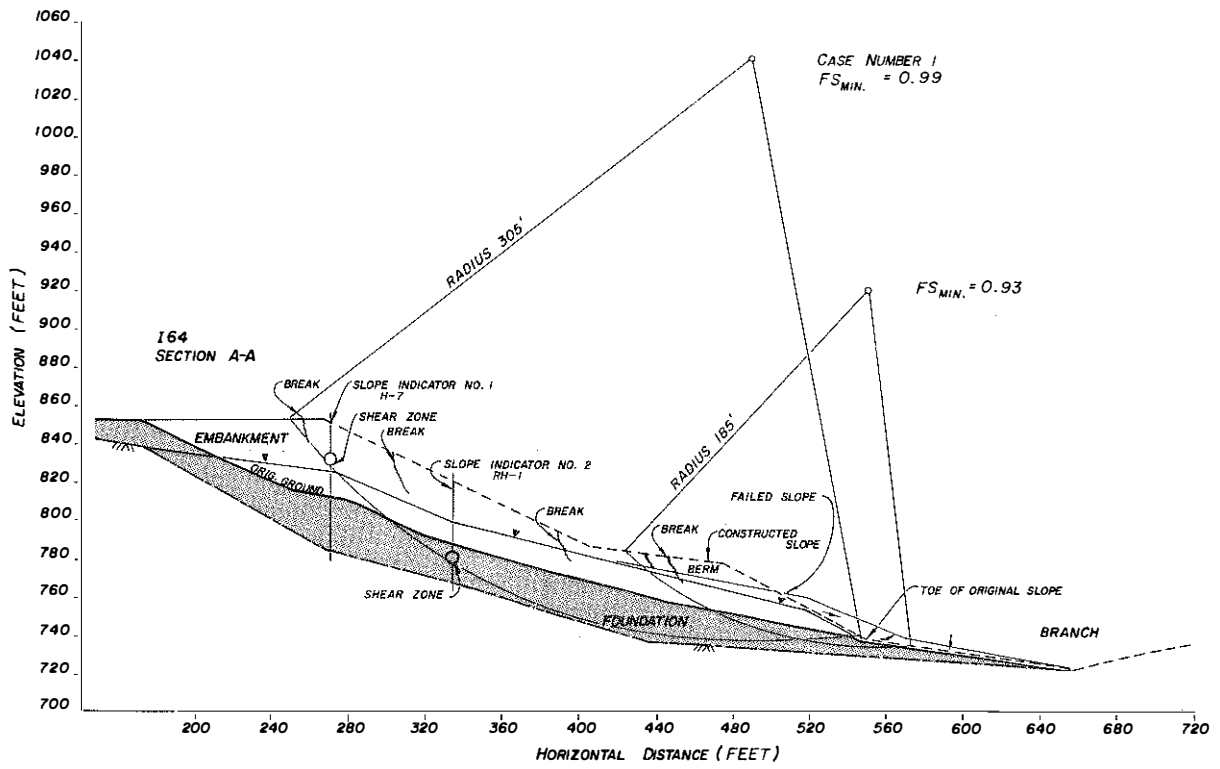
Case 1 considers the long-term stability of the constructed slopes using the observed phreatic surface obtained in March 1973. As shown in Figure 18, two potential slip surfaces were obtained by the computer program's search operation. Both slip circles were located very close to the observed failure points. Safety factors of the smaller and larger slip circles were 0.93 and 0.99, respectively. In the analyses represented by Case 2, both the embankment and foundation soils were assumed to have a ϕ' -value of 29.4° and a c' equal to zero. The water table was assumed to be 5 to 15 feet lower than that observed in March 1973. The computed safety factor was 1.14. Case 3 represents the probable short-term stability of the slopes, assuming excess pore pressures due to consolidation of the foundation were equal to zero. The safety factor obtained for this case (1.19) indicates that the embankment slopes were initially stable, although the stability was relatively low. Case 4 considers the long-term stability of the failed slopes. The safety factor (0.96) obtained was about the same as for Case 1, indicating the present slope configuration of the embankment is unstable. Additionally, the potential shear surface (see Figure 19) associated with Case 4 is shifted deeper into the upper portion of the embankment. This analysis indicates that all traffic lanes in the slide area may eventually be affected.

Figure 18. Potential Slip Surfaces of As-Constructed Slopes, Case 1.

The long-term safety factor (0.99) based on ground water observations shows that the entire embankment is in an unstable condition and that total failure will eventually occur. Movement of the embankment started when a slide occurred in the berm (1967) located at the bottom portion of the embankment. The long-term safety factor of the berm was 0.93. This small slide was triggered by deep erosion in a branch located at the toe of the berm. Consequently, with failure of the berm, progressive failure spread throughout the embankment and eventually the eastbound lanes of I 64 were endangered. Deep erosion in a ditch located in the left flank of the slip triggered additional movement of the upper portion of the embankment. There was excellent agreement between the theoretical critical or potential shear surfaces obtained from the computer program and the actual failure surface determined from slope indicators and surface observations (see Figure 18).

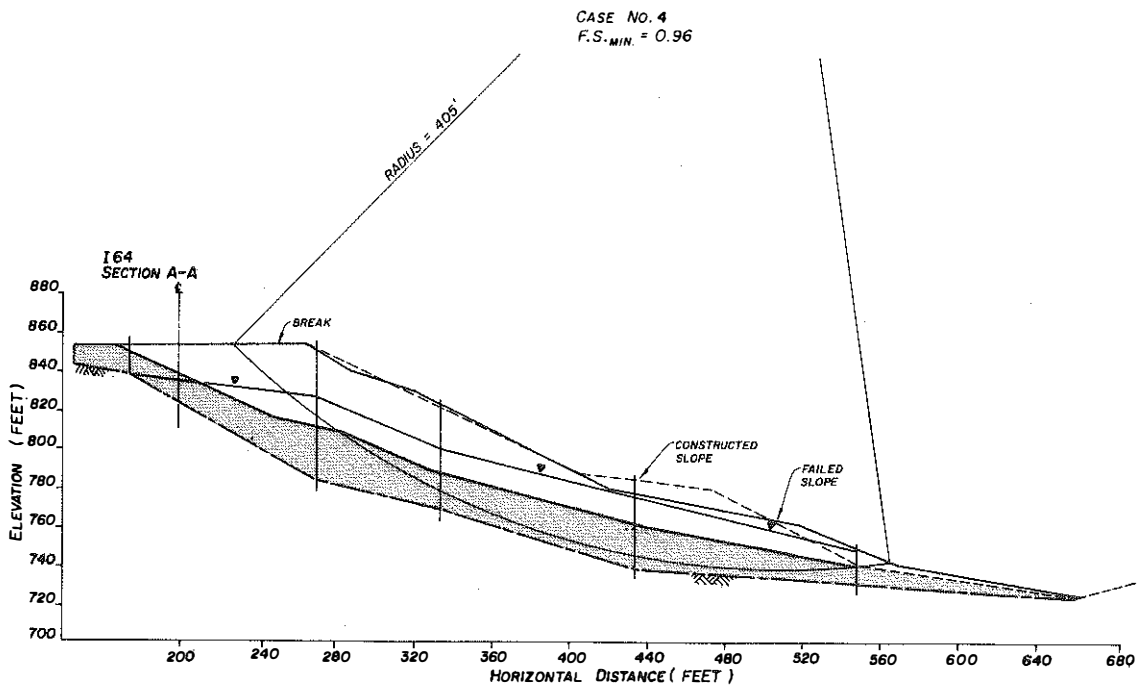
Figure 19. Potential Slip Surface of Failed Slope Section, Case 4.

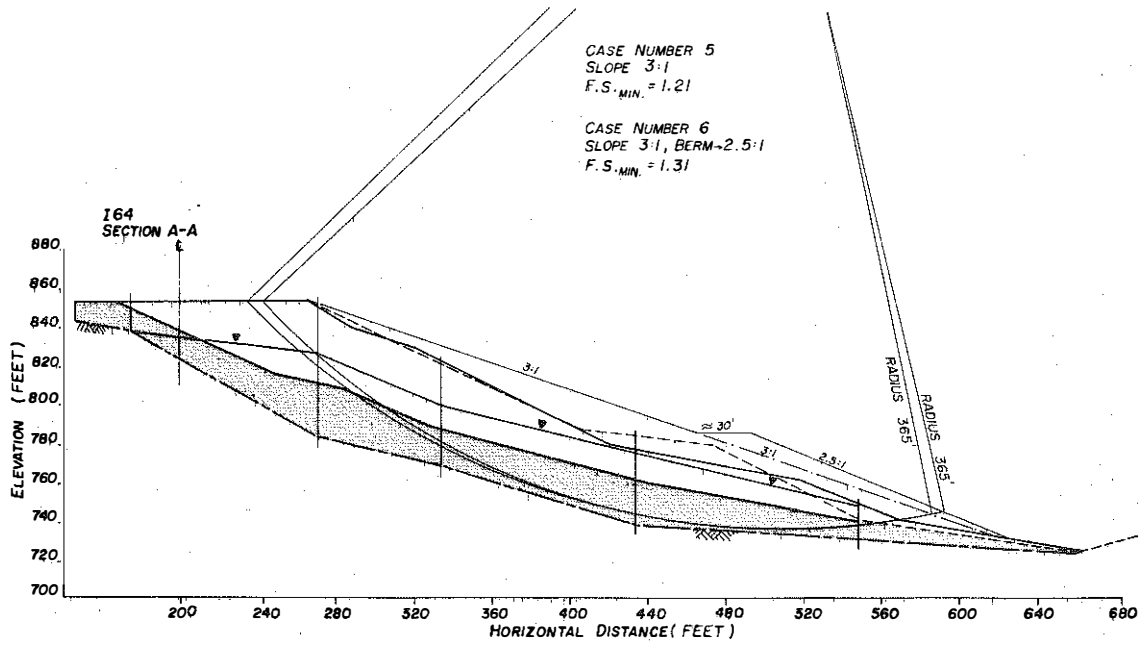
In the remedial analyses, several berm and slope configurations were investigated. For a 3 horizontal to 1 vertical slope, the computed safety factor was 1.21 (Case 5). For the sloping berm configuration shown in Figure 20 (Case 6), the minimum safety factor was 1.31. Both of these remedial designs are considered inadequate. For the slope configurations shown in Figures 21, 22 and 23, the minimum safety factors were 1.43, 1.43 and 1.46. The configuration shown in Figure 23 had been proposed previously (2) as a remedial solution. The safety factor for this configuration is near the value (1.50) normally accepted for design of permanent structures.

Figure 20. Critical Shear Surfaces, Cases 5 and 6.

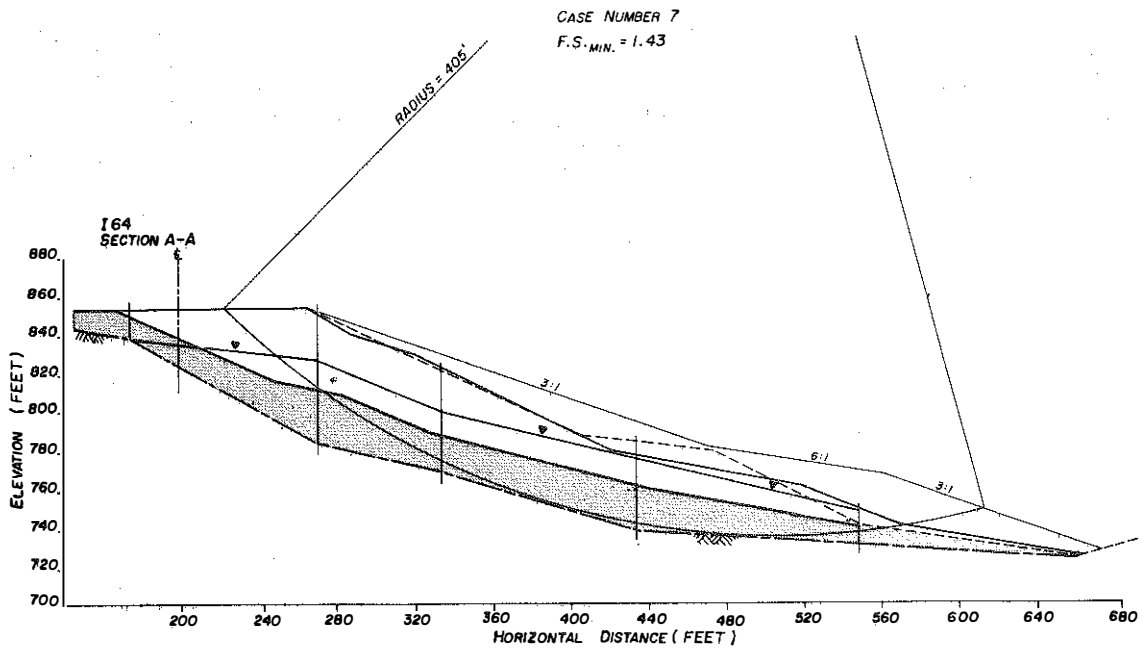
Figure 21. Critical Shear Surface, Case 7.

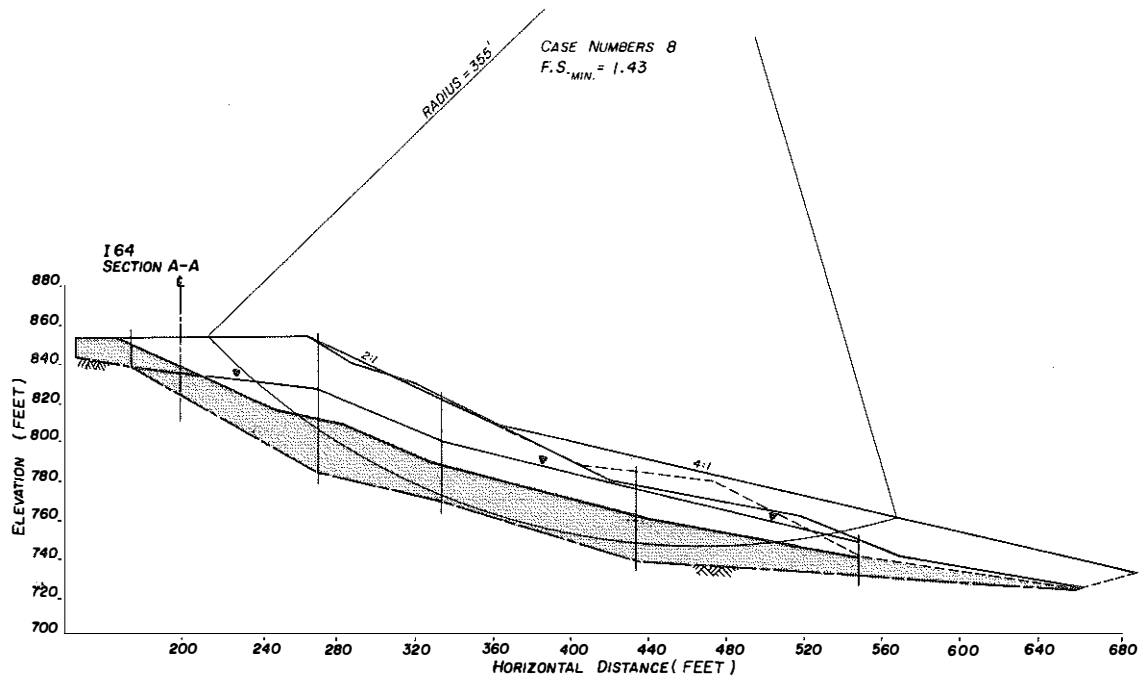
Figure 22. Critical Shear Surface, Case 8.

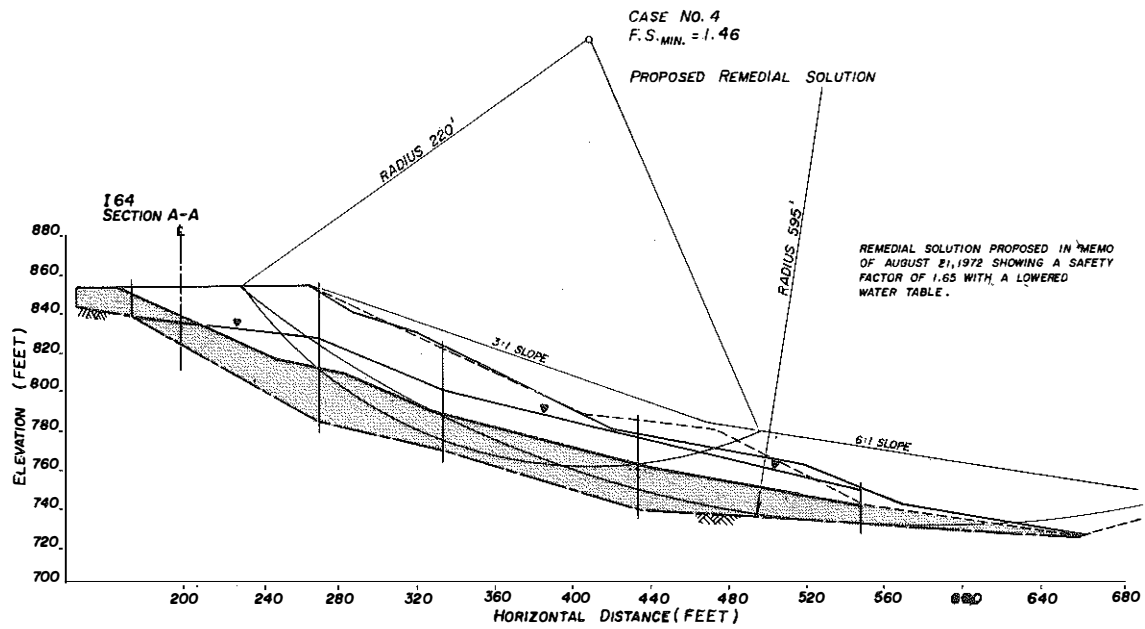
9	1.46	1.71	29.4	24.0	29.4	Observed	Proposed Remedial Solution: 3:1 Slope and 6:1 Sloped Berm at Bottom of Failure (Figure 23)

Figure 23. Critical Shear Surface of Proposed Remedial Solution, Case 9.

I recommend, dutifully, the 3:1 and 6:1 configuration shown in Figure 23 (mentioned there and elsewhere as Case 9). This is the same filling profile determined at the August 2, 1972, meeting (Note:

Slope stability analyses indicated the remedial slope configuration previously proposed (2) and shown in Figure 23 (Case 9) is sufficient to increase the stability of the unstable embankment to an acceptable level. Two alternate solutions shown in Figure 21 (Case 7) and Figure 22 (Case 8) might be considered on the basis of economy. Both indicate comparable factors of safety to Case 9 but would reduce the amount of earthwork required.*

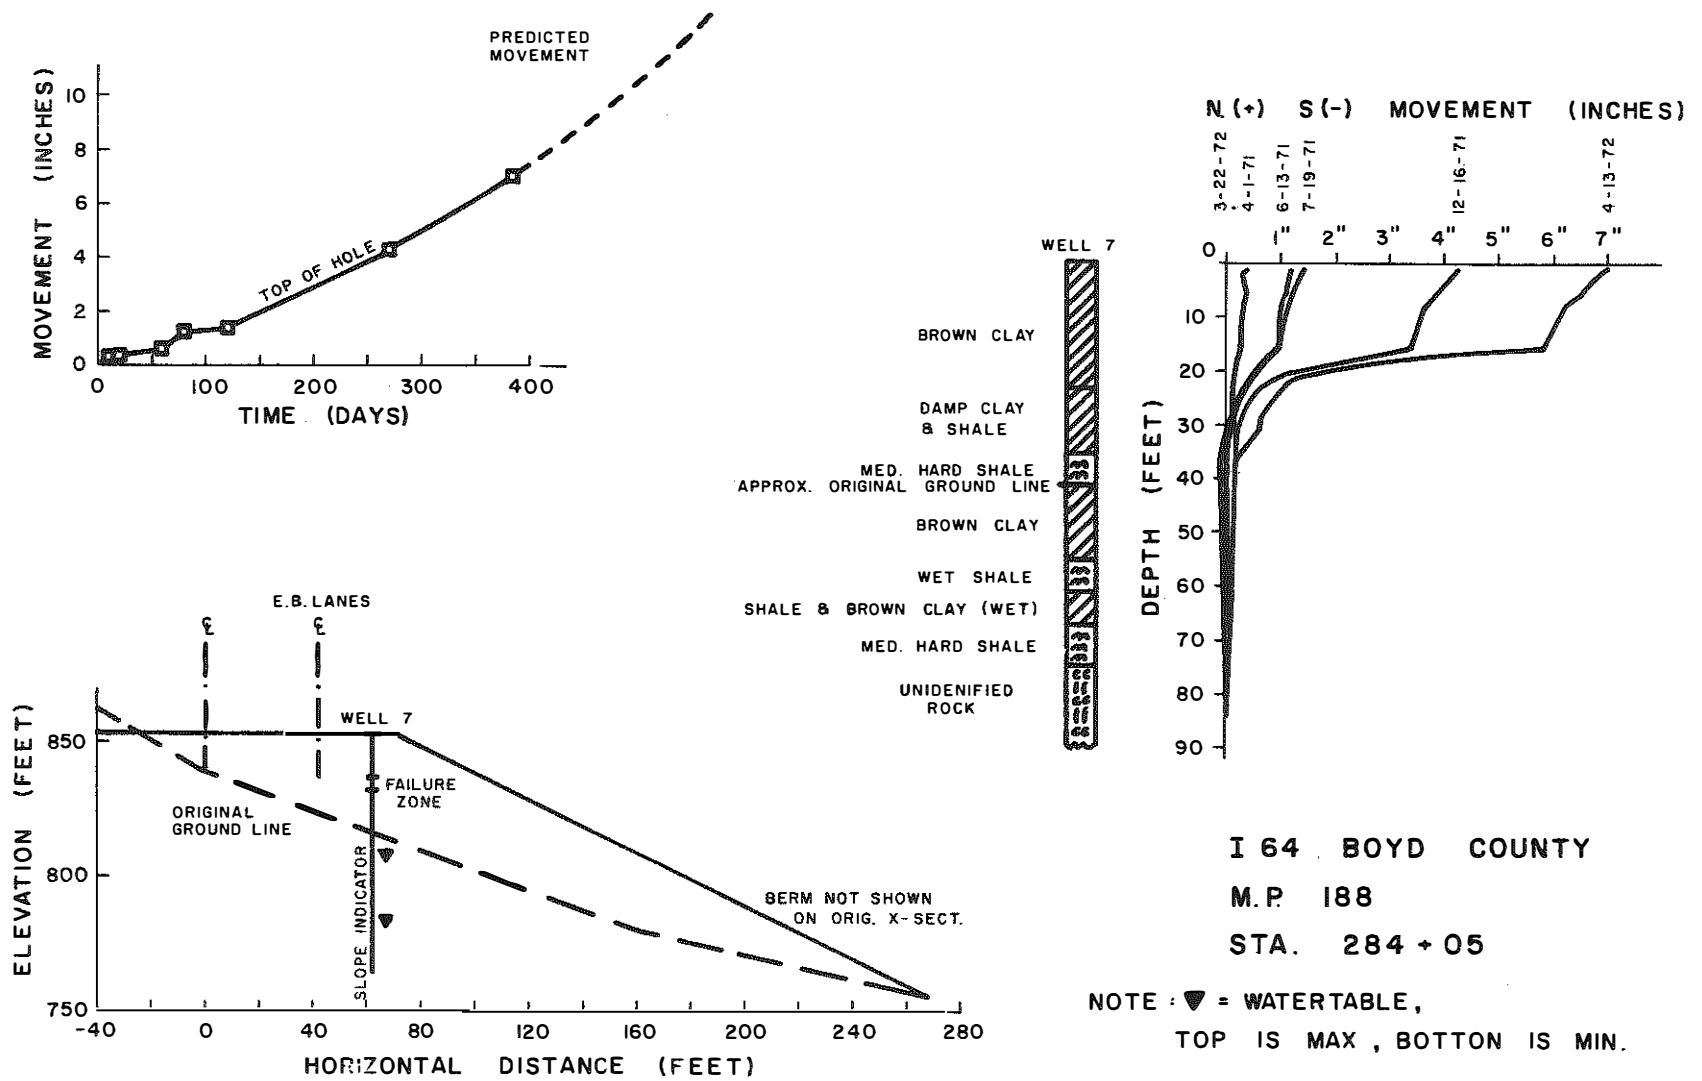
Figure 1.

Seven borings were made at the site; logs are attached hereto. Depth from roadway elevations varied from 42 to 90 feet. Results show that the foundation is composed of alternating layers of shale and sandstone. In the main failure area, the embankment is resting on damp clay and shale (Figure 1).

The latest reading of the slope indicator was April 13, 1972. A period of 399 days had elapsed since initial readings (Figure 1). During this time, the maximum movement was approximately 7 inches. This displacement extended from the top of the casing to some 16 feet below pavement elevation. A definite zone of slippage was found in the embankment between 16 and 21 feet below roadway elevation. Figure 1 also shows the rate of movement. Acceleration of movement is apparent. Failure seems inevitable. Only the eastbound lanes appear to be endangered at this time.

Immediate action is recommended. Two remedial solutions have been considered. Both have been successfully used elsewhere. One is to remove the slide completely, install drainage systems and rebuild the embankment with normal or lighter weight material. It is felt this scheme would imperil the remaining embankment and would not correct the problem in the berm at the toe of the fill. The other solution, which is preferred, is to: 1) place a pipe along the southeastern margin of the slope to carry runoff now carried by a paved ditch, 2) extend existing culvert downstream, 3) construct granular drainage blankets by terracing or benching existing slopes, 5) construct the berm on 10:1 and additional fill to provide embankment slope of 3:1 (Figures 2 and 3), and 5) construct paved ditches. The berm is to be merged or buttressed into both hill sides opposite the present embankment. On-site surveys should be made to establish complete plans. No. 9 stone is suggested for the drainage blankets. Perforated pipe is recommended in conjunction therewith. Two previous slides on I 64 have been corrected by a similar method (Stations 3030 to 3033 and 3167 to 3170). This method not only seems to be giving immediate results in this area but also seems to be better for long-range stability.

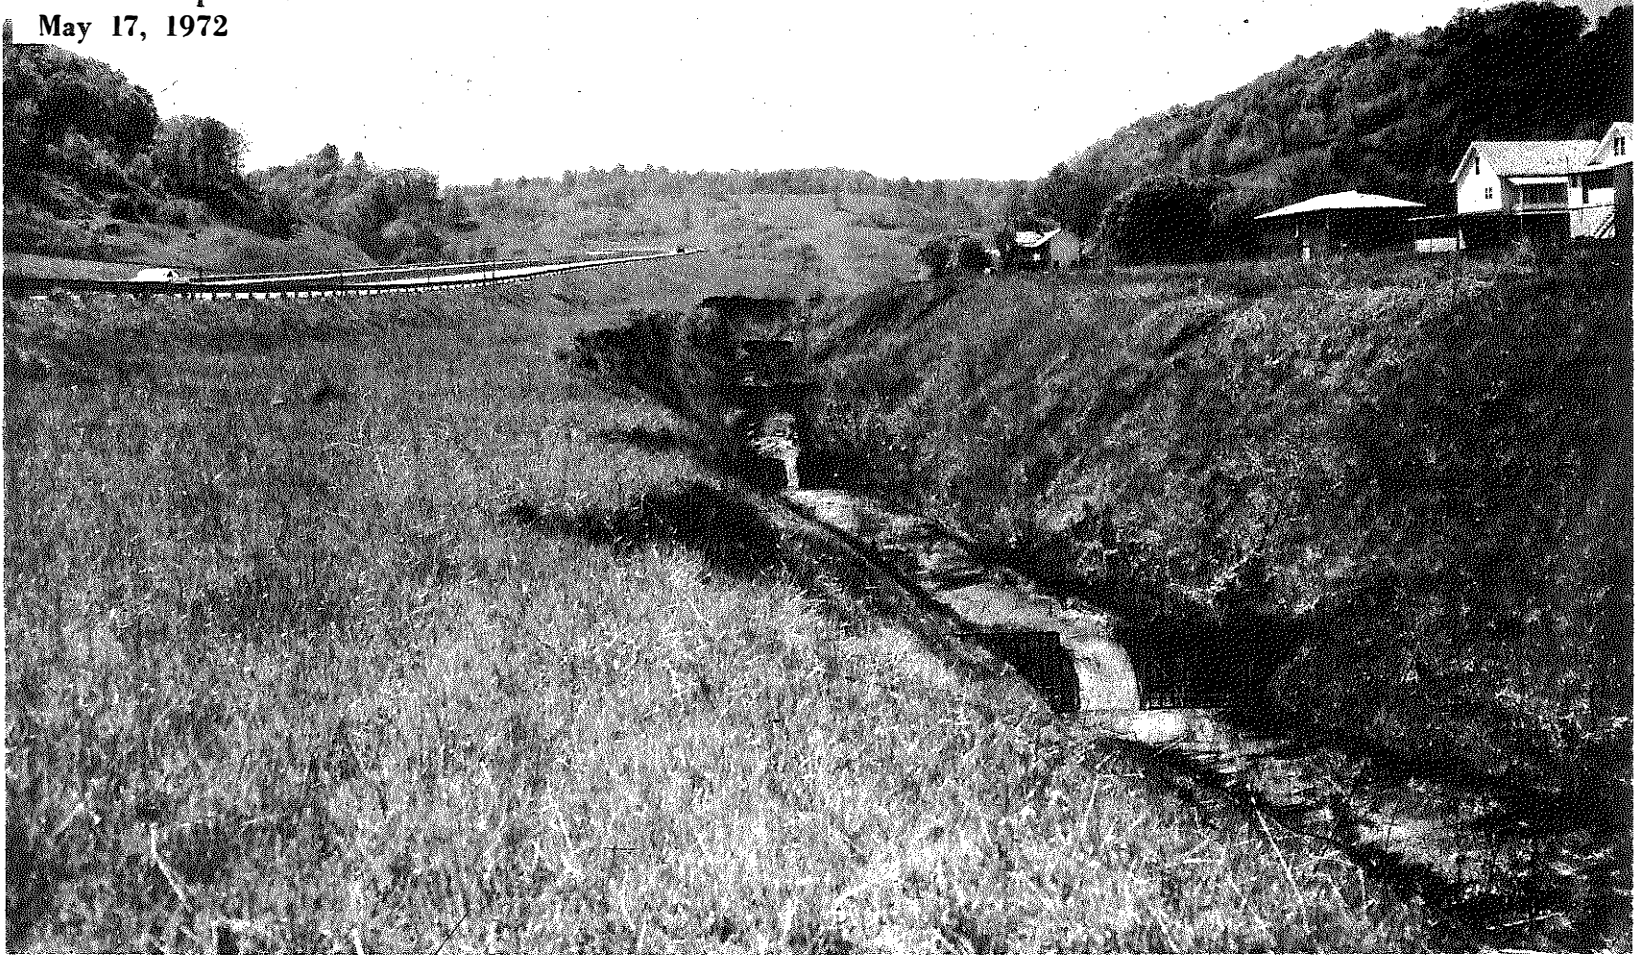
Figure 5.

A channel change constructed on the north side of I 64 from Station 390+00 to 420+00 has been eroding since the time of construction. Soil conditions in this area are such that velocities of 2-3 fps cause constant erosion. Down-cutting of the stream bed (Figure 4) has caused loss of sod and severe sluffing of the banks. This erosion has now lowered the flow line of the stream some 6 feet (according to District 9 officials). The channel is typically V-shaped. An inspection of the site on April 11, 1972, indicated that erosion had progressed to the point of endangering both private property and the road. An earlier attempt to control the situation by dumping large stone (quarry run) in the channel at some locations was not successful; high velocities during peak discharge dilapidated those fill-ups.

I 64 - 8(6) 180, M.P. 190-191
CONCEPTIONAL REMEDY FOR CHANNEL EROSION
Ditch - Checks, 2 to 3 Ft. High
23 - Ft. Drop in 1900 Ft.
May 17, 1972

Original plans show a drop of 25.3 feet between Stations 397+53 and 421+37. They also show slopes of -0.90 percent and -1.24 percent through this area, but apparently the valley-fill material (silty alluvium) continues to erode steadily. Any remedy other than continuous paving would have to slow the low-flow velocity significantly. One device which seems to offer remedy at a relatively low cost is some type of ditch-check. These devices have apparently fallen into disuse in roadside ditches. However, it is believed they have not been designed to provide continuous (stair-step) ponding. For instance, Standard Drawings 11.19b and 11.20a would not necessarily provide this feature. These should be used at low heights (2 to 3 feet) and frequent intervals (150 to 350 feet -- depending on stream profile) to obtain the desired effect (Figure 5). This structure system has been used for similar purposes in the past and seems to be the most logical solution for this problem. Each check should have a rock blanket extending 20 to 30 feet downstream and 3 to 4 feet up each stream wall to dissipate the energy from the weir-type checks. A spillway flume does not seem necessary. Soil-saving dams (Cf. **Handbook of Culvert and Drainage Practices**, Armco, 1937) or small dams, such as those used for settling basins, might be considered as alternatives.
