MEMORANDUM TO: J. R. Harbison
State Highway Engineer
Chairman, Research Committee**SUBJECT:** Research Report No. 359; "Experimental Installations of Impact-Attenuating Devices;" Final Report on Study KYHPR-70-64; HPR-1(8), Part II.

March 1973

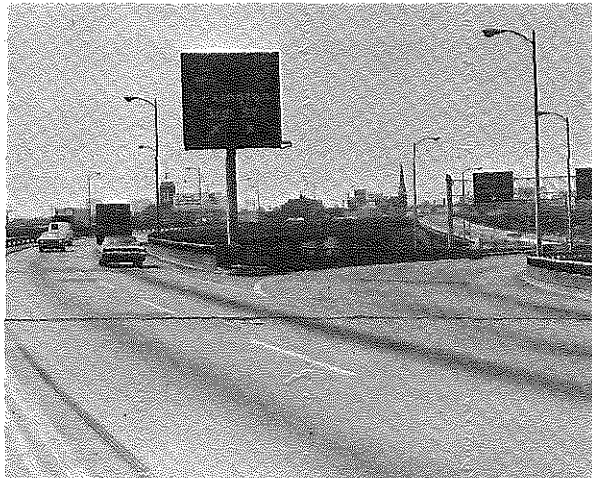
Location (d) is pictured in Figure 8. In November 1971, the Division of Research recommended that the existing nine-foot long concrete nose be removed and a HI-DRO Cushion installed. The Energy Absorbing Barrier Committee approved the recommendation. Installation of the barrier is to be accomplished in conjunction with a forthcoming safety improvement project scheduled for this section of roadway.

Figure 8. Location 3(d) before Installation of a HI-DRO Cushion.

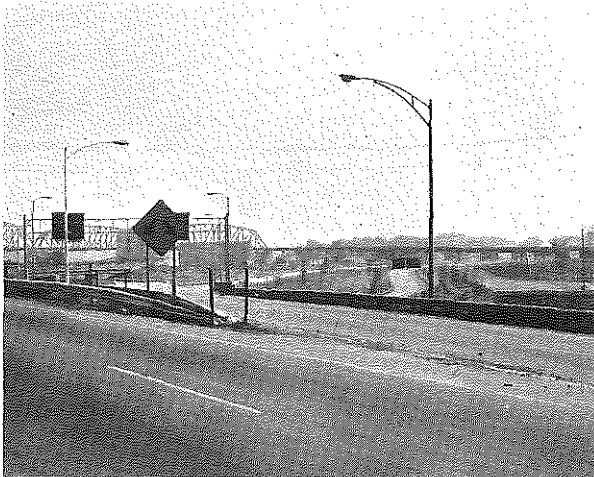
Figure 30. Location 3(c) as it Existed Until May 1970.

Figure 30 pictures this site as it existed until May 1970. The gore had a history of many accidents and had an alarmingly high severity rate. Specifically, in a 37-month period before the barrier was installed, 24 accidents were investigated by police. There were two fatalities and seven Type "A" injuries, i.e., visible signs of injury (bleeding, distorted members, etc.) or victim had to be carried from the site. Two injuries were Type "B" (bruises, abrasions, swelling, etc.) and one was a Type "C" injury, i.e., no visible injury but complaint of pain or momentary unconsciousness; fourteen were non-injury accidents. Ten of the accidents occurred in daylight and fourteen in darkness.

To decrease the severity of accidents in this gore area, plans were made to increase the recovery area between the bifurcating roadways by filling back to the bridge structure, turning the guardrail on a longer radius, and installing a Fitch barrier. This procedure would provide a crash cushion and also increase the recovery area by some 100 feet. Figure 31 shows this gore area after guardrail removal and leveling.

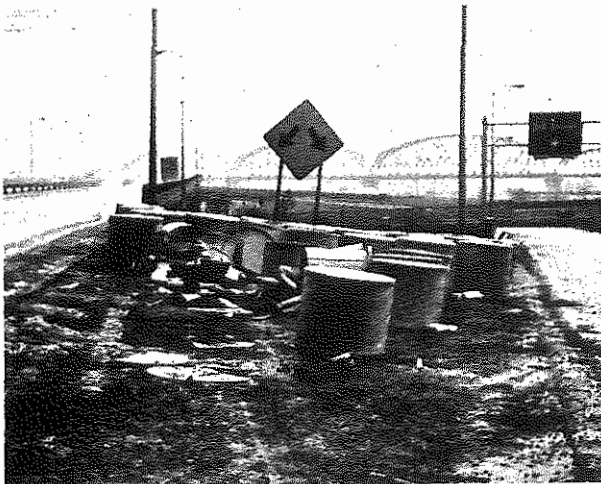
The average cost of replacement for these four hits and vandalism damages was \$146 per module. Included in this cost were materials, labor, and equipment usage. Table 2 summarizes information concerning hits at this location.

One problem encountered at this location was the cross slope of the gore area. It is believed to have caused several, lighter, top-heavy, modules to tip over under their own weight as a result of the strong axes of the inserts being placed along the slope. Another problem is the rather unpleasing appearance the barrier has developed with time. Specifically, the barrier is dirty, due to vehicle spray and dust.

Figure 33. Aftermath of a Major Impact at Location 3(c).

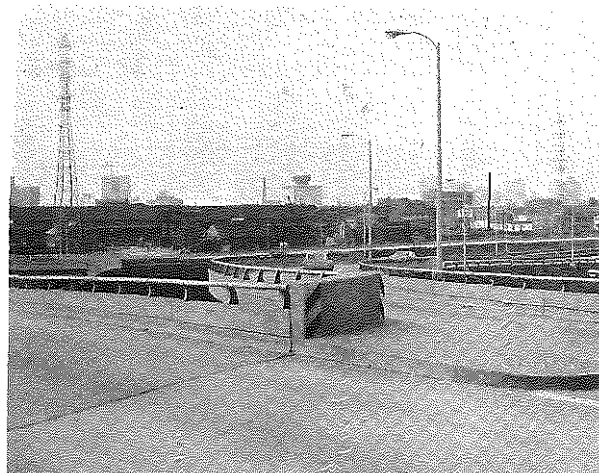
Figure 34 pictures this site prior to the installation of the HI-DRO Cushion system. The site was deemed appropriate for a barrier installation because of its potentially hazardous configuration and because a site inspection showed positive proof that this area had been the scene of several accidents -- which, for various reasons, were not reported to the Louisville Police Department.

Figure 34. Location 3(a) Prior to Installation of a HI-DRO Cushion System.

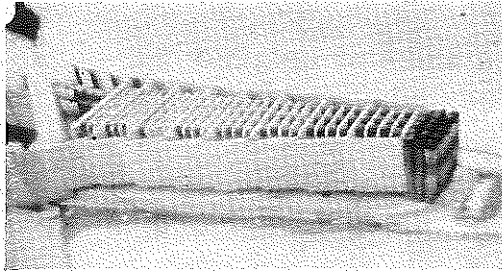
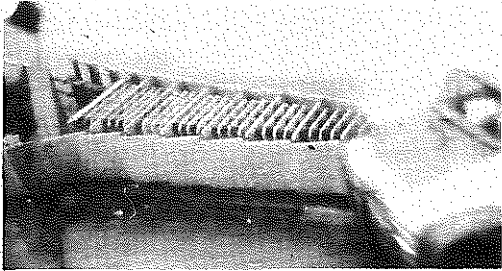
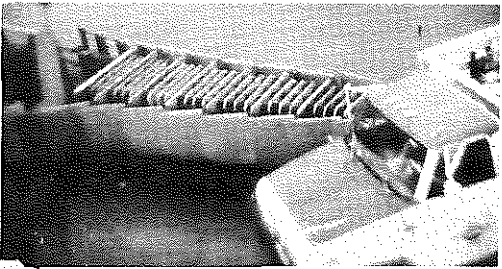
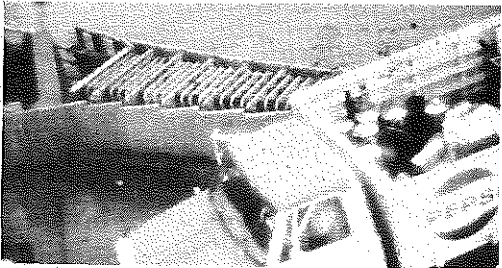
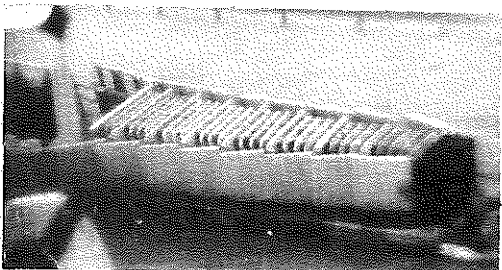
Since installation, there have been four known hits. All were rather insignificant, and none was reported to the police. Apparently no injuries were sustained. Three of the four impacts were recorded on film by a camera monitoring system. Circumstances contributing to the first hit, which was of least significance and probably involved contact with only a restraining cable, are unknown. The most severe damage was obvious vandalism; a late model car slowly but intently approached the front of the barrier; the driver then applied power and pushed the barrier back some three feet. Another filmed hit revealed snowy roadway conditions and an out-of-control vehicle sliding sideways into the front of the barrier system. These first two hits were recorded by the camera system under nighttime conditions. The most recent hit occurred during wet daytime conditions and involved a

All four impacts involved very minor damage to the barrier system. Following the vandalism hit, which was the only hit to involve significant barrier displacement, the barrier was repositioned without difficulty. The repair cost, including labor, materials and equipment usage, was estimated at \$60 for each of the first three hits. Table 3 summarizes the available information pertaining to these four impacts.

Figure 35. Impact of a Six-Wheeled Truck with HI-DRO Cushion at Location 3(a).

On several inspections of the system during winter months, alarming amounts of frozen liquid in the cells were observed. This appeared to be the case during the impact recorded on film during snowy conditions. Obviously, this condition significantly reduces the effectiveness of the barrier. District 5 engineers attributed the freezing to the inability to obtain proper solution of calcium chloride in the water in individual cells.

Finally, the problem of side panels not staying in position was encountered. This is an unpleasing attribute as well as a potential hazard to motorists. The panels are held in place by a small fender panel clip which merits the attention of the manufacturer.

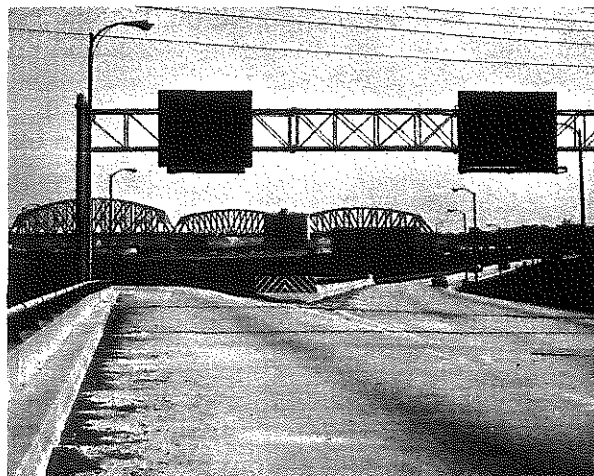
Figure 36 pictures this site prior to installation of the HI-DRO Cushion system. This site was also chosen for an impact attenuator due to its hazardous configuration. Inspection of the site showed visible signs of accidents -- not reported to the Louisville Police Department.

Since installation, there has been only one known impact; this occurred on January 14, 1972. Contributing circumstances are unknown since no police report was made. The hit was of such magnitude that the barrier had to be taken to the district garage for repairs. Total cost for repair (including labor, materials and equipment usage) was \$321. Evidently, the impact was at a relatively high speed or involved a large vehicle.

Figure 36. Location 3(b) Prior to Installation of the HI-DRO Cushion.

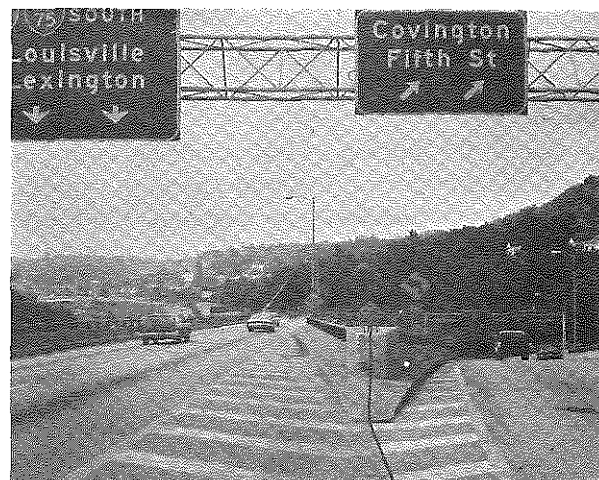
Obviously, the frequency of hits and the corresponding high maintenance costs were the main problems at this location. The bridge wall at this site is fronted by a 22-foot long curb of gradually decreasing height. At the time of installation, it was decided that removal of the curb was impractical, and plans were made for the installation of the Fitch modules on the curb itself. However, width and cross slopes of the curb interfered. Consequently, the 24-foot long barrier was placed ahead of and in front of the 22-foot curb. Available recovery area was diminished; and, possibly, some hits would not have occurred had this not been done.

Figure 37. Location 7 Prior to Installation of the Fitch Inertial Barrier.

Other problems were observed at this location. Apparently, bridge vibrations caused at least two modules to split along a riveted seam. No other explanation could be offered. Also, the camera monitoring system, when actuated by maintenance personnel removing debris and reinstalling modules after impacts, showed wet sand being shoveled from the roadway and put into replacement modules. This practice seemed to invite adverse performance of the barrier during freezing weather.

Due to unusually high maintenance costs and recovery area constraints of this Fitch installation, a decision was made to replace the Fitch system with a HI-DRO Cushion. The concrete curb was removed down to a horizontal plane at the through-lane gutter line, and a HI-DRO Cushion was installed on the leveled portion on October 19, 1972. Cost of the system, excluding installation costs, was \$8,157.

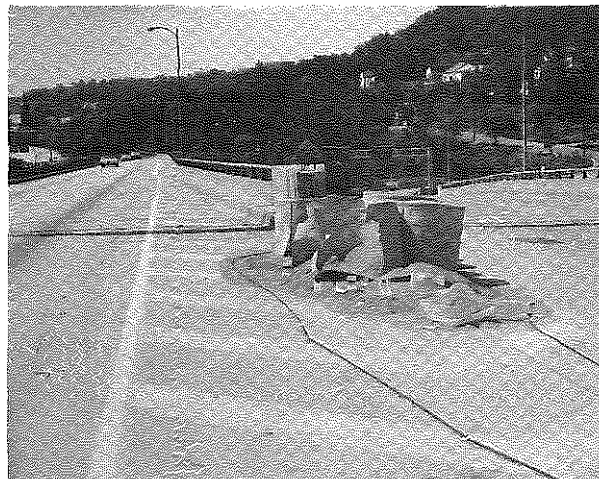
As of May 1, 1972, there had been a total of 100 modules destroyed. District 6 engineers submitted cost estimates so that overall estimates could be calculated. Based on this information (Table 4), the cost of replacement (including labor, materials and equipment usage) was found to be \$136 per module. Thus, the total cost of maintenance was estimated at \$13,600.

Figure 39. Impact No. 6 at Location 7 (7 Barrels destroyed).

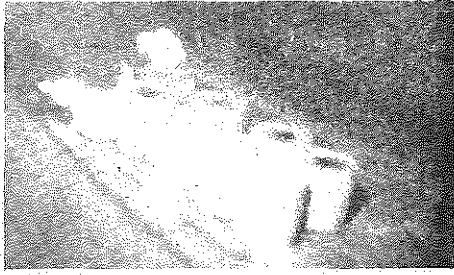
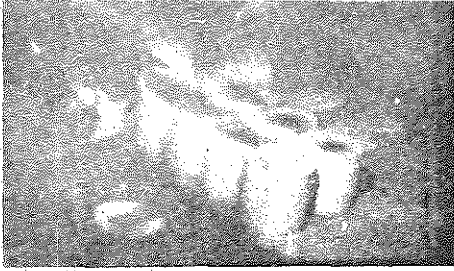
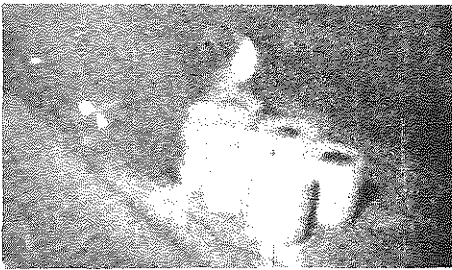
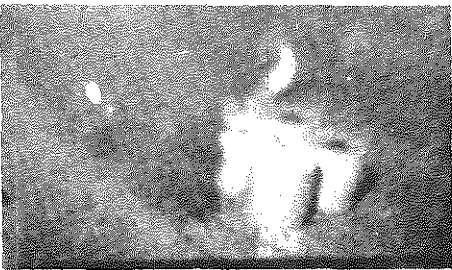
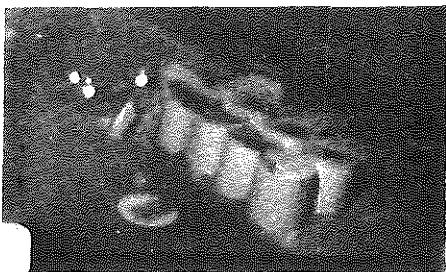
Figure 40. Photographs of Actual Impact in Progress at Location 7. (Vehicle Backing Away from Damaged Barrier in Photograph No. 5).

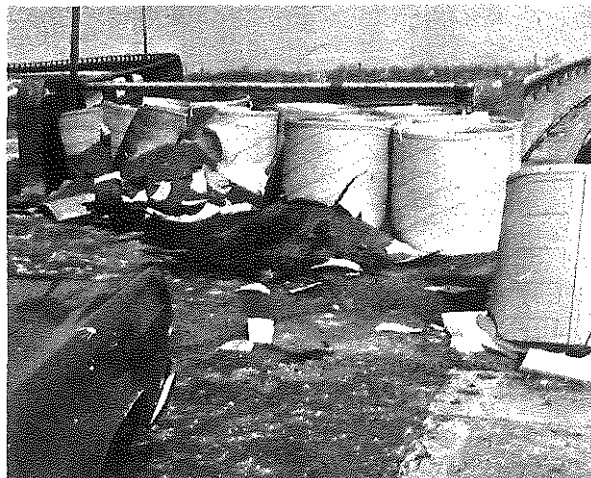
There have been two impacts with this barrier -- both were major. The first hit occurred on November 7, 1971; 18 modules were destroyed. Figure 43 shows the aftermath of this first impact. The second hit, in which 19 modules were destroyed, occurred on January 29, 1972. There were no police reports of these apparent drive-away situations. Considering the apparent magnitude of these impacts, the Fitch system was extremely effective. Costs of replacement modules, including 10 which were vandalized, are shown in Table 5.

This site was relatively problem-free. However, District personnel complained of excessive sand and debris after impacts, causing some disruption of normal traffic flow. Research personnel also noted some freezing of moist sand during winter. Special Provision No. 86-A requires that the modules contain a sand-salt mixture (95 percent air-dried natural sand and 5 percent commercial quality salt thoroughly mixed with the sand to prevent freezing).

Figure 43. Aftermath of an Impact at Location 14.
