Subject: The I 64, I 65, I 71 Route Junction, Louisville

**AN OPERATIONAL ANALYSIS OF THE
I 64, I 65, I 71 ROUTE JUNCTION IN LOUISVILLE**

KYP-72-36

April 1972

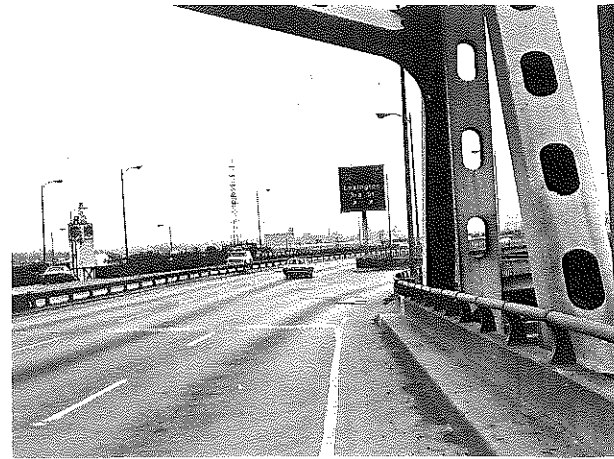
Figure 2. I 65 Southbound just South of the Kennedy Bridge at the Ramp to Third Street and I 64 - I 71 Eastbound.

There were 14 accidents at this location during the study period. Of these, five were the rear-end type, four were with fixed objects, three were sideswipes, and two were combination rear-end and sidewise encounters (involving three vehicles). These accidents were generally spread throughout the day, but several occurred during the evening rush hour. Eleven of the accidents involved property damage; three caused injuries (four persons). There, 10 of the 14 accidents occurred during wet weather. This tends to indicate that pavement conditions might have played a significant role in these accidents. Friction measurements for the outer and inner lanes were 34 and 36, respectively. There are three southbound lanes crossing the Kennedy Bridge; the outside-lane traffic must turn right; the middle lane is optional with respect to I 65, south, or I 64 and I 71, east; traffic in the innermost lane must continue on I 65. Apparently, conflicts arise when unwary drivers desiring to exit toward 3rd Street find themselves in the innermost lane and when those trapped in the outermost lane desire to continue southward on I 65. A possible remedy might be to improve the advance signing (north of bridge) to emphasize lane assignments.

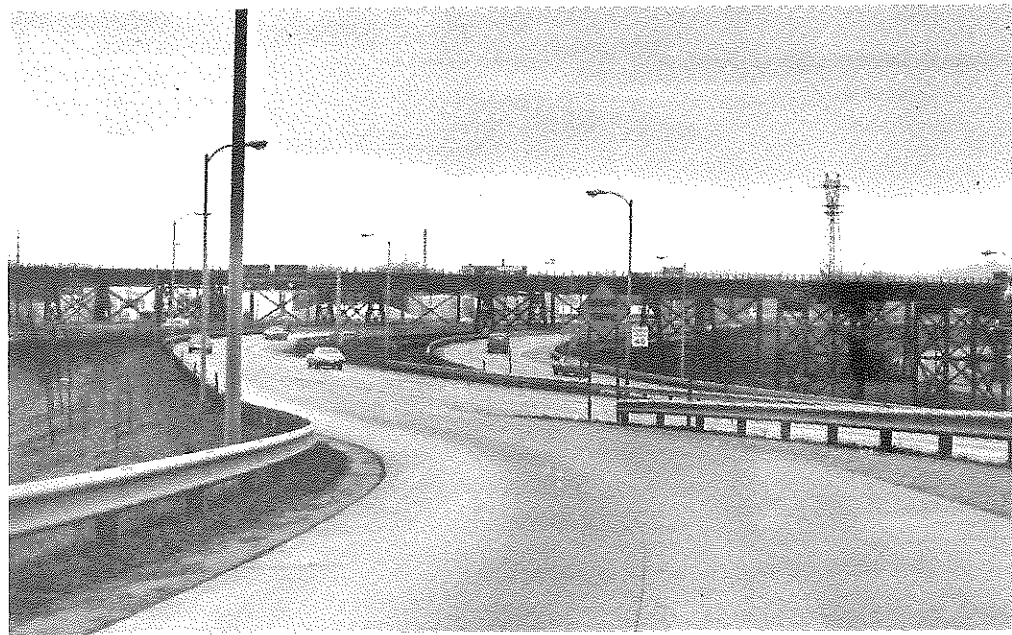
Figure 1. Merge of the Ramp from I 65 Southbound to I 64 - I 71 Eastbound with the Ramp from I 65 Northbound to I 64 - I 71 Eastbound.

There were 18 accidents at this location during the study period. Of these 18 accidents, 13 were rear-end type, and 3 were multiple rear-end collisions. There was also one oblique accident and one fixed-object-type accident. Of the 18 accidents, 17 involved property damage, and there was only one injury reported. Friction measurements on the ramp from I 65 southbound and from I 65 northbound were 34 and 40, respectively. These compare with a recommended minimum friction value of 37 as presented in National Cooperative Highway Research Program Report 37. This

minimum value corresponds to that required for normal driving needs at a mean speed of 50 mph. The speed limit for this section of the interchange is 50 mph. Normal needs encompass all driving, cornering, and braking maneuvers by the majority of drivers under normal traffic conditions. Report 37 further states that the friction level should be higher whenever it is economically or technically feasible. The friction measurements at the four other high accident locations can also be compared with the minimum friction value. It is interesting to note that only one of the rear-end collisions occurred during wet weather conditions. Of the 16 rear-end collisions at this site, 14 occurred on the ramp from I 65 southbound. This indicates that this ramp is the source of the accident problem. It should also be noted that the majority of those accidents occurred during the evening rush hour, which points to congestion as the probable cause of accidents. Another possible contributing factor is the short acceleration lane of the ramp from I 65 southbound.

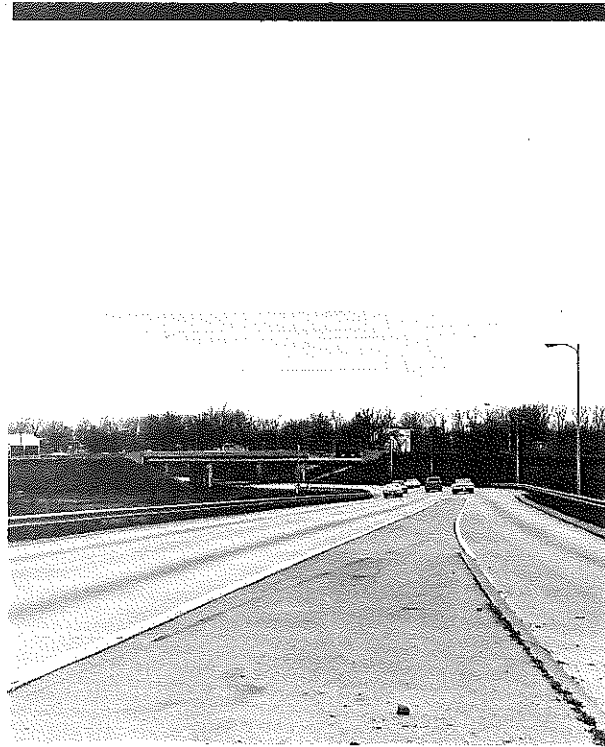
Figure 3. I 64 Westbound between Story Avenue and the I 71 Overpass.

A total of 13 accidents occurred on this 0.2-mile section during the study period. Of these, six involved fixed objects, four were rear-end collisions, and three were sideswipes. Eight caused property damage, and five resulted in 11 personal

injuries. Five occurred in wet weather; three of the six fixed-object accidents were during wet weather conditions. Three of the four rear-end accidents occurred during the morning rush hour when traffic was backed up on the expressway. Two of the three sideswipes involved vehicles which were merging into traffic from the Story Avenue ramp. The friction measurements in the outer and inner lanes were 31 and 33, respectively.

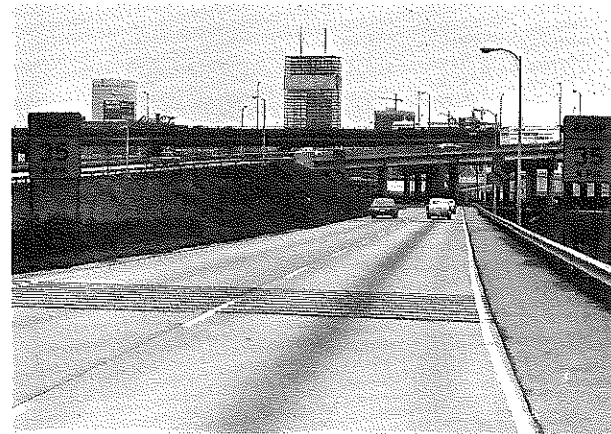
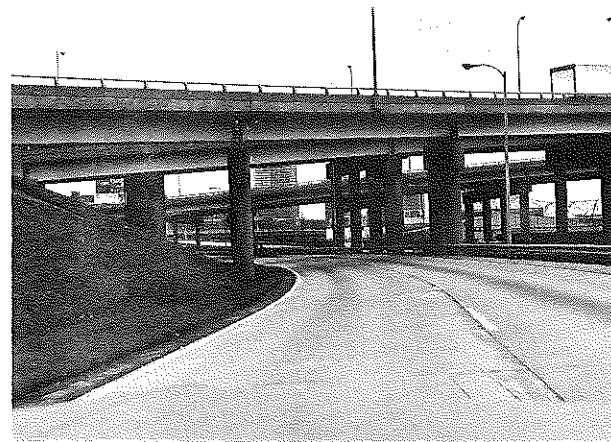
Figure 4. Ramp from I 64 Westbound to I 65 Southbound.

Nine accidents occurred on this 0.2-mile section of road during the study period. Six involved fixed objects, two were sideswipes, and one was a rear-end collision. Only two occurred during wet weather; they were sideswipes. Friction measurements in the outer and inner lanes were 40 and 44, respectively. The problem at this location is caused by the sharp curvature of this ramp, which was the probable cause of the fixed-object accidents. There are dual-mounted warning signs advising motorists to reduce speed to 35 mph and there are two sets of rumble strips; however, drivers continue to lose control.

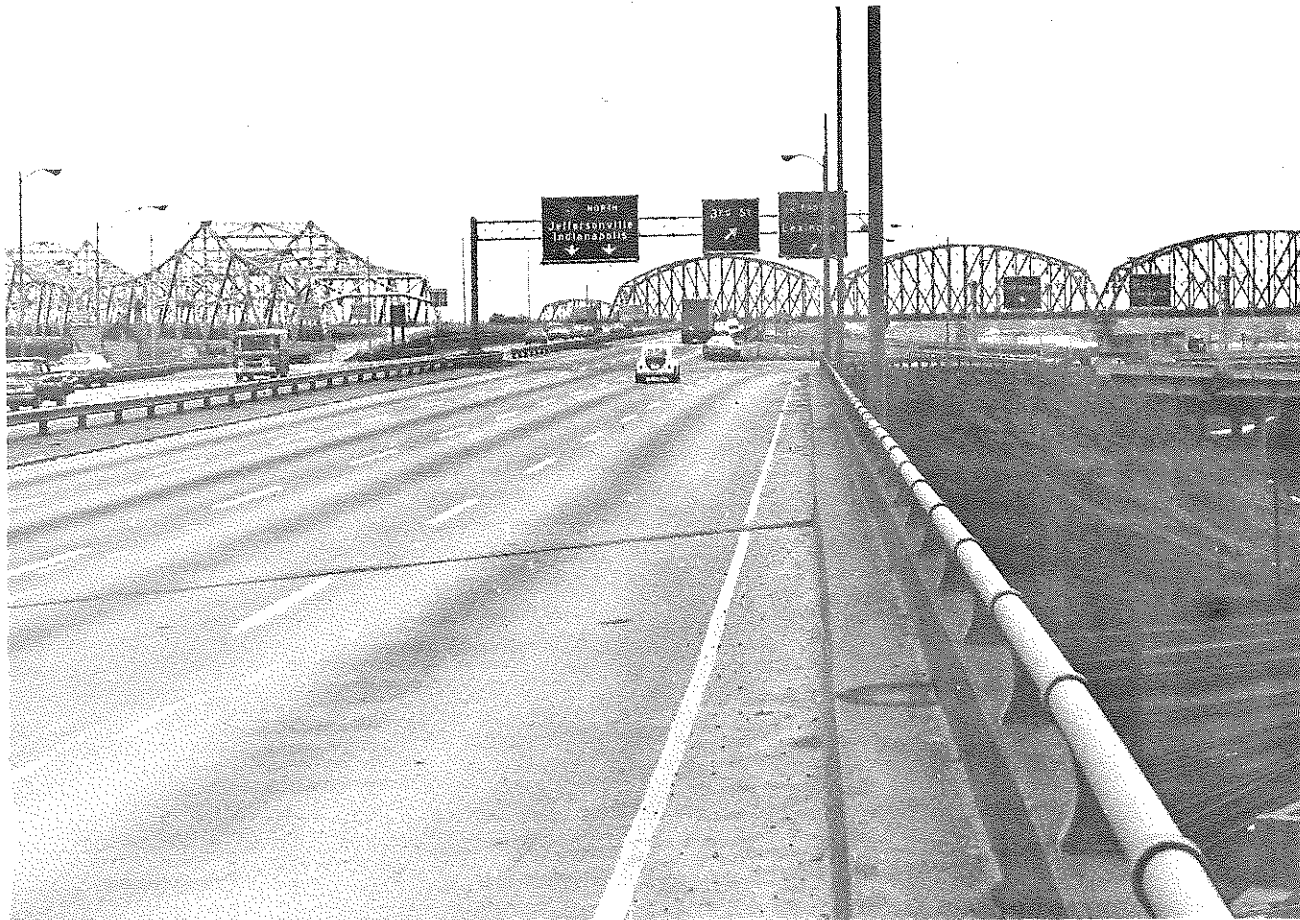
Figure 5. I 65 Northbound at the Exit Ramp to Third Street and I 64 - I 71 Eastbound.

Eight accidents occurred at this location during the study period. Three were rear-end collisions, three were sideswipes, and two involved fixed objects. Three of the accidents occurred during wet weather. The friction measurements in the outer and inner lanes were 33 and 39, respectively. The accidents did not occur at any particular time of the day. No pattern could be found from accident reports.
