Subject: Research Report, "Experimental Guardrail Installation,"
F 160(10), Mercer County, US 127

EXPERIMENTAL GUARDRAIL INSTALLATION
[F 160(10), Mercer County, US 127]
Final Report

September 1971

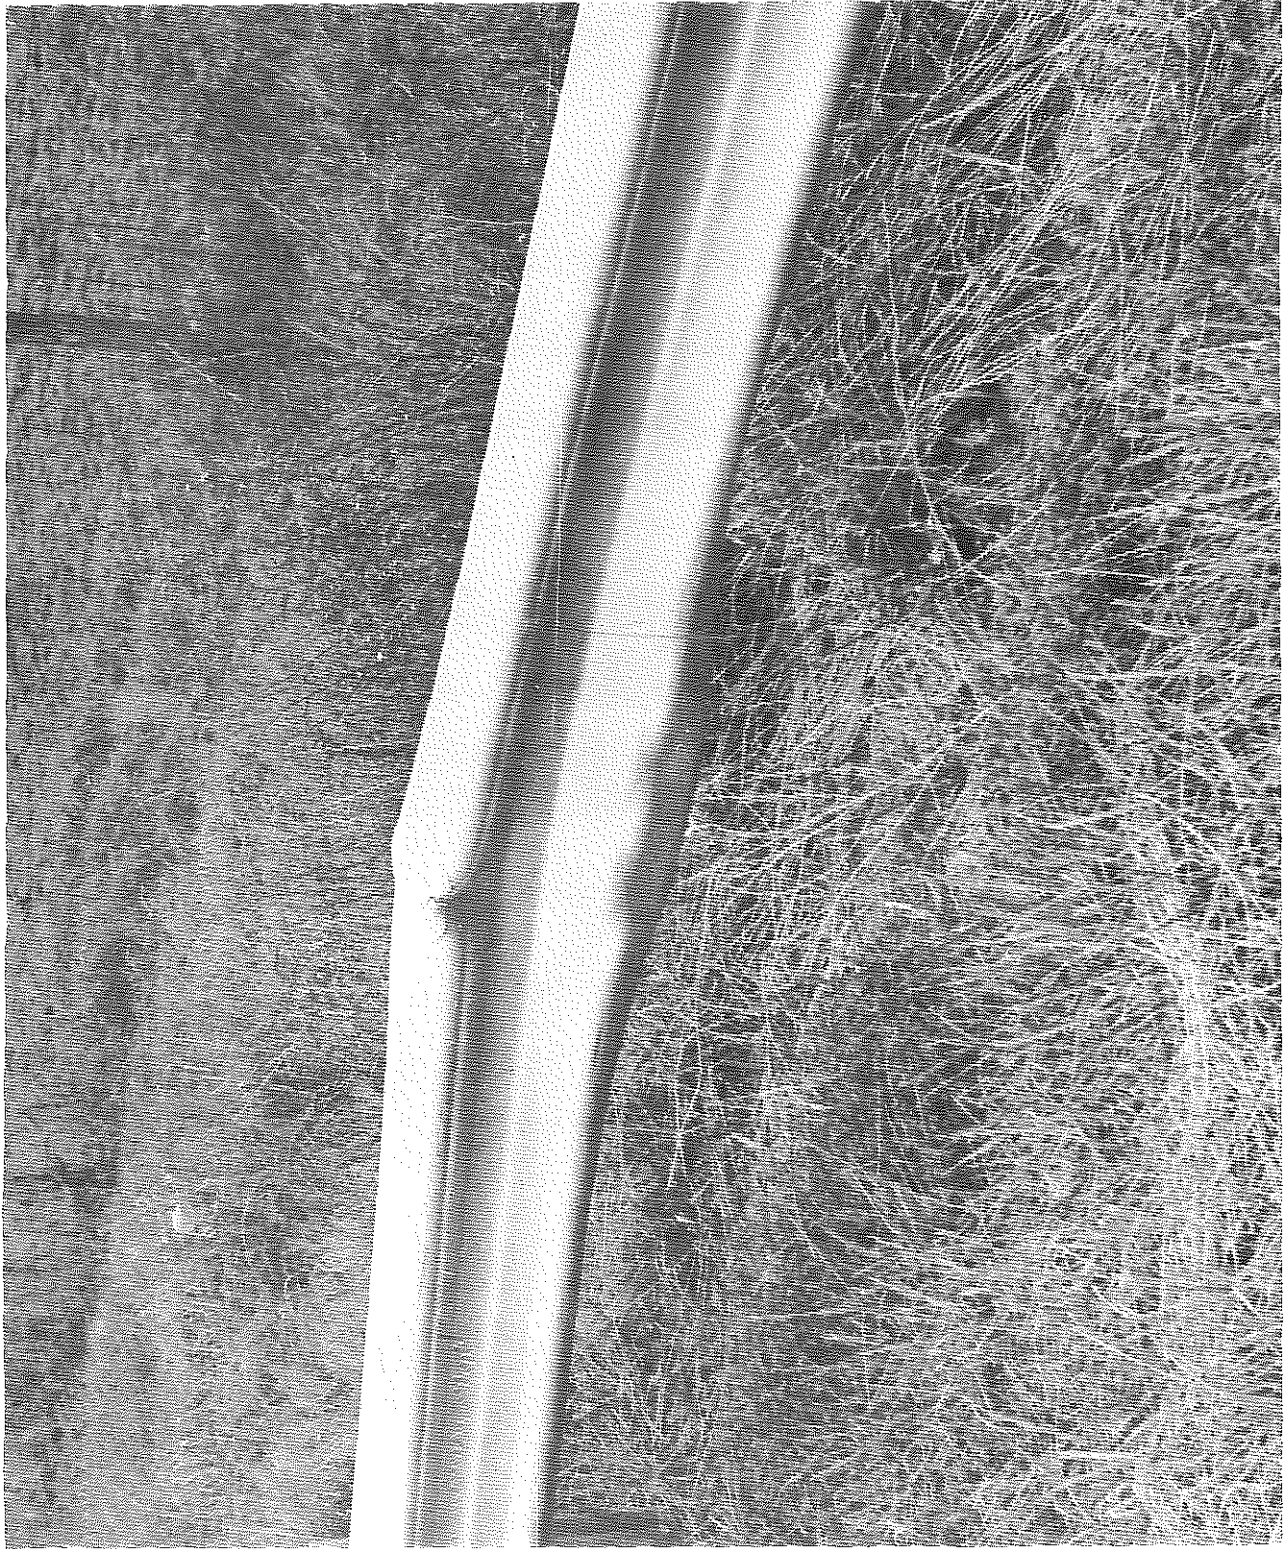
There was no apparent corrosion or discoloration. Two sections had been damaged by vehicles, one slightly and the other sufficiently to require replacement. A 30-foot section of the guardrail had been replaced with salvaged steel. It had been painted by brush with aluminum paint and the condition was poor. Daubs of aluminum paint appeared on the aluminum rails near posts which were painted in the spring of 1967. Aluminum guardrail is shown in Figures 2 through 9.

Figure 4. Damaged Section of Aluminum Guardrail

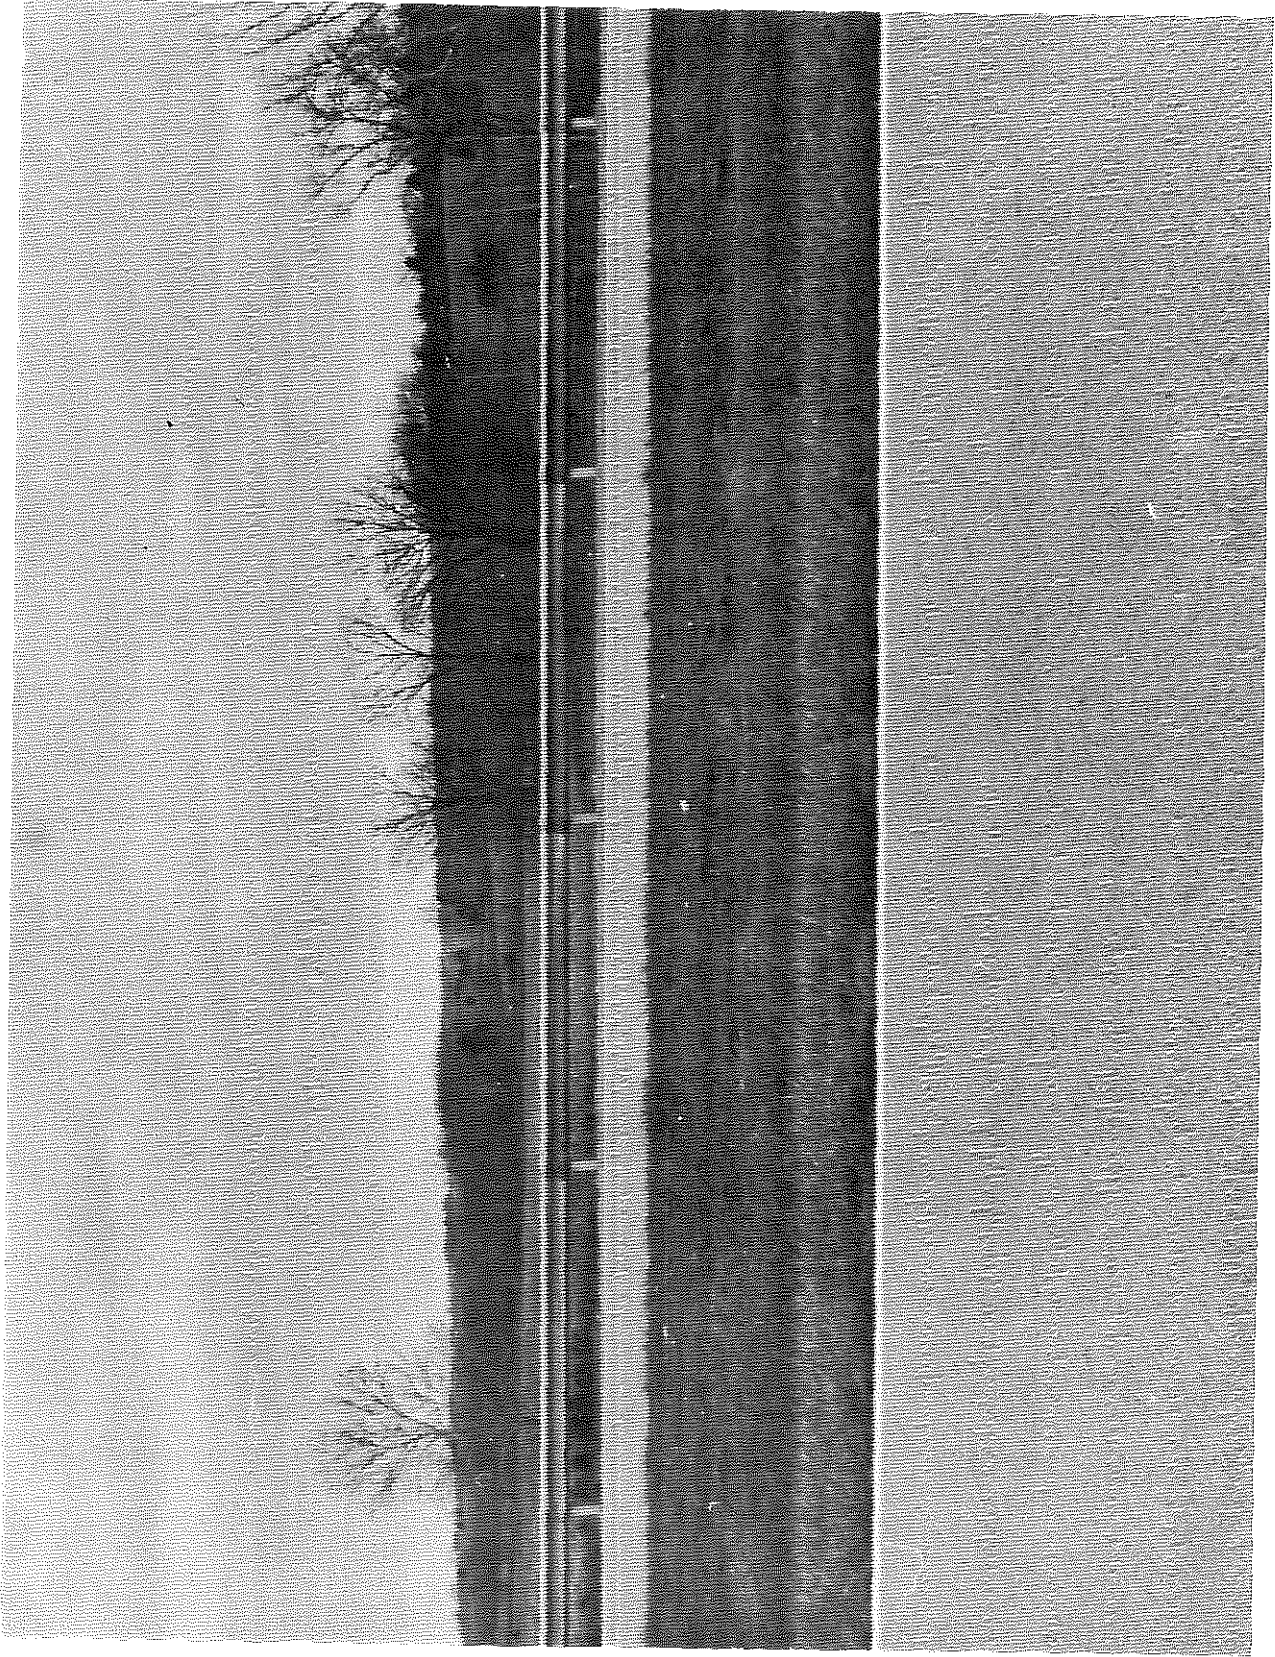
Figure 7. Galvanized Steel Guardrail with Discoloration at the Joints

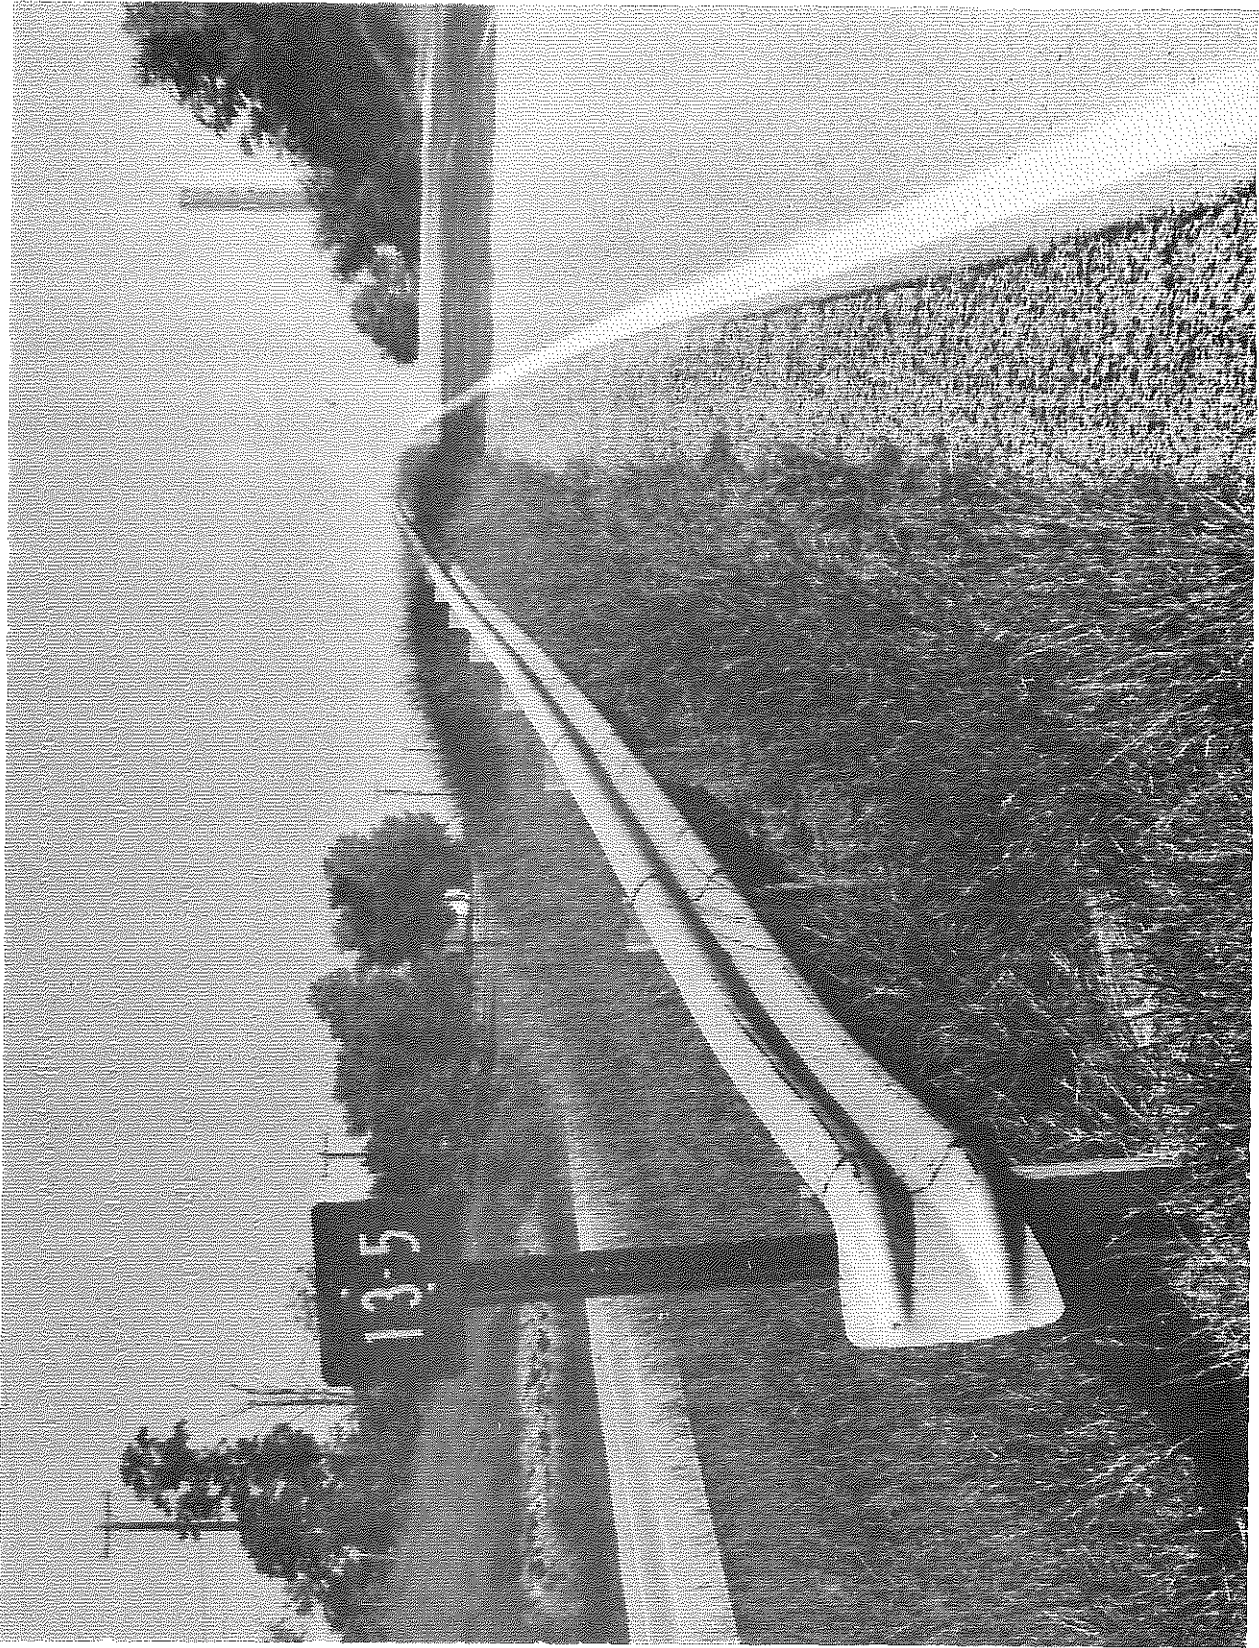
Figure 8. Section of Painted Steel Guardrail

These guardrails were rusted throughout and needed repainting again. The paint was very thin and peeling in areas. Rust was especially prevalent in the scarred areas and the center portion of the guardrail.

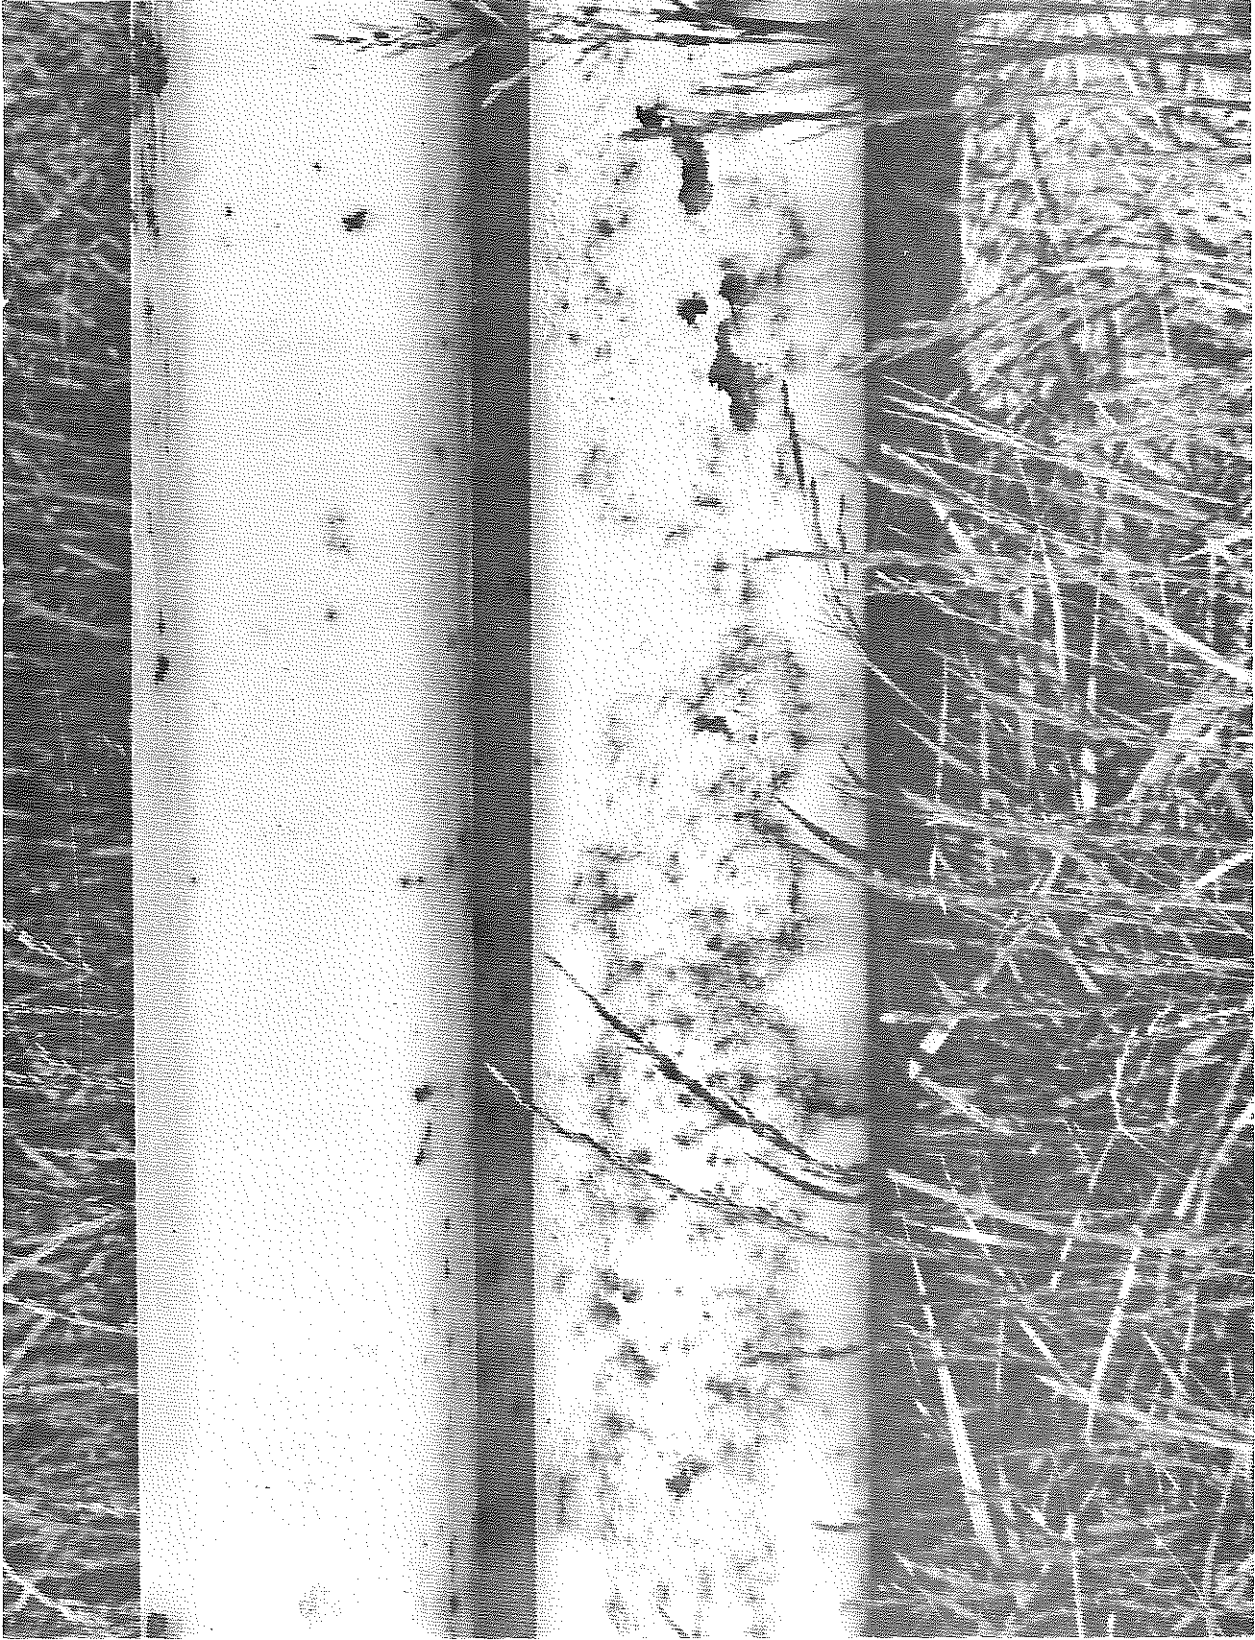
Figure 10. Closeup of Painted Steel Guardrail Showing Severe Rusting

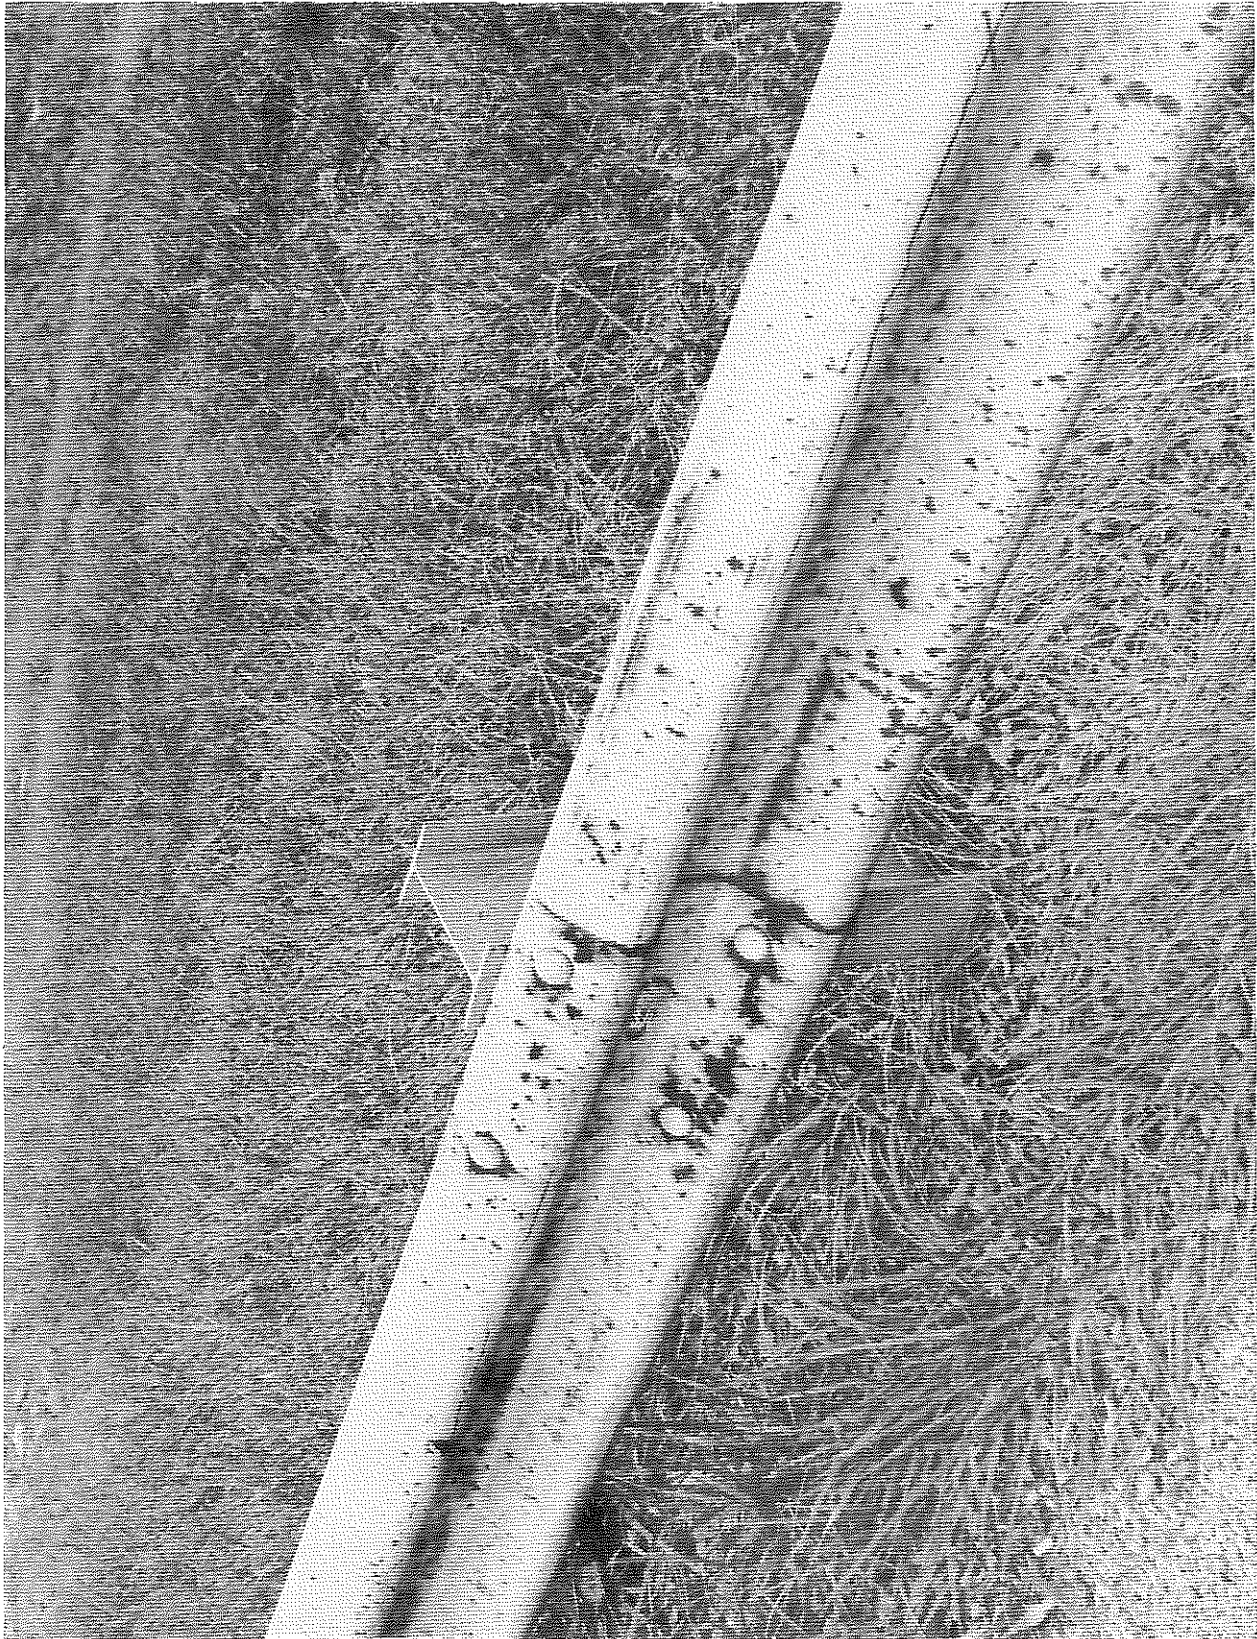
A section of guardrail at Sta 500+00 was damaged by a truck in 1964 and had not been repaired. All sections were of uniform condition and will not be summarized here by individual sections. The condition of the sections was poor. Figures 8 through 11 are of the painted steel guardrails.

Figure 11. Painted Steel Guardrail in Poor Condition

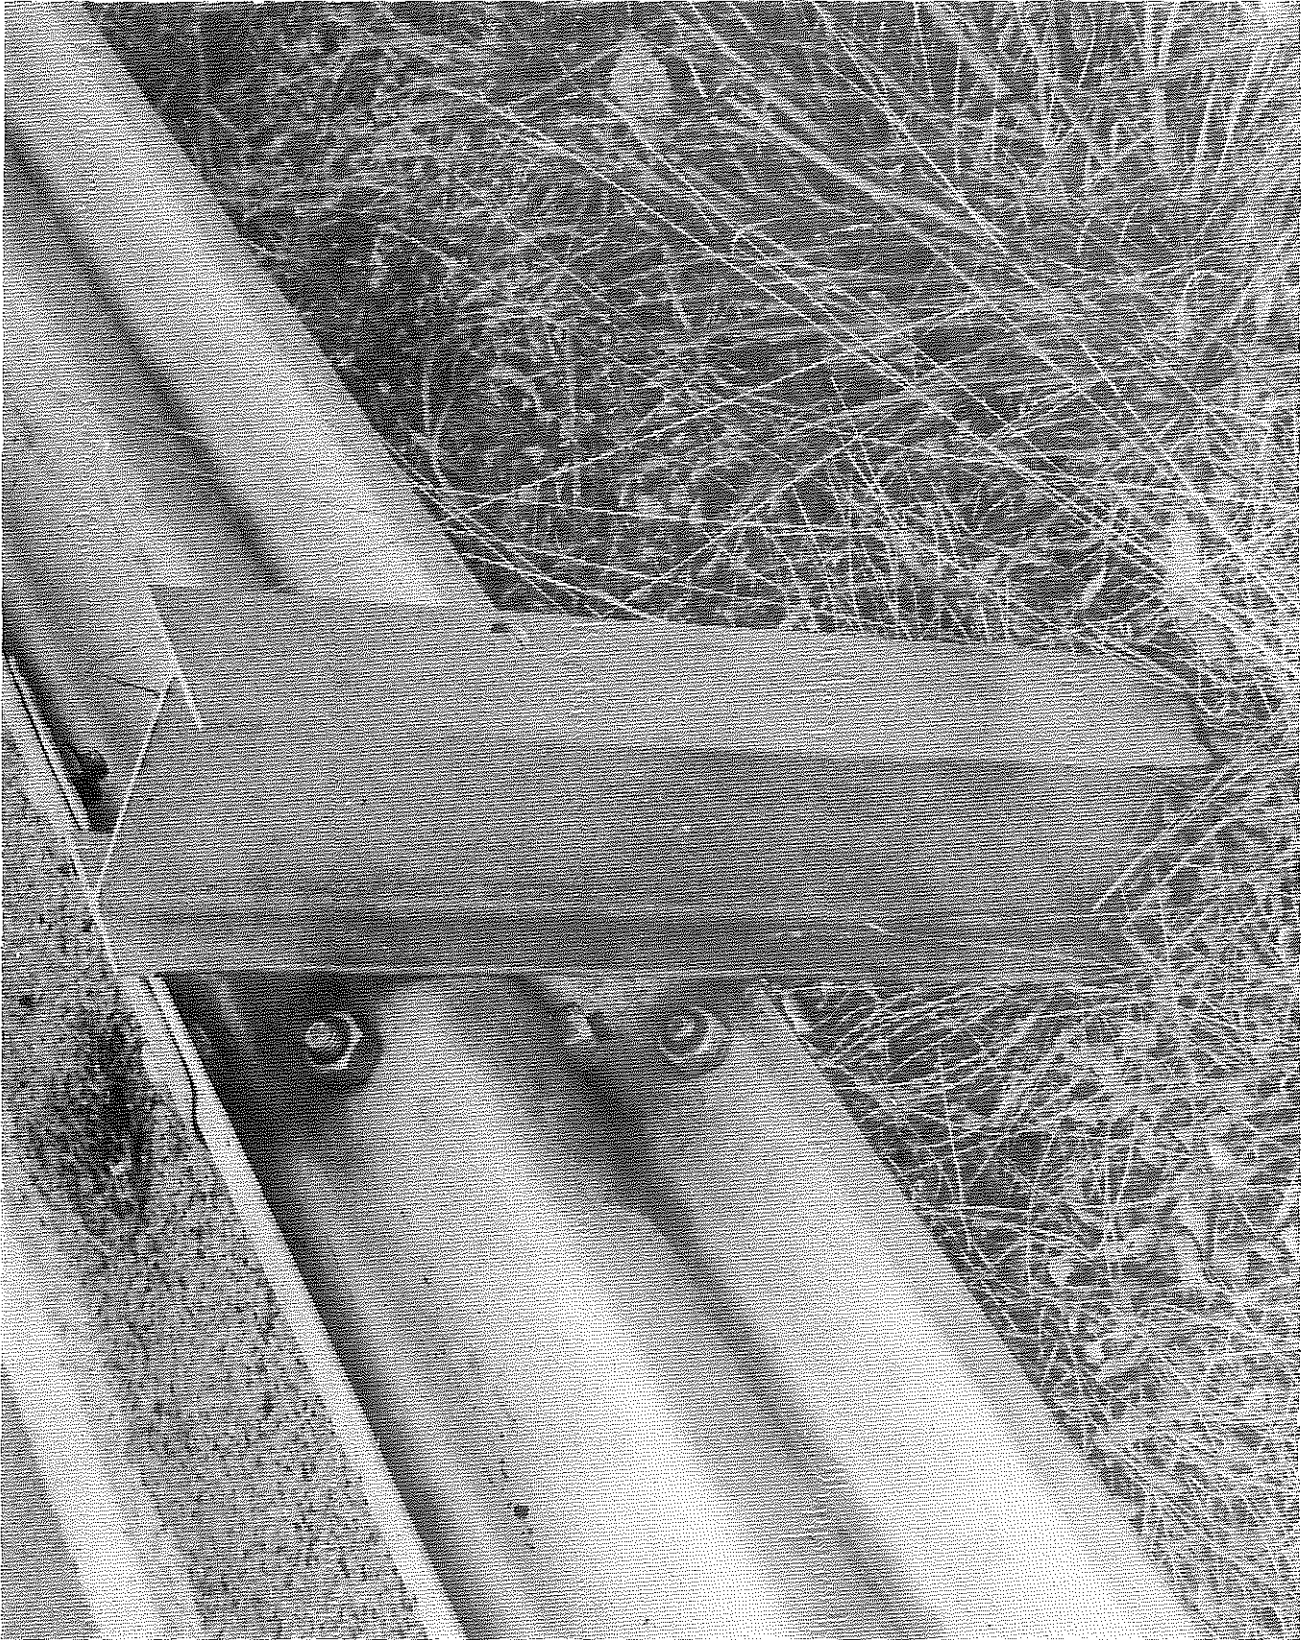
Figure 12. Guardrail Post

The guardrail posts (all steel) were repainted with aluminum paint in the spring of 1967. The edges showed rust, and in a few places rust could be seen under the recent coat of paint. A small amount of corrosion was also evident at the ground level of the posts. Generally, the posts were in good condition. Guardrail posts are shown in Figures 12 through 14.

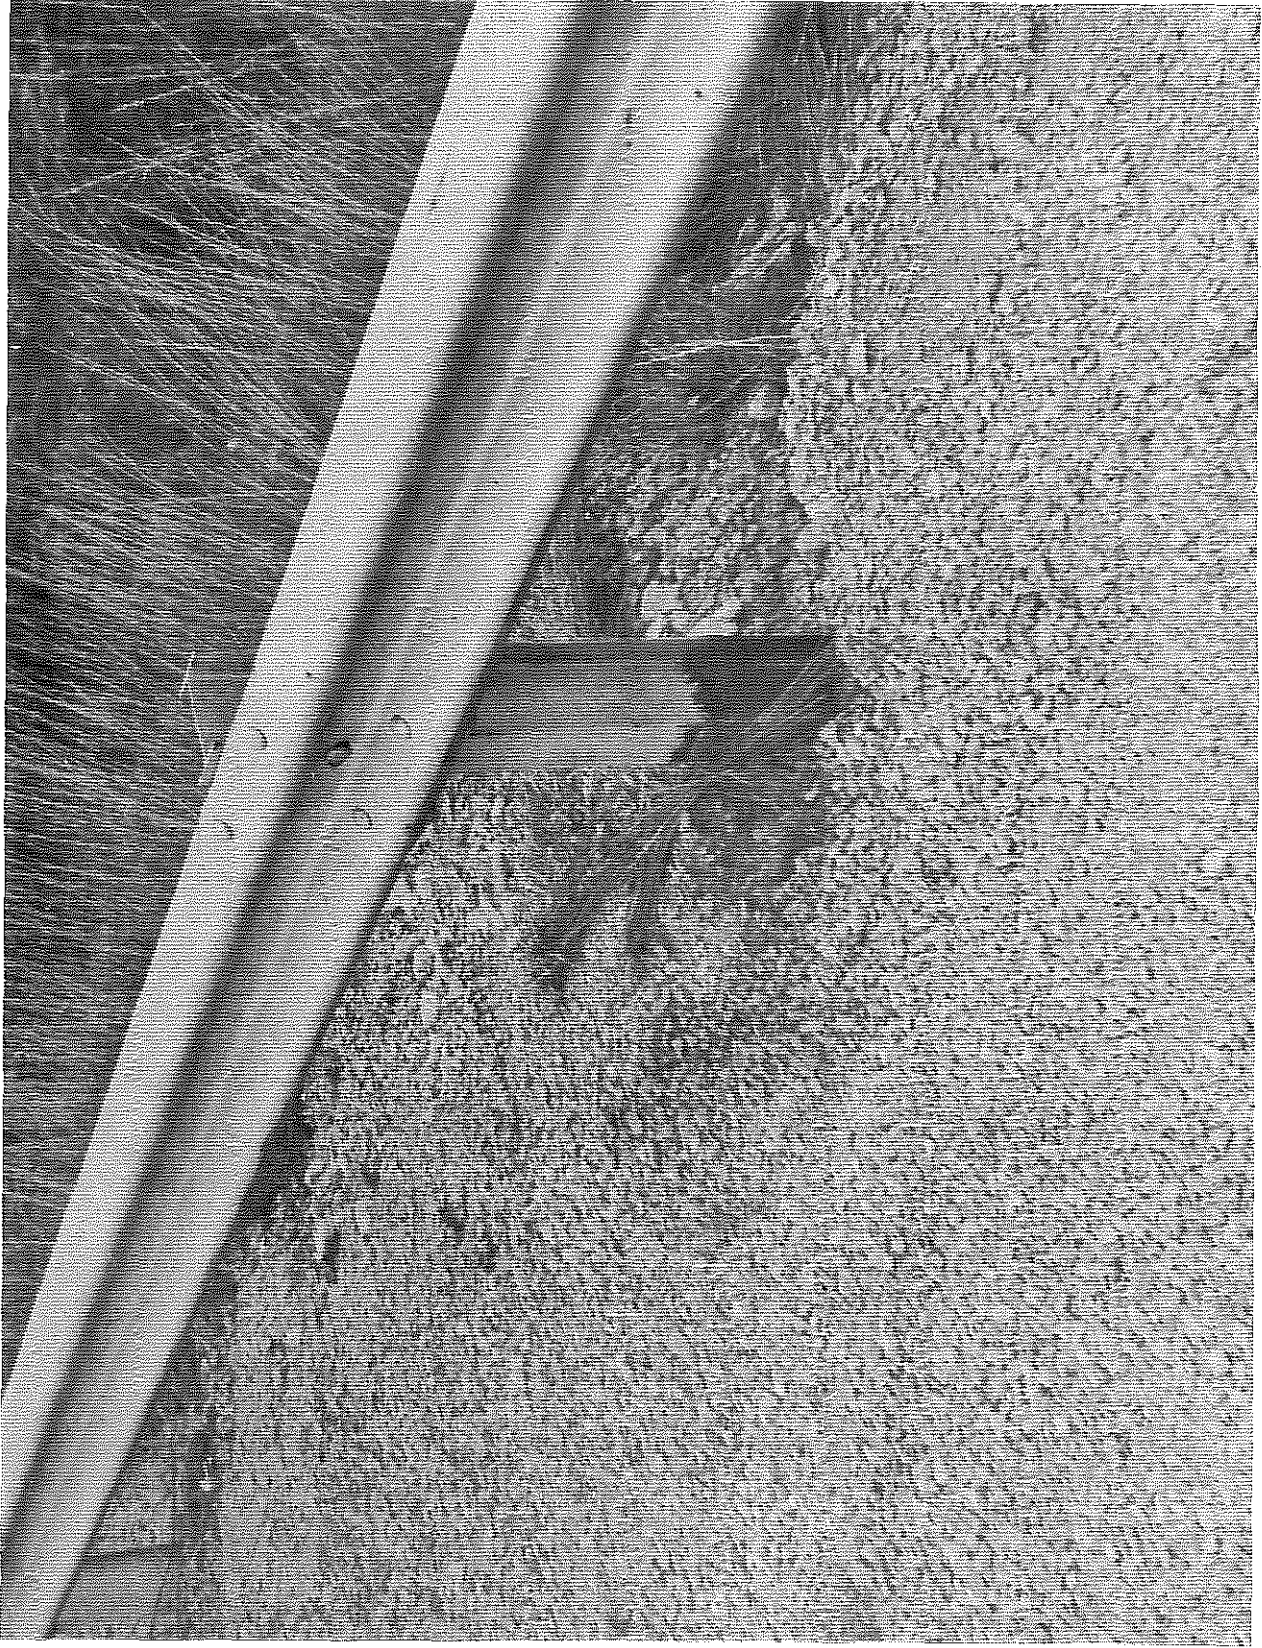
Figure 13. Guardrail Post Exposed below Painted Portion.

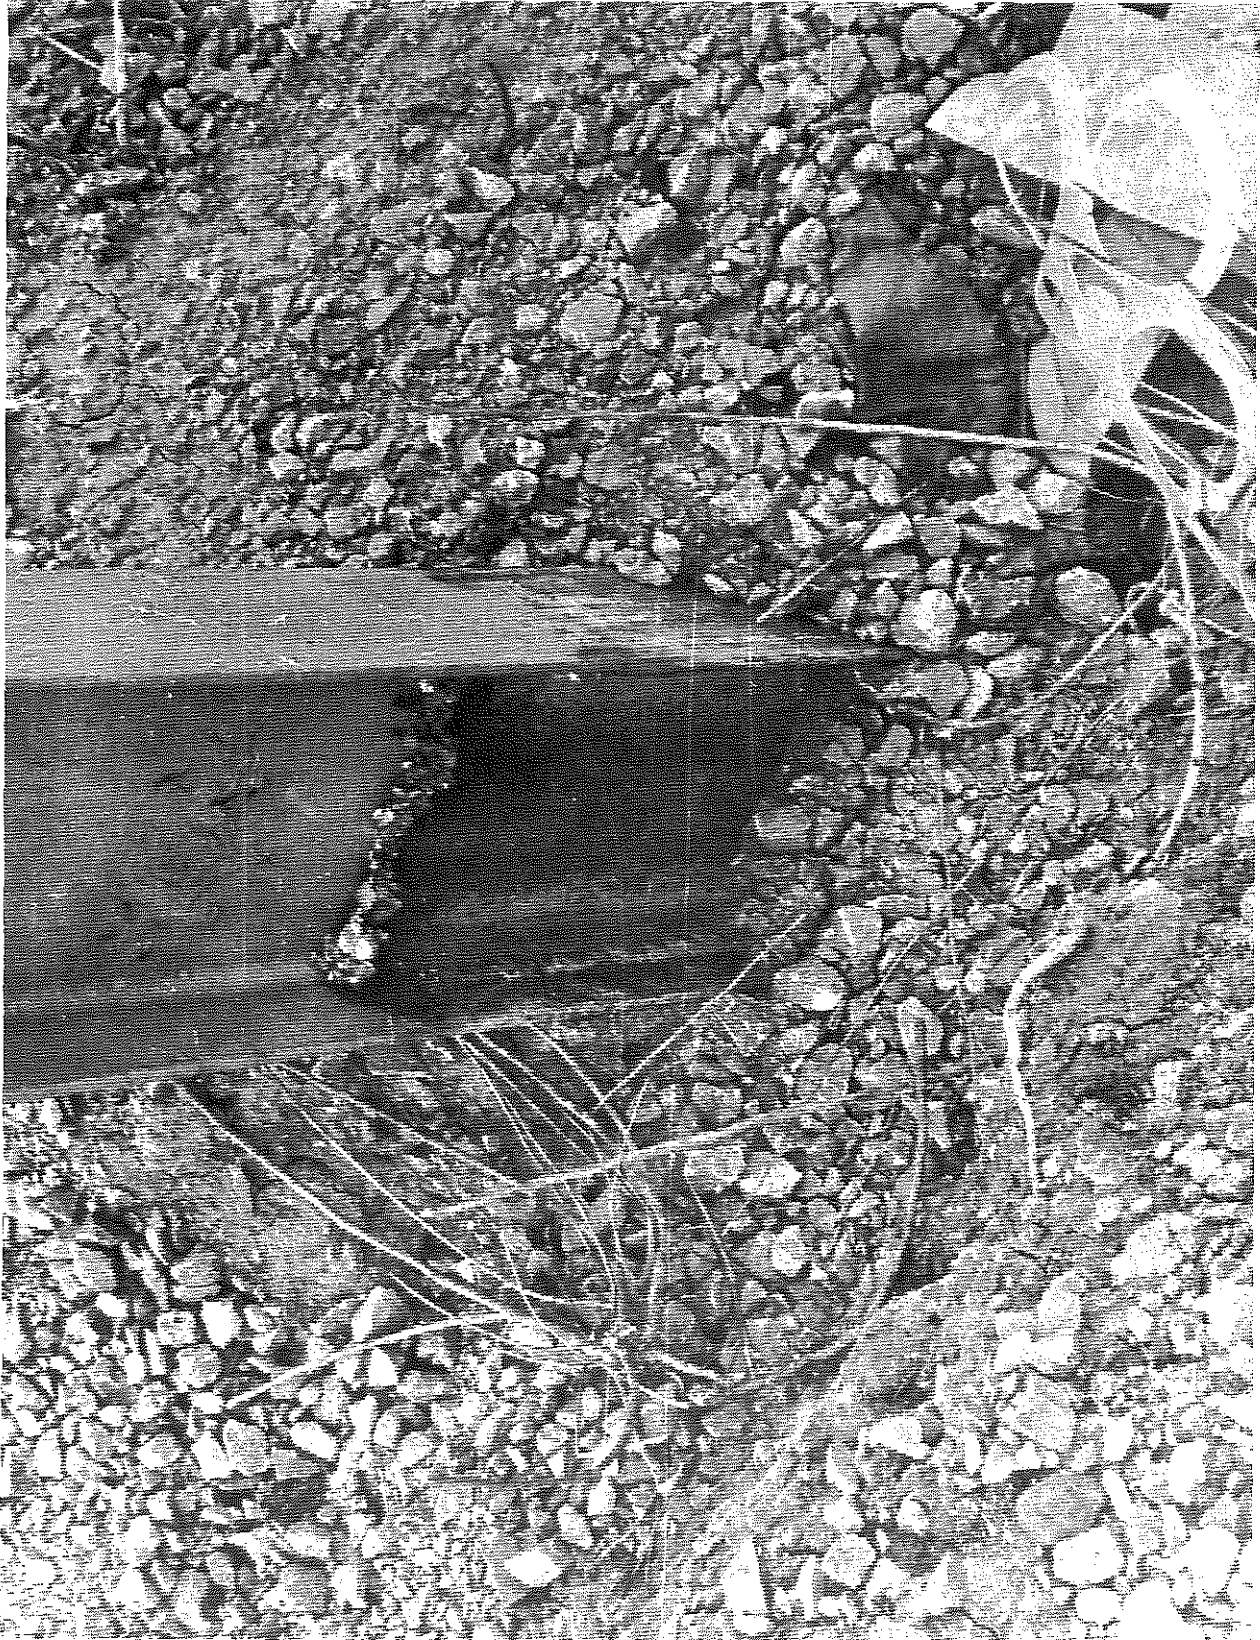
Figure 14. Closeup of Guardrail Post Exposed below Painted Portion
