THE BUMP AT THE END OF THE BRIDGE

KYHPR-64-17; HPR-1-(4), Part II

Division of Research
DEPARTMENT OF HIGHWAYS
Commonwealth of Kentucky

June 1969

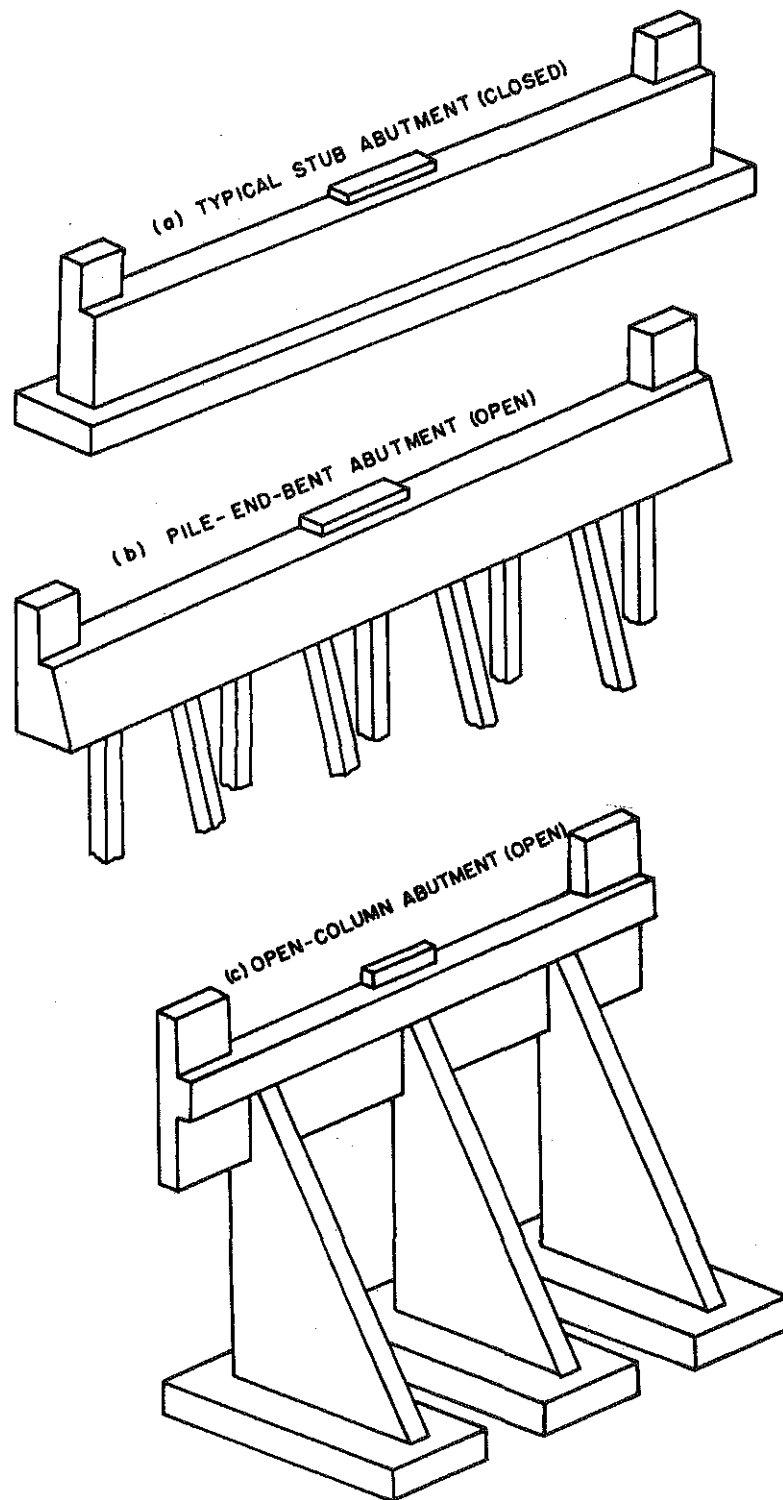
Figure 6 Typical Types of Abutments Used in Kentucky

A comparison of the most commonly used types of abutments (see Figure 6), with respect to the three settlement groups, Figure 7a, revealed that the open-column type (open-end) was more commonly

associated with Settlement Group III than either the pile-end-bent (open-end) type or stub type (closed-end) in 1964. The relationship between average height of embankment, average thickness of foundation soil and type of abutment with respect to settlement groups is shown in Figures 7b and c. Notice that stub abutments are associated with smoother bridge approaches, smaller average heights of embankment and thinner foundation soils. The pile-end-bent abutments had greater average heights of embankment and thicknesses of foundation soils than the open-column abutment, but the pile-end-bent abutments had better bridge approaches. The better performance of approaches located behind stub abutments may be attributed to smaller settlements associated with shallower embankments and foundation soils. The comparatively larger time for consolidation before construction of the pavement and the need for less hand compaction near the abutment may account for better performance of approaches associated with pile-end-bent abutments than those approaches at open-column abutments. However, in 1968 there was an increase in percentage of faulted approaches for all types of abutments with the percentage for pile-end-bents increasing the most. There were small differences in percentages between the pile-end-bent and open-column abutments. Although the percentage of faulted approaches increased, stub abutments still had a comparatively high percentage of smooth approaches in 1968. For both surveys, there was a large number of defective bridge approaches associated with all types of abutments.

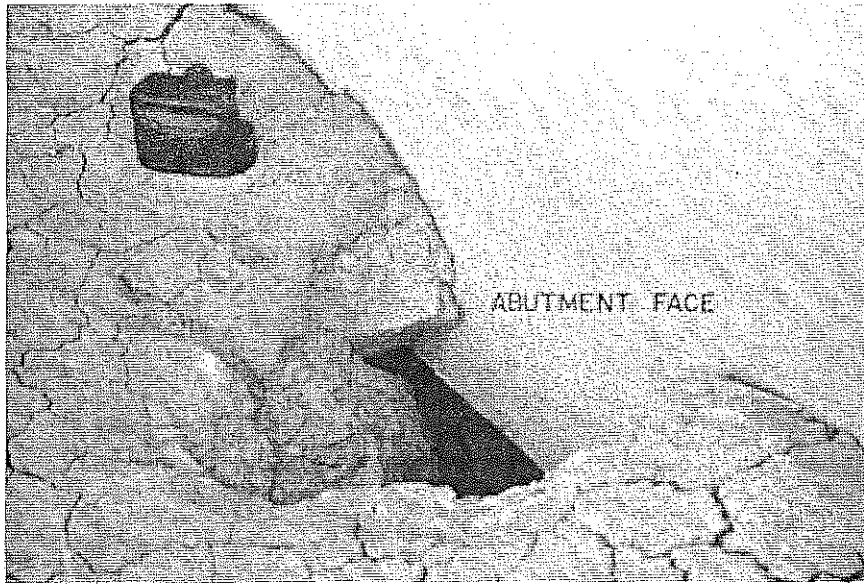
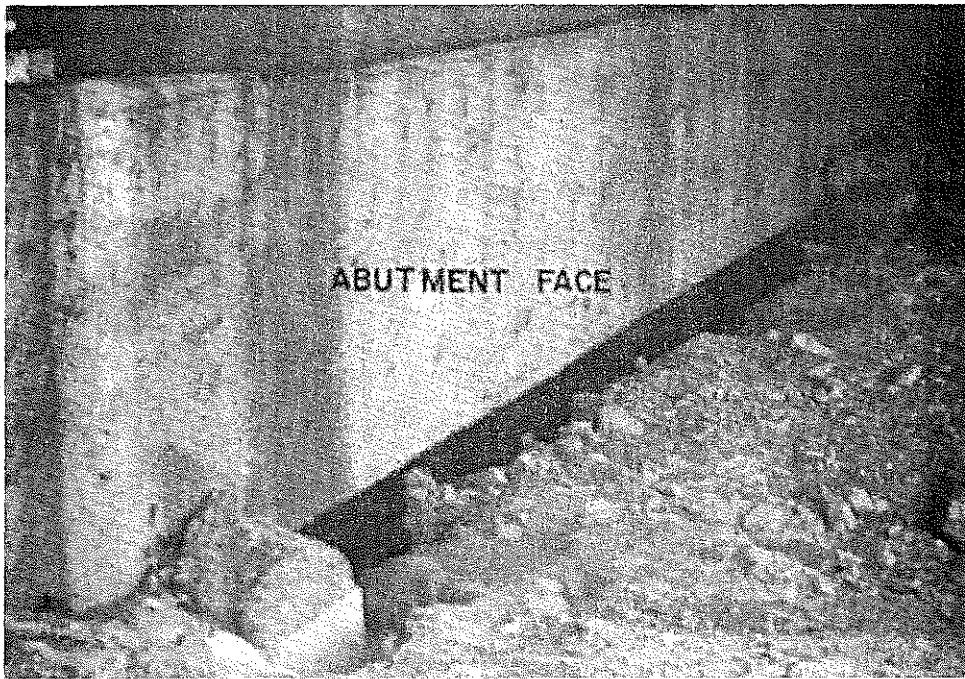
In a few cases, the 1964 study indicated that erosion of soil adjacent to the abutment (Figure 8) contributed to the development of the approach fault. In one observed case, grouting material from the mudjacking operation had effused from underneath the face of the abutment. As shown in Figure 9, there was an increase in the percentage of repaired approaches when such erosion occurred. This type of erosion appears to be a result of ground water seepage (including runoff from the pavement) as shown diagrammatically in Figure 10.

Loss of material around the abutment could result in a loss of subgrade material and, consequently, cause the approach to settle. By 1968 the percentage of defective approaches had increased noticeably, and there were no significant differences in percentages of smooth approaches as well as faulted approaches for approaches with erosion and without erosion. However, the number of faulted approaches with erosion at the face of the abutment increased considerably.

Figure 8 Illustration of Erosion of Soil at the Abutment Face

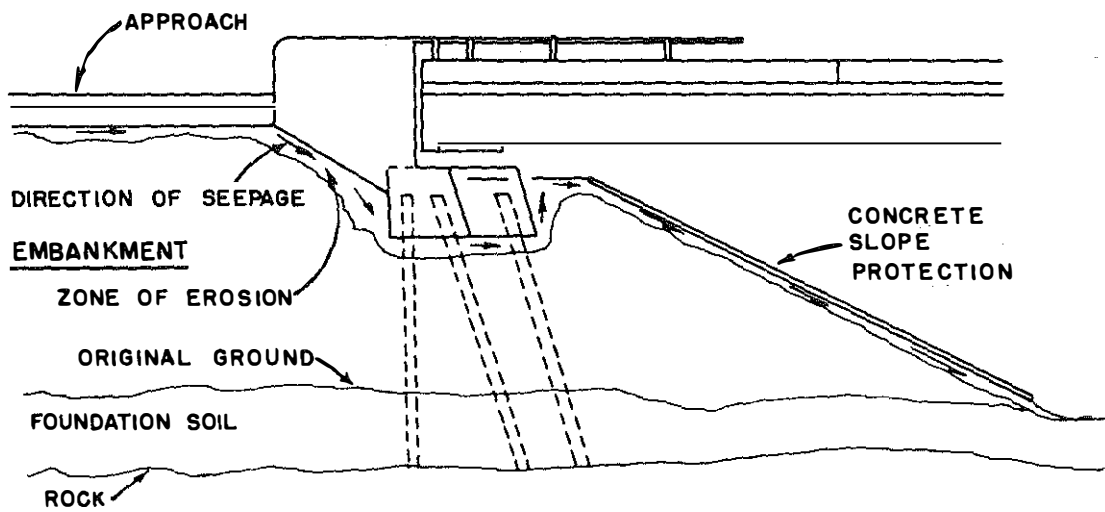
Figure 10 Direction of Seepage and Zone of Erosion

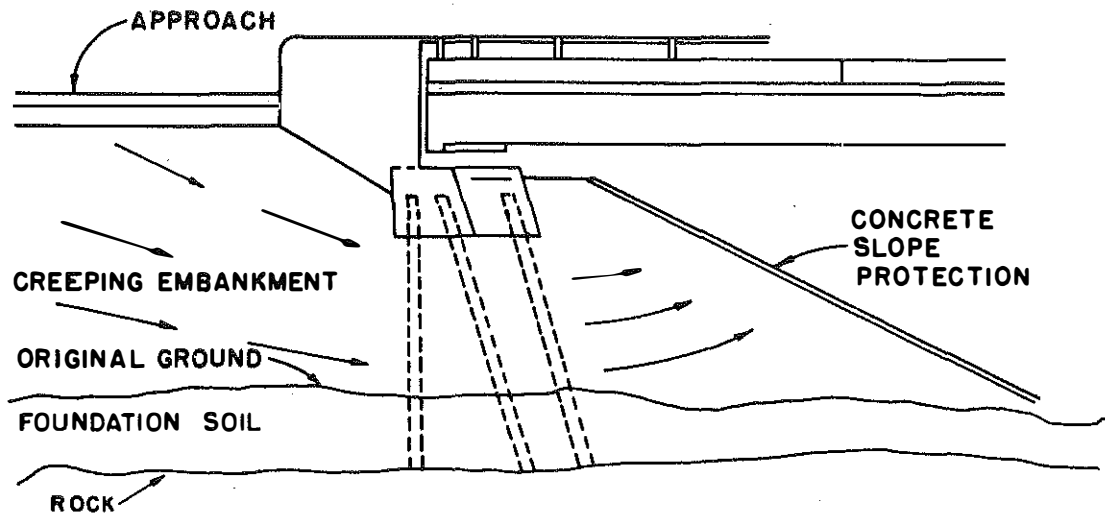
There was suggestive evidence that progressive failure, or creep, of the approach embankment may, in some cases, contribute to development of the approach fault. Figure 12 is a comparison of approach embankments with cracked concrete slope protections, embankments with uncracked concrete slope protections, and embankments with no slope protection, suggesting a relationship between cracked slope protections and bridge approach settlement. One possible explanation for the cracked slope protections could be progressive failure of the embankment, as shown in Figure 13, resulting in a loss of subgrade support. In some cases, slope protections did appear to be bulging outward.

Figure 13 Creep of Embankment Slopes

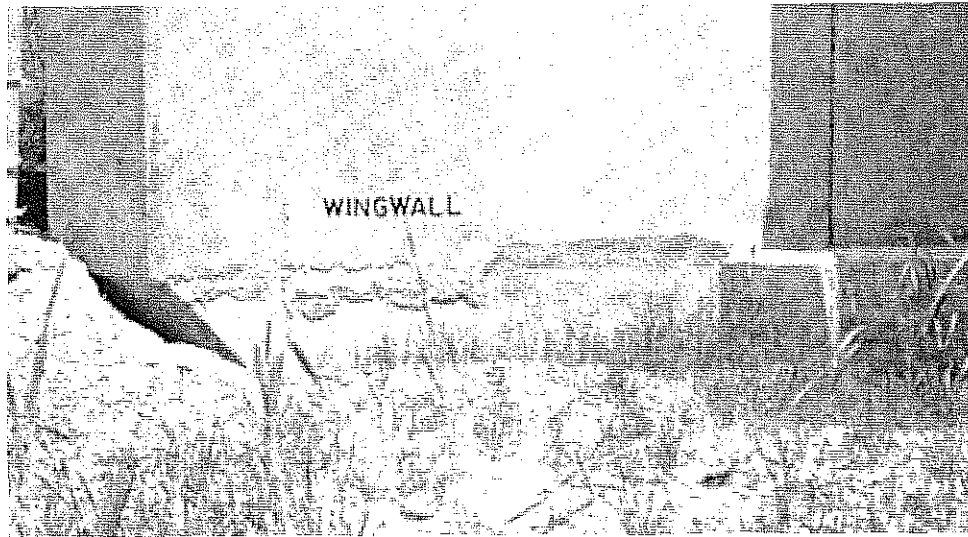
A comparison of those approaches with embankments that appeared to have settled from the face of the abutment and those which had not (see Figure 14) revealed that there was a greater percentage of

Figure 14 Settlement of Fill from Wingwall and Abutment
