COMMONWEALTH OF KENTUCKY
DEPARTMENT OF HIGHWAYS
FRANKFORT, KENTUCKY 40601

August 23, 1968

SUBJECT: Final Performance Reports on:
1) A Concrete Pavement without
Transverse Joints
2) Wire Mesh Reinforcement in Bituminous
Concrete Overlays
3) Limestone Sand Blankets to Control
Reflection Cracking in Bituminous Overlays
4) Experimental Joint Installations for Concrete
Pavements

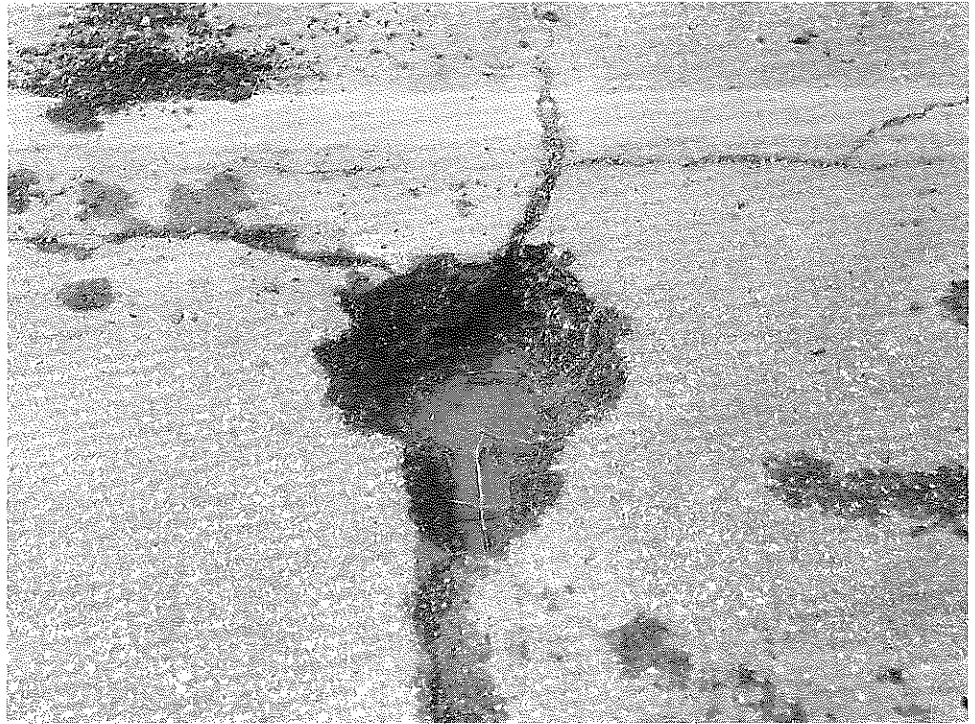
Small holes were dug in the bituminous overlay to expose the wire mesh (Figures 1 and 2). The wire mesh was badly corroded and several strands had ruptured. Strands which were intact broke easily and it was concluded that the corroded wire mesh was incapable of distributing any load. A circular memorandum from the U. S. Department of Transportation (5) concludes that placement of the reinforcement

Figure 1. Exploration Hole to Study Condition of Wire Mesh.

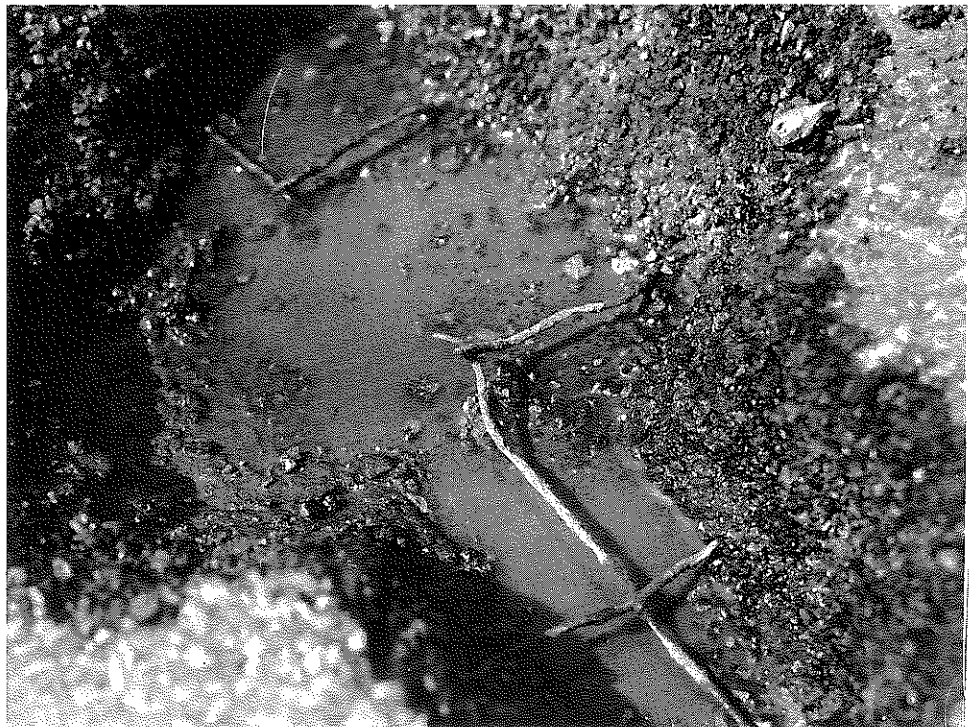
Figure 2. Close-up View Showing Deteriorated Condition of Wire Mesh.

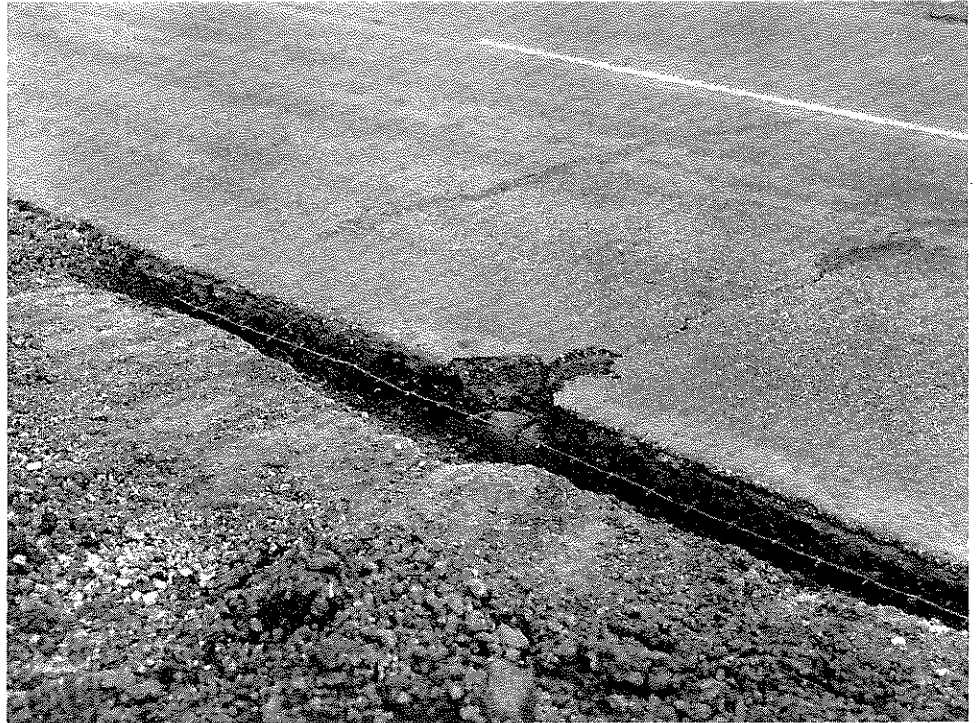
By digging near the edge of the pavement at Location 2, it was found that the overlay had cracked over the edge of wire mesh as well as over the joint in the PCC pavement (Figure 3). This confirms the hypothesis put forth in the 1960 report (2).

Figure 3. View Showing Reflection Crack over Joint in Rigid Slab and Associated Crack at Edge of Wire Mesh Reinforcement.

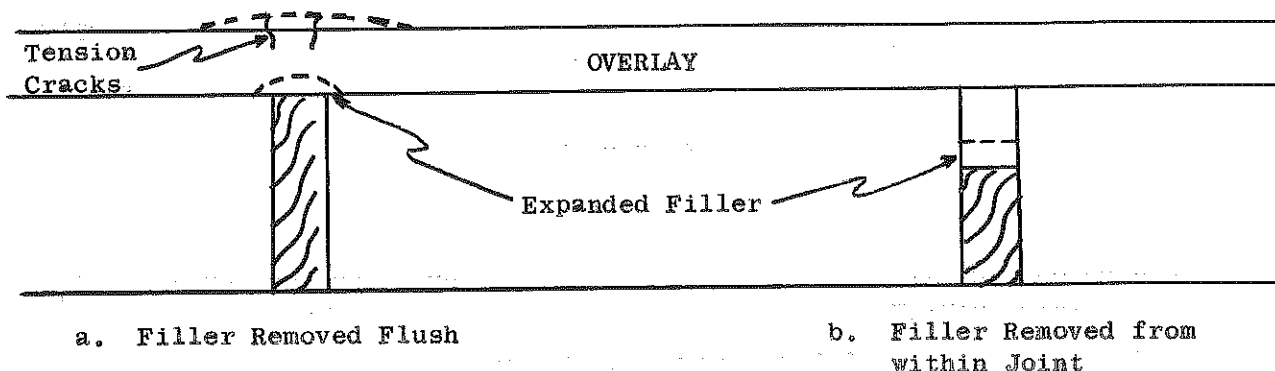
The method of preparing the joints on this experiment did not prove effective. It was impossible to remove the joint-filler material from the joint void. Cleaning with a patrol grader, at best, only removed excess material from the pavement surface and, as depicted in Figure 1a, the joint void still remains full of material. After placement of an overlay, subsequent expansion of the pavement slabs may force material up and out of the joint voids. Vertical displacement, in turn, introduces a deformation of the overlay resulting in tension cracks on the surface. The obvious solution would be to remove the filler to some depth within the joint void as indicated in Figure 1a.

Figure 1. Joint Preparation

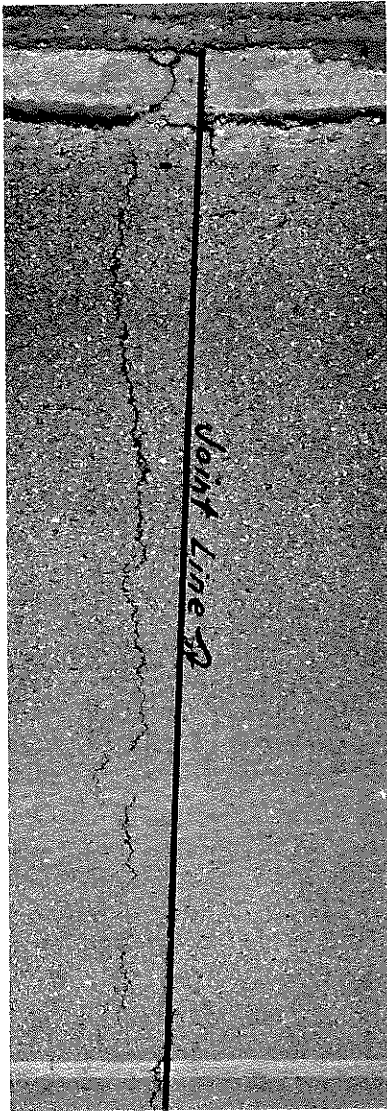
JOINT NUMBER 1

NBL- Ragged crack extending full width of lane parallel to rigid pavement joint indicating crack is along northern edge of sand mat.

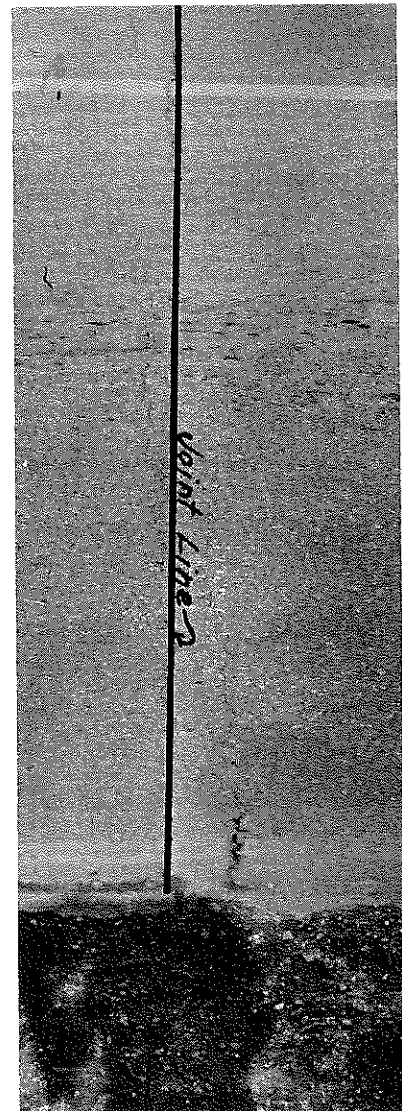
SBL- Hairline crack extending full width of lane with indication of second crack along southern edge of sand mat.

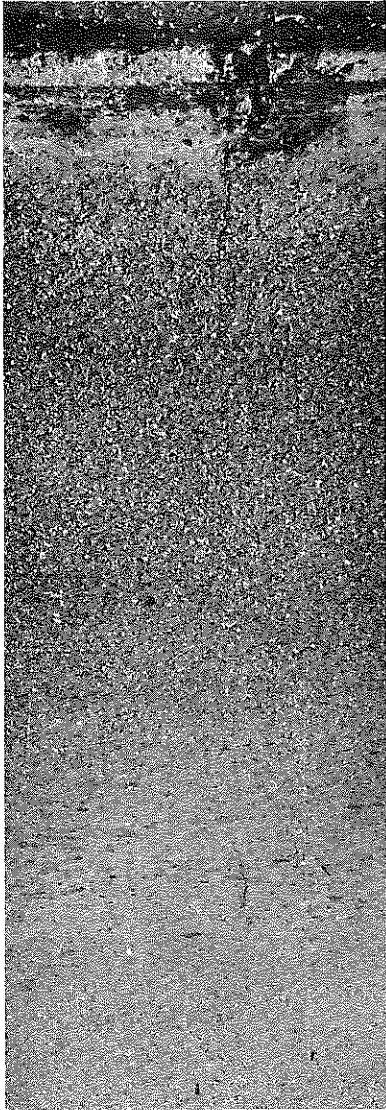
JOINT NUMBER 2

NBL- Narrow crack from edge of pavement to outside wheel-track. Sixteen-inch long narrow crack across inside wheel track and a 22-inch narrow crack across center stripe.

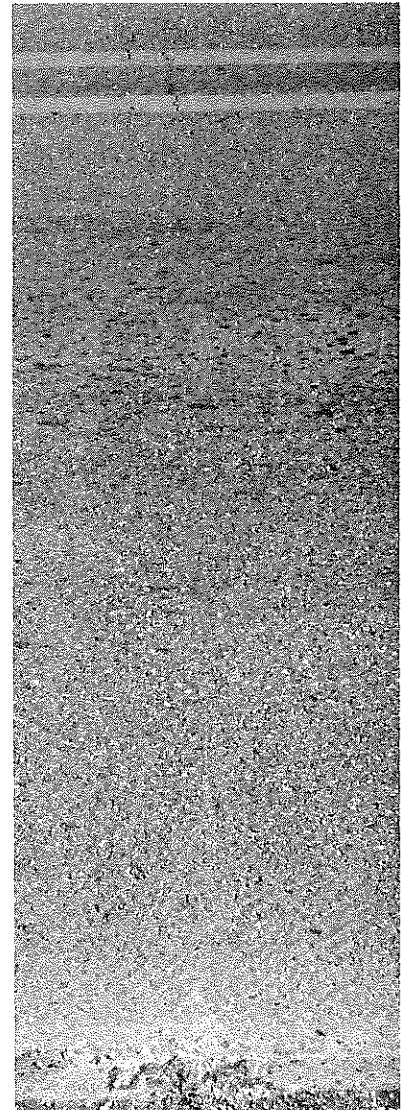
SBL- No cracking evident in bituminous overlay.

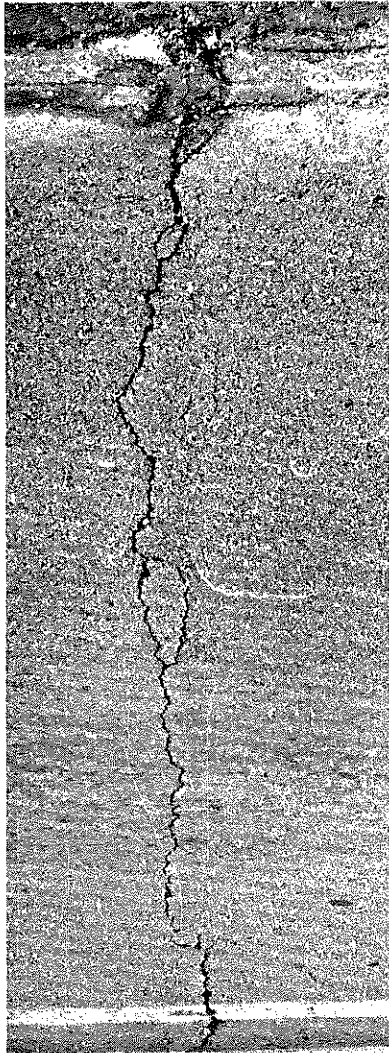
JOINT NUMBER 3

NBL- Crack 1/2 inch wide extending full width of lane. Crack is beginning to ravel. No indication of joint failure in rigid pavement.

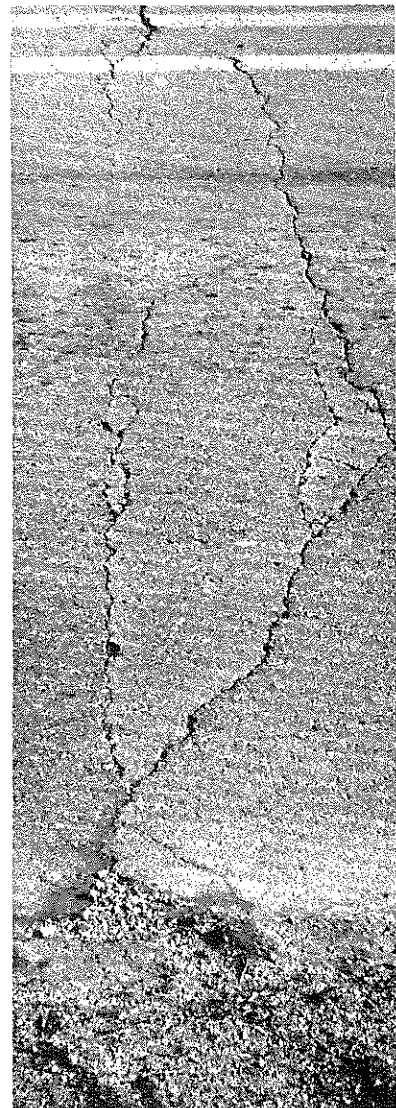
SBL- Progressive dendritic crack pattern. Cracks are 1/2 inch wide and beginning to ravel. No indication of joint failure in rigid pavement

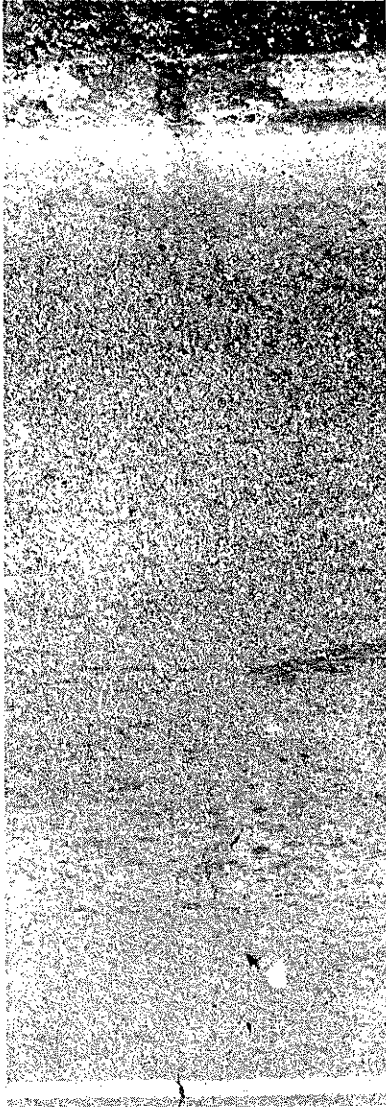
NBL- No cracking.

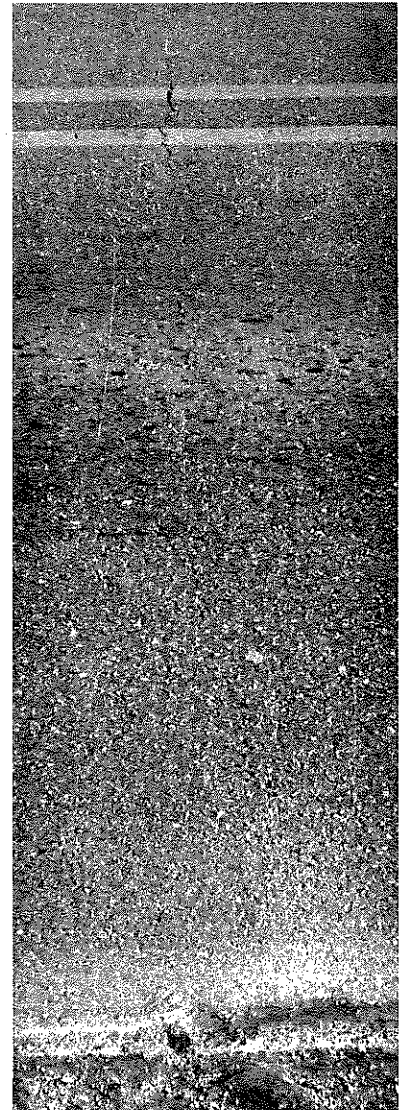
SBL - A crack across the center
stripe 18 inches long by
1/4 inch wide.

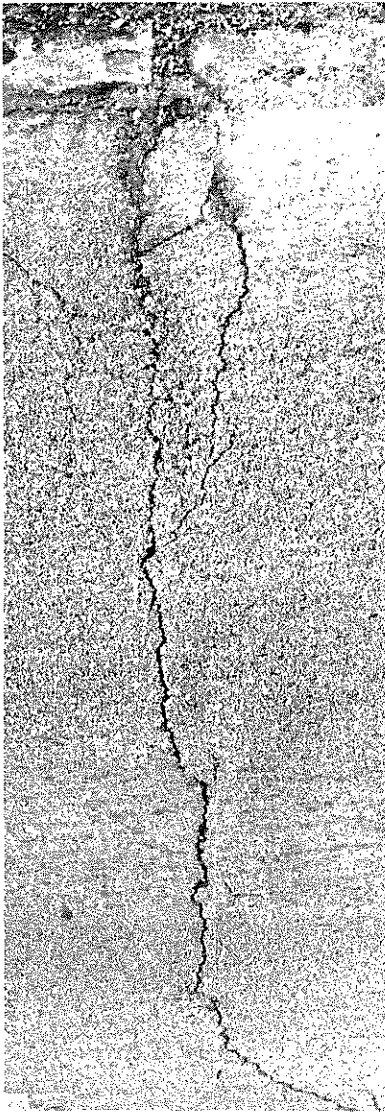
JOINT NUMBER 5

NBL- A wide, ragged crack extending the full width of lane. Map cracking at curb indicates corner failures of rigid pavement slabs. Joint of lip curb separated 1-1/2 inches.

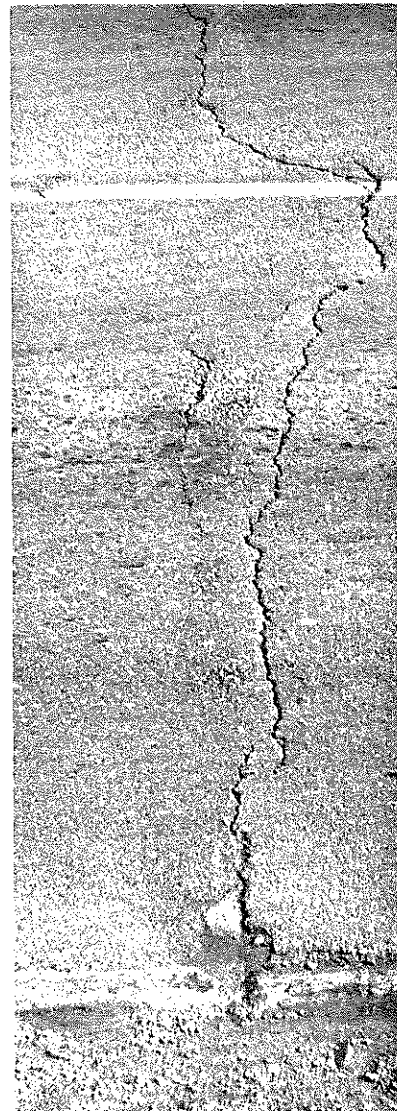
SBL- A wide, ragged crack extending full width of lane. No indication of corner failure. However, joint faulting indicated in relative downward movement of northern slab.

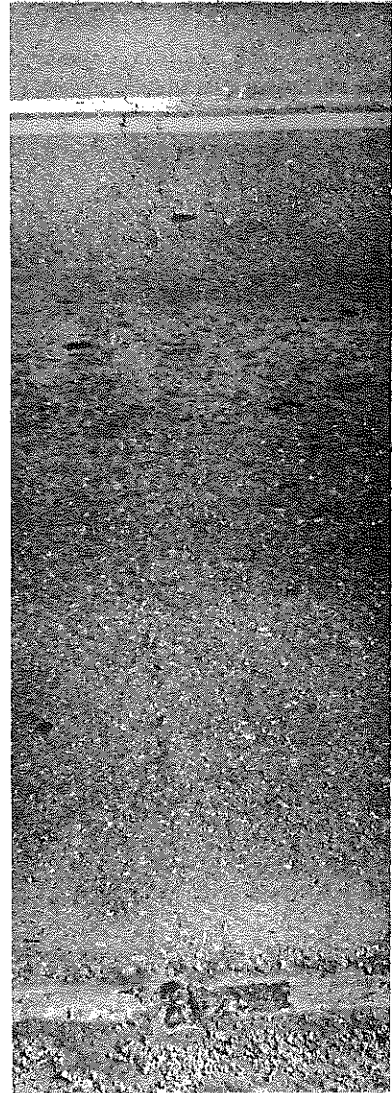
SBL- Hairline crack from inside wheel track across center stripe.

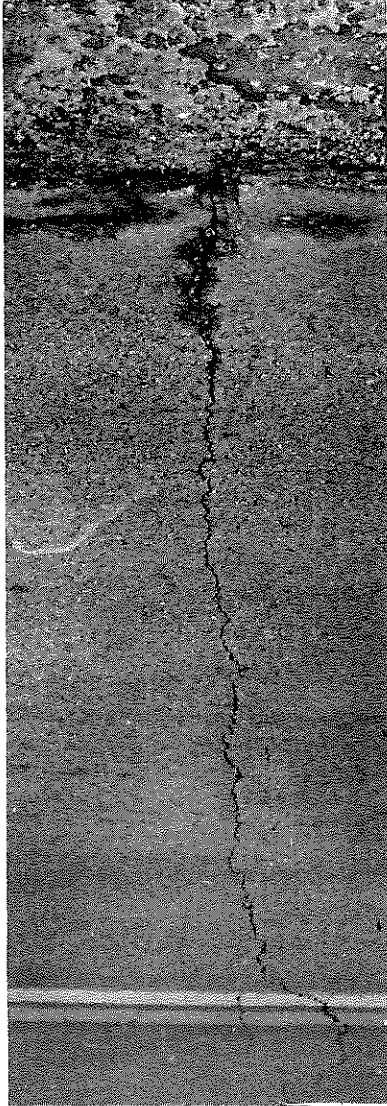
JOINT NUMBER 7

NBL- Crack extending full width of lane beginning to ravel from edge of pavement to outside wheel track.

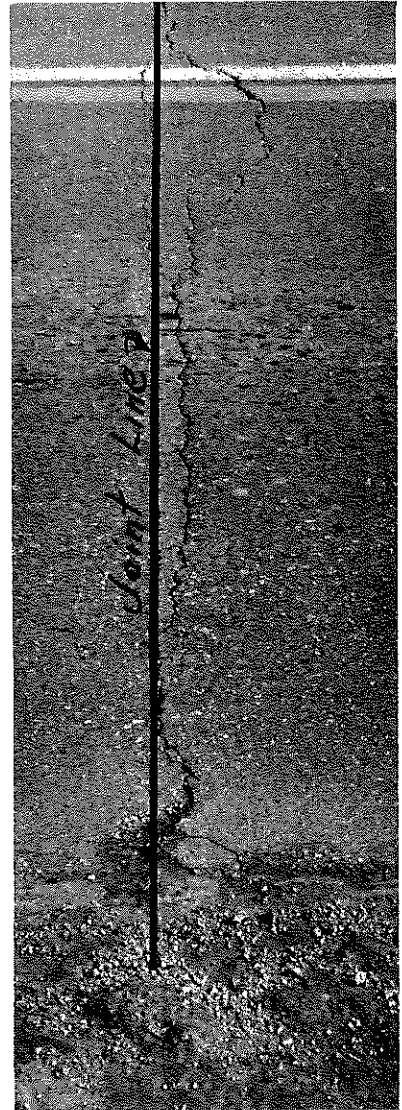
SBL- A crack 1/2 inch wide from edge of pavement to outside wheel track, and a hairline crack from outside wheel track to center stripe. At outside wheel track crack deviates to a parallel crack running along southern edge of sand mat. Indication of slight relative vertical movement of rigid slabs.

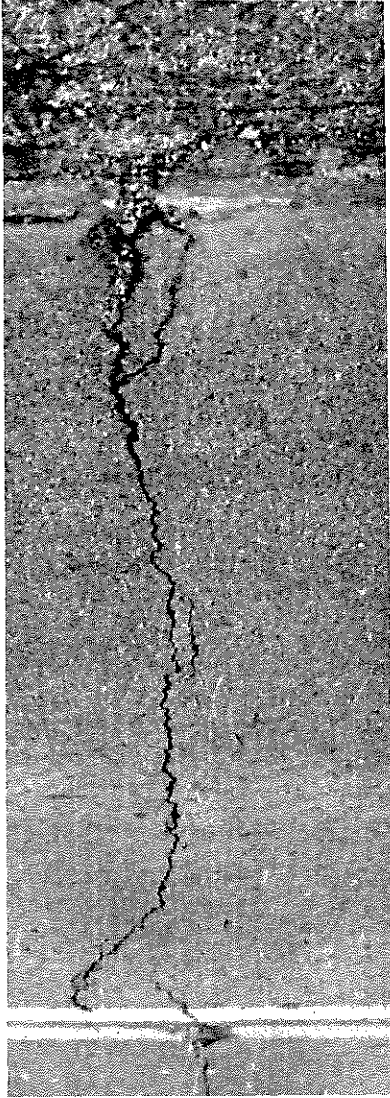
JOINT NUMBER 8

NBL- Wide, ragged crack extending full width of lane. Joint of lip curb indicates joint separation of 2-inches.

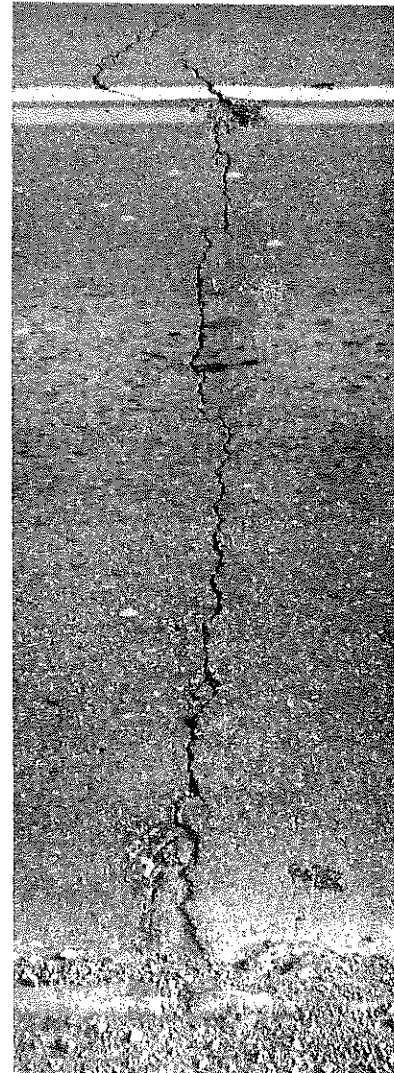
SBL- Wide, ragged crack extending full width of lane. Extensive raveling at center stripe and from outside wheel track to edge of pavement. Joint of lip curb indicates joint separation of 1-1/2 inches.

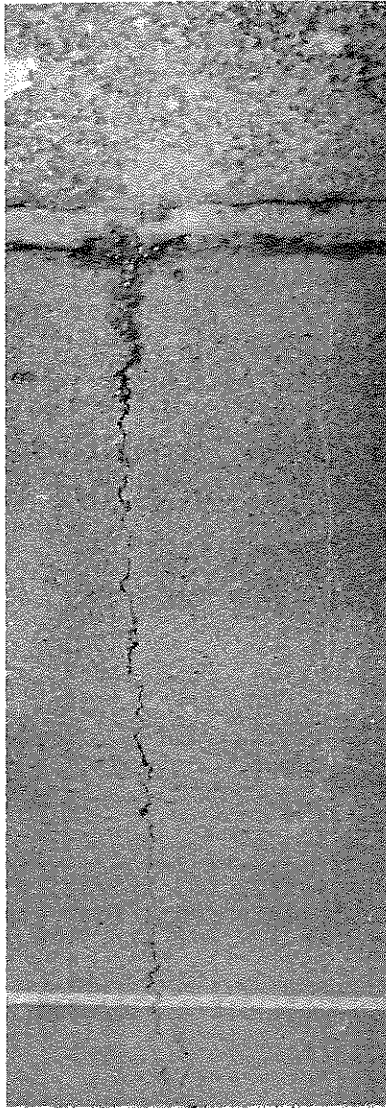
JOINT NUMBER 9

NBL- A narrow, straight crack extending full width of lane.

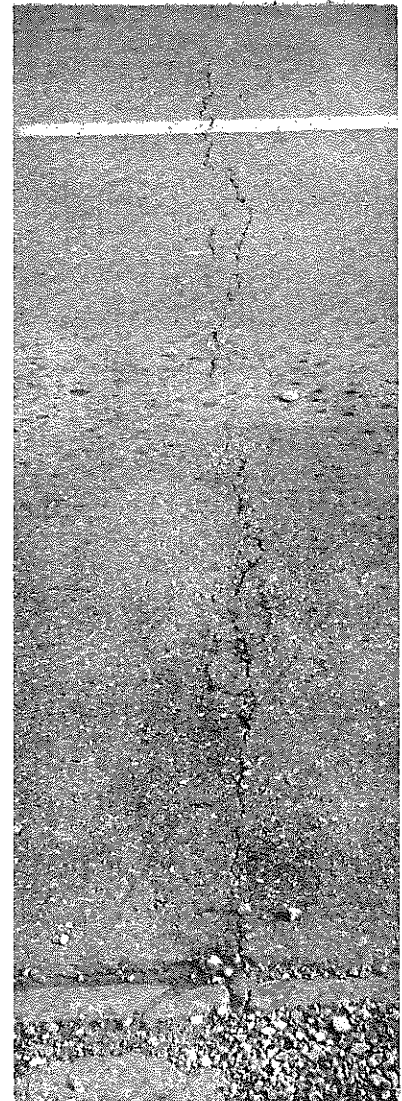
SBL- Narrow crack extending full width of lane.

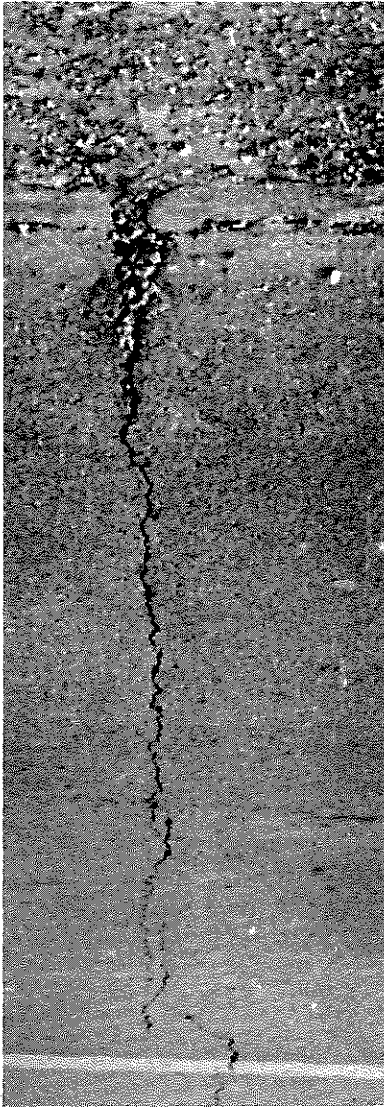
JOINT NUMBER 10

NBL- Wide, ragged crack extending full width of lane with extensive ravelling from outside wheel track to edge of pavement.

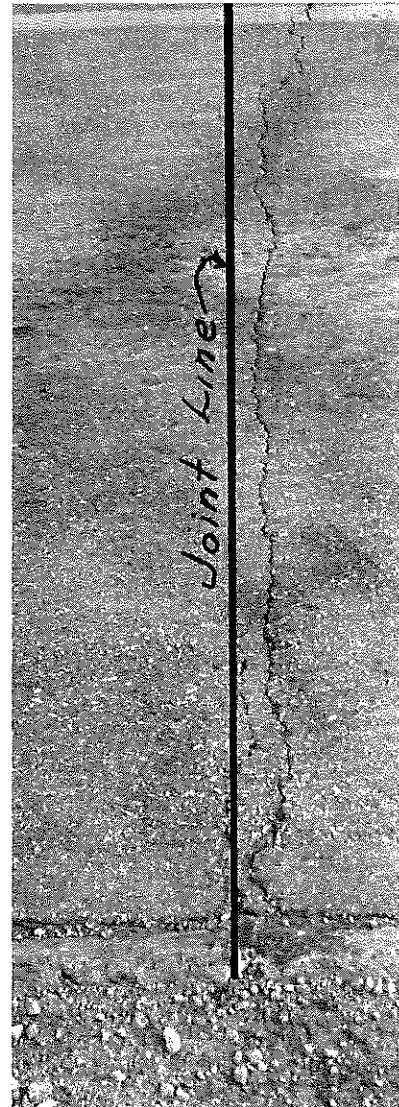
SBL- Crack extends along southern edge of sand mat from center stripe to edge of pavement.

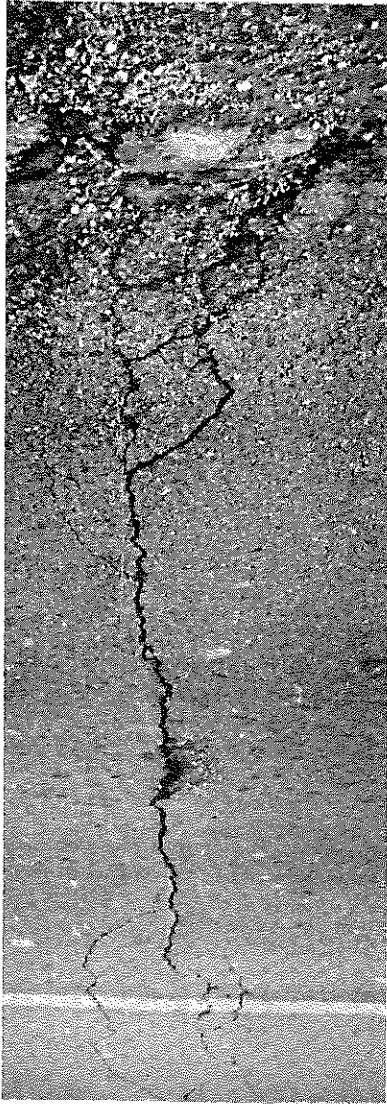
JOINT NUMBER 11

NBL- Joint shows extensive map cracking with wide, ragged cracks. Relative vertical movement of slabs apparent.

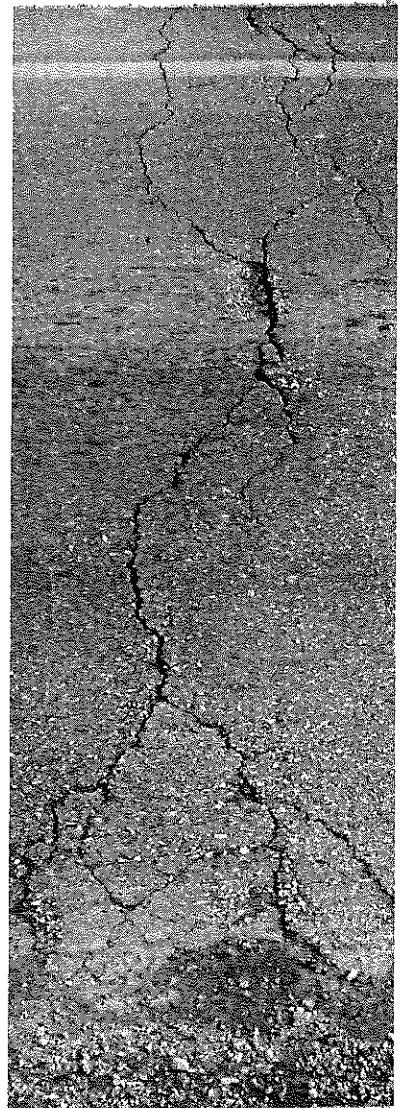
Observations of Joint 11 revealed an extensive dendritic crack pattern in the southbound lane; whereas, the northbound lane remained in excellent condition. This joint was the only one in both sections where this type cracking occurred. The width of the stone mat was 30 inches and 48 inches in the northbound and southbound lanes respectively. Indications are that, at some width greater than 30 inches, bonding of the two layers may be broken to such an extent that may encourage cracking.

SBL- Extensive dendritic map cracking with ravelling. Indication of corner failure of rigid slabs.

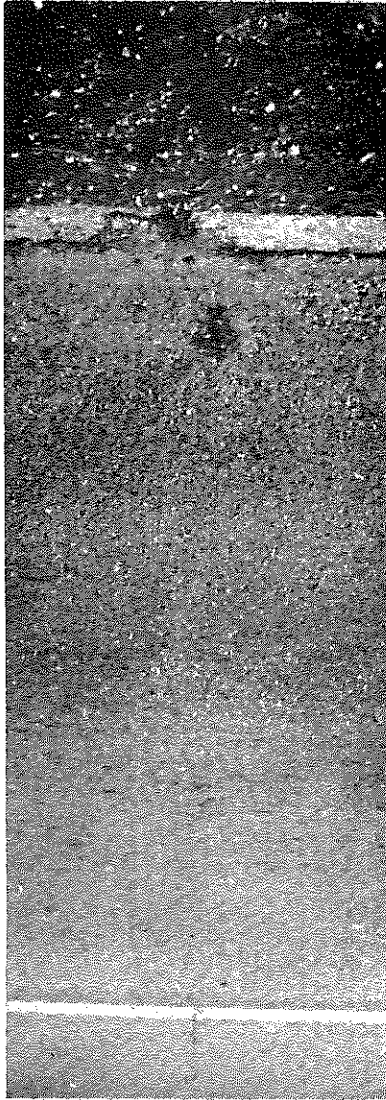
NBL- No cracking.

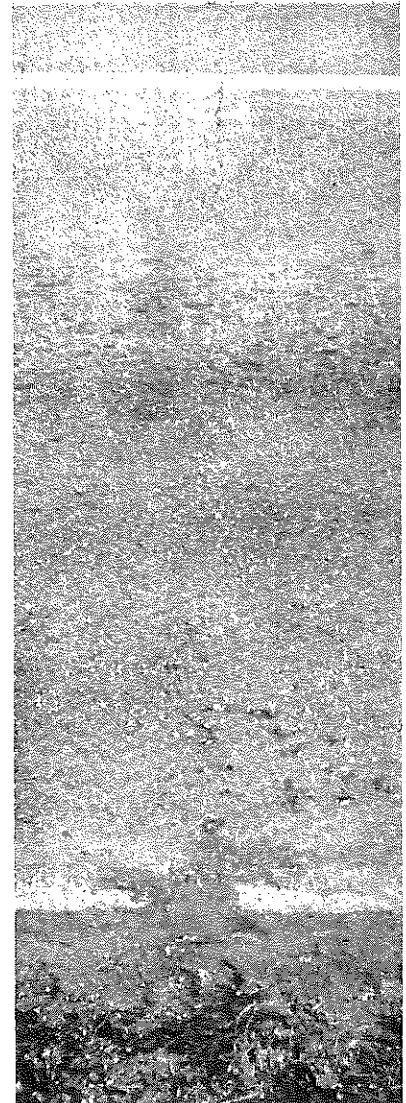
SBL- Hairline crack from inside
wheel track to center stripe.

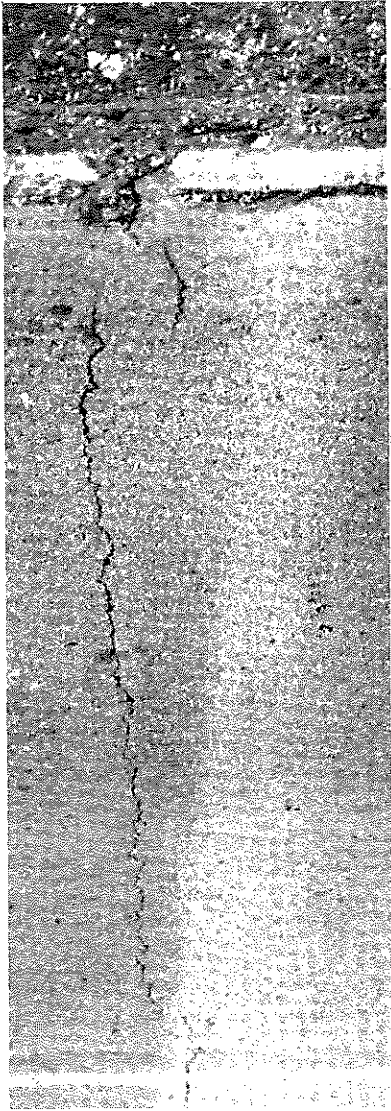
JOINT NUMBER 13

NBL- Narrow crack extending full width of lane.

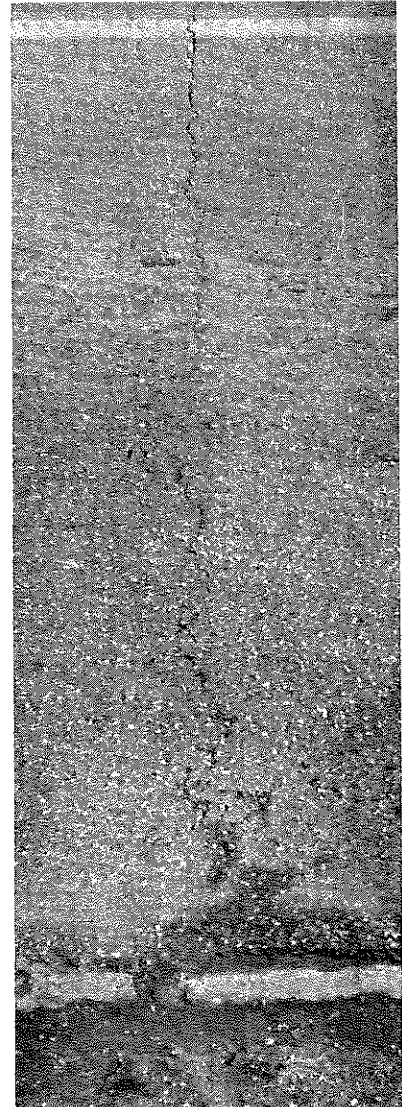
SBL- Crack extending full width of lane.

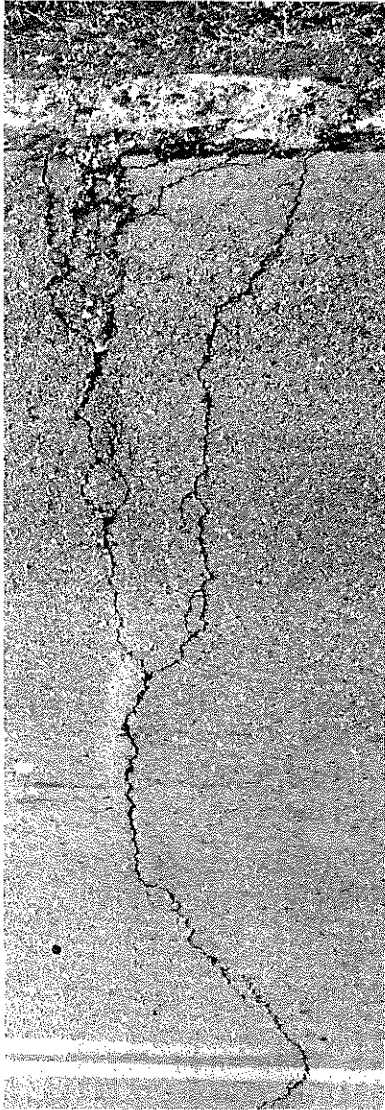
JOINT NUMBER 14

NBL- Ragged crack extending full width of pavement. Indication of fault cracking and corner failure.

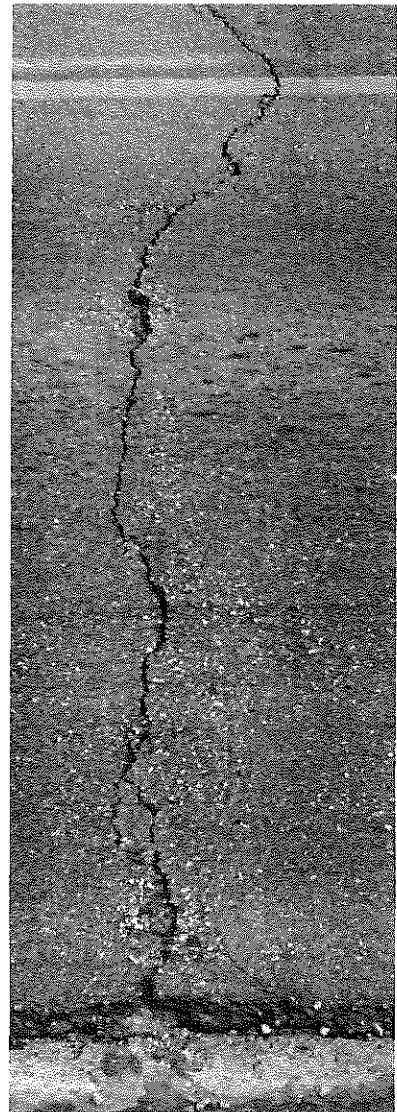
SBL- Ragged crack extending full width of lane. Indication of joint faulting.

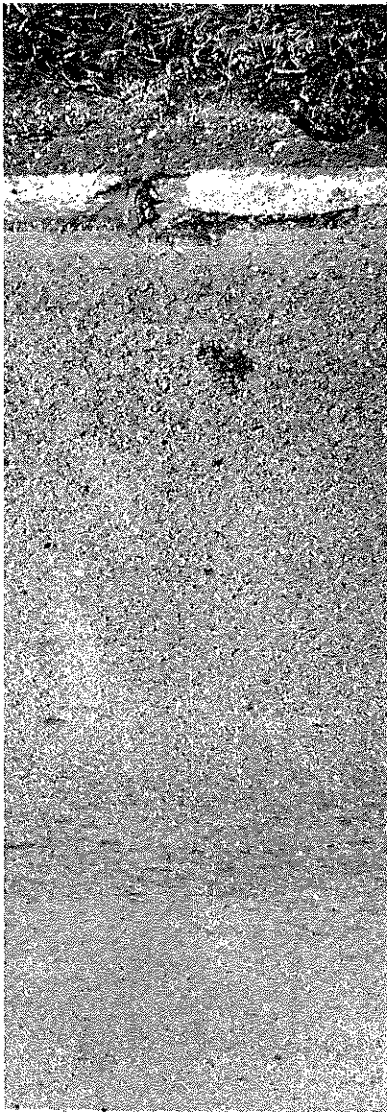
JOINT NUMBER 15

NBL- Small hairline cracks from inside wheel track to center stripe.

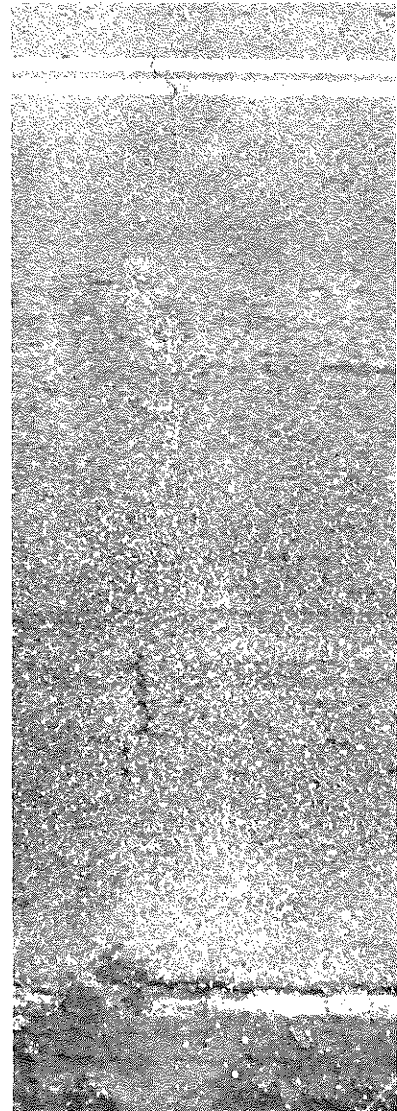
SBL- Hairline crack from outside wheel track to center stripe.

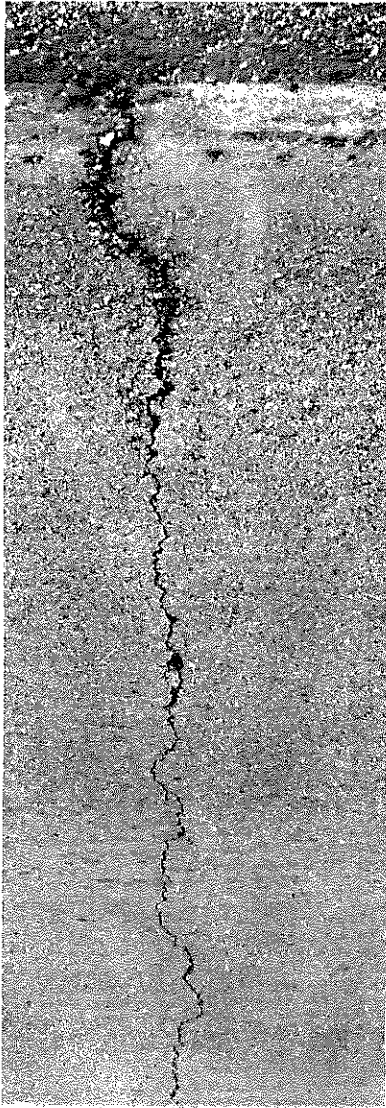
JOINT NUMBER 16

NBL- Wide, ragged crack extending full width of lane beginning to ravel.

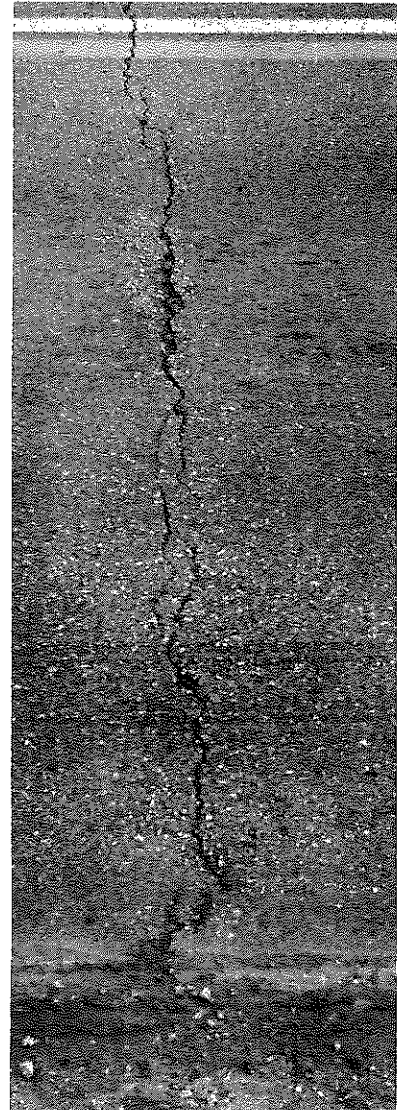
SBL- Wide, ragged crack extending full width of lane beginning to ravel.

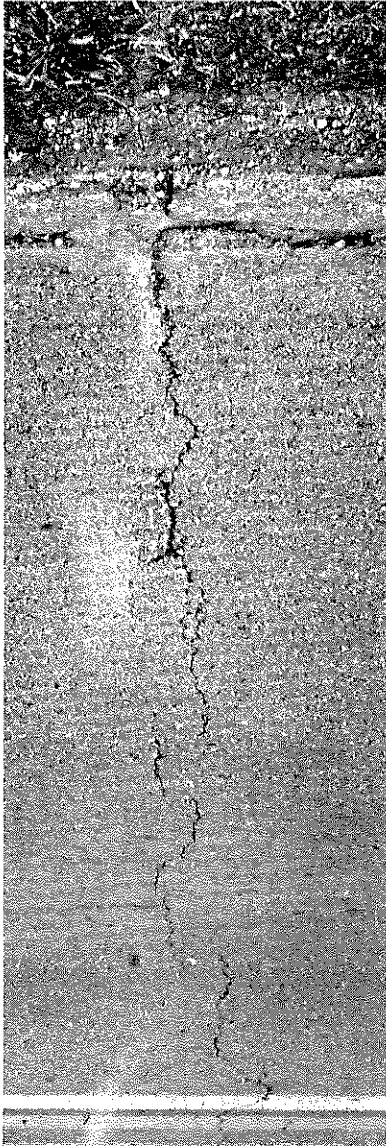
JOINT NUMBER 17

NBL- Ragged crack extending full width of lane beginning to ravel.

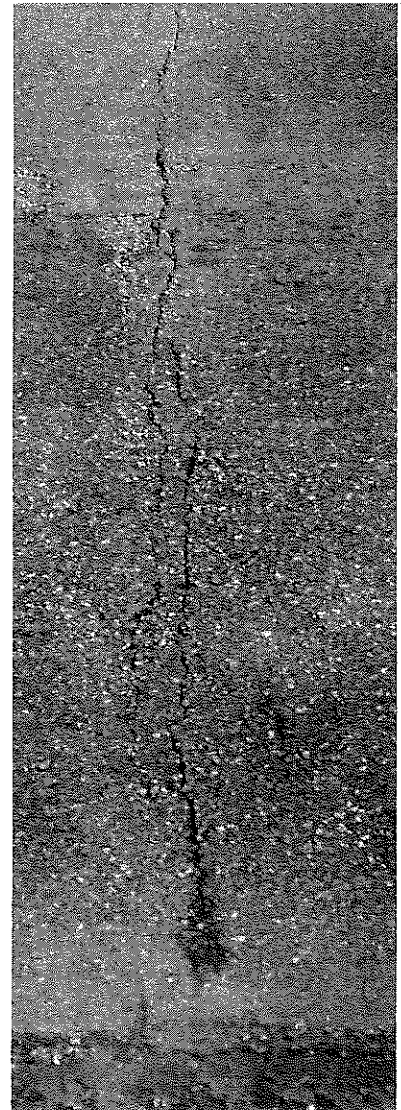
SBL- Ragged crack extending full width of lane.

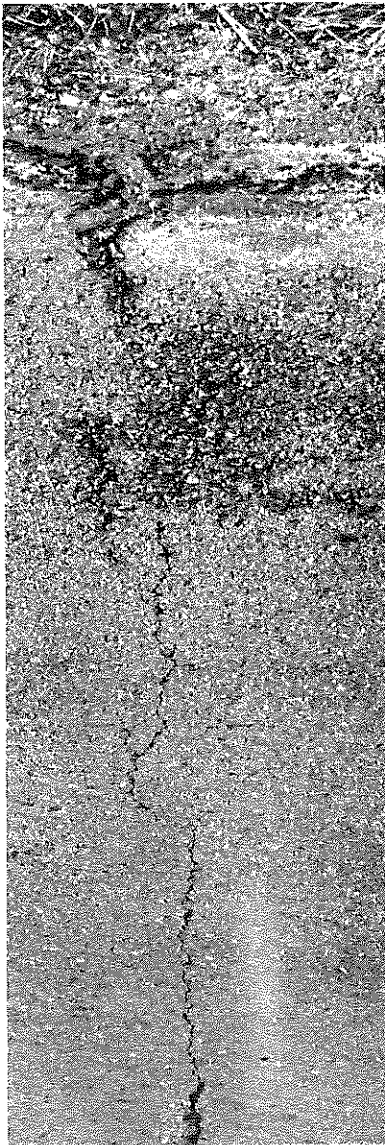
JOINT NUMBER 18

NBL- Crack extending full width of lane. Some ravelling has occurred toward edge of pavement.

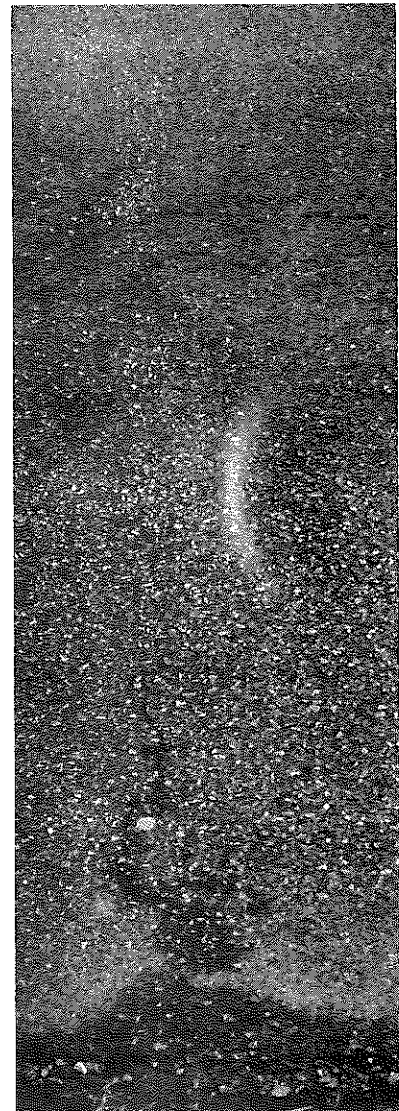
SBL- Narrow crack extending from edge of pavement to outside wheel track.

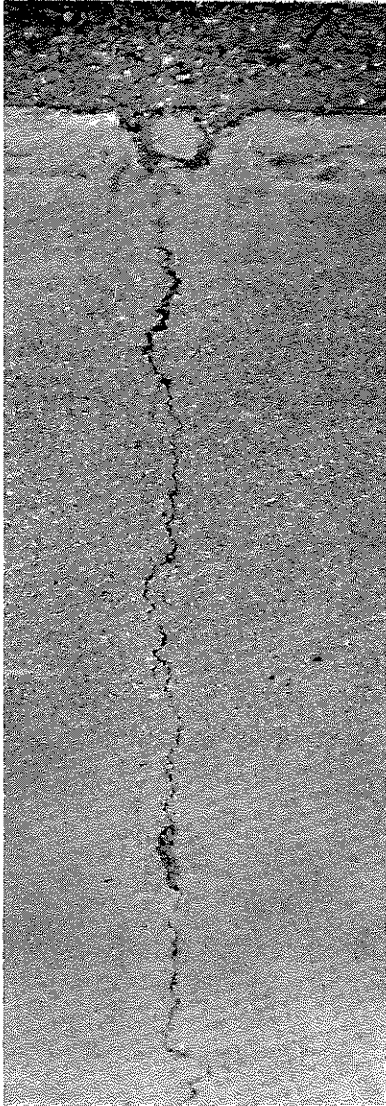
JOINT NUMBER 19

NBL- Ragged crack extending full width of lane. Beginning to ravel in wheel tracks.

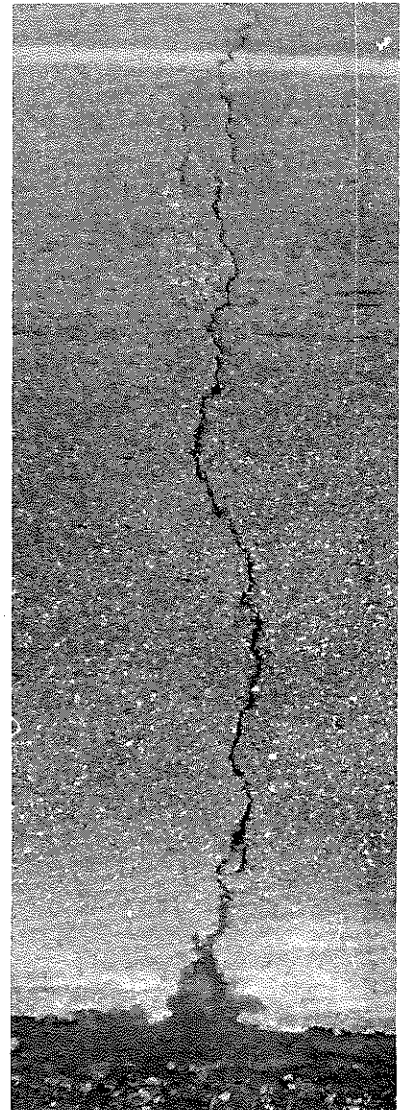
SBL- Ragged crack extending full width of lane beginning to ravel at edge of pavement.

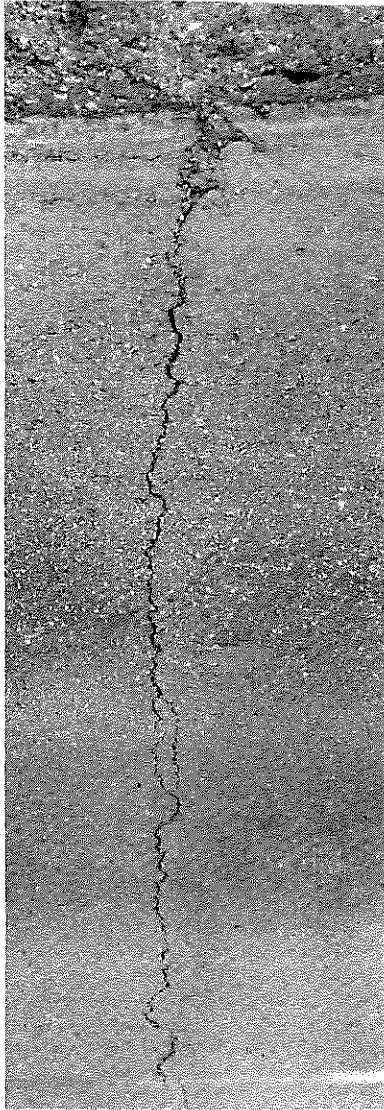
JOINT NUMBER 20

NBL- Ragged crack extending
full width of lane.

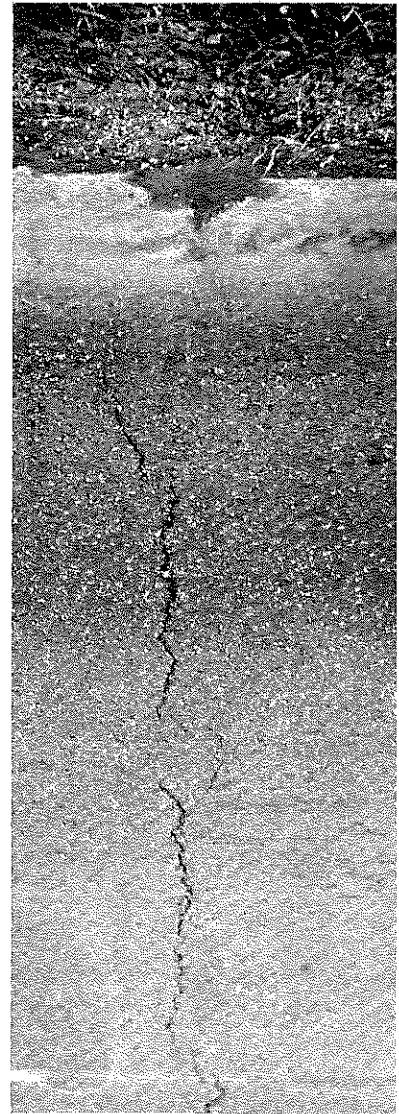
SBL- Ragged crack extending
full width of lane.

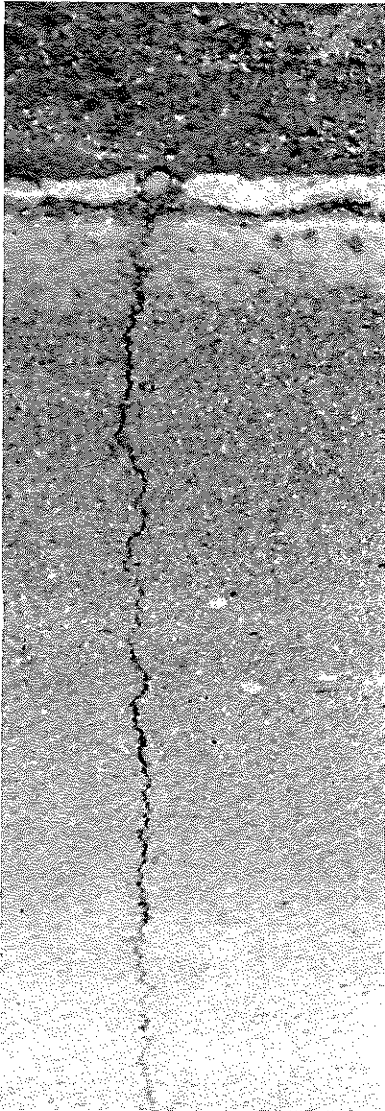
JOINT NUMBER 21

NBL- Wide, relatively straight crack extending full width of lane.

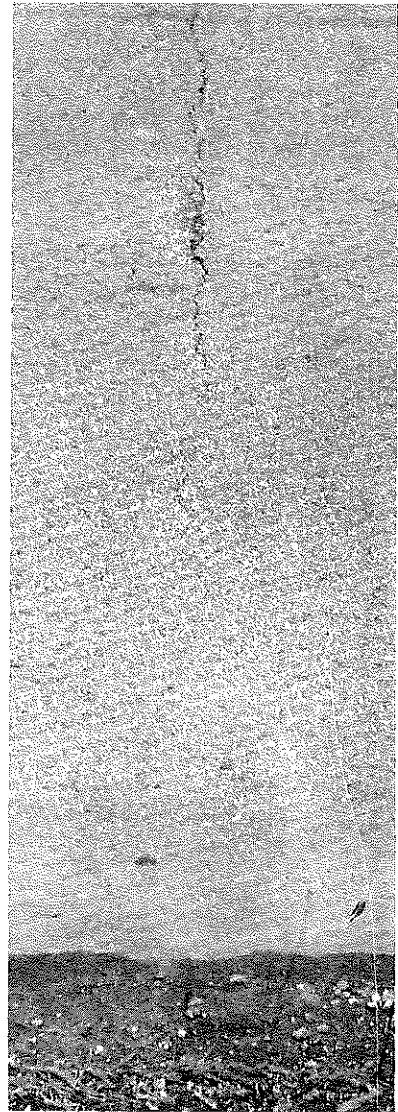
SBL- Crack extending from center of lane to center stripe. Ravelling has occurred in inside wheel track.

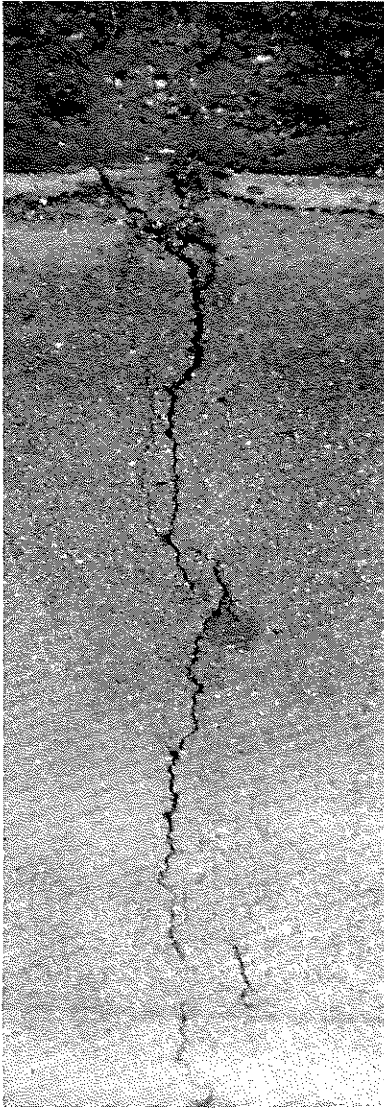
JOINT NUMBER 22

NBL- Wide, ragged crack extending full width of lane and beginning to ravel.

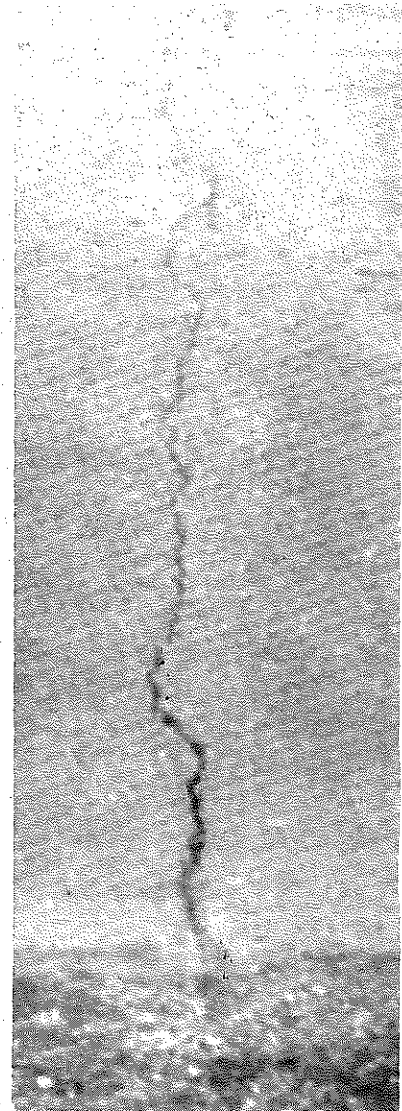
SBL- Wide, ragged crack extending full width of lane.
