COMMONWEALTH OF KENTUCKY
DEPARTMENT OF HIGHWAYS
FRANKFORT, KENTUCKY 40601

August 23, 1968

SUBJECT: Final Performance Reports on:
1) A Concrete Pavement without
Transverse Joints
2) Wire Mesh Reinforcement in Bituminous
Concrete Overlays
3) Limestone Sand Blankets to Control
Reflection Cracking in Bituminous Overlays
4) Experimental Joint Installations for Concrete
Pavements

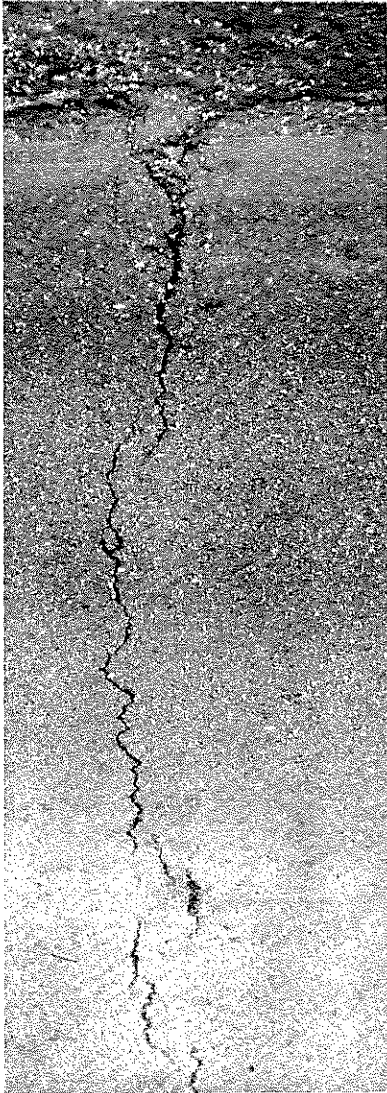
JOINT NUMBER 23

NBL- Wide, ragged crack extending full width of lane. Beginning to ravel in inside wheel track and from outside wheel track to edge of pavement.

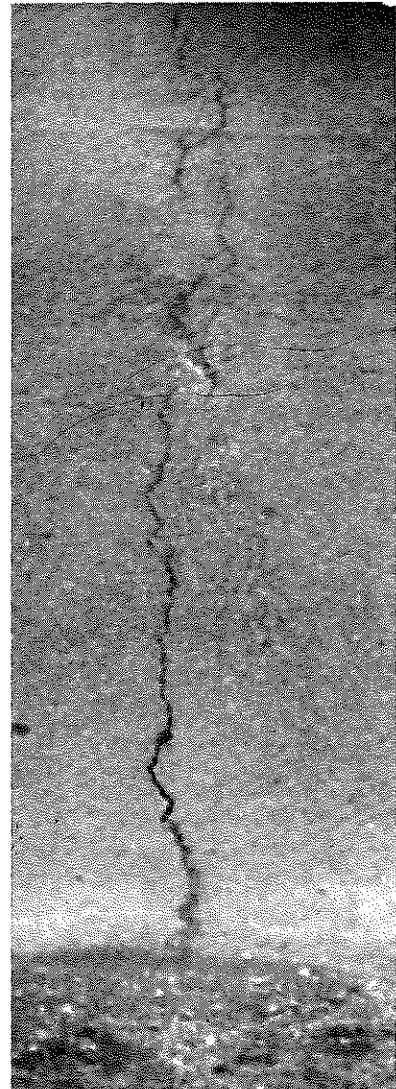
SBL- Wide, ragged crack extending full width of lane.

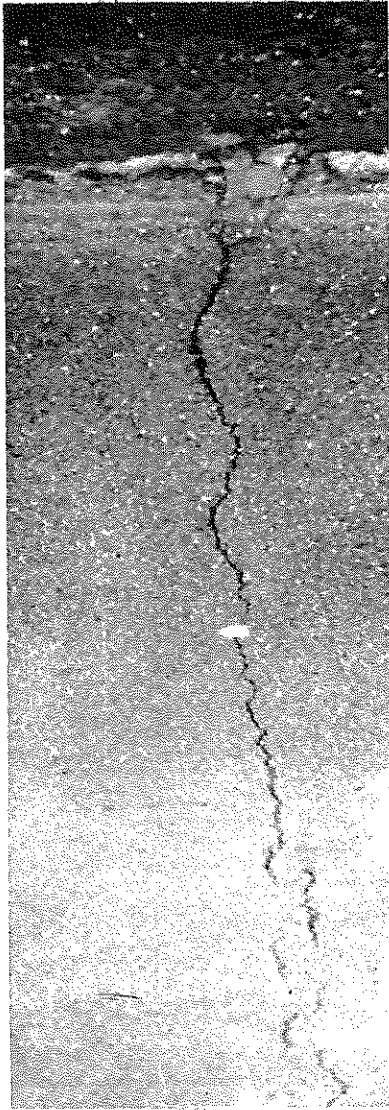
JOINT NUMBER 24

NBL- Wide, ragged crack extending full width of lane.

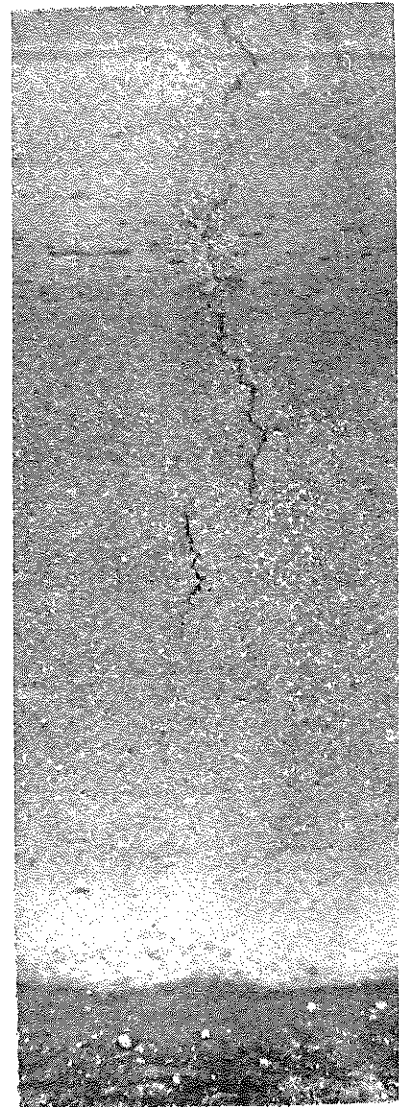
SBL- Crack extending from outside wheel track to center stripe.

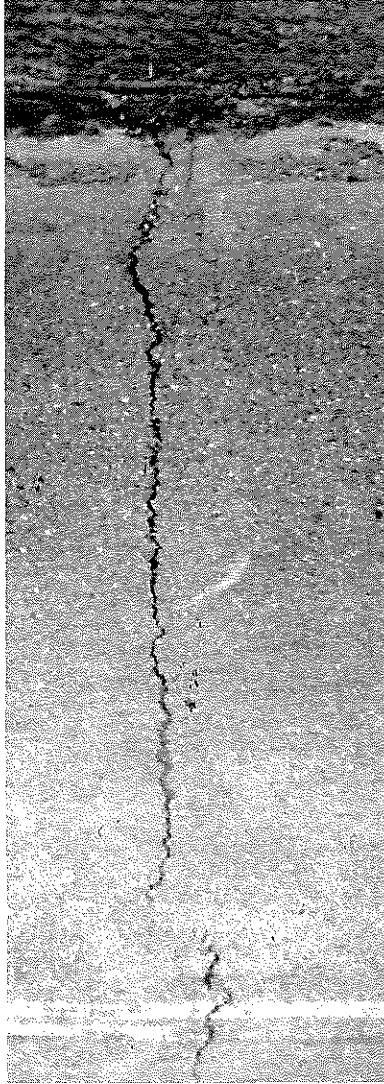
NBL- Wide crack extending full width of lane.

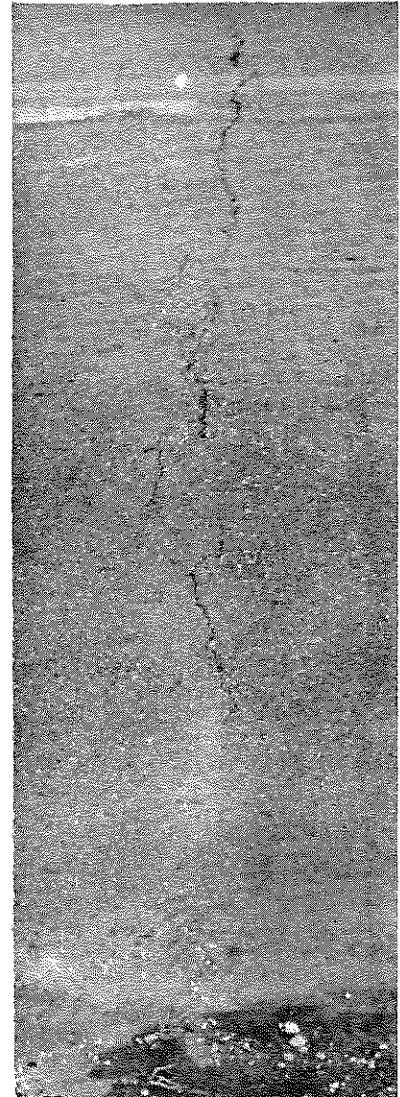
SBL- Crack extending from outside wheel track to center stripe with ravelling at inside wheel track.
