COMMONWEALTH OF KENTUCKY
DEPARTMENT OF HIGHWAYS
FRANKFORT

September 19, 1966

SUBJECT: Research Report; "Interim Performance Report,
Experimental Use of Thermoplastic Pavement-
Striping Materials;" KYHPR-64-18, HPR 1(1),
Part II.

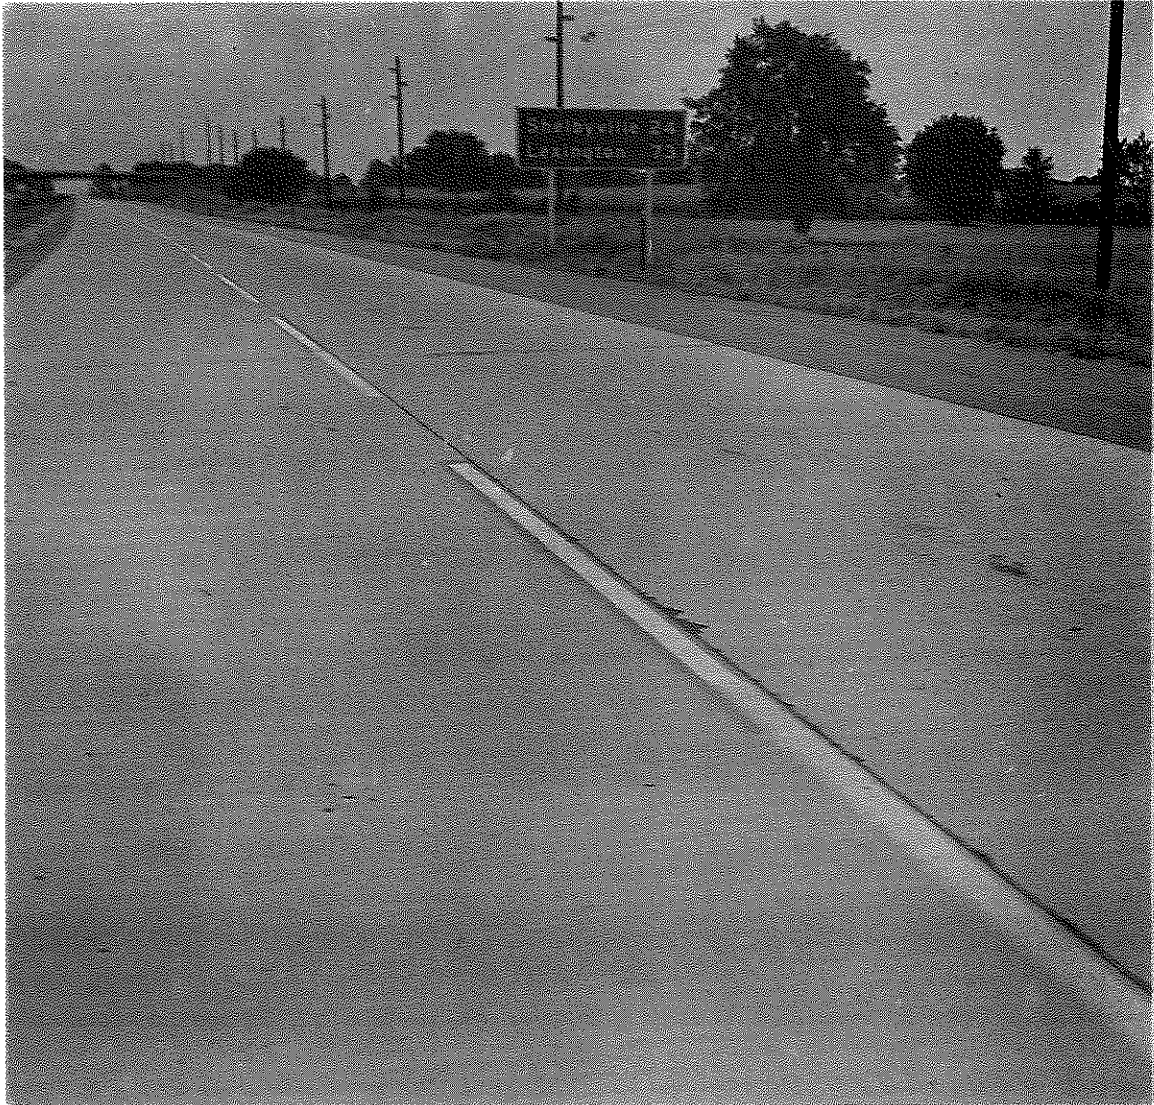
Figure 2. Portion of Test Site 7 Showing Epoxy Primer under Thermoplastic Line.

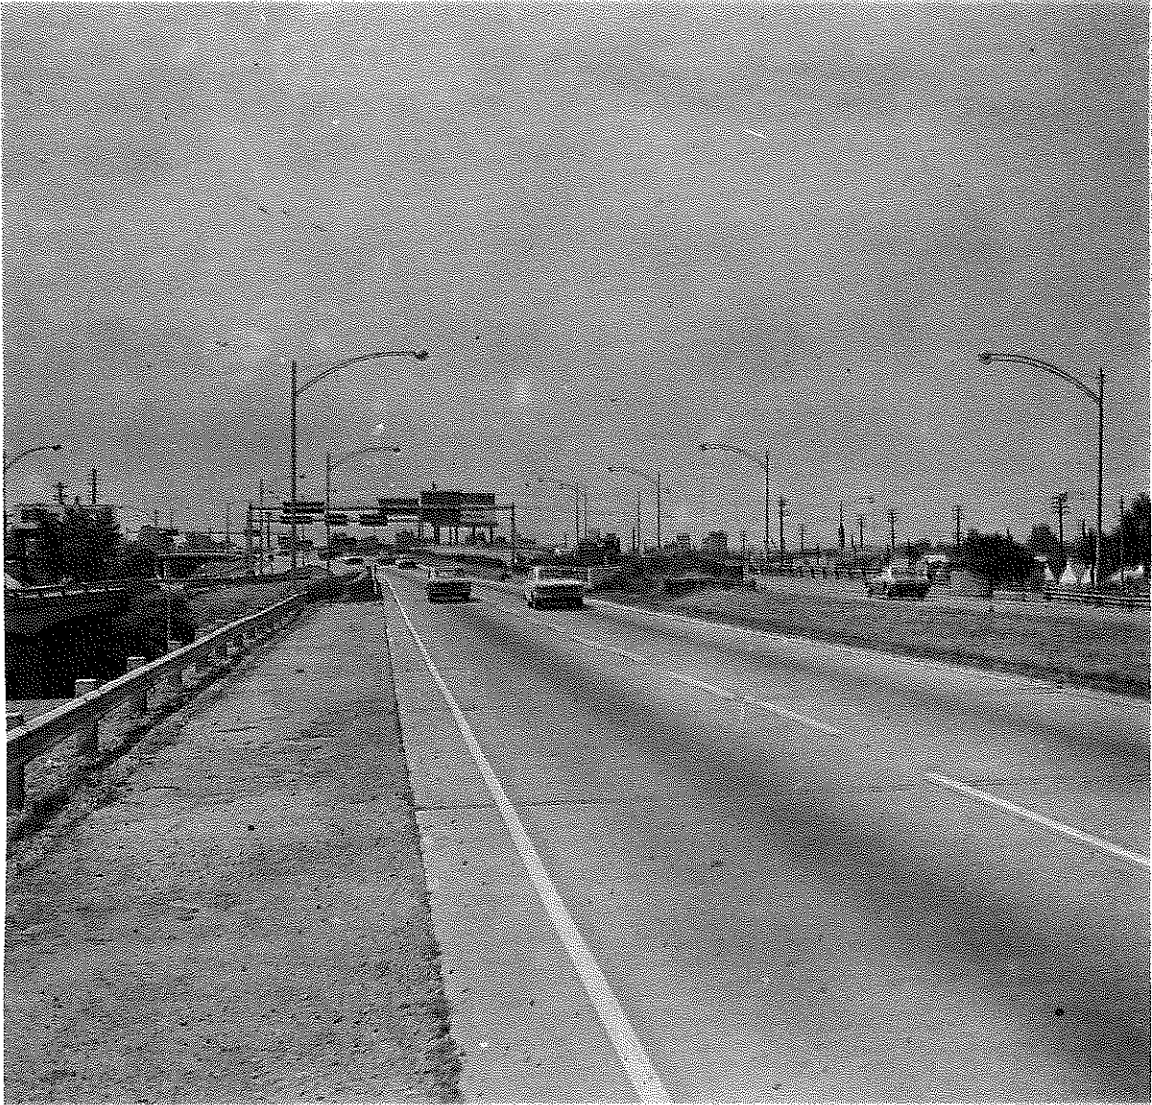
The general workmanship of the thermoplastic installations at Test Sites 8 and 9 was considered to be very poor. The alignment of the edge-lines was quite irregular; and, in some instances, large bulges were present (see Figure 3, Attachment 6). The contractor did not shape up a number of places where excess material was allowed to flow out of the die. A number of unsightly white stains were present on the pavement (see Figure 4, Attachment 7), and drippings on the pavement were common. Before acceptance, the contractor was required to remove and correct all large bulges, remove splotches and stains, and correct a number of skip-dash lines. The general appearance of the thermoplastic installations at Test Sites 5, 6, and 7 were satisfactory. Only one area of drippings was noted.

Figure 3. Portion of Test Site 8 Showing Irregular Alignment of Edge-Lines.

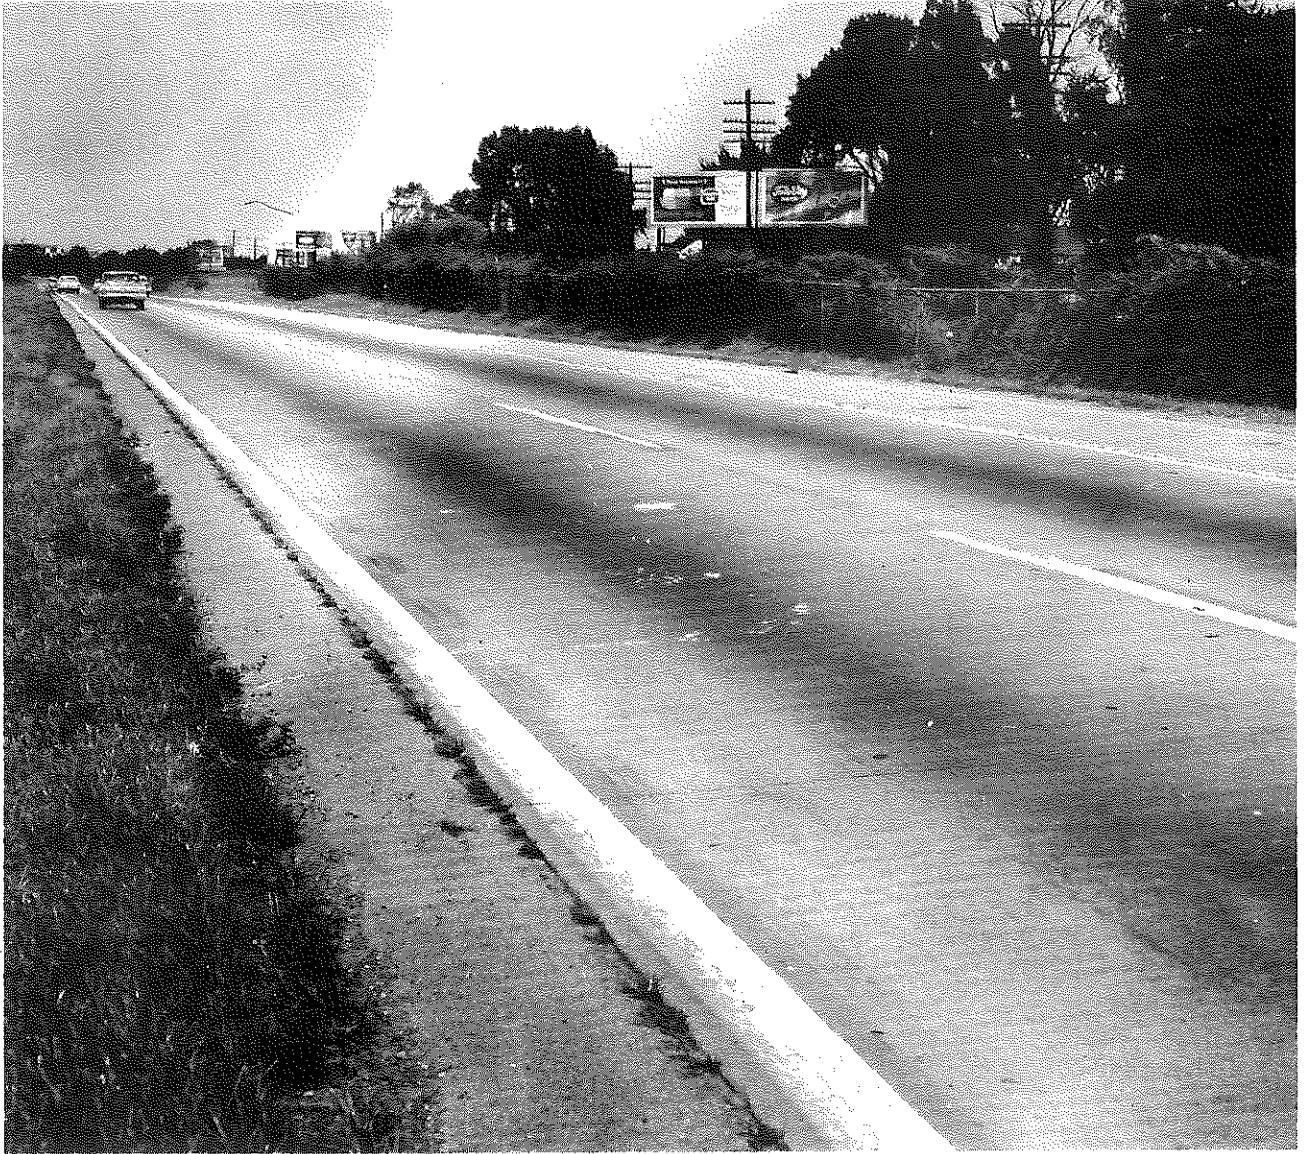
Figure 4. View of Test Site 8 Showing Unsightly Thermoplastic Drippings on Pavement.

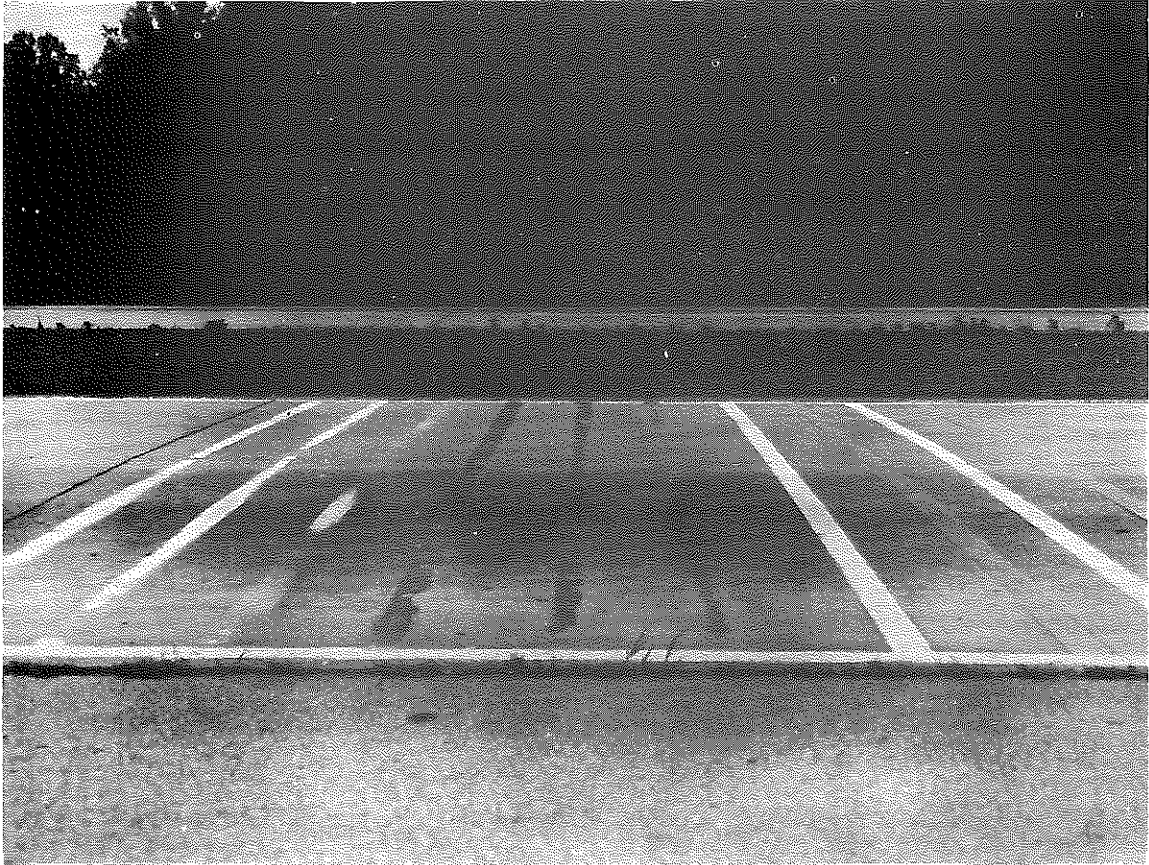
These lines were applied November 2, 1962. The Kentucky paint lines have been repainted twice--during the spring of 1963 and spring of 1964 (see Table 2, Attachment 8 for repainting history and costs). These lines were inspected on July 7, 1966 (see Figure 5, Attachment 9), and notations of the condition of each line follows:

- Line 1: White Kentucky Paint (3 applications of paint and drop-on beads at 3-day intervals). Approximately 15 percent of line has spalled, and the bond of the remainder ranges from good to poor. Line needs repainting.

- Line 2: White Kentucky Paint (2 applications of paint and drop-on beads at 3-day intervals). Spalling of 25 percent of the line had occurred. A large portion of the drop-on beads was missing; and the line needs repainting.

- Line 3: White Kentucky Paint (1 application of paint and no drop-on beads). This line was completely missing except for a three-foot portion in the outer lane. Line needs repainting.

- Line 4: Yellow Kentucky Paint (3 applications of paint and drop-on beads at 3-day intervals). The reflectance of the line was good, but 10 percent of the line was missing. Bond of the remaining portions appeared to be poor, and the line needs repainting.

- Line 5: Yellow Kentucky Paint (2 applications of paint and drop-on beads at 3-day intervals). Extensive spalling of 40 percent of the line had occurred. Repainting of the line is necessary at this time.

Line 6: Yellow Kentucky Paint (1 application of paint and no drop-on beads). Except for a 3-foot portion in the outer lane, this line was completely missing and needs repainting.

Line 7: White Perma-Line Thermoplastic. The condition of this line was good. A few, small, bubble-craters were present. Bonding was excellent; reflectance was good; and no visible wear or damage was noted except for 3 1-inch spalled areas.

Line 9: White Catatherm Thermoplastic. The appearance of this line was good. A large number of small bubble-craters were present, and alligator cracking had occurred in the center of the right lane. Bonding was excellent, and no spalled or chipped portions were noted.

Line 10: Yellow Catatherm Thermoplastic. The appearance of this line was fair. This line had an extreme number of transverse and alligator cracks over the entire length, and a large number of large bubble-craters were present. There were no missing portions, and the bond was good.

Figure 5. Transverse Lines on Portland Cement Concrete Pavement in Test Site 1, I 264, Jefferson County. Note comparative wear of Kentucky paint lines which received multiple applications. Lines were placed in November, 1962, Kentucky paint lines were repainted in the springs of 1963 and 1964, and photograph was taken during July, 1966. First 6 lines are Kentucky white and yellow paint--3, 2 and 1 applications, respectively; lines 7 and 8 are Perma-Line; and lines 9 and 10 are Catatherm.

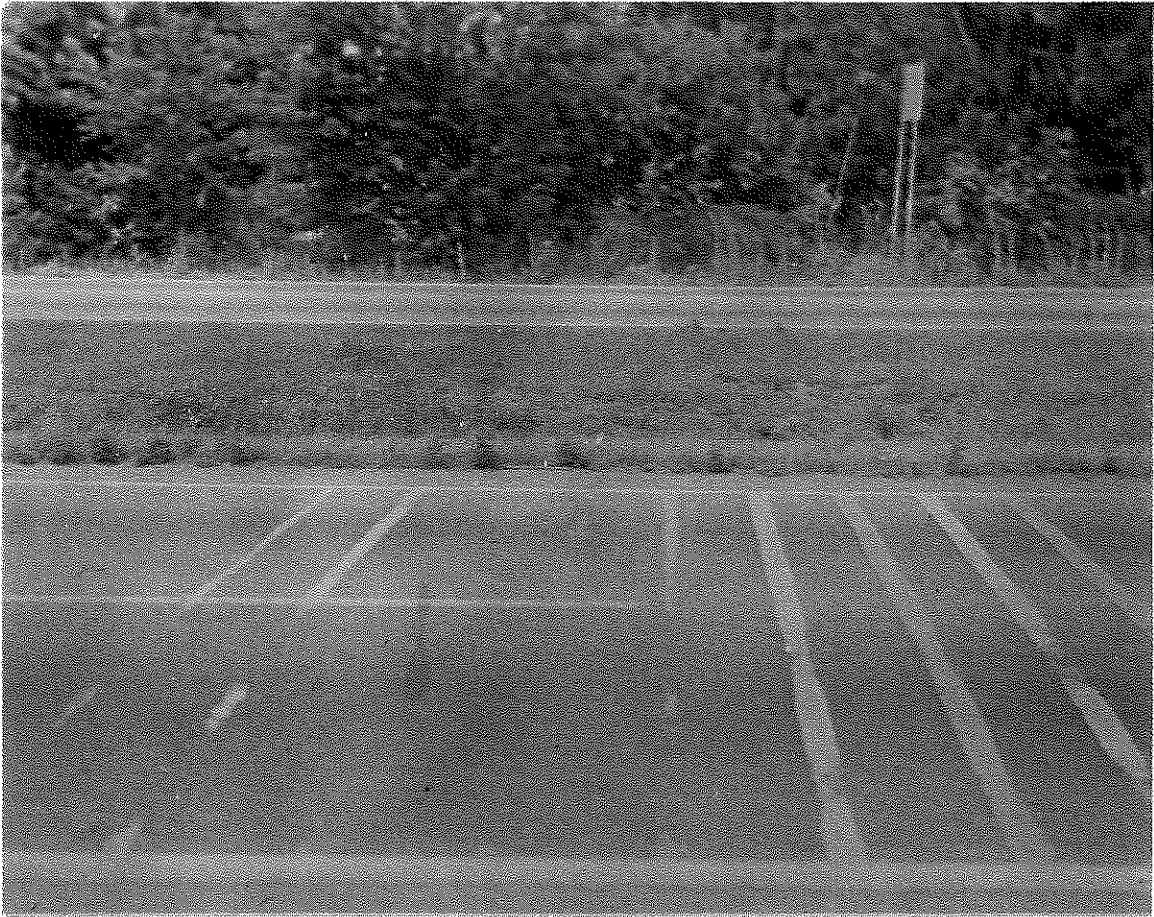
The transverse lines in this subsection were applied November 2, 1962. The transverse lines of Kentucky paint have not been repainted. These lines were inspected July 7, 1966 (see Figure 6, Attachment 12), and notations of the condition of each line follows:

- Line 1: White Kentucky Paint (1 application of paint, and drop-on beads). This line was completely devoid of paint and needs repainting.
- Line 2: White Kentucky Paint (2 applications of paint at 3-day intervals, and drop-on beads). The left-lane portion of this line was visible but badly worn, and the right-lane portion was devoid of paint. Repainting is recommended for this line.

- Line 3: White Kentucky Paint (3 applications of paint at 3-day intervals, and drop-on beads). The paint in the right-lane portion was missing, and the paint in the left-lane portion was badly worn. This line should be repainted.

- Line 4: Yellow Kentucky Paint (1 application of paint, and drop-on beads). This line was completely devoid of paint and needs repainting.
- Line 5: Yellow Kentucky Paint (2 applications of paint at 3-day intervals, and drop-on beads). The paint was completely missing except for a small portion in the left lane. This line will have to be repainted.

- Line 6: Yellow Kentucky Paint (3 applications of paint at 3-day intervals, and drop-on beads). Paint in the inner lane was very dim, and the paint in the outer lane was missing. Repainting is recommended.

Line 7: White Perma-Line Thermoplastic. This line was in fair condition. The bond and reflectance were good, but the line was worn in the outer-lane wheel tracks.

Line 8: Yellow Perma-Line Thermoplastic. This line had a good over-all appearance. The bond was good, but a small amount of spalling had occurred in the outer lane.

Line 9: White Catatherm Thermoplastic. This line was in poor condition. Some cracking was noted; and the line was badly worn in the outer lane.

Line 10: Yellow Catatherm Thermoplastic. Some transverse cracking was present, and the line was worn in the outer-lane wheel tracks. The bond and reflectance were good; but the general condition of the line was poor.

Figure 6. Transverse Lines on Bituminous Concrete Pavement in Test Site 2, I 264, Jefferson County. Lines were placed in November, 1962, and photograph was taken during July 1966. The Kentucky paint lines have not been repainted. Some minor edge spalling can be seen in lines 9 and 10. First 6 lines are Kentucky white and yellow paint--1, 2, and 3 applications, respectively; lines 7 and 8 are Perma-Line; and lines 9 and 10 are Catatherm.

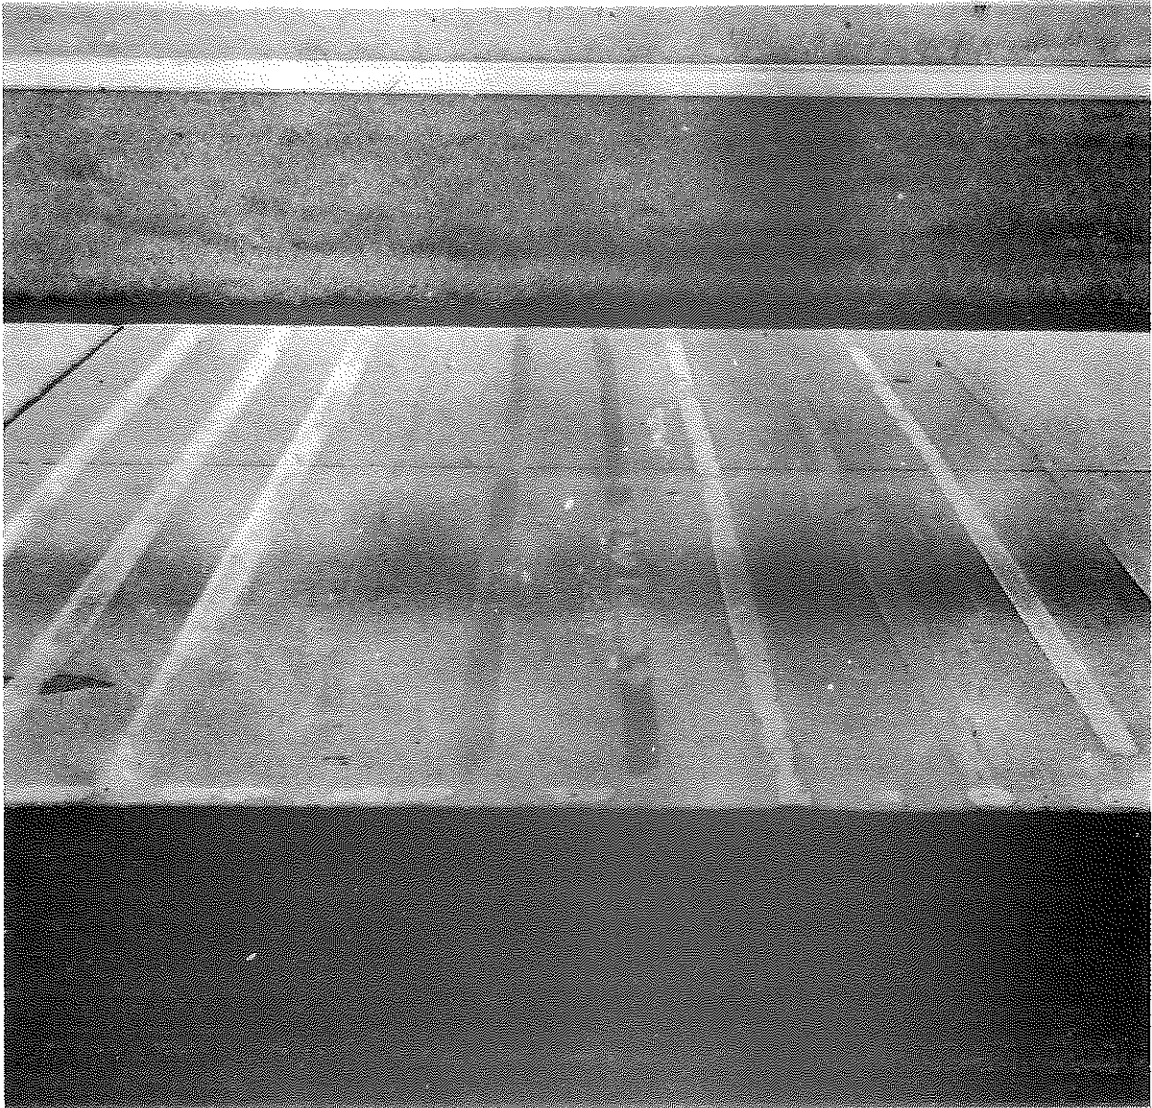
The transverse lines in this test site were applied on October 19, 1962. The Kentucky paint lines were repainted during the spring of 1963 and 1964 (see Table 2, Attachment 8 for repainting history and costs). These lines were inspected on June 29, 1966 (see Figure 7, Attachment 13), and notations of the condition of each line follows:

- Line 1: White Kentucky Paint (1 application of paint, and drop-on beads). During the past year, extensive spalling over 50 percent of the line has occurred; and repainting is needed.

- Line 2: White Kentucky Paint (2 applications of paint at 3-day intervals, and drop-on beads). At the present time, 50 percent of the line has spalled and this line needs repainting.

- Line 3: White Kentucky Paint (3 applications of paint at 3-day intervals, and drop-on beads). Over one-half of the line has spalled and repainting is needed.

- Line 4: Yellow Kentucky Paint (1 application of paint, and drop-on beads). The line was worn over its entire length, and repainting of the line is necessary.

- Line 5: Yellow Kentucky Paint (2 applications of paint at 3-day intervals, and drop-on beads). The general condition of this line was good except for a small amount of spalling. Repainting of this line is recommended.

- Line 6: Yellow Kentucky Paint (3 applications of paint at 3-day intervals, and drop-on beads). Extensive spalling of the outside lane has occurred, and repainting is necessary.

Line 7: White Perma-Line Thermoplastic. Extensive spalling of over 35 percent of the line had occurred, and the appearance of the line was poor. A close examination revealed small alligator cracks and numerous small craters. The bond of the line varied from poor to good.

Line 8: Yellow Perma-Line Thermoplastic. The left-lane portion had spalled extensively and the bond of this portion was poor. The bond and appearance of the right lane was satisfactory. A few craters were present. The over-all appearance of this line was very poor, and of all the thermoplastic transverse lines, this line was in the worst condition.

Line 9: White Catatherm Thermoplastic. A large number of craters and alligator cracks were present. In the left-lane portion, the bond was poor and excessive spalling had occurred. The appearance of the line was very poor.

Line 10: Yellow Catatherm Thermoplastic. The over-all condition of this line was very poor. Very wide alligator cracks were present. Due to poor bonding, this line had edge spalling in the left lane.

Figure 7: Transverse Lines on Portland Cement Concrete Pavement in Test Site 3, I 64, Shelby County. Lines were placed in October, 1962, Kentucky paint lines were repainted in the springs of 1963 and 1964, and photograph was taken during April, 1965. First 6 lines are Kentucky white and yellow paint--1, 2, and 3 applications, respectively; lines 7 and 8 are Perma-Lines; and lines 9 and 10 are Catatherm. Note spalling of all thermoplastic lines and flaking of Kentucky paint lines which received multiple applications.

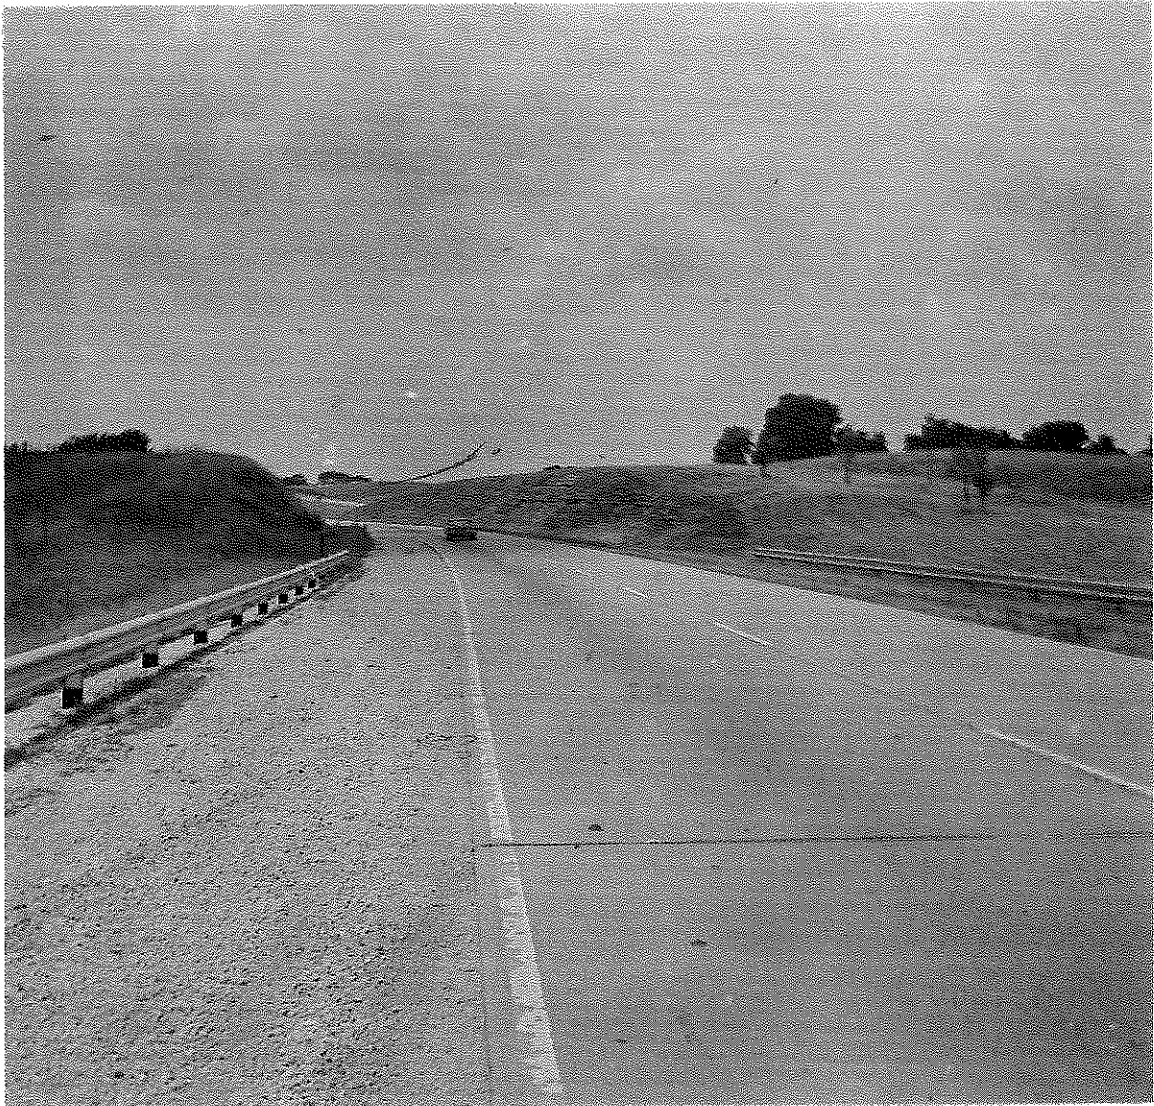
On April 15, 1965, footage totaling 17,179 feet or 17.2 percent was unacceptable, and the subsection was rated as substandard in over-all appearance (see Figure 8, Attachment 14). This footage was not covered by warranty provisions, and no repairs were made.

Figure 8: View of East-bound Lane of Test Site 3, I 64, Shelby County, showing a Portion of Subsection 1, Perma-Line. Photograph was taken during April, 1965 and shows spalling of the edge-line receiving drainage.

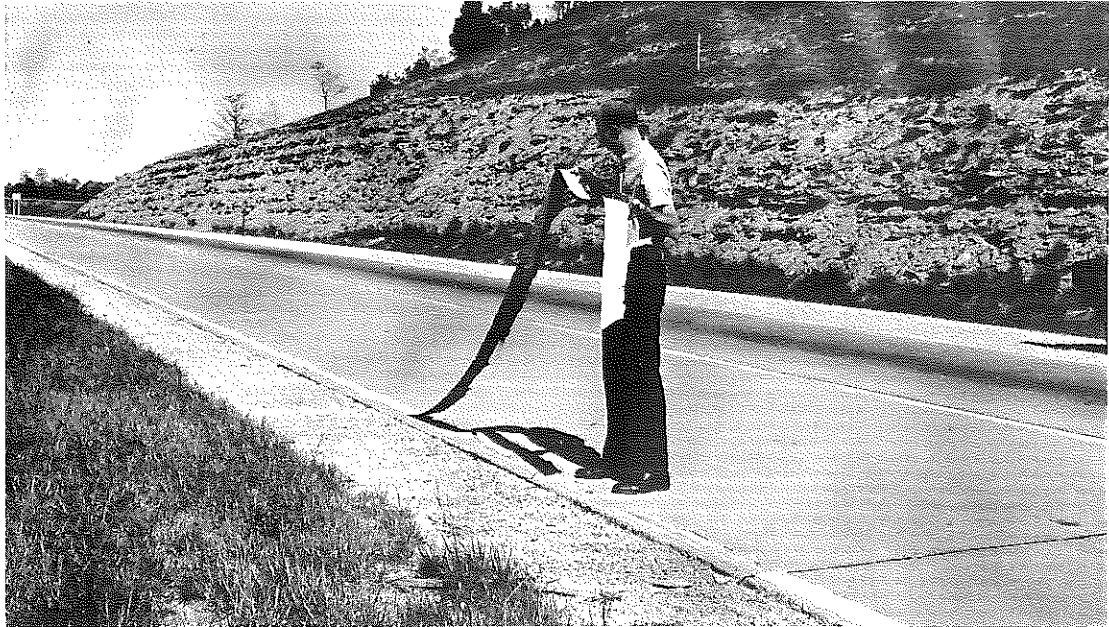
Figure 9. Photograph Showing Poor Bond of Thermoplastics in Test Site 3, I 64, Shelby County. In many areas, portions of line as long as 10 feet could easily be pulled up by hand.

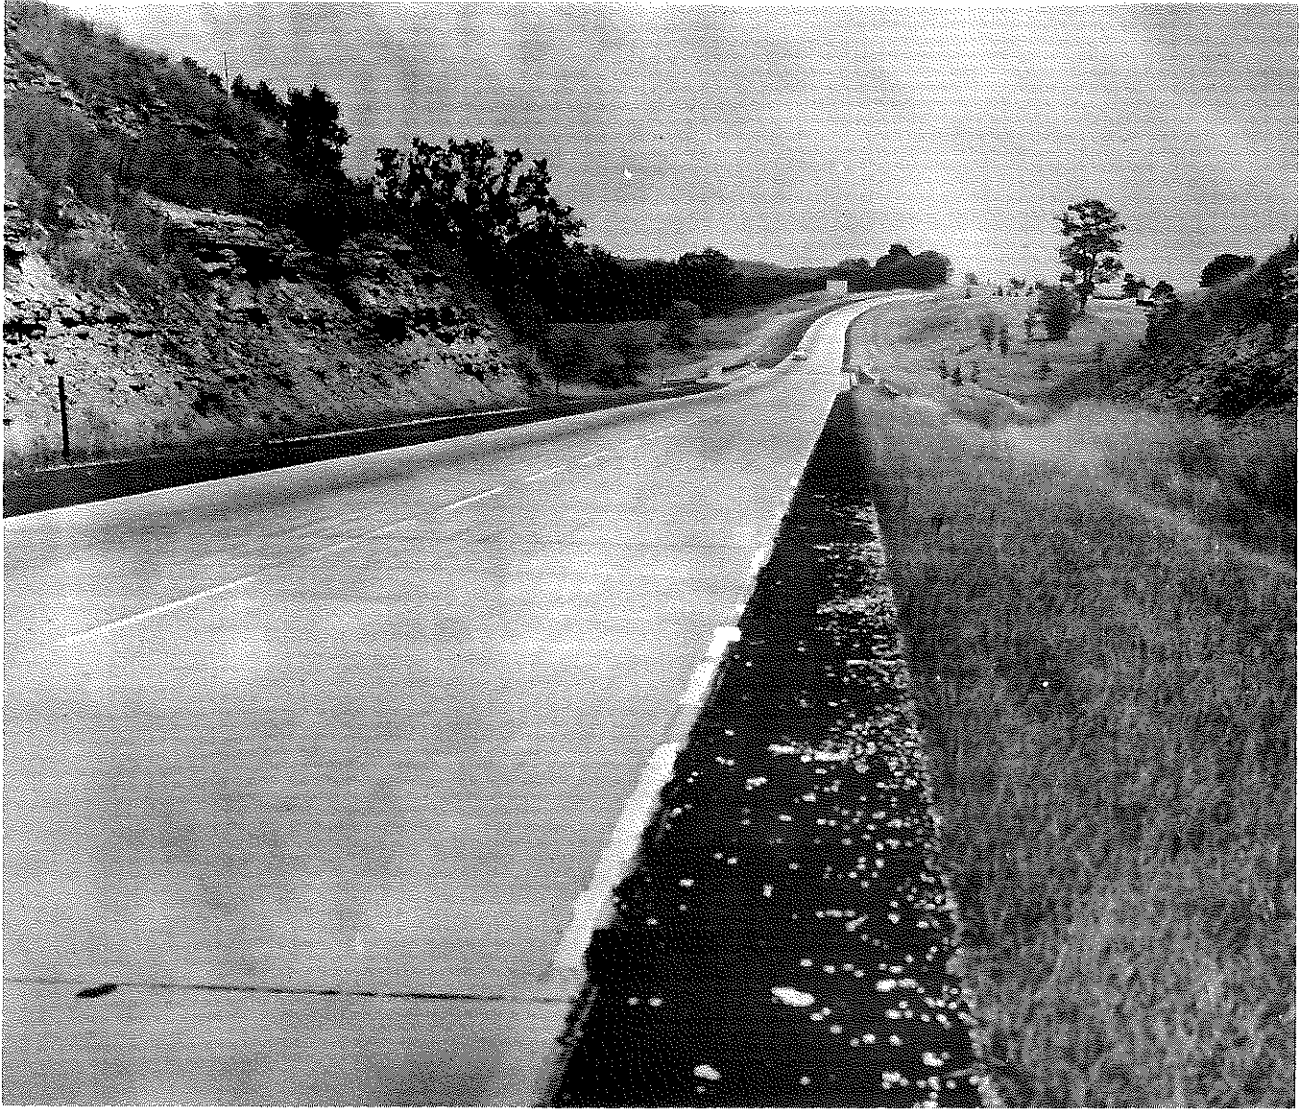
Figure 10. Spalled Thermoplastic on the Recently Paved Shoulders of Test Site 3. It is possible that this material could fuse to the asphalt and create a hazardous condition.

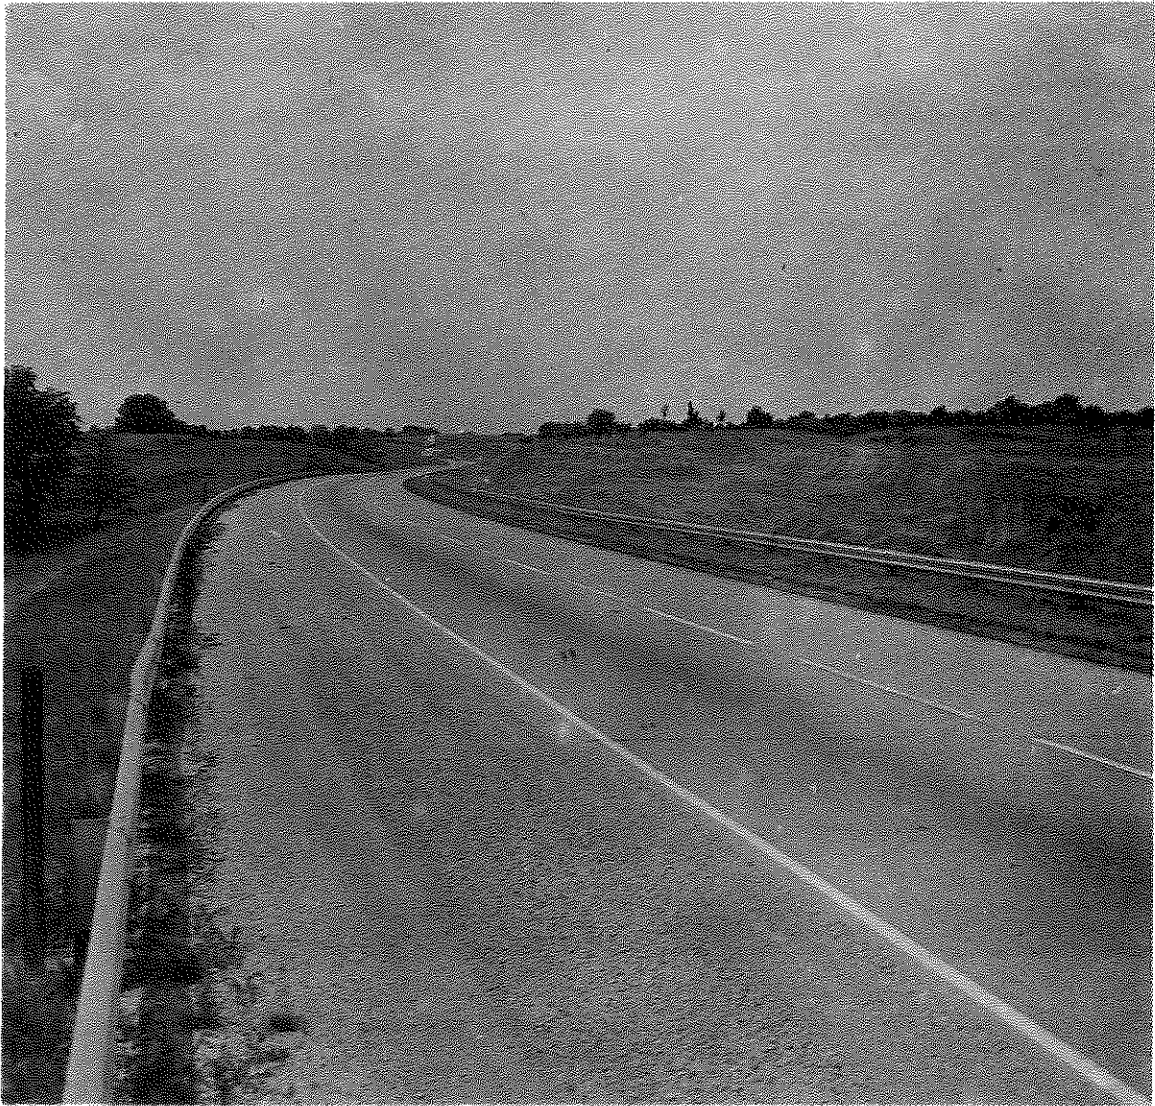
Figure 11. A Portion of the Kentucky Paint (Control) Section in Test Site 3, Eastbound Lanes I 64, Shelby County (Looking West). Since the original installation in 1962, the center-lines have been repainted three times and the edge-lines have not been repainted. Note contrasting quality of inside and outside edge-lines. Photograph was taken during April, 1965.

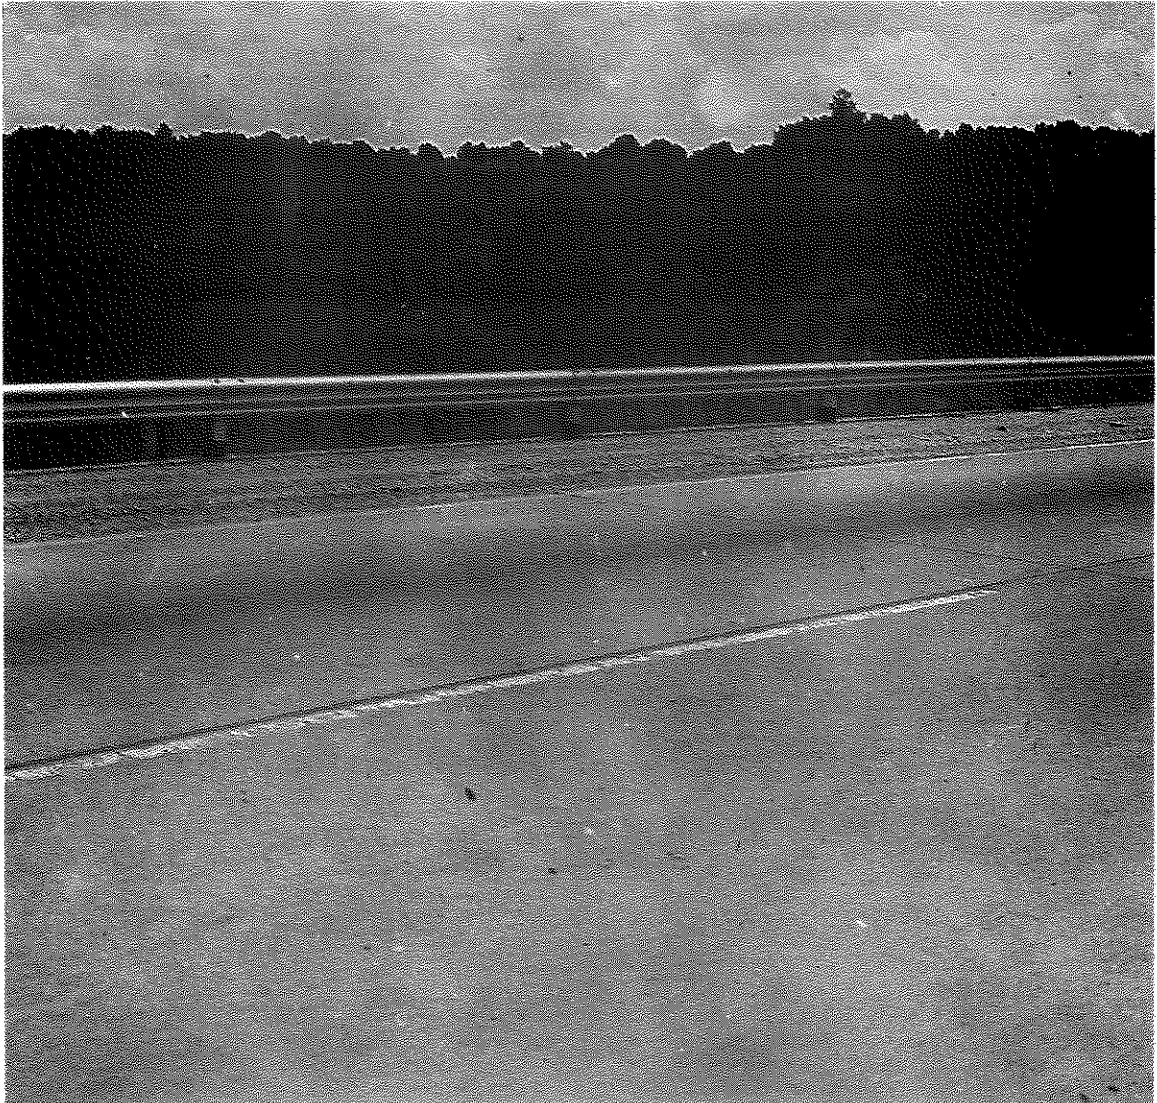
On April 15, 1965, this subsection ranked poor in over-all appearance (see Figure 12, Attachment 18). A total of 27,656 feet or 27.6 percent of line was considered to be unsatisfactory; and this reflects the damage that occurred during the winter of 1964-65. Cataphote was allowed to have 800 lineal feet of unsatisfactory line for any selected 2,000 lineal feet of line or 842 feet of roadway length (ref. to warranty provisions, Test Site 1, Subsection 1). There were 15 areas in this subsection that exceeded this allowable tolerance, and the excess over 800 feet for each area, according to the guarantee, had to be replaced at no cost to the Department. According to inspection notes of the Division of Research, the Cataphote Corporation was committed to replace or make restitution for 3,176 lineal feet of line in this subsection; and on November 11, 1965, Cataphote satisfied the warranty provisions by repairing 3,302 feet of line. This left 24,354 feet or 24.3 percent of line in an unsatisfactory condition at the beginning of the 1965-66 winter.

Figure 12. A Portion of the Catathern Subsection, Test Site 3, I 64, Shelby County during April, 1965. Note extreme spalling of center-line and edge-line.

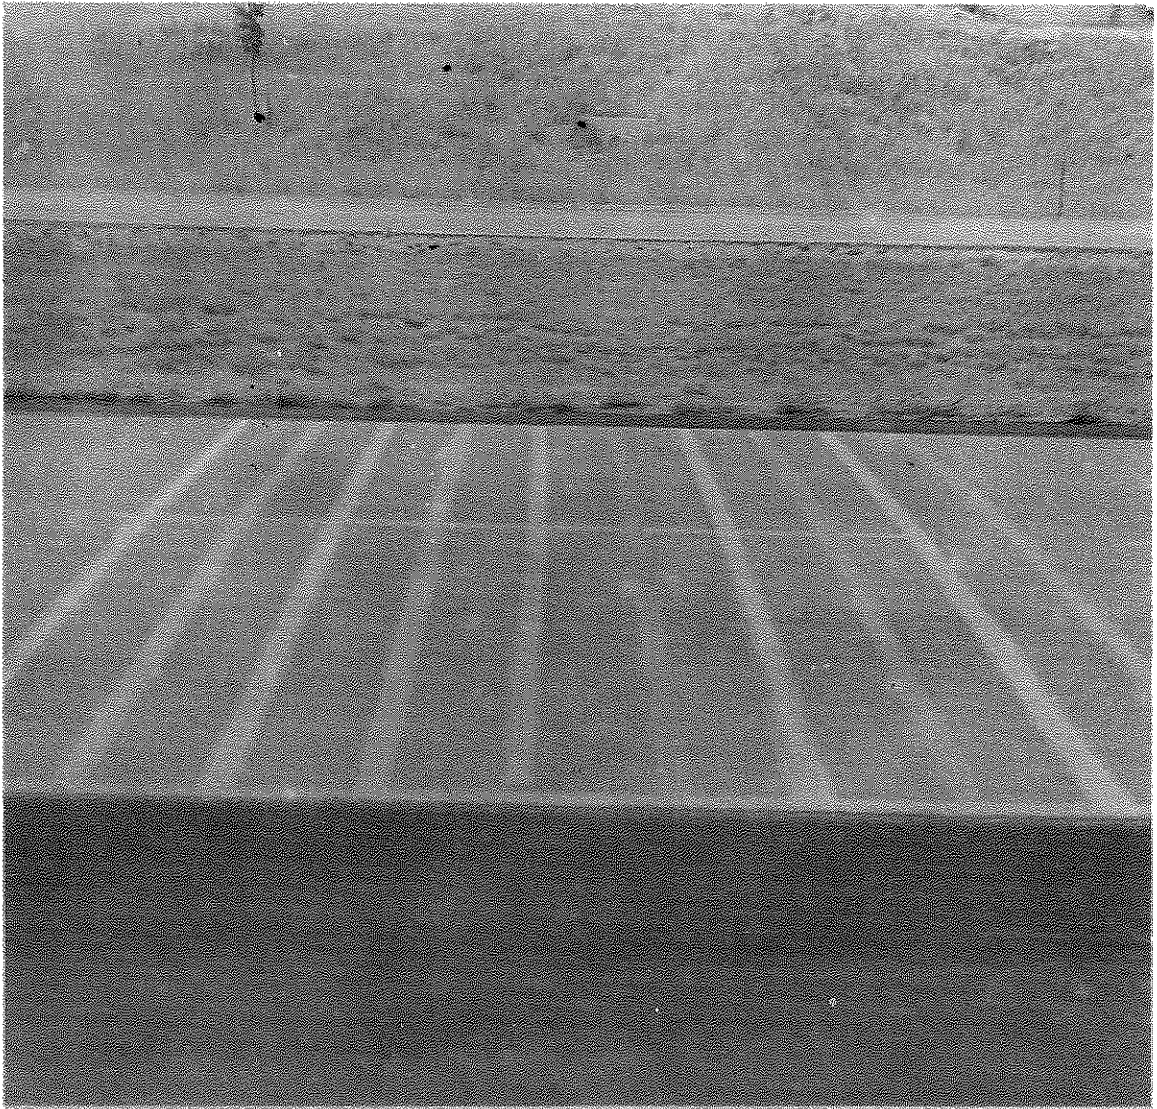
These lines were applied on November 27, 1962. The transverse lines of Kentucky paint have not been re-stripped. These lines were inspected on April 20, 1966 (see Figure 13, Attachment 19) and notations of the condition of each line follows:

- Line 1: White Catatherm Thermoplastic. A large number of alligator and transverse cracks were present, and the line was rated as fair. The bond and reflectivity were good.

Figure 13. Transverse Lines on Bituminous Concrete Pavement in Test Site 4, I 64, Clark County. Lines were placed in November, 1962, and photograph was taken during April, 1966. Lines 1 and 2 are Catatherm, lines 3 and 4 are Perma-Line, and the succeeding pairs of lines are Kentucky paint--1, 2, and 3 applications, respectively. The Kentucky paint lines have not been repainted.

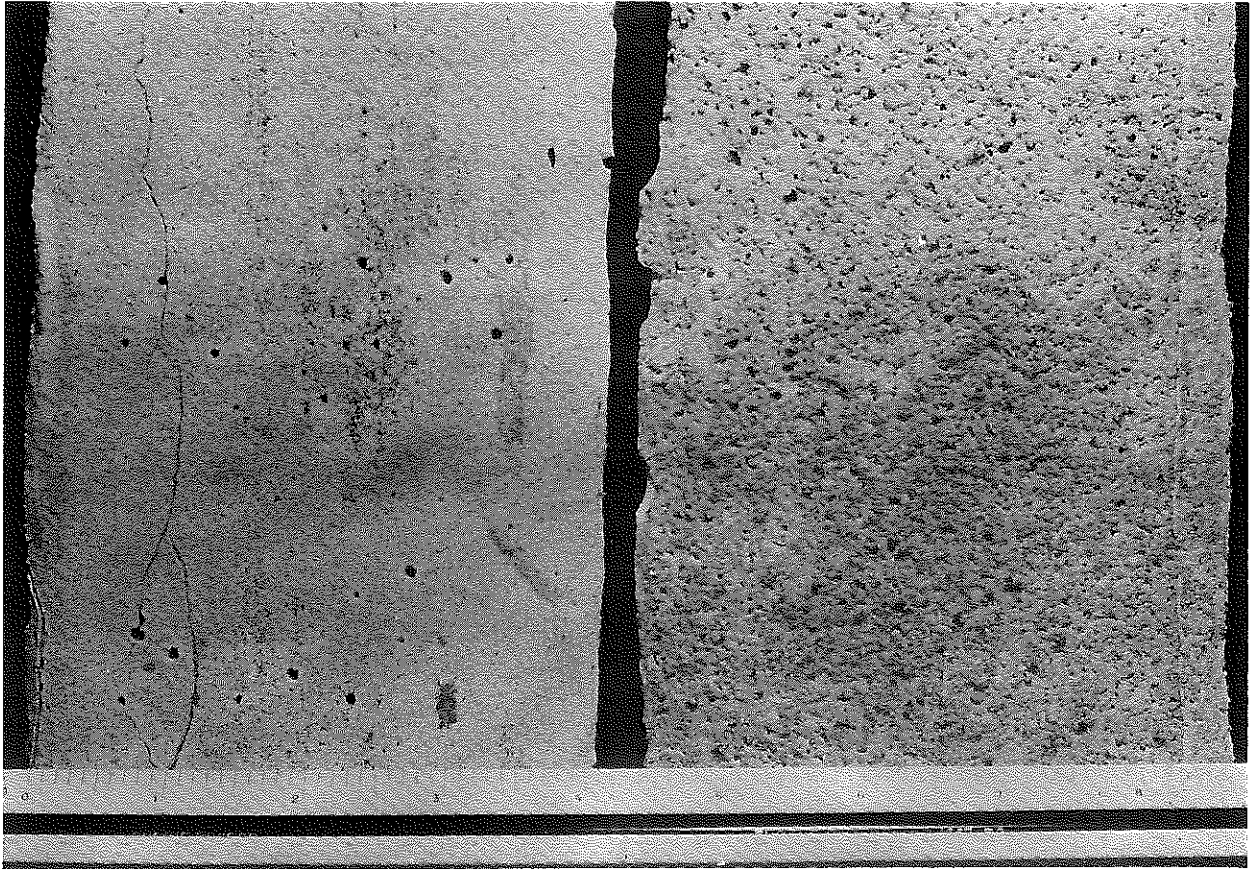
Figure 15. Photograph of a Portion of Spalled Line Showing Top and Bottom Surfaces. Note laitance on bottom surface.

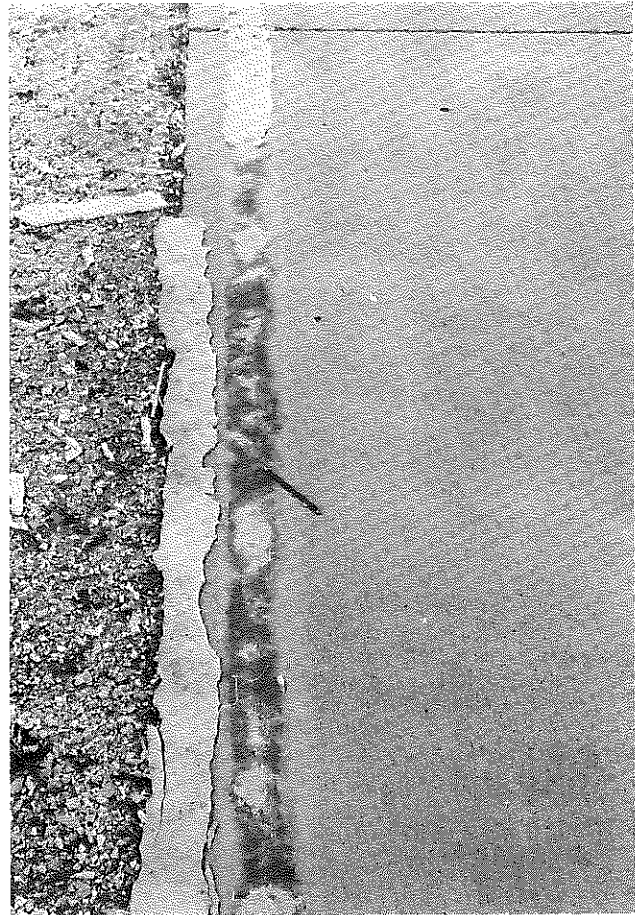
Figure 16.

Photograph Showing Retention of Water on the Underneath Side of a Thermoplastic Stripe.

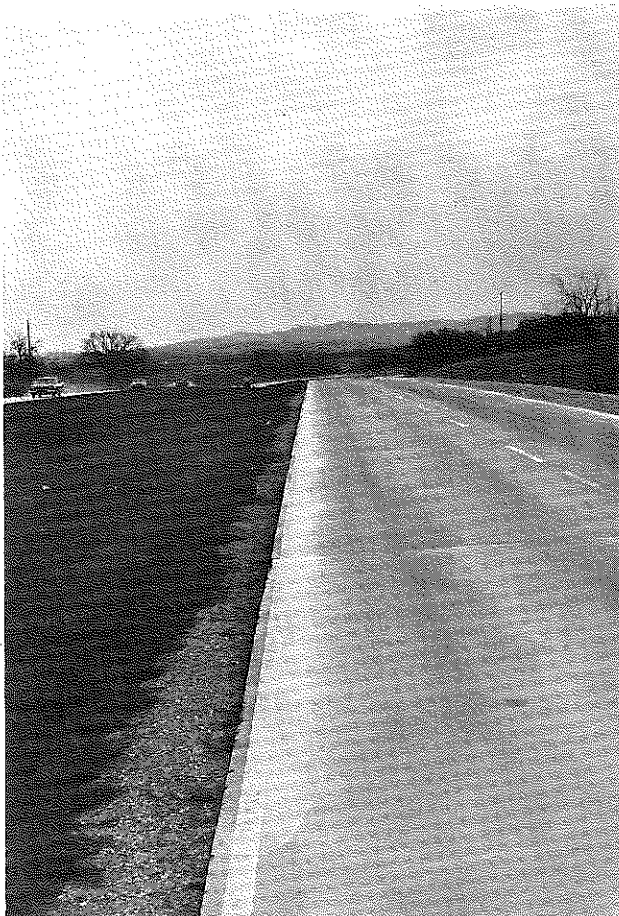
Figure 17.

Thermoplastic Edge-Lines Impounding Water.
