SUBJECT: Research Report: "Fifth Annual Performance Survey of  
Reinforced Concrete Pipe Culverts;" KYHPR-64-22,  
Part II, HPS-HPR-1(26)

FIFTH ANNUAL  
PERFORMANCE SURVEY OF REINFORCED  
CONCRETE PIPE CULVERTS  
KYHPR-64-22; HPS-HPR-1(26)

R. D. Hughes  
Research Engineer  
Research Division  
DEPARTMENT OF HIGHWAYS  
Commonwealth of Kentucky

June, 1965

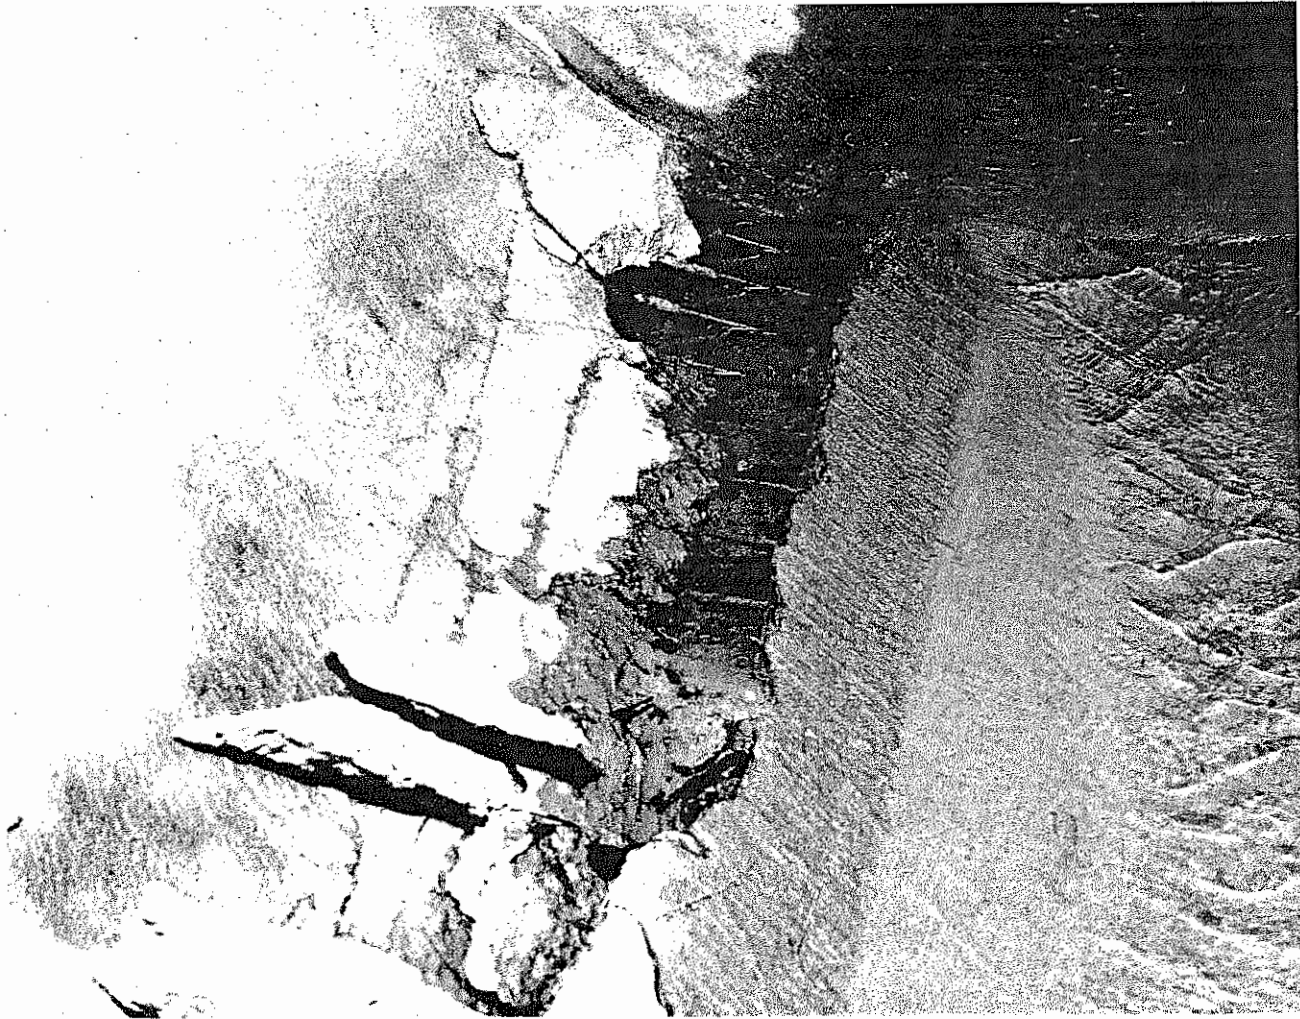
Fig. 4. Failure in Bottom of 60-inch Culvert Under a 28-foot  
Fill, Station 1619 + 45L, I64-3(7)35, Shelby County

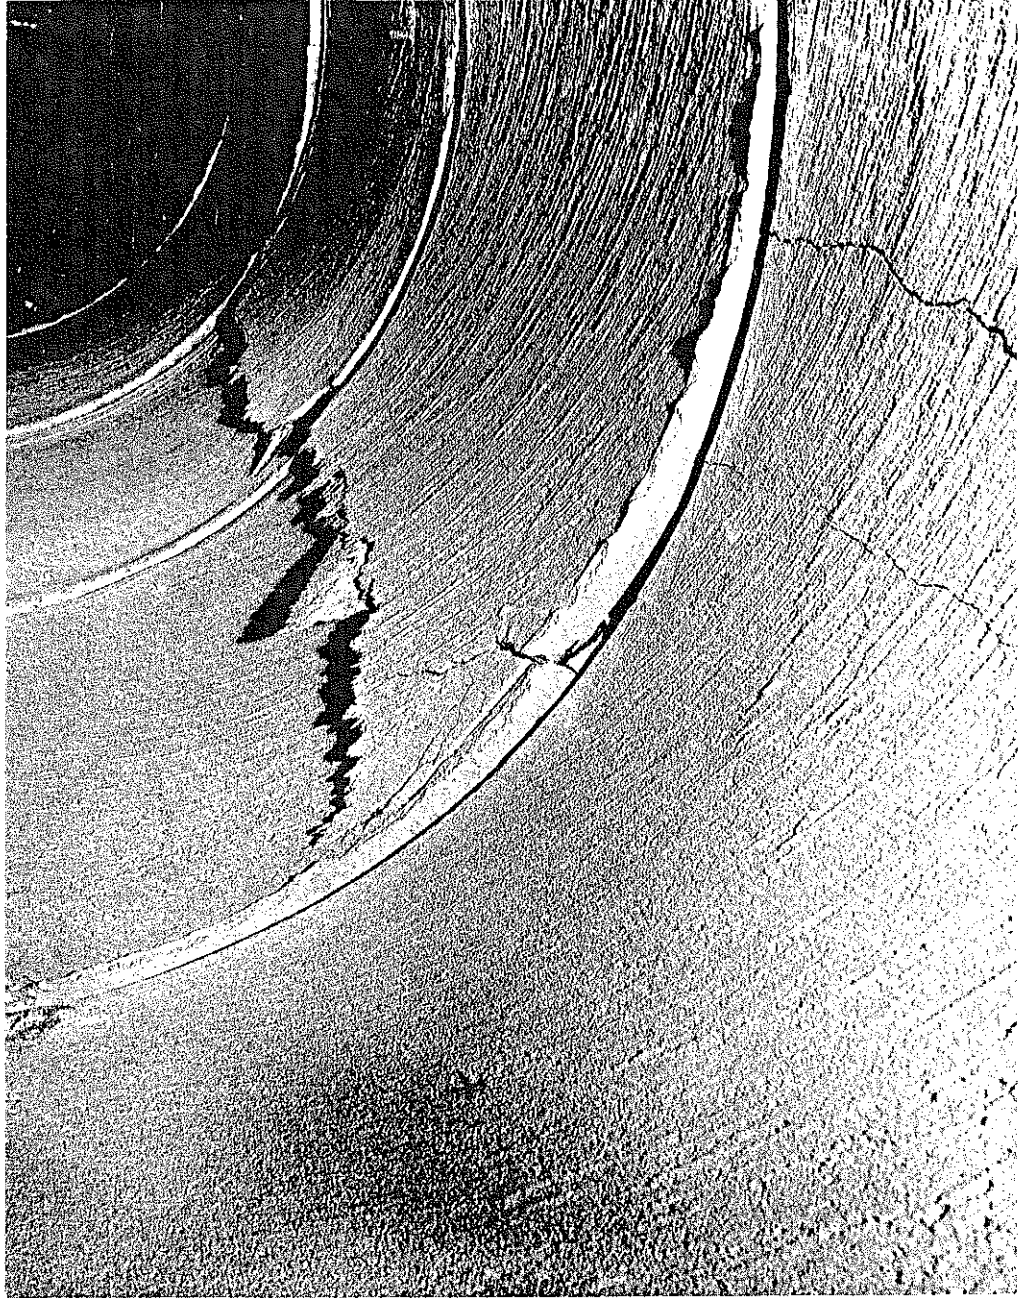
Fig. 5. Failure in Top of 60-inch Culvert Under a 28-foot Fill,  
Station 1619 + 45L, I64-3(7)35, Shelby County

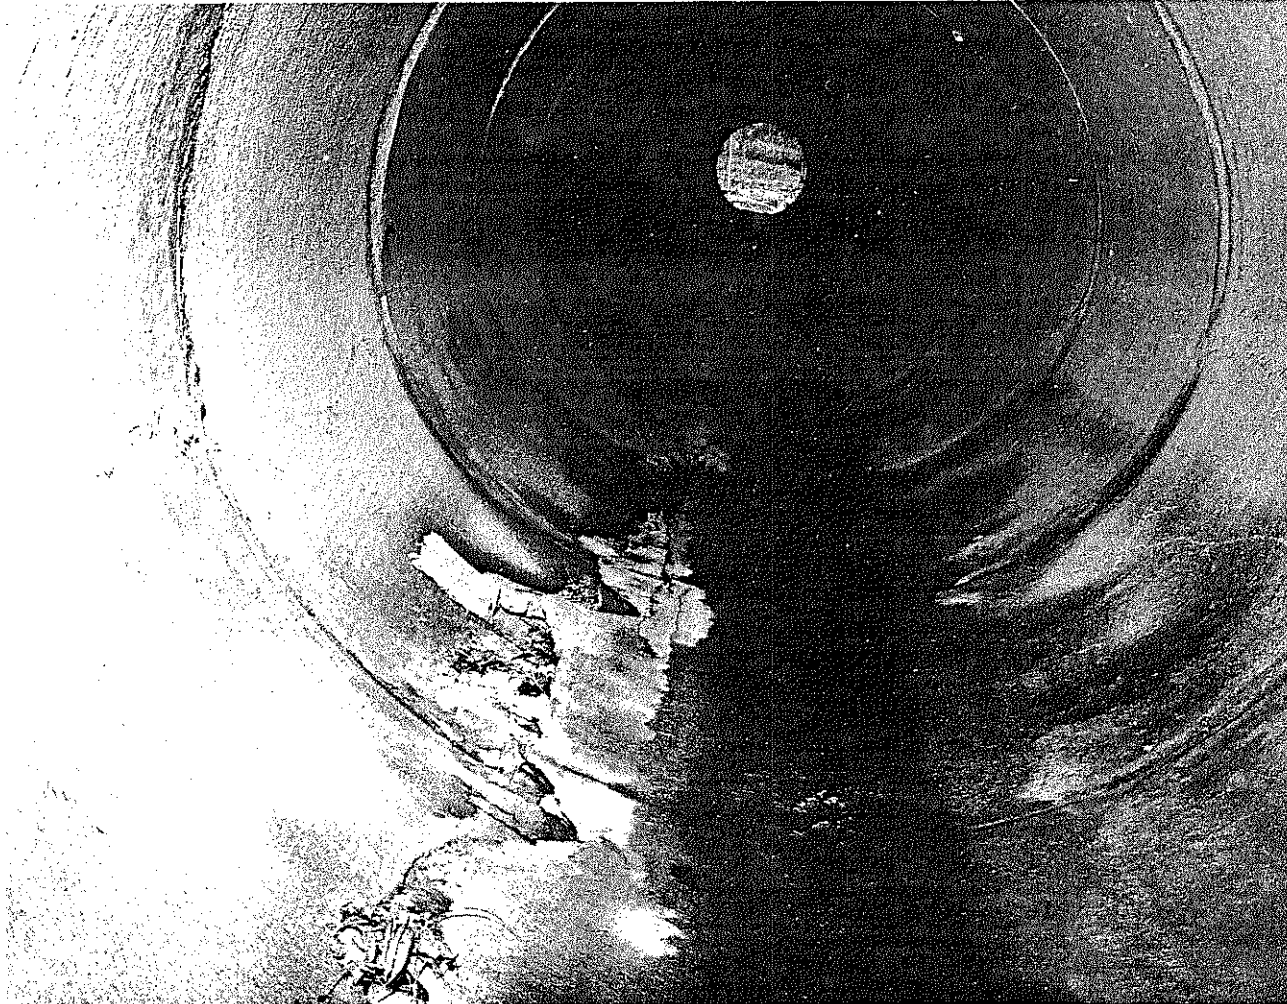
Fig. 6. Failure in Bottom of 54-inch Culvert Under a 32-foot Fill, Station 1633 + I64-3(7)35, Shelby County

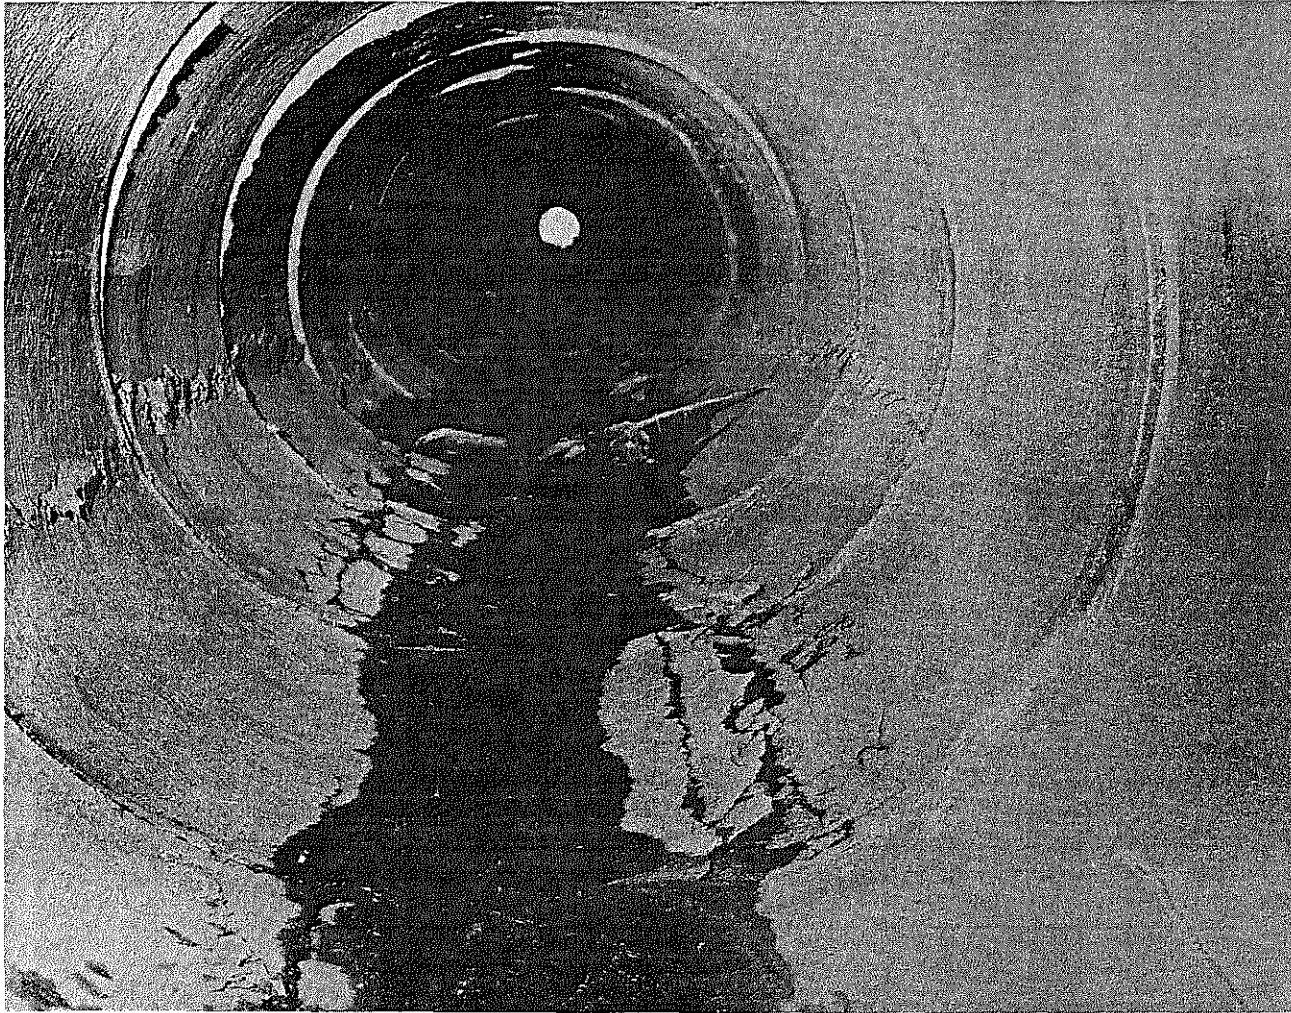
Fig. 7. Failure in Bottom of 54-inch Culvert Under a 53-foot  
Fill, Station 1087 + 50, I75-7(5)160, Grant County

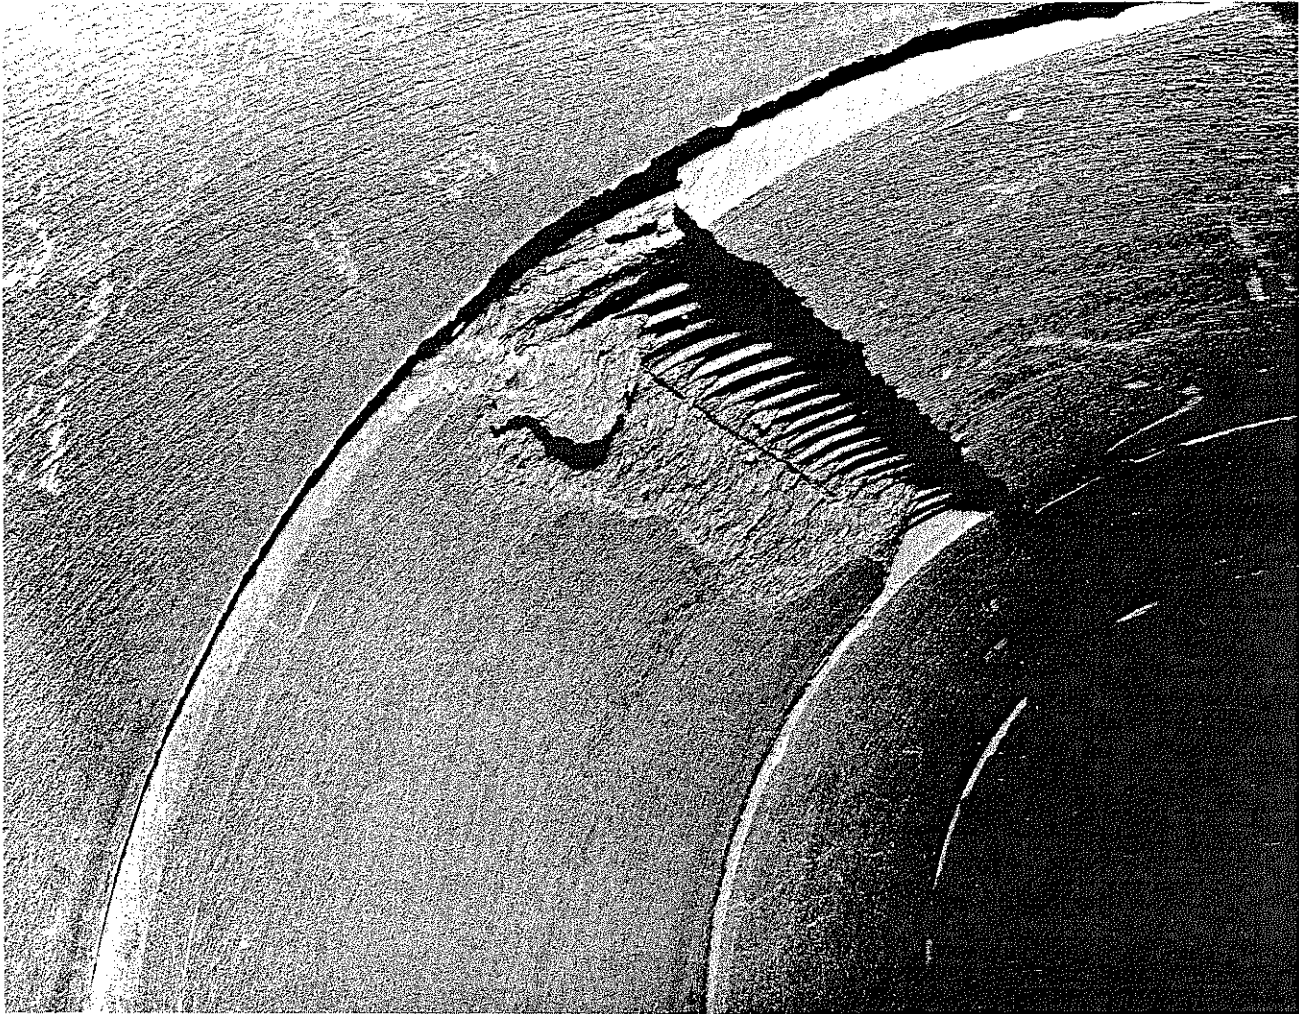
Fig. 8. Failure in Top of 54-inch Culvert Under a 53-foot Fill,  
Station 1087 + 50. I75-7(5)160, Grant County

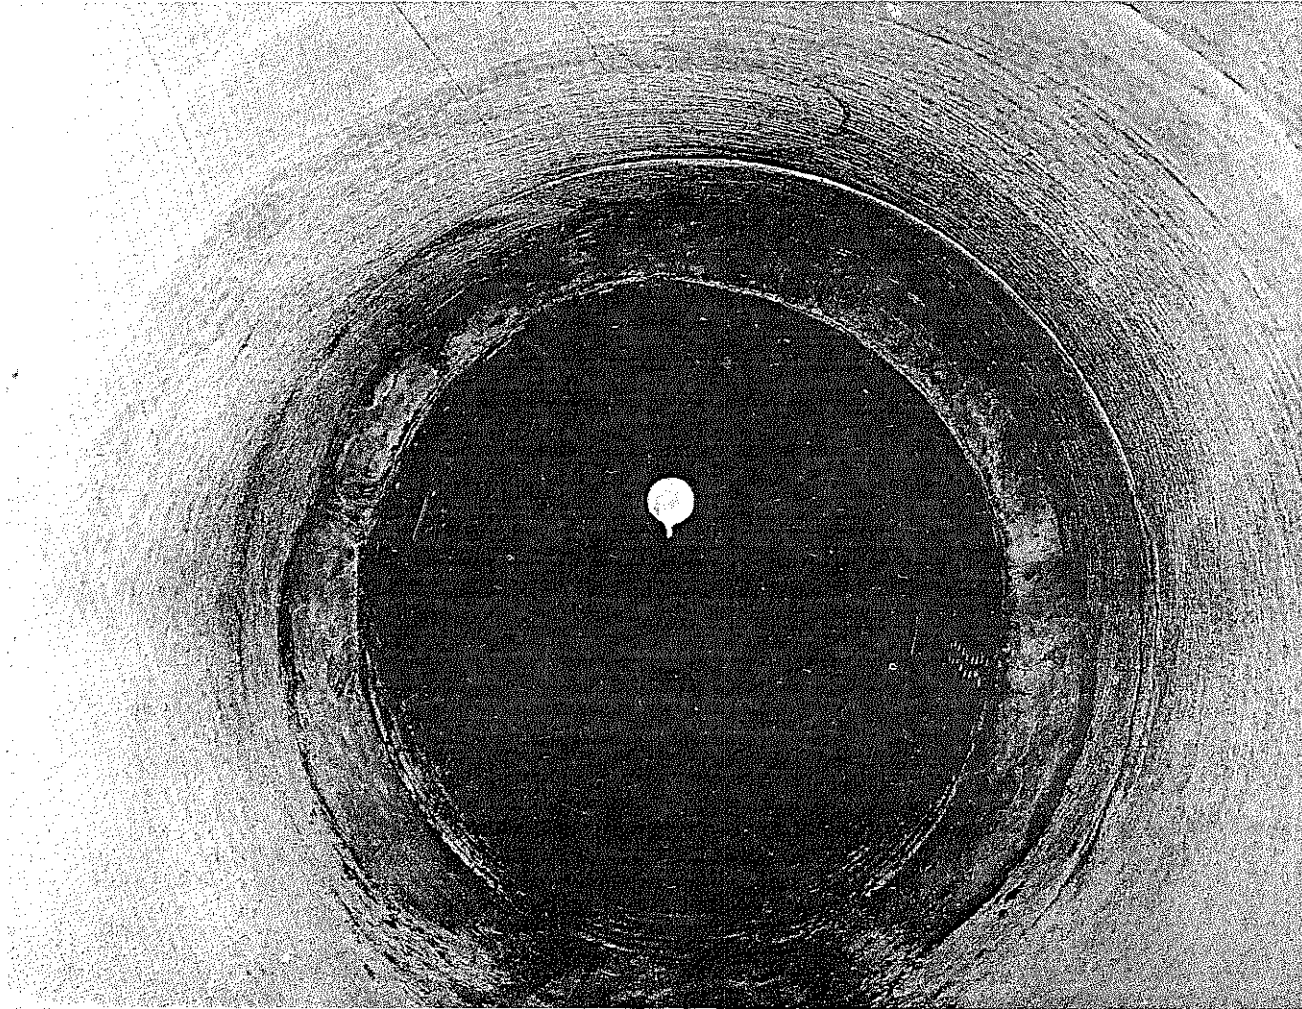
Fig. 9. Transition from concrete pipe to corrugated metal liner in culvert at Station 1255 + 25 on Project I64-3(3)31 in Shelby County

Several culverts were found to be in serious distress at the time of the first inspection, and repairs were deemed necessary. The culverts recommended for repair and the repairs as made are listed in Table III. The more seriously distressed sections were lined with corrugated metal pipe and

grout was pumped between the original pipe and liners. The liners were of a gage equivalent to that as would normally be required for a standard, corrugated metal pipe under a fill height equal to that above the damage conduit. Naturally, the liners were effective in preventing further development of distress and more than likely less conservative (structurally) repairs should be effected in the future, if necessary. The mortaring and epoxy patching of cracks proved rather ineffective in that cracks reflected through the patching material in a rather short period of time. The epoxy used in the repair of cracks was of a type which is adversely affected by moisture. Figures 4 through 8 show some of the failures that were observed in the more distressed sections. Figures 9 and 10 are views of a corrugated metal liner as installed in one distressed conduit.

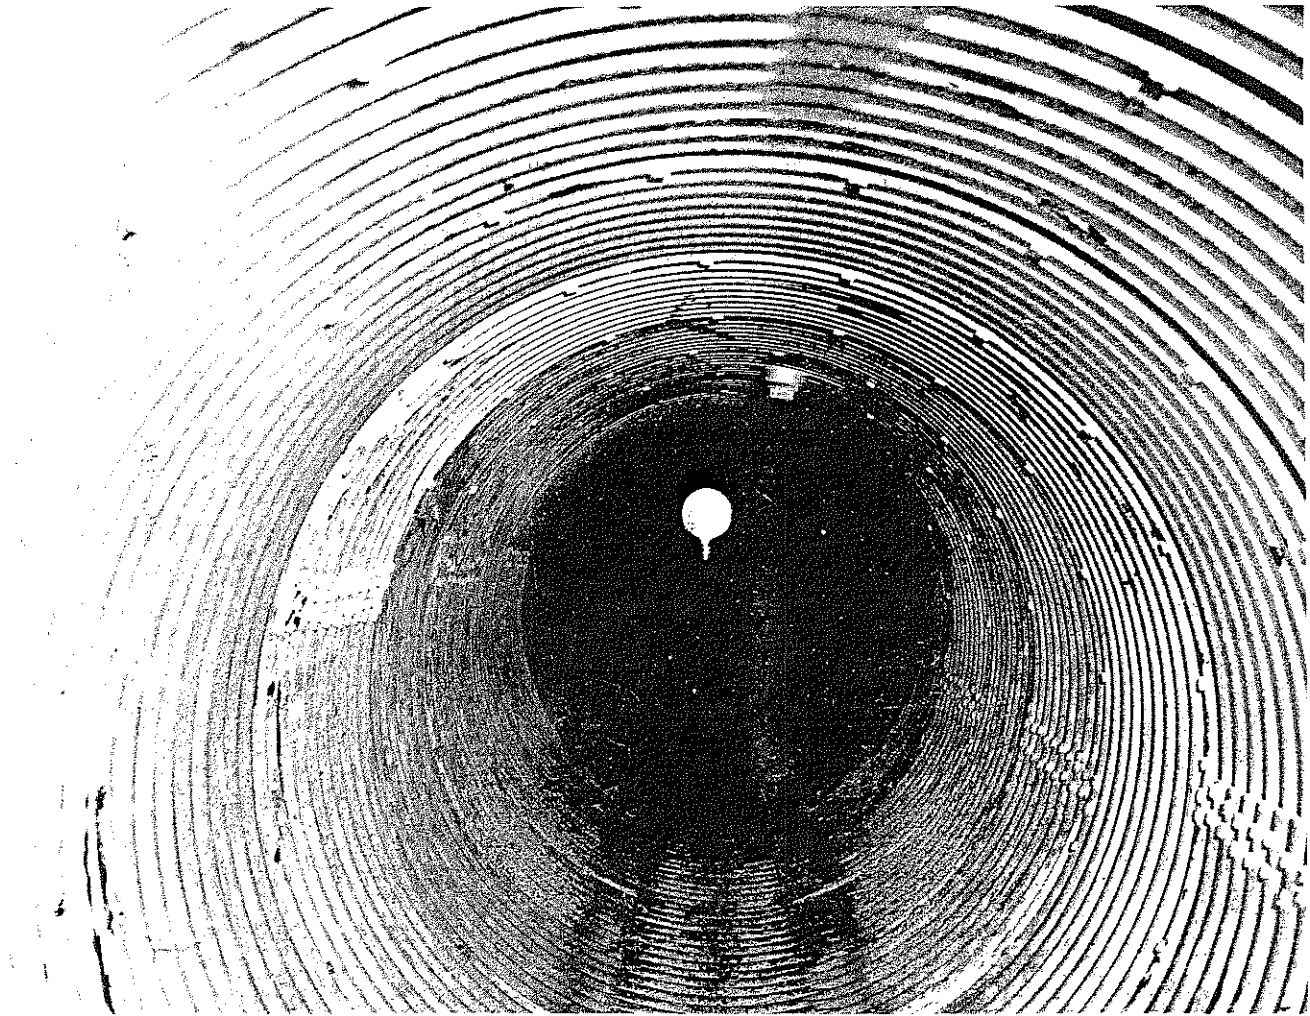
Fig. 10. Corrugated metal liner in culvert at Station 1255 + 25 on Project I64-3(3)31 in Shelby County
