May 8, 1964

SUBJECT: Inspection Report; Performance of Initial Surfacing
Projects, Constructed During 1963; Class I, Bituminous
Concrete, Containing PAC-9.

SUBJECT: Performance of Initial Treatments, Constructed
During 1963; Class I Bituminous Concrete Sur-
face, Containing PAC-9.

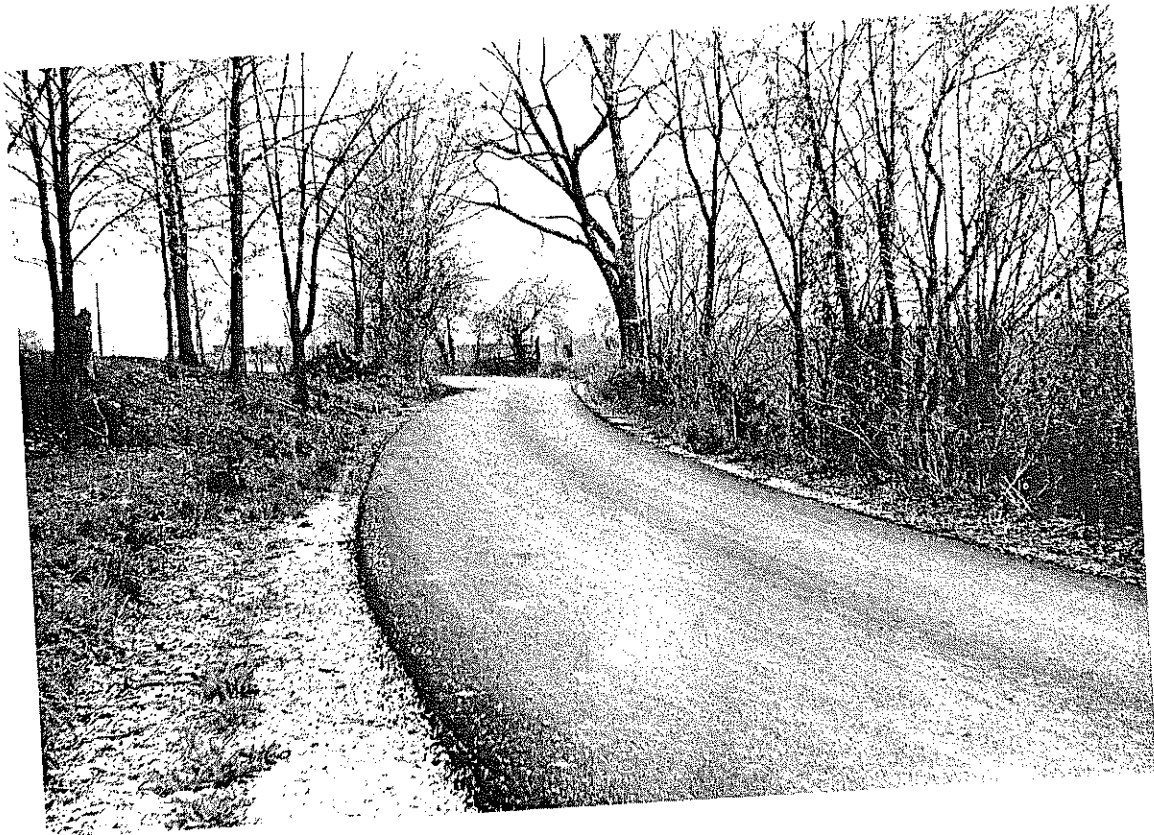
Comments: The overall appearance of the road was good.
The mixture was tight and appeared to contain
an ample amount of asphalt cement.

Fig. 1. Anderson County, RS3-911. General Condition of the
Leathers Road (4-27-64)

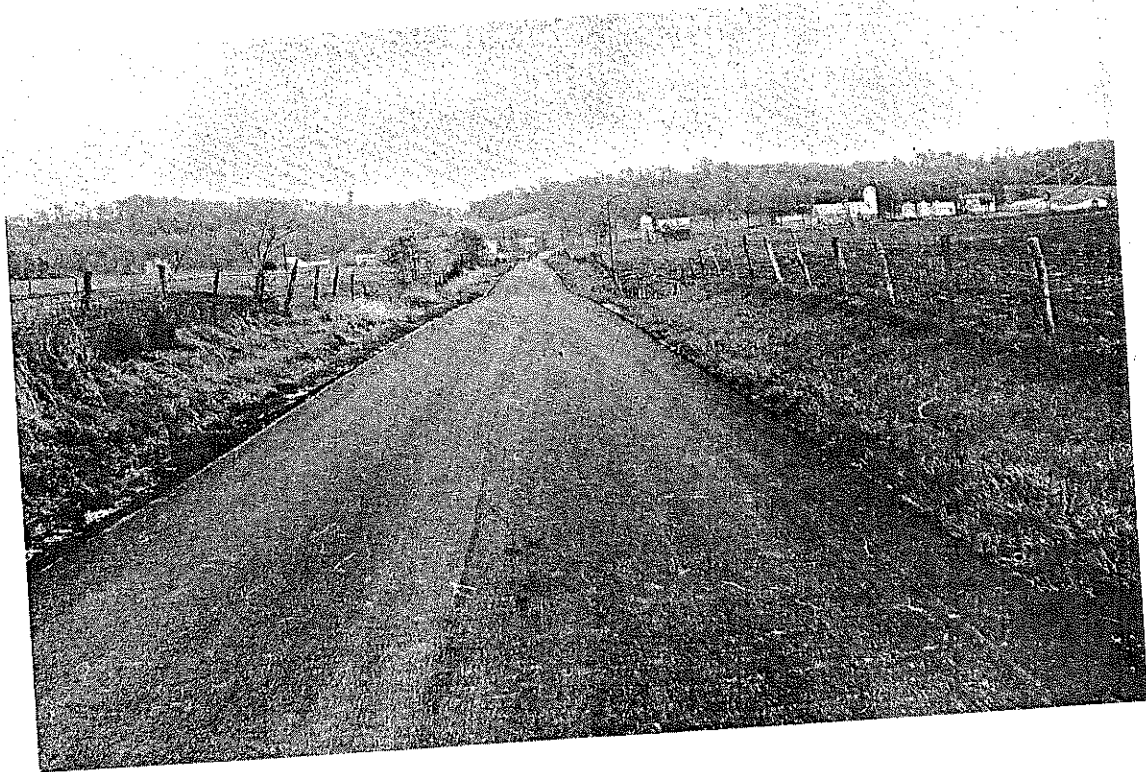
Fig. 2. Meade County, RS82-523. General Condition of the Bee Knob Road (4-21-64)

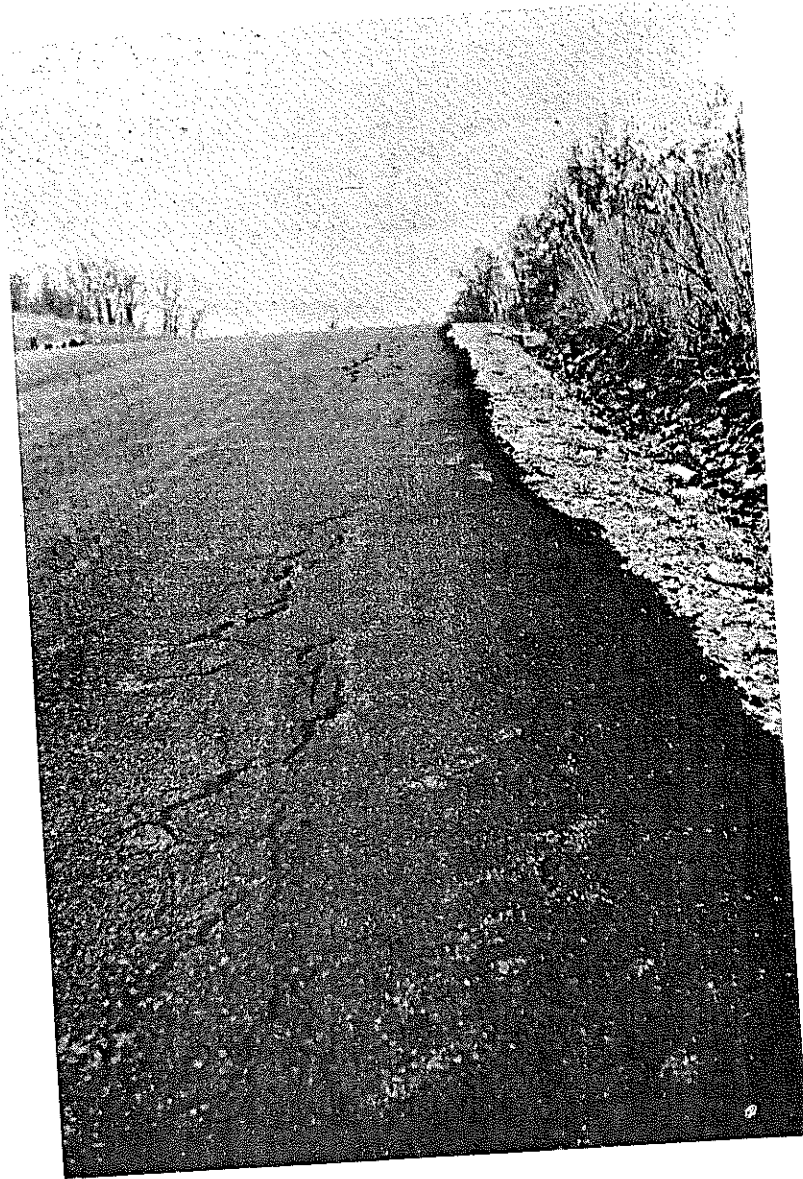
At present all of the surfaces are in good condition. In general the surface courses are dense, appear to contain an ample amount of asphalt cement, and the centerline joints are tight. No significant amount of flushing of the asphalt cement was apparent on any of the surfaces. Only a very small amount of rutting and cracking has occurred to date. Cracking and rutting of the surface was noted on only five of the seventeen roadways inspected and in every case the cracking was limited to a very small percentage of the total surface. On most of the roadways the shoulders are very narrow, or virtually non-existent, and some cracking along the pavement edge, such as shown in Figure 3 attached, may be anticipated.

Comments: The mixture was dense and appeared to contain an ample amount of asphalt cement. The overall condition of the surface was good. Some cracking has occurred along the edge of the north-bound lane for an approximate distance of 150 feet (Fig. 3).

Fig. 3. Meade County, RS82-523. Rutting and Cracking Near the Pavement Edge. The failed area is approximately 150 feet in length. (4-21-64)

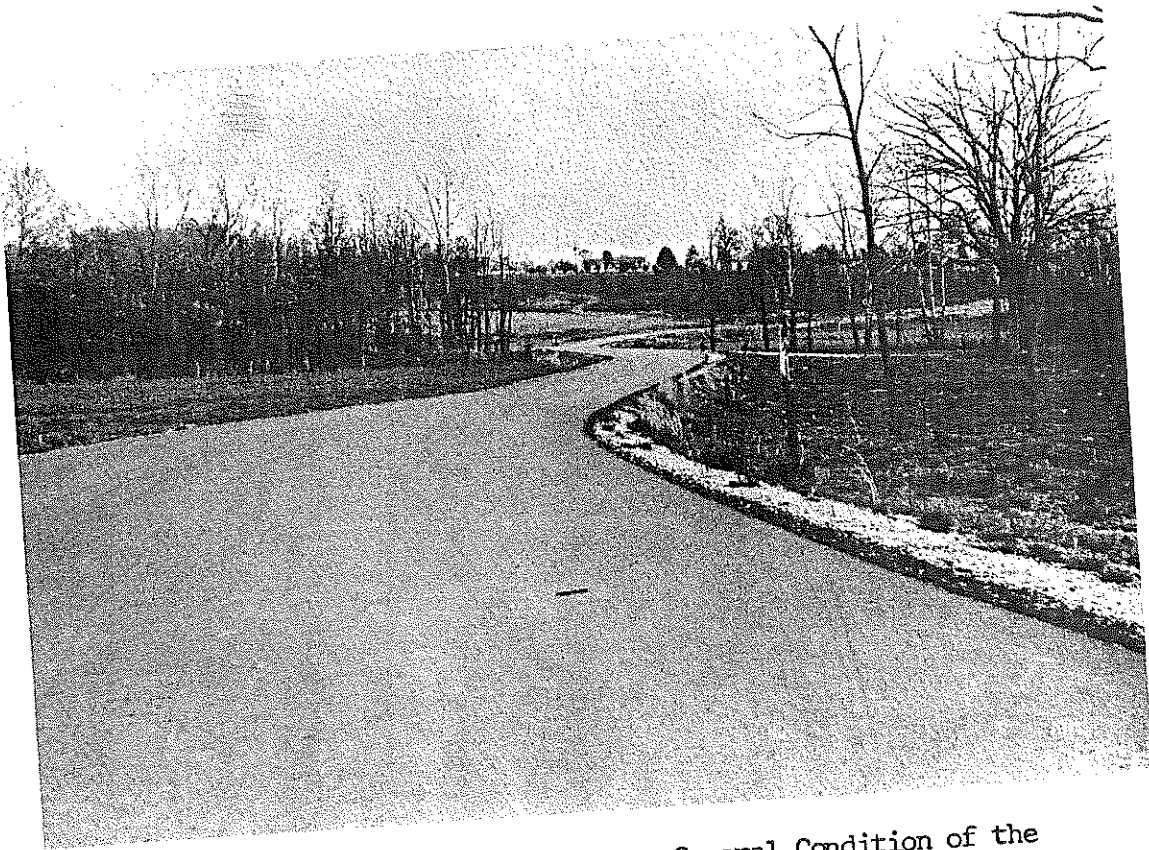
Fig. 4. Hart County, RS50-220. General Condition of the
Laton-Turner Road (4-21-64)

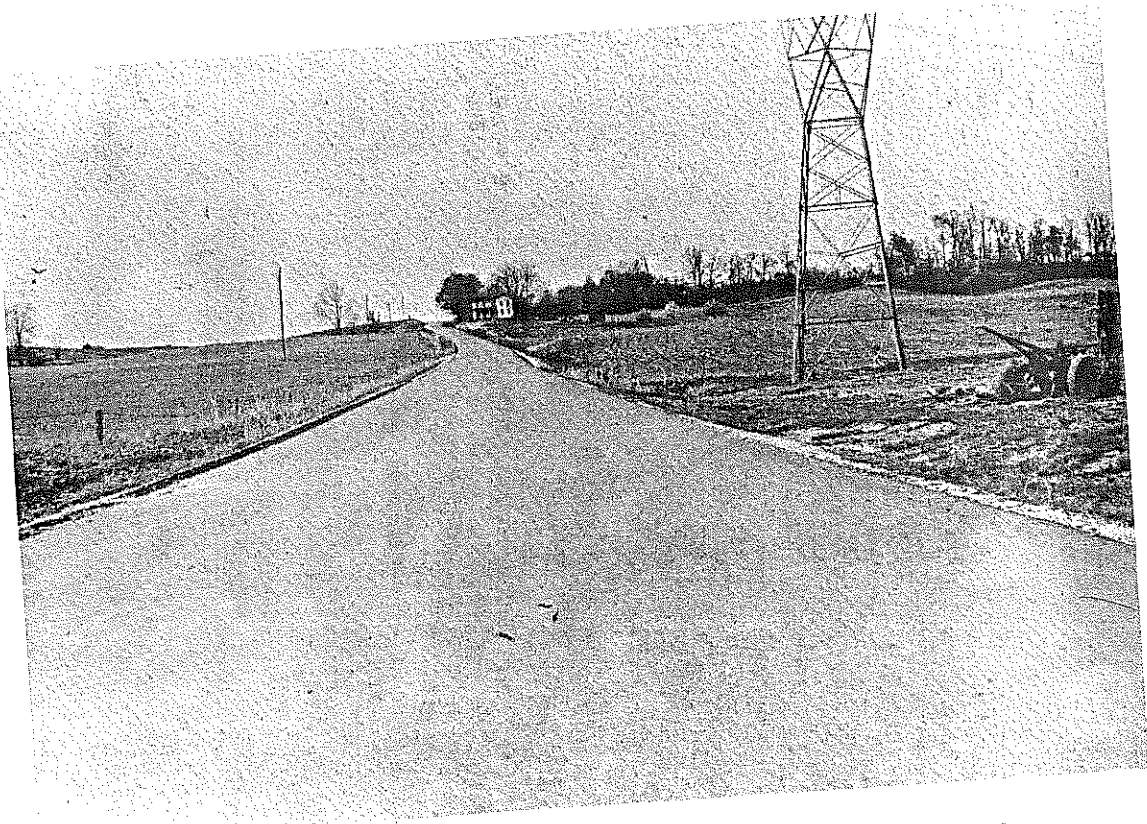
Fig. 5. Hart County, RS50-220. General Condition of the
High Hickory Road (4-21-64)

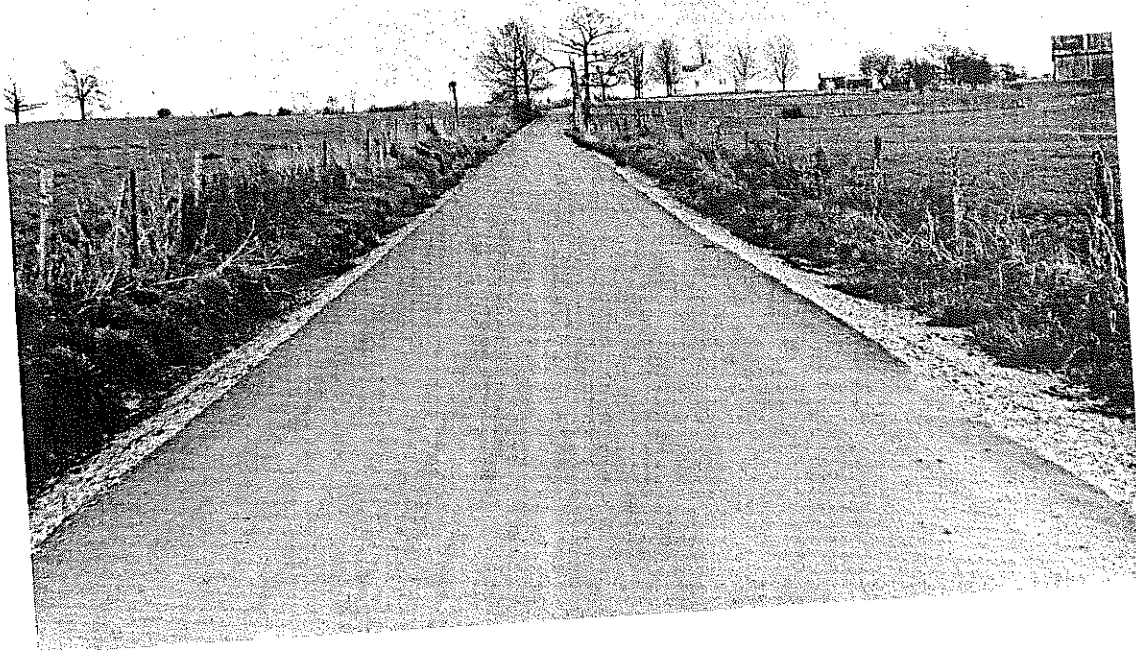
Fig. 6. Larue County, RS62-441. General Condition of the
McCubbins Road (4-21-64)

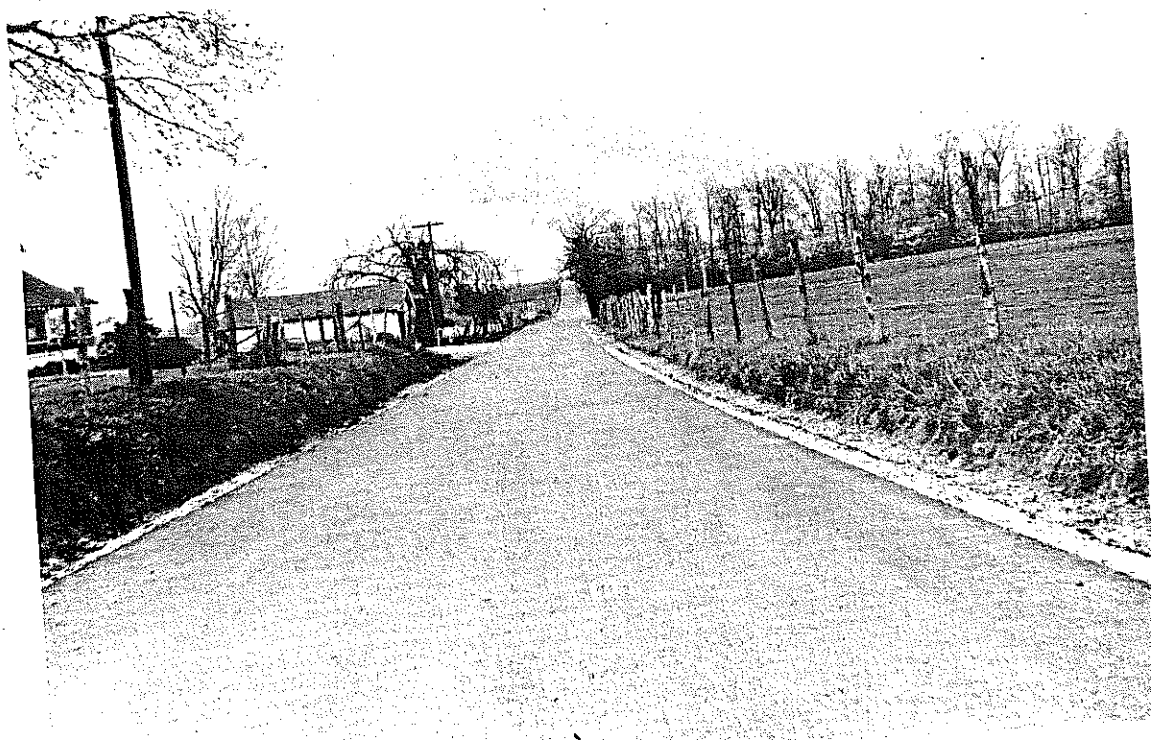
Fig. 7. Larue County, RS62-701. General Condition of the
Parkers Grove Road (4-21-64)

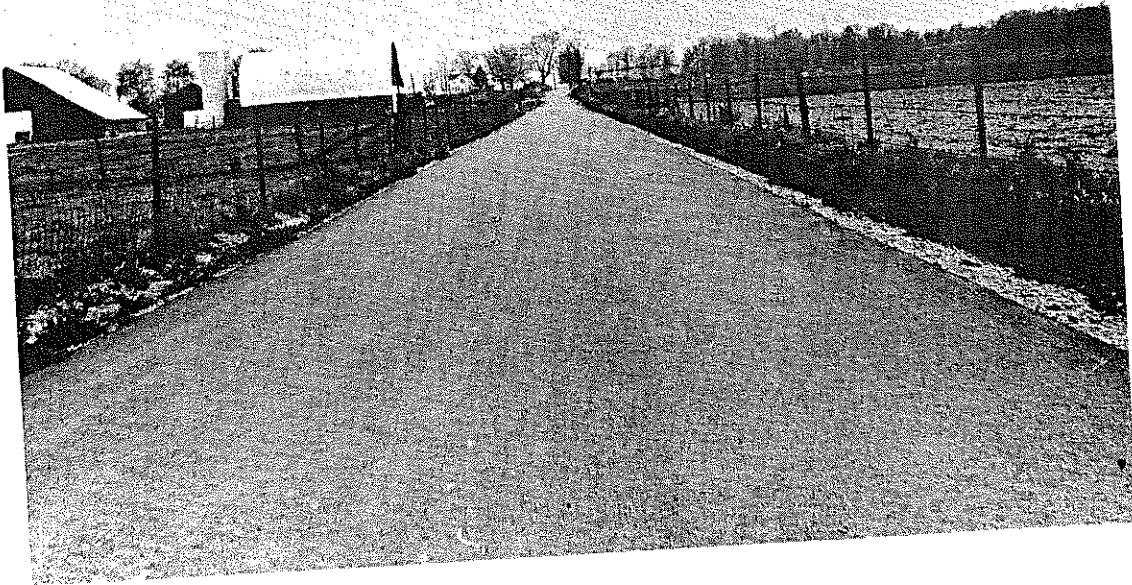
Comments: No cracking was apparent in any of the surfaces. The mixture was dense and appeared to contain an ample amount of asphalt cement. There was some rutting near the edge of the surface on the Harned Road. All of these roads appeared to be lightly trafficked.

Fig. 8. Larue County, RS62-441. General Condition of the Harned Road (4-21-64)

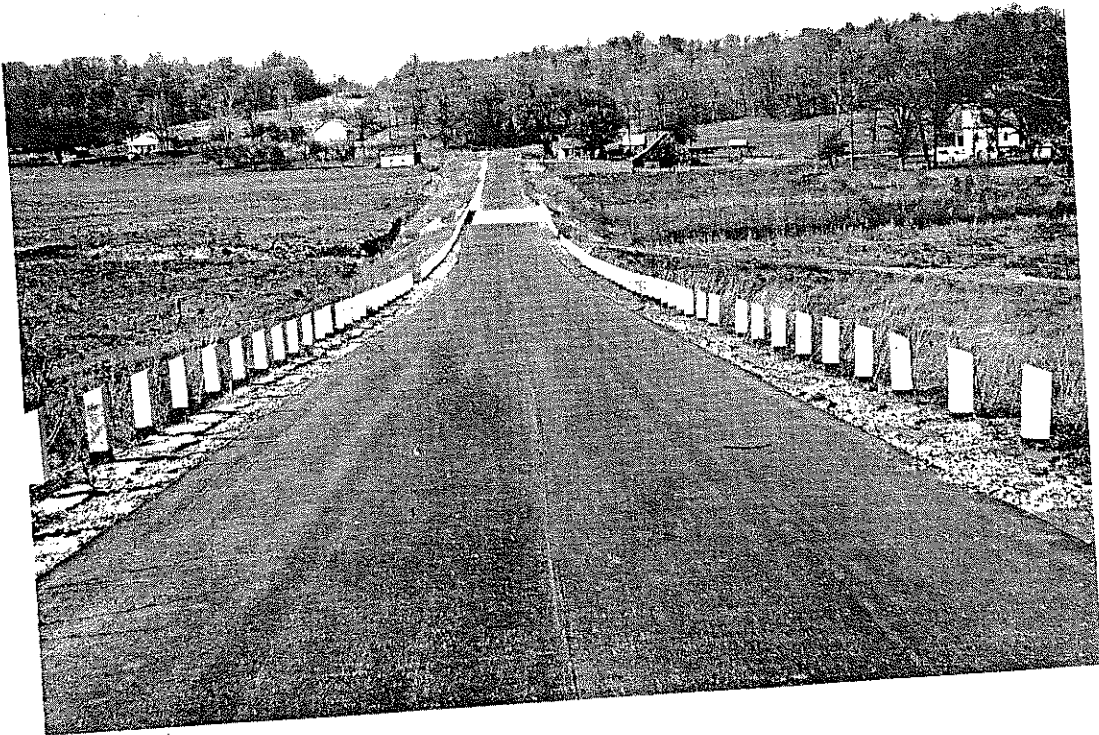
Comments: The roadway was in very good condition. No failures were apparent in the surface.

Fig. 9. Crittenden County, RS28-606. General Condition of the Irma-Salem Road. The road is paved with 1 1/2 inches of binder mixture and 1 inch of surface mixture. (4-22-64)

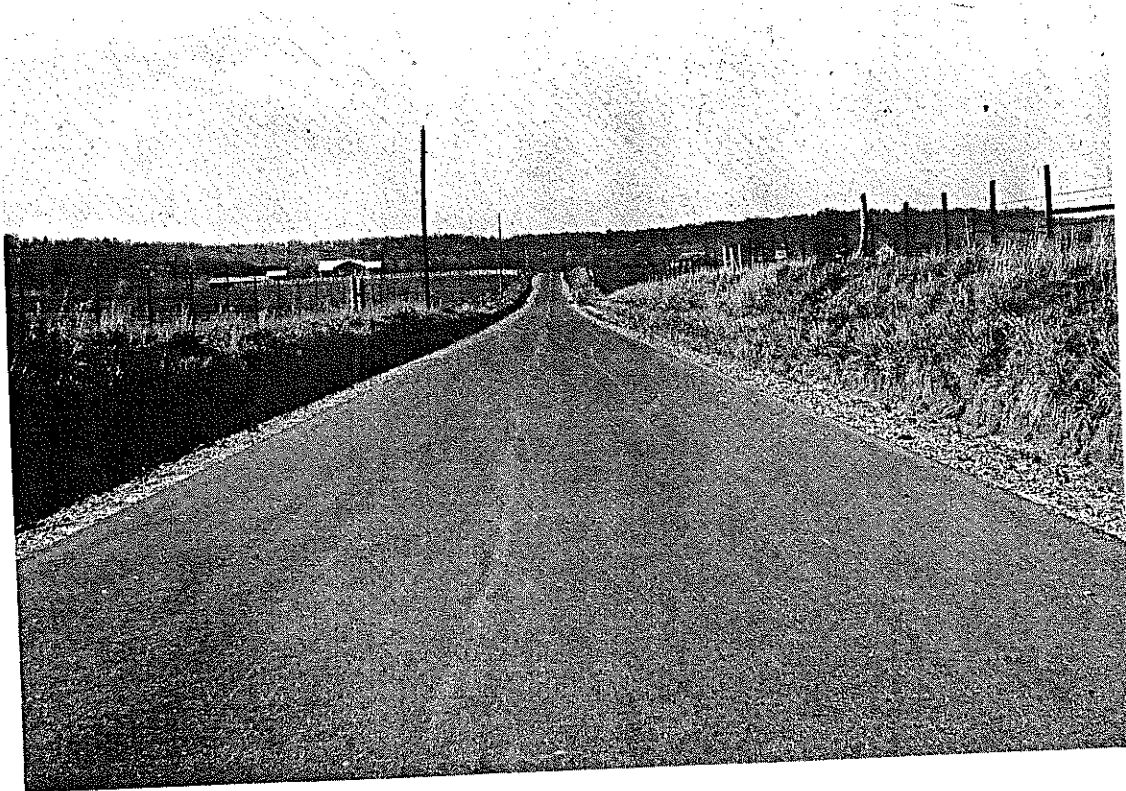
Fig. 10. Livingston County, SP70-750. General Condition of the Hampton-Bayou Road (4-22-64)

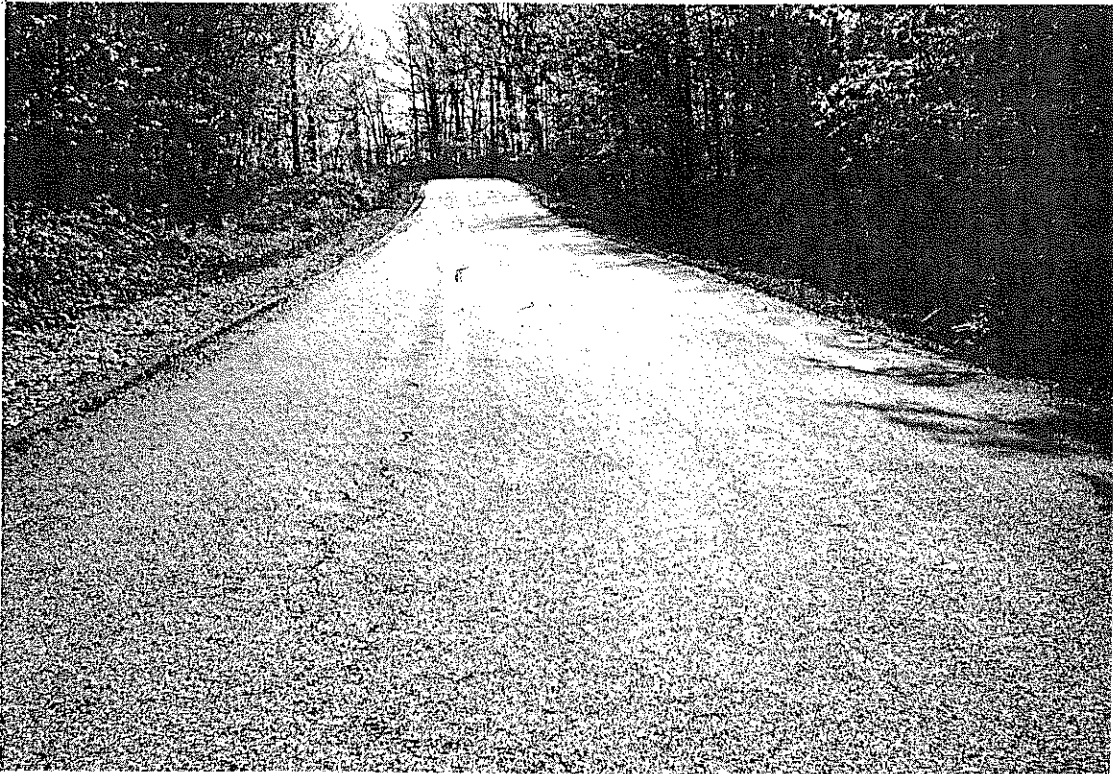
Comments: The mixture was not as dense as that on the other roads inspected. Overall the surface was in good condition. For a distance of approximately 100 feet rutting has occurred in both lanes and in one lane the surface has cracked (Fig. 11). The ditches were cleaned out over the full length of the project; but, in some spots they are again filling up with sediment.

Fig. 11. Livingston County, SP70-730. Rutting and Cracking in Cut Section. The area in distress is approximately 100 feet long. (4-22-64)

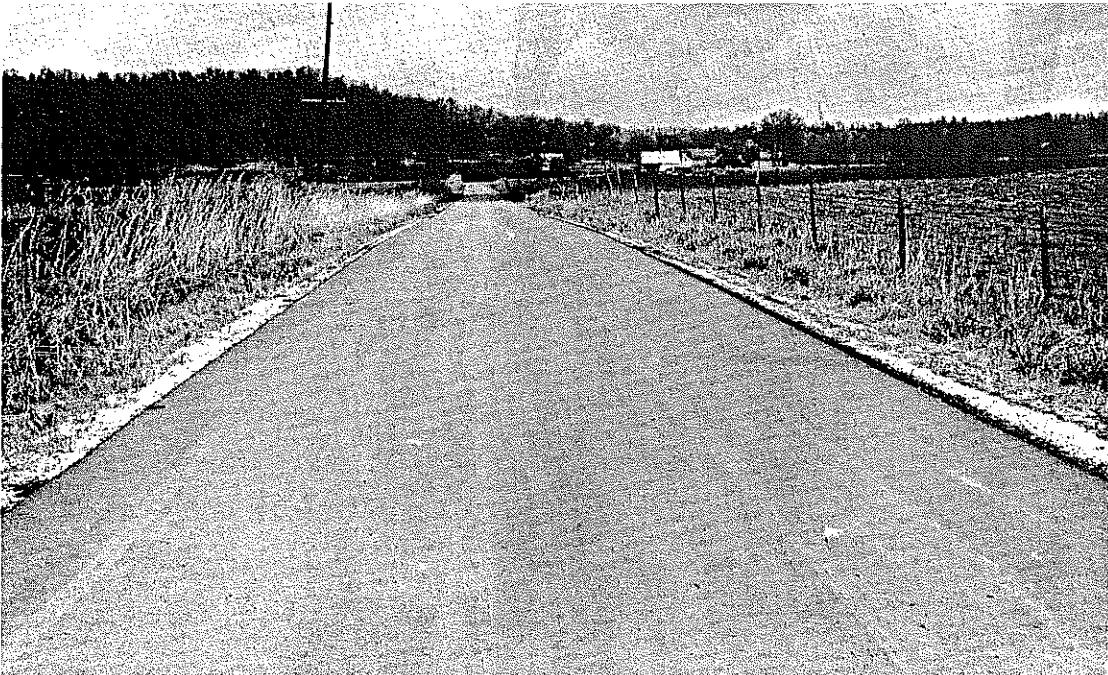
Fig. 12. Todd County, RS110-176. General Condition of the Fulcher School Road (4-22-64)

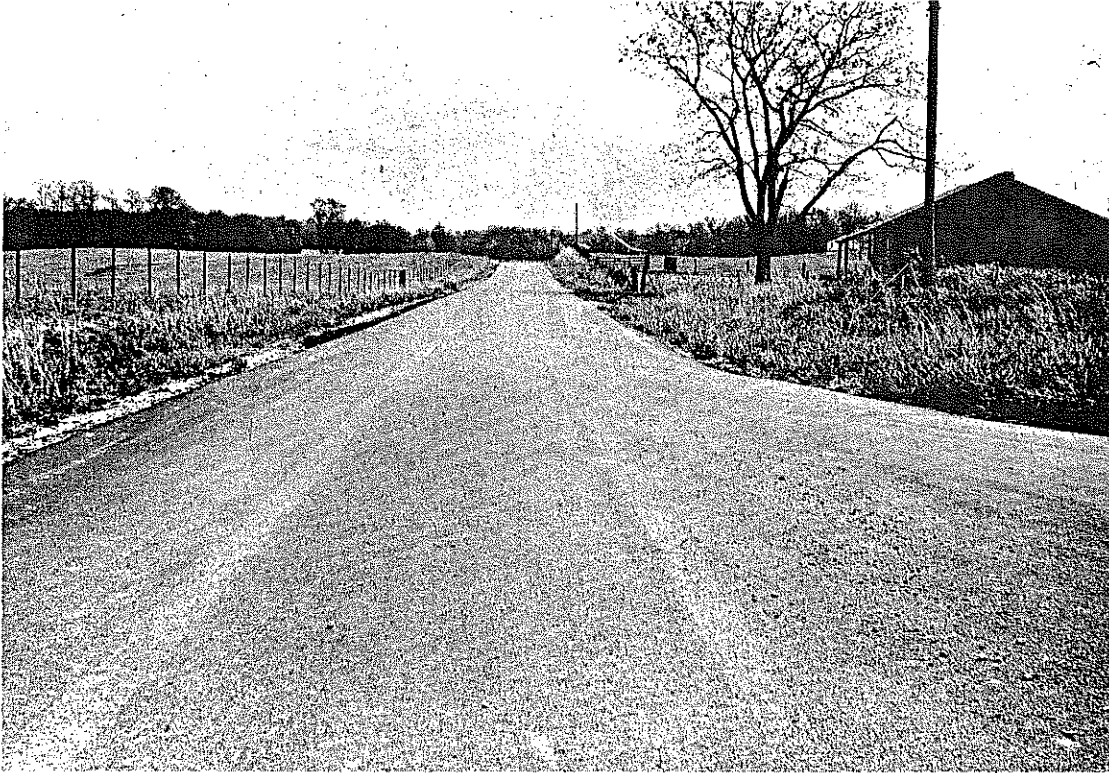
Fig. 13. Todd County, RS110-196. General Condition of the Fulcher Road (4-22-64)

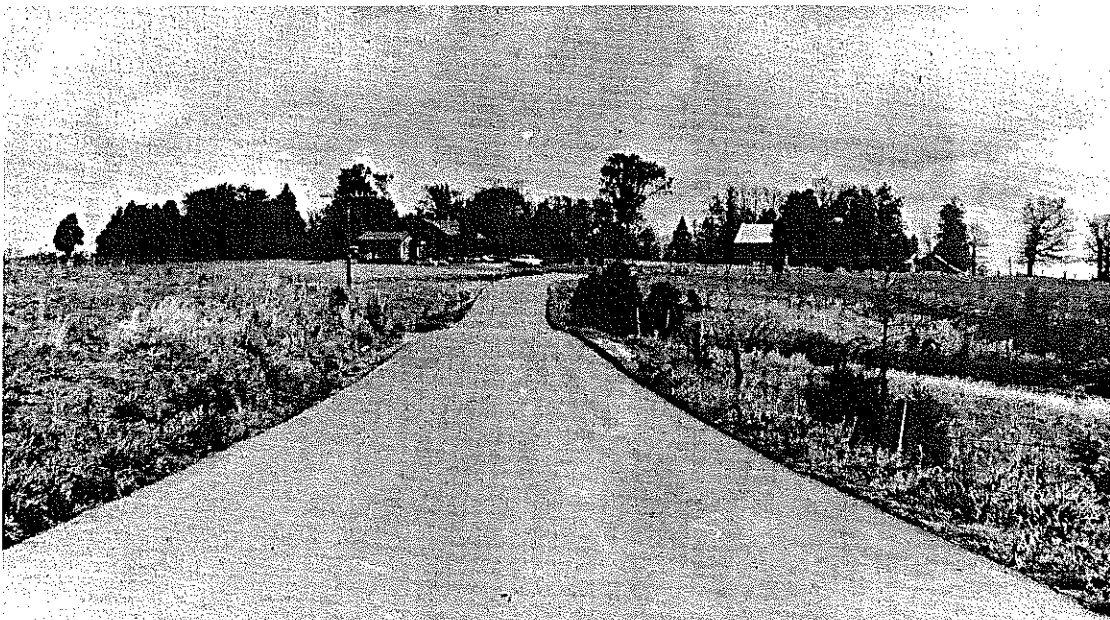
Fig. 14. Logan County, SP71-506. General Condition of the Dunmor-Deerlick Road (4-22-64)

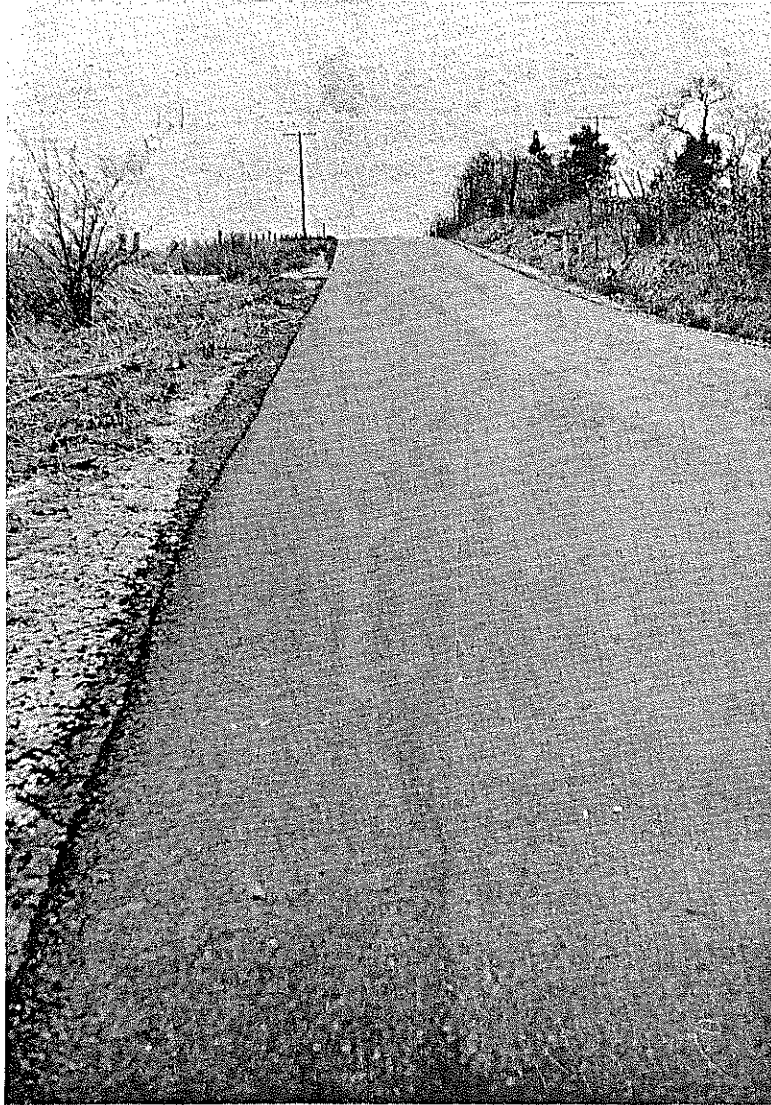
Comments: The surface was dense and appeared to contain an ample amount of asphalt cement. Small bleeding spots were widely scattered over the surface. Some longitudinal cracking was noted in the outside wheel-track of the south-bound lane.

Fig. 15. Logan County, SP71-506. Cracking in the Wheel Track
(4-22-64)

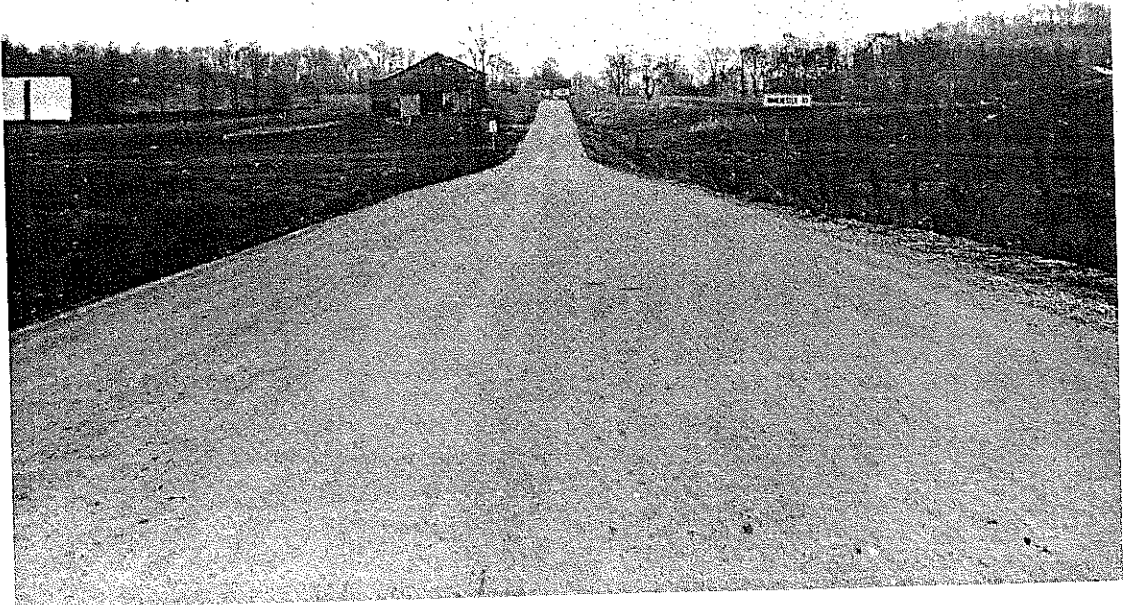
Fig. 16. Clay County, SP26-165. General Condition of the Grace-Fogertown Road (4-24-64)

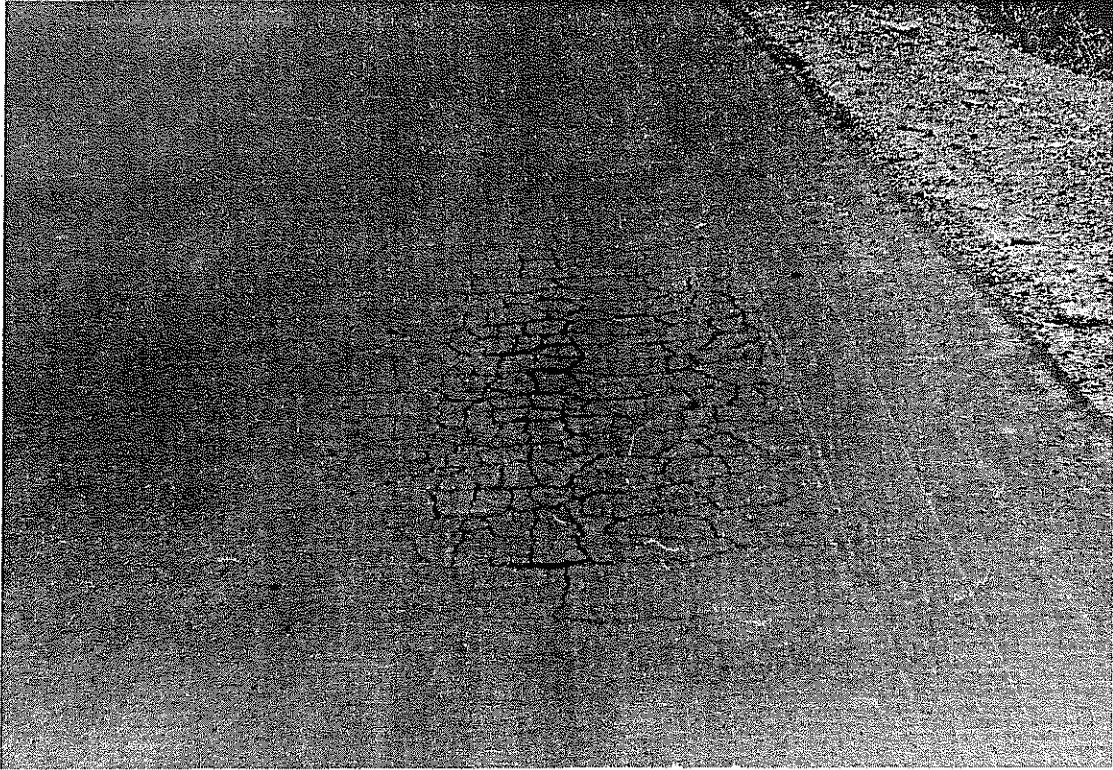
I am sure that you will find Mr. Florence's photographs and observations to be reassuring -- that is, provided that certain exceptions are admissible. Figure 17, SP26-165, illustrates what I would consider to be an admissible exception. Perhaps, we should not even expect roads of this type to withstand heavily loaded trucks without sustaining severe, recurring damage. Also, mention is made in the report to instances where the edge-support is inadequate; but, there again, this may be an admissible exception when the type and class of road is taken into account. Weaknesses in the foundation material seem to become exposed in a very disturbing way; however, this seems to be the general rule rather than the exception on all light-surfacing projects which carry loads heavier than passenger cars.

Comments: The overall condition of the surface was good. The mixture was dense and appeared to contain an ample amount of asphalt cement. Loaded coal trucks haul over the north-bound lane for a distance of approximately 1/2 mile, at the southern end of the surfacing. Alligator cracking, such as shown in Fig. 17, has occurred in five areas in the north-bound lane within this 1/2 mile section.

Fig. 17. Clay County, SP26-165. Alligator Cracking in Wheel-Track. Loaded coal trucks haul over the north-bound lane on the southernmost 1/2 mile of the surfacing. Five failed areas, such as shown above, have occurred in the section of roadway traveled by the loaded trucks. (4-24-64)

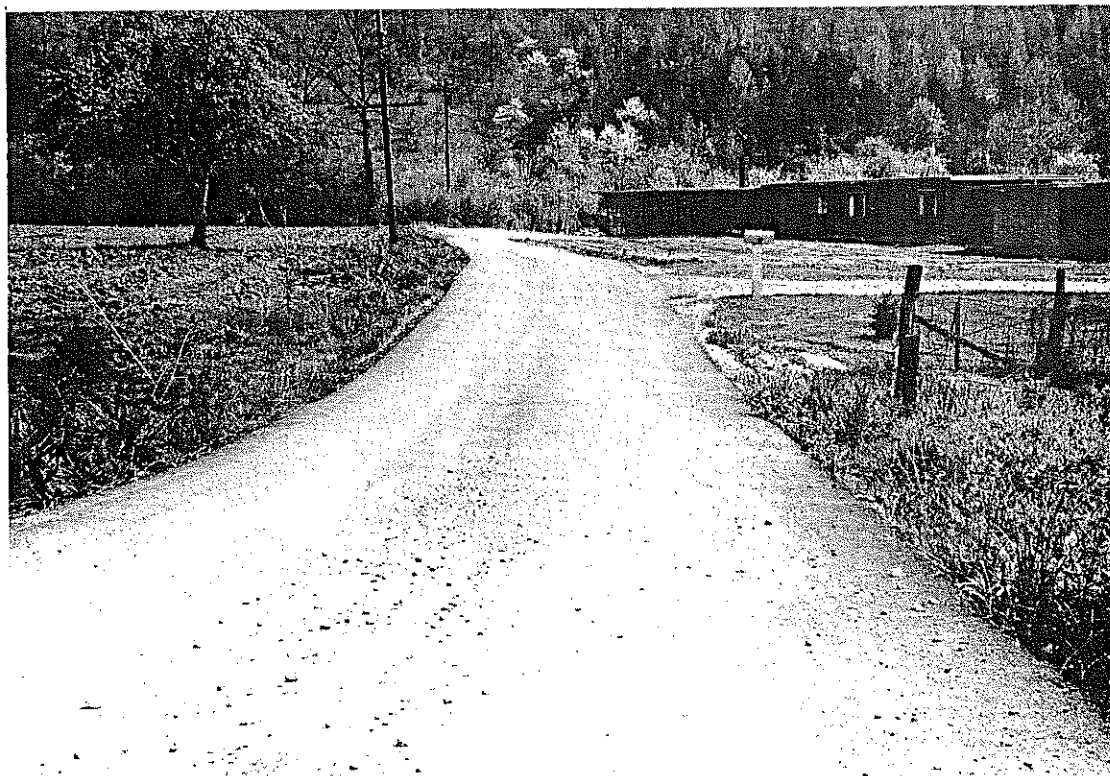
Fig. 18. Harlan County, RS48-898. General Condition of the Dupree Road (4-24-64)

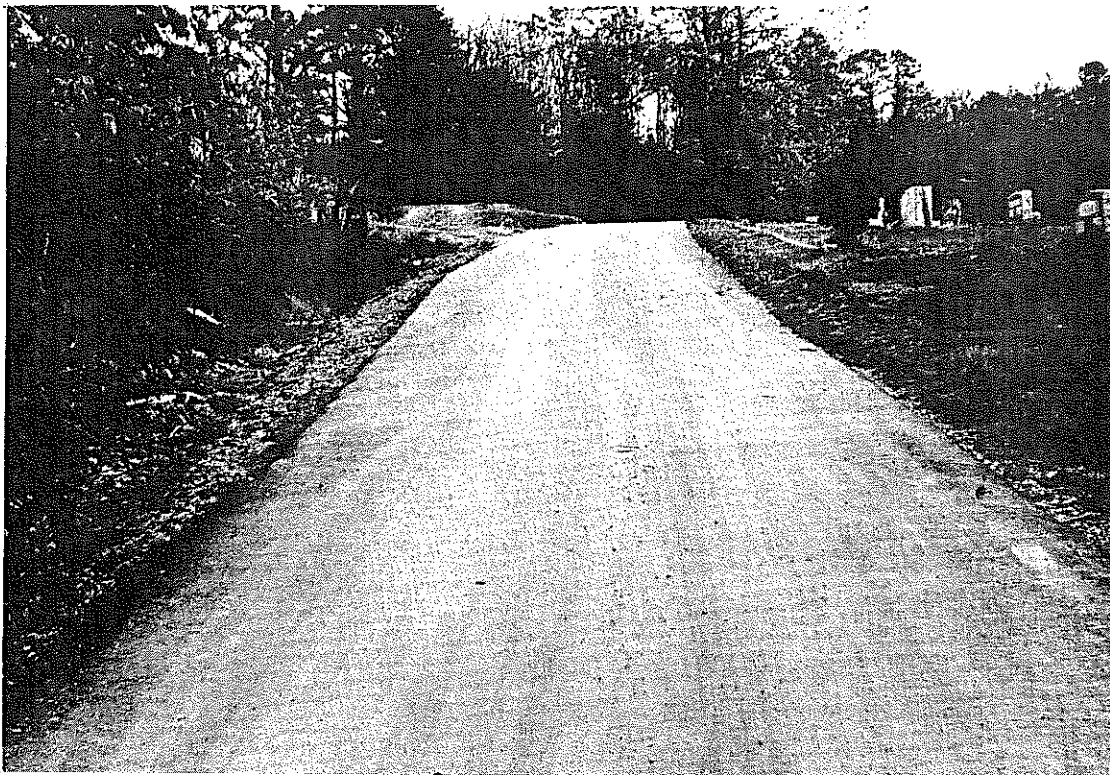
Fig. 19. Harlan County, RS48-933. General Condition of the Huff Cemetery Road (4-24-64)

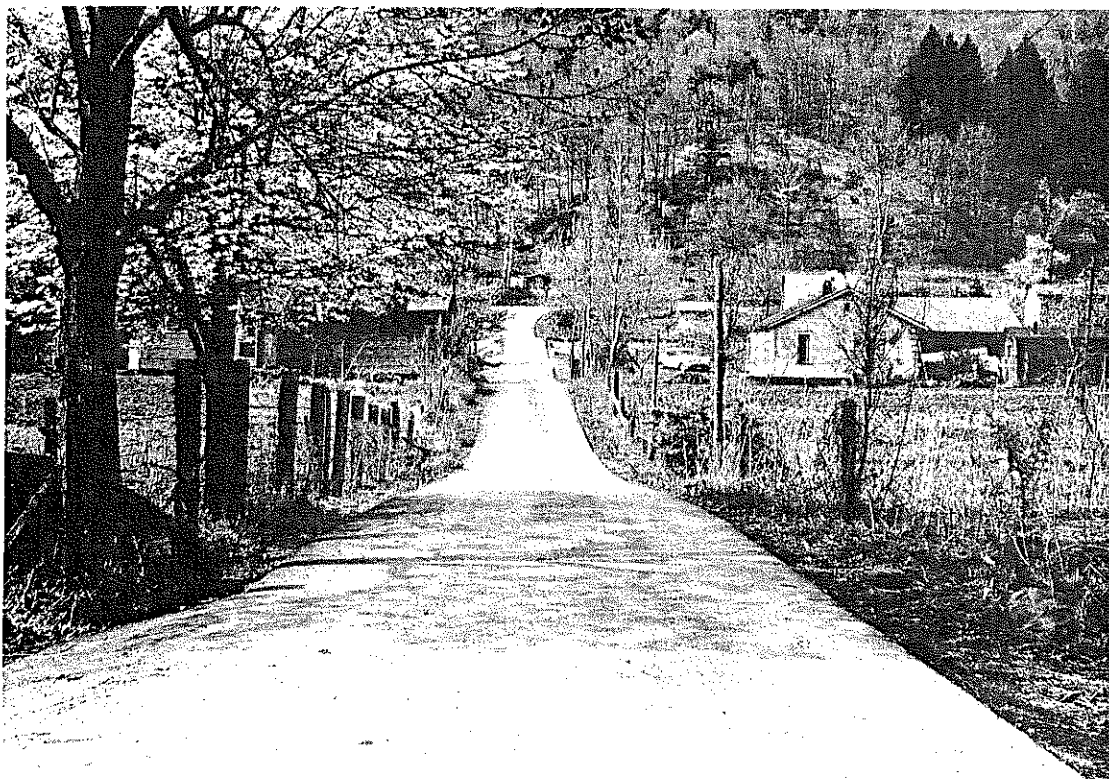
Fig. 20. Harlan County, RS48-953. General Condition of the Lewis Road (4-24-64)
