COMMONWEALTH OF KENTUCKY  
DEPARTMENT OF HIGHWAYS  
FRANKFORT

SUBJECT: Final Construction and Interim Performance Report;  
Experimental Use of Thermoplastic, Pavement-Striping  
Material (Experimental Construction and Research, Report  
No. 3); KYHPR-64-18, HPS-HPR-1(25)

Report No. 3

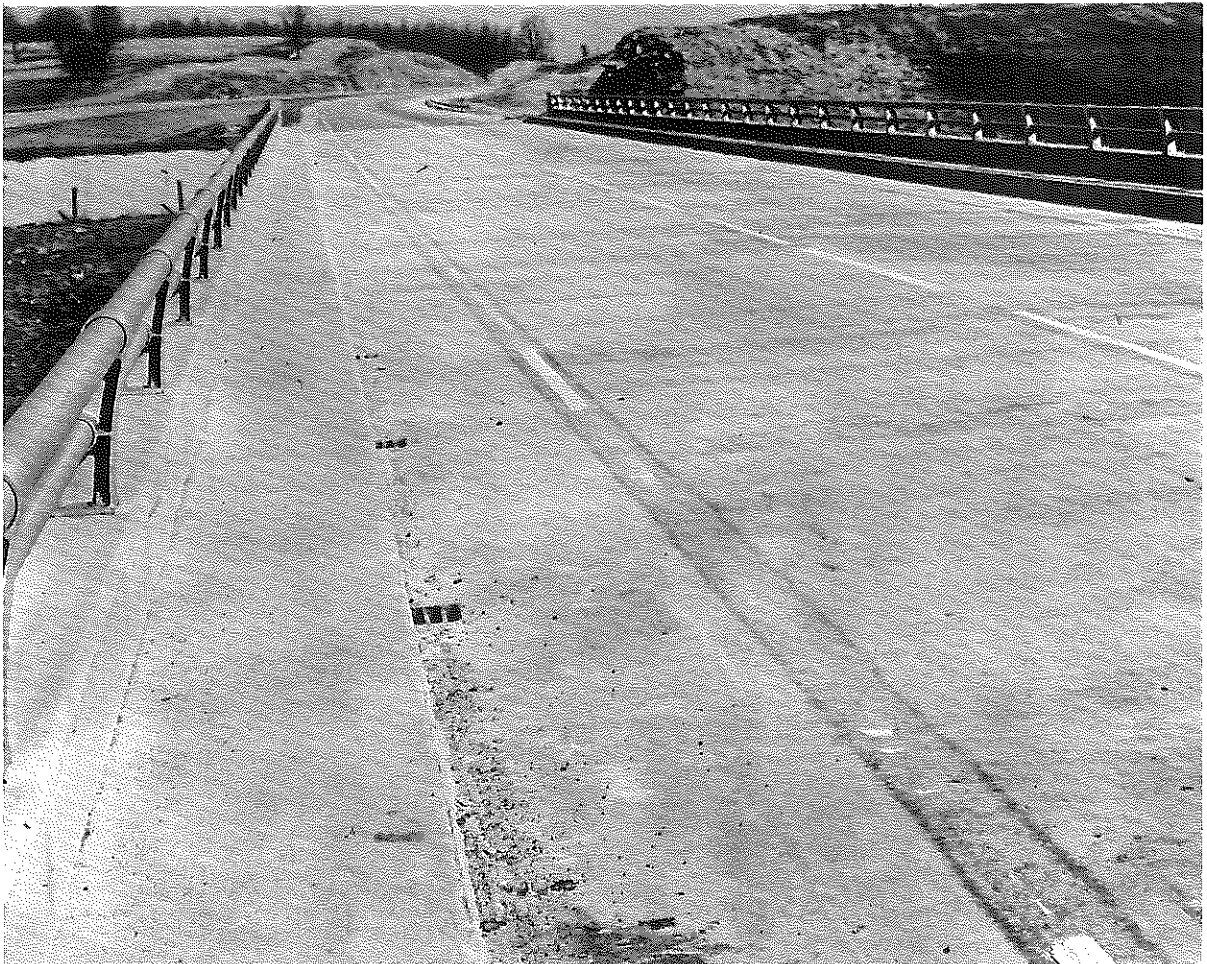
Figure 13: View of Concrete Bridge Deck, I 64, Clark - Montgomery Counties, Showing Spalled and Missing Portions of Plastic Edge-line (Catatherm Subsection). The darkened portion along the edge-line in the foreground indicates a heavy application of bonding primer. This line was placed in November 1962, and the photograph was taken in February 1963.
