STATUS REPORT
ON
LANDSLIDE AREA
on
I-75, Covington, Kentucky

A Slide Area Being Studied
As Part of Research Project

DEVELOPMENT OF A PRACTICAL METHOD
OF LOCATING AND TRACING SEEPAGE
WATER IN UNSTABLE SLOPES

May 15, 1963

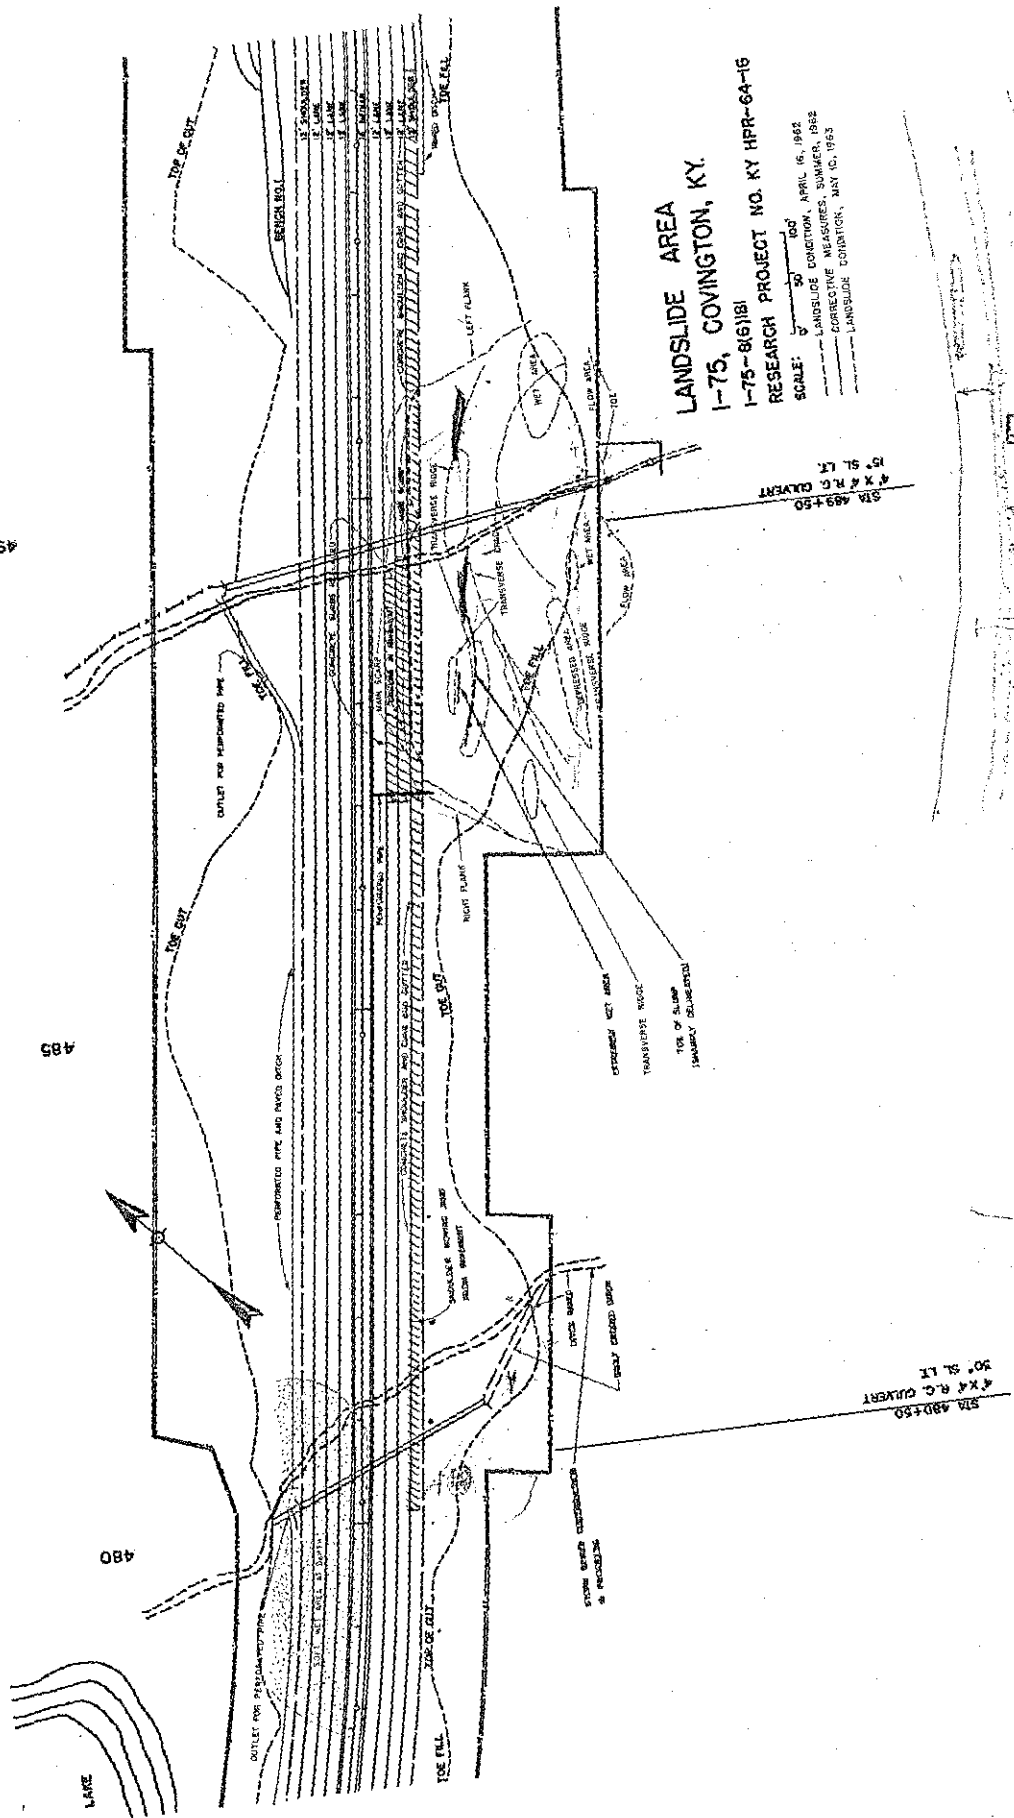
Fig. 1. Plot Plan of Landslide Area.

A site plan of the general area of earth movement is shown in Figure 1. The details shown in black in this figure represent features that were being constructed or had been constructed at the time the first earth movement was noted.

APRIL 16, 1962 --- The site was again visited by Research Division personnel on this date. The conditions noted to exist at this time are indicated by dashed red lines in Figure 1. Figures 3, 4 and 5 were taken in the immediate vicinity of Station 487 where the major distress was observed. In Figure 3 the sag in the pavement shows that the base has dropped away from the concrete slab and is no longer providing support. This sag can also be seen in Figure 4. Figure 5 shows very clearly that the DGA base is no longer providing support for the slab. In Figures 3 and 4 the distorted line of guard rail posts also indicate large movements. It should be noted in Figure 3 that the embankment slope outside the bituminous shoulder had been covered with a heavy clay preventing the DGA base from draining.

MARCH 25-28, 1963 --- Personnel of the Research Division were on the site and the conditions noted at this time are indicated in green in Figure 1. The following is a list of conditions found to exist at this time and some of the maintenance and exploratory work that was done during these few days.

4. Several areas of seepage water outcropping on the slope of the embankment, as indicated in Figure 1, were noted.

SUMMER, 1962 --- During the summer of 1962 certain measures were taken to attempt to repair the damage that had been done by the landslide and to prevent further movement. The measures are indicated by solid red lines in Figure 1 and are listed below:

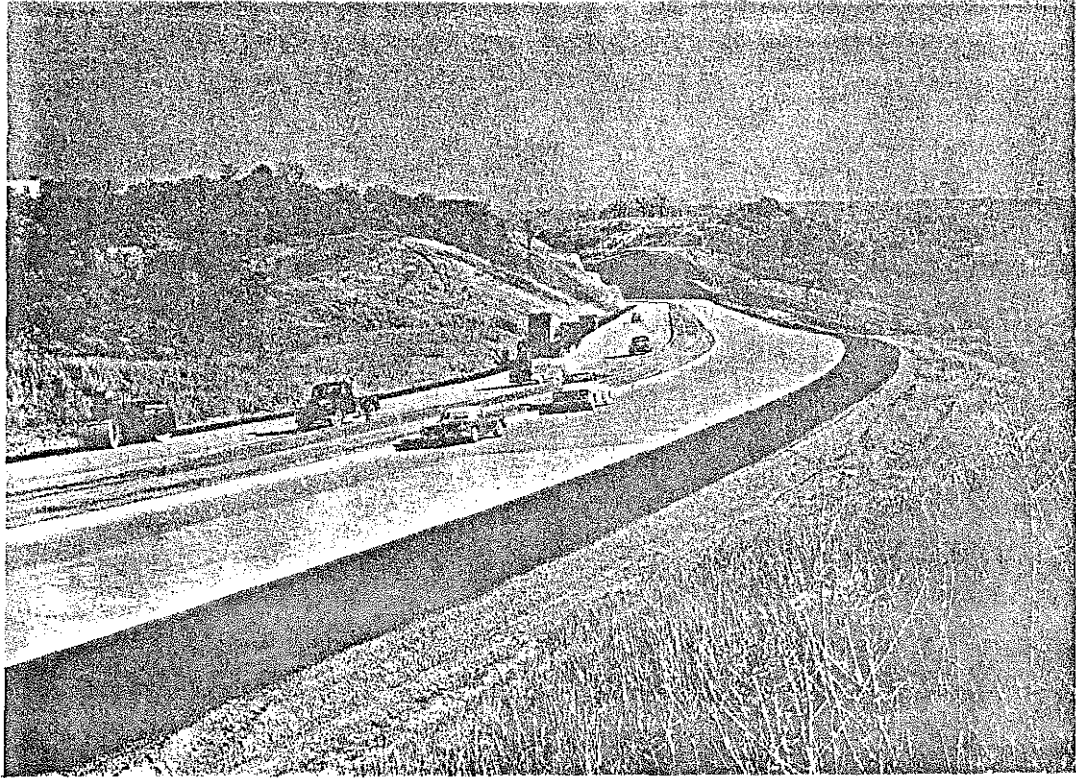
OCTOBER 27, 1961 --- Personnel of the Division of Research had visited the general area in which the landslide later developed on October 27, 1961. The photograph shown in Figure 2 is a general view of the area at this time. It can be seen that driving lanes had been completed by this time and that the paving of the shoulders with bituminous concrete was well underway. It was also noted that the median strip had just been filled with a fine silty sand to a depth of three to seven feet.

Fig. 2. General View of Landslide Area on October 27, 1961.

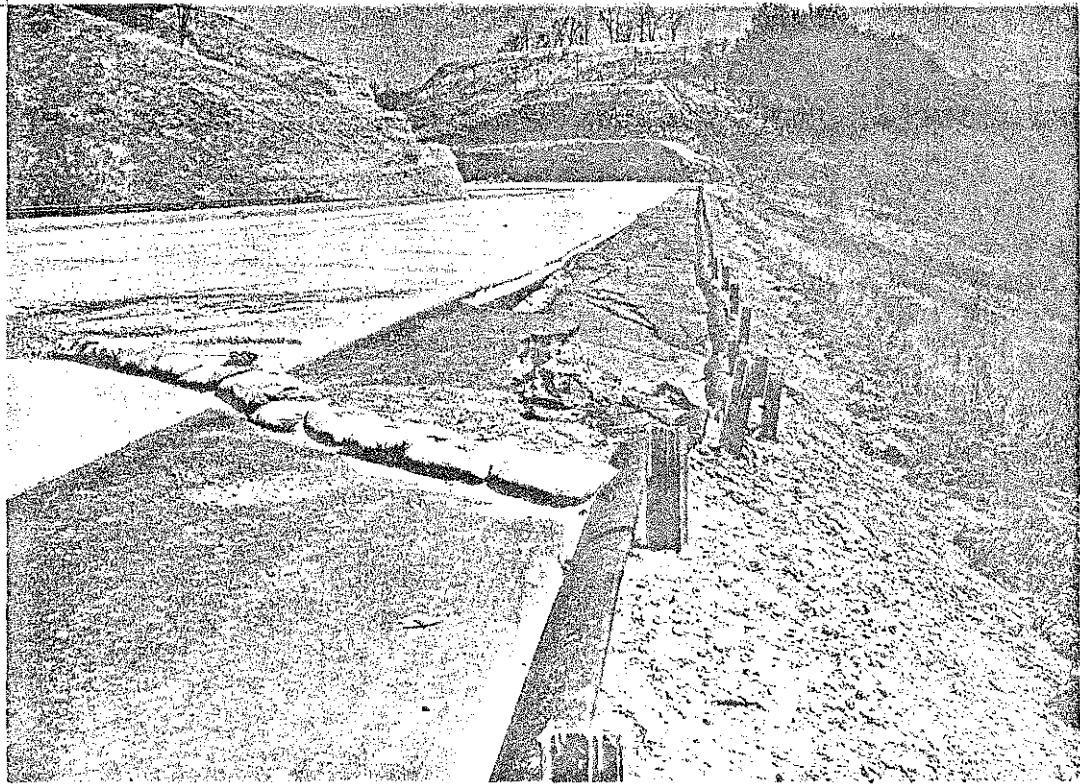
Fig. 3. Area of Major Distress (Looking North), April 16, 1962.

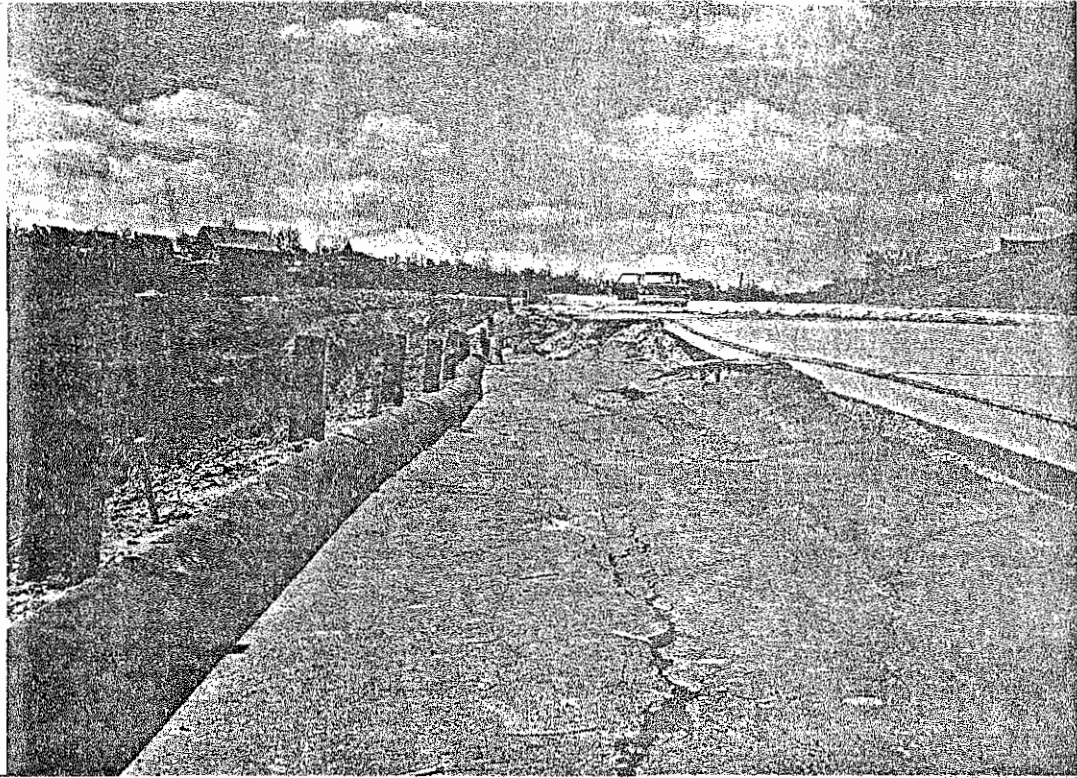
Fig. 4. Area of Major Distress (Looking South), April 16, 1962.

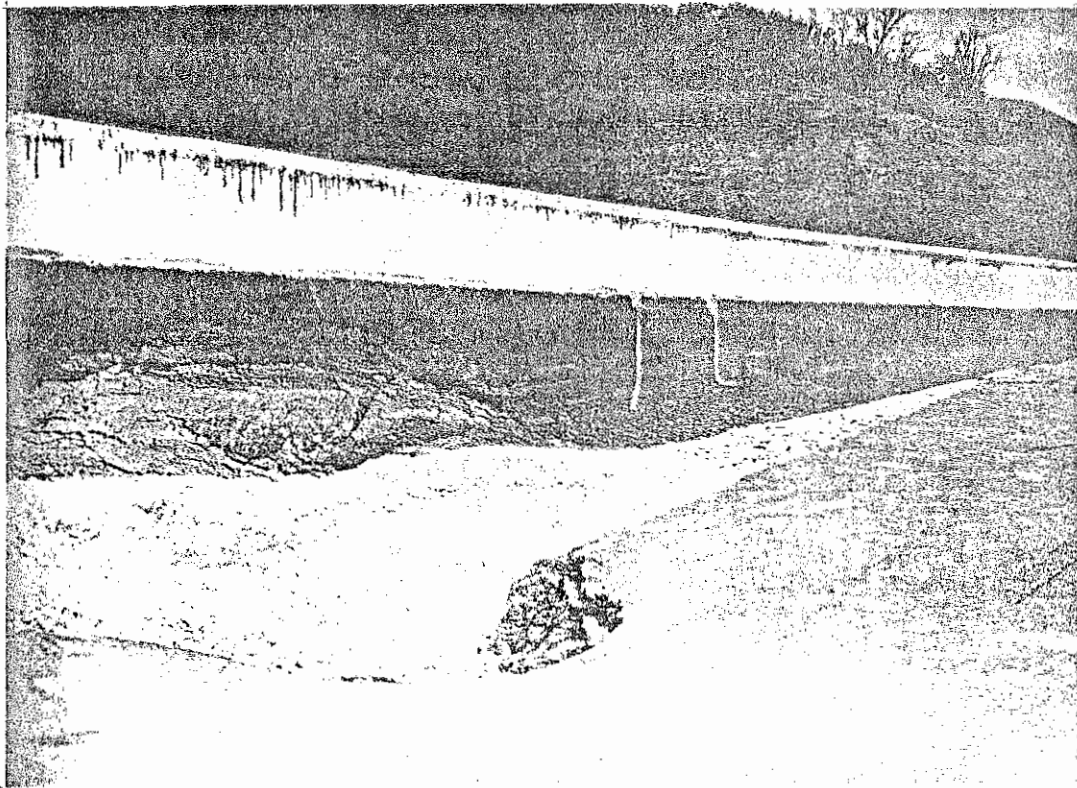
Fig. 5. DGA Base That Has Dropped Away from the Slab, April 16, 1962.

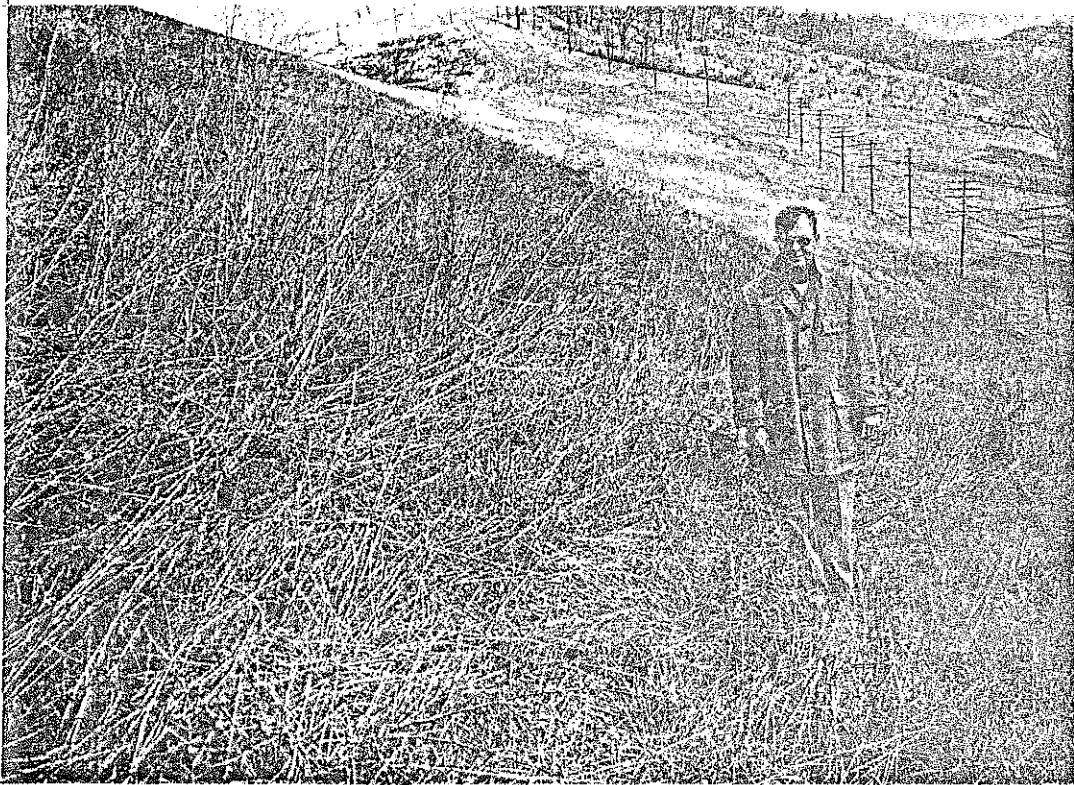
The area of movement extended over a length of approximately 450 feet from about Station 486+50 to 491+00. In Figure 6 an attempt is made to show that the toe of the slumped mass had moved out and over the embankment a distance of approximately two feet. The roll of soil over the embankment was about one foot high.

Fig. 6. Toe of Slump Indicating a Roll of Material of About One Foot, April 16, 1962.

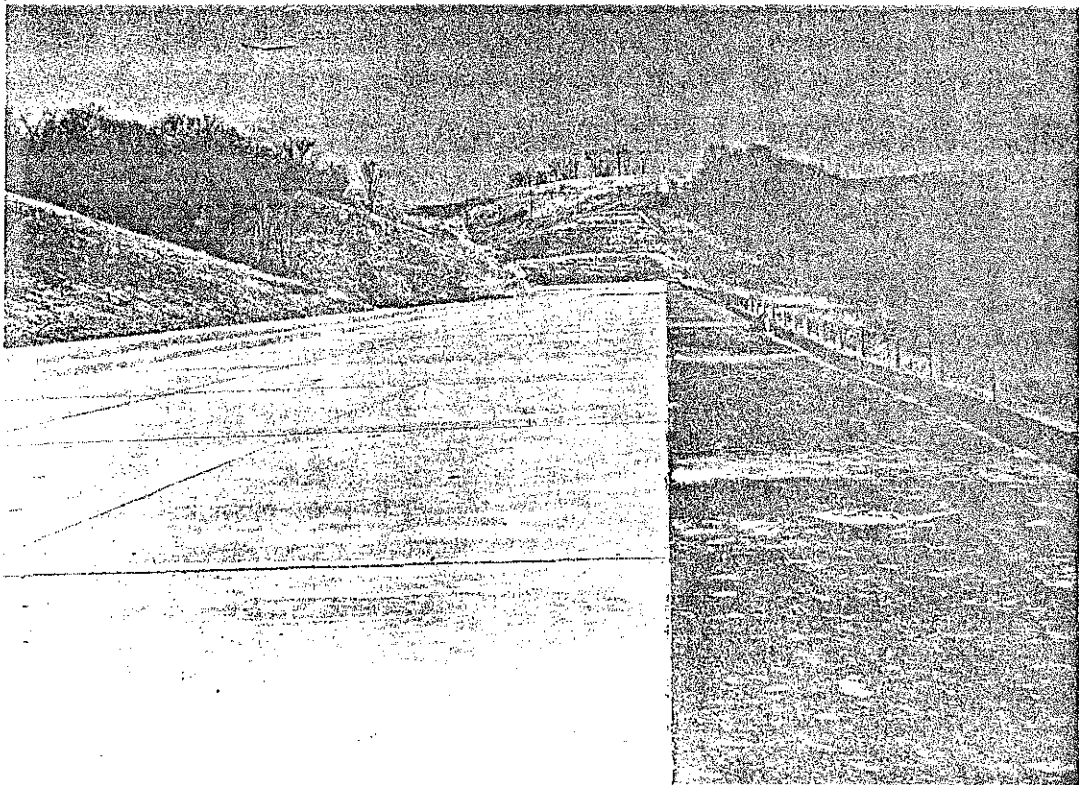
A second slide of less severe nature had started to develop near Station 482. Figure 7 shows that the shoulder had already started to move down and away from the concrete pavement. The slope of the embankment in this area had been badly eroded (see Figure 8) by discharge from a 4-foot by 4-foot box culvert that passes beneath I-75.

Fig. 7. Area of Minor Slide, April 16, 1962.

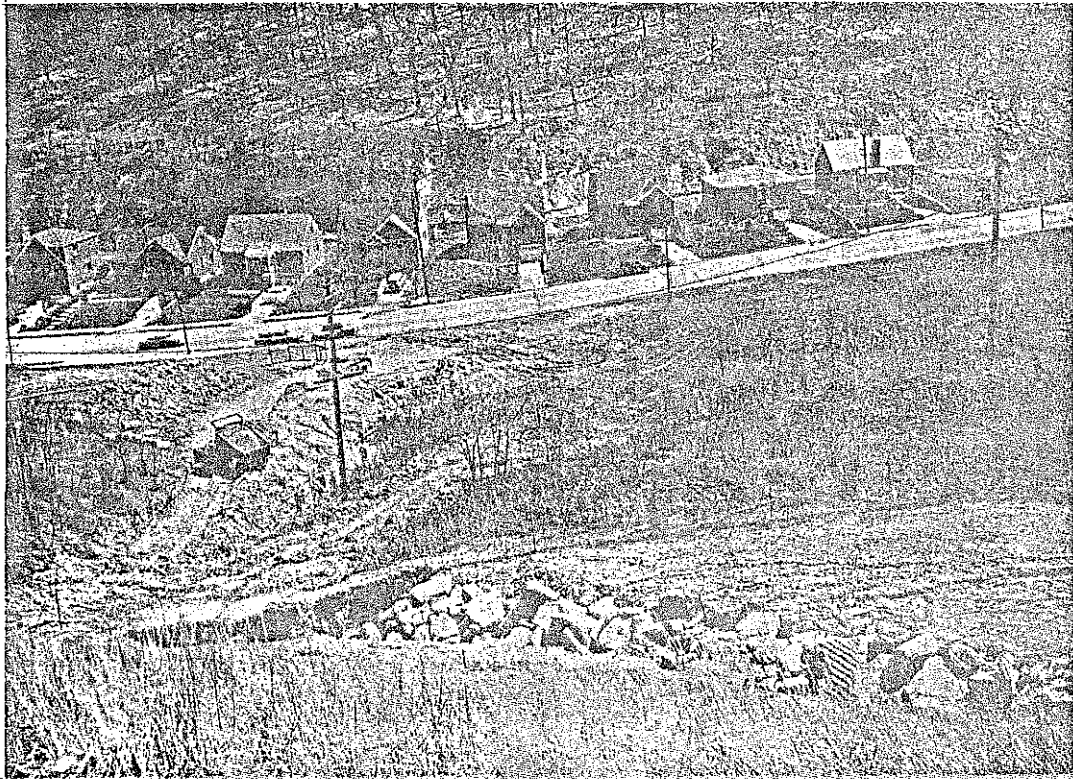
Fig. 8. Embankment Slope in Area of Minor Slide, April 16, 1962.

6. The badly eroded ditch shown in Figure 8 was paved (see Figure 9).

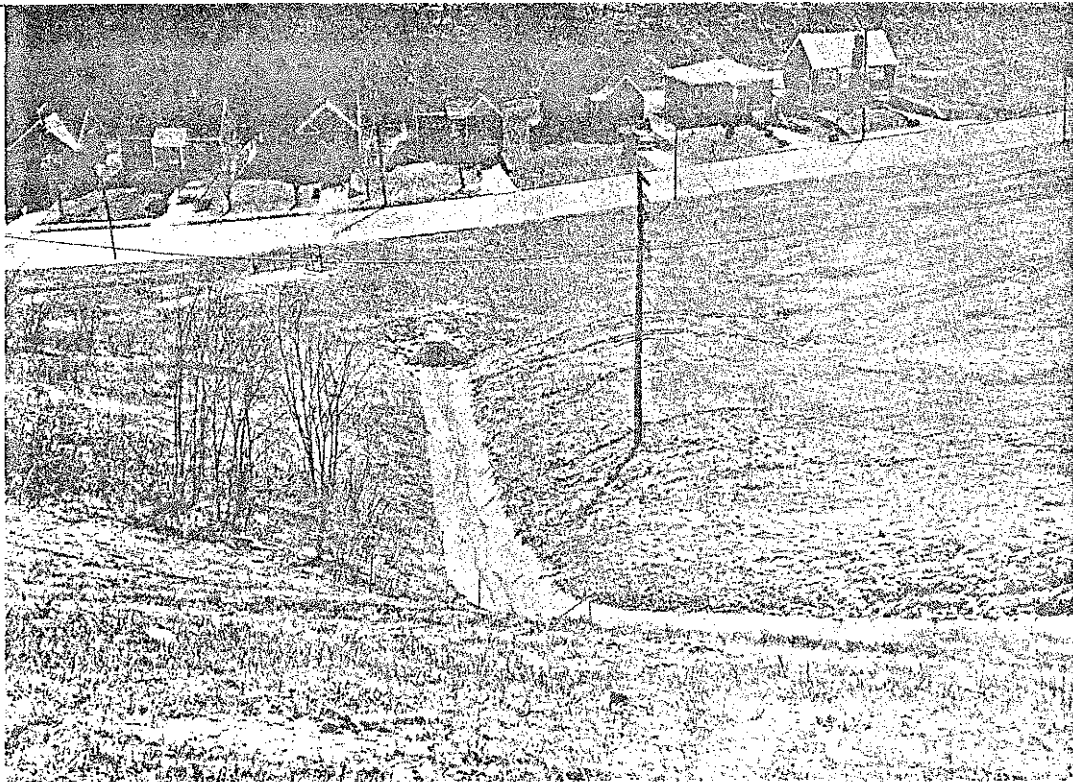
Fig. 9. Embankment Slope Shown in Figure 8. Note That Ditch Had Been Paved. Photograph Taken March 27, 1963.

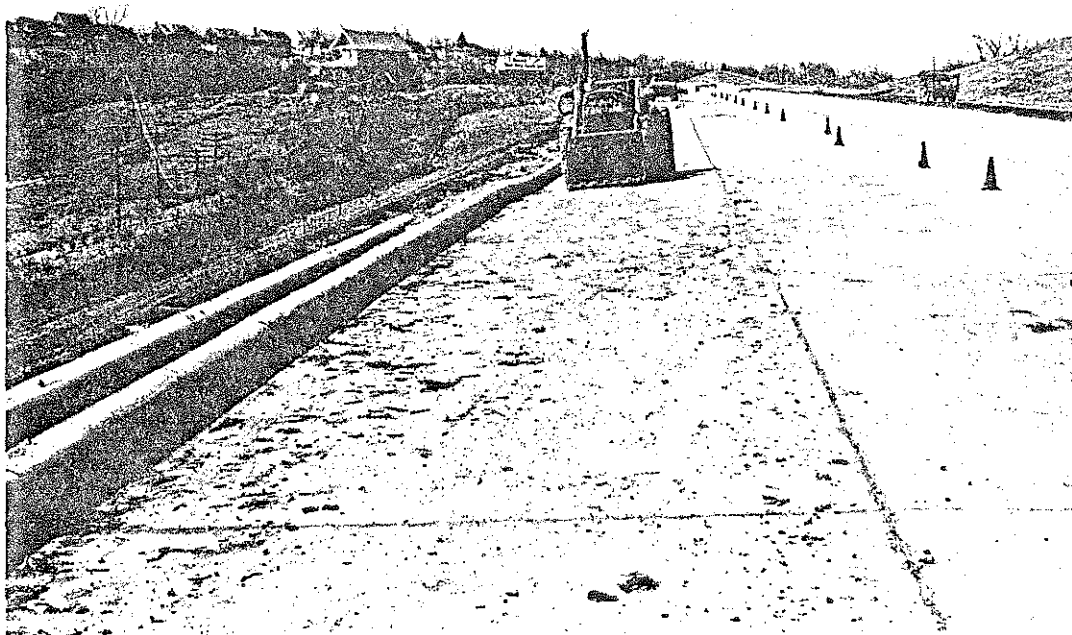
1. Figures 10, 11, and 12 show the condition of the pavement in the area between Stations 486+50 and 491+00. The views in Figures 10 and 11 are somewhat restricted and show the extent to which the concrete shoulder had dropped between Stations 486+50 and 489+10. Figure 12 not only shows the area of major movement to the right of the photograph but also shows the slight dip of the pavement where men are standing near Station 489+75 to 491+00. Figure 13 is a close up view showing the embankment pulled down and away from the gutter.

Fig. 10. Slide Area on March 27, 1963 (Looking South).

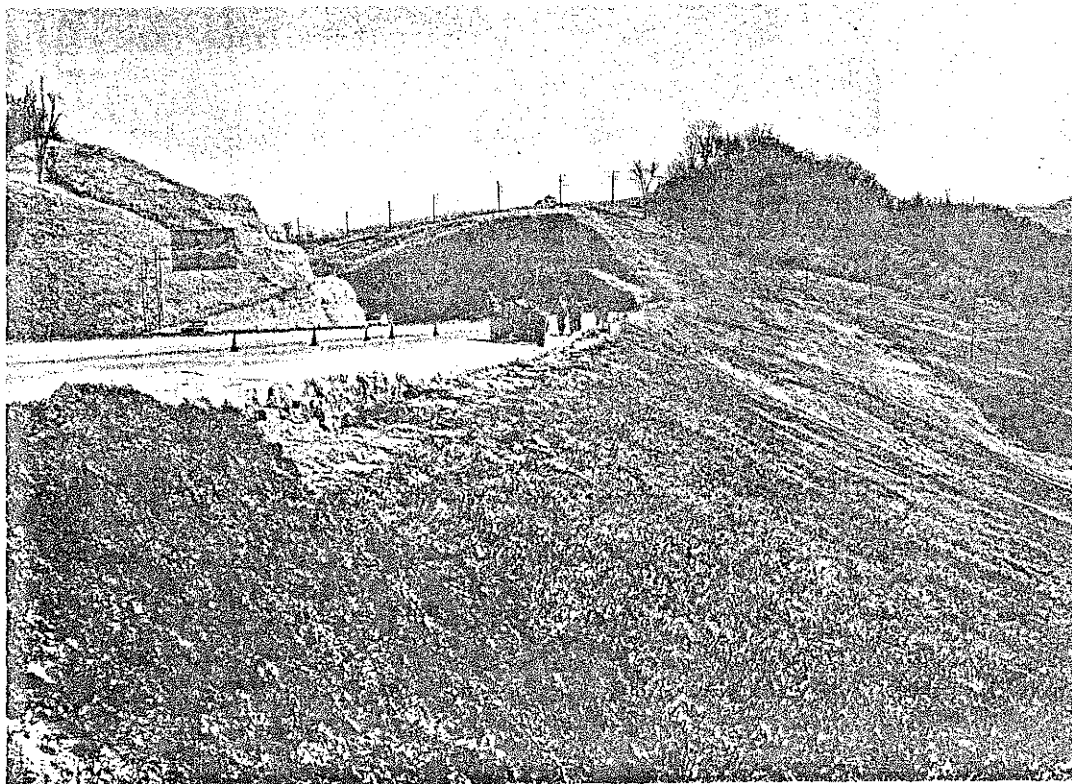
Fig. 11. Slide Area on March 27, 1963 (Looking North).

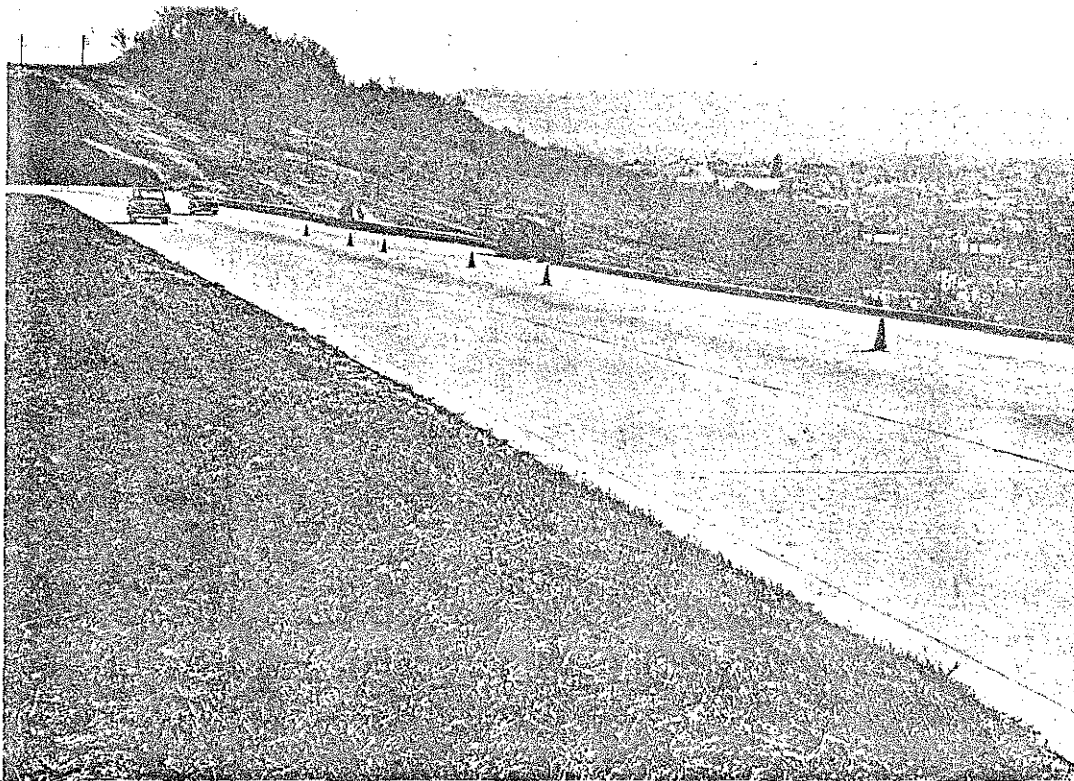
Fig. 12. Slide Area on March 27, 1963 (Looking Northeast).

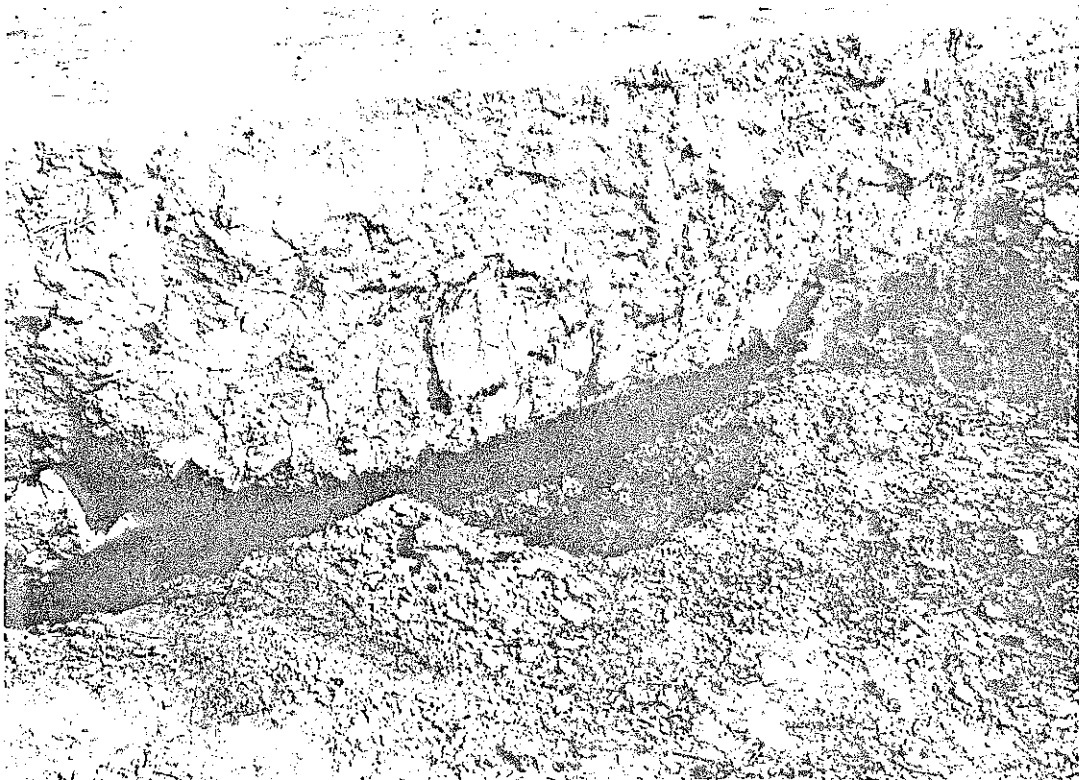
Fig. 13. Close Up Showing Embankment Pulled Down and Away From the Concrete Gutter, March 27, 1963.

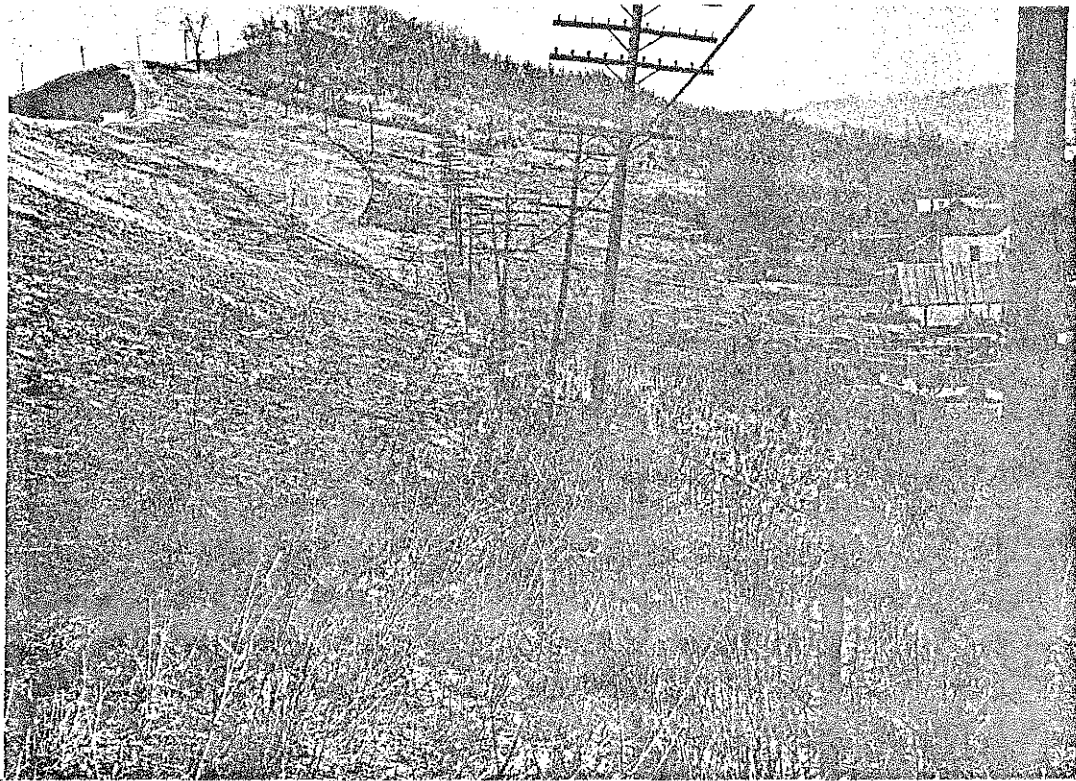
2. Beyond the toe of the embankment, out on original ground which was not disturbed during construction, there were indications of deep-seated movement as manifested by distorted and tilted fence and telephone lines (see Figure 14).

Fig. 14. Area of Toe of Embankment Showing Distorted Telephone and Fence Lines, March 27, 1963.

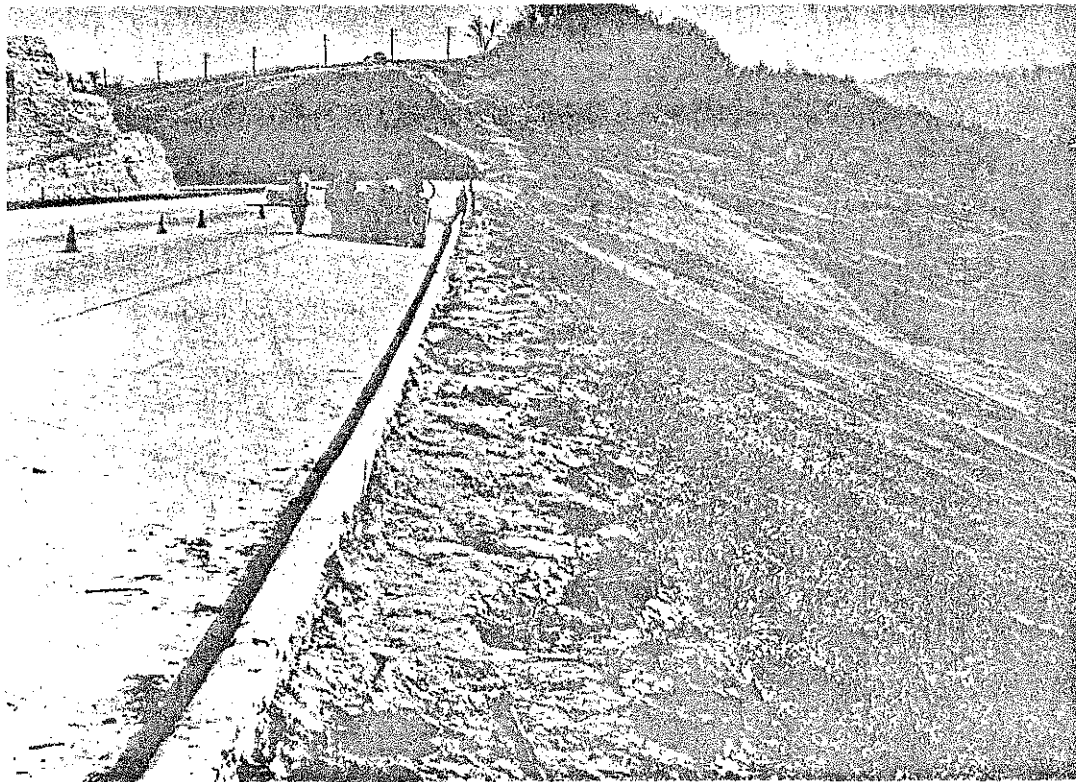
Fig. 15. Timber Piles and Clay Fill Between Piles and Shoulder, March 27, 1963.

3. A group of 44 timber piles 25 to 32 feet long were driven vertically just outside the shoulder between Stations 487+50 and 489+75. The zone between the piles and the shoulder was backfilled with a clay (see Figure 15). This work was done on March 25-27, 1963.

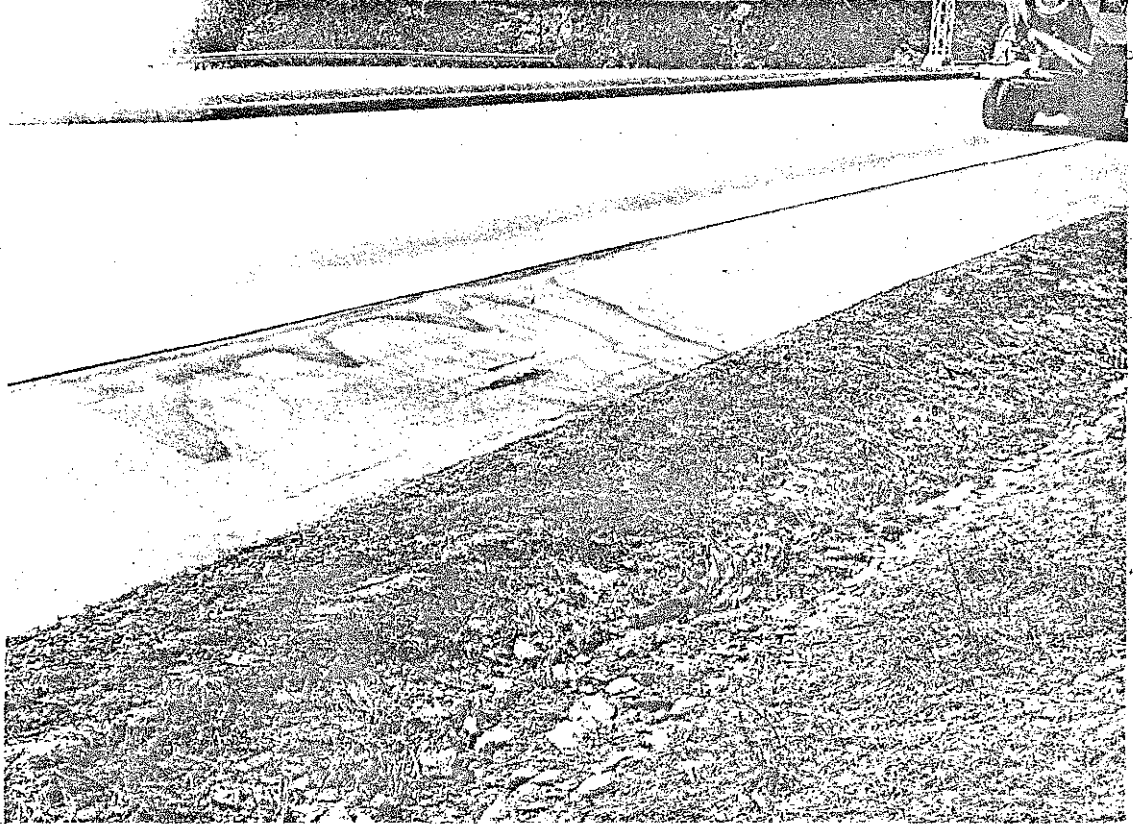
9. A situation that was rather common between Stations 467+00 and 487+75 and between Stations 491+70 and 507+00 is illustrated in Figure 16. Significant amounts of water were observed to be flowing through the joint between the shoulder and the pavement in the south-bound lanes.

Fig. 16. Water Flowing Through the Joint Between the Shoulder and
and Pavement, March 27, 1963.

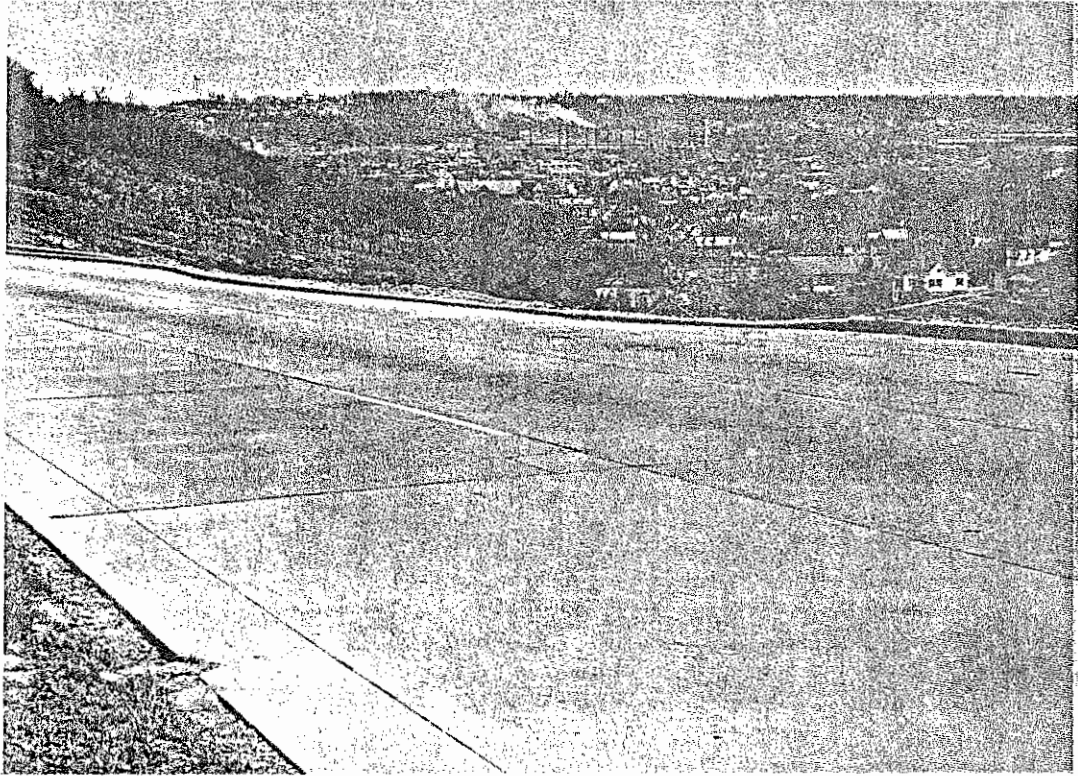
APRIL 2, 1963 --- The site was visited again and conditions were very much the same as on March 28. The water level in some drill holes had risen slightly. Figures 17 and 18 illustrate the condition of the pavement and shoulder on this date. Water was still flowing through the joint between the shoulder and the pavement (see Figure 19).

Fig 17. Slide Area on April 2, 1963 (Looking Northeast).

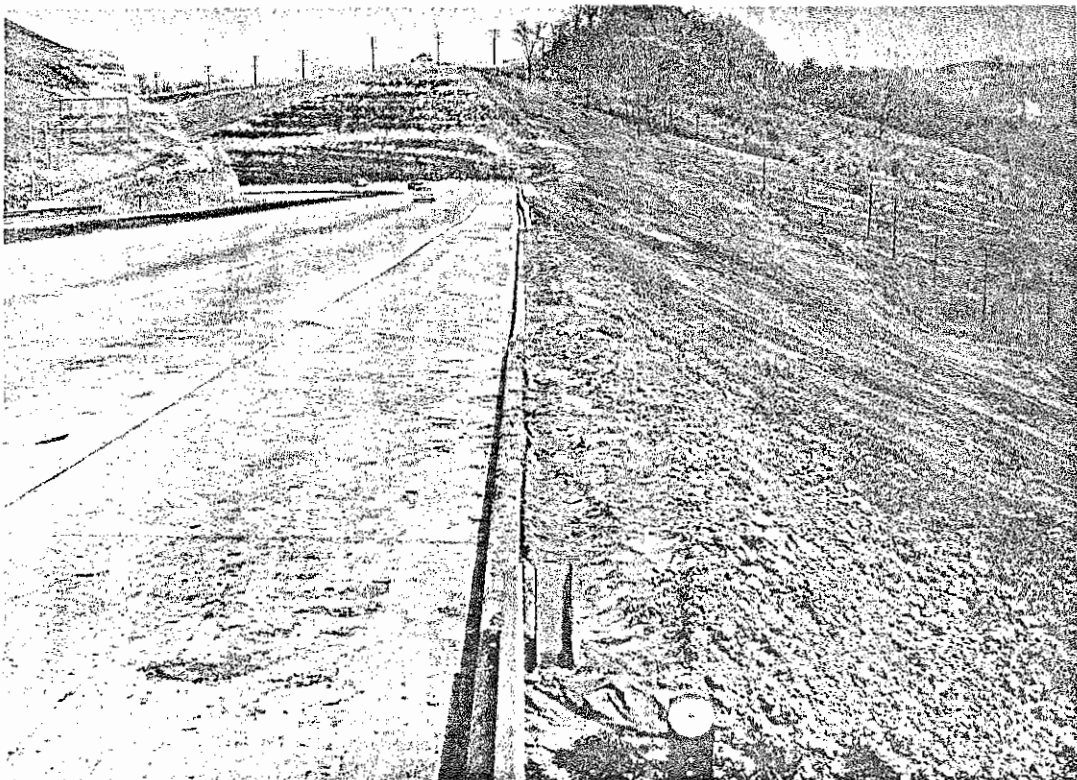
Fig. 18. Slide Area on April 2, 1963 (Looking North).

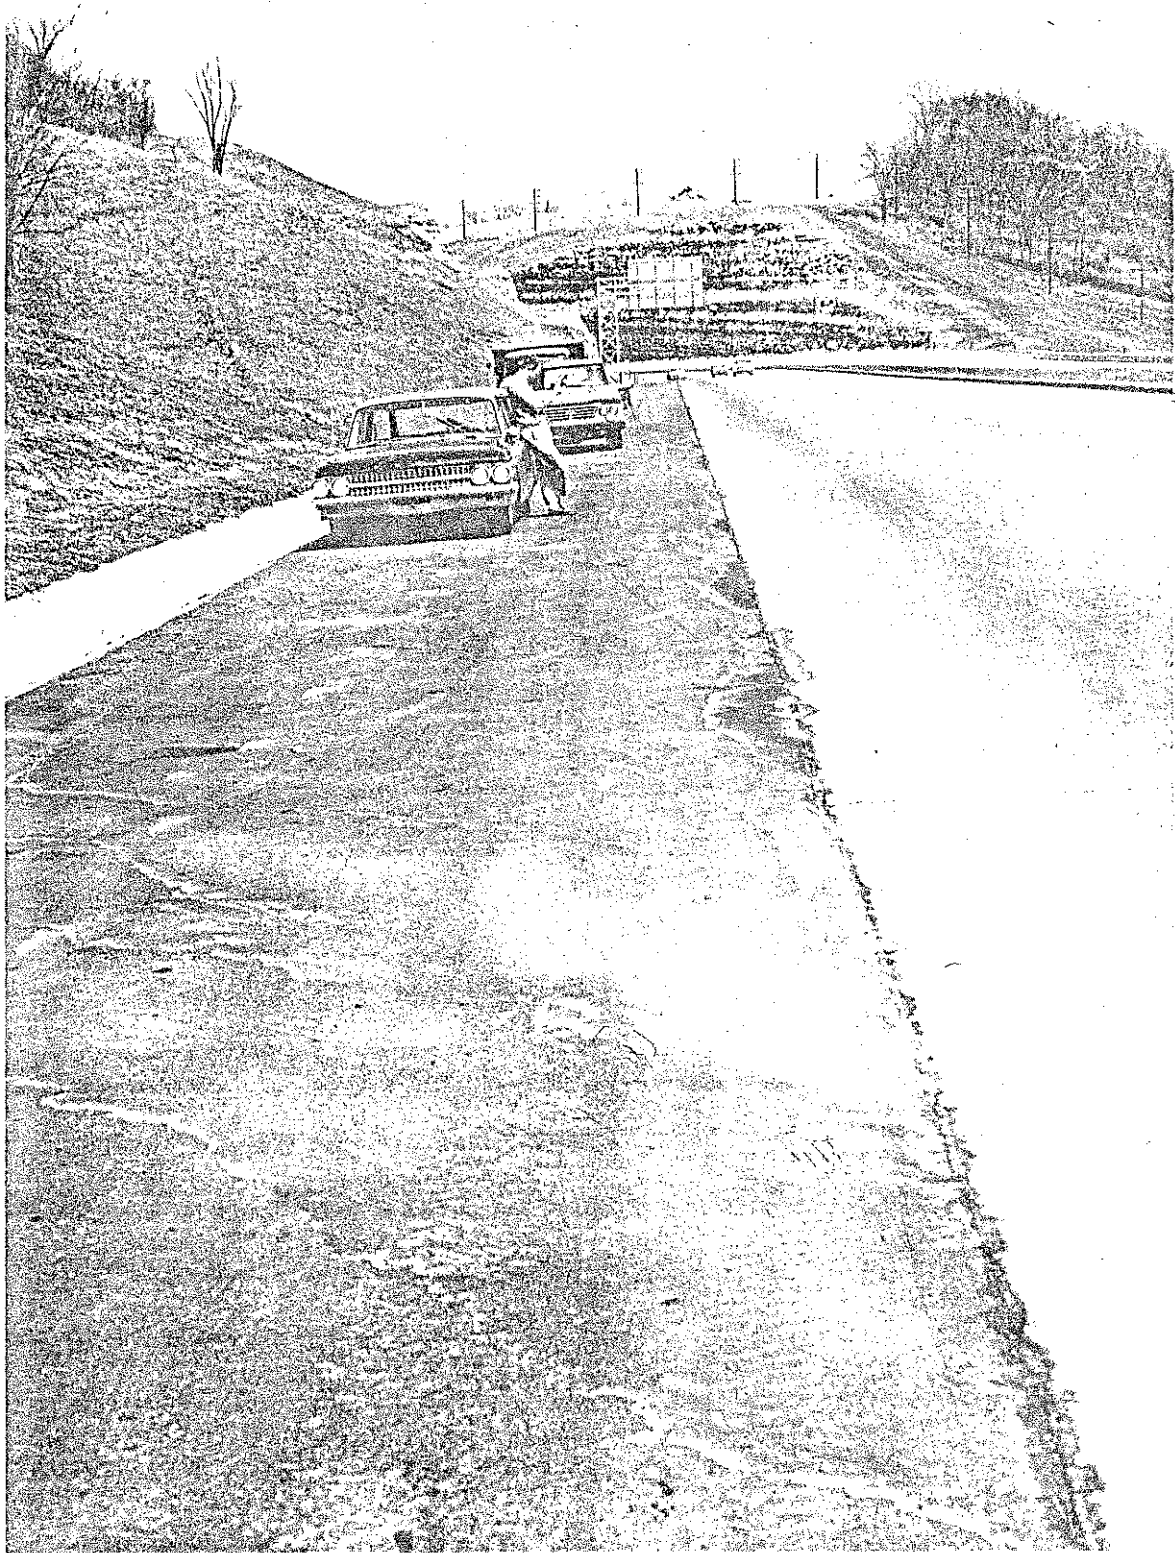
Fig. 19. Water Flowing Through the Joint Between the Shoulder and Pavement, April 2, 1963.

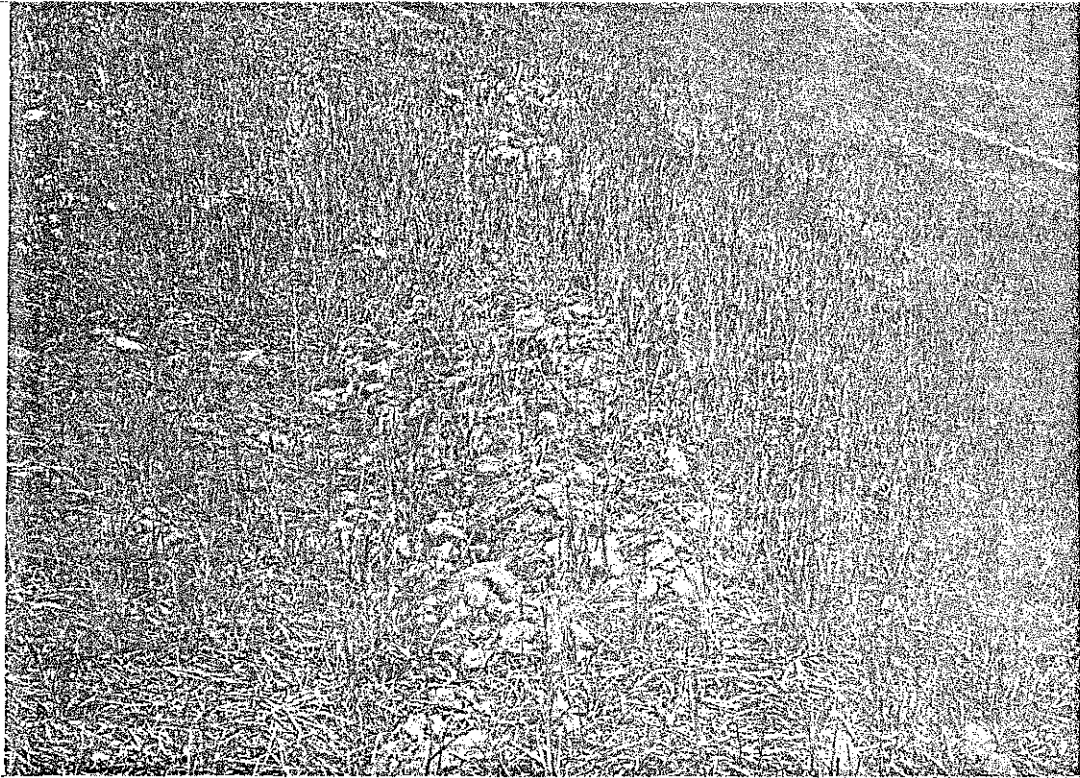
APRIL 25, 1963 --- During the week before this date, the concrete shoulder between Station 487+00 and Station 491+25 had been removed and replaced with sand and dense graded aggregate. It was also evident that some additional movement had occurred since April 16. Very pronounced transverse ridges and cracks had become quite evident (see Figures 20, 21 and 22). The right flank of the slide area had also become very prominent (see Figure 23). At the toe of the embankment there were several extremely wet areas (see Figure 24). Some of the embankment had apparently flowed out over the original ground.

Fig. 20. Transverse Ridge on Embankment Slope, April 25, 1963
(Looking North).

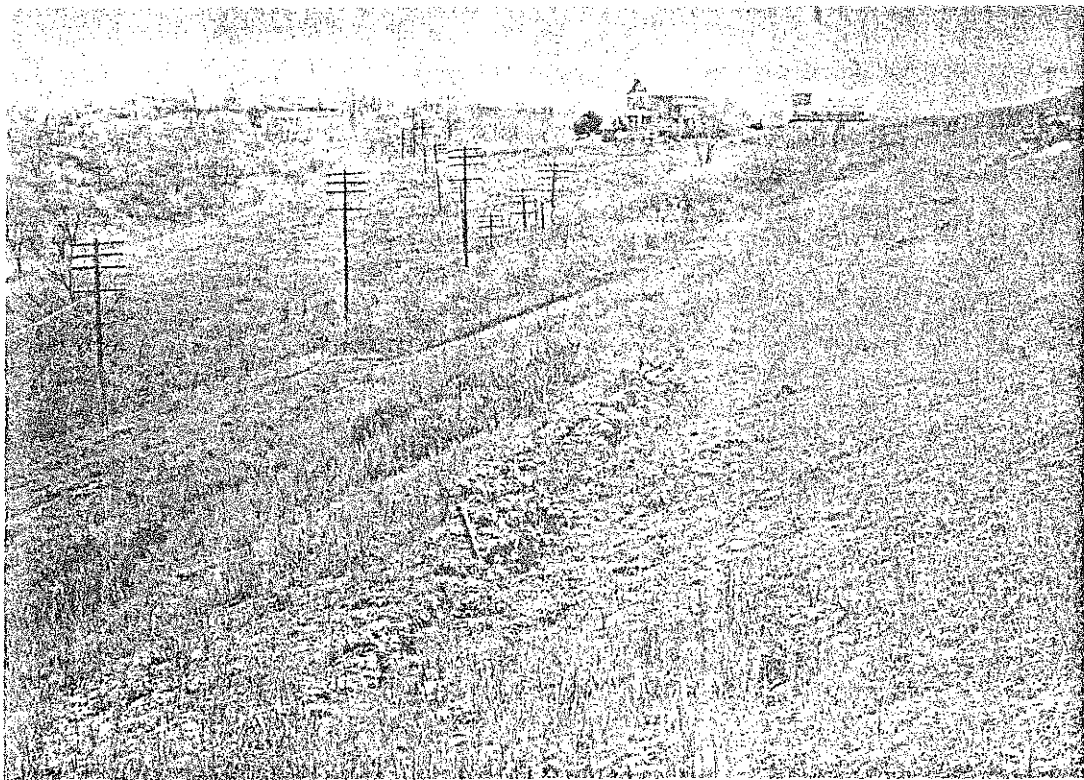
Fig. 21. Transverse Ridge and Crack on Embankment Slope,
April 25, 1963 (Looking South).

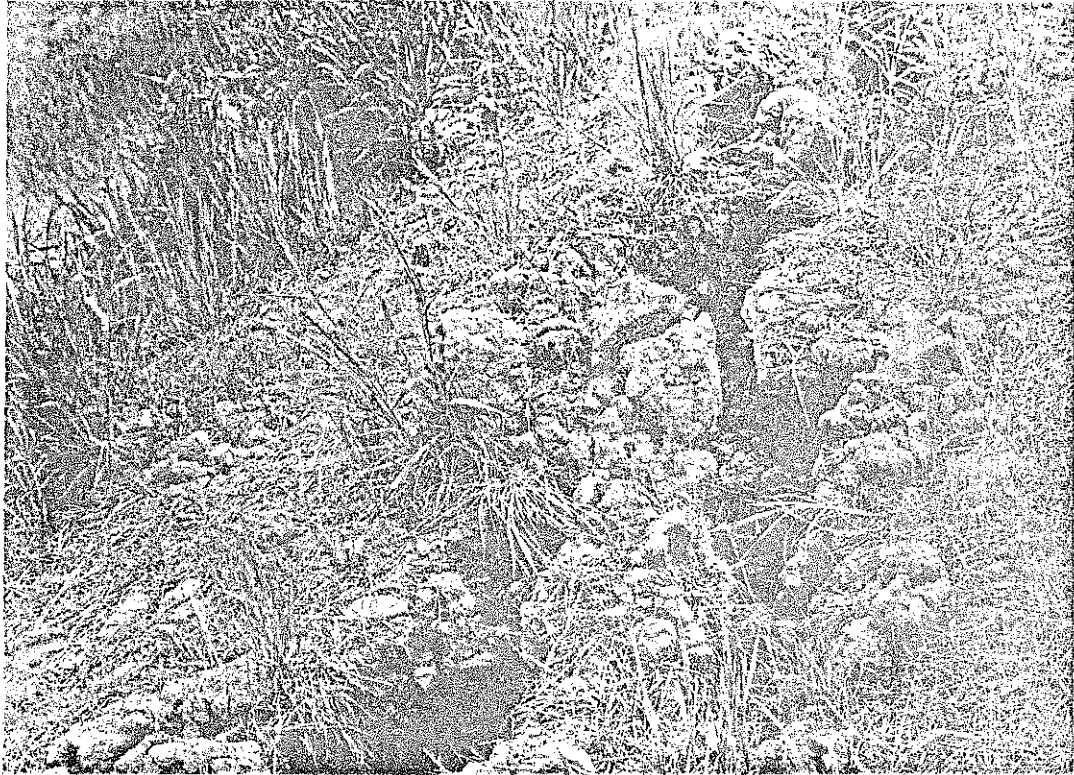
Fig. 22. Close Up of Transverse Crack, April 25, 1963.
