STATUS REPORT
ON
LANDSLIDE AREA
on
I-75, Covington, Kentucky

A Slide Area Being Studied
As Part of Research Project

DEVELOPMENT OF A PRACTICAL METHOD
OF LOCATING AND TRACING SEEPAGE
WATER IN UNSTABLE SLOPES

May 15, 1963

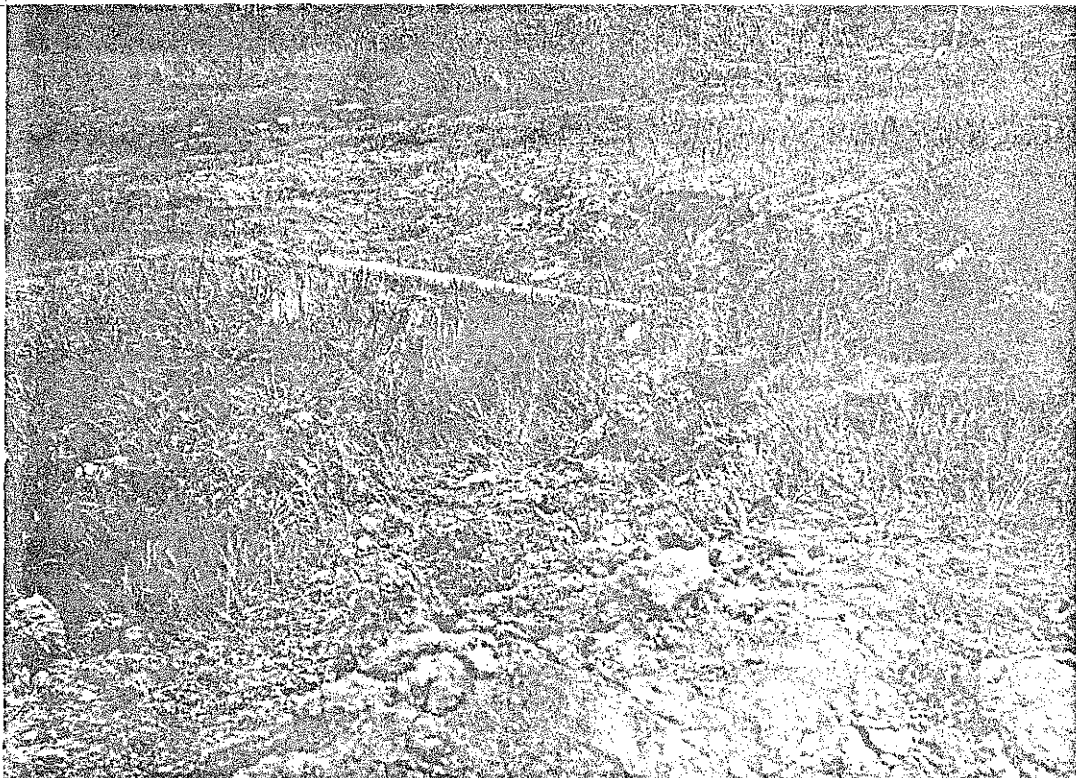
APRIL 25, 1963 --- During the week before this date, the concrete shoulder between Station 487+00 and Station 491+25 had been removed and replaced with sand and dense graded aggregate. It was also evident that some additional movement had occurred since April 16. Very pronounced transverse ridges and cracks had become quite evident (see Figures 20, 21 and 22). The right flank of the slide area had also become very prominent (see Figure 23). At the toe of the embankment there were several extremely wet areas (see Figure 24). Some of the embankment had apparently flowed out over the original ground.

Fig. 23. Right Flank of Slide Zone, April 25, 1963.

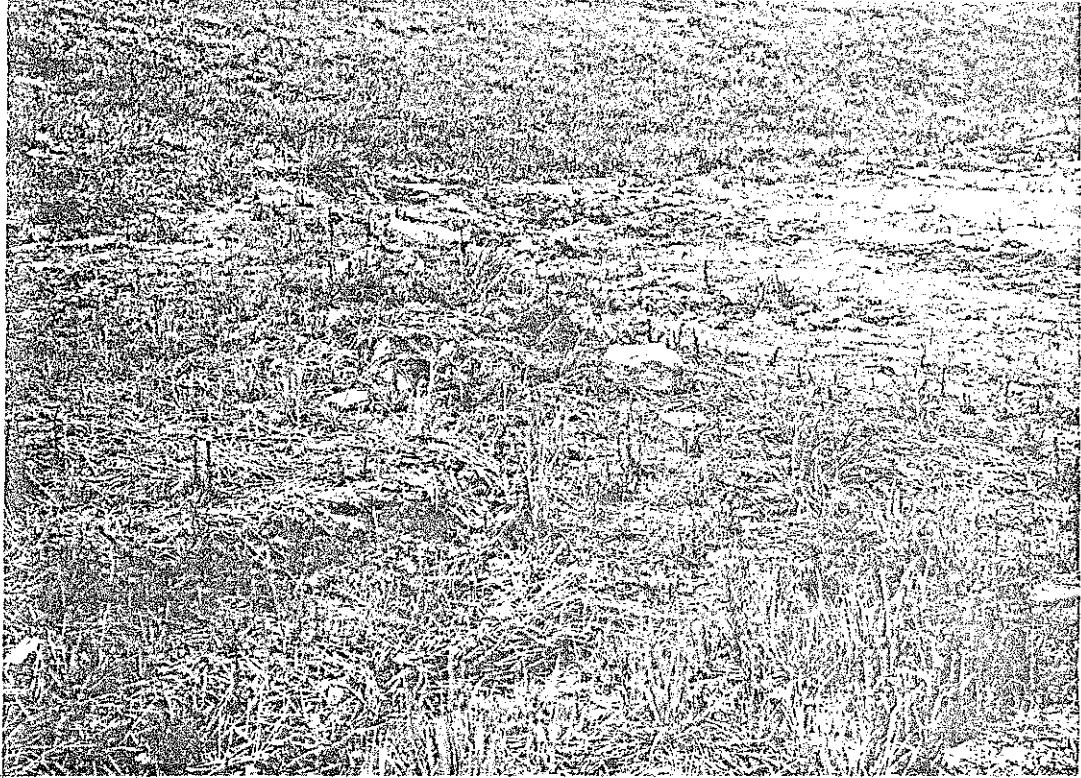
Fig. 24. Wet Area at Toe of Embankment Showing Slight Soil Flow, April 25, 1963.

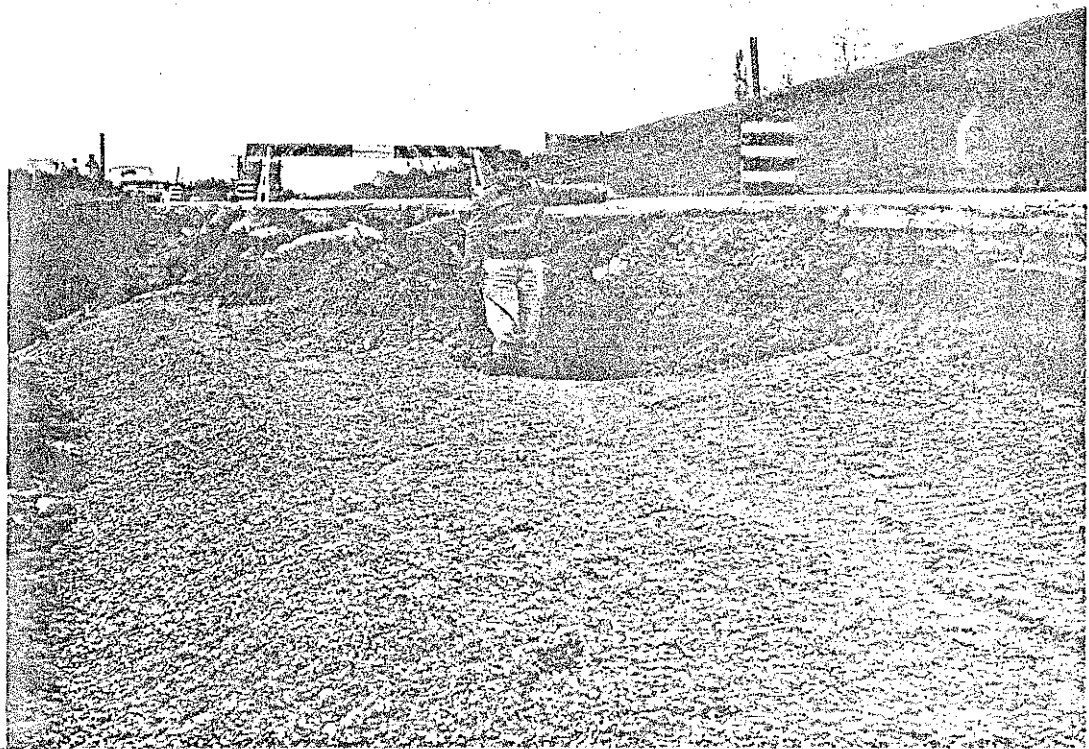
The shoulder of the roadway had dropped three to four feet (see Figure 25) and the main scarp of the slide was located some four to six feet back under the outside driving lane (see Figure 26). The escarpment at the right flank of the slide area had become more pronounced (see Figure 27.) The transverse ridges and cracks had become more prominent (see Figure 28). Figure 29 shows the condition near the toe of the embankment on this date. Note the tilted telephone poles and the discontinuity in the fence line just behind the front telephone pole. Between pole 3 and 4 a ridge of soil some four to five feet high had developed outside the right-of-way on original ground.

Fig. 25. Slide Area at Station 487+50, April 30, 1963 (Looking South).

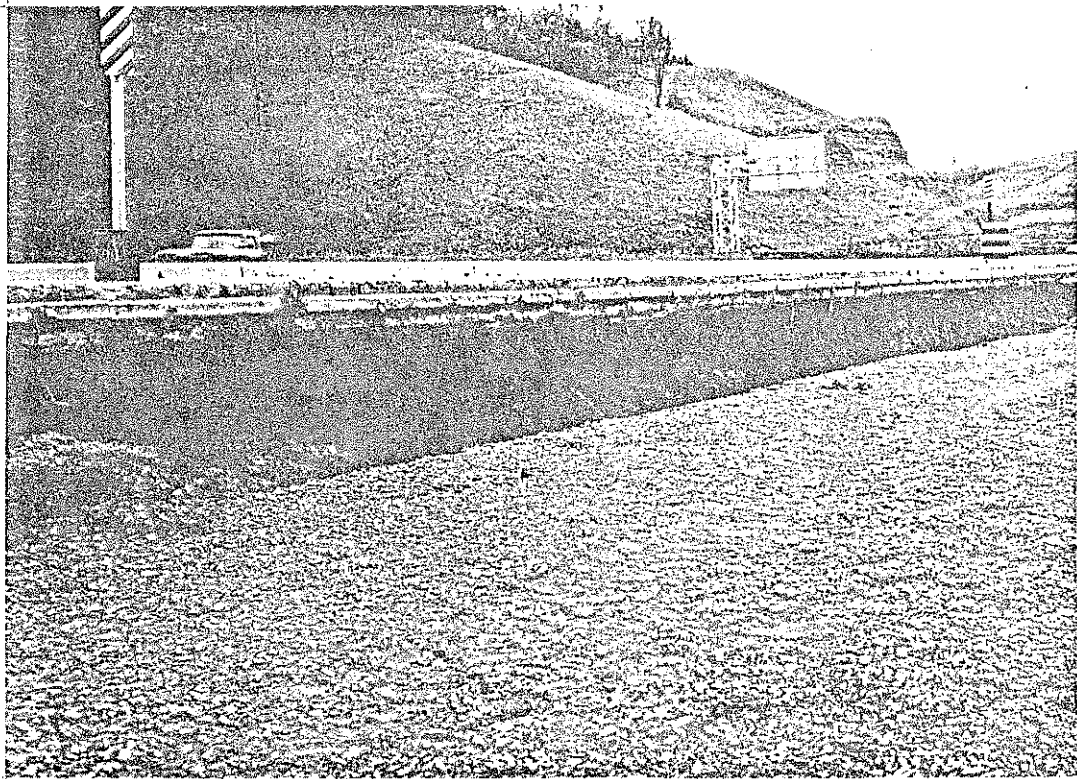
Fig. 26. Slide Area Near Station 489, April 30, 1963.

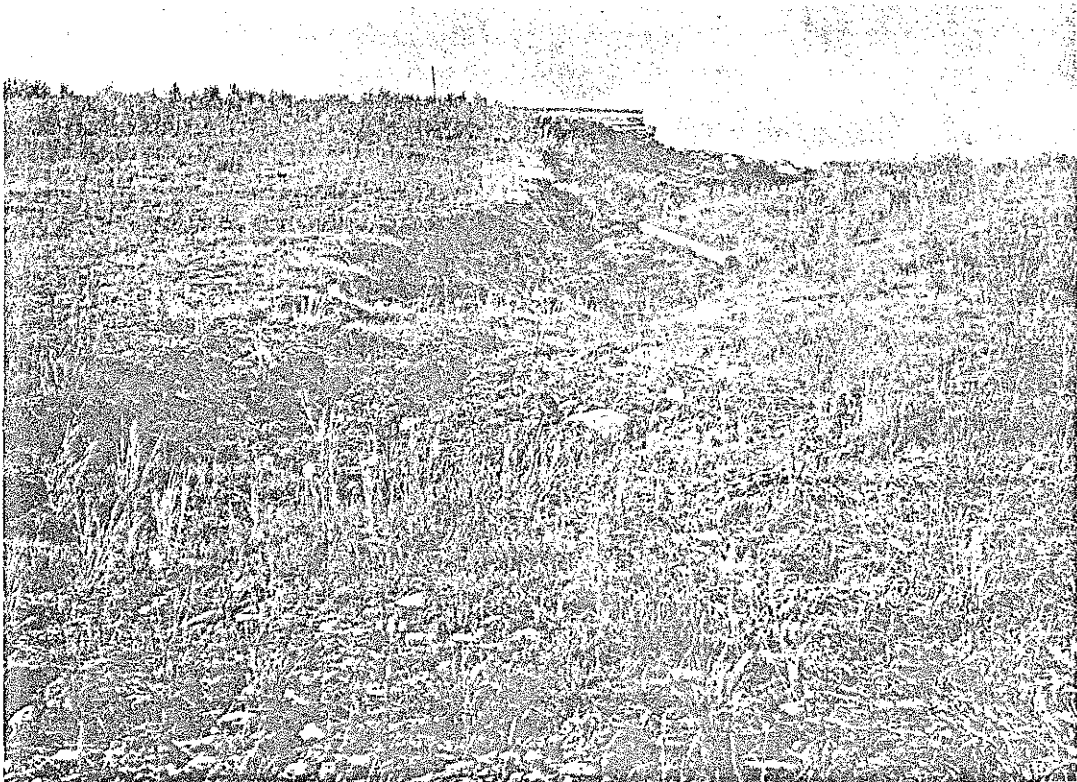
Fig. 27. Escarpment at Right Flank of Slide Area, April 30, 1963.

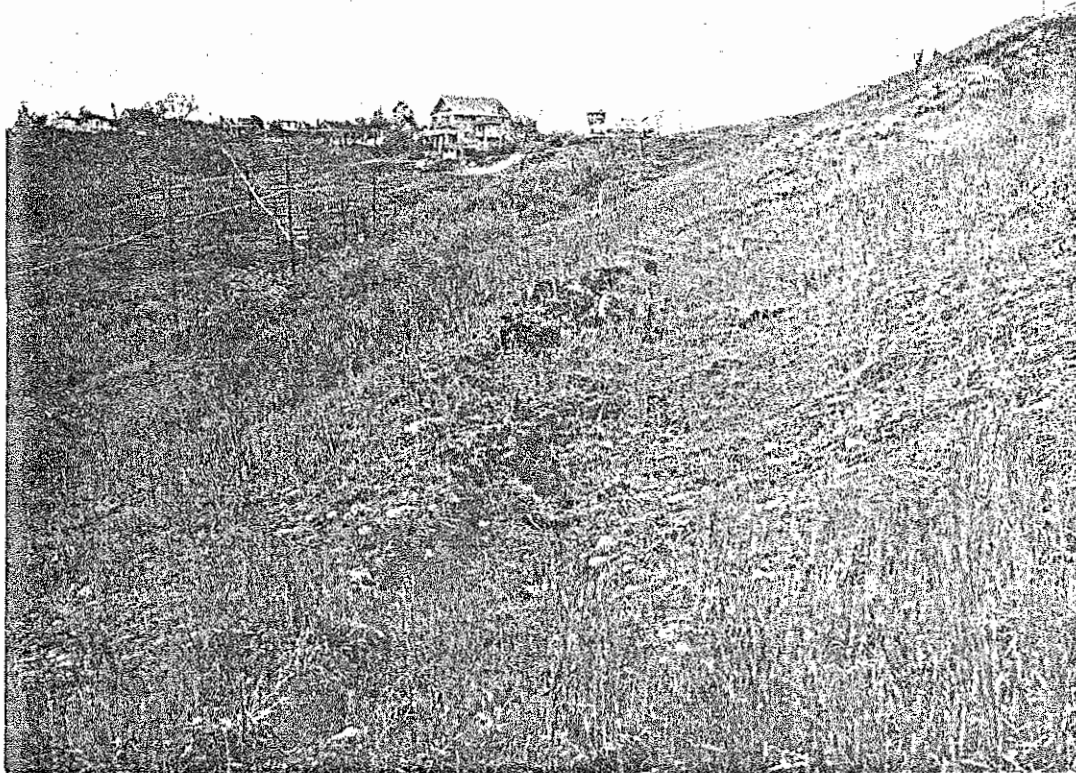
Fig. 28. Transverse Crack and Ridge, April 30, 1963 (Looking South). This Is Same View Shown in Figure 21.

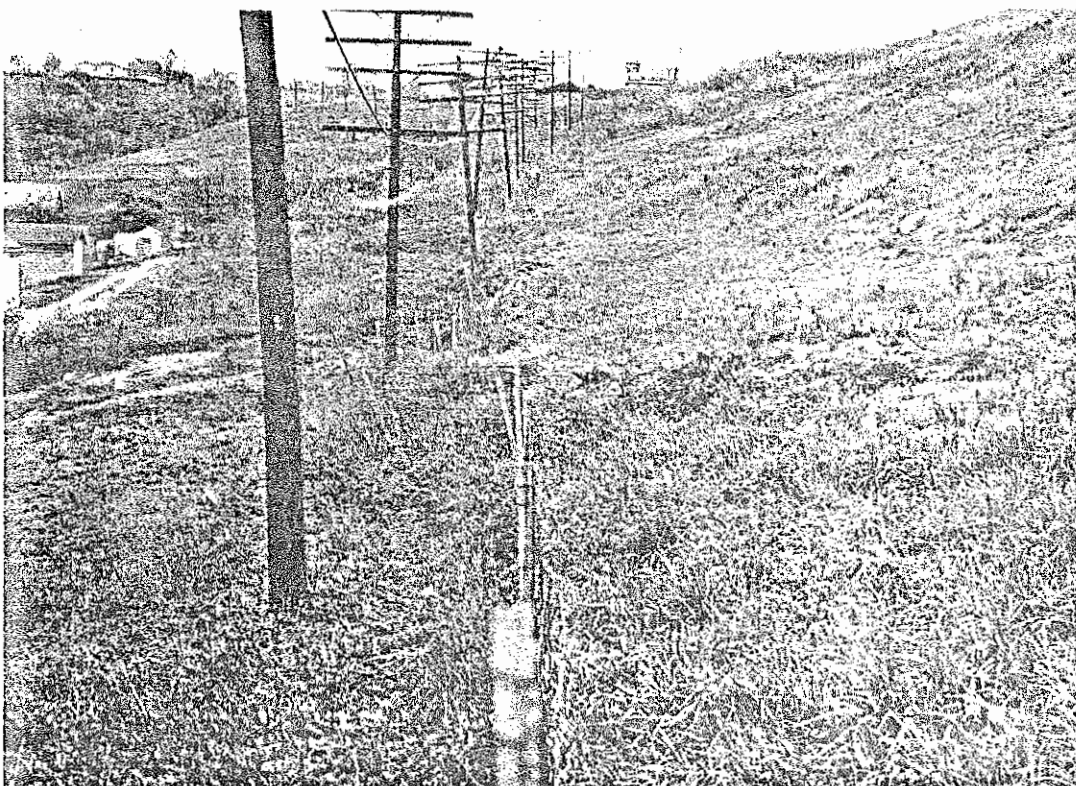
Fig. 29. Toe of Embankment in Landslide Area, April 30, 1963 (Looking South).

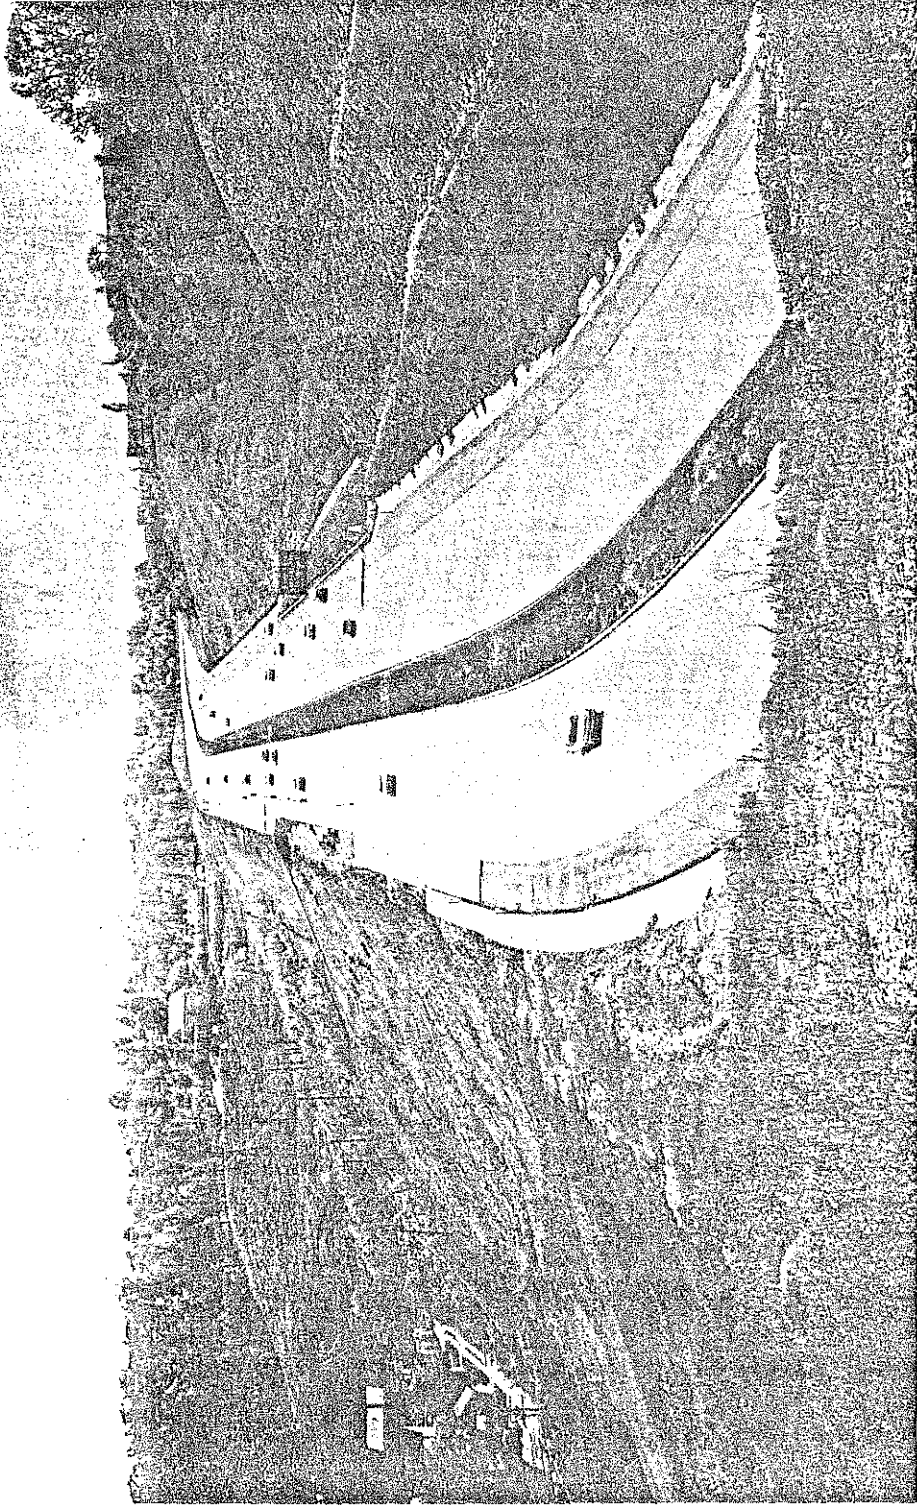
MAY 2, 1963 --- Observations indicated that movement was still occurring at this time. Figure 30 shows the general landslide area on this date.

Fig. 30. General View of Landslide on May 2, 1963 (Looking South).

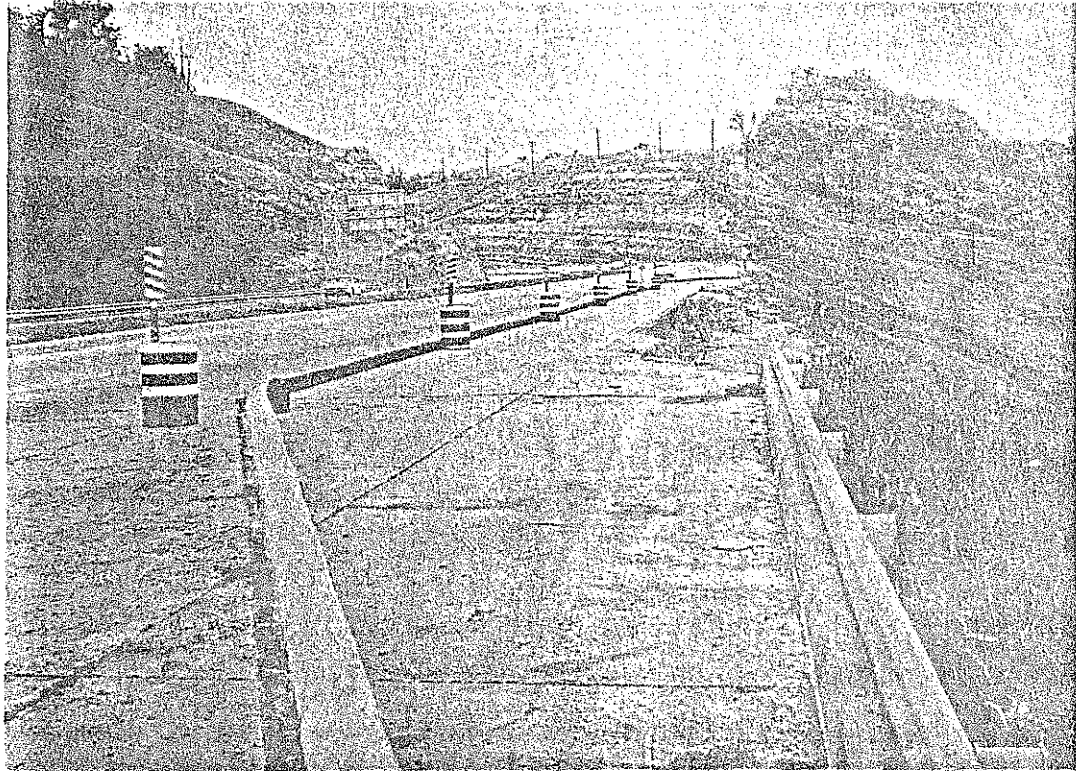
Fig. 31. Bituminous Curb To Prevent Surface Water From Spilling Over the Embankment, May 9, 1963 (Looking North).

MAY 9, 1963 --- A bituminous curb section was placed between Station 486+25 and 491+50 (see Figure 31). This work was done as a temporary measure to prevent surface water falling on the pavement from spilling over onto the embankment in the landslide area.

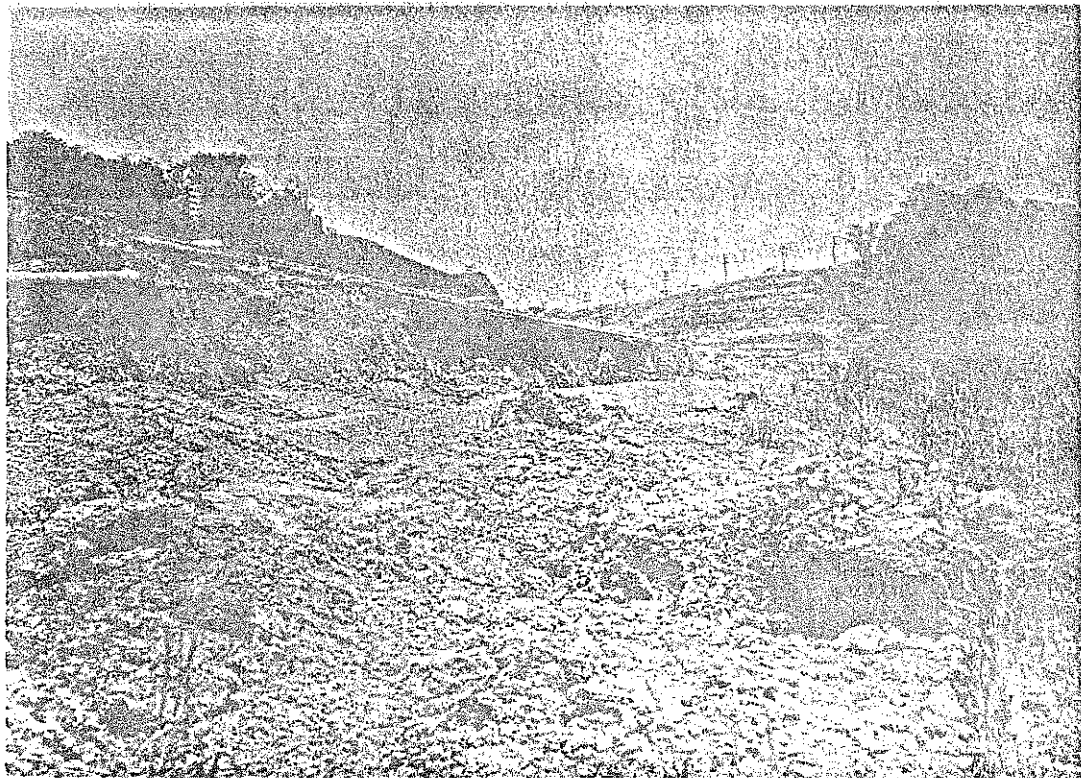
A condition at the main scarp is shown in Figure 32. In Figure 33 layers of cement grout and mudjacking material that was placed in the summer of 1962 can be seen exposed as a result of the landslide. The timber piles that had been driven near the shoulder on March 25-27, 1963, were exhibiting three distinct types of behavior. The piles near Station 488 were tilted back toward the pavement and had apparently just begun to cease moving with the embankment (see Figure 34). To the north near Station 490 the tops of the piles are exposed for some four or five feet and are tilted toward the toe of the embankment (see Figure 35). The other piles were still apparently moving with the soil mass.

Fig. 32. Main Scarp of Landslide, May 10, 1963 (Looking North).

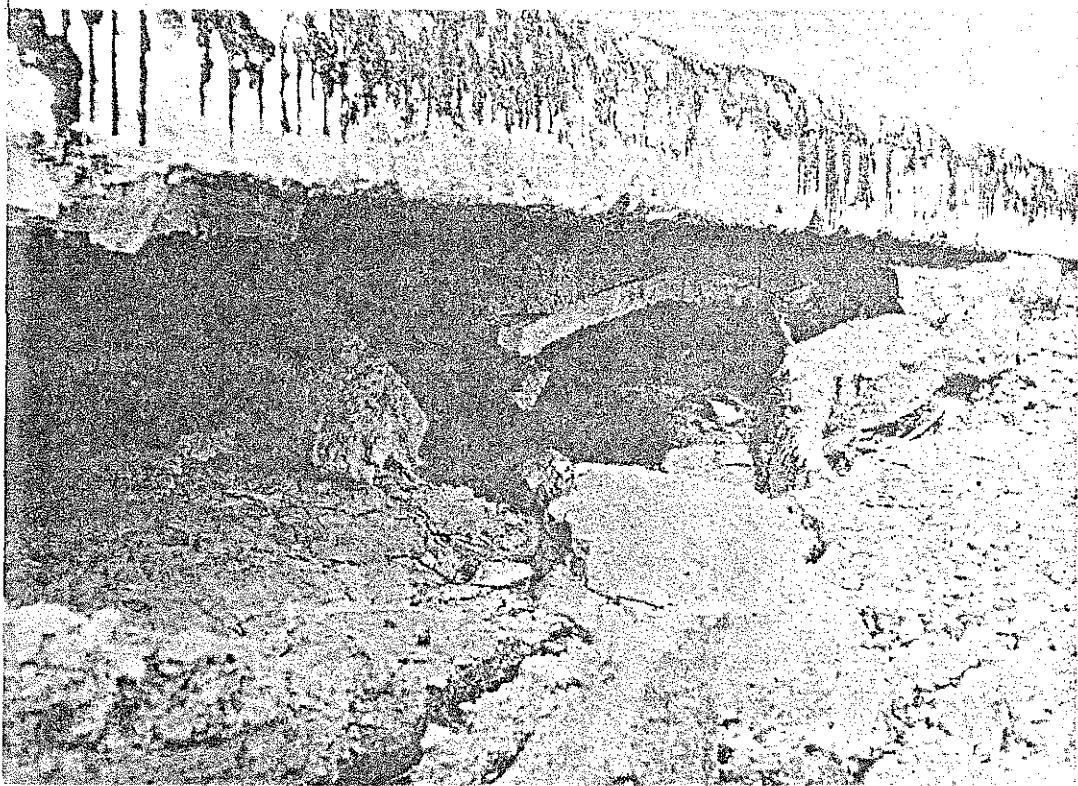
Fig. 33. Layers of Old Cement Grout and Mudjacking Material, May 10, 1963.

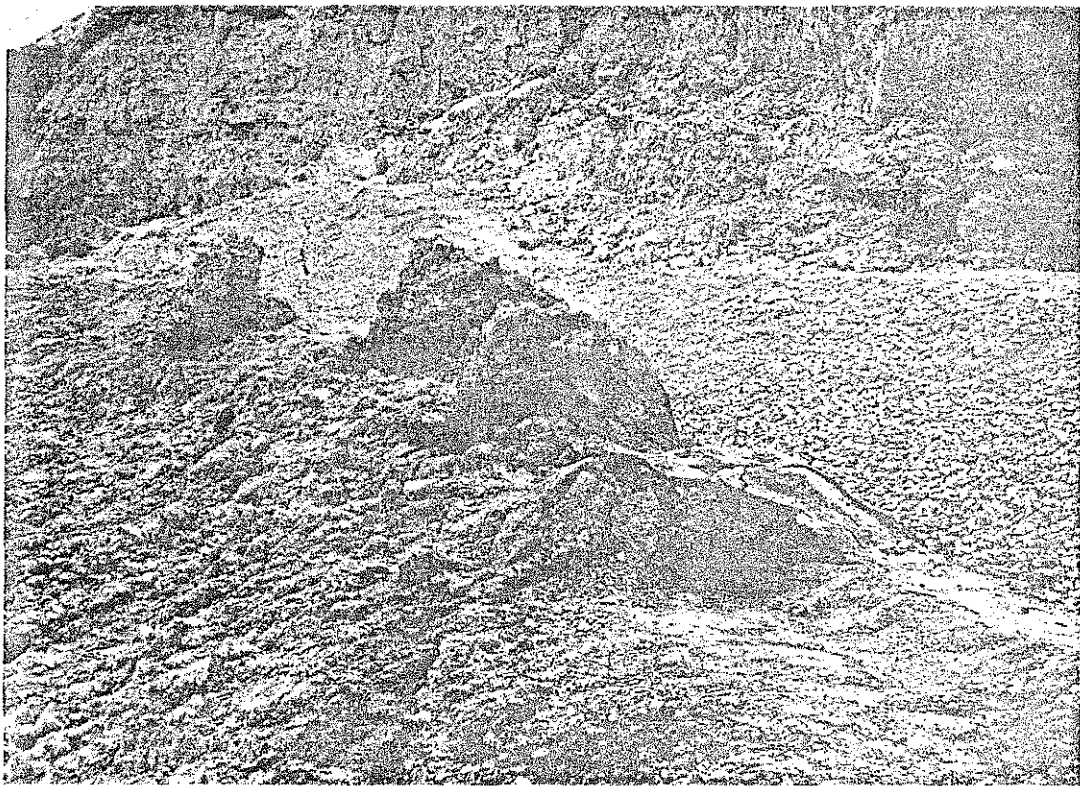
Fig. 34. Condition of Timber Piles Near Station 488, May 10, 1963.

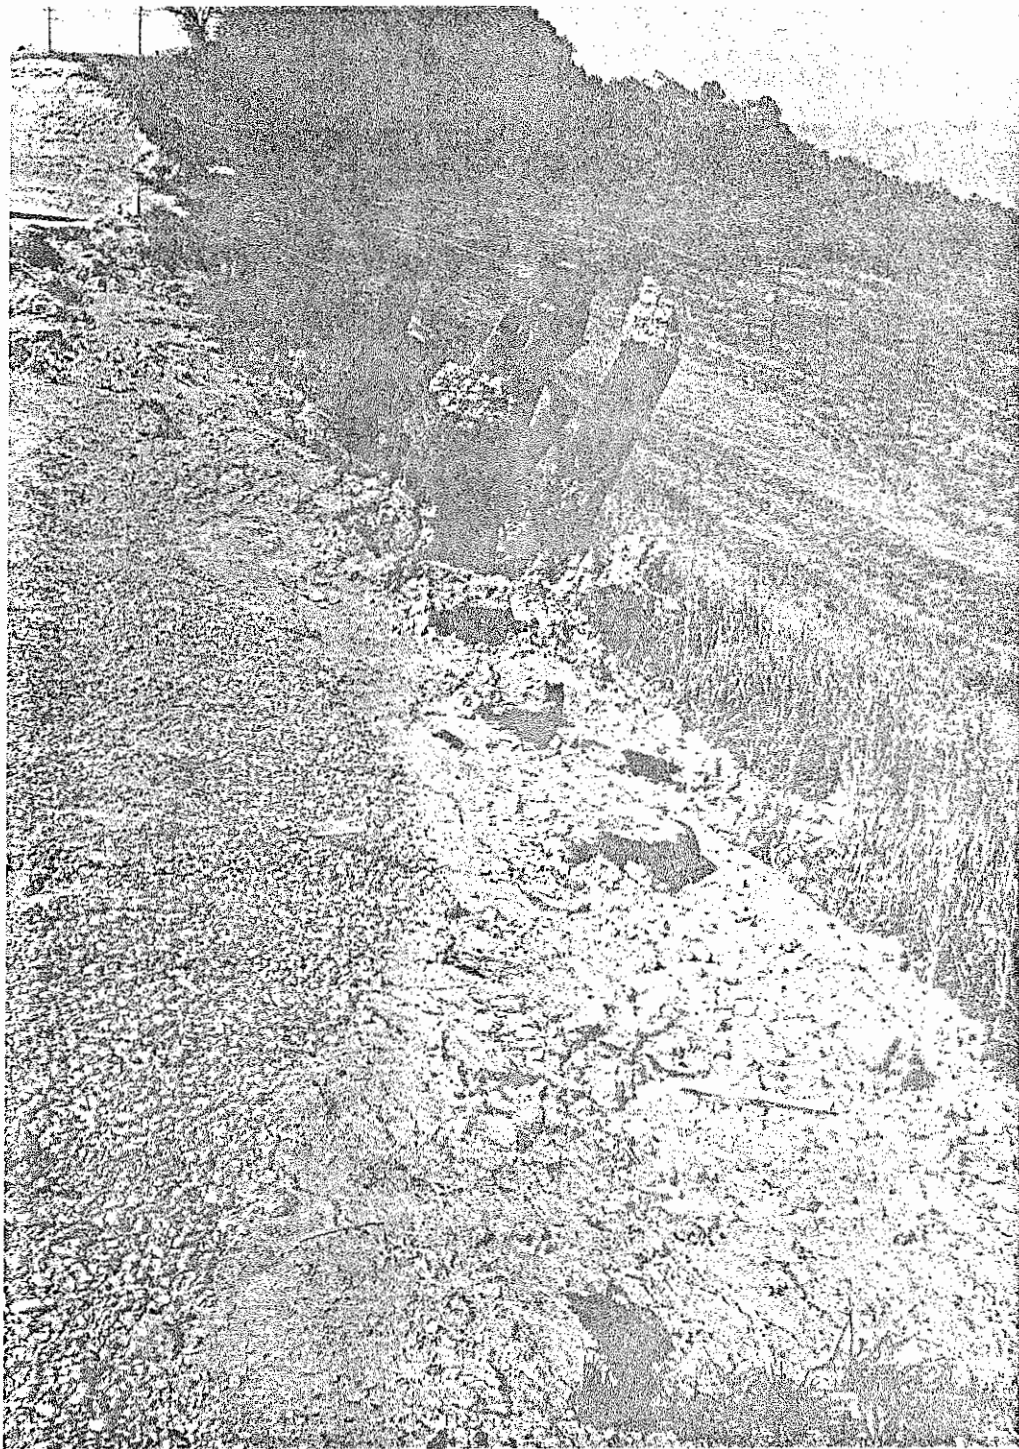
Fig. 35. Condition of Timber Piles Near Station 490, May 10, 1963.

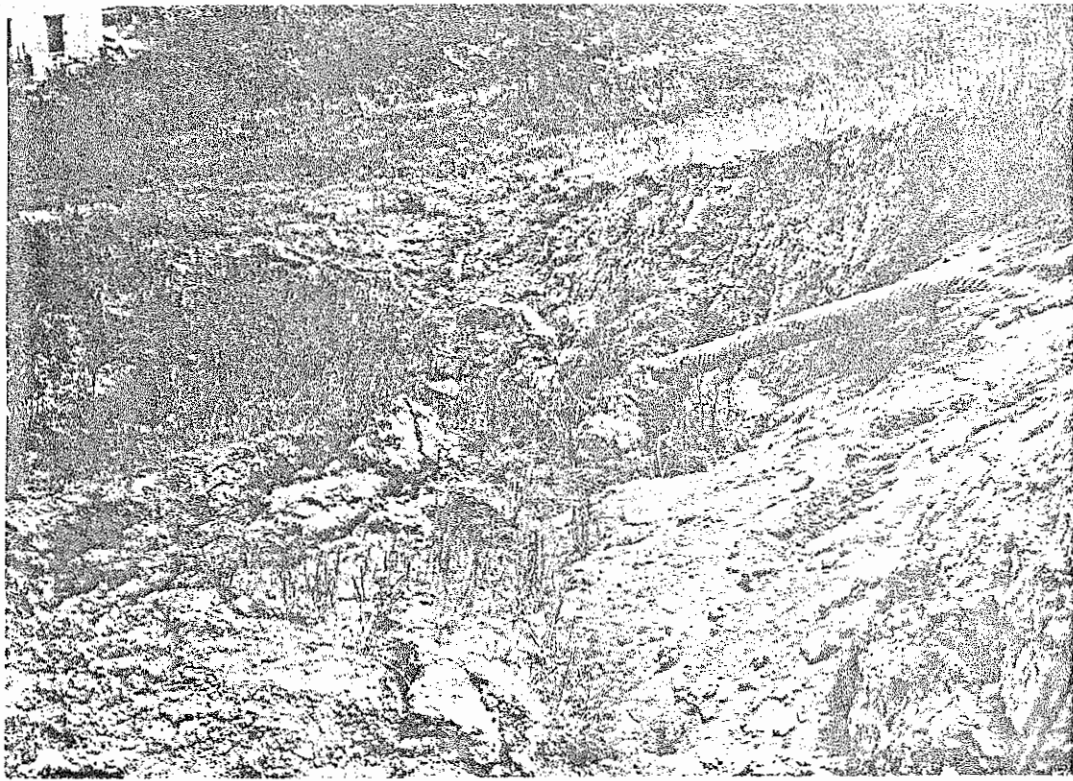
The right flank of the landslide is shown in Figure 36. The area around the perforated pipe was still extremely wet. Photographs of transverse cracks and ridges on the embankment slope are shown in Figures 37 and 38.

Fig. 36. Right Flank of Landslide, May 10, 1963.

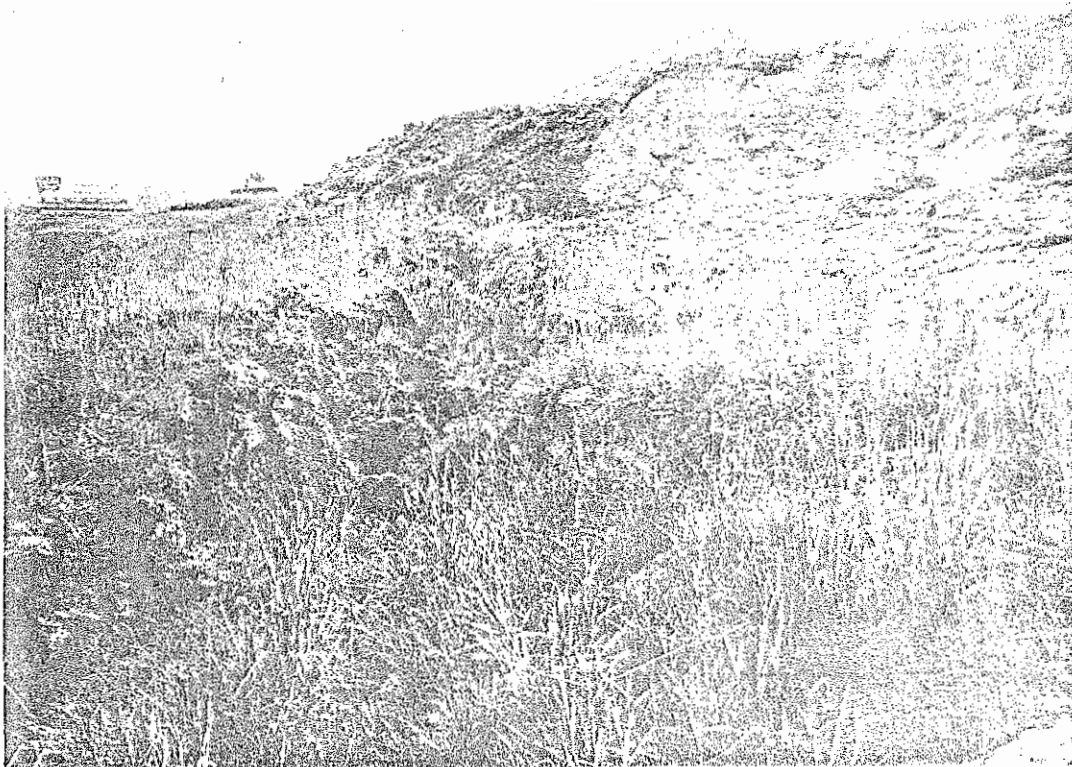
Fig. 37. Condition of Embankment Slope, May 10, 1963 (Looking South).

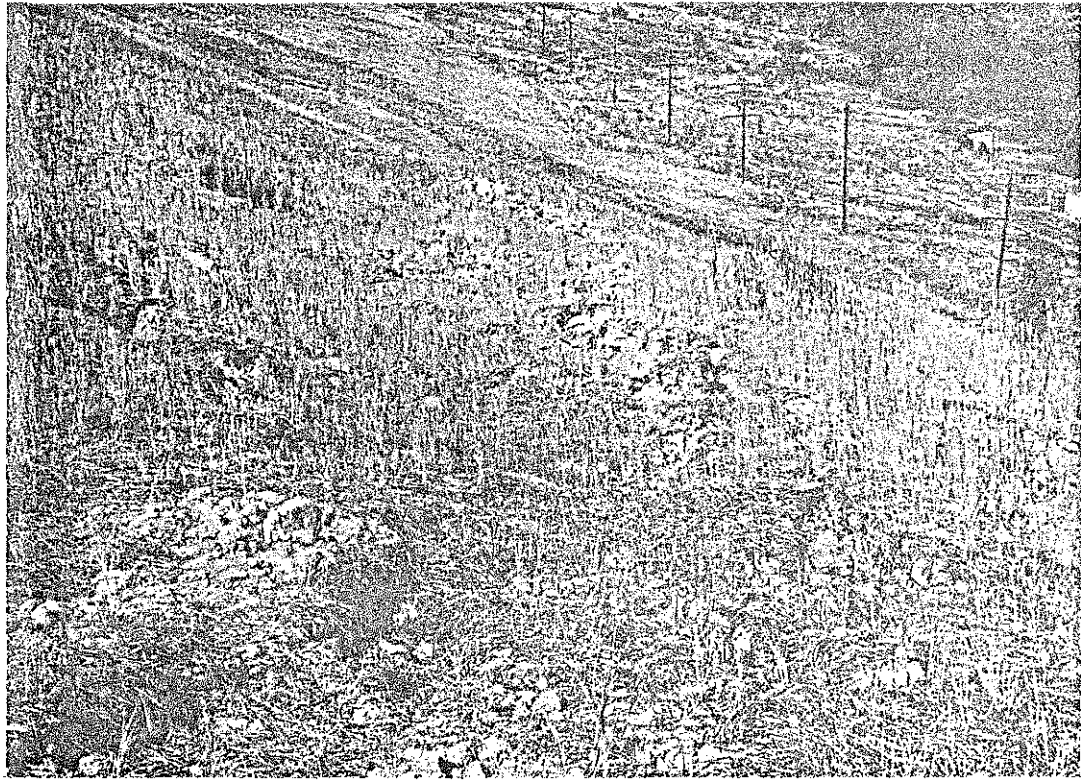
Fig. 38. Transverse Cracks and Ridges on Embankment Slope, May 10, 1963 (Looking North).

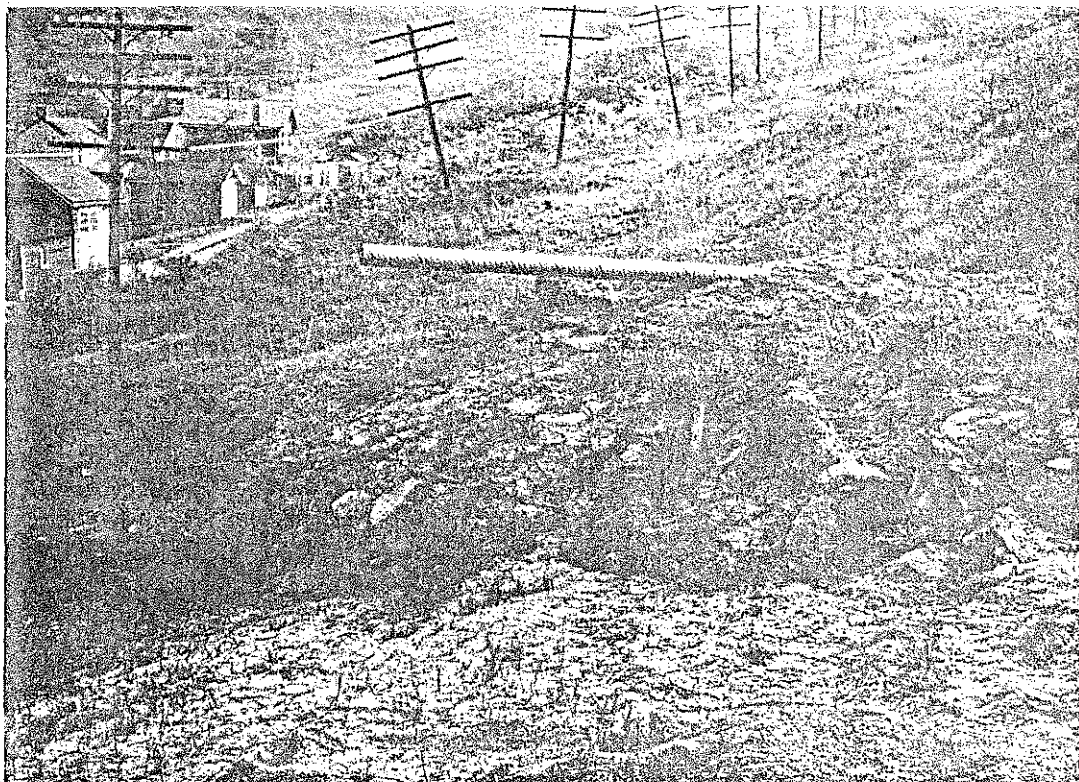
The conditions at the toe of the embankment have gradually deteriorated (see Figures 39-42). The toe of the embankment (Figure 39) as well as original ground has flowed significantly (Figures 40-42).

Fig. 39. Soil Flow Area at Toe of Embankment, May 10, 1963 (Looking South).

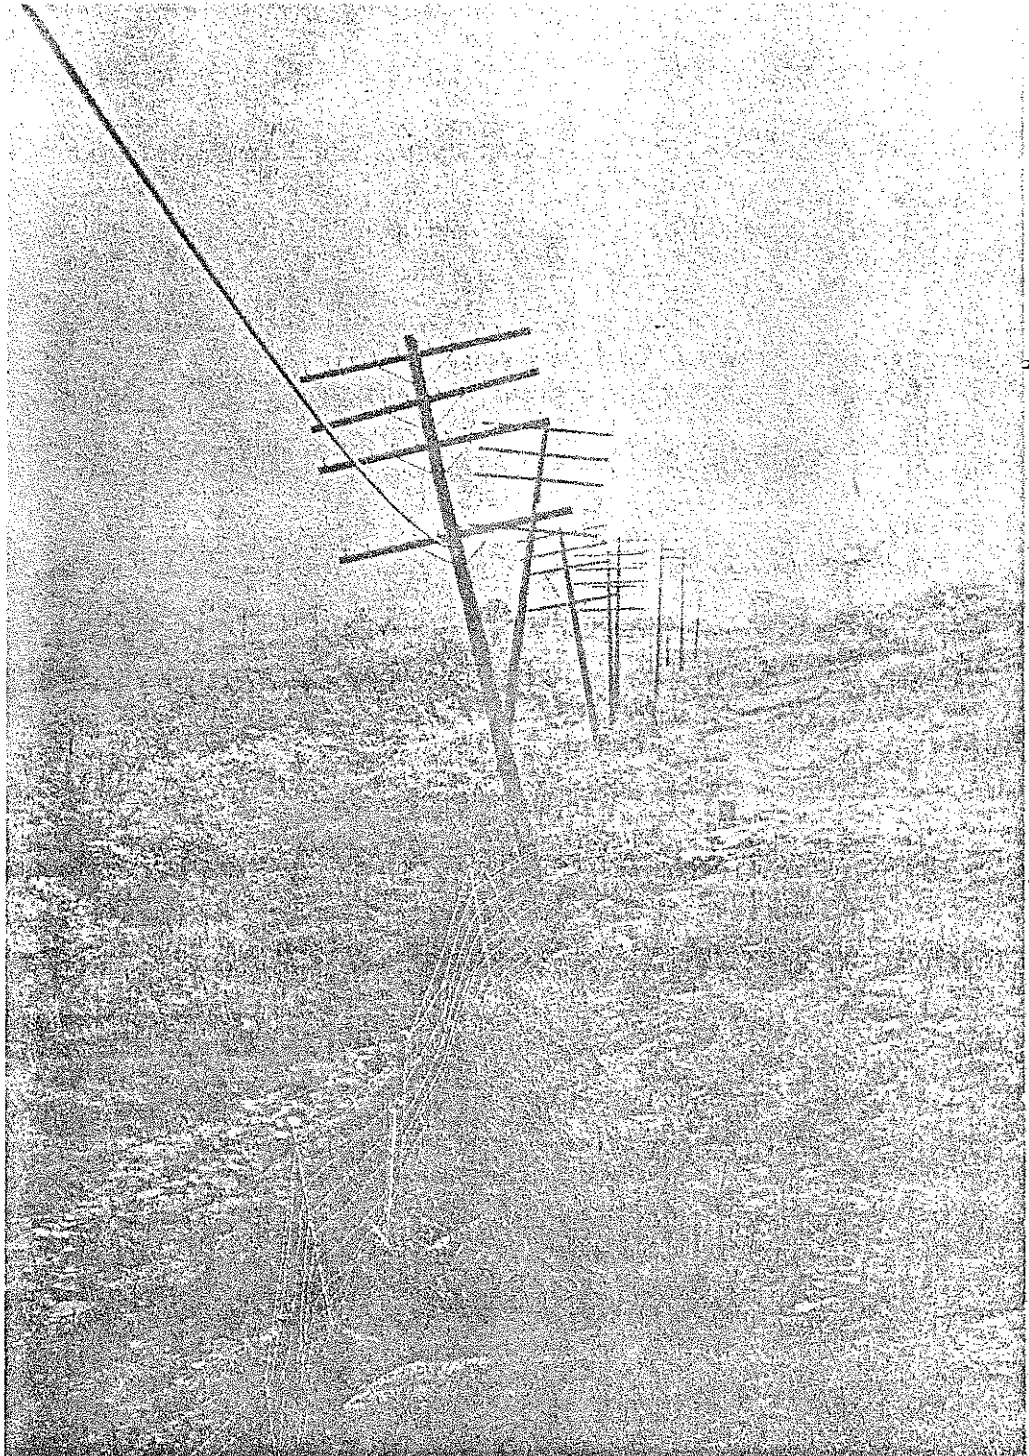
Fig. 40. Condition Near Toe of Embankment, May 10, 1963
(Looking South).

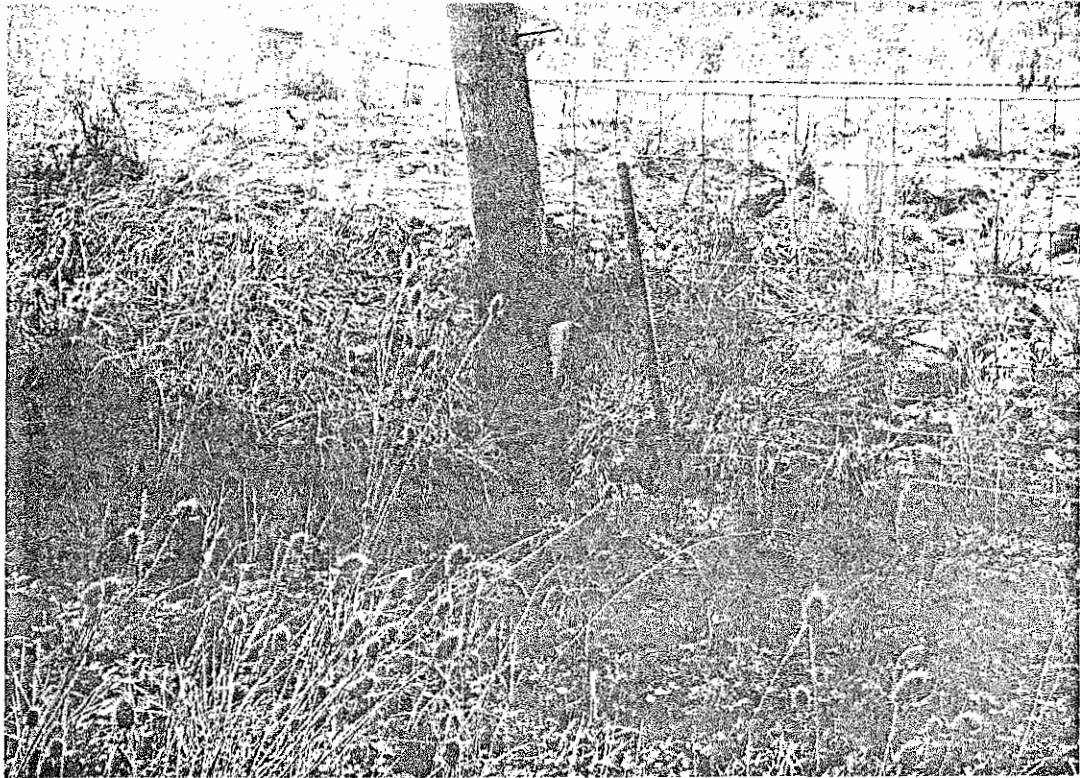
Fig. 41. Soil Flow of Original Ground, May 10, 1963.

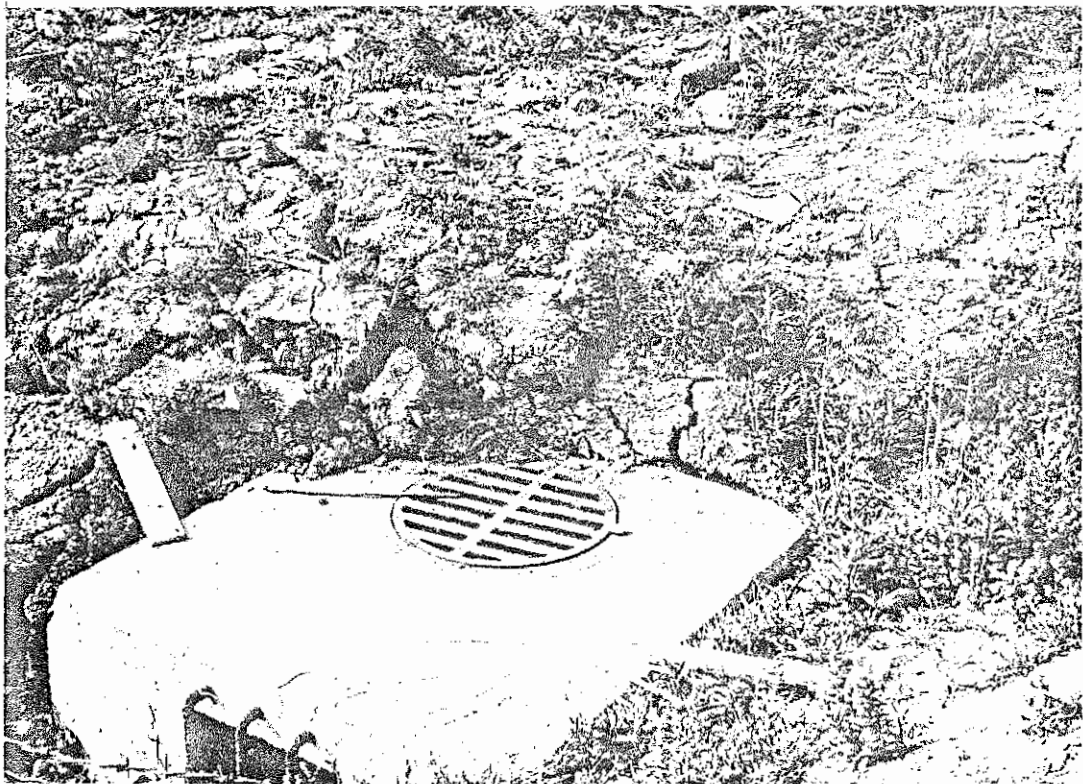
Fig. 42. Soil Flow Over Junction Box, May 10, 1963.

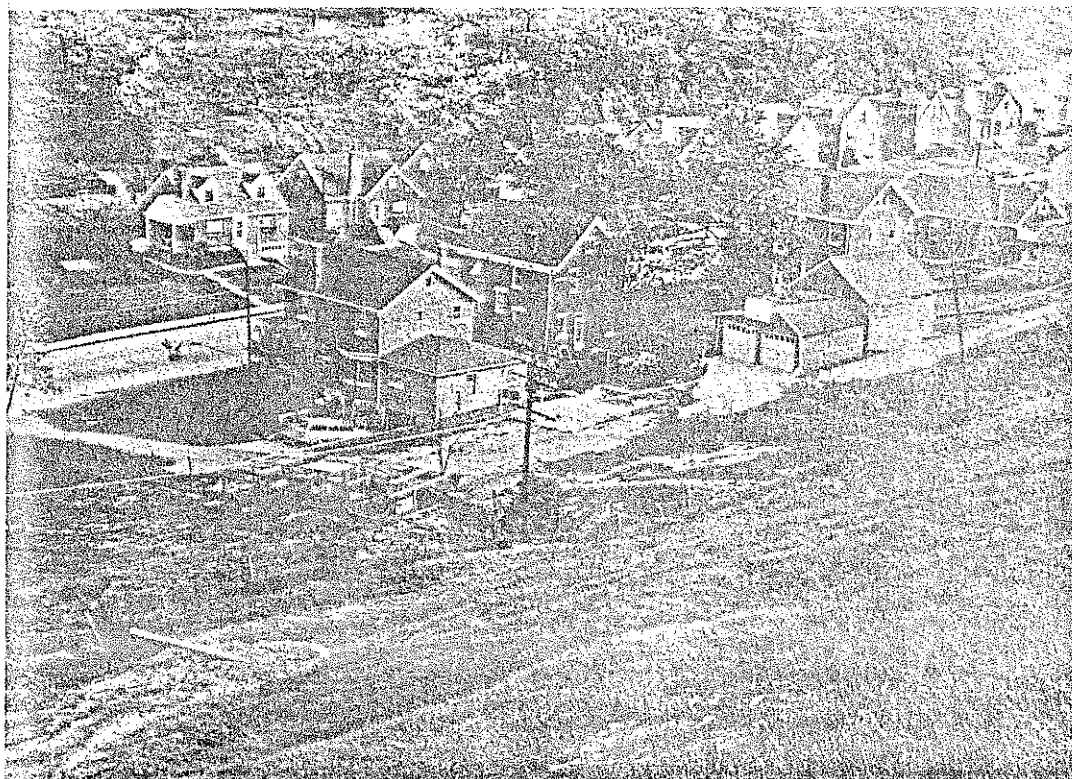
The residents of the house shown in the center of Figure 43 have reported some very recent damage to their property that may be associated with the landslide. The short length of sidewalk between the concrete slab at the rear of the house and the house has buckled (see Figures 43-44). The rear concrete wall of the basement garage already exhibits a new crack that has opened about 3/8-inch. This crack is horizontal, runs the full length of the garage and is about midway up the wall from the floor.

Fig. 43. Houses at Foot of Slope Below Landslide Area, May 10, 1963 (Looking Southeast).

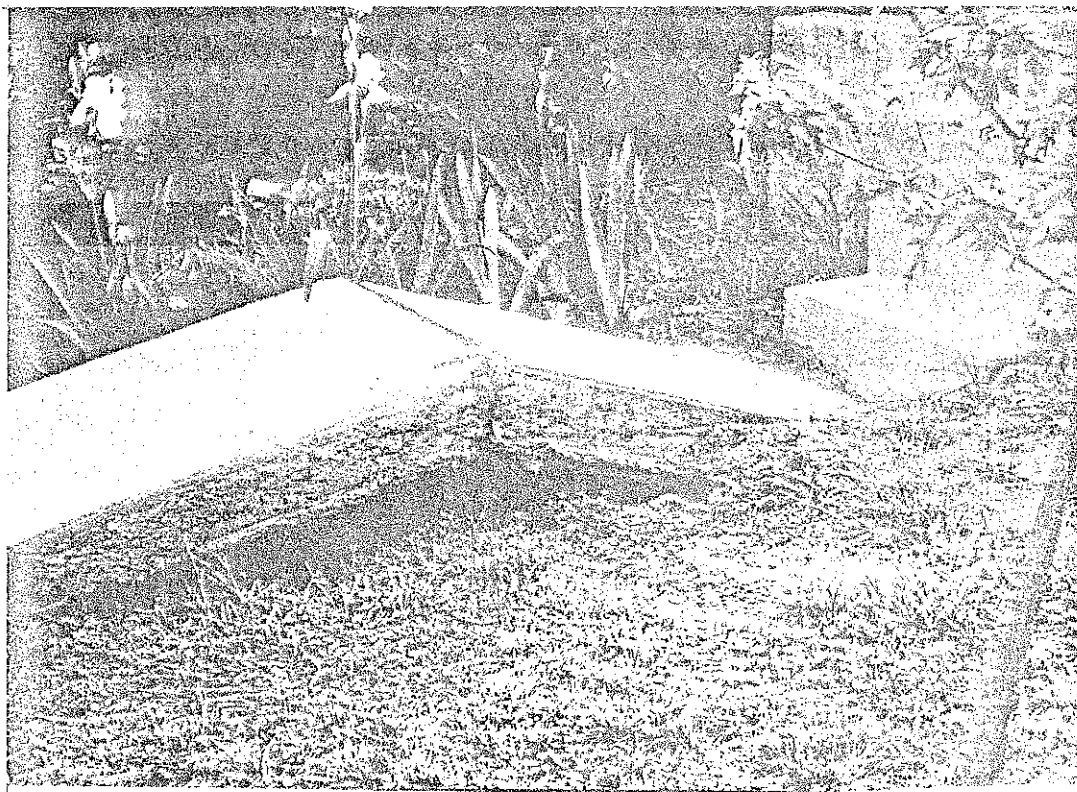
Fig. 44. Buckled Sidewalk, Near Residence at Foot of Slope, May 10, 1963.
