SUBJECT: Interim Report on Rural Secondary, Base-  
Stabilization Projects; July, 1963.

INTERIM REPORT

RURAL SECONDARY, BASE  
STABILIZATION PROJECTS

July, 1963

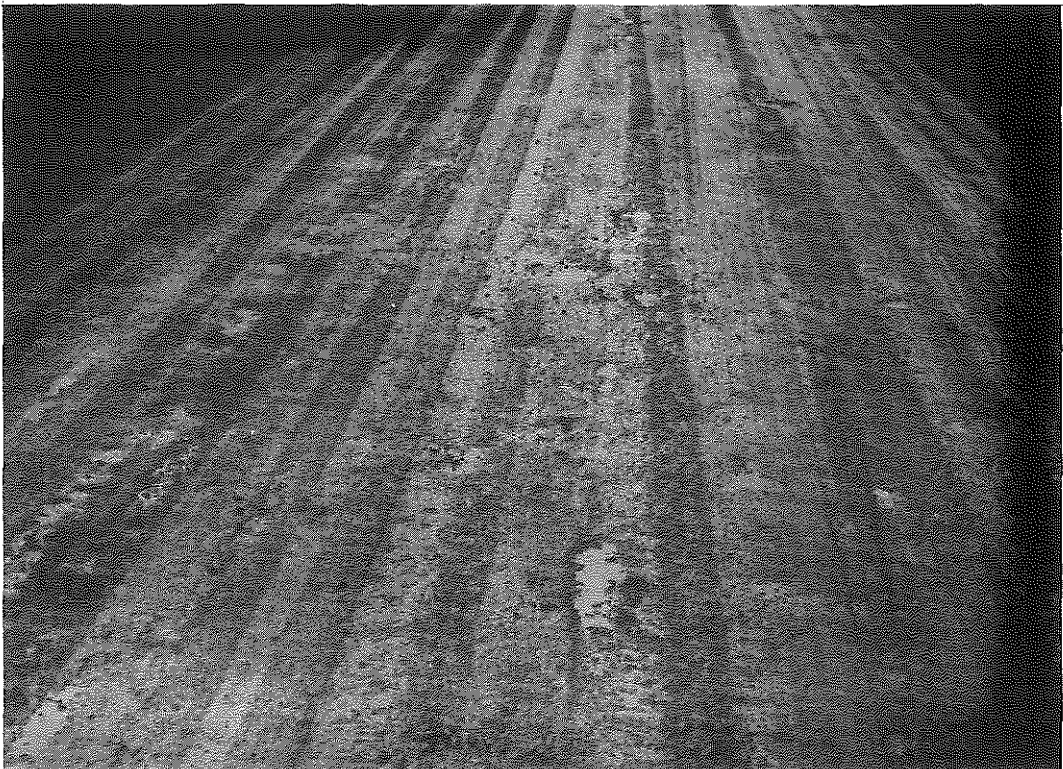
Performance Surveys: At end of construction: Fig. 6 shows the condition of the roadway after a brief rain shower that fell during construction.

Fig. 6. RS 2-415. Potholed Condition of Compacted Roadway after a Rain Shower, July, 1962.

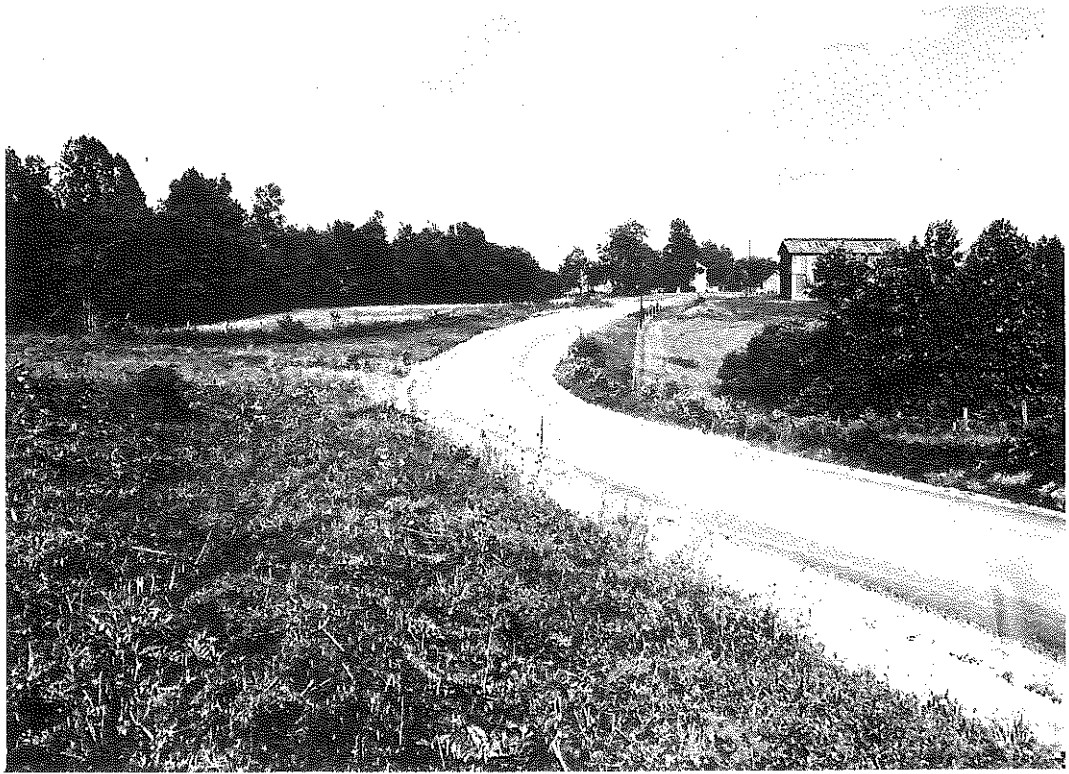
August 8, 1962: The base appeared to be dense and holding in place very well. Figure 7 illustrates the generally excellent condition that was typical of the project on this date.

Fig. 7. RS 2-415. Condition of Roadway on August 8, 1962.

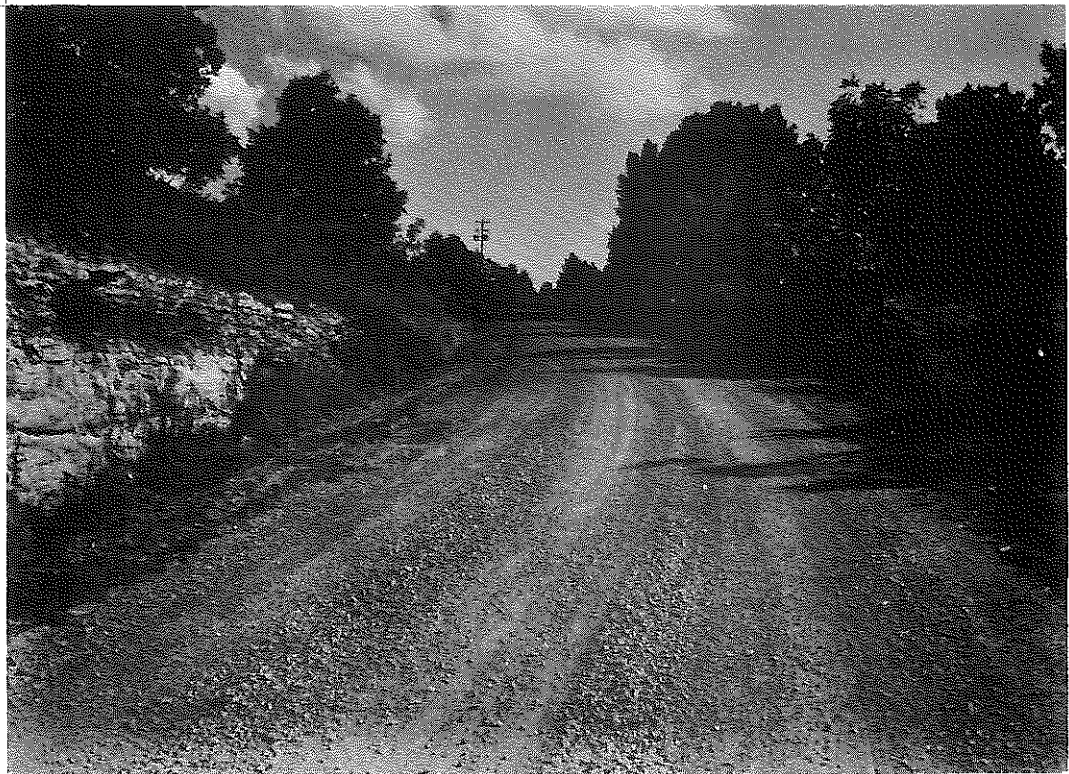
In Fig. 8 the difference in raveling that occurs between treated and untreated sections can be noted. It can be seen that there is very little loose material on the treated base in the background of the photograph while, in the foreground, loose untreated granular material covers the roadway.

Fig. 8. RS 2-415. Photograph Showing Difference in Raveling in Treated and Untreated Base, August 8, 1962.

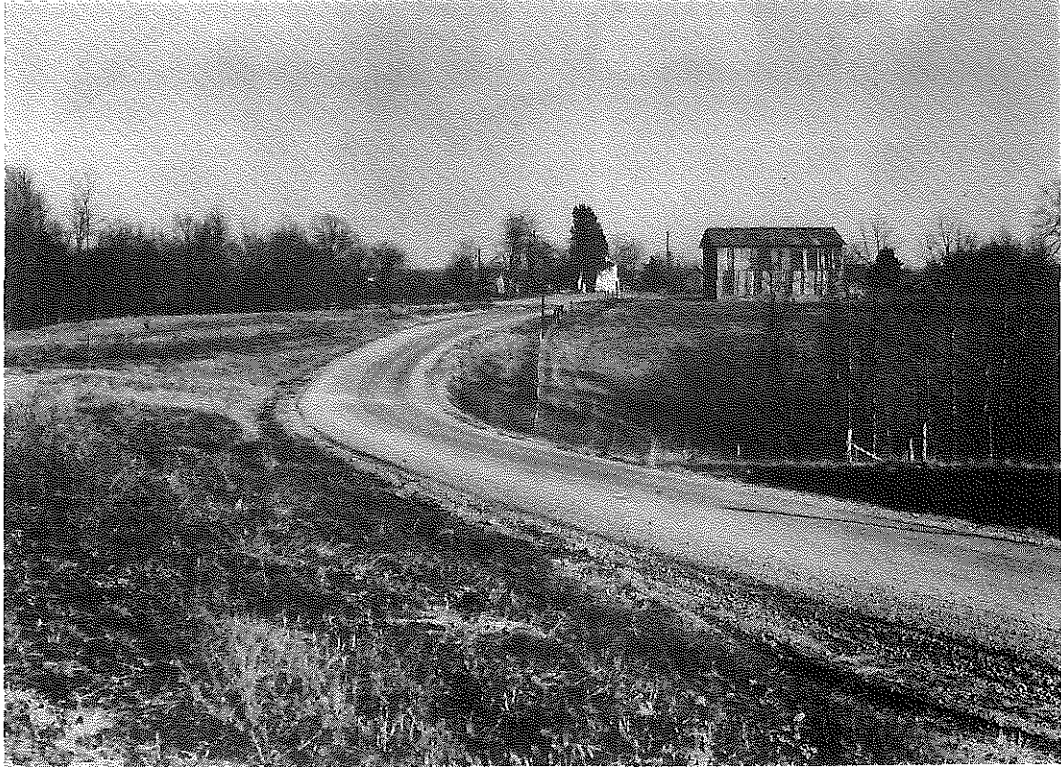
December 18, 1962: The roadway was in very good condition at this time as shown in Fig. 9. The base, however, had been covered with a Double A-2 seal in the fall of the year by a crew of the Maintenance Division.

Fig. 9. RS 2-415. Condition of Roadway on December 18, 1962.

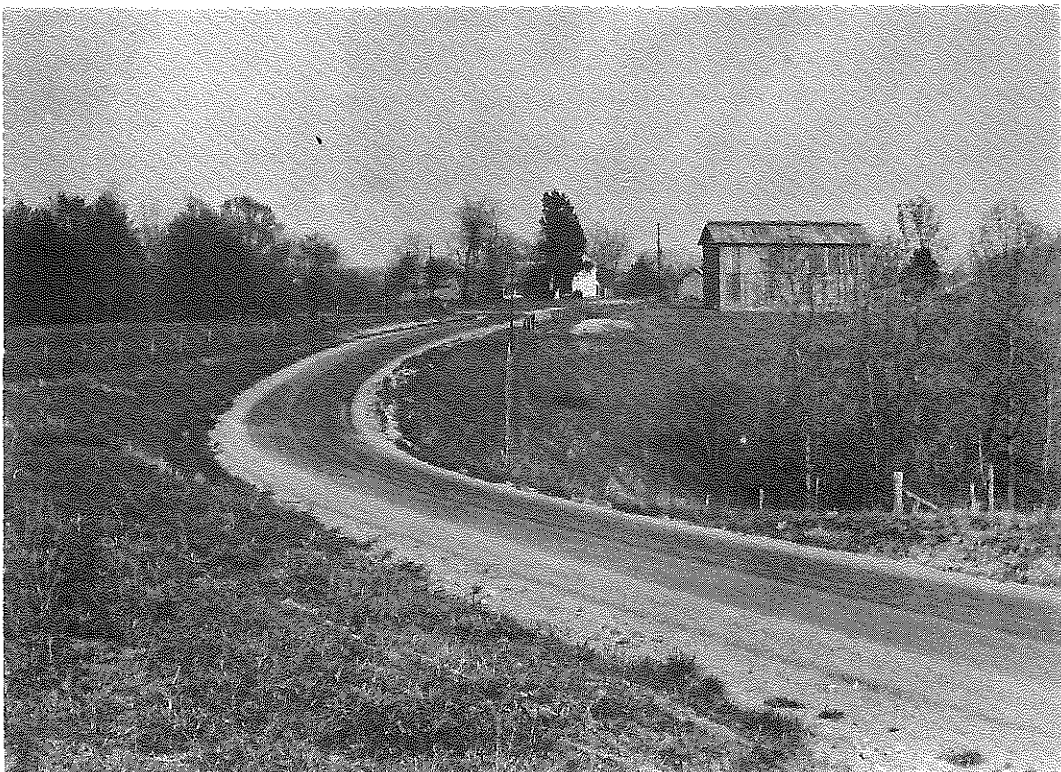
April 11, 1963: Loose stone was noted along the side of the roadway over the entire length. The seal was in very good condition (Fig. 10). There were several areas on the southern portion of the project showing evidence of weakness. These areas were usually observed where poor drainage was present (Fig. 11).

Fig. 10. RS 2-415. Condition of Roadway on April 11, 1963.

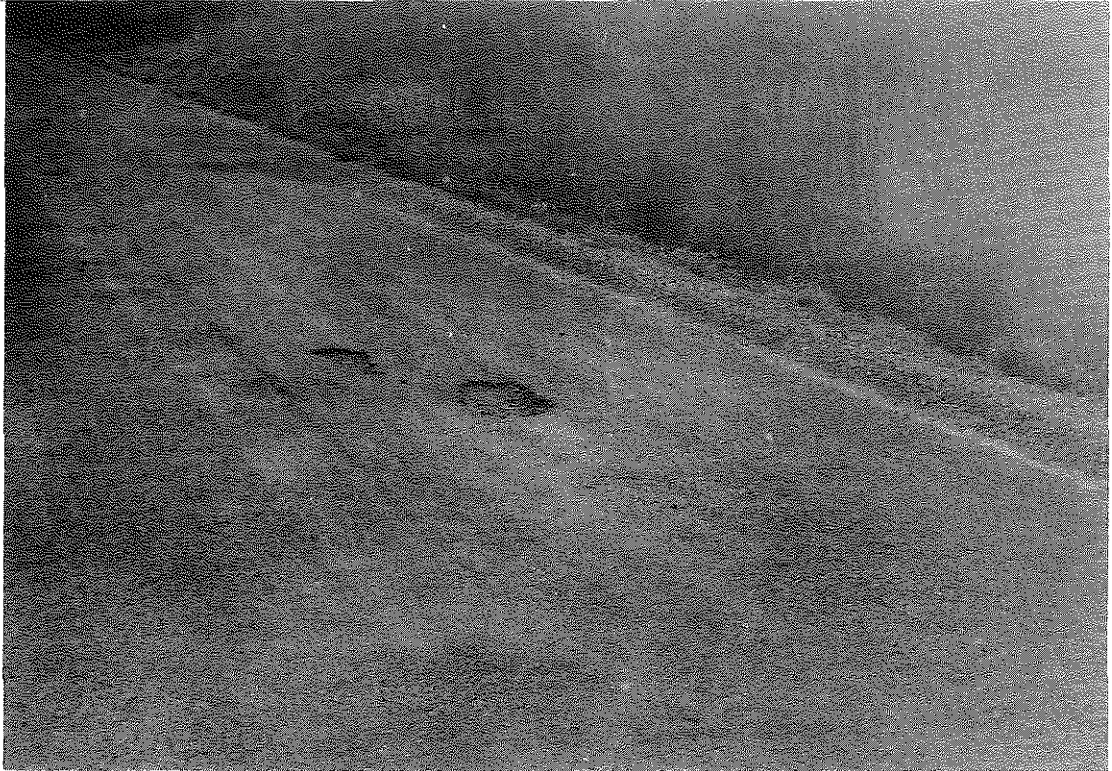
Fig. 11. RS 2-415. Condition of Roadway in Poor Drainage Area,  
April 11, 1963.

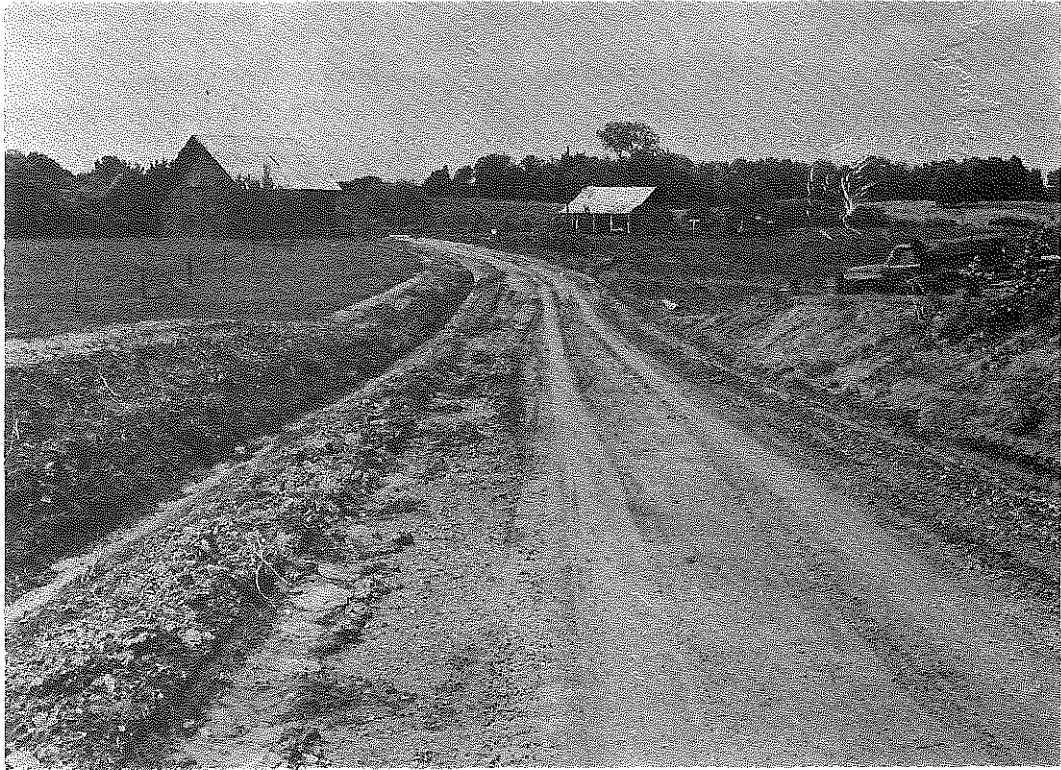
Initial Condition Survey: May 9, 1962: Several areas were noted where the metal appeared to be thin and the roadway soft due to poor drainage conditions. A few areas of rock outcropping were also observed. The metal on the eastern most mile of the project was very thin with excessive amounts of clay inter-mixed, as shown in Fig. 1. The remainder of the project was in much better condition, as shown by Fig. 2.

Fig. 1. RS 24-655-1. Condition of Roadway on Eastern-Most Mile of Project on May 9, 1962.

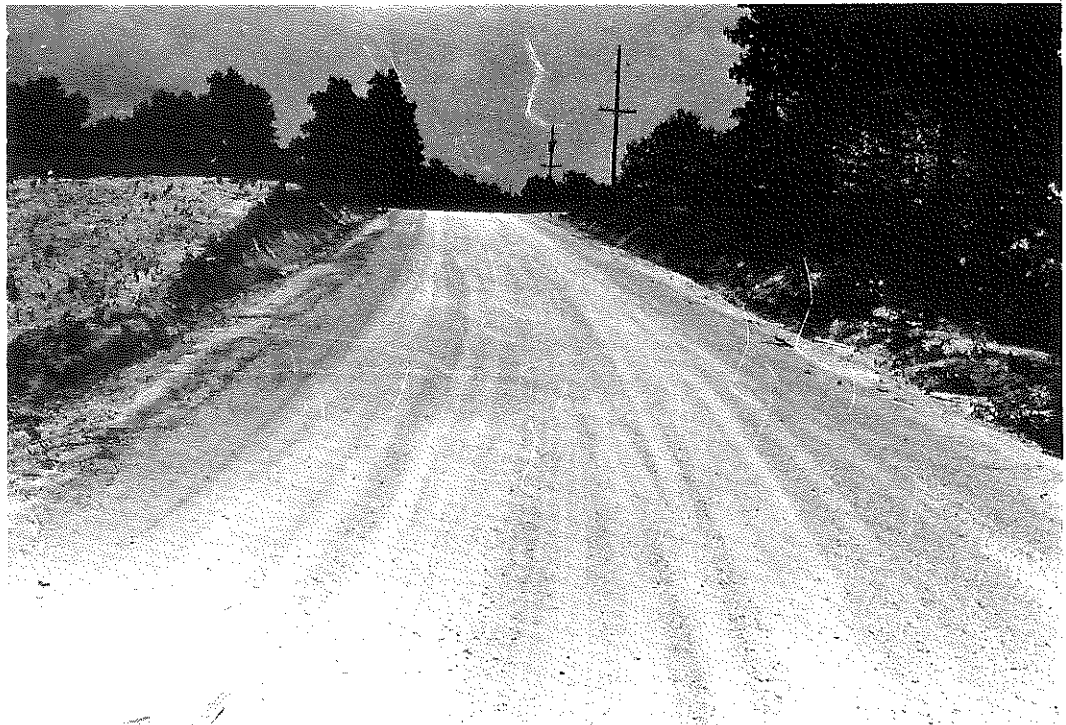
Performance Surveys: July 30, 1962: Much and wide-spread raveling was observed on the eastern portion of the project (low sodium chloride content)(Fig. 7). The western portion was retaining the aggregate significantly better, but some minor raveling had developed (Fig. 8).

Fig. 8. RS 24-655-1. Condition of Western Part of Project, July 30, 1962.

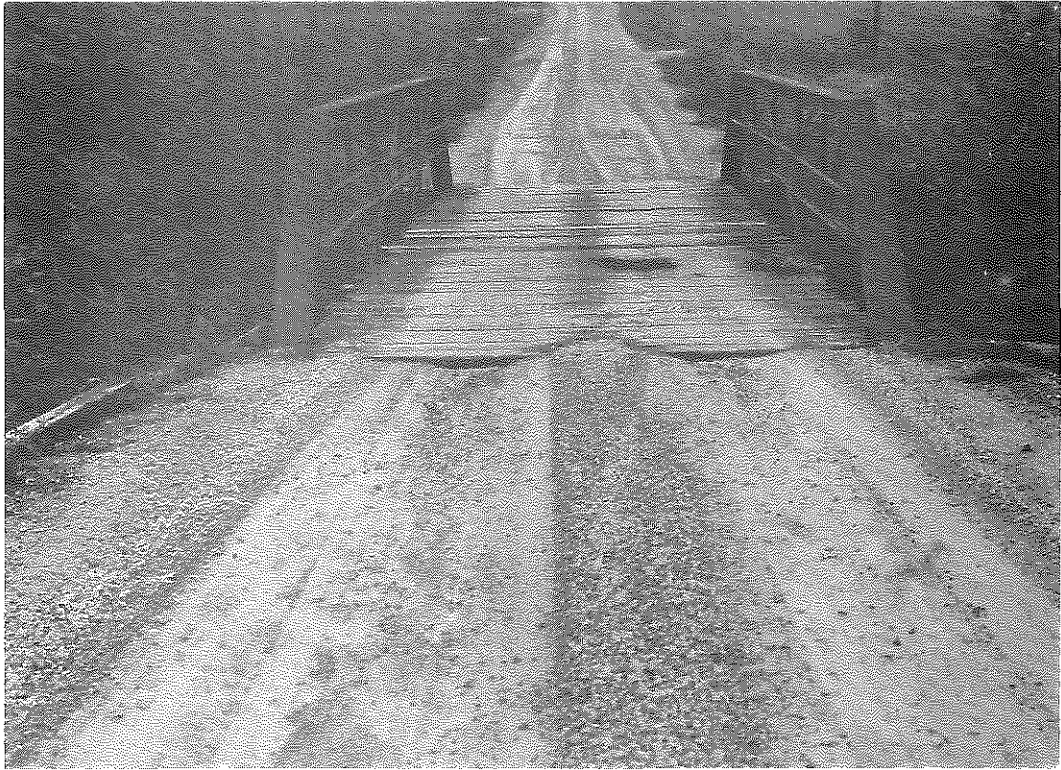
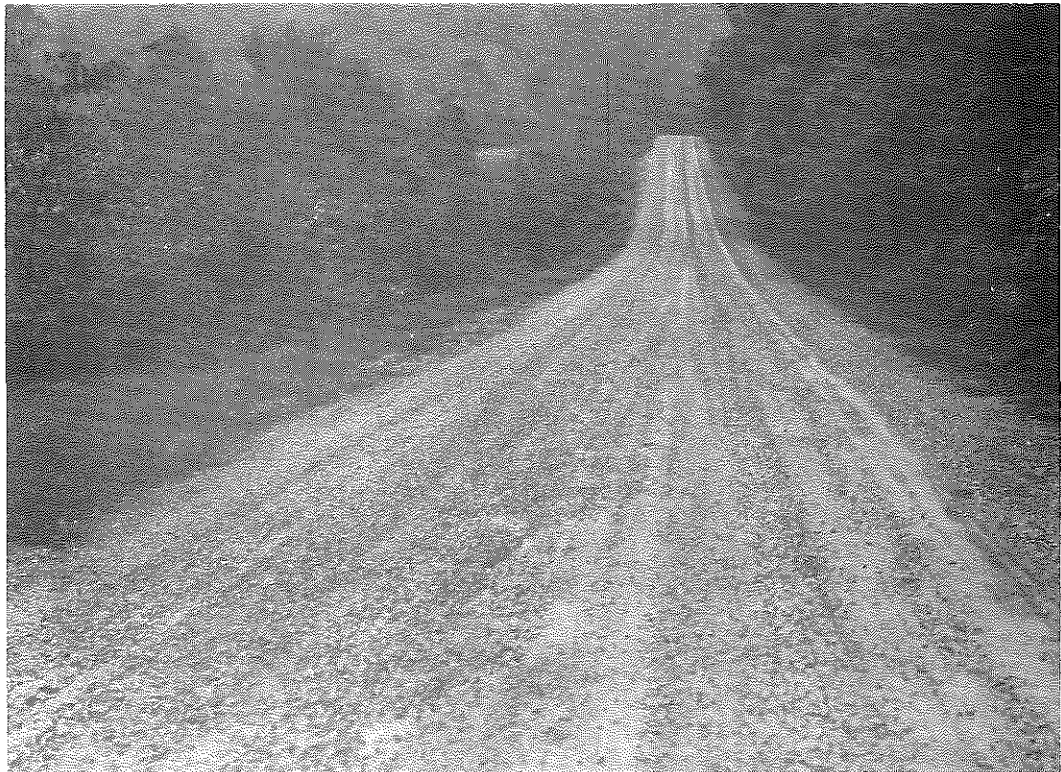
September 25, 1962: On the eastern section of the project raveling had continued and numerous potholes had developed. Much material had been carried off by erosion (Figs. 9 and 10). Scattered potholes were present in the western portion.

Fig. 9. RS 24-655-1. Condition of Eastern Portion of Project, September 25, 1962.

Fig. 10. RS 24-655-1. Condition of Eastern Portion of Project, September 25, 1962.

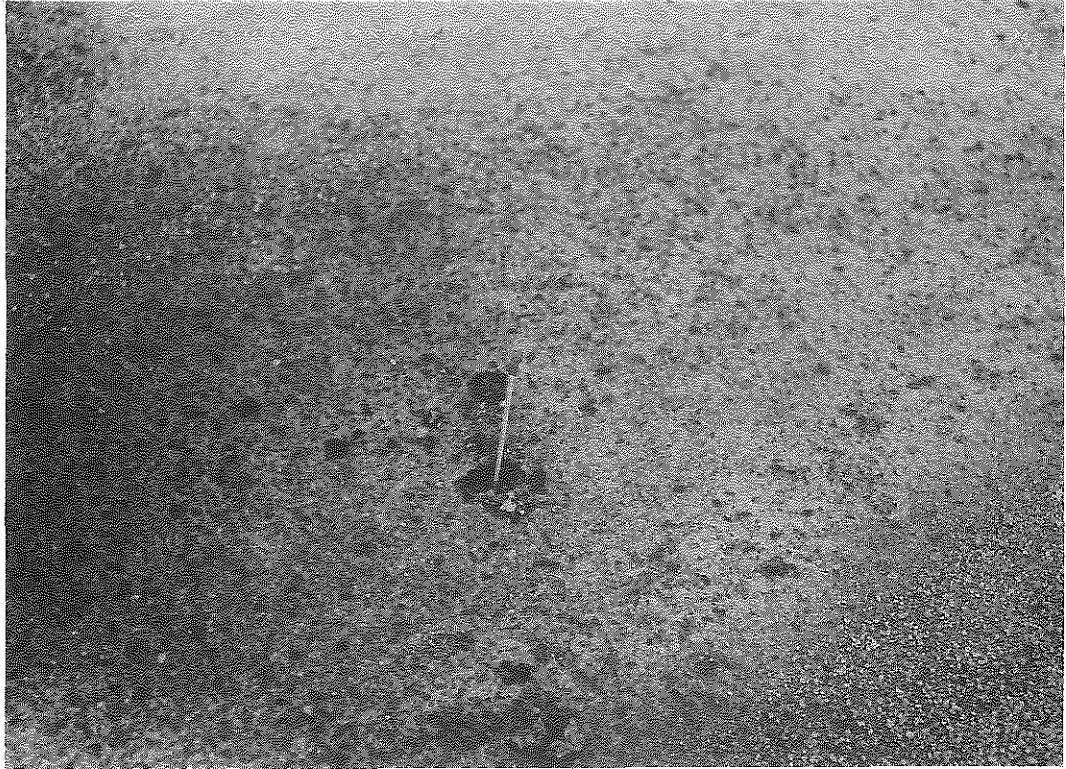
December 19, 1962: A Double A-2 seal had been placed by a maintenance crew since the last inspection. The seal was in good condition (Fig. 11) and there were only a very few potholes on the entire project; however, some wet areas were noted (Fig. 12). The road has not been accepted for state maintenance because of substandard widths.

Fig. 11. RS 24-655-1. Seal Coat, December 19, 1962.

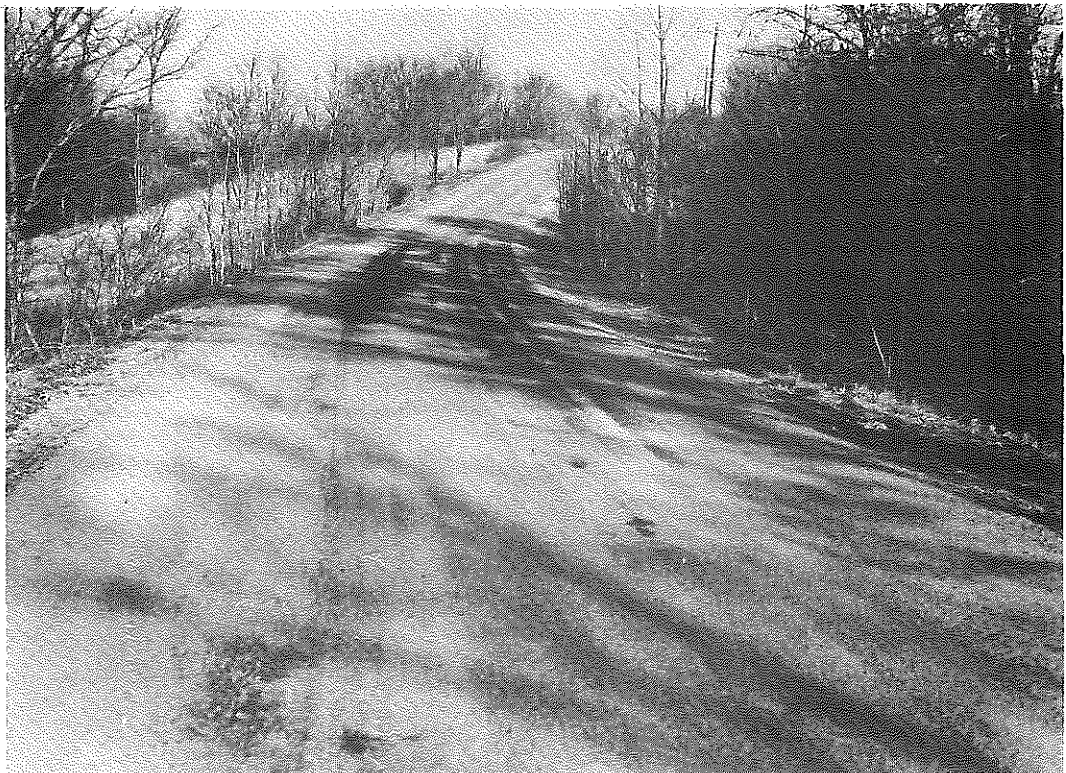
Fig. 12. RS 24-655-1. Photograph Showing Wet Area, December 19, 1962.

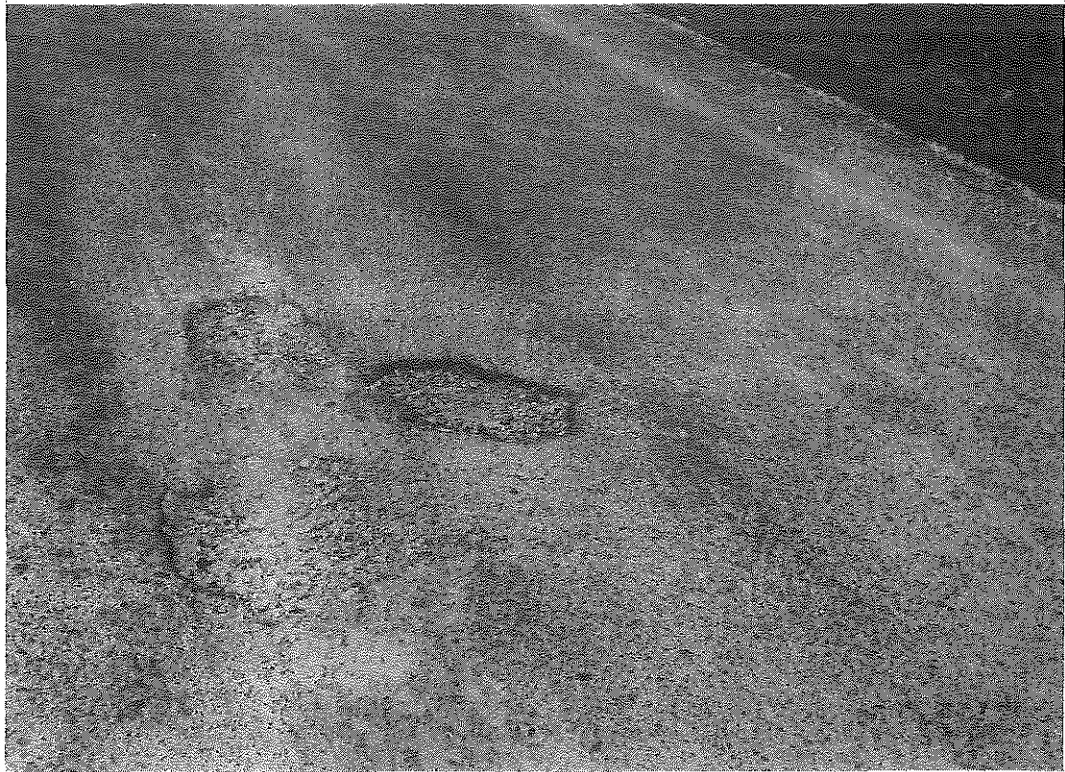
April 11, 1963: Loose stone was present on both sides of the roadway over most of the distance. Mild rutting was noted in areas on the western part of the project. Potholes were noted in only one low area on the eastern part (Fig. 13), although some were starting to form in other areas. The roadway was generally in good condition with the western portion slightly better. Figure 14 shows the bridge which is the dividing point between the eastern and western sections.

Fig. 13. RS 24-655-1. Potholes Formed in a Low, Wet Area,  
April 11, 1963.

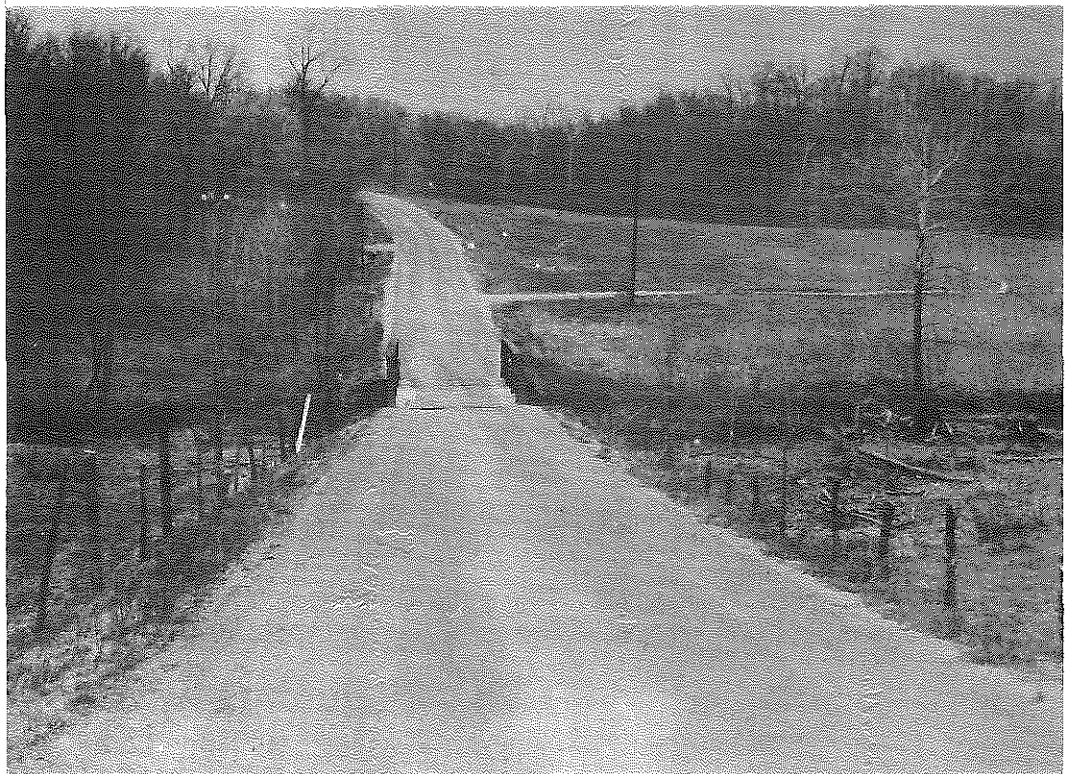
Fig. 14. RS 24-655-1. Condition of Roadway on April 11, 1963.  
The eastern portion of the project is in the background.

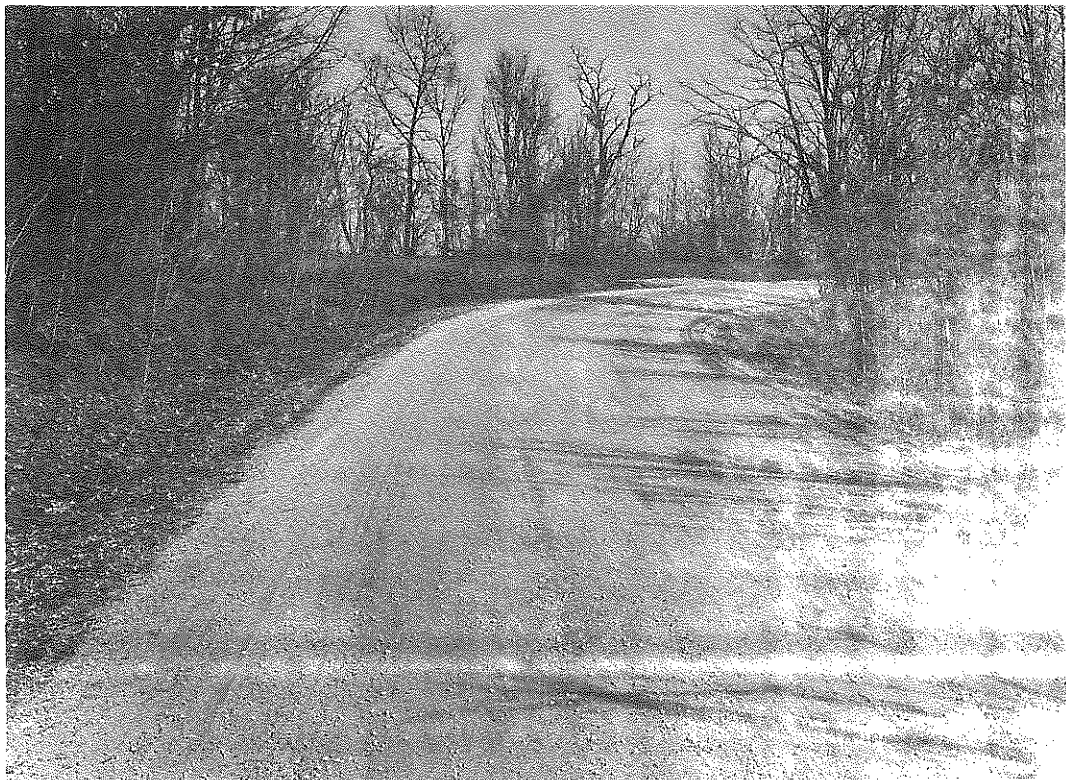
Performance Surveys: February 5, 1963: Some sections were still in good condition showing very little raveling (Fig. 4). Other areas showed many potholes, wet and soft places. Subgrade had pumped through the dense-graded aggregate and the aggregate was thin in areas.

Fig. 4. RS 32-189. Condition of Roadway on  
February 5, 1963.

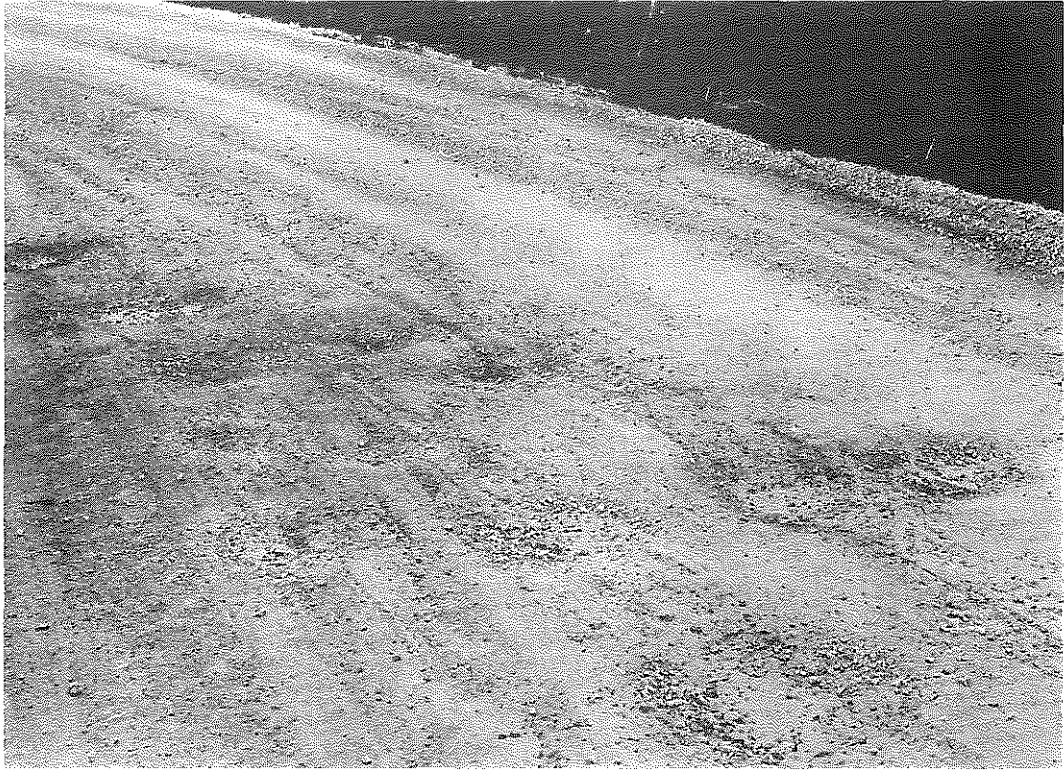
April 23, 1963: Lack of crown had permitted water to flow down the roadway causing erosion. Water collecting on the roadway in the low areas has resulted in many large potholes (Fig. 5). Numerous potholes are also present on the crests of rises and hills (Fig. 6). Several soft areas were noted and in some of the soft areas clay was intermixed with the granular material (Fig. 7). The DGA was generally tight with some raveling on the curves (Fig. 8). A patrol grader was in the process of blading the roadway (Fig. 9).

Fig. 5. RS 32-189. Condition of a Low Area of Roadway,  
April 23, 1963.

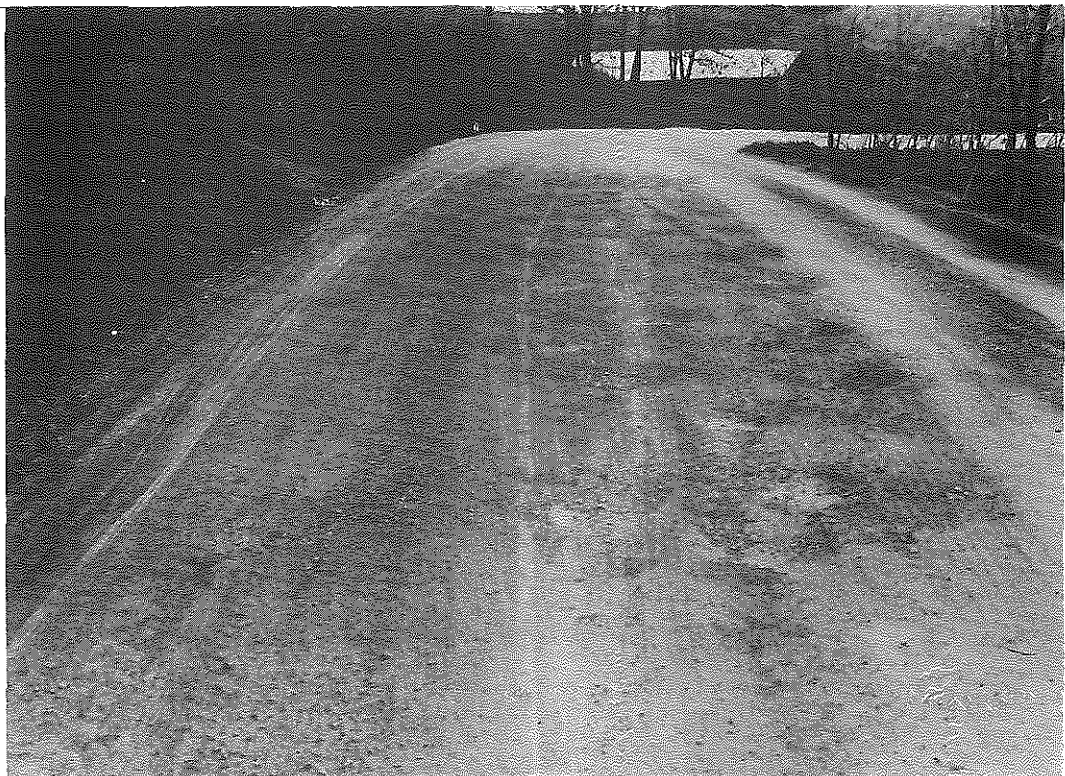
Fig. 6. RS 32-189. Condition of Roadway at the Crest of a Rise,  
April 23, 1963.

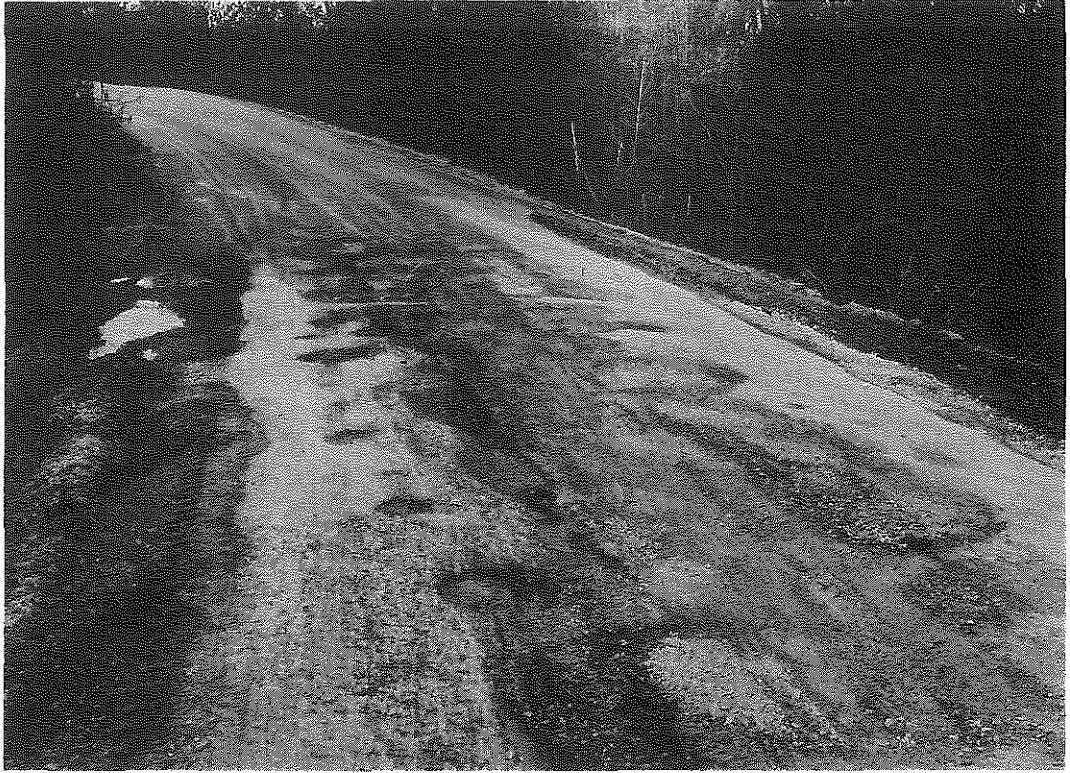
Fig. 7. RS 32-189. Soft Area in Roadway, April 23, 1963.

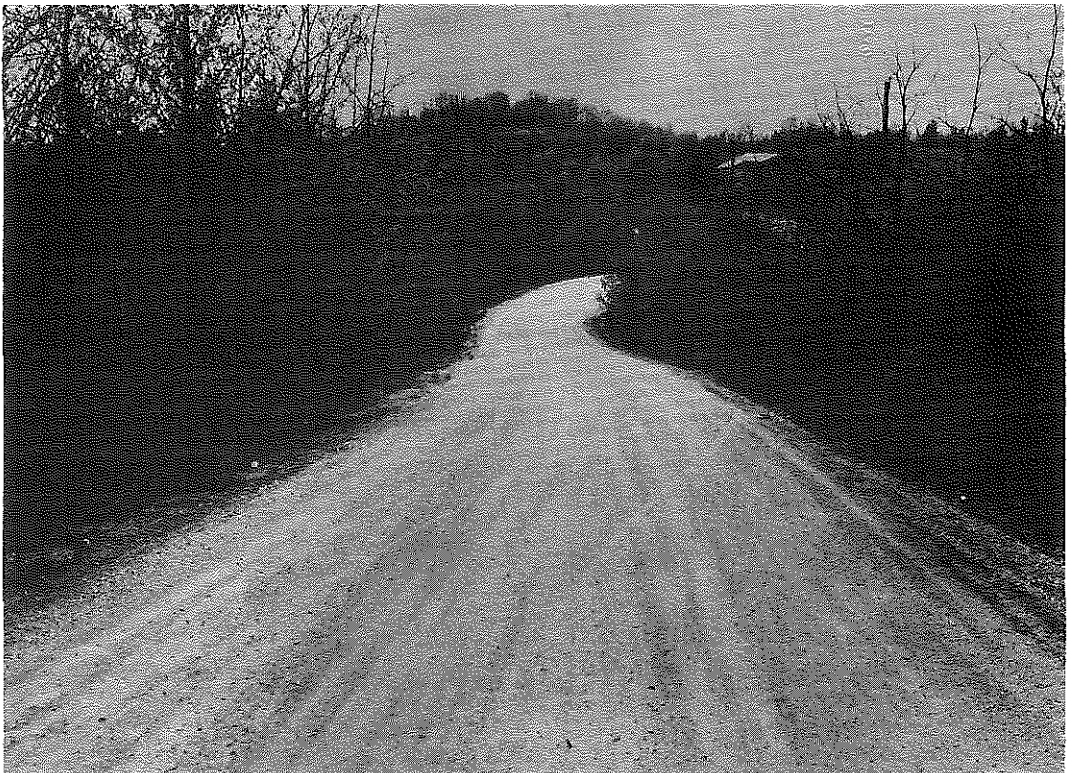
Fig. 8. RS 32-189. Condition of Roadway on April 23, 1963.

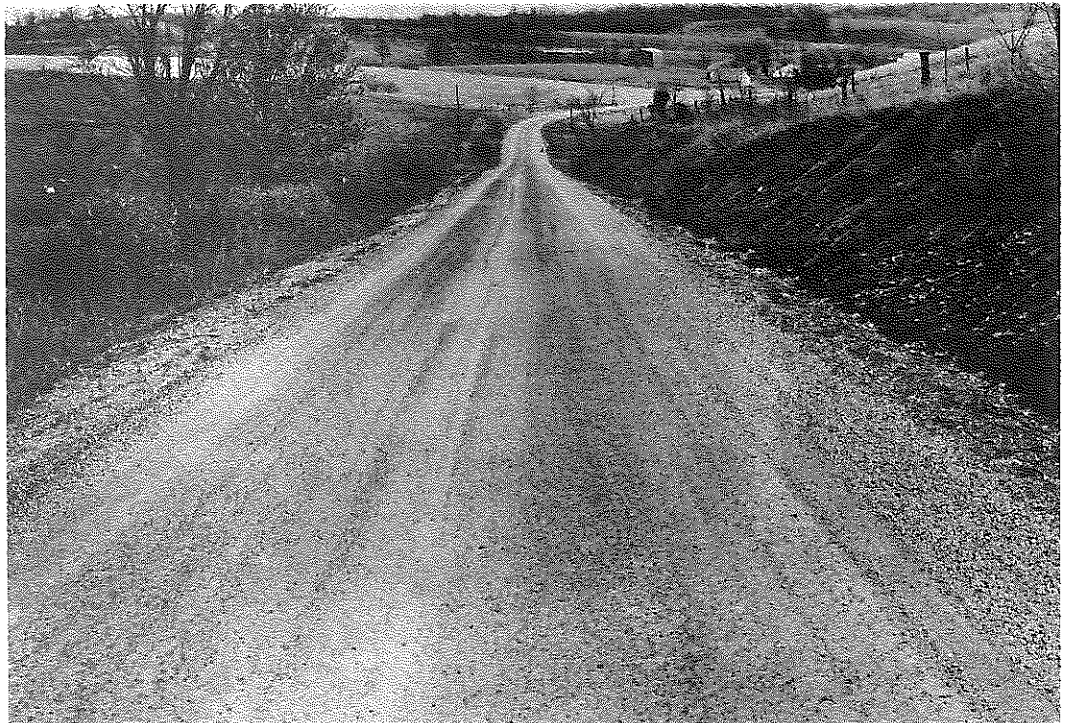
April 23, 1963: Loose metal was noted over the entire length of the project. Rutting was occurring in several areas, mostly in the outside wheel track of the southbound lane. Map cracks were observed over the length of the roadway. In some areas this cracking was quite severe (Fig. 7). Scattered potholes were present and several large chip seal patches had been made. Figure 8 shows the general condition of the roadway.

Fig. 8. RS 35-750. Condition of Roadway on April 23, 1963.

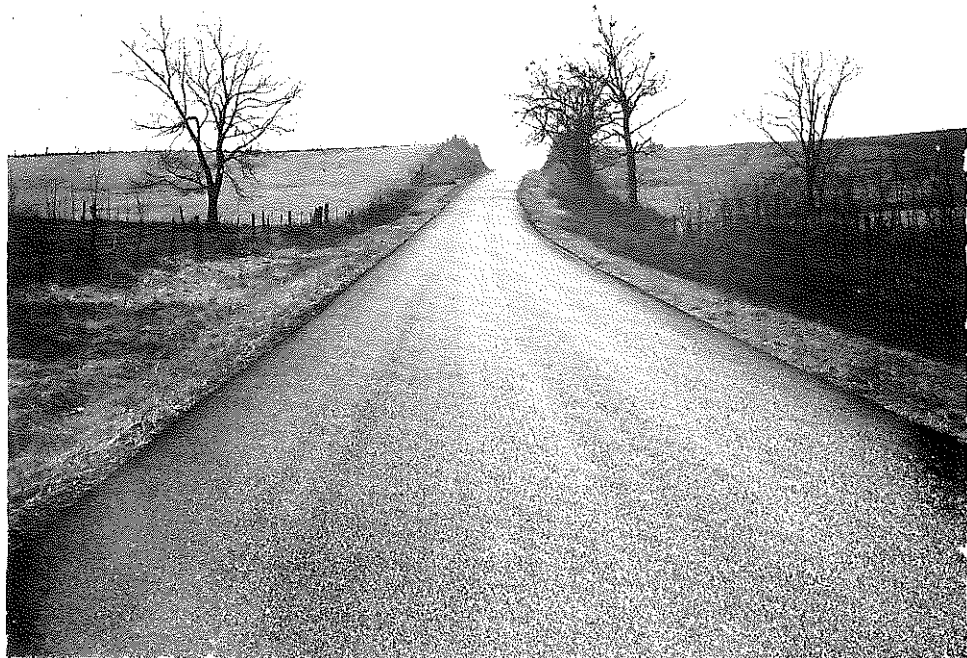
February 13, 1962: The general condition of the project was excellent (Fig. 1). Some areas of rutting and base failures were noted in the outside wheel track of the southbound lane for a distance of approximately 0.3 mile near Buena Vista (Fig. 2). These areas coincide with weak places noted in earlier surveys. This weak condition could also be due to placing a wider pavement than originally existed. There appeared to be some water trapped in the pavement system between the surface and base.

Fig. 1. RS 40-326. Condition of Roadway on February 13, 1962.

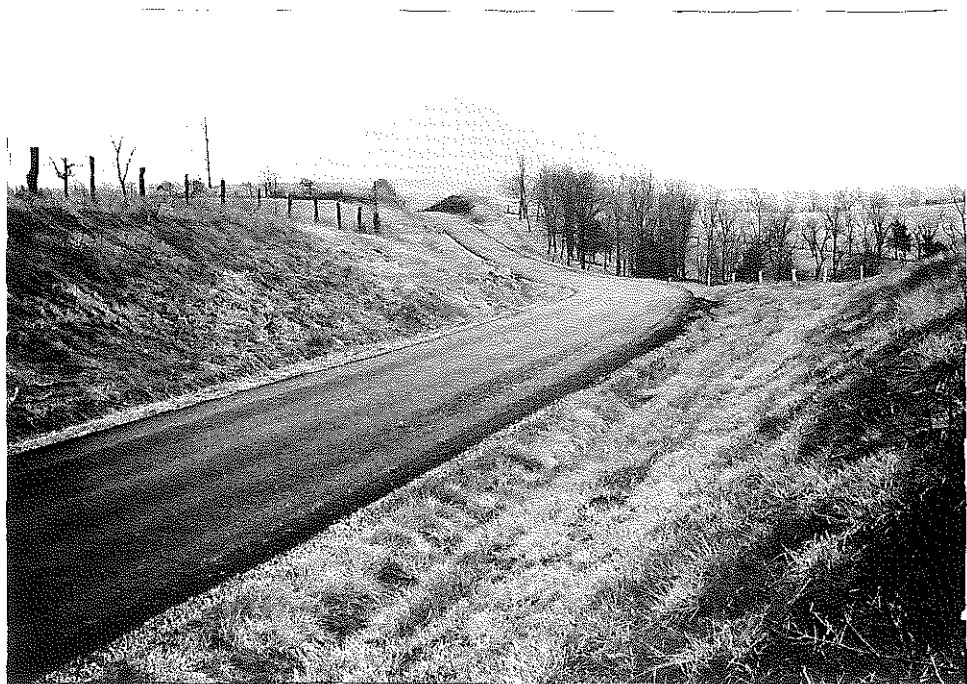
Fig. 2. RS 40-326. Area of Distress in Outside Wheel Track of Roadway, February 13, 1962.

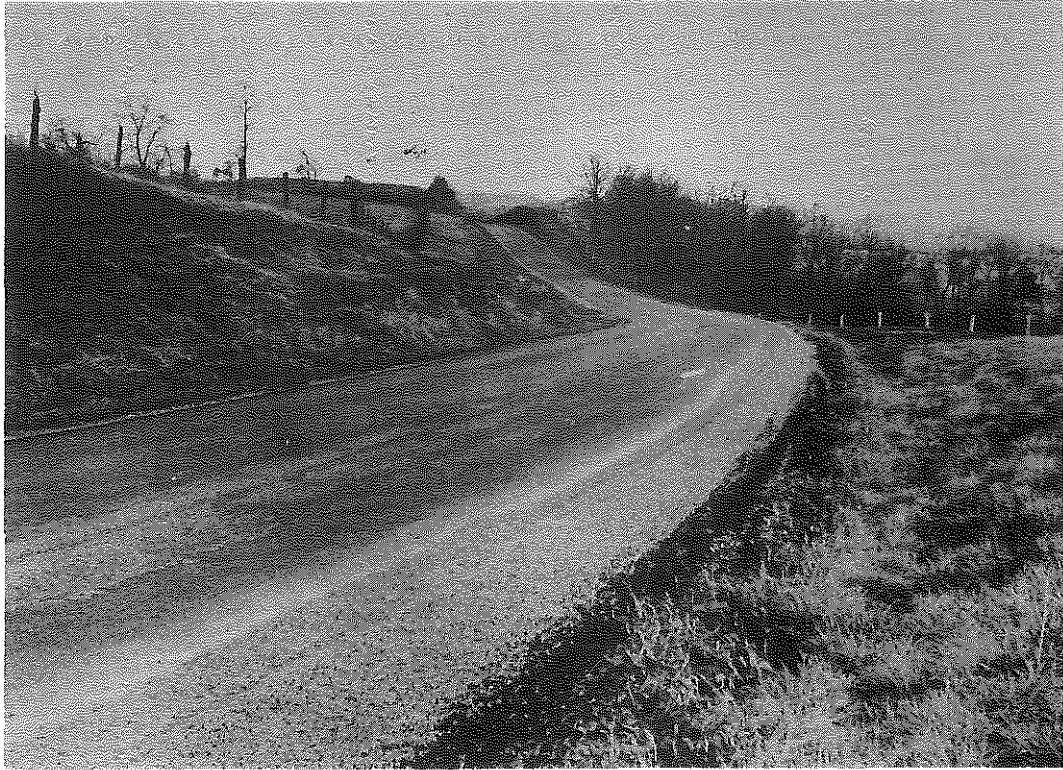
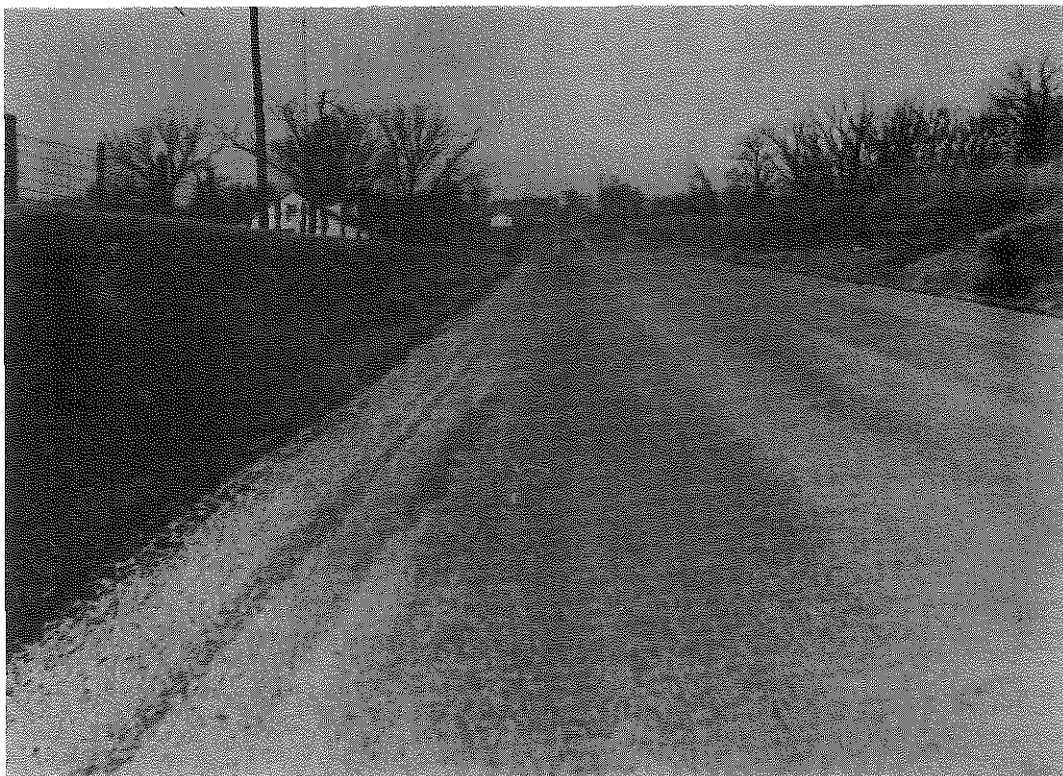
December 27, 1962: The sealed surface appeared to be tight and impervious to water (Figs. 3 and 4). Rutting in the outside wheel track of the southbound lane near Buena Vista was still present. Two areas of surface cracking were noted - one 0.3 mile south of Buena Vista in the center of the pavement (Fig. 5) and one 0.7 mile south of Buena Vista in the outside wheel track of the southbound lane (Fig. 6). Subgrade was starting to extrude through the surface at these locations.

Fig. 3. RS 40-326. Condition of Roadway on December 27, 1962.

Fig. 4. RS 40-326. Condition of Roadway on December 27, 1962.

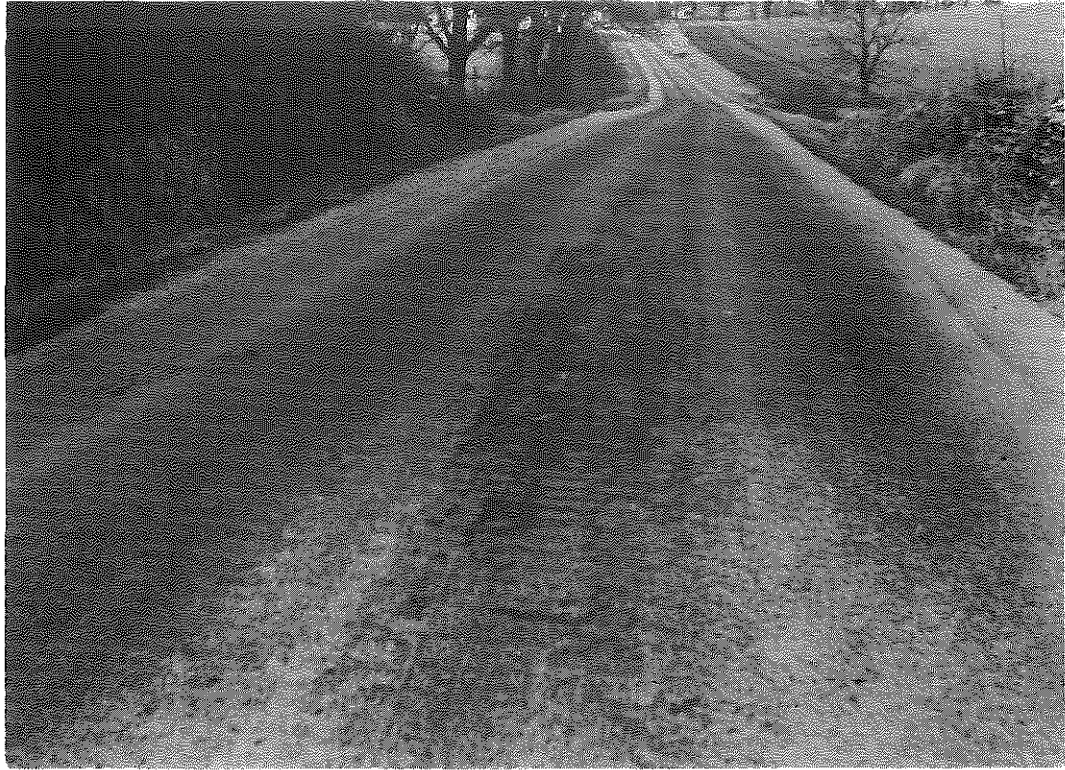
Fig. 5. RS 40-326. Distressed Area in Center of the Roadway,  
December 27, 1962.

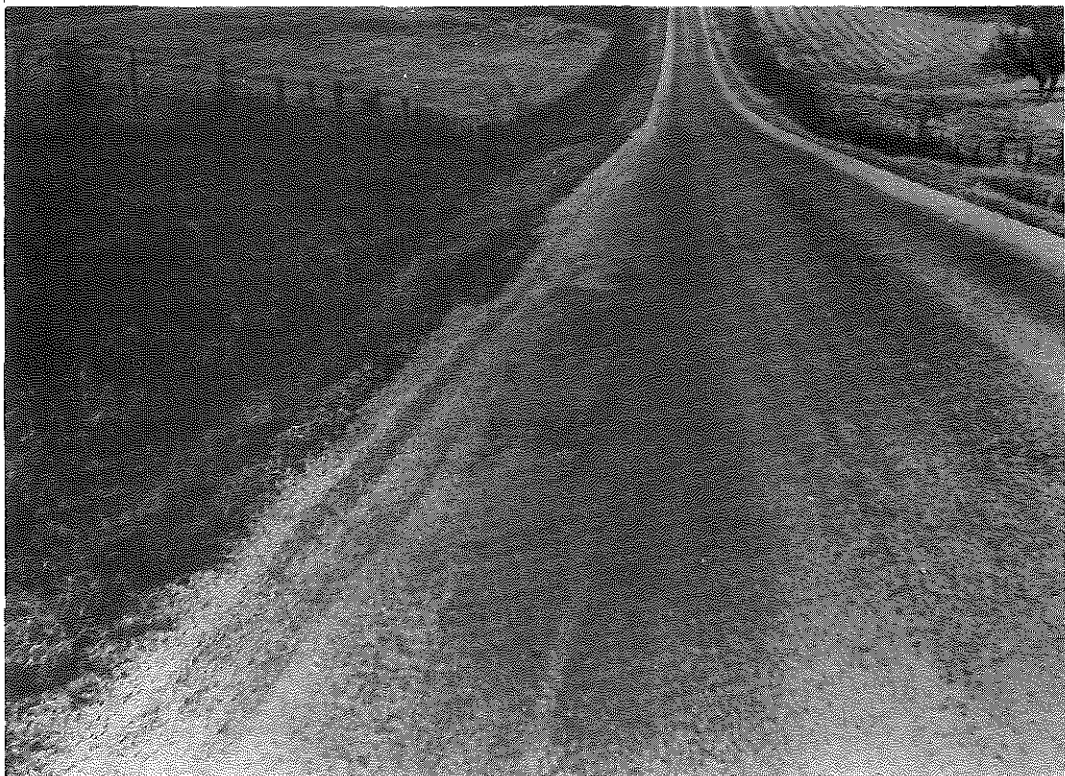
Fig. 6. RS 40-326. Distressed Area in Outside Wheel Track of  
Roadway, December 27, 1962.
