SUBJECT: Interim Report on Rural Secondary, Base-  
Stabilization Projects; July, 1963.

INTERIM REPORT

RURAL SECONDARY, BASE  
STABILIZATION PROJECTS

July, 1963

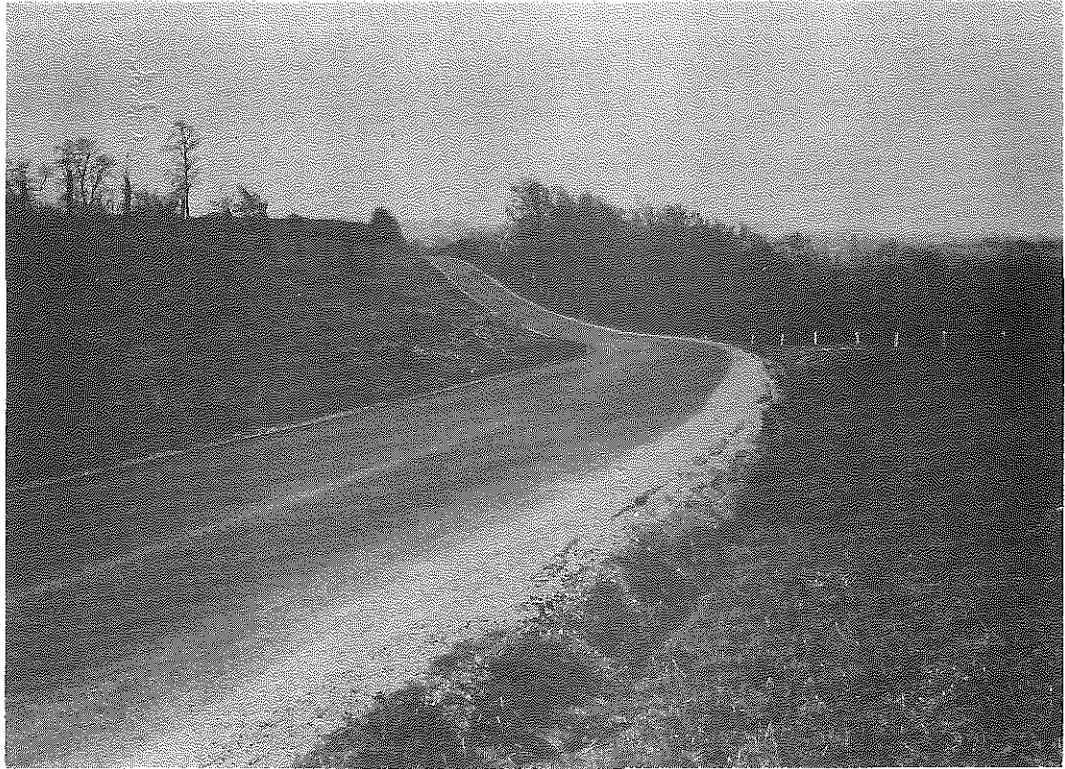
April 19, 1963: Figure 7 shows the general condition of the roadway. Most of the failures noted were in the outside wheel track of the southbound lane. Some areas of settlement and cracking were observed over the length of the project (Fig. 8). Several patches had been placed, one over the center of the road failure observed in the previous survey. Settlement was again occurring in the patch.

Fig. 7. RS 40-326. Condition of Roadway on April 19, 1963.

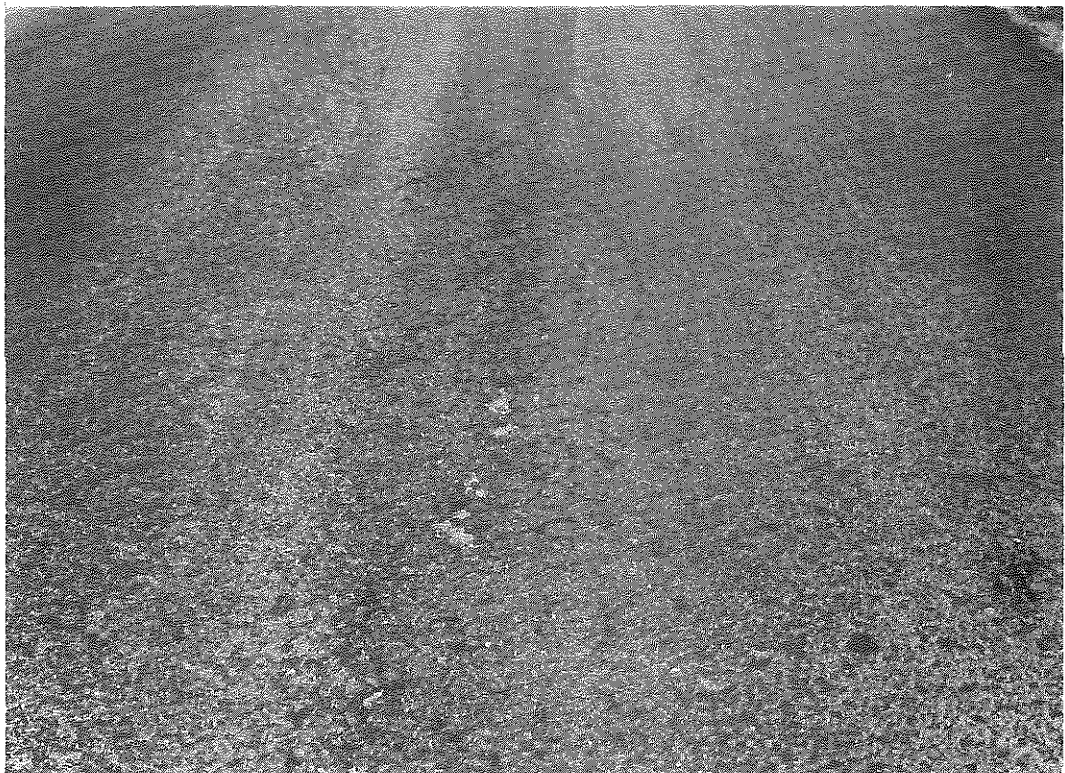
Fig. 8. RS 40-326. Distressed Area of Roadway, April 19, 1963.  
Note subgrade starting to extrude through the surface.

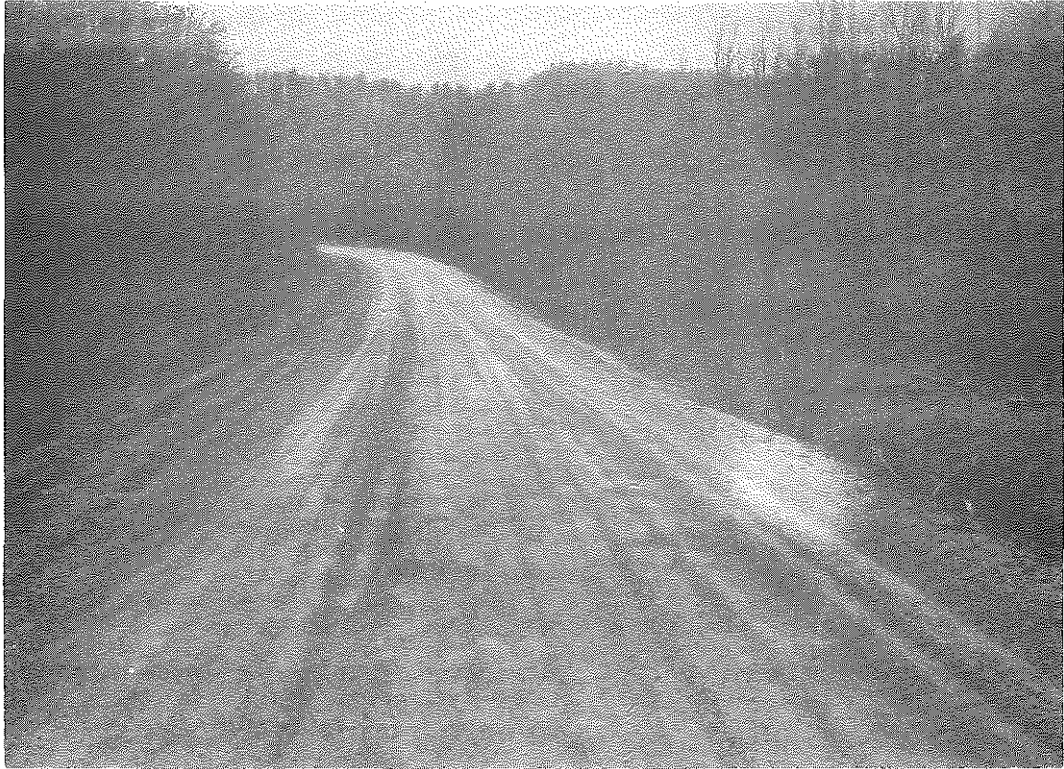
April 15, 1963: Considerable raveling and loss of fines was occurring on RS 65-549 (Fig. 5), the light oil application not being too effective. Only a small number of open potholes were observed on this project. On project RS 65-289 numerous potholes were noted but raveling was not as severe (Fig. 6). It appeared that an application of some type of asphalt surface treatment had been placed on this project.

Fig. 5. RS 65-549. Condition of Roadway on April 15, 1963.

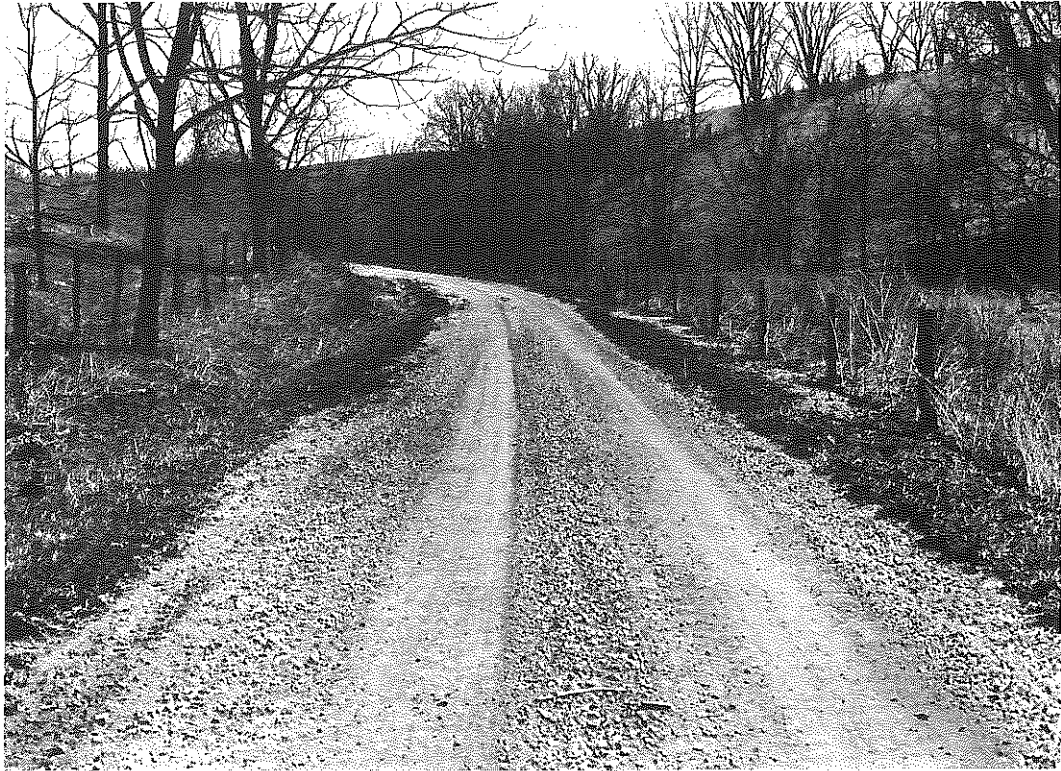
Initial Condition Survey: March 21, 1963: The drainage of the roadway was very poor (Figs. 1 and 2). In some areas the ditches are filled and water has been flowing across the road. The outer foot or two on each side of the metal was extremely soft and unstable (Fig. 3). North of Grassy Lick Creek are many areas where the road is unstable over the entire width. The average thickness of the existing metal was two inches north of the creek and three and one-half inches south of the creek. Figure 4 is a general view of one of the better sections of the project.

Fig. 1. MP 87-377. Poor Drainage Area on Southern Portion of Roadway, April 10, 1963.

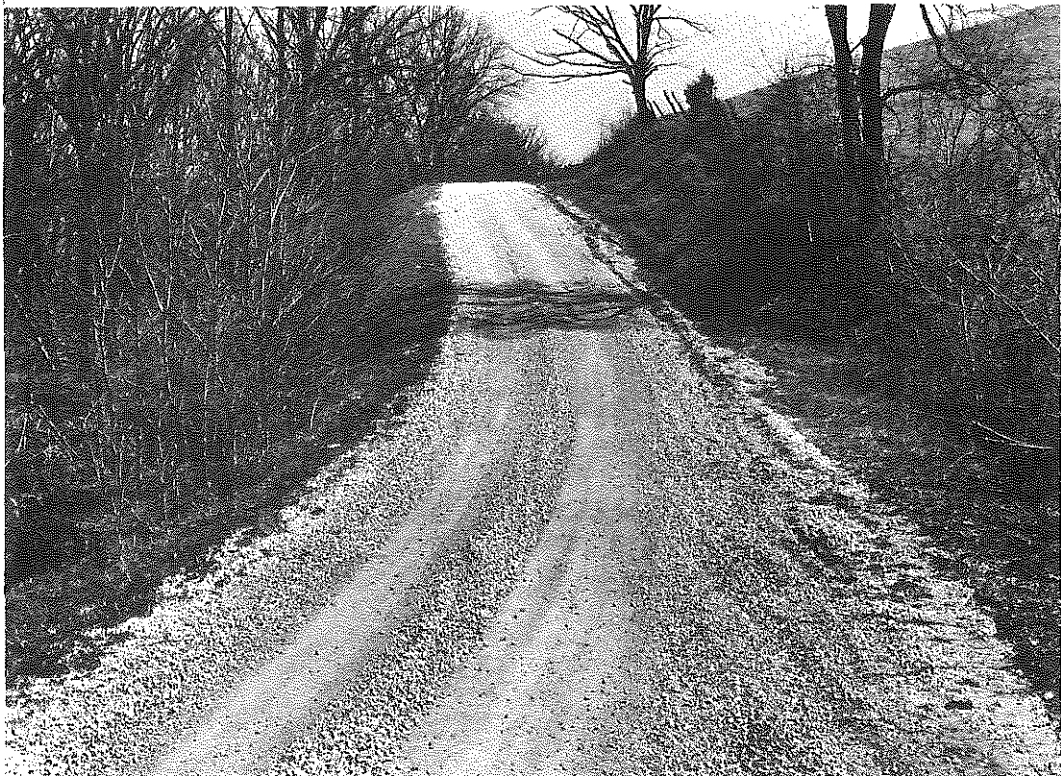
Fig. 2. MP 87-377. Poor Drainage Condition on Northern Portion of Roadway, April 10, 1963.

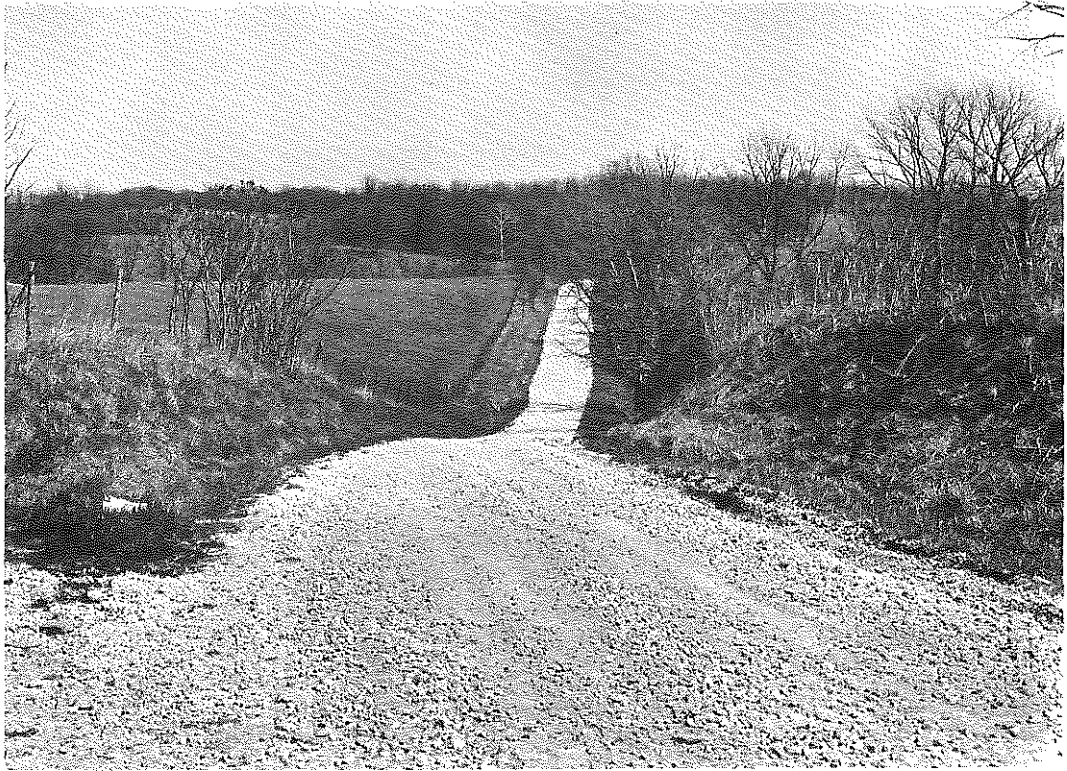
Fig. 3. MP 87-377. Northern Portion of Roadway on April 10, 1963. Note soft area on the right of the road.

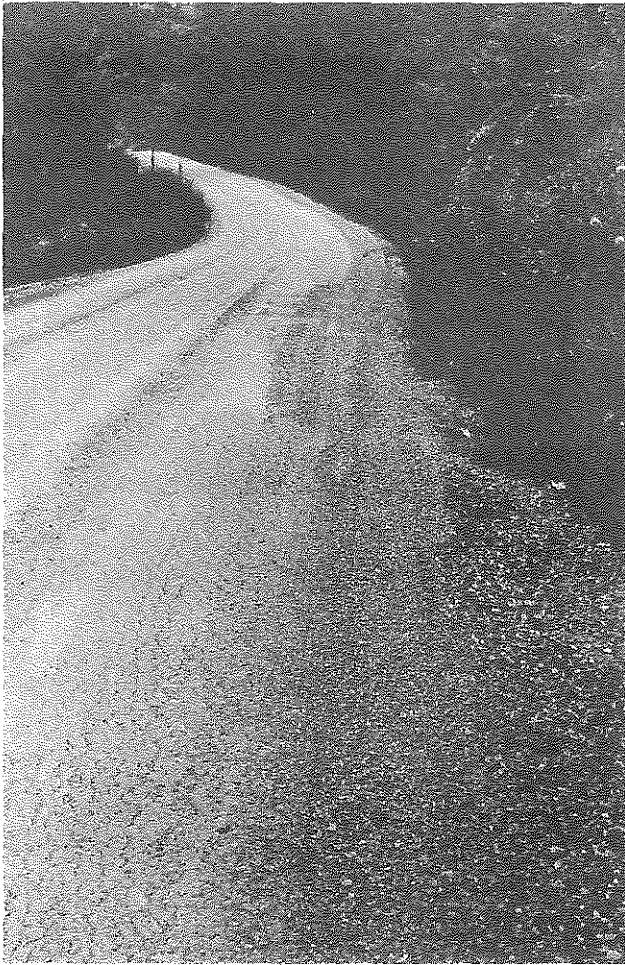
Survey: At end of construction: Figures 4 to 7 show completed sections at the time of construction and shortly after. Note longitudinal cracking due to side slip and failure occurring on the right in Fig. 5. Also potholes formed (Fig. 6) two days after rain.

RS 95-376. Road Condition Shortly After Construction, September, 1962.

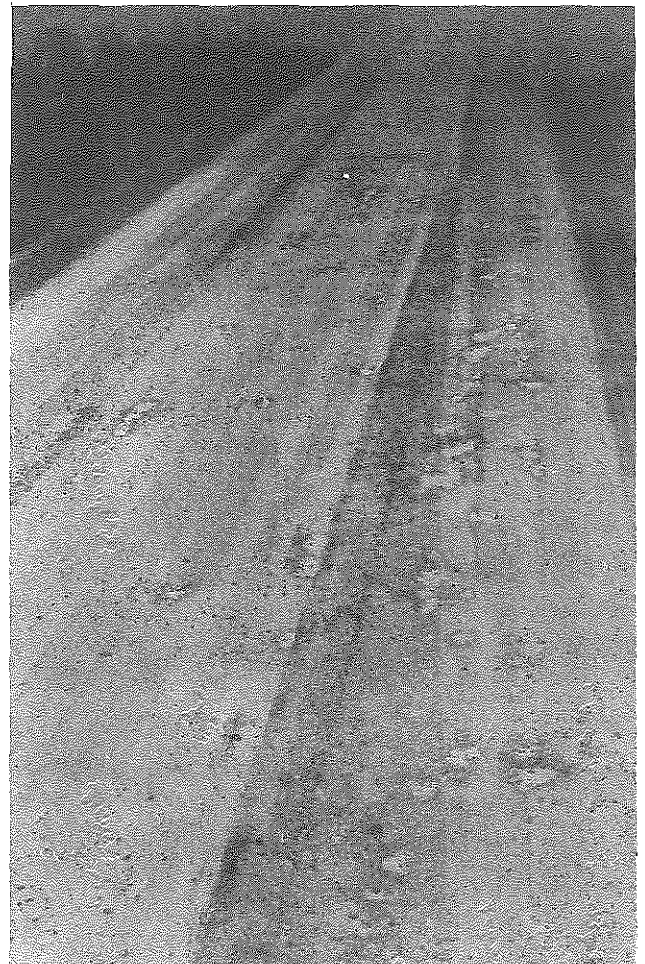
Fig. 6.

RS 95-376. Completed Roadway Two Days After a Rain Shower, September, 1962.

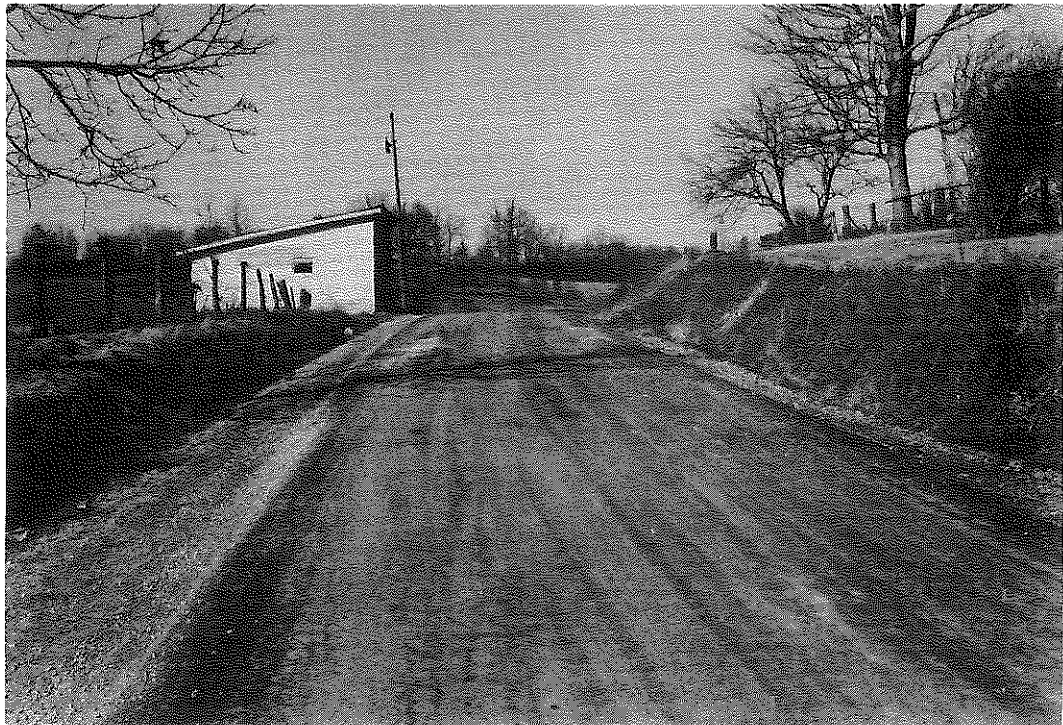
February 6, 1963: A light road oil had been applied to the road since the completion of construction. Map cracking and soft places were observed (Fig. 8). Numerous patches (Fig. 9) and many potholes were also noted.

Fig. 8. RS 95-376. Roadway Condition at South End of Project on February 6, 1963.

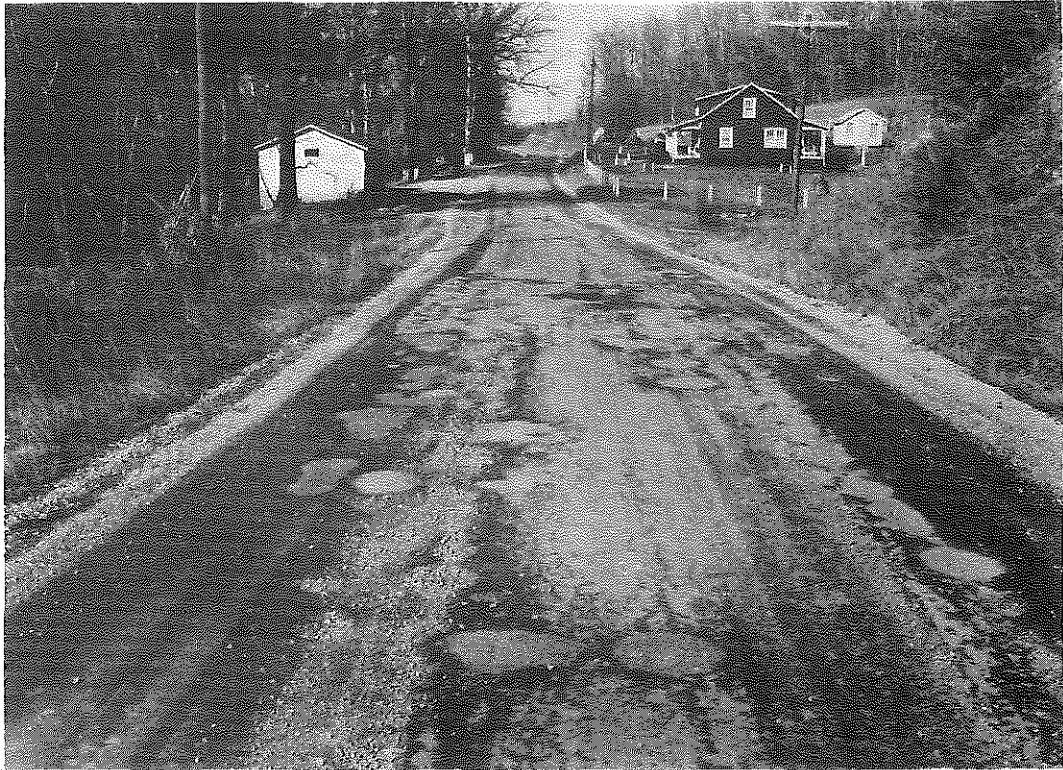
Fig. 9. RS 95-376. Condition of Roadway on February 6, 1963.

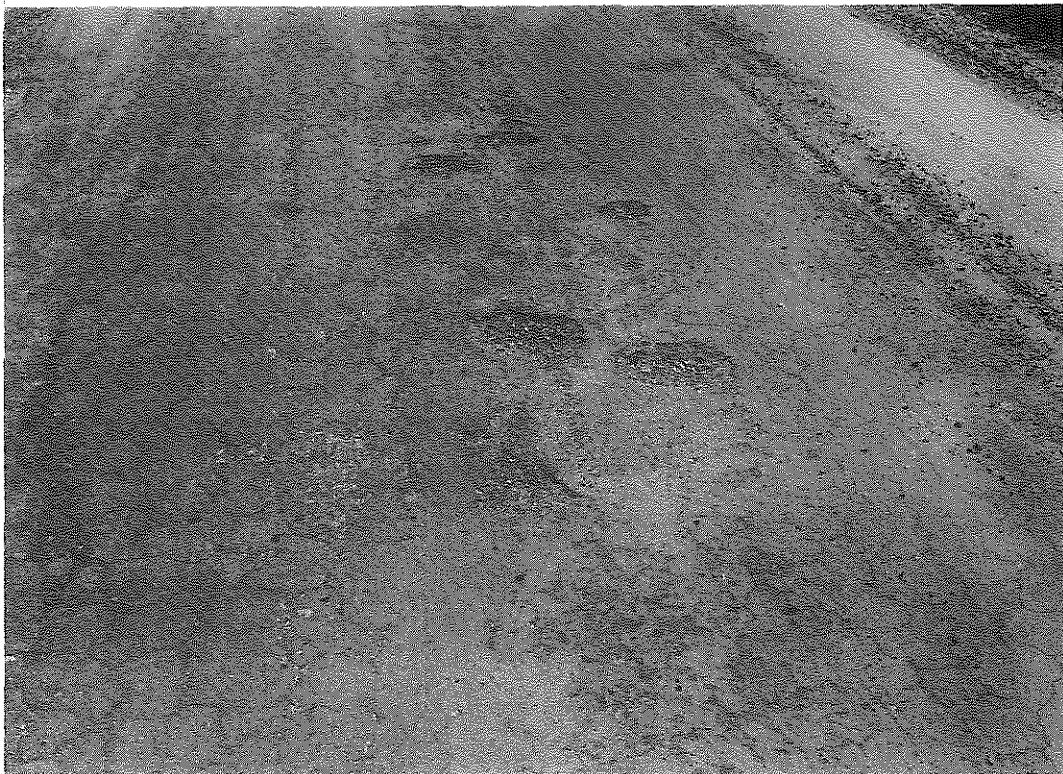
April 15, 1963: Many potholes, both patched and open, were present over the entire project (Fig. 10). Figure 11 shows the amount of raveling occurring over the project. Several soft areas were noted. In the foreground of Fig. 12 is the best section of the roadway.

Fig. 10. RS 95-376. Potholes and Map Cracks on Roadway, April 15, 1963.

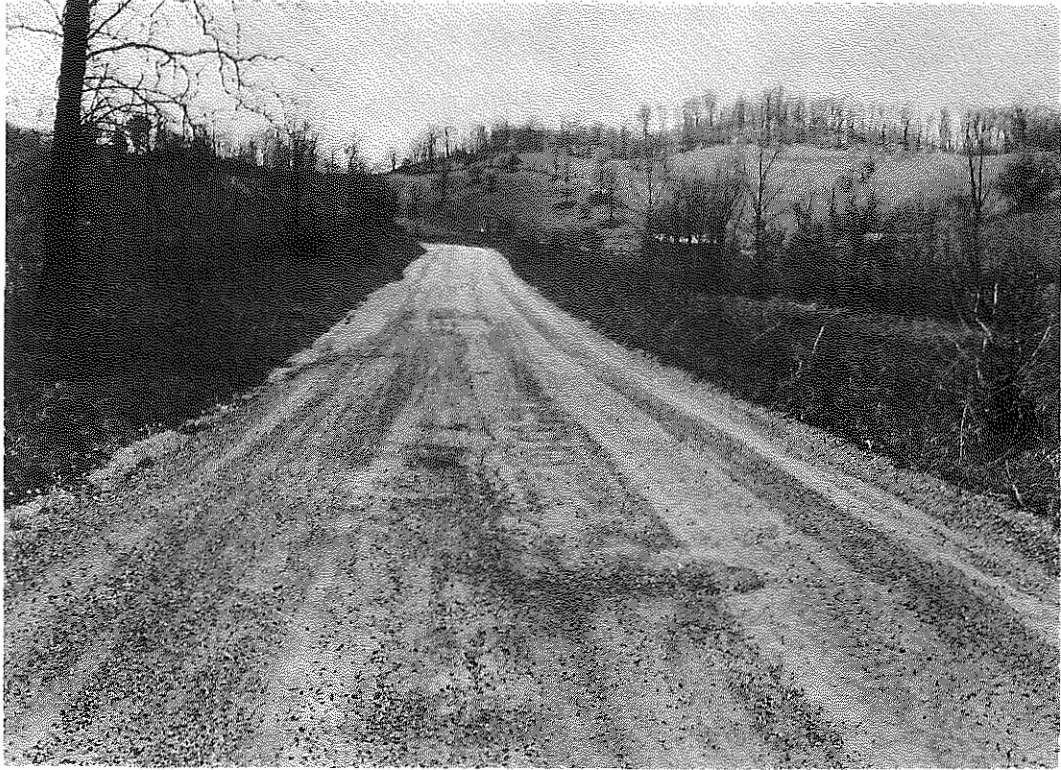
Fig. 11. RS 95-376. Condition of Roadway on April 15, 1963.

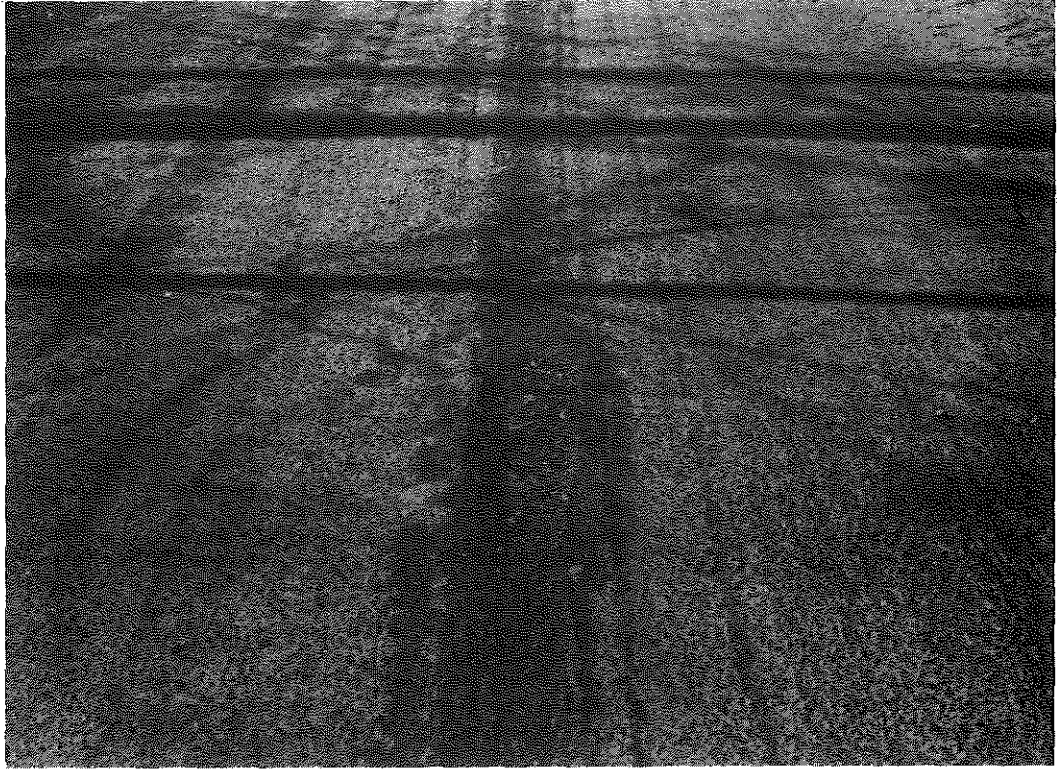
January 22, 1963: The seal did not bond to the base in some areas (Fig. 5), however, it was generally in very good condition (Fig. 6). Figure 7 shows a low wet area on RS 100-635 where the only failure on these projects has occurred to date. Several wet areas were noted on project RS 100-615 (Fig. 8).

Fig. 7. RS 100-635. Condition of Roadway in a Low Area,  
January 22, 1963.

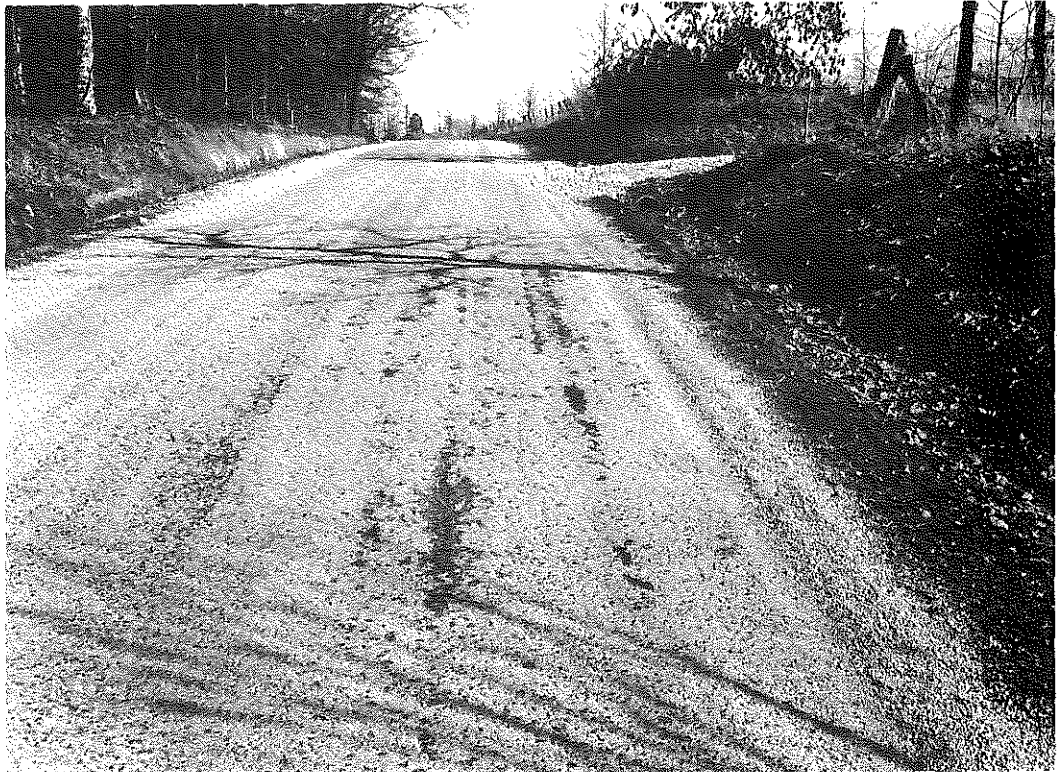
Fig. 8. RS 100-615. General View of a Wet Area, January 22, 1963.
