COMMONWEALTH OF KENTUCKY  
DEPARTMENT OF HIGHWAYS  
FRANKFORT

SUBJECT: Performance Report, Class I, Type B, Initial Treatment,  
PAC-9; Butler County, Morgantown-Woodbury Road; RS 16-1516,  
RS 16-516, RS 16-326

SUBJECT: Inspection-Performance Report; Plant-Mix, Initial  
Treatment; Morgantown-Woodbury Road, Butler County

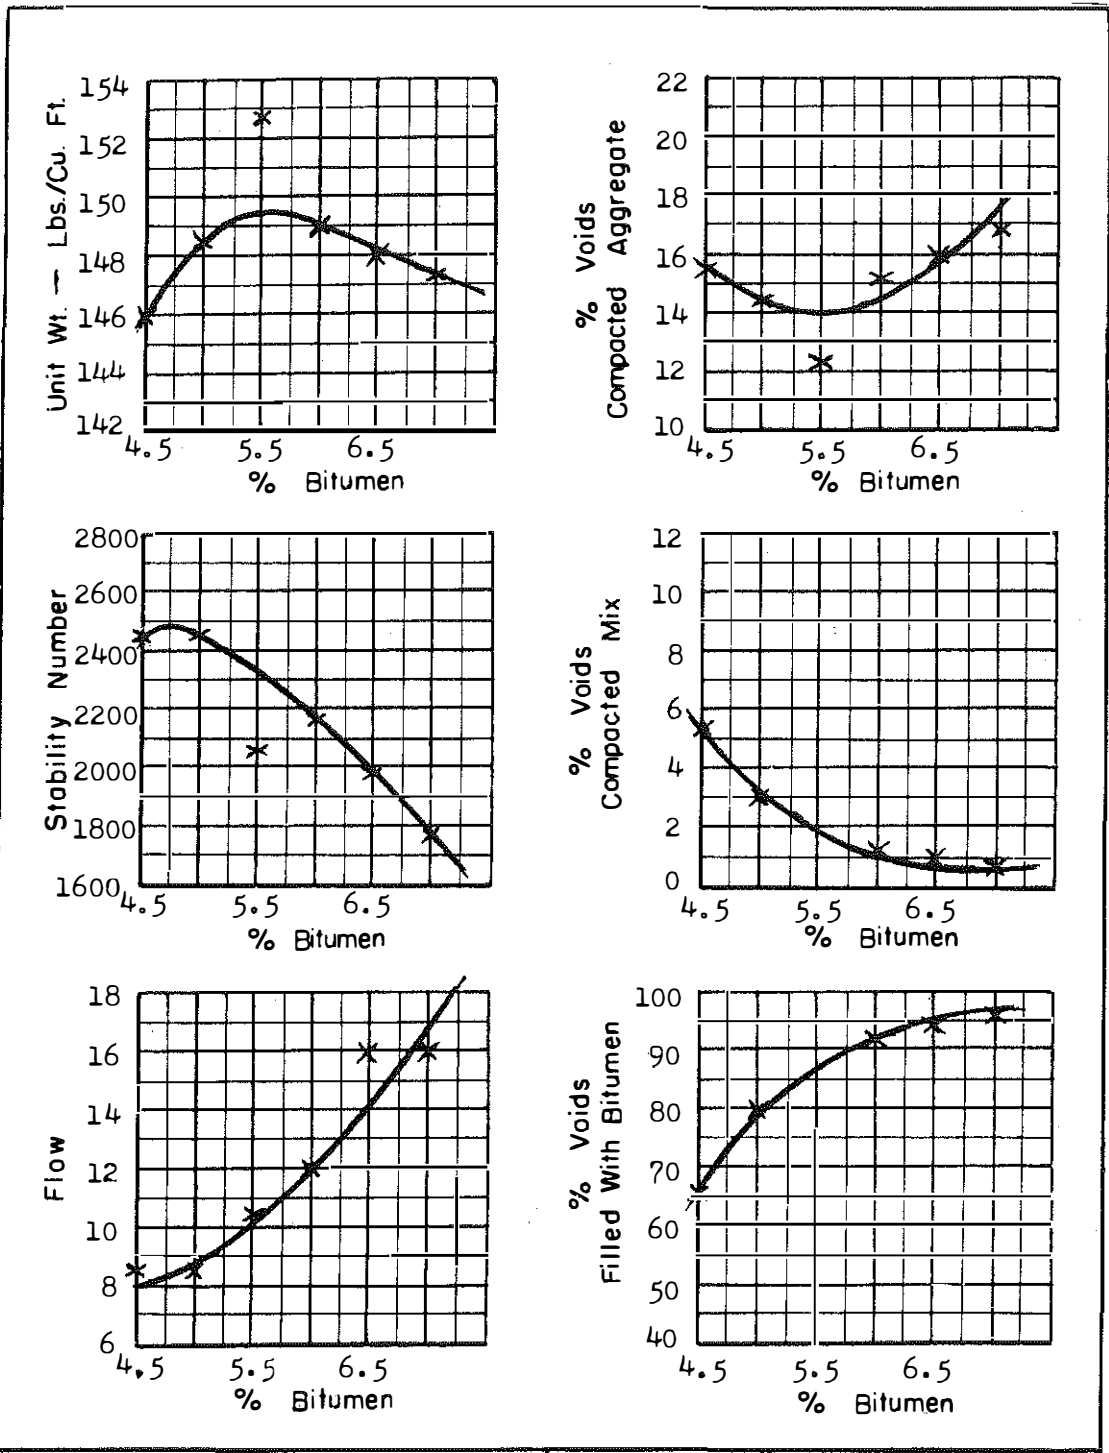
Fig. 1. Marshall Test Property Curves.

In addition to the gradation and extraction data and the stability data given in Tables I and II of the earlier report, a Marshall mix-design series has been performed on aggregates sampled from the project during its construction; and the normal criterion as applied thereto indicated an optimum asphalt content of 5.0 percent. (Note: PAC-5 asphalt was used in these tests rather than PAC-9 which was used on the job.) It may be noted from the graphs of these results, which are included here as Fig. 1, that all of the mixes used on the project were essentially at or above the zero air-voids condition. This was, in fact, the condition sought as the principal experimental feature of the project. However, inasmuch as all of the sections were similar in this respect, the only differences among the sections is in the amount of excess asphalt. Therefore, comparisons of performance are limited to that range of asphalt contents only.

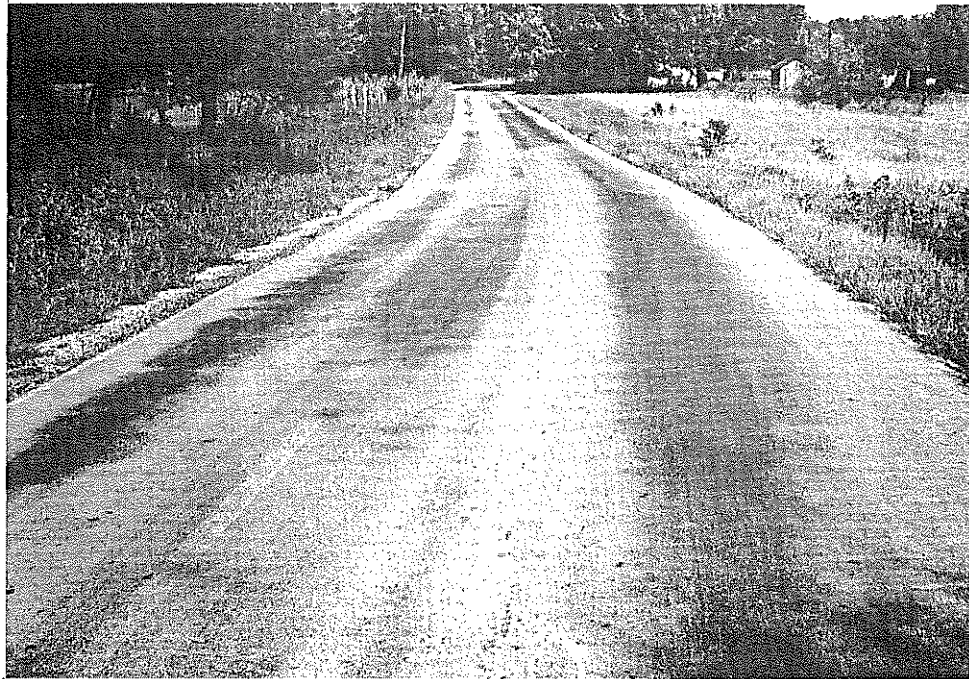
- 6.0% Asphalt - Flushing has been rather spotty  
(See Figs. 2 and 3)
- 6.5% Asphalt - Flushing has occurred in the wheel  
tracks (See Fig. 4)
- 7.0% Asphalt - Excess asphalt has bled to the  
surface throughout the entire section  
(See Figs. 3 and 5)

Fig. 4. Section of Surface Containing 6.5 Percent Asphalt  
(9-13-62).

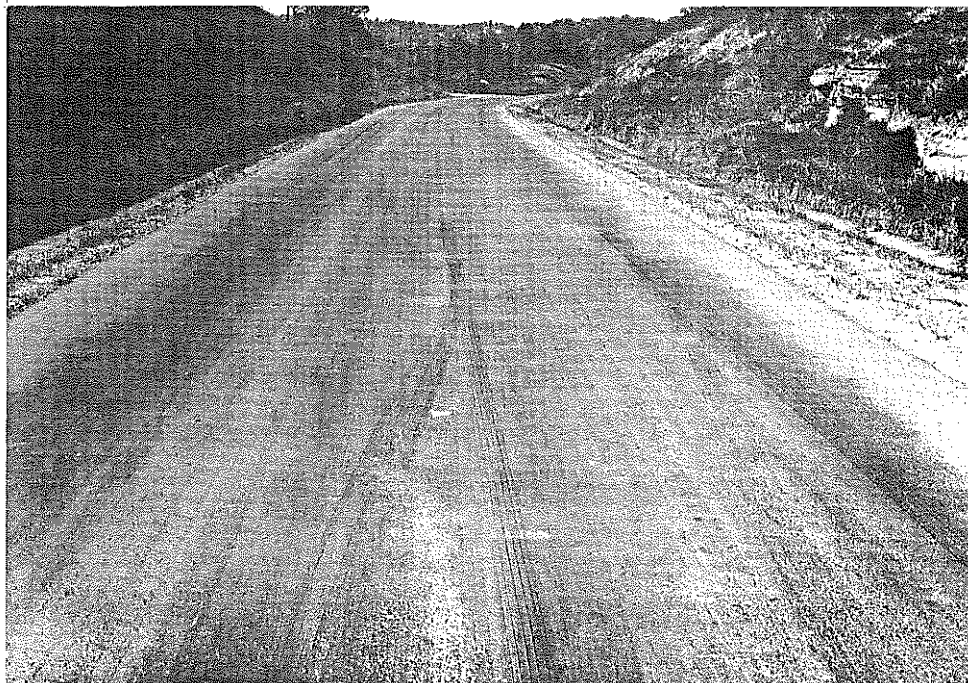
Fig. 5. Section of Surface Containing 7.0 Percent Asphalt  
(9-13-62).

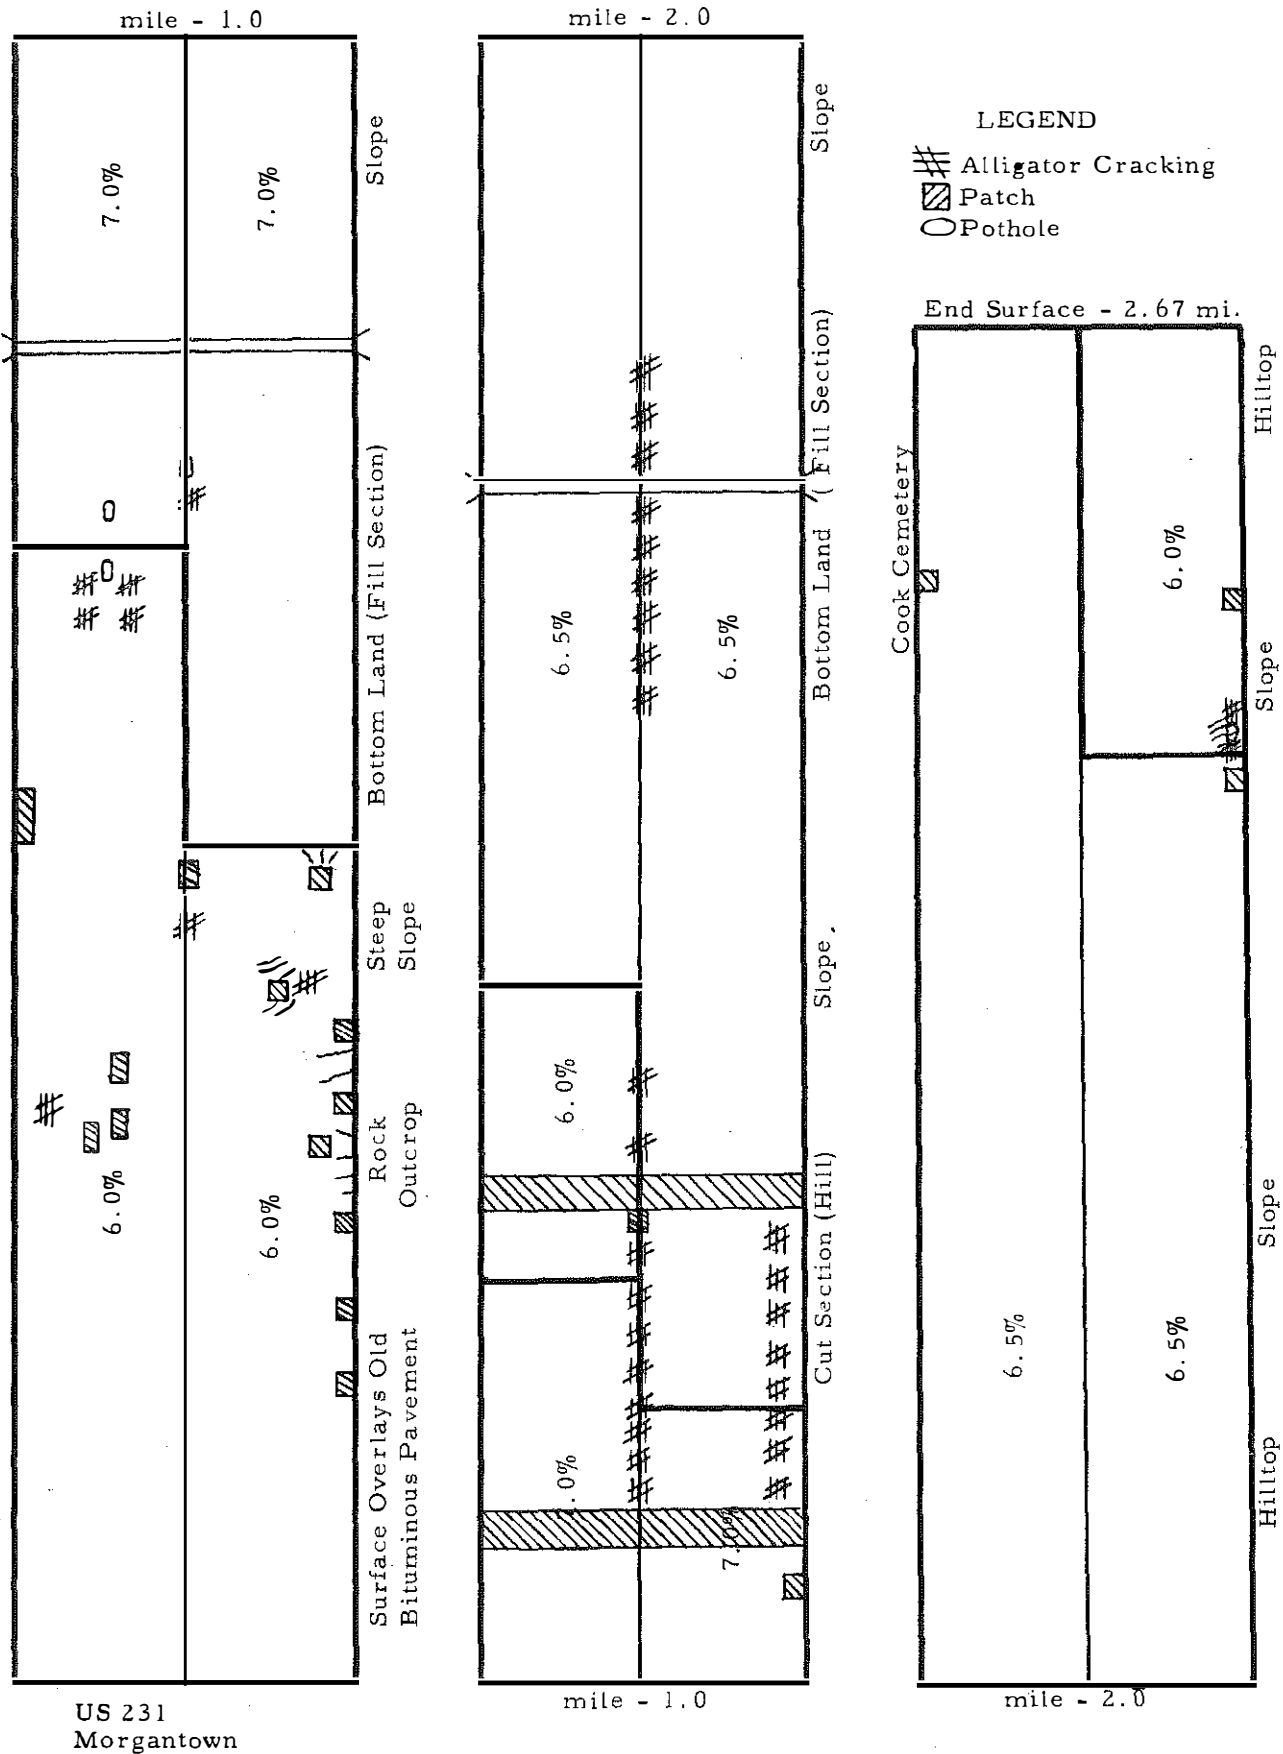
A detailed inspection was made of the project in September and October, 1962, and the locations of failures in the pavement are shown in

black in Fig. 6. All of the failed areas except one were small pot-holes; the one exception extended across the full width of the surface (Fig. 7). This failure was located in a cut-section near the center of the project. On 8,130 lane-feet of surface which was placed at an asphalt content of 6.0 percent, there were eight failures (pot-holes) which required patching; on 13,965 lane-feet which was laid at 6.5 percent asphalt, two pot-holes and one large failed area required patching; and, in 6,090 lane-feet of surface laid at 7.0 percent asphalt, only one rather large pot-hole needed patching. The project was inspected at the end of December, 1962, and it was noted that no additional failures had occurred.

An inspection was made of the pavement on April 8, 1963, and it was found that fairly extensive damage to the pavement had resulted from the severe weather in January and February. Failures had occurred in all of the test sections, and their locations and types are diagrammed, in red, in Fig. 6. No attempt has been made to show every crack in the pavement, but patches and their general location are shown.

Fig. 6. Diagram Indicating Location of Failures. The failures which occurred prior to October, 1962, are shown in black. The failures indicated in red were noted on the inspection of April 8, 1963.

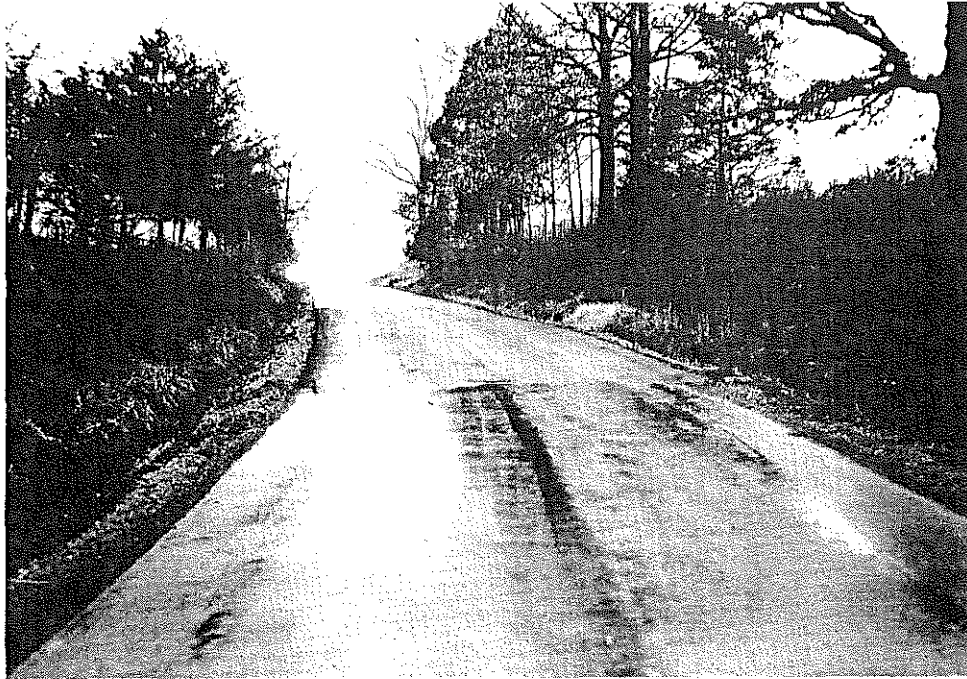
a similar one which occurred the previous winter in a section laid at 6.5 percent asphalt (Fig. 7). These failures, of course, are attributable to instability of the base and subgrade and are rather typical of performance in cut-sections where drainage is poor and where the subgrade is susceptible to frost damage.

Fig. 7. Large Failed Area in a Cut-Section. The failure occurred during the winter of 1961-62. The surface contains 6.5 percent asphalt (1-7-63).

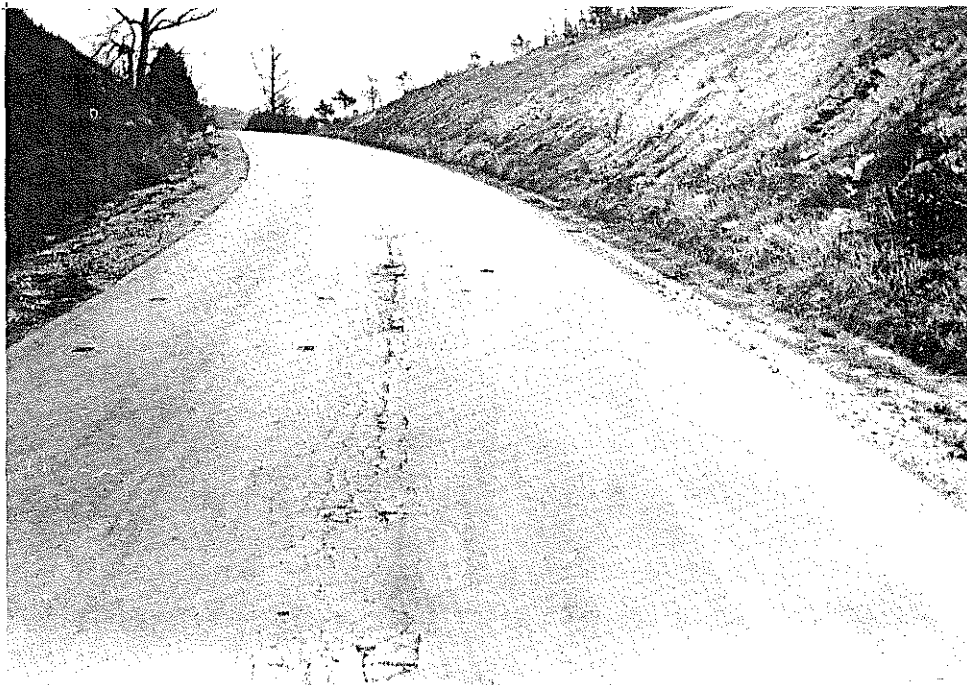
Near the center of the project the road crosses a hill and is in a cut-section. Within this 0.3 mile stretch of roadway, there is considerable alligator-type cracking along the centerline and in the outside wheel-track of the southbound lane (Fig. 8). This cracking is located in a section of surface laid at 6.5 percent asphalt and continues into a section laid at 7.0 percent asphalt. Pieces of the pavement were beginning to ravel out. One failure within the cut-section extends across the full width of pavement and is approximately 30 ft. long (Fig. 9). The asphalt content of the surface was 7.0 percent. This failure is located close to

Fig. 8. Alligator Cracking Along the Centerline and Outside Wheel-Track of Southbound Lane. The surface contains 7.0 percent asphalt. Cracking, along the centerline joint, was the most extensive type of failure which occurred on the project (4-8-63).

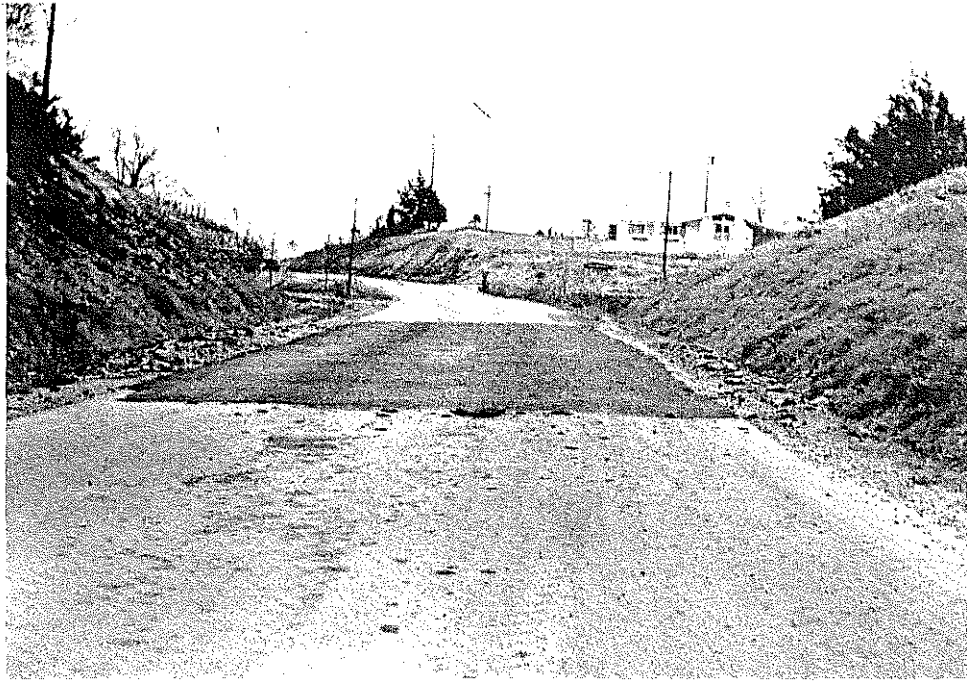
Fig. 9. Large Failure in Cut-Section. The failure occurred during the winter of 1962-63, and is located near the failure shown in Fig. 7. The surface contains 7.0 percent asphalt (4-8-63).

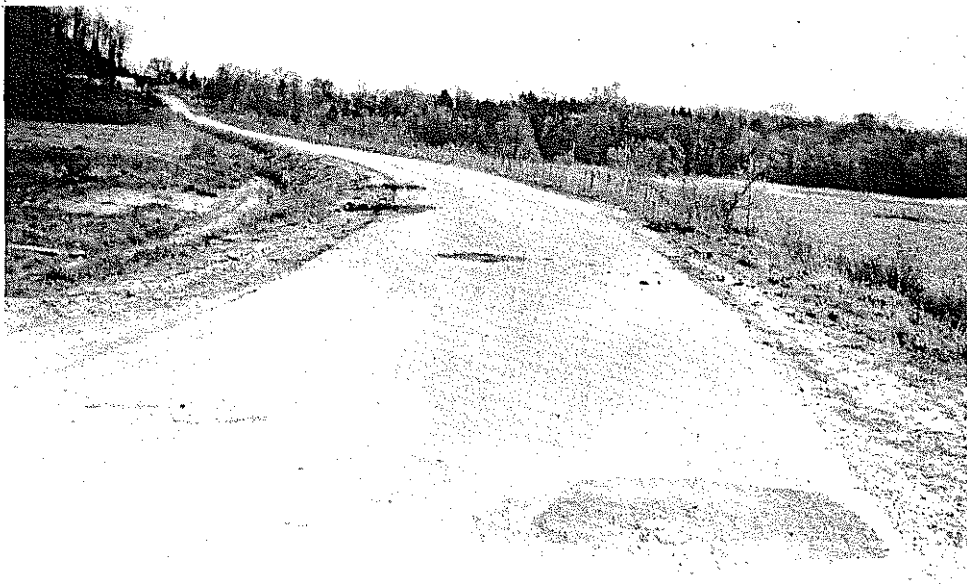
Pot-holes and cracking, of a limited extent, are very noticeable in a section of the surface near the city limits of Morgantown (Fig. 10). The failures there occurred mostly during the winter of 1961-62, and most of them are located over an outcrop of ledge rock. The surface at this location contains 6.0 percent asphalt.

Fig. 10. Small Failures (Pot-Holes) in Surface Containing 6.0 Percent Asphalt. The right lane, in the background, contains 7.0 percent asphalt (4-8-63).
