SUBJECT: Seal-Coat Application to
Clark Memorial Bridge

SEAL COAT APPLICATION TO
CLARK MEMORIAL BRIDGE

SUBJECT: Seal Coat Application to
Clark Memorial Bridge

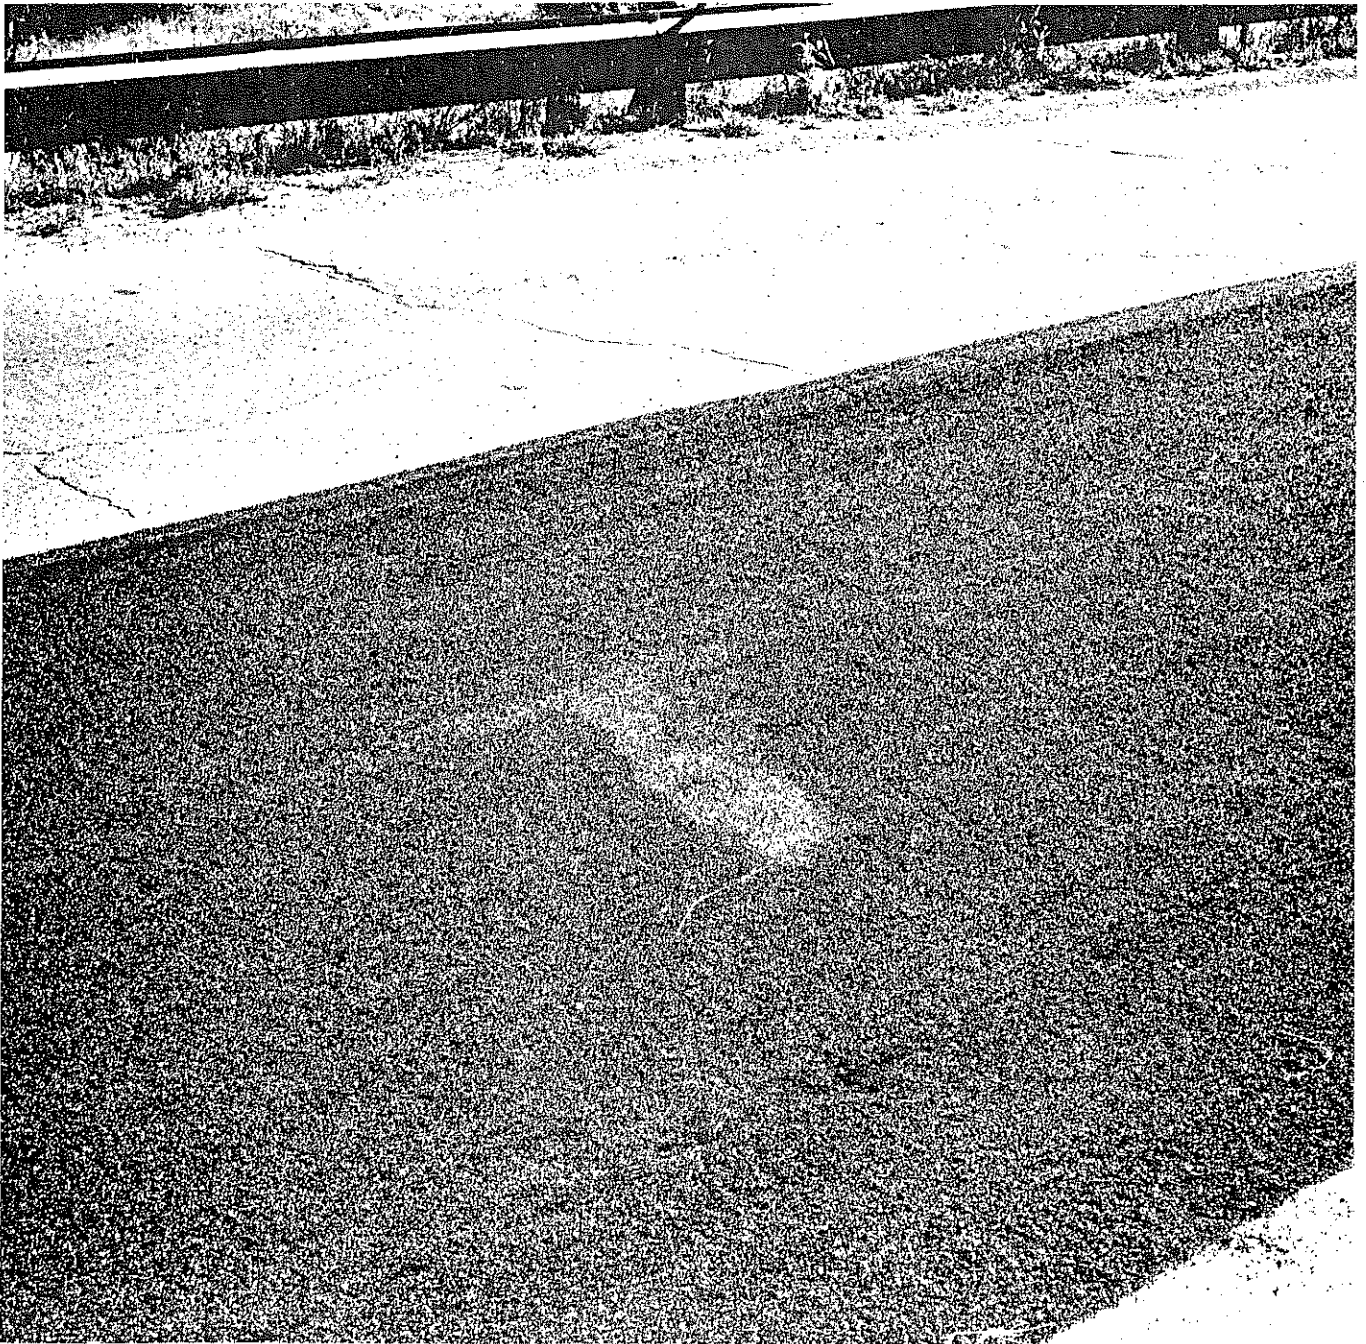
Fig. 3. Photograph Showing Surface Texture Soon After Rolling on Section using the Latex Additive.

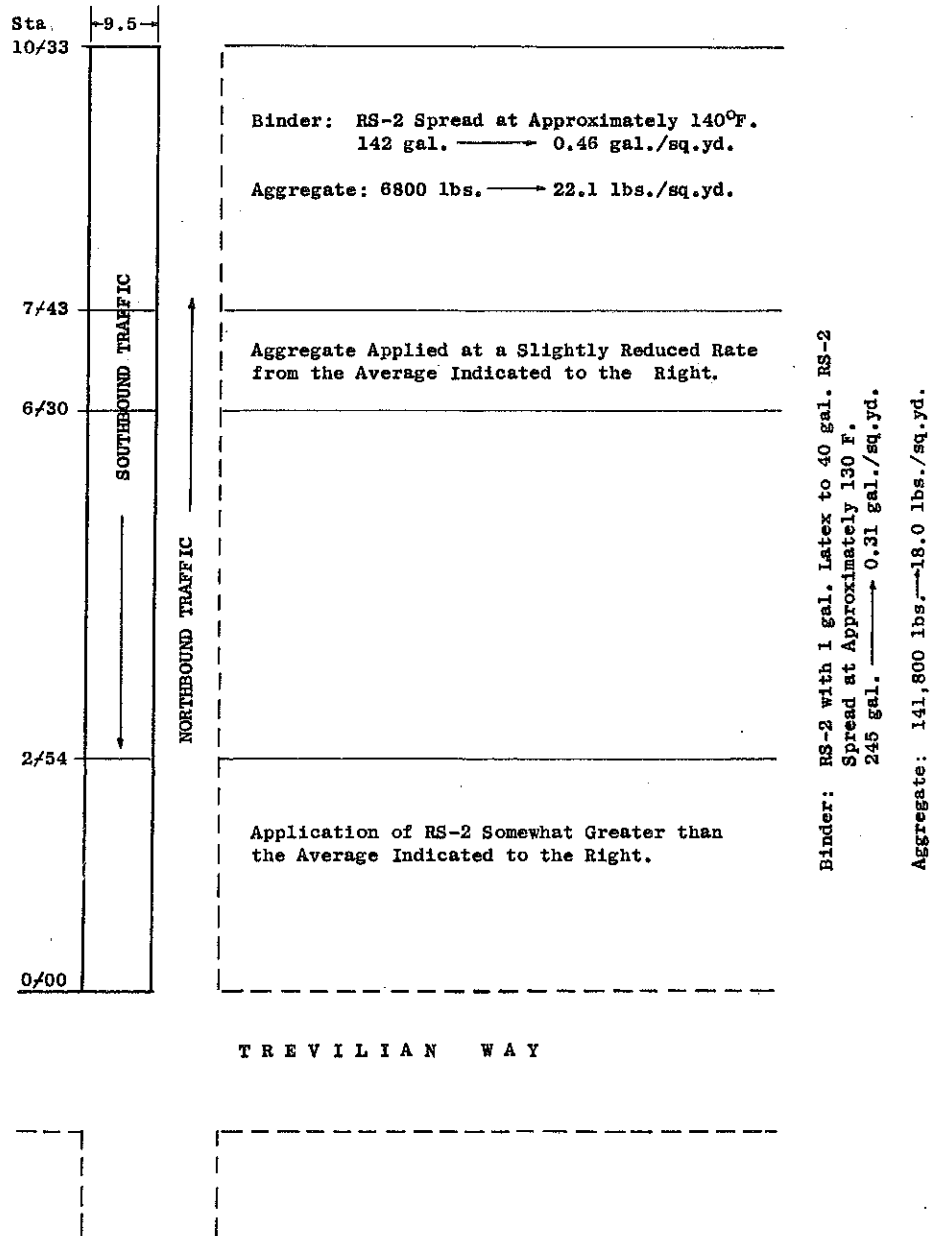
The application of emulsion to the roadway was started at about 9:00 a. m. on October 6, 1961, when the temperature and the relative humidity at Standiford Field were reported to be 55°F and 80 percent. The aggregate was spread by a Flaherty Spreadmaster and a 4-ton pneumatic roller was available for rolling purposes. The seal coat was completed at approximately 11:30 a. m. and traffic was kept off the section until about 2:00 p. m. when the temperature and relative humidity were 74°F and 44 percent. A photograph of the seal coat on the latex section soon after rolling is shown in Fig. 3. A layout of the test section shows the rates of application and the materials used (See Fig. 4).

Fig. 4. Layout of Test Section.
