COMMONWEALTH OF KENTUCKY
DEPARTMENT OF HIGHWAYS
FRANKFORT

SUBJECT: Structural Repair of Concrete Pavement
Barren County Project U 543(3)

SUBJECT: Columbia Avenue, Glasgow, Barren County,
Project U 543(3), Epoxy Resin; 6-7-62 & 6-14-62

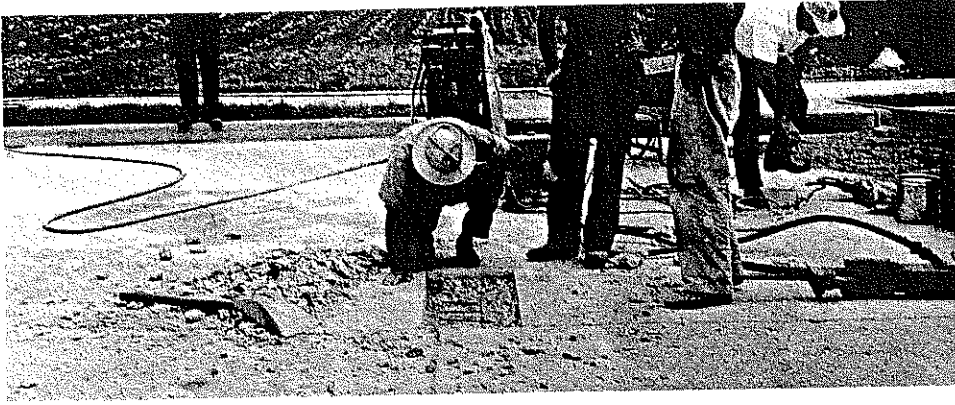
Fig. 1. Defective Area at Station 55 + 75. Hole has not been completely routed and cleaned, 6-7-62.

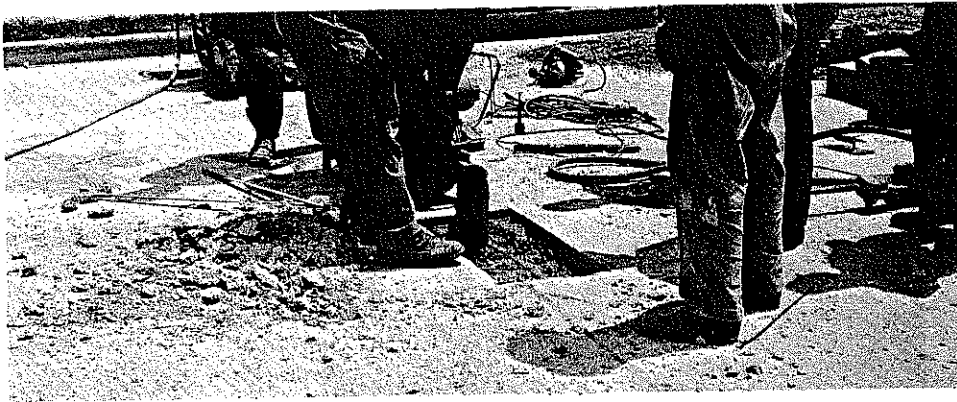
Fig. 2. Station 55 + 75. Hole has been thoroughly cleaned, primed with epoxy, and is receiving the first shovel of "epoxy" patch material, 6-7-62.

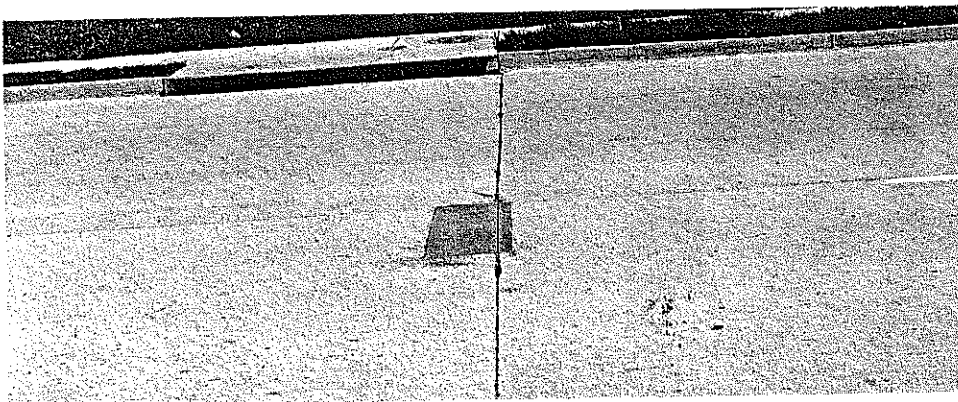
Fig. 3. Station 55 + 75. Joint was re-sawed through the epoxy patch; joint had not been sealed, 6-14-62.

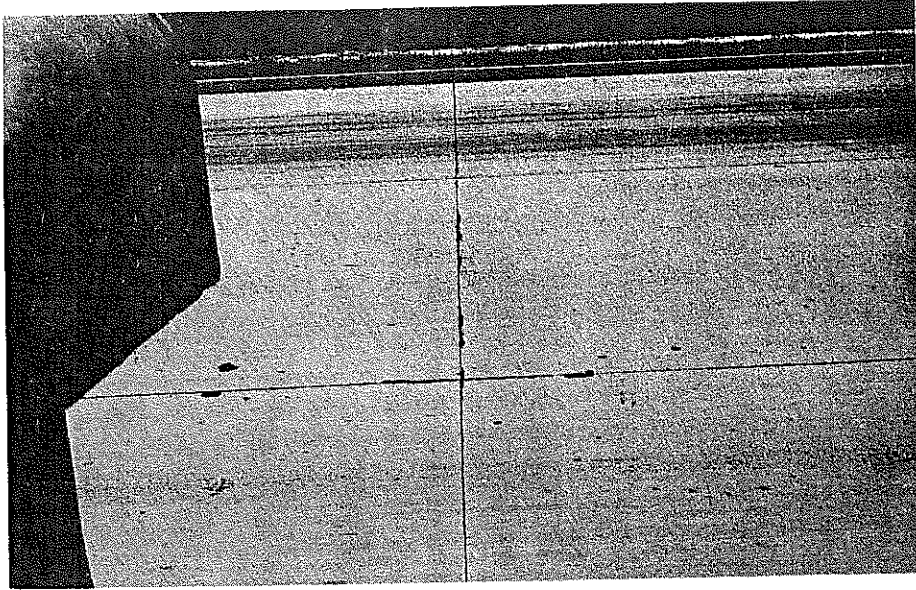
Fig. 4. Defect at Station 59 + 75, 6-7-62.

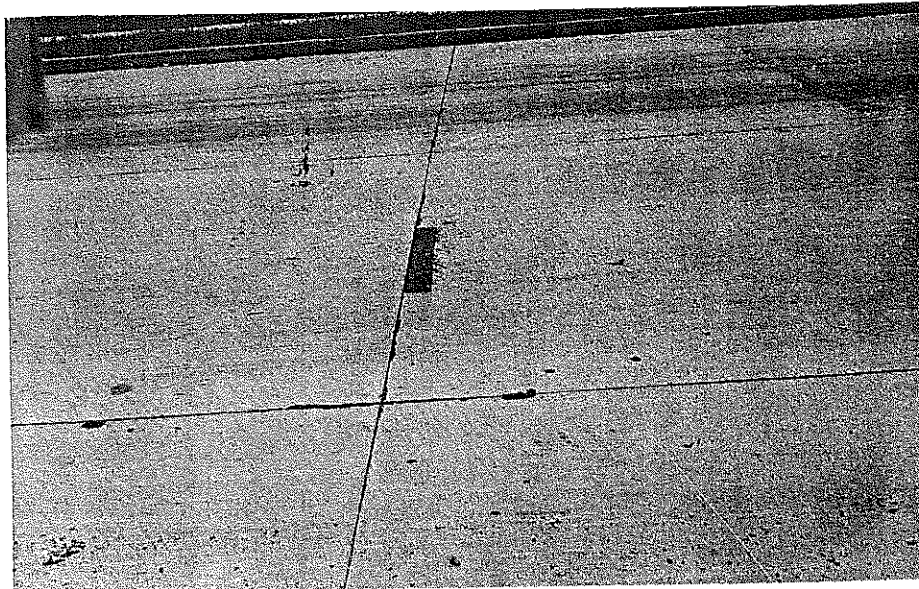
Fig. 5. Repaired Area at Station 59 + 75. Masonite divider wrapped in sheet polyethylene was used to maintain the joint; the divider has been removed but the polyethylene sheeting remains. The joint had not been sealed, 6-14-62.

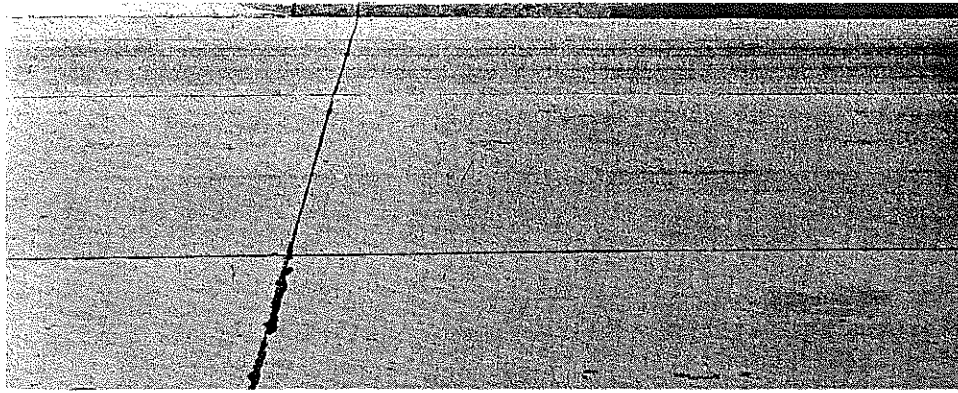
Fig. 6. Defect (transverse crack acting as a working joint) at Station 63 + 27, 6-7-62.

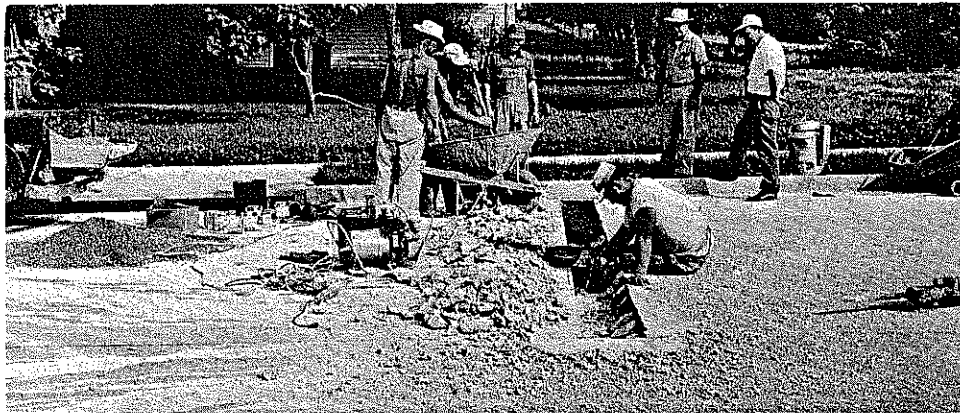
Fig. 7. Routed Defective Area at Station 63 + 27. A groove was formed along the right hand edge of the repair area; the hole is primed with epoxy and some epoxy patching material has been placed as backfill, 6-7-62.

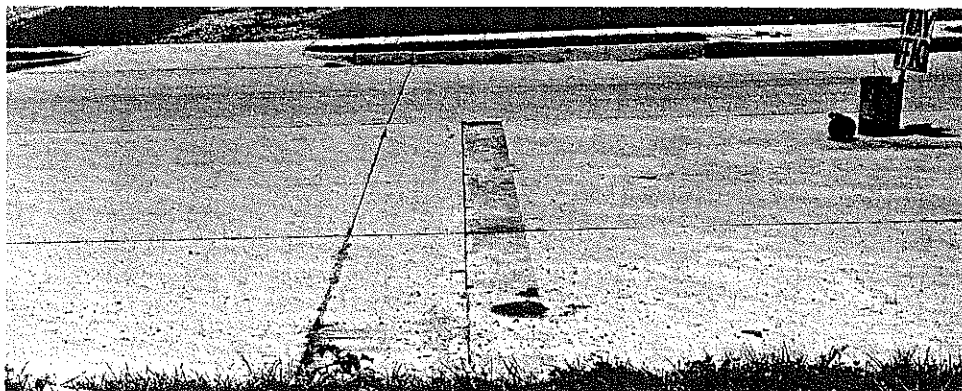
Fig. 8. Repaired Area at Station 63 + 27. Masonite divider wrapped in sheet polyethylene was used to maintain the joint; the divider has been removed but the polyethylene sheeting remains. The joint has not been sealed, 6-14-62.

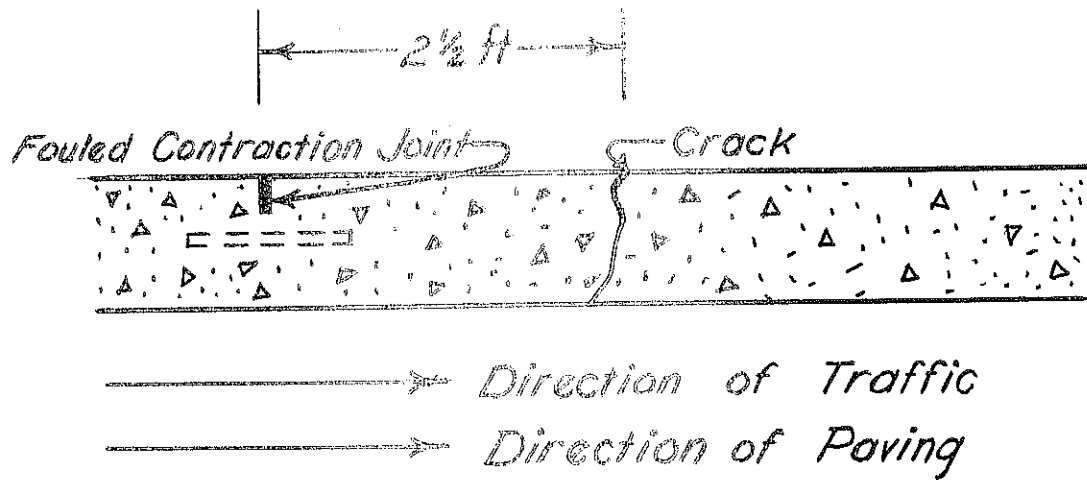
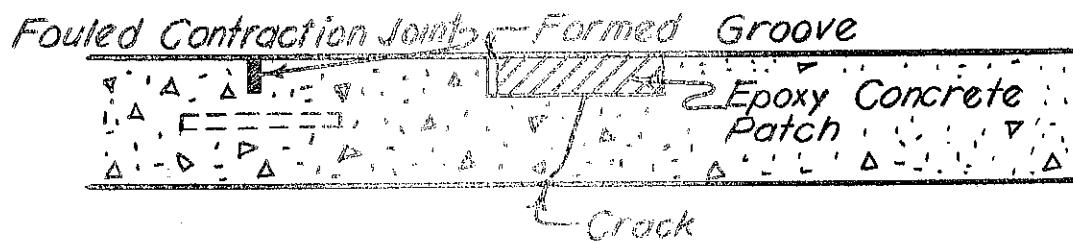
Fig. 9. Sketch Showing the Type and Location of the Crack at Station 63+27, and the Type of Repair Made.

in order to be able to seal the crack with regular joint filler. However, it was apparent that this approach would not provide a significant amount of load-transfer. Ideally, the concrete lying between the joint and a line some two feet away, but completely embracing the crack, should have been removed to full depth, the face of the joint cleaned, dowels straightened, etc., the end of the broken slab painted with epoxy, and the slab restored to the joint with regular concrete. However, this would have necessitated several days curing and would have interfered with traffic. Although this kind of restoration might have been made wholly with epoxy concrete, which would have hardened sufficiently in 24 hours to permit traffic to use the pavement, the cost of this volume of epoxy concrete would have been prohibitive (perhaps \$1500 per cu. yd.). Therefore, and in order to minimize interference with traffic, the fouled joint was left undisturbed, and a left wide swath (embracing the crack) was sawed, chipped out to the depth of the wire mesh, and backfilled with the epoxy concrete. The formed groove was thus offset some six inches from the crack and toward the fouled joint and in the direction of the approach of traffic. However, the epoxy concrete bridged the crack in the underlying concrete (beneath the mesh), and it may be of some interest in the future as to the possible recurrence of a crack reflecting through the epoxy concrete patch, the possibility of a crack occurring at the formed groove at the edge of the patch, or the possibility that the crack might form at the joint as it was originally intended to do. The repairs made here are better illustrated in the attached sketch (see Fig. 9).

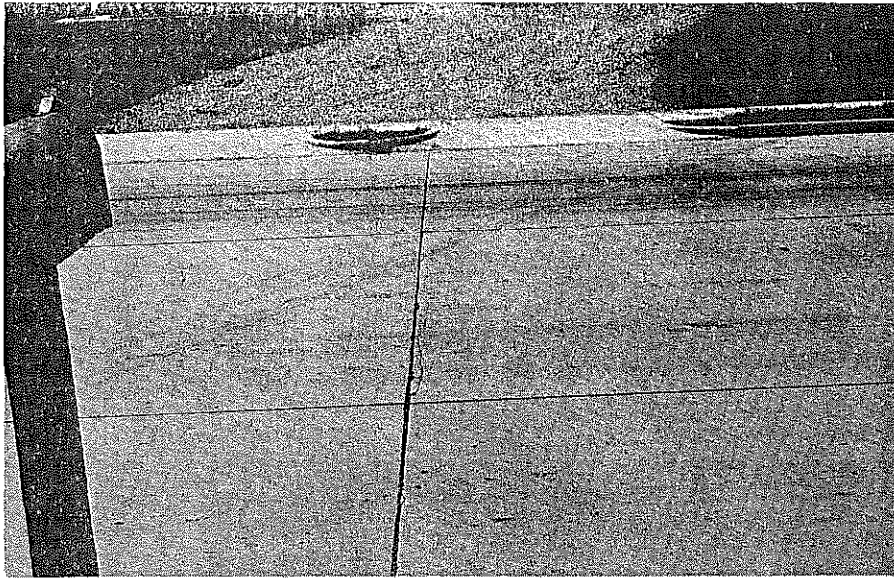
Fig. 10. Defect at Station 64 + 25, 6-7-62.

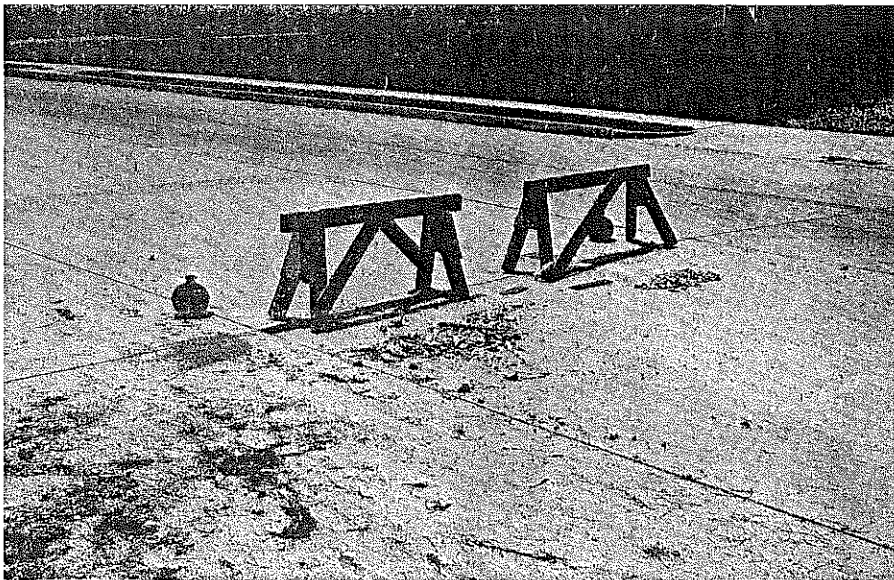
Fig. 11. Repaired Area at Station 64 + 25, 6-14-62.

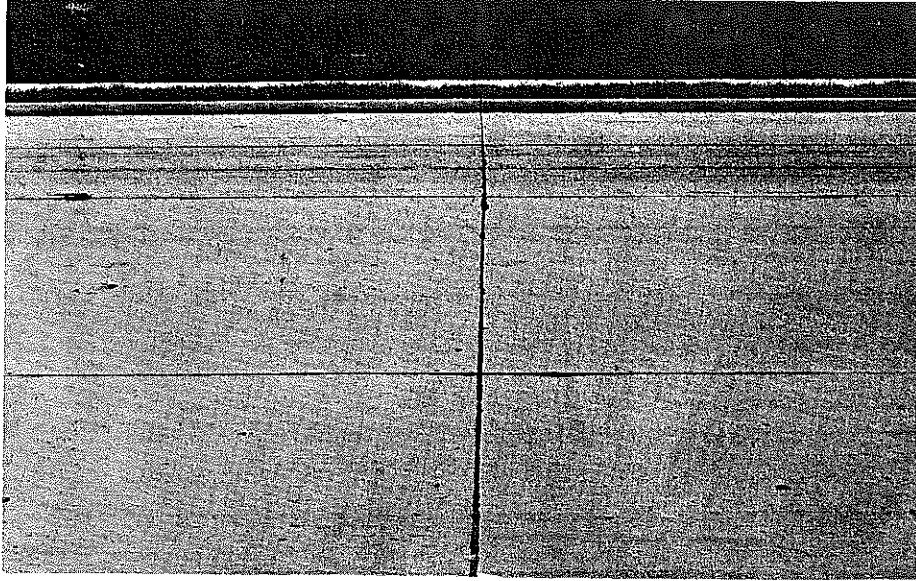
Fig. 12. Defect at Station 64 + 75, 6-7-62.

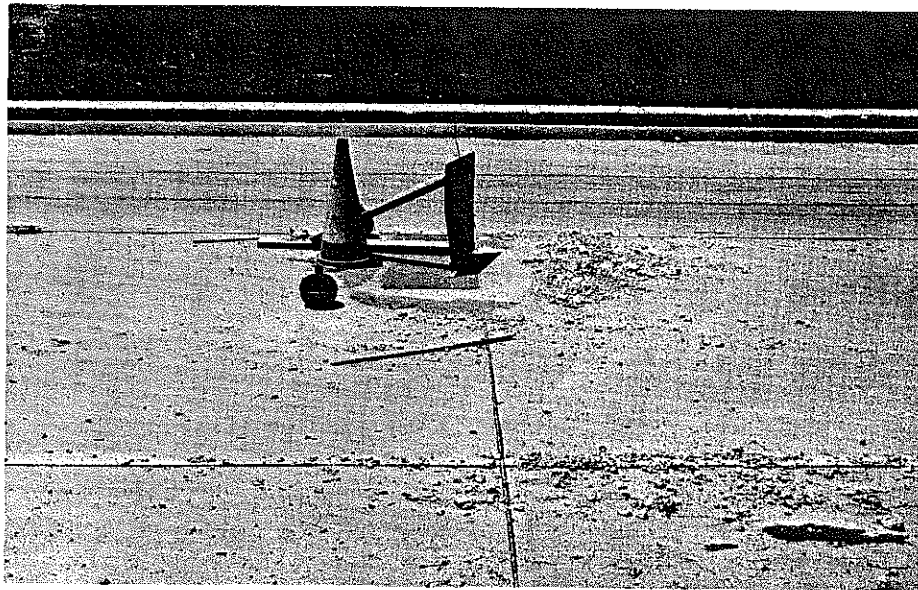
Fig. 13. Repaired Area at Station 64 + 75. Margin of patch nearest foreground was finished about 5/8" high; material was allowed to sag due to crown in pavement, 6-14-62.
