Commonwealth of Kentucky
Department of Highways

TEN RURAL HIGHWAY BASE STABILIZATION PROJECTS

James H. Havens
Senior Research Engineer

August , 1957

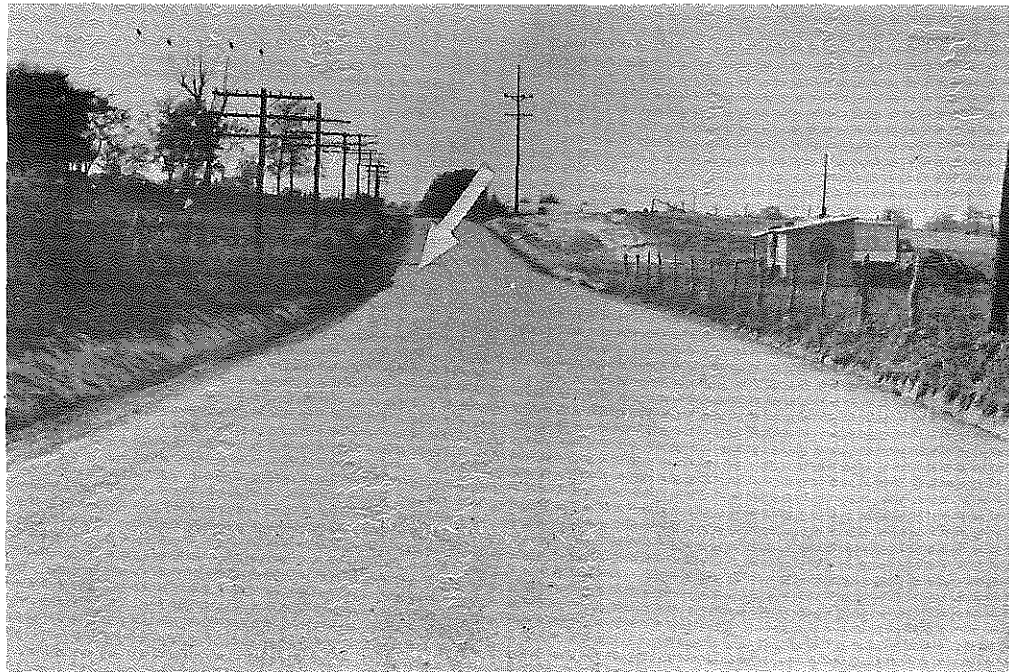
Fig. 6: Breckinridge Co.: Curve at Middle of Project, after Sealing. Arrows point to spots where single seal failed to stick. (10-17-56)

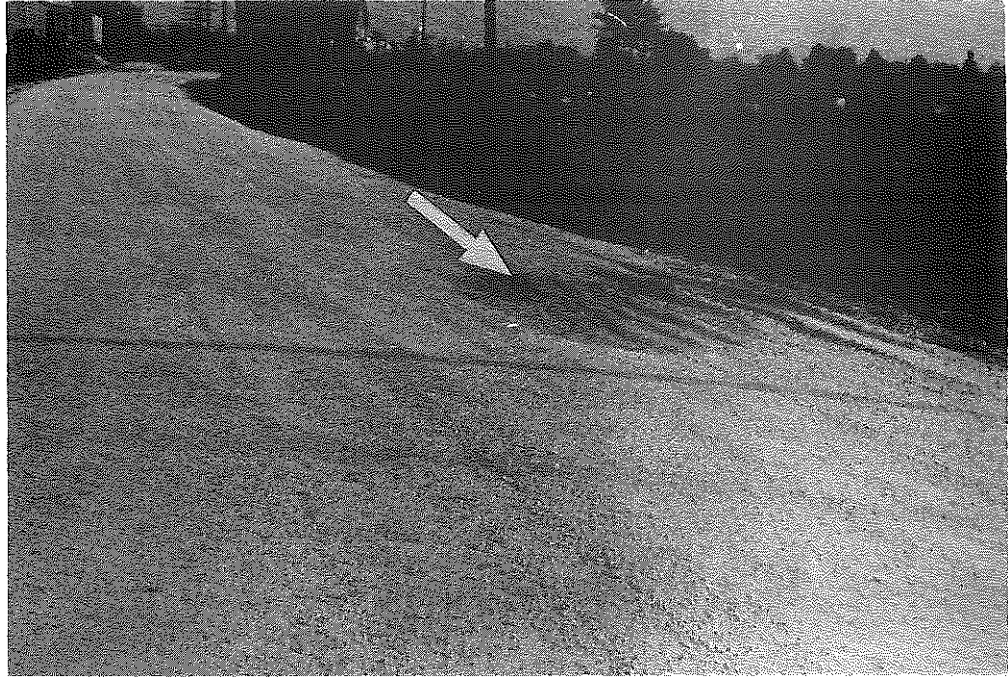
Fig. 7: Breckinridge Co.: Same Section of Road Shown in Fig. 3, after Application of Single Seal Coat. Arrow indicates a soft spot, kept saturated by pond in field to left.

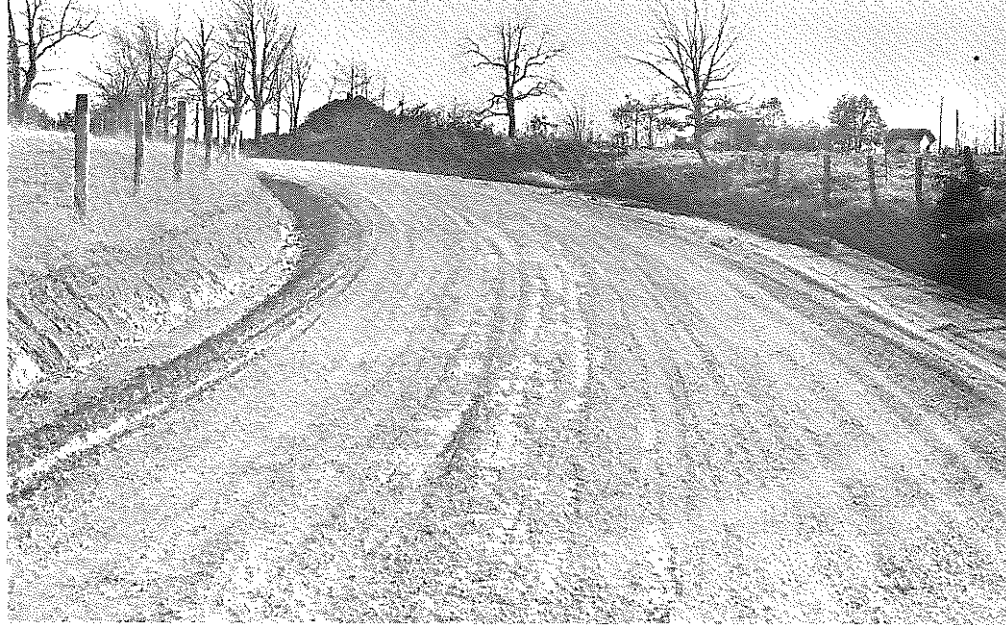
1. Breckinridge County - From the series of pictures, it is quite obvious that there has been a considerable loss of seal from the road. Further, it is a well recognized fact that soil-cement bases, unless adequately protected and sealed, are not in themselves sufficiently resistant to wear and weather. Loss of seal here is not considered as a failure of the base or of the seal material, but as evidence of the need for intermediate treatment and preparation of these bases for application of the seal -- that is: treatment to bond the seal properly to the base. The road was quite dry and dusty when the seal asphalt was applied, and the emulsion apparently broke before it had thoroughly penetrated the dust layer. Therefore, sufficient bond was not made with the base. If the asphalt bleeds to the surface, it sticks to tires and seal is peeled off. As a precautionary measure against recurrence of this condition, it is suggested either that the finished base be sprinkled to promote penetration of the seal asphalt (RS-2) or that the

Fig. 9: Breckinridge Co.: General Condition of Road after about 2-1/2 Months. Failure of seal coat to stick is attributed to absence of prime. (1-3-57)

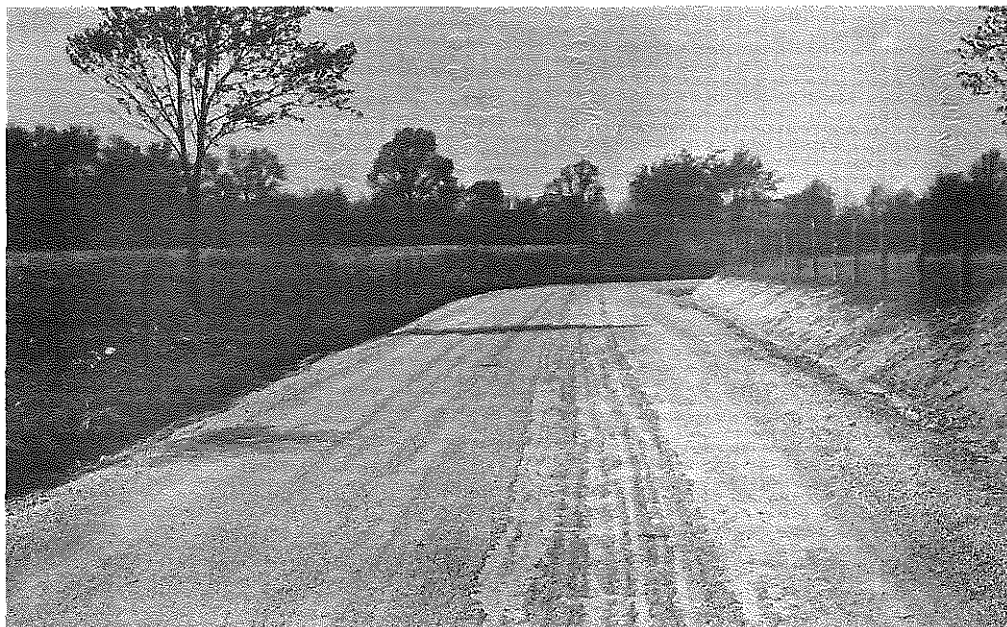
Fig. 10: Breckinridge Co.: Failure of Seal. Soil cement should probably have been primed with diluted emulsion and cured before applying seal. (1-3-57)

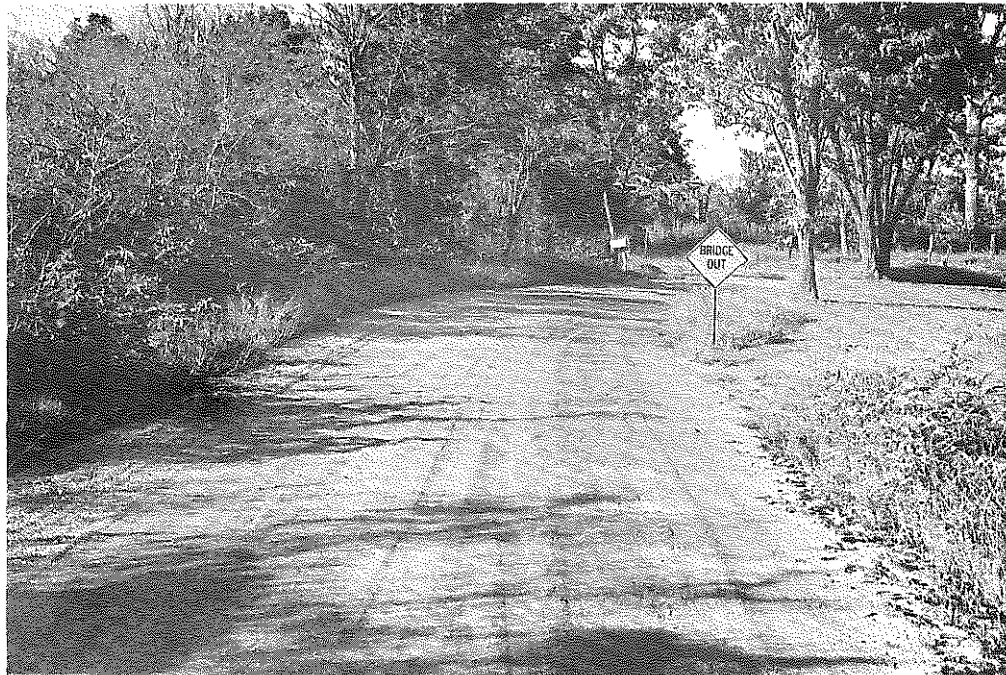
3. Ballard County - The performance of this road has not been entirely satisfactory. Several rich spots were observed during construction, and these have remained soft and unstable. While there has been very little tendency for the asphalt to bleed to the surface, some sections are deeply marked and re-marked by each passing vehicle. In some sections this continued masticating action has caused the seal to crack and check. Some of the sections are soft enough to create a noticeable drag or deceleration on an automobile. The instability is obviously in the base. The coarse gravel particles have a rather oily appearance and are not at all coated with asphalt, while the mortar portion is black and sticky with asphalt.

Fig. 26: Ballard Co.: Dark Mottling Resulting from a Tendency of the Seal Asphalt to Bleed. Seal is badly cracked from instability and movement within the base. (8-4-57)

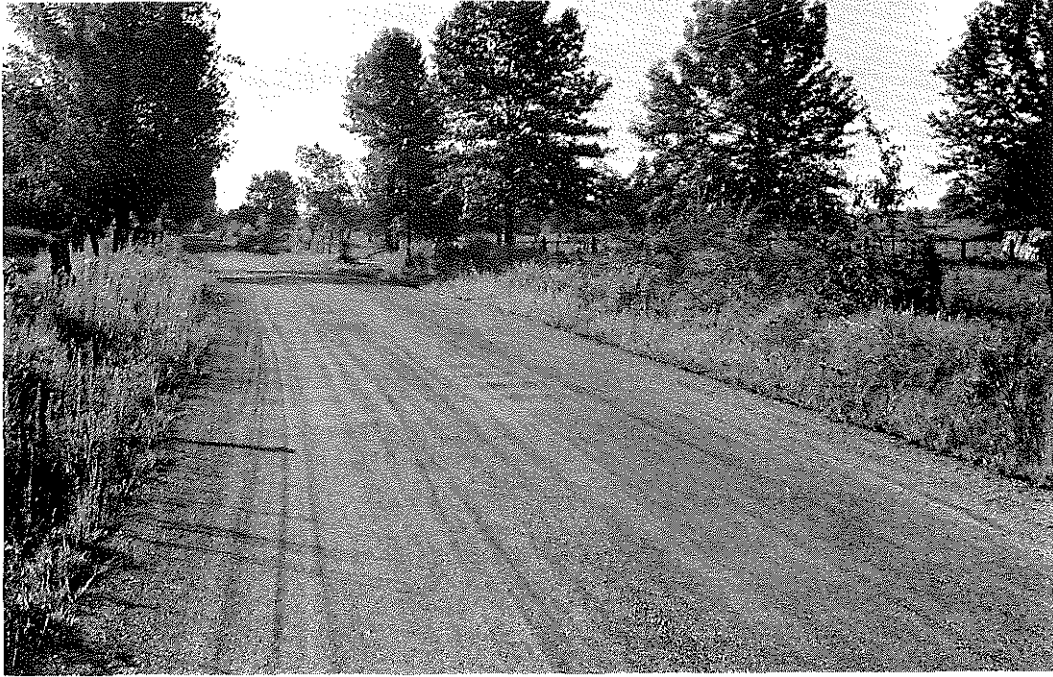
Fig. 27: Ballard Co.: Section Showing Rutting and Shoving although Seal has not yet Broken. Section appeared excessively rich during construction. Note: Bridge is being replaced with one of pre-cast type. (8-4-57)

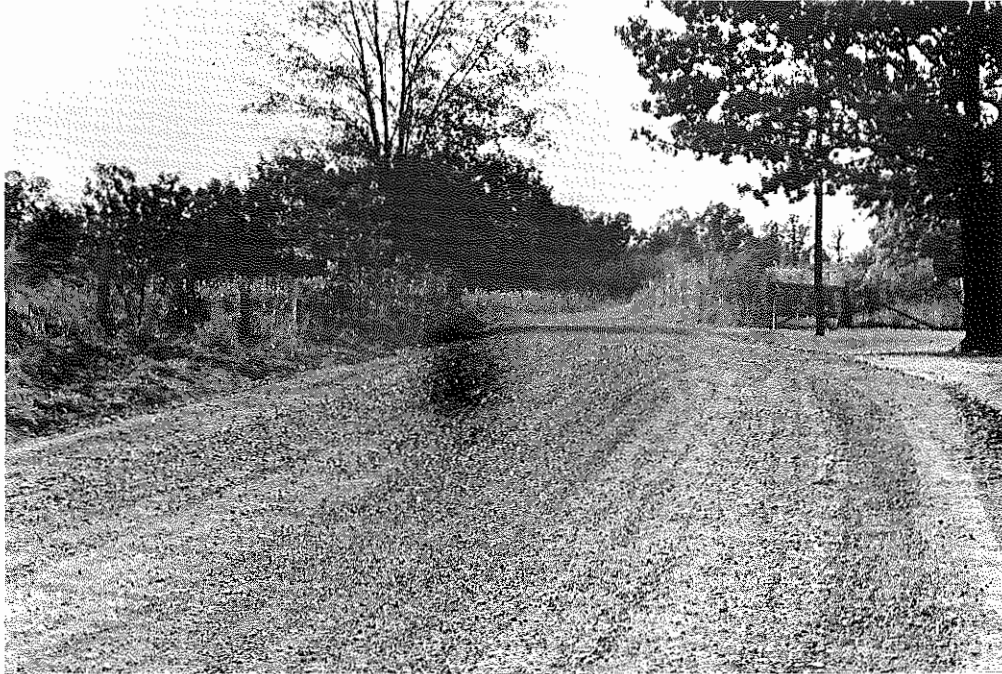
Fig. 28: Ballard Co.: Section Showing Rutting and Some Shoving. Seal here is not broken but base is soft and easily deformed. Each passing vehicle re-marks the road. Failure is impending throughout most of the length of the project. (8-4-57)

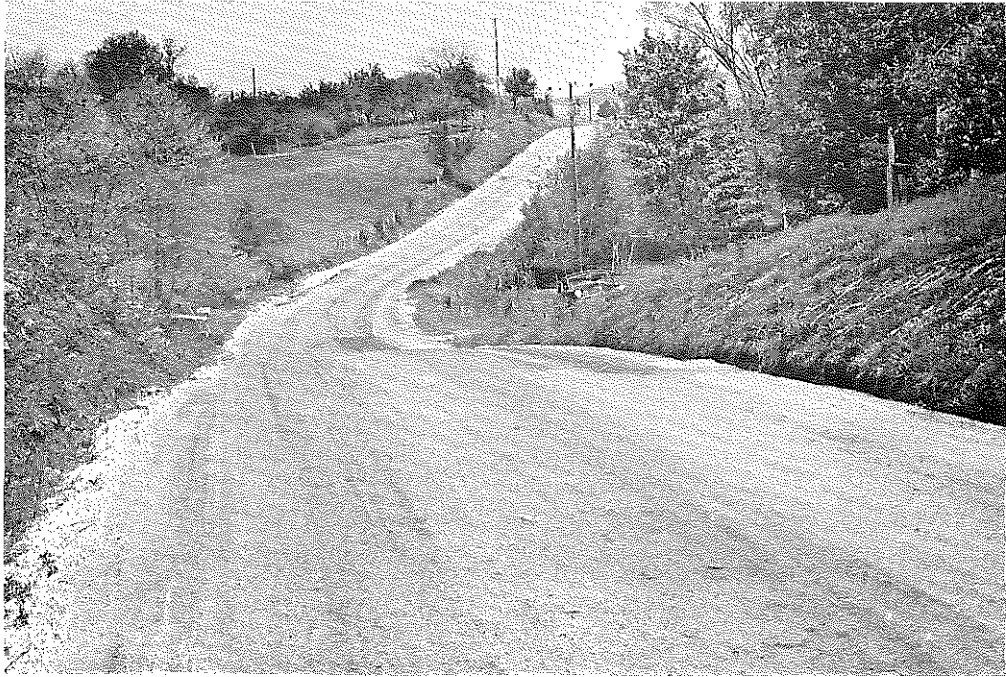
6. Wayne County - About a quarter of a mile of this road was badly washed during the flash flood (see photographs), and part of the seal and base were lost. A little skin patching has been done elsewhere, and the remainder of the road is in very good condition.

Fig. 45: Wayne Co.: After 7 Months. This section was flooded and eroded during spring rainy season. Arrow indicates one end of flood damaged section. (4-24-57)

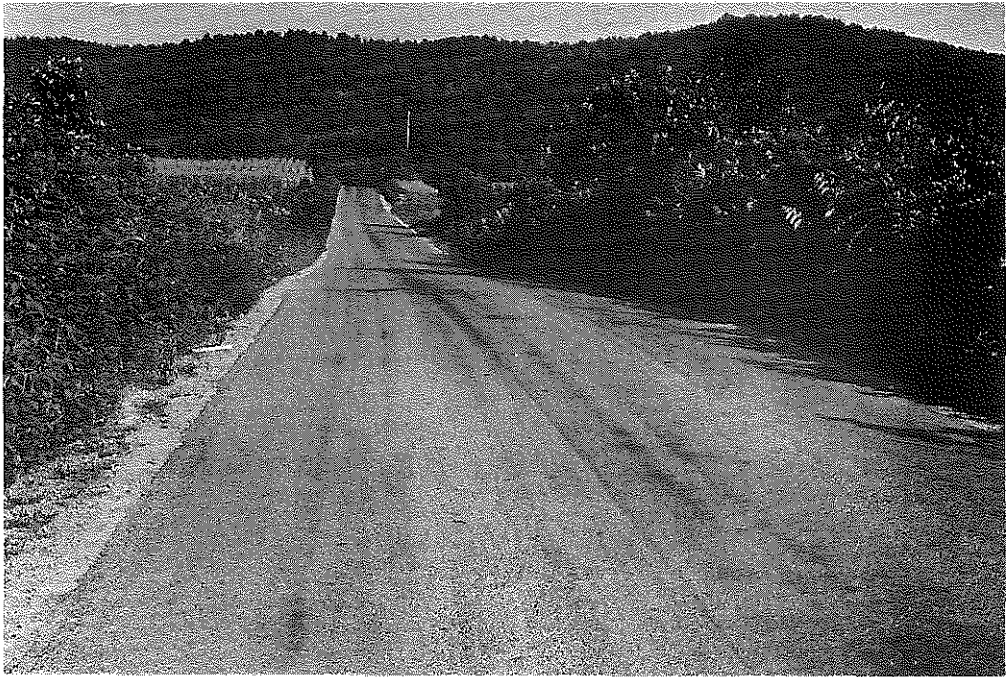
Fig. 46: Wayne Co.: Typical Section after 7 Months. Note patching. (4-24-57)

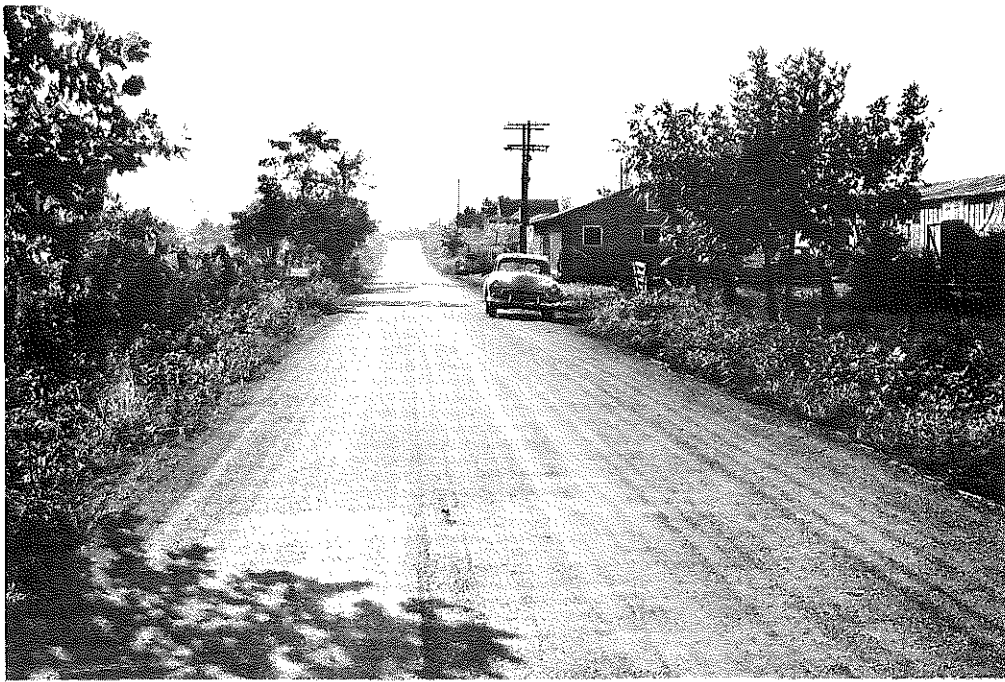
Fig. 48: Wayne Co.: Section Affected by Earlier Flood. (8-5-57)

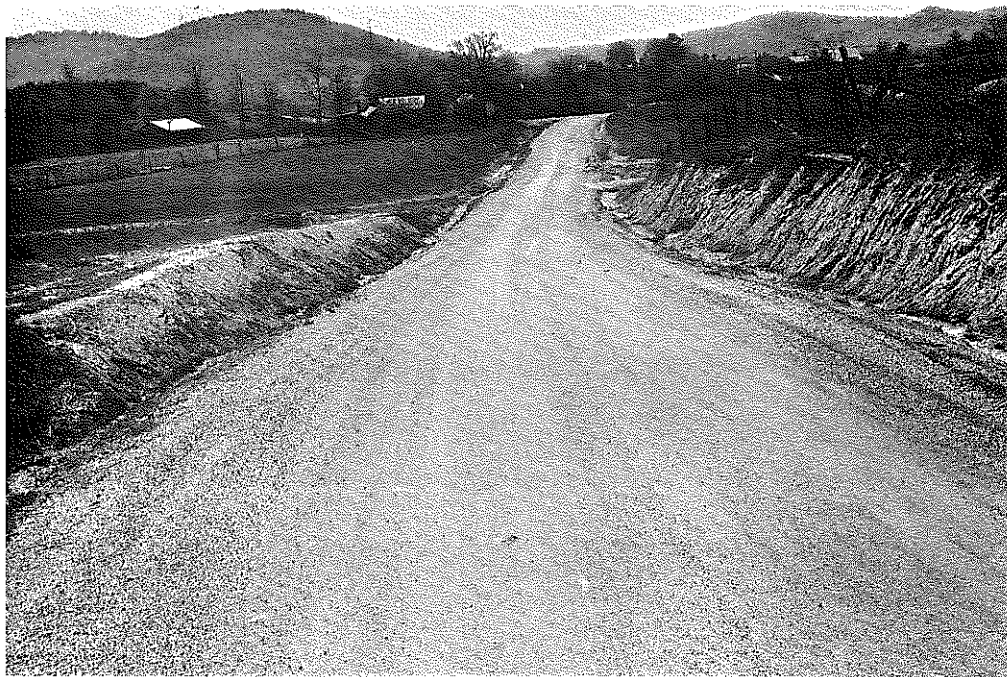
7. Madison County - General performance here has not been quite as good as it has in Barren County. There has been some consolidation or deformation in the wheel tracks, several small pot-holes have developed, and in one sharp curve most of the seal and base have been raveled away. At two locations where culverts were installed, water has overrun the fills and caused some damage. Some repairs have been made there and a few of the pot-holes have been patched (see recent photographs). Logging trucks are known to have used the road, and this may account for most of the deformation, since the road was not designed for very heavy wheel loads.

Fig. 50: Madison Co.: Sharp Curve Where Severe Wear and Raveling have Occurred, after 7 Months. (4-24-57)

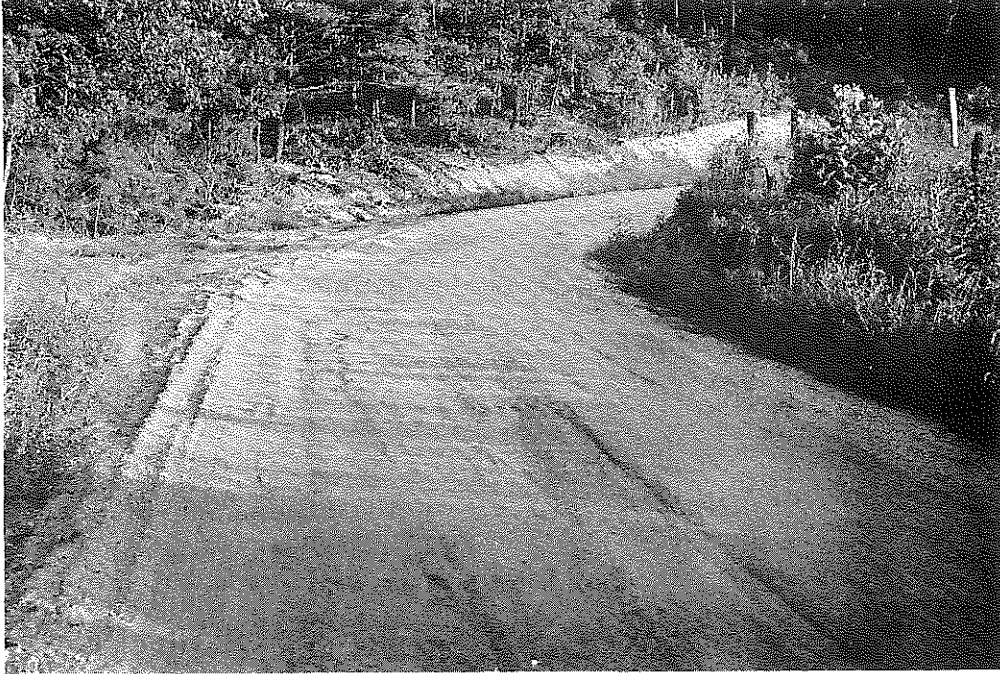
Fig. 51: Madison Co.: Section Where Culverts Were Installed. Some damage due to flood has occurred. Wheel-tracks show considerable deformation which may have been caused by heavy logging trucks. (4-24-57)

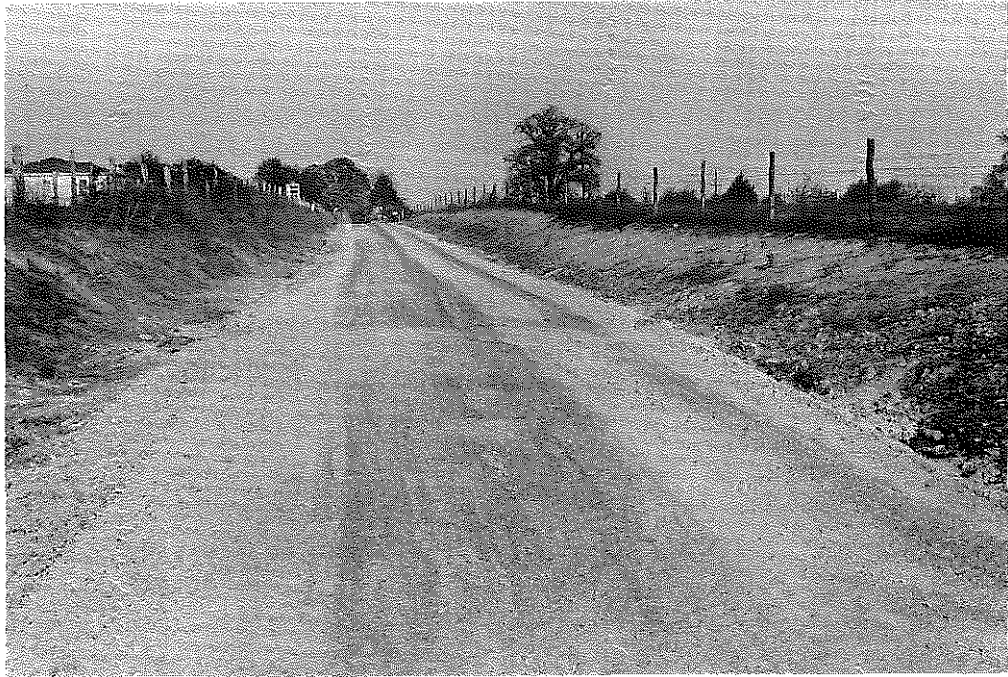
8. Montgomery County - Several prominent failures have developed here; but, as mentioned earlier, the cause is attributable to sub-base conditions rather than to the base itself. Shale outcroppings at several places along the sloping grades not only prevent subsurface drainage of the base but concentrate subsurface water at these points.

Fig. 57: Montgomery Co.: Shale Outcroppings in Ditches and Near Roadway Surface. These cause poor drainage and instability. (3-13-57)

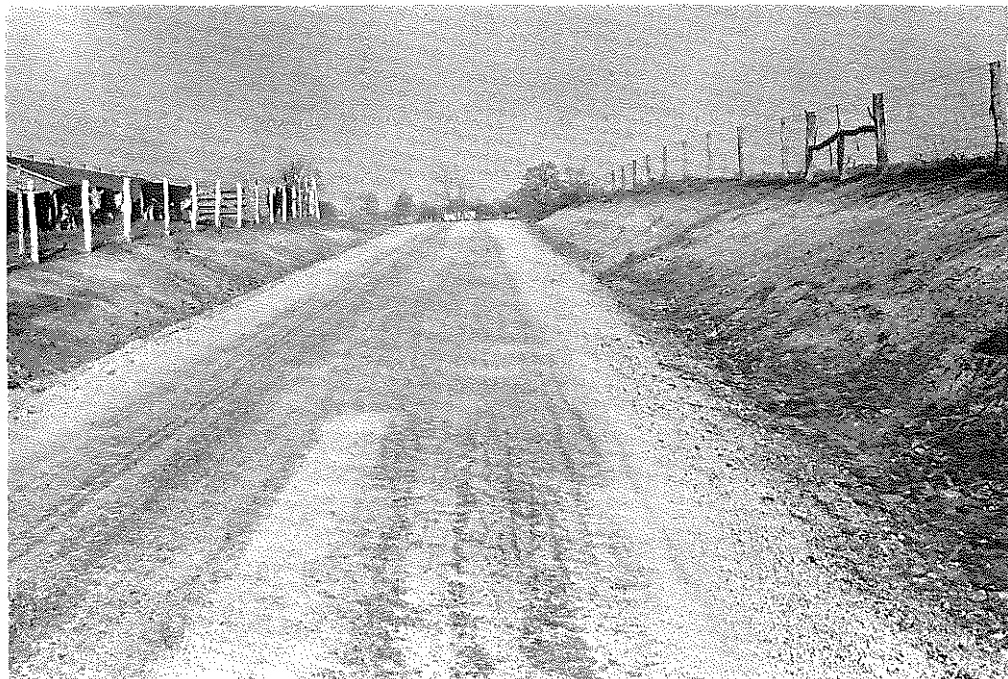
Saturation has therefore weakened the base and caused failure. Sections of the road both above and below the outcroppings have shown fair to good performance.

Fig. 58: Montgomery Co.: Shale Outcropping and Poor Side Drainage, which Cause Poor Performance. (5-27-57)

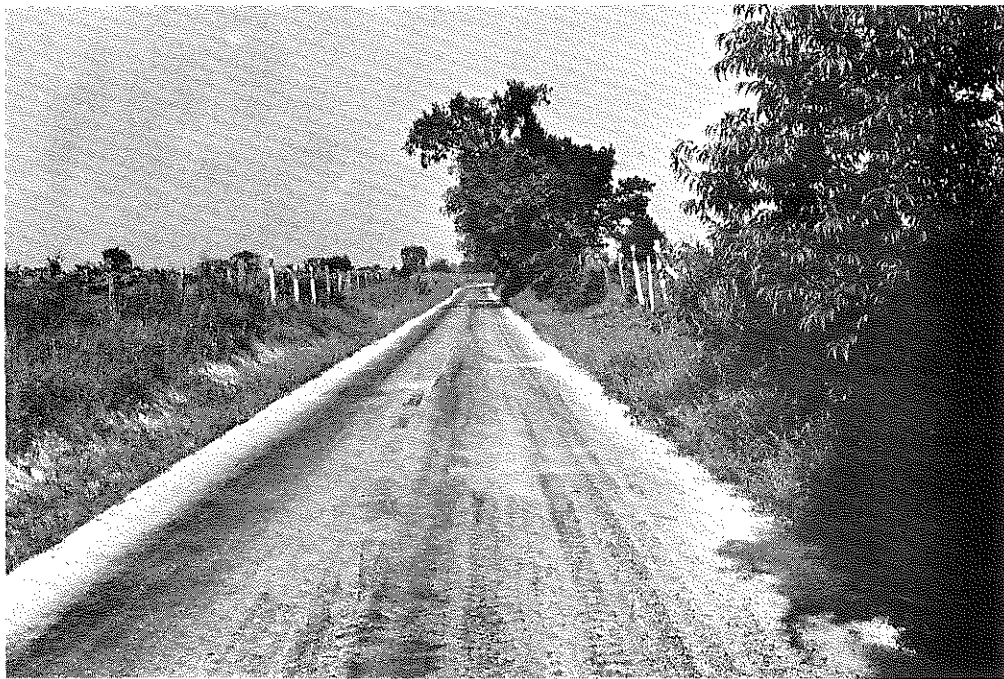
Fig. 60: Montgomery Co.: Curve Showing Wear and Raveling. (8-20-57)

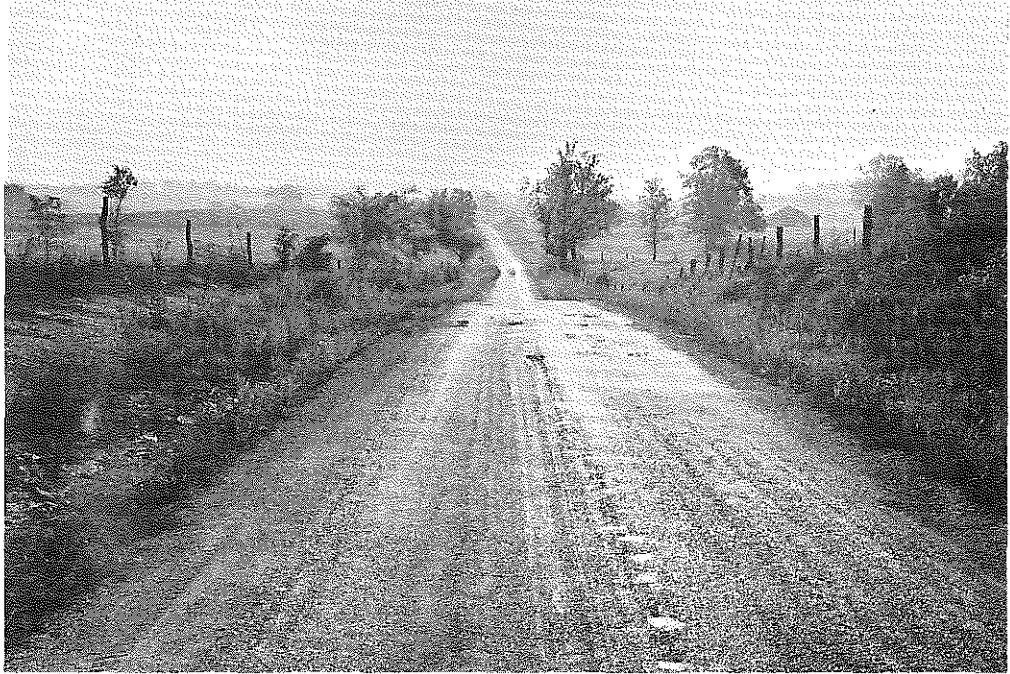
Fig. 61: Montgomery Co.: Section Showing a Few Pot-Holes. However, condition is generally good. (8-20-57)

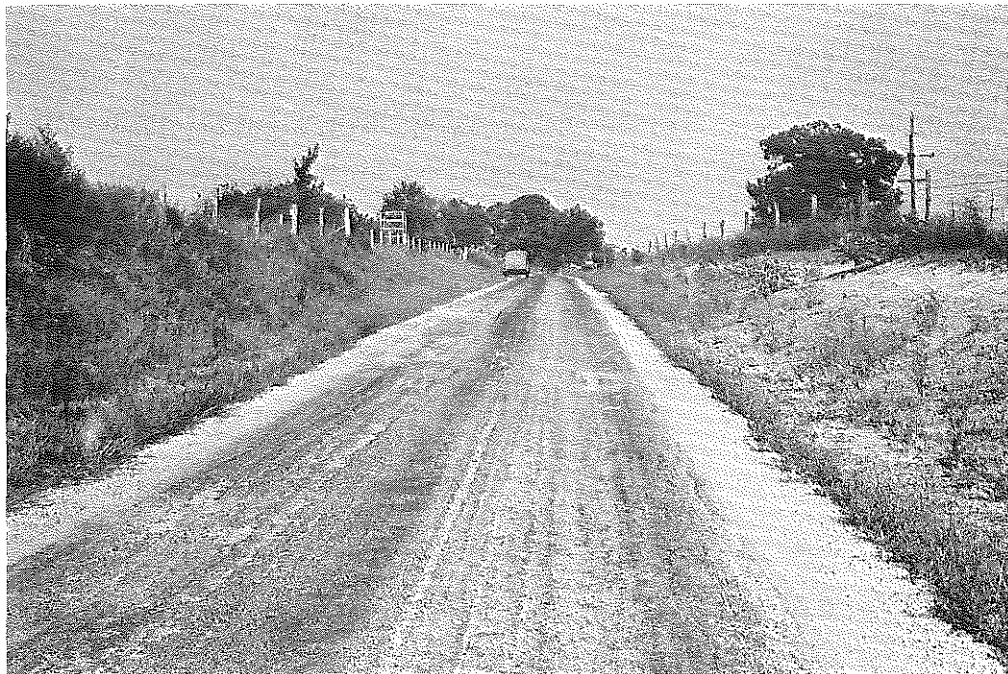
Fig. 62: Montgomery Co.: Section Affected by Underlying Shale and Poor Drainage. (8-20-57)

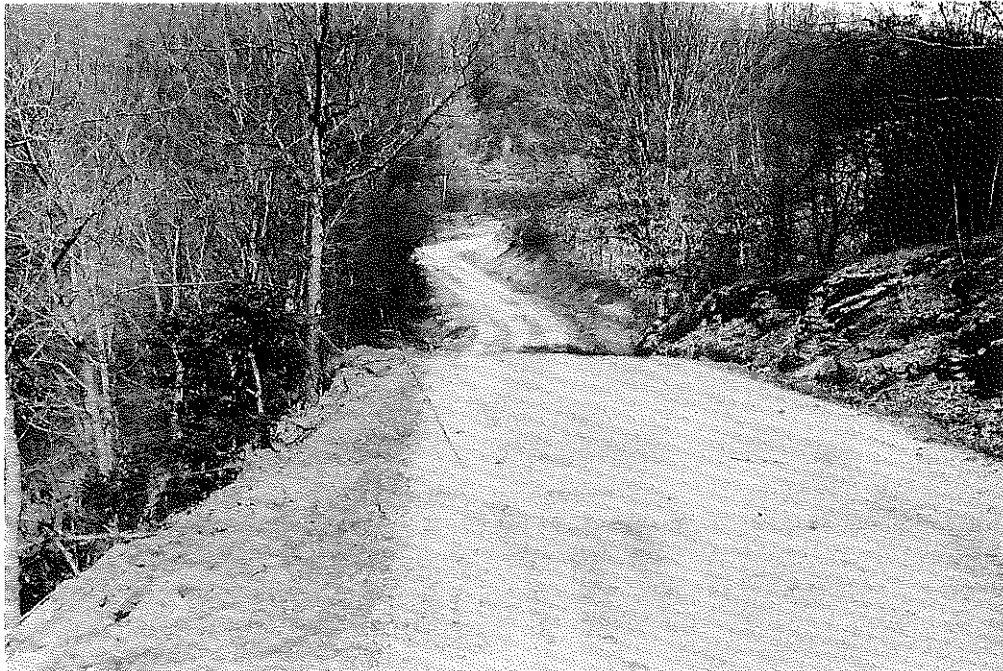
Fig. 66: Lawrence Co.: Showing Unstable Fill near Middle of Project, after 6 Months. (3-13-57)

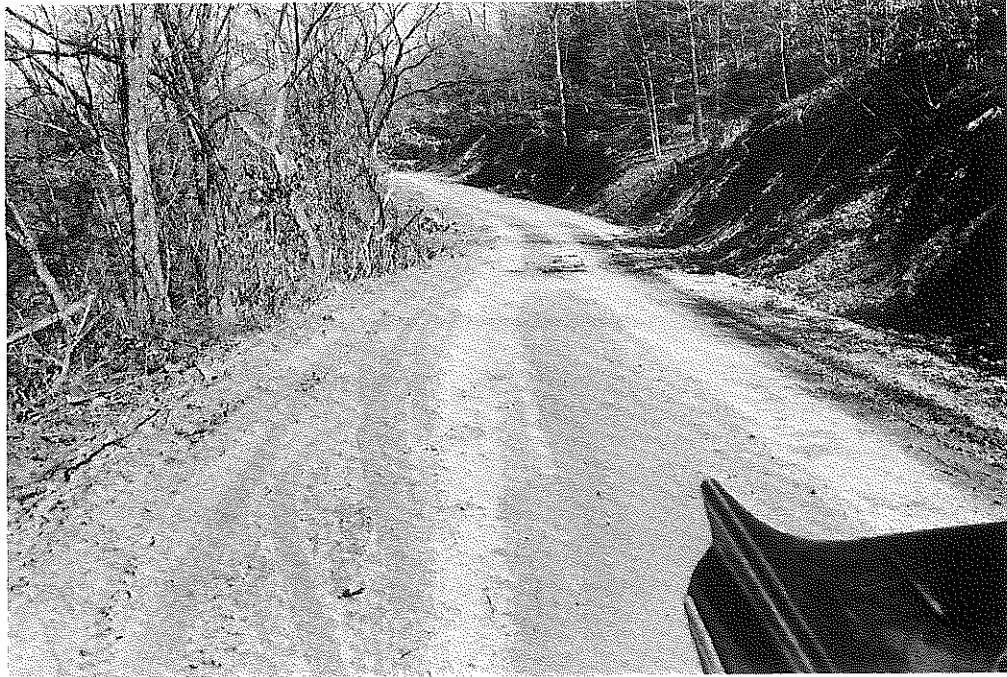
Fig. 67: Lawrence Co.: Same Section Shown in Fig. 64 during Construction. Slopes and roadway have eroded, most of the loose seal stone has been washed away. After 6 months. (3-13-57)

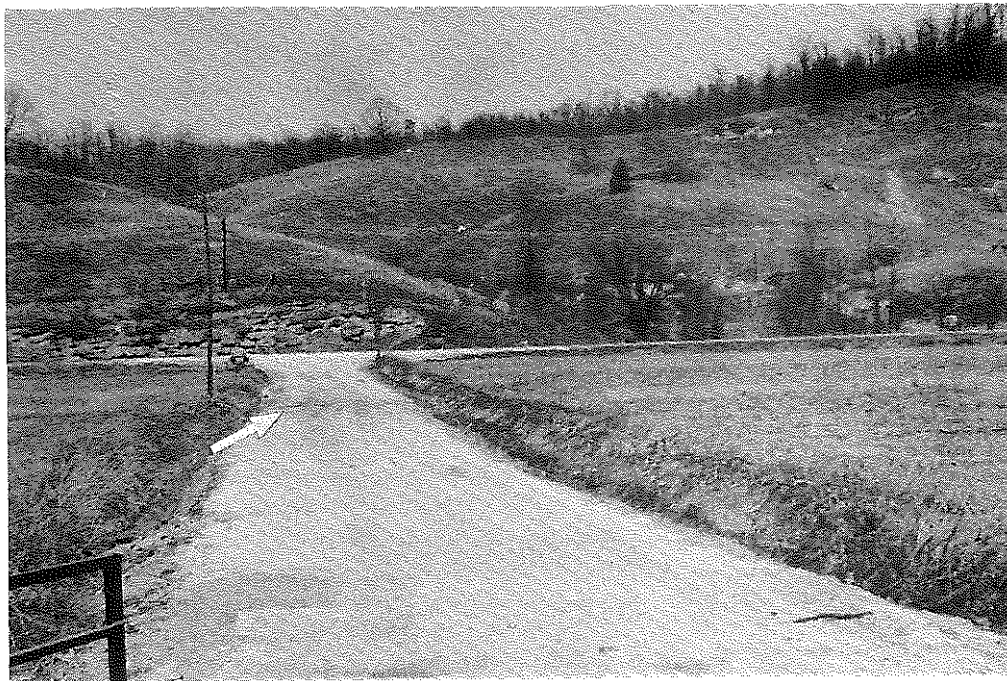
Fig. 68: Lawrence Co.: Similar Section, after 6 Months. Note back slopes sliding onto roadway. (3-13-57)

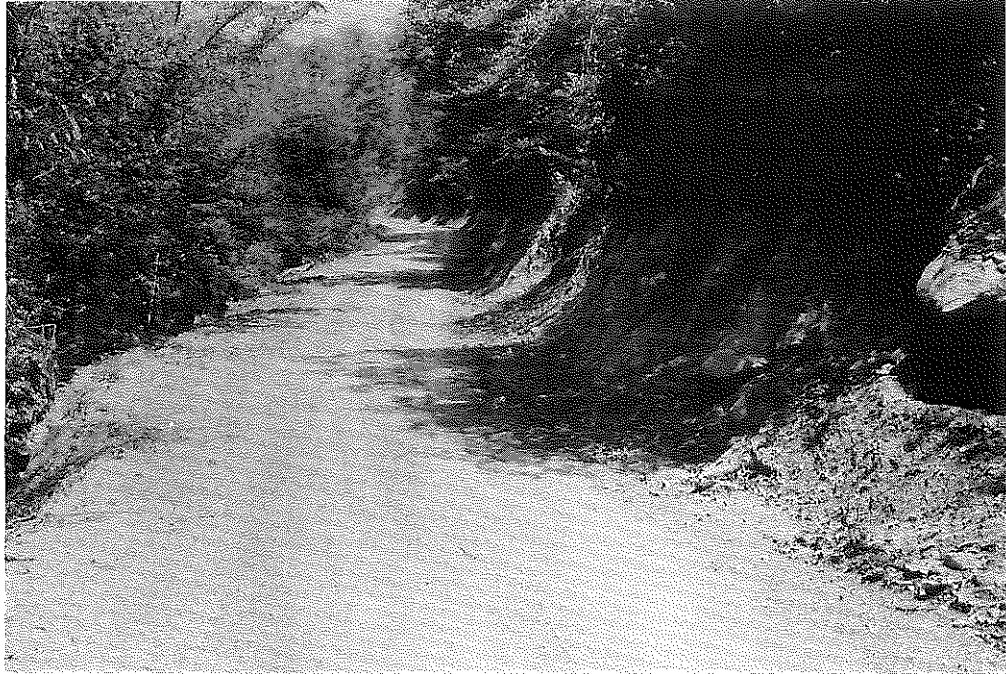
Fig. 69: Lawrence Co.: Creek Bottom Section, after 6 Months. Bridge approach had been inundated by flood. Note unstable area indicated by arrow. (3-13-57)

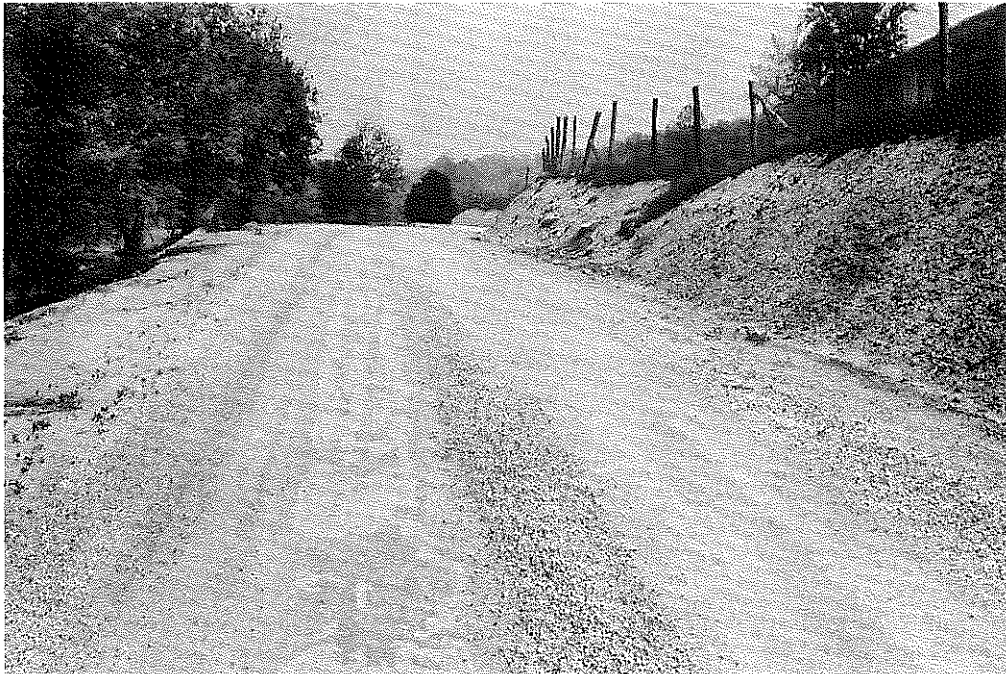
Fig. 70: Lawrence Co.: Narrow Section along Creek Bluff, Badly Eroded. (5-2-57)

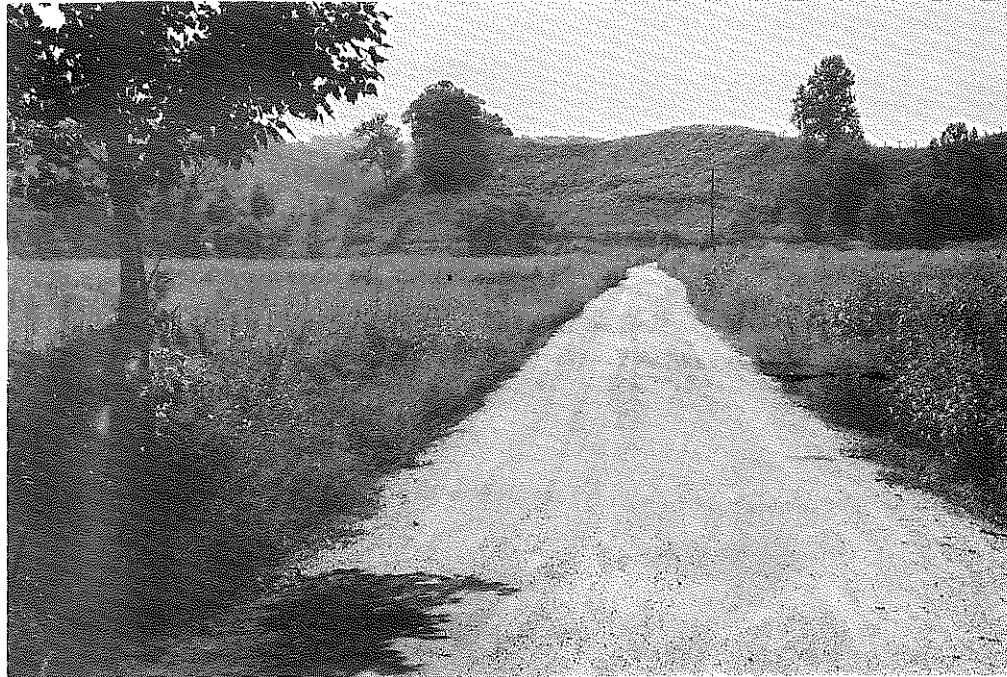
Fig. 71: Lawrence Co.: One of the More Stable Sections, Showing Failure of Seal to Stick. (5-2-57)

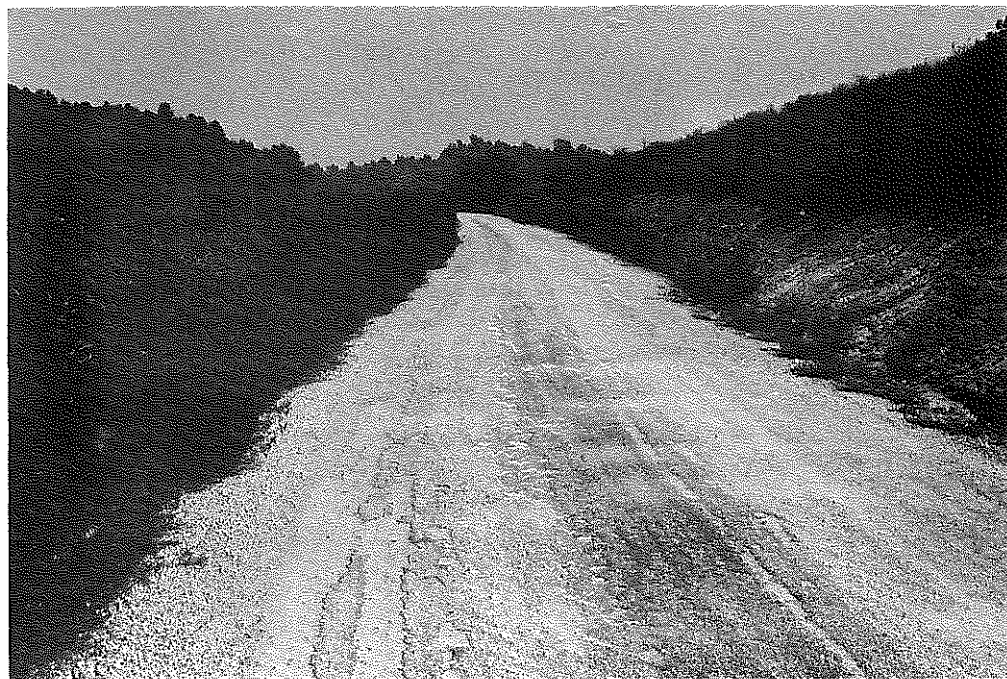
Fig. 72: Lawrence Co.: Recent Picture of Entrance to Project. Portions of this section did not stabilize. (8-20-57)

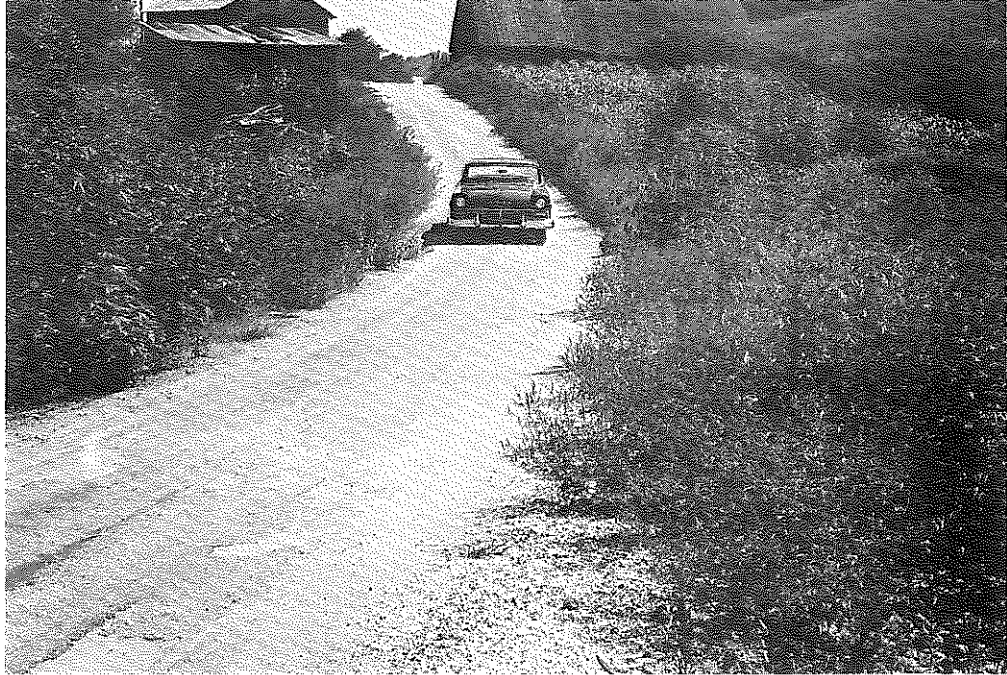
Fig. 73: Lawrence Co.: Section with Severe Loss of Seal Coat. Base seems sound and in good condition. (8-20-57)

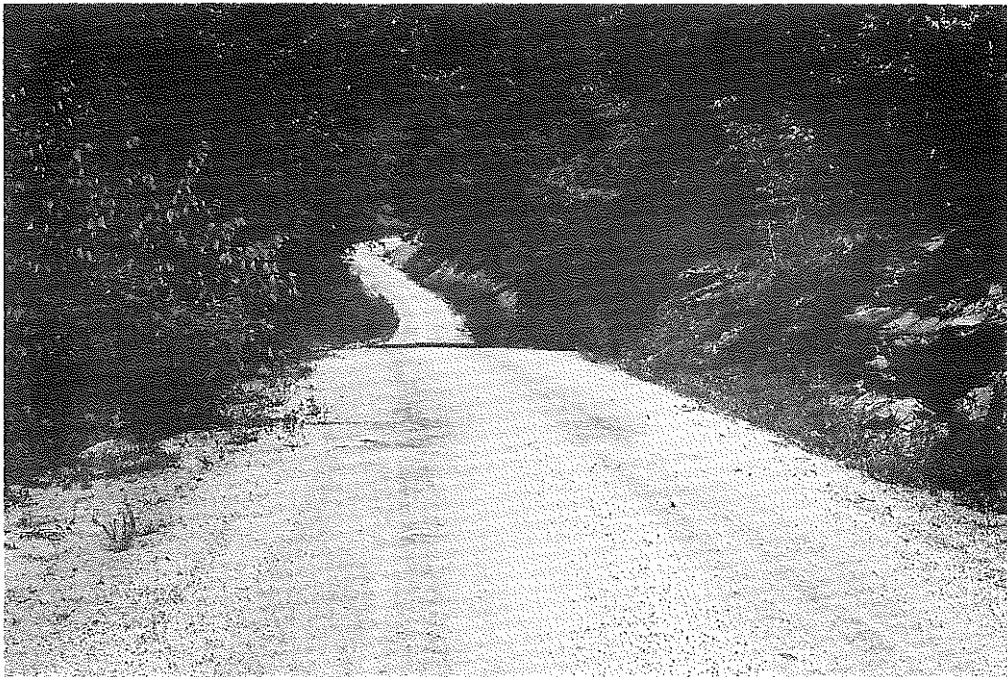
Fig. 74: Lawrence Co.: Narrow Fill and Loss of Seal Coat. Base here is in very good condition. (8-20-57)

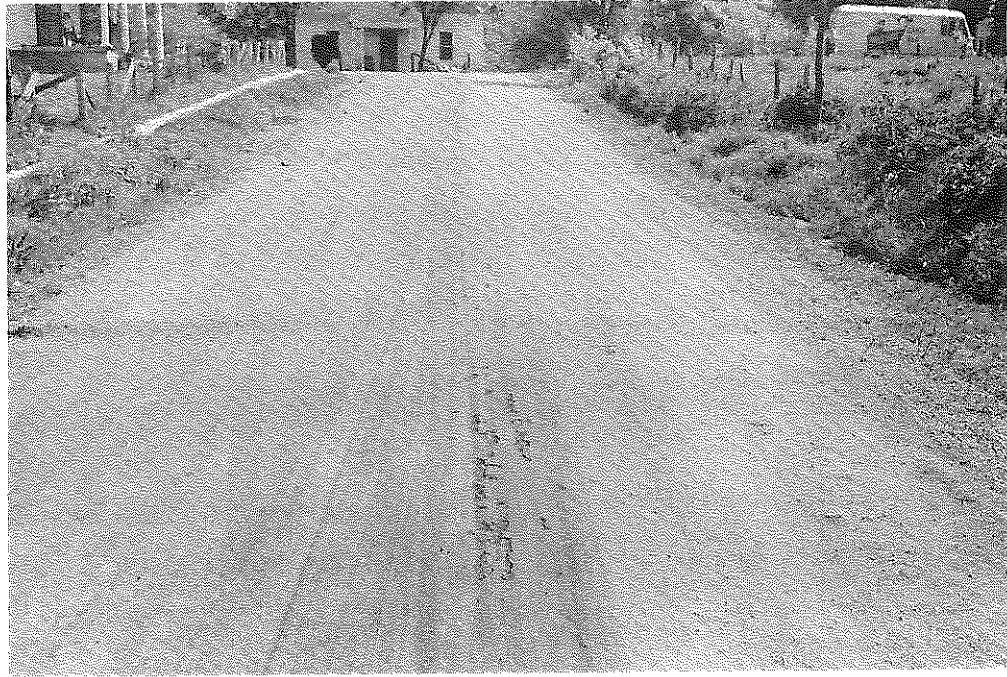
Fig. 81: Johnson Co.: W. Van Lear, after 7 Months. Softness has developed in area shown in foreground. (5-2-57)

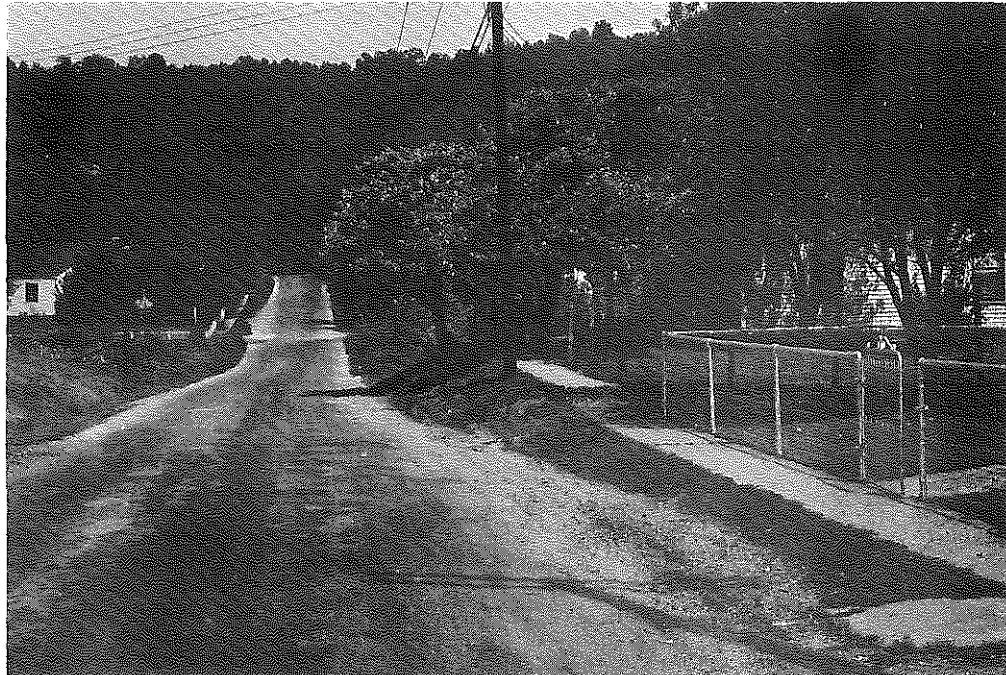
Fig. 83: Johnson Co.: Raveling and Pot-Holes in W. Van Lear Section. Maintenance crew adding more rock to bog shown in Fig. 80. (5-2-57)

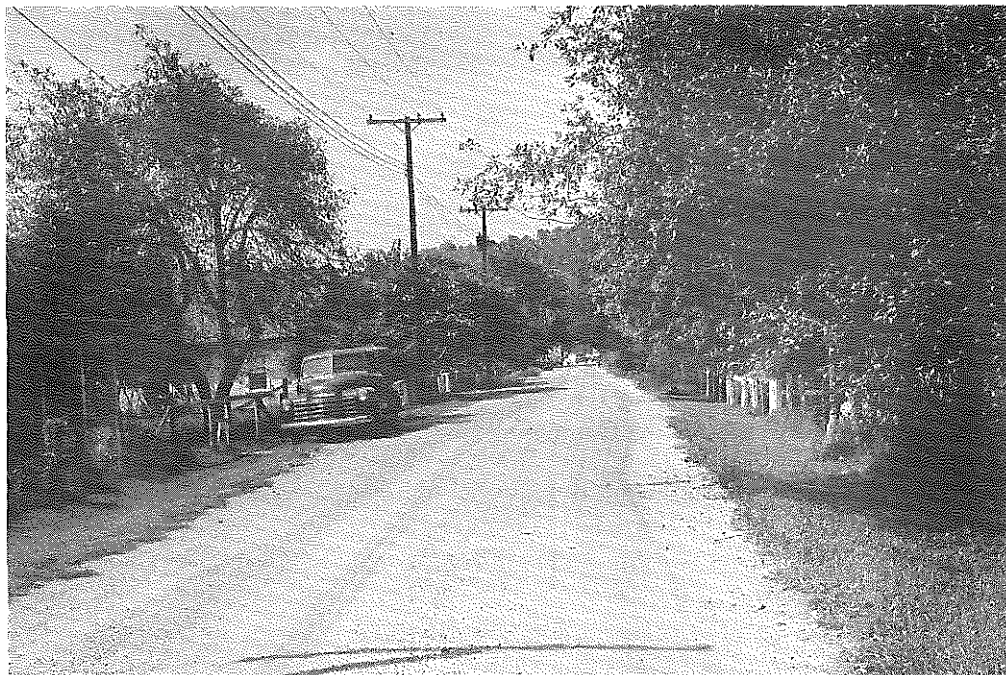
Fig. 84: Johnson Co.: Same Street Shown in Previous Fig. Softness occurred at one spot because of clay pocket in the left foreground. (8-20-57)

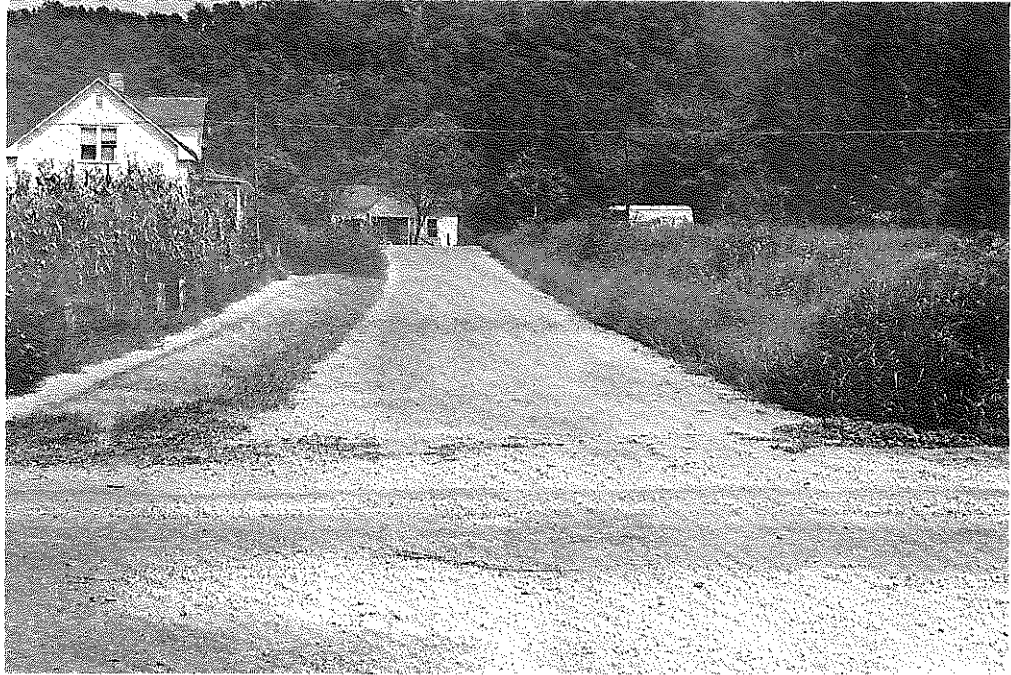
Fig. 85: Johnson Co.: Street Showing a Few Soft Spots and Pot-Holes but no Extensive Failure. (8-20-57)
