COMMONWEALTH OF KENTUCKY
DEPARTMENT OF HIGHWAYS
FRANKFORT

A SURVEY INSPECTION OF PLAIN CORRUGATED METAL PIPE
ARCHES AND MULTI-PLATE METAL PIPE ARCHES IN KENTUCKY

Eugene M. West
Research Engineer

March, 1957

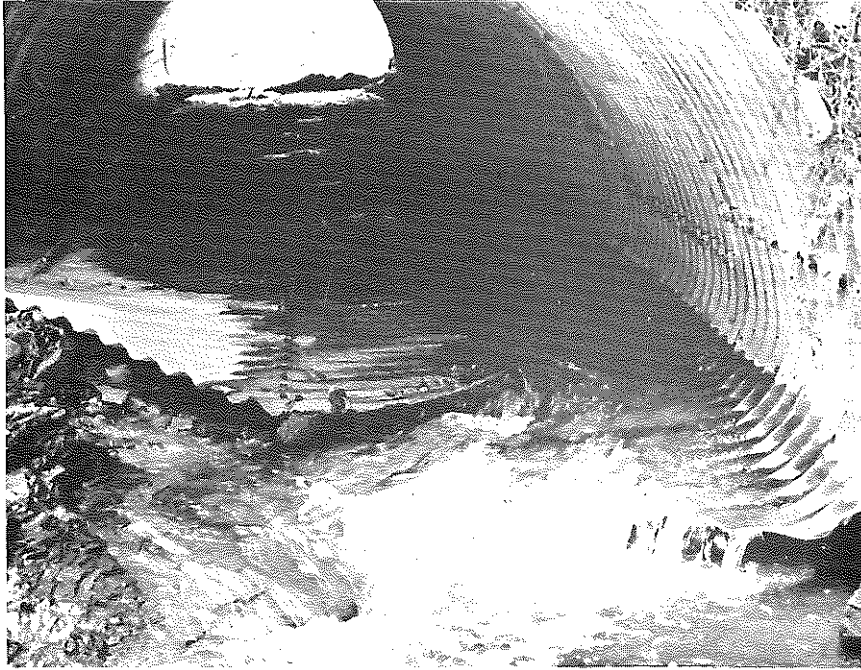
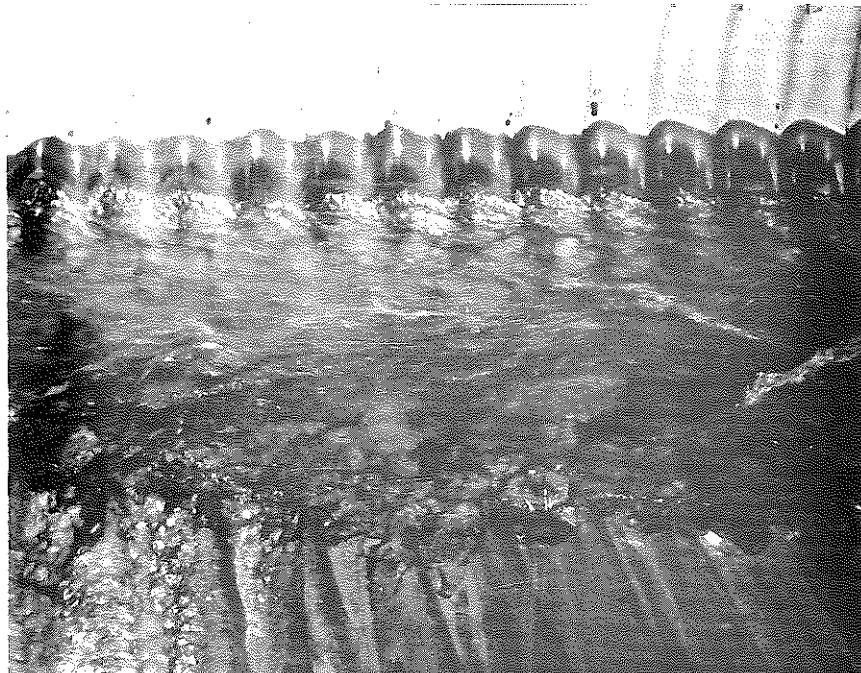
On the Harveyton-Stacey Road (Ky. 267) in Perry County, three un-paved structures were found to have their inverts completely cut by rusting for the entire length of the culvert. One of these, a 159 by 96 in. pipe arch, 70 ft. long, had an unusually wide strip of metal from the invert missing, as shown in Fig. 2; and the arch itself had been deformed by the consequent loss of strength. Another structure on this road, shown in Fig. 3, had been paved with concrete at some undetermined earlier date, probably because of rusting in the invert. There were some signs of deterioration in the concrete; but these were slight, and the arch itself was not deformed. This structure had been placed -- as had all of those inspected on this road -- in 1949.

Fig. 2 - Unpaved Pipe Arch on Ky. 267, Showing Effects of Highly Corrosive Water.

In extreme cases, where the invert is already scaling away or becoming perforated, virtually immediate maintenance will be needed to preserve the structure. Such structures were found, in this study, on three roads; and it may be assumed that there are more. Unless attention is given to these very soon, either extreme maintenance or replacement may become necessary.
