COMMONWEALTH OF KENTUCKY
DEPARTMENT OF HIGHWAYS
FRANKFORT

On the basis of these limited studies, the attached "Preliminary Report on the Performance of Kentucky Rock Asphalt" has been prepared by J. H. Havens and E. G. Williams. The intent of this report is to show what has been found with regard to the underlying cause of the pavement distress, to record a few ideas on the manner in which the cause might have developed, and to make recommendations concerning research that should be carried out to determine whether and how rock asphalt can be used and controlled satisfactorily in the future.

SUBJECT: Performance of Kentucky (Natural Sandstone)
Rock Asphalt

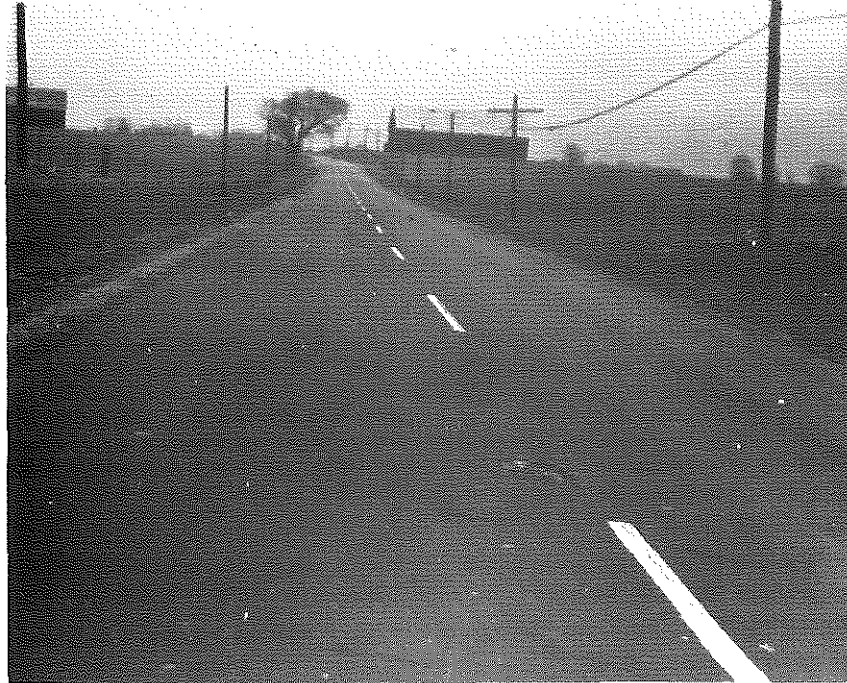
Fig. 1 - U. S. 421 near Midway showing where entrance was made through the crust with a thin blade, crust was easily lifted up revealing small sand pockets between the loosened crust and the lower layer. A scaled section in the wheel track of the left lane is visible, and in the foreground there are indications of wrinkling and shoving.

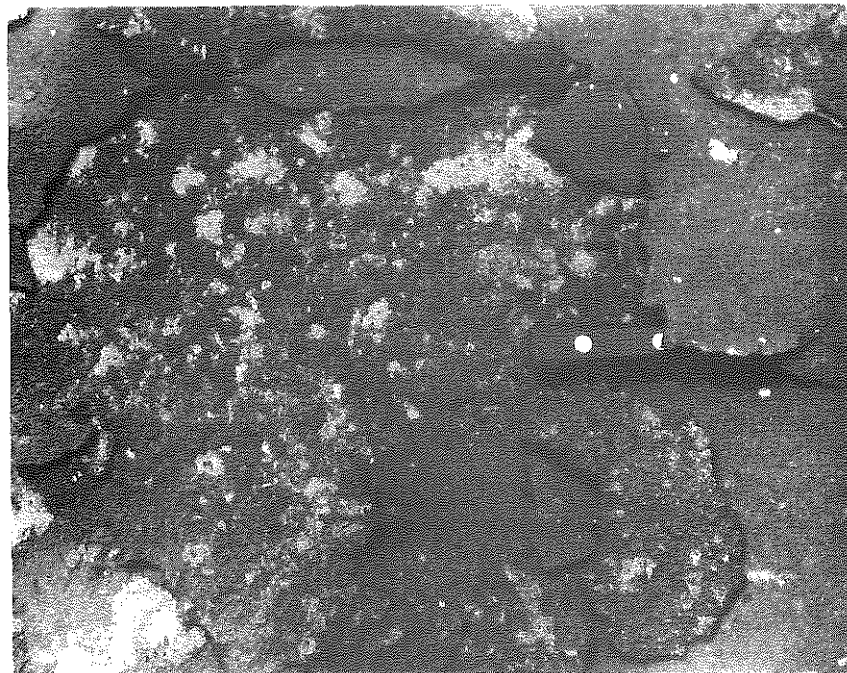
Fig. 2 - Close up of the section in Fig. 1 showing loosened crust and pockets of stripped sand. The surface was not broken here until this exposure was made. Crust contained 6.94% asphalt by extraction; 77°F Pen. - 36. Asphalt in the material underlying the crust seemed much softer.

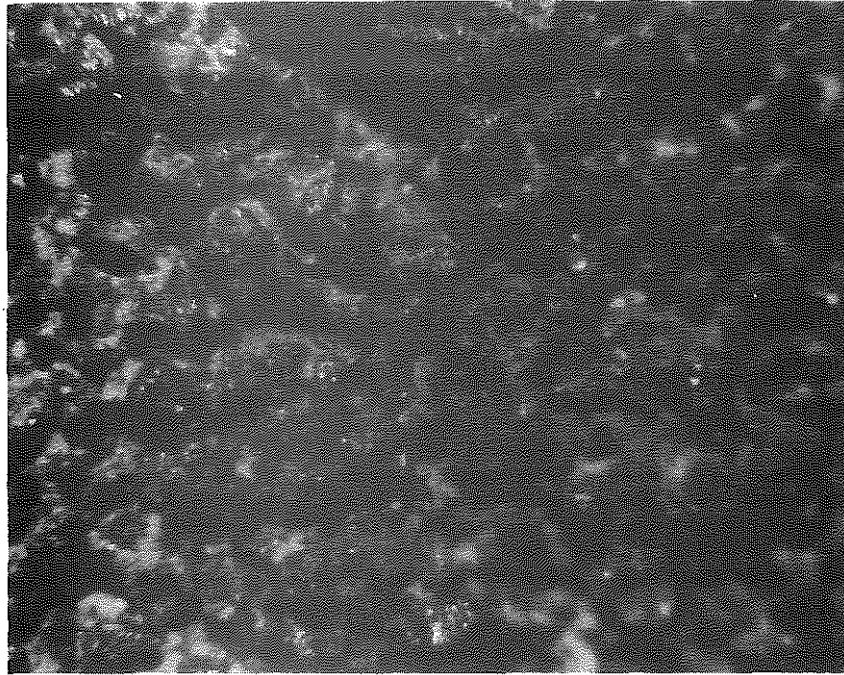
Fig. 3 - Photomicrograph showing the texture of the top surface of material removed from the location illustrated in Fig. 2. All the sand grains are well coated with asphalt.

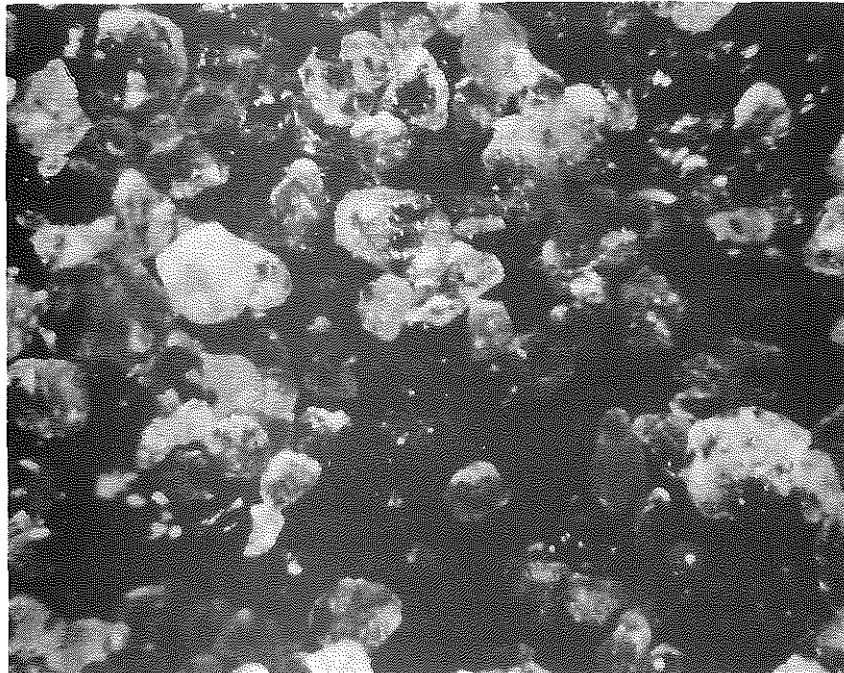
Fig. 4 - Photomicrograph of the lower side of the crust, showing stripped sand grains. The loose crust here was approximately $3/16''$ thick.

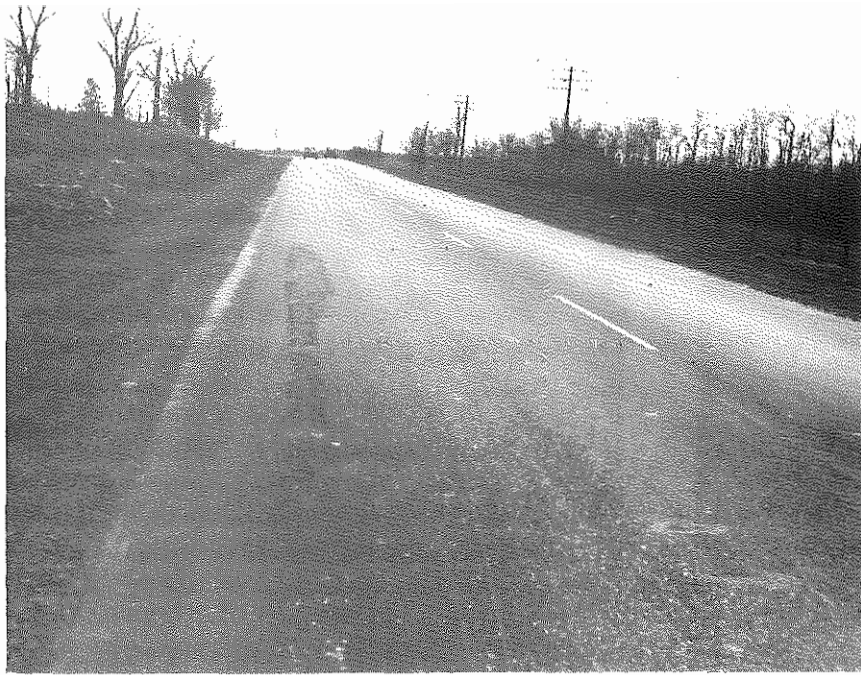
Fig. 5 - U. S. 27 south of Lexington, showing typical scaling in the outer wheel track of the left lane. On this road, these failures were very localized.

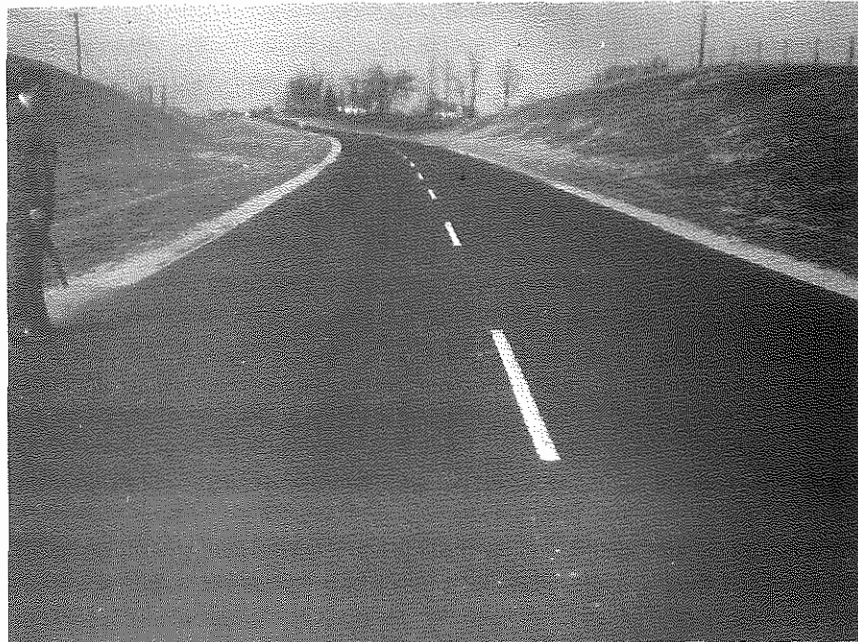
Fig. 6 - U. S. 27 south of Lexington showing where entrance was made through the crust near scaling in the wheel tracks.

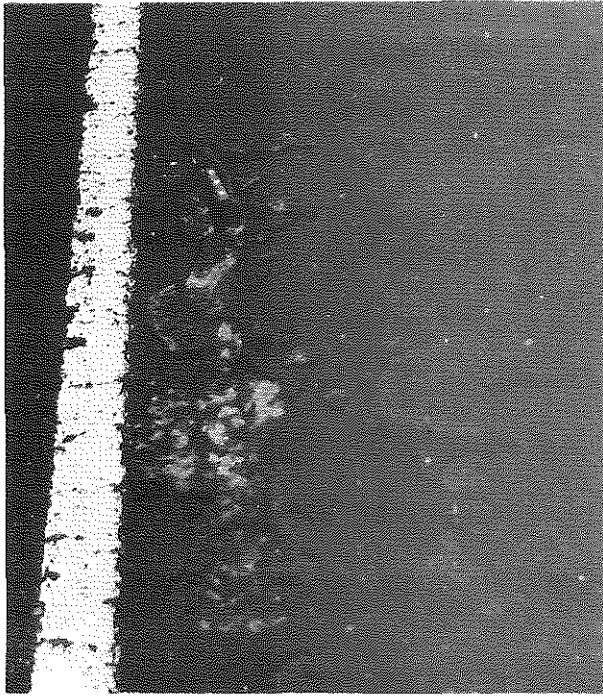
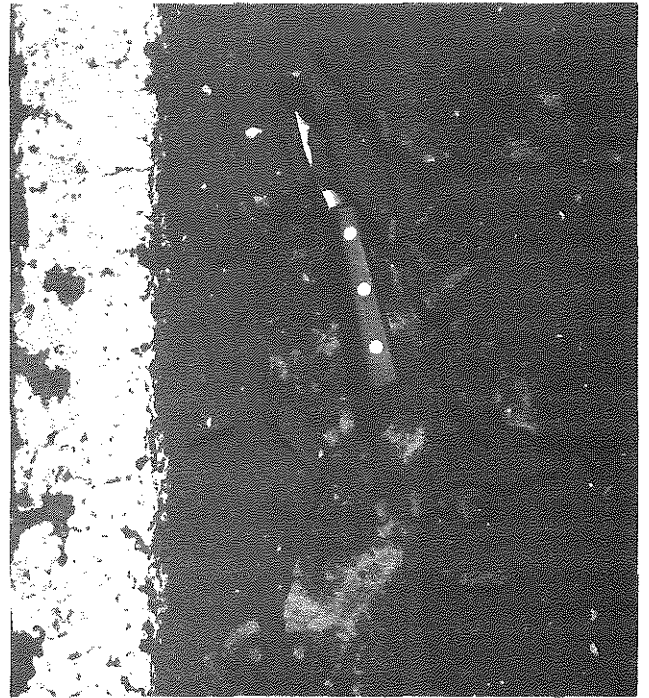
Fig. 7 - U. S. 27, showing two close-up views of an opening in the crust and underlying pockets of stripped sand. Only in a few places was it possible to insert a blade in this manner.

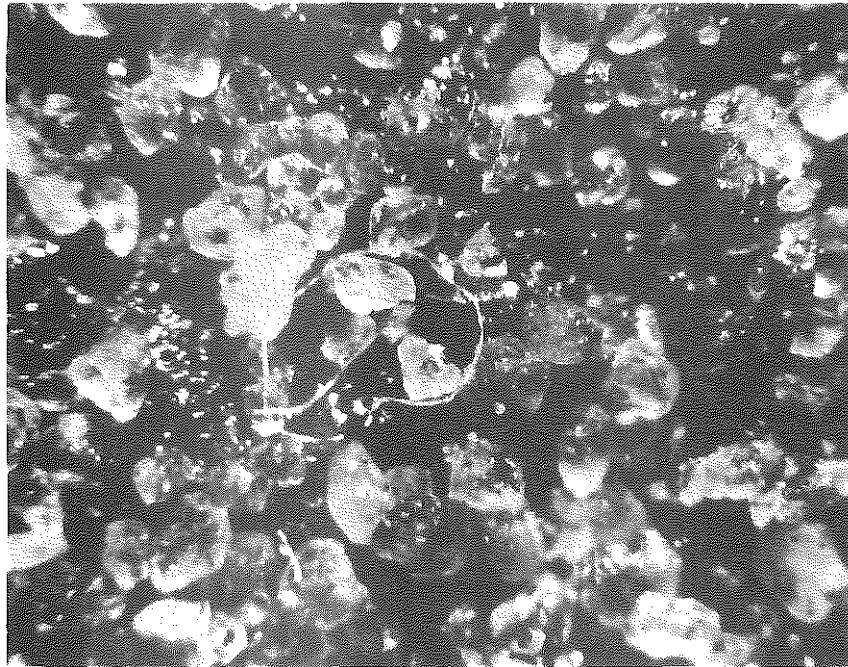
Fig. 8 - Photomicrograph showing stripped sand grains clinging to the lower side of the loosened crust.

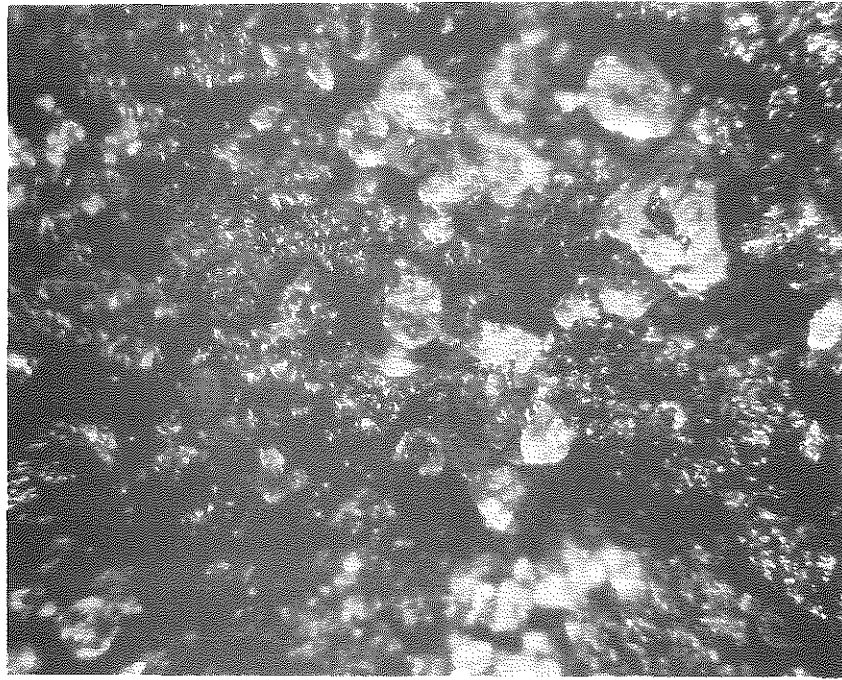
Fig. 9 - U. S. 27, Photomicrograph showing exposed surface after loose scale was removed. A few stripped sand grains are visible; but, for the most part, the particles are well coated.

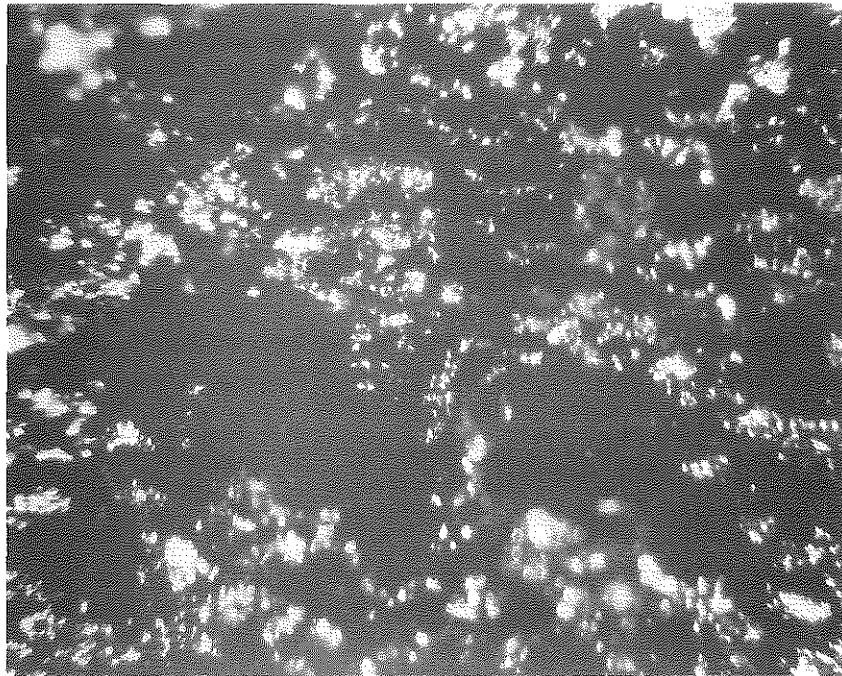
Fig. 10 - U. S. 27 Photomicrograph of a freshly broken cross-section of material taken from the lower layer. All the sand grains are fully coated, and light areas merely represent reflected light.

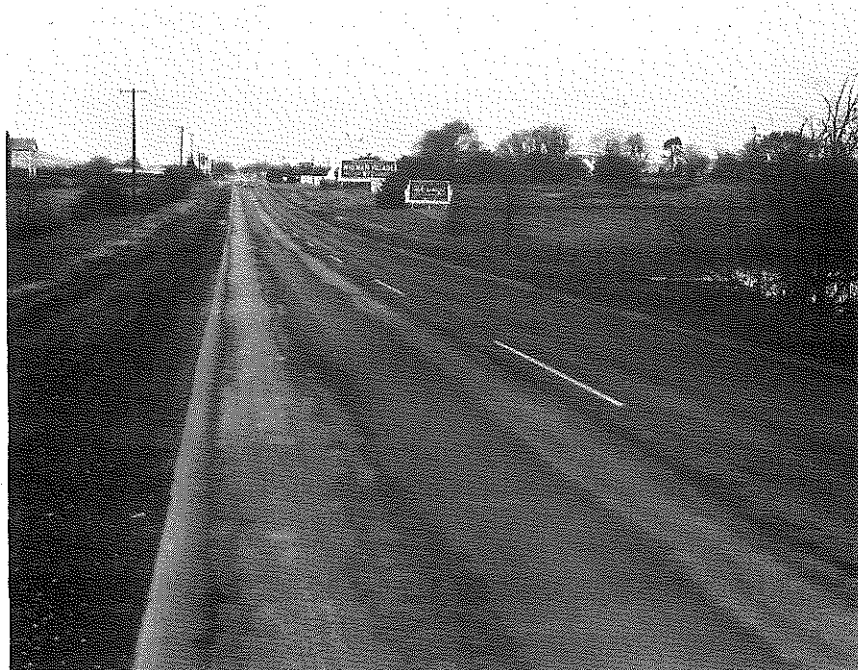
Fig. 11 - U. S. 31 W at Horse Cave. Extensive rutting has taken place in the wheel tracks throughout the entire length of the resurfacing project. Traffic is now riding on the binder course. The failure here began in much the same manner as in other cases but it seems to have progressed more rapidly. Most of the original material has been thrown onto the shoulder where apparently it is of some value as a stabilizer. The binder where exposed, has the appearance of a very nice surface course.

An opening was made at the edge of the pavement just north of Horse Cave where drainage conditions seemed rather poor. There were no indications of water in the binder or the underlying, older rock asphalt surface. Below the older rock asphalt was a course that appeared to be a black base: it was dry and solid. There was a concrete curb that prevented any deeper excavation. A small chisel was driven through the binder in the middle of the inside wheel track and there were no indications of moisture in the dust of the crushed aggregate.

The rock asphalt that remains on the road is poorly consolidated; slightly damp in places; shows indications of having been shoved and re-arranged, loosened, and recompact: and a blade was easily inserted through the full depth of the rock asphalt course. Apparently stripping has not been confined to any particular level or location within the traffic zone. So much stripping has occurred, the material looks gray rather than black.

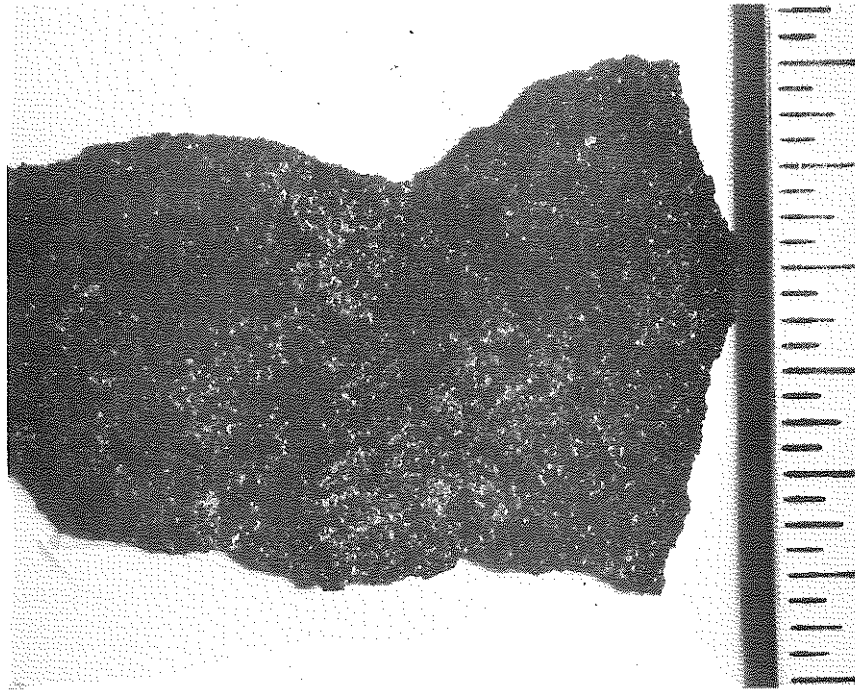
Fig. 23 - U. S. 52, Photograph of the lower side of scale taken from the location shown in Fig. 22, revealing stripped sand.

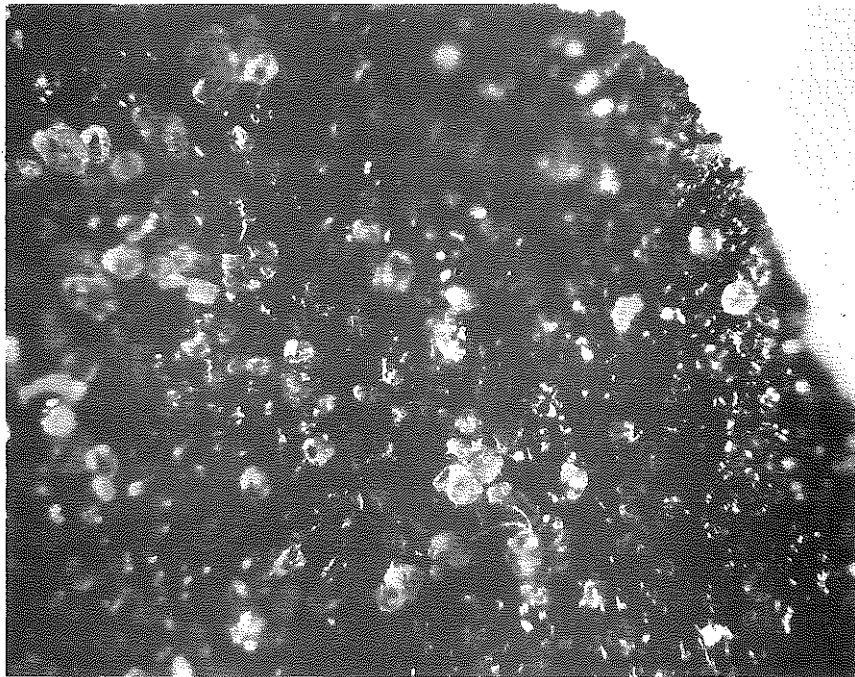
Fig. 24 - U.S. 52, Photomicrograph of the lower side of loosened scale showing un-coated, stripped, sand.
