COMMONWEALTH OF KENTUCKY
DEPARTMENT OF HIGHWAYS
FRANKFORT

December 13, 1954

(Rural Secondary Projects 1949-1951)

November, 1954

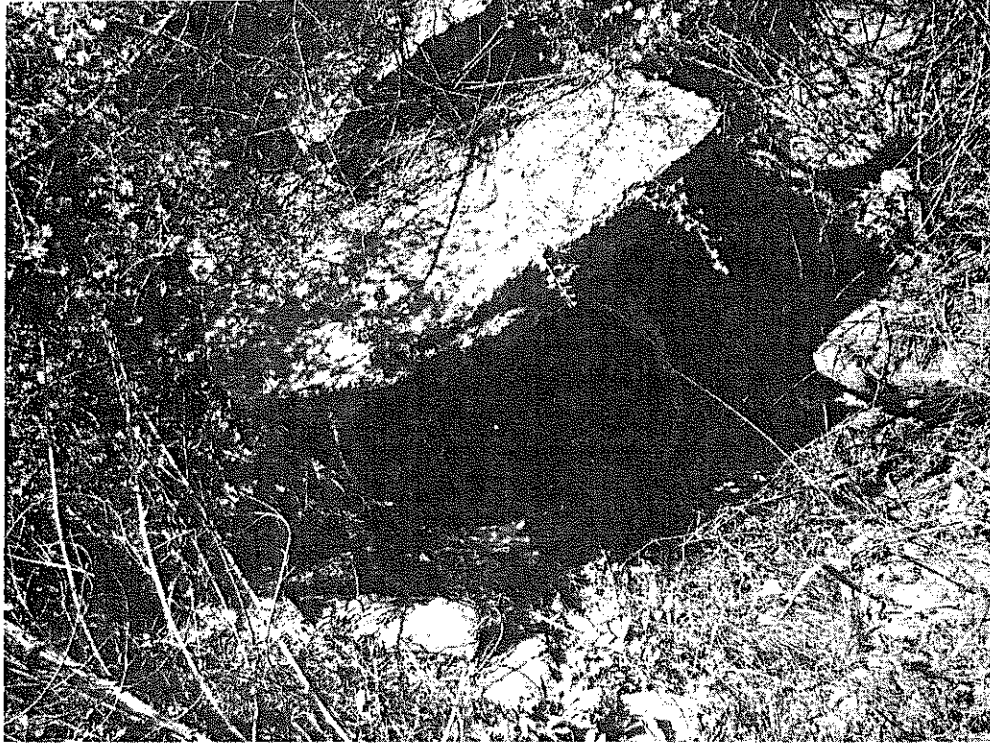
Deterioration of this type was dependent upon exposure to light, and particularly to direct sunlight. Ends of pipe which were shaded, such as the one shown in Fig. 3, were generally free from cracks in the pavement. On the other hand, end openings that were fully exposed invariably showed pronounced cracking of the pavement. This was so whether the culvert consisted of a circular pipe (Fig. 4 and 5) or an arch (Fig. 6). The extent of cracking was influenced by both the size of opening and the thickness of pavement. As one would expect, cracks extended farther

Fig. 3 - Inlet of a 24-in. diameter coated and paved culvert completely shaded by overhanging rock. No scaling was evident, and only minor cracking had occurred for a distance of 3 to 5 in. These conditions were typical of all coated and paved pipe which were shaded and placed on sufficient slopes to prevent ponding of water at the inlet and outlet.

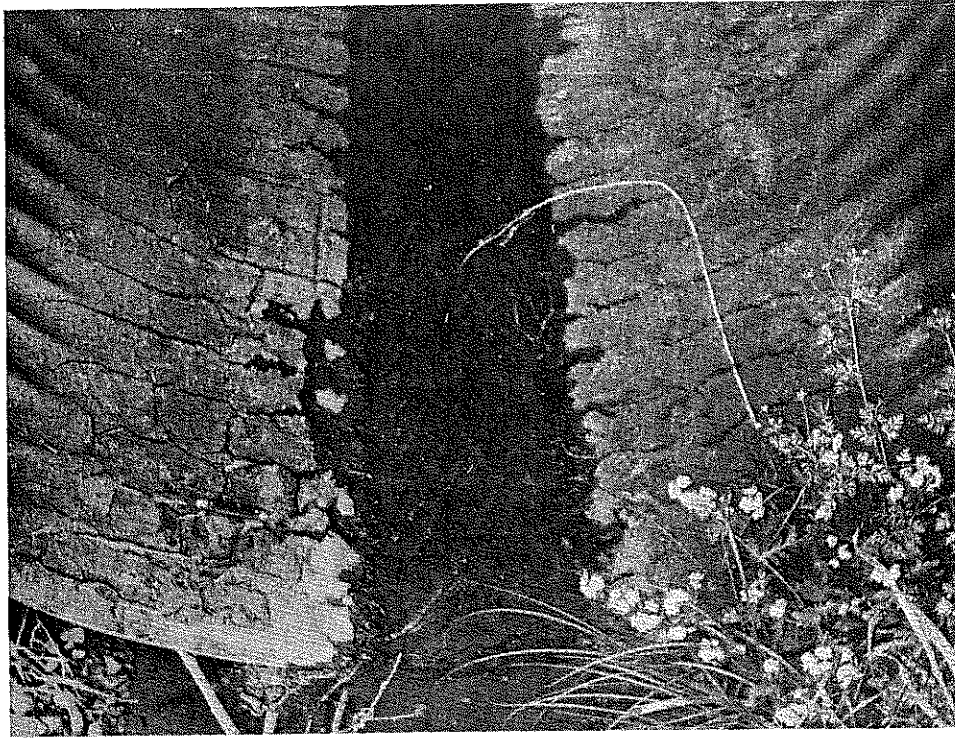
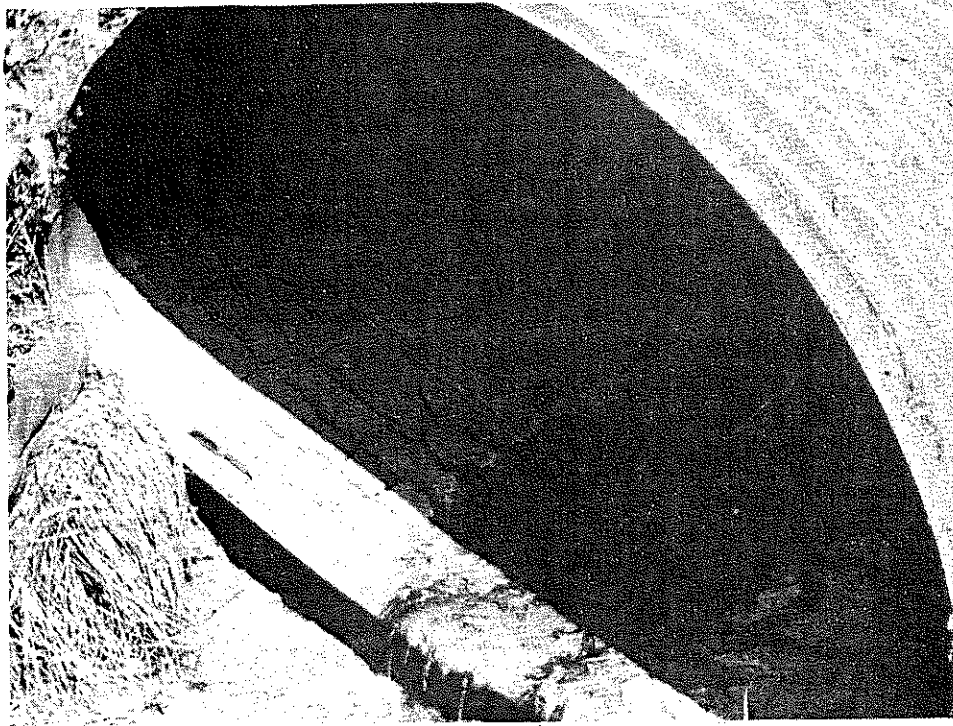
Fig. 4 - Outlet ends of (a) 42-in. diameter pipe and (b) 58x36-in. pipe arch, both installed in 1949. Note the cracking patterns in the paved inverts.

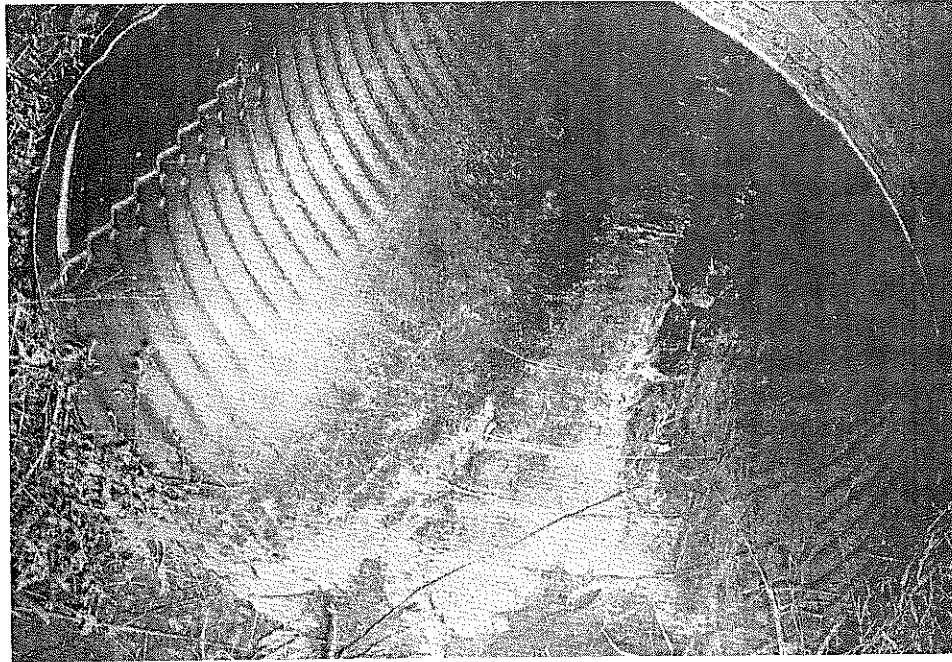
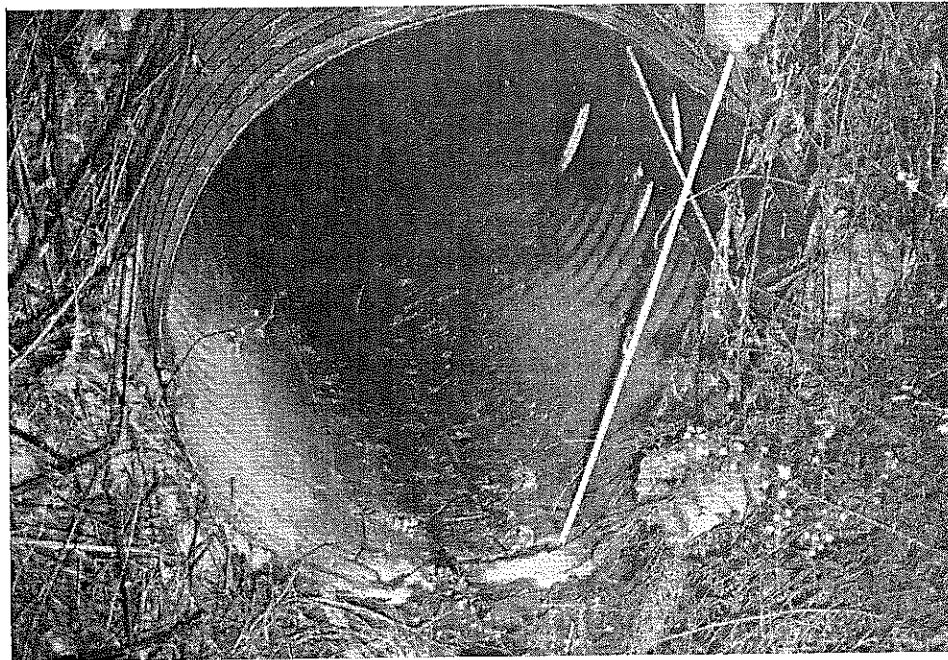
Fig. 5 - Inlet (a) and outlet (b) ends of a 42-in. diameter coated and paved pipe placed in 1952. Cracking was pronounced, but deterioration had not progressed to the extent indicated for the pipe in Fig. 4 which had a greater period of exposure.

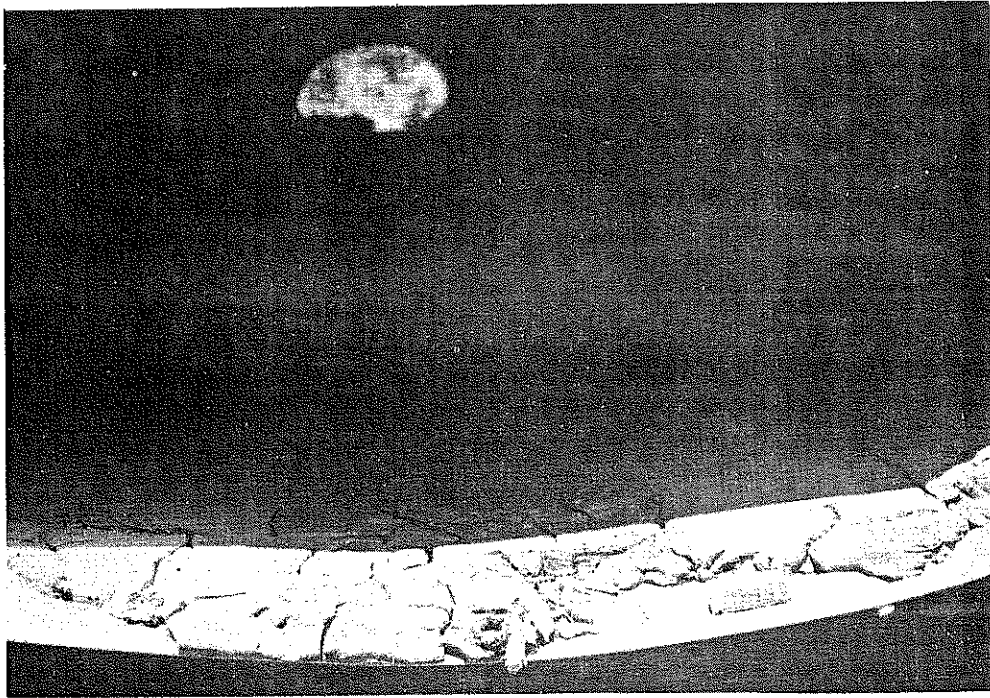
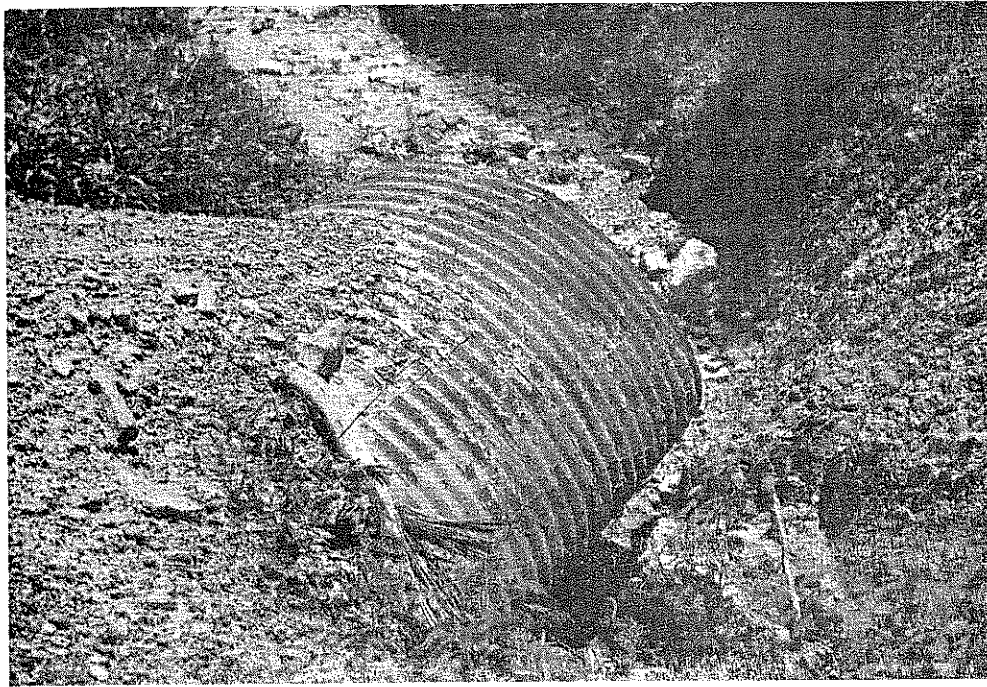
Fig. 6 - Views of a 34x59-in. coated and paved pipe arch showing (a) cracking of the pavement at the outlet, and (b) scaling of the outside coating at the same end of the arch. Date of installation - 1950.

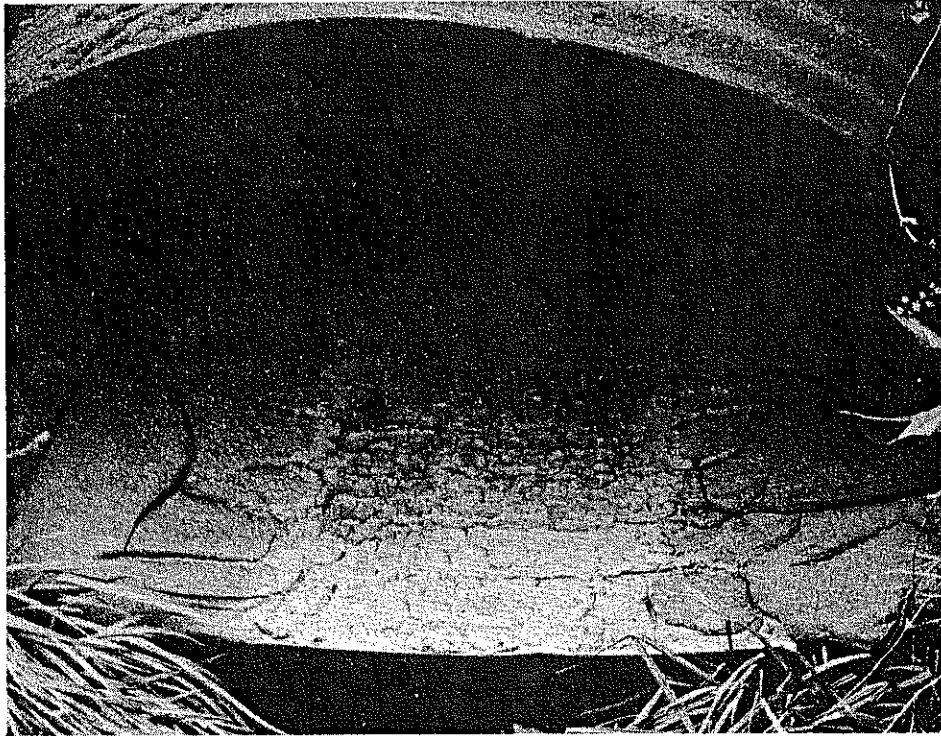
A different type of deterioration, which obviously resulted from ponding of water at an end of the pipe is shown in Figs. 7, 8, and 9. Here scaling is associated with the cracking that occurred through exposure to light. The scaling condition existed invariably where ponding had occurred, and apparently it was dependent upon alternate wetting and drying at a relatively slow rate.

Fig. 7 - Combined scaling and cracking at the outlet of a 44x26-in. pipe arch installed in 1949. In some way this end of the structure had been bent upward providing for intermittent ponding to a slight depth, and consequent wetting and drying.

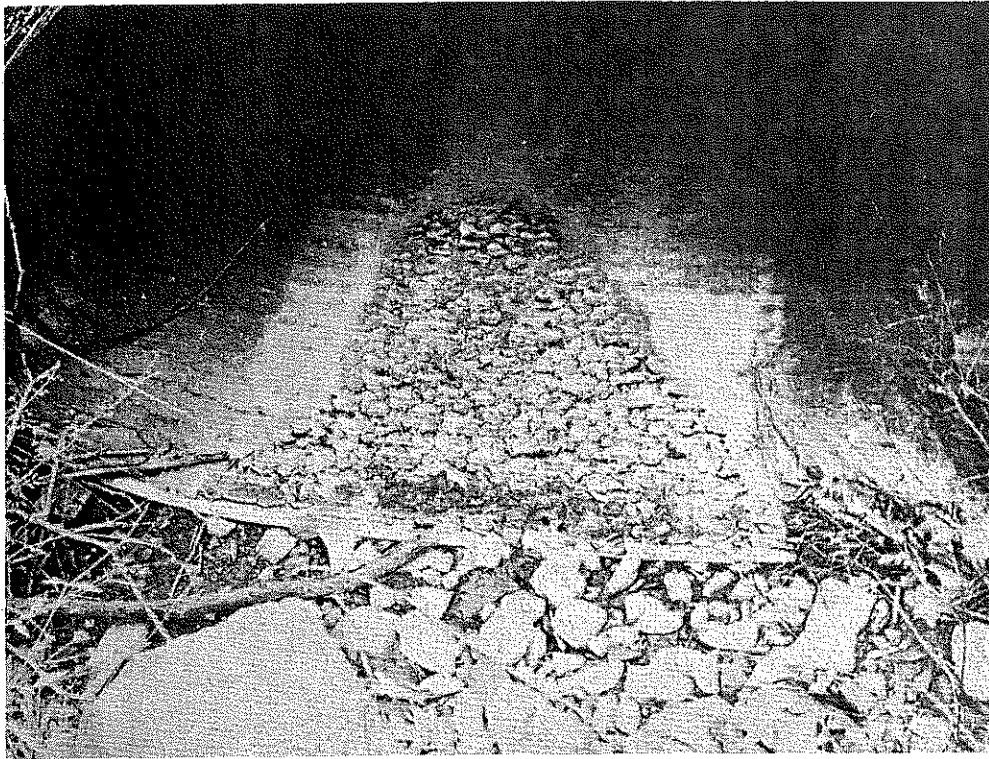
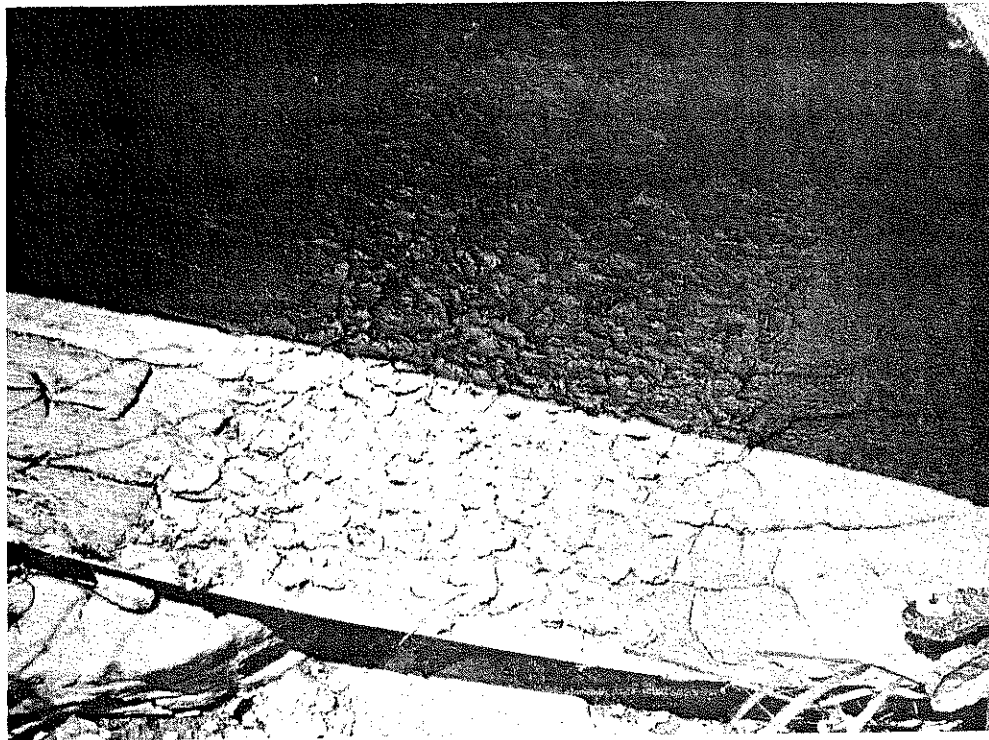
Fig. 8 - Scaling at both the inlet (a) and outlet (b) of a 65x40-in. pipe arch installed in 1949. Associated cracking was more extensive at the outlet than at the inlet, which is not subjected to direct sunlight.

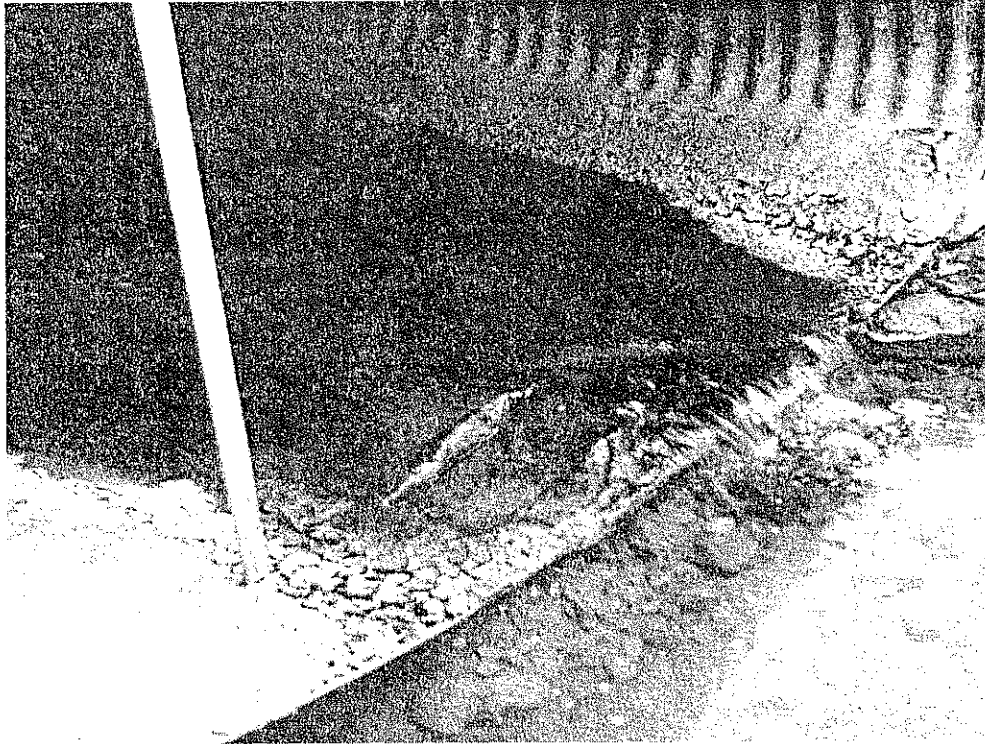
Generally scaling caused by ponded water was localized, since the possibilities for ponding are limited even in a culvert on 0 percent gradient. However, in a pipe having relatively low flow most of the time with slight fluctuations in the water surface, a favorable condition for wetting and drying exists throughout its entire length. Thus, scaling has occurred in several of the pipes at the general level of low flow or the so-called "trickle line". This is illustrated in Fig. 9.

Fig. 9 - Scaling along the edges of the low water level or "trickle line" in the paved invert of a 72x44-in. pipe arch installed in 1949. This condition extended throughout the entire length of the culvert.

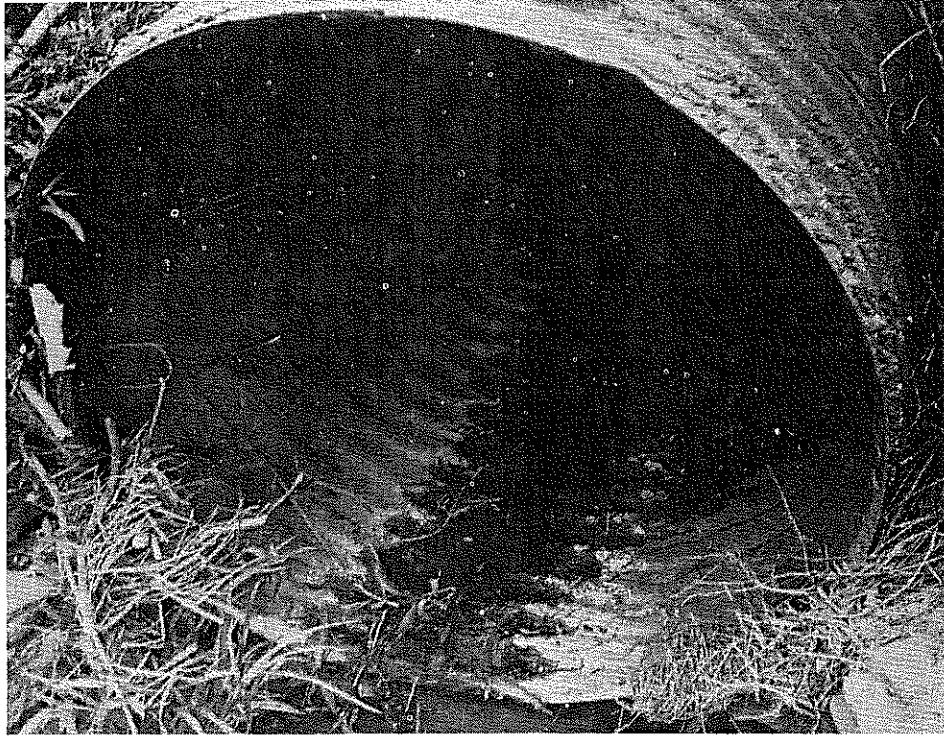
Abuses of this nature led to peeling and scaling of the coating with subsequent exposure of the spelter. As a rule, when the pavement was positioned incorrectly and there was reasonably continuous low flow, a portion of the bituminous coating was scaled and some of the coating had been completely removed throughout the entire length of the culvert at the trickle line. Damage to the coating was always confined to a strip approximately 4 inches wide in small culverts and as much as one foot wide in large sections. A typical example of misplaced pavement is shown in Fig. 10.

Fig. 10 - Coated and paved pipe placed with the invert shifted almost 90 degrees to the left. The knife (see arrow) marks the lower edge of the pavement. Water has flowed on the coating since installation of the pipe in 1949, and considerable scaling has occurred in the trickle line.

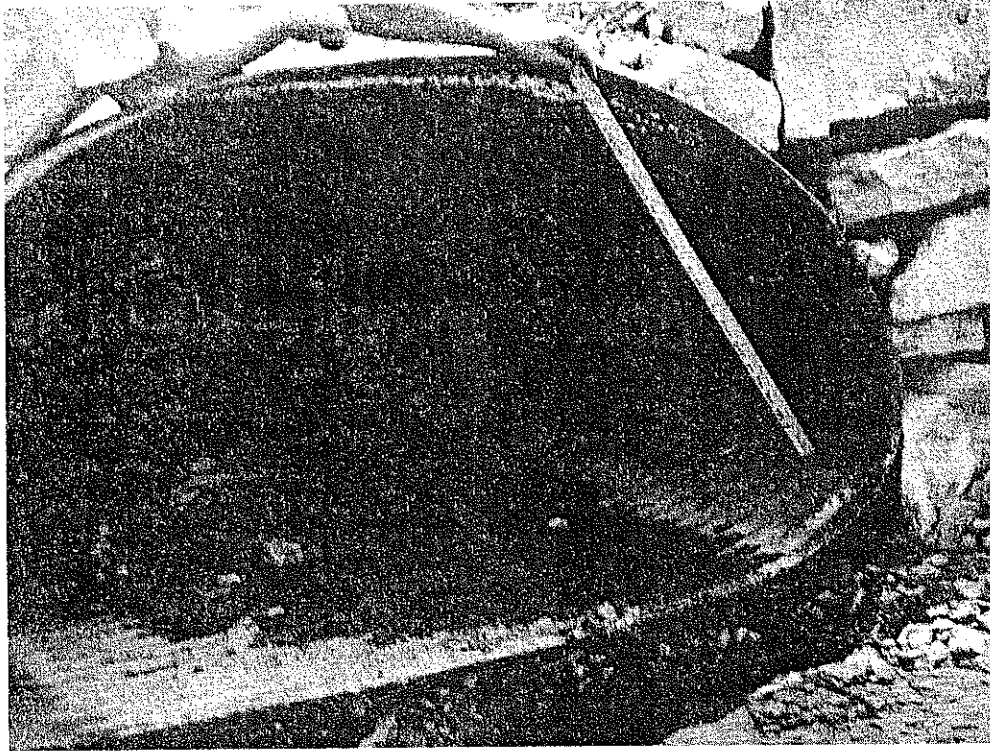
Some of the effects of burning drift are illustrated by Fig. 11 and 12. The structures were installed in 1949, and about two years later the drift was burned. Both ends of the archs are now covered with rust, and much of the protective coating is gone even from the interior of the pipe adjacent to the one in which the burning occurred. Where rusting was severe, even the spelter was no longer available to provide protections.

Fig. 11 - Outlet end of 72x44-in. pipe arch in which drift has been burned. Although it is not evident in the photograph, the entire bituminous coating has been destroyed and only fragments of the pavement remain in the invert. Extensive rusting was present throughout the pipe at the elevation indicated by the pointer, and on the inside crown of the structure. Date of installation - 1949.

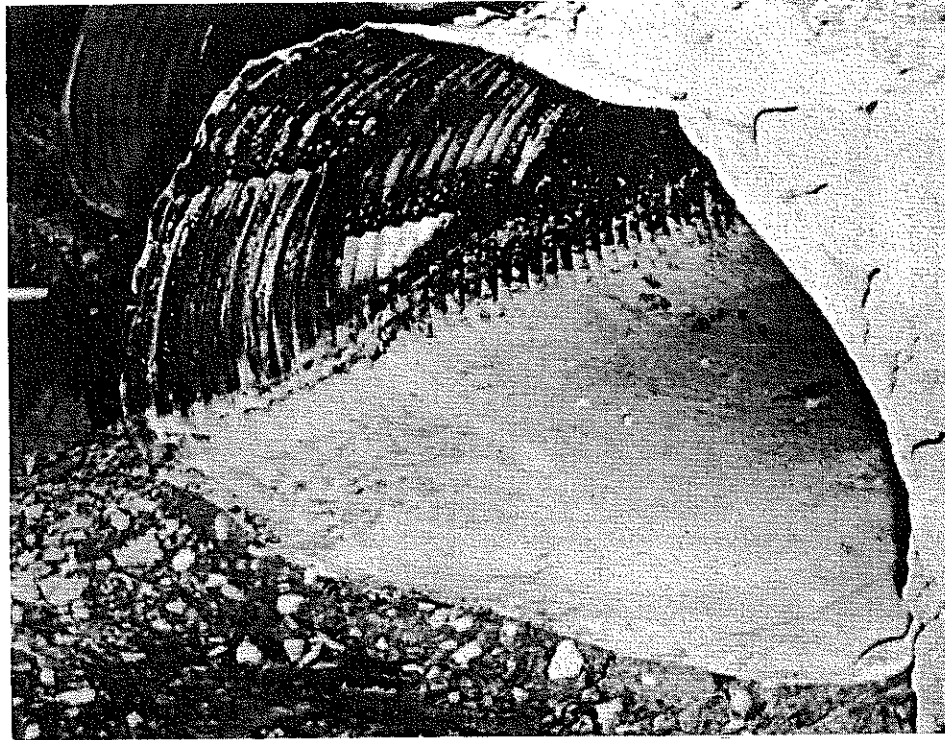
Fig. 12 - Outlet end of a companion 72x44-in. pipe arch placed alongside the arch shown in Fig. 11. The pavement was in good condition, but much of the coating on the left side had been removed by intense heat from fire in the adjacent structure.

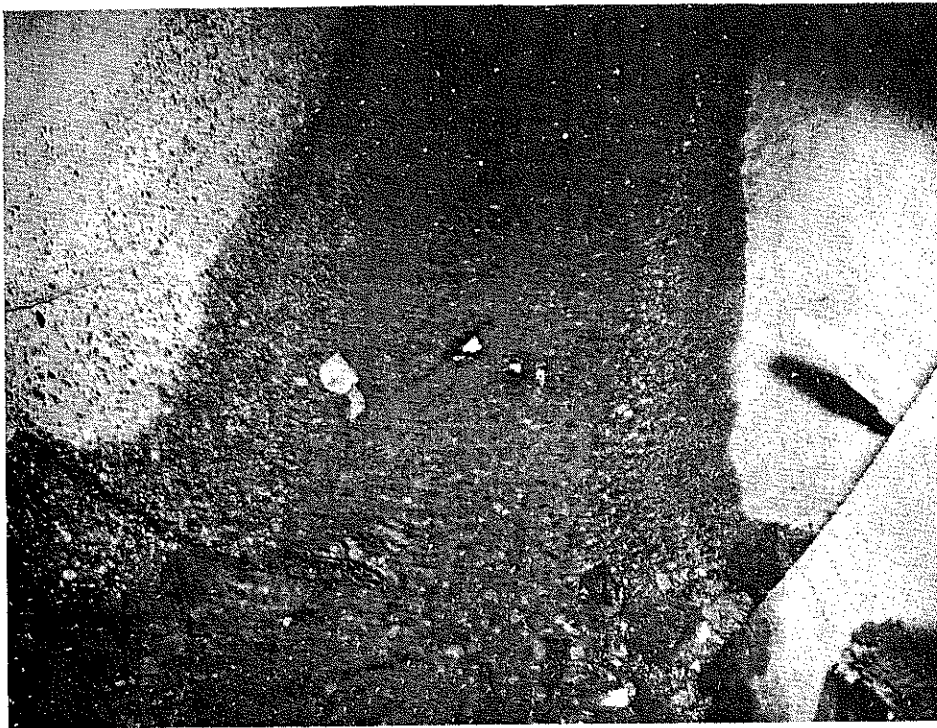
Fig. 14 - Interior of reinforced concrete pipe. Exposure of coarse aggregate has resulted from corrosion and removal of mortar by acid water. Date-August, 1954
Age - 4-1/3 yr.

1. Reinforced concrete - In these two sections of pipe considerable corrosion has caused removal of mortar and exposure of the aggregate. (See Fig. 14) In this case, the aggregate used was Ohio River Gravel, and in view of other similar inspections, it is believed that corrosion would have progressed further had the coarse aggregate been limestone.

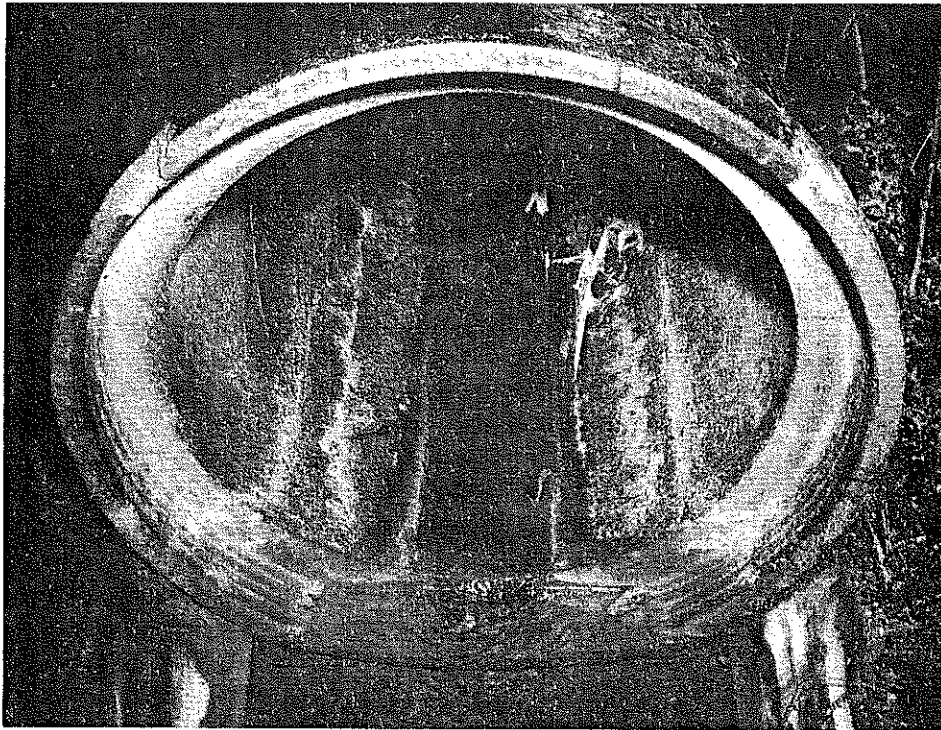
Fig. 15 - Vitrified clay pipe. Although staining and discoloration are evident at the edges of the flow line, structurally the pipe is in excellent condition. Date - August 1954; Age - 4-1/3 yr.

2. Vitrified clay - Both sections of pipe were in excellent condition with no visible deterioration (See Fig. 15).
3. Corrugated metal, asbestos bonded, bituminous coated and paved - Both sections were in excellent condition with no visible deterioration (See Fig. 16).

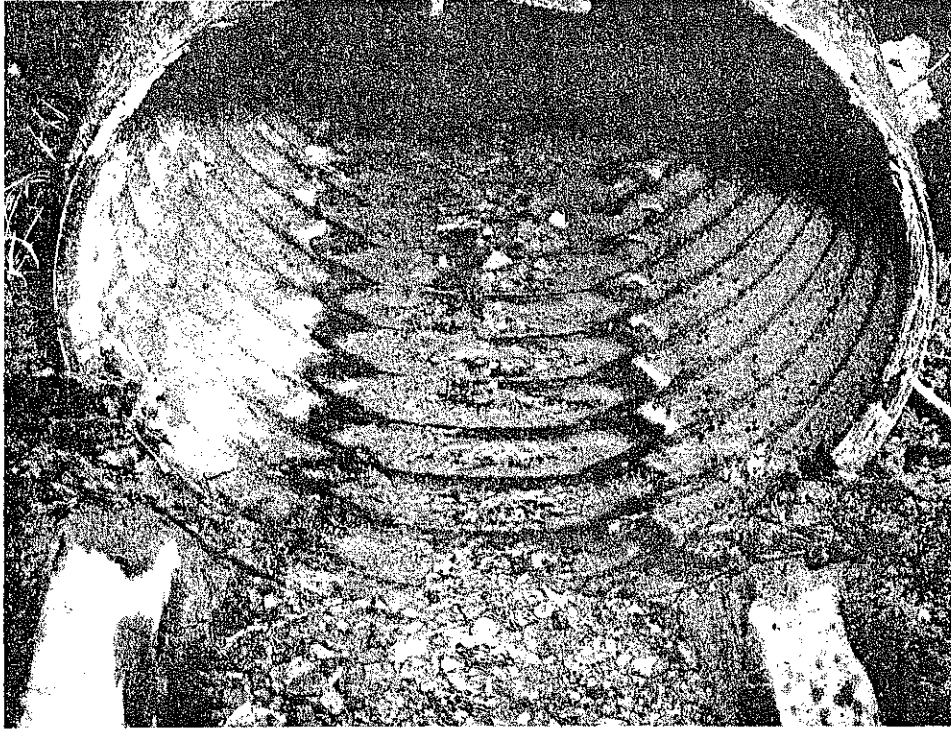
Fig. 16 - Corrugated metal, asbestos-bonded, bituminous coated and paved pipe. The flow line has been obscured by silt but the pavement in the invert has remained smooth and intact. There is no evidence of any deterioration. Date - August, 1954; Age 4-1/3 yr.

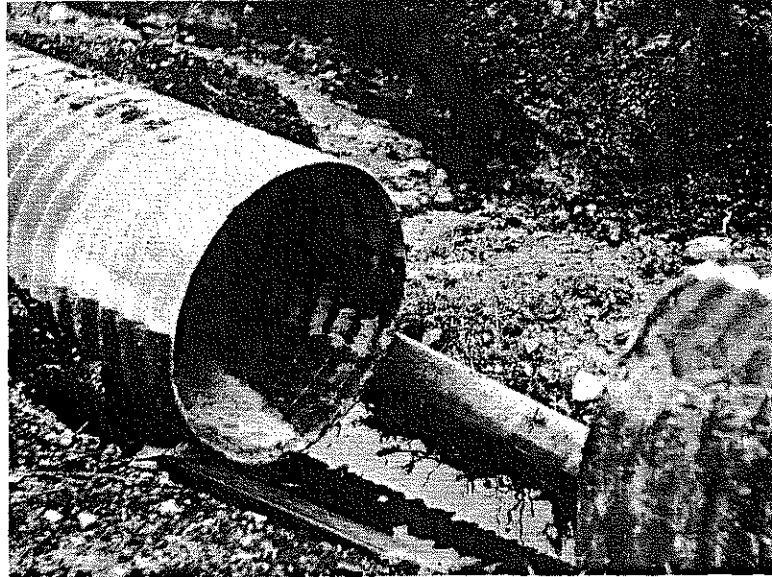
4. Corrugated metal, half-coated and paved - The pavement and coating in the remaining section was in excellent condition, and there was no evidence of corrosion in the upper portion or crown since that has not been exposed to the acid water flow (See Fig. 17). During periods of high flow the acidity is greatly reduced.

Fig. 17 - Corrugated metal, half-coated and paved pipe. Note that the pavement and coating are in excellent condition. Date - August , 1954; Age 4-1/3 yr.

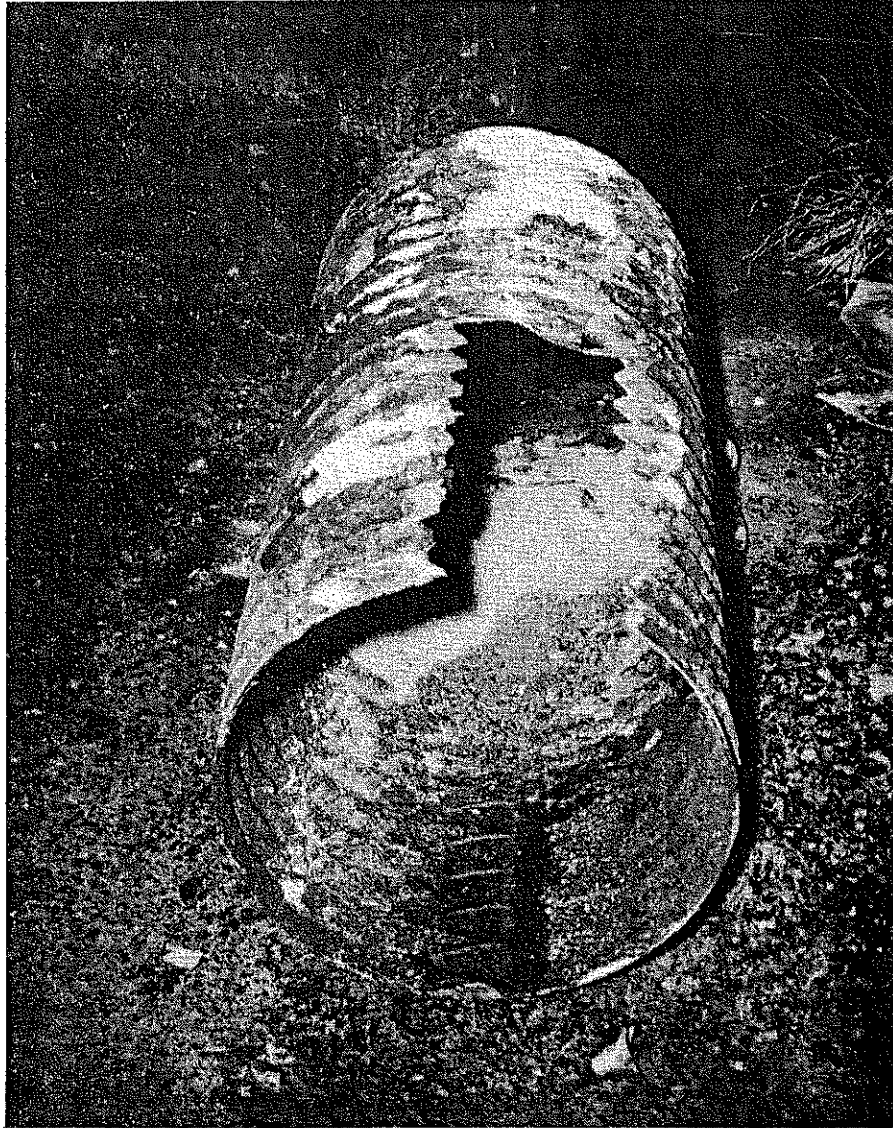
5. Corrugated metal, plain galvanized - Both sections removed and abandoned after two months of service.
6. Corrugated metal, full double coating without paving - Removed July 23, 1954, with invert eaten out (See Fig. 18).

Fig. 18 - Upstream section of corrugated metal pipe, full double coated without pavement. Note that part of the invert has been eaten away by corrosion (pipe is rotated 180 degrees). Date - August 1954. Date of removal - July 1954; Age at failure - 4-1/4 yr.

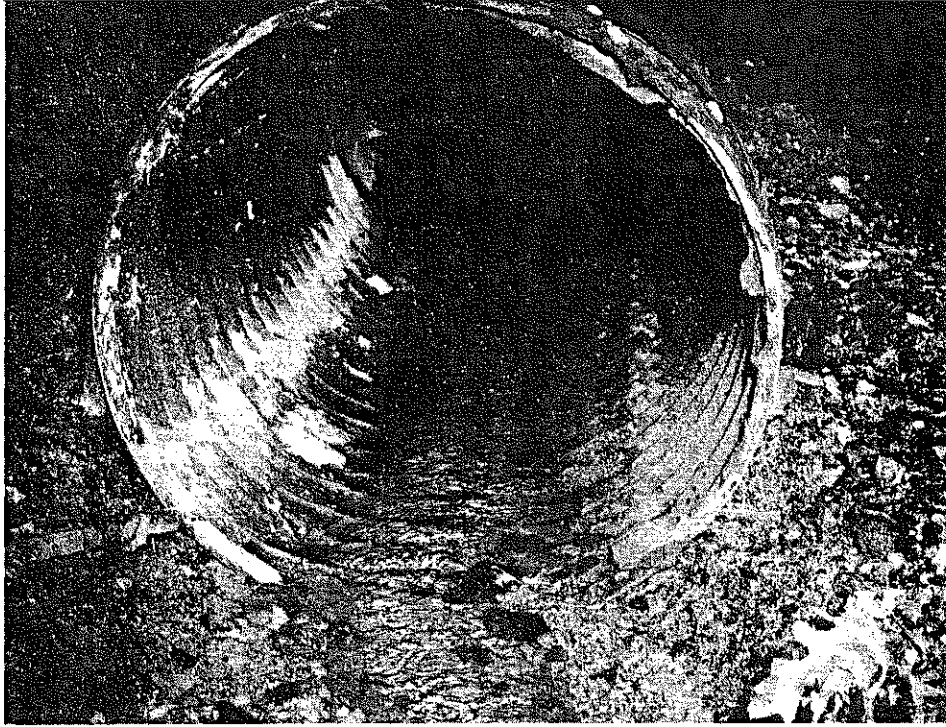
7. Corrugated metal, full coated and paved according to Kentucky Special Specification No. 1-R. - As illustrated in Fig. 19, the coating was peeling at several points in this pipe, and there was evidence of serious rust at places where the coating was removed.

Fig. 19 - Corrugated metal pipe, full coated and paved according to Kentucky Special Specification No. 1-R. The coating has peeled at some points immediately above the pavement in the invert. Rusting has occurred to a minor extent in areas where the coating is missing. Date - August 1954; Age 4-1/3 yr.

Apparently the fairly generalized peeling of coating material on the inside of one section of pipe No. 7 (corrugated metal full coated and paved according to Kentucky Special Specification No. 1-R) at the Mortons Gap installation has no connection with any of the influences mentioned above, and no direct cause is evident at this time. The exposed metal is far enough above low flow to avoid water of high acidity, but there is considerable rusting at places thus exposed.
