Report No. 1

A BANK GRAVEL BASE CONTAINING CALCIUM CHLORIDE

(U.S. 62, Paducah-Eddyville Road)

W. B. Drake  
Research Engineer

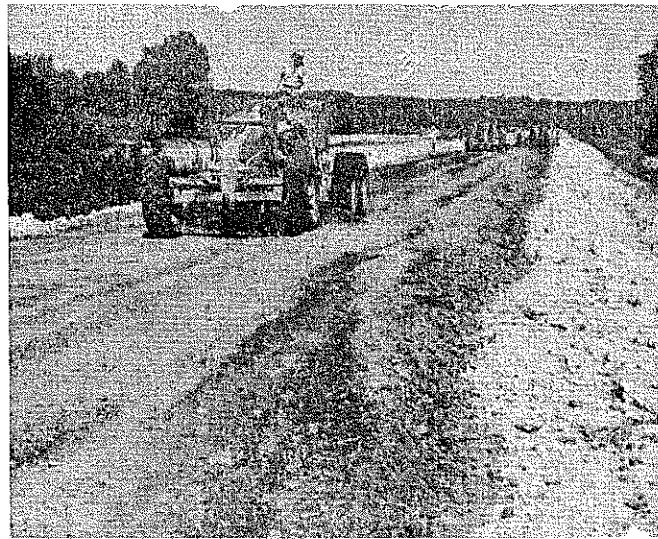
Fig. 8. Mixing binder soil and gravel with a patrol grader. This method was generally successful in producing thorough mixture if the two materials were relatively dry. On a few occasions, rain fell during the period between placement and mixing and as a result the soil was poorly distributed throughout the gravel, sometimes accumulated in pockets. (See Fig. 19)

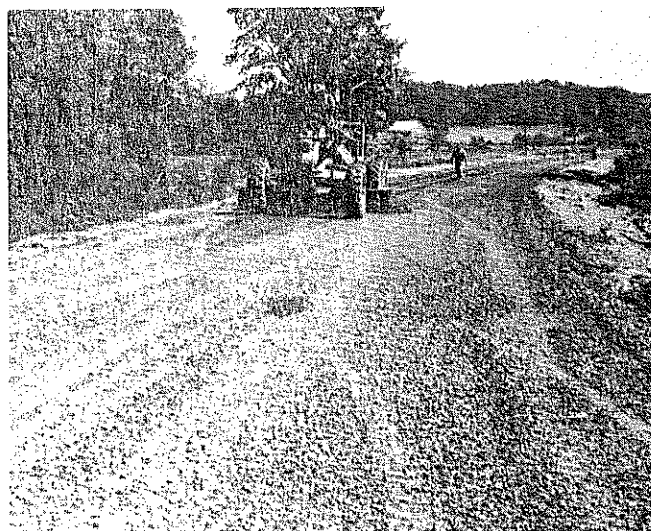
Fig. 12. Finishing to final section with a patrol grader. The cross section in this curve was checked with a string line and it was found that too much super-elevation had been placed in the final course. This condition was remedied easily with the grader followed by the two rollers in the usual order.

measurements showed that the grade or section was in error, as was the case at the location illustrated in Fig. 12, the condition could be rectified quickly and effectively with a few passes of a grader followed by the usual operation for finished rolling.

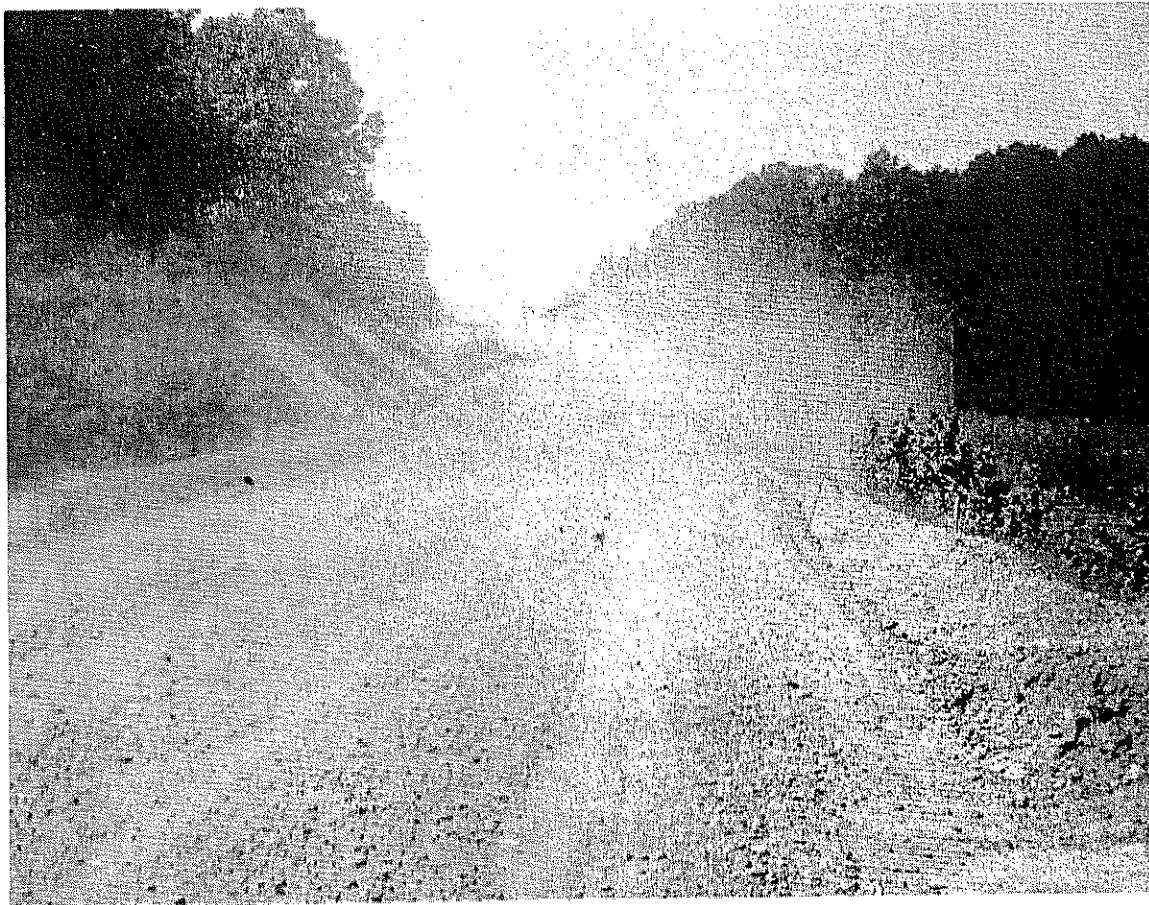
Fig. 14. Section of untreated base with binder soil showing the loss of fines through dust created by construction traffic. Note the loose gravel in the foreground that has raveled from the compacted base. A loaded gravel truck has just passed and the top of the cab can be seen dimly in the distance.

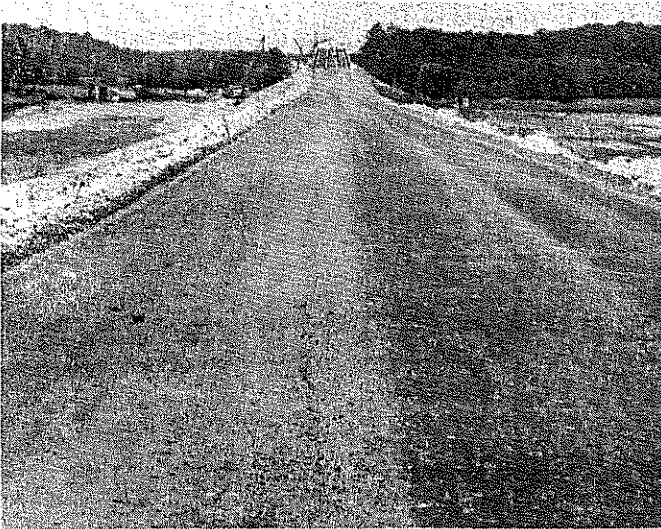
Fig. 15. A finished section of the first 2-inch stabilized course. Very little traffic had used this section at the time. Within the next two days, severe erosion of the edges occurred following a heavy rainfall (See Fig. 16).

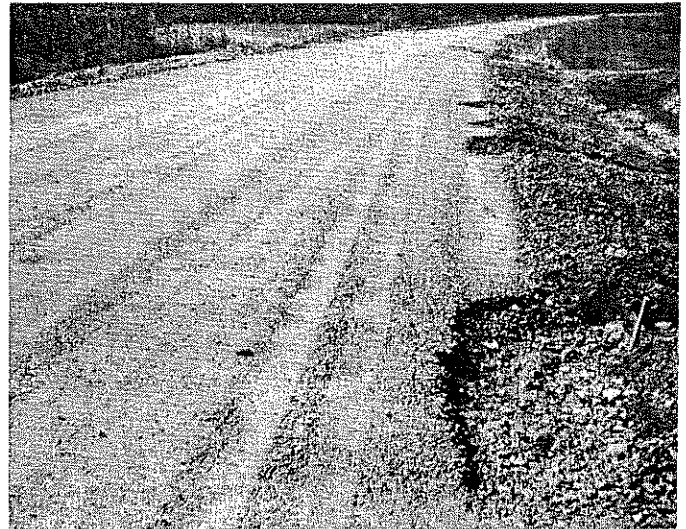
Fig. 16. Erosion of bank gravel base and shoulders following the heavy rainfall of August 28. Only the top 2 inches of base had been treated at the time, and water removed both treated and untreated material as shown. Eroded places were refilled with stabilized gravel and recompacted.

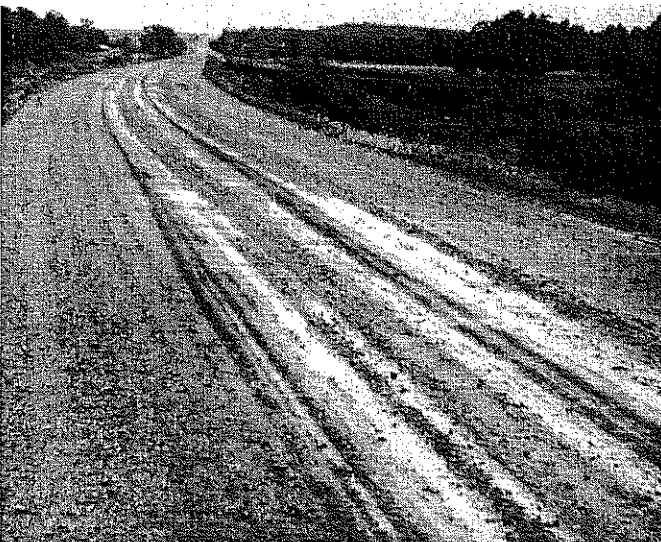
Fig. 17. A section of completed base following a rainfall of 2.40 inches within the preceding 77 hours (September, 10-13). This portion of the base had cured for one week before the heavy rain occurred. There was only slight evidence of softening of the base at this point, although a considerable amount of traffic to and from the Cumberland River Bridge project passed over this base during and following the rain.

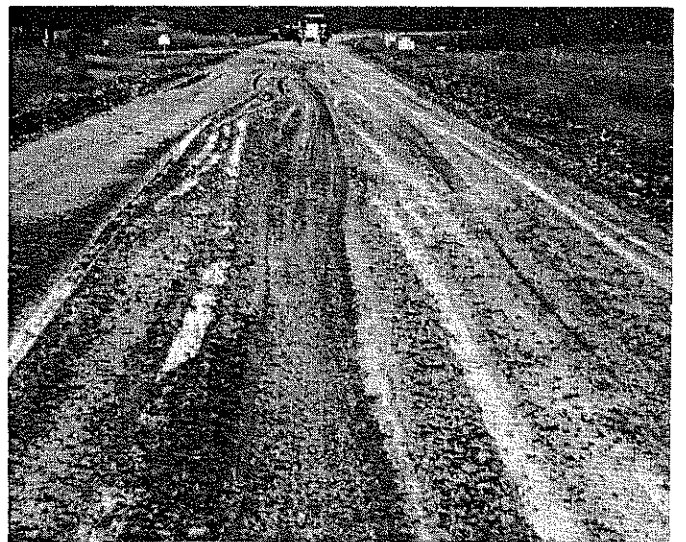
Fig. 18. A freshly laid section of base at Sta. 115+00 which was severely rutted by passing traffic after the rainfall of September 10. Further rutting occurred during and after the rain of September 12-13. Softening was much in evidence with considerable rutting of the uncured portions. Material shown was placed just two days prior to the first rainfall.

treated base. Damage to the surface was somewhat in proportion to the length of time the material had been in place, or the time it had cured. In the sections nearest the bridge, which had been down almost one week, the damage was limited as shown in Fig. 17. In contrast, those portions of the treated base which had been in place no more than two or three days were rutted and gouged to the extent that in some spots the road was almost impassible for a few hours. One of the more heavily damaged sections of treated base is shown in Fig. 18.

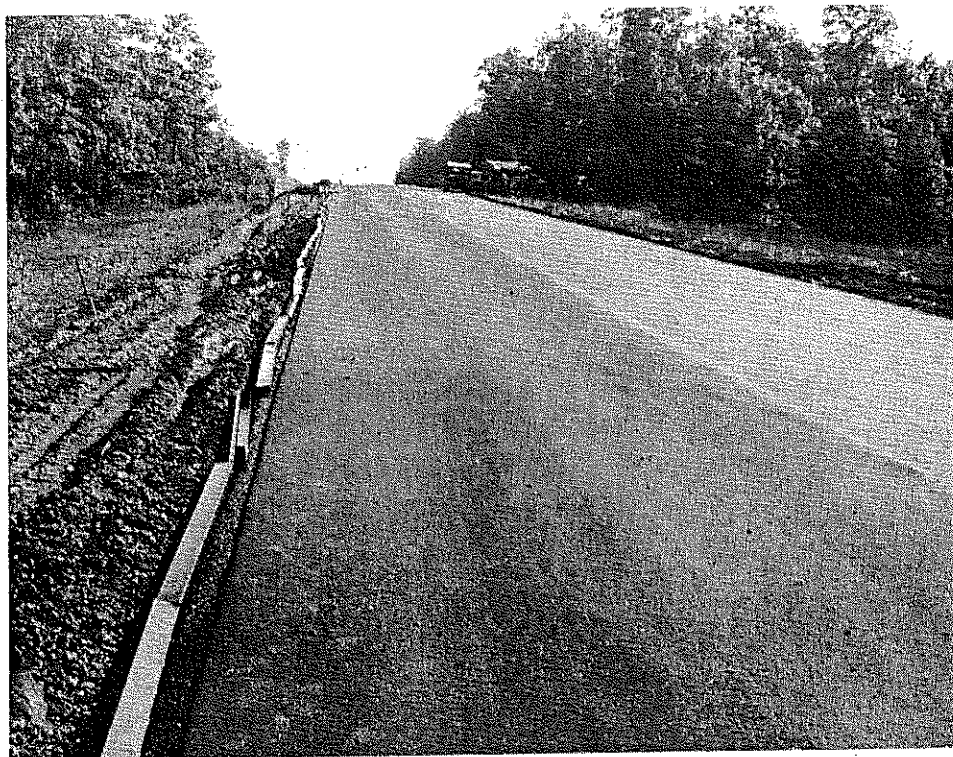
Trucks loaded with the plant mix, while passing over this section on September 25, caused such serious shoving in some spots on the north lane it was necessary to take corrective measures. Accordingly, three strips of base in this lane were cut out with a blade grader to a depth of from 2 to 8 inches and for a width of approximately 8 feet. The total length of the three strips was almost 1000 feet.

Fig. 19. Finished pavement at about Sta. 190/00 as it appeared on October 8, 1951. A section of the finished base under the left (North) lane was soft and shoved under loads at the time of bituminous binder-course construction. This condition existed in three spots totaling about 1000 feet in length. Upon examination it was found that the binder soil and gravel in the first 2-inch course of stabilized base had not been properly mixed and that lenses of binder soil were present. Records showed that this binder soil had been placed on the road and became very wet while in a windrow, and it remained wet at the time of mixing with the gravel.

Before replacement was started, the subgrade or subbase exposed by the cut was rolled with the pneumatic roller until it was firm. Bank gravel direct from the pit was hauled to the spots, tail-gated, and rolled continuously with the pneumatic roller. Immediately after the base replacement was completed, the bituminous binder course was laid over the entire 1500-foot section and on toward Kuttawa. The finished pavement, which is illustrated in Fig. 19, showed no further evidence of weakness in this section.

Before the bituminous binder was laid, base material to a depth of from 2 to 8 inches and for a width of 8 feet was removed in the left lane. Prior to replacement, the exposed surface was rolled until firm, after which the excavations were refilled with bank-run gravel which was rolled continuously as it was spread. The bituminous binder course followed immediately. Forms shown here were used later in the construction of a lip curb.

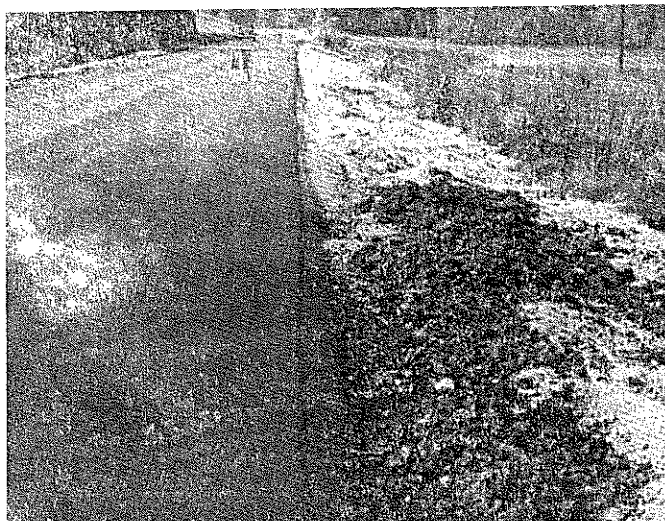
Fig. 20. Weak spot within the 8000-foot section where existing traffic-bound material was trenched 0.7 foot, prior to base construction. Subgrade soil worked up through the base in several spots and kept the base weak even after the bituminous binder was placed. When the surface course reached this section, material was excavated by hand at all the locations showing signs of failure, the openings were backfilled with surface mix, and the pavement finished. Note excavated material on the shoulder.

operations could not be carried out with equipment. Material from the excavations was wasted on the shoulder, and the entire depth in all cases was refilled with bituminous surface course by end dumping from trucks. The bituminous mix was raked and rolled, and then the surface course was placed over the top with the finishing machine. One of the spots where bituminous replacement was used (Approximately Sta. 220/00), is illustrated in Fig. 20.

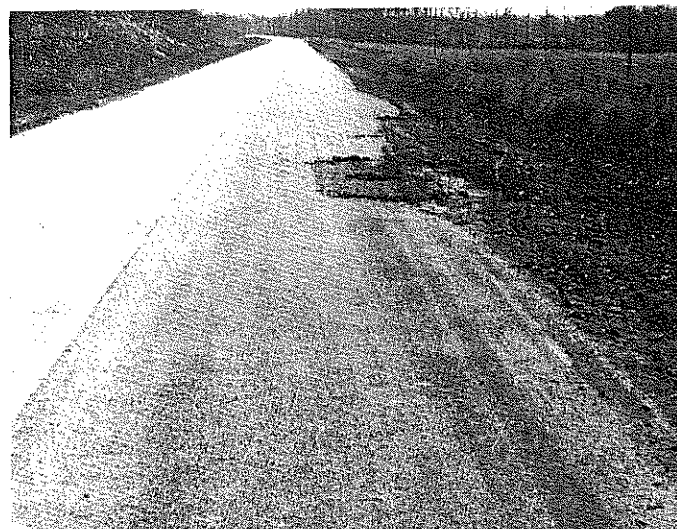
Fig. 21. Location shown in Fig. 20 after four months. The cracked pavement has been patched with a thin layer of porous cold patch. There was very little bond between the patch and the pavement. The failure is confined to the right wheel track of the north lane for a distance of 15 to 20 feet.

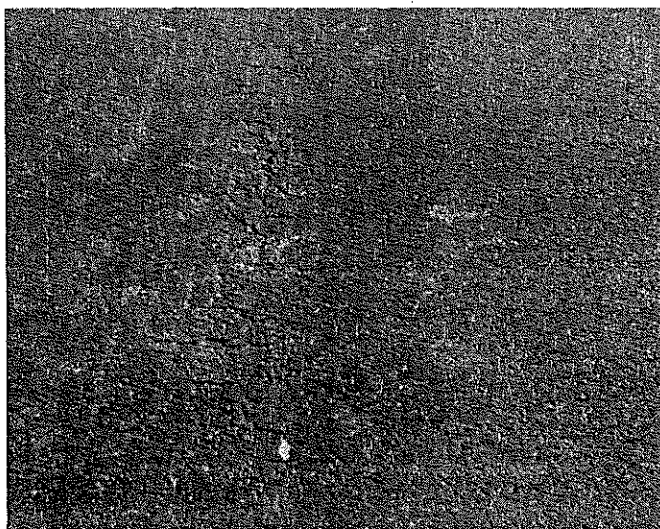
Fig. 22. Cracks in the finished surface that appeared just after paving near Sta. 233+00. This failure occurred at a point where the base was originally 20 inches in depth, a part of which was removed and replaced as described in Fig. 20 above.

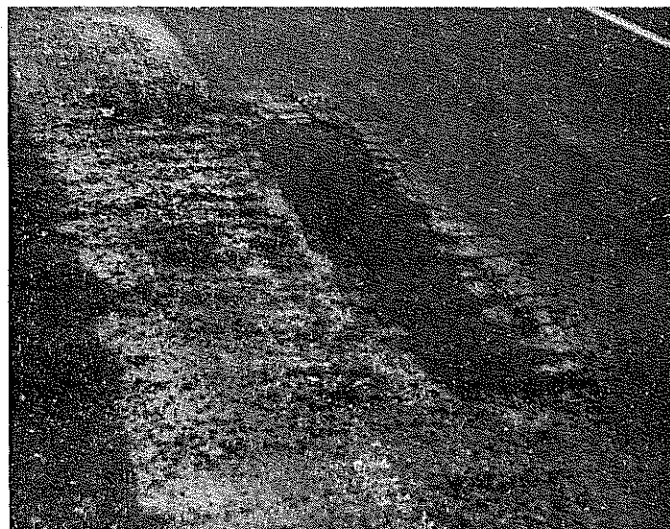
Fig. 23. Location shown in Fig. 22 after four months. The thin porous cold patch was raked from the failure of this picture.

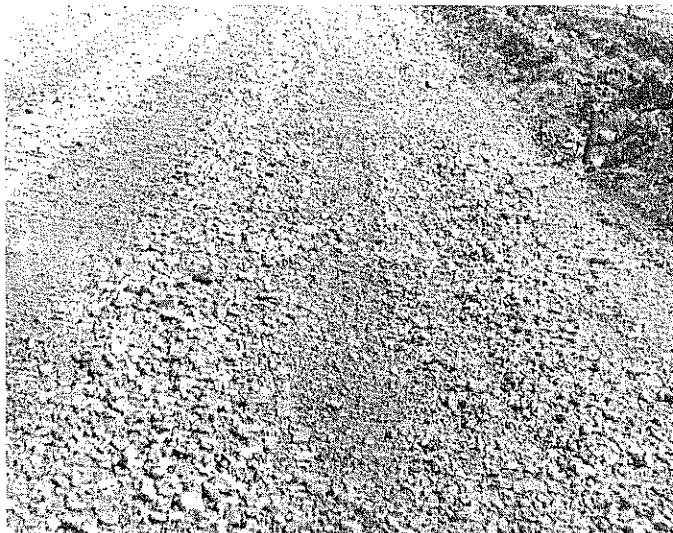
When the base was started in Livingston County, gravel was taken from the Young Pit which lay between the rivers. This source as noted in the discussion of mix design, had material running as large as five inches in size, and the clay content was relatively high. High plasticity was characteristic of the fine fractions. An entire 4-inch course and about half of the second 4-inch course of the Livingston County base was laid with this material. Construction procedures were the same as those used on the untreated base in Lyon County. Results, from the standpoint of raveling on exposed surfaces, are illustrated in Fig. 24.

Fig. 24. Raveling of the initial 4-inch base course in Livingston County. A large quantity of gravel 4-inches and larger was contained in this material from the Young pit located between the rivers.

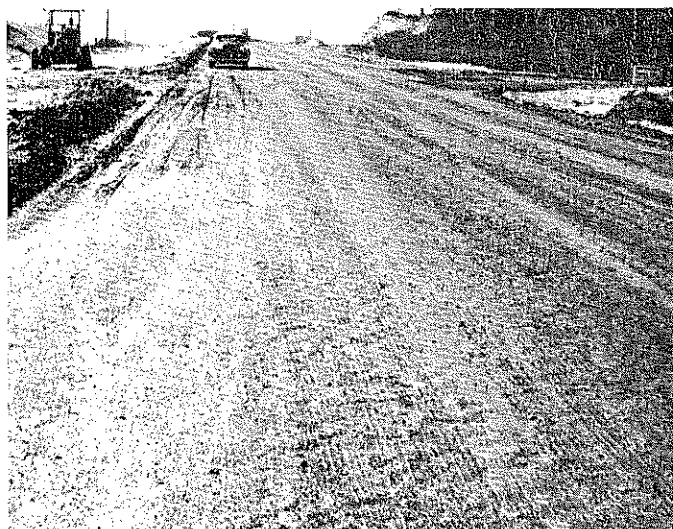
Fig. 26. A section of non-plastic base in Livingston County looking west toward station 450/00. The gravel was from the Max Bohannon pit, and was exceptionally sandy at this point. Note the evidence of non-consolidated material.

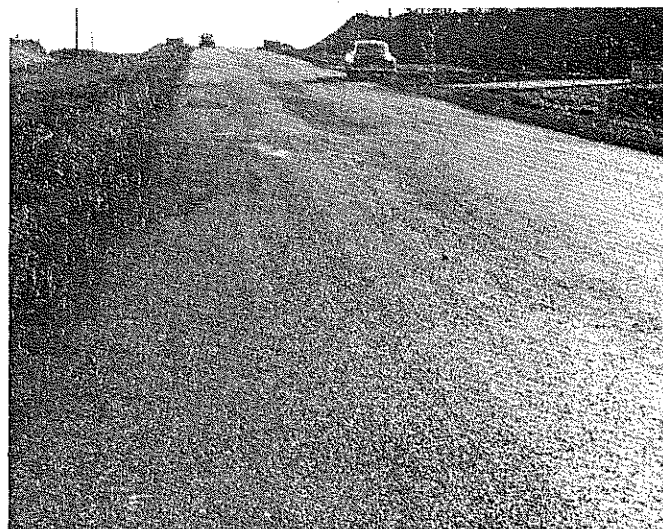
Fig. 27. Patched binder course at the location of the non-consolidated base in Fig. 26. The dark section in the center of the pavement is not a patch but was caused by a badly cracked condition. Conditions shown existed about four months after the binder course was laid. Final surfacing of this portion of the road will be carried out during the 1952 season.

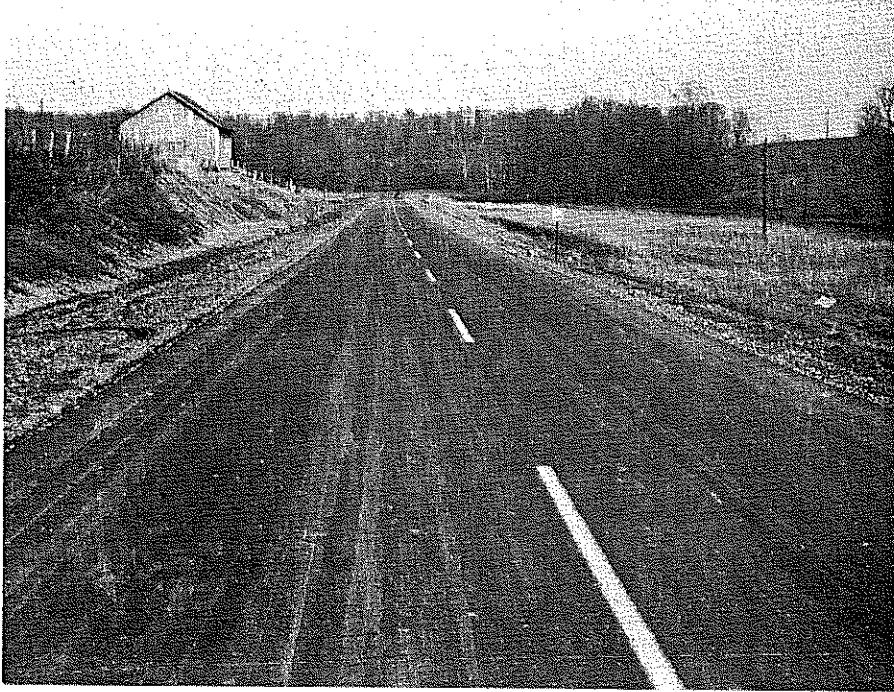
Fig. 28 was taken at approximately the same location as Fig. 18, and apparently the restoration of this rutted base was successful. The riding qualities of the finished pavement are excellent. Fig. 29 shows the completed pavement at about the same location as Fig. 17. An excellent cross-section was obtained throughout.

Fig. 28. Finished pavement at the same location shown in Fig. 18. Excellent riding qualities were obtained. The photograph was taken four months after construction.

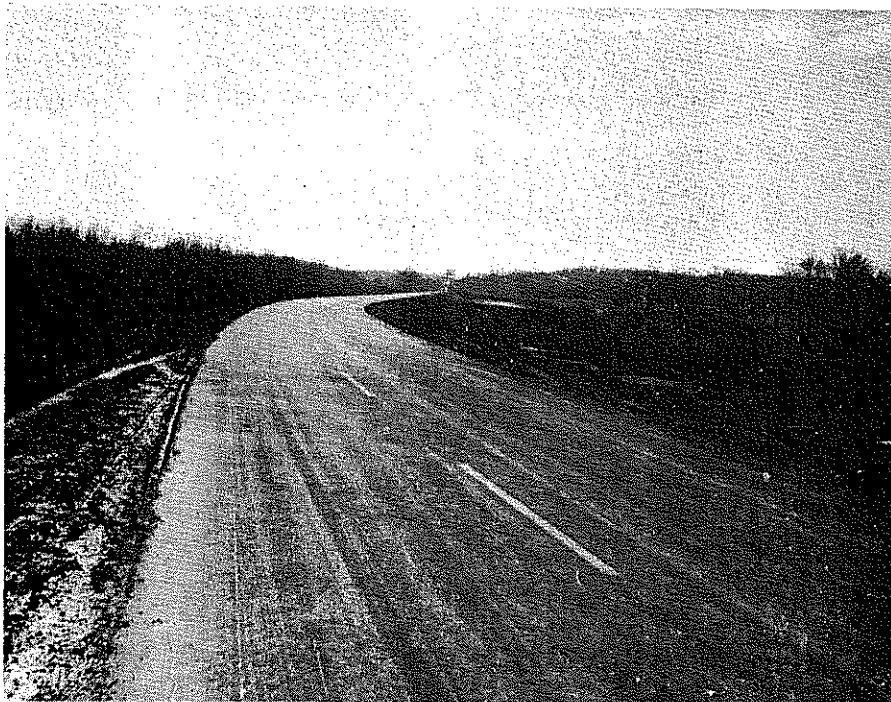
Fig. 29. Completed pavement near the location of Fig. 17, as it appeared on February 18, 1952. The cross section, as illustrated in this photograph, was excellent throughout the project.
