Commonwealth of Kentucky
Department of Highways

Progress Report

EXPERIMENTAL JOINTING INSTALLATIONS
FOR CONCRETE PAVEMENTS

Project F 367 (10) - U.S. 27 Campbell County
 Prefabricated Neoprene Seal

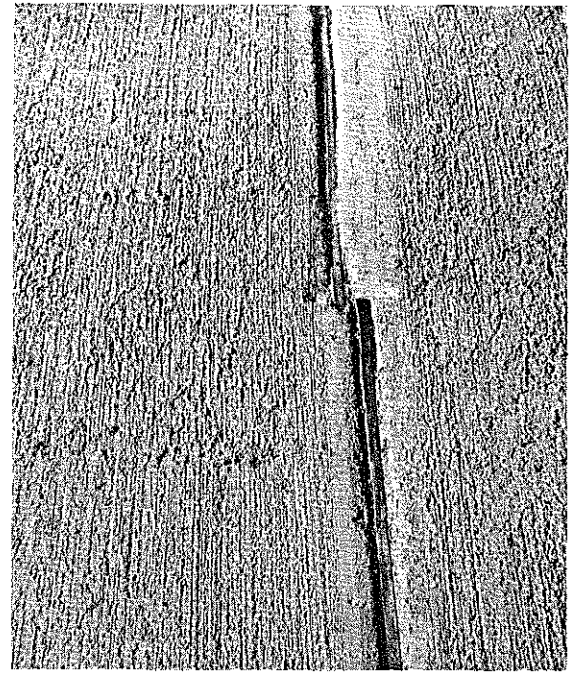
Due to the lack of experience of the crew and inept handling, the placement of the experimental joints was not at all satisfactory. Two of these joints were knocked out of position by the finishing machine, as illustrated in Figs. 3 and 5.

Fig. 3. Closeup of Joint at Sta-622,42 in February, 1949. At the center of the pavement the neoprene sealer did not form a continuous seal.

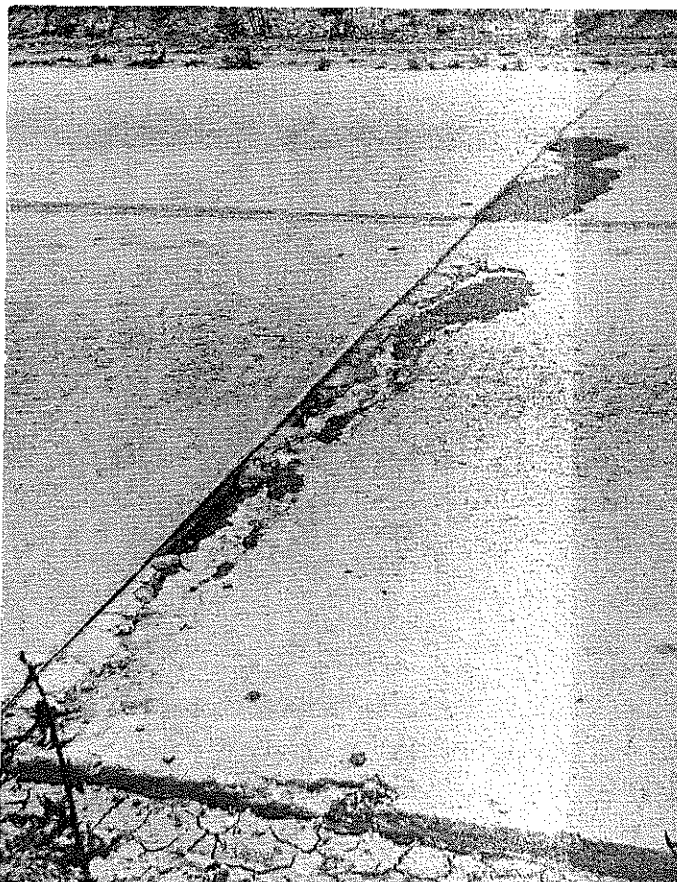
Fig. 4. Joint at Station 622,42 in June, 1951. Slight spalling at this joint was noted as early as September, 1949, and this condition extended rapidly from the near edge toward the center. Deterioration in the near lane had almost reached the center line before the far lane was affected.

At the time of the last inspection, June 8, 1951, the spalled area at Joint No. 1 had progressed to the full width of the pavement; and at Joints No. 2 and 3, the spalled areas had increased proportionately, extending past the center of the north-bound lane. (See Figs. 4, 5, and 7).

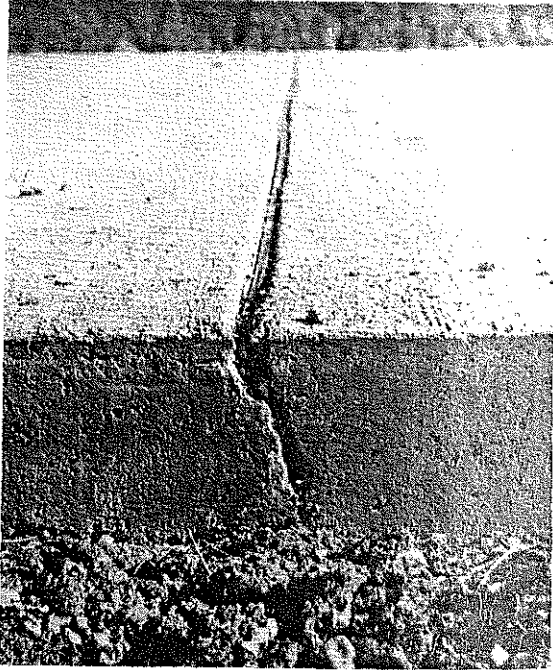
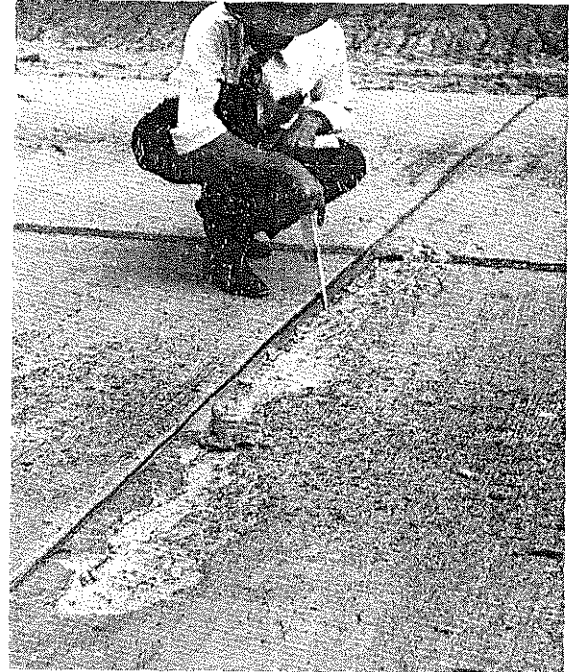
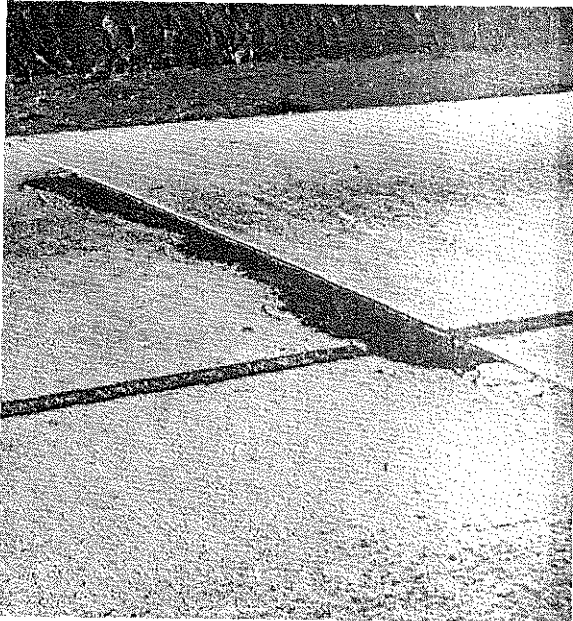
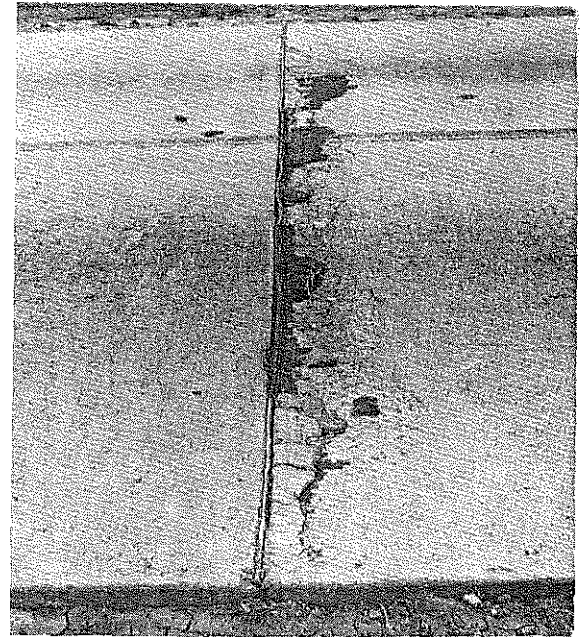
Fig. 5. View of joint at Station 622/22 on Project F 367(10), U. S. 27, Campbell County, showing the condition at various stages since installation.

February, 1949. In the finishing operations this joint was tilted considerably.

September, 1949. Severe spalling developed within the first few months that the pavement was in use.

December, 1949. Patching restored the riding qualities of the pavement, but did not prevent further failure about the joint.

June, 1951. Spalling about the joint extended with time and the bituminous patch material was removed by passing traffic.

September 27, 1949. (See Figs. 5 and 6). This condition was the most serious at Joint No. 1 where one entire face of the seal was exposed for as much as 7 or 8 feet in the south-bound lane. Spalling was slightly in evidence at Joint No. 2; and, at Joint No. 3, spalling had begun in an area approximately 3 feet long by 8 inches wide paralleling the joint on the south side. All areas of spalling first occurred in the south-bound lane and were confined to the south side (or forward side) of the joints. The condition became more aggravated with the passage of time - Joint No. 1 requiring a bituminous patch prior to December 30, 1949. On July 28, 1950, the spalling at Joint No. 1 had progressed to the center of the north-bound lane and the spalled areas at both Joints No. 2 and 3, had increased in width and had crossed over into the north-bound lane. This condition was not found at any of the standard joints on the project.

In view of the conditions of these particular joints, which are definitely failures, further observations of this project can be considered of little or no value. However, in view of difficulties that arose during placement it is doubtful that the neoprene sealers themselves were at fault. To the extent that they

complicated finishing operation they were at fault, but at least a considerable portion of the damage may be attributed to the joint assembly and its poor installation. If further investigations are desired on this type of design, it is recommended that additional installations be made only if control of the placement and finishing is worked out in advance.

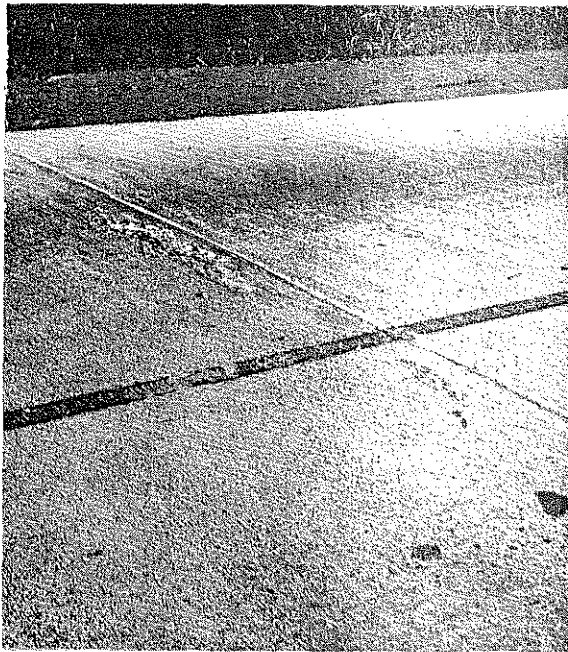
Fig. 6. Joint at Station 622/62 in December, 1949. The first evidence of spalling at this joint was recorded three months prior to this time.

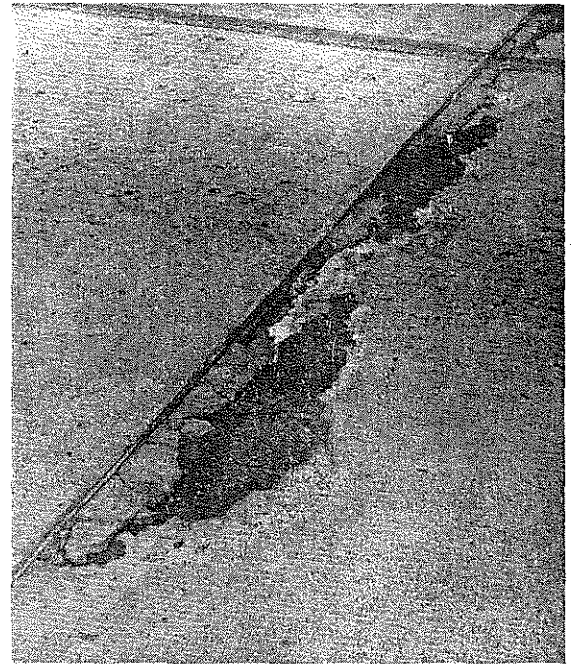
Fig. 7. Joint at Station 622/62 in June, 1951. This condition, as shown in Fig. 9, extends almost throughout the full width of the pavement.

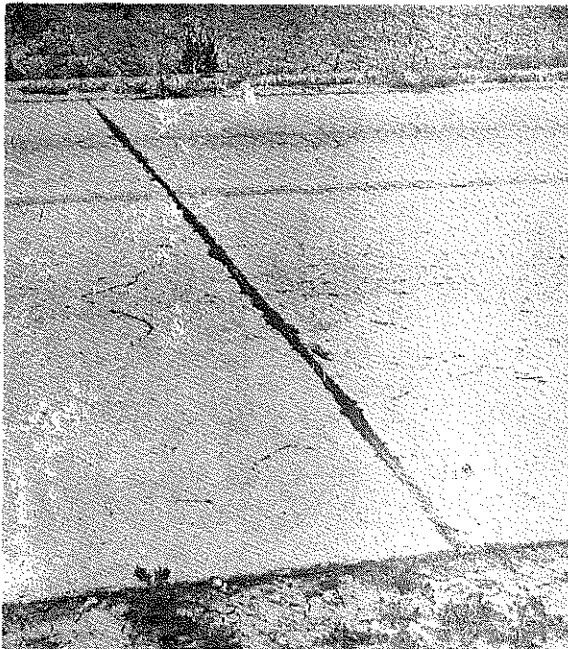
Fig. 8. Comparison joint of standard design at Station 622/82, in June, 1951. The sealer here, as in all other standard joints on the project, was hot-poured rubber asphalt compound.

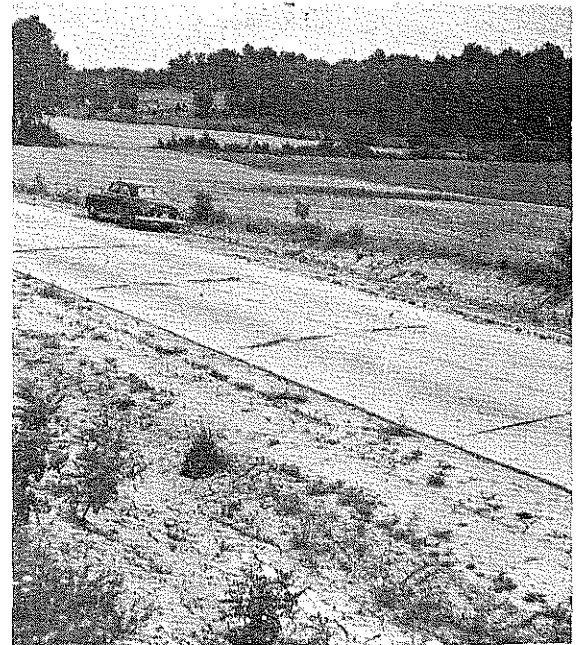
Fig. 9. General view of the three experimental joints with neoprene seals and the comparison joint of standard design. The order of stationing is from 622/22 on the left to 622/82 (standard joint) on the right.

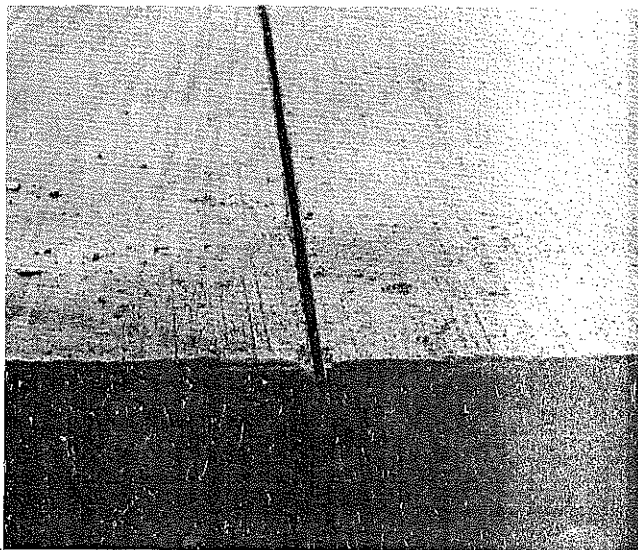
The first aluminum joints (identified as experimental Joints No. 11 and 12) were placed September 30 in Lane Four, at the second and third full-width (11 feet) joints nearest the Shelbyville end (Fig. 16). Joint No. 12 was tilted to the rear (See Fig. 25), and was tilted slightly ahead with respect to the direction of paving. Due to these unsatisfactory results, further installations were postponed until adjustment could be made in the "joint-holding" apparatus.

Fig. 25. An inclined joint at Station 305,400. The direction of paving was from left to right.

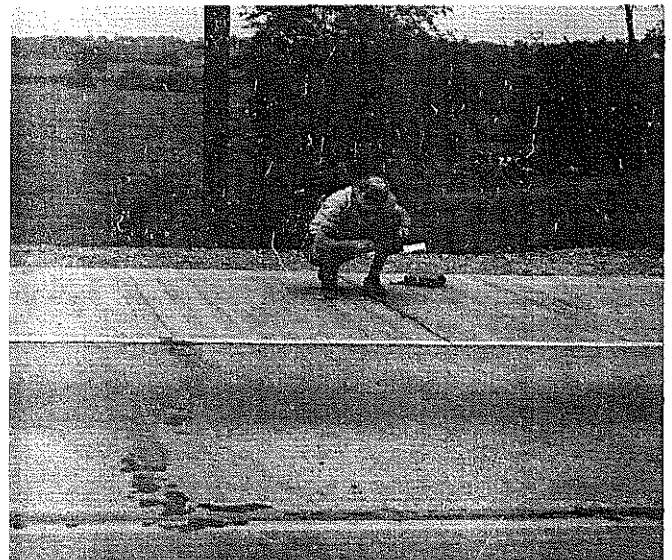
Fig. 26. Making width measurements over Joint No. 2 at Station 245,450 in June, 1951. At this time the truck lanes had been in service about 8 months, and there was no apparent difference in the condition of the standard and the aluminum joints, nor any difference in the condition of the concrete about the two types of joints.
