Commonwealth of Kentucky
Department of Highways

OBSERVATION ON SEAL COATS, TACK COATS, PENETRATION
MACADAM, AND BLADE SPREAD HOT MIX IN 1951

December 7, 1951

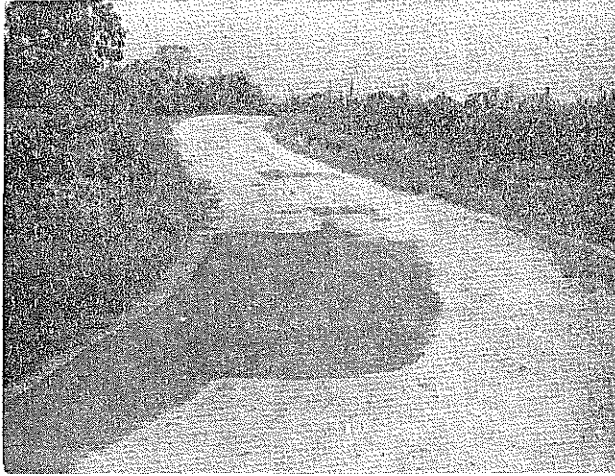
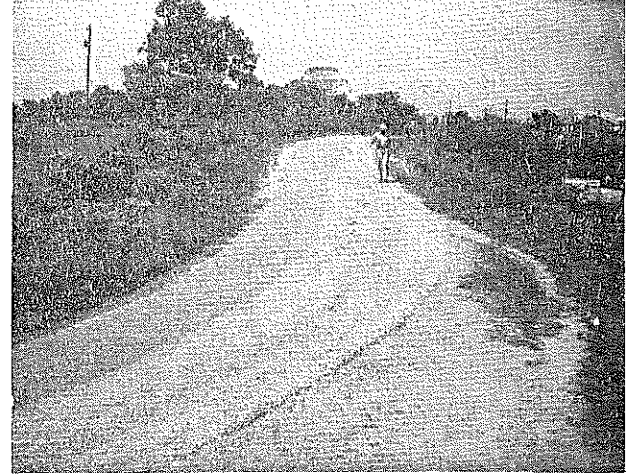
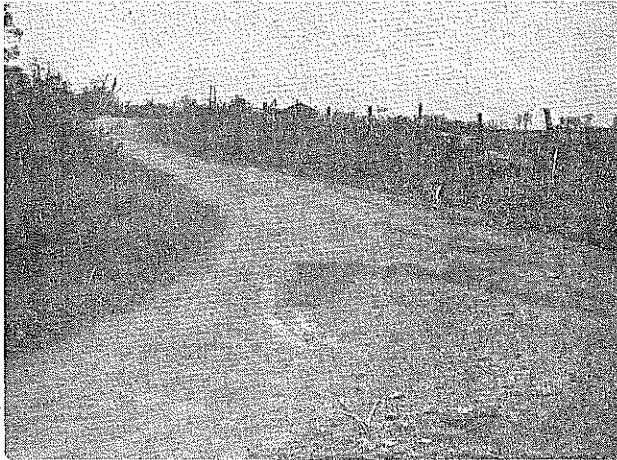
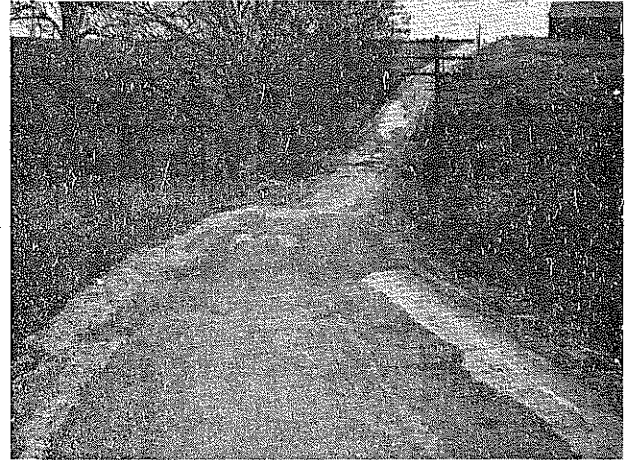
Fig. 2. Grant County RH Group 4 (1950). The top photos and lower left were taken on the Dry Ridge-Northcut Road. The average performance of that portion of the project is shown. Many "Base" failures were in evidence. The lower right photo was taken on the Dry Ridge-Folsom Road and shows the heavy maintenance required because of base failure. Very little of the original seal coat was left.

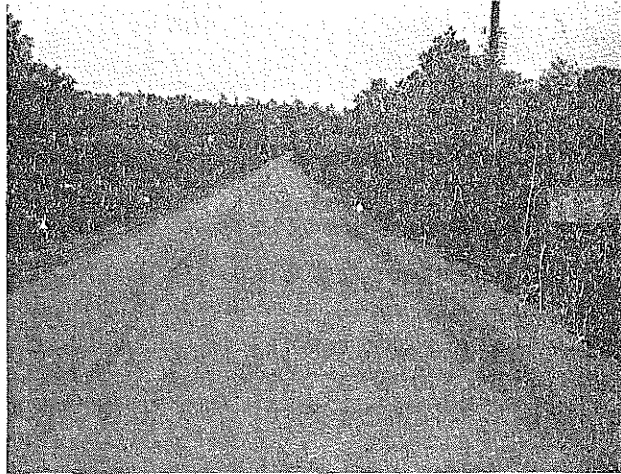
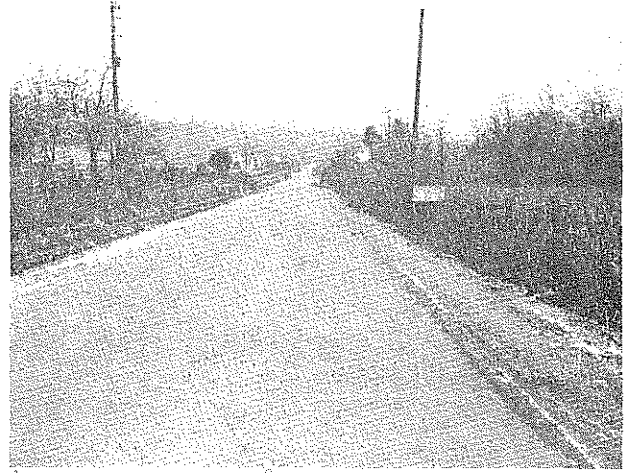
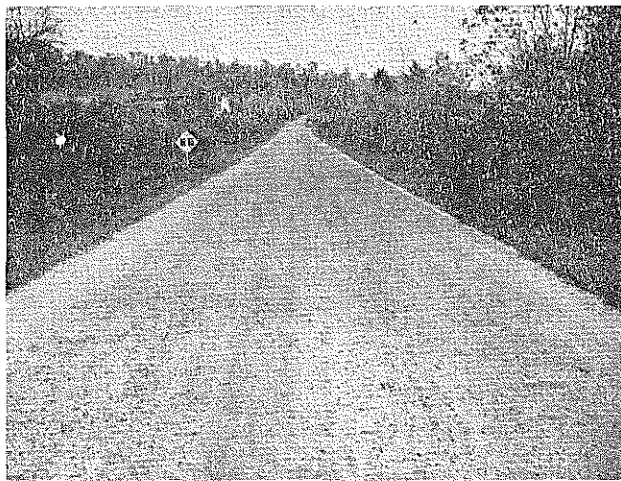
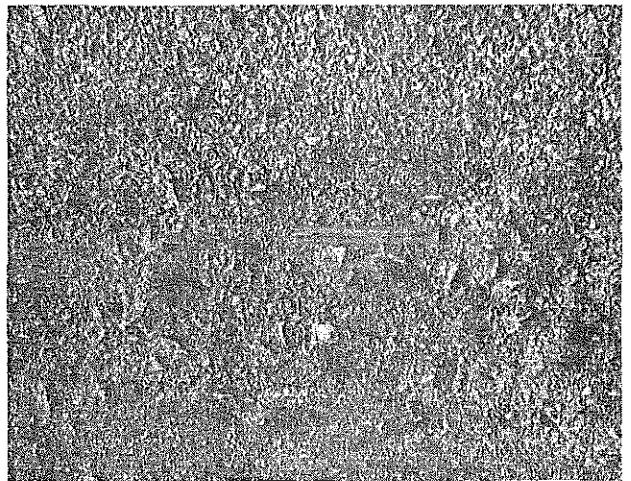
Fig. 3 shows a section of this pavement photographed in October, 1950, January, 1951, and October, 1951. The closeup shows some of the No. 4 size stone of the penetration mat. The small stone showing is No. 9 that was used for the seal cover.

The seal seems to be adequate and performing properly .

Fig. 3. Pulaski County SP 100-75 (1950). - These photos of the surface of the penetration macadam project were taken in test section No 1. The right lane was given an extra half gallon of RS-1 Emulsified Asphalt. The seal coat consisted of 0.45 gal. of RS-2 with 15 pounds of No. 9 limestone. The seal coat performance has been excellent throughout the project.

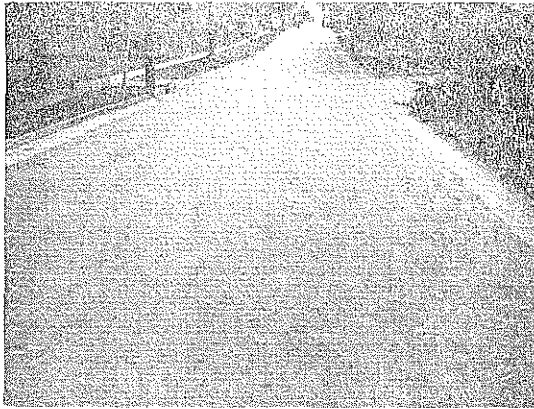
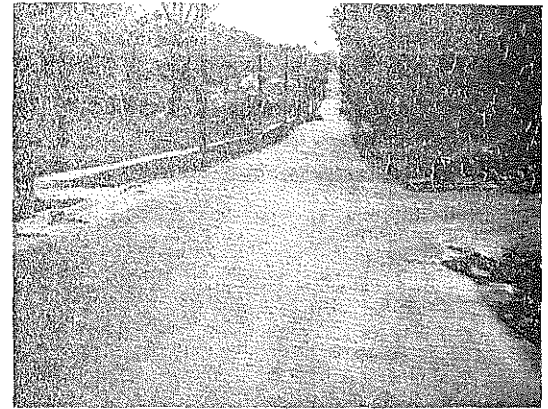
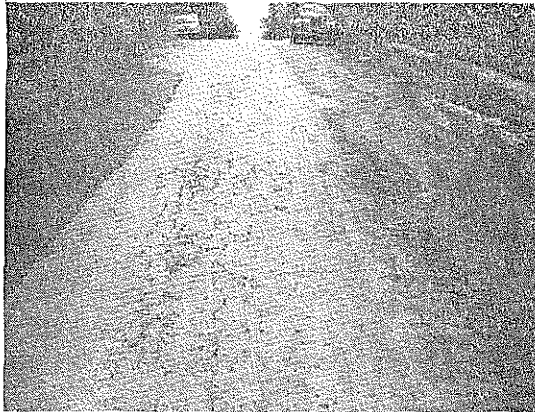
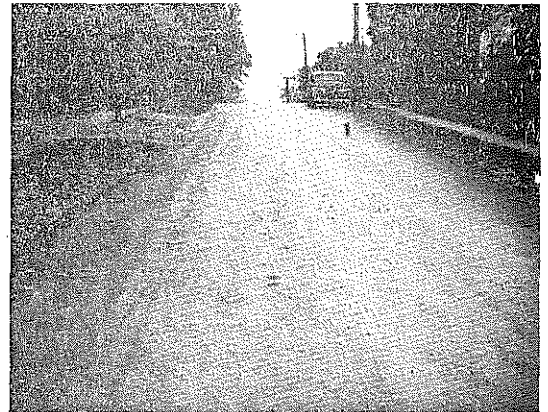
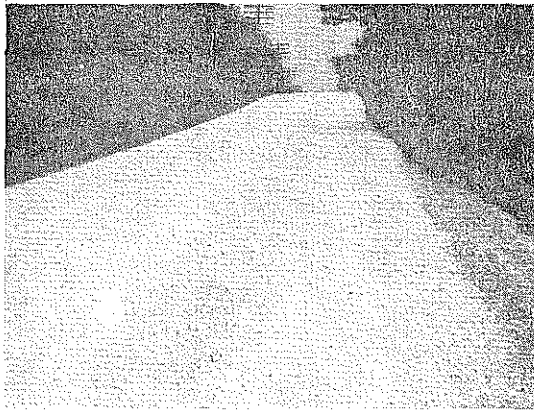
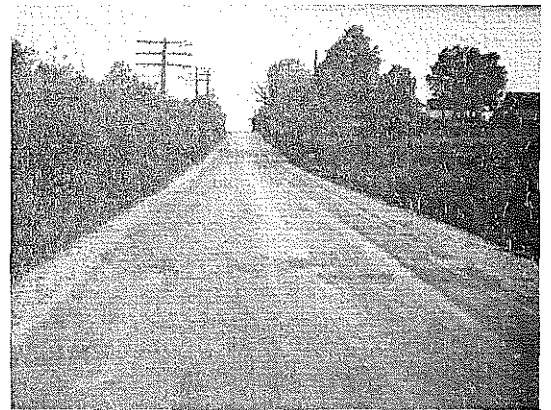
Fig. 4. Laurel County SP Group 47 (1950). This NAC-8 seal had both urban and rural sections. The top photos are of Sublemity Street in London and had No. 9 stone for chips. The middle photos are of College Street and had No. 8 stone cover. The bottom photos are rural sections and the portion in the foreground was placed over traffic bound base.

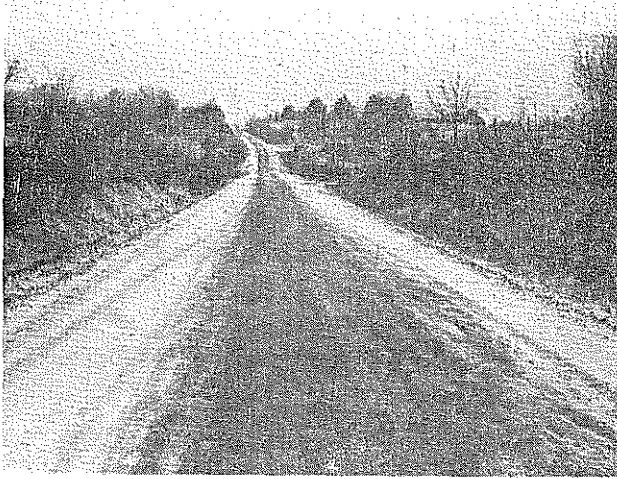
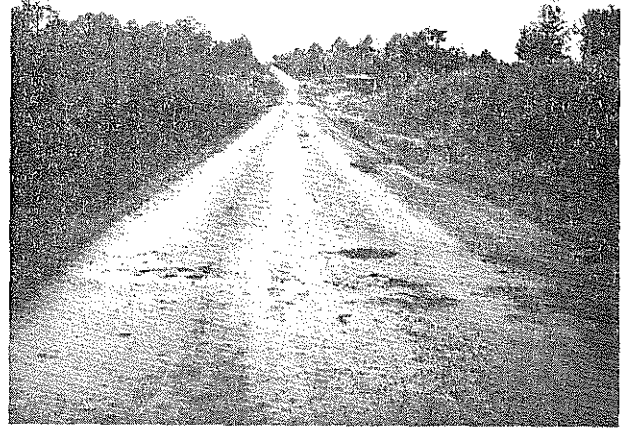
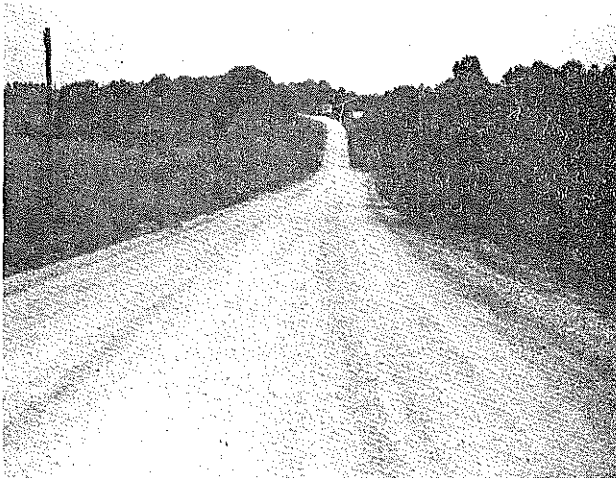
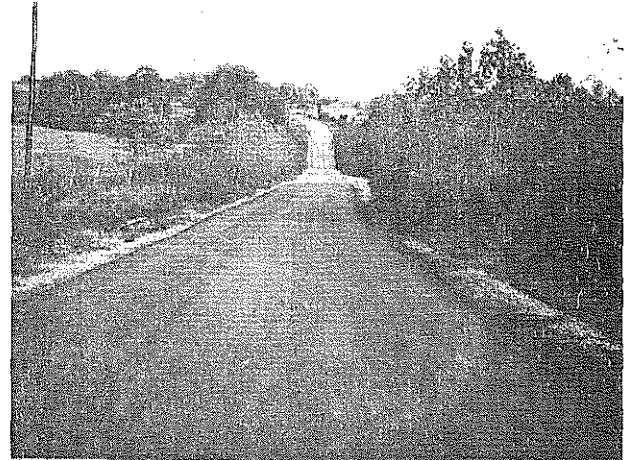
Pulaski County, SP 100-215 (1950) was an NAC-8 seal over traffic bound base. Sealing of the road was carried out about the middle of September, 1950. The road was inspected in January, 1951, and it was found at that time that many base failures were beginning to show. Fig. 5 shows four photographs taken at various times on this project. The upper photographs show the location that was noted in Fig. 8 of the January, 1951, report on this project. This section has held up a little better than the average for the project. Only pot-hole patches were required here. The two bottom photos show the heavy maintenance that has been required for most of the road. New full width patches were used for many places.

This type seal appeared to be too light an application for this road. Maintenance quantities have exceeded the original applications.

Fig. 5. Pulaski County SP 100-215 (1950). These two sets of photos show what happened to the very light NAC-8 seal (initial treatment) during one year. The road is being maintained as a bituminous pavement. The maintenance has been quite heavy as shown by the full width patches in the lower right photo. The light portion of pavement in the distance is the original seal

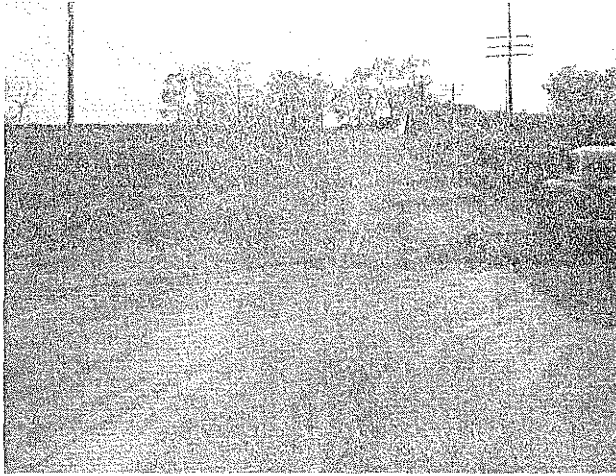
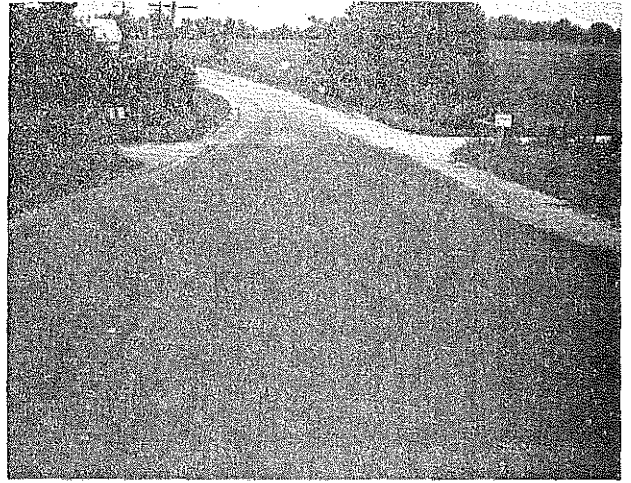
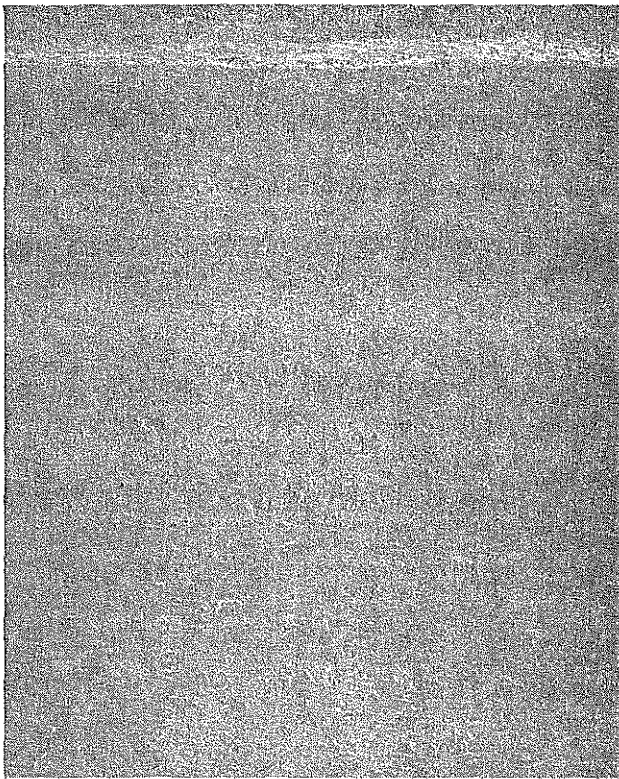
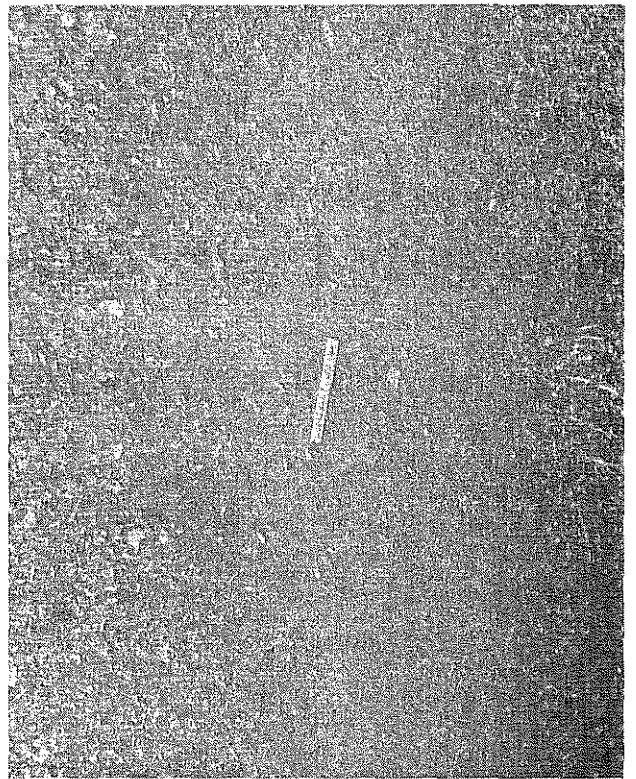
immediately after resurfacing. The rock asphalt is considerably thinner than it was when it was placed. This can be noted in the two bottom photos in Fig. 6. The rock asphalt is still very effective as a seal but has lost the appearance of a rock asphalt surface. The aggregate of the Class F mix is showing through the seal.

Fig. 6 - Mercer County SP Group 16 (1950). Top right photo is looking north. Note lumps of Rock Asphalt. Top left photo is looking south at same location. Lumps have disappeared. Bottom photos show close up of seal texture.

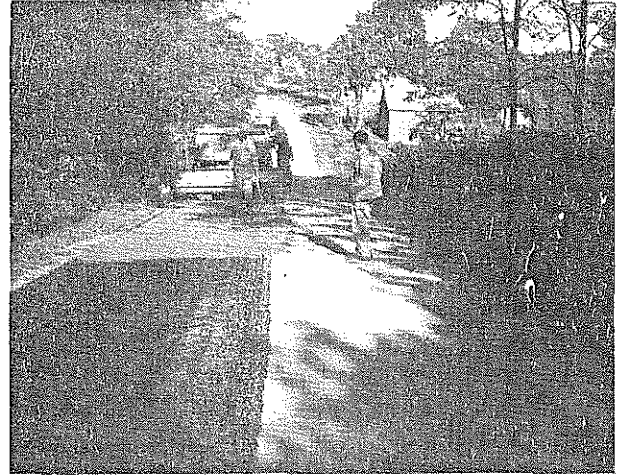
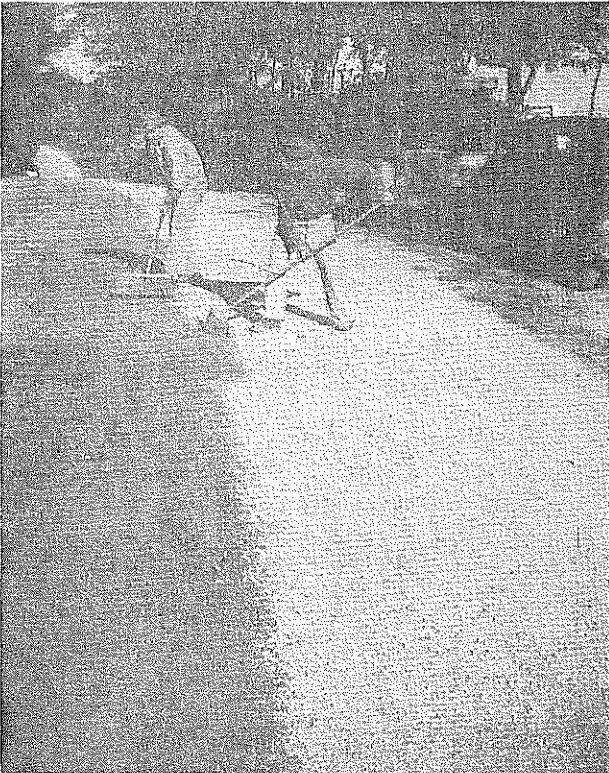
(b)
Spreading damp stone (note overlap caused by variable road width).

(c)
Hand brooming made necessary by dampness in stone.

Fig. 7(b and c) illustrates various phases of placing the aggregate. Also, parts b, c, and d in Fig. 7 show the damp and often clumpy condition of the aggregate which hampered the spreading of this stone with the Buckeye Spreader Box. Hand brooms used immediately after applying the stone helped considerably to give the road a uniform layer of aggregate. Fig. 8(a) shows the difference that was apparent when dry aggregate was used. Undoubtedly, the differences in aggregate should be given careful consideration in future evaluations of the different sections.

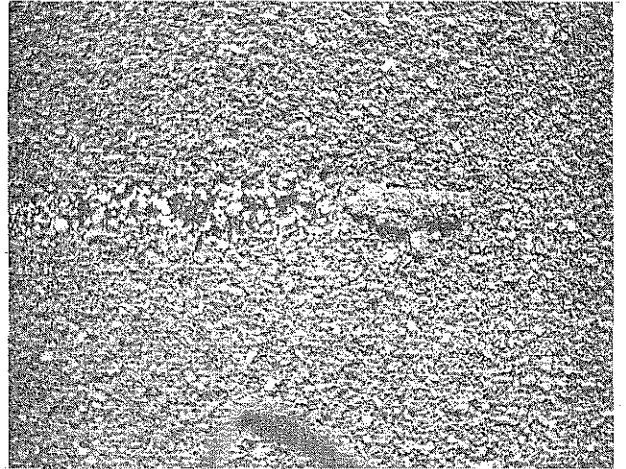
(d)
Near view of surface showing "lumping" caused by dirt and moisture in aggregate.

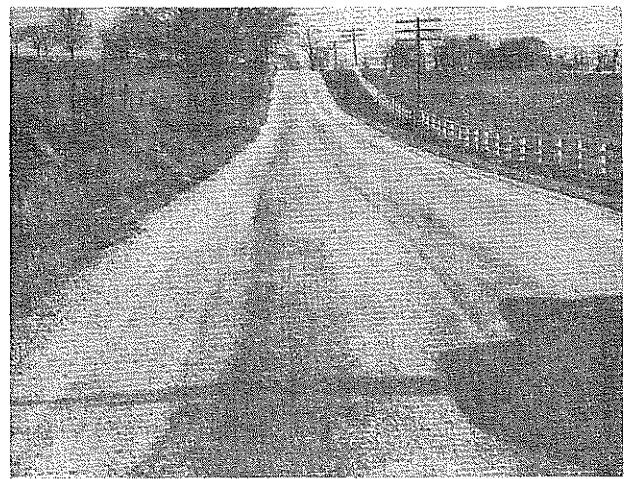
(d)
NAC-8 double application after one month of use.

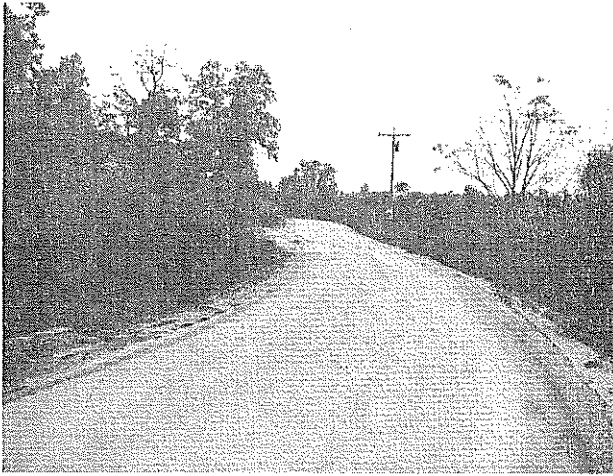
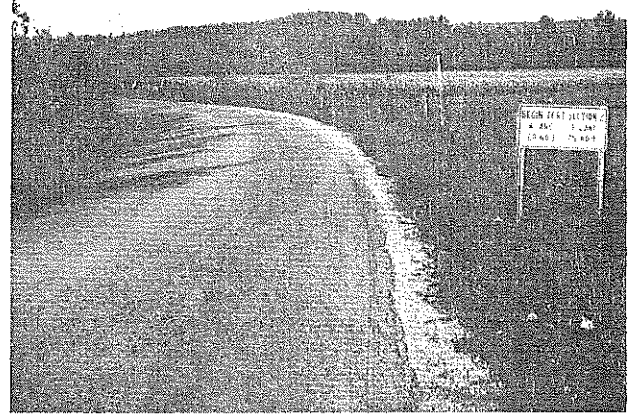
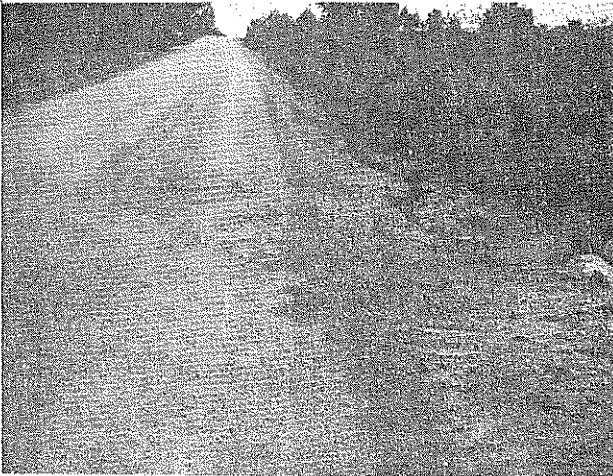
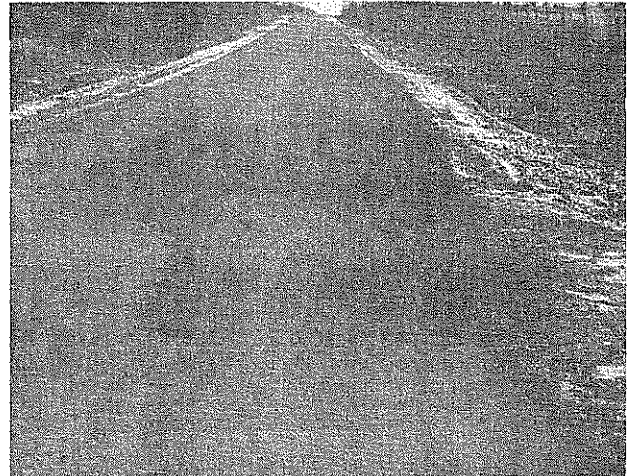
A few base failures have occurred noticeably in the east or north-bound traffic lane. A failure is noted in Fig. 10. Ledge rock was just below the surface, and this led water under the pavement. This condition was noticed before construction but it was not feasible to remedy the situation at that time. The pavement cracked and broke up during construction as shown by the lower left photograph.

Fig. 10. Pulaski County SP 100-75 (1950). The overall appearance of this penetration macadam road is excellent. The photos in Fig. 3 are from this project also. The upper photos were taken at approximately the same location in test section No. 2. The lower photos are of a failure caused by ledge rock being left about 6" below the pavement surface. The section failed before completion of the paving. It was not feasible to remedy this situation during construction. A few failures mostly in the east lane have occurred. The general condition is excellent.

It is highly desirable to patch the failures just after they occur. This type surface is very susceptible to raveling if a failure gets under way. The road has had excellent maintenance.

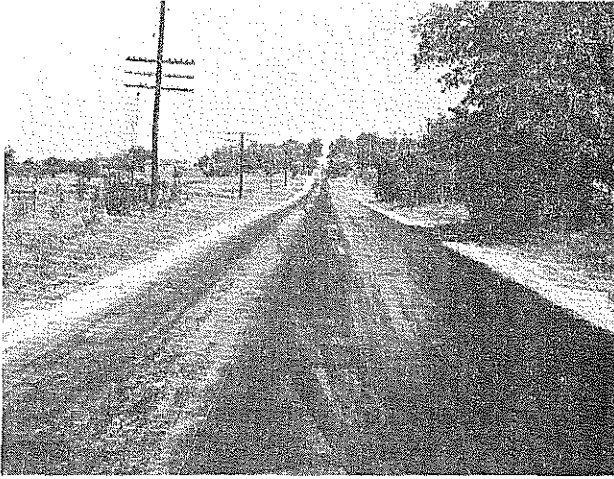
Fig. 11. Original surface, looking north from Station 47+00. A prime coat had been applied to the right lane.

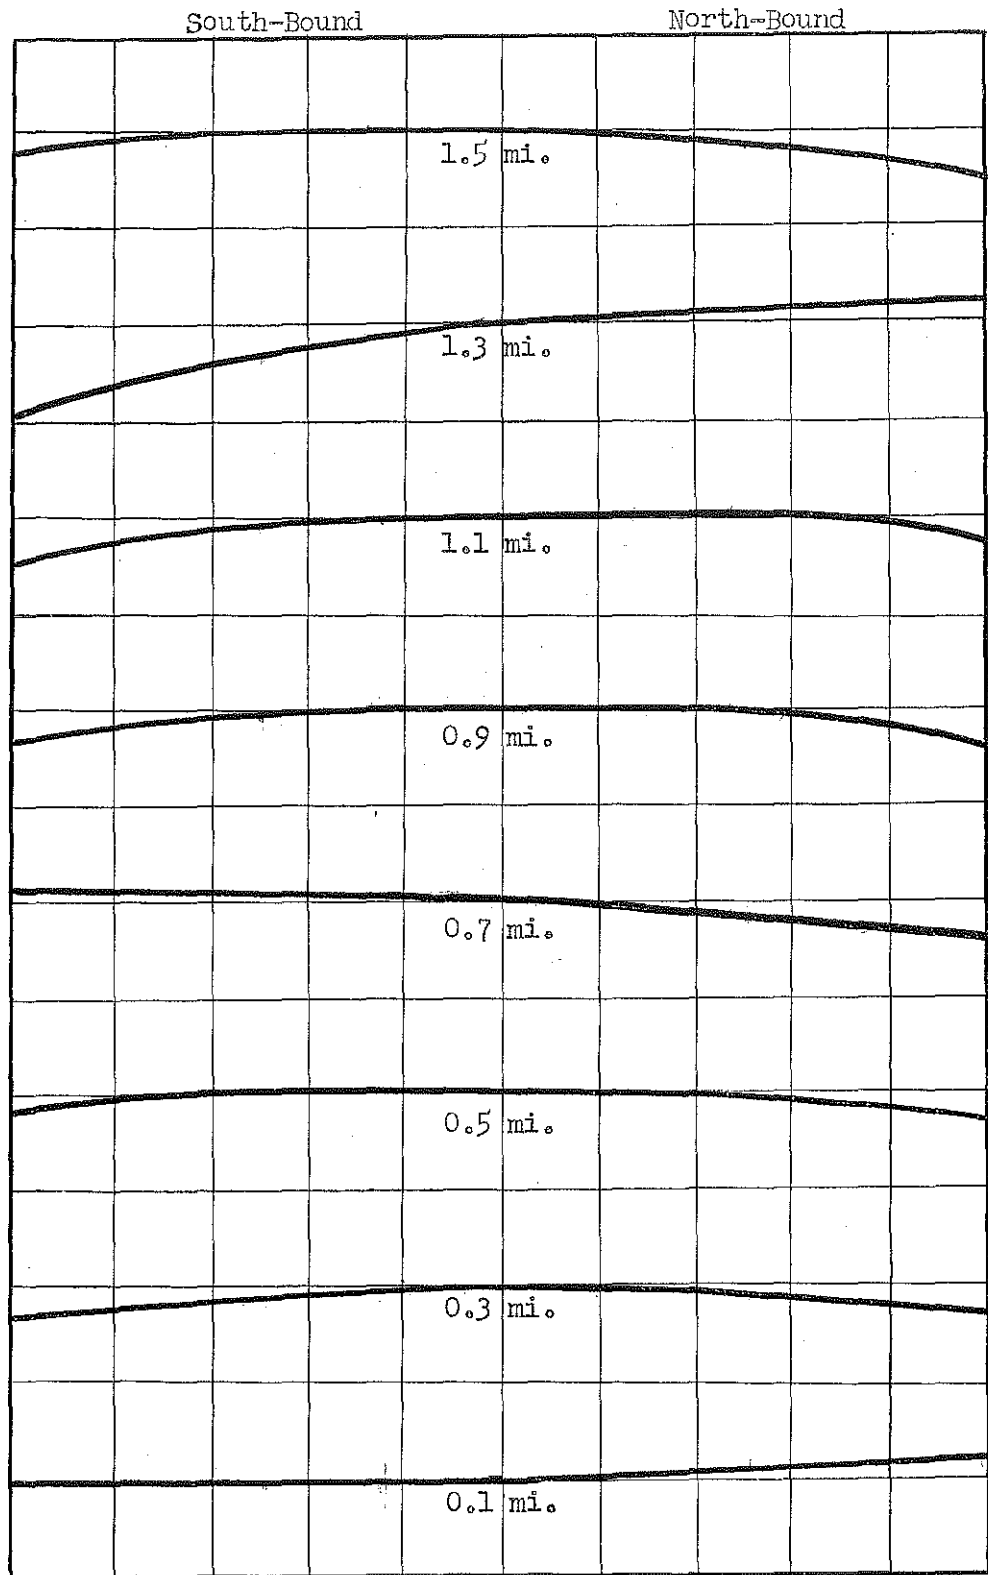
Random checking proved that a reasonable amount of crown was constructed over most of the length. This is illustrated by the cross-sections of the final surface plotted in Fig. 21. For these, readings were taken at the centerline and edges of the pavement at intervals of 0.2 mile throughout the total length of the project. The shape of the section at 0.1 mile from the beginning was probably influenced by an easement to the preceding super-elevated curve. That at 1.3 miles lies in a three- to four-hundred foot

Fig. 21 - Cross-sections of completed surface taken at intervals of 0.2 mile as a random check on the crown section.
