Phase I Inspection of the Stay Cable System on the US 231 William H. Natcher Bridge over the Ohio River

Kentucky Transportation Center Research Report — KTC16-01/KHIT77-1F

Research Report
KTC-16-01/KHIT77-1F

January 2016

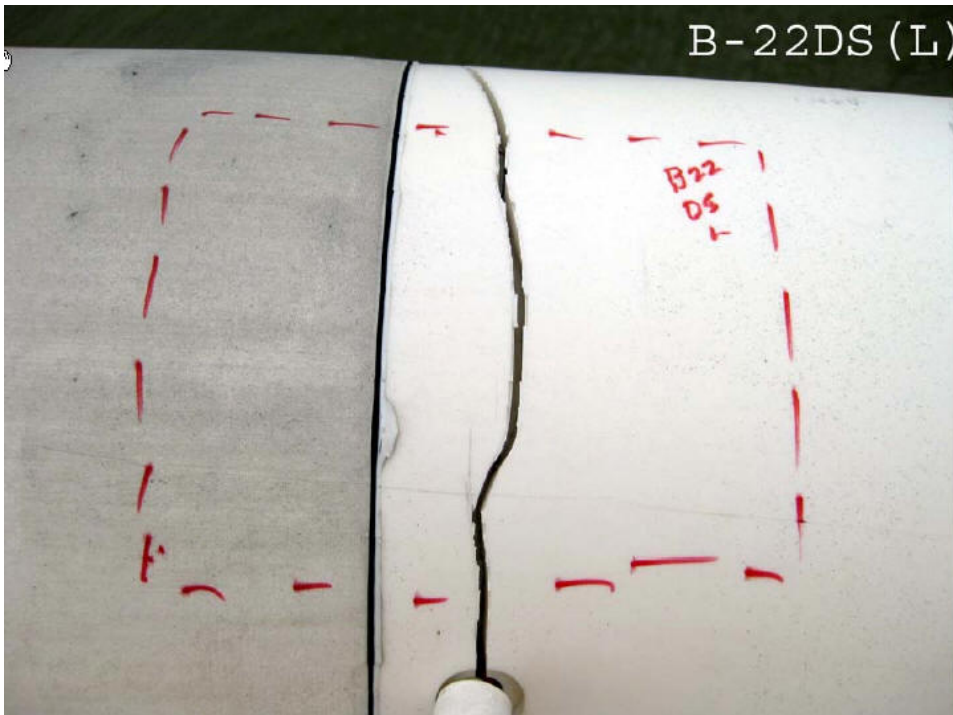
Figure 12. Crack in Connection Sleeve Coupler at Cable B22D. Note Inked Cutting Outline.

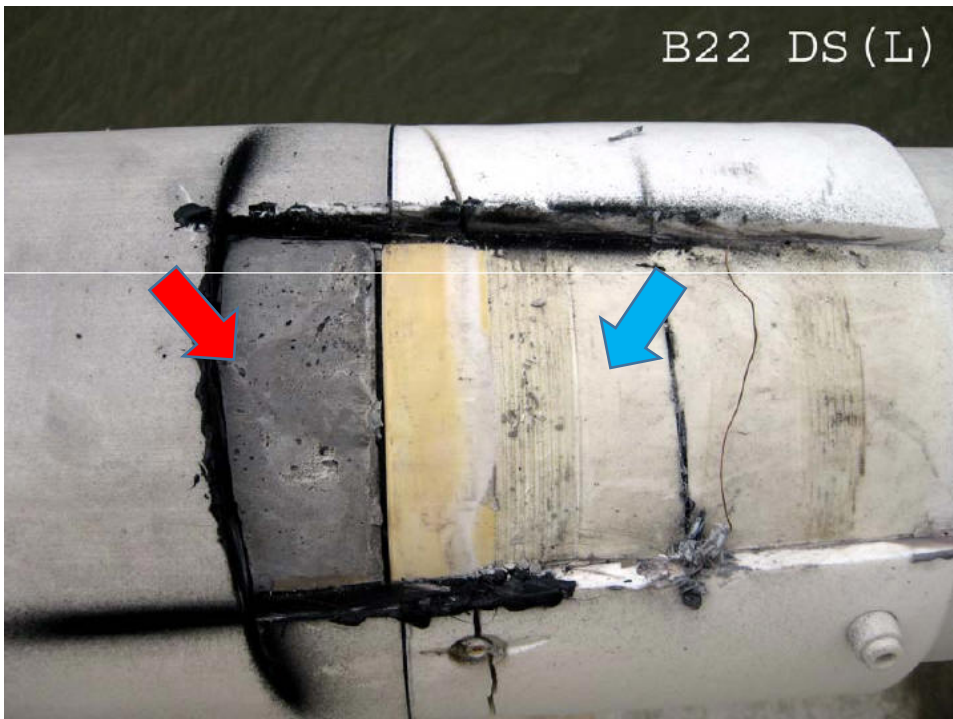
Figure 13. Connection Sleeve and Coupler after Coupon Extraction. Note Grout (Red Arrow) and the Transition Pipe (Blue Arrow).

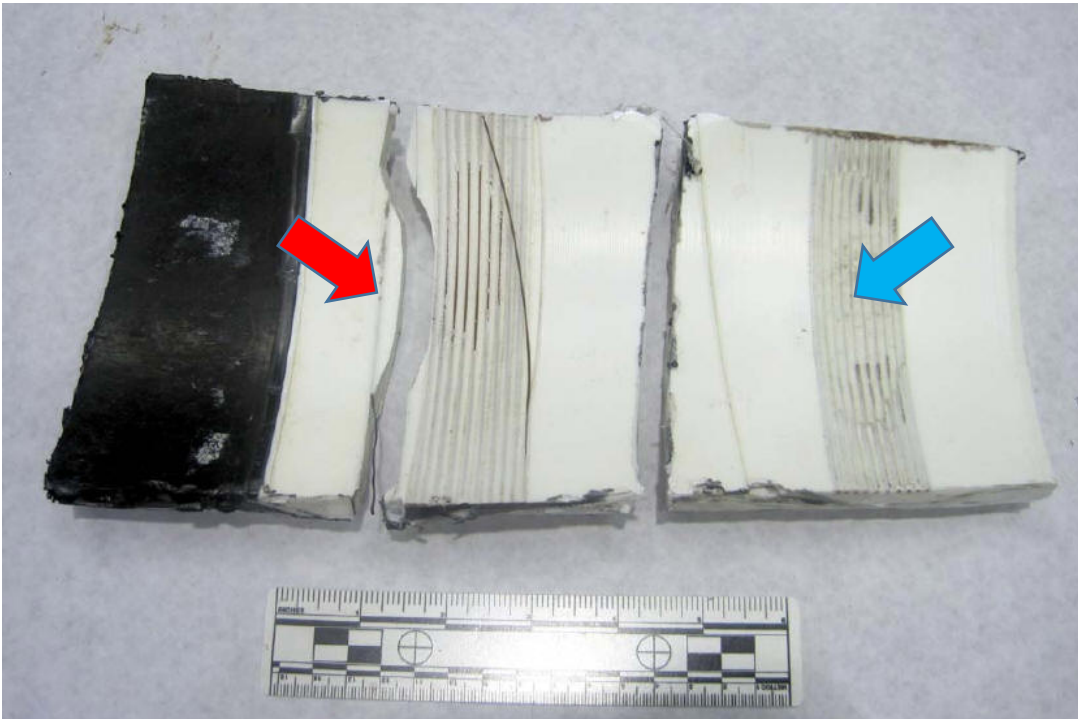
Figure 14. Extracted Coupon (Inner View). Note Fracture Face (Red Arrow) and Lack of Fusion Area in Electrofusion Weld (Blue Arrow).

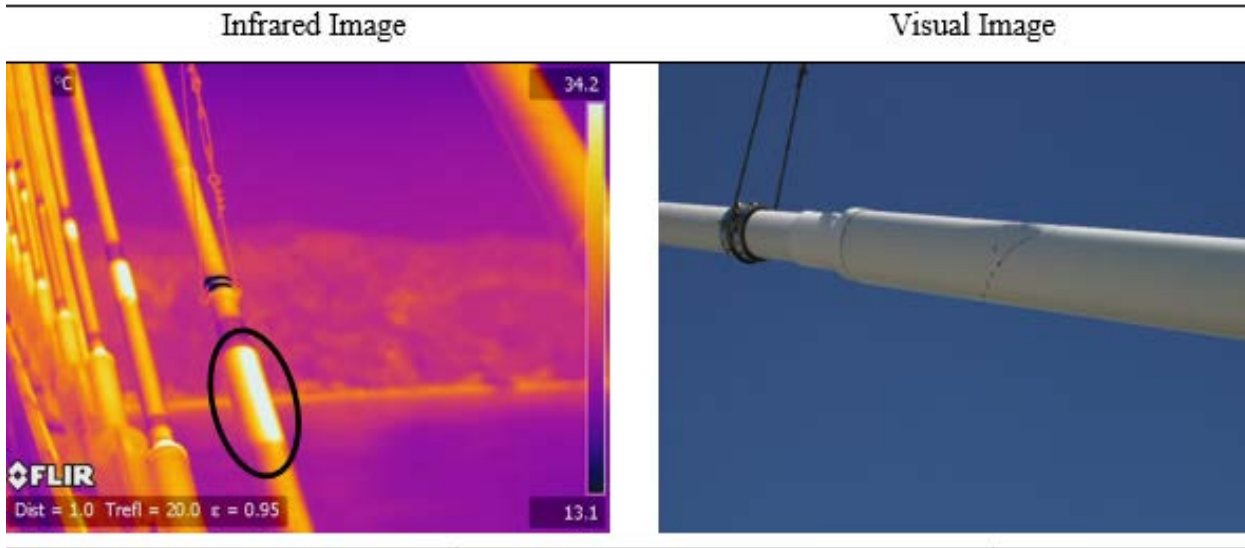
Figure 28. Images of Deck Anchorage Connection Sleeve of Cable B5U Infrared (Thermal) Image (a) Showing Void under Connection Sleeve Piping Compared to (b) GPR Detected Defect Shown in Visual Image (Op. Cit. 10, p. 17).

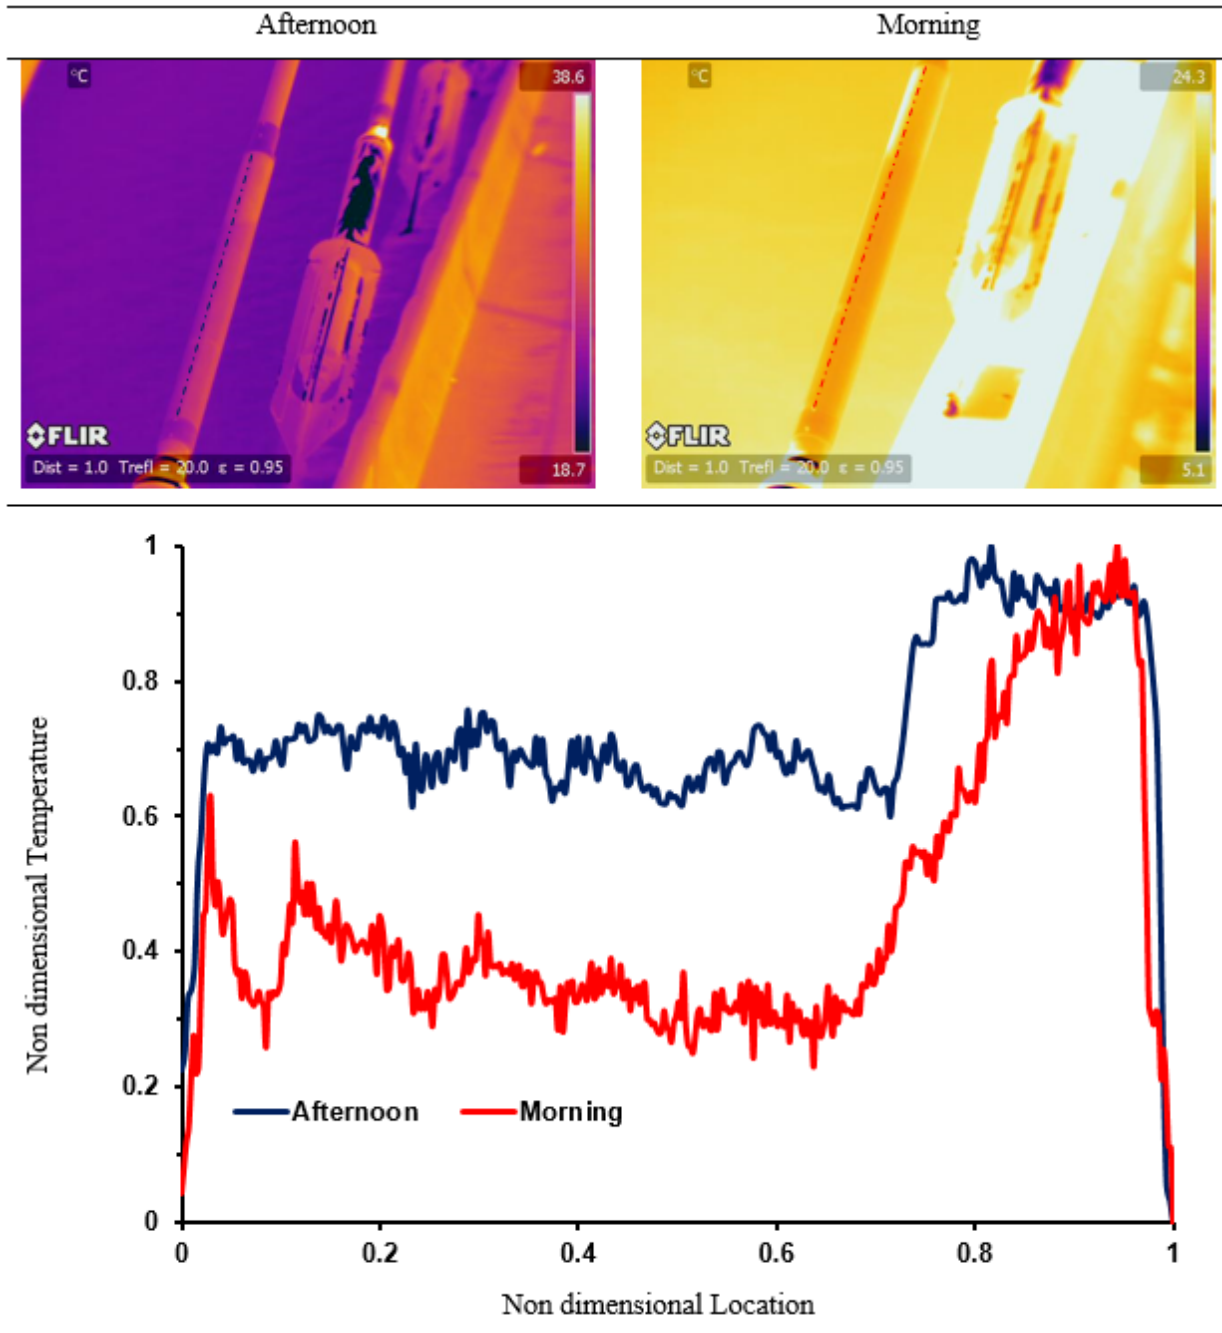
Figure 30. Infrared Images of Deck Anchorage at C6U. Afternoon Imaging was Performed at 4:50 pm CDST (Top Left) While the Morning Imaging was done at 10:50 am (Top Right). Non-dimensional Temperature of the Dashed Lines Show a Distinction between the Void and Grout-Filled Areas inside the Connection Sleeve Pipe in the Both Morning and Afternoon Sessions (Op. Cit. 10, p. 18).

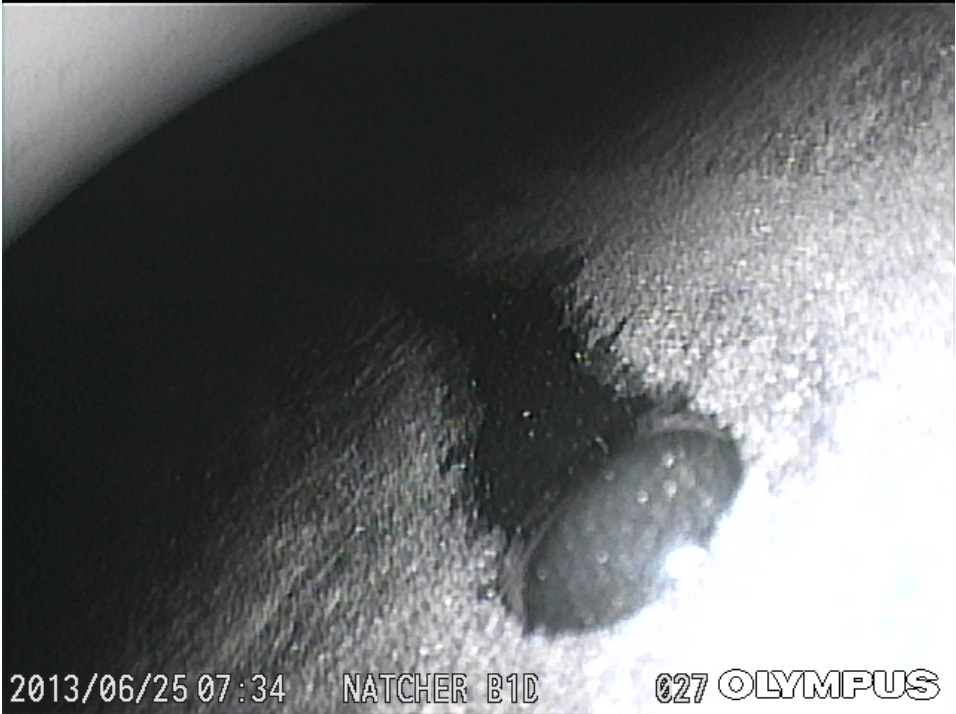
Figure 40. Picture inside a Grout Void Showing the Presence of Water in a Grout Void.

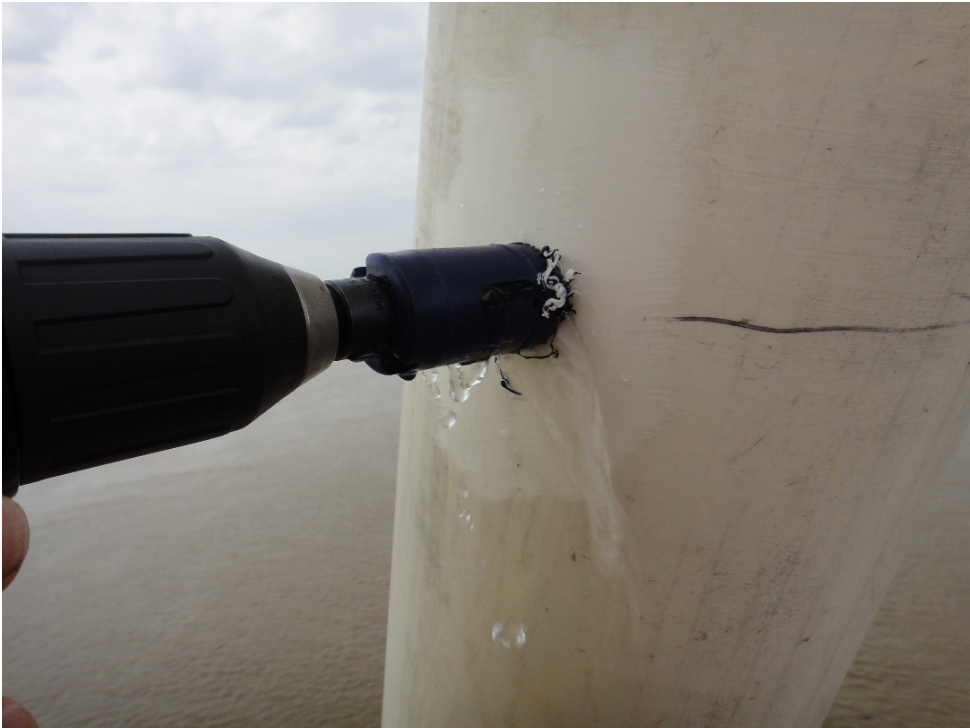
Figure 41. Water Leaking from a Grout Void in the Connection Sleeve Pipe at Stay Cable B12D.

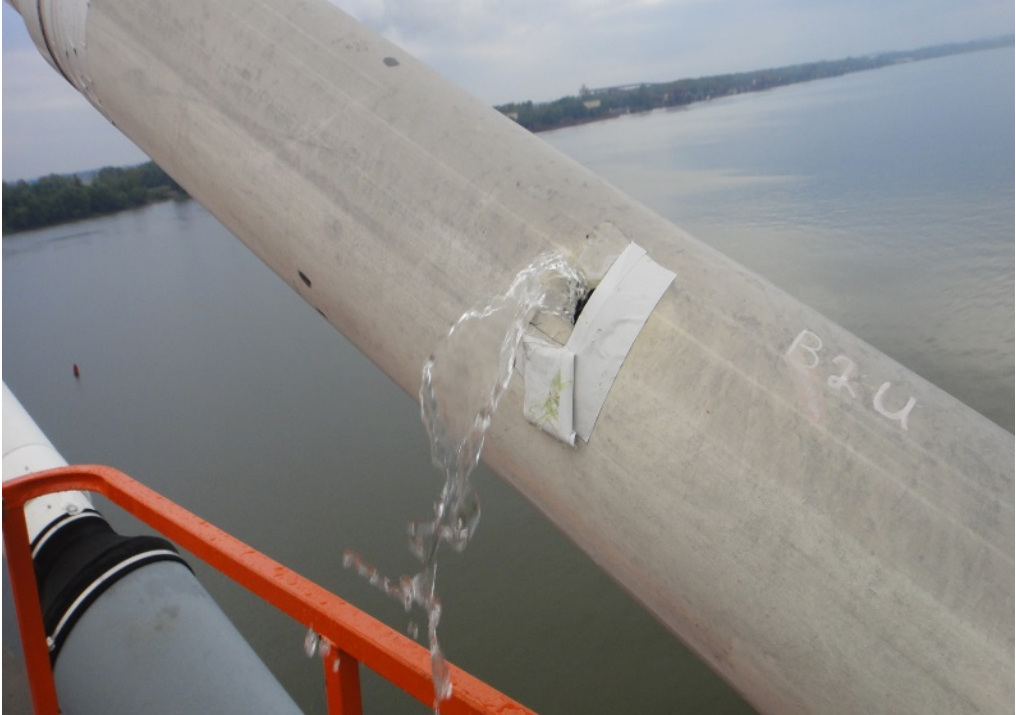
Figure 43. Water Gushing from Void in Cable B2U after Tape Covering Hole was Removed.

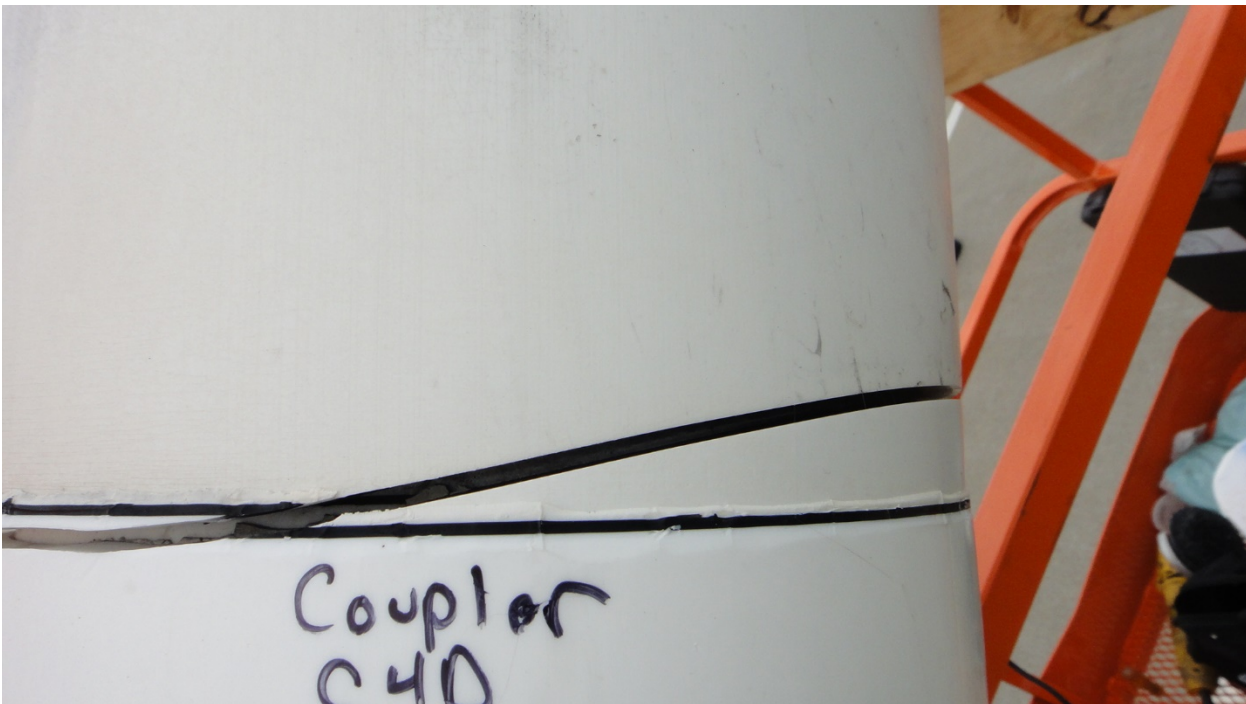
Figure 45. Crack Growth from Coupler Butt Weld into Connection Sleeve Pipe Section (Looking Downward).

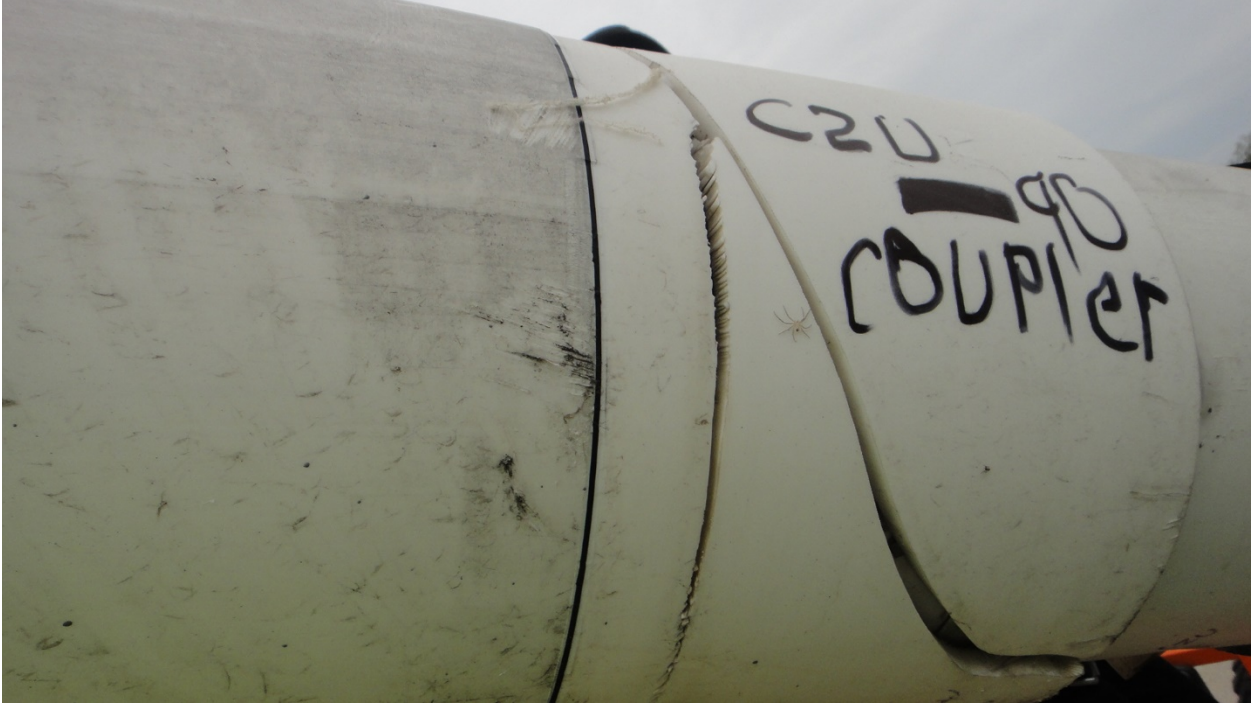
Figure 46. Complex Condition State 6 Cracking – A Single Crack at the Top of the Pipe Which Grew Radially in both the Clockwise and Counter-clockwise Direction to the Bottom of a Coupler (Looking Upward).

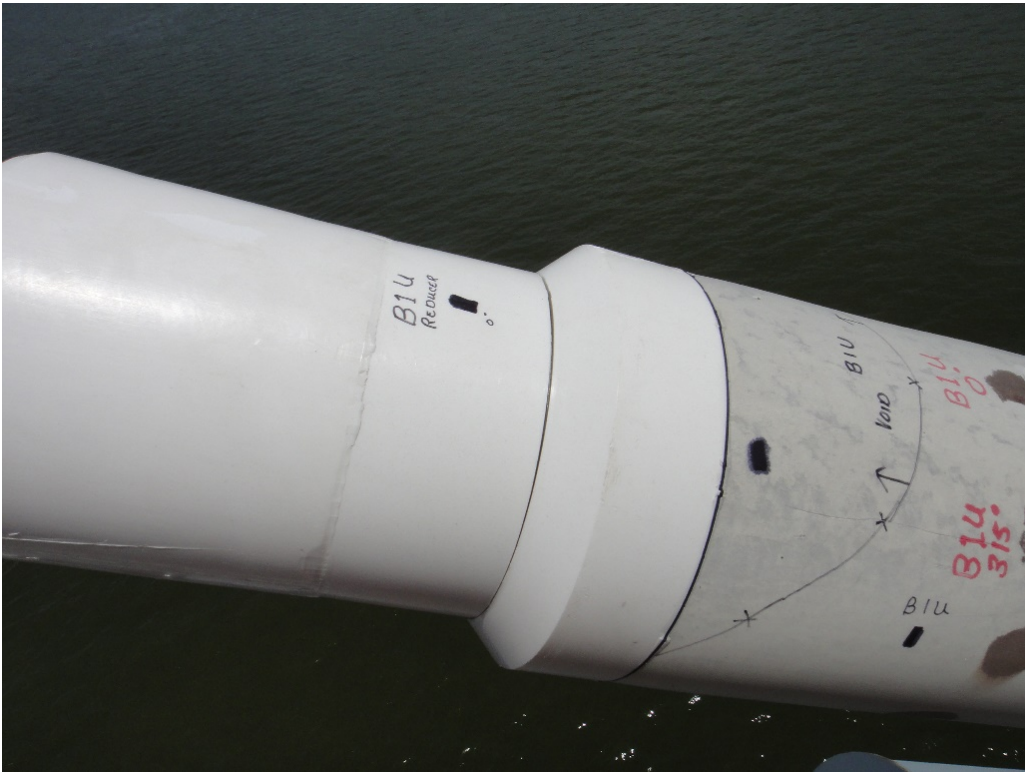
Figure 47. Simple Condition State 3 Cracking Perpendicular to Axis of Piping.

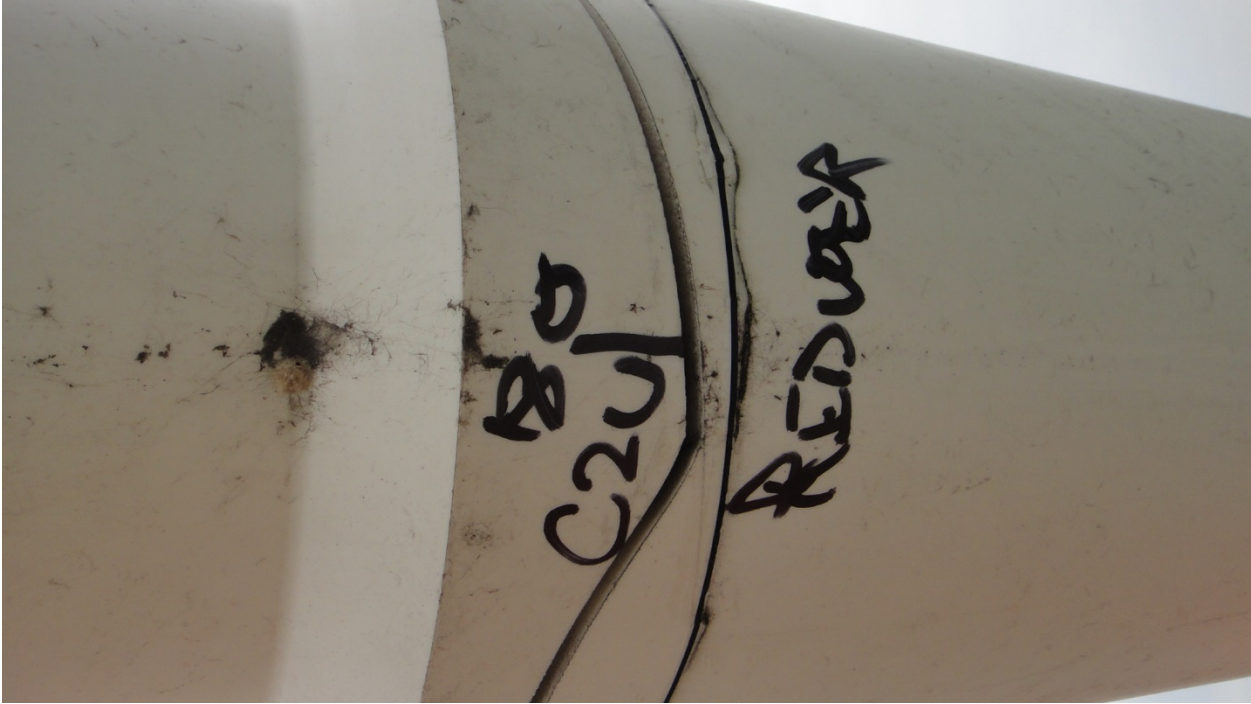
Figure 48. Bottom Side of HDPE Reducer Where Cracks Growing Clockwise and Counter-Clockwise from the Top Side Merge.

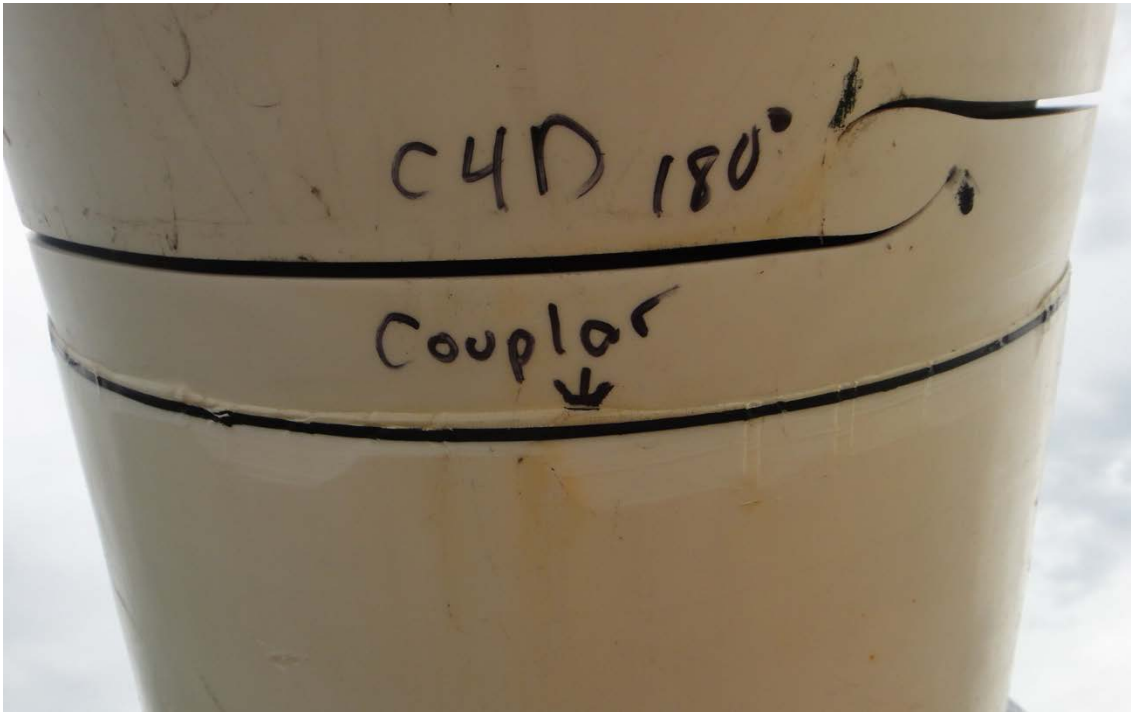
Figure 49. Bottom Side of HDPE Reducer Where Cracks Growing Clockwise and Counter-Clockwise from the Top Side Terminate.

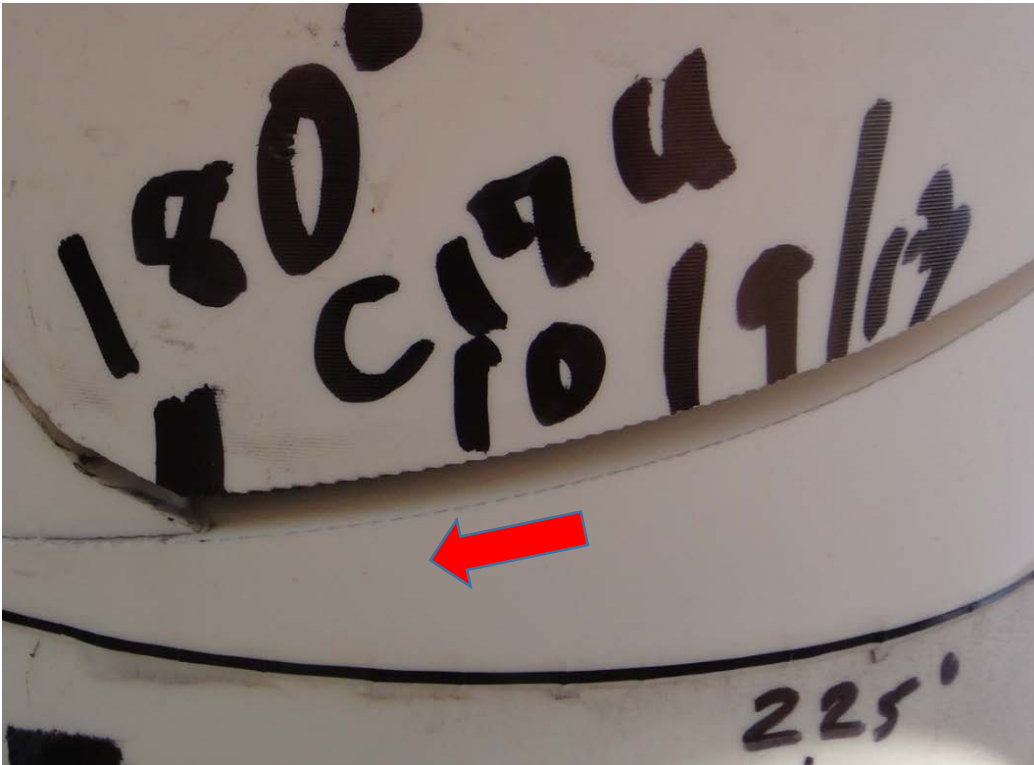
Figure 51. Sawtooth Edge of Fatigue Crack with Arrow Pointing in the Direction of Propagation.

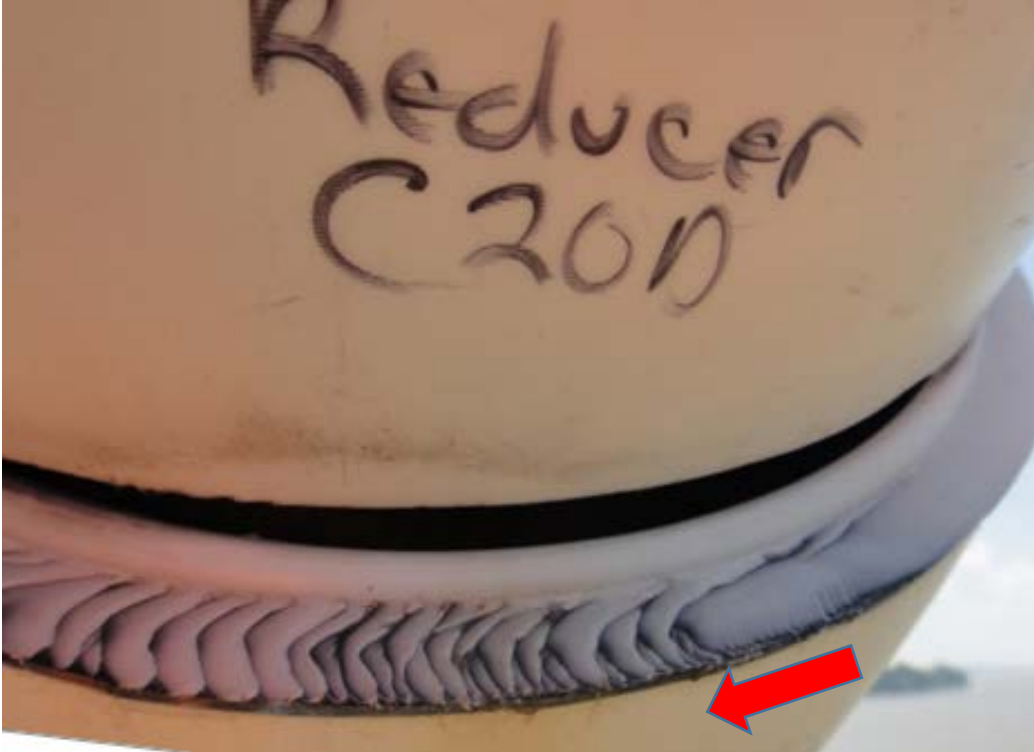
Figure 52. Fracture Surface Marks (Steps) Indicating Clockwise (Right- to- Left) Crack Growth Typical of Low-Cycle Fatigue Crack Propagation at Reducer-to-Connection Sleeve Pipe Butt Weld.

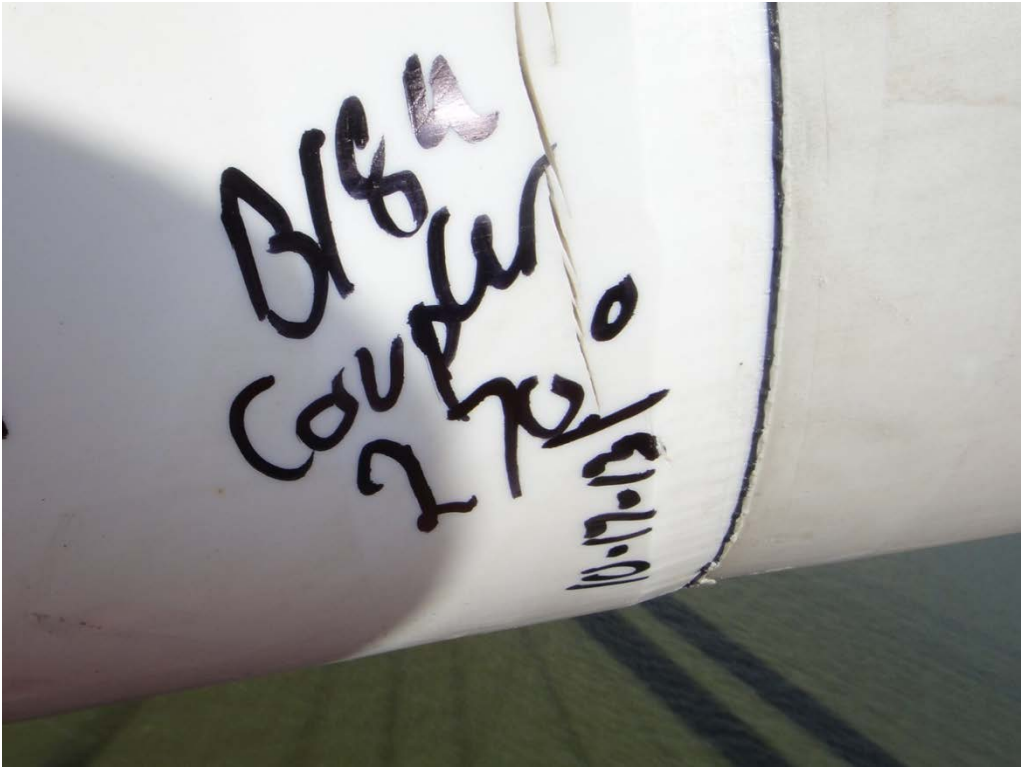
Figure 53. Individual Crack Sites That Merge to Create Stepped Crack Faces.

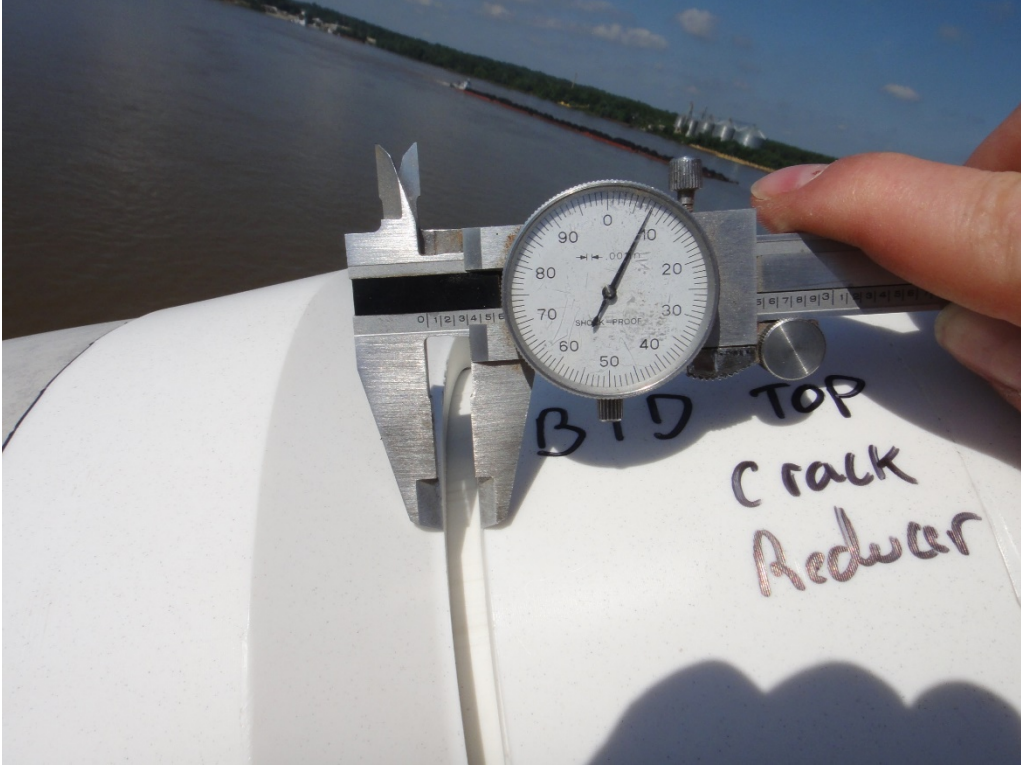
Figure 54. Large Crack Opening without Signs of Significant HDPE Deformation.

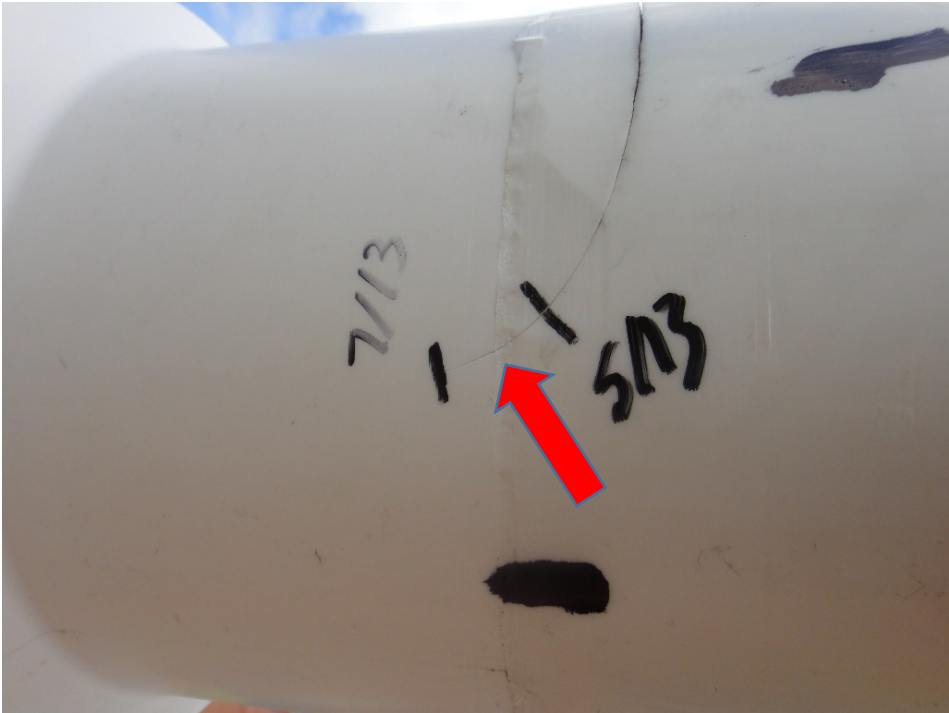
Figure 55. Crack Growth in Reducer Indicated by Marks (5/13 – Consultant and 7/13 – KTC).

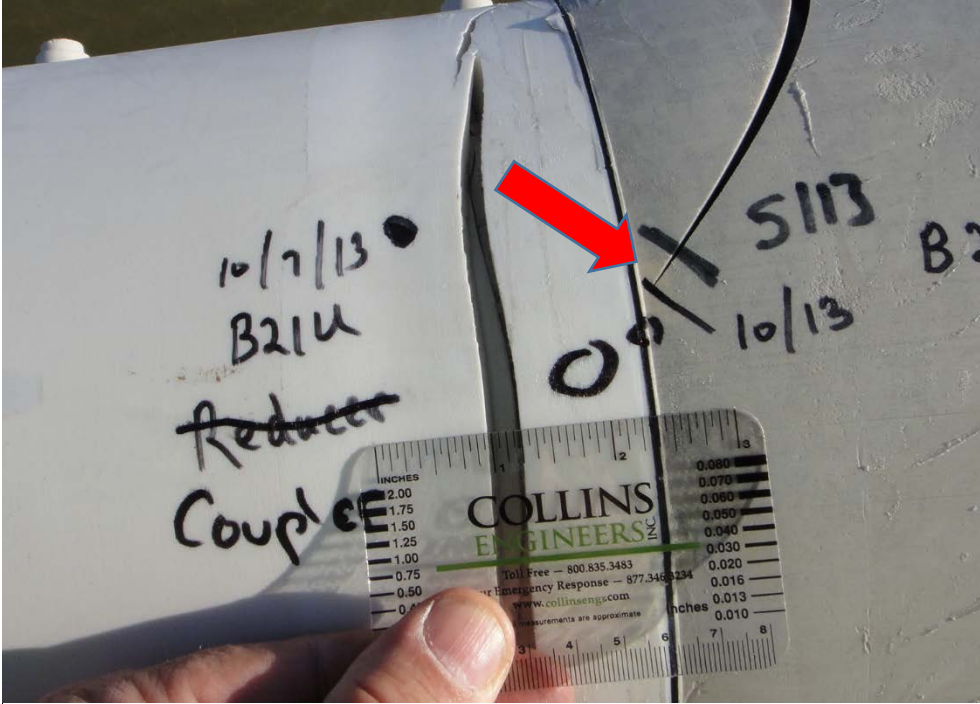
Figure 56. Crack Growth in Connection Sleeve Pipe Indicated by Marks (5/13 – Consultant and 10/13 – KTC).

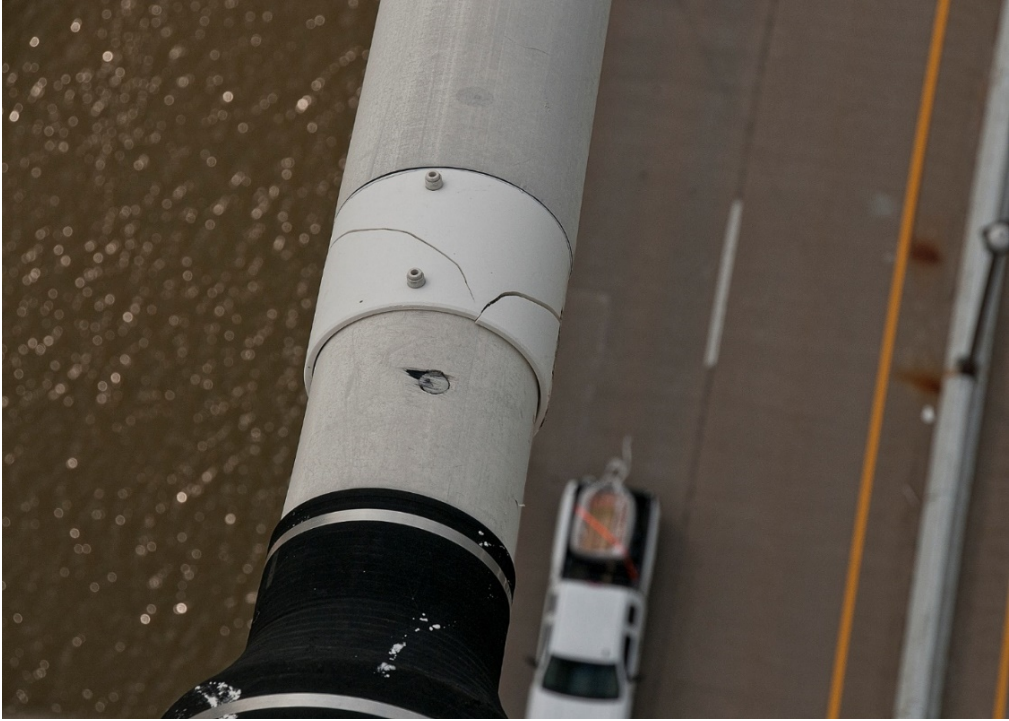
Figure 57. Coupler Crack at Tower Anchorage on Cable B1U.

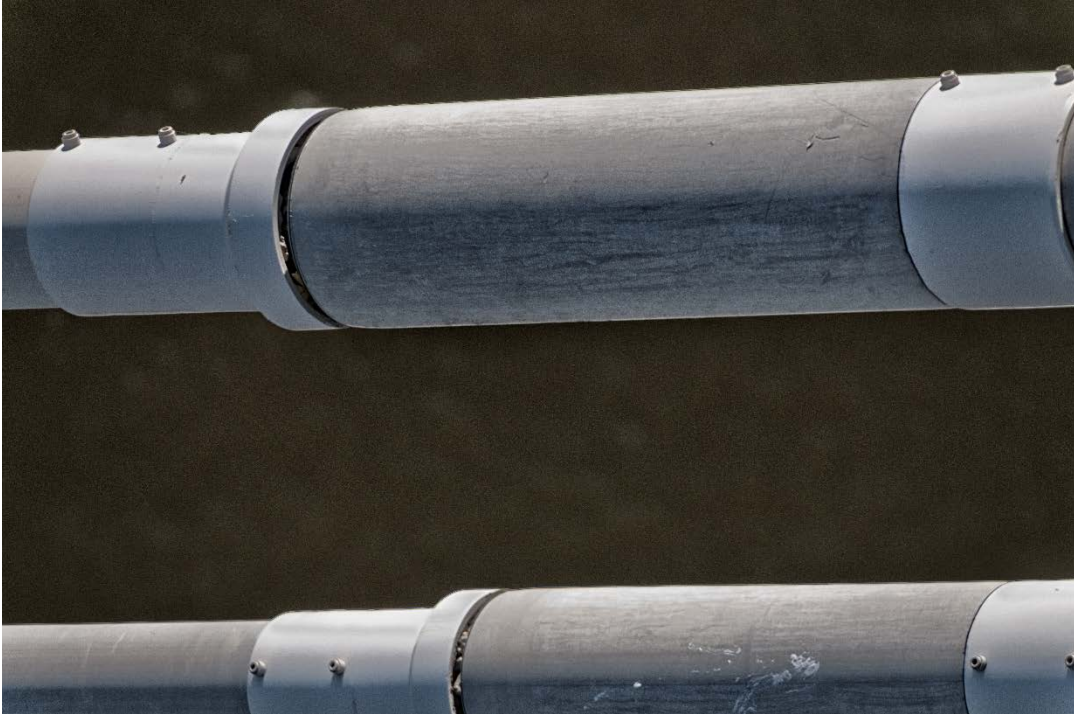
Figure 58. Cables B4D and B5D at Tower Anchorage Showing Gaps Created by Butt Weld Fracture between Reducers and Pipe Sections of Connection Sleeves.

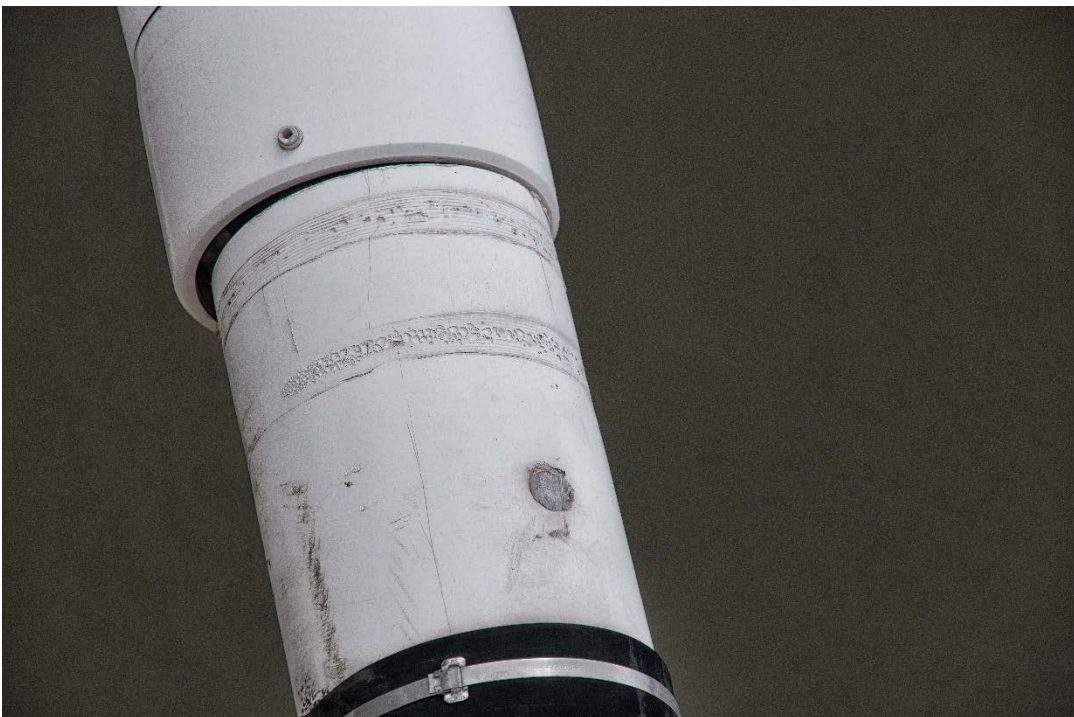
Figure 59. Slippage of Coupler off Transition Pipe at Tower Anchorage B4D due to Shear Failure of Electrofusion Welds.

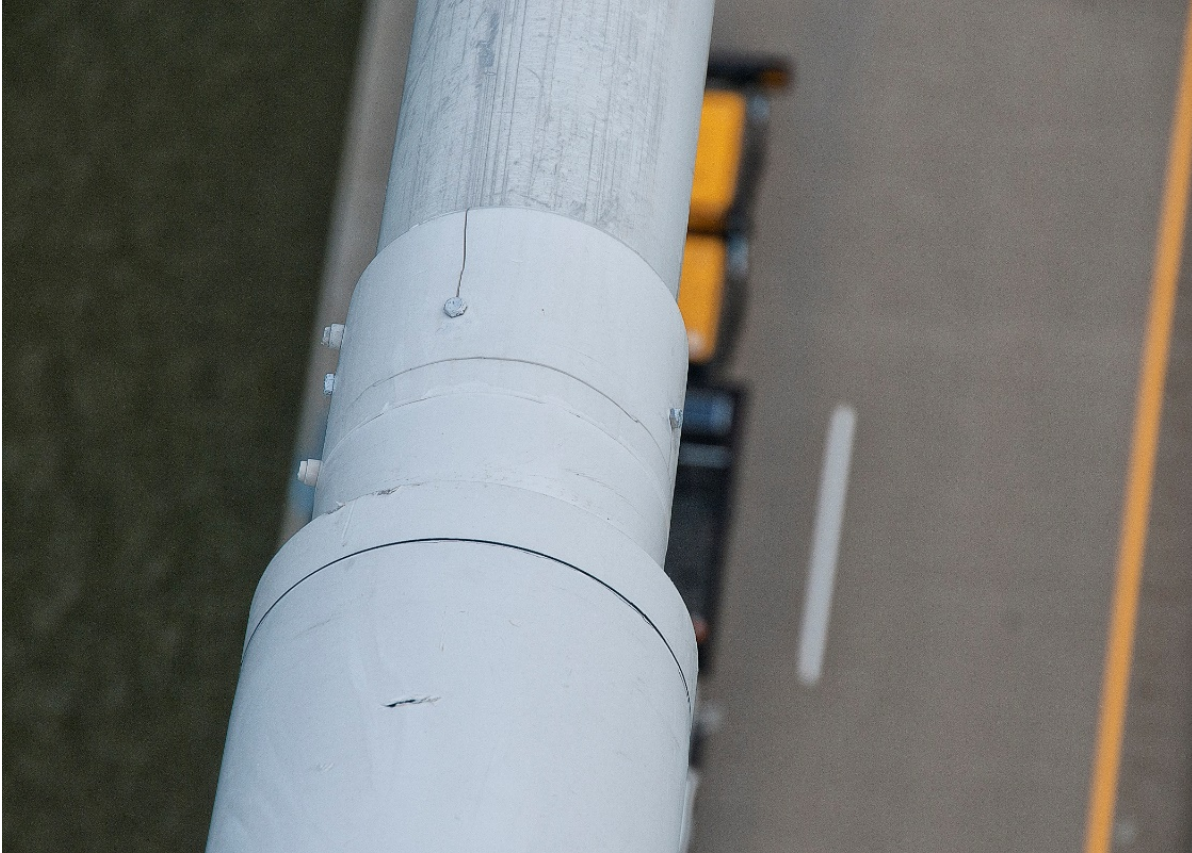
Figure 60. Longitudinal Cracking of Reducer at Lag Bolt Retrofit Added During Construction.

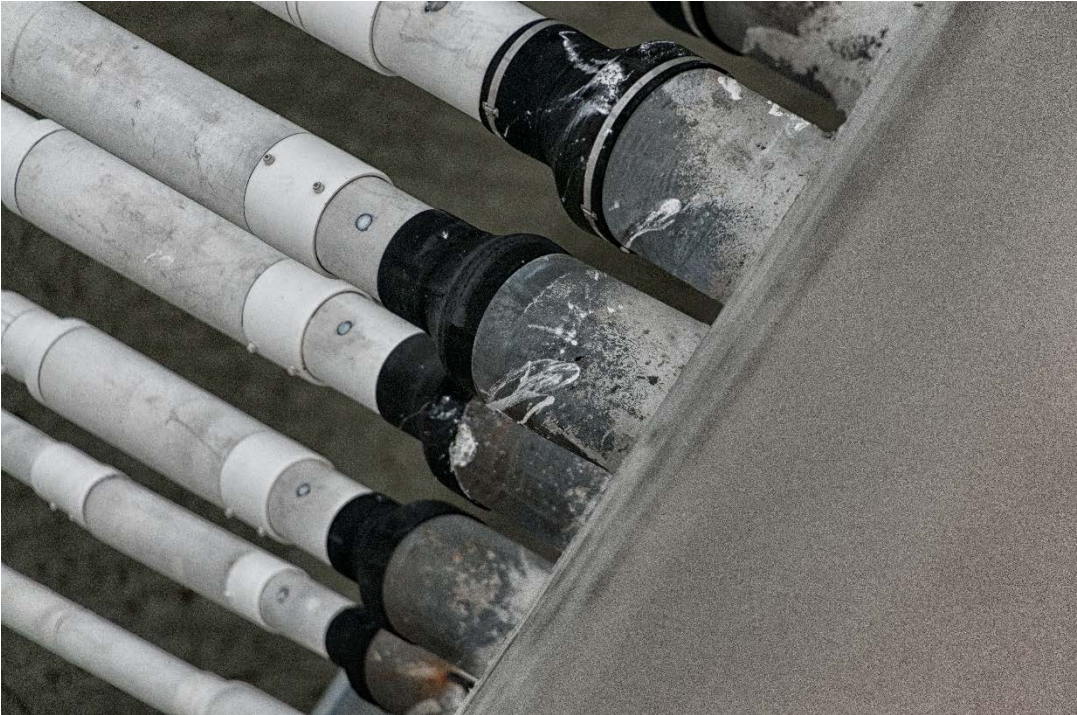
Figure 70. Neoprene Boots at the Upstream Side (Span 9) of Tower B Showing Missing Boot Retaining Bands.

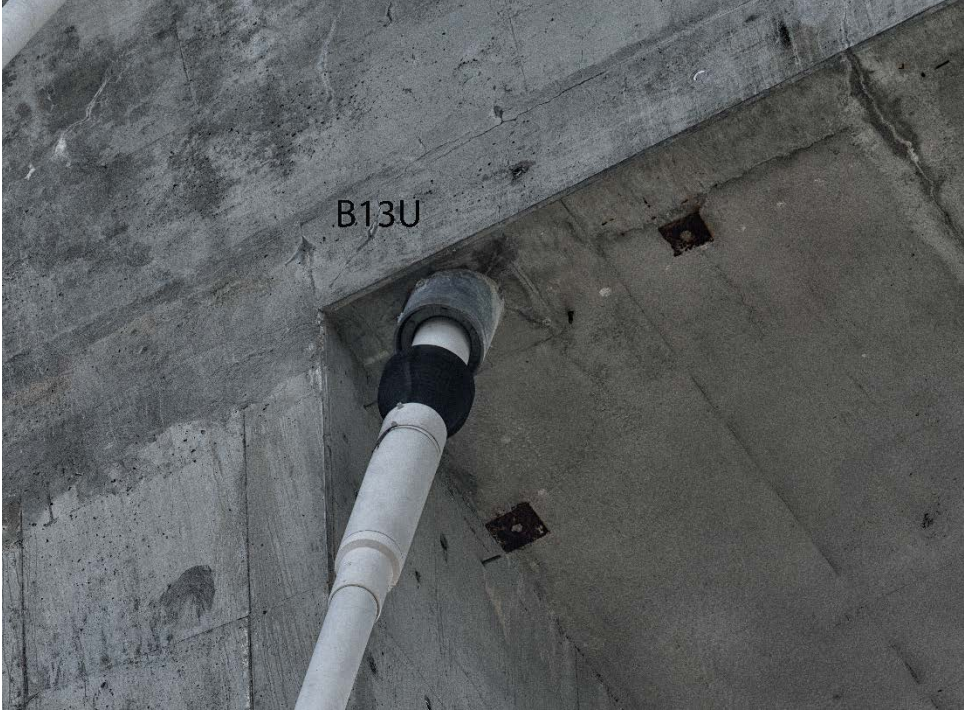
Figure 71. Detached Neoprene Boot at Tower Anchorage of Stay Cable B13U.

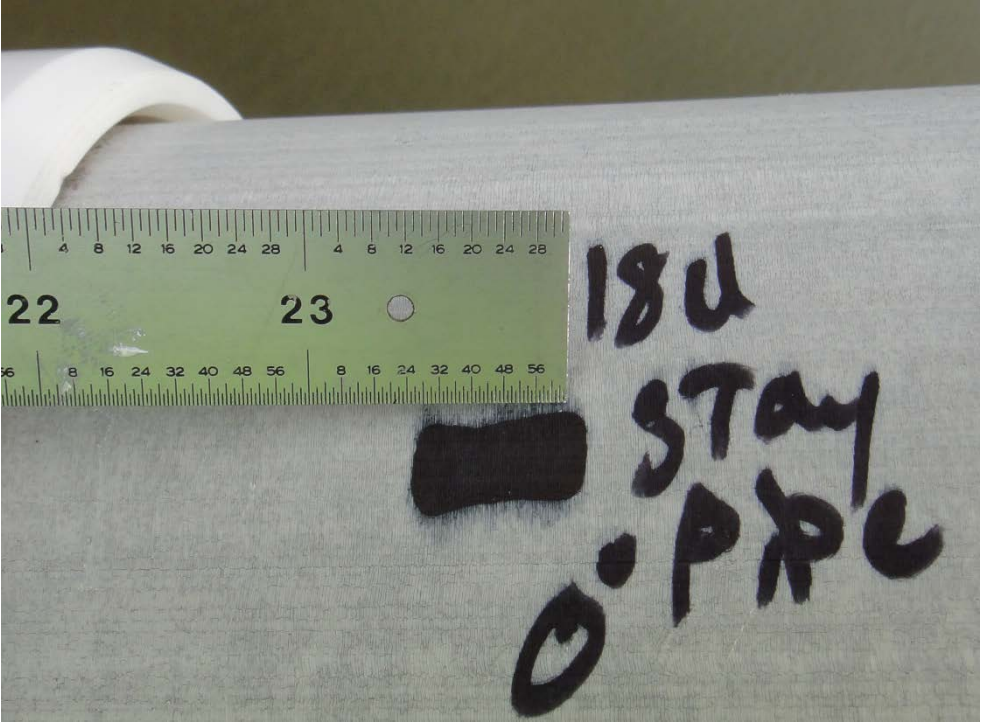
Figure 74. Penetrant Test Showing Indelible Ink Bleeding into Micro-cracks at the Topmost Portion of a Stay Pipe.

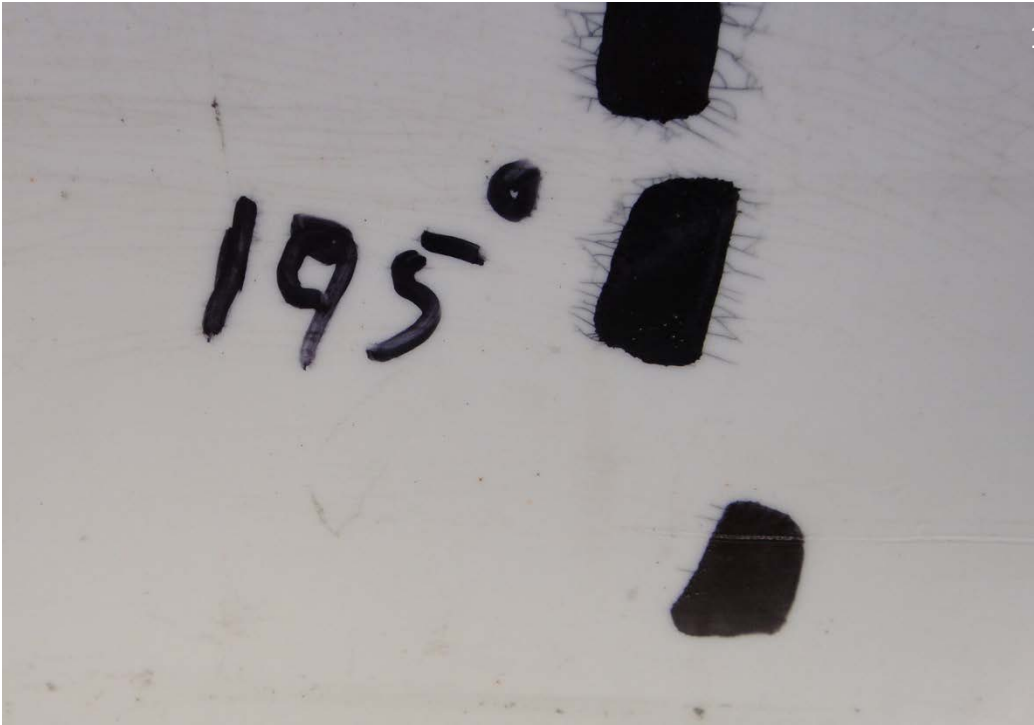
Figure 76. Close up Picture of Ink Marks on the Bottom Side of the Connection Sleeve at B20U Showing Signs of Minor Micro-cracking (Ink Bleeding).

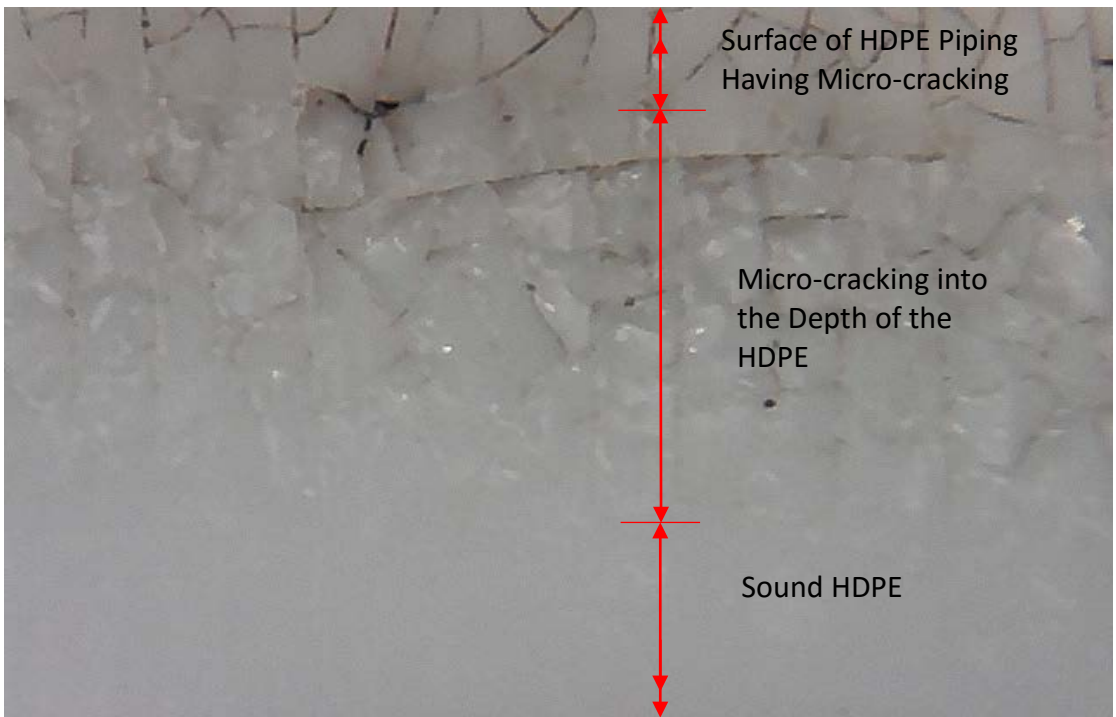
Figure 84. Magnified Picture of the Surface of a Coextruded HDPE Pipe Adjacent to A Scrape Showing the Interwoven Pattern of the Micro-cracking with Depth into Surface down to Sound HDPE.
