Phase I Inspection of the Stay Cable System on the US 231 William H. Natcher Bridge over the Ohio River

Kentucky Transportation Center Research Report — KTC16-01/KHIT77-1F

Research Report
KTC-16-01/KHIT77-1F

January 2016

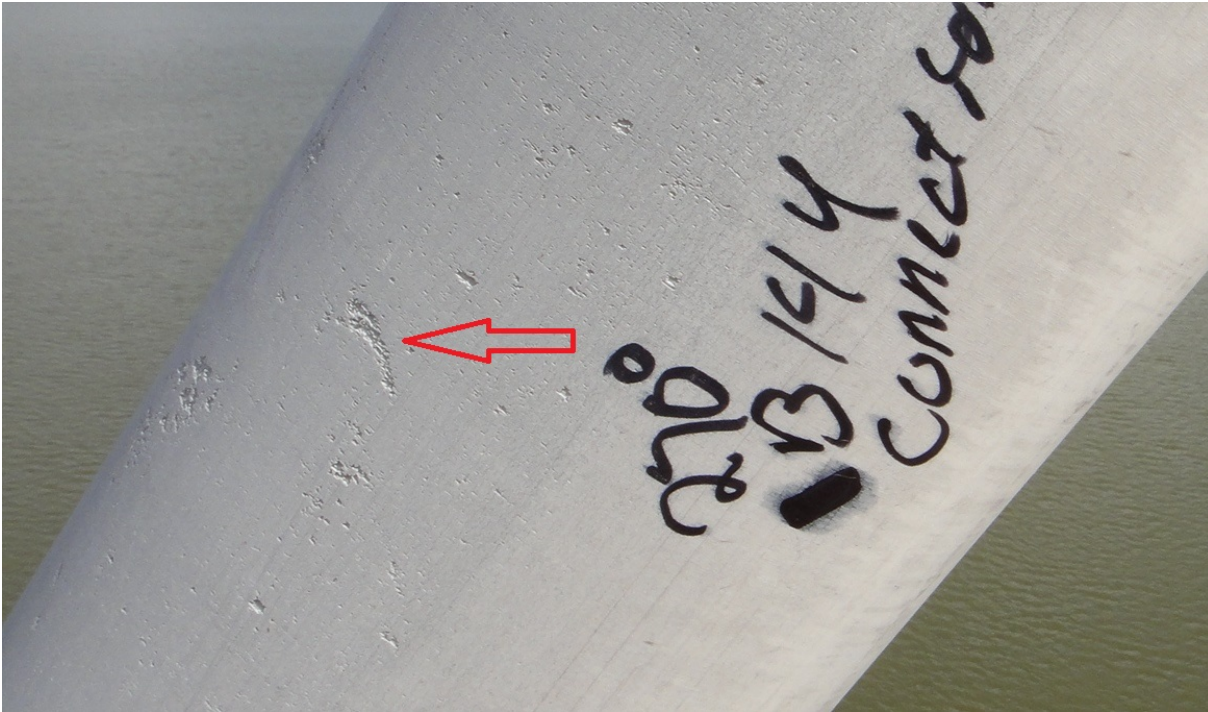
Figure 86. Spalling of Coextruded HDPE on Surface of a Connection Sleeve.

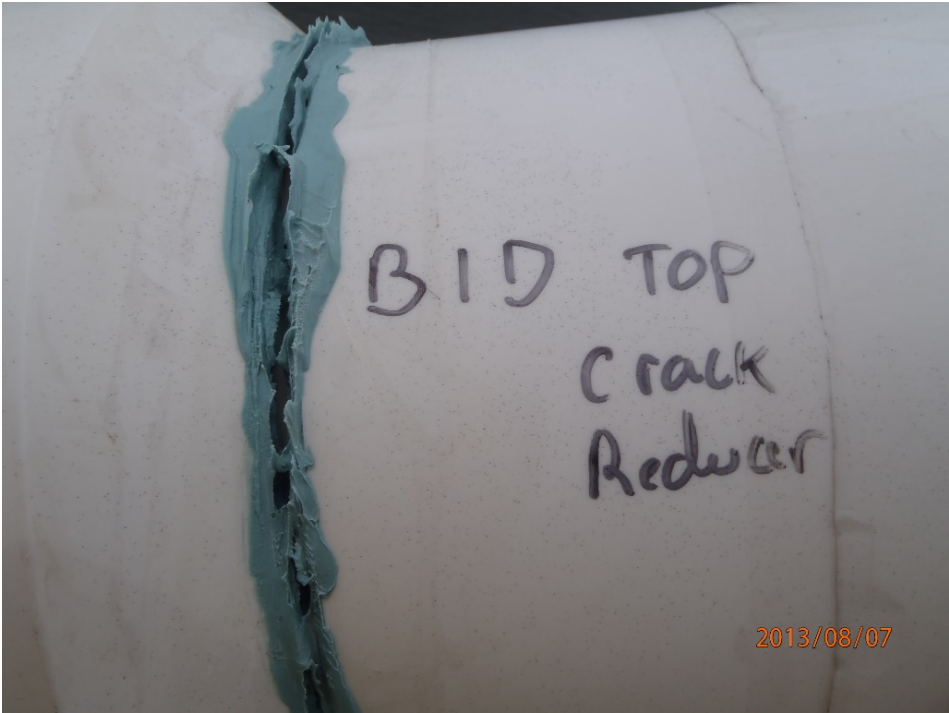
Figure 97. Failure of Stopaq® Paste Seal Found Several Months after the Repair.

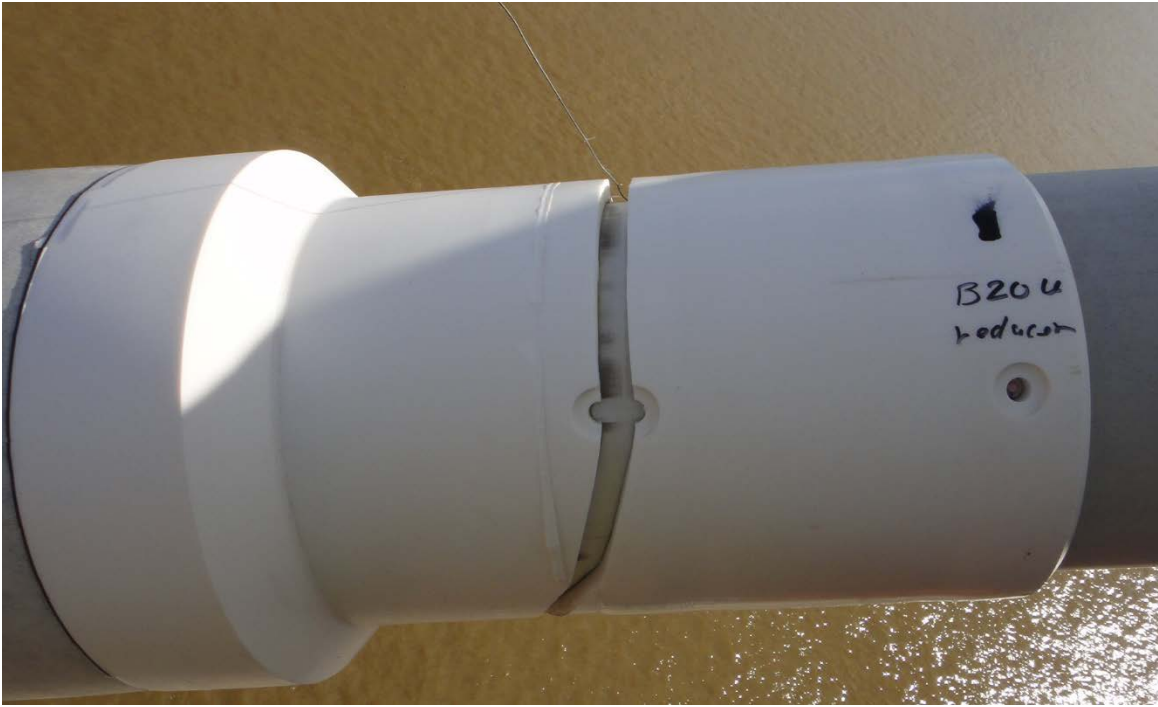
Figure 101. Broken Heating Wire of Electrofusion Weld and Missing Weld Nipples of Cracked Reducer.

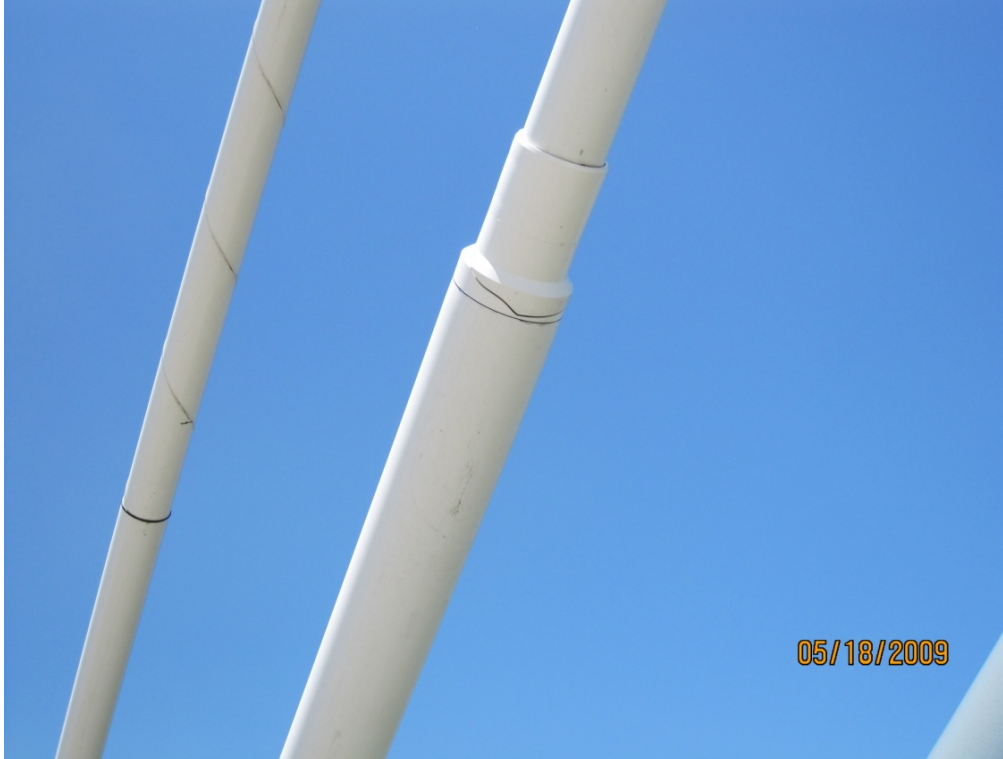
Condition Category 1: Crack in Large End of HDPE Reducer.

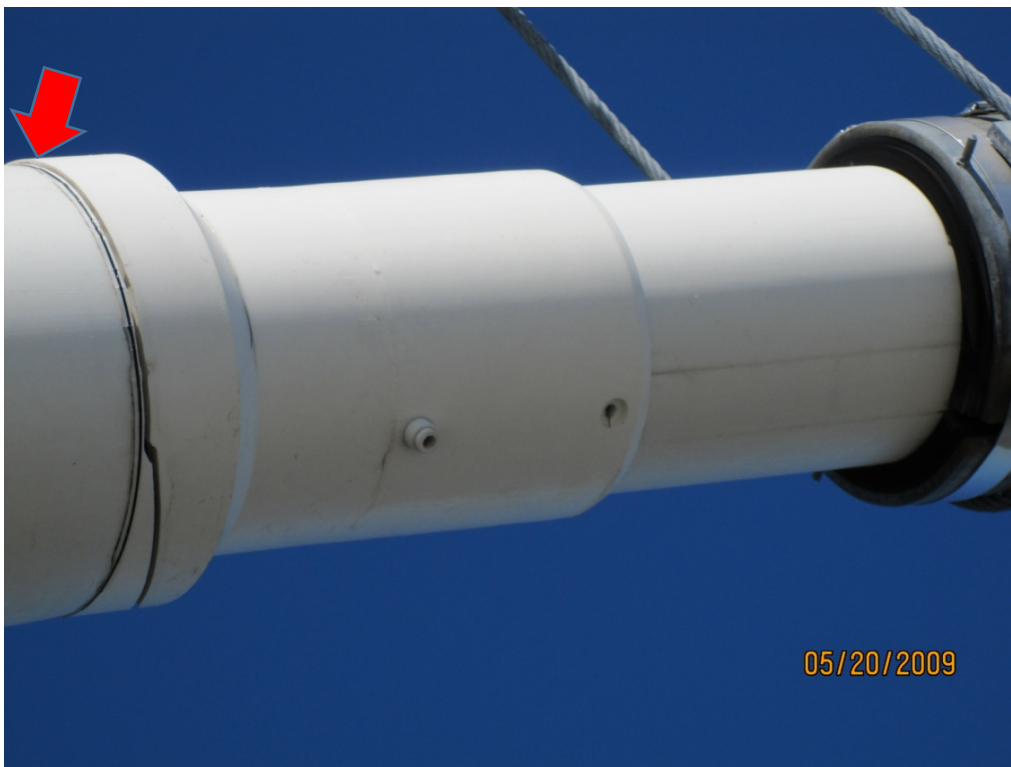
Condition Category 2: Crack Primarily in Reducer-to-Connection Sleeve Pipe Section Butt Weld.

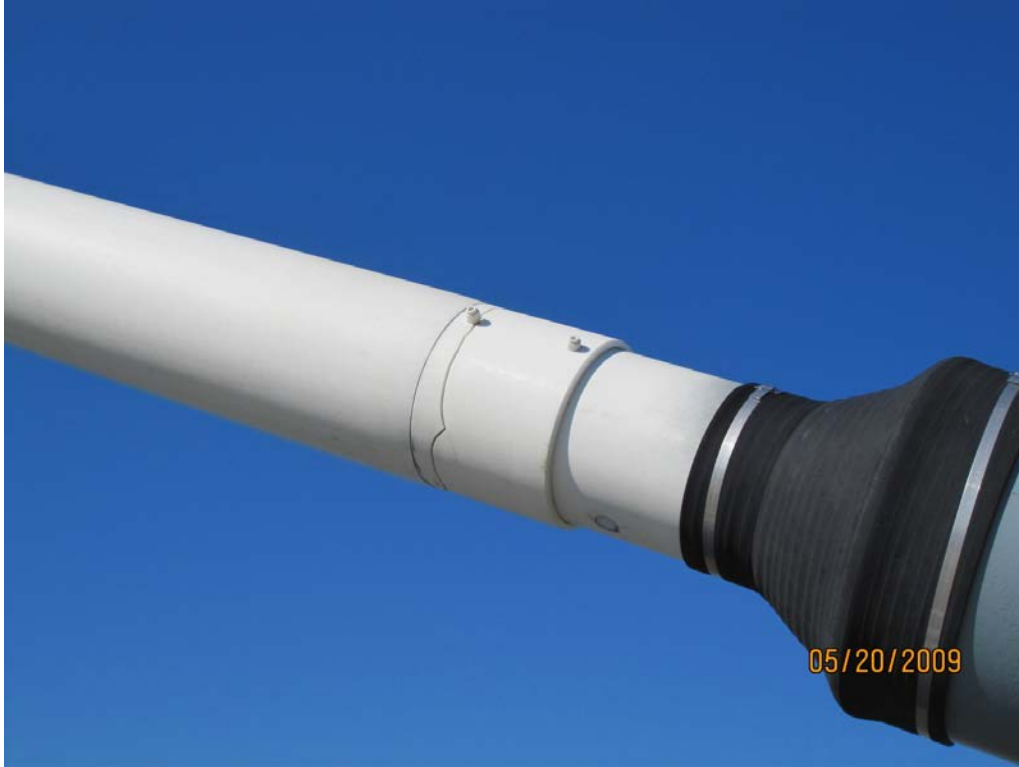
Condition Category 3: Crack Primarily in Small End of Reducer.

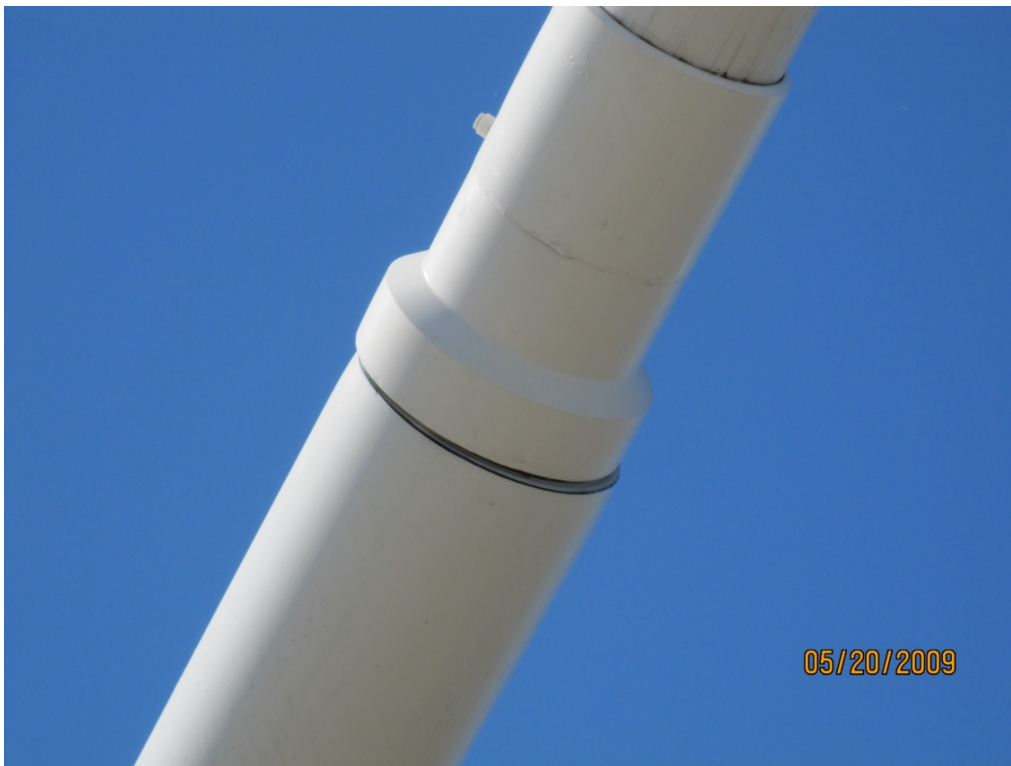
Condition Category 4: Crack in Reducer-to-Connection Sleeve Pipe Section Butt Weld with Lateral Displacement.

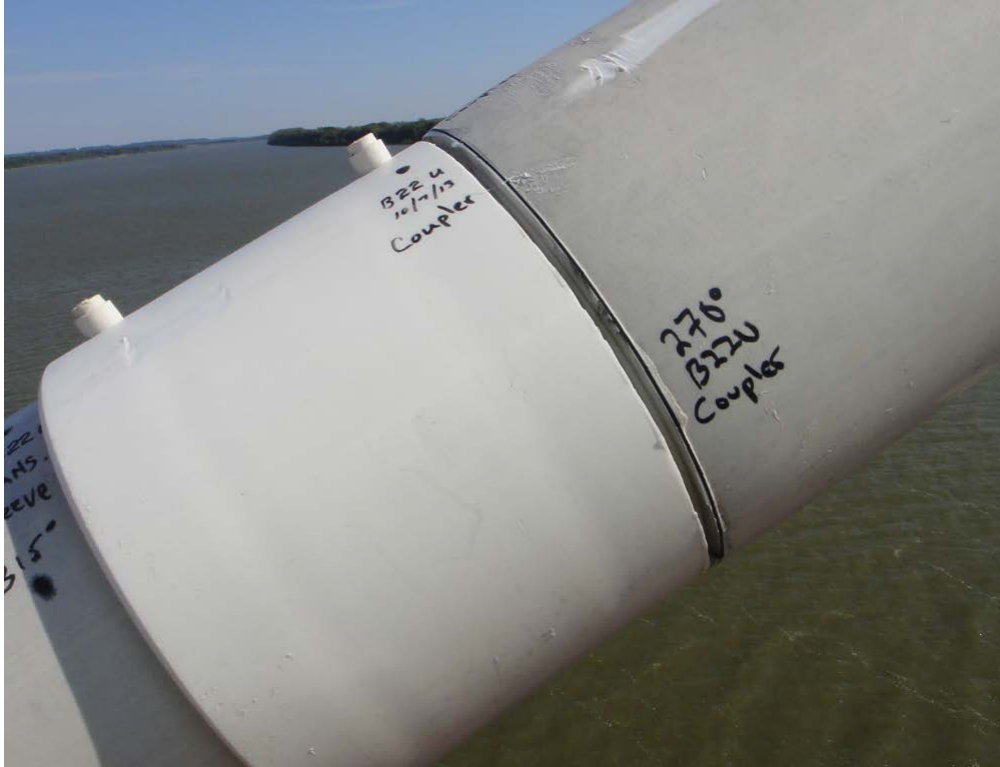
Condition Category 5: Crack in Coupler-to-Connection Sleeve Pipe Section Butt Weld.

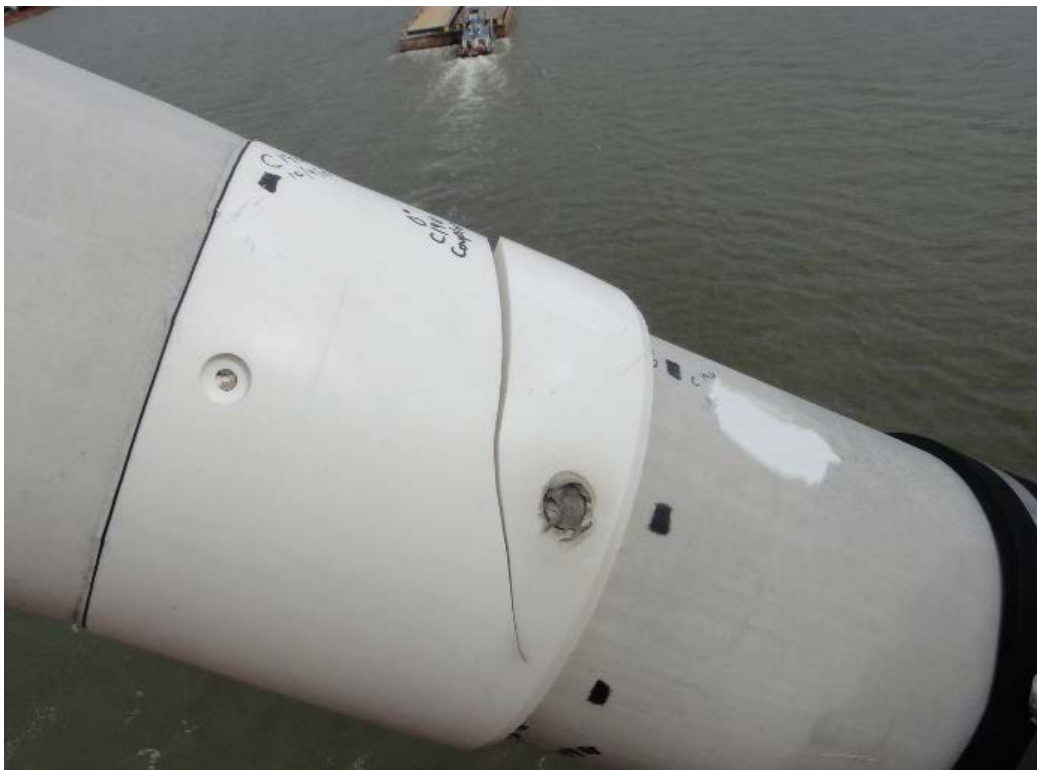
Condition Category 6: Crack in Coupler.

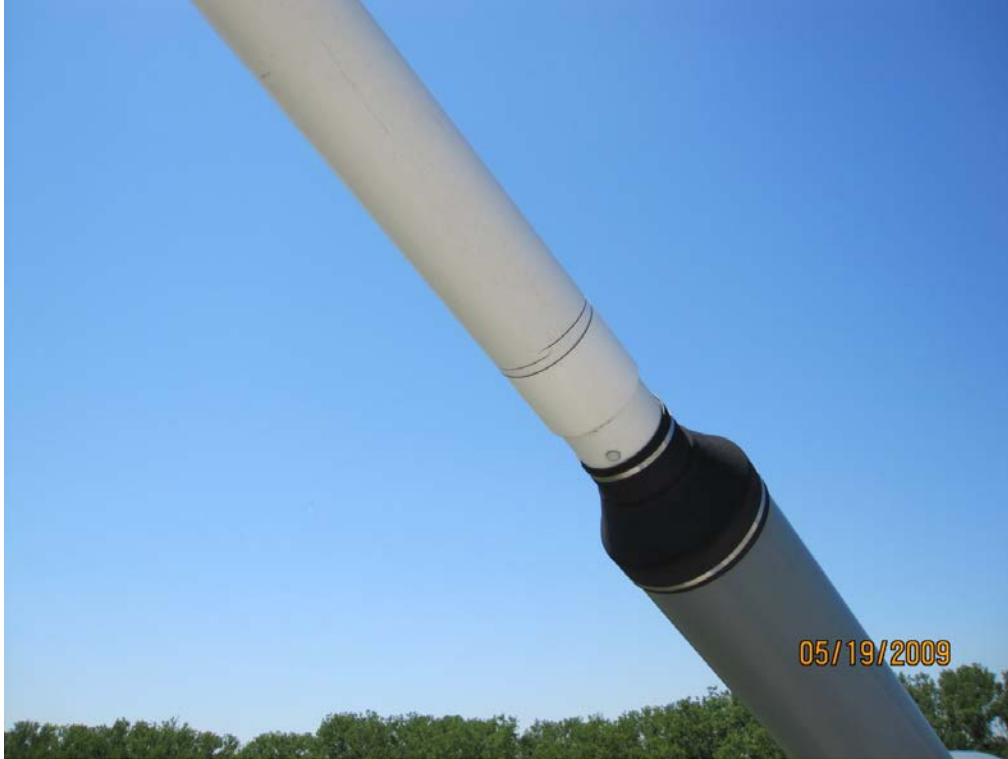
Condition Category 7: Crack in Connection Sleeve Pipe Section.

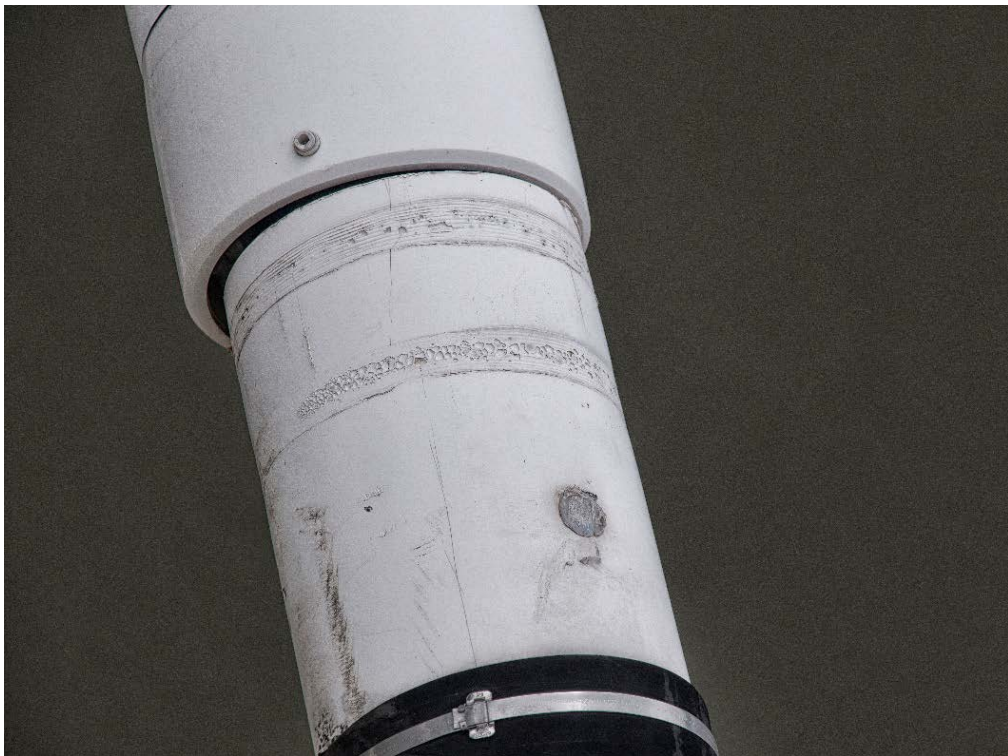
Condition Category 8: Failure of Electrofusion Weld between Connection Sleeve Coupler and Transition Pipe with Longitudinal Separation.

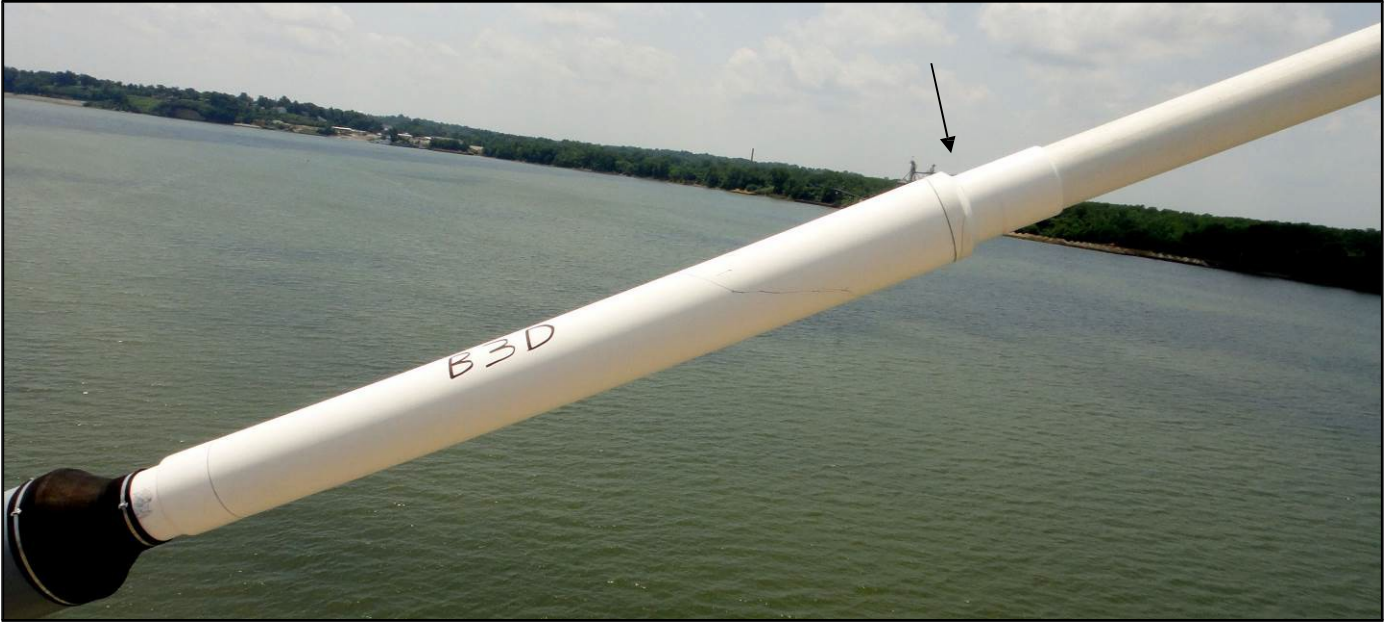
Figure 5: **B3D**: Reducer Crack at Notch Located at Diameter Transition

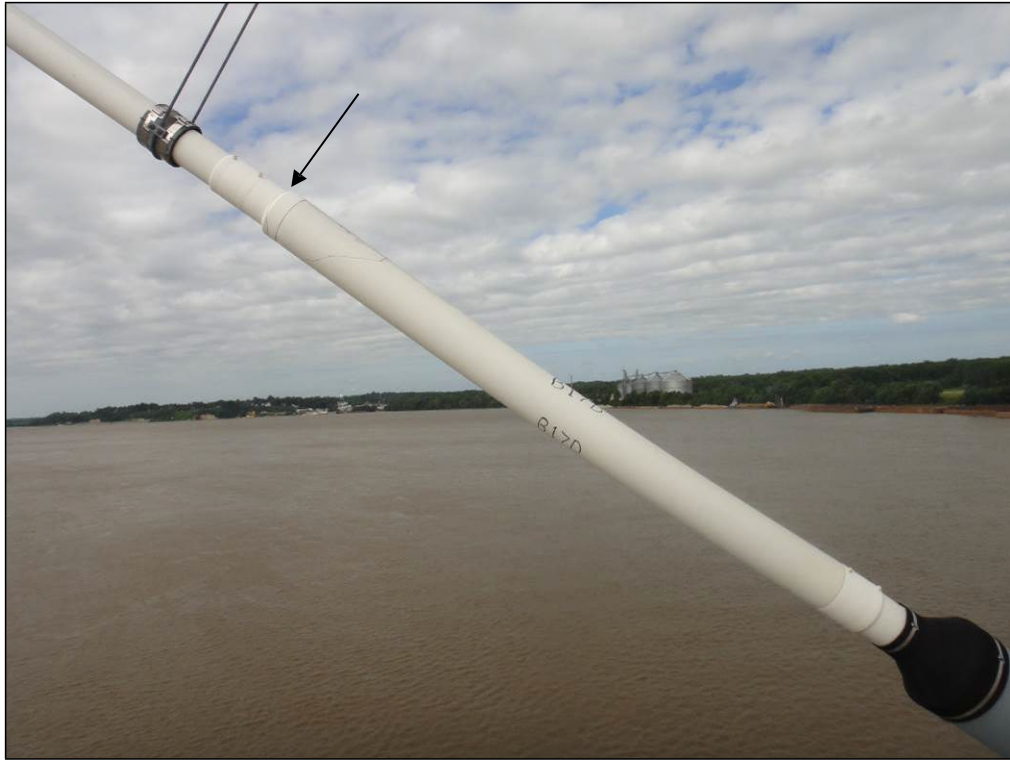
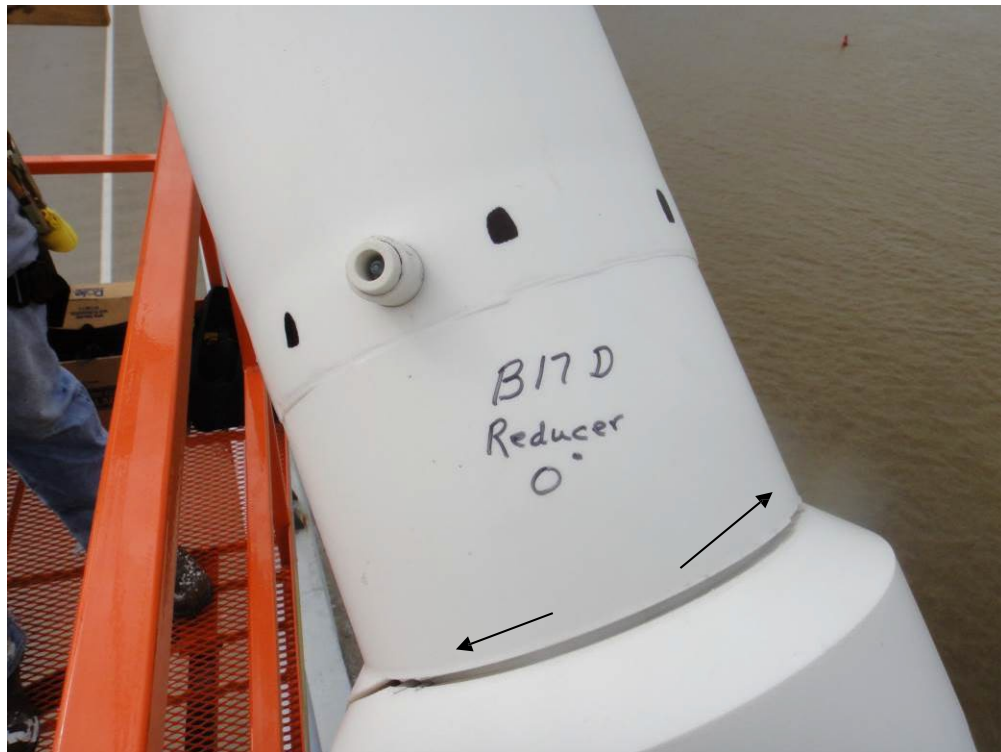
Figure 19: B17D: Reducer Crack at Notch Located at Diameter Transition

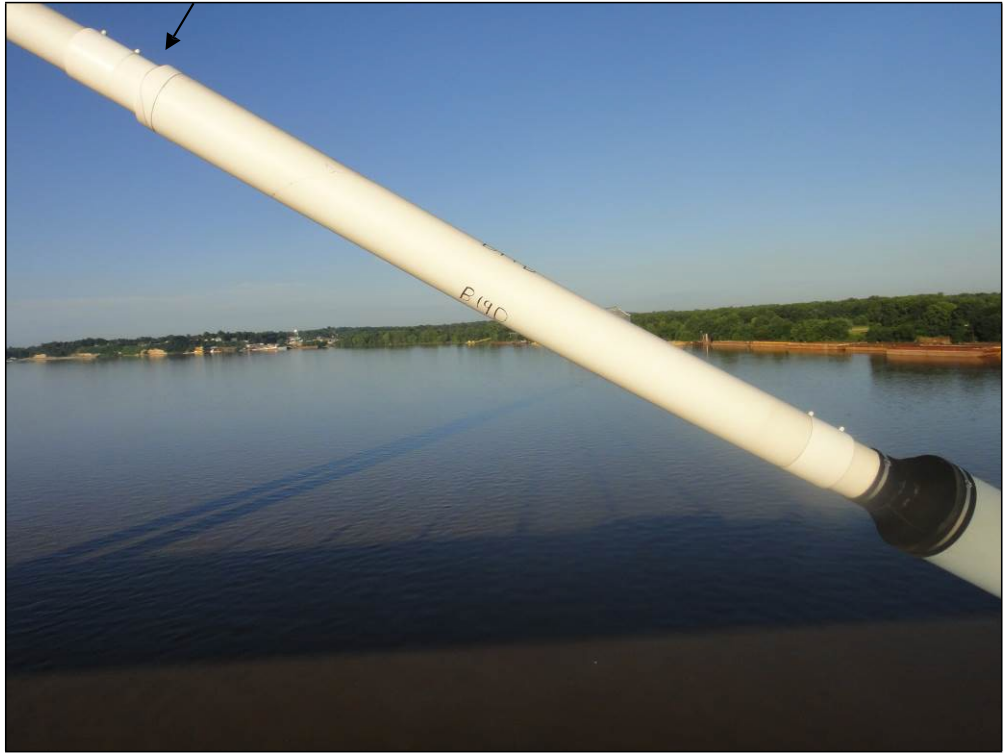
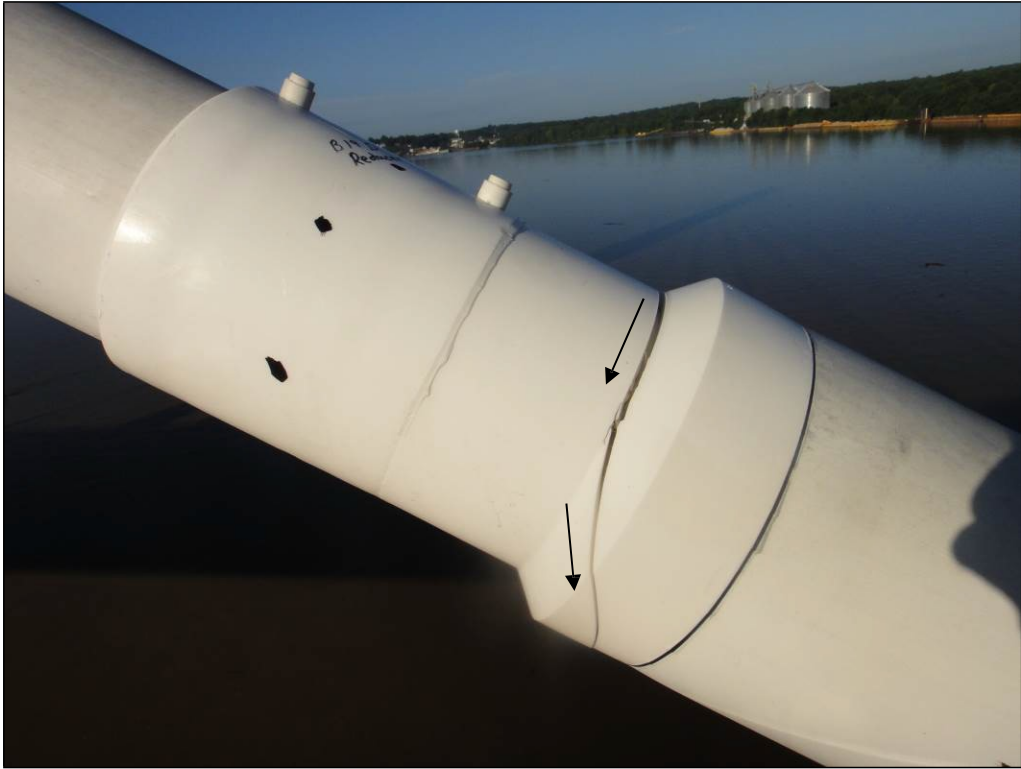
Figure 21: B19D: Reducer Crack at Notch Located at Diameter Transition

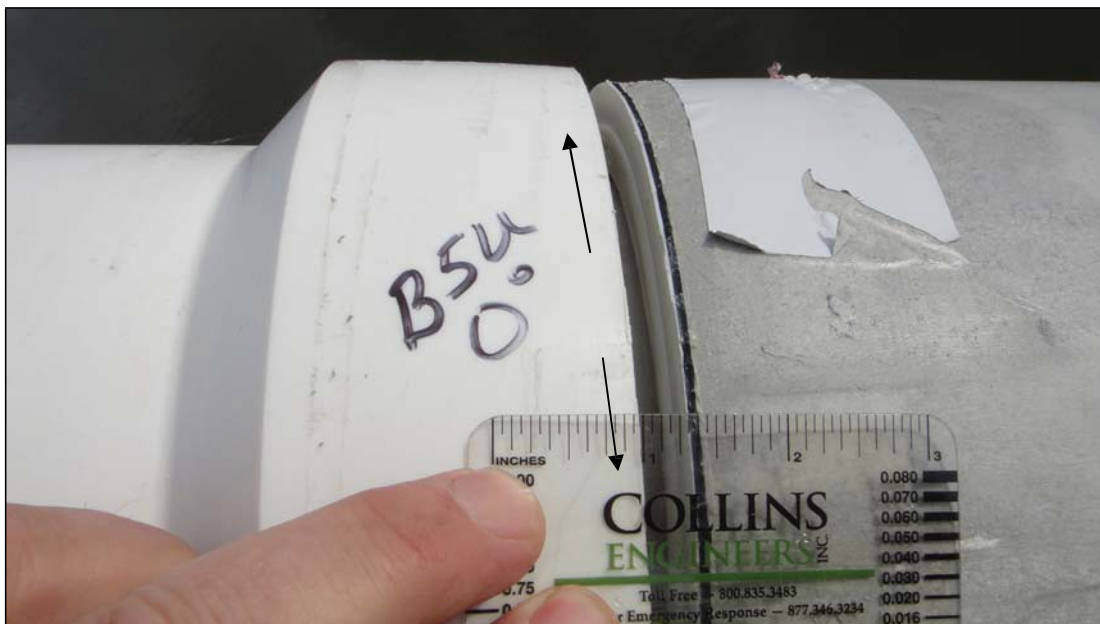
Figure 27: B5U: Reducer Crack at Fusion Butt Weld to Larger Diameter Pipe

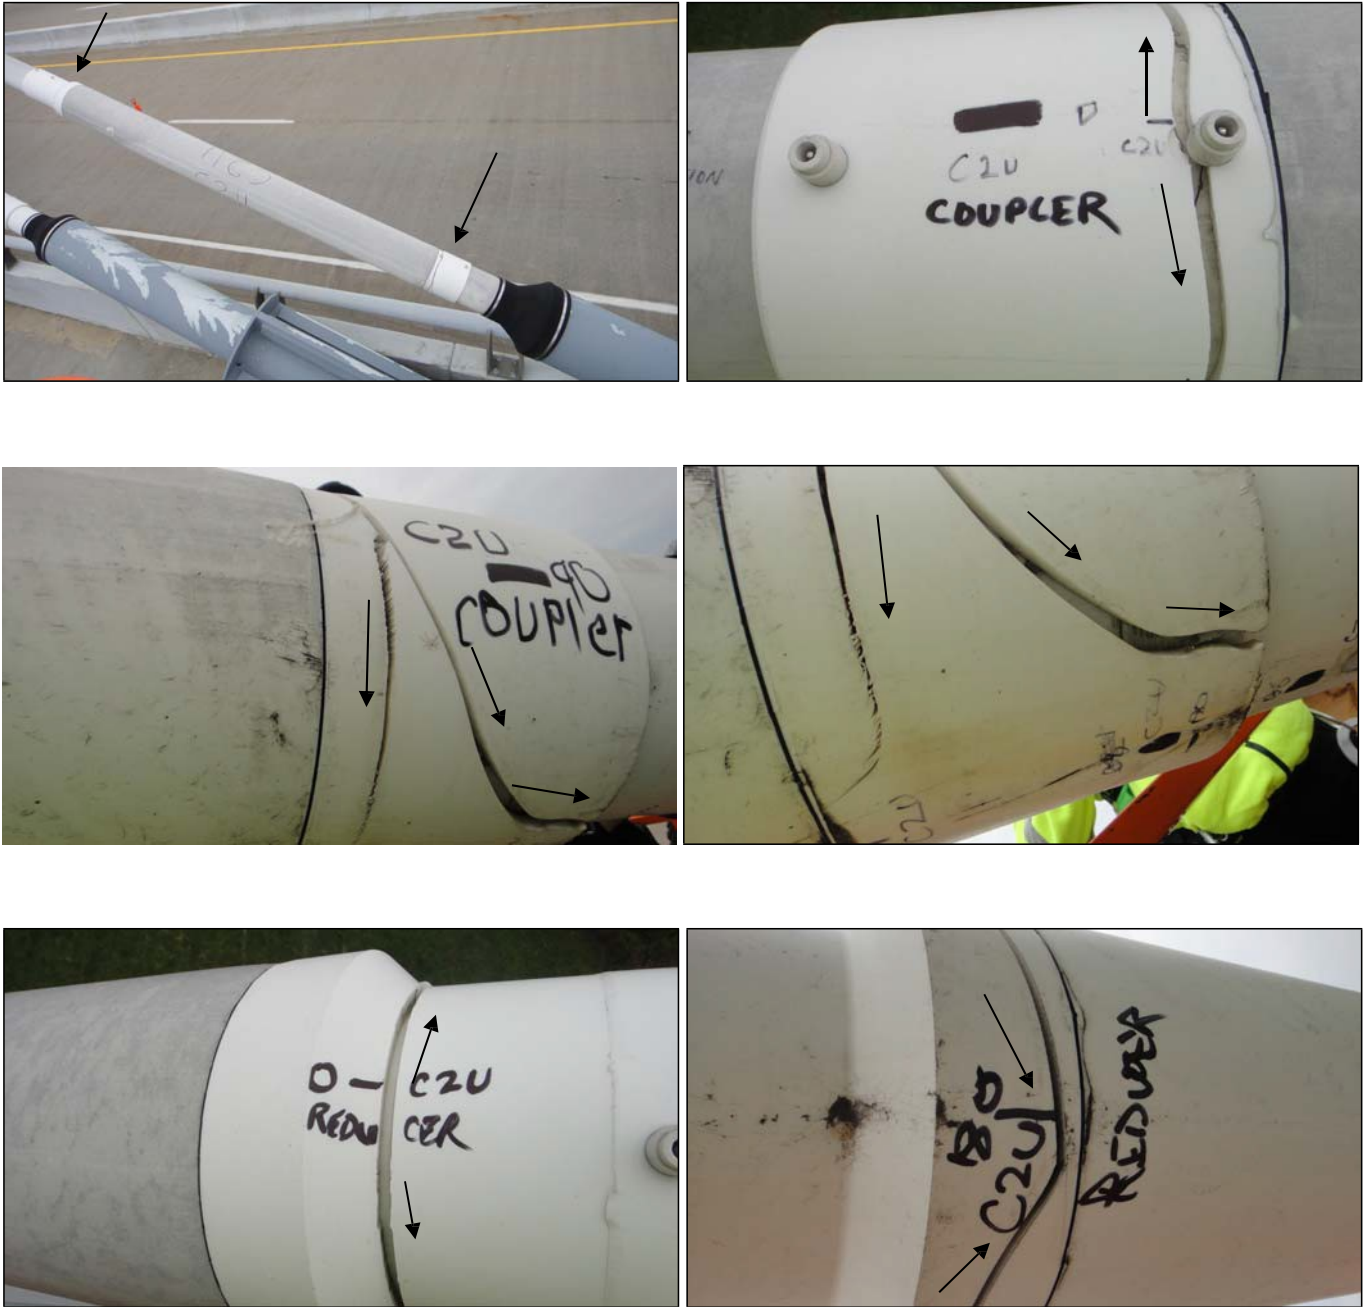
Figure 30: C2U: Bottom Coupler Crack at Nipple Hole (4 photographs) & Reducer Crack at Size Transition Originating at the Top, i.e. 0° (Bottom 2 photographs)

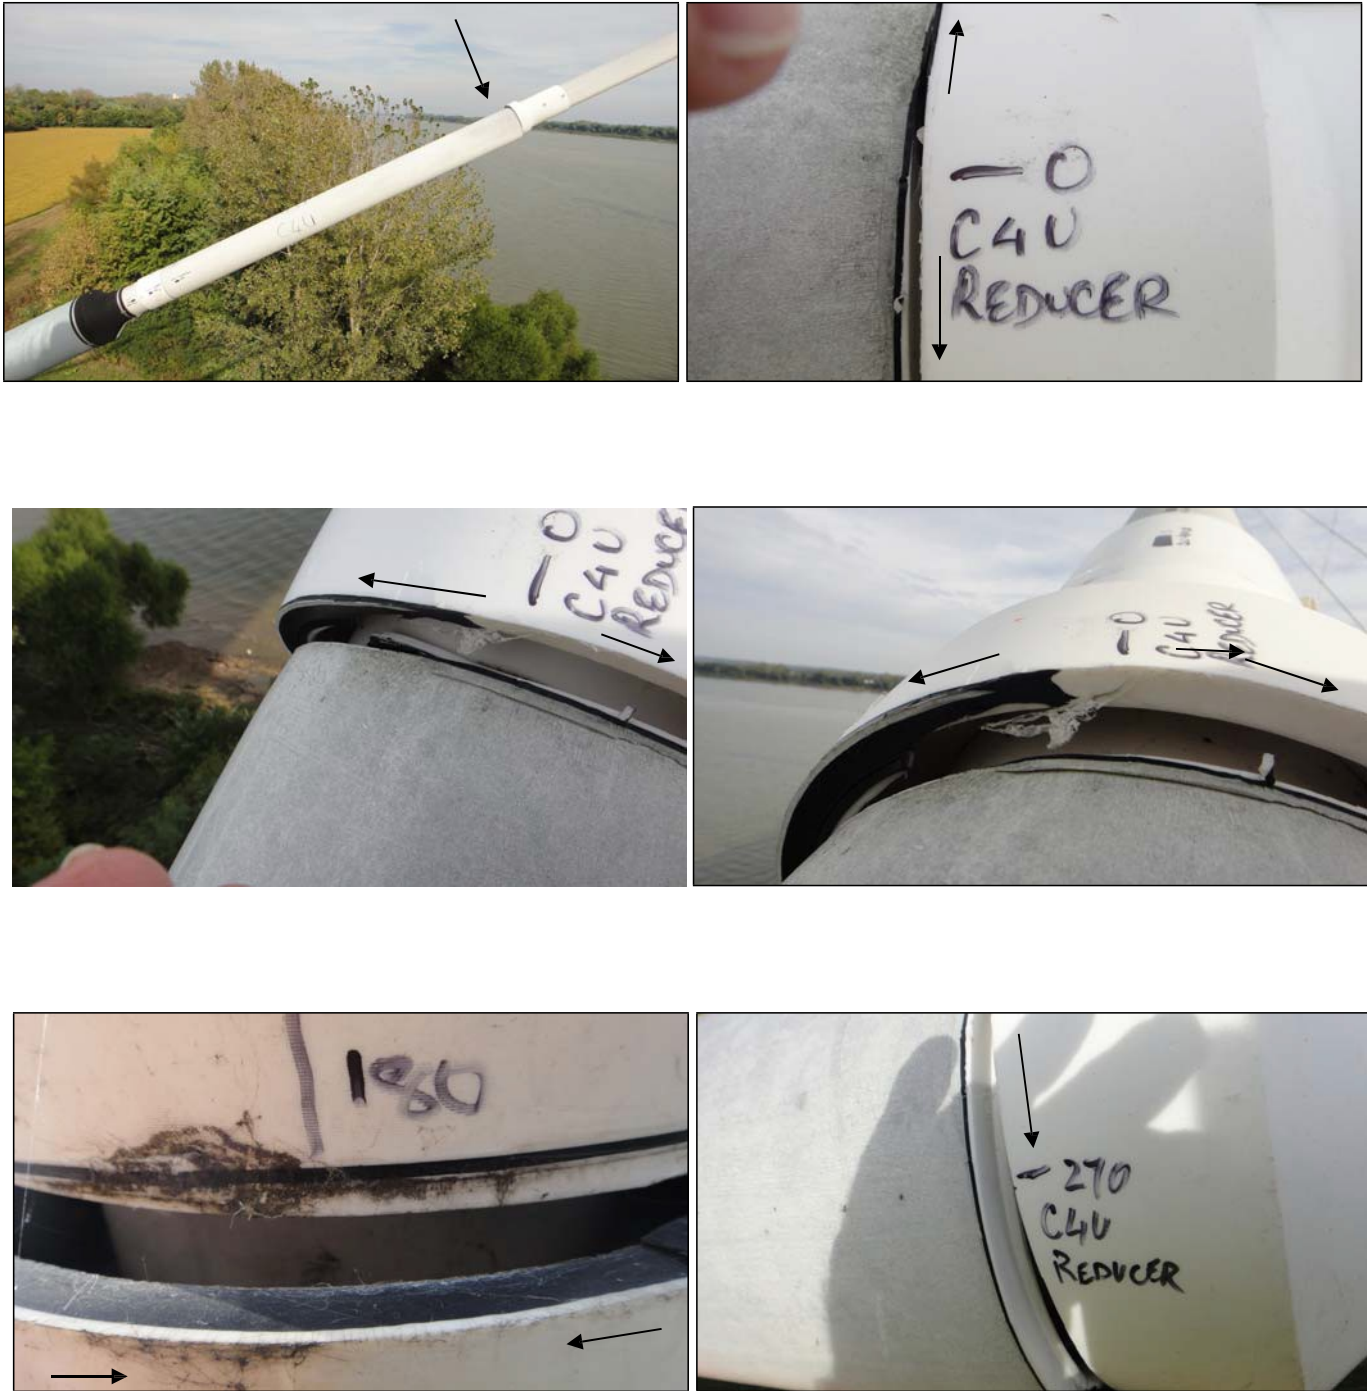
Figure 31: C4U: Reducer Crack at Butt Weld to the Larger Diameter Pipe with Significant Vertical Displacement

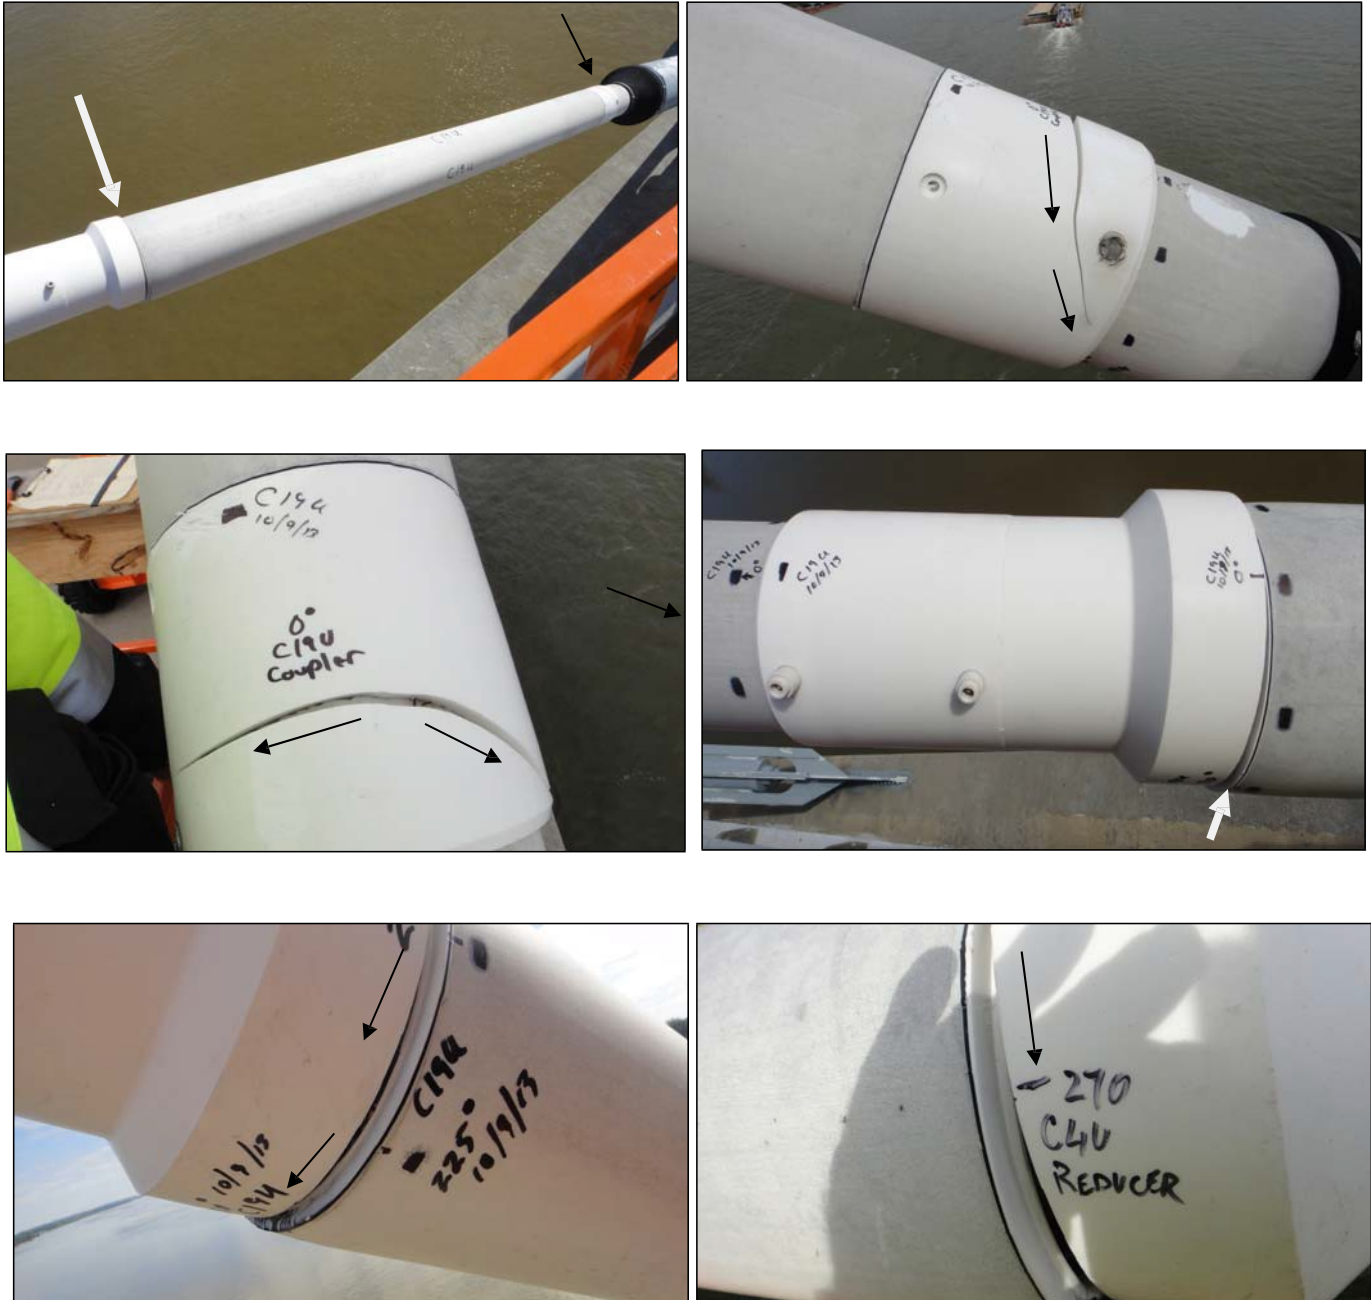
Figure 33: C19U: Bottom Coupler Crack in Middle of Specimen and Reducer Crack at Butt Weld to the Larger Diameter Pipe

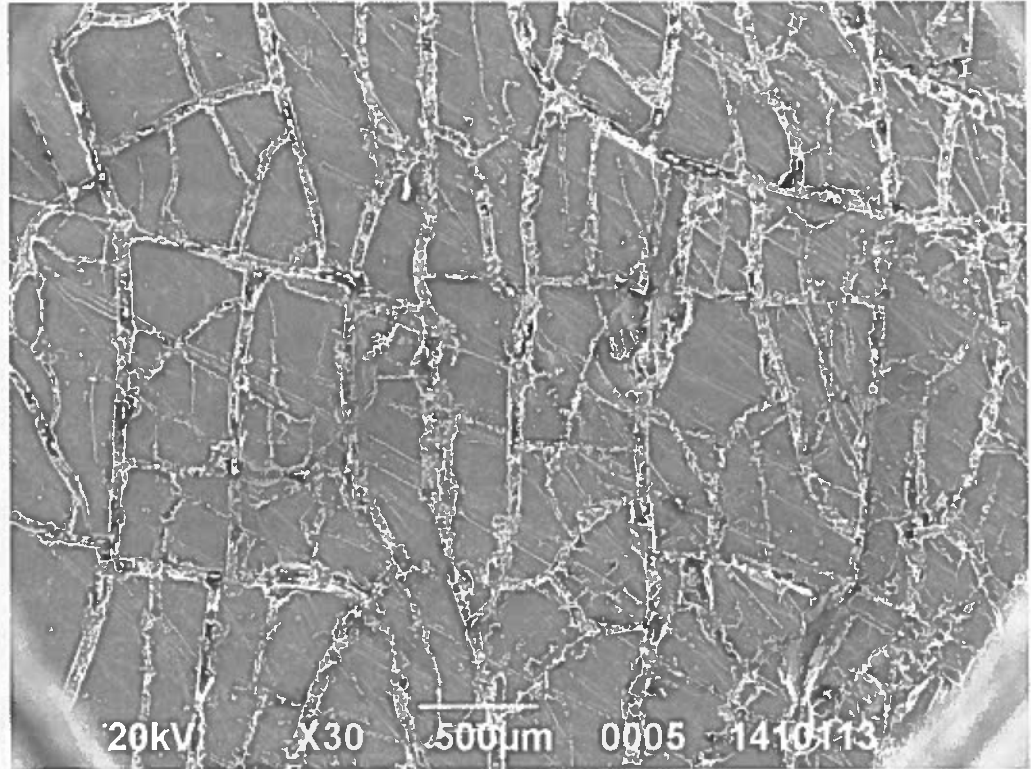
Figure 7 above displays a scanning electron microscope (SEM) image of Sample B. Note extensive micro-cracking networking (“Map Cracking”).

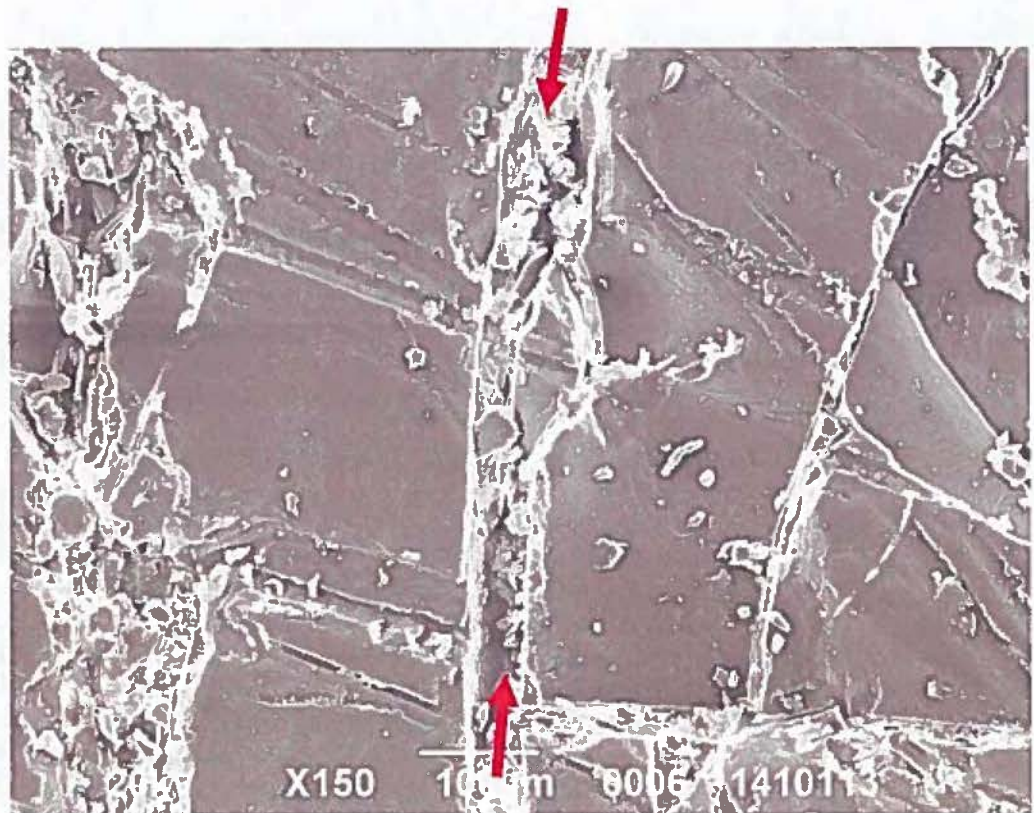
Figure 8 above displays a scanning electron microscope (SEM) image of Sample B, taken at higher magnification from the approximate center of Figure 7. Note debris trapped within the extensive micro-cracking ("Map Cracking") network (e.g. between red arrows).
