Re: Concrete Pavement without Transverse Joints,  
U. S. 31-W, Franklin-Tennessee State Line Road

Report No. 2

A CONCRETE PAVEMENT WITHOUT  
TRANSVERSE JOINTS

W. B. Drake  
Research Engineer

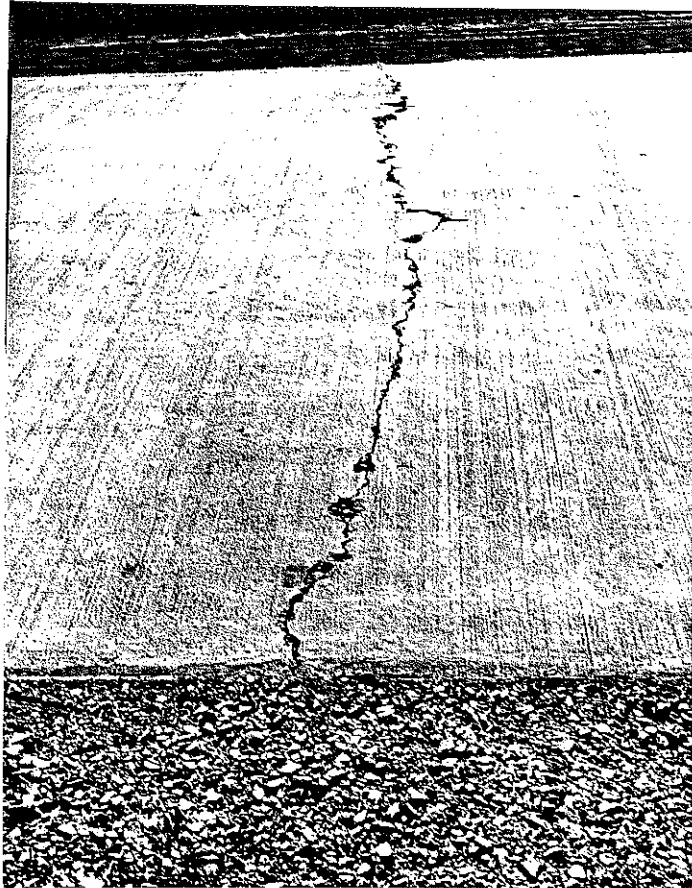
Fig. 2. This is an example of a class A, open type of crack with spalling. The crack is very pronounced. The location of this crack is at Station 193+22.

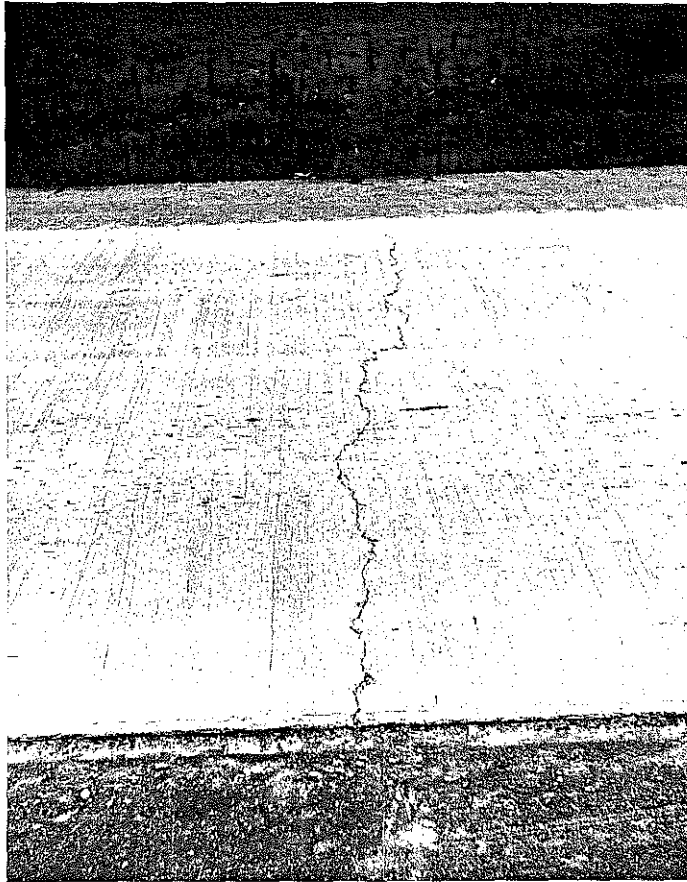
Fig. 3. This is an example of a B class crack at Station 20+90. It is a prominent crack with little evidence of spalling.

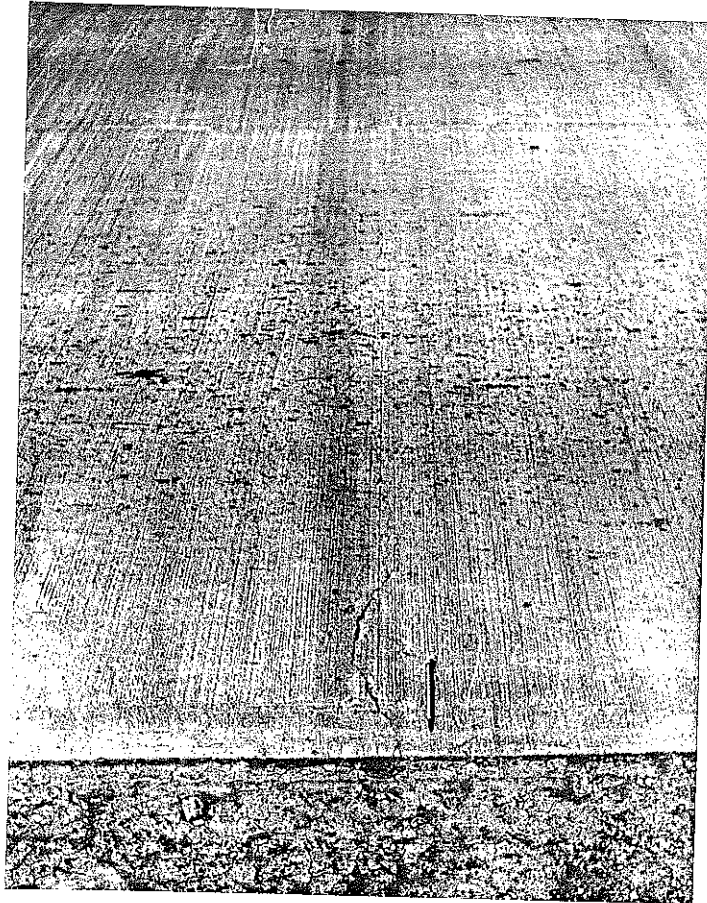
Fig. 5. An example of a class D type crack at Station 110+44. The crack extends only part way across the pavement and portrays the earliest visible form.

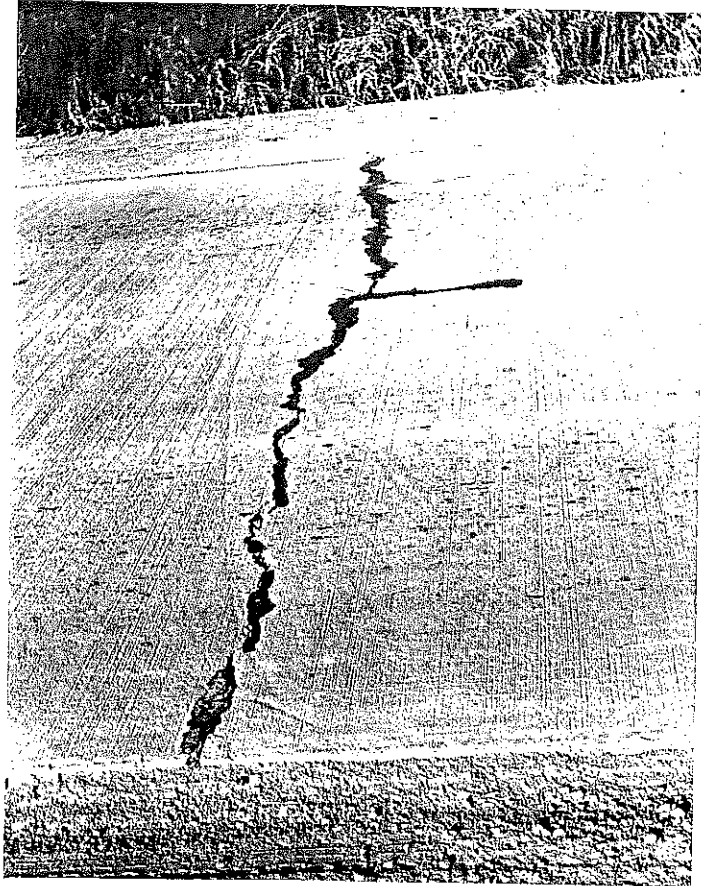
The OA-2 filler was applied throughout the job sometime prior to the experimental installation on November 16 and 17, and this application included practically all the cracks as well as the few transverse, butt type joints. For that operation there was no grooving or cleaning of the cracks in advance. A Class "C" crack at Station 82+51, illustrated in Fig. 6, is typical of cracks sealed with this material. All but 132 cracks and 8 joints on the project were left with this type of filler intact.

Fig. 6. A type C crack filled with OA-2 (Asphaltic Cement) filler at Station 82+51. This filler failed to penetrate the crack, and the opening is evident the entire width of the pavement.

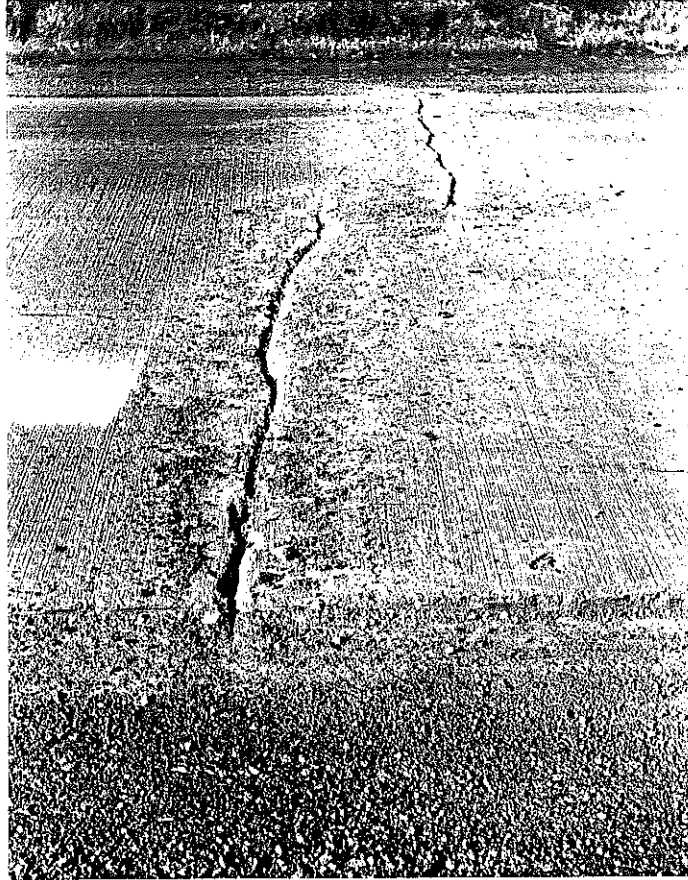
Fig. 8. A crack that has just been cut located at Station 304+00. This photograph was taken in advance of the cleaning operation.

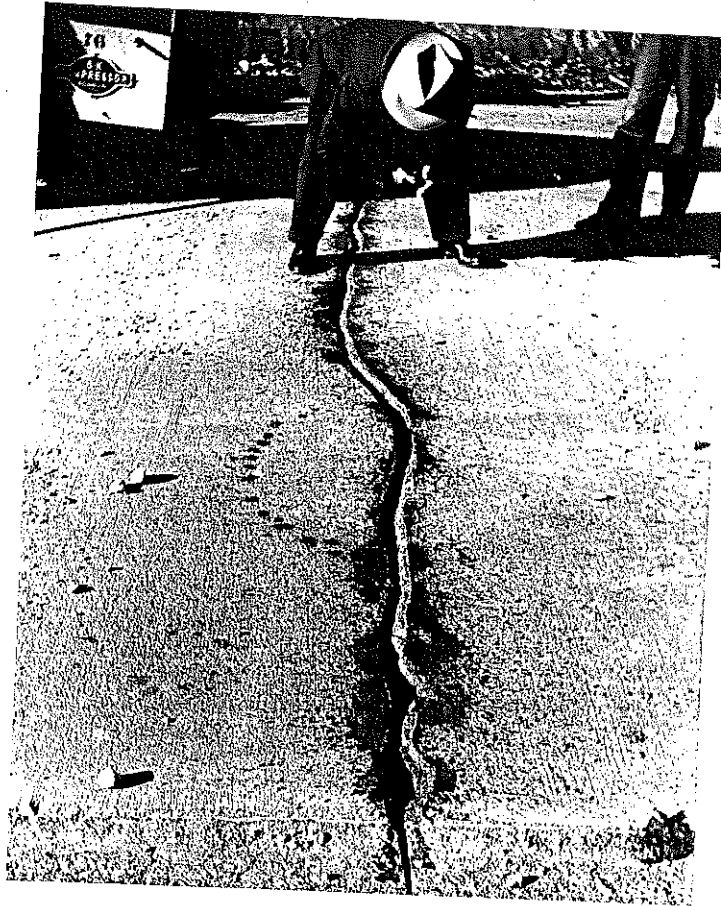
Fig. 12. Class A crack that has been prepared for filling. The spalling is evident in the near portion of the crack. The dust has just been washed out with water causing the wet places shown.

spalled-type, Class A cracks after it had been prepared for filling.

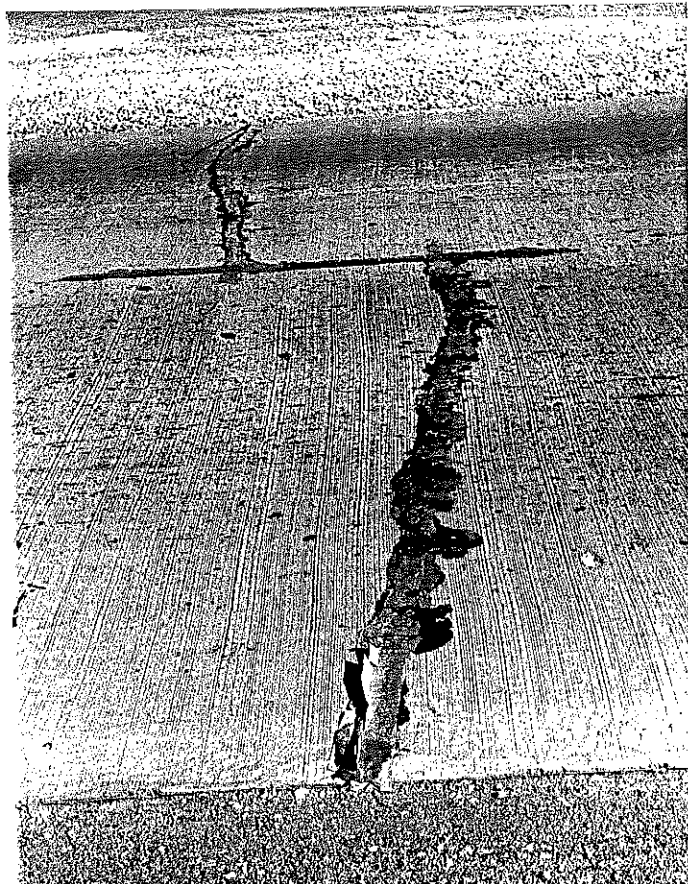
While passing over this route on December 3, 1949, a quick check was made as to the condition of the filler. The filler was in place and intact. The material was soft and plastic after two weeks in place, Fig. 14 was taken at this time.

Fig. 14, A photo taken two weeks after the filling operation. The black material on top of the pavement is what was left of the original OA-2 (Asphaltic Cement) filler. The enamelite was very pliable and most of the paper is still intact.
